## BRIDGE INSPECTION REPORT

2801744  
Structure File NumberBRIDGE NUMBER **GEA 00422 0986 R**YEAR BUILT **1960**DIST **12** Bridge Type **322** TYPE SERVICE **1 5** **LA DUE RES. 0.71 MI E 44**

GEA-422-0986R  
SFN 2801744

State Route 422 (Eastbound) over La Due Reservoir Geauga County, Ohio  
(Four Span, Steel Beam Bridge)

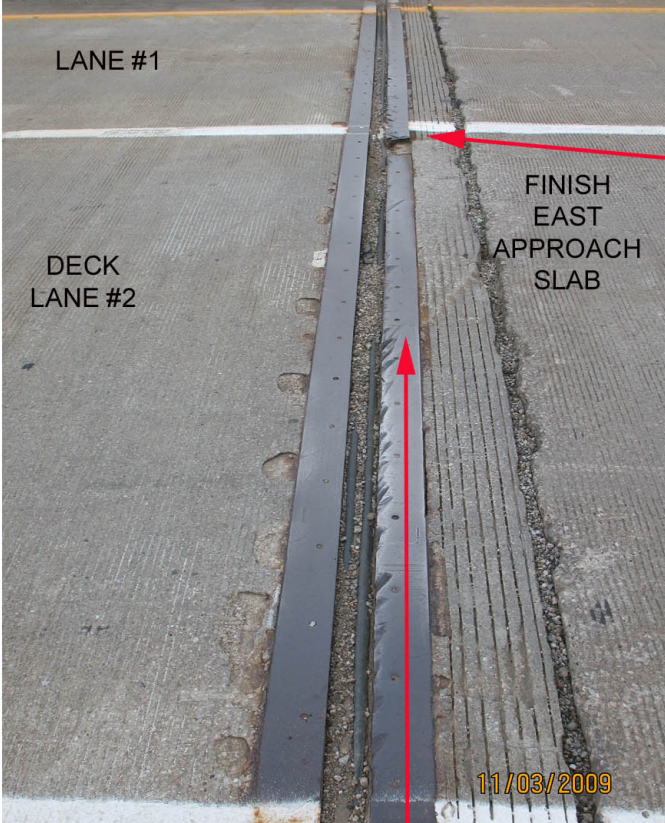
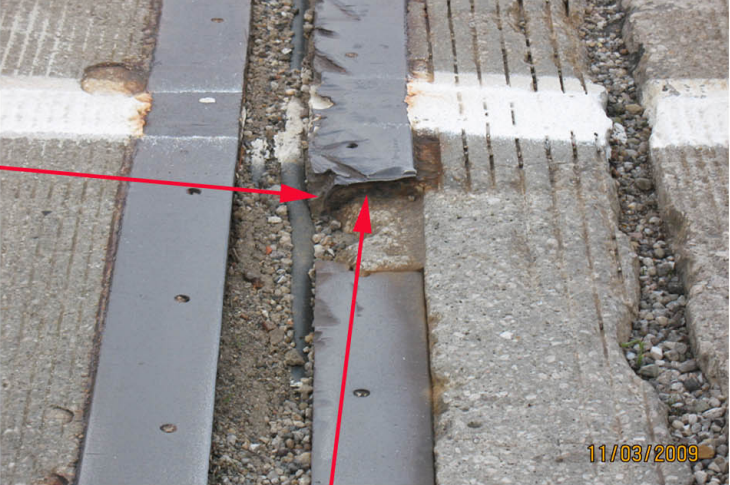
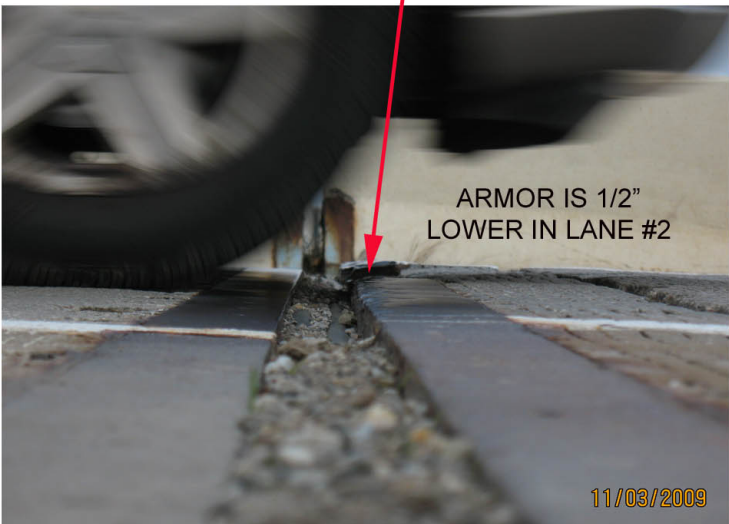
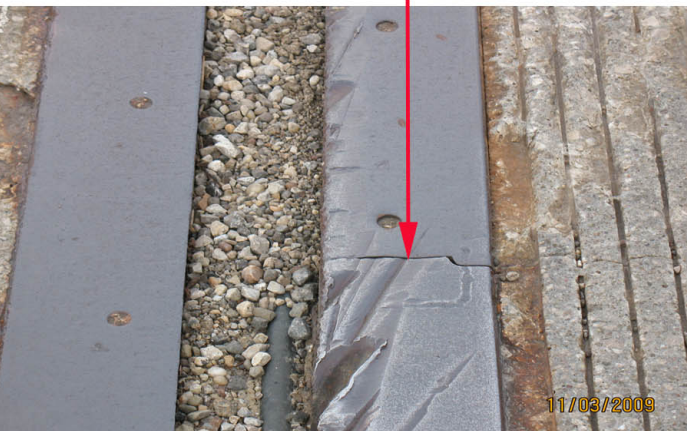
FL: A FEW TRANSVERSE CRACKS. FLOOR <1% DETERIORATED.  
WS: CRACKS. WS <1% DETERIORATED.  
RAILING: MINOR SPALL AND DELAMINATIONS ON LEFT RAIL.  
EXJTS: DECK SIDE OF START (W) JOINT IS 1/2" LOWER THEN THE  
APPROACH SLAB SIDE. FINISH BACKWALL ARMOR IS GOUGED AND  
CRACKED, A 6" LENGTH OF THIS ARMOR IS MISSING; SEE  
ATTACHED PHOTOS 1 - 5 DATED 11/3/09.

P1 - P4: SHOWS EAST EXJT. NOTE MANY GOUGES, MISSING AND CRACKED ARMOR. MOST DAMAGE IS TO LANE #2 EASTBOUND.

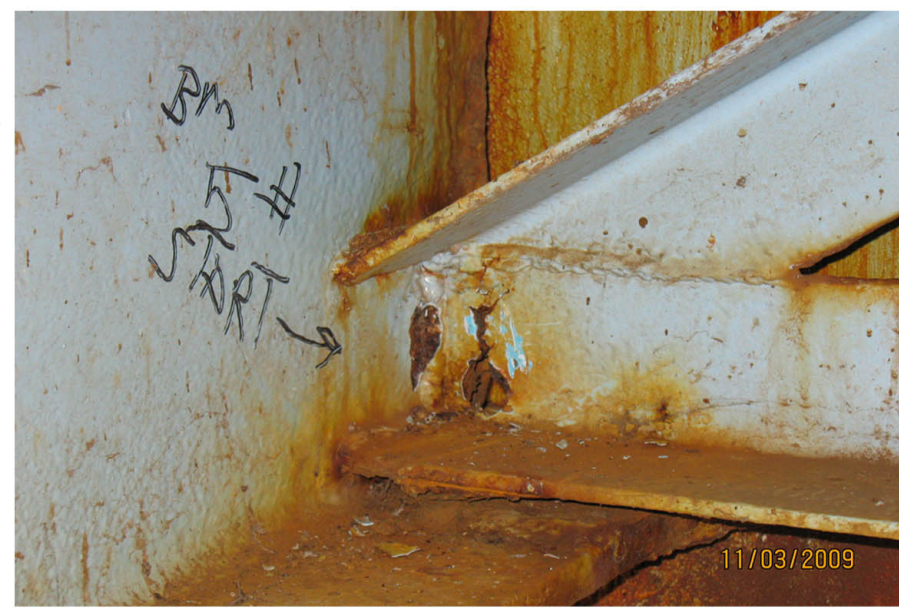
P7: CRACKED AND RUSTING THRU HOLE TO START (W) ENDFRAME AT BEAM #5.

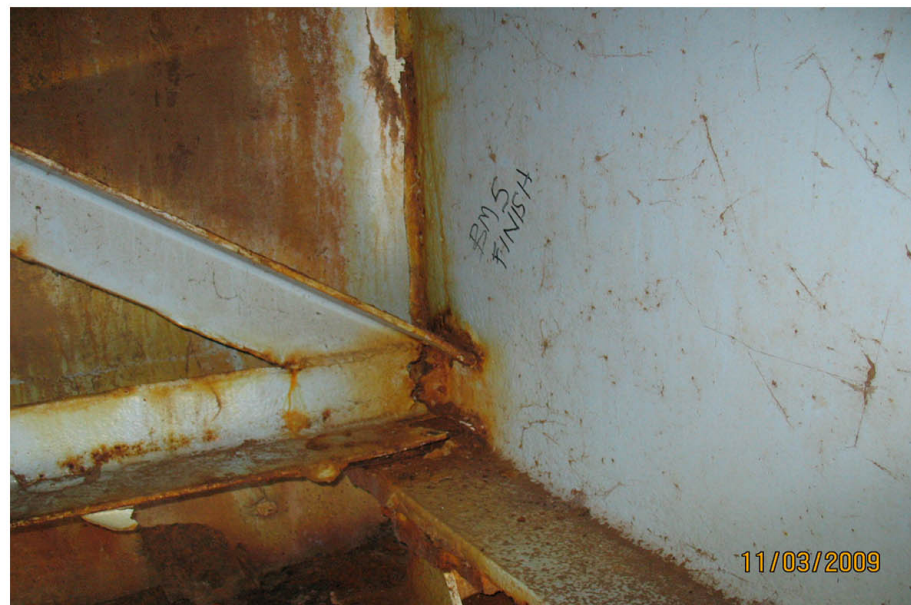
P8: SEVERED ENDFRAME AT FINISH ABUTMENT TO BEAM #5.

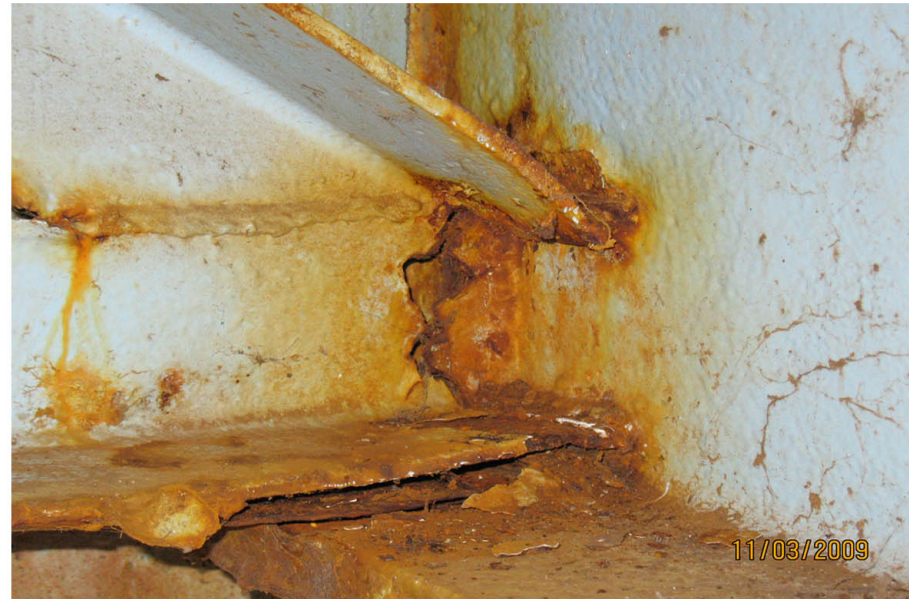
P9: CLOSE-UP OF P8.

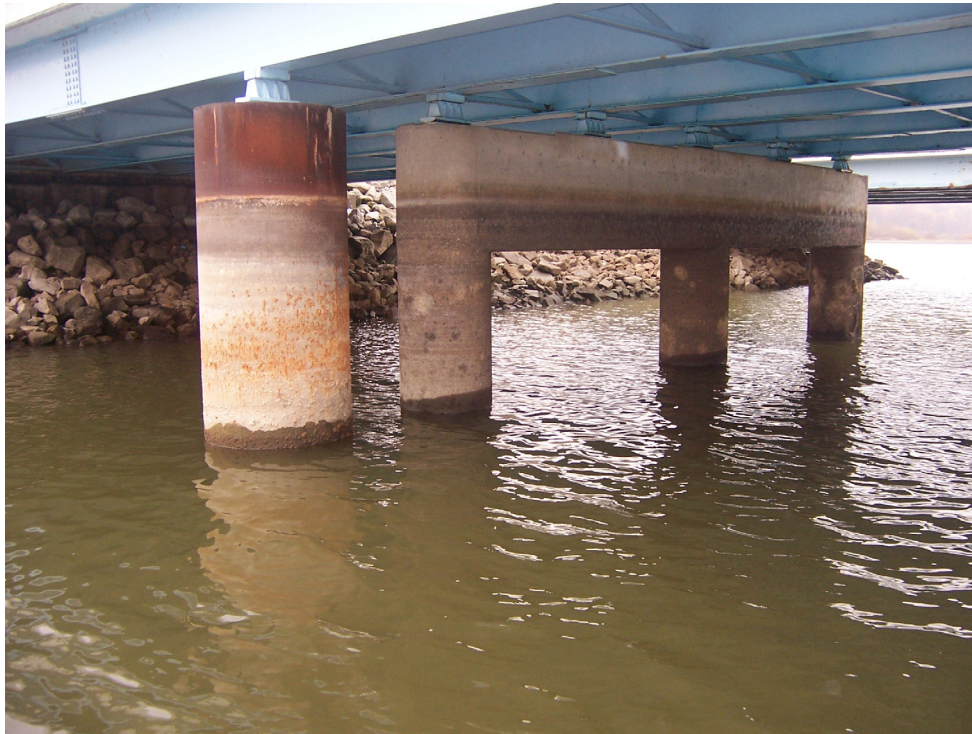
- The bottom composition is flat mud and small stone.
- Each abutment is surrounded with large diameter riprap stone (shown in Photos 5 and 6). This stone slopes downward toward the piers.

Photo 5 – Facing Northwest. Pier 1 and West Abutment with Riprap Stone.

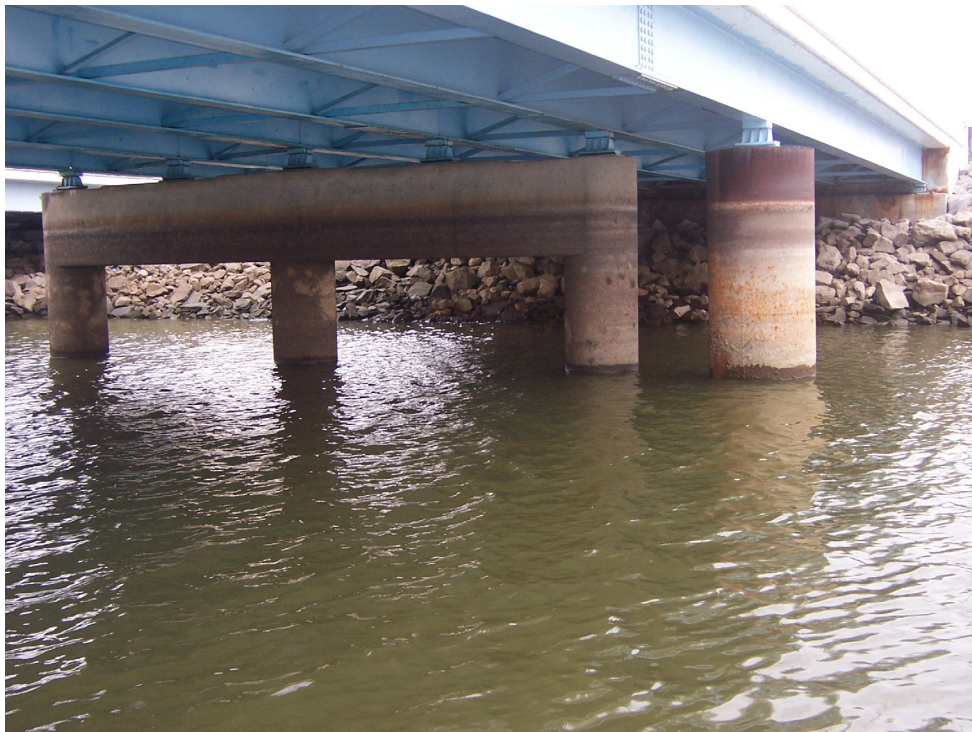
Photo 6 – Facing East. Pier 3 and East Abutment with Riprap Stone.

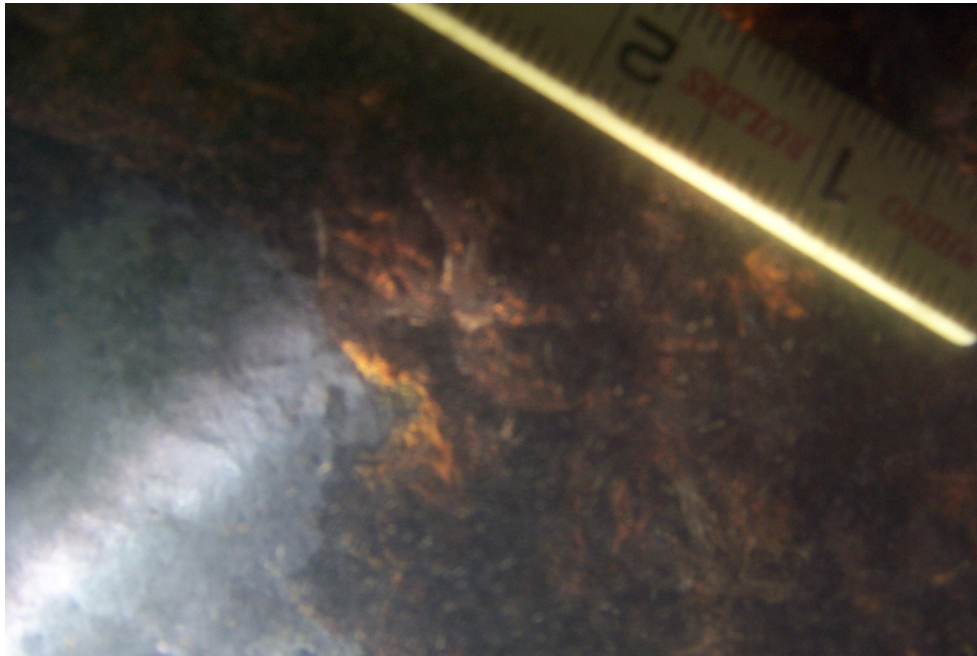
- The concrete surfaces had up to ¼-inch scaling. The concrete was sounded in numerous locations and found to be hard with no signs of delamination.
- The steel jacketed concrete drilled shafts had a 1/8-inch layer of surface corrosion (see Photo 7).
- Underwater visibility was less than 2 feet with no current.

- The concrete surfaces had up to ¼-inch scaling.
- The steel jacketed concrete drilled shaft has a 1/8-inch layer of surface corrosion. Photo 7 is an underwater picture of this corrosion on Pier 3.
- Steel and rebar debris are located between the drilled shaft and the adjacent concrete column at Pier 3's south end.

*Photo 7 – Facing North. South side of Pier 3 steel jacket on the drilled shaft at the mudline. Typical 1/8-inch thick corrosion of the steel.*

Because of the satisfactory conditions found during the underwater inspection, there are no recommendations at this time.
