BRIDGE INSPECTION REPORT

2801744
Structure File NumberBRIDGE NUMBER **GEA 00422 0986 R**YEAR BUILT **1960**DIST **12** Bridge Type **322** TYPE SERVICE **1 5** **LA DUE RES. 0.71 MI E 44**

Underwater Inspection Report for:

State Route 422 (Eastbound) over La Due Reservoir Geauga County, Ohio
(Four Span, Steel Beam Bridge)

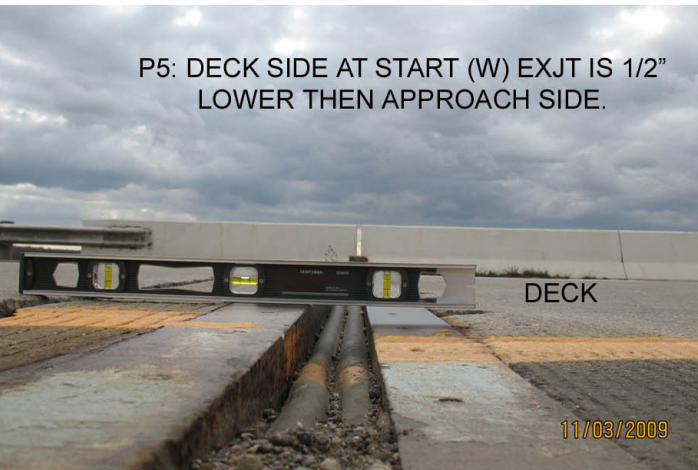
FLOOR: A FEW TRANSVERSE CRACKS. FLOOR <1% DETERIORATED.
WS: CRACKS. WS <1% DETERIORATED.
RAILING: MINOR SPALL AND DELAMINATIONS ON LEFT RAIL.
EXJTS: DECK SIDE OF REAR (WEST) JOINT IS 1/2" LOWER THEN
THE APPROACH SLAB SIDE. FORWARD BACKWALL ARMOR WHICH
IS SLIGHTLY HIGHER THAN THE DECK ARMOR IS GOUGED AND
CRACKED WITH 6" OF MISSING ARMOR. SEE ATTACHED
PHOTOS 1 - 5 DATED 11/03/09.

P1 - P4: SHOWS EAST EXJT. NOTE MANY GOUGES, MISSING AND CRACKED ARMOR. MOST DAMAGE IS TO LANE #2 EASTBOUND.

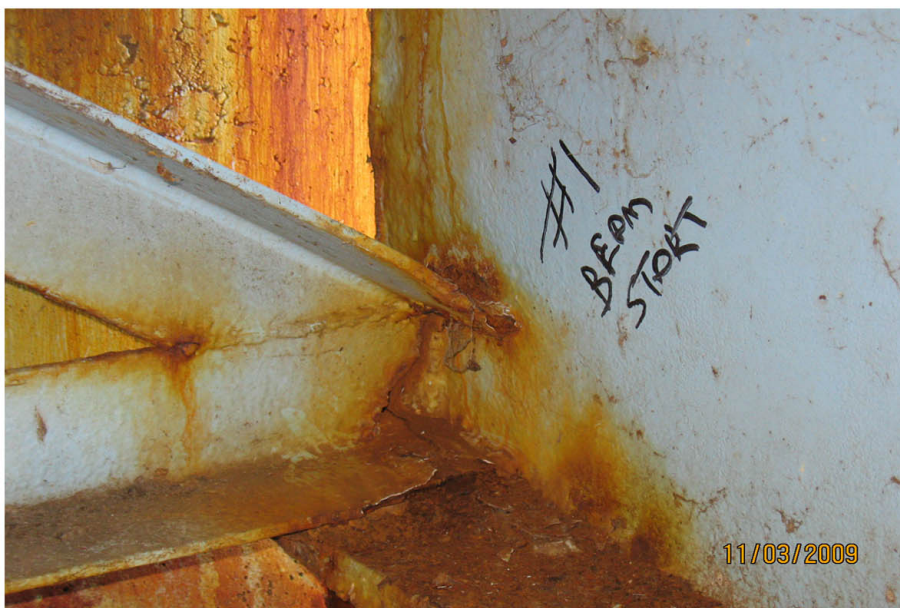
BEAMS: RUST SECTION LOSS NEAR ABUTMENTS. BEAM #1 WEB AT
START ENDFRAME FLEXES WITH HEAVY LIVE LOAD.
XFRAMES: ENDFRAME RUST SECTION LOSS. CRACKS AND RUSTING
THRU HOLES TO ENDFRAMES AT BOTH ABUTMENTS. SEE
ATTACHED PHOTOS 6 - 9 DATED 11/3/09.
BEARINGS: RUSTED SECTION LOSS. REAR ABUTMENT ROCKERS #2,#3,
#4 AND #5 ARE LOOSE. FORWARD ABUTMENT ROCKERS #3,
#4 & #5 ARE LOOSE.
PCS: FADED PAINT. 2% RUST. PCS IS 1-5% DETERIORATED.
LLR: VERTICAL MOVEMENT OF BEAM ENDS ABOVE ALL LOOSE ROCKERS.
WEB OF BEAM #1 AT REAR FLEXES.

P6: START (W) ABUTMENT AT BEAM #1. CRACKED ENDFRAME. WEB OF BEAM HERE FLEX'S WITH HEAVY LOAD.

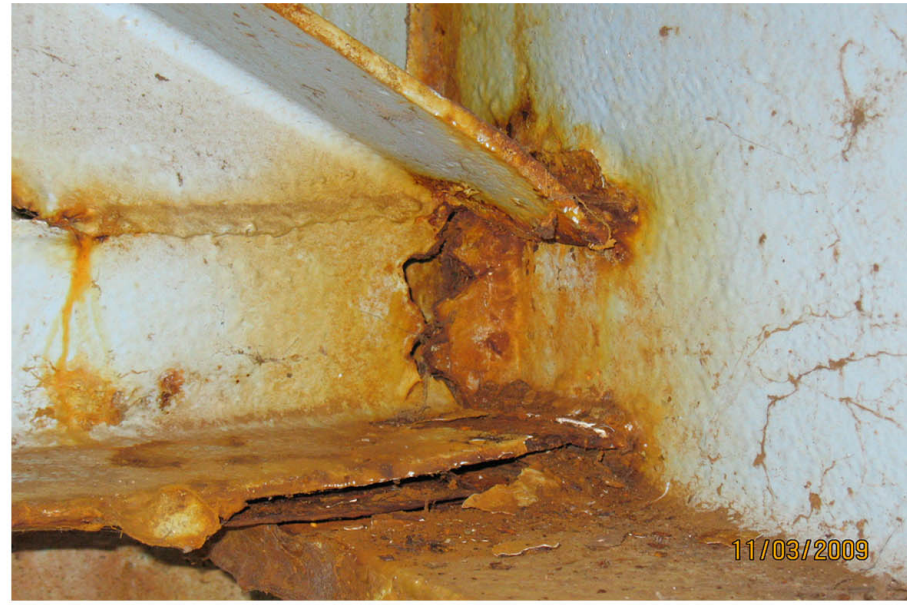
P9: CLOSE-UP OF P8.

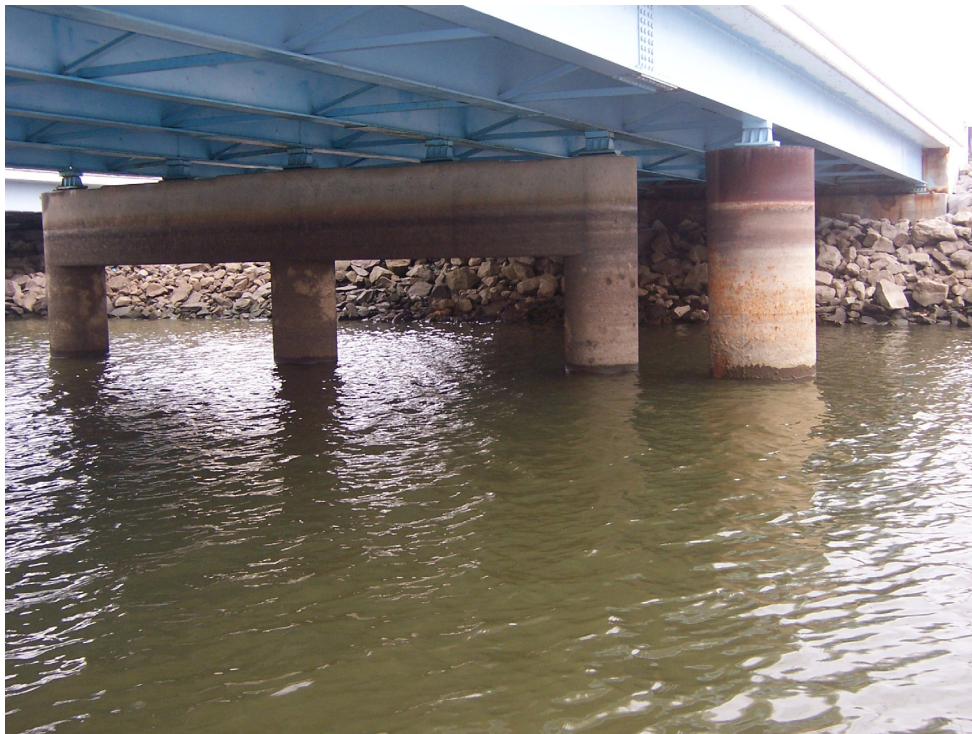
- The bottom composition is flat mud and small stone.
- Each abutment is surrounded with large diameter riprap stone (shown in Photos 5 and 6). This stone slopes downward toward the piers.

Photo 6 – Facing East. Pier 3 and East Abutment with Riprap Stone.
