DESCRIPTION

Bridge GEA-422-0986 R (SFN 2801744) carries two lanes of State Route 422 eastbound over La Due Reservoir in Geauga County, Ohio. The structure, built in 1960, consists of a four-span, steel beam bridge carried by three reinforced concrete column piers and two reinforced concrete abutments. Each pier has three round concrete columns and one steel jacketed concrete drilled shaft. This is shown in Photos 1, 2, 5 and 6. Both abutments were more than six feet above the water level and not considered part of this inspection. To be consistent with ODOT's Topside Inspection Report dated 11/13/08, Pier 1 is the west pier. Likewise this report numbers beams and columns starting at the north going south.

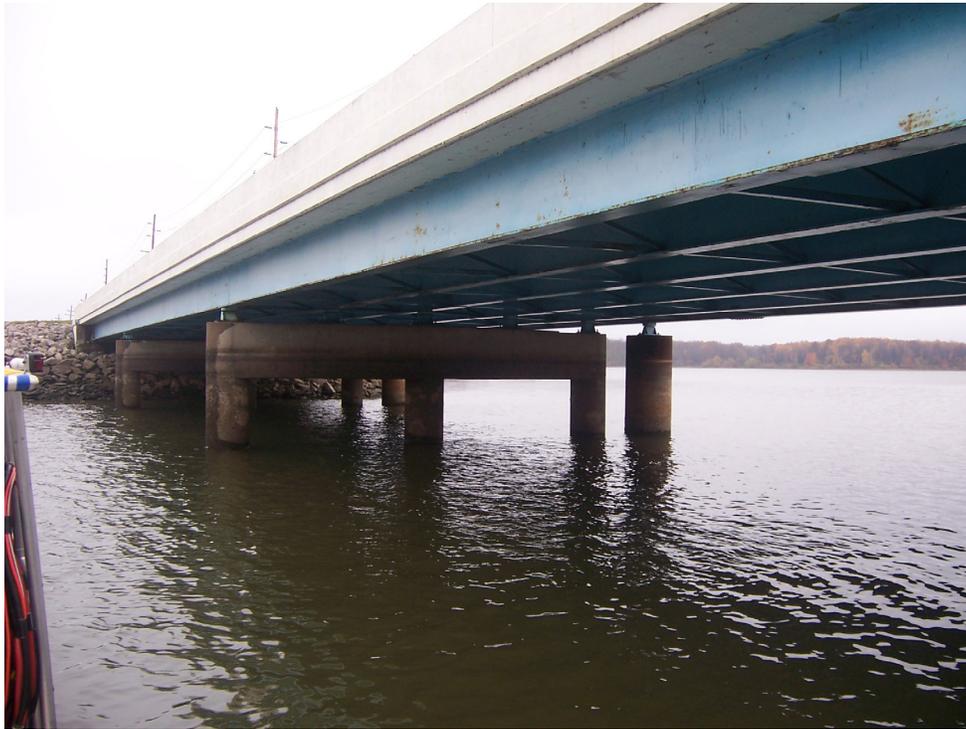
Photo 1 – Facing Southeast. North Elevation of the Bridge.

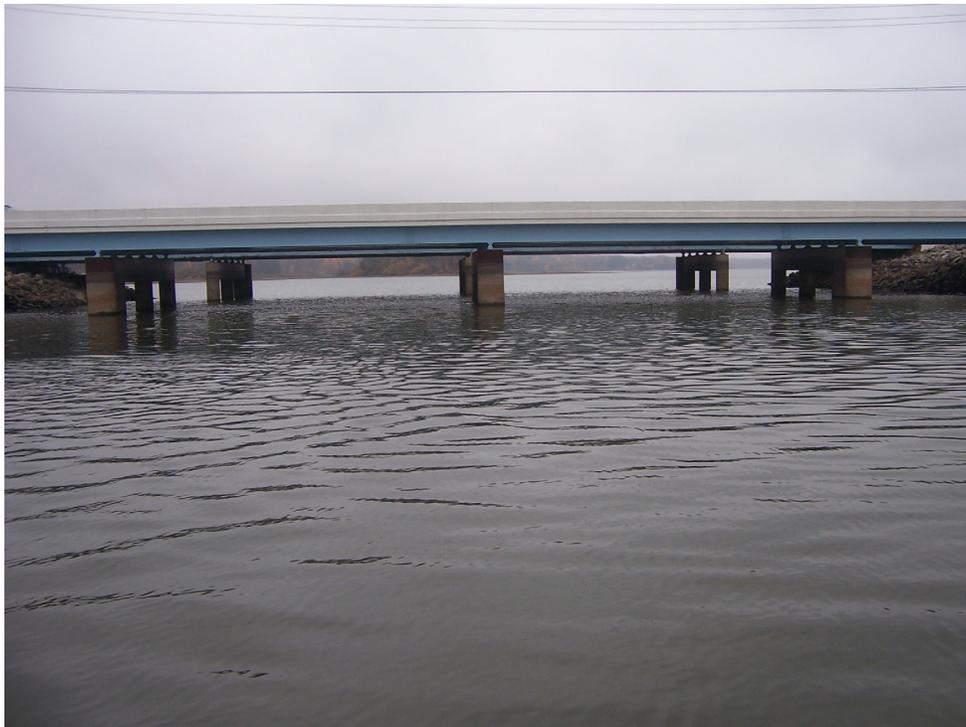
Photo 2 – Facing North. South Elevation of the Bridge.

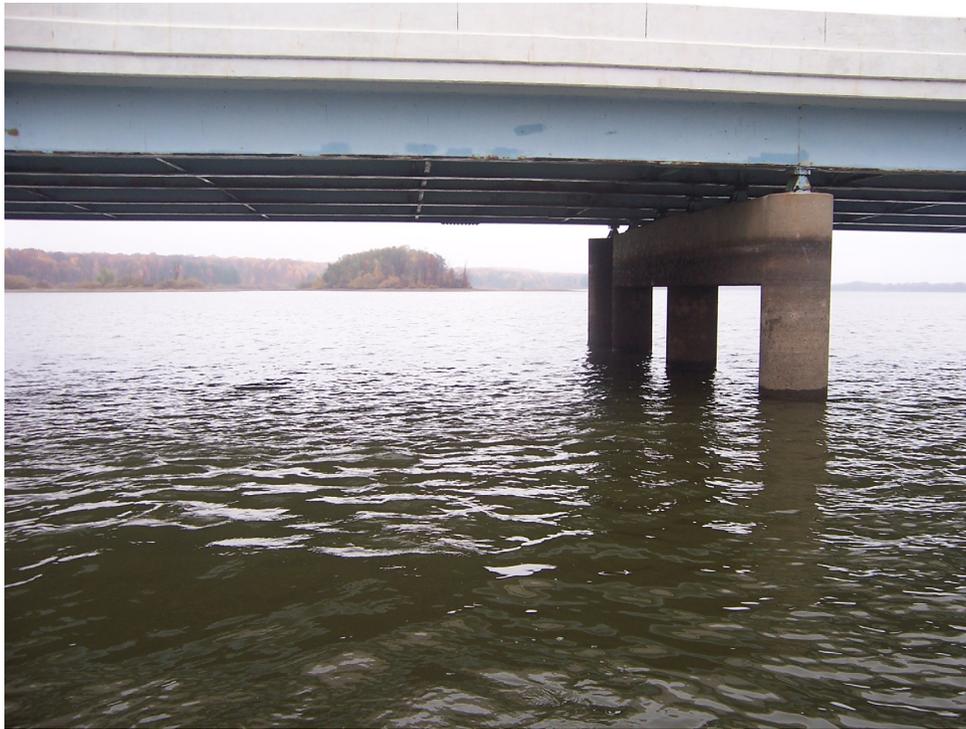
Photo 3 – Facing North. View of La Due Reservoir and Bridge GEA-422-0986 L.

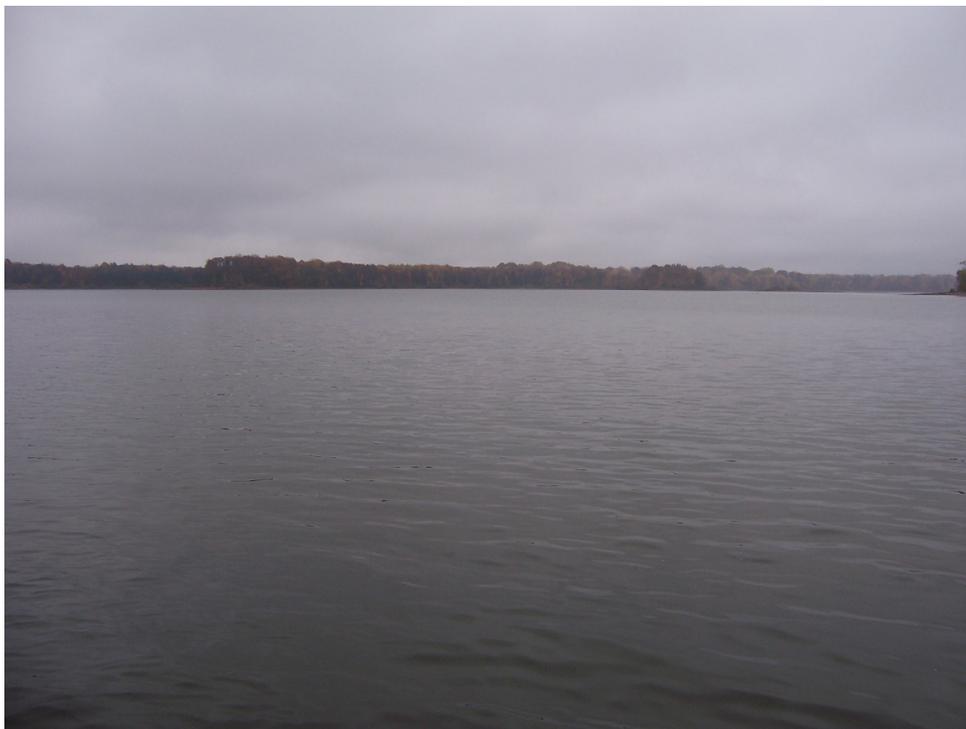
Photo 4 – Facing South. View of La Due Reservoir from the Bridge.

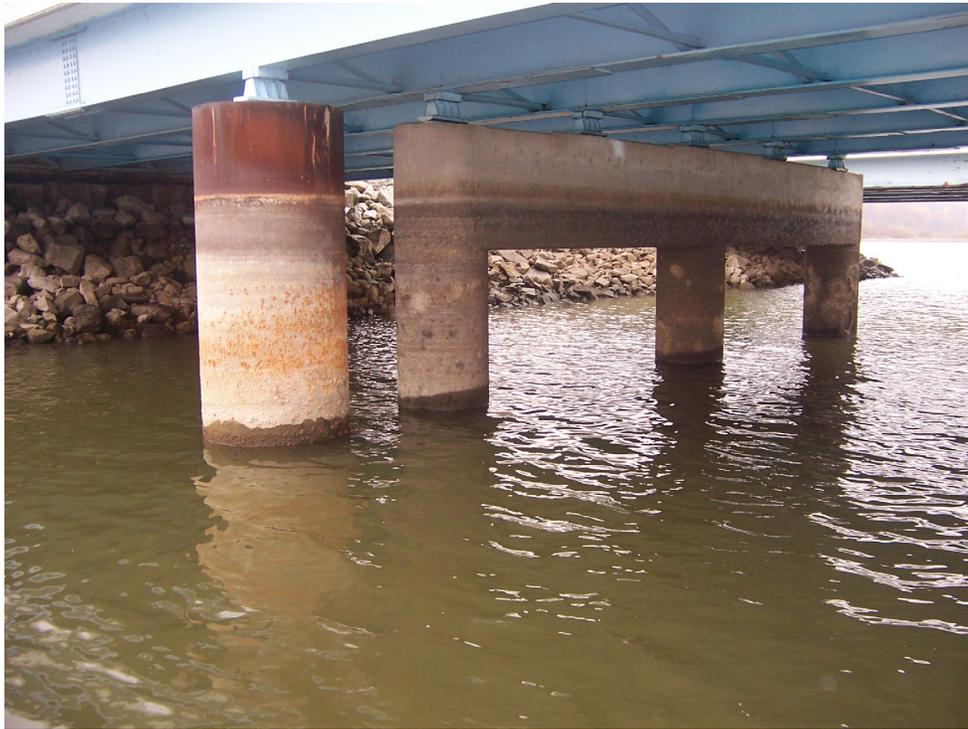
- The bottom composition is flat mud and small stone.
- Each abutment is surrounded with large diameter riprap stone (shown in Photos 5 and 6). This stone slopes downward toward the piers.

Photo 5 – Facing Northwest. Pier 1 and West Abutment with Riprap Stone.

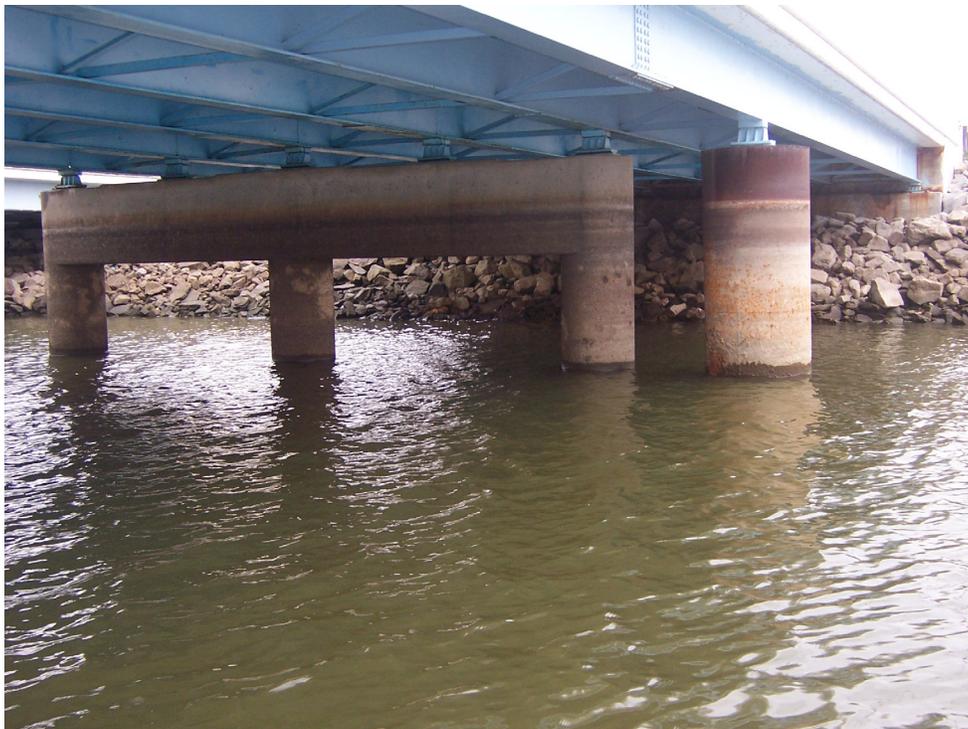
Photo 6 – Facing East. Pier 3 and East Abutment with Riprap Stone.

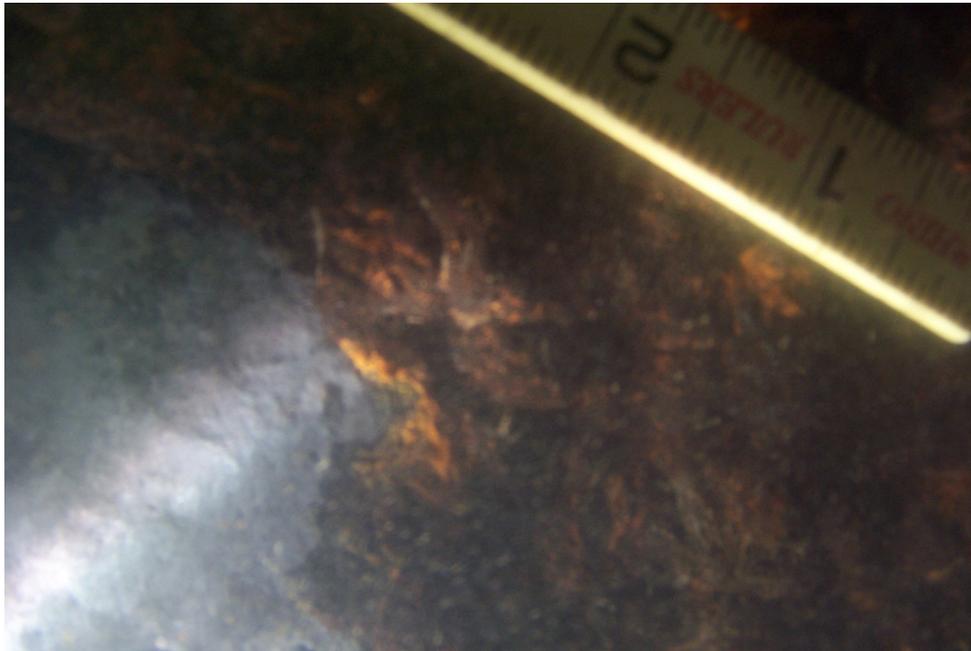
- The concrete surfaces had up to ¼-inch scaling. The concrete was sounded in numerous locations and found to be hard with no signs of delamination.
- The steel jacketed concrete drilled shafts had a 1/8-inch layer of surface corrosion (see Photo 7).
- Underwater visibility was less than 2 feet with no current.

- The concrete surfaces had up to ¼-inch scaling.
- The steel jacketed concrete drilled shaft has a 1/8-inch layer of surface corrosion. Photo 7 is an underwater picture of this corrosion on Pier 3.
- Steel and rebar debris are located between the drilled shaft and the adjacent concrete column at Pier 3's south end.

The previous Topside Inspection Report dated 11/13/08 was available for comparison. The light concrete scaling on the columns and the surface corrosion of the steel jackets on the drilled shafts remains unchanged from the previous inspection. A small amount of wood formwork and steel debris was discovered around the bottom of Piers 2 and 3 respectively. There was no undermining, no scour and no other significant defects found at the time of inspection.

Photo 7 – Facing North. South side of Pier 3 steel jacket on the drilled shaft at the mudline. Typical 1/8-inch thick corrosion of the steel.

Because of the satisfactory conditions found during the underwater inspection, there are no recommendations at this time.
