**Underwater Inspection of
SFN - 2801744
State Route 422 over the La Due Reservoir
(GEA-422-0986 R)
July 25, 2014
For
Ohio Department of Transportation
District-12**

(South Elevation of Bridge)

By
GPI/Greenman-Pedersen, Inc.

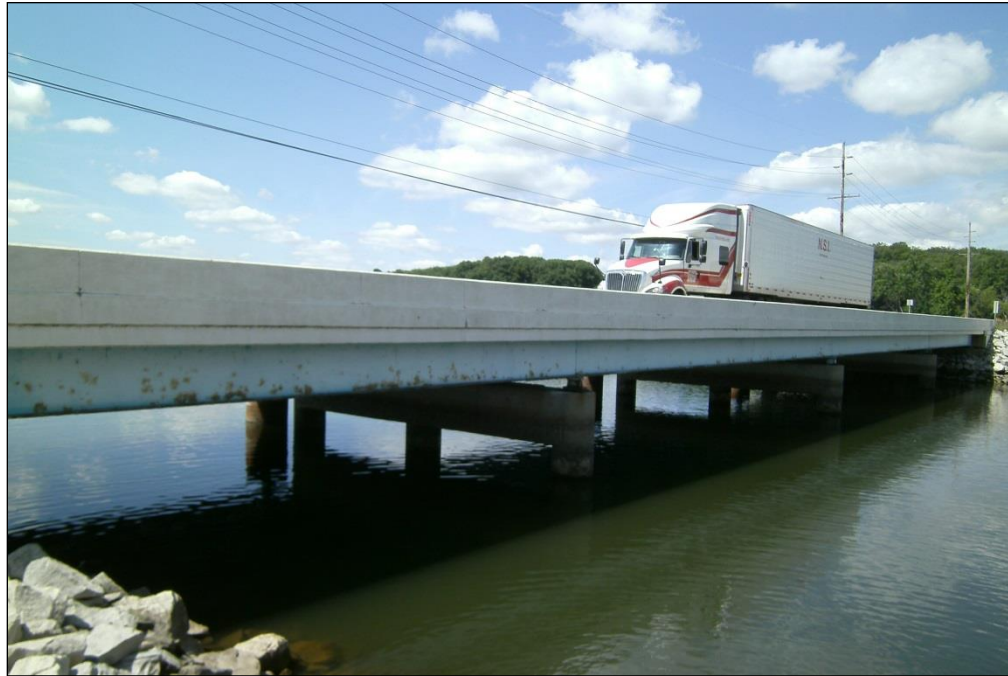
Photograph 1
Overall View of
the North
Elevation.
Looking
Southwest

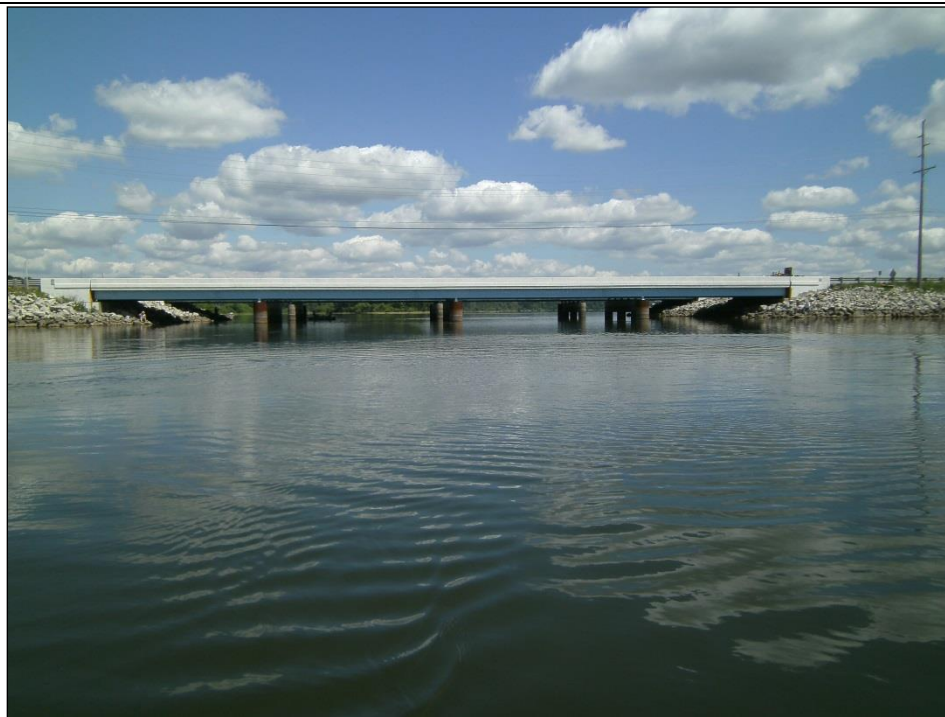
Photograph 2
Overall View of
the South
Elevation.
Looking North.

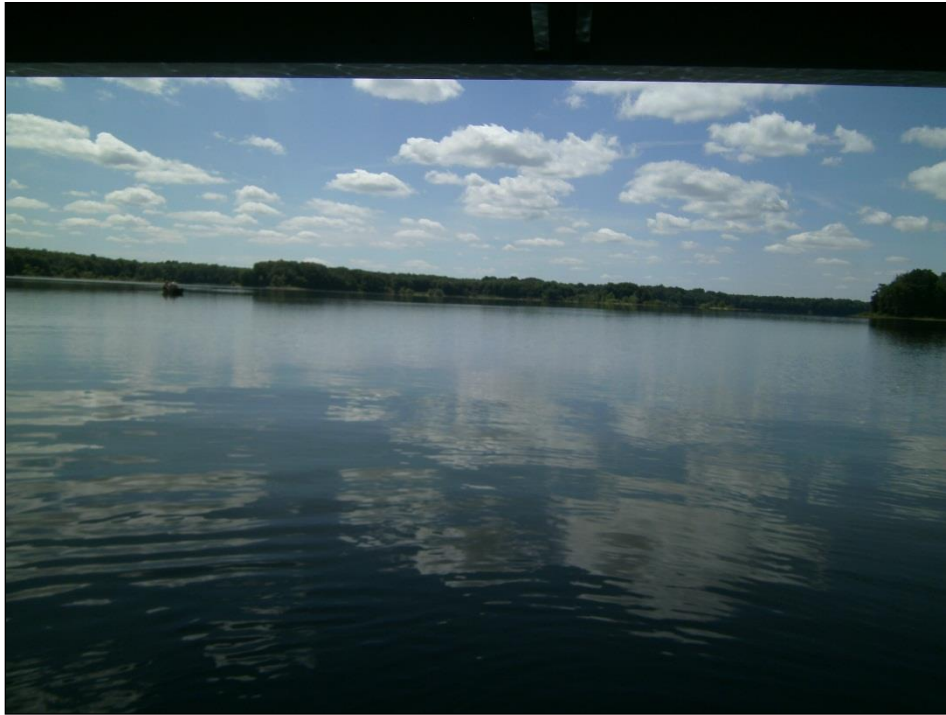
Photograph 3
South approach
(upstream)
Looking South.

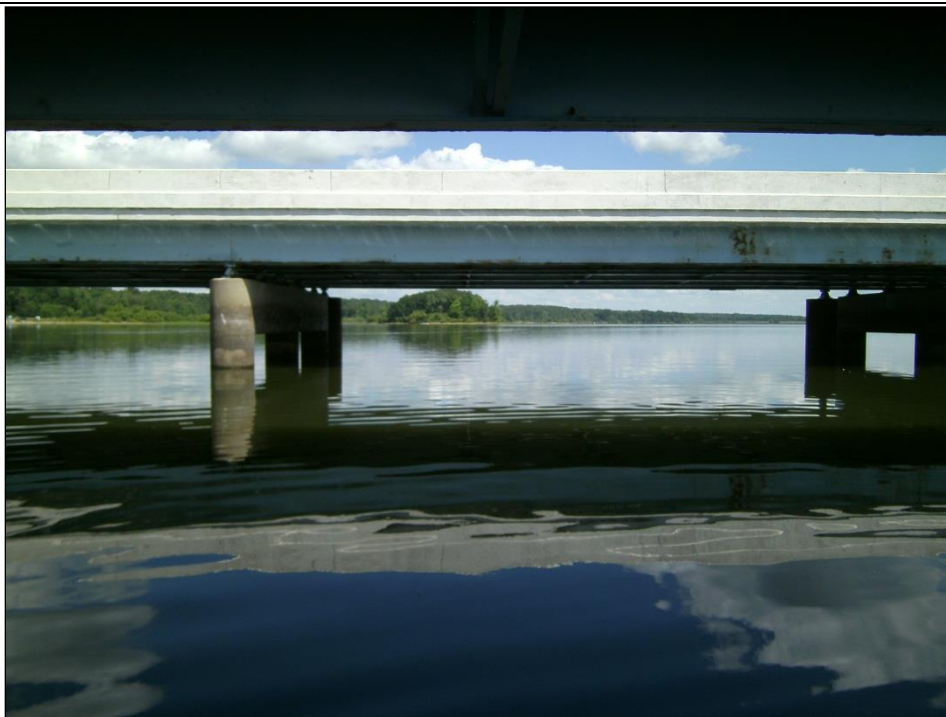
Photograph 4
North approach
(downstream).
Looking North.

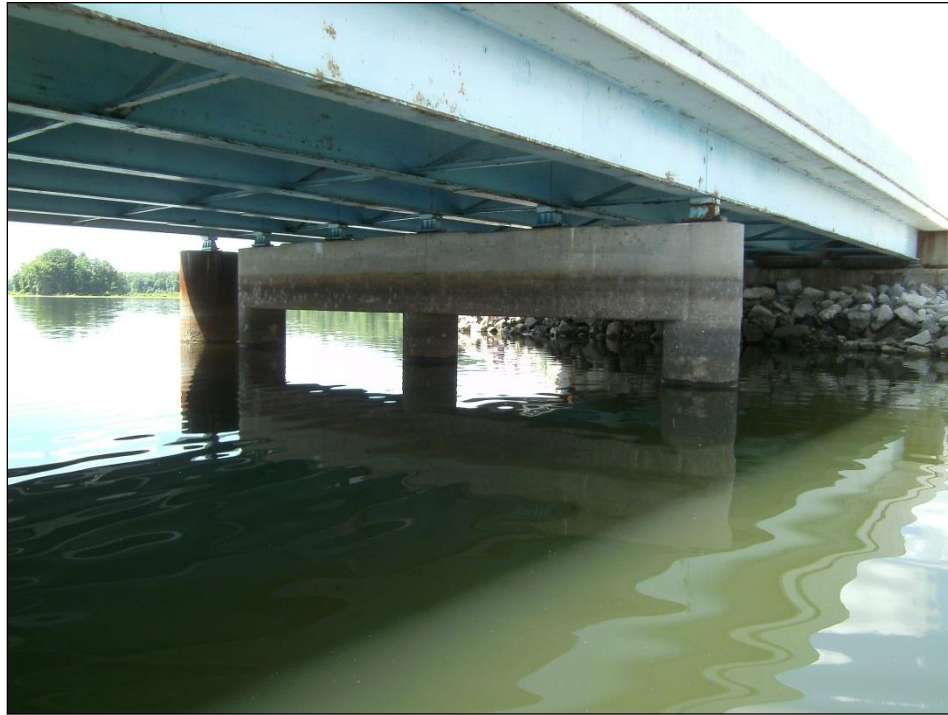
Photograph 5
View of Pier 1,
East Face.
Looking South
west.

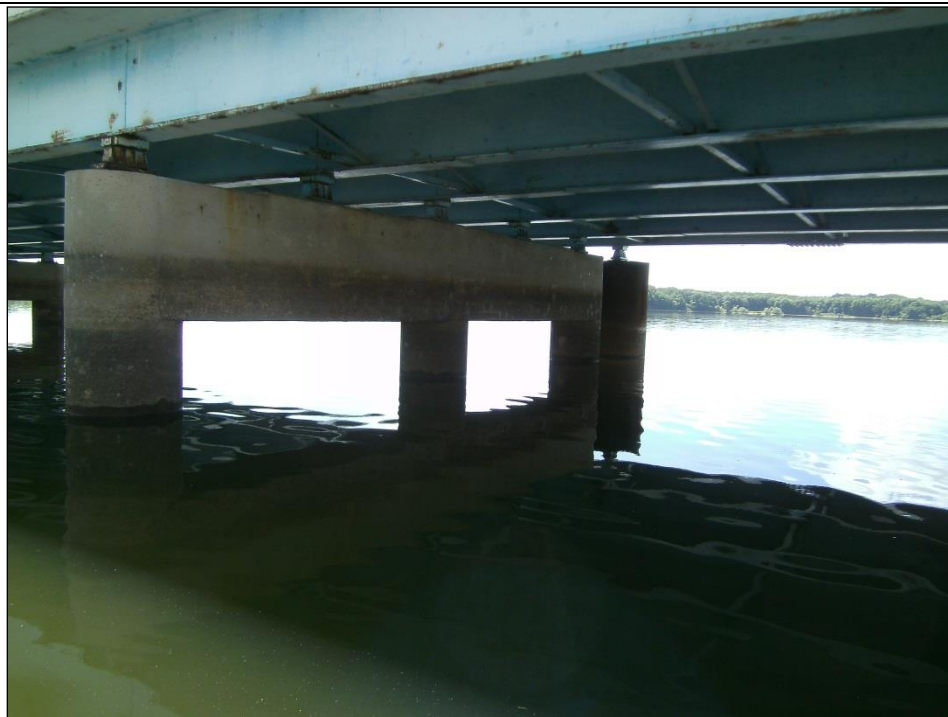
Photograph 6
View of Pier 1,
West Face.
Looking
Southeast.

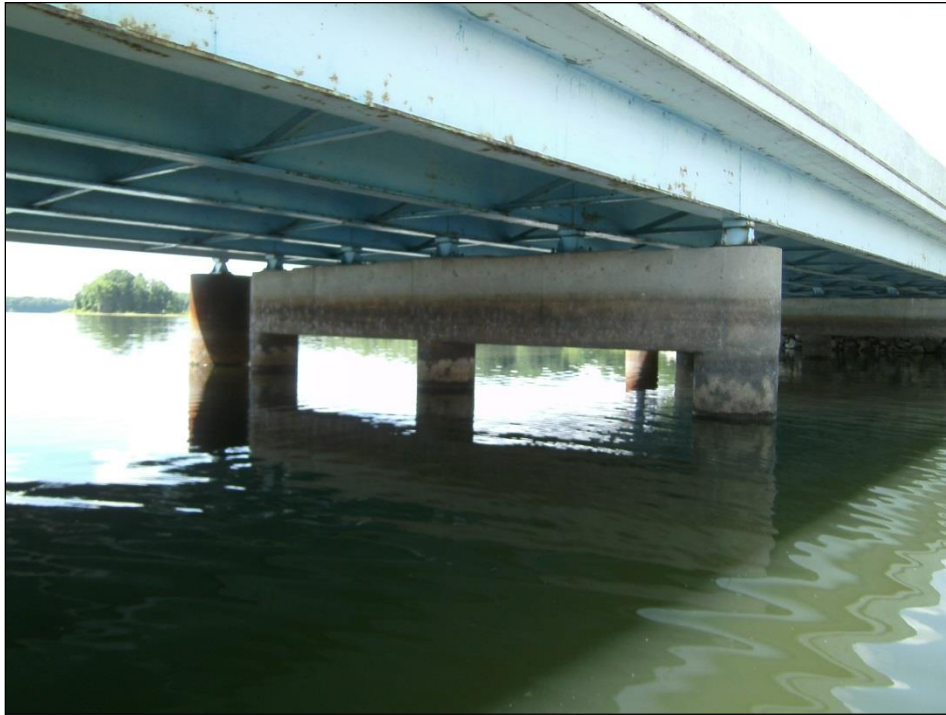
Photograph 7
View of Pier 2,
East Face.
Looking
Southwest.

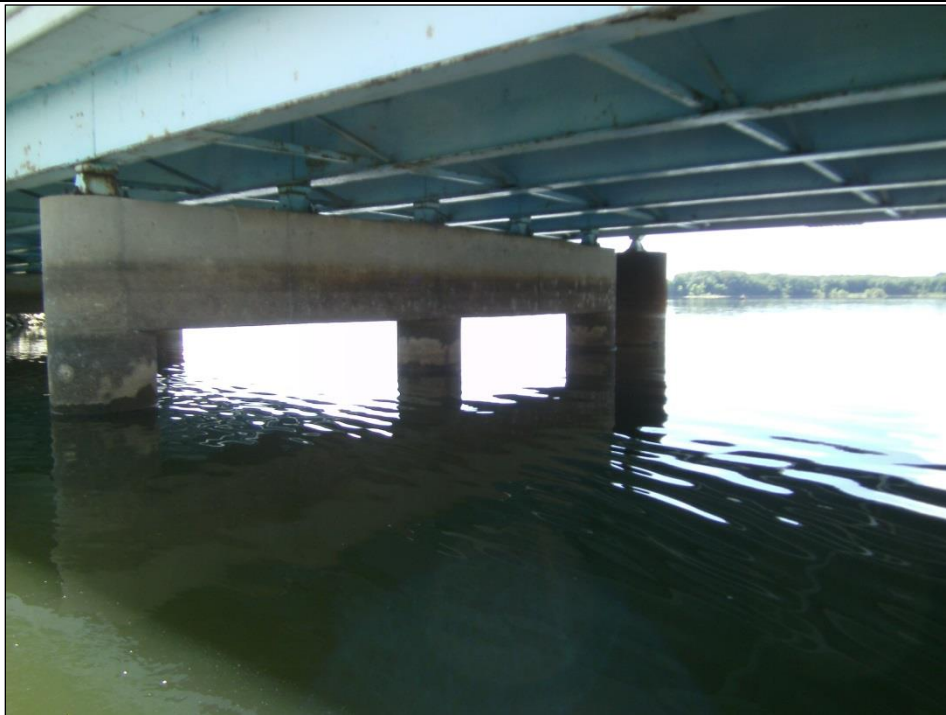
Photograph 8
View of Pier 2,
West Face.
Looking
southeast.

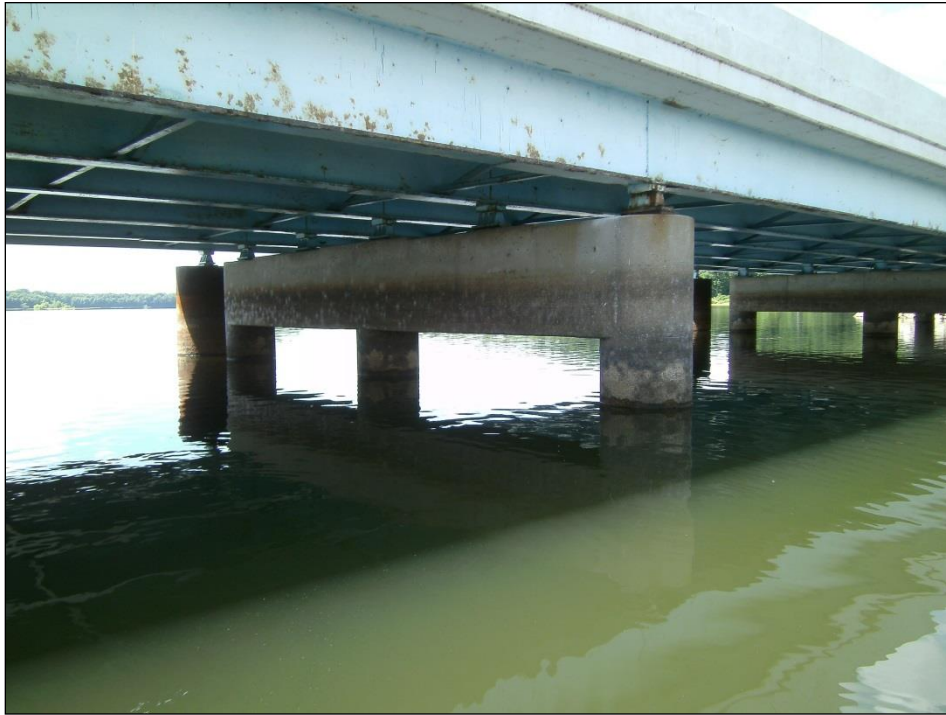
Photograph 9
View of Pier 3
East Face.
Looking
southwest.

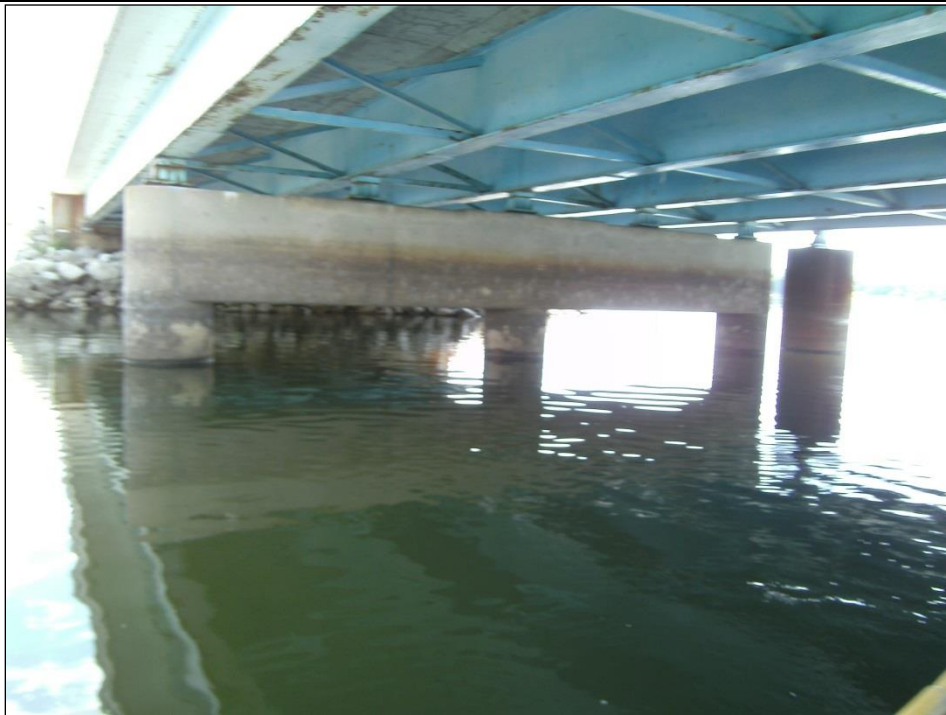
Photograph
10
View of Pier 3,
West Face.
Looking East.
