BRIDGE INSPECTION REPORT

4301714
Structure File NumberBRIDGE NUMBER **LAK 0002 1656 R**YEAR BUILT **1964**DIST **12** Bridge Type **322** TYPE SERVICE **1 5** **GRAND RIVER**

Underwater Inspection Report for:

State Route 2 over Grand River
Lake County, Ohio
(Three Span Steel Beam Bridge)

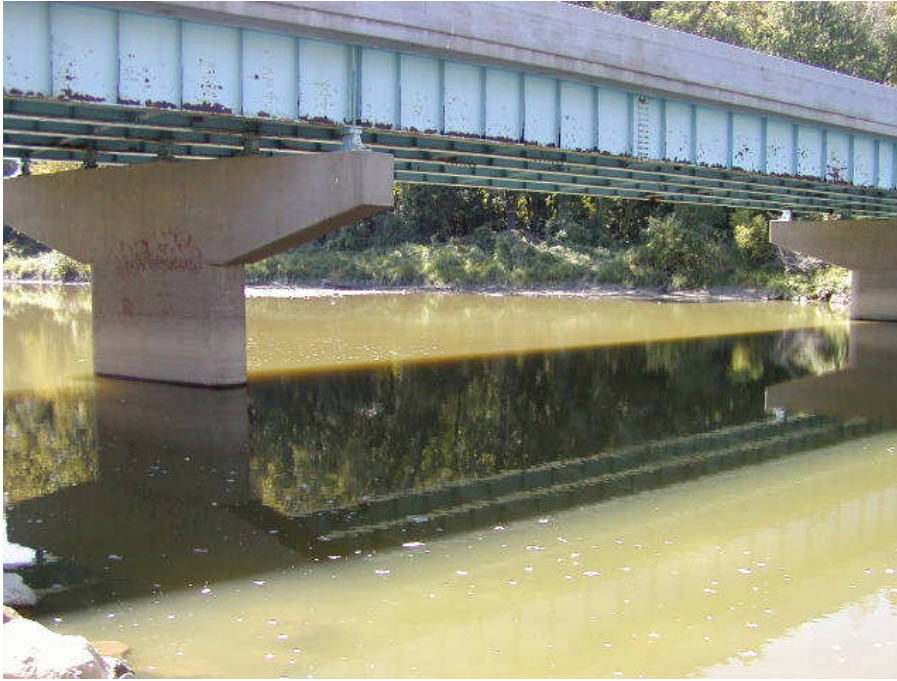
Photo 1. Elevation view looking upstream (east).

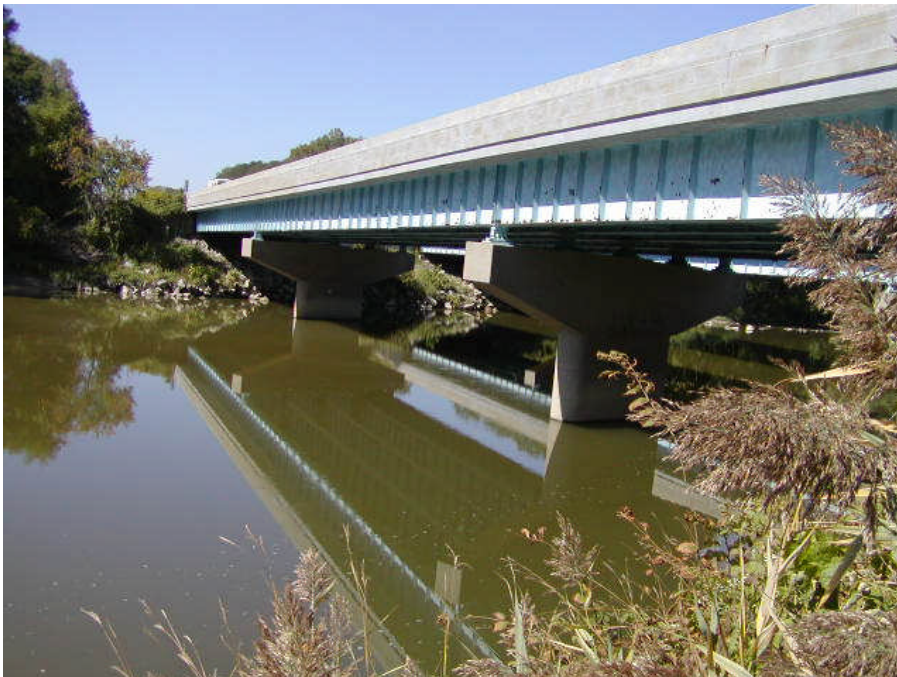
Photo 2. Elevation view looking downstream (west).

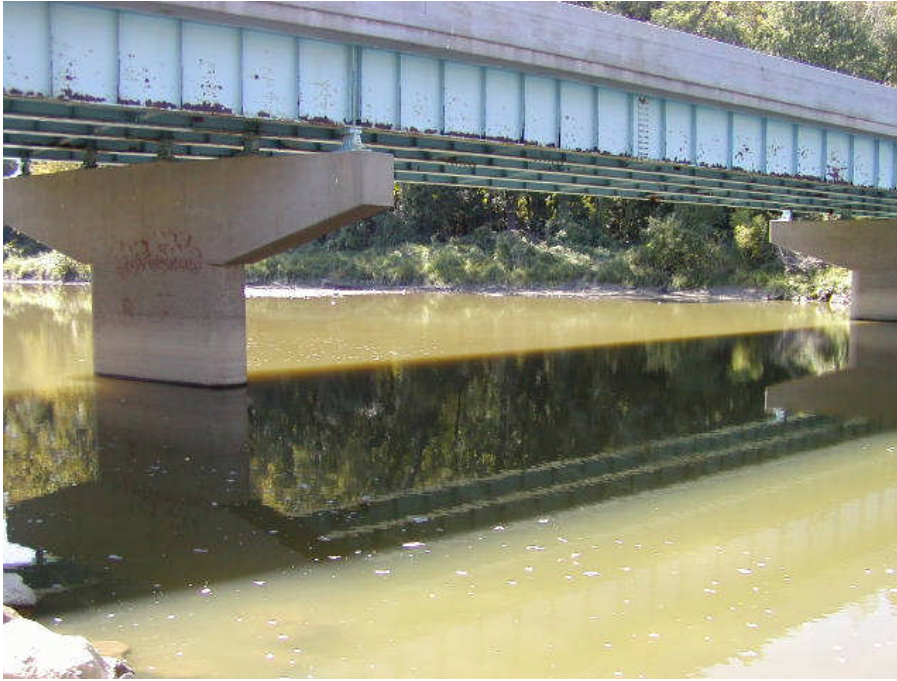
Photo 3. Pier 2 (north face).

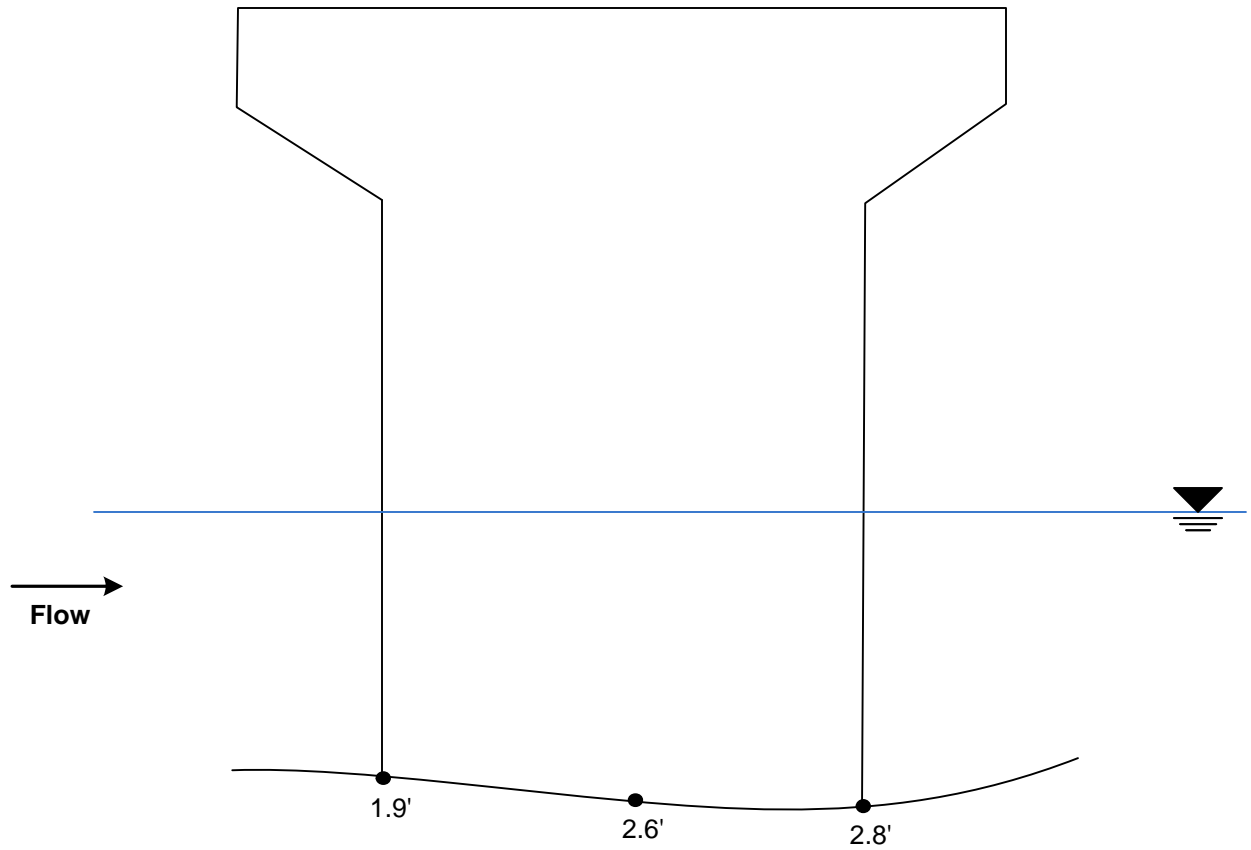
FIG. NO.:
3

- Light tree debris is present on the upstream and downstream faces of the piers.
- There is a small scour depression located on the upstream face of Pier 1R. The depression measures approximately 5 feet in diameter and 2 feet deep.

Pier 1R Looking South

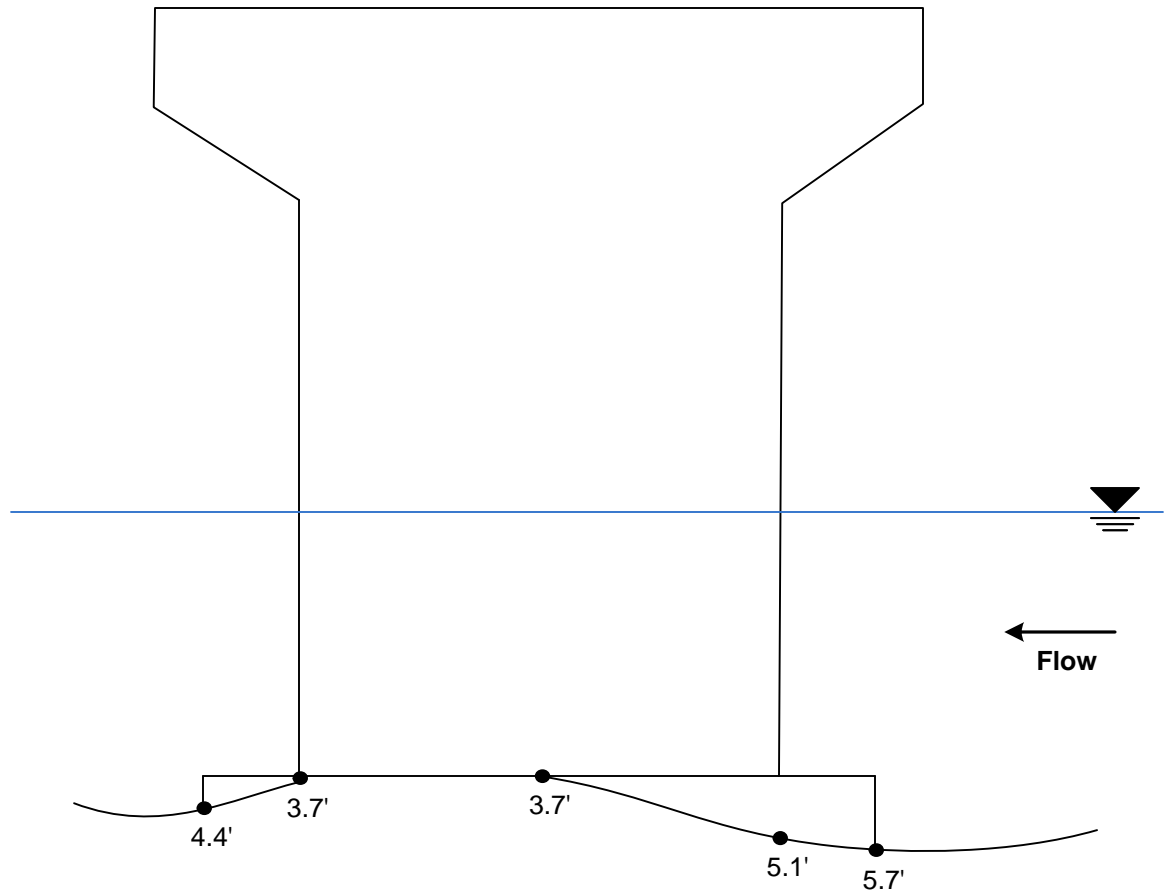
FIG. NO.:
4

Pier 2R Looking North
