**Underwater Inspection of
SFN - 4301714
State Route 2 over the Grand River
(LAK-2-1656R)
July 23, 2014
for
Ohio Department of Transportation
District-12**

(North Elevation of Bridge)

By
GPI/Greenman-Pedersen, Inc.

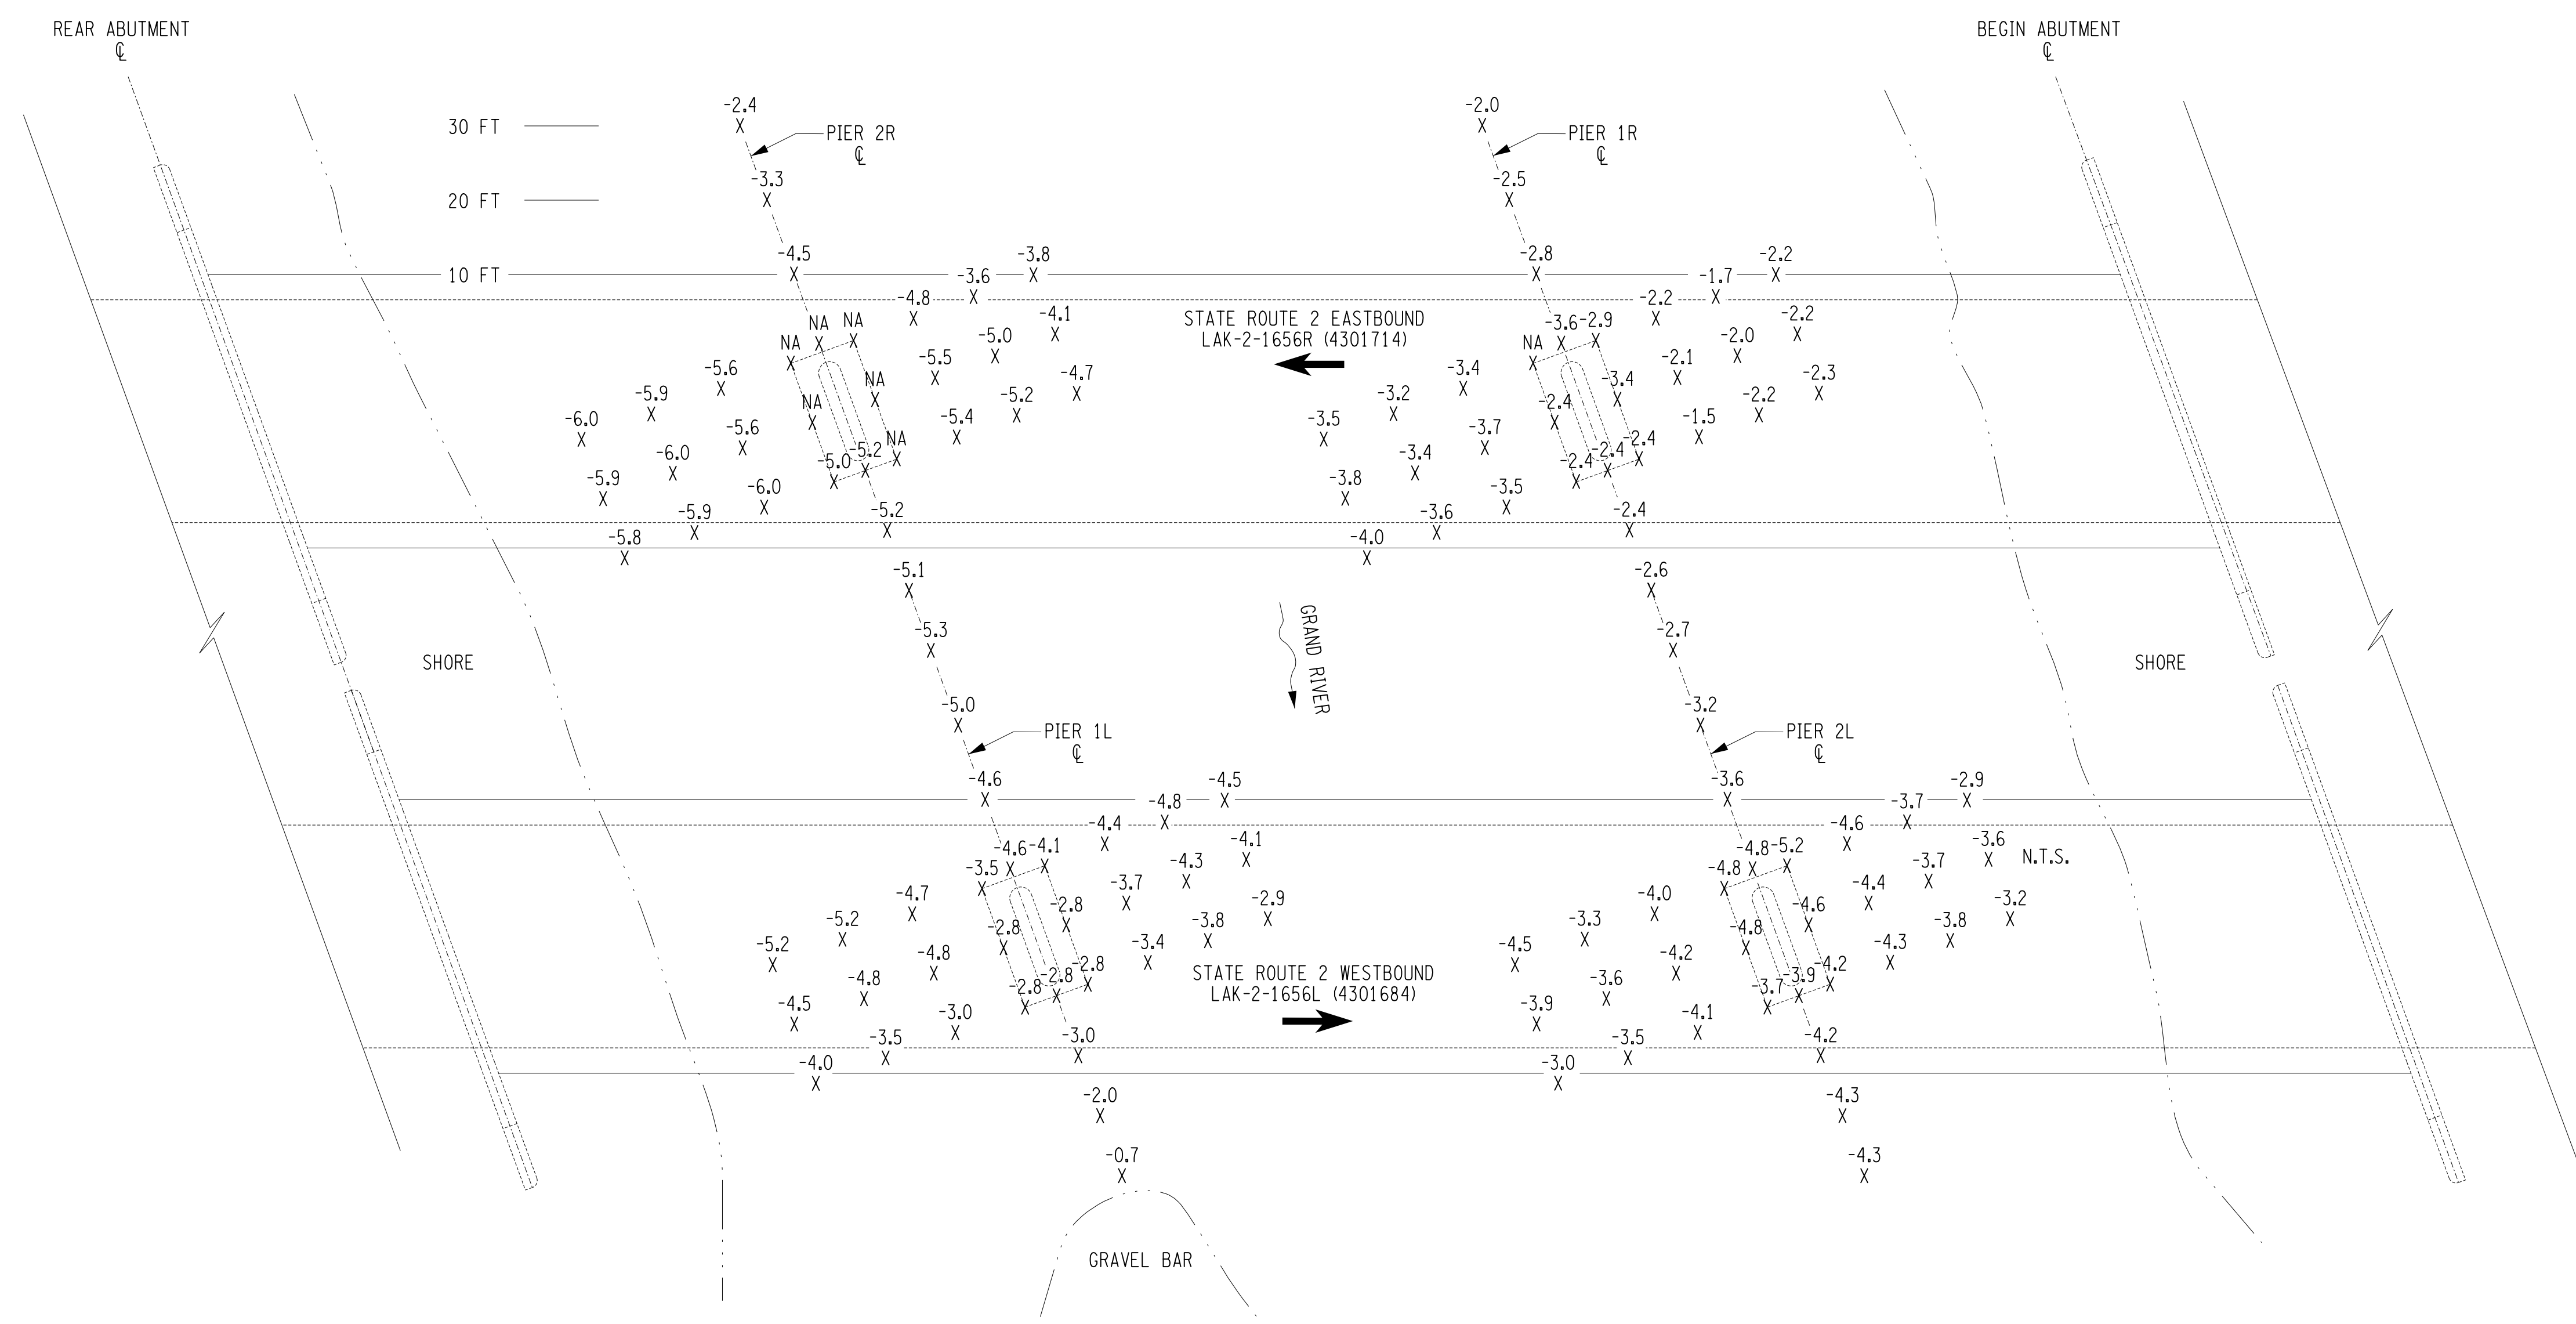
SOUNDING PLAN

The Grand River flows South to North under this structure. The thalweg of this river runs between Pier 1R and rear abutment. A maximum depth of 6.0 feet was found under the structure in the thalweg. Flow at this bridge was approximately 1 foot per second.

- The Channel has stayed relatively the same since the last inspection with some minor changes in streambed elevation.
- Penetrations taken during soundings were typically less than 1 inch.

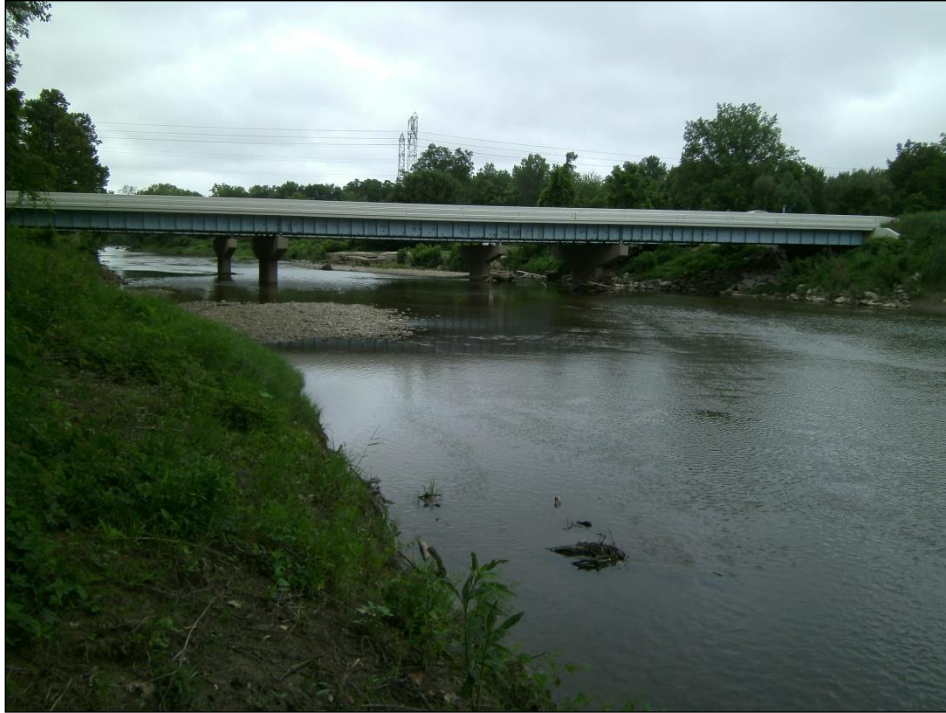
Photograph 1
Overall View of
the South
Elevation.
Looking North

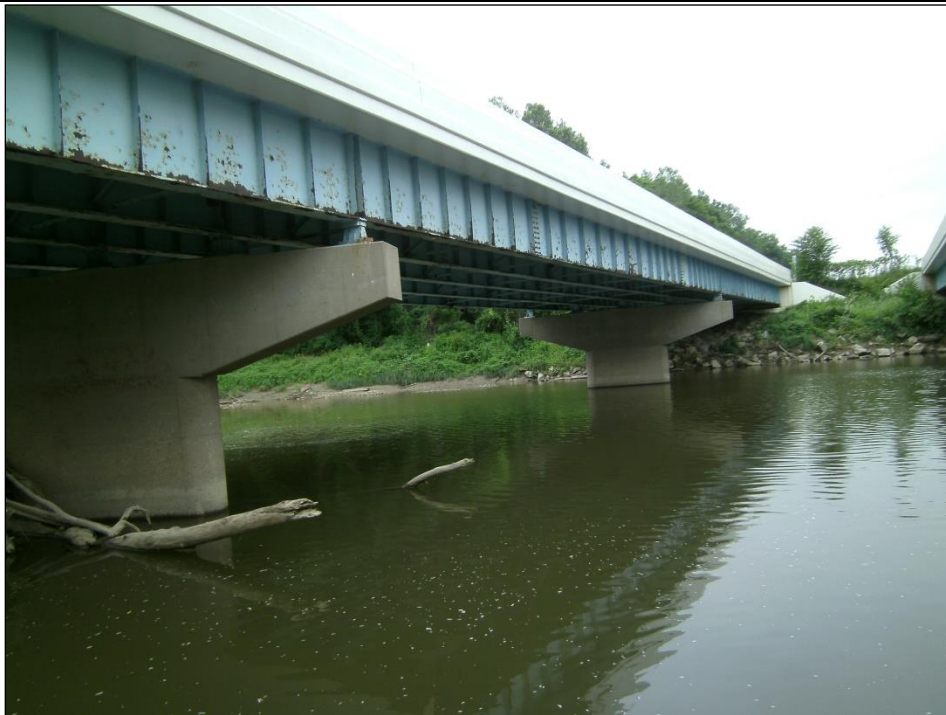
Photograph 2
Overall View of
the North
Elevation.
Looking South

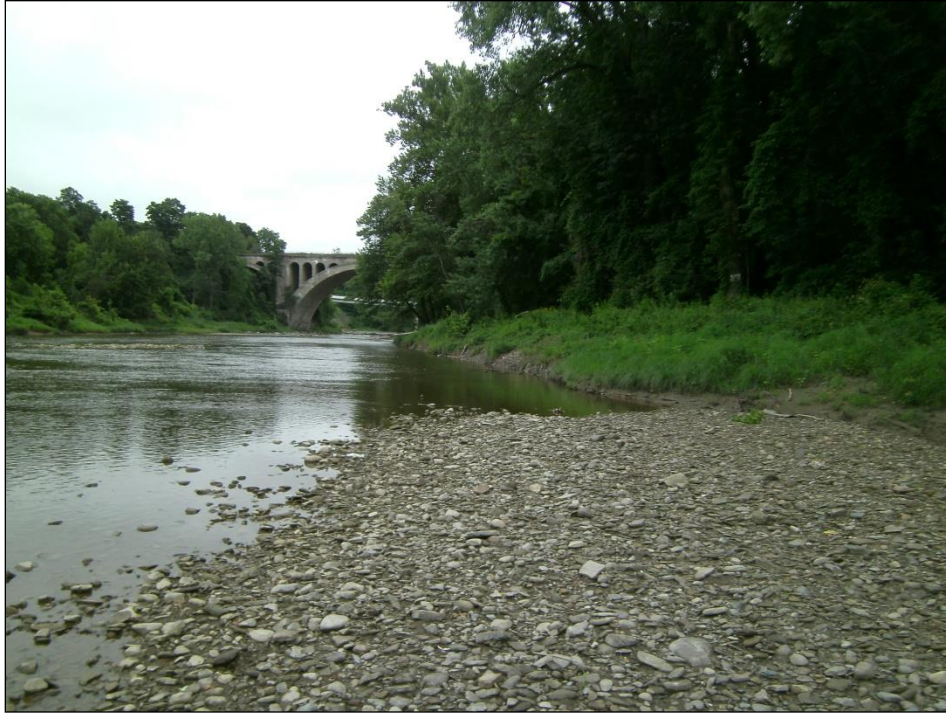
Photograph 3
South approach
(upstream)
Looking South.

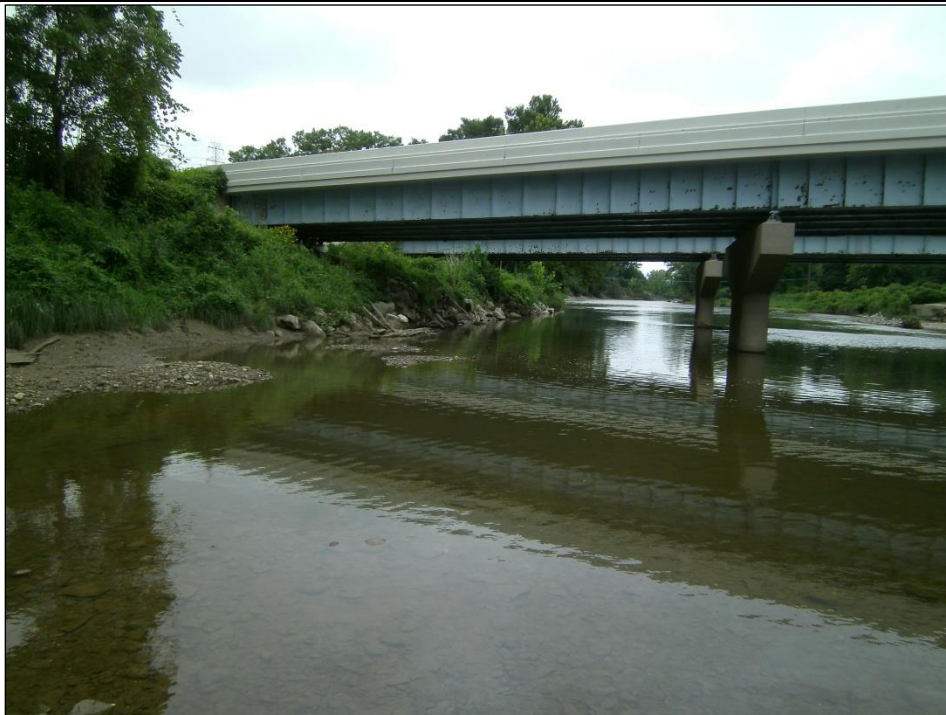
Photograph 4
North approach
(downstream).
Looking North.

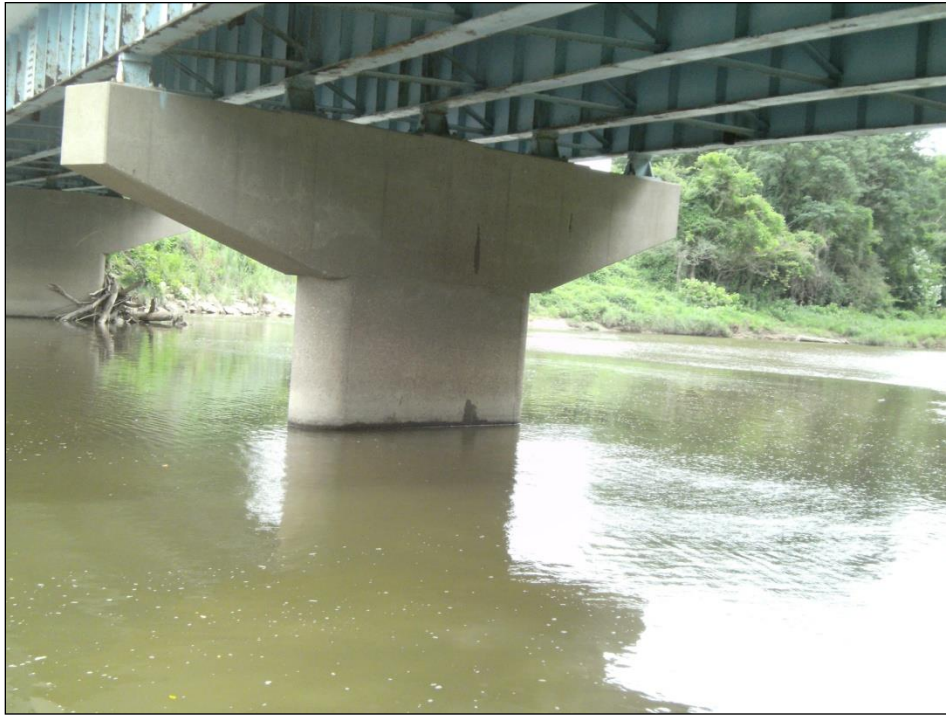
- Light to moderate scaling where confirmed as documented in underwater inspection done in 2007 and has not advanced in severity.
- Light timber debris 8 inch diameter tree submerged underwater at upstream nose. (No photo)
- The footer on Pier 1R is exposed 2 vertical inches along entire east face from upstream nose to downstream nose. Top of footer is exposed on all sides where confirmed as documented in underwater inspection done in 2007. No undermining was observed The exposure of the footing appears to be due to local scour of the mudline in the vicinity of the Pier and a high water event within the last year.

Photograph 5
View of Pier 1R,
West Face.
Looking East.

- Re-inspect the submerged substructure units at the normal maximum recommended interval of five (5) years and after a significant event such as flood, impact or other phenomenon that could affect the structural integrity of the bridge. Timber debris located at Piers and adjacent around Piers should be removed. Large riprap should be placed around exposed footings and Pier noses.

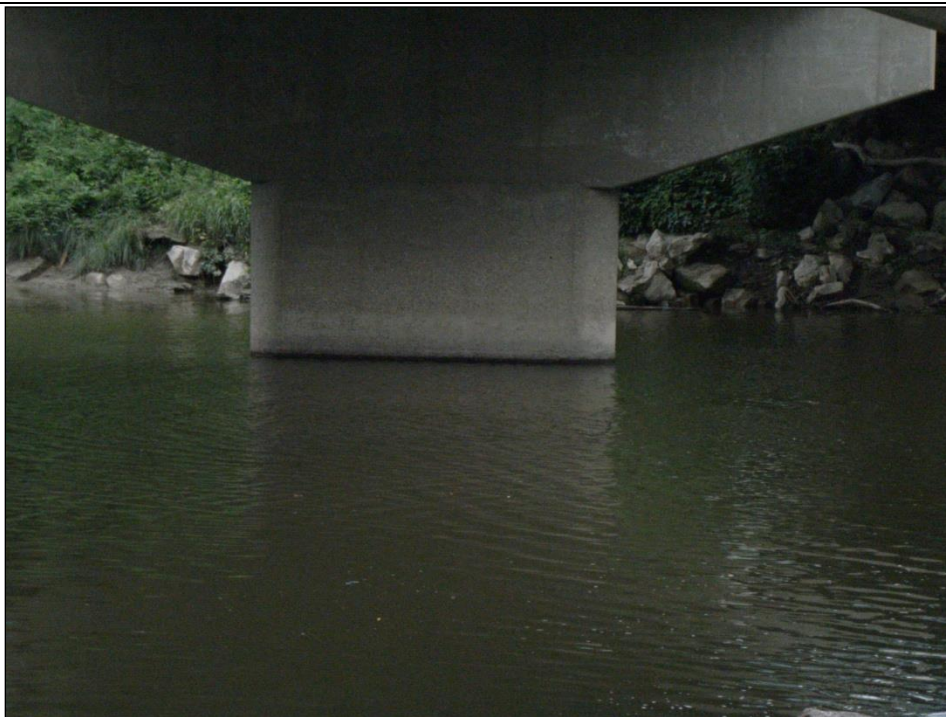
Photograph 6
View of Pier 1R,
East Face.
Looking West.

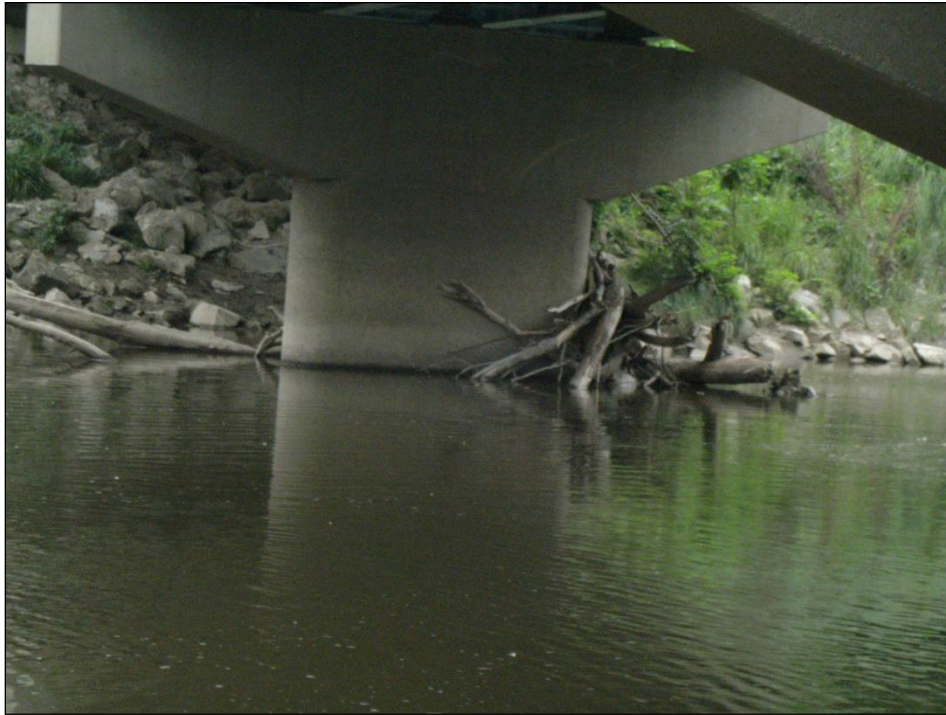
- Light to moderate scaling where confirmed as documented in underwater inspection done in 2007 and has not advanced in severity.
- Heavy timber debris 8 to 12 inch diameter trees submerged underwater and above water at upstream nose. Extends approximately 5 feet upstream of nose and 30 feet down east and west face of Pier. (See photo 9)
- The footer on Pier 2R is exposed 2 vertical inches starting at downstream nose and continuing 4 feet up west face of Pier. No undermining was observed. The exposure of the footing appears to be due to local scour of the mudline in the vicinity of the Pier from timber debris lodged at upstream nose of Pier and a high water event within the last year.
- The scour depression 20 feet upstream of upstream nose was confirmed as documented in underwater inspection done in 2007 and has not advanced in severity.

Photograph 7
View of Pier 2R
West Face.
Looking East.

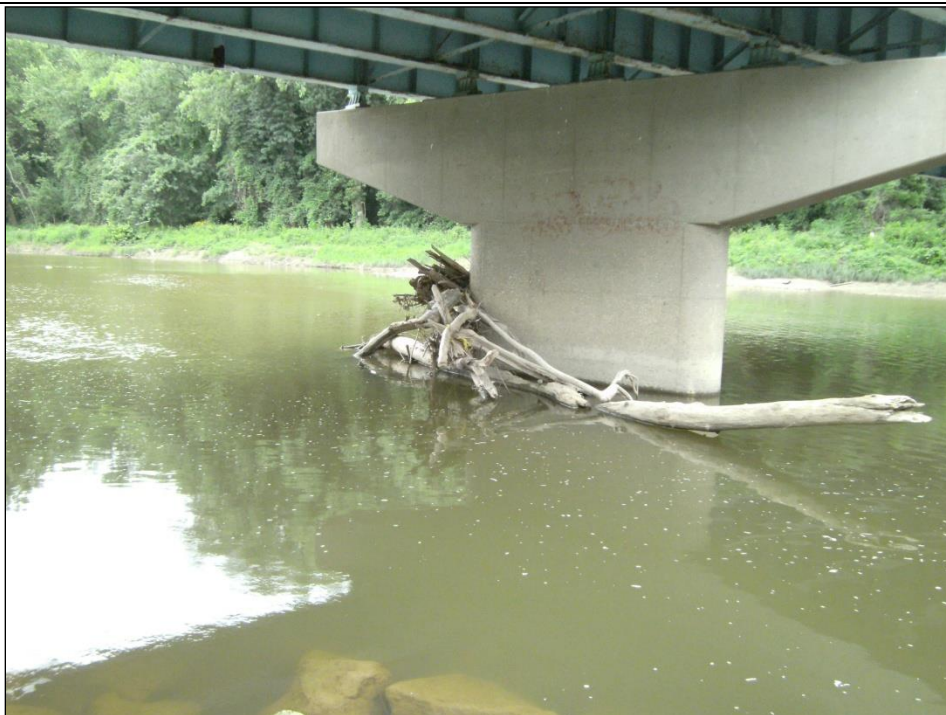
Photograph 8
View of Pier 2R
East Face.
Looking West.

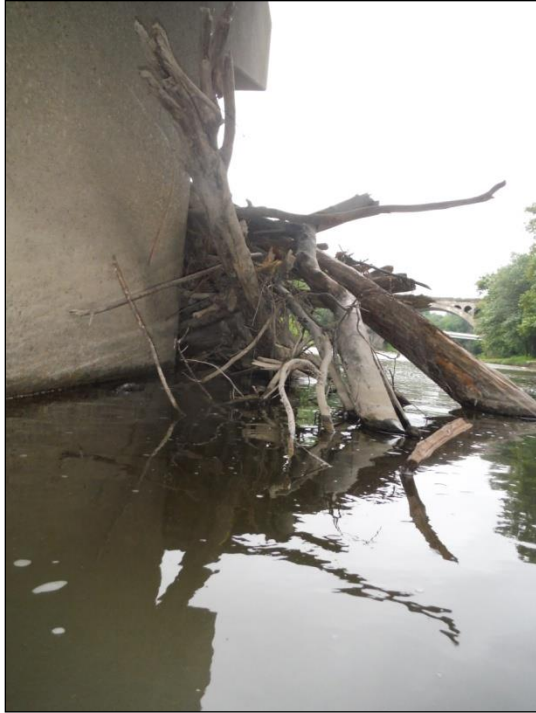
Photograph 9
View of Pier 2R
West face.
Timber debris.

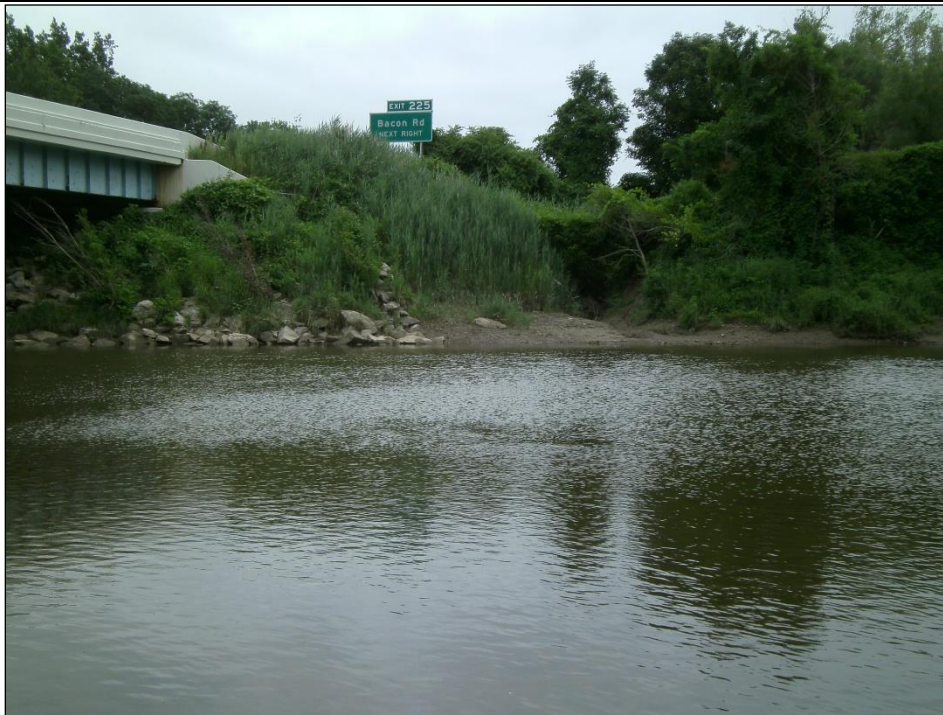
Presence & Condition of Riprap or Scour Countermeasures: Both embankments are protected by 2 to 4 foot diameter dumped riprap extending out from abutments into river and from fascia to fascia. Placed riprap is present from east shoreline into water to east face of Pier 1R fascia to fascia and extends past upstream and downstream noses approximately 15 feet.

Photograph
10
View of
Southeast
shoreline.
Looking East.
