## BRIDGE INSPECTION REPORT

4303040  
Structure File NumberBRIDGE NUMBER **LAK 00084 1888**YEAR BUILT **2006**DIST **12** Bridge Type **121** TYPE SERVICE **1 5** **GRAND RIVER**

LAK-84-1888  
SFN 4303040

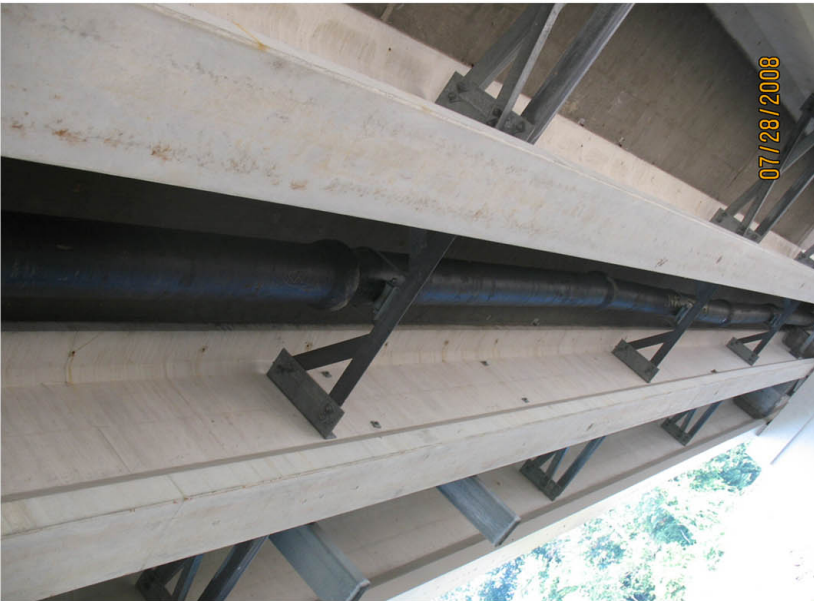
UTIL: SOME MISALIGNMENT OF 16" PIPE IN BAY 3#; SEE ATTACHED  
PHOTO 3 DATED 7/28/08.

P3: TYPICAL MISALIGNMENT OF 16" PIPE IN BAY #3

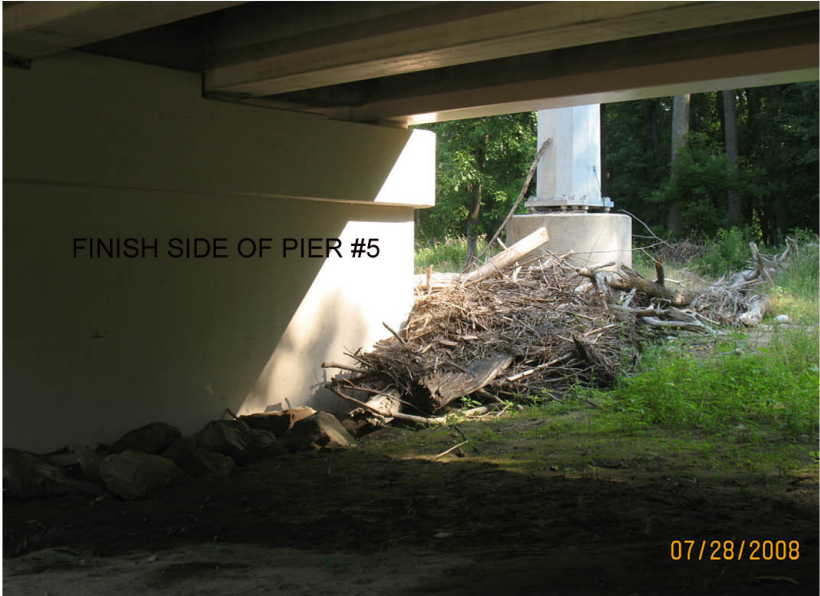
ALIGNMENT: RIVER FLOWS MOSTLY INTO FINISH SIDE OF PIER #2.  
SOME S CURVE GOING ON TO UP RIVER SIDE. SEE  
ATTACHED PHOTOS 4 - 7 DATED 7/28/08.

P4: NOTE LOG JAM BETWEEN PIER 5 AND UTIL POLE FOUNDATION. HIGH WATER FLOWS THRU HERE.
