BRIDGE INSPECTION REPORT

LAK 00084 1888

GRAND RIVER

Underwater Inspection Report for:
Route 84 over the Grand River in Lake County, Ohio
(Seven Span, Prestressed Concrete I-Beam Bridge)

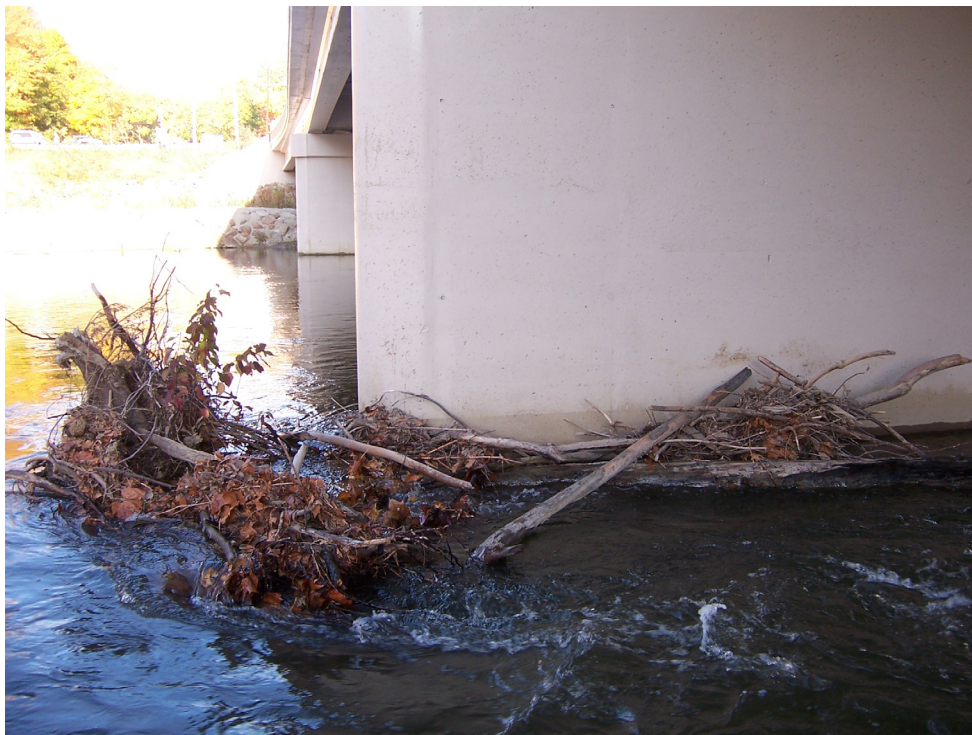
Photo 6 – Facing North. Pier 2 with Timber Debris on the Upstream Nose.

The small amount of timber debris lodged on the upstream nose of Pier 2 is insignificant and will probably float away during the next high water event. Hence we are not recommending any action be taken at this time regarding the debris.

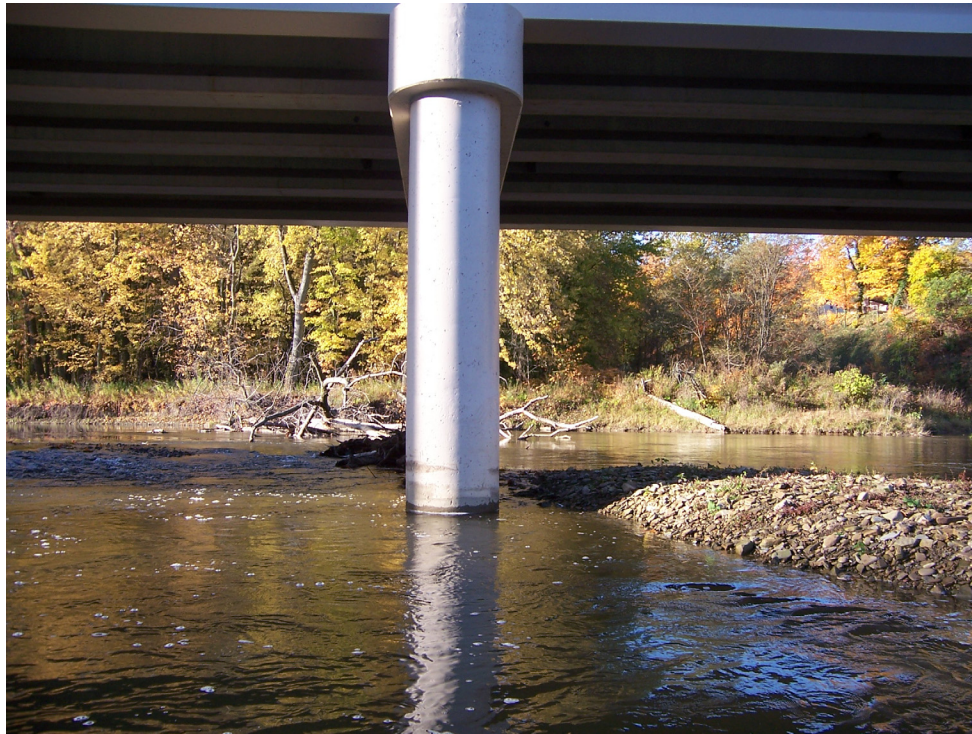
- The channel alignment for this new structure is poor. The upstream channel makes two 90-degree bends just prior to approaching the piers. The water flow changes direction from east to north and then back to east again just upstream of the bridge. This poor alignment creates significant eddy currents and localized scour during high flow events. In Photos 1, 7 and 8, one can see the large piles of stone above water at the northeast corners of Piers 2 and 3. Simultaneously, the upstream noses and southwest corners of the same piers have deeper holes scoured into the streambed (see Soundings). Piers 2 and 3 are textbook examples of poor channel alignment and the resulting redistribution of bottom material.

Photo 7 – Facing West. Pier 2 with a pile of stone deposited on the northeast corner.

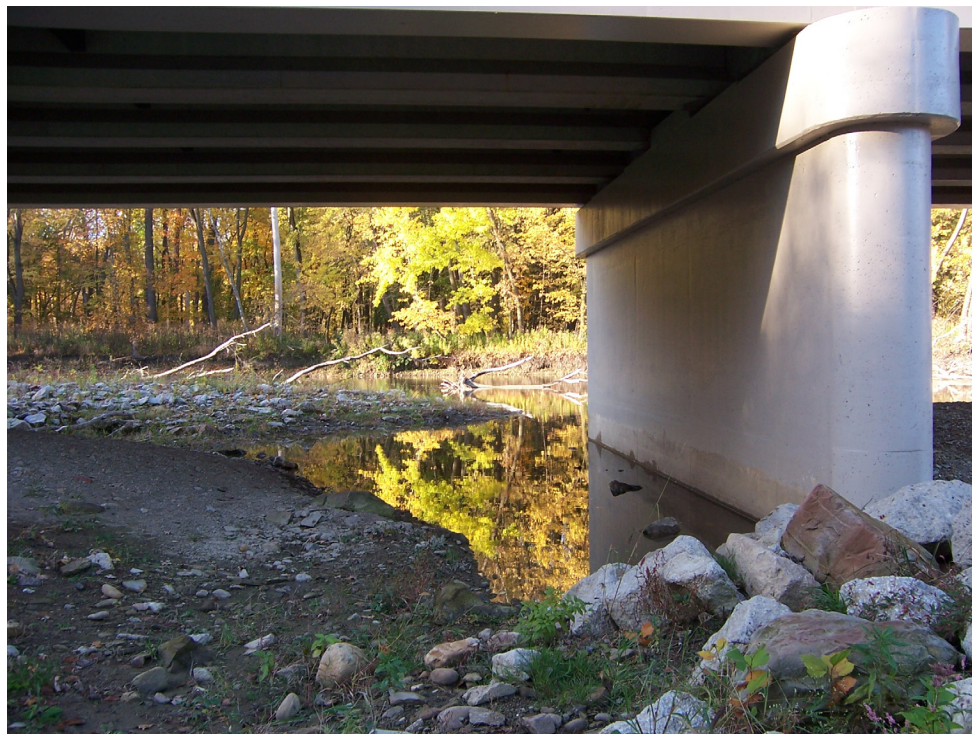
- Both the north and south faces of Pier 3 have a hairline vertical crack at the midpoint traveling from the mudline to the top of the pier.
- The 7/28/2008 ODOT inspection found 12 vertical inches of exposed footer on the upstream nose of this pier. No exposed footer was found during this inspection.

Photo 8 – Facing West. South face of Pier 3

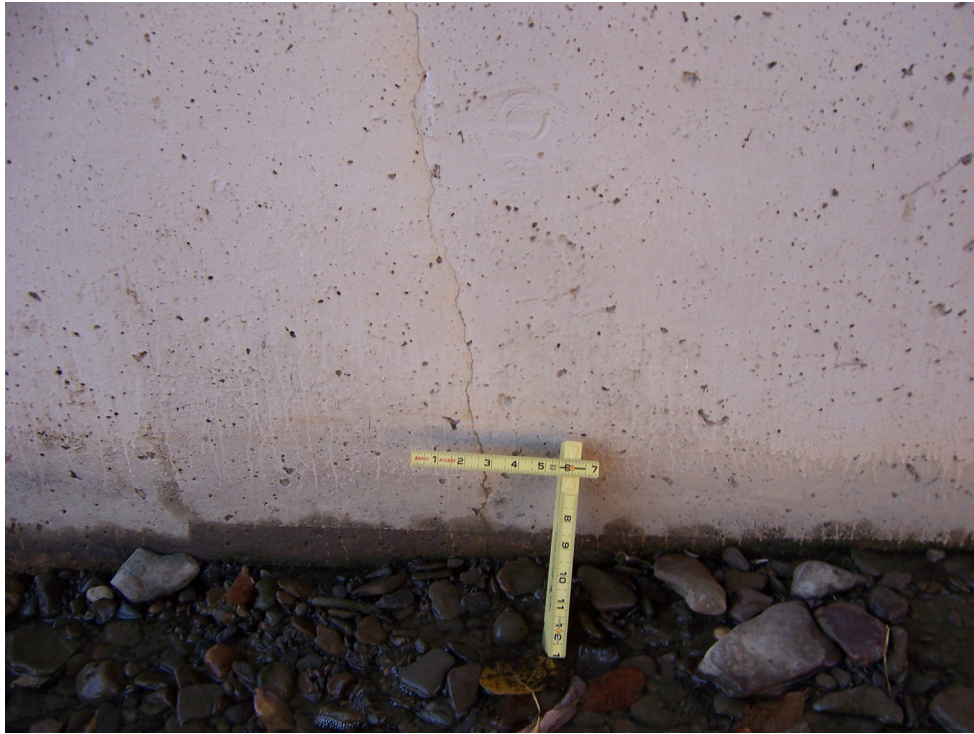
- There are two hairline vertical cracks spaced evenly across the width of the south face of Pier 2. These appear not to travel through the pier. The north face of the pier has only one vertical hairline crack located at the midpoint. This is shown in Photo 9.
- 12-inch diameter timber debris is wedged on the upstream nose of Pier 2 (see Photo 6).
- The 7/28/2008 ODOT inspection found 15 vertical inches of exposed footer on the upstream nose of this pier. No exposed footer was found during this inspection.

Photo 9 – Facing South. Hairline Vertical Crack at the center of the north face of Pier 2.

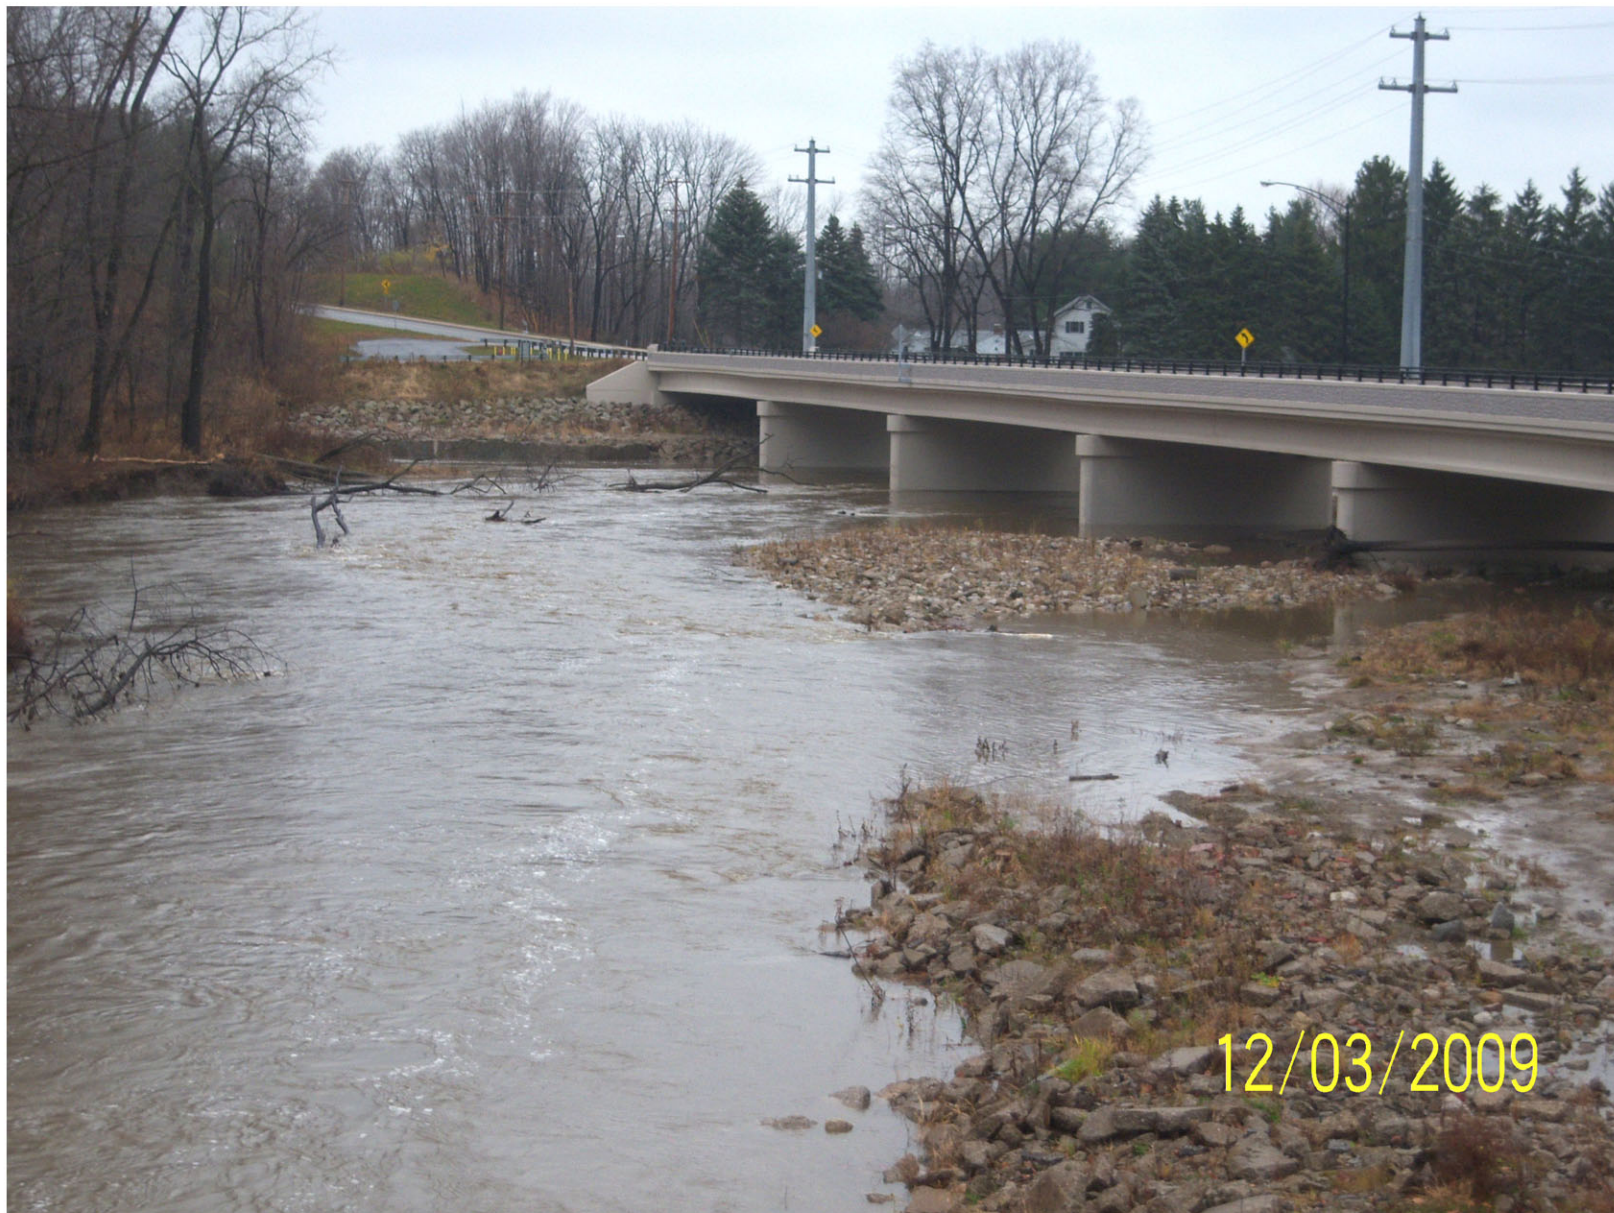
Braided channel upstream of SR 84.JPG

ALIGNMENT: CHANNEL MAKES 90 DEGREE BEND JUST UPSTREAM OF
BRIDGE. BRAIDED CHANNEL DURING HIGH FLOW. SEE
ATTACHED PHOTO DATED 12/03/09. SOME DIAGONAL FLOW
INTO PIER STEMS.
PROTECTION: LARGE STONE AROUND BASES OF PIERS 4, 5 AND 6
HAS PARTIALLY WASHED AWAY. SEE ATTACHED PHOTOS
4 THRU 7 DATED 7/28/08.

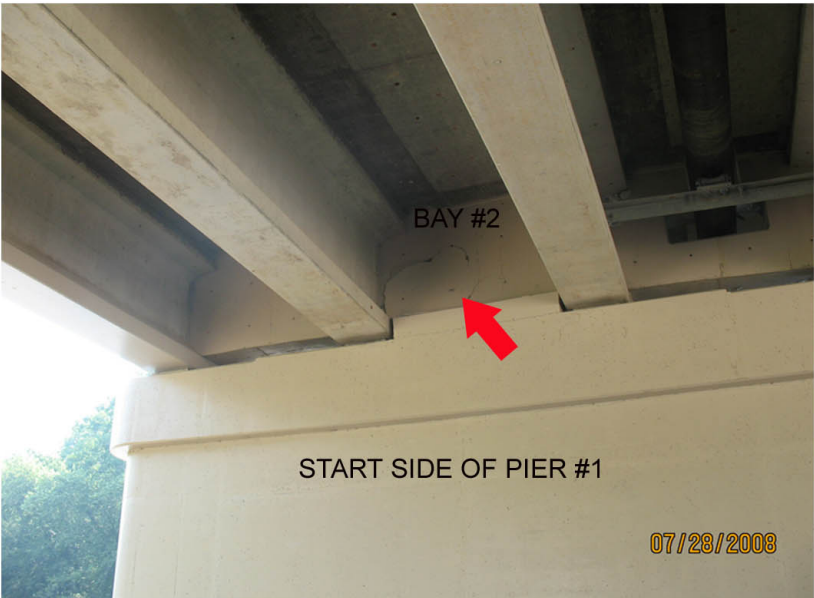
BEAMS: ONE SMALL CHIP ON LEFT FASCIA BEAM SPAN 3.
DIAPHRAGMS: 5 SF DELAMINATION TO CONCRETE IN BAY #2 OVER
PIER #1. SEE ATTACHED PHOTOS 1 AND 2 DATED
7/28/08.

P1: 5 SF DELAM TO CONCRETE DIAPHRAGM.

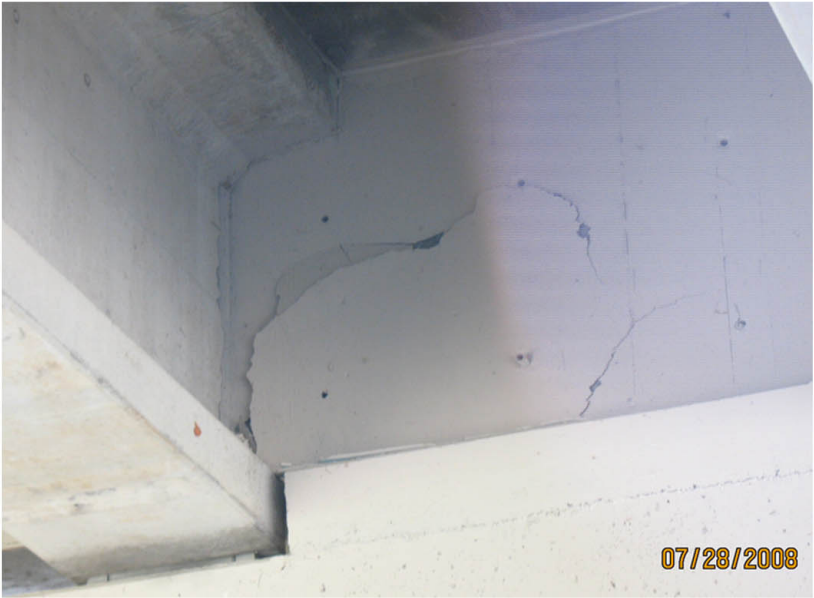
P2: CLOSE-UP OF P1.

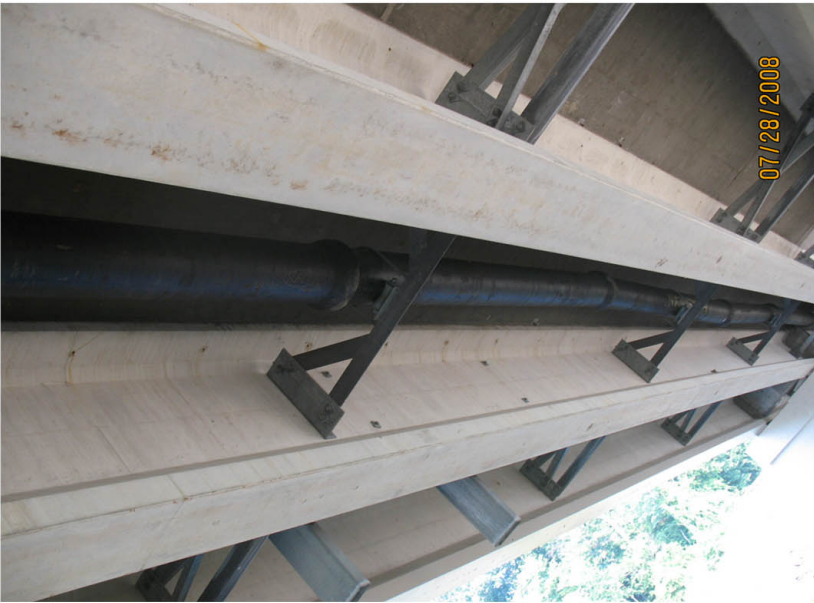
UTILITIES: SOME MISALIGNMENT OF 16" PIPE IN BAY #3. SEE
ATTACHED PHOTO 3 DATED 7/28/08.

P3: TYPICAL MISALIGNMENT OF 16" PIPE IN BAY #3

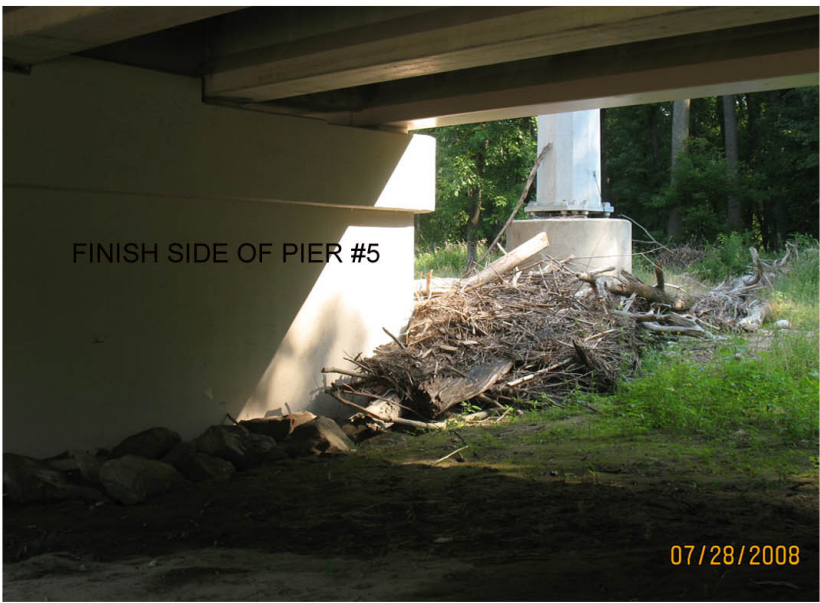
P4: NOTE LOG JAM BETWEEN PIER 5 AND UTIL POLE FOUNDATION. HIGH WATER FLOWS THRU HERE.

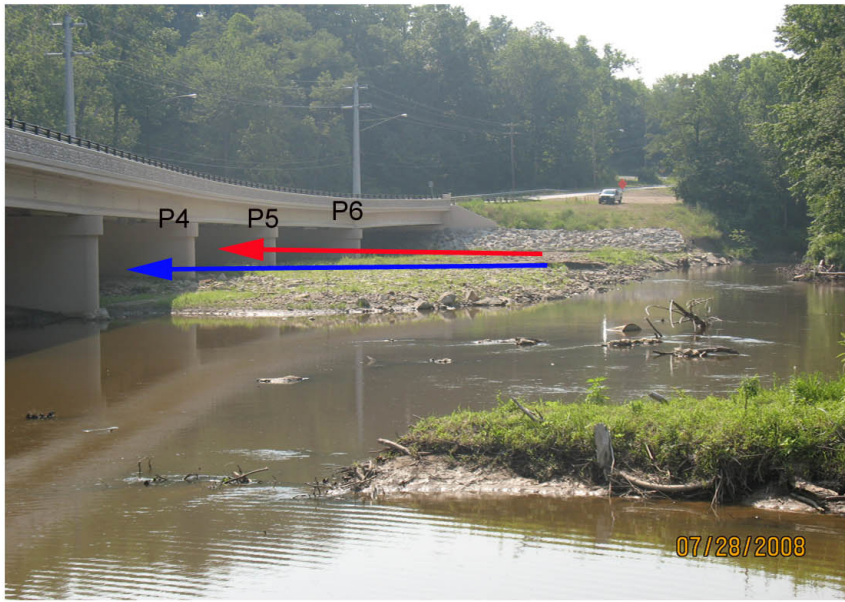
P5: RED LINE AND BLUE LINE SHOW PATH OF HIGH WATER FLOW.

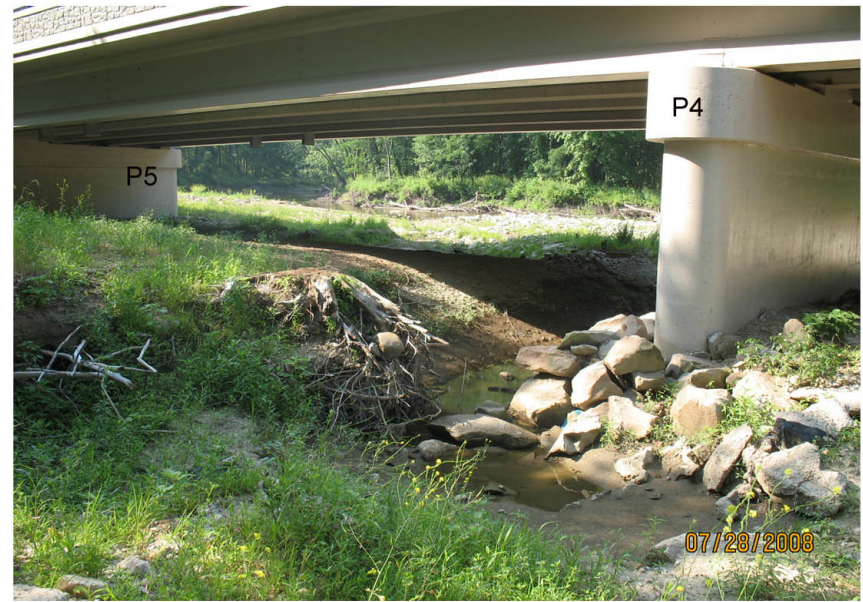
P6: THIS IS THE PATH OF THE RED LINE IN P5. NOTE SOME WASH OUT TO FINISH SIDE OF PIER #4.

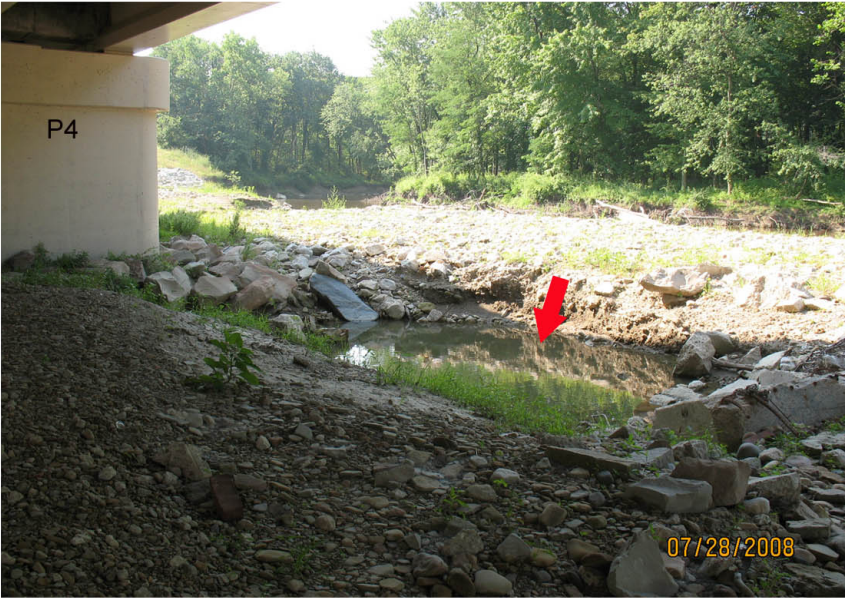
P7: THIS IS THE PATH OF THE BLUE LINE IN P5. NOTE THE SMALL POND THAT THE ARROW IS POINTING TO. POND IS AS DEEP AS 3 FT.
