BRIDGE INSPECTION REPORT

4303040
Structure File NumberBRIDGE NUMBER **LAK 00084 1888**YEAR BUILT **2006**DIST **12** Bridge Type **221** TYPE SERVICE **1 5** **GRAND RIVER**

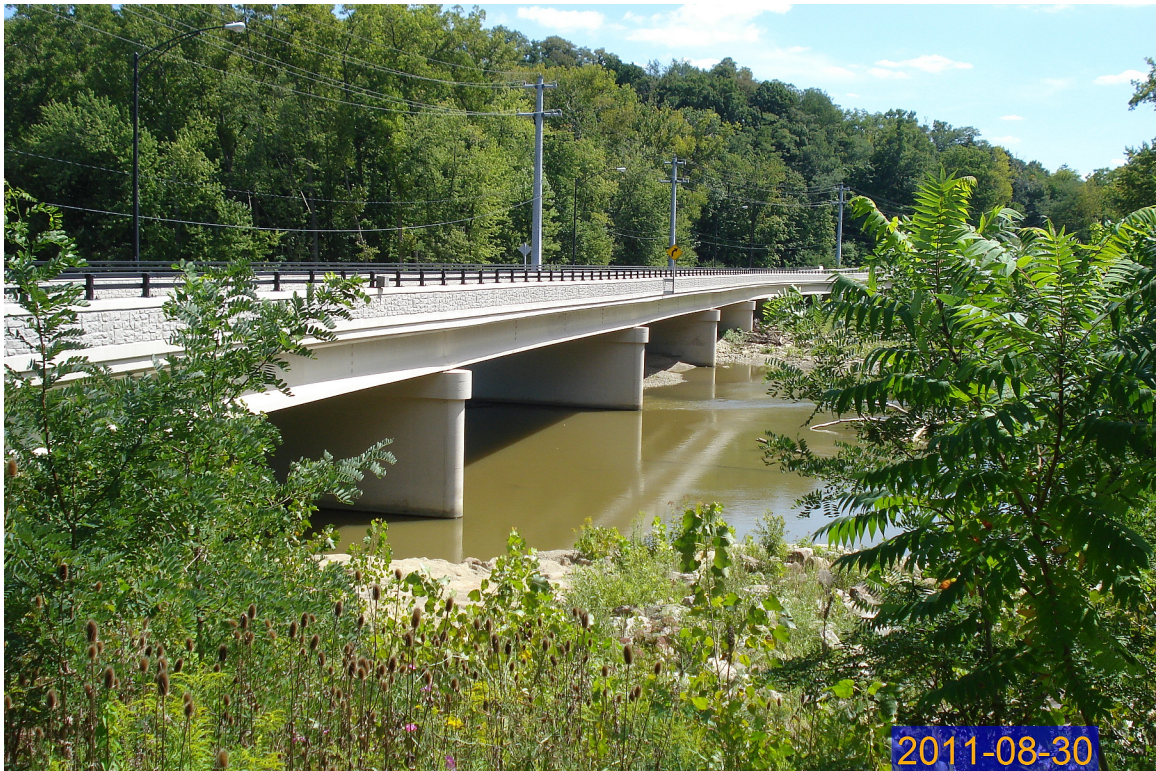
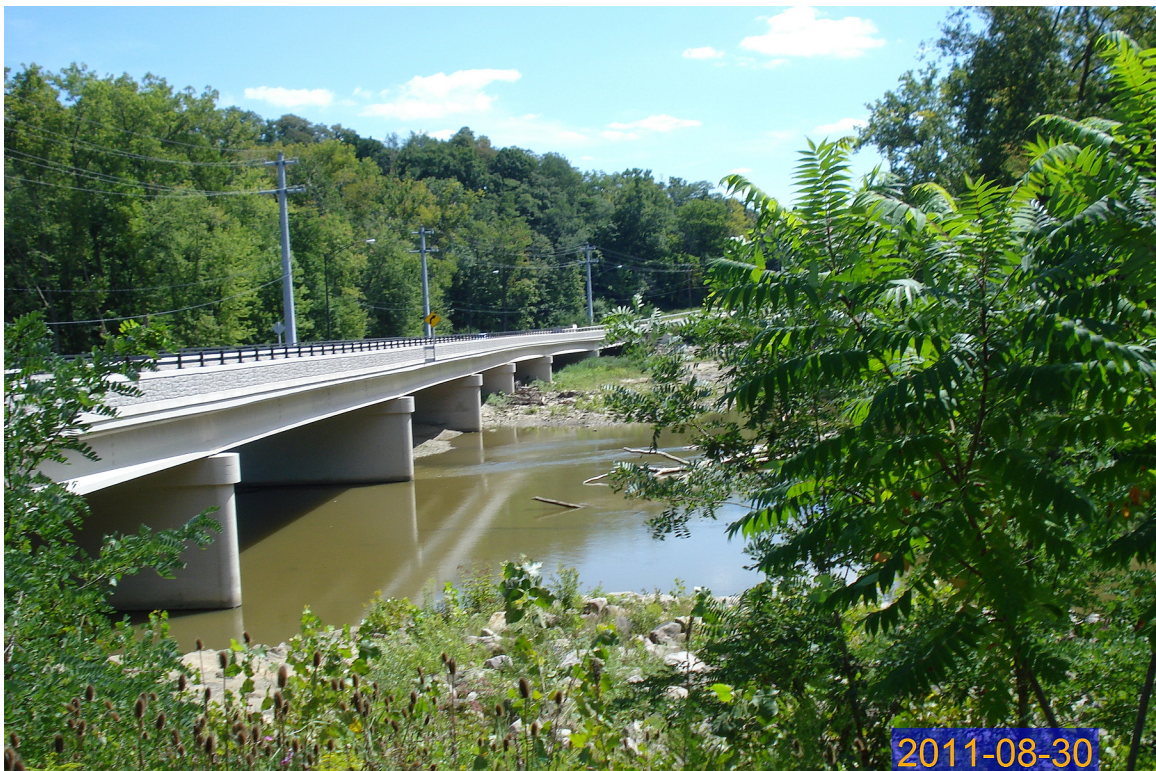
ALIGNMENT: CHANNEL MAKES 90 DEGREE BEND JUST UPSTREAM OF
BRIDGE. BRAIDED CHANNEL DURING HIGH FLOW. SEE ATTACHED
PHOTO DATED 12/03/09. SOME DIAGONAL FLOW INTO PIER STEMS.
NOTE: USGS STREAM DATA
COLLECTION MONITOR STATIONED ON WEST BANK.
PROTECTION: LARGE STONE AROUND BASES OF PIERS 4, 5 AND 6
HAS PARTIALLY WASHED AWAY. SEE ATTACHED PHOTOS 4-7 DATED
7/28/08.

Looking upstream, both photos, note changed path of river from previous years.

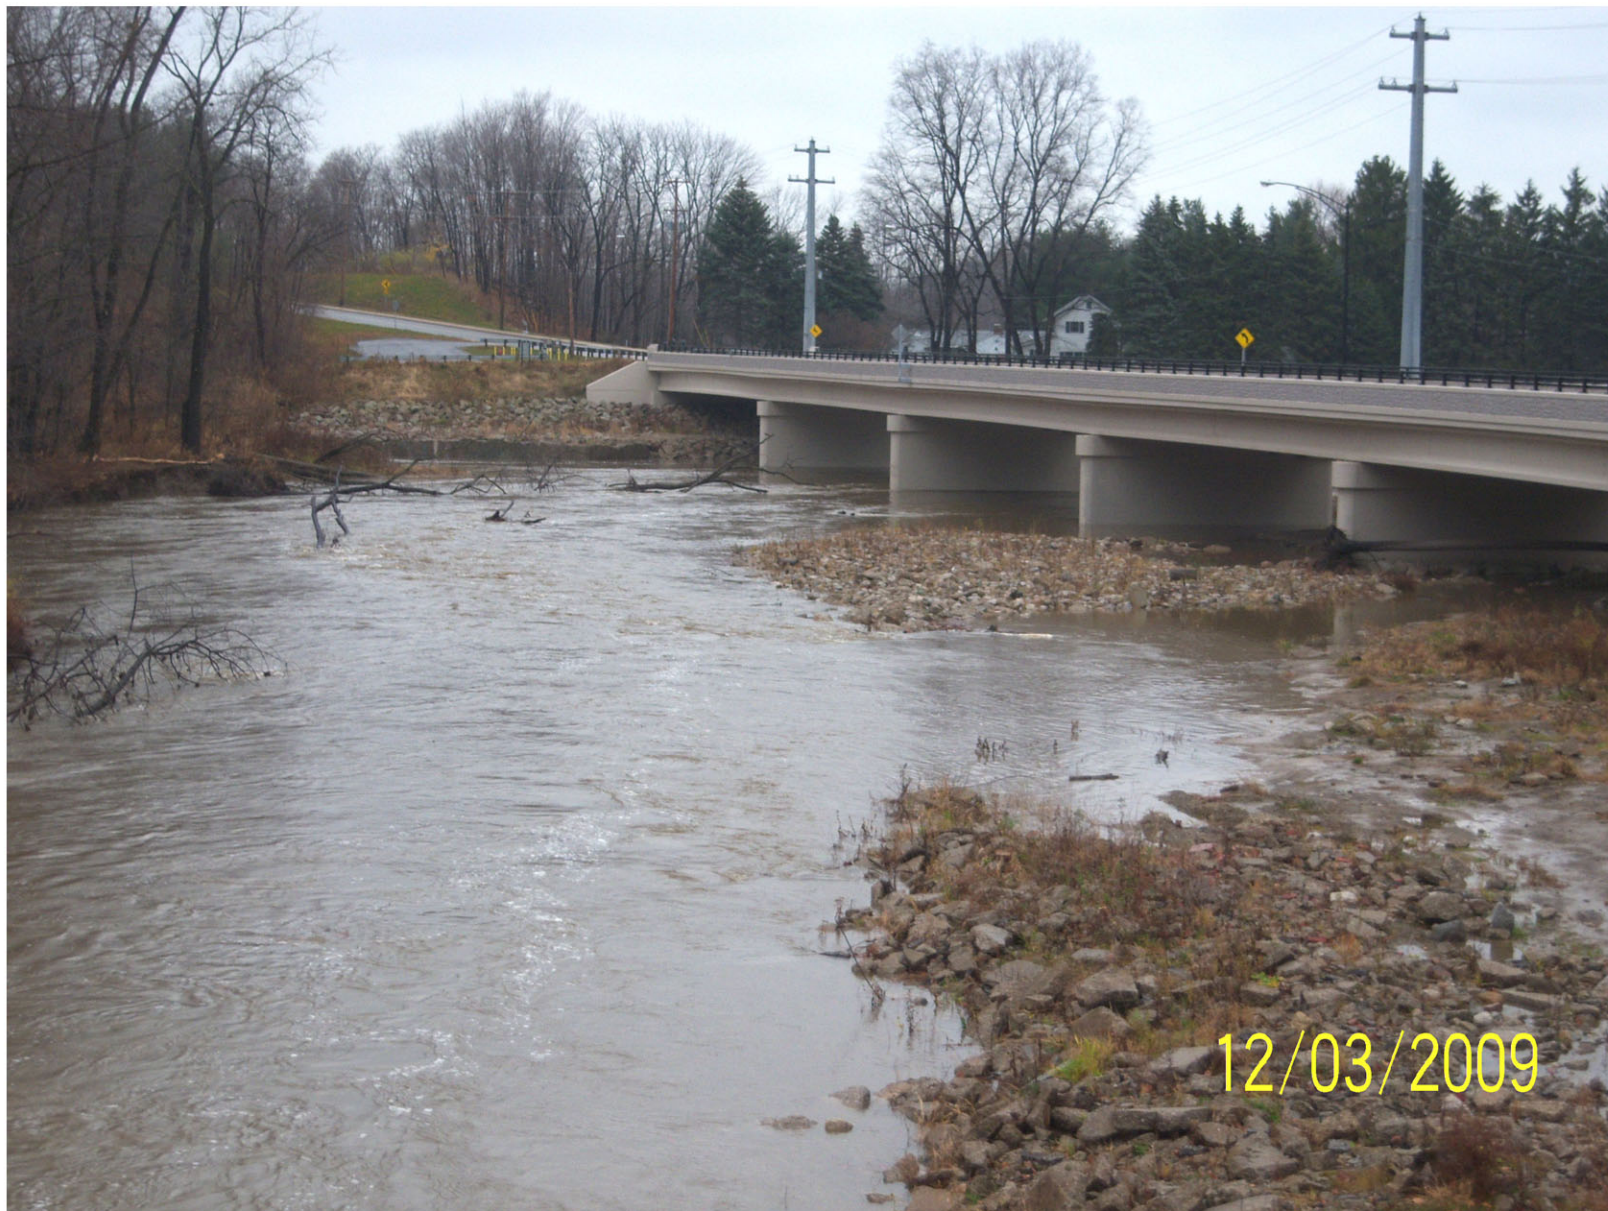
Braided channel upstream of SR 84.JPG

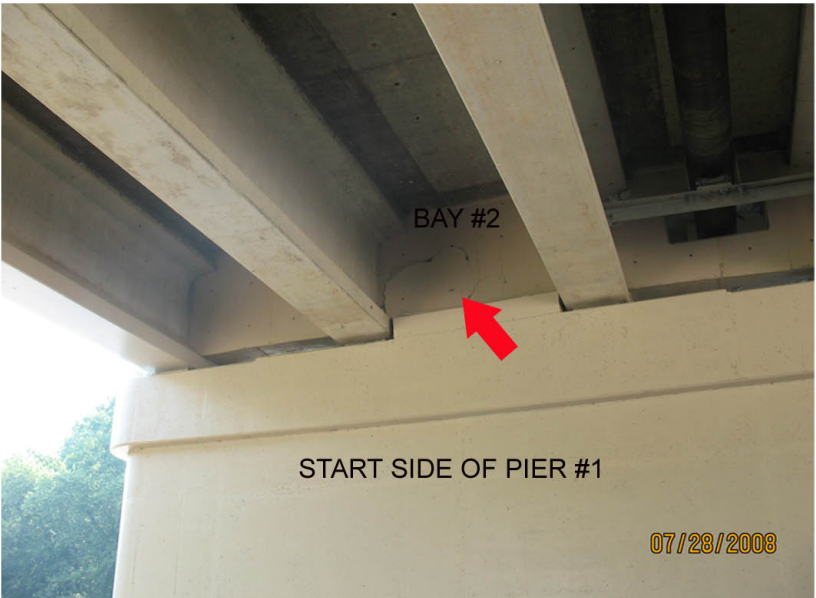
BEAMS: ONE SMALL CHIP ON LEFT FASCIA BEAM SPAN 3.
DIAPHRAGMS: 5 SF DELAMINATION TO CONCRETE IN BAY #2 OVER
PIER #1. SEE ATTACHED PHOTOS 1 AND 2 DATED 7/28/08.

P1: 5 SF DELAM TO CONCRETE DIAPHRAGM.

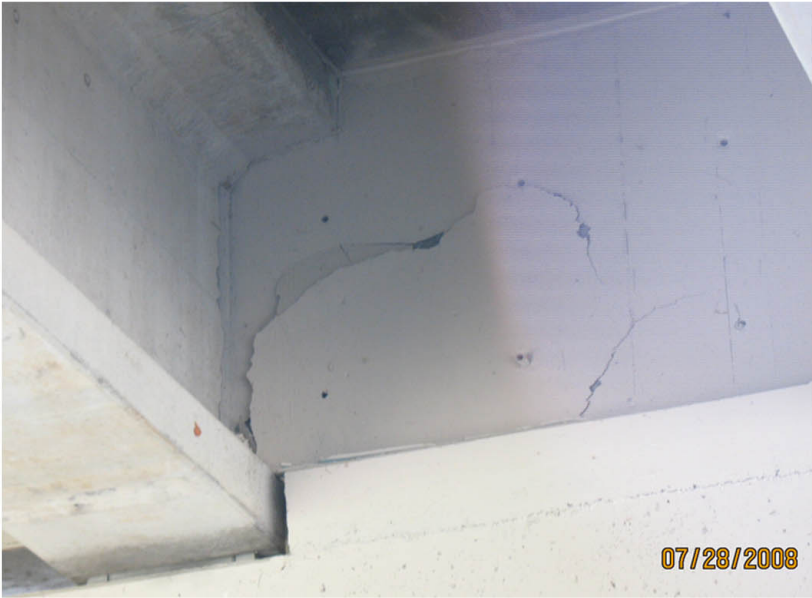
P2: CLOSE-UP OF P1.

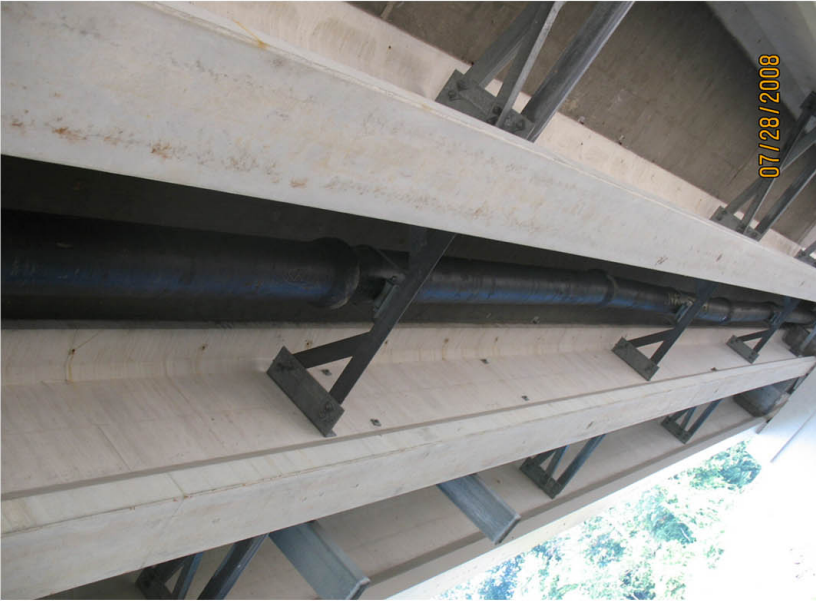
UTILITIES: SOME MISALIGNMENT OF 16" PIPE IN BAY #3. SPAN 6,
CONSTANT LEAKING AT THE RELEIF VALVE. SEE ATTACHED PHOTO 3
DATED 7/28/08.
INSPECTED WITH MIKE GERSTENSLAGER.

P3: TYPICAL MISALIGNMENT OF 16" PIPE IN BAY #3

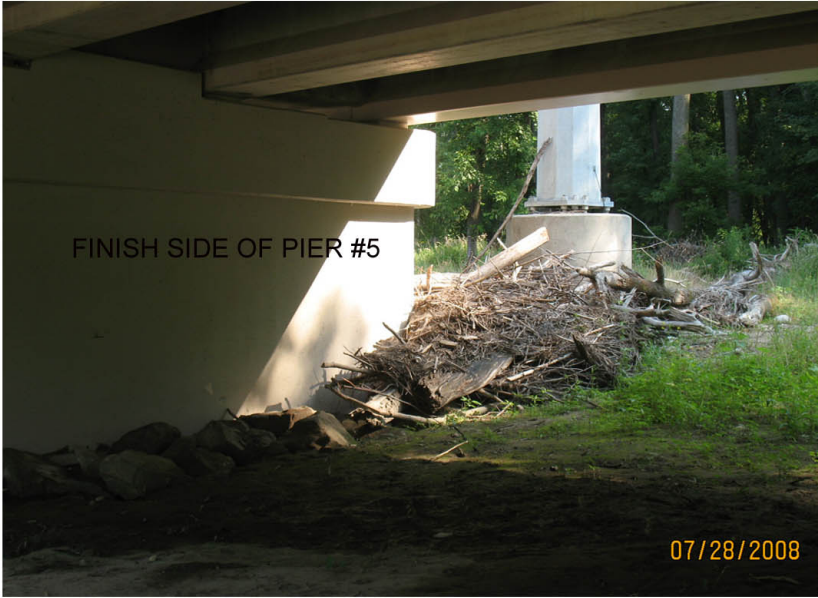
P4: NOTE LOG JAM BETWEEN PIER 5 AND UTIL POLE FOUNDATION. HIGH WATER FLOWS THRU HERE.

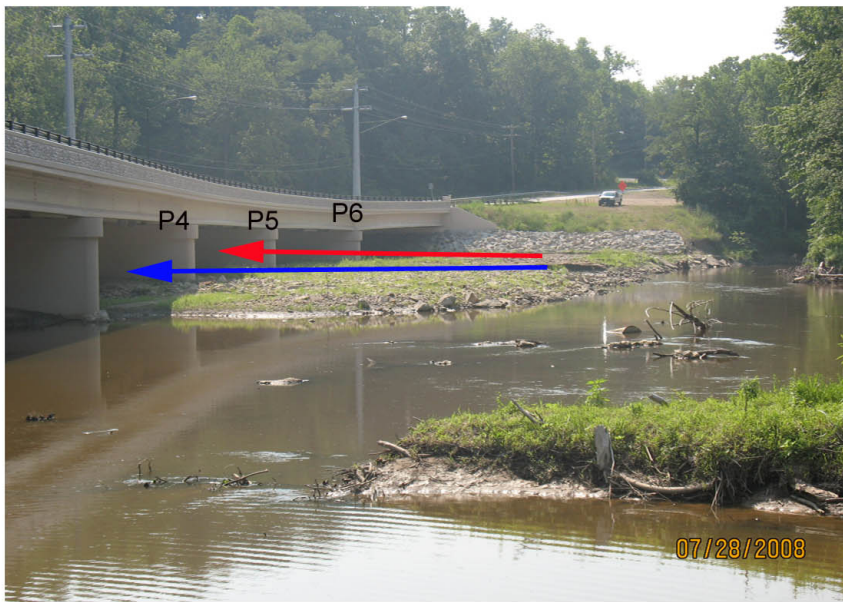
P5: RED LINE AND BLUE LINE SHOW PATH OF HIGH WATER FLOW.

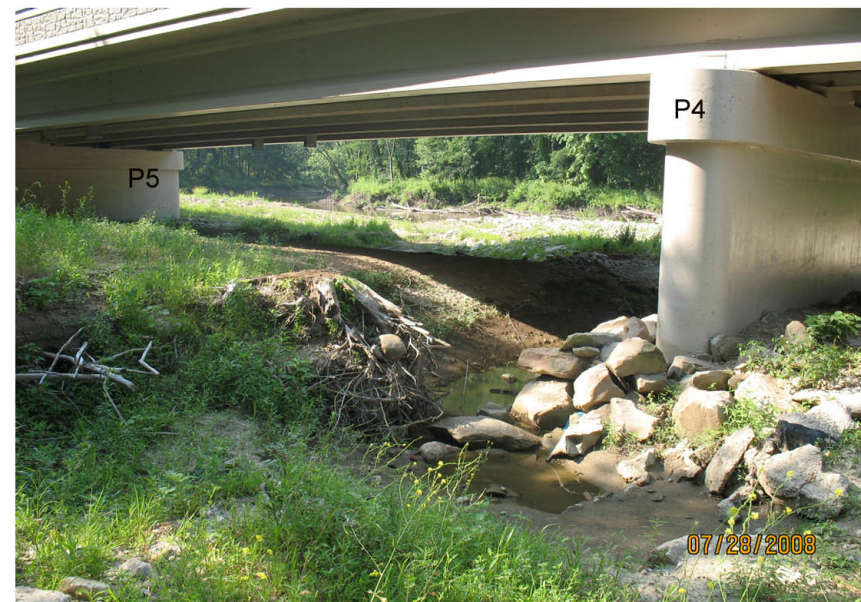
P6: THIS IS THE PATH OF THE RED LINE IN P5. NOTE SOME WASH OUT TO FINISH SIDE OF PIER #4.

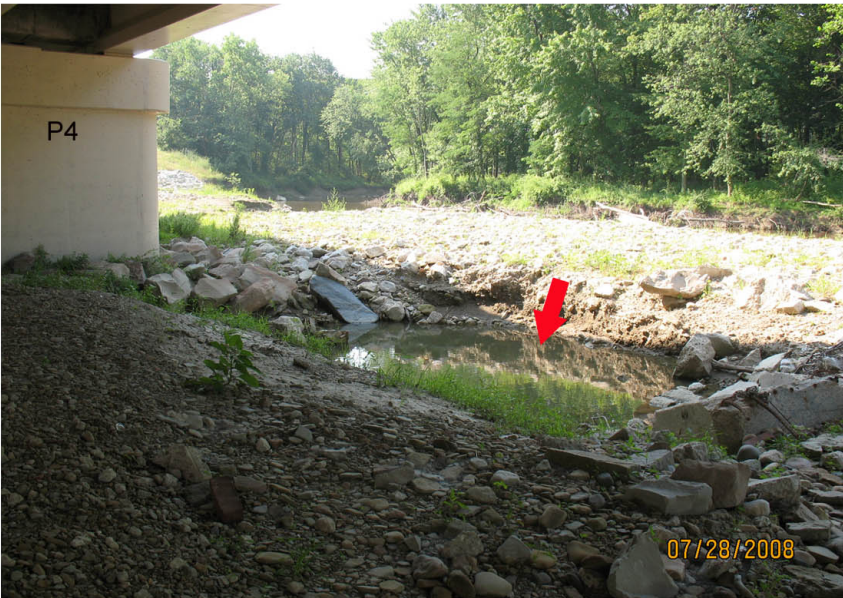
P7: THIS IS THE PATH OF THE BLUE LINE IN P5. NOTE THE SMALL POND THAT THE ARROW IS POINTING TO. POND IS AS DEEP AS 3 FT.
