**Underwater Inspection of  
SFN - 4303040  
Route 84 over the Grand River  
(LAK-84-1888)  
July 23, 2014  
for  
Ohio Department of Transportation  
District-12**

**By**  
**GPI/Greenman-Pedersen, Inc.**

Structure File Number: 4303040  
Facility: Route 84  
Feature: Grand River  
County: Lake

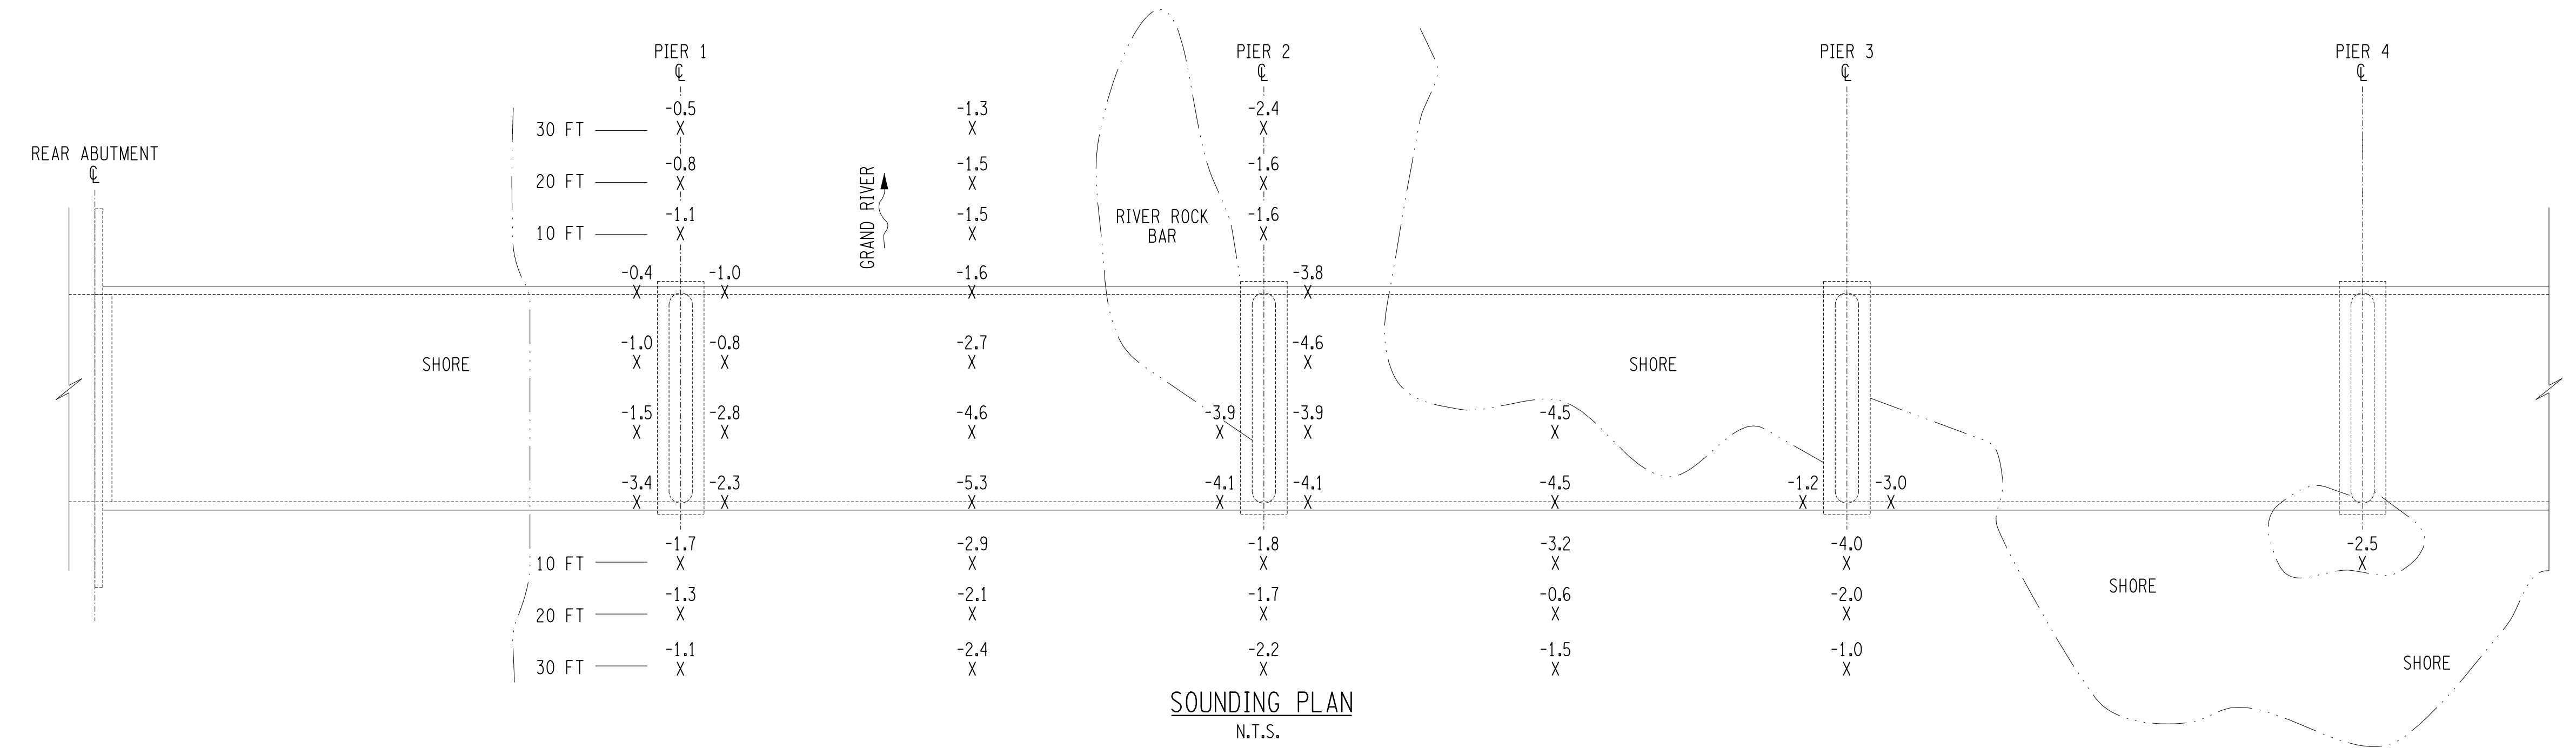
SOUNDING PLAN  
N.T.S.

The Grand River flows Southwest to Northeast under this structure. The thalweg of this river runs between Pier 1 and Pier 2. A maximum depth of 5.3 feet was found under the structure in the thalweg. Flow at this bridge was 1 foot per second.

- As mentioned in previous report (2009) the channel alignment is poor and is unchanged. Localized scour holes noted in 2009 report have been reduced in size, while other areas not noted in previous report have localized scour present. Please refer to sounding data to reference these changes.
- Penetrations taken during soundings were typically 1 to 2 inches, except in two locations. 30 feet upstream of Pier 1 and at upstream nose of Pier 3, where there was 6" penetration in to the soft silt/mud.

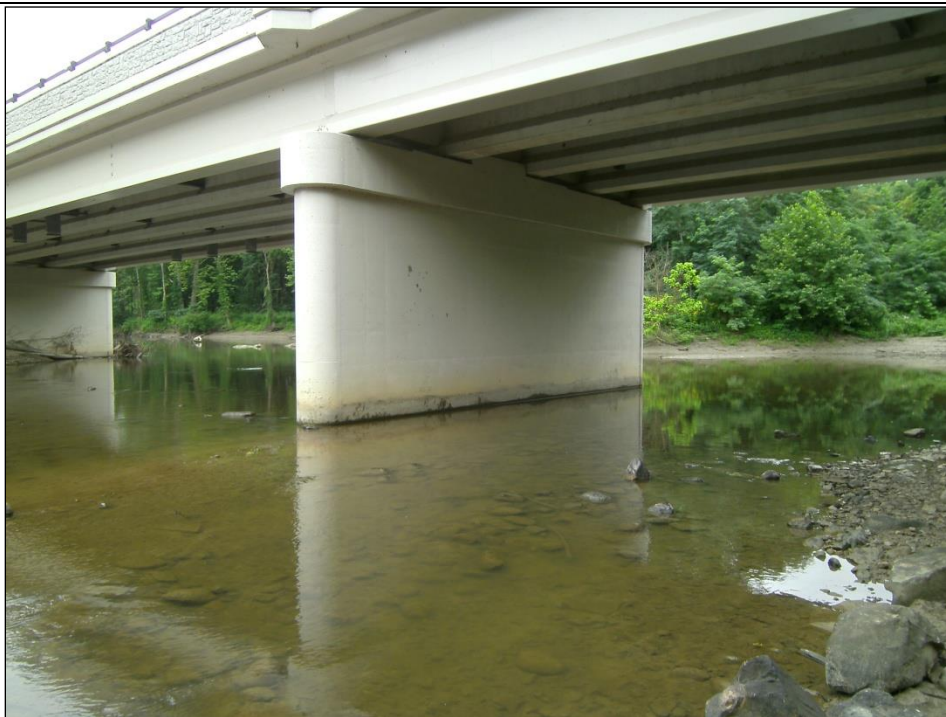
Photograph 6  
View of Pier 1,  
North Face.  
Looking  
Southwest.

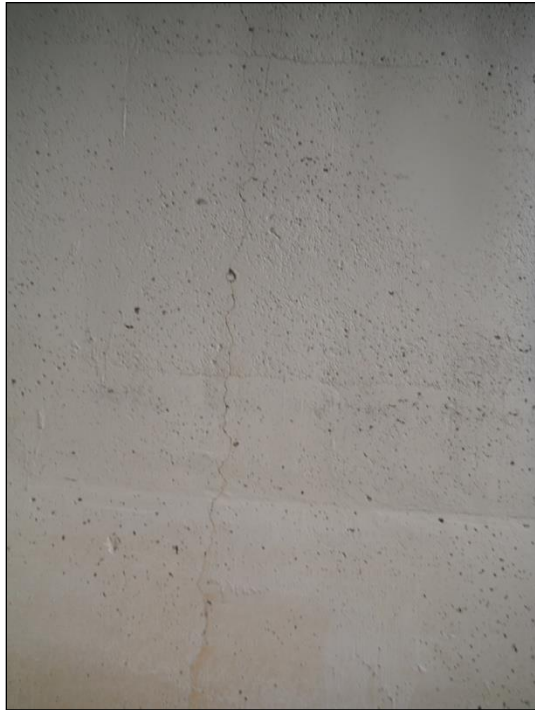
- Two hairline cracks spaced evenly across on north and south face of Pier 1 from mudline to top of Pier where confirmed as documented in inspection done in 2009, and has not advanced in severity. (See photo 7)
- Timber debris 8 inch diameter tree submerged underwater at upstream nose. Wraps around nose down south face of Pier. (See photo 8)

Photograph 7  
Typical hairline  
cracks (Pier 1).  
Looking South.

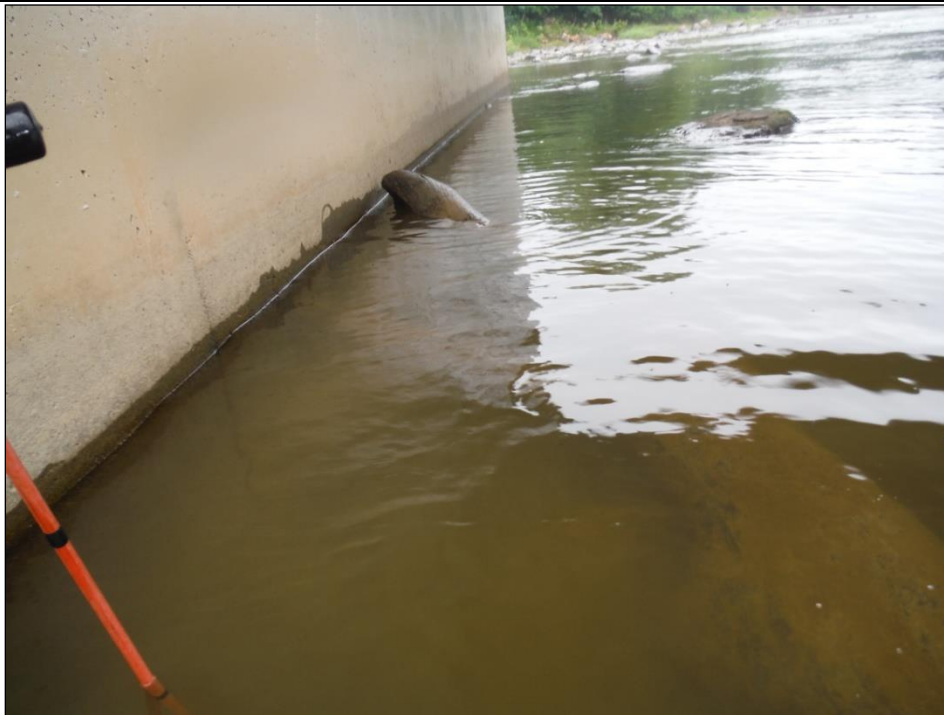
Photograph 8  
Timber debris  
south face Pier 1.

- Re-inspect the submerged substructure units at the normal maximum recommended interval of five (5) years and after a significant event such as flood, impact or other phenomenon that could affect the structural integrity of the bridge. Timber debris located at Piers and adjacent around Piers should be removed. Large riprap should be placed around exposed footings and Pier noses as recommended in 2009 report.

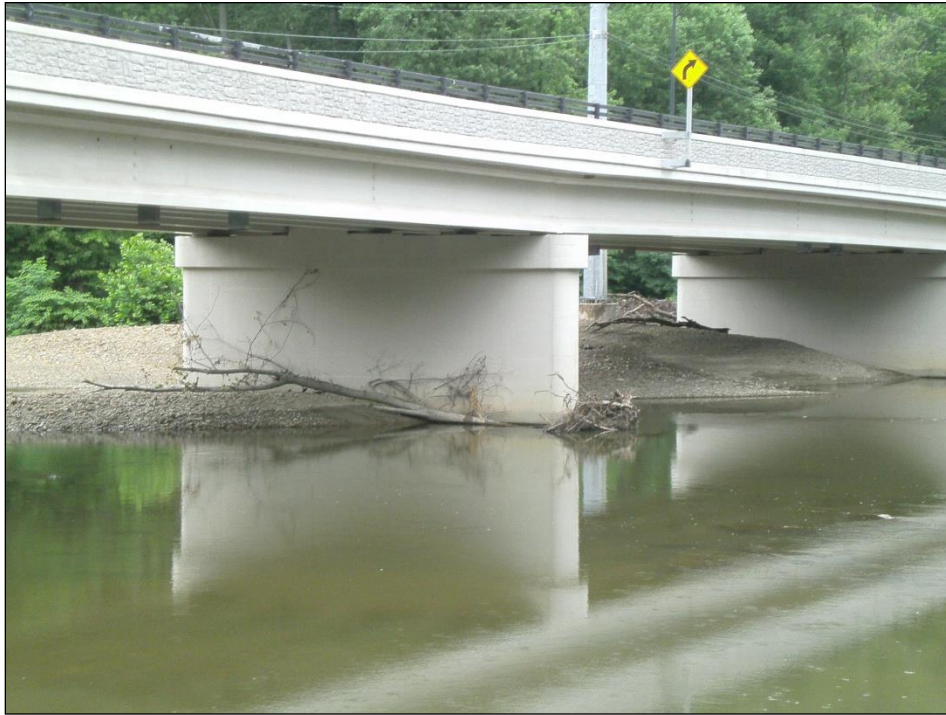
- Two hairline cracks spaced evenly across on south face of Pier 2 and one hairline crack located midpoint on north face where confirmed as documented in inspection done in 2009, and has not advanced in severity.
- Timber debris with 8 inch diameter tree at upstream nose. Debris pile is approximately 4 to 5 feet high. Tree wraps around nose down entire north and south face of Pier. (See photo 9)
- The footer on Pier 2 is exposed 2 to 4 vertical inches starting 5 feet from upstream nose on the north face continuing around upstream nose to south face of Pier to downstream nose. The exposure of the footing appears to be due to local scour of the mudline in the vicinity of the Pier 2.

Photograph 9  
View of Pier 2  
and Pier 3, North  
Face. Timber  
debris at Pier 2.  
Looking  
Southeast.

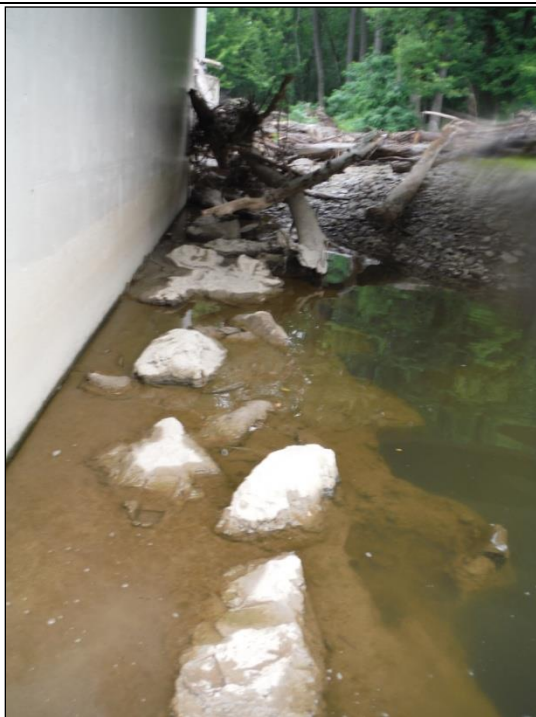
- Both the north and south faces of Pier 3 have a hairline vertical crack mid Pier from mudline to top of Pier where confirmed as documented in inspection completed in 2009, and has not advanced in severity.
- The footer on Pier 3 is exposed 12 to 14 vertical inches on upstream nose continuing on south face of Pier to mid Pier. (See photo 10)

Photograph  
10  
View of Pier 3,  
South Face.  
Exposed footer  
underwater.  
Looking East.

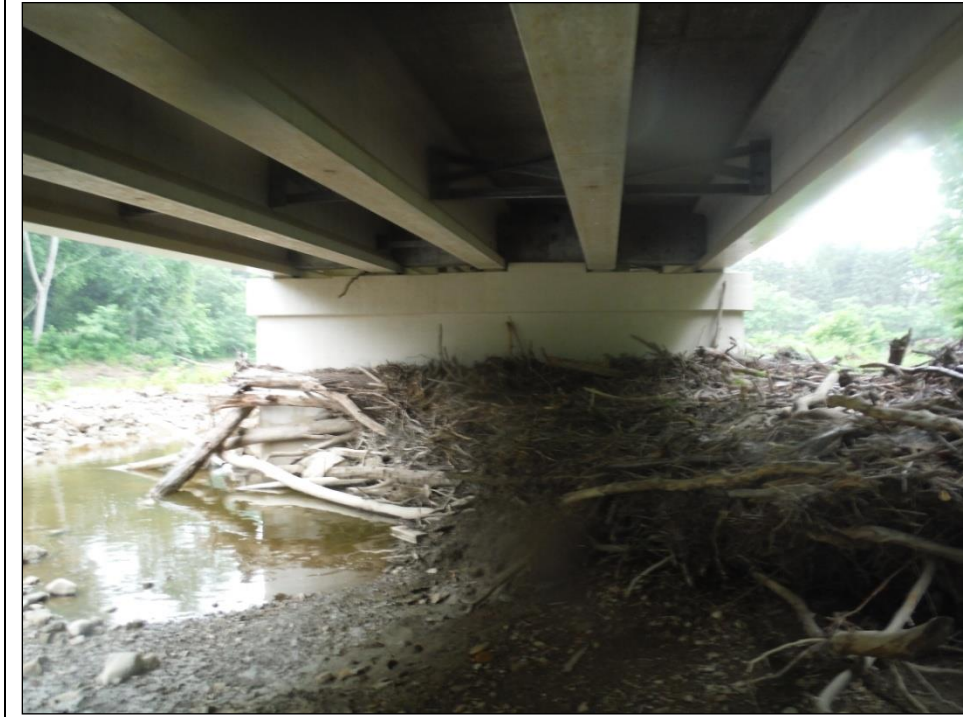
- Large timber debris pile adjacent to Pier 4 approximately 8 to 10 feet high. Continues from south face of Pier 4 south to mid span. (See photo 11)
- No other deficiencies noted for Pier 4.

Photograph  
11  
View of Pier 4,  
South Face.  
Large pile of  
timber debris.  
Looking North.
