2014 PHYSICAL CONDITIONS INSPECTION REPORT

CUY-490-0100
SFN 1811991

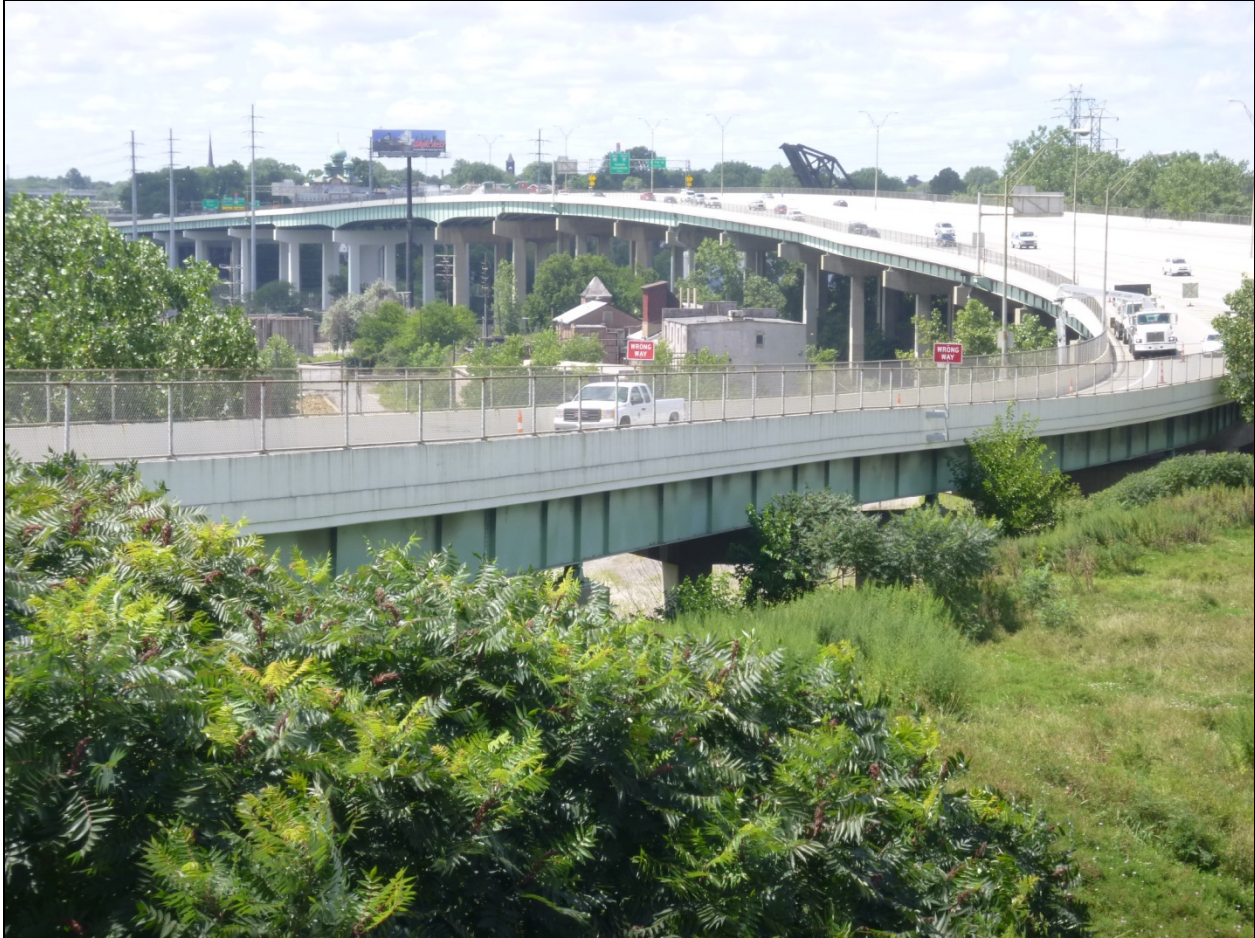
Ohio Department of Transportation

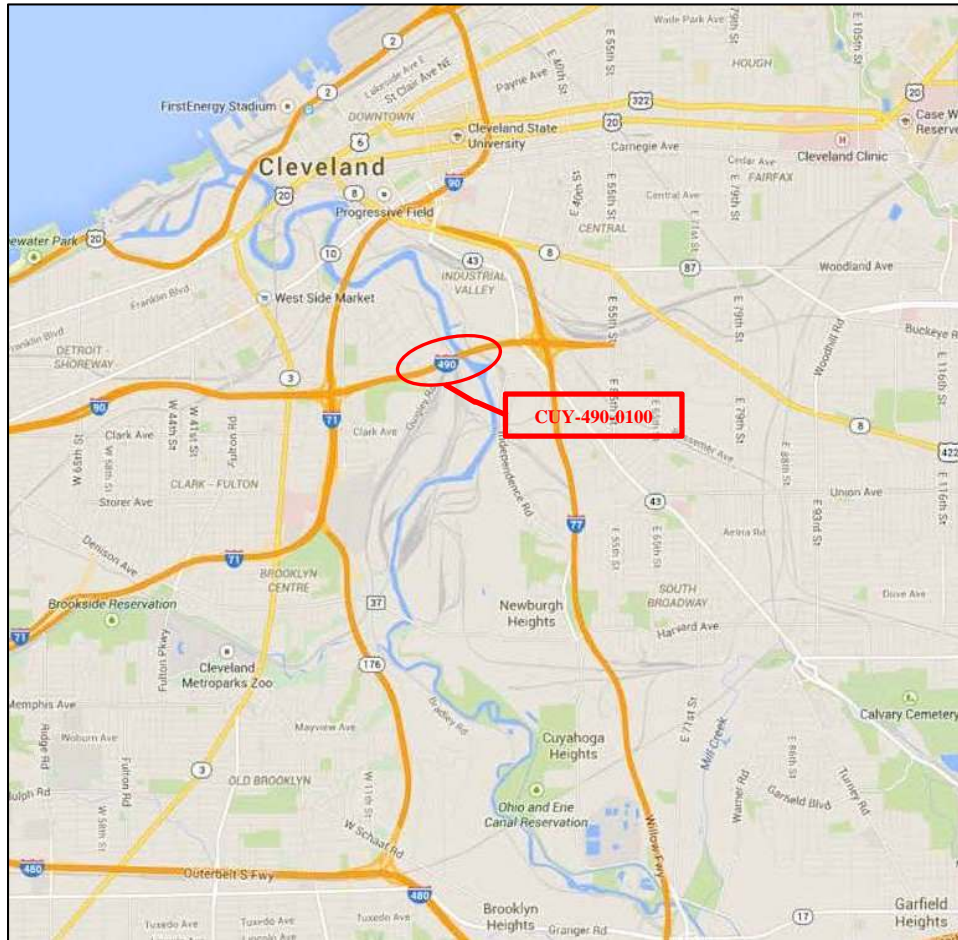
GENERAL APPRAISAL AND OPERATING STATUS

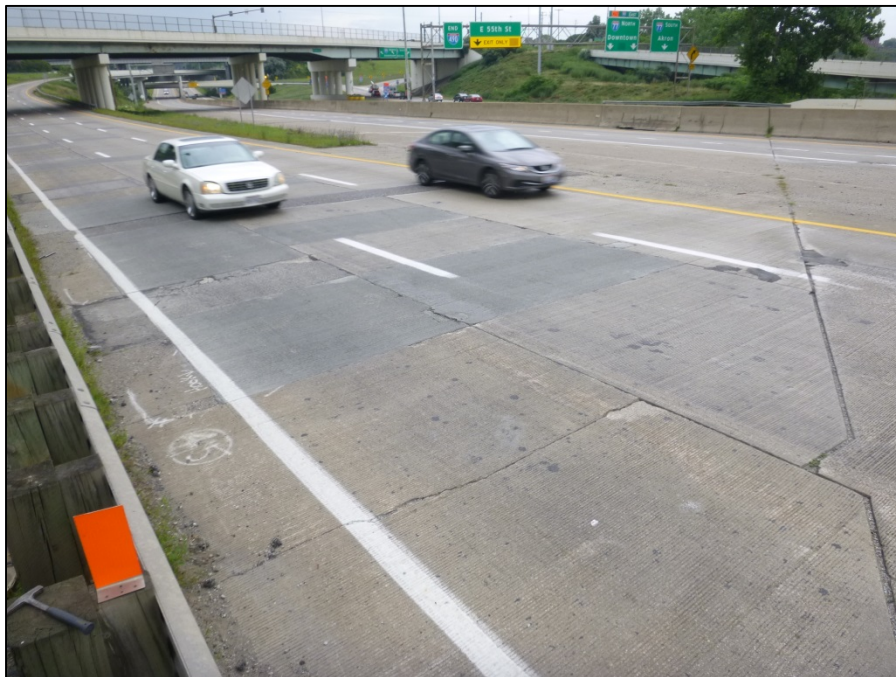
Picture #1: Westbound forward approach pavement exhibits cracks and asphalt patches.

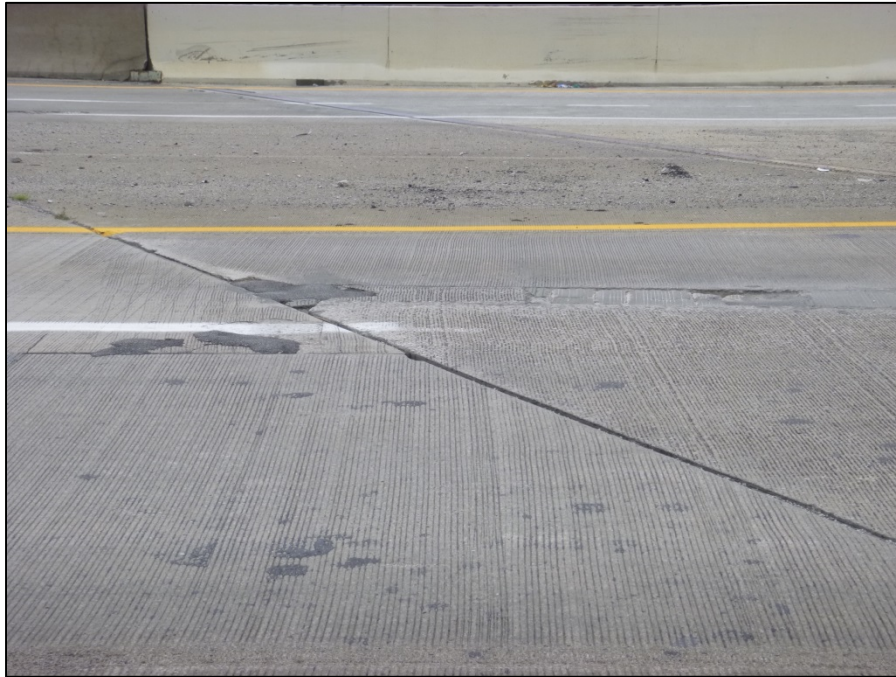
Picture #2: Westbound forward approach slab patches deteriorating, looking south.

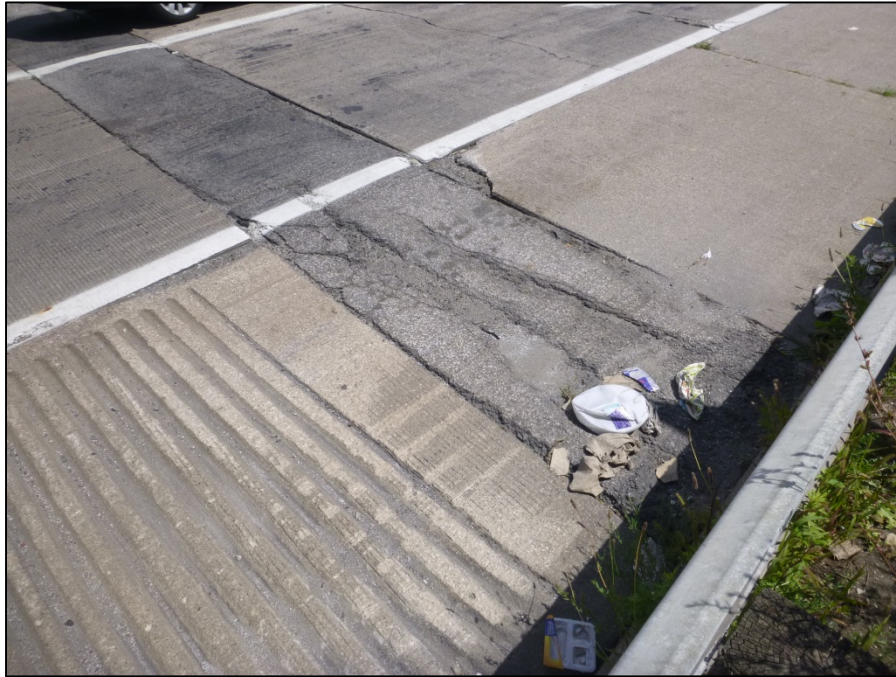
Picture #3: Cracking asphalt in the south shoulder and settled pavement in the lanes at the pavement relief joint at eastbound Ramp C-B to Broadway Avenue.

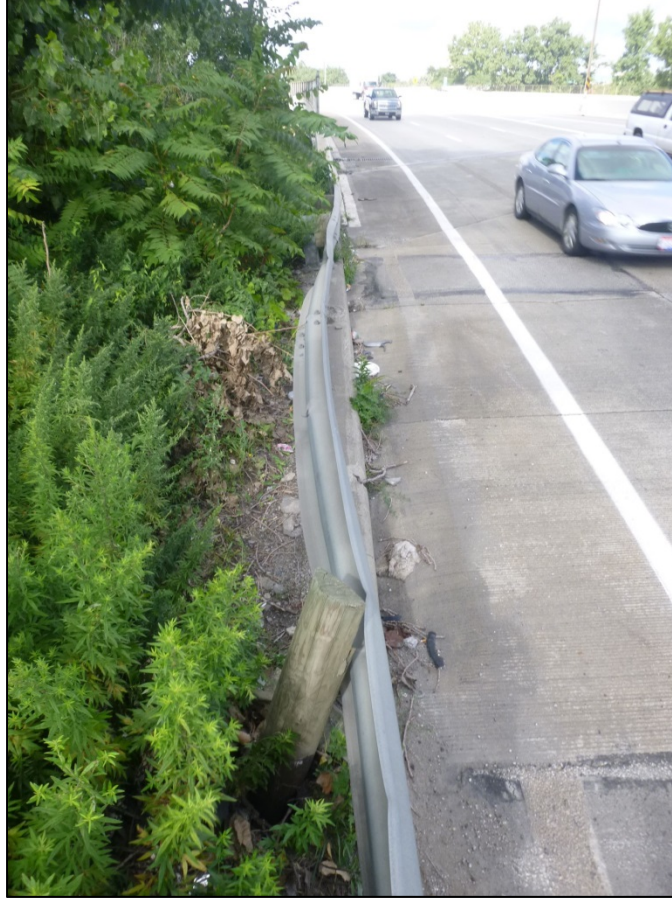
Picture #4: Three consecutive posts sheared off or missing at the eastbound forward approach, looking west.

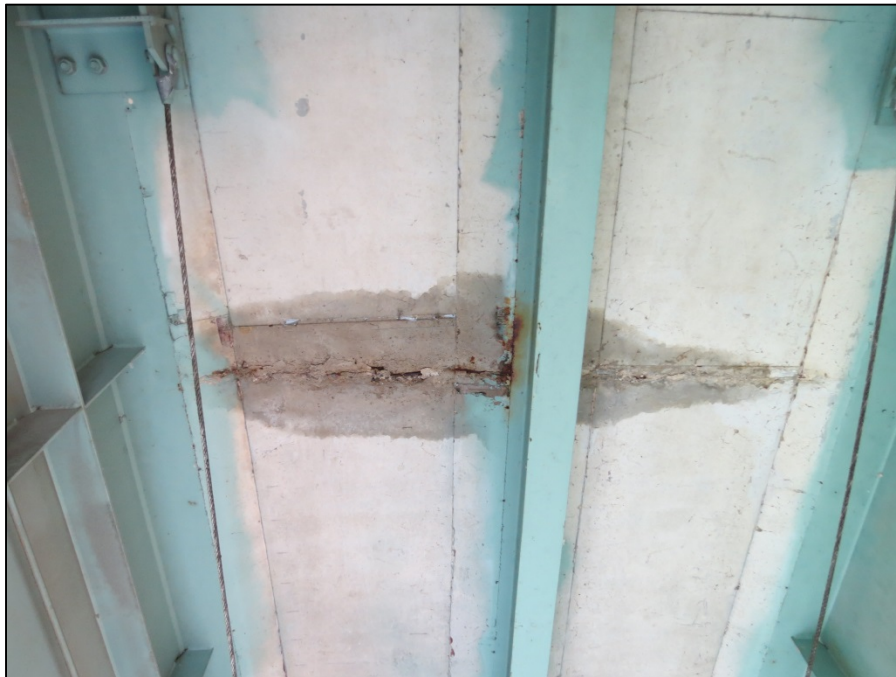
Picture #5: Typical leaking deck construction joint in span 6L between girders A and C, looking east. Note minor deterioration to stringer top flange.

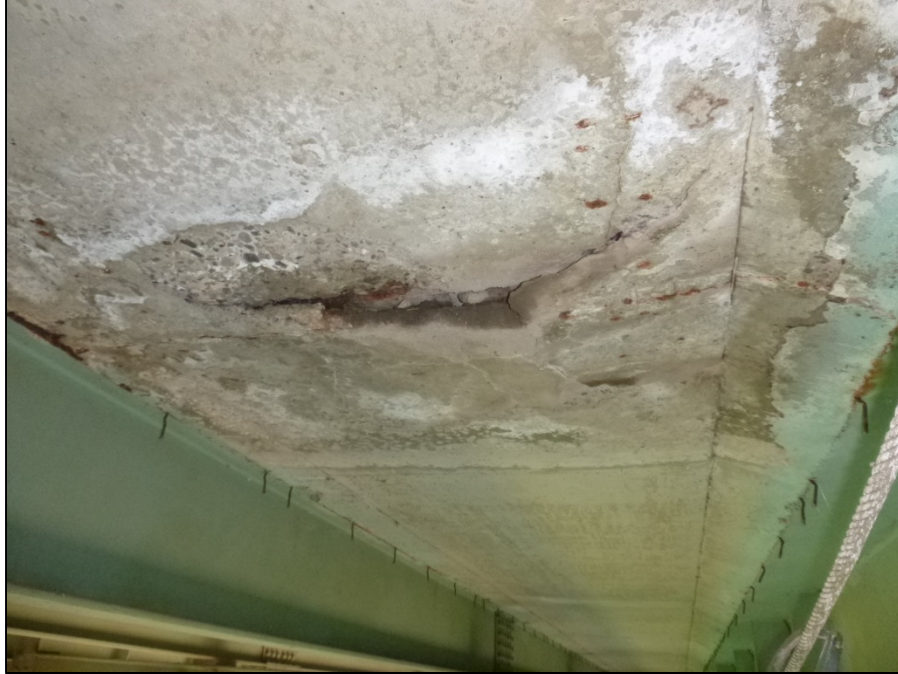
Picture #6: Spalled and delaminated underside of deck between girder 4-B and stringer 4-3 in span 14L over Independence Road.

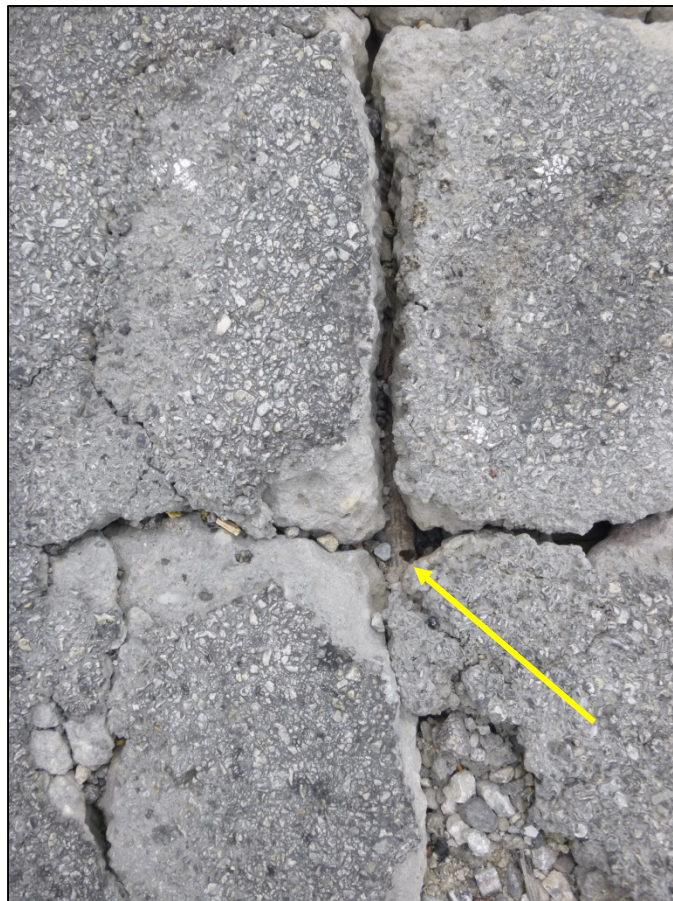
Picture #7: Exposed reinforcing steel in westbound deck patch over pier 14, looking south.

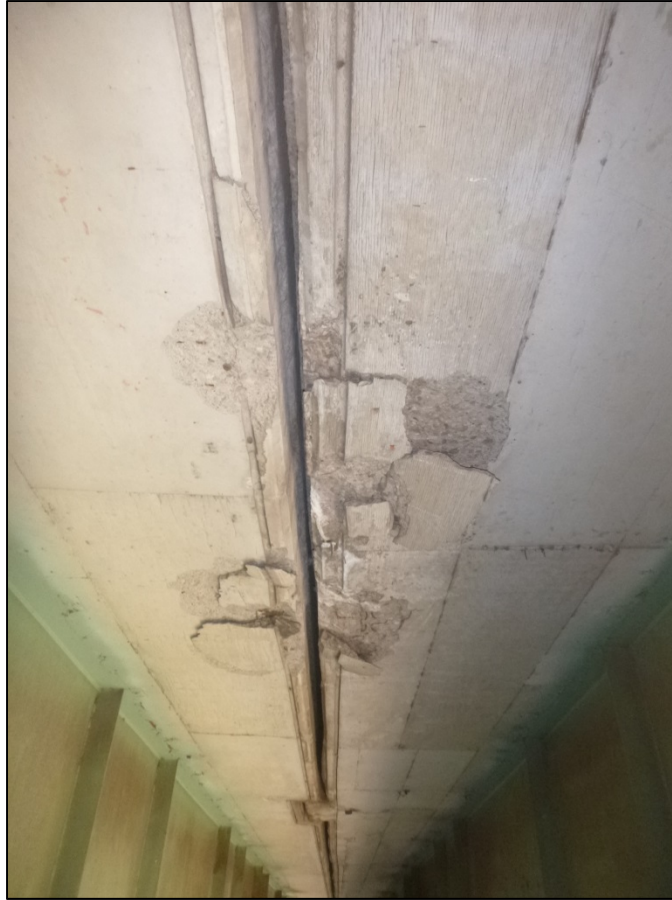
Picture #9: Multiple spalls in span 19 with exposed reinforcing steel, looking east.

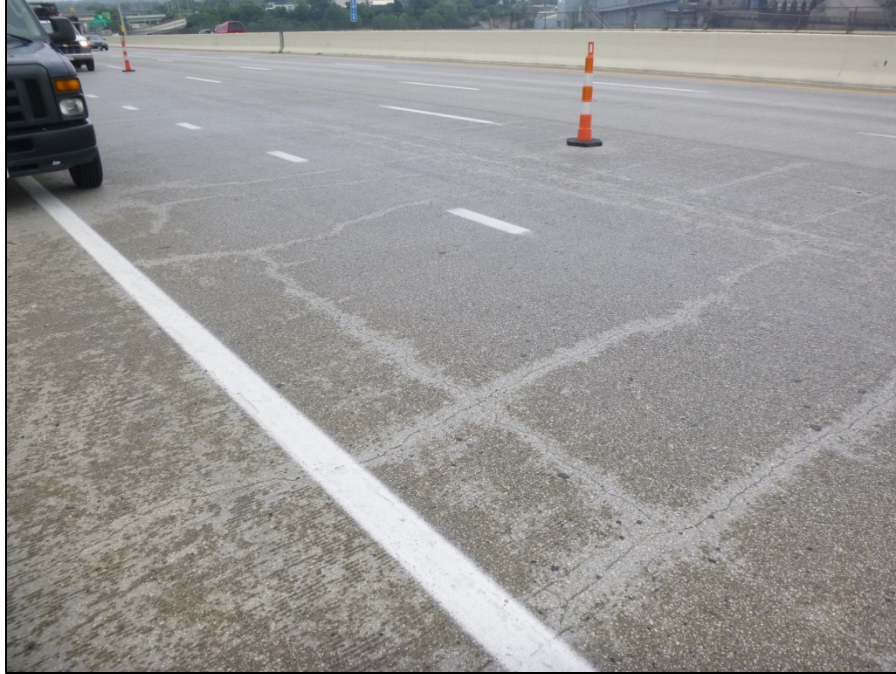
Picture #10: Typical cracking in wearing surface, unit 4, westbound deck, looking south.

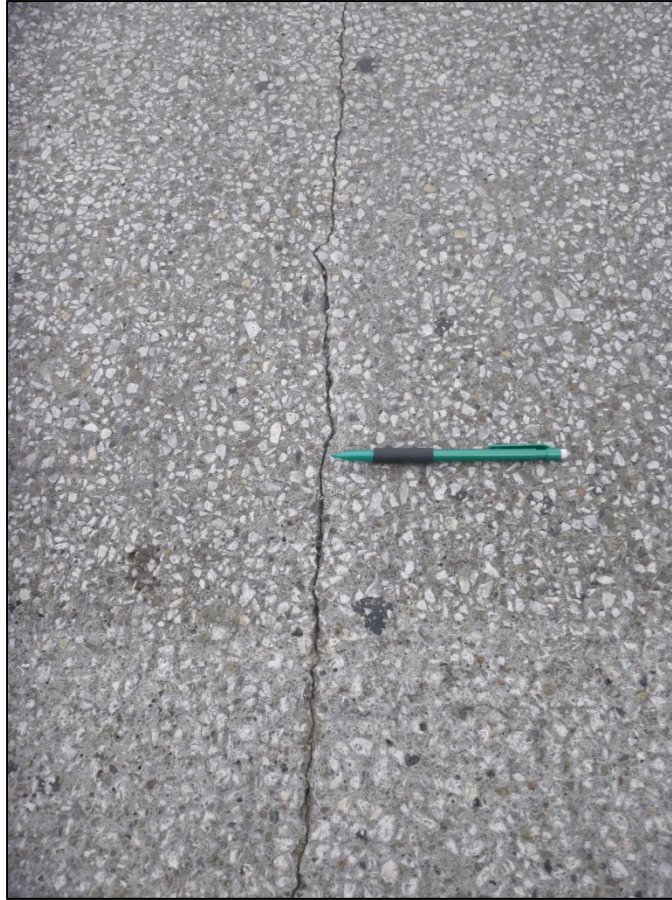
Picture #11: Full width 1/8" crack in eastbound wearing surface near Sta. 990+60, looking north.

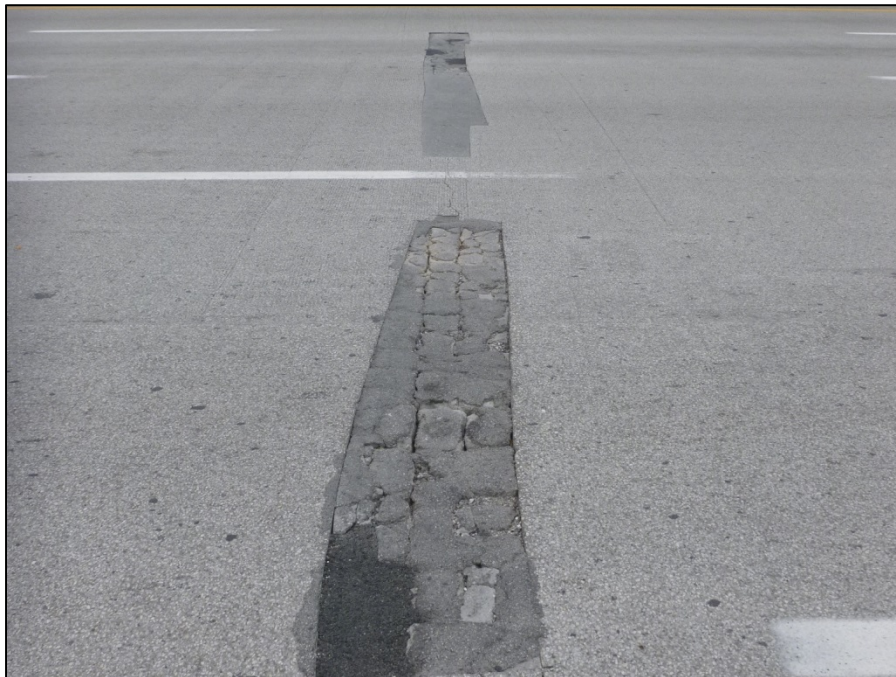
Picture #12: Deteriorating patch at full width transverse crack in westbound deck over pier 14, looking south.

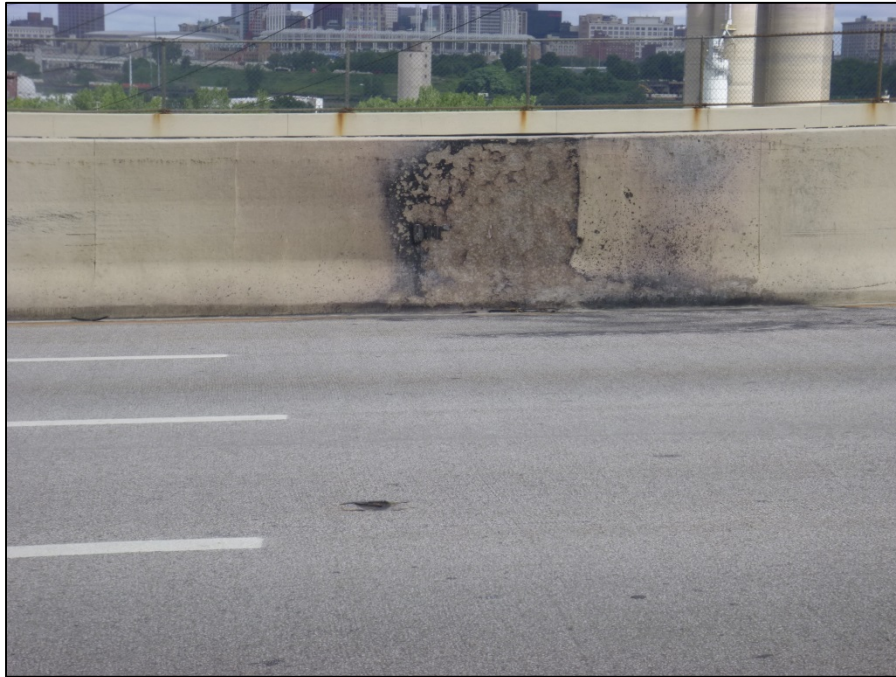
Picture #13: Fire damage to Unit 2 eastbound median barrier near Sta. 992+00, looking north.

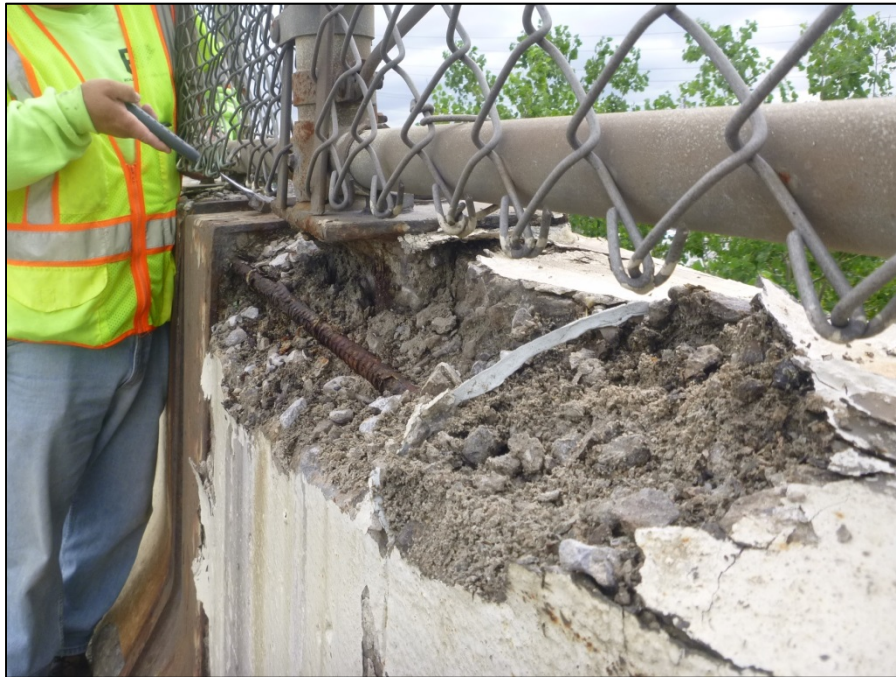
Picture #14: Concrete deterioration on eastbound railing at expansion joint 1, looking east. Note the fence post is now unsupported.

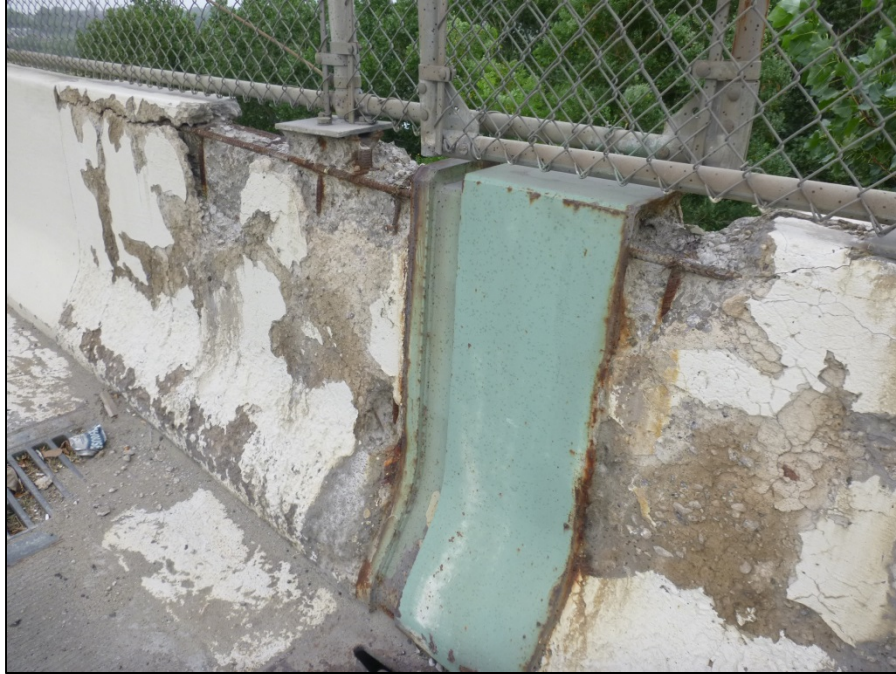
Picture #15: Cracked, spalled, and scaled concrete on westbound railing at expansion joint 4, looking north.

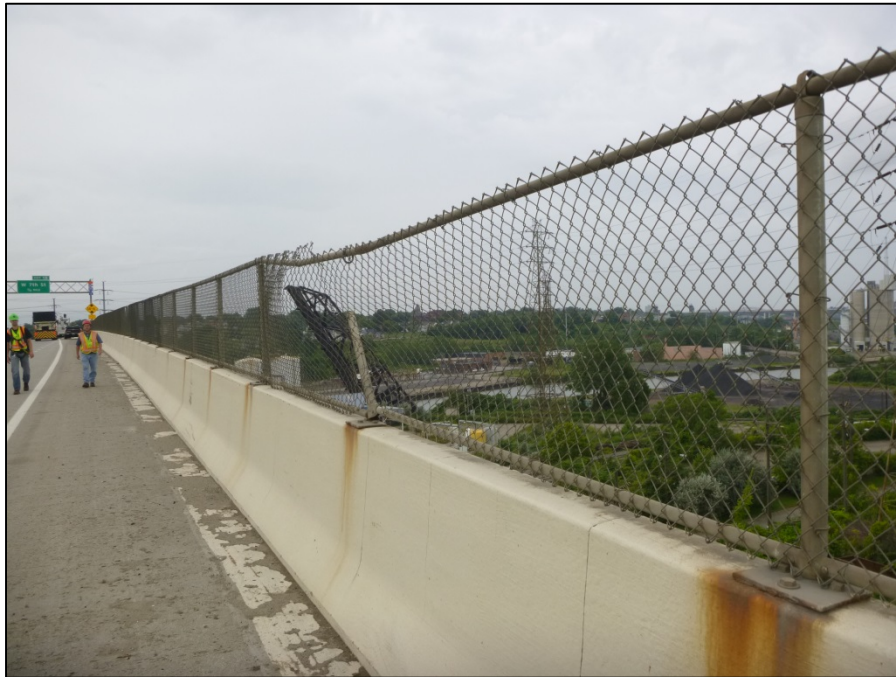
Picture #16: 20 feet of damaged westbound fence, including broken post, in Unit 4 at Sta. 1007+88, looking northwest.

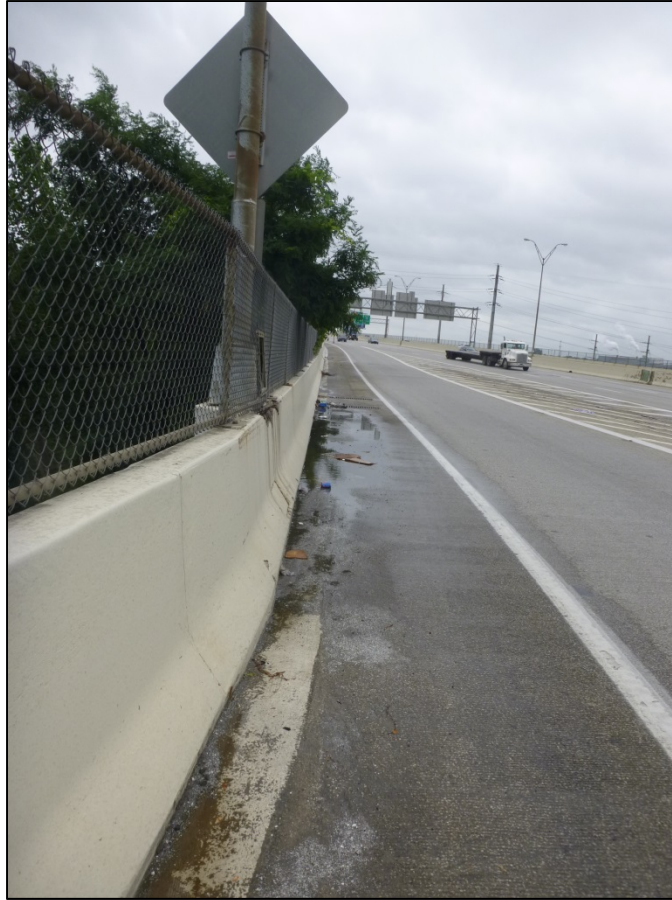
Picture #17: Ponding adjacent to two scuppers on westbound deck in Unit 1, looking east. Note the trees overhanging the fence onto the deck.

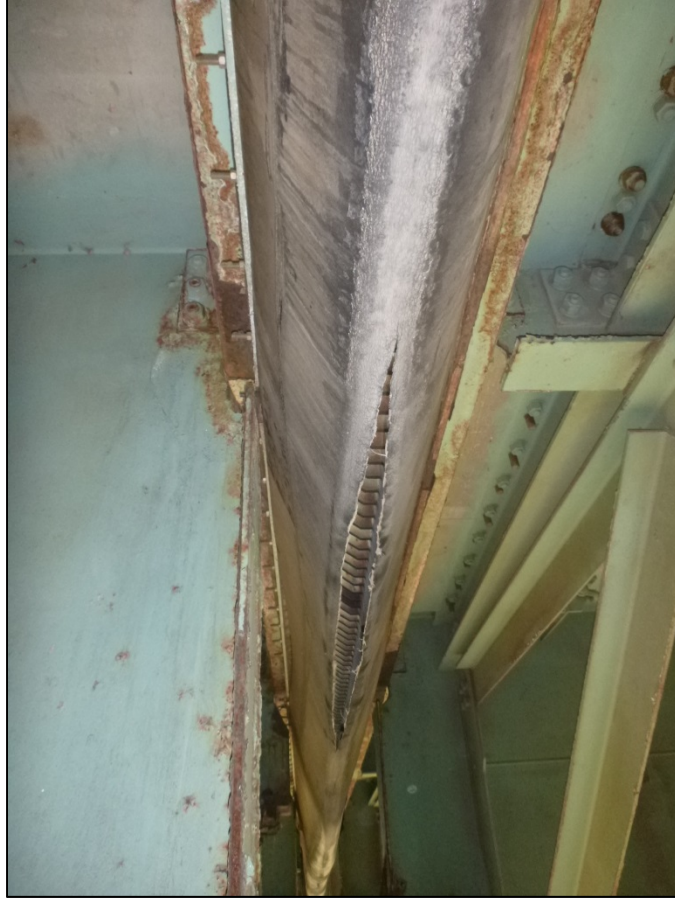
Picture #19: Failed neoprene trough at roller 4R, girder G, looking south.

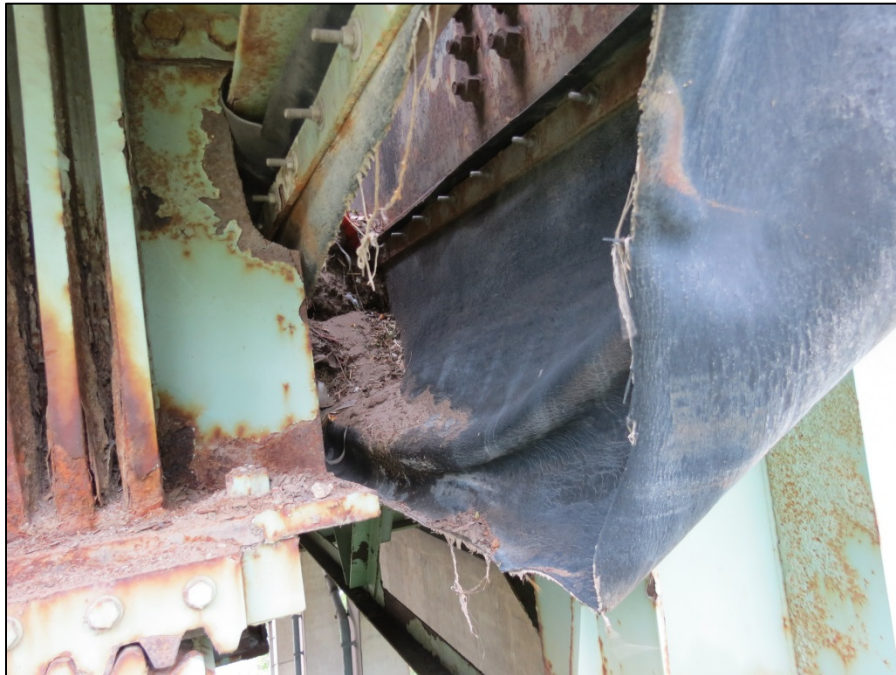
Picture #20: Failed neoprene drainage trough at roller 4L, girder A, looking south.

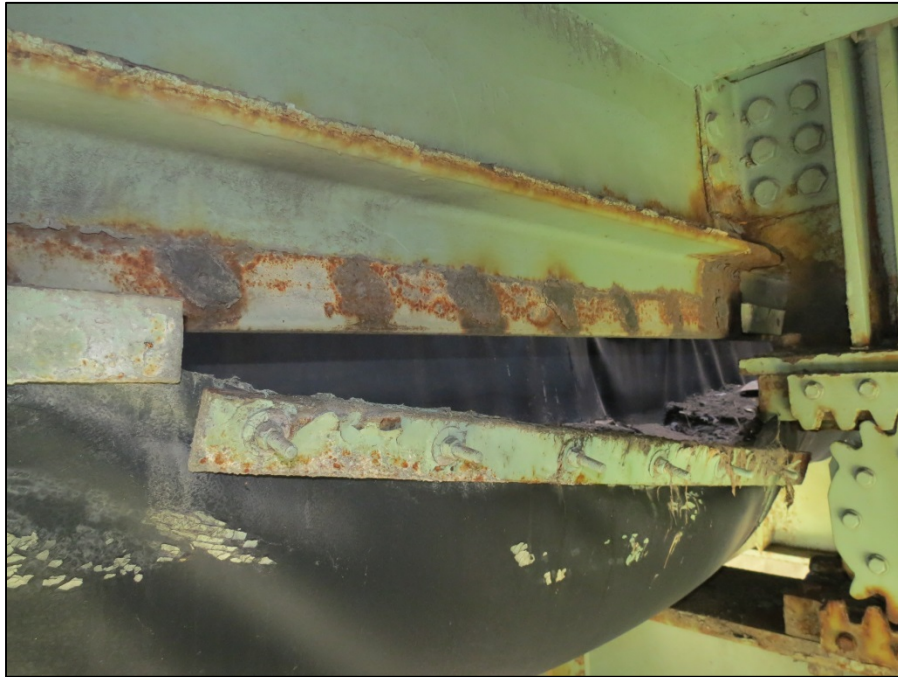
Picture #21: Failed neoprene trough support at roller 5R, looking northwest.

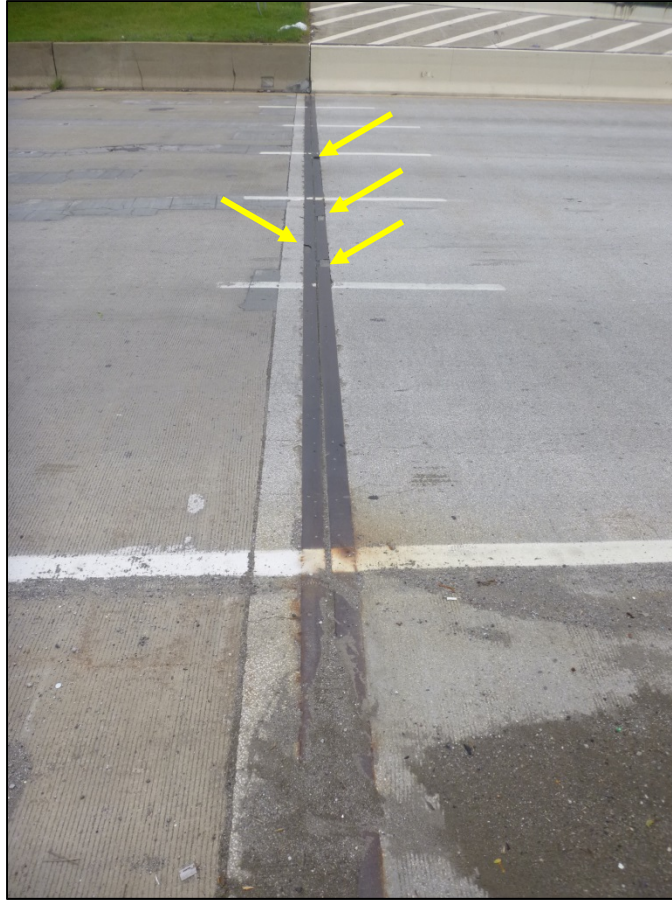
Picture #22: Multiple holes in the eastbound rear abutment steel joint armor , looking north.

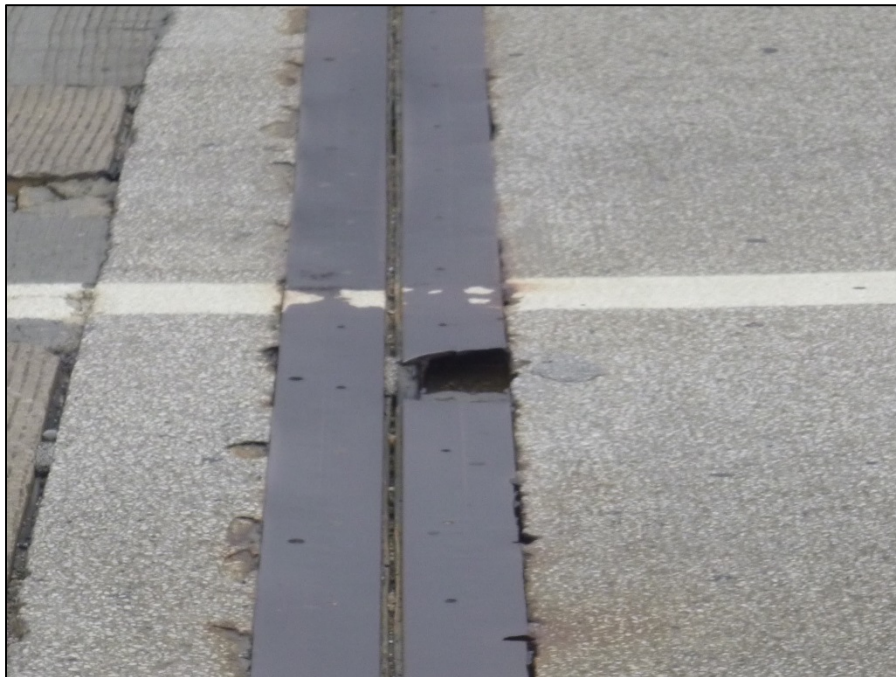
Picture #23: Deep hole below broken joint armor near lane 3/4 lane line at eastbound rear abutment, looking north.

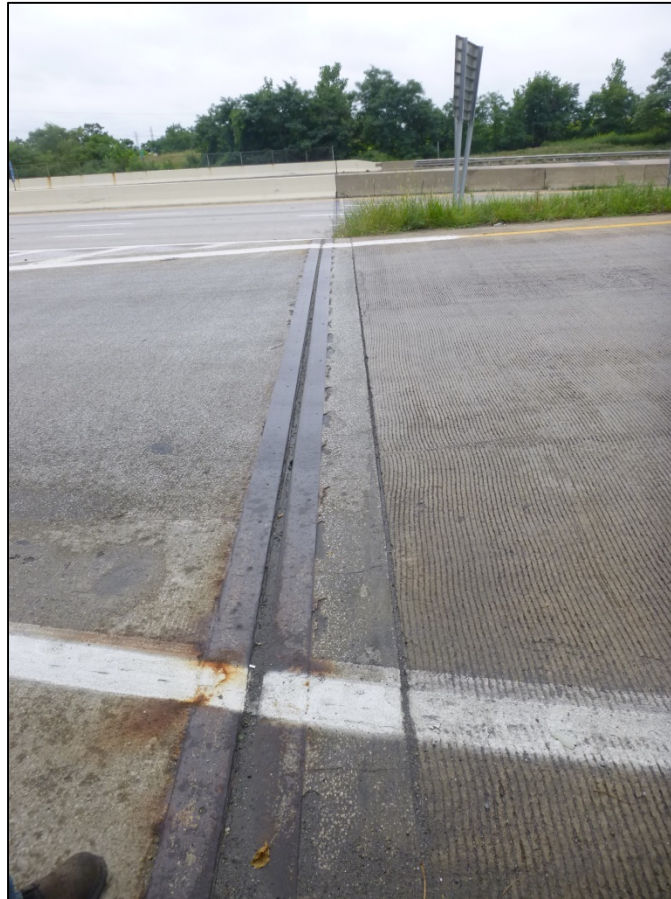
Picture #24: Typical full width spalling on westbound abutment expansion joint headers, looking south along ramp C-7.

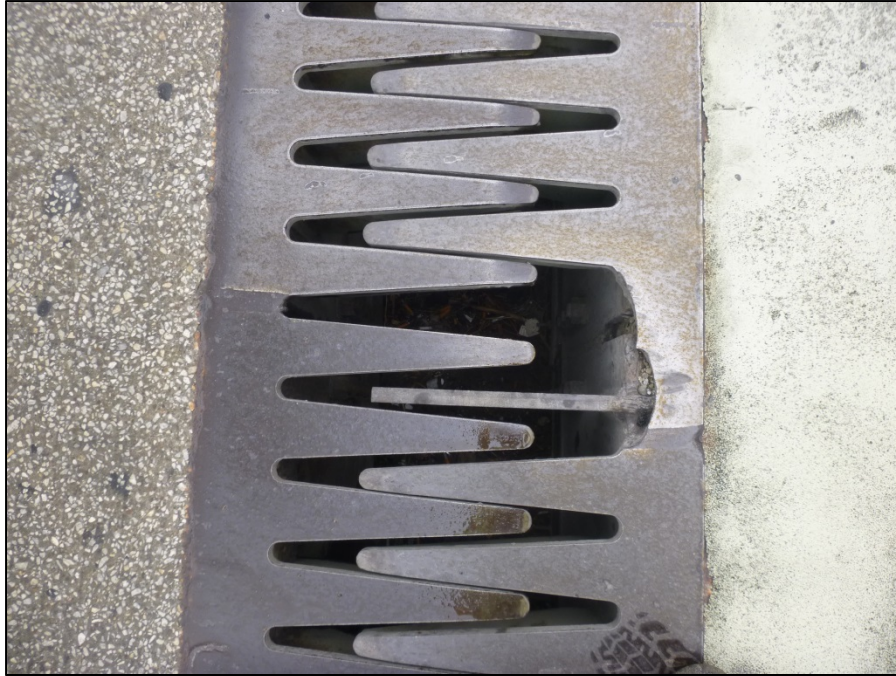
Picture #25: Missing finger in westbound intermediate expansion joint 2, lane 4, looking south.

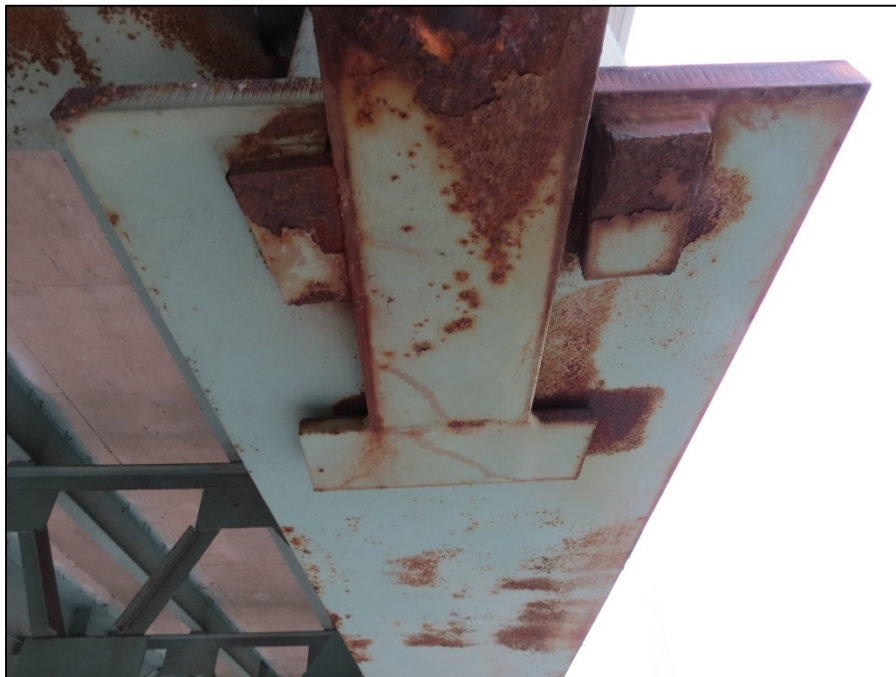
Picture #26: Shear key rubbing on south keeper plate of girder A in span 9L, looking west.

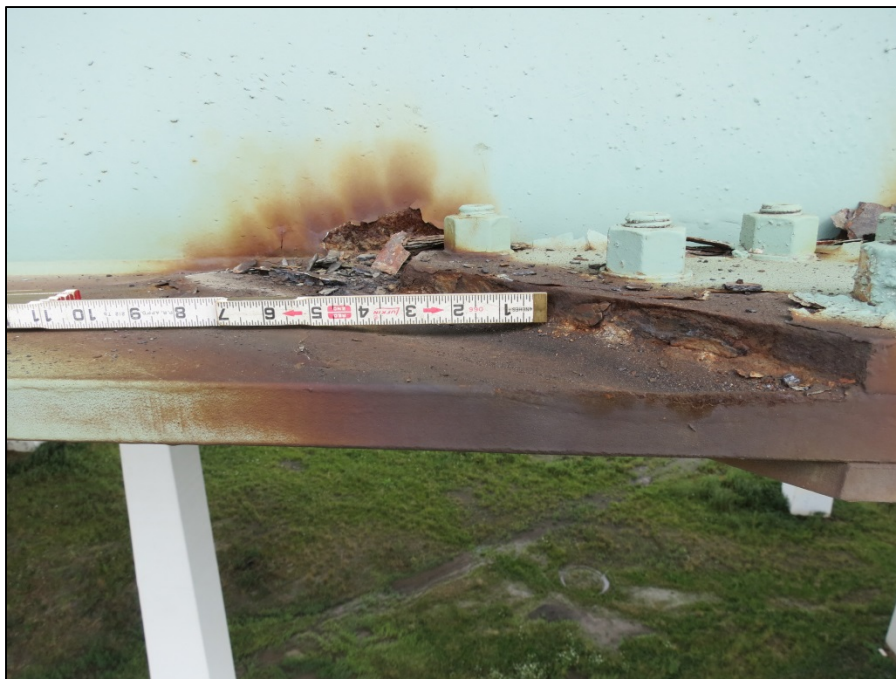
Picture #27: 1/4" section loss to exterior half of girder M bottom flange in span 8R, looking north.

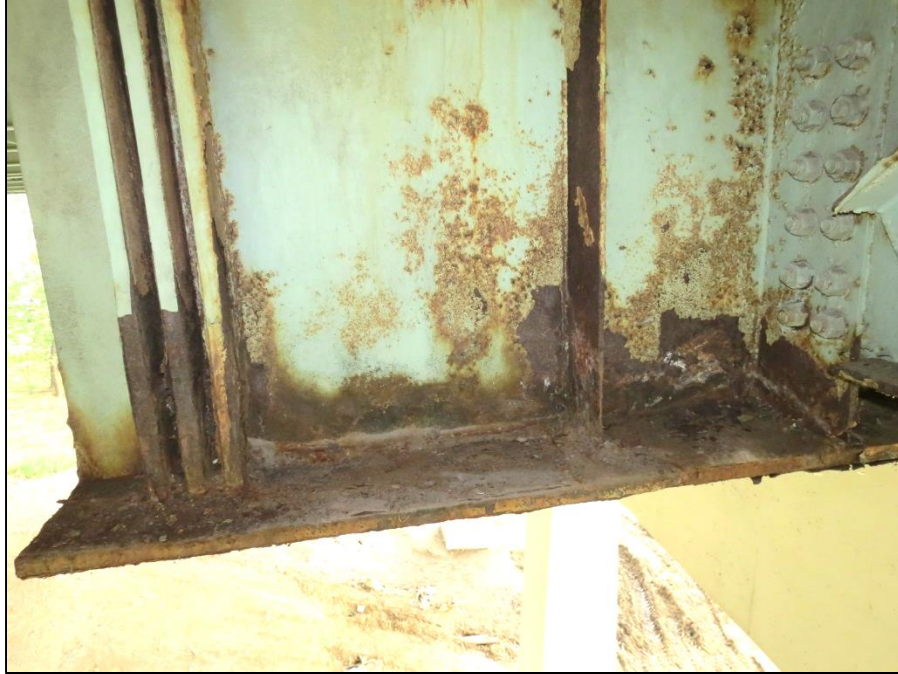
Picture #28: Section loss to girder F bottom flange in span 4L, looking north. Note bottom of transverse stiffener is nearly rusted through.

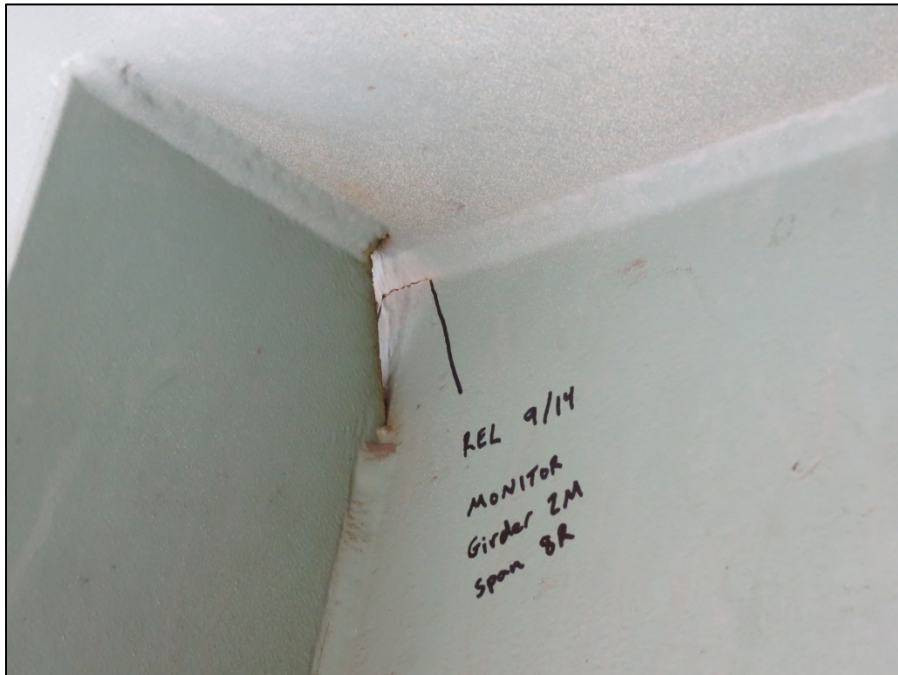
Picture #29: Possible 1" crack near girder M compression flange in span 8R, looking south.

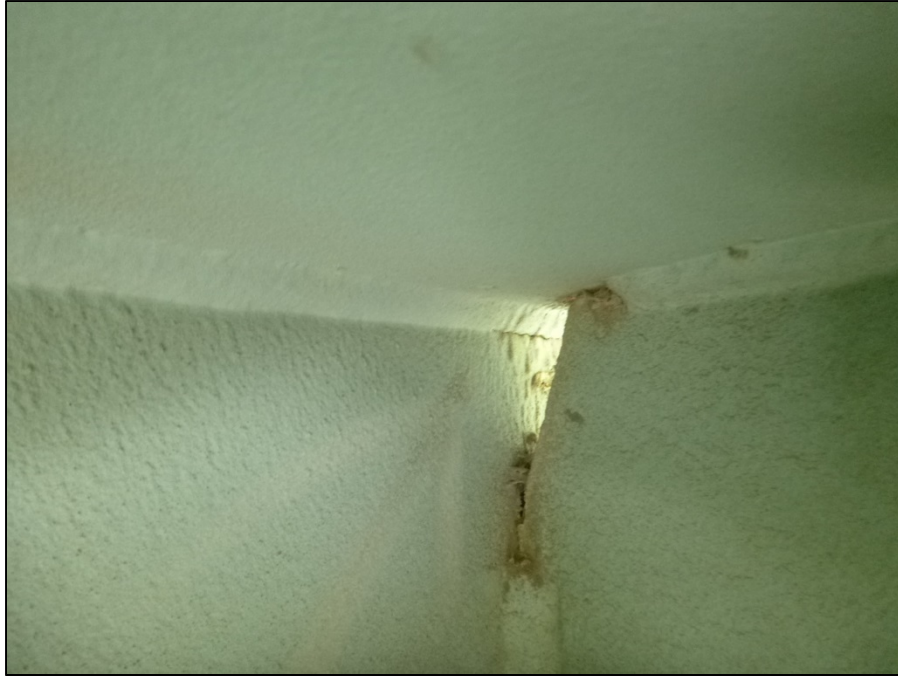
Picture #30: Possible crack or weld undercut on girder G in span 9R, looking south.

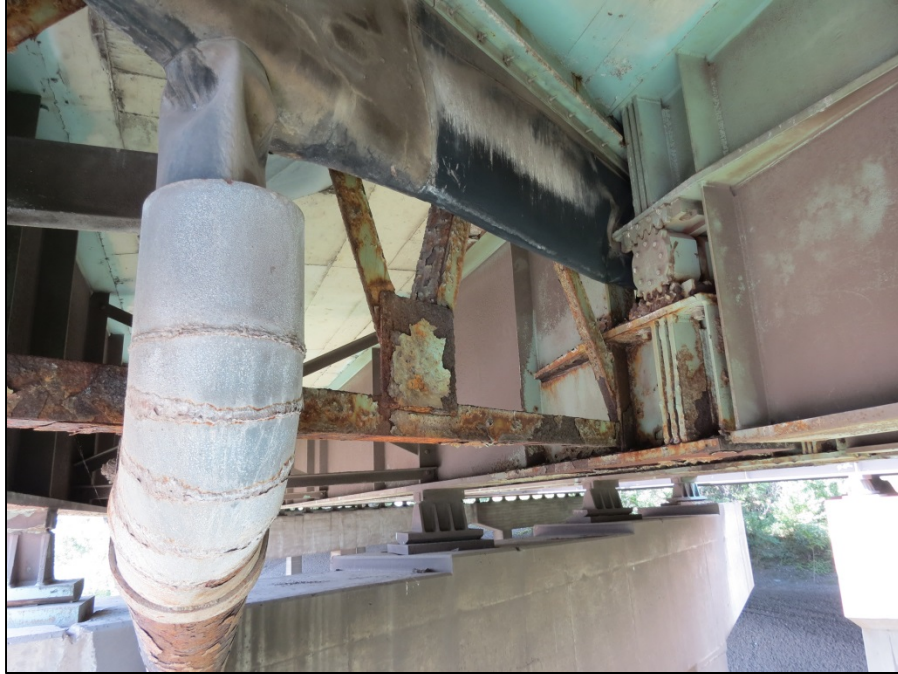
Picture #31: South bay hinge crossframe in span 24 C-B, looking west. Up to 50% section loss on members.

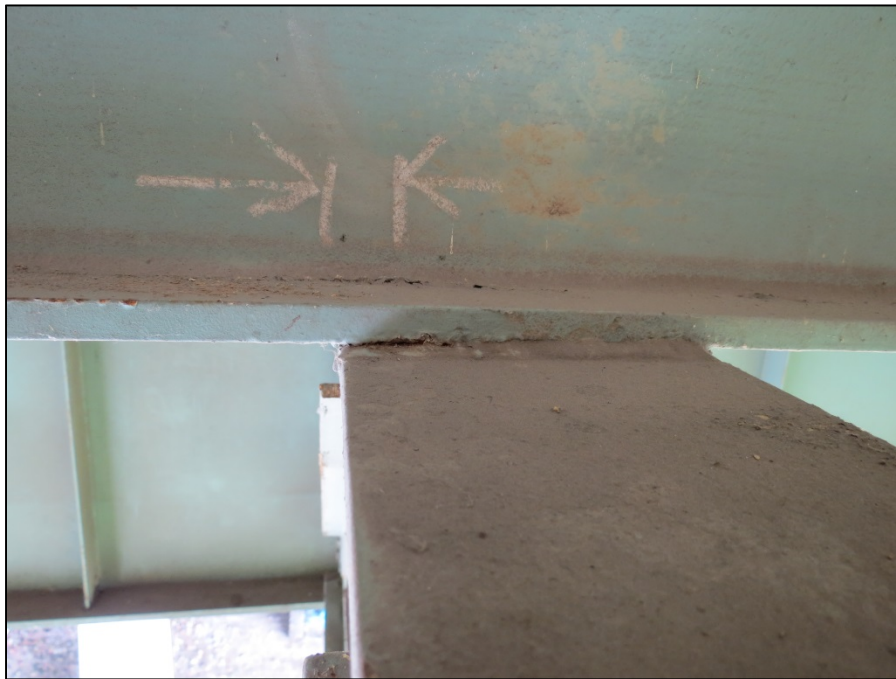
Picture #33: 1.75” crack in stringer 13 to floorbeam 3 weld in span 5R, looking north.

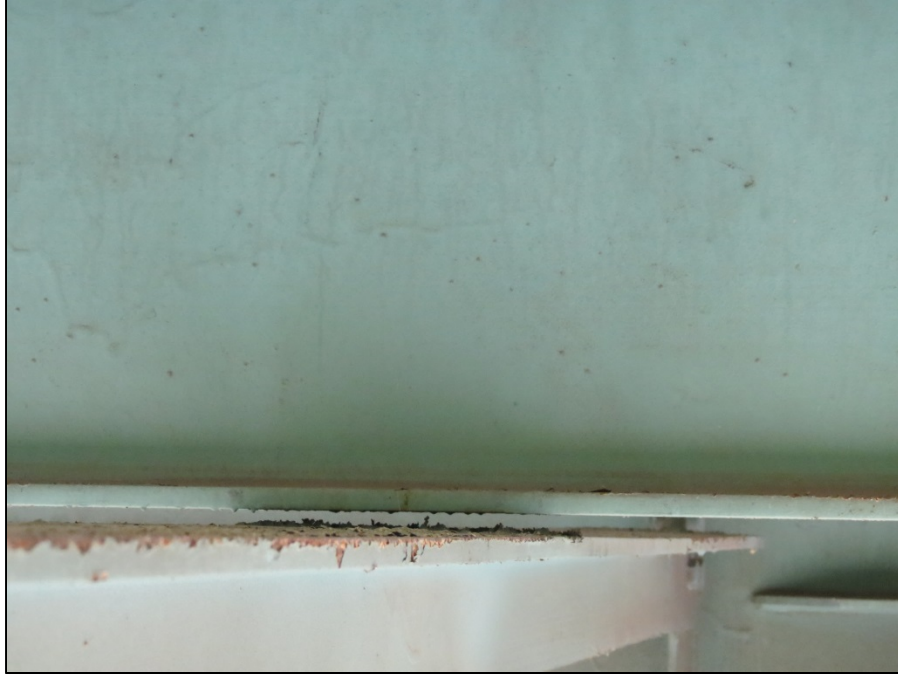
Picture #34: 3/4" gap between stringer 5 and floorbeam 6 in span 7L, looking north.

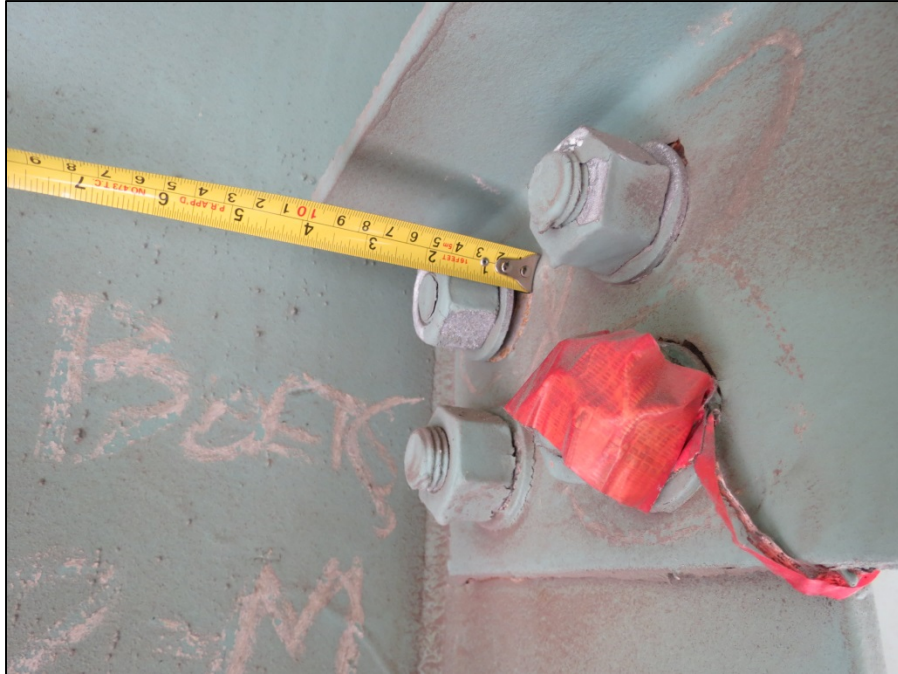
Picture #35: All 4 bolts in floorbeam top chord connection to girder M loose, span 9R, looking southwest.

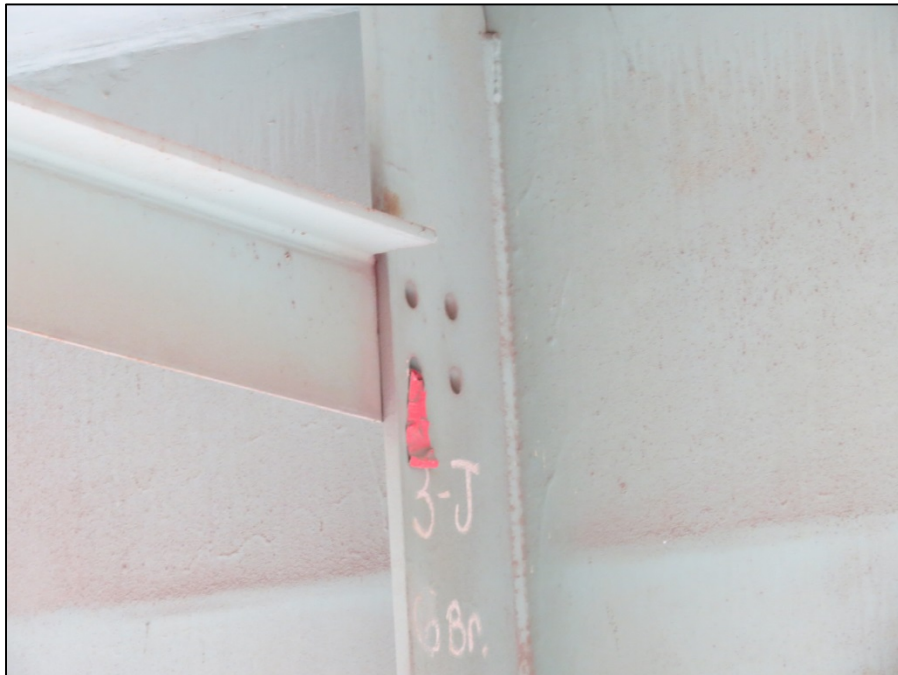
Picture #36: All 4 bolts in floorbeam top chord connection to girder J missing, span 11R, looking southeast. Note, this is the 1 foot of floorbeam rated critical.
