2014 PHYSICAL CONDITIONS INSPECTION REPORT

CUY-490-0100
SFN 1811991

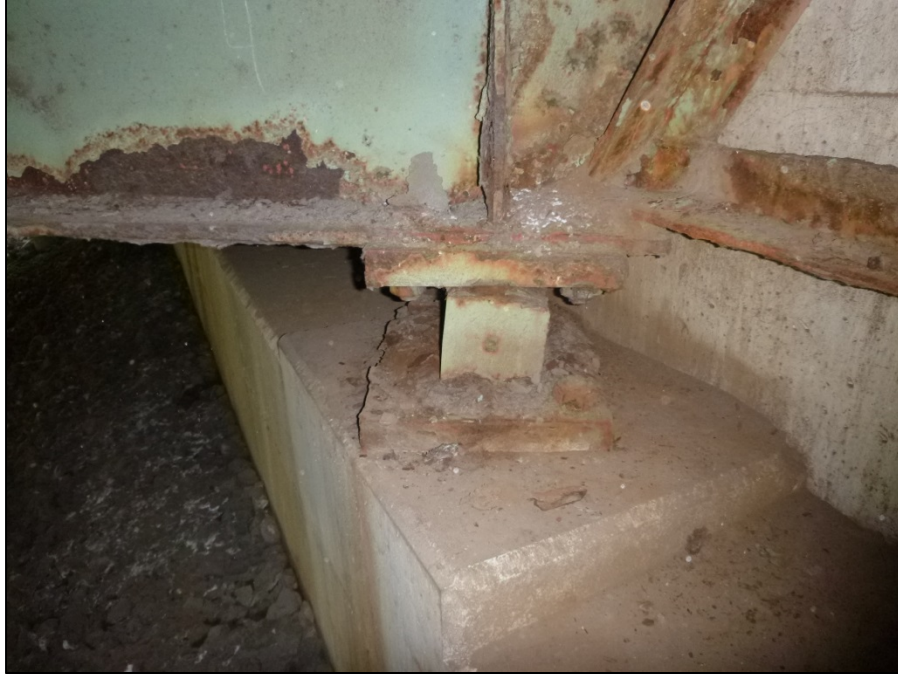
Picture #37: Rust and debris around girder 6-G rocker at forward abutment, looking north.

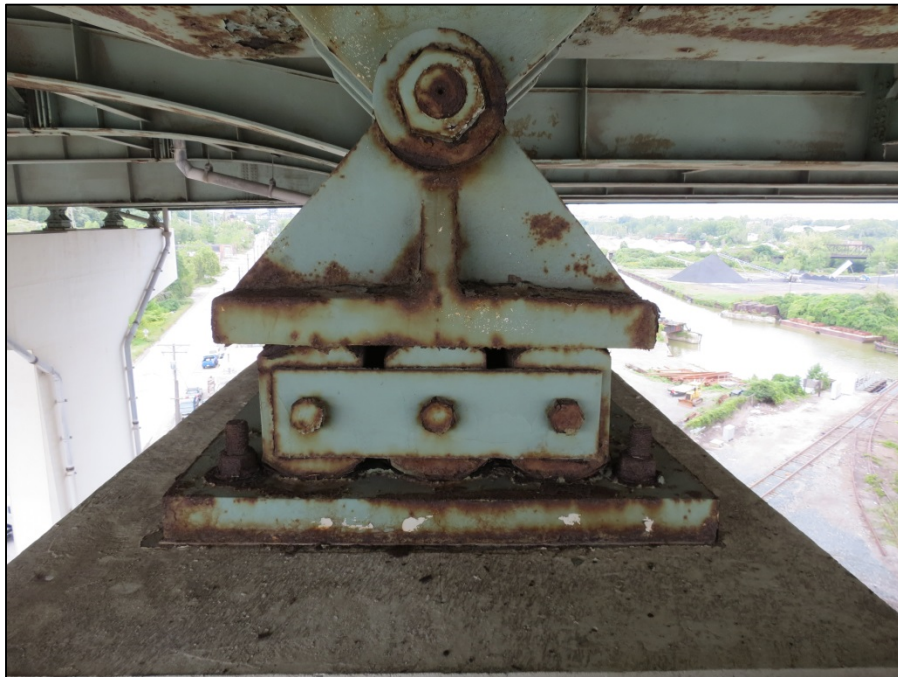
Picture #38: Surface corrosion on girder J roller bearing at pier 9R, looking north.

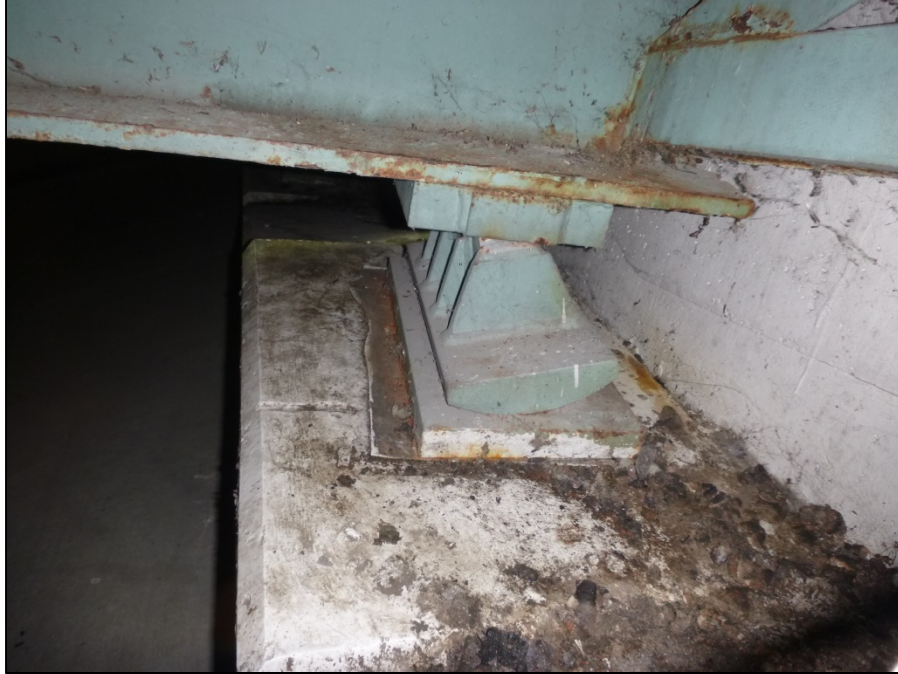
Picture #39: West abutment bearing 1-EA leaning 17° east at 75°F, looking south.

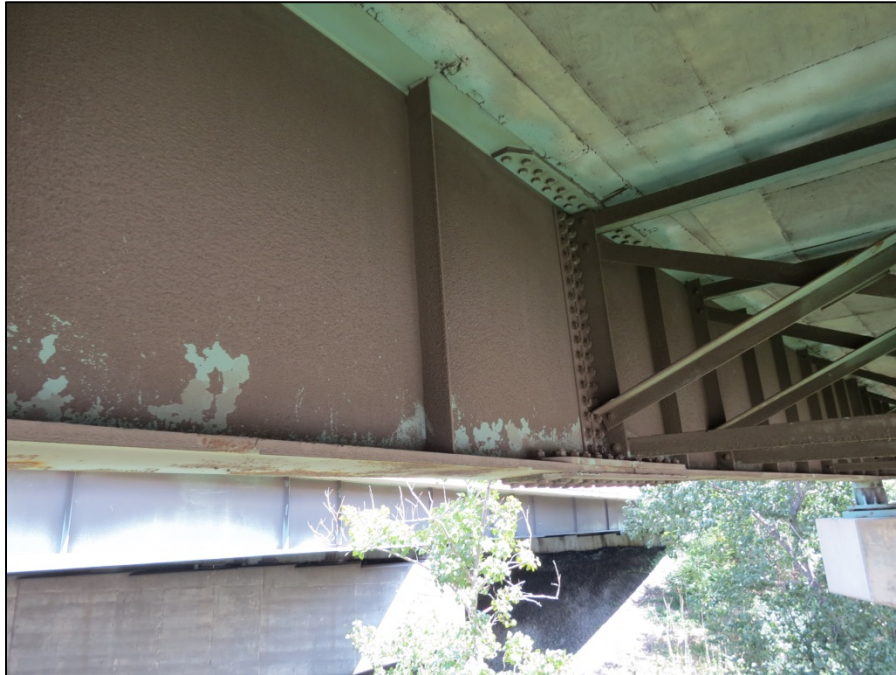
Picture #41: Dirt build up on web of girder CB-A in span 24CB, looking east.

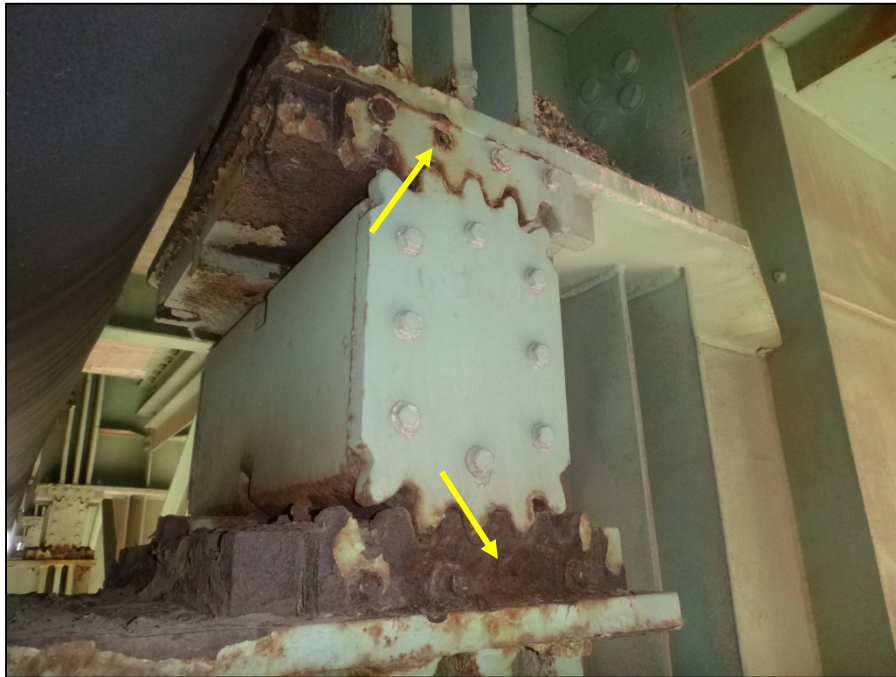
Picture #42: Broken/missing bolts on girder D roller 3 alignment plate, looking north.

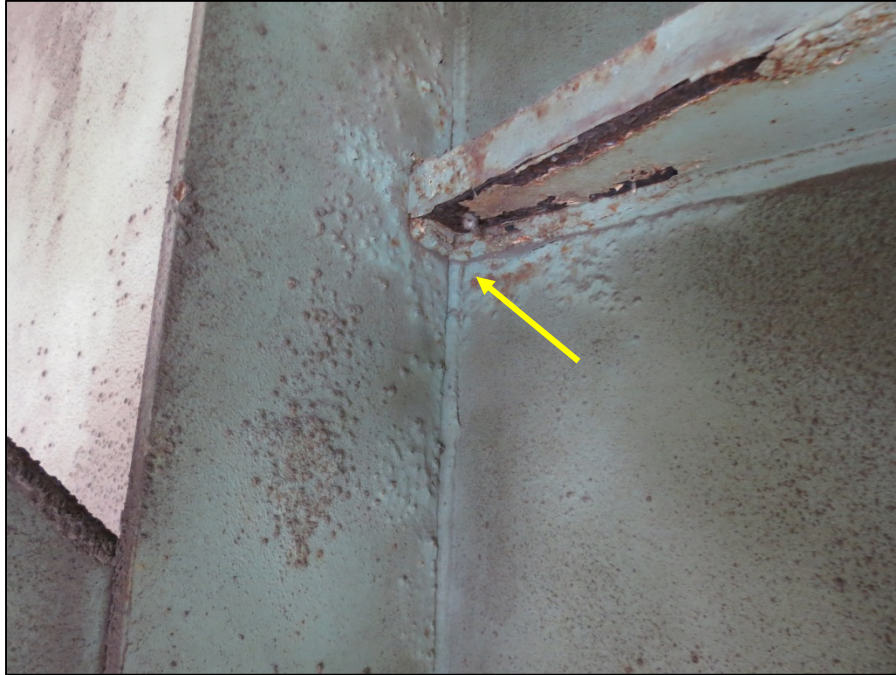
Picture #43: Tri-axial weld on girder V, span 21R, looking north.

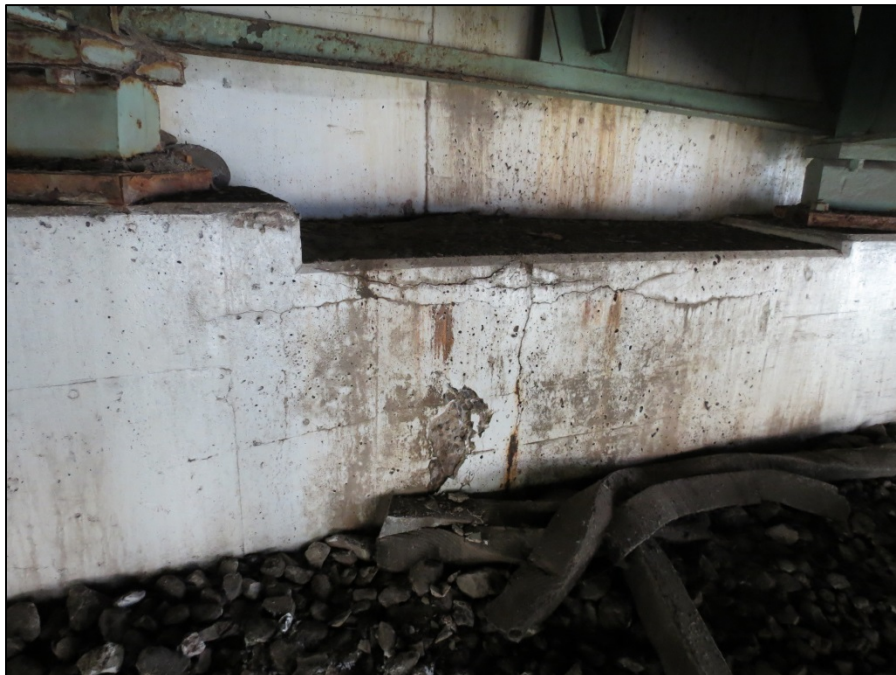
Picture #45: Deterioration to forward abutment wall between girders E and F, looking east.

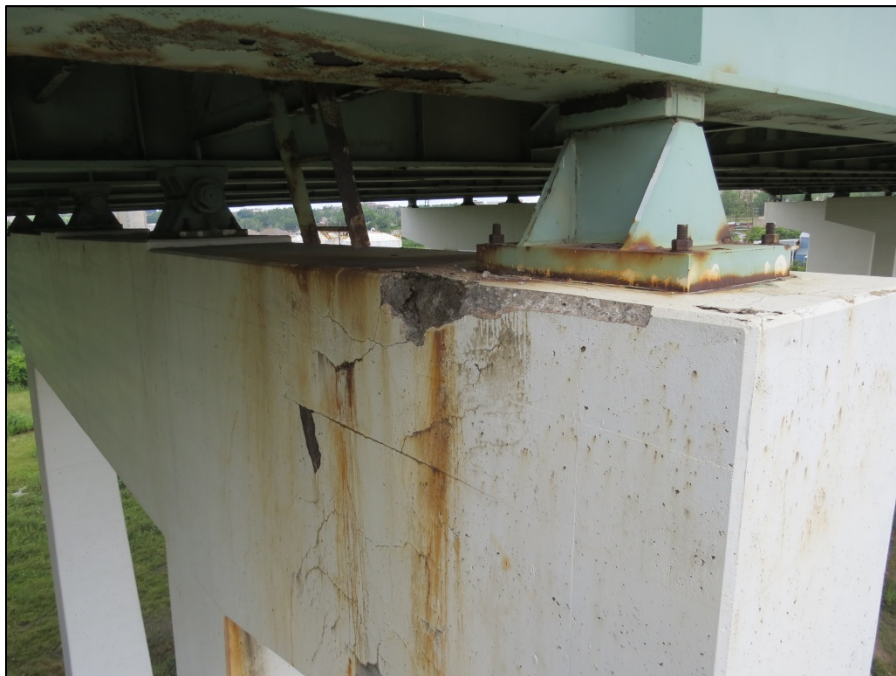
Picture #46: Deterioration to south end of pier 7R cap due to leaking deck access manhole, looking east.

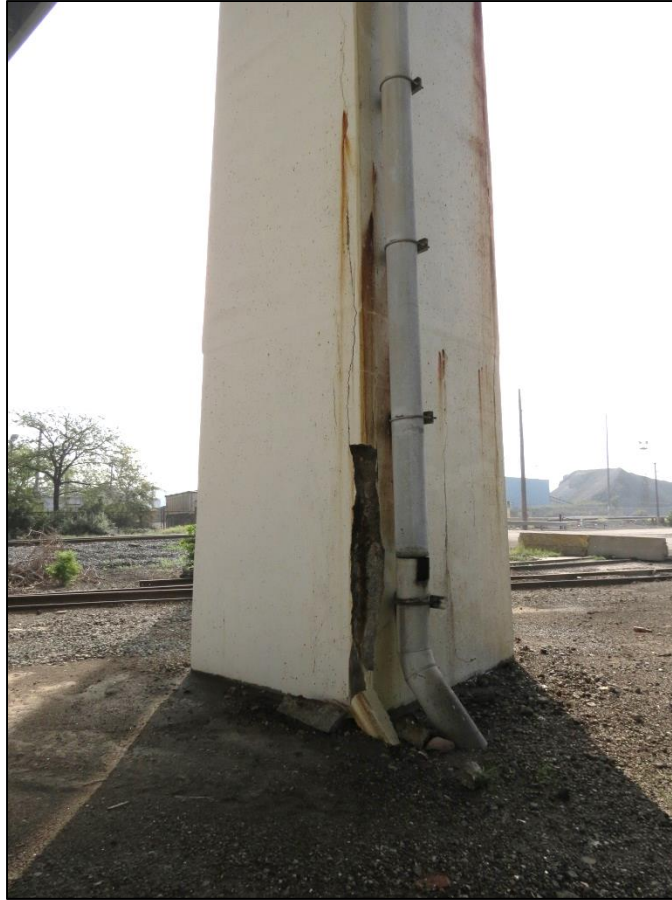
Picture #47: Large delaminations, spalls, and cracks with rust staining and efflorescence on south column of pier 9R, looking south.

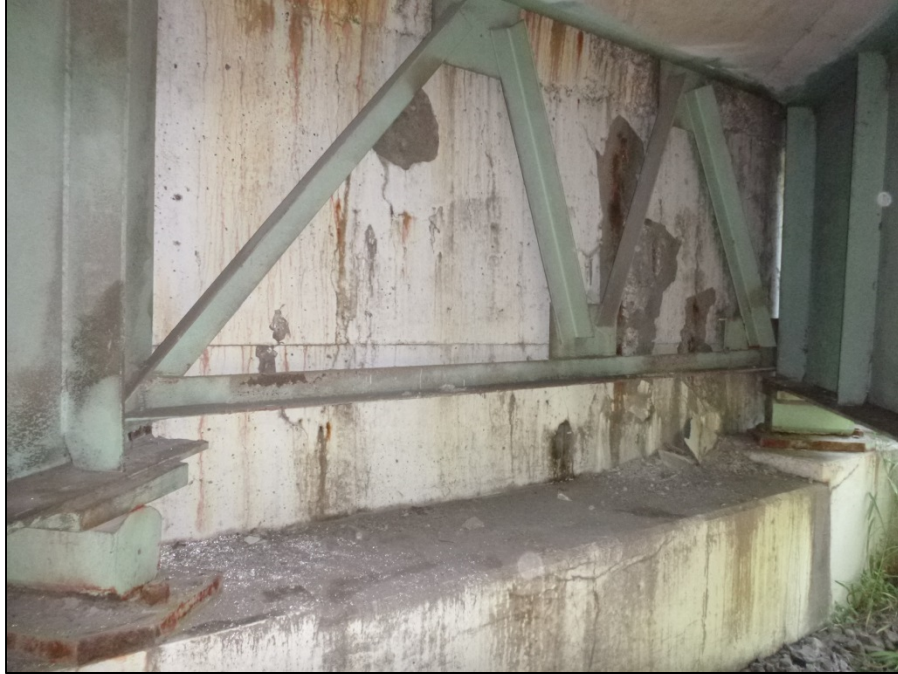
Picture #48: Large spalls and delamination on ramp C-B abutment backwall between girders D and E, looking east.

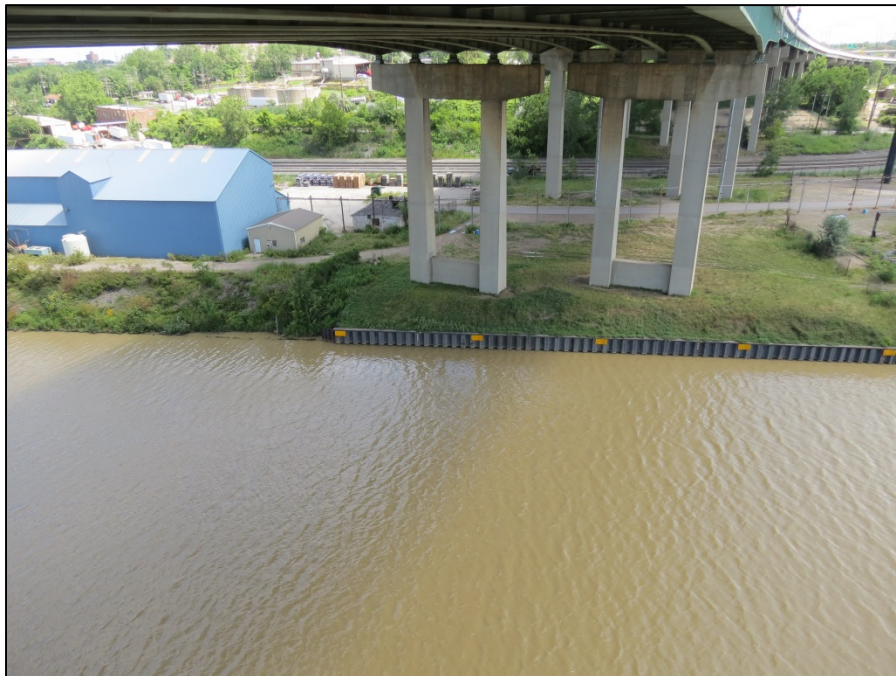
Picture #49: General view of east bank bulkhead, looking east.

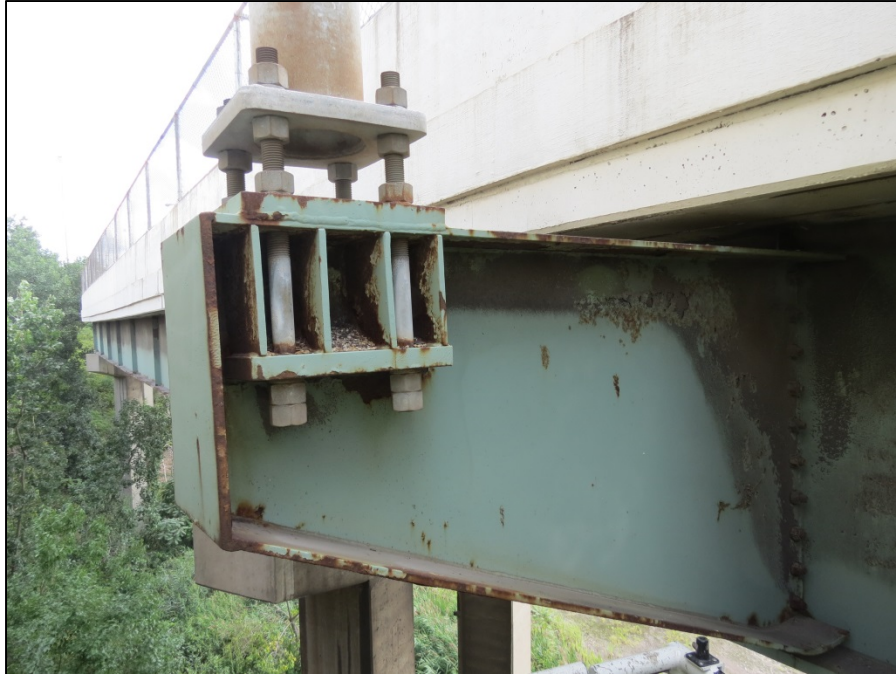
Picture #50: Eastbound exit sign support in fair condition with debris and minor section loss, span 23R, looking east.

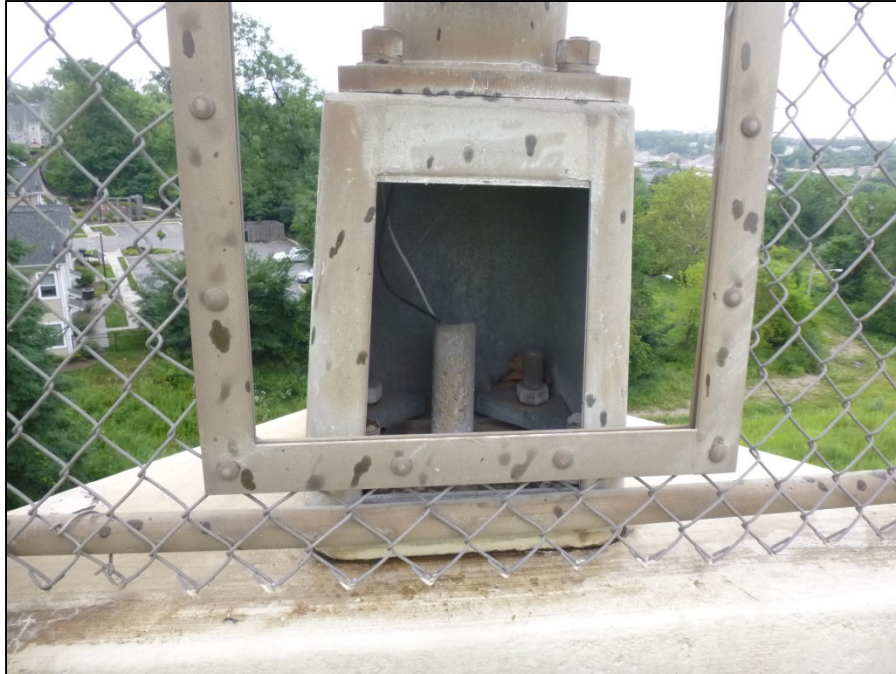
Picture #51: Missing electrical cover plate exposing westbound light pole wiring at Sta. 991+35, looking north.

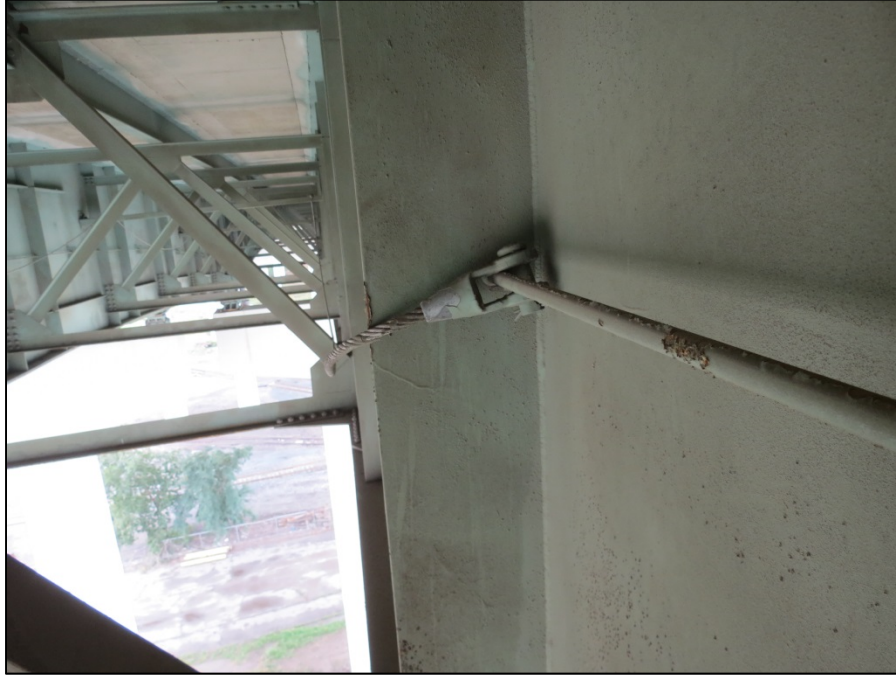
Picture #52: Safety cable improperly attached to handrail on south face of girder D at floorbeam 7, span 11L, looking west.

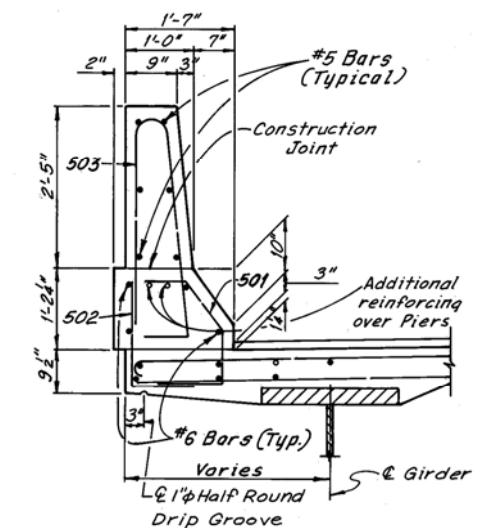
EXTERIOR CURB AND PARAPET DETAIL
(4'-0" Chain Link fence not shown)

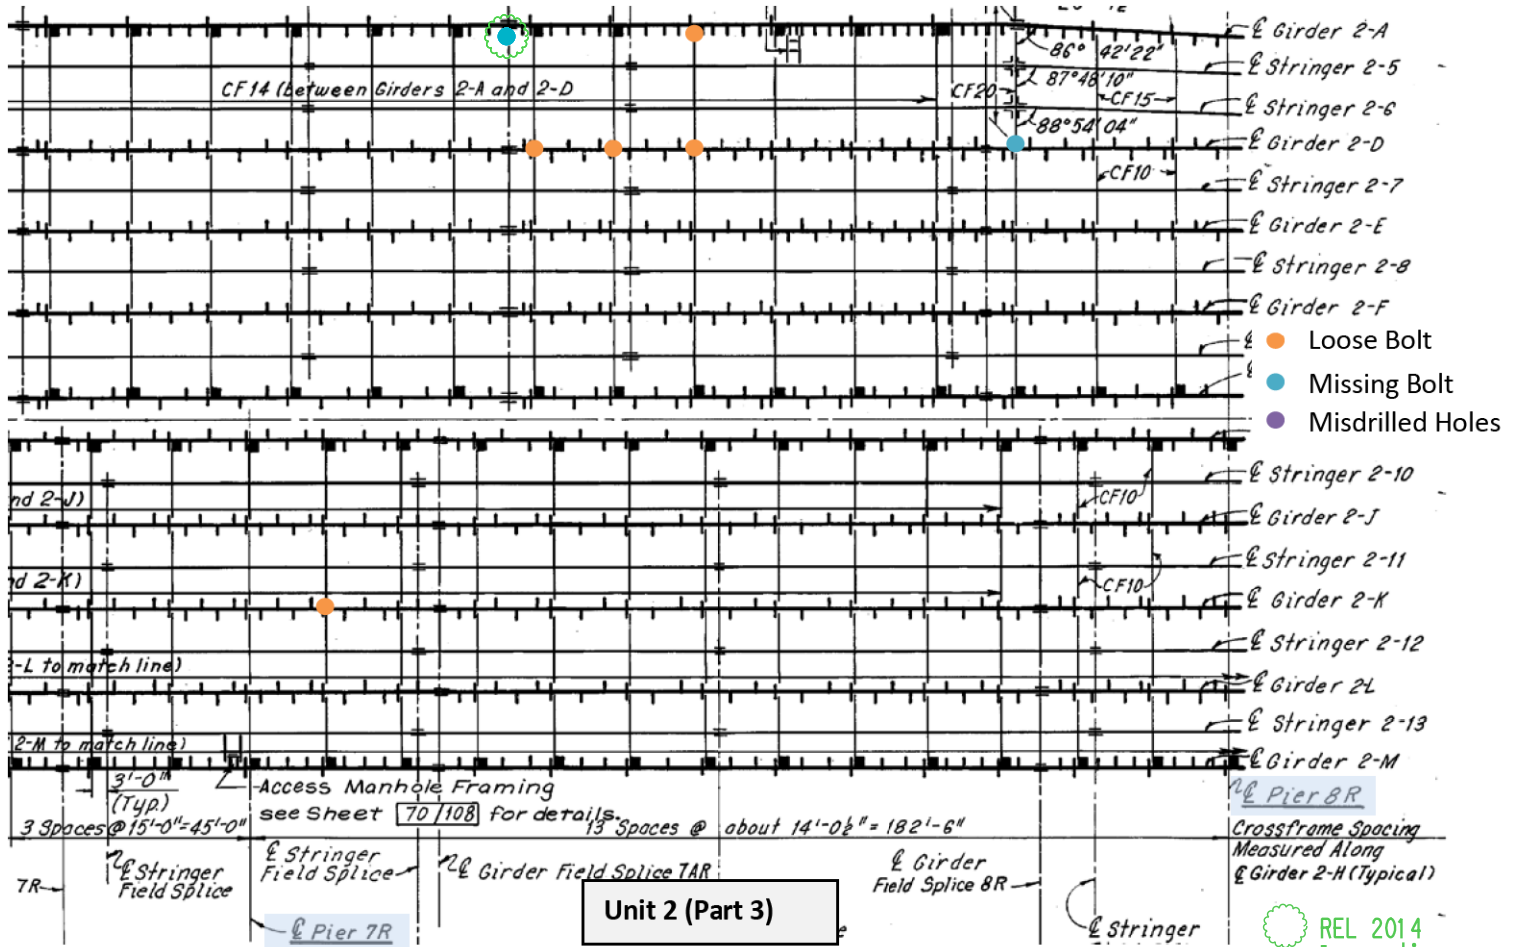
- Loose Bolt
- Missing Bolt
- Misdrilled Holes
- REL 2014 Inspection

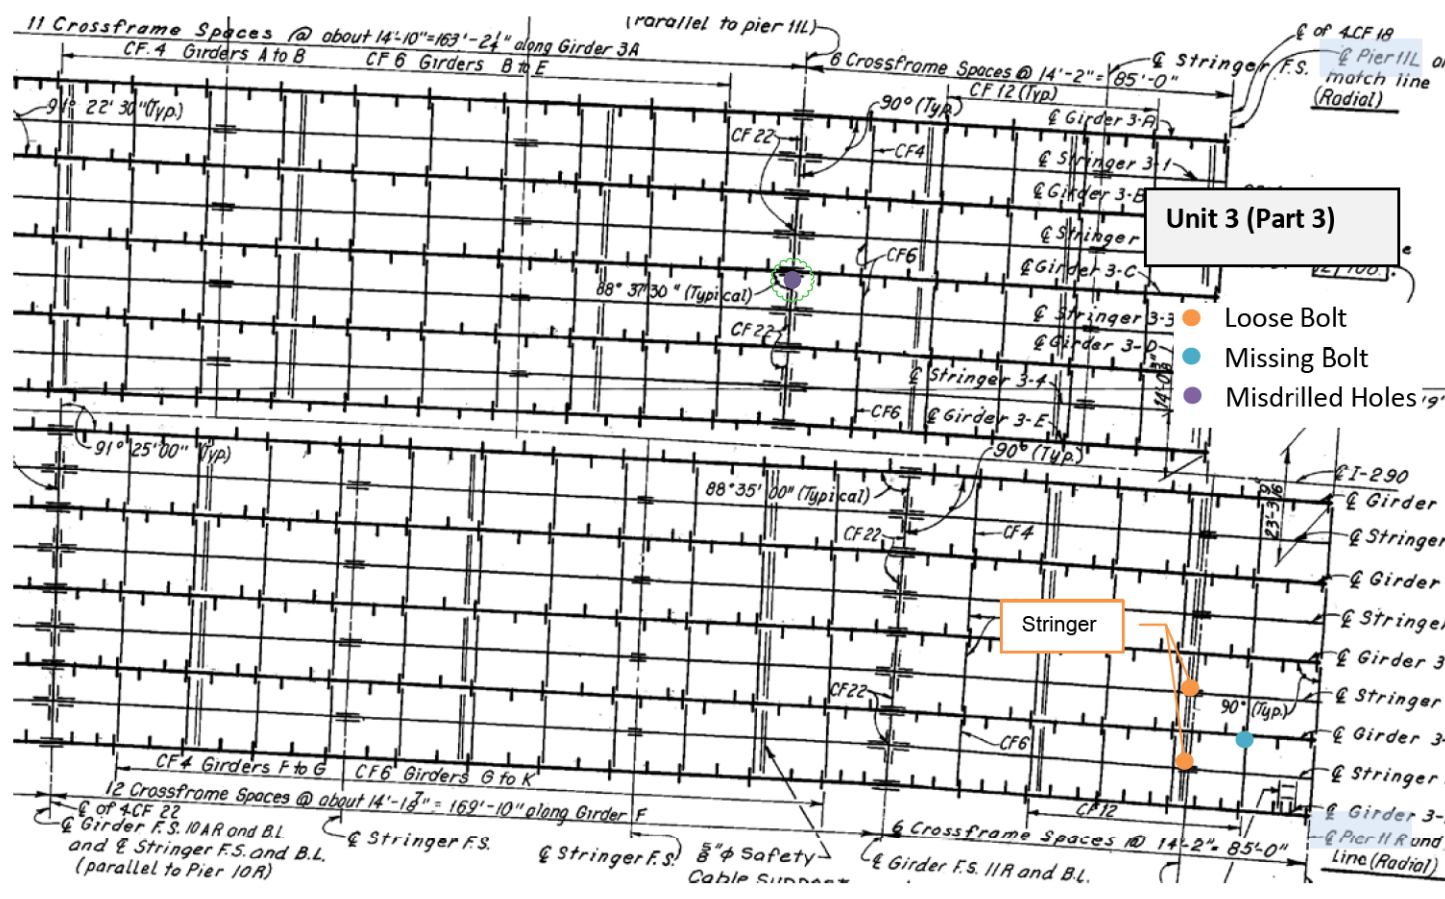
- Loose Bolt
- Missing Bolt
- Misdriilled Holes
- REL 2014 Inspection

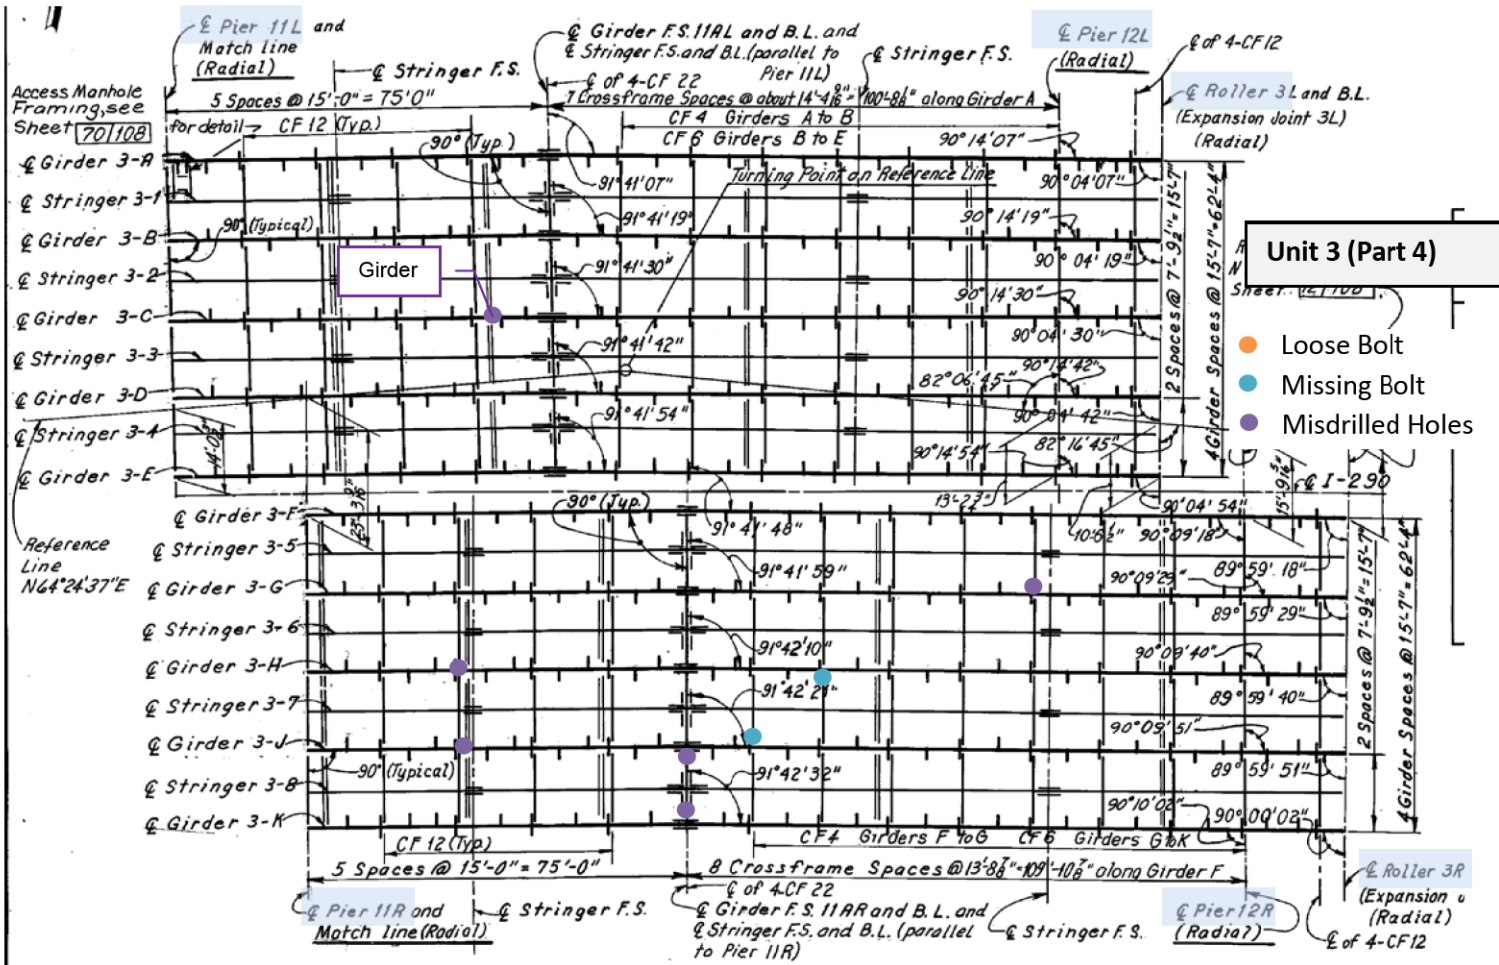
- Loose Bolt
- Missing Bolt
- Misdriilled Holes

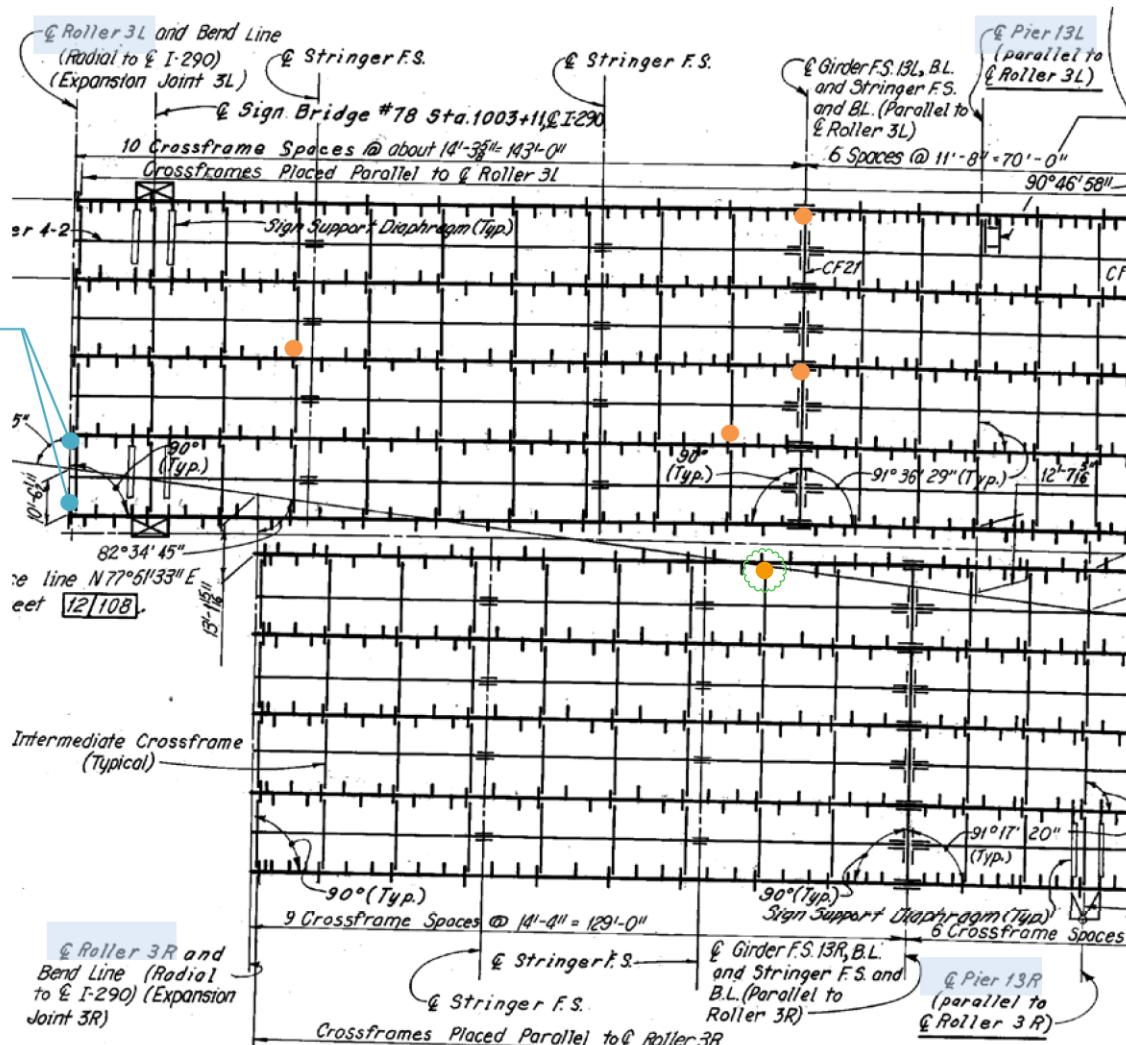
- Loose Bolt
- Missing Bolt
- Misdrilled Holes

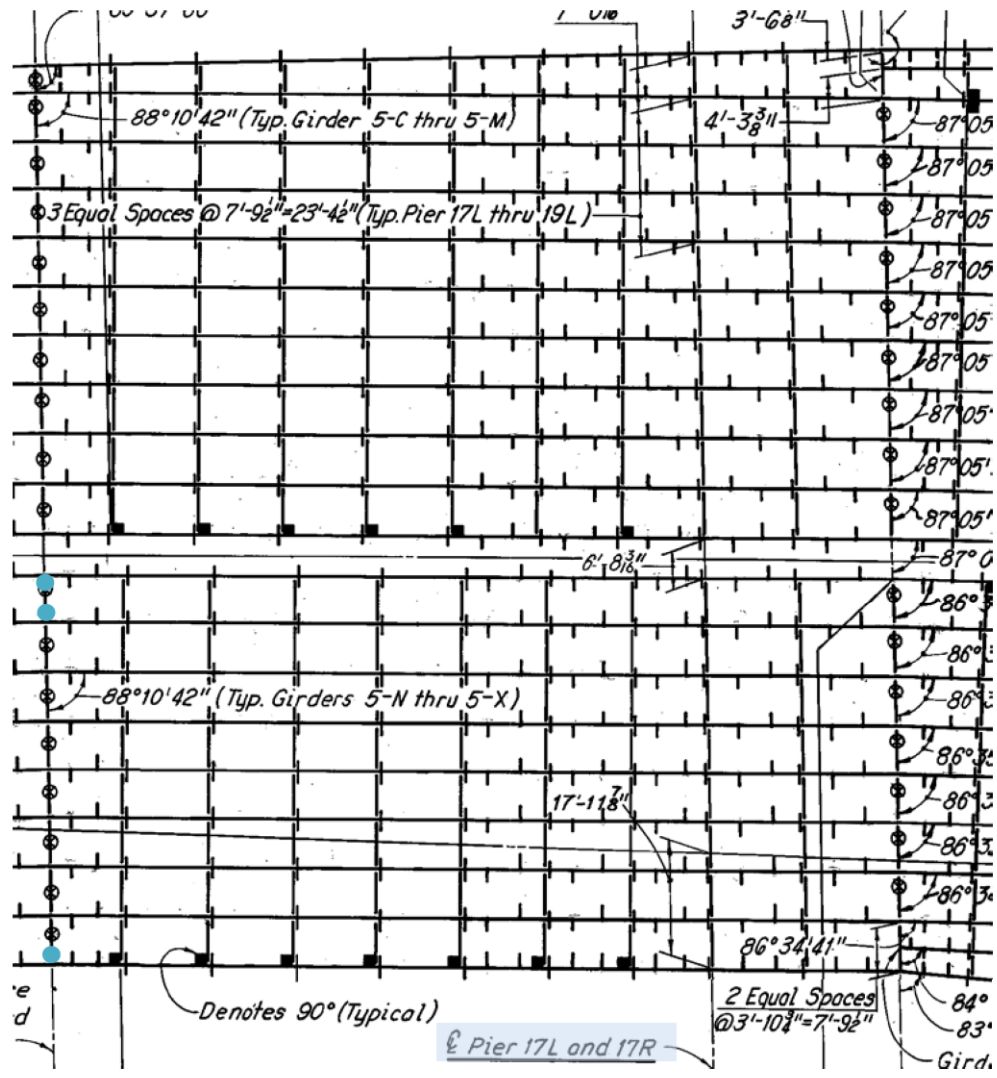
- Loose Bolt
- Missing Bolt
- Misdrilled Holes
- REL 2014 Inspection

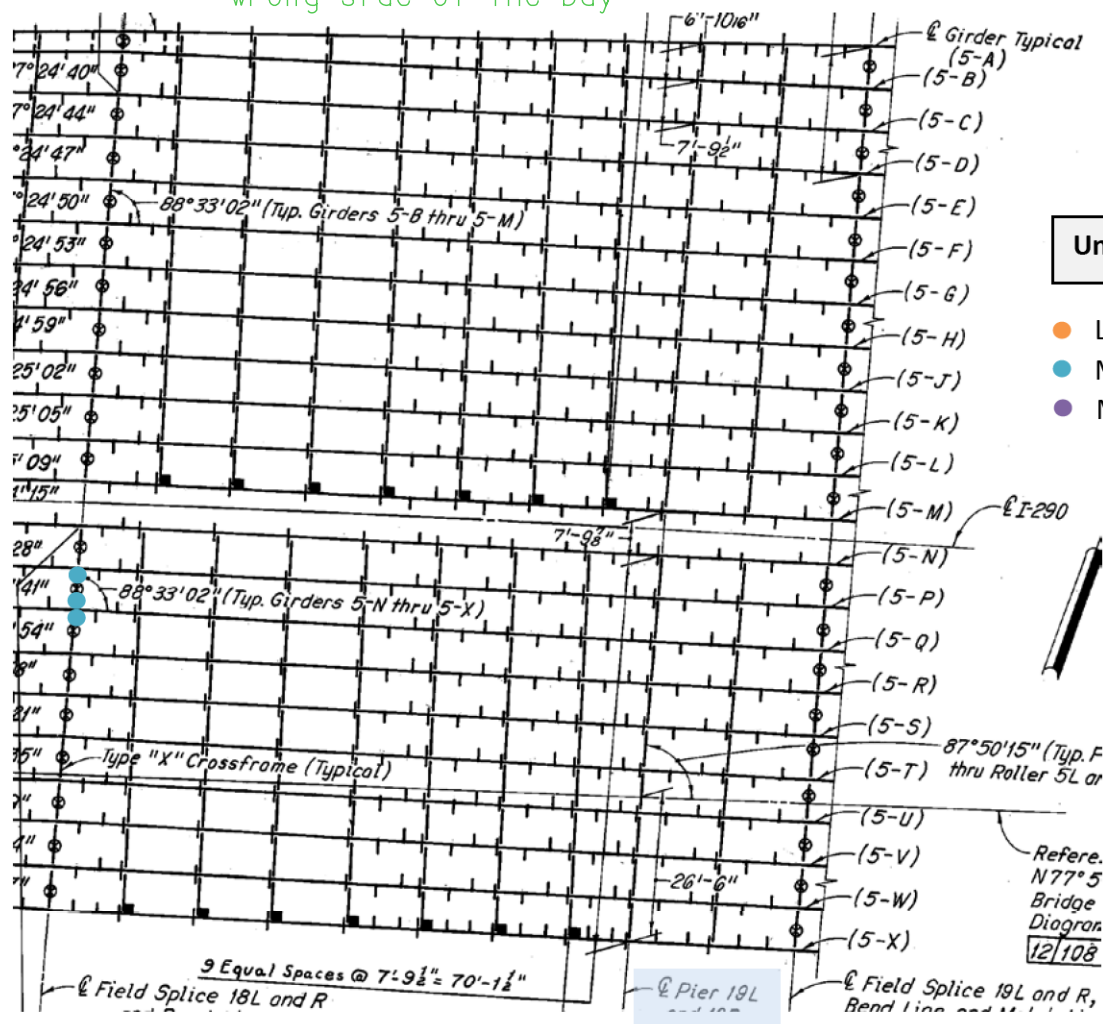
These are shown on wrong side of the bay

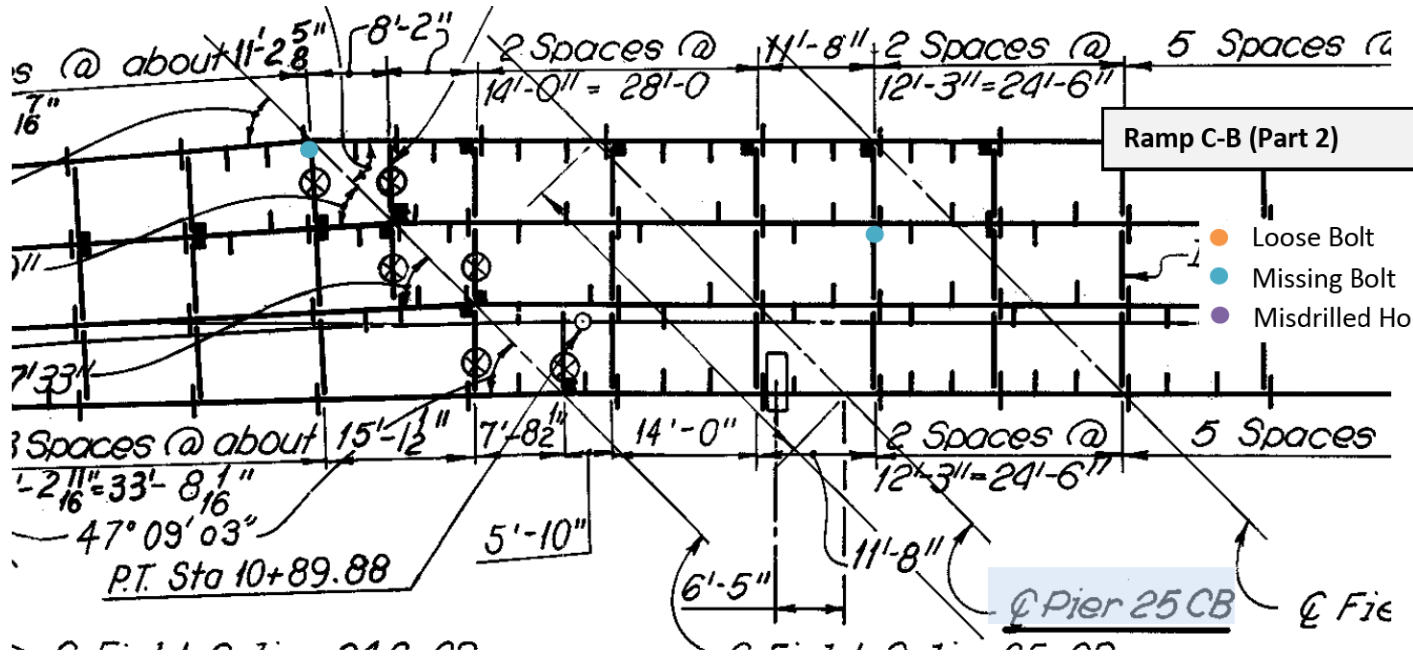
Pier Deterioration Drawings

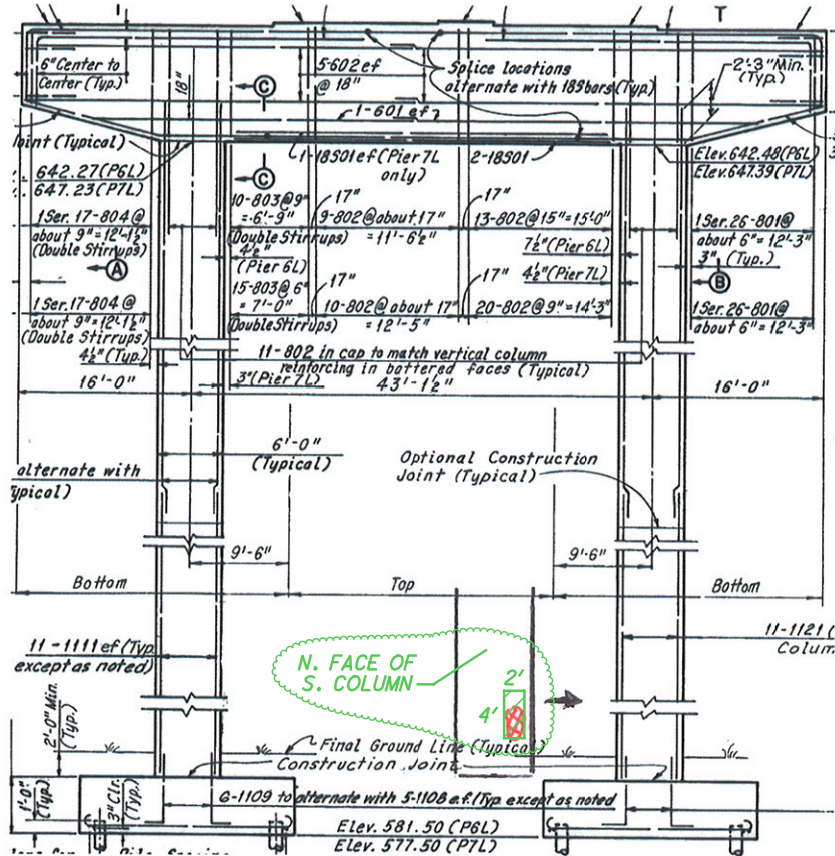
- ▣ = SPALL
- ▨ = DELAM
- = REL 2014 Inspection

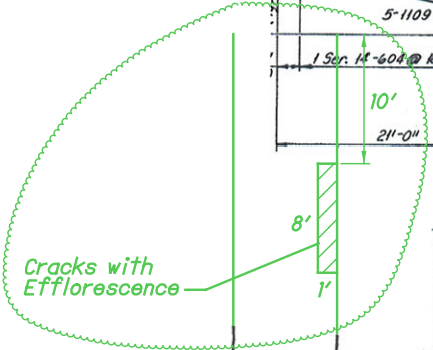
- = SPALL
- = DELAM
- = REL 2014 Inspection
