**2014 UPDATE TO THE 2013 PHYSICAL CONDITIONS INSPECTION  
REPORT**

**CUY-480-1842 L**  
**SFN 1812521**

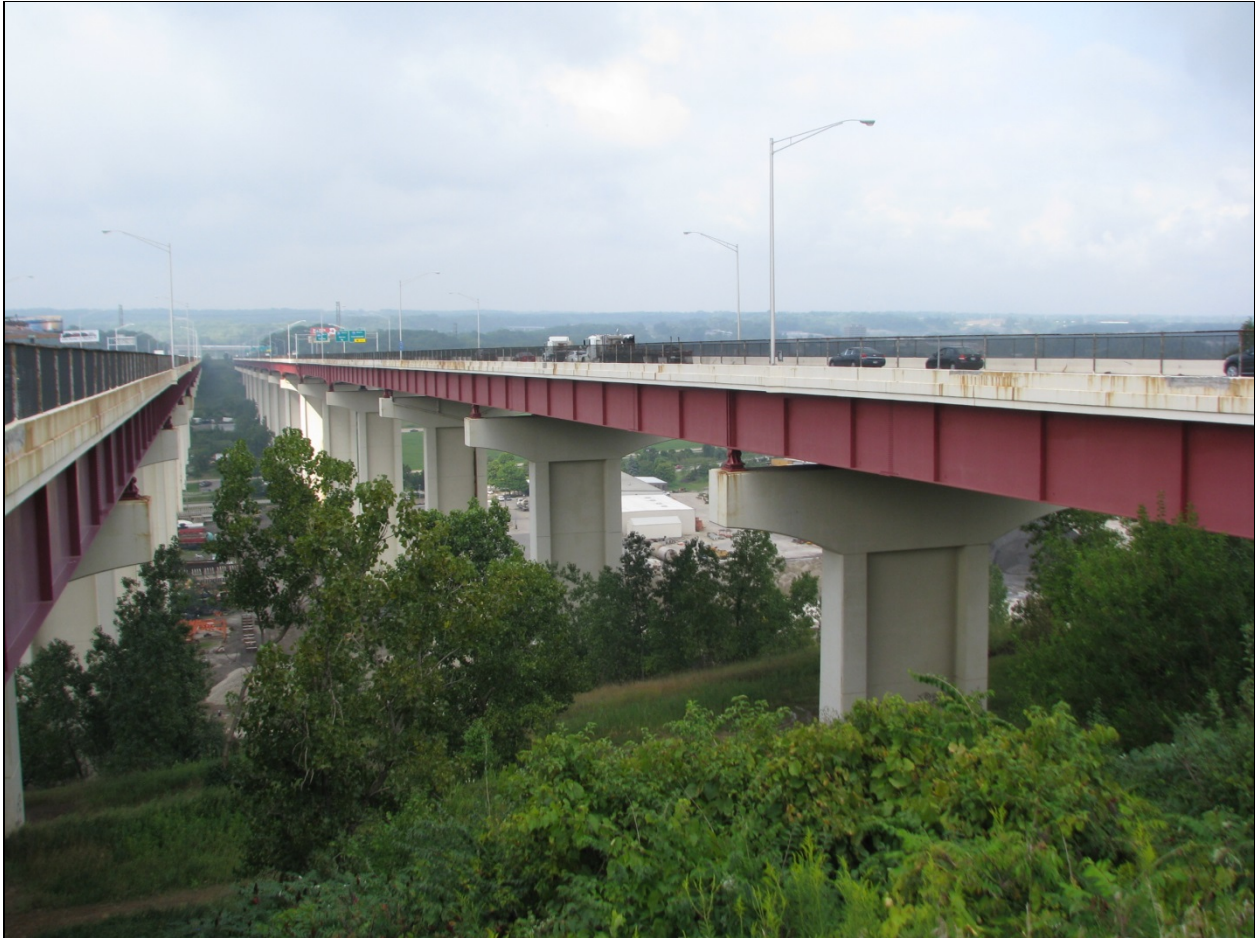
**Westbound Valley View Bridge Over the Cuyahoga River Valley**

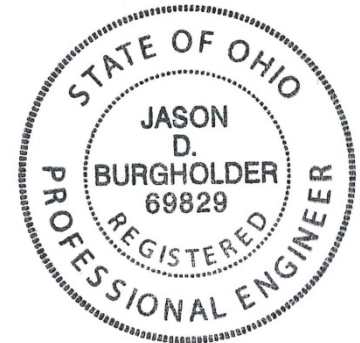
2014 UPDATE TO THE 2013 PHYSICAL CONDITIONS INSPECTION REPORT

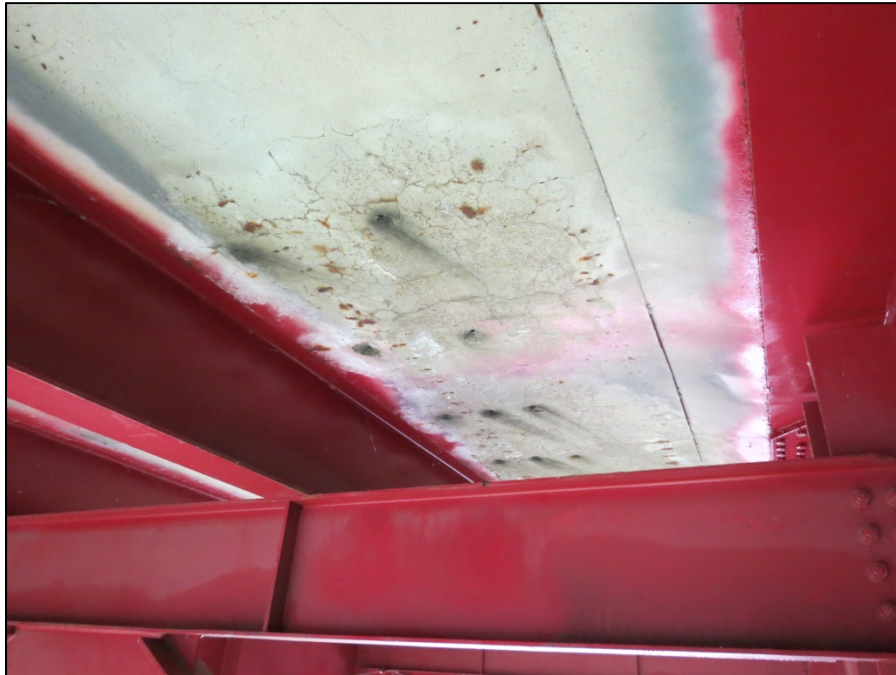
Picture #1: Leaking and cracks around holes drilled through deck in span 2, center bay, near floorbeam 8.

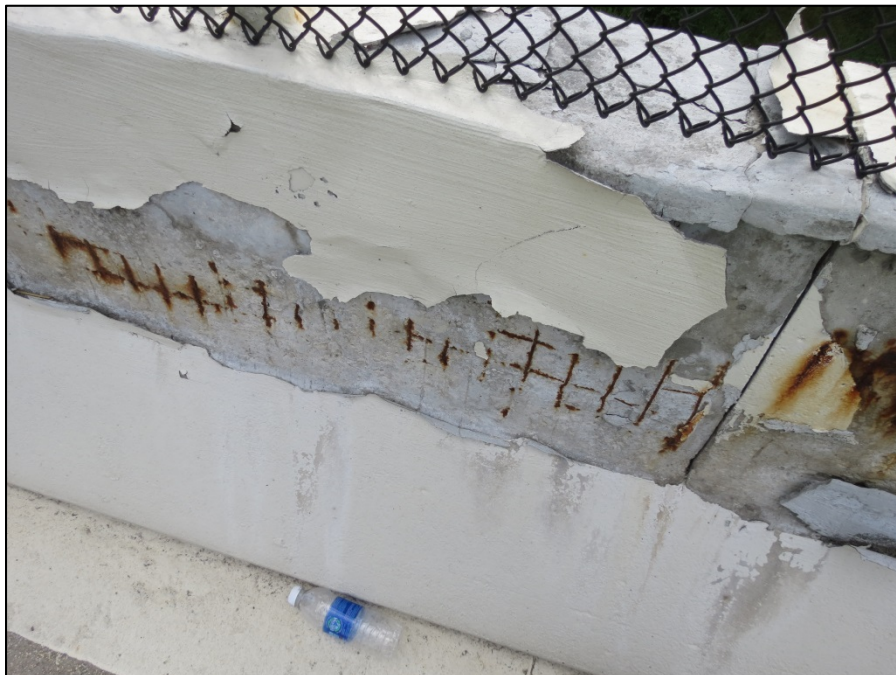
Picture #2: South parapet repairs and sealing failing in span 15, looking south.

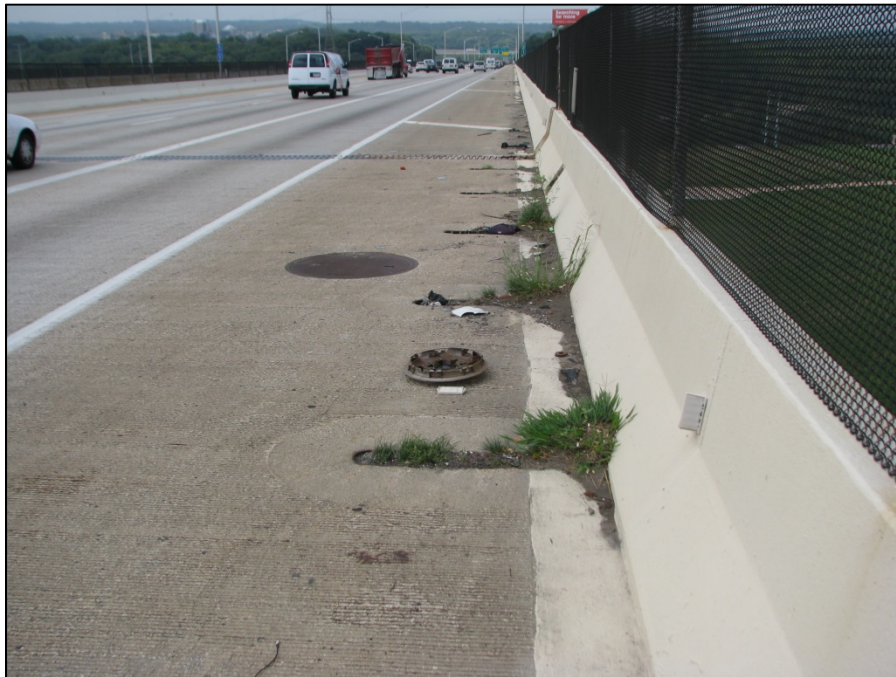
Picture #3: Typical debris in scupper grates and one plugged downspout along the north parapet at pier 9, looking west.

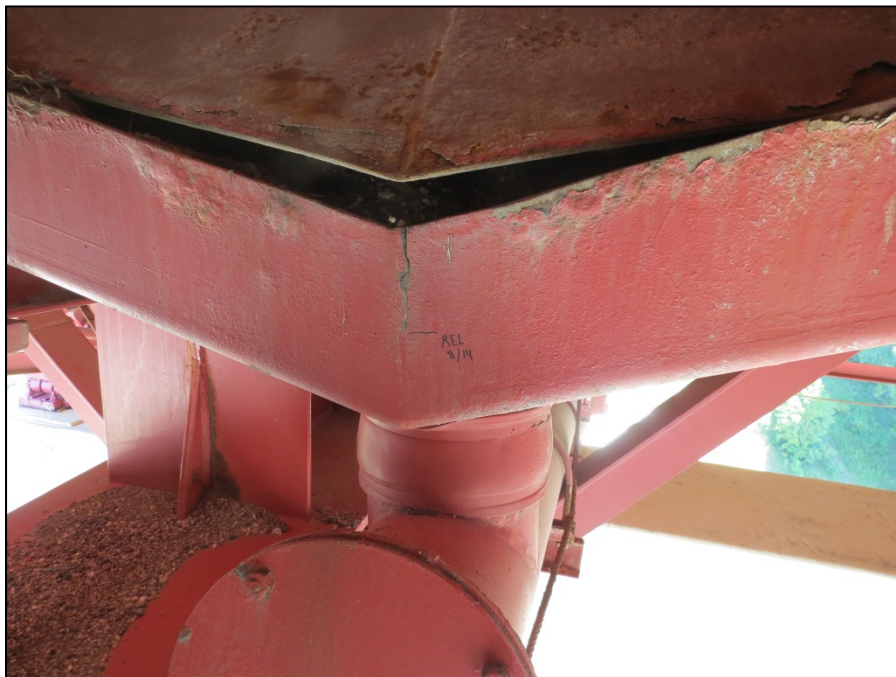
Picture #5: Crack in drainage trough next to south face of girder B in span 12, looking east.

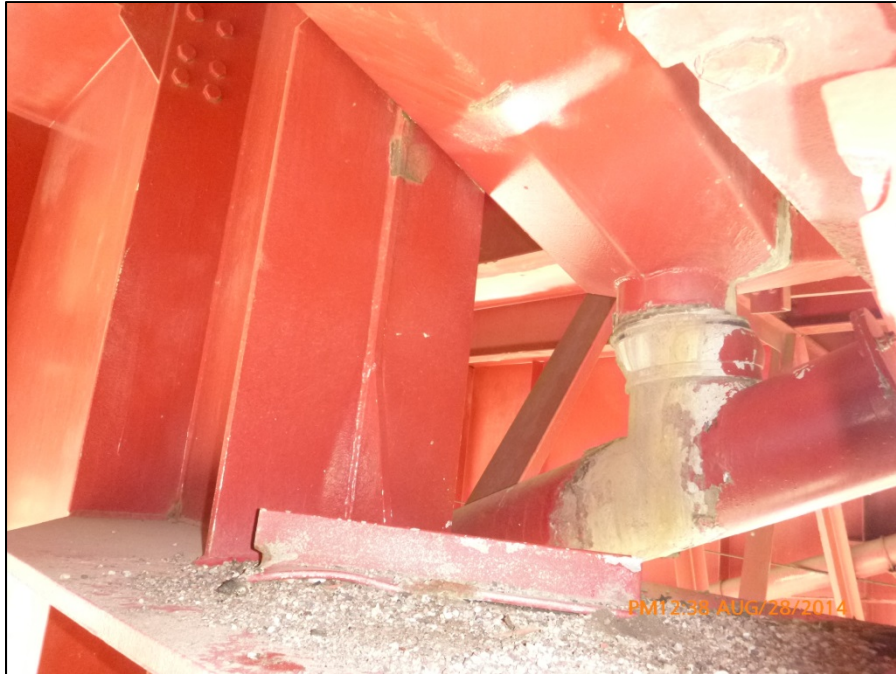
Picture #6: Broken drainage trough support angle next to girder B in span 9, looking east.

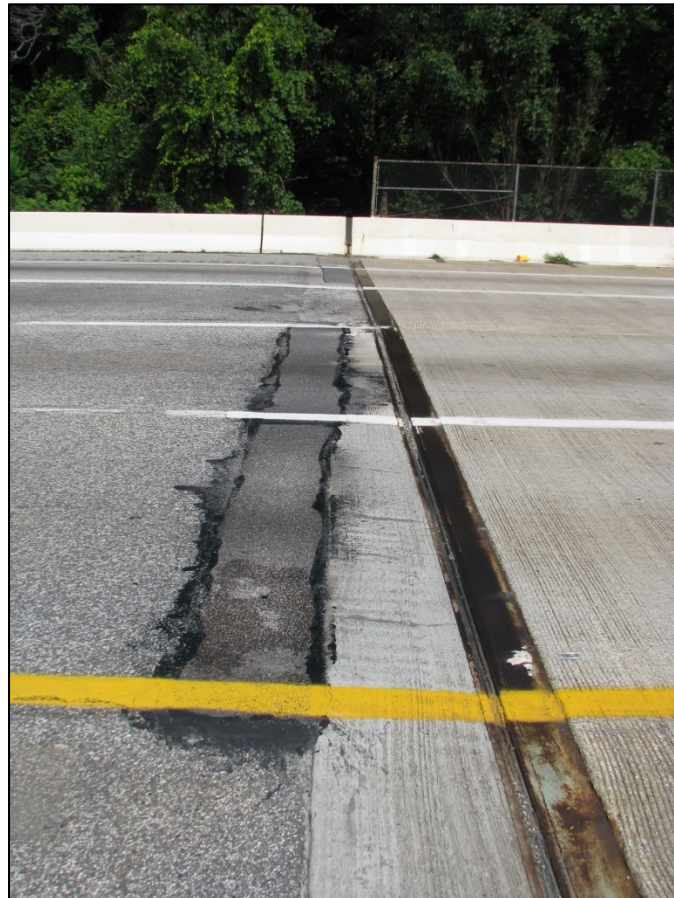
Picture #7: Rear abutment expansion joint header repair, looking north.

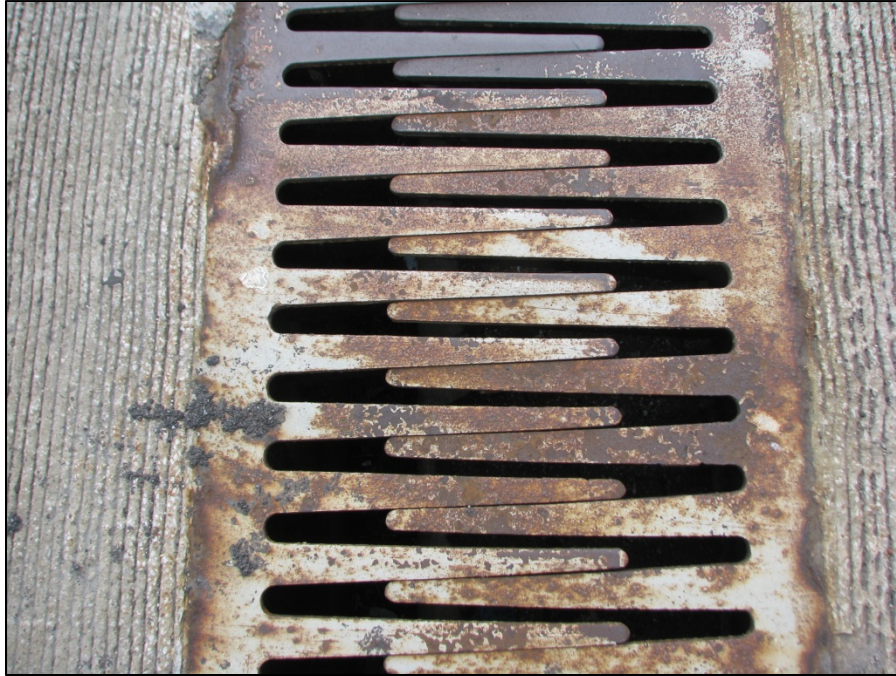
Picture #8: Finger joint in span 6 misaligned transversely, looking south.

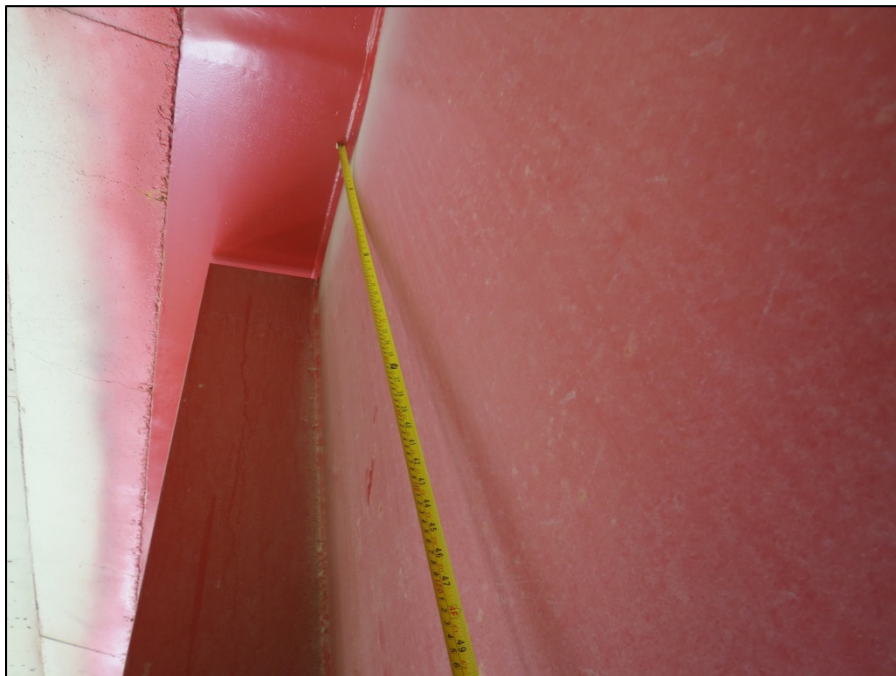
Picture #9: 1” bow near top of girder B web, west of span 14 floorbeam 1, looking north.

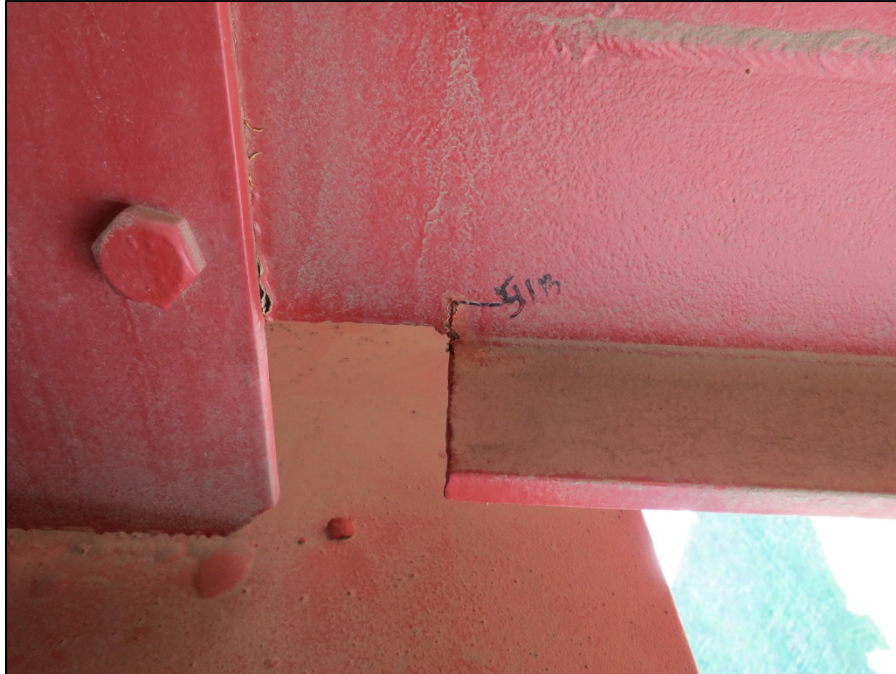
Picture #10: Active 3/4-inch cope crack on floorbeam 10 at connection to south face of girder B in span 12, looking east.

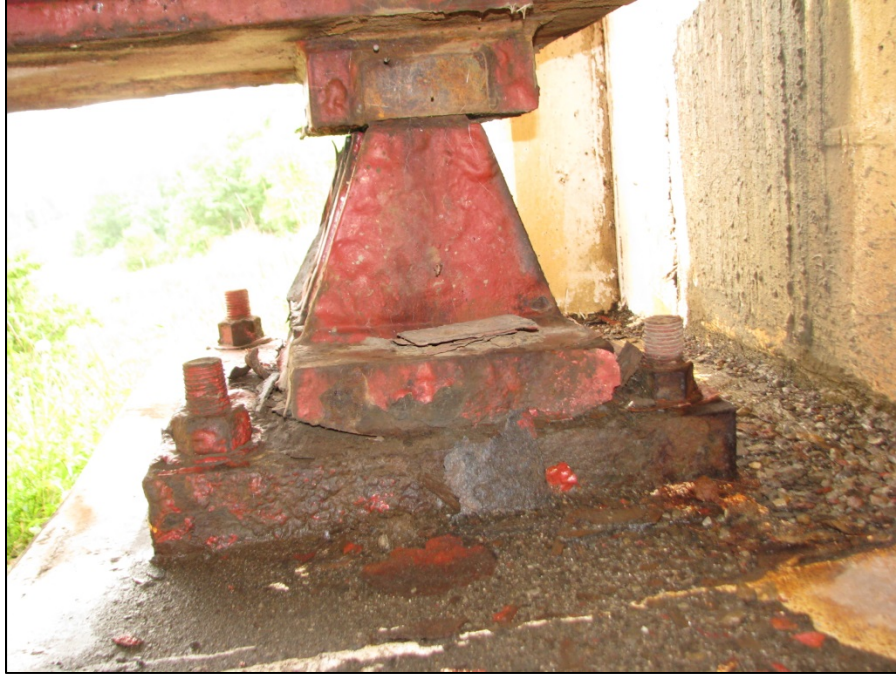
Picture #11: Dirt and deterioration on forward abutment girder A bearing, looking north.

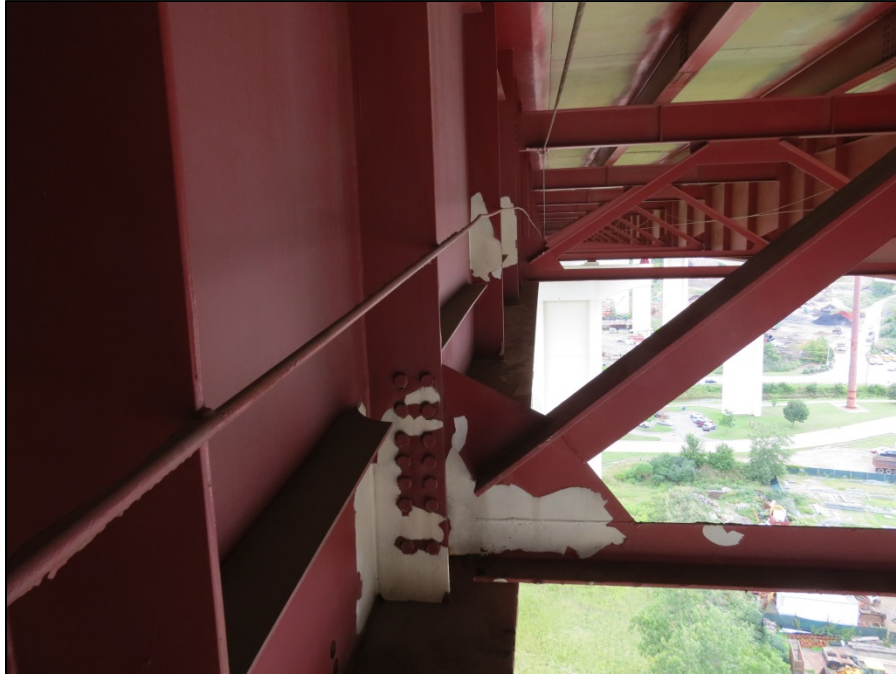
Picture #12: Top coat paint failure on south face of girder B in span 7, looking east.

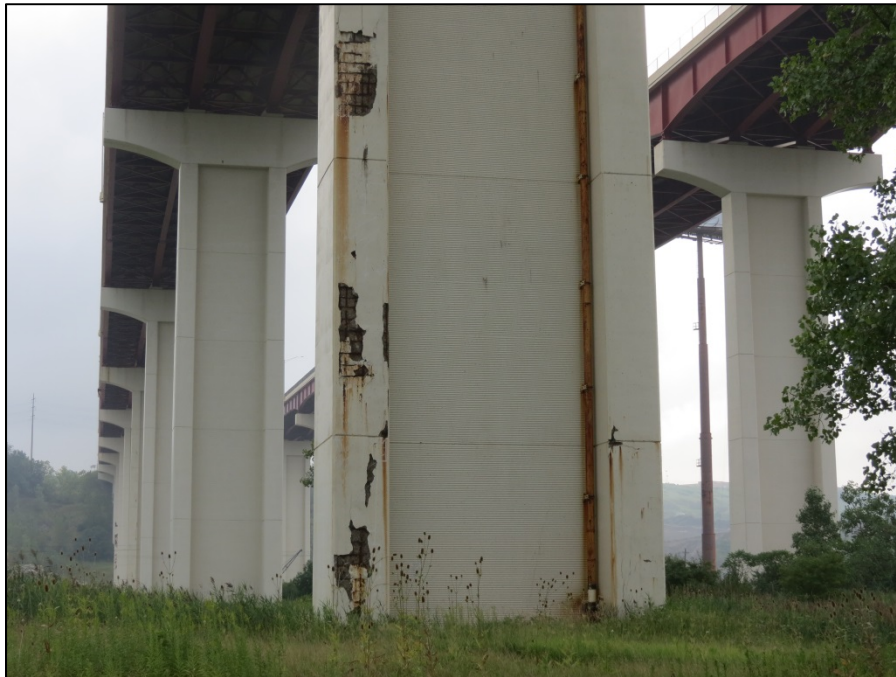
Picture #13: Deterioration on west face of pier 6, looking east.

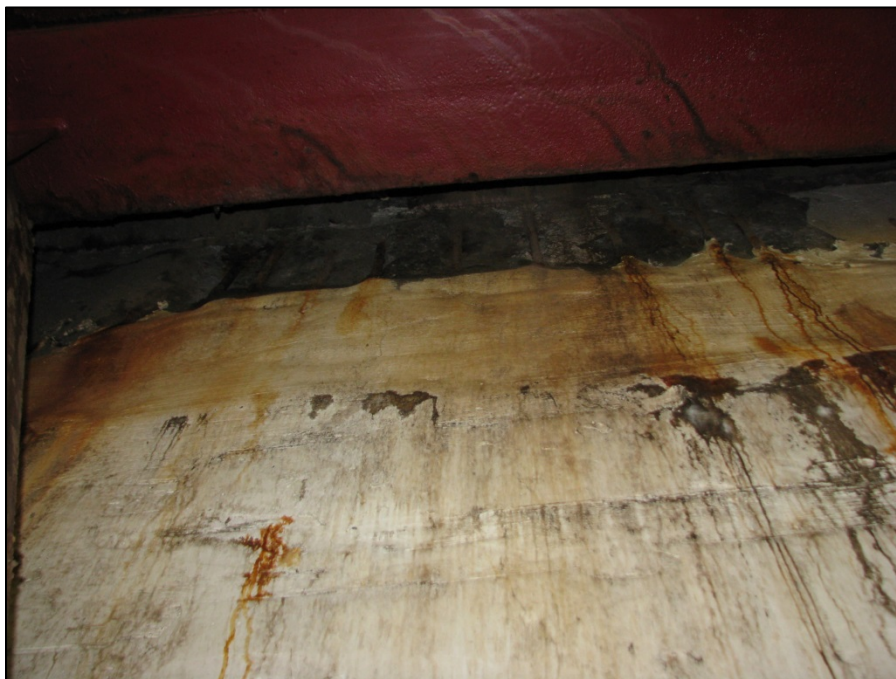
Picture #14: Top 3 feet of forward abutment backwall not patched and some patches already failing, looking east.

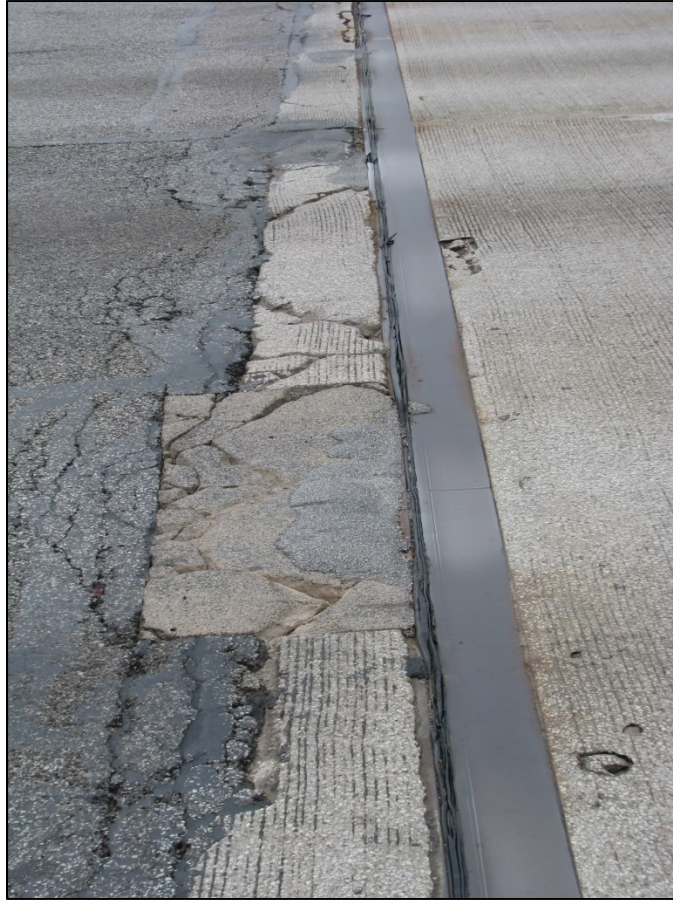
Picture #15: Top of the forward abutment backwall breaking up in lane 1N and 2N, looking south.

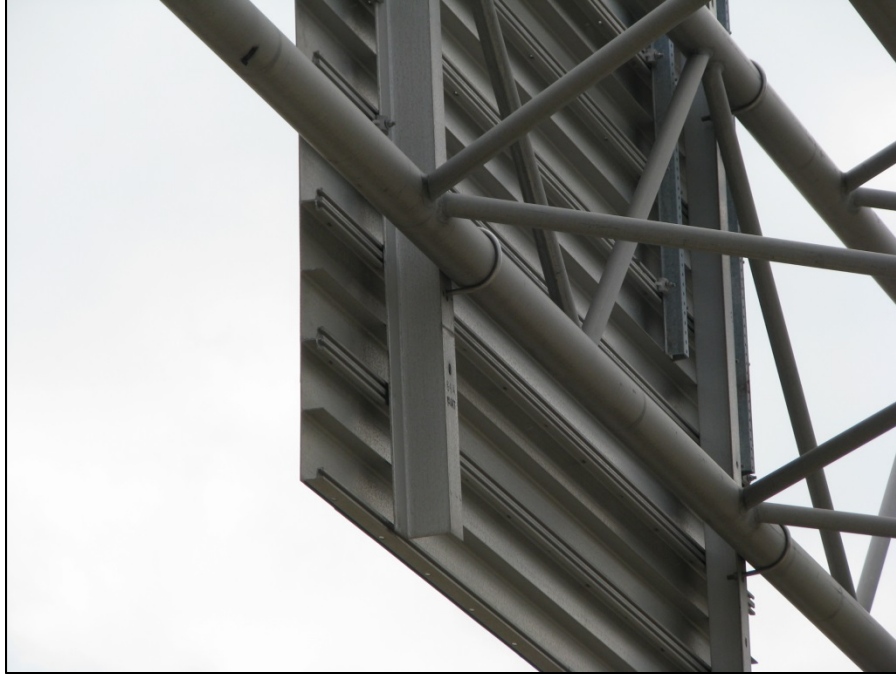
Picture #16: Sign clips missing from bottom half of overhead sign in span 11, looking south.

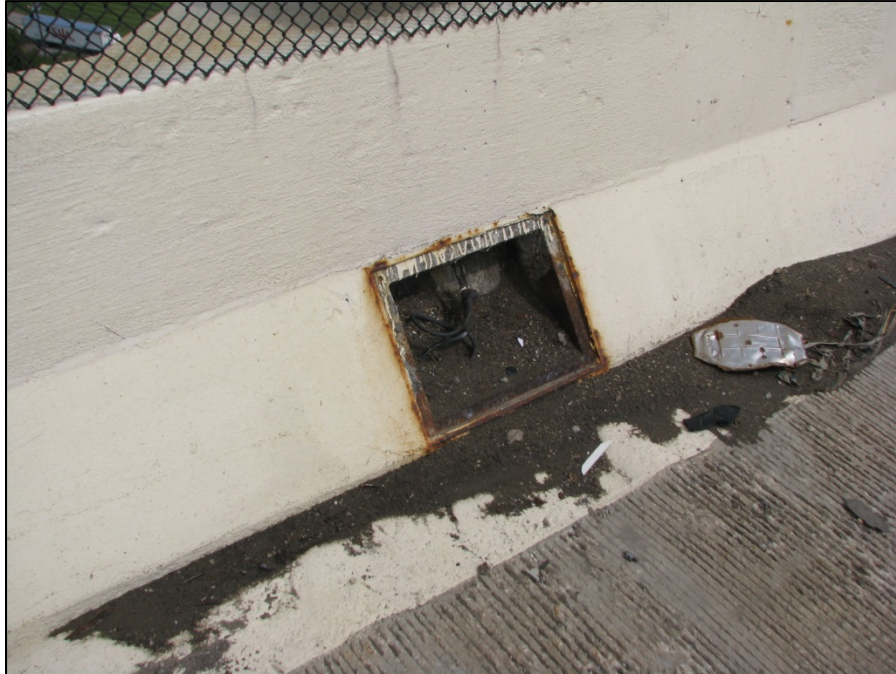
Picture #17: Missing electrical junction box cover in north parapet in unit 3.

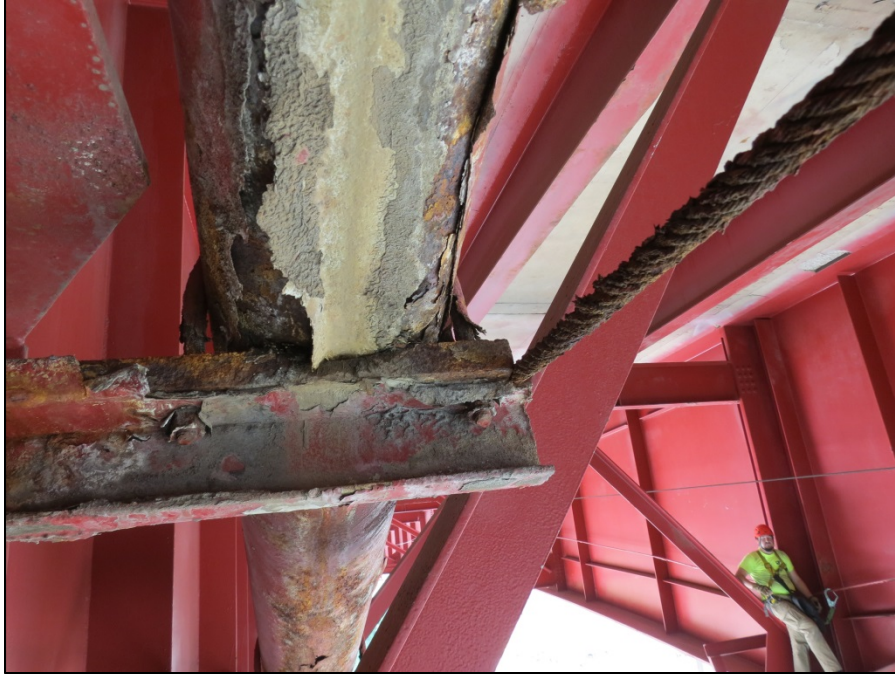
Picture #18: Deteriorated safety cable along south face of girder B near pier 9 prior to snapping, looking east.

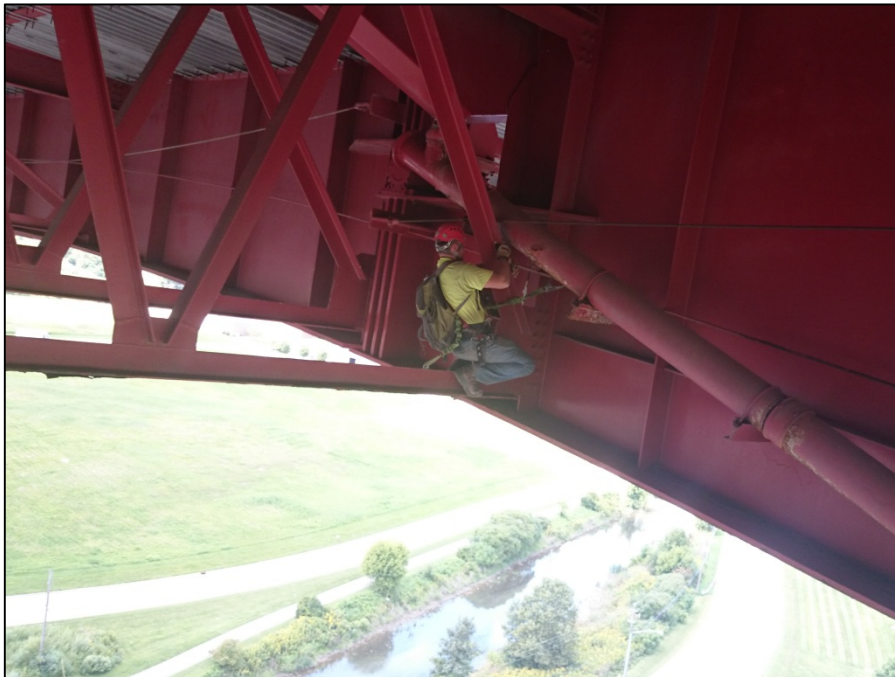
Picture #19: Inspector passing under deteriorated cable prior to snapping, looking north.

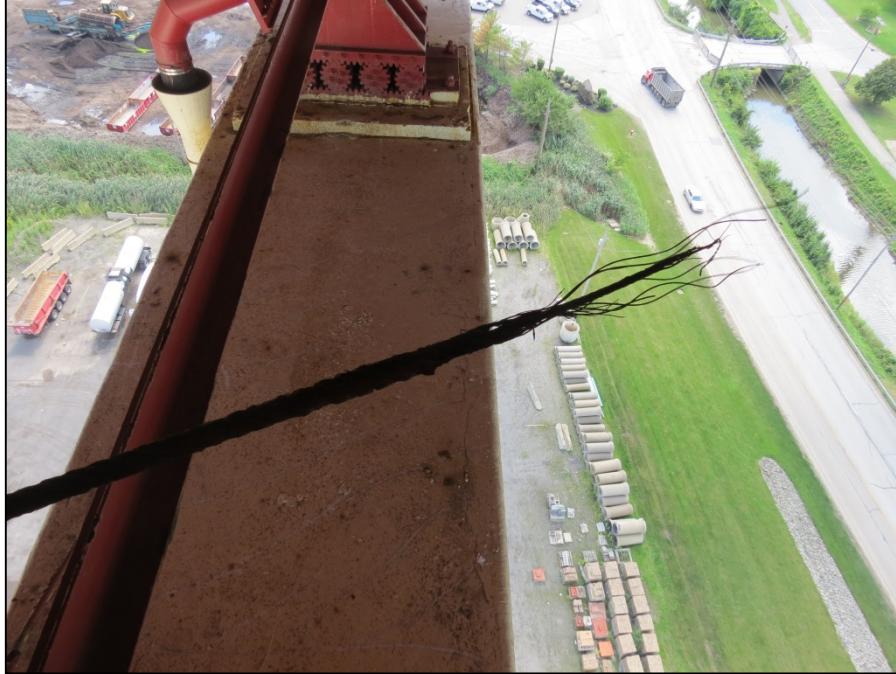
Picture #20: After safety cable snapped at pier 9, looking south.

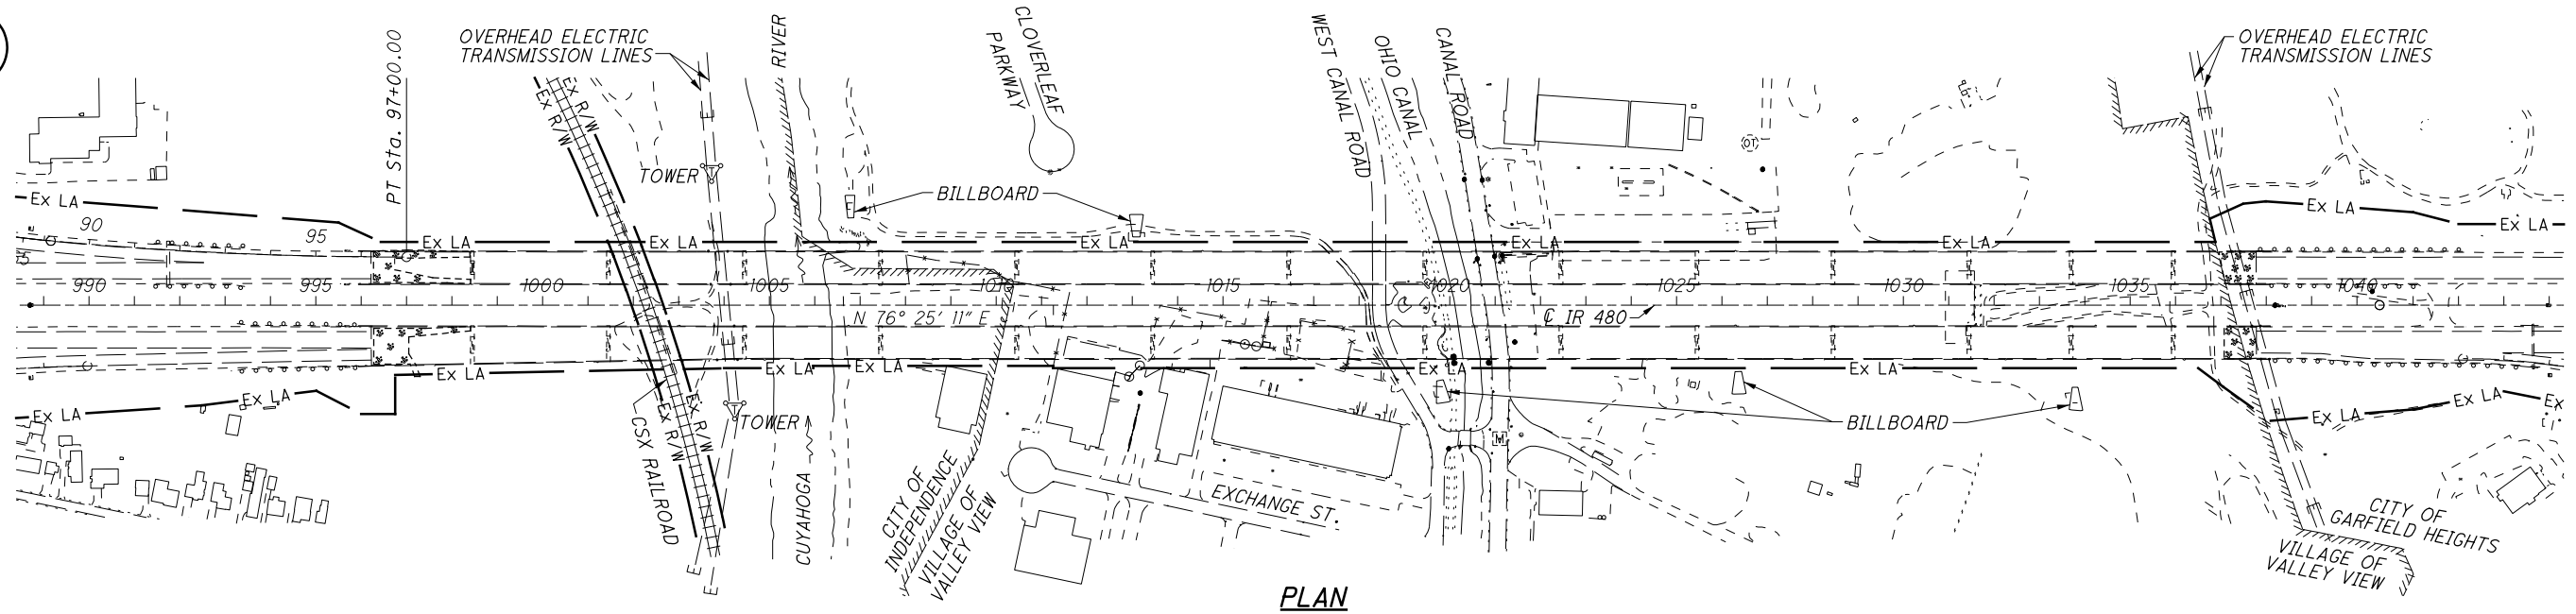
Rear abutment slope protection repaired in 2013 where washed out. Downspout drainage has cut a deep channel between the base of pier 3 and the river. Top of pier 3 footing has not been exposed. Crushed aggregate slope protection at forward abutment has slid down hill leaving top 6" of footing exposed.

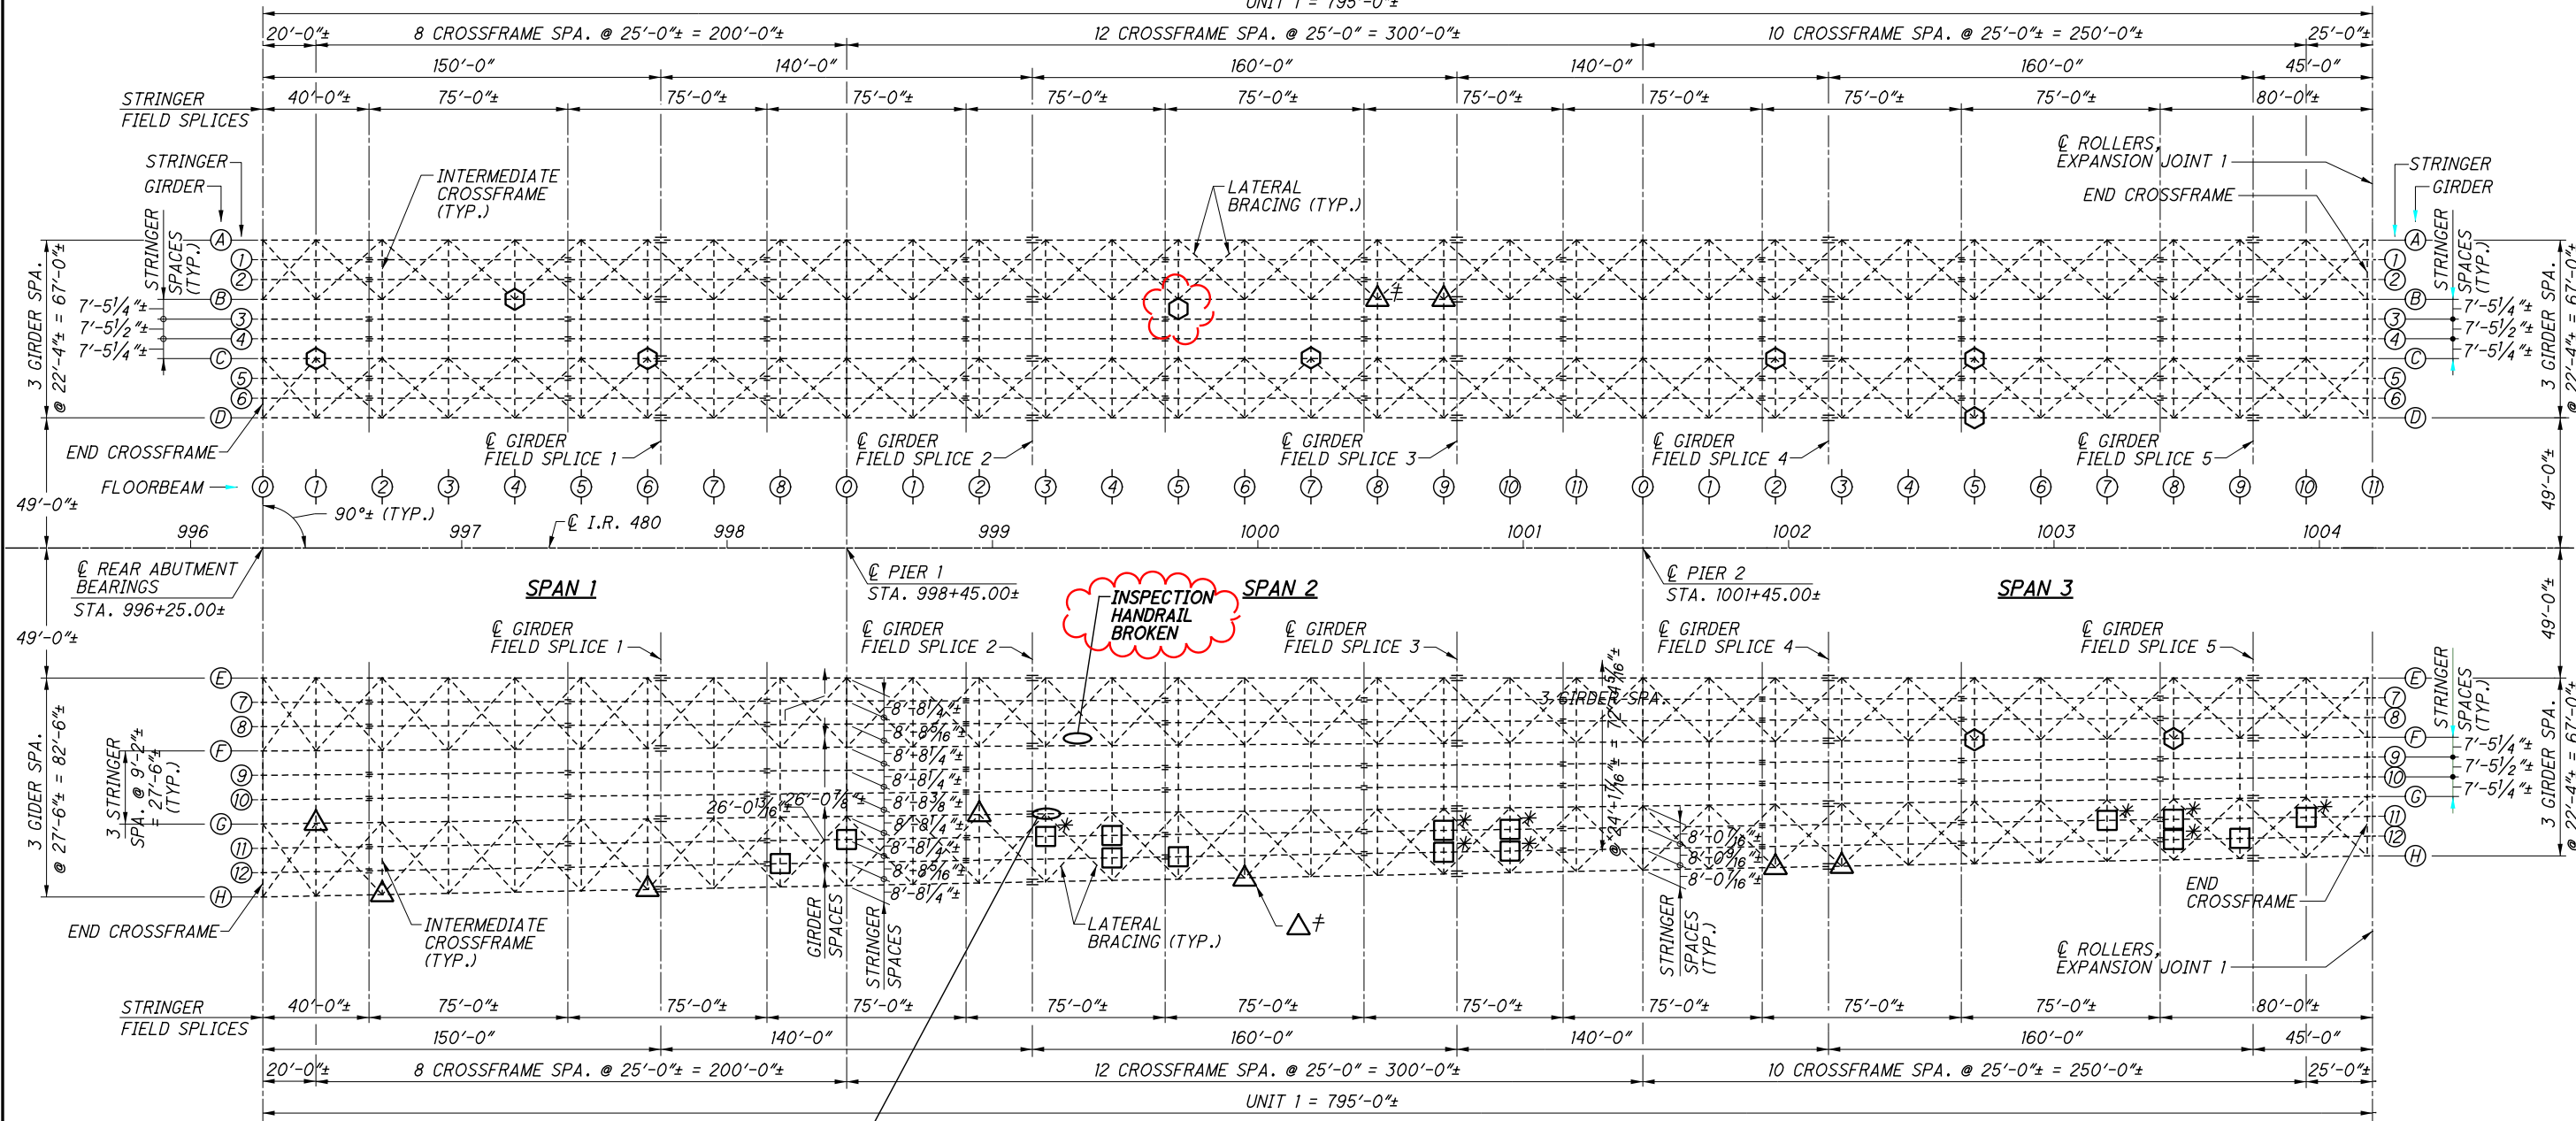
### UNIT 1 FRAMING PLAN

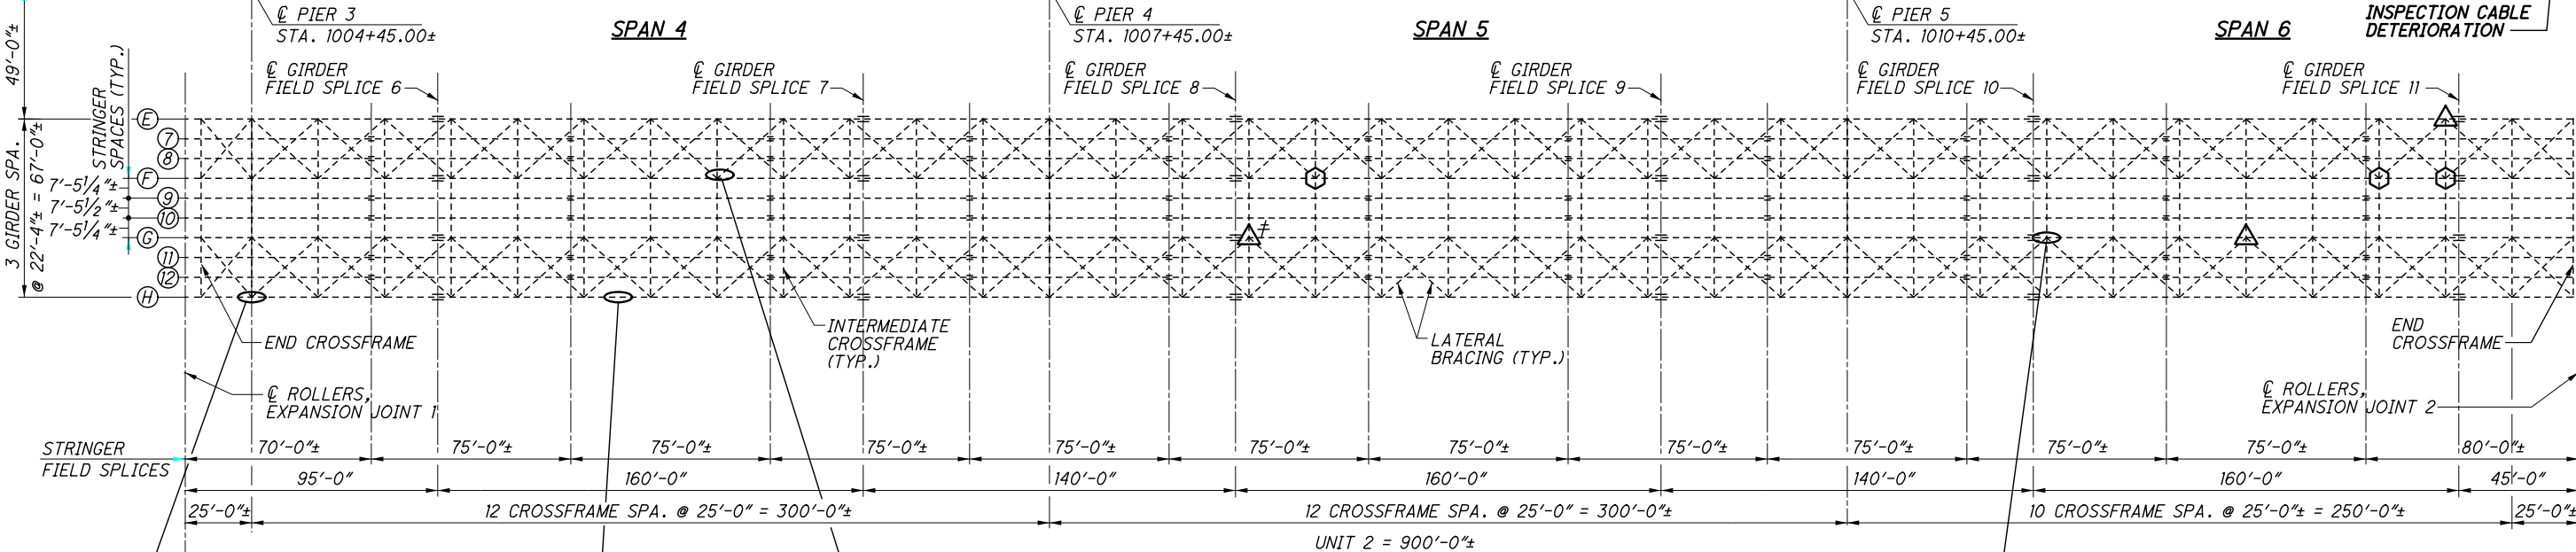
INSPECTION CABLE  
DETERIORATION

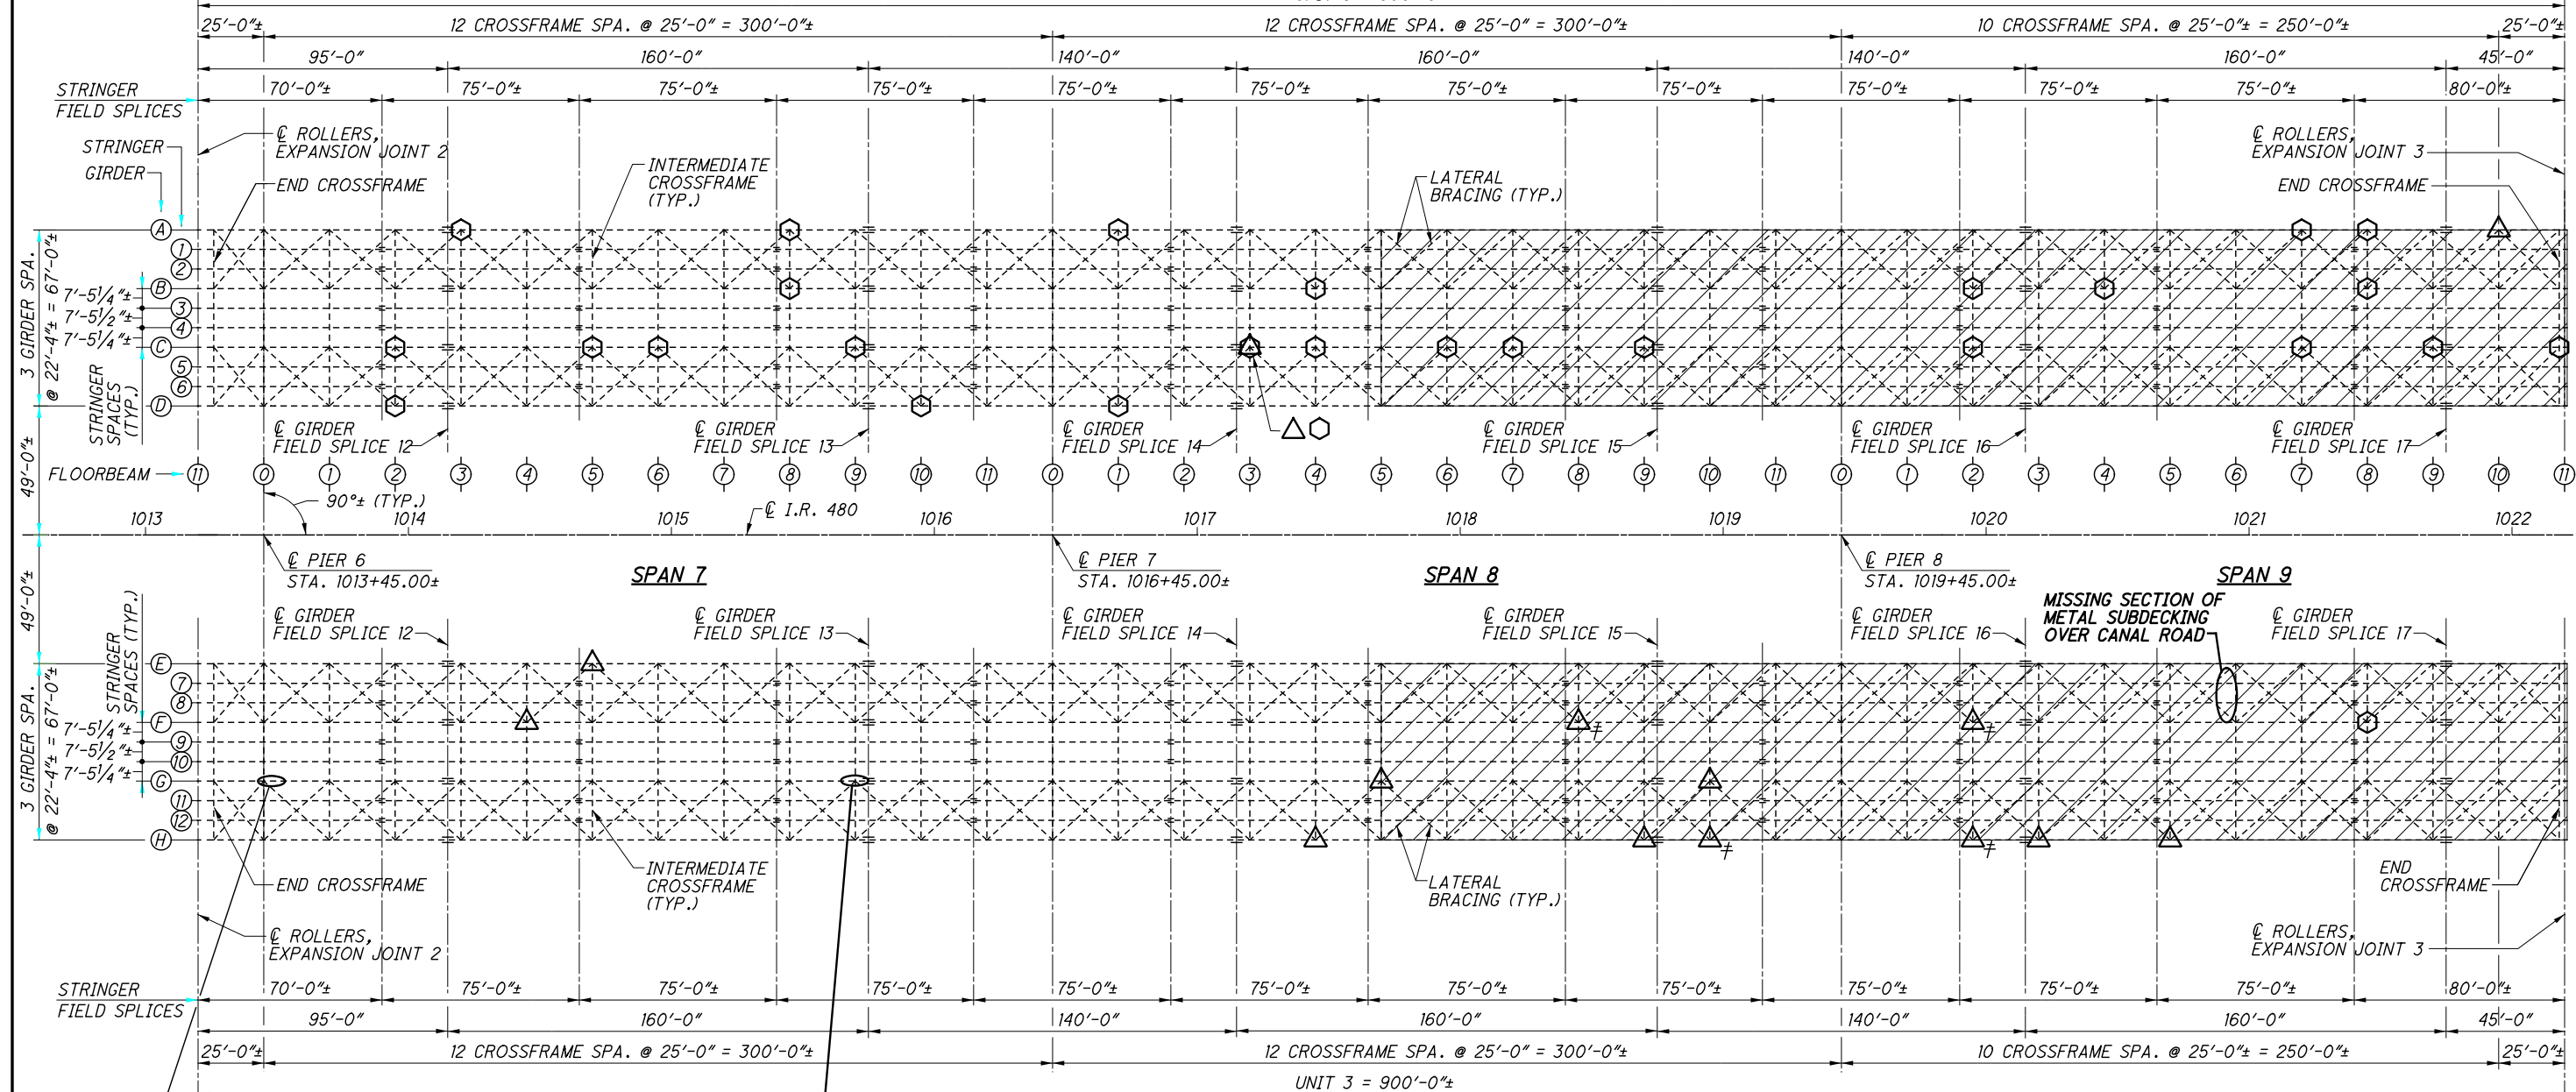
ACTIVE 1/4" WEB CRACK AT TOP OF TRANSVERSE STIFFENER
