**2014 UPDATE TO THE 2013 PHYSICAL CONDITIONS INSPECTION
REPORT**

CUY-480-1842 R
SFN 1812548

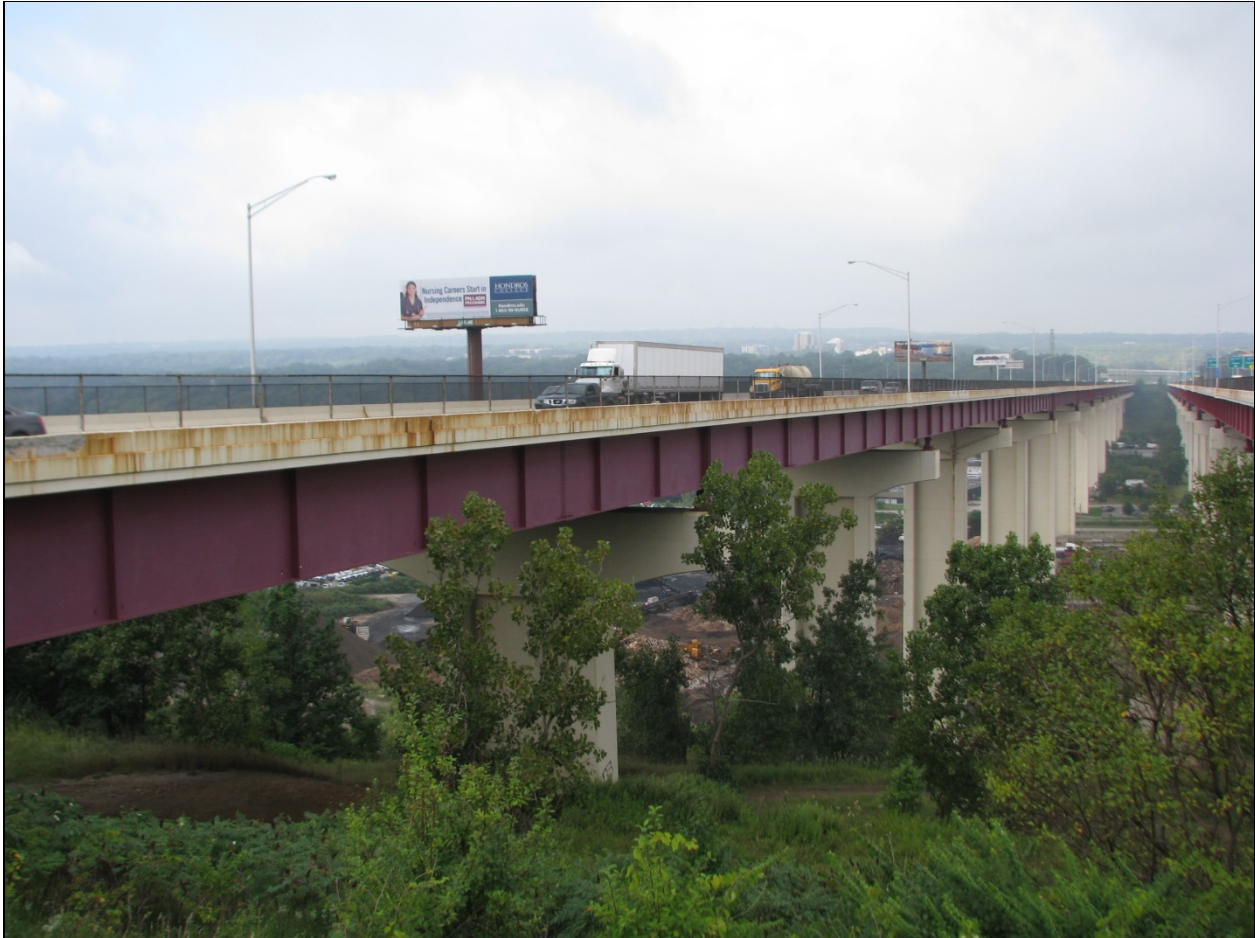
Eastbound Valley View Bridge Over the Cuyahoga River Valley

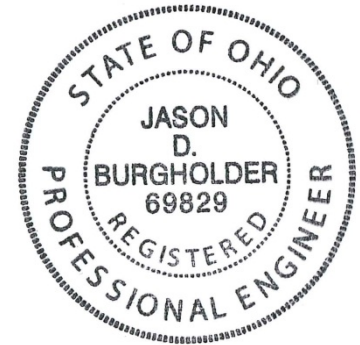
2014 UPDATE TO THE 2013 PHYSICAL CONDITIONS INSPECTION REPORT

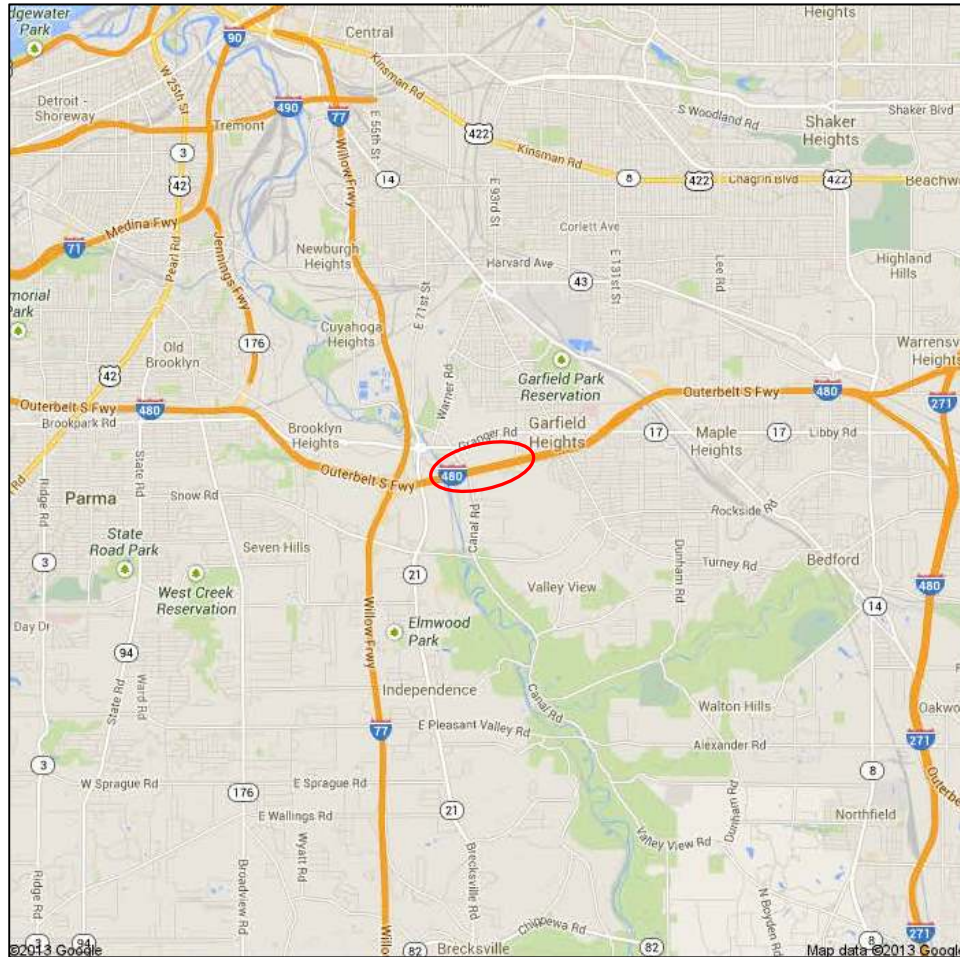
GENERAL APPRAISAL AND OPERATING STATUS

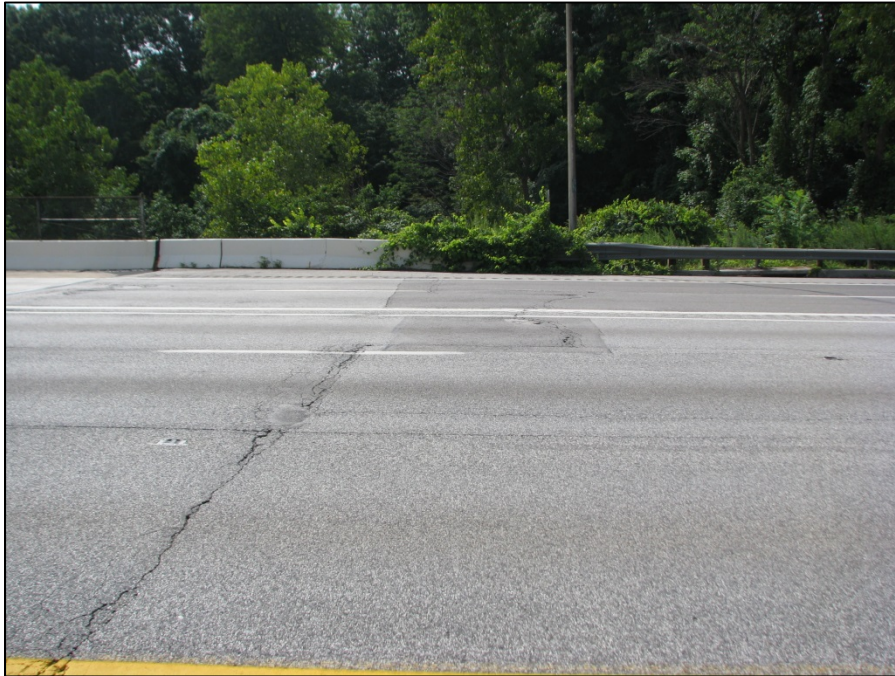
Picture #1: Rear approach wearing surface looking south.

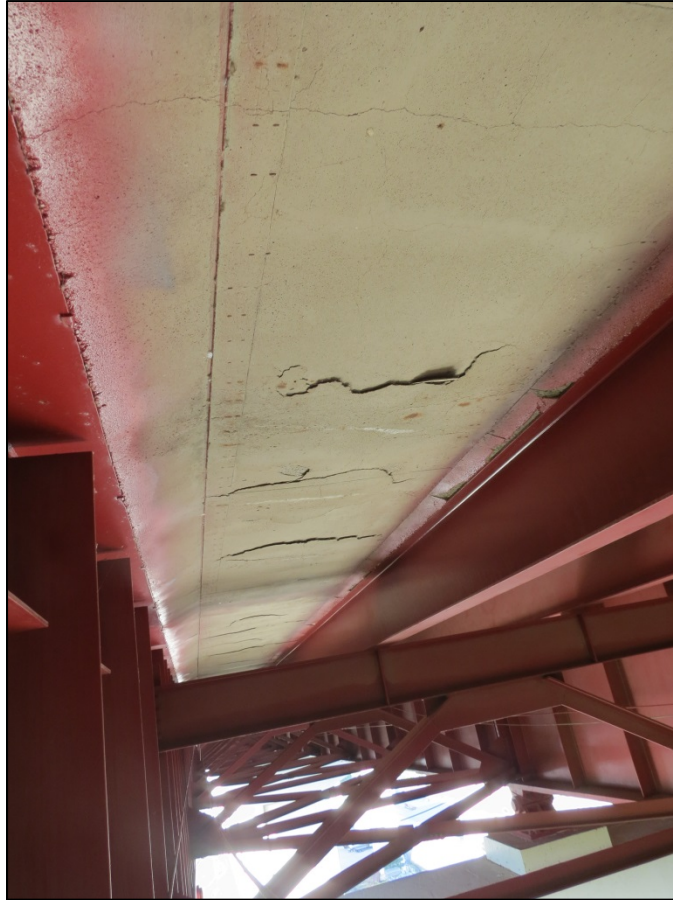
Picture #2: Typical deck cracks and delaminations in span 15.

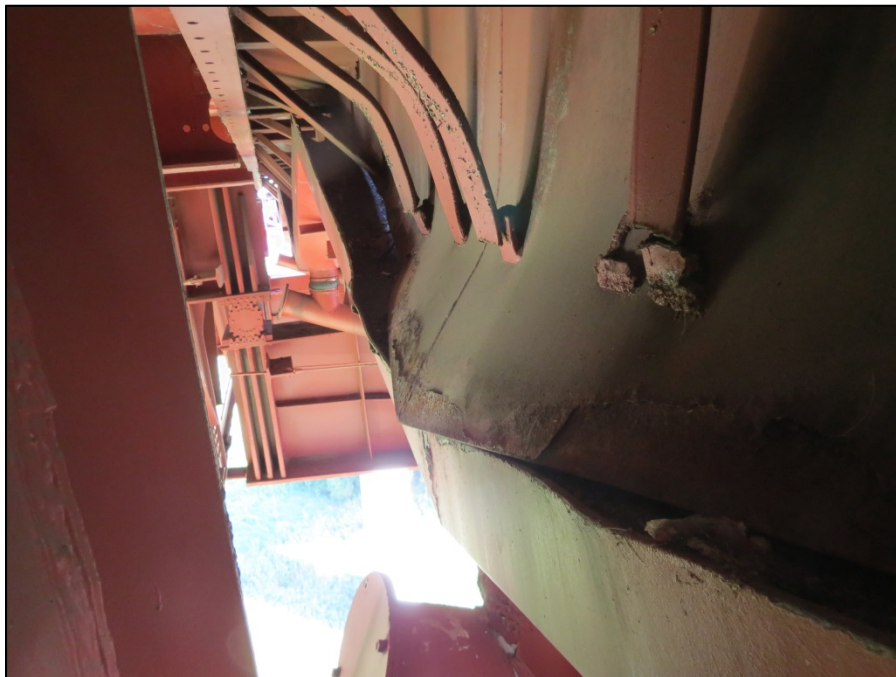
Picture #3: Steel flashing bent out of trough. Support angles bent and broken Looking north from girder G in span 3.

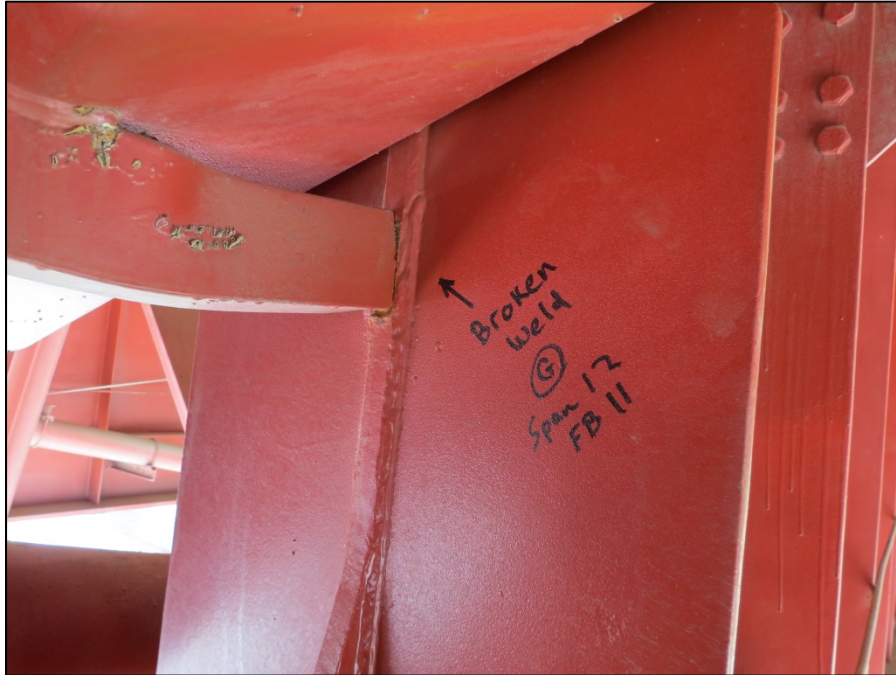
Picture #4: Cracked weld connecting drainage trough support angle to girder G in span 12, looking north.

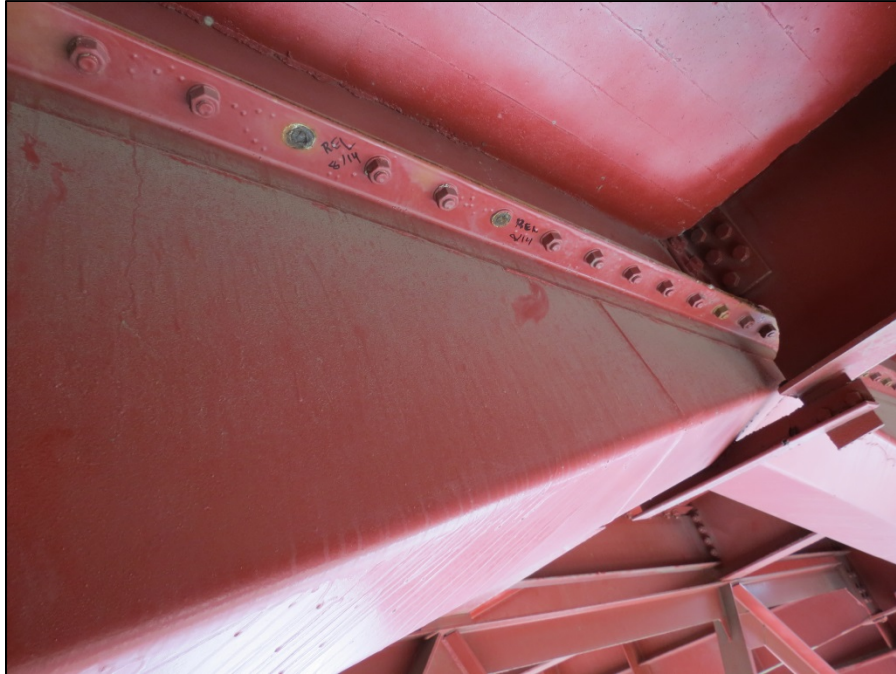
Picture #5: Two broken bolts connecting drainage trough to joint support armor between girders E and F near pier 12, looking west.

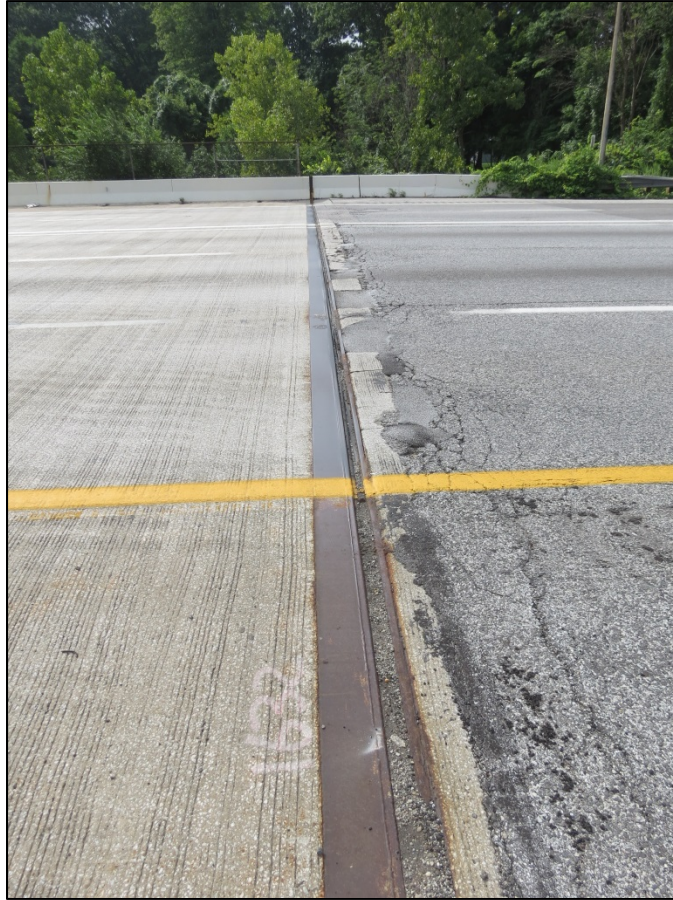
Picture #6: Rear abutment joint header breaking up, looking south.

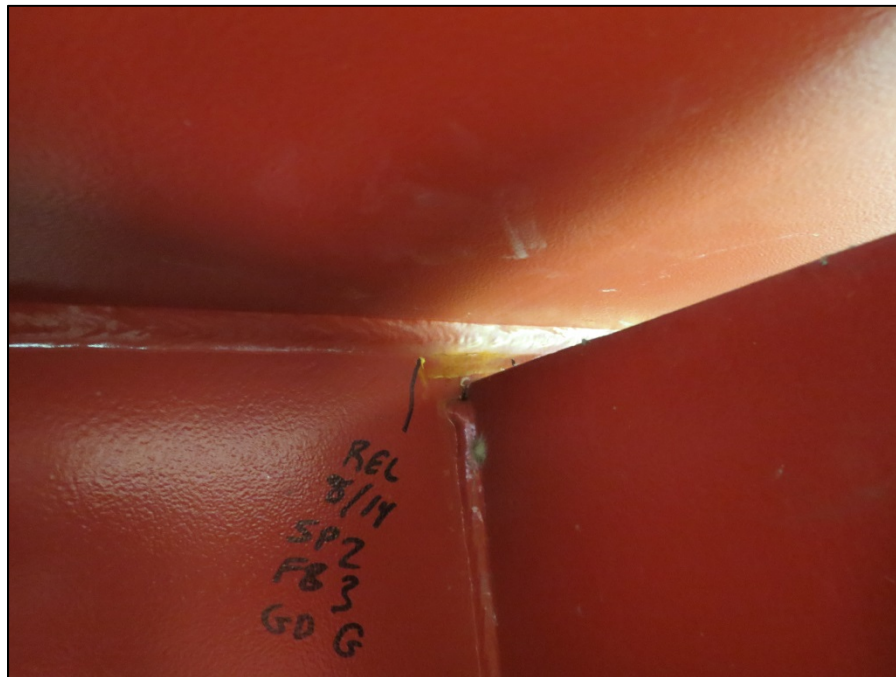
Picture #9: New 2.25” active crack on south face of girder G, span 2.

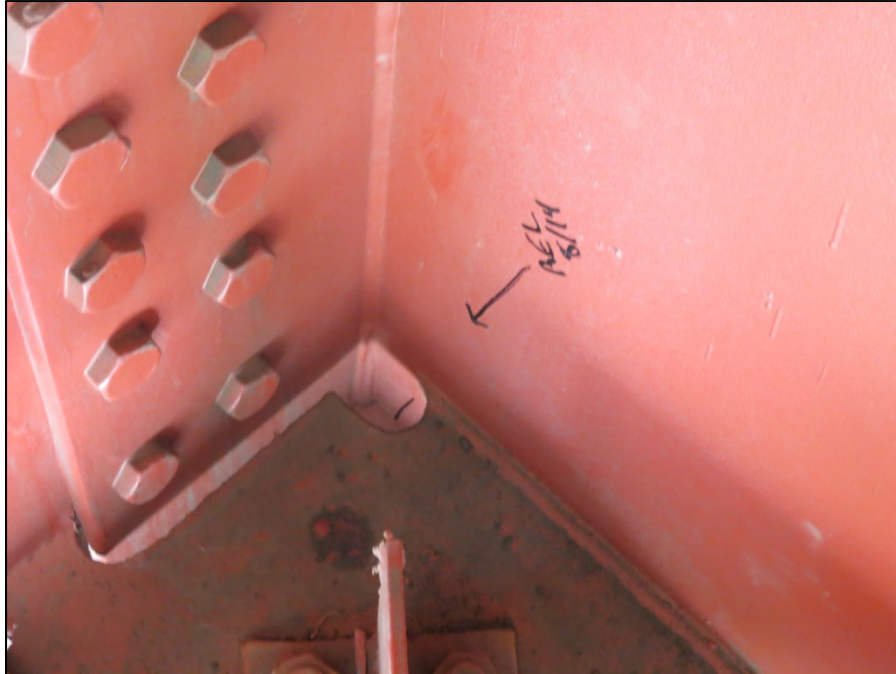
Picture #10: New 1.5" active crack on north face of girder F, span 4.

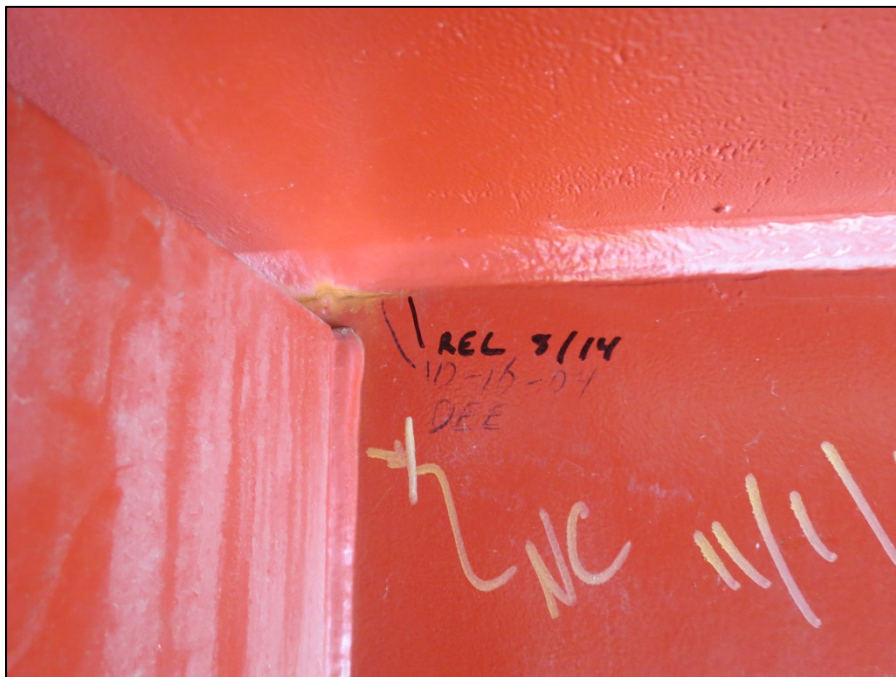
Picture #11: Active 3.25" crack on south face of girder G, span 6.

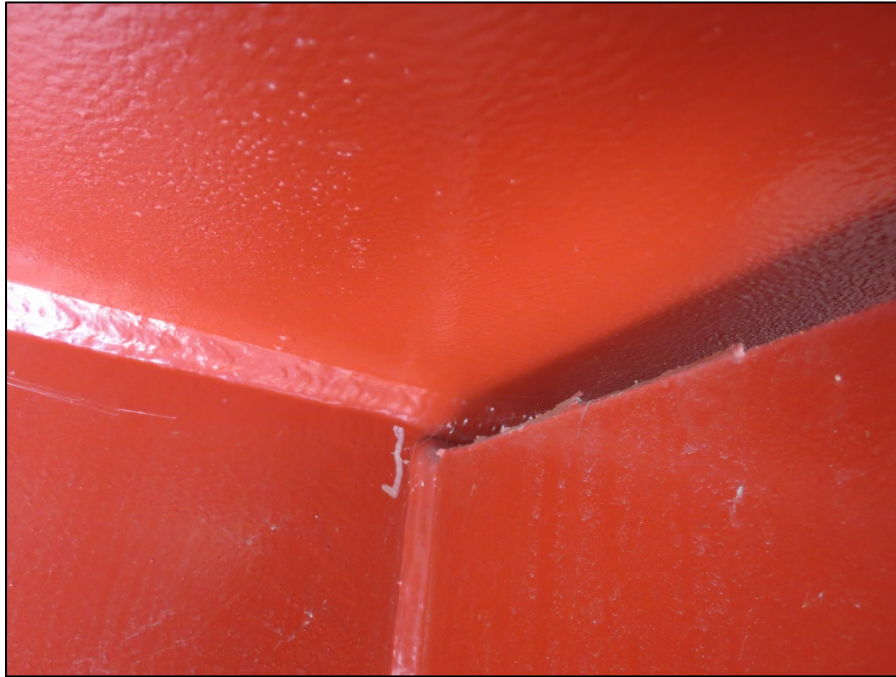
Picture #12: New 1.75” active crack on south face of girder G, span 7.

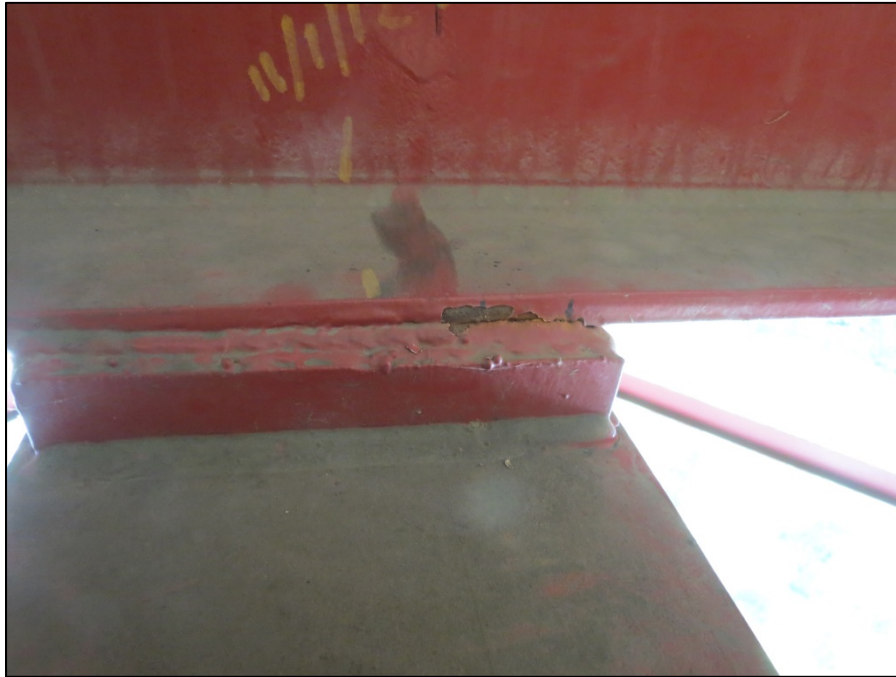
Picture #13: Cracked stringer 11 welded connection to floorbeam 8 in span 3, looking south.

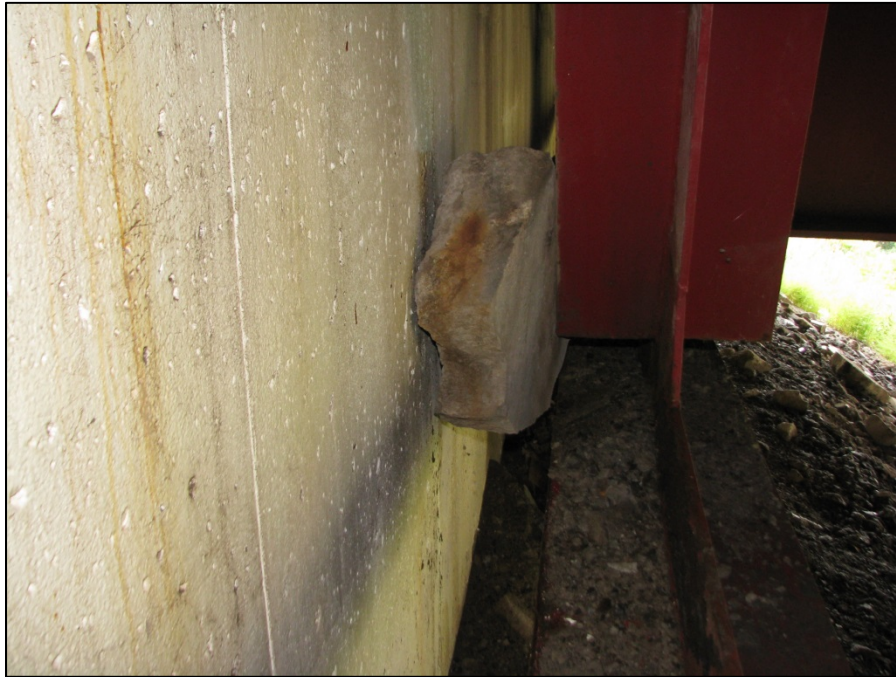
Picture #14: Large chunk of backwall concrete wedged between center bay end floorbeam and the forward abutment backwall, looking south.

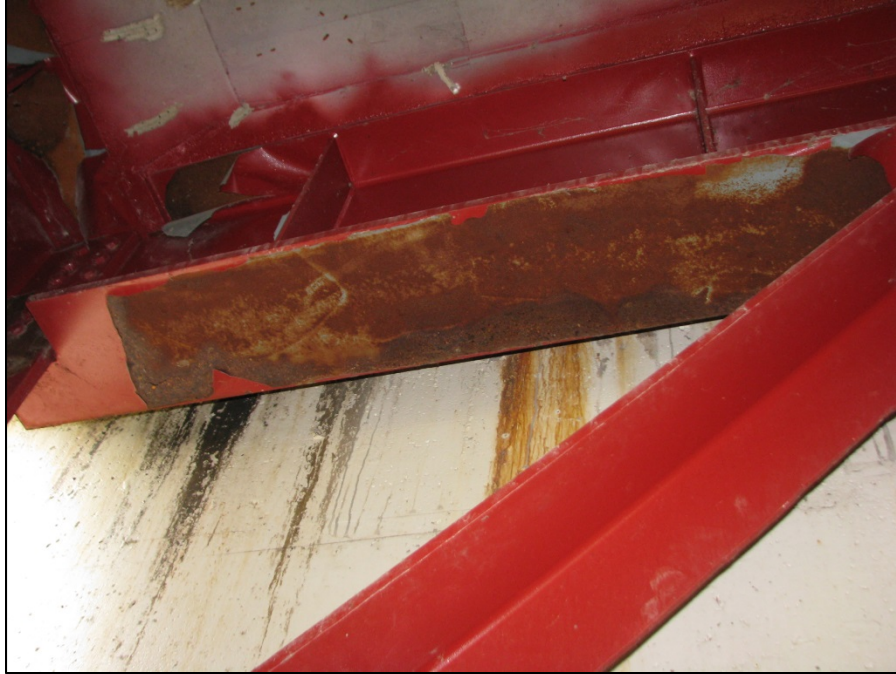
Picture #16: Paint failure on rear abutment end floorbeam near girder H.

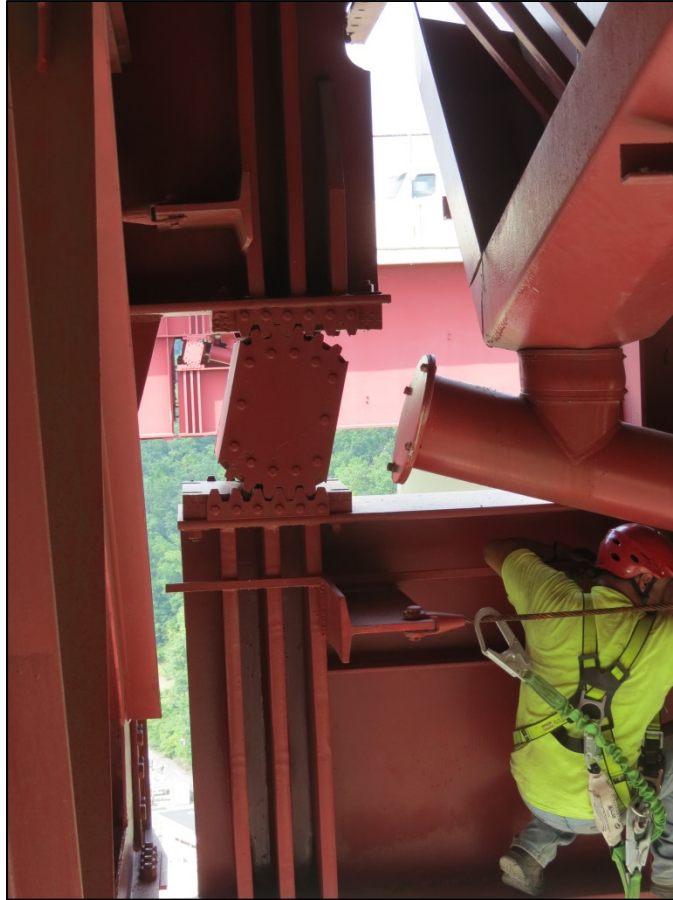
Picture #17: Girder E hinge rocker near pier 12 tilted 12° East at 90°F.

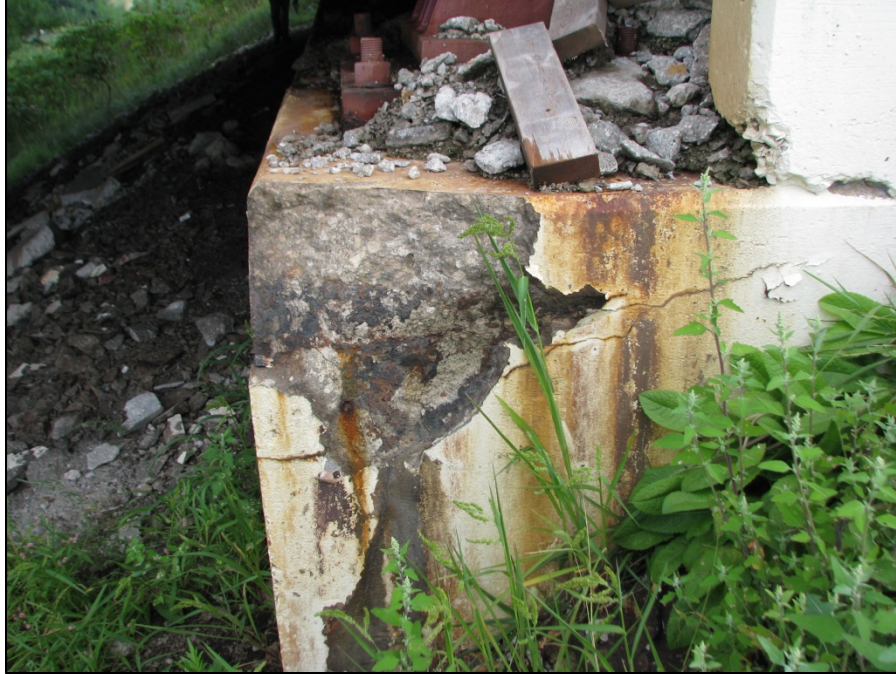
Picture #18: Spalls and deterioration at south end of forward abutment. Note debris on seat.

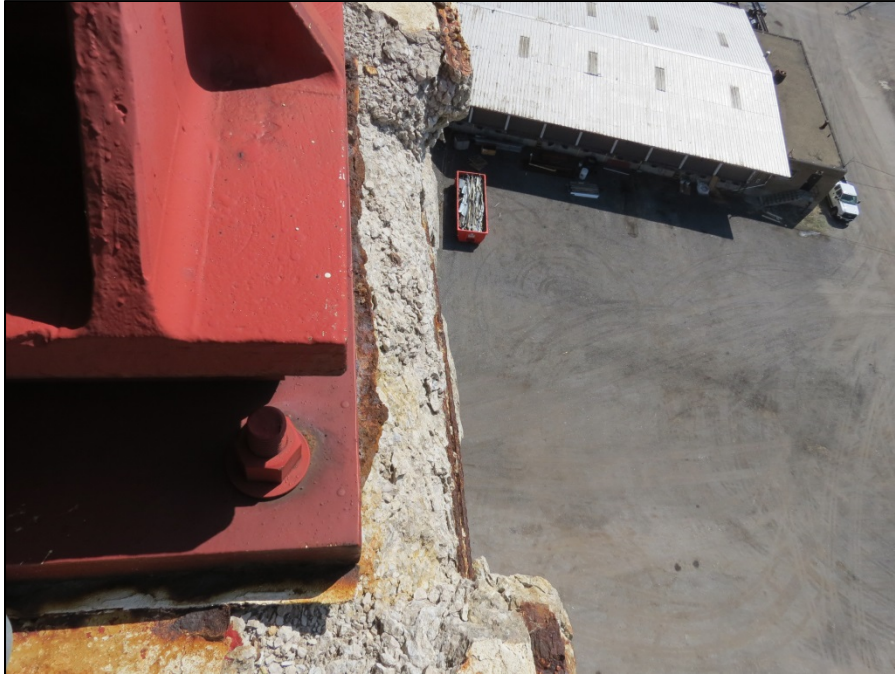
Picture #19: South end of pier 4 cap deterioration undermining edge of girder H bearing.

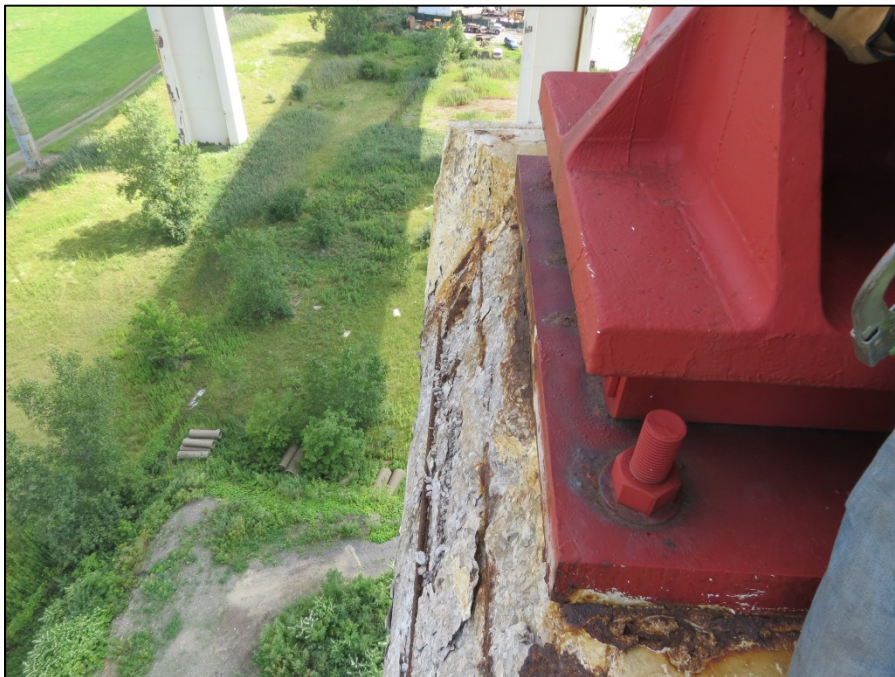
Picture #20: North end of pier 5 cap deterioration undermining edge of girder E bearing.

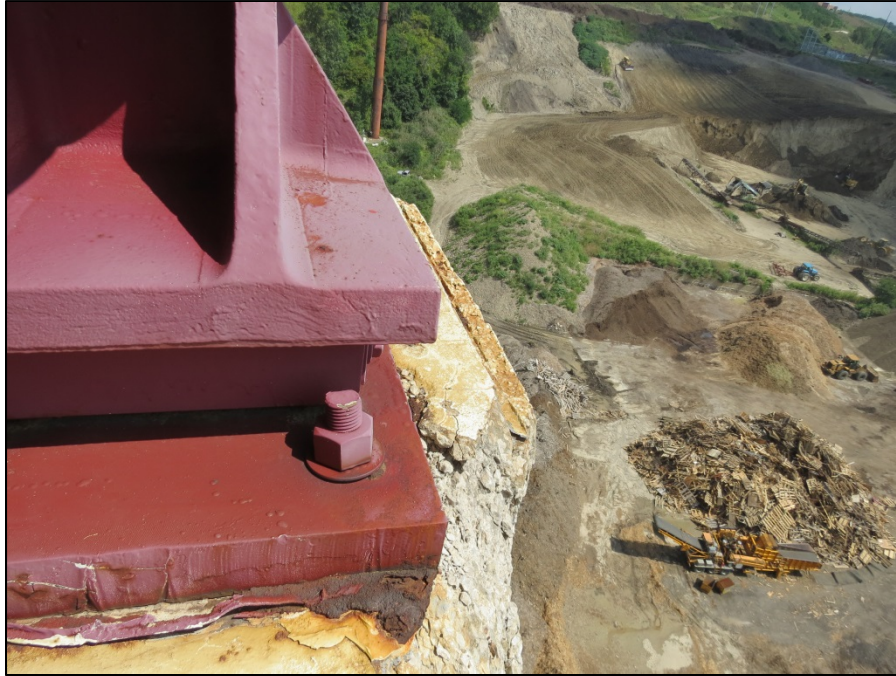
Picture #21: South end of pier 11 cap deterioration undermining edge of girder H bearing.

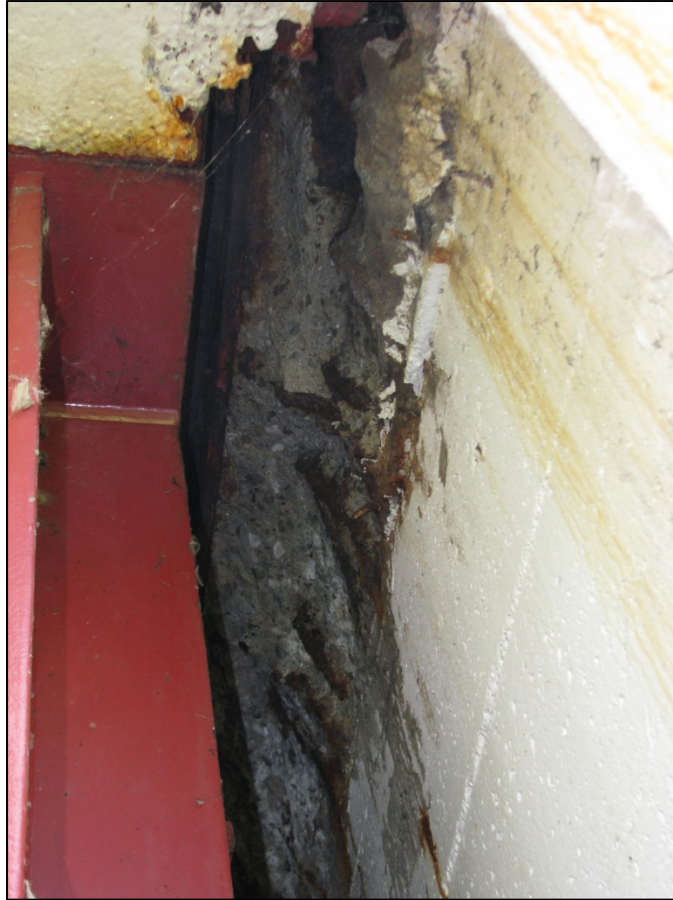
Picture #22: Top of rear abutment backwall continuing to deteriorate behind girder E.

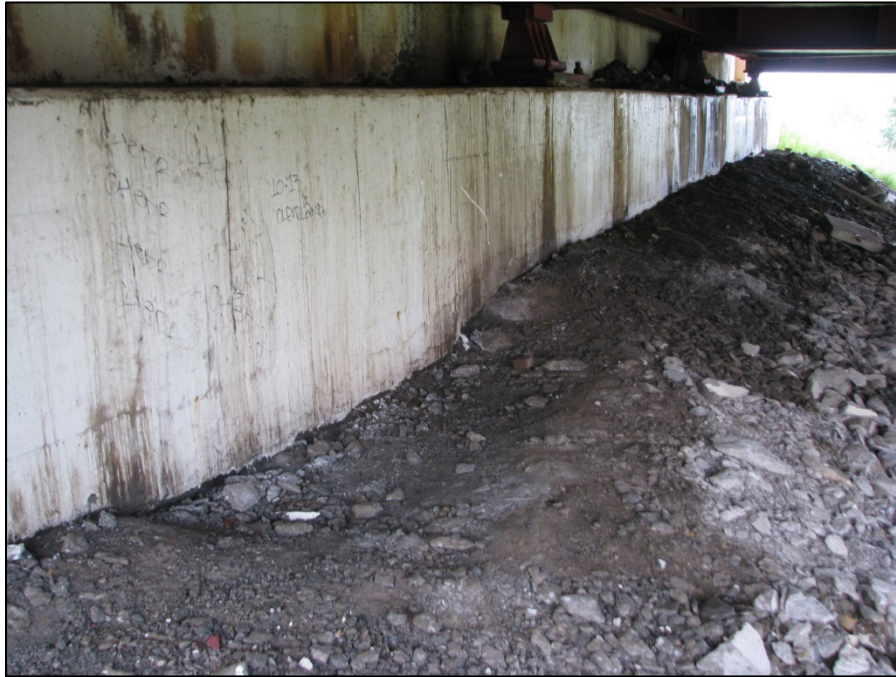
Picture #23: Top of forward abutment slope protection never restored after 2013 rehab.

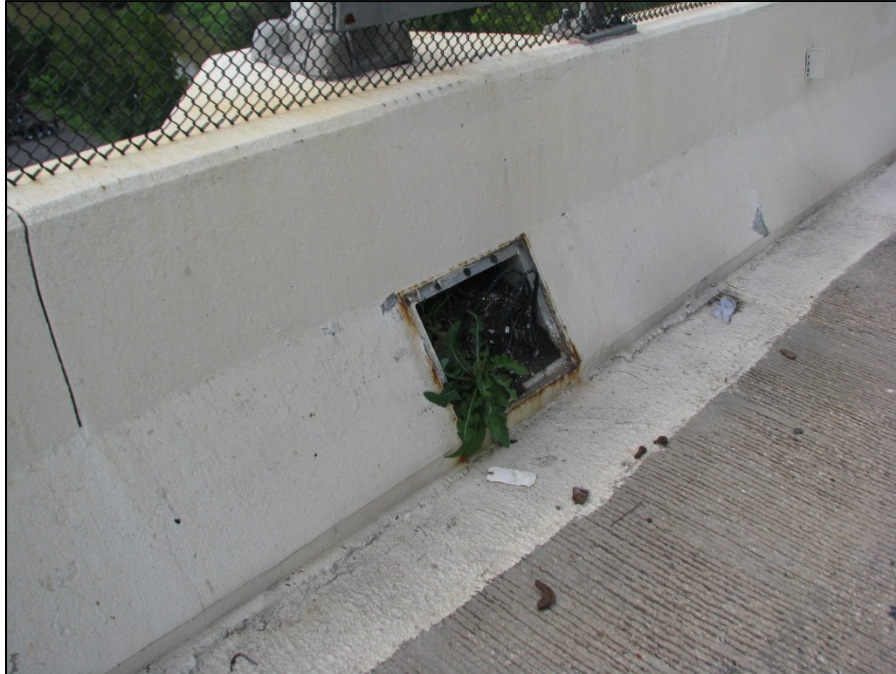
Picture #24: Electrical junction box cover missing from south parapet in span 5.

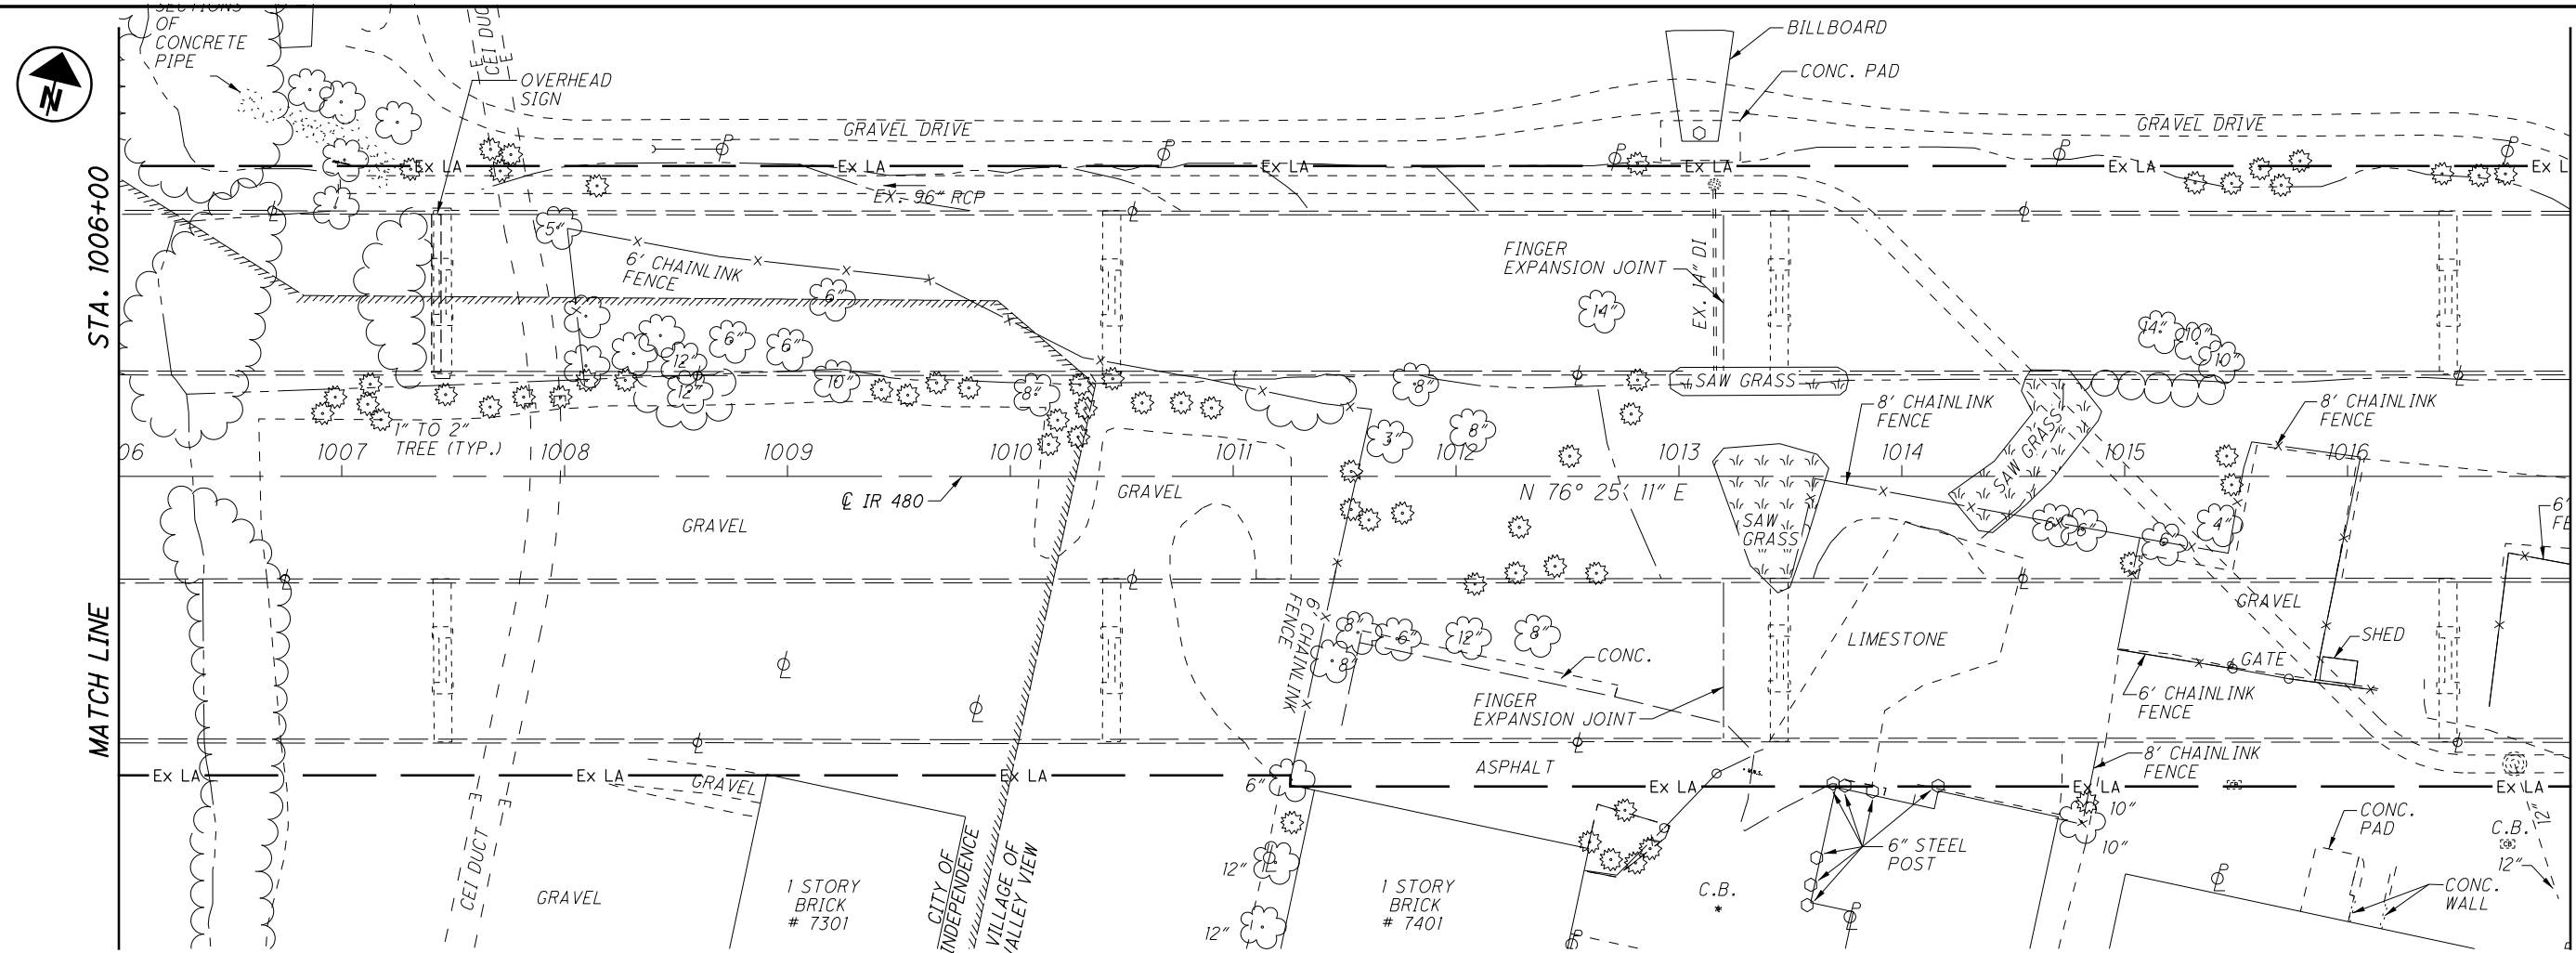
F:\2013\113012 IR 480\113012-1\480_1842RGP002.dgn 11/14/2013 2:08:09 PM RogerBrokaw

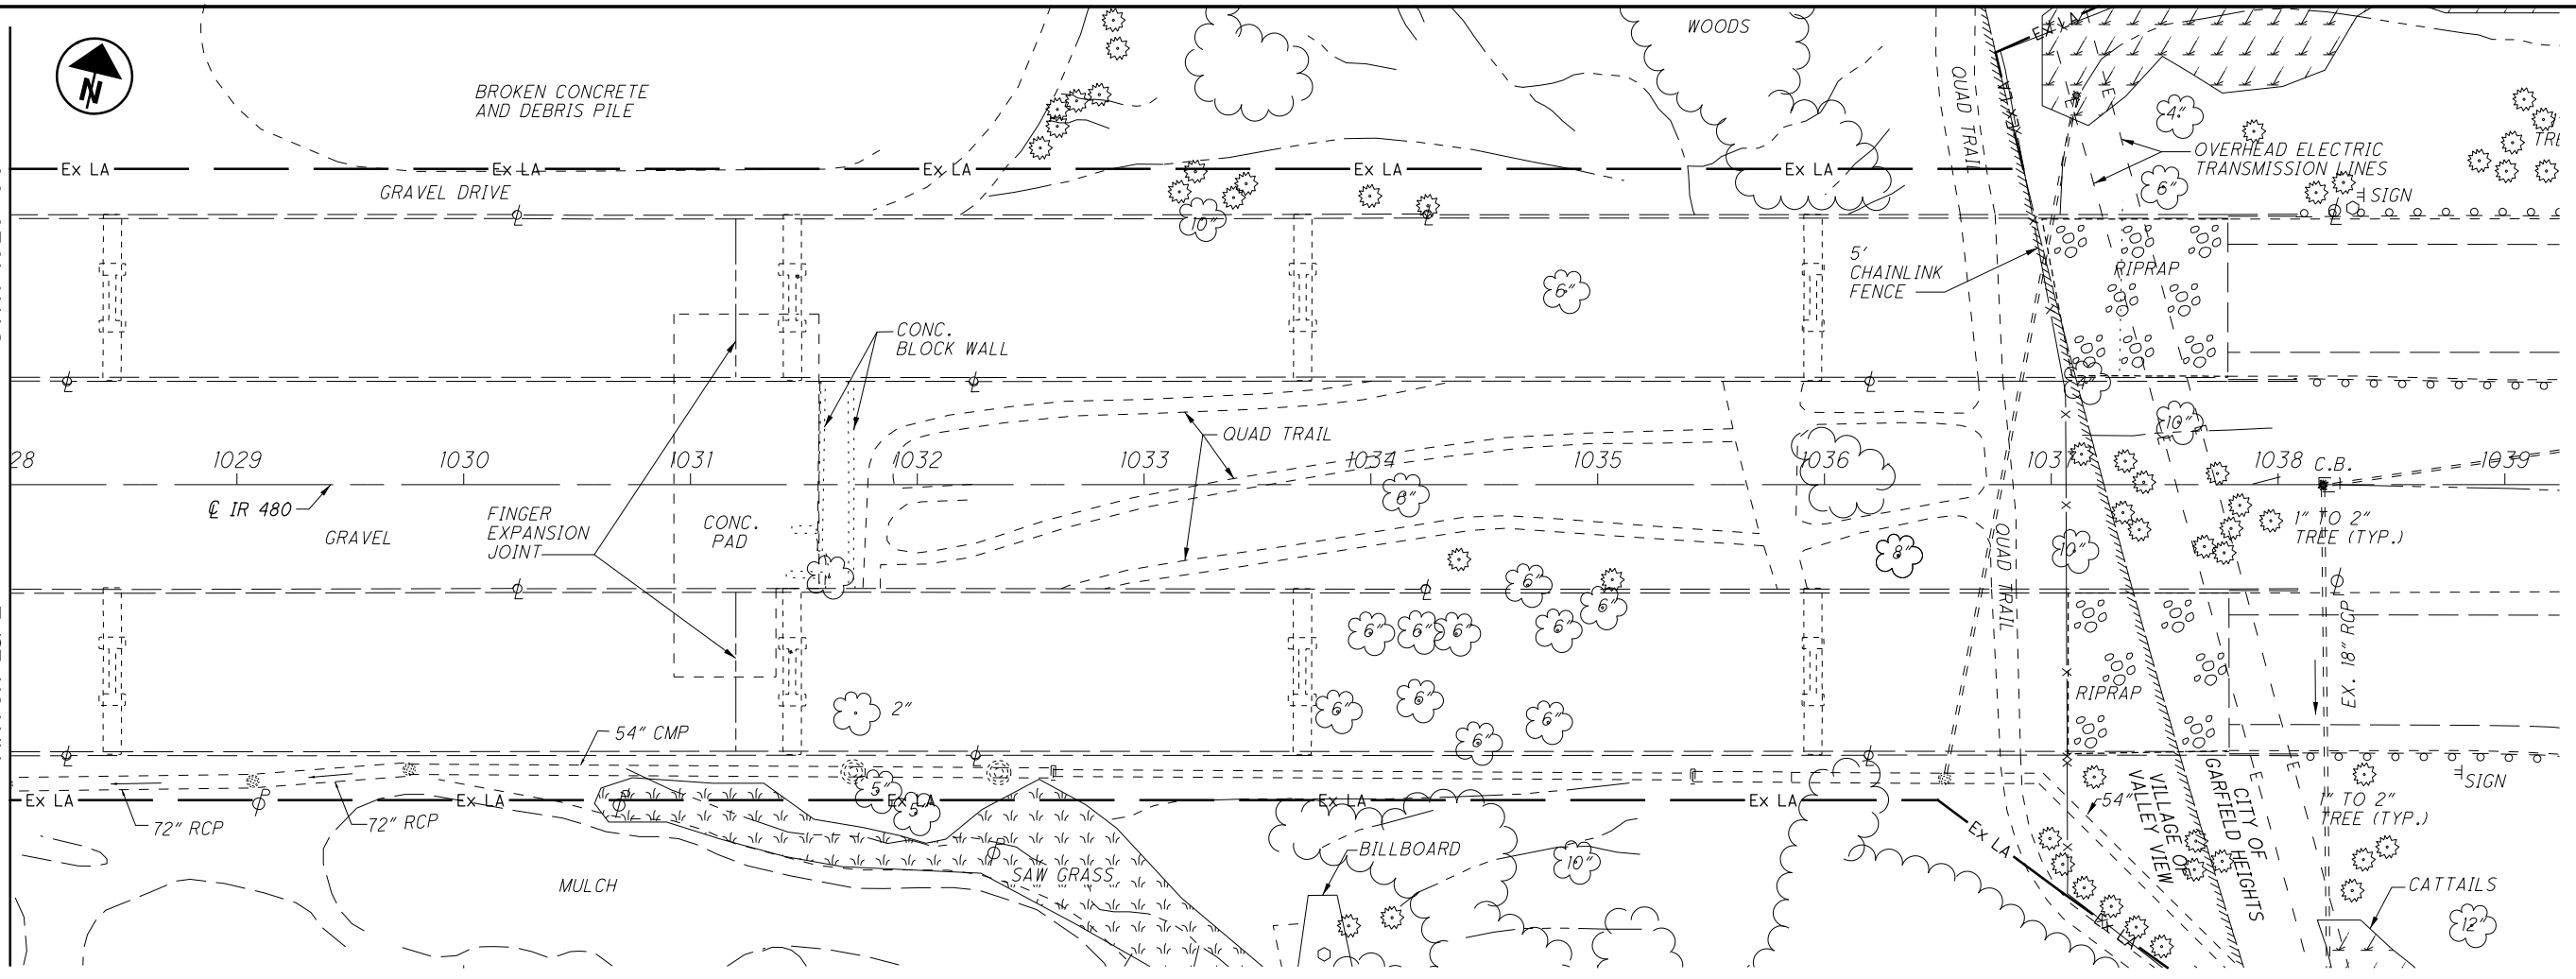
STA. 1028+00
MATCH LINE

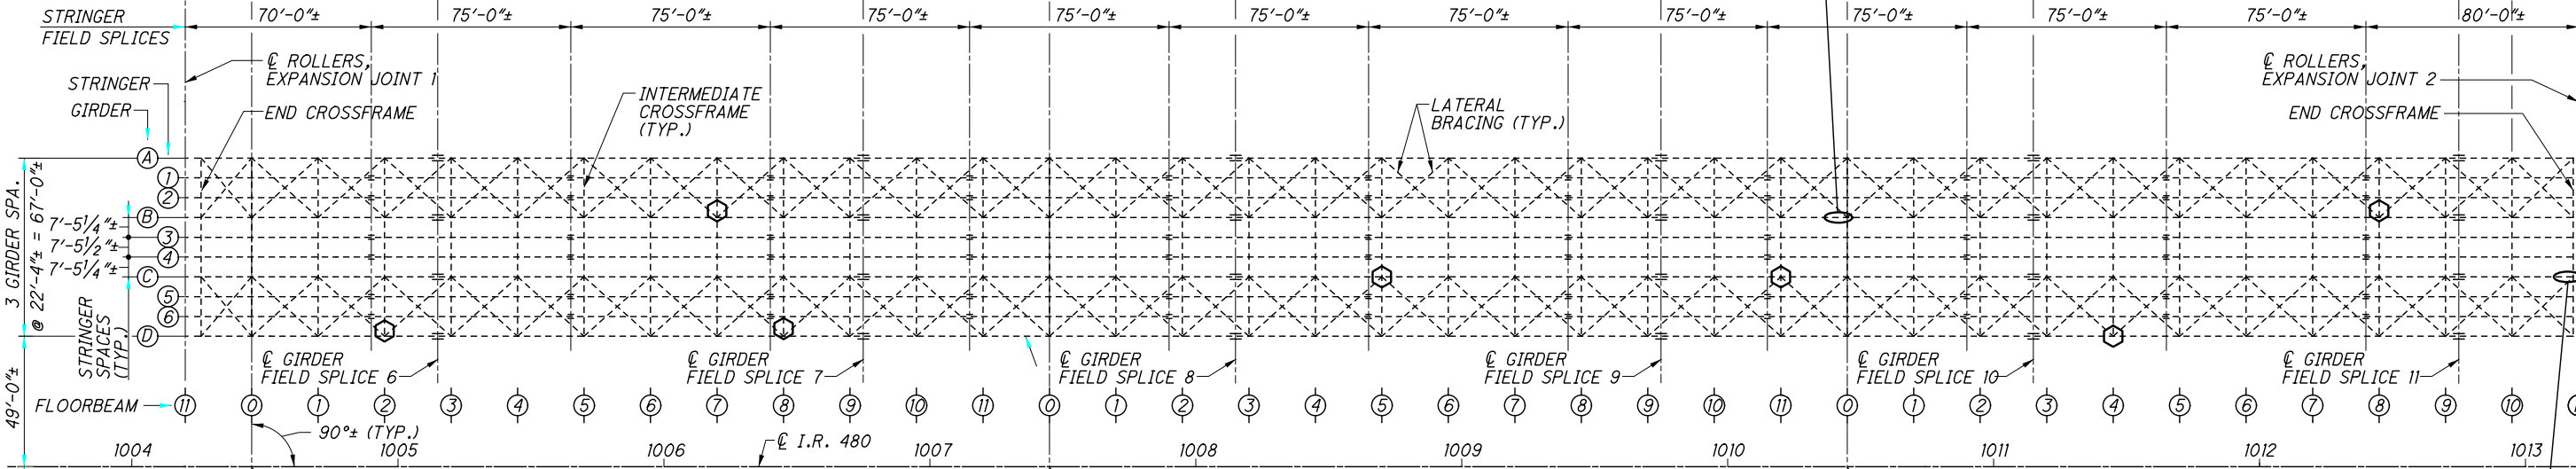
BROKEN INSPECTION HANDRAIL WELD

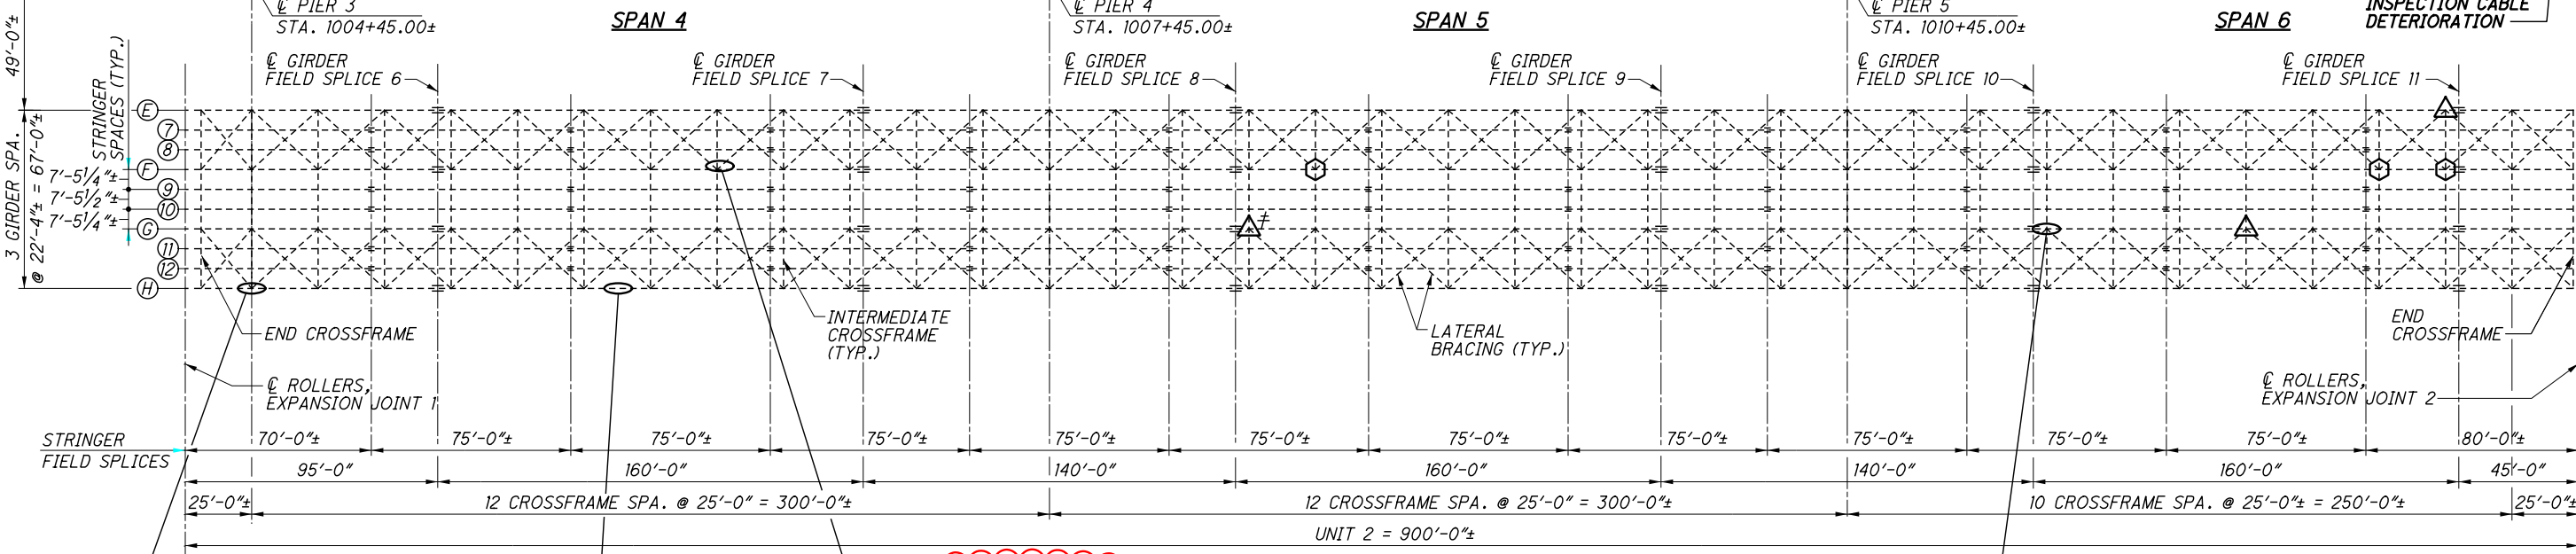
INSPECTION CABLE DETERIORATION
