**2014 UPDATE TO THE 2013 PHYSICAL CONDITIONS INSPECTION
REPORT**

CUY-480-1842 R
SFN 1812548

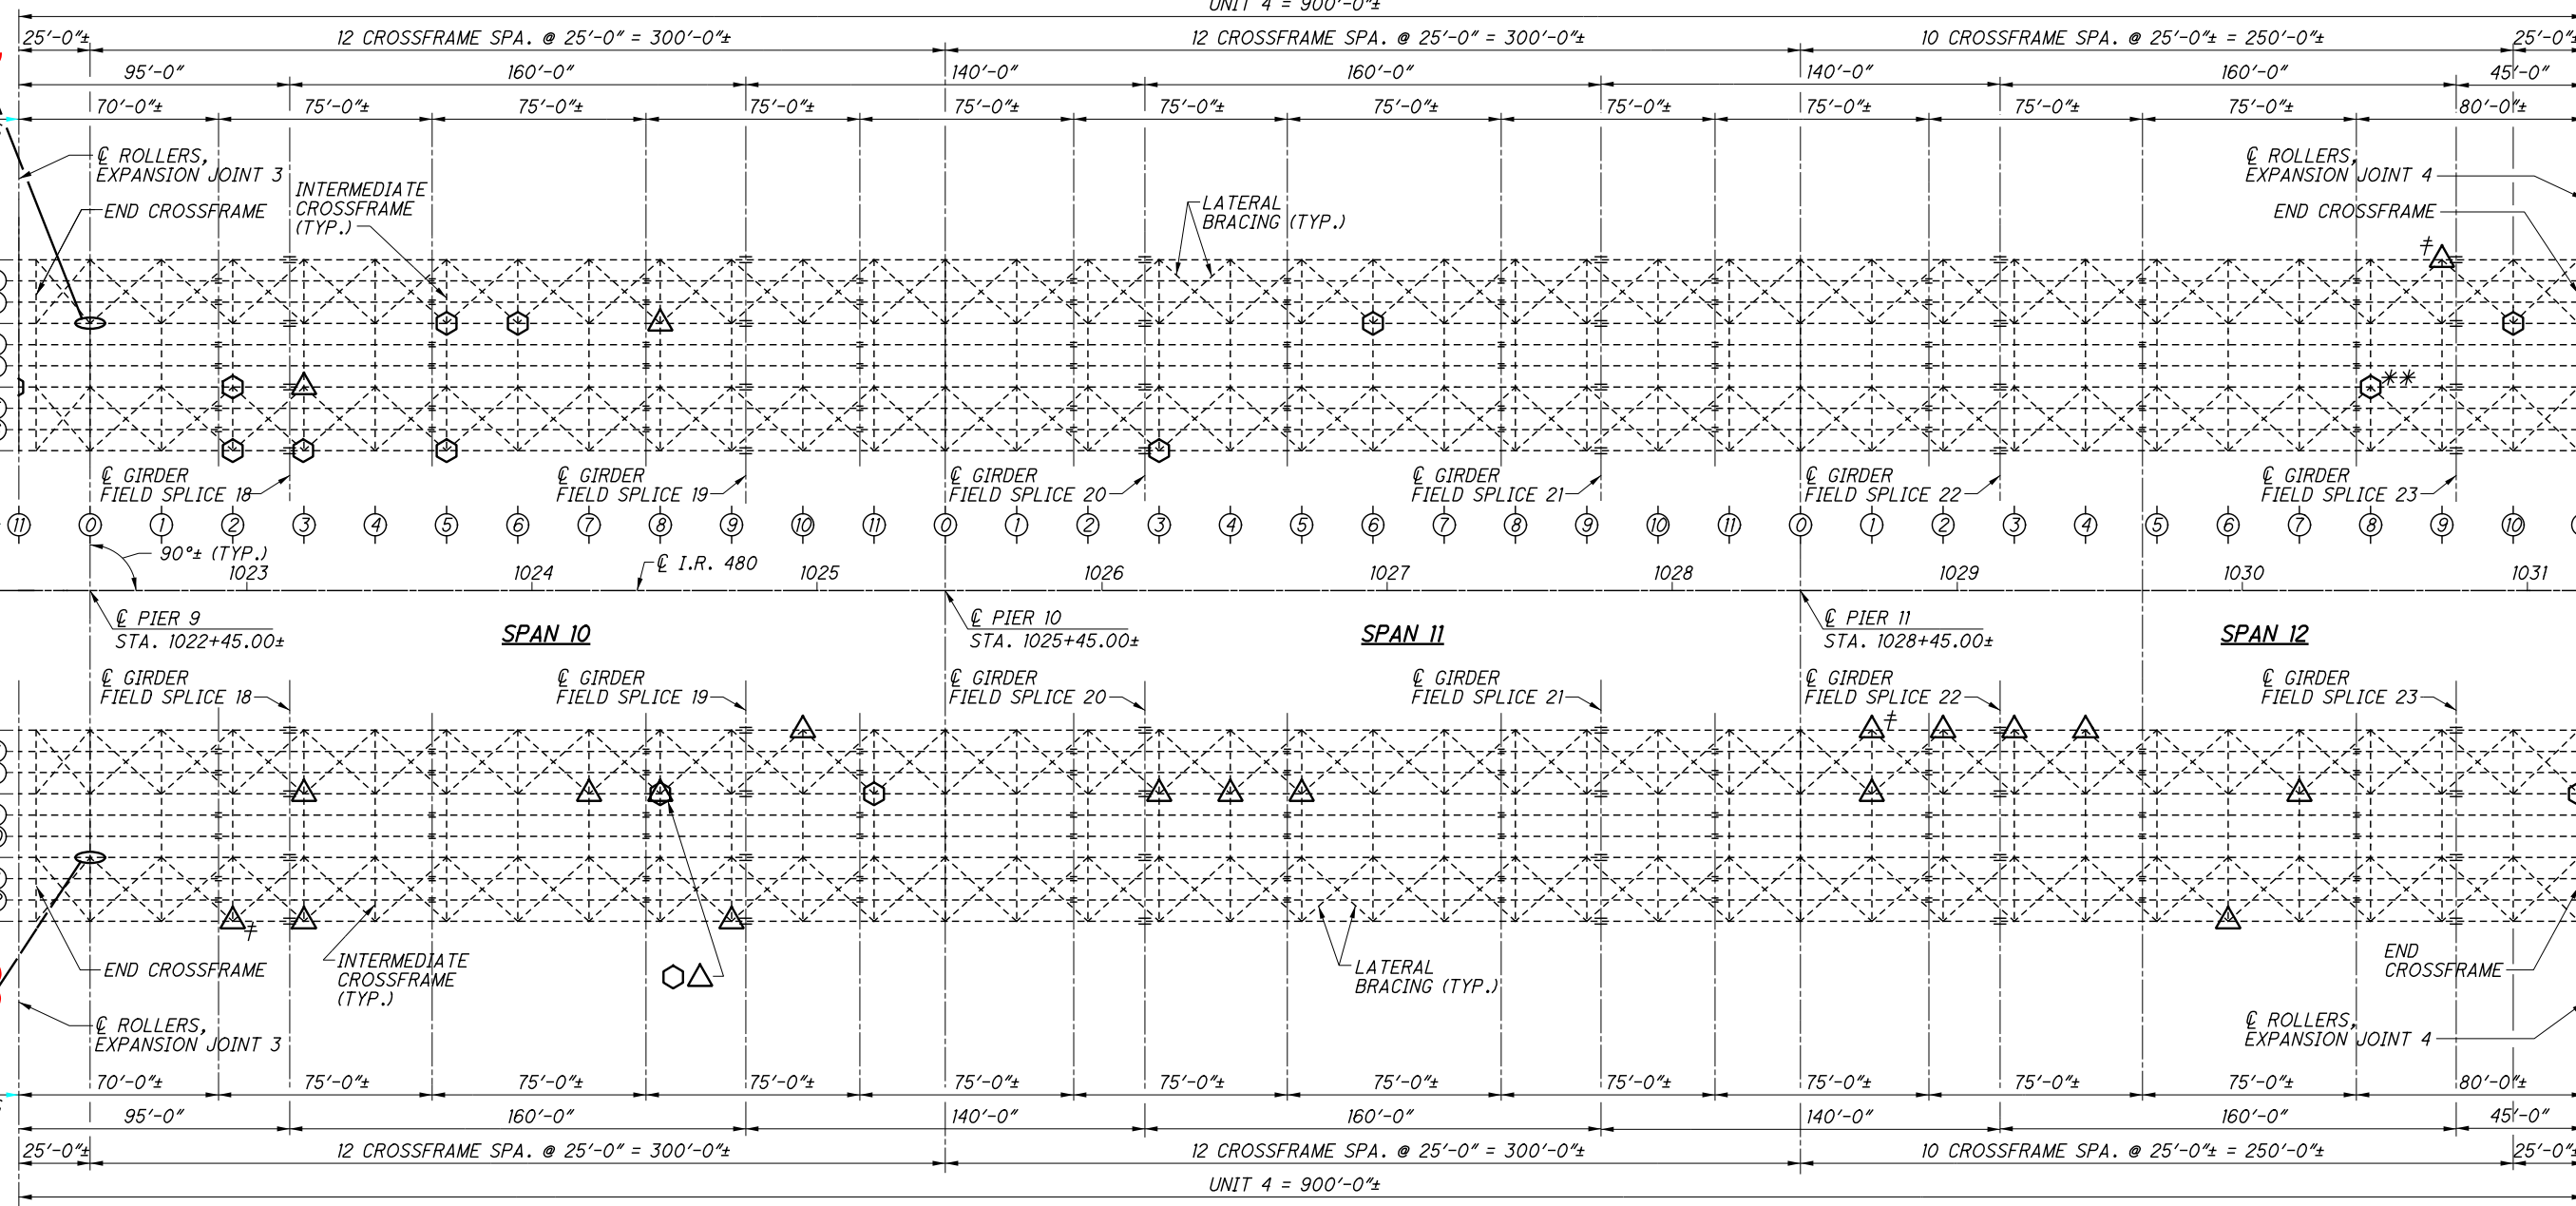
BROKEN INSPECTION CABLE
