**Baker Slope Stability Study Report
(Reference Document)**

**Innerbelt Bridge
Construction Contract Group 1 (CCG1)**

Slope Stability Evaluation Report of the West Bank

CUY-90-14.92
PID 77332

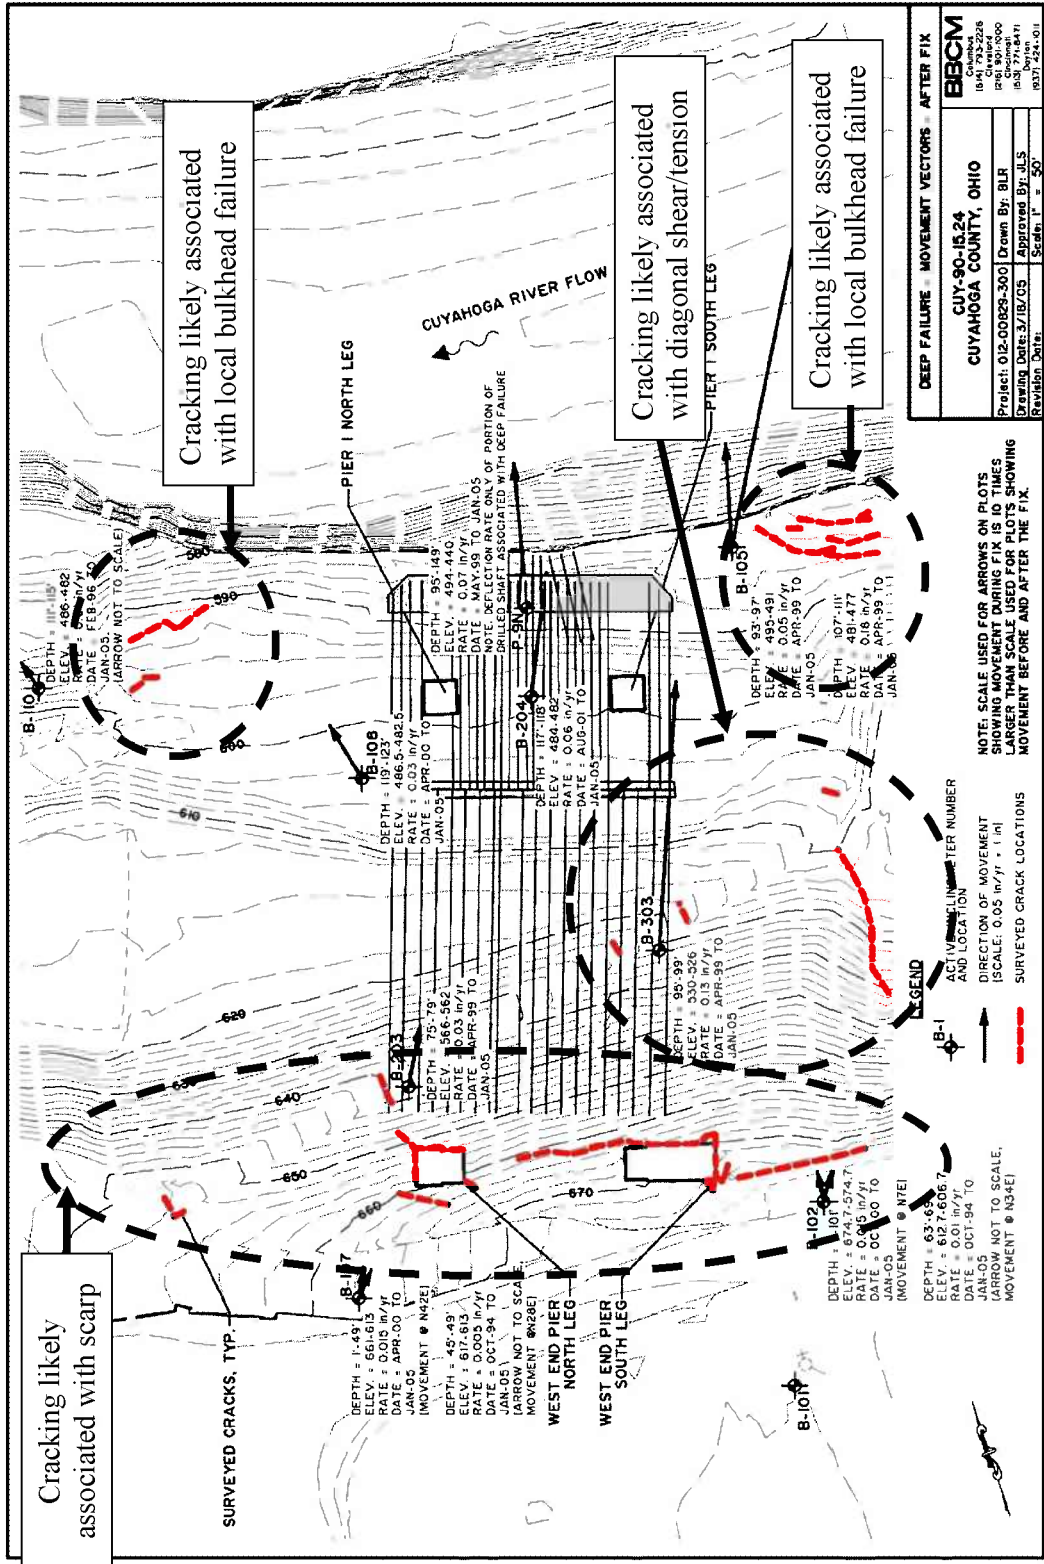
Figure 1: West bank slope in the vicinity of the existing I-90 West Abutment and Pier I foundation and stabilization structure (BBCM, 2005a). Dashed lines indicate the surveyed location of surface cracking.

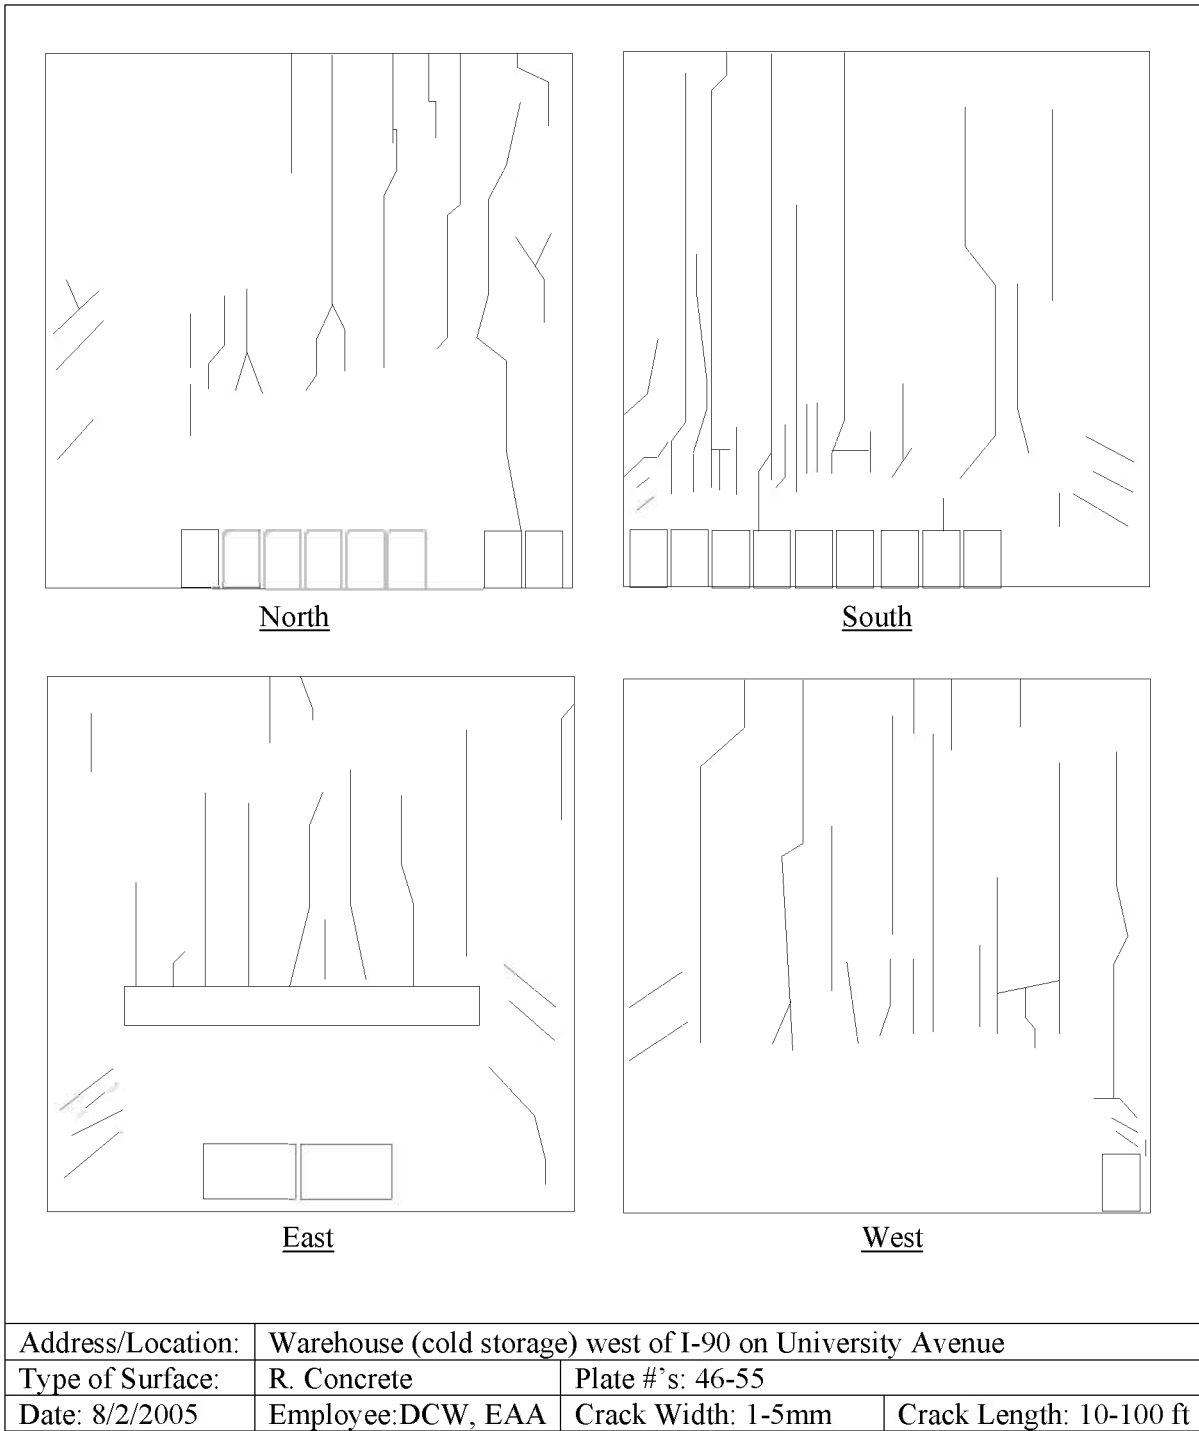
Figure 9: Crack mapping for the warehouse (cold storage) west of I-90 on University Avenue. The location and extent of the cracking is approximate only (BBCM, 2005b).

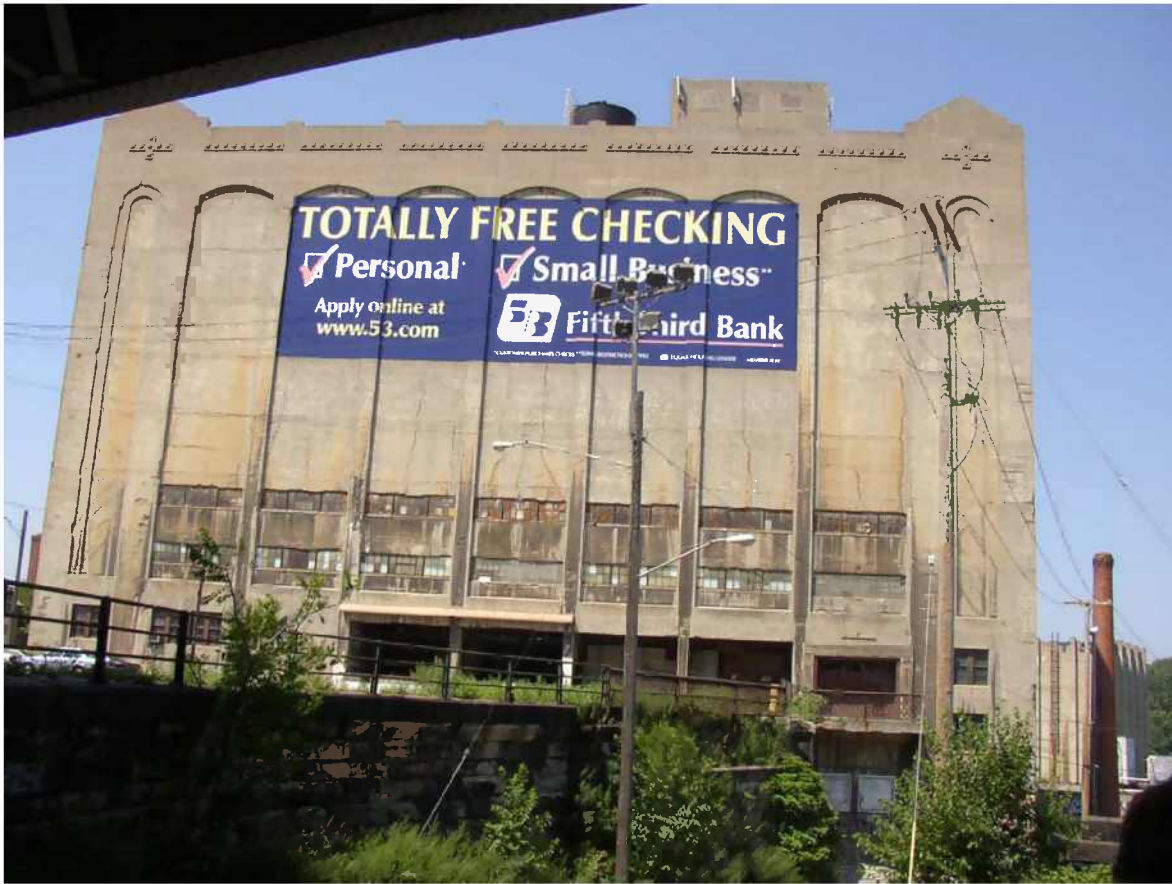
Figure 10: Warehouse (cold storage) west of I-90 on University Avenue. Photo is looking at the east wall of the warehouse (BBCM, 2005b).

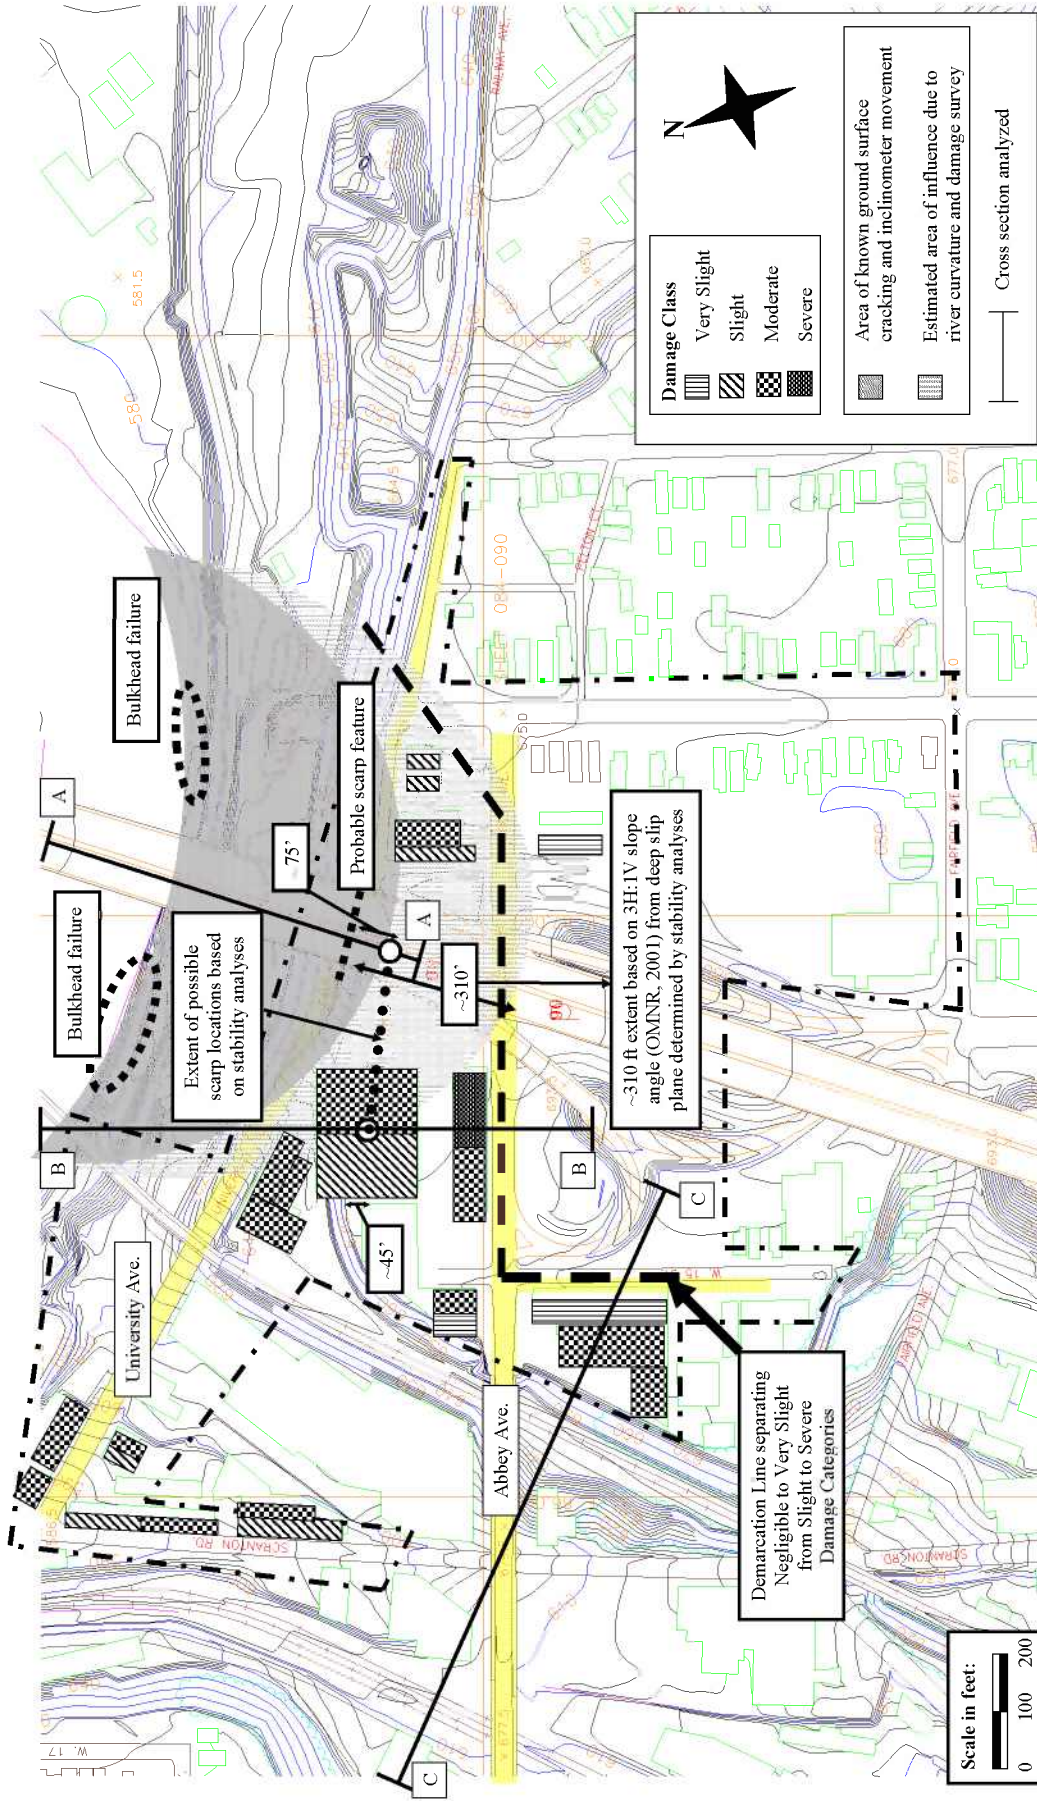
Figure 11: Expected creep influenced zone as estimated from the geologic history, river geometry, numerical analyses and exterior masonry condition survey (BBCM, 2005b).

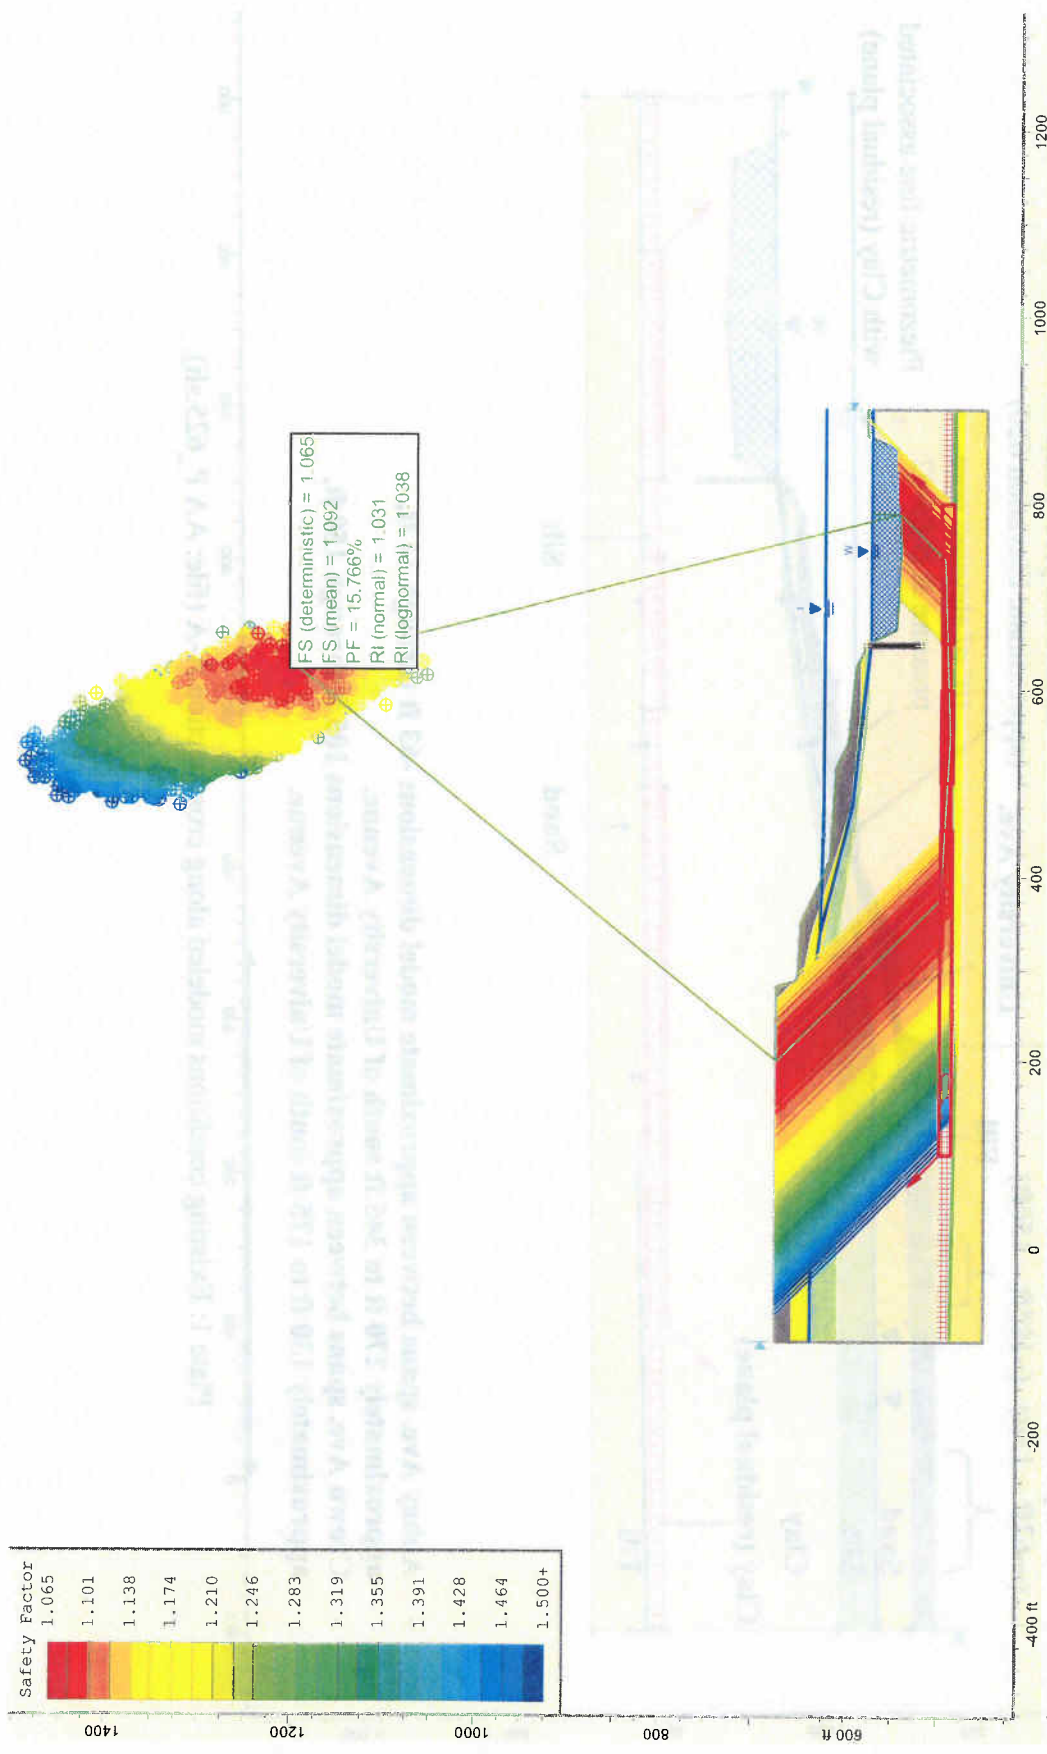
Plate 2: Results of the slope stability analysis within cross section A-A for the existing conditions (file: AA_P_625.sli). The minimum Factor of Safety equals 1.065. The estimated Factor of Safety along Abbey Ave. approximately ranges between 1.36 and 1.56.

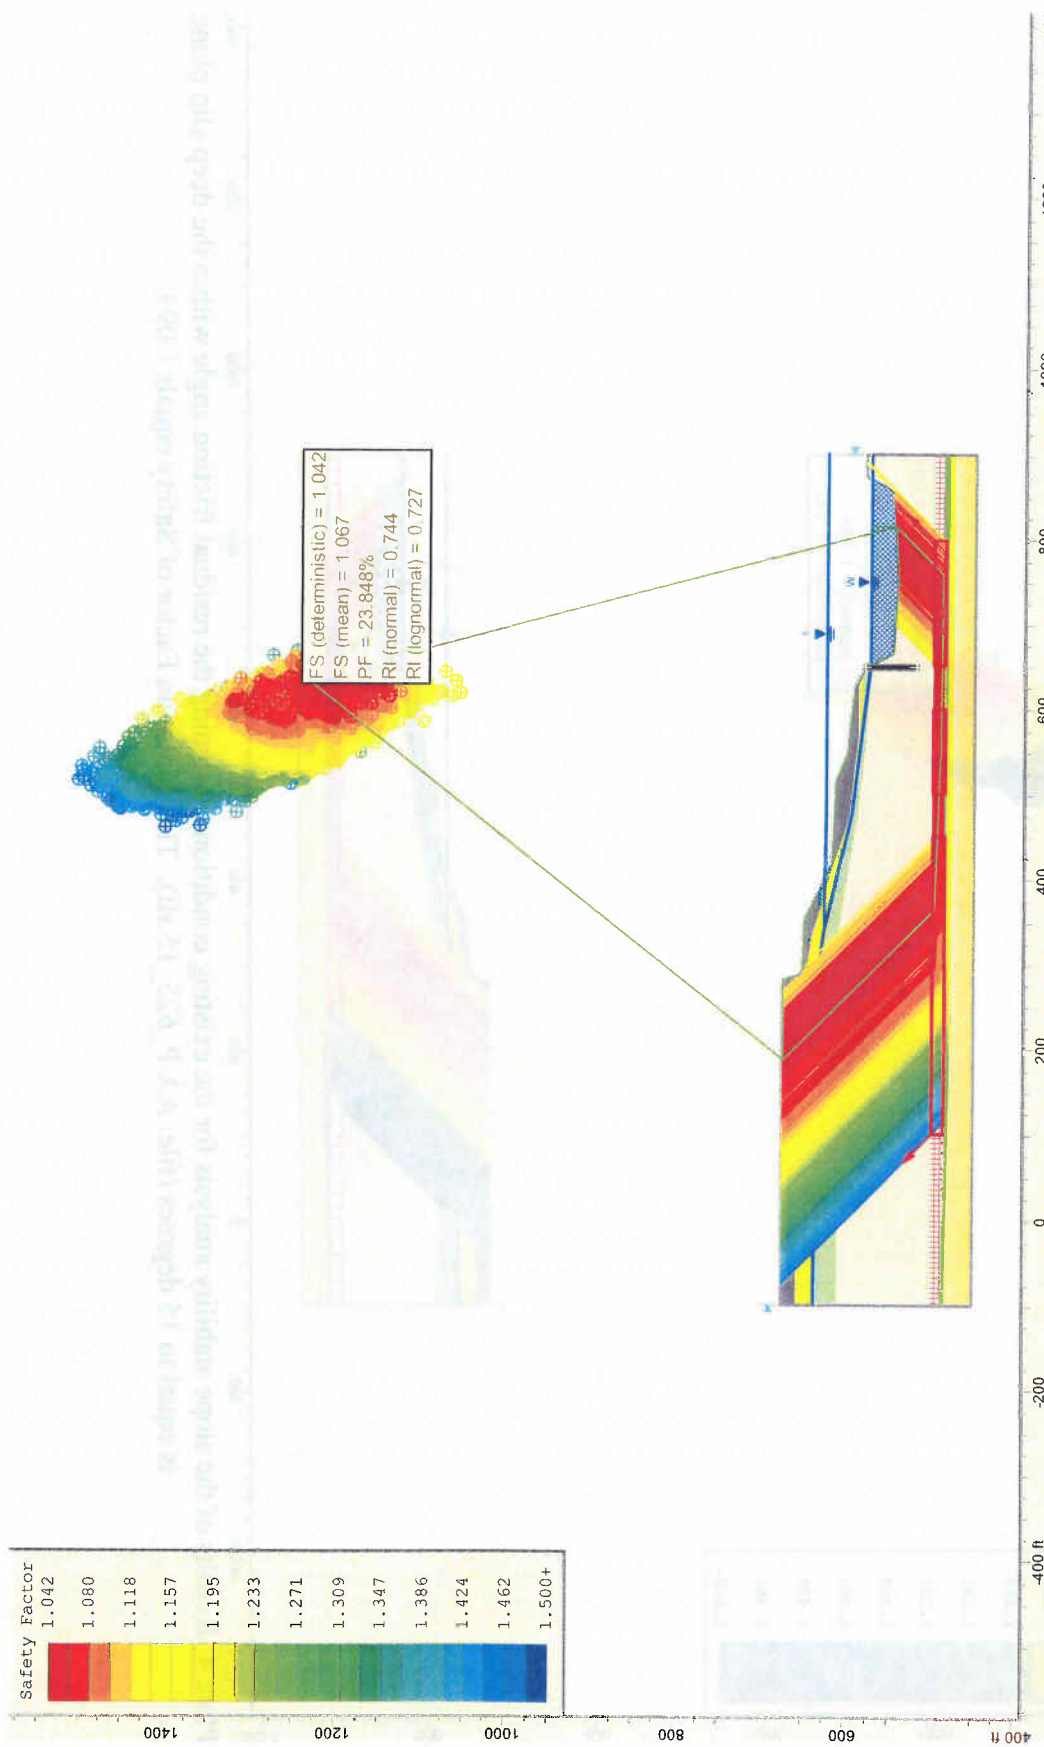
Plate 3: Results of the slope stability analysis within cross section A-A for the existing conditions assuming the residual friction angle within the deep slip plane is equal to 13 degrees (file: AA P_625_13.sli). The minimum Factor of Safety equals 1.042.

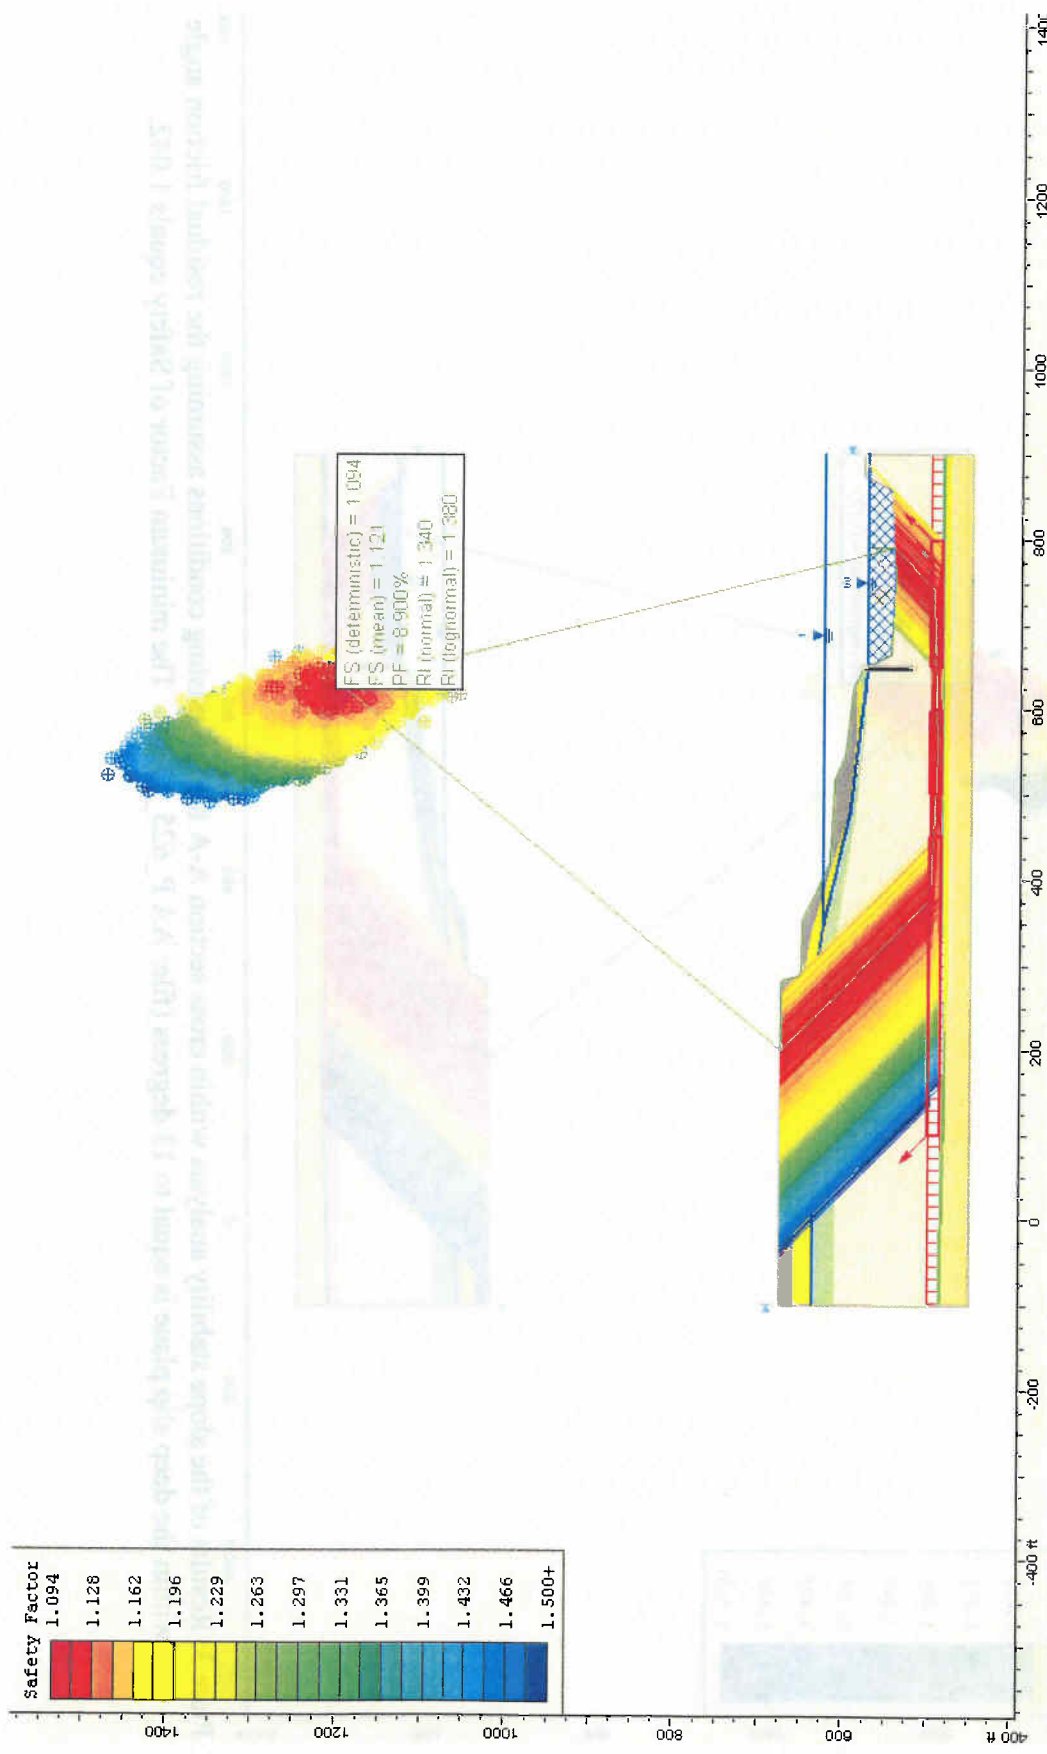
Plate 4: Results of the slope stability analysis for the existing conditions assuming the residual friction angle within the deep slip plane is equal to 15 degrees (file: AA P_625_15.sli). The minimum Factor of Safety equals 1.094.

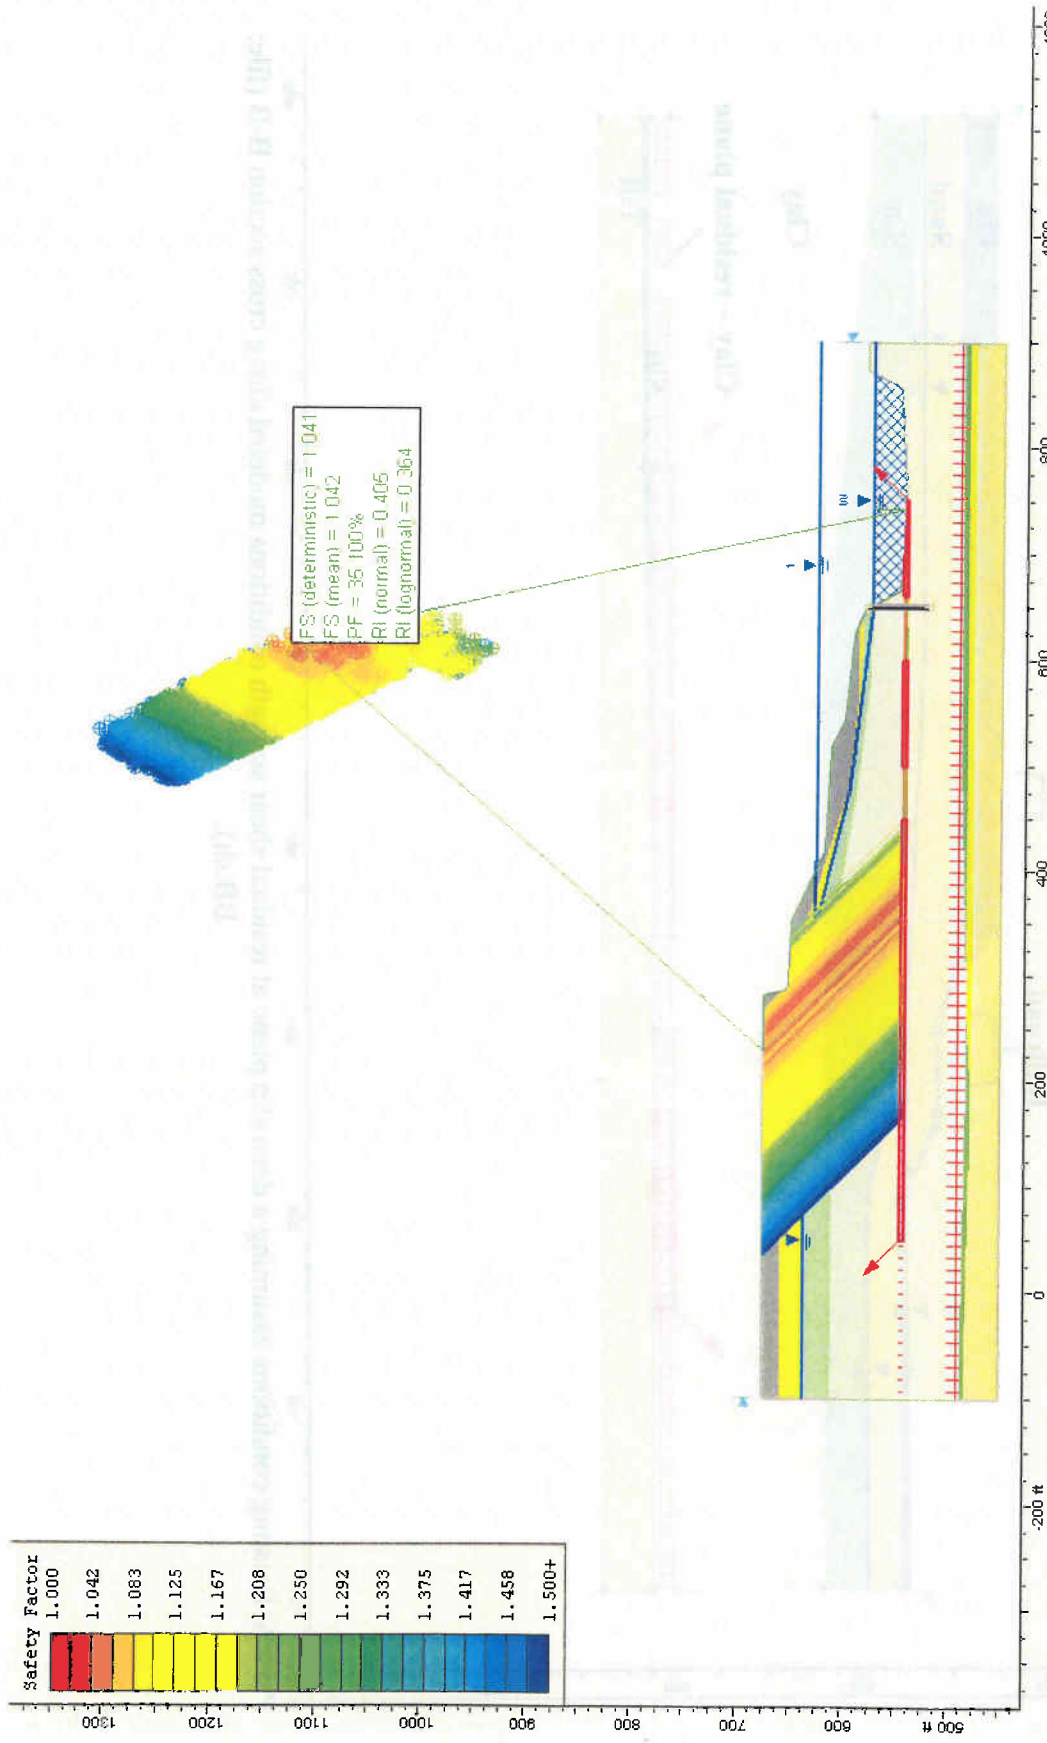
Plate 5: Results of the slope stability analysis for the existing conditions for a potential shallow slip plane (file: AA P_625SH.sli). The minimum Factor of Safety equals 1.041.

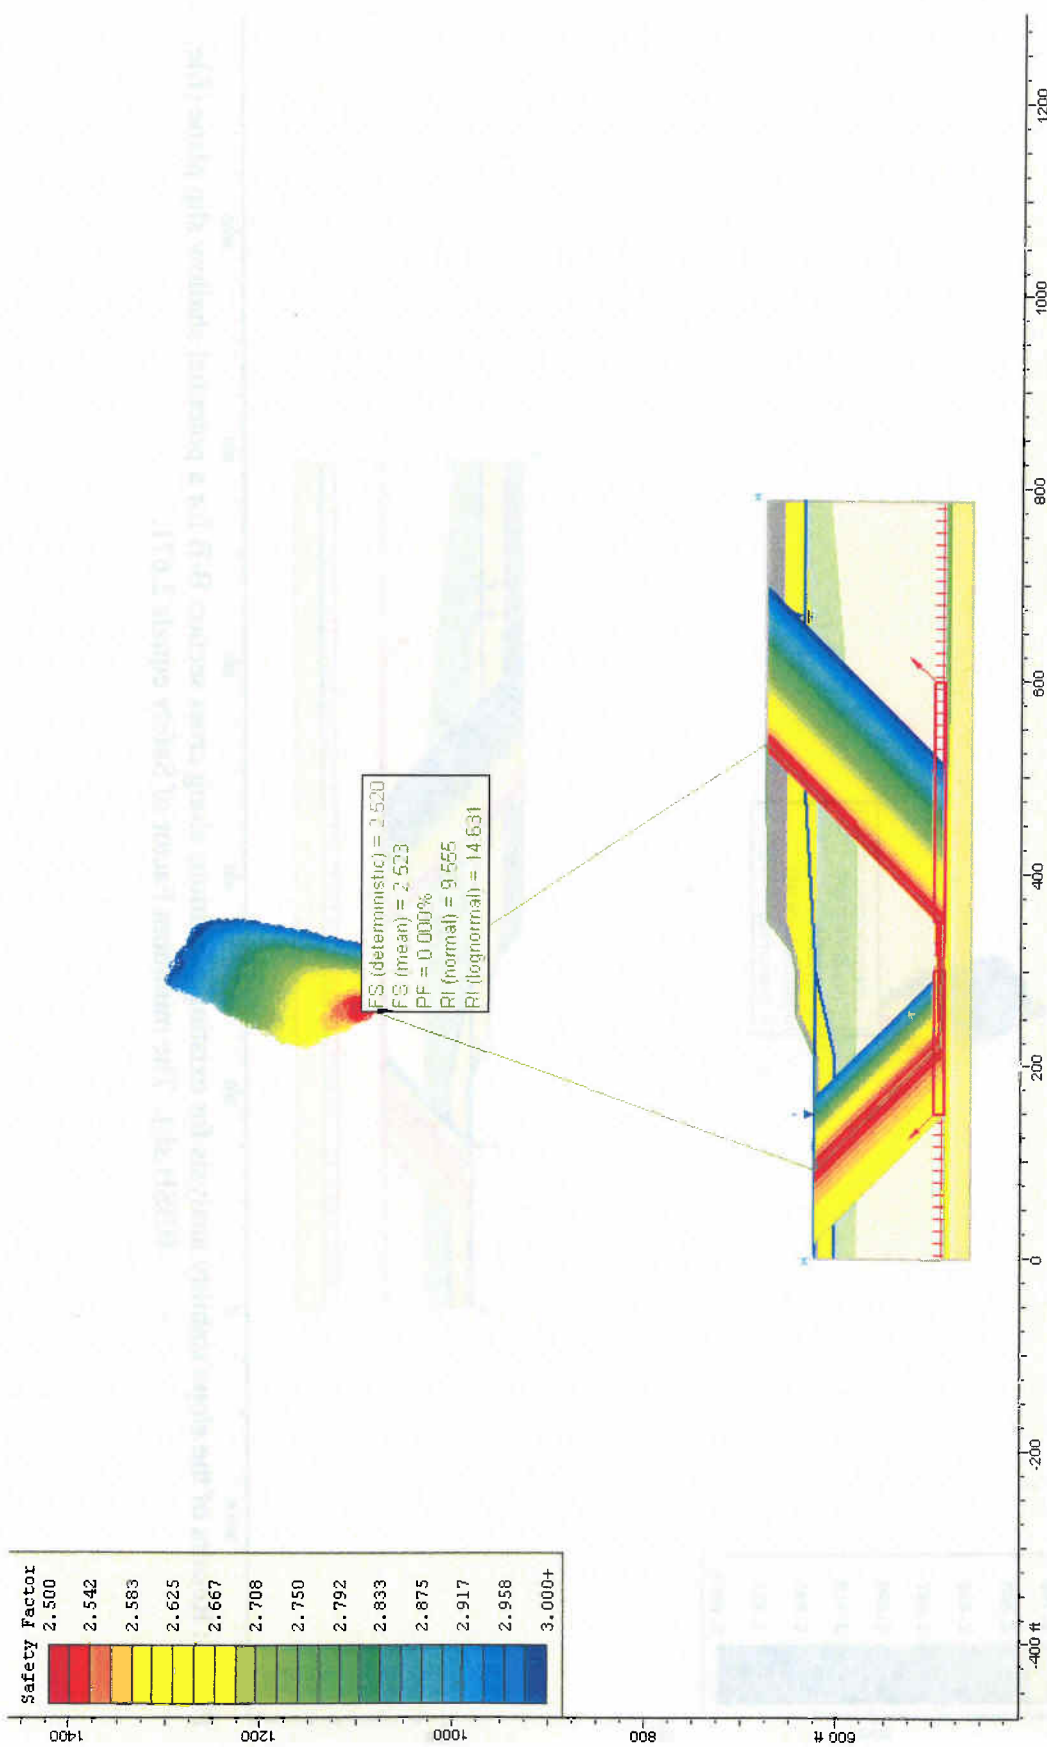
Plate 7: Results of the slope stability analyses for existing conditions along cross section B-B assuming a deep slip surface at residual shear strength conditions (file: BB.sli). The minimum Factor of Safety equals 2.52. The results presented were obtained by using the Simplified Janbu method instead of the Spencer method since the resulting Factor of Safety exceeds the allowable maximum Factor of Safety produced by the Spencer method.

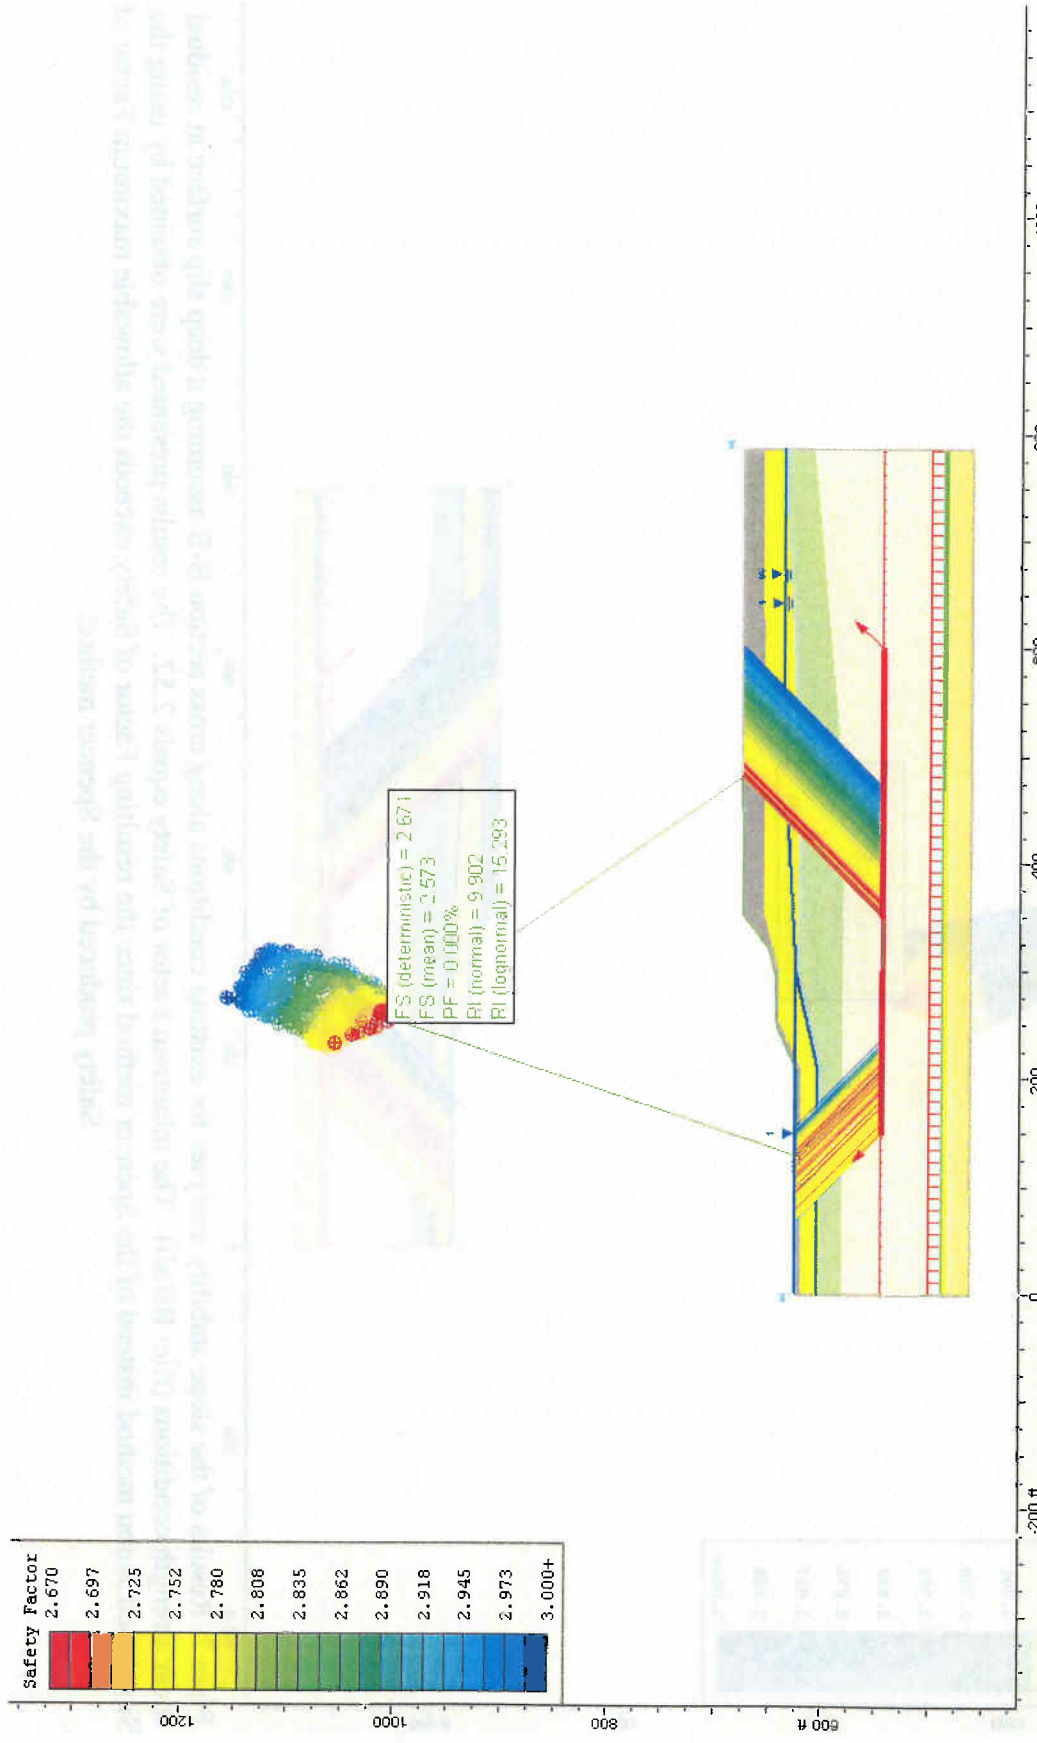
Plate 8: Results of the slope stability analysis for existing conditions along cross section B-B for a potential shallow slip plane (file: BBSH.sli). The minimum Factor of Safety equals 2.671.

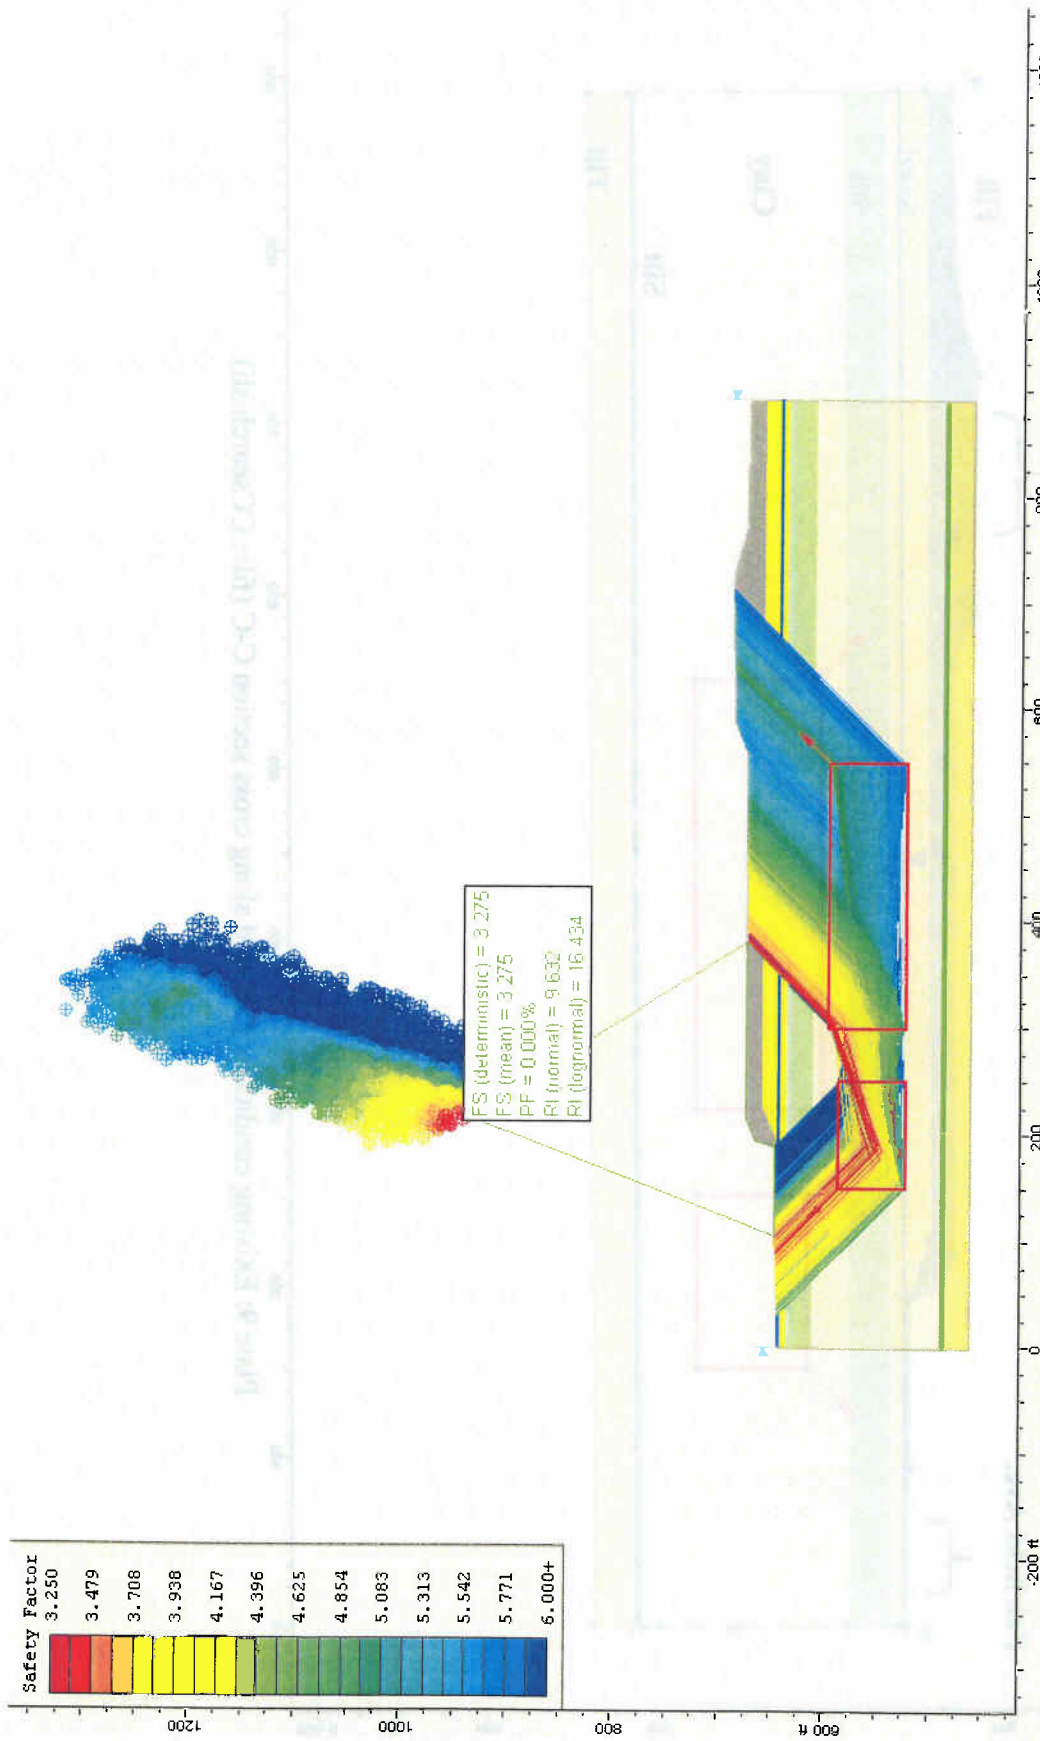
Plate 10: Results of the slope stability analyses for existing conditions along cross section C-C assuming a deep block slip surface (file: CCsearch.sli). The minimum Factor of Safety equals 3.275. The results presented were obtained by using the Simplified Janbu method instead of the Spencer method since the resulting Factor of Safety exceeds the allowable maximum Factor of Safety produced by the Spencer method.

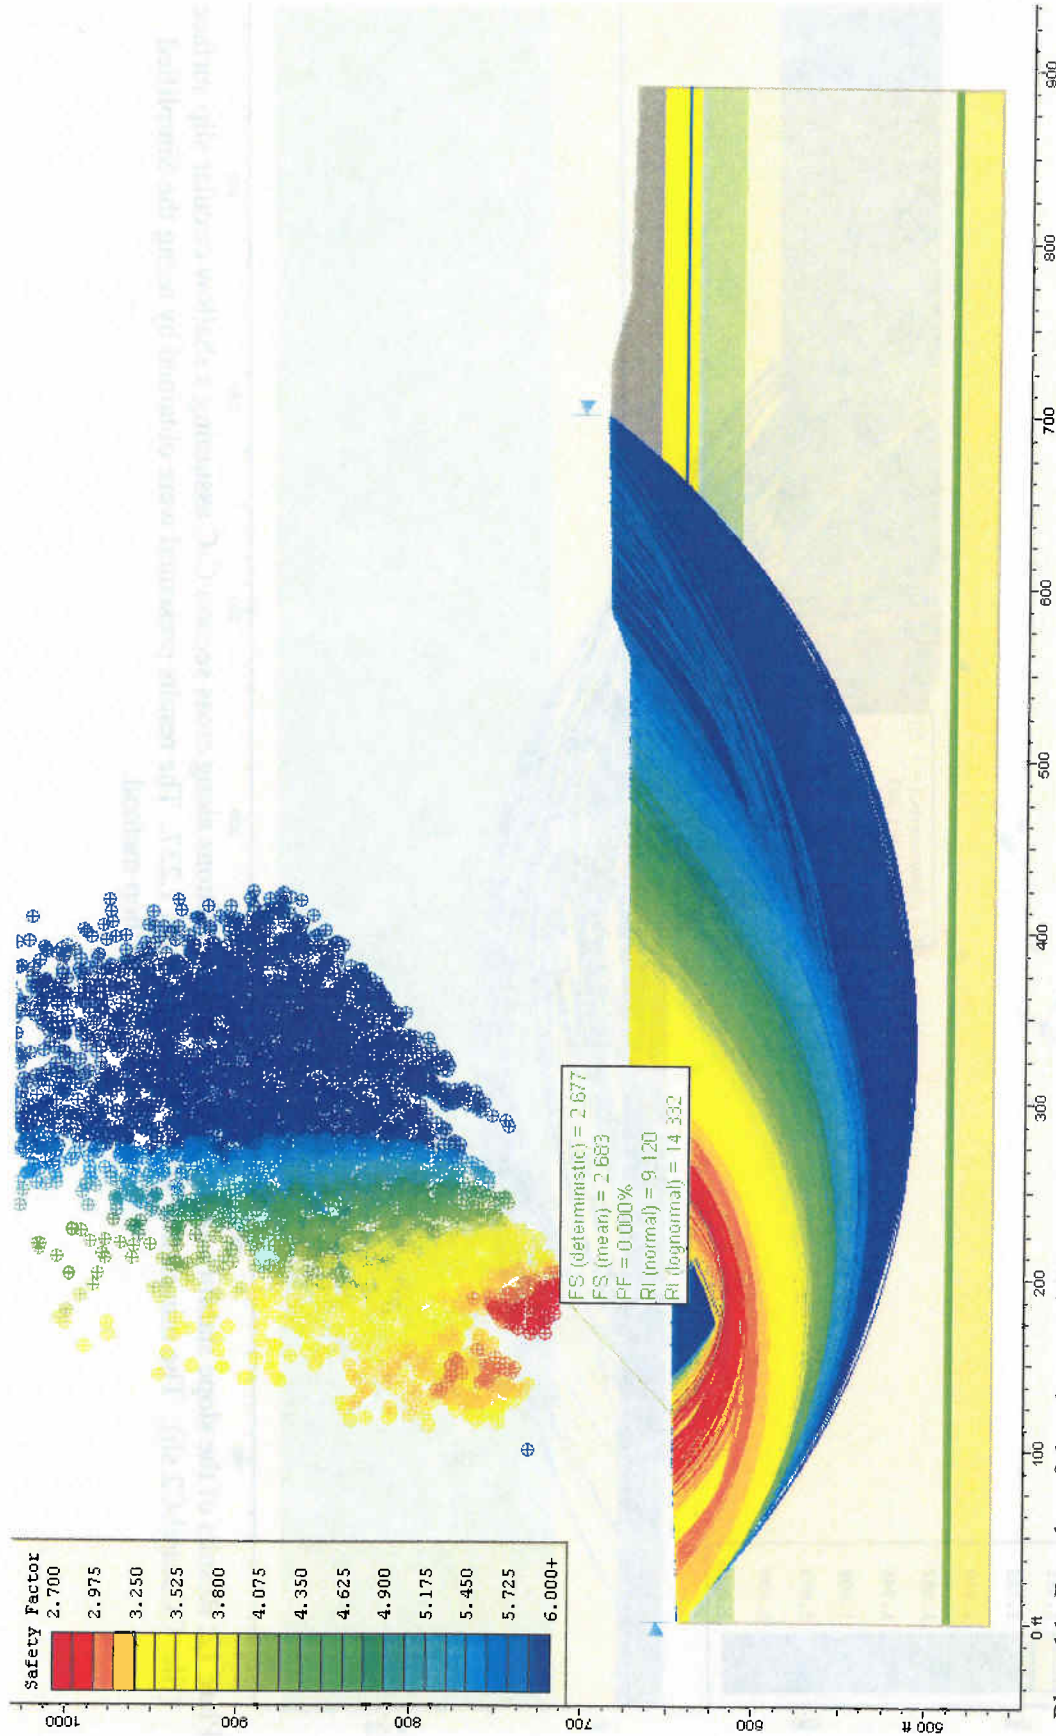
Plate 11: Results of the slope stability analyses for existing conditions along cross section C-C assuming a deep circular slip surface (file: CCsearchC.sli). The minimum Factor of Safety equals 2.677. The results presented were obtained by using the Simplified Bishop method.
