**Baker Slope Stability Study Report
(Reference Document)**

**Innerbelt Bridge
Construction Contract Group 1 (CCG1)**

Slope Stability Evaluation Report of the West Bank

CUY-90-14.92
PID 77332

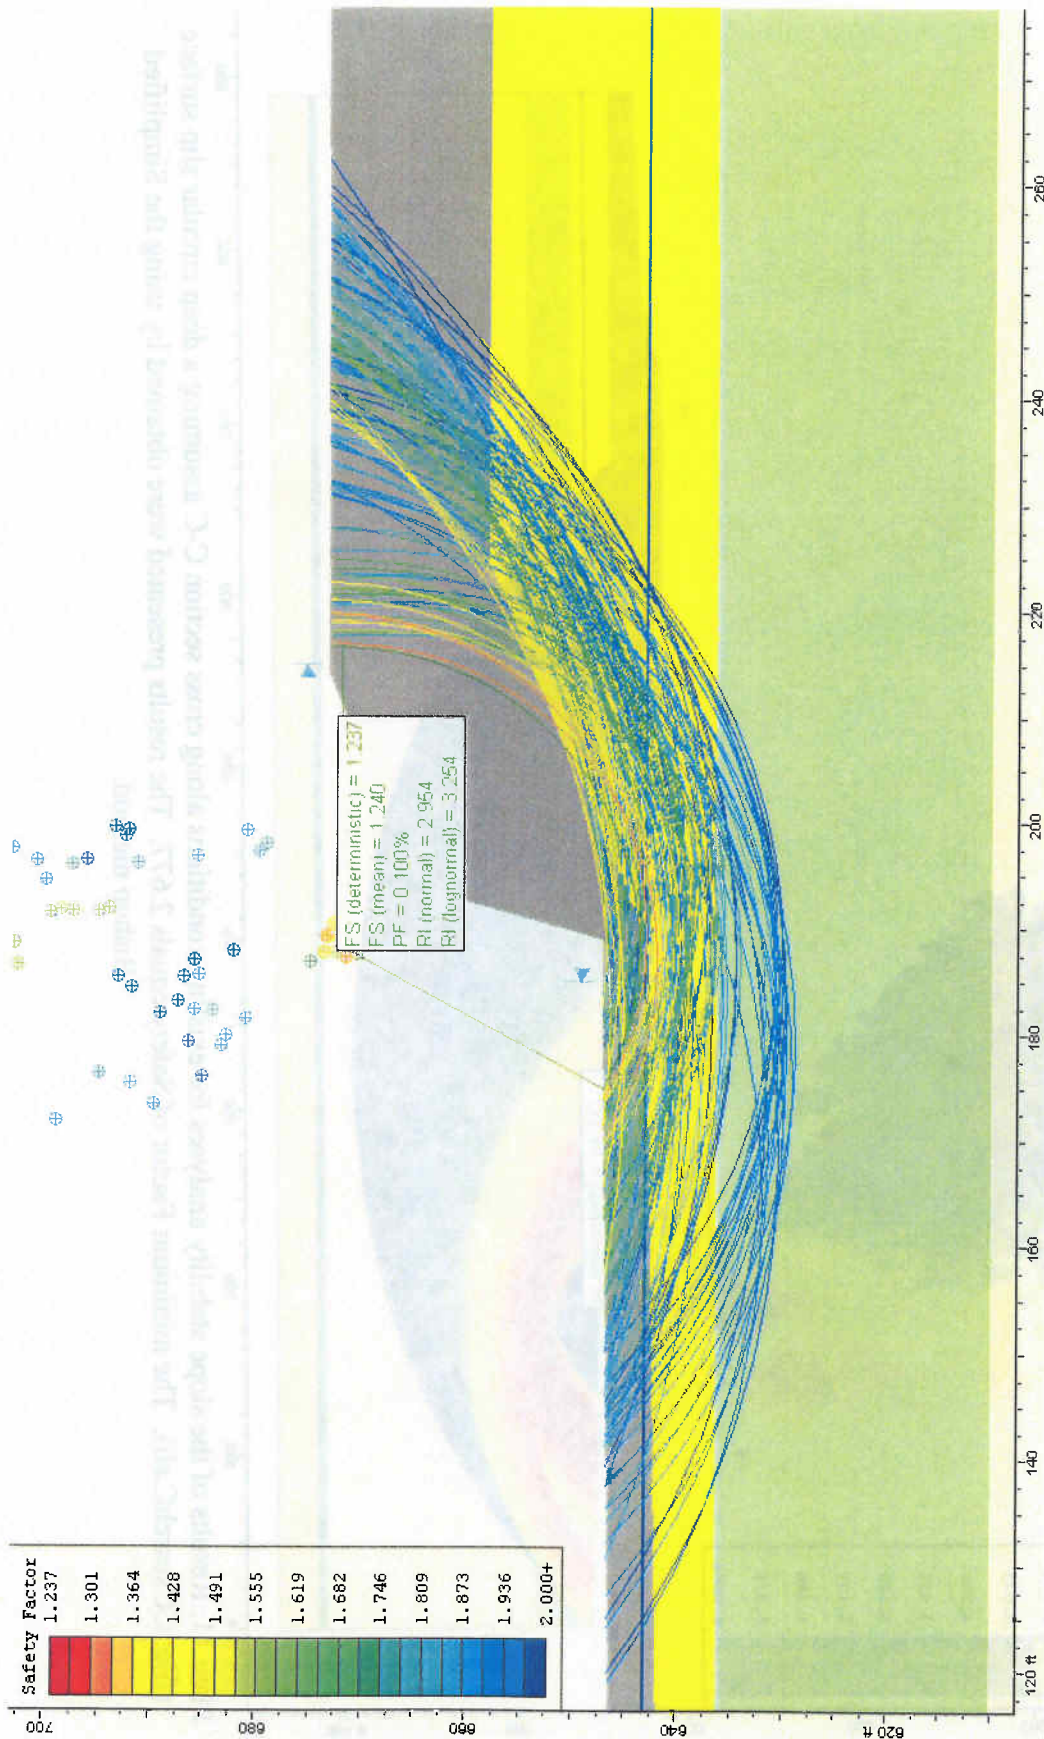
Plate 12: Results of the slope stability analyses for existing conditions along cross section C-C assuming a shallow circular slip surface (file: CCsearchC2.sli). The minimum Factor of Safety equals 1.237. The results presented were obtained by using the Simplified Bishop method.

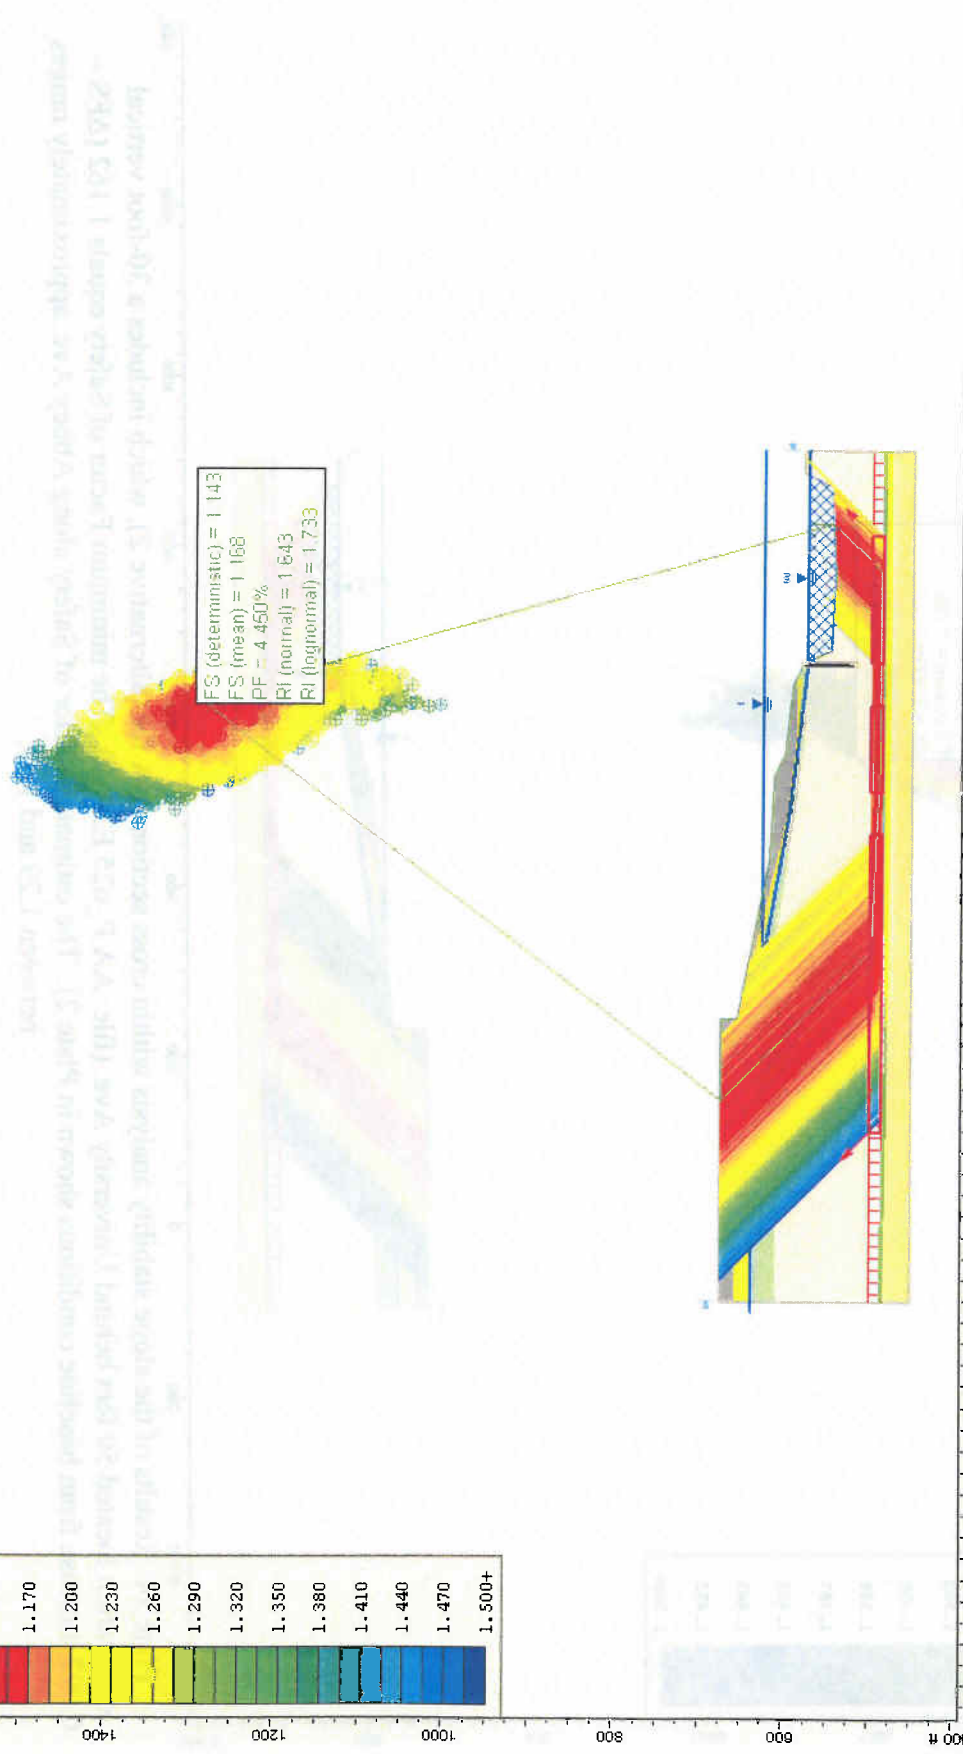
Plate 13: Results of the slope stability analysis within cross section A-A for (alternative 1), which includes a 20-foot vertical excavation located 50 feet behind University Ave. (file: AA_P_625 E20.sli). The minimum Factor of Safety equals 1.143 (Δ FS = 0.078 increase from baseline conditions shown in Plate 2). The estimated Factor of Safety along Abbey Ave. approximately ranges between 1.29 and 1.44.

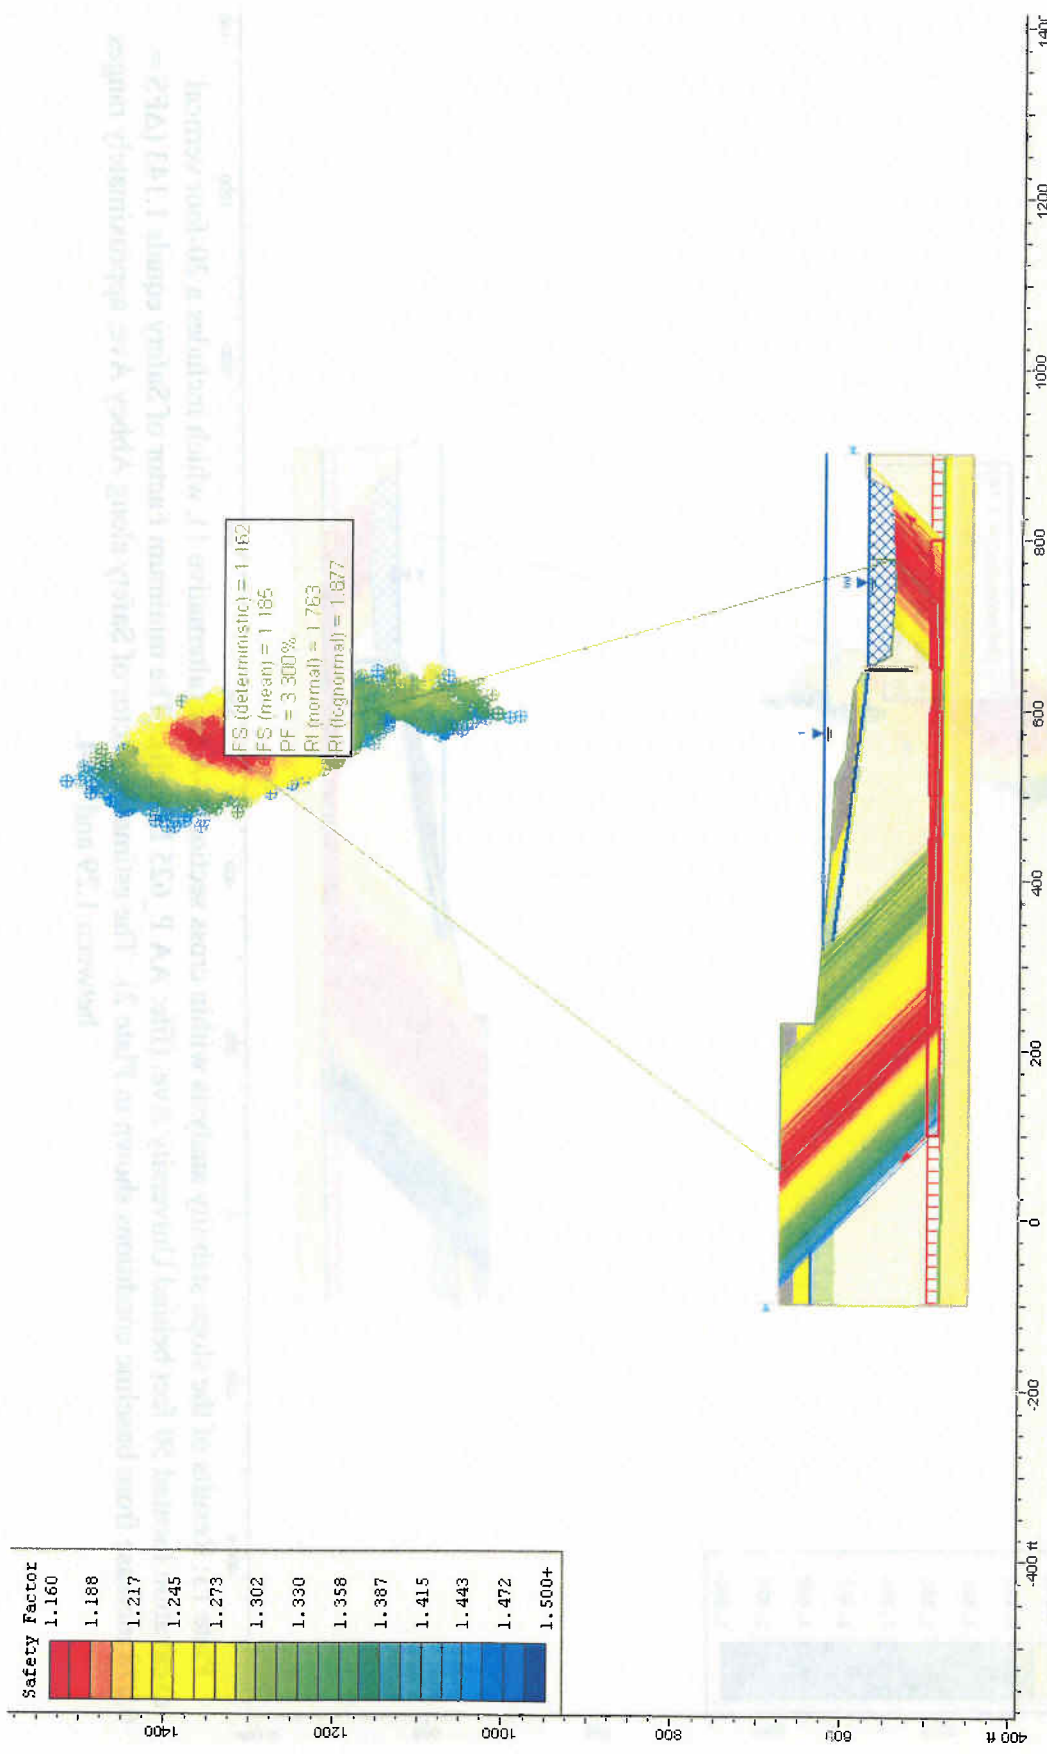
Plate 14: Results of the slope stability analysis within cross section A-A for (alternative 2), which includes a 30-foot vertical excavation located 50 feet behind University Ave. (file: AA_P_625_E30.sli). The minimum Factor of Safety equals 1.162 (Δ FS = 0.097 increase from baseline conditions shown in Plate 2). The estimated Factor of Safety along Abbey Ave. approximately ranges between 1.29 and 1.45.

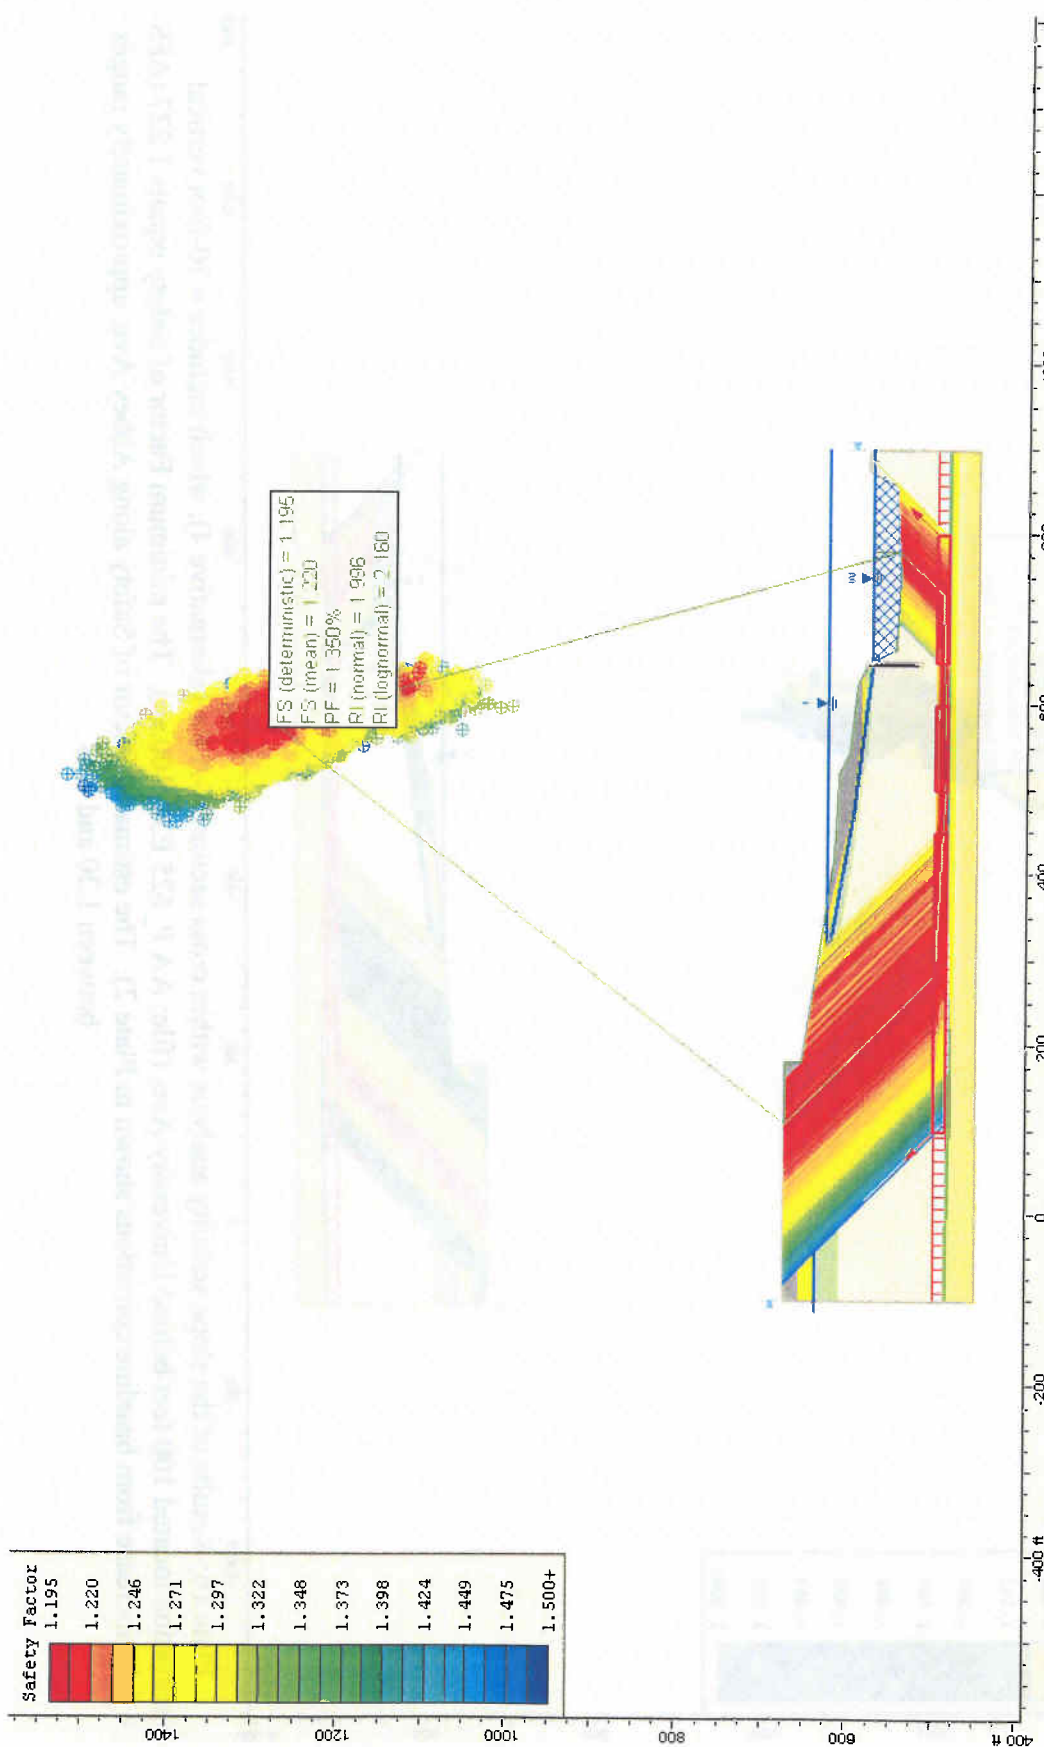
Plate 15: Results of the slope stability analysis within cross section A-A for (alternative 3), which includes a 20-foot vertical excavation located 100 feet behind University Ave. (file: AA_P_625 E20_100.sli). The minimum Factor of Safety equals 1.195 (Δ FS = 0.13 increase from baseline conditions shown in Plate 2). The estimated Factor of Safety along Abbey Ave. approximately ranges between 1.26 and 1.42.

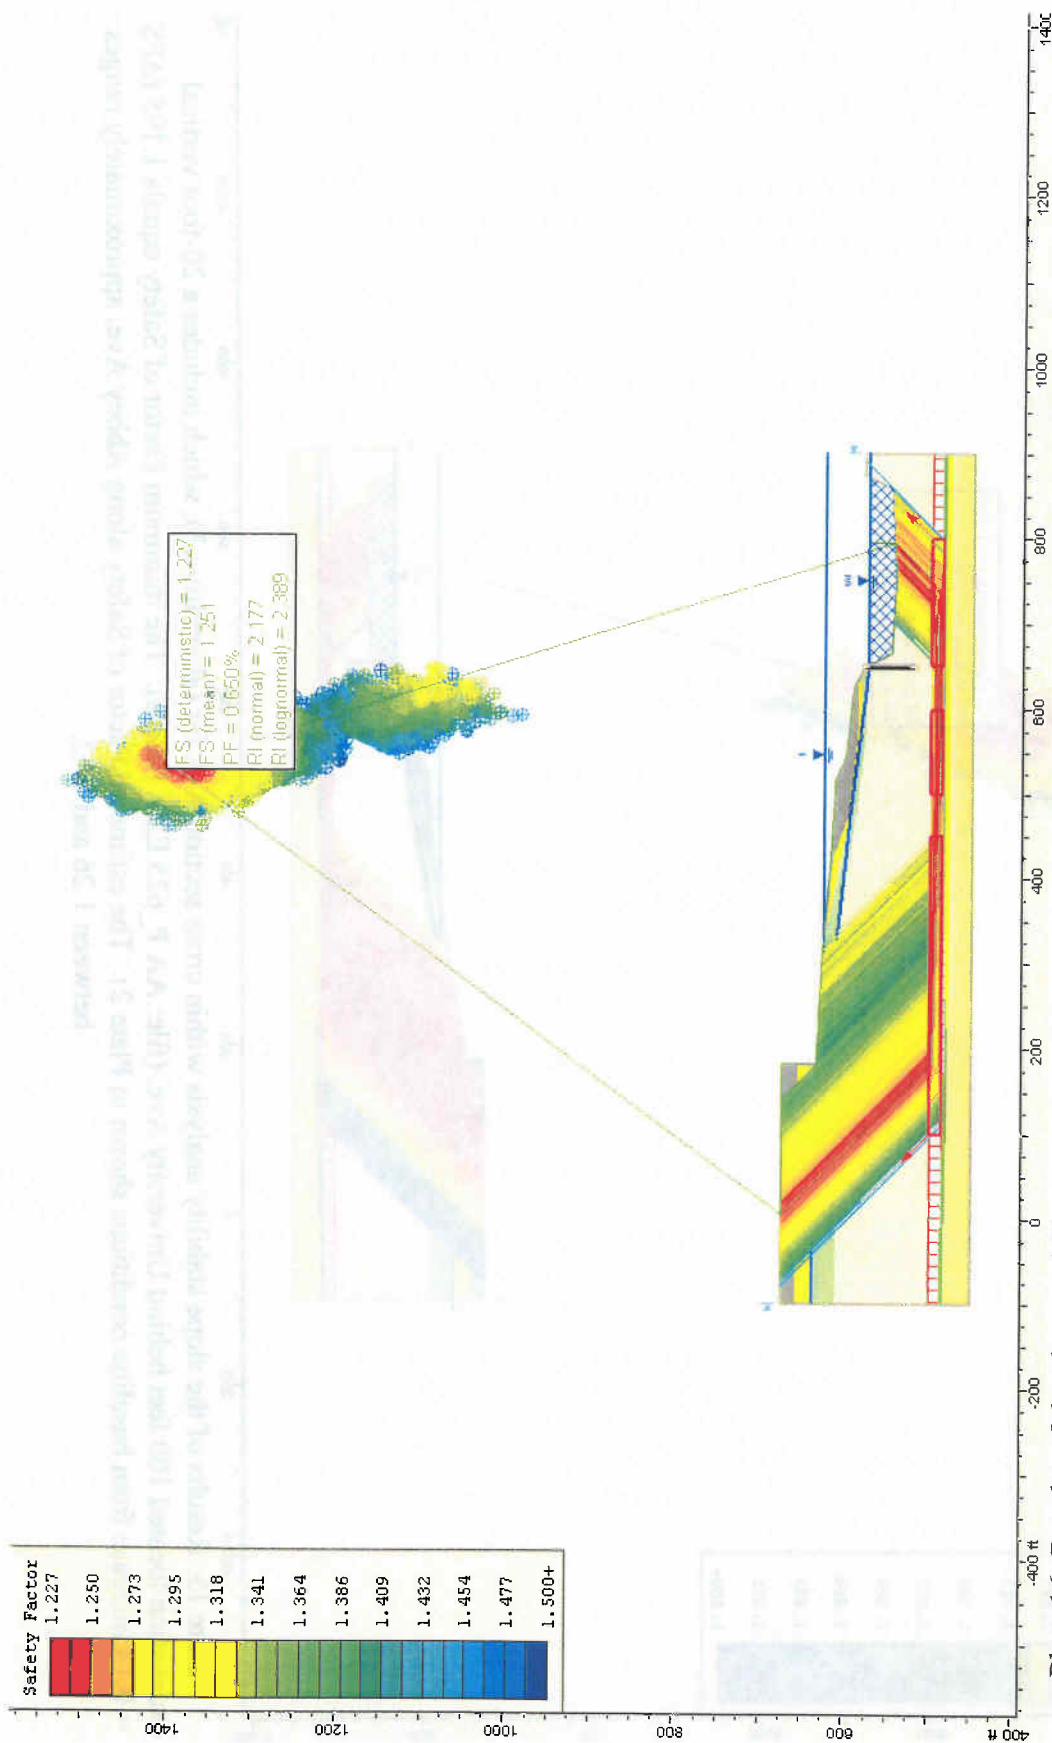
Plate 16: Results of the slope stability analysis within cross section A-A for (alternative 4), which includes a 30-foot vertical excavation located 100 feet behind University Ave. (file: AA_P_625 E30_100.sli). The minimum Factor of Safety equals 1.227 (Δ FS = 0.16 increase from baseline conditions shown in Plate 2). The estimated Factor of Safety along Abbey Ave. approximately ranges between 1.30 and 1.41.

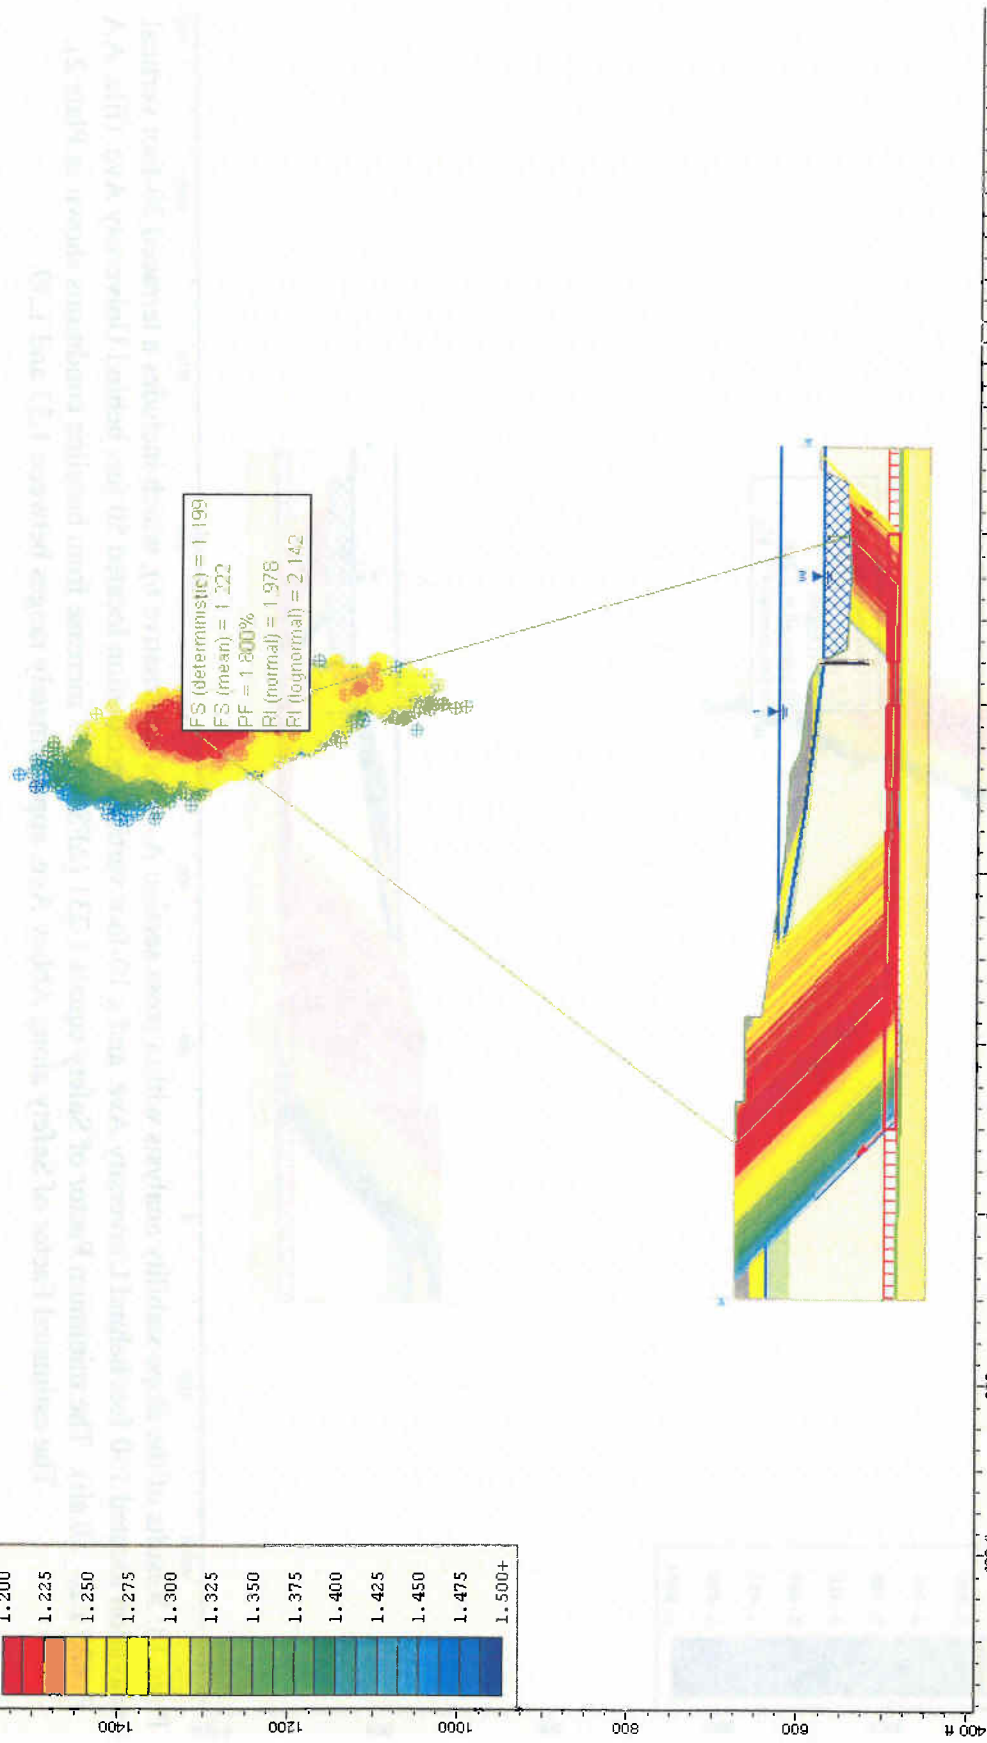
Plate 17: Results of the slope stability analysis within cross section A-A for (alternative 5), which includes a terraced 10-foot vertical excavation located 150 feet behind University Ave. and a 20-foot vertical excavation located 50 feet behind University Ave. (file: AA_P_625 E10_20.sli). The minimum Factor of Safety equals 1.199 ($\Delta FS = 0.13$ increase from baseline conditions shown in Plate 2). The estimated Factor of Safety along Abbey Ave. approximately ranges between 1.32 and 1.41.

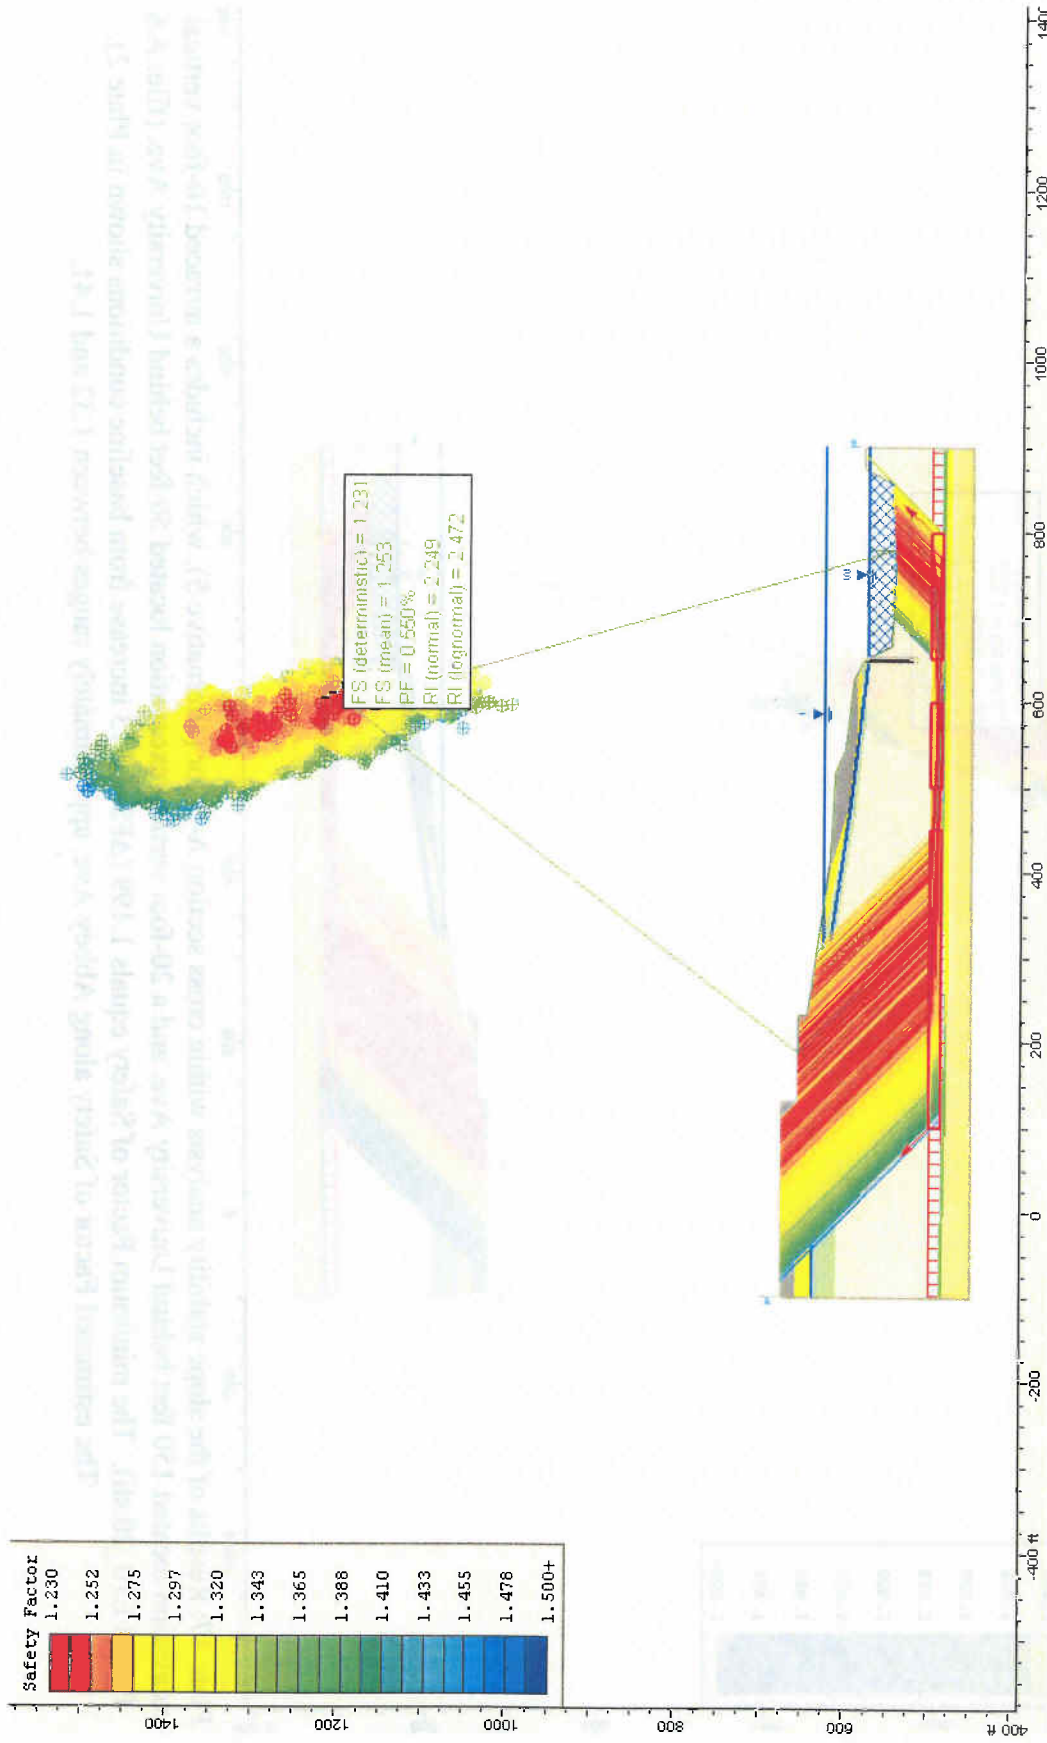
Plate 18: Results of the slope stability analysis within cross section A-A for (alternative 6), which includes a terraced 20-foot vertical excavation located 150 feet behind University Ave. and a 10-foot vertical excavation located 50 feet behind University Ave. (file: AA_P_625 E20_10.sli). The minimum Factor of Safety equals 1.231 ($\Delta FS = 0.17$ increase from baseline conditions shown in Plate 2). The estimated Factor of Safety along Abbey Ave. approximately ranges between 1.33 and 1.39.

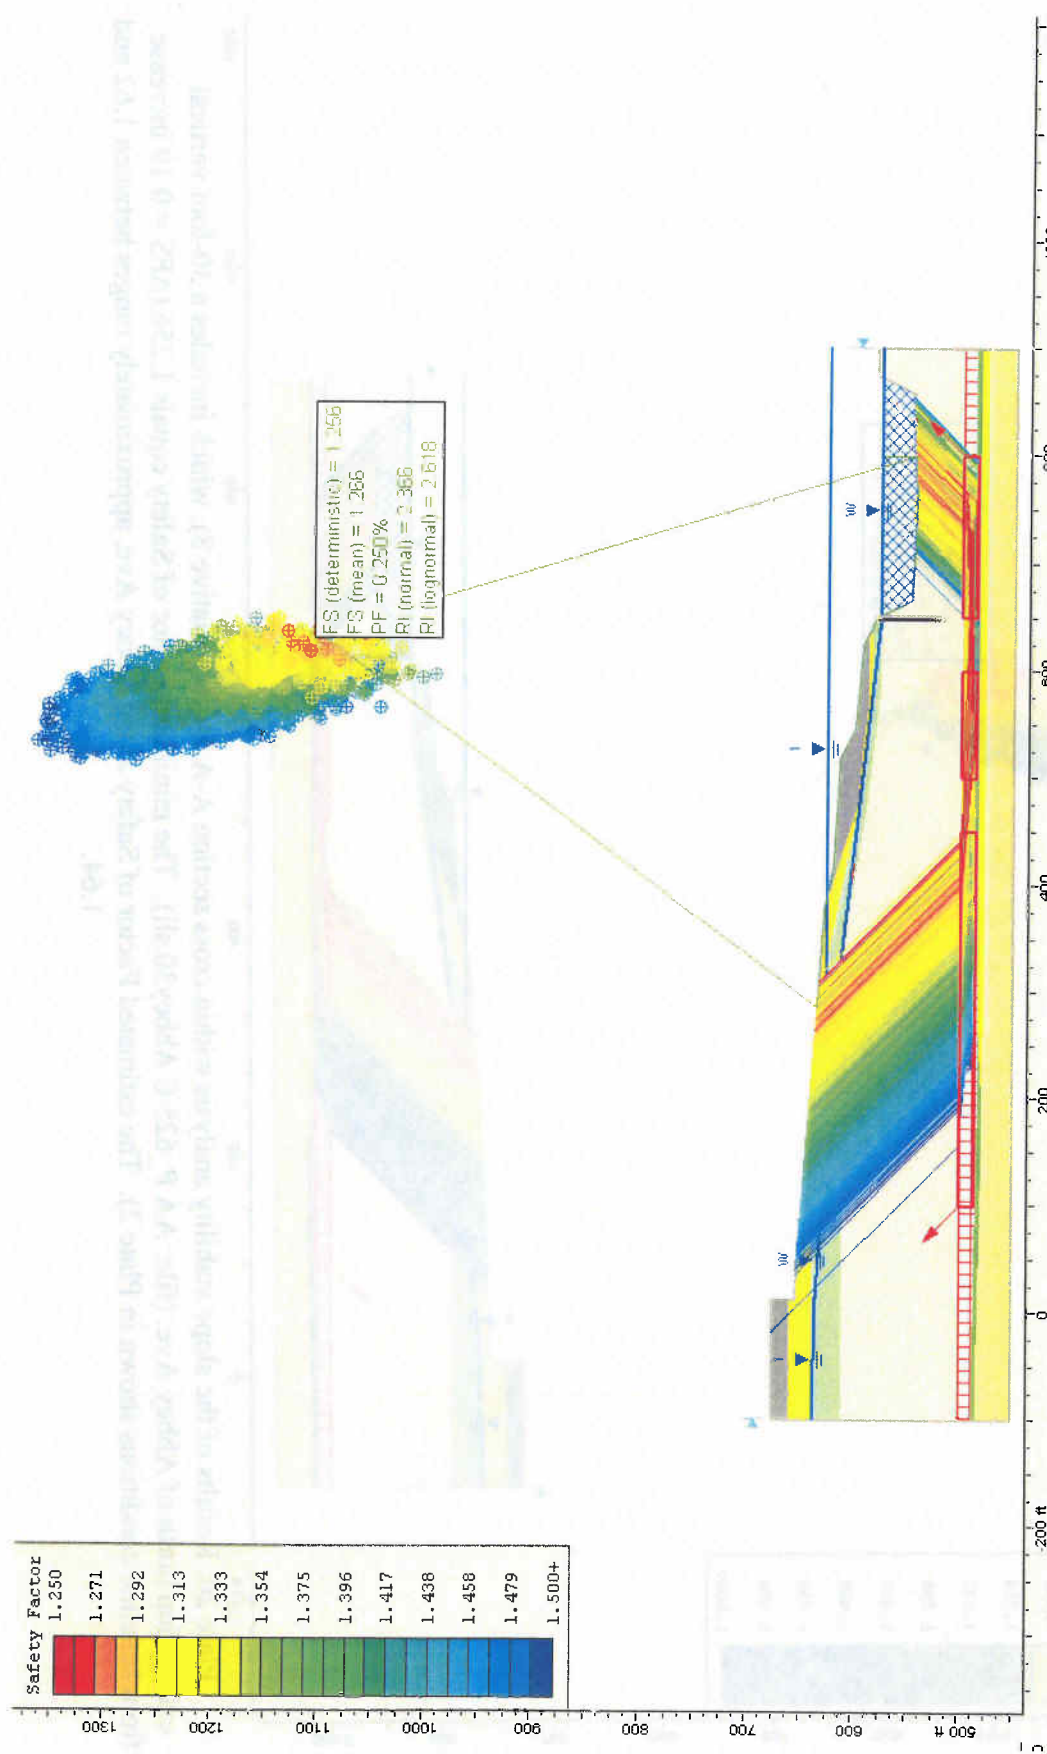
Plate 19: Results of the slope stability analysis within cross section A-A for (alternative 7), which includes a 20-foot vertical excavation north of Abbey Ave. (file: AA_P_625 E Abbey20.sli). The minimum Factor of Safety equals 1.256 ($\Delta FS = 0.19$ increase from baseline conditions shown in Plate 2). The estimated Factor of Safety along Abbey Ave. approximately ranges between 1.56 and 1.90.
