Re: October 2015 Annual Report
CUY-90-15.24 Slope Monitoring
PID 96504
EDP Project No. 069032.00

OCTOBER 2015 QUARTERLY REPORT

**CUY-90-15.24 SLOPE MONITORING
PID 96504
CLEVELAND, OHIO
SME PROJECT NO. 069032.00**

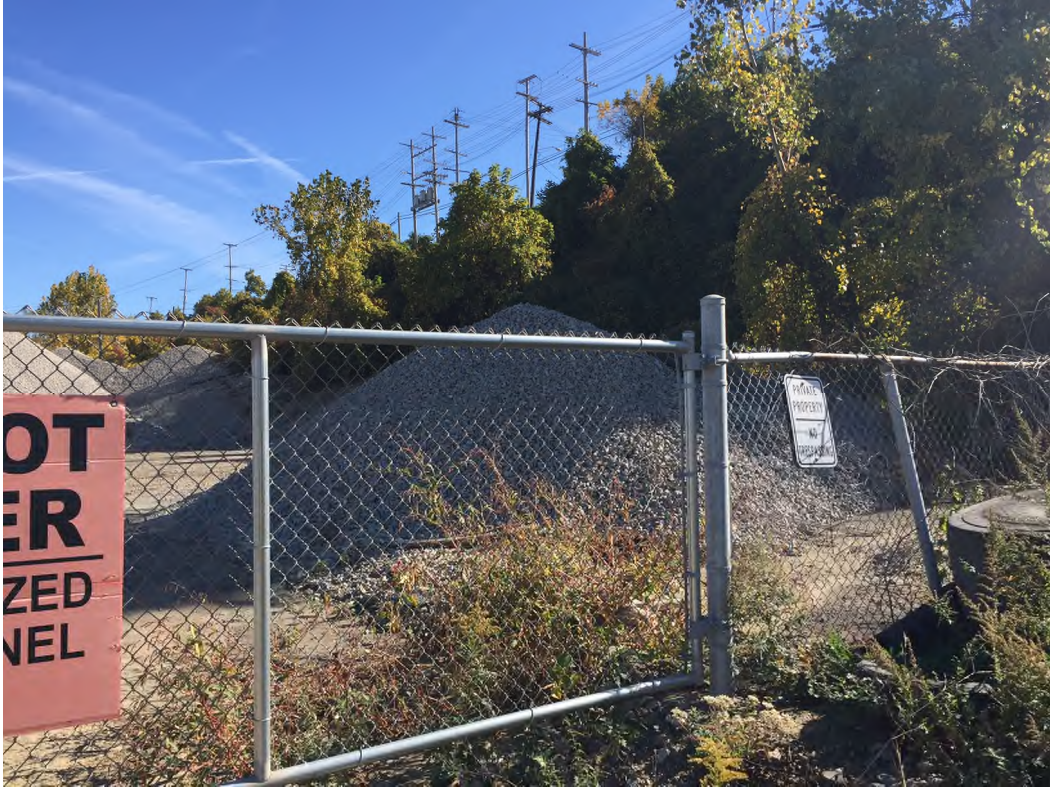
Figure 4. Aggregate stockpile east of the ODOT right-of-way (October 23, 2015)

We observed and photographed the aggregate stockpiles on October 23, 2015. The photos are Figures 4 and 5 which are included in Appendix A. Only a small pile of aggregate closest to the right-of-way fence remains. This pile has been virtually unchanged since January 2014. The pile is about 8 feet high and covers only a small area of the property.

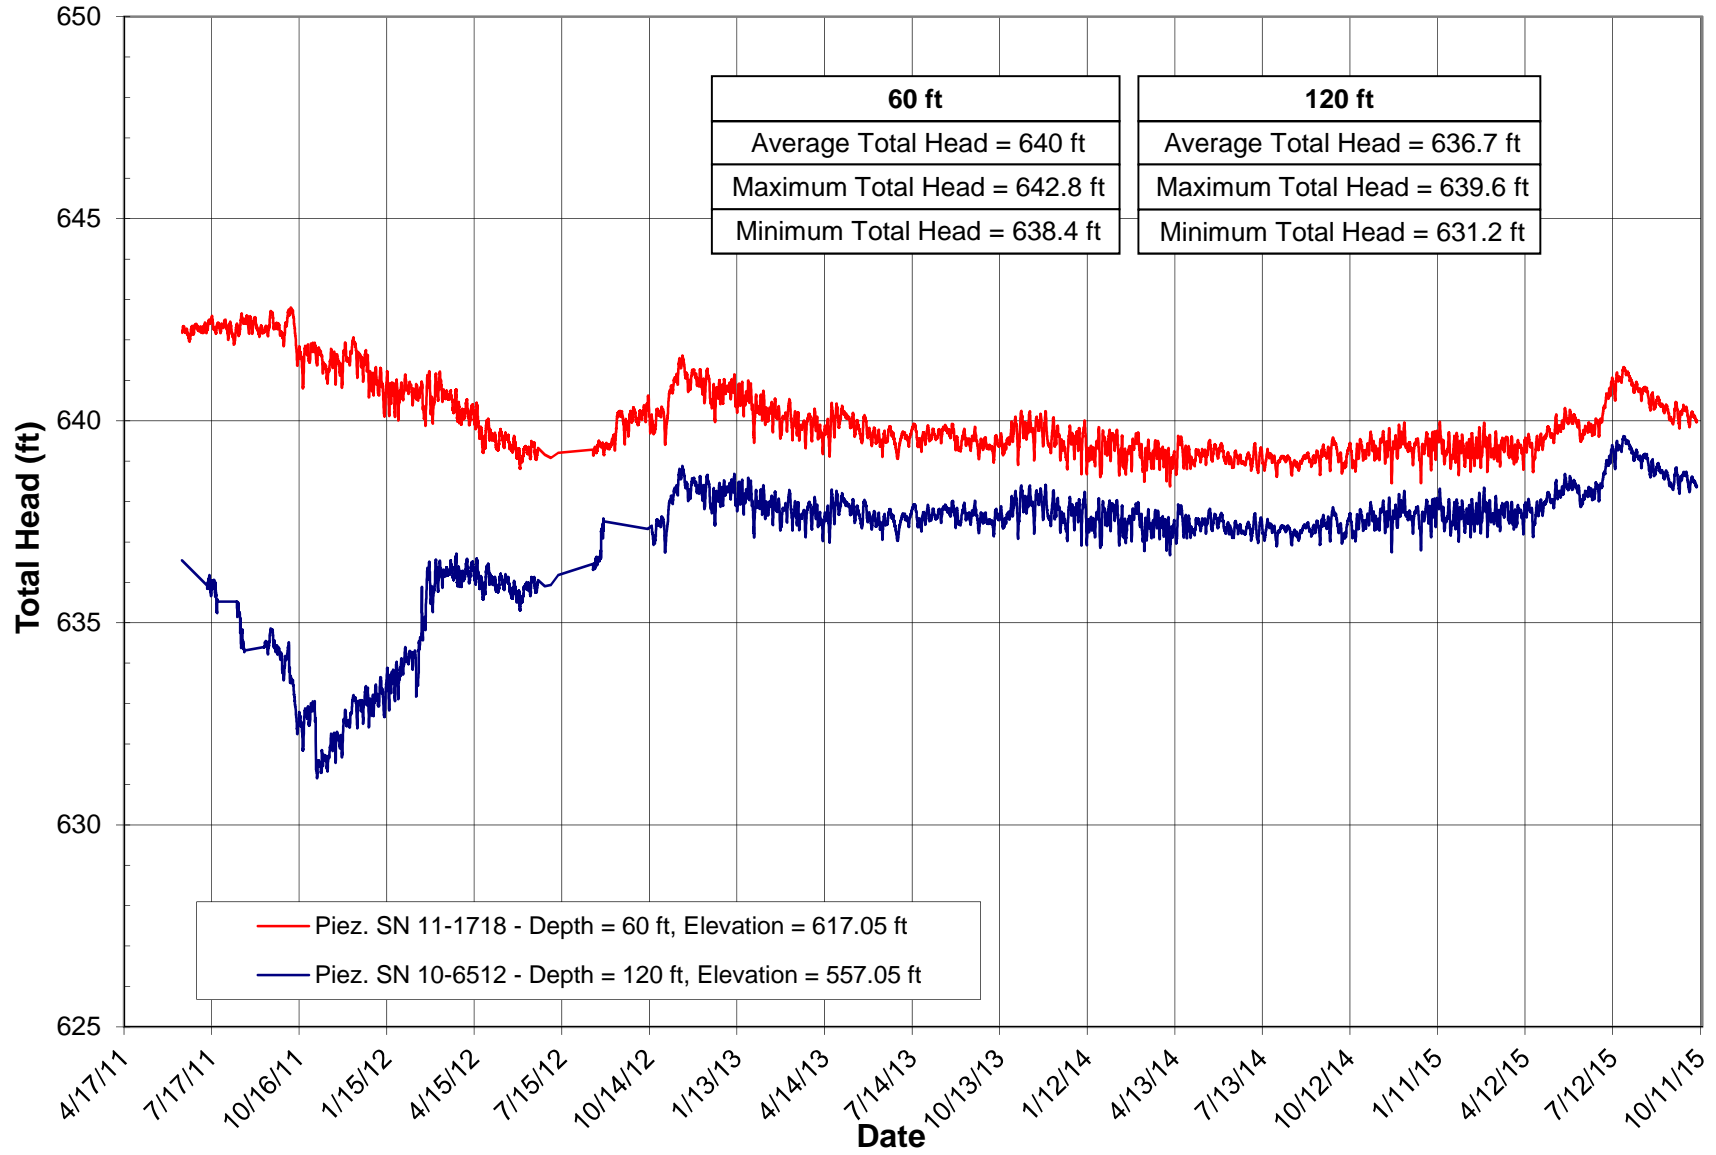
P-001-10 VW Piezometer Readings

P-001-10. Total head in both piezometers at P-001-10 increased slightly during November and December 2014 and then remained constant through June 2015. The greatest rate of increase occurred during July 2015. Since the end of July, the total head in both piezometers decreased by about 1.5 feet. The net change in total head for the year was an increase of about 1 foot.

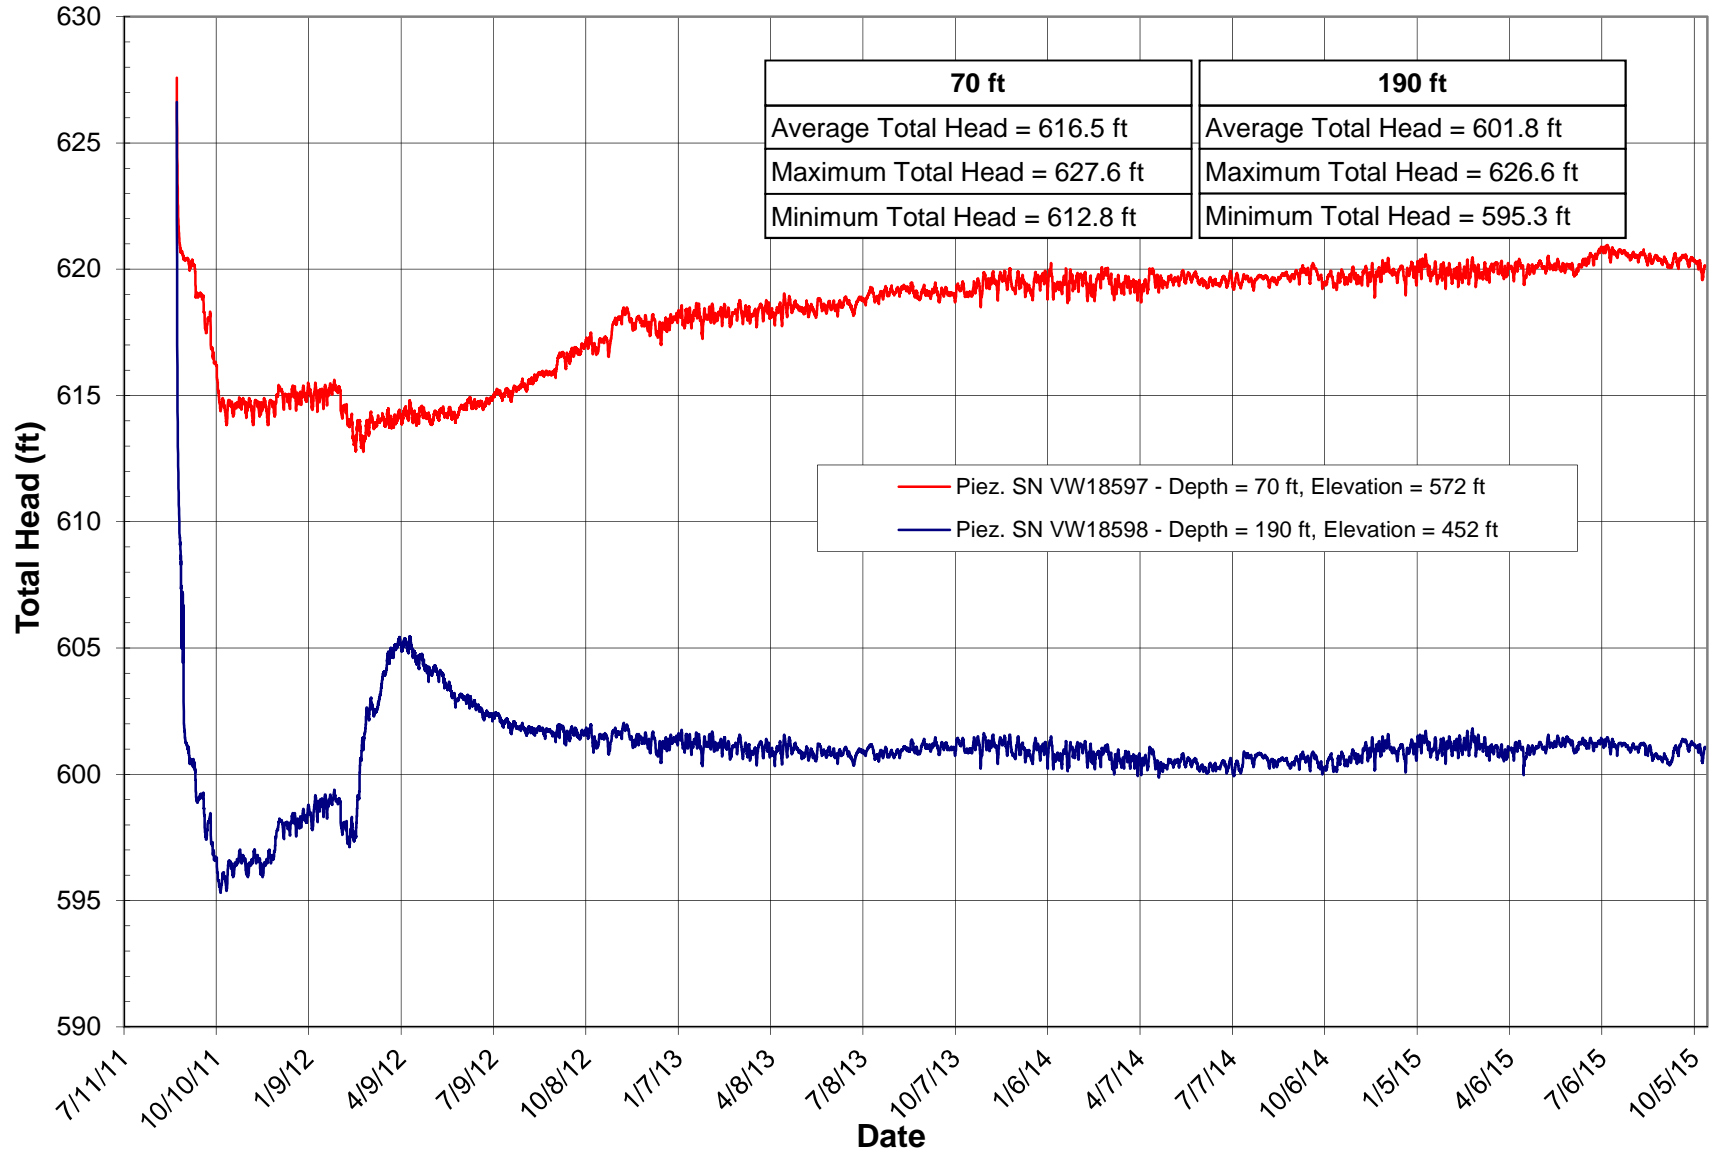
P-002-10 VW Piezometer Readings

P-002-10. The total head in both piezometers at this location increased through June 2015. Total head began to decrease in early July 2015. The net change in total head over the past year has been an increase of about 0.5 feet in both piezometers.

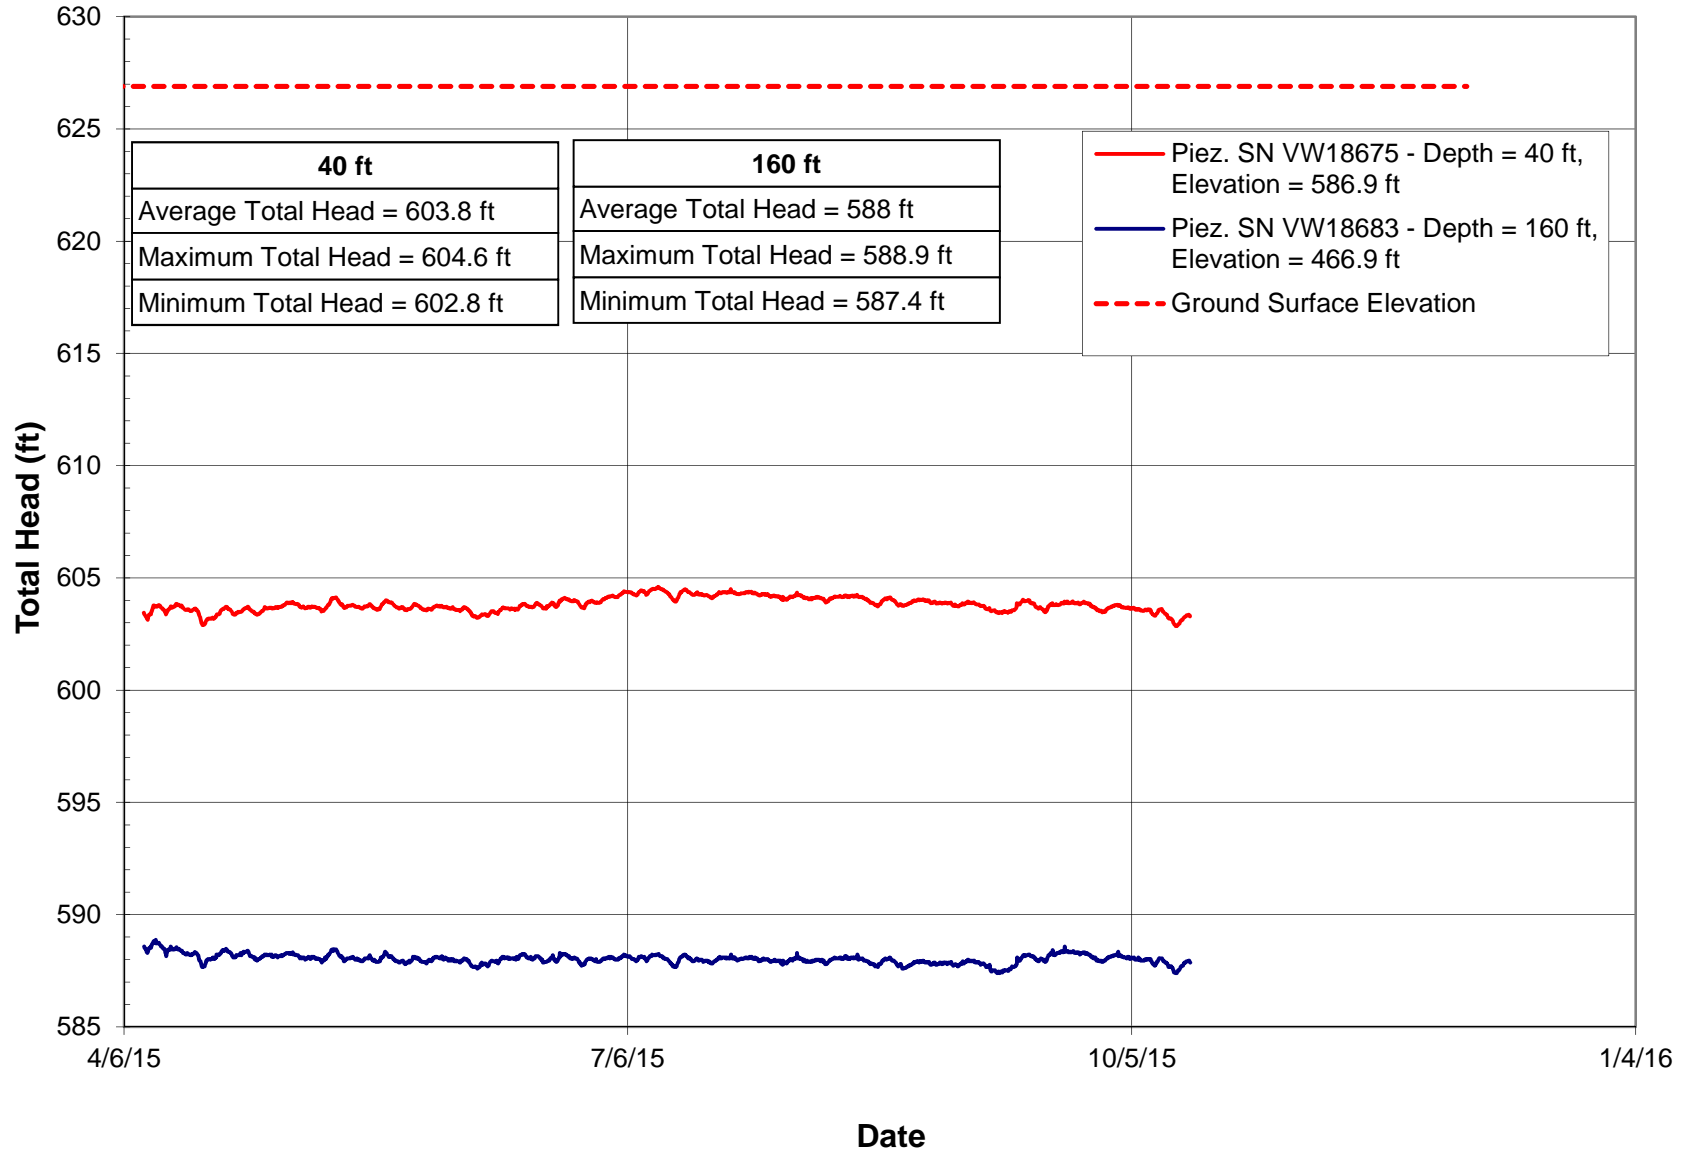
P-007-13 VW Piezometer Readings

P-007-13. Total head in the shallow piezometer at this location increased slightly during late June and into July 2015 but decreased soon after. There has been no significant change in total head in either piezometer at this location since we began taking readings in April 2015.

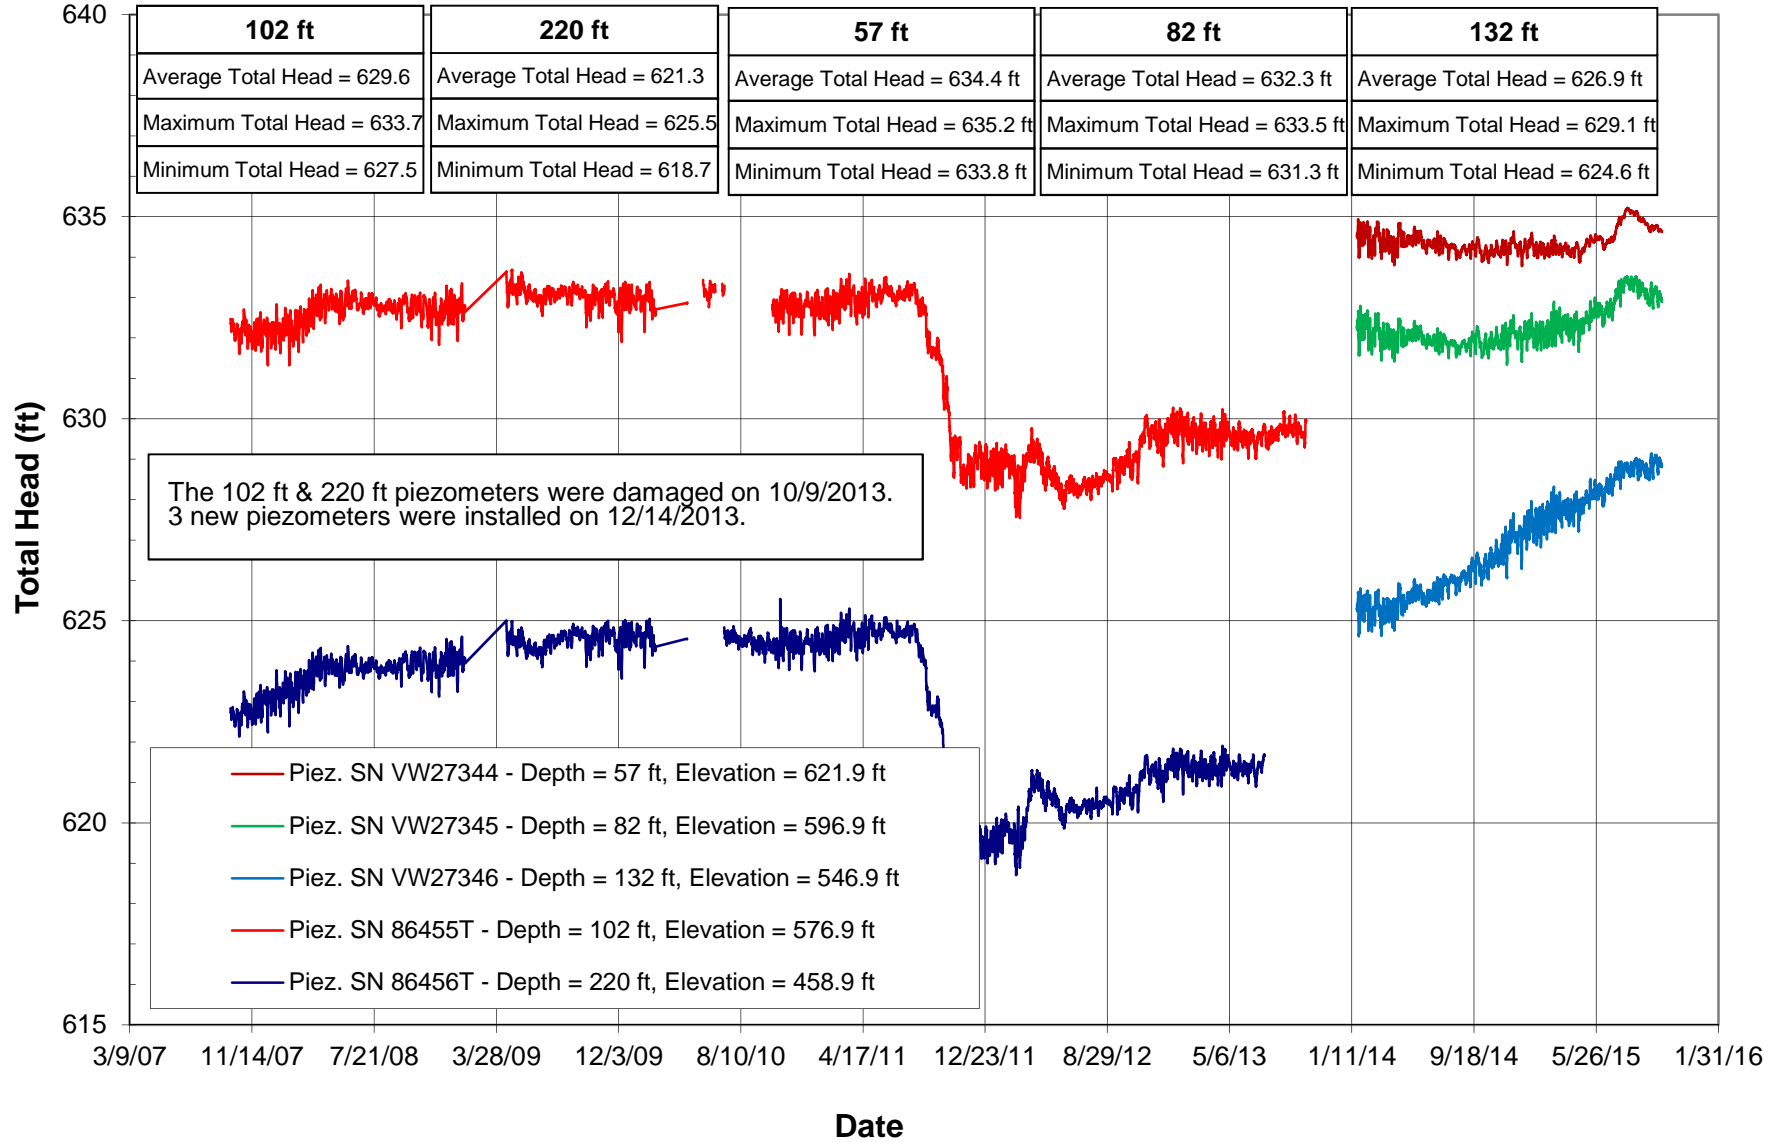
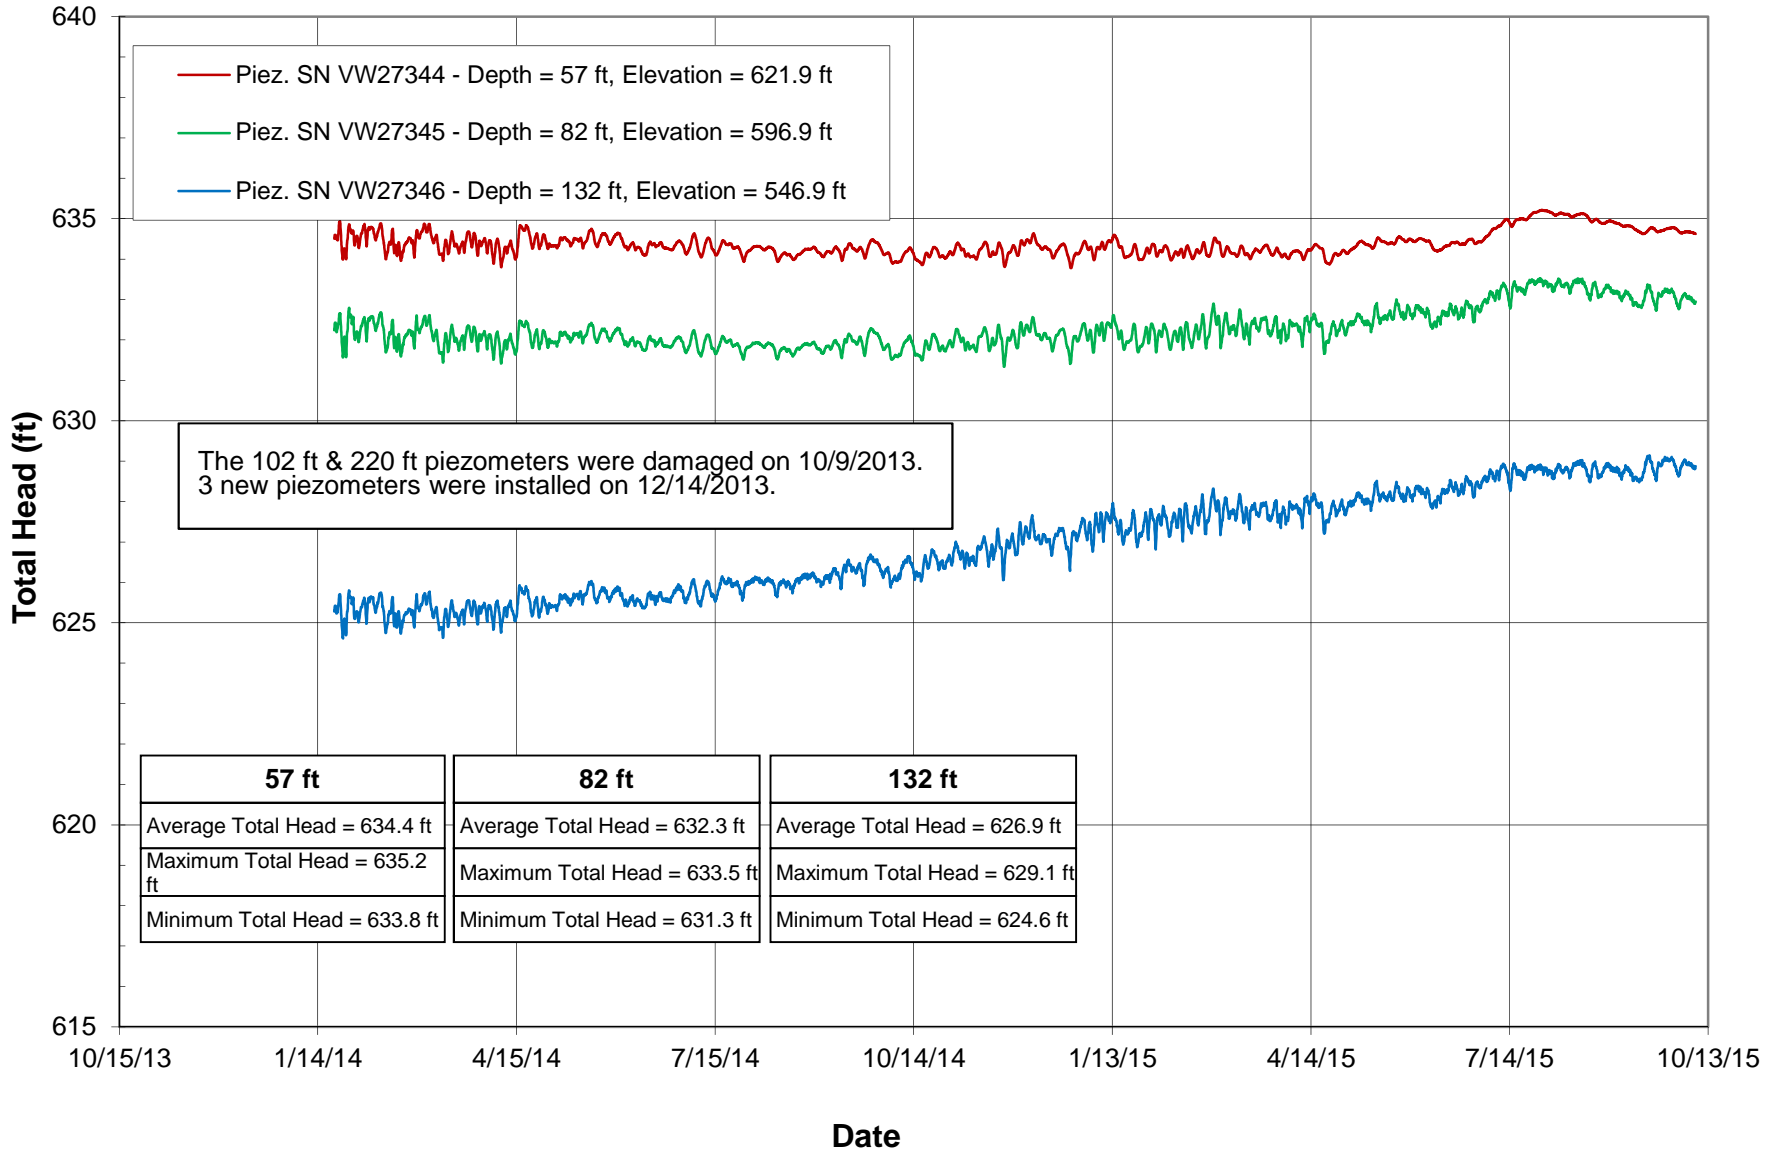
B-05-07 VW Piezometer Readings

B-05-07. Pore pressure in the deepest piezometer continued to increase at a constant rate with an increase in total head of about 3.4 feet since April 2014. Readings in the two shallower piezometers showed no significant change through the first part of the year, but began increasing after April 2015. This increase continued until about the end of July, when pore pressures began to decrease. Net changes in total head for the year are increases of about 0.5 feet and 1 foot for the piezometers at 57 feet and 82 feet, respectively.

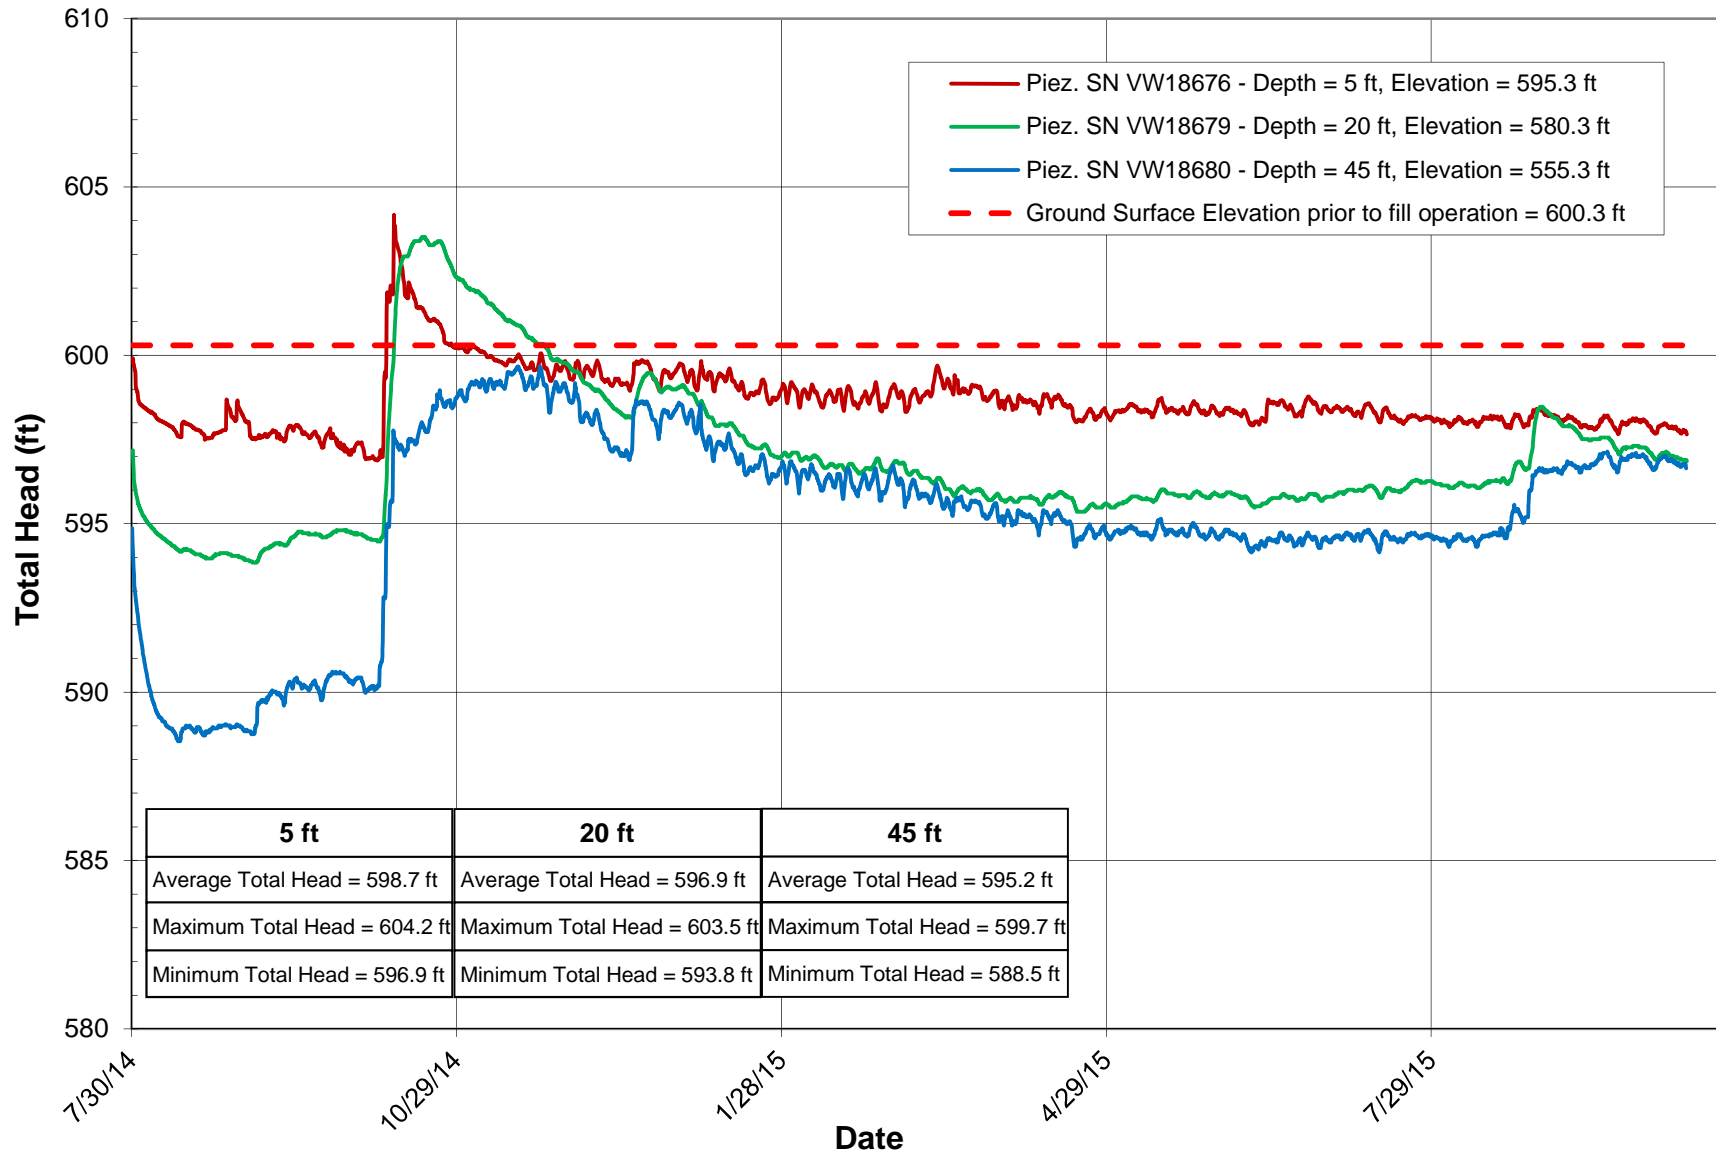
TGR P-3 VW Piezometer Readings

TGR P-3. In early October 2014, a large amount of fill was placed in the area adjacent to this location causing an increase of 7 to 7.5 feet of total head in all three piezometers. After the fill was in place, the pore pressures began to decrease with the rate of change decreasing over time. Pore pressure in the shallowest piezometer decreased rapidly during the first month and has been trending downward slowly ever since with a net change of about 2 feet for the year. Total head in the two deeper piezometers decrease at a fairly constant rate until about April 2015. At that

time pore pressures in the deepest piezometer appeared to have reached equilibrium. In April 2015, pore pressures in the piezometer at 20 feet began to slowly to increase. Then beginning on or about August 20, total head in both piezometers increased by about 2.5 feet in one week. No indication of this increase is seen in the shallowest piezometer. Following this increase, total head in the piezometer at 20 feet began to decrease, while total head in the deepest piezometer continued to increase slowly. Total head readings in these two deeper piezometers now differ by only about 0.2 feet.

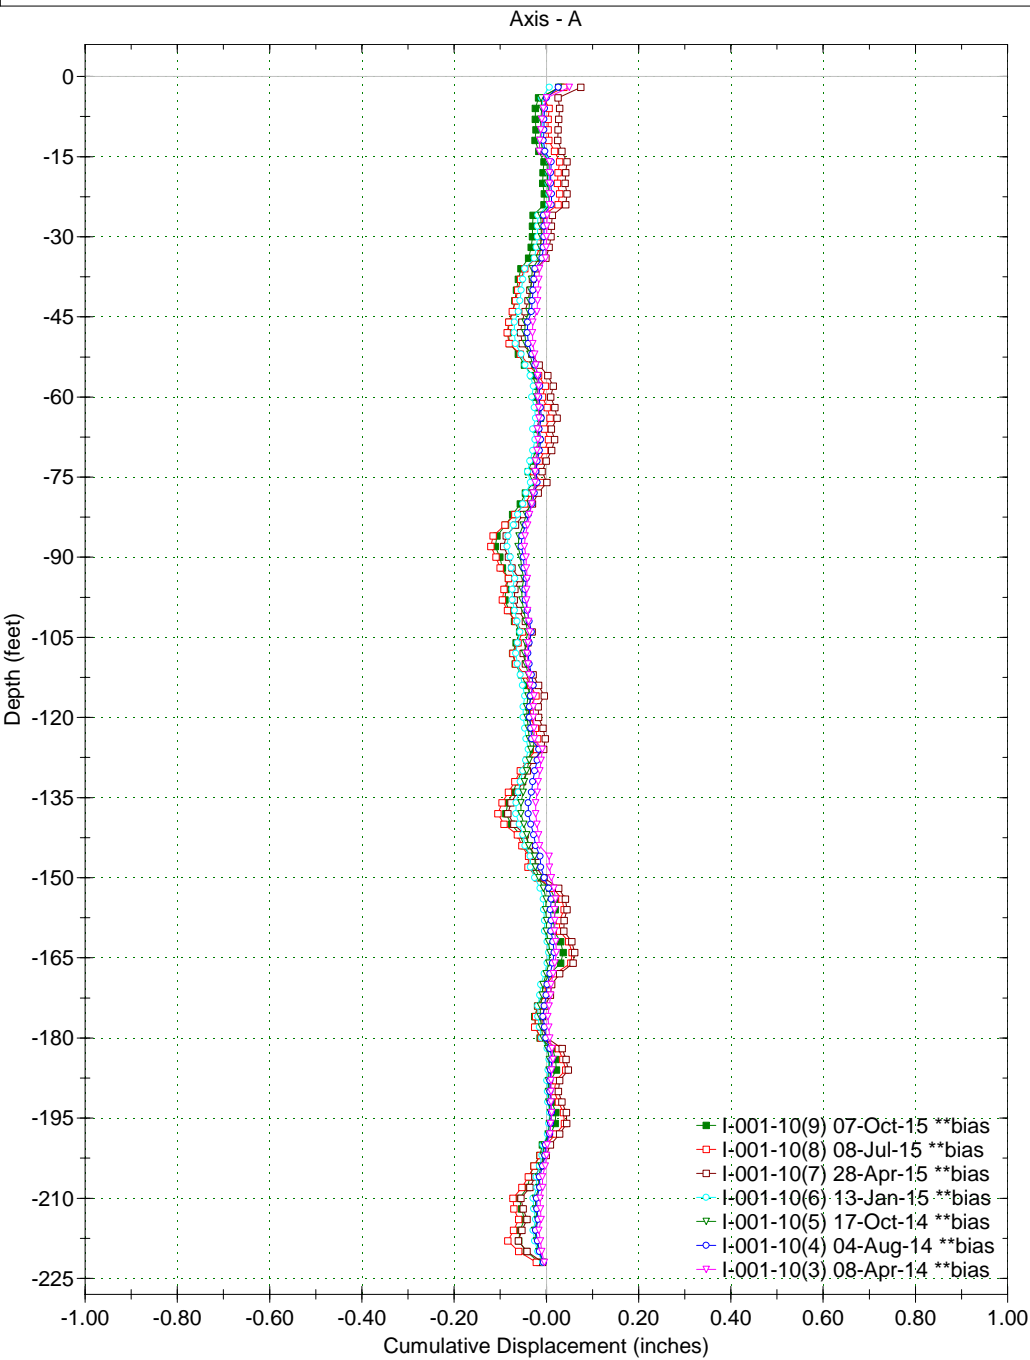
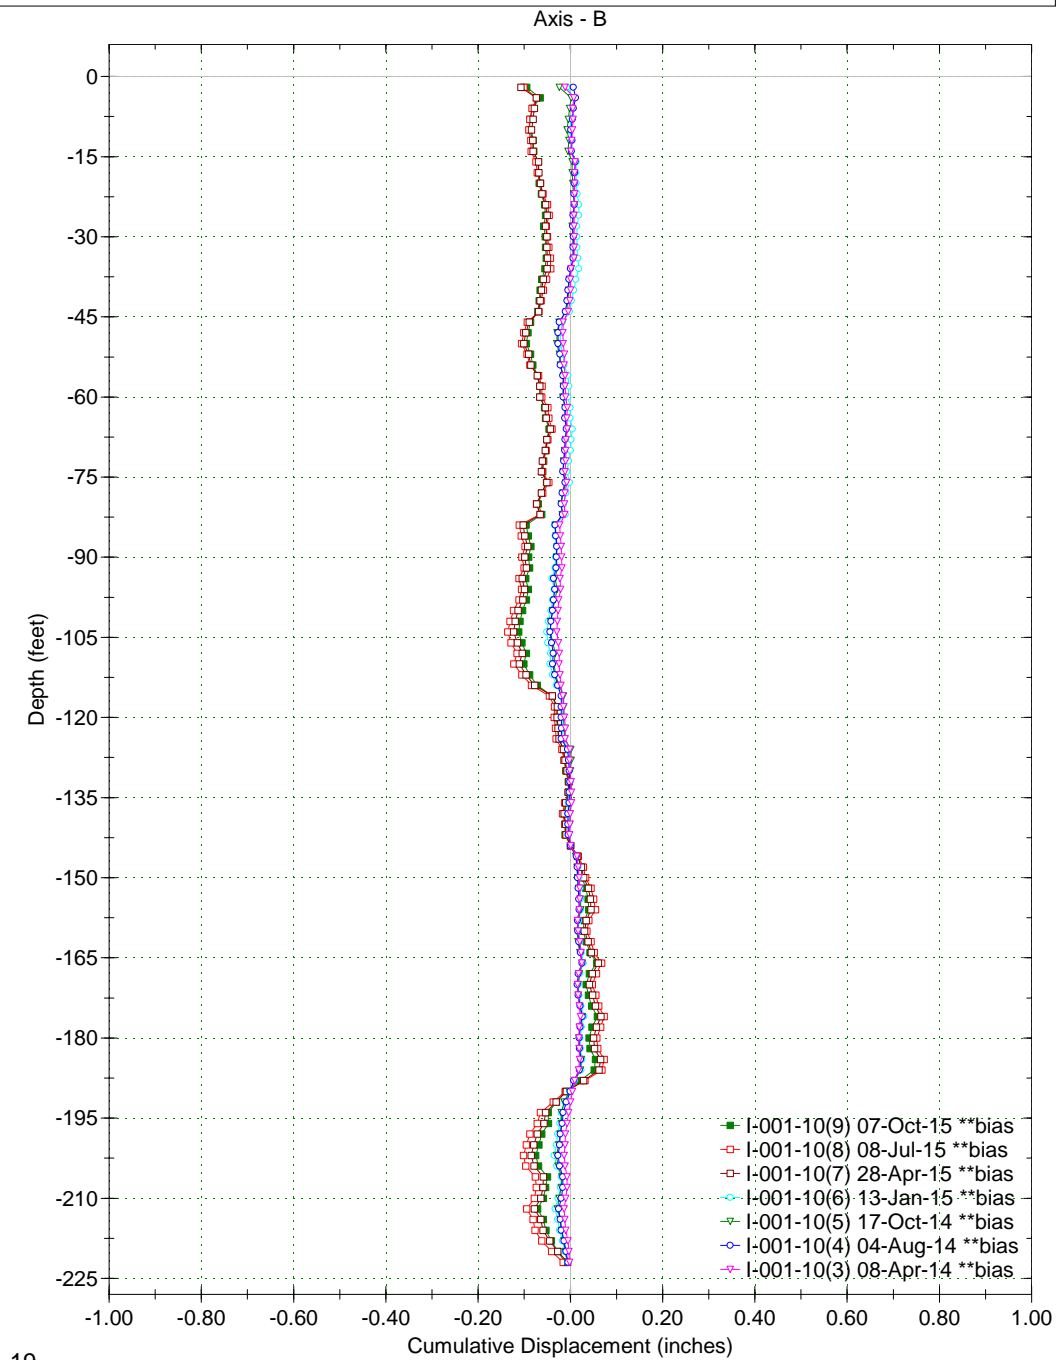
I-001-10. The April 2015 quarterly readings at this location indicated negative B-axis displacement of about 0.1 inches between 110 and 120 feet and between 190 and 200 feet. Since the April quarter displacements have been negligible.

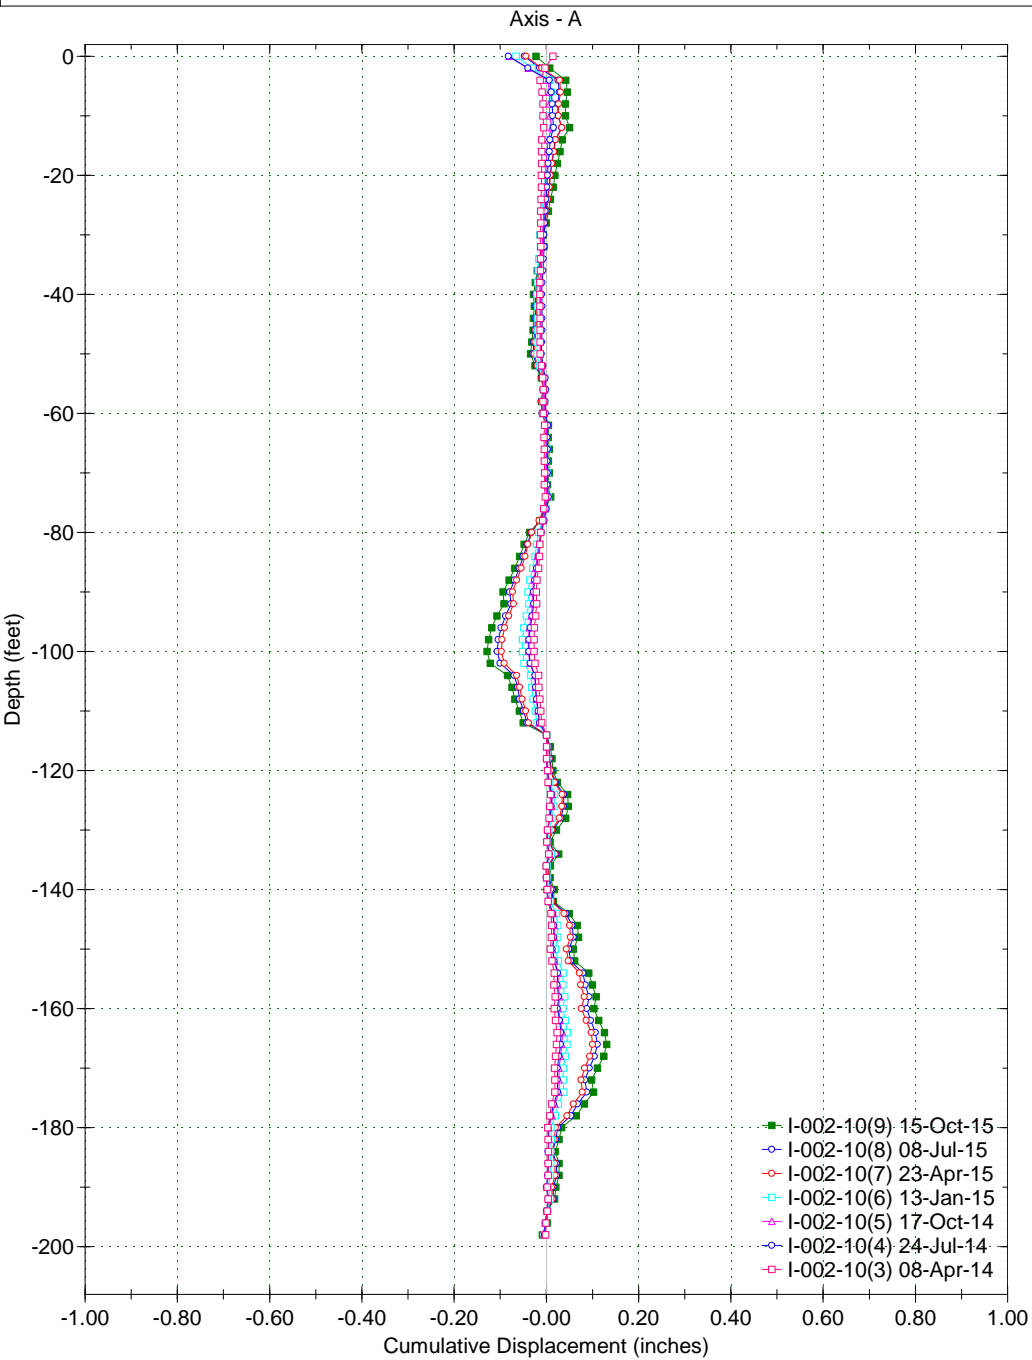
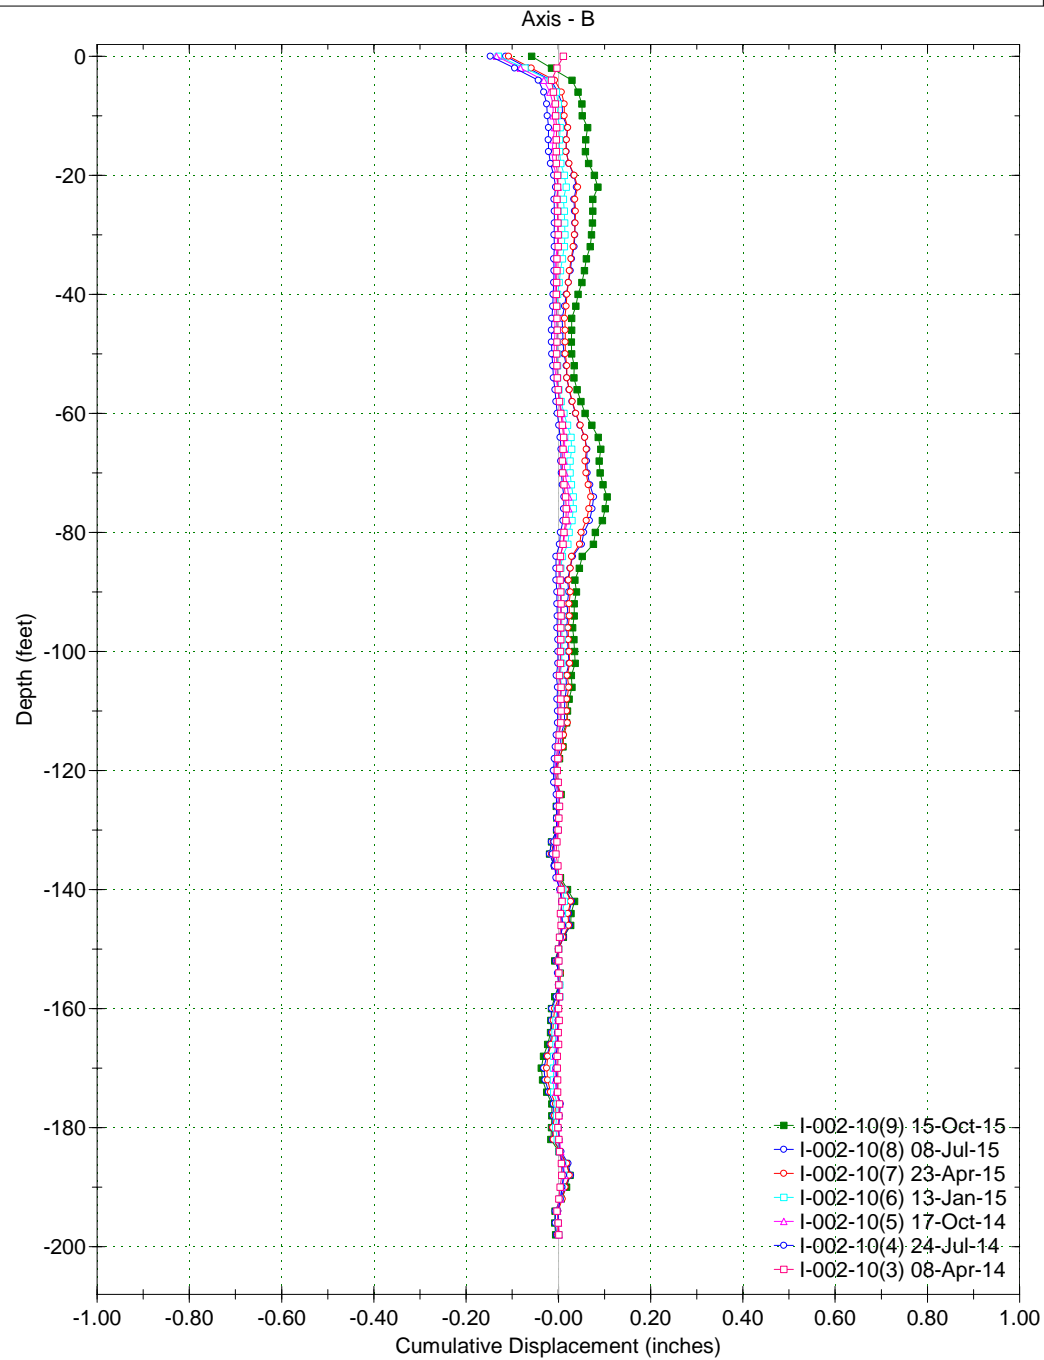
I-002-10. Displacements in both axis directions continued to increase throughout the year. A-axis movement is occurring in the negative direction between 78 and 116 feet and in the positive direction between 142 and 180 feet. At both intervals, the maximum displacement is now about 0.12 inches. B-axis movement is occurring in the positive direction from the surface to a depth of about 110 feet. Displacement this past year has been about 0.1 inches.

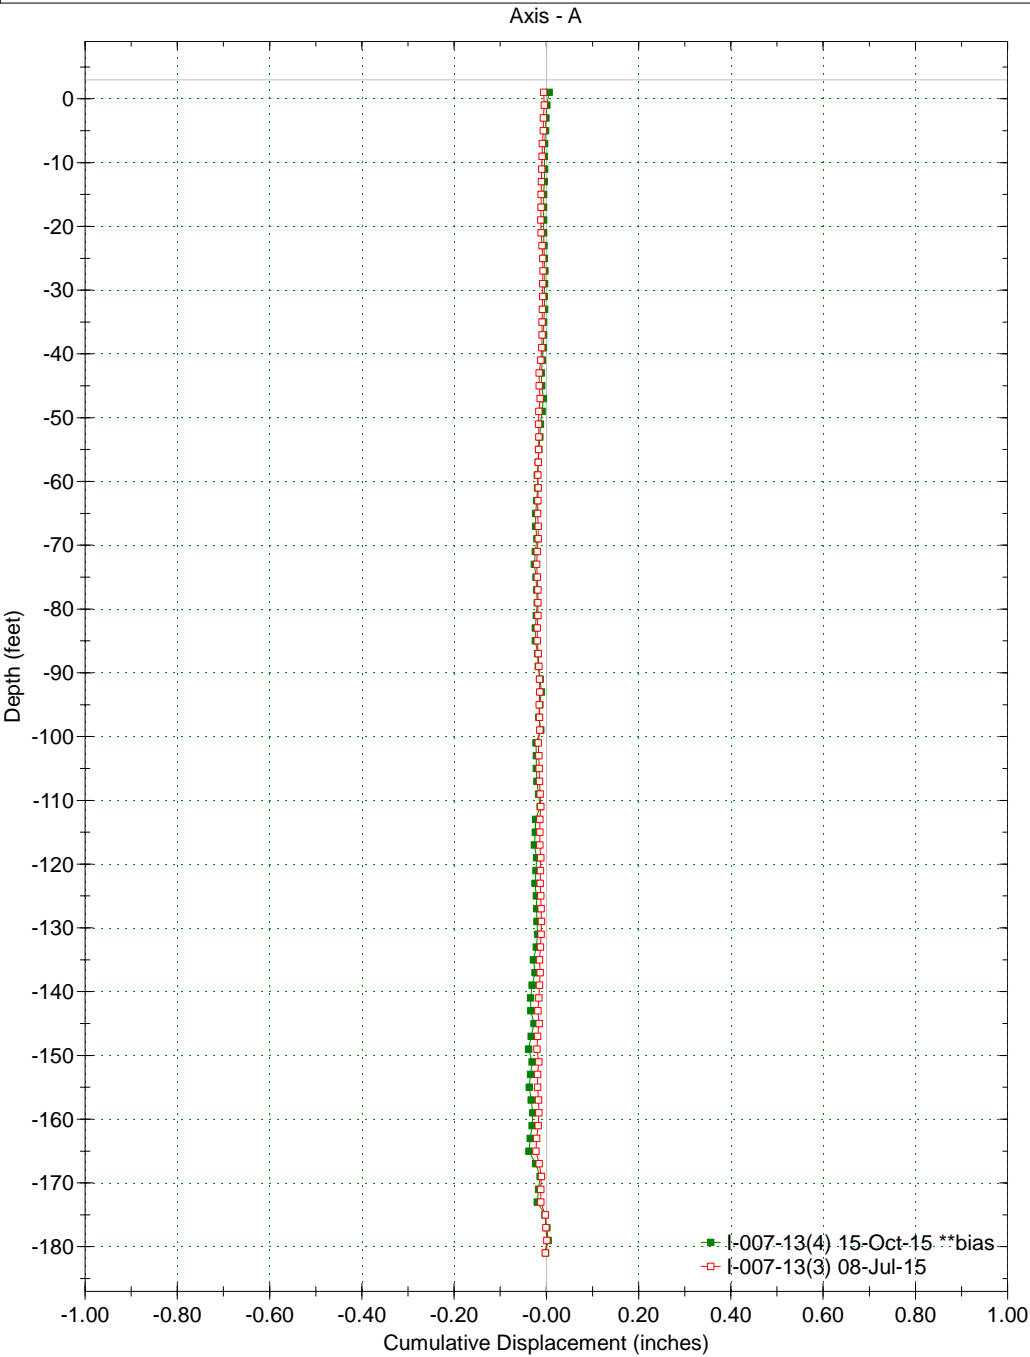
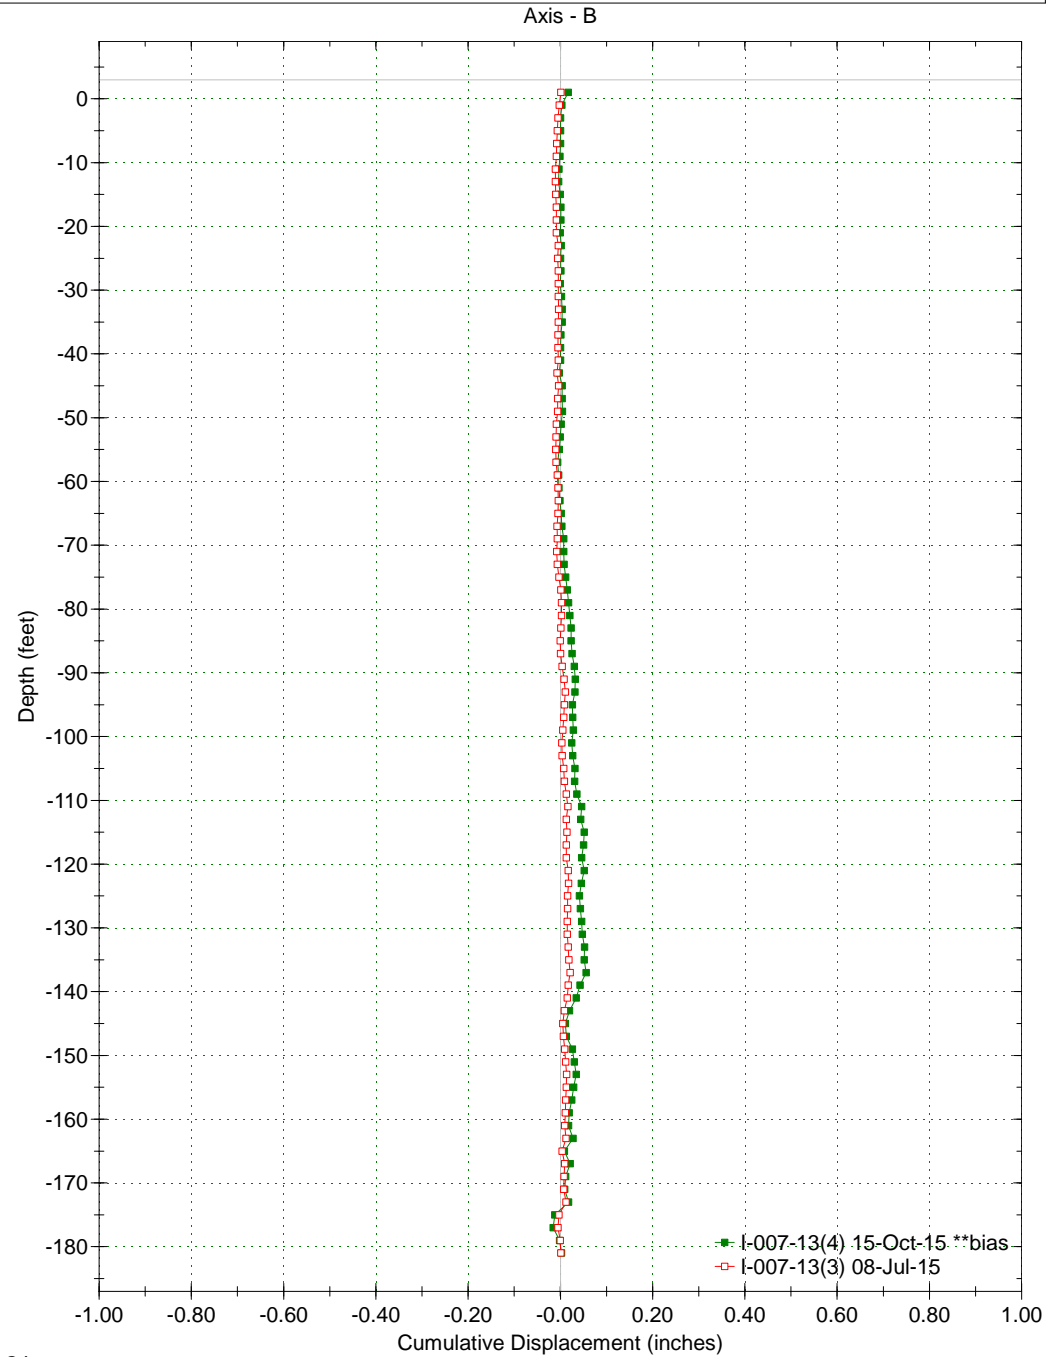
I-007-13. This past quarter's readings indicate slight displacements in the positive B-axis direction between 65 and 145 feet. Movement in the A-axis direction has been negligible since the April 2015 baseline readings.
