Re: October 2015 Annual Report
CUY-90-15.24 Slope Monitoring
PID 96504
EDP Project No. 069032.00

OCTOBER 2015 QUARTERLY REPORT

**CUY-90-15.24 SLOPE MONITORING
PID 96504
CLEVELAND, OHIO
SME PROJECT NO. 069032.00**

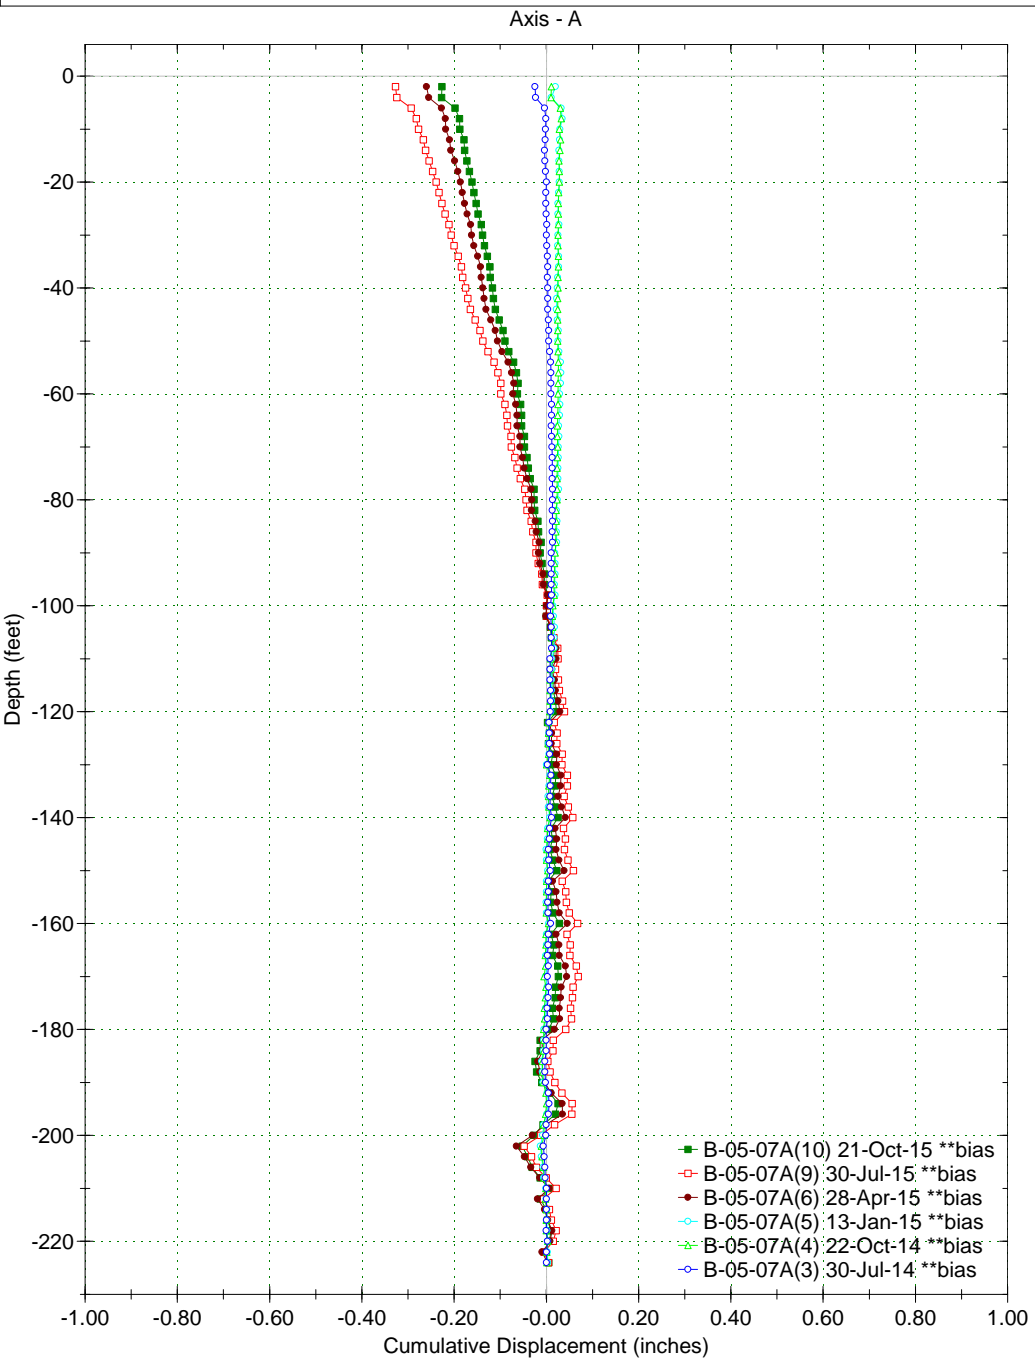
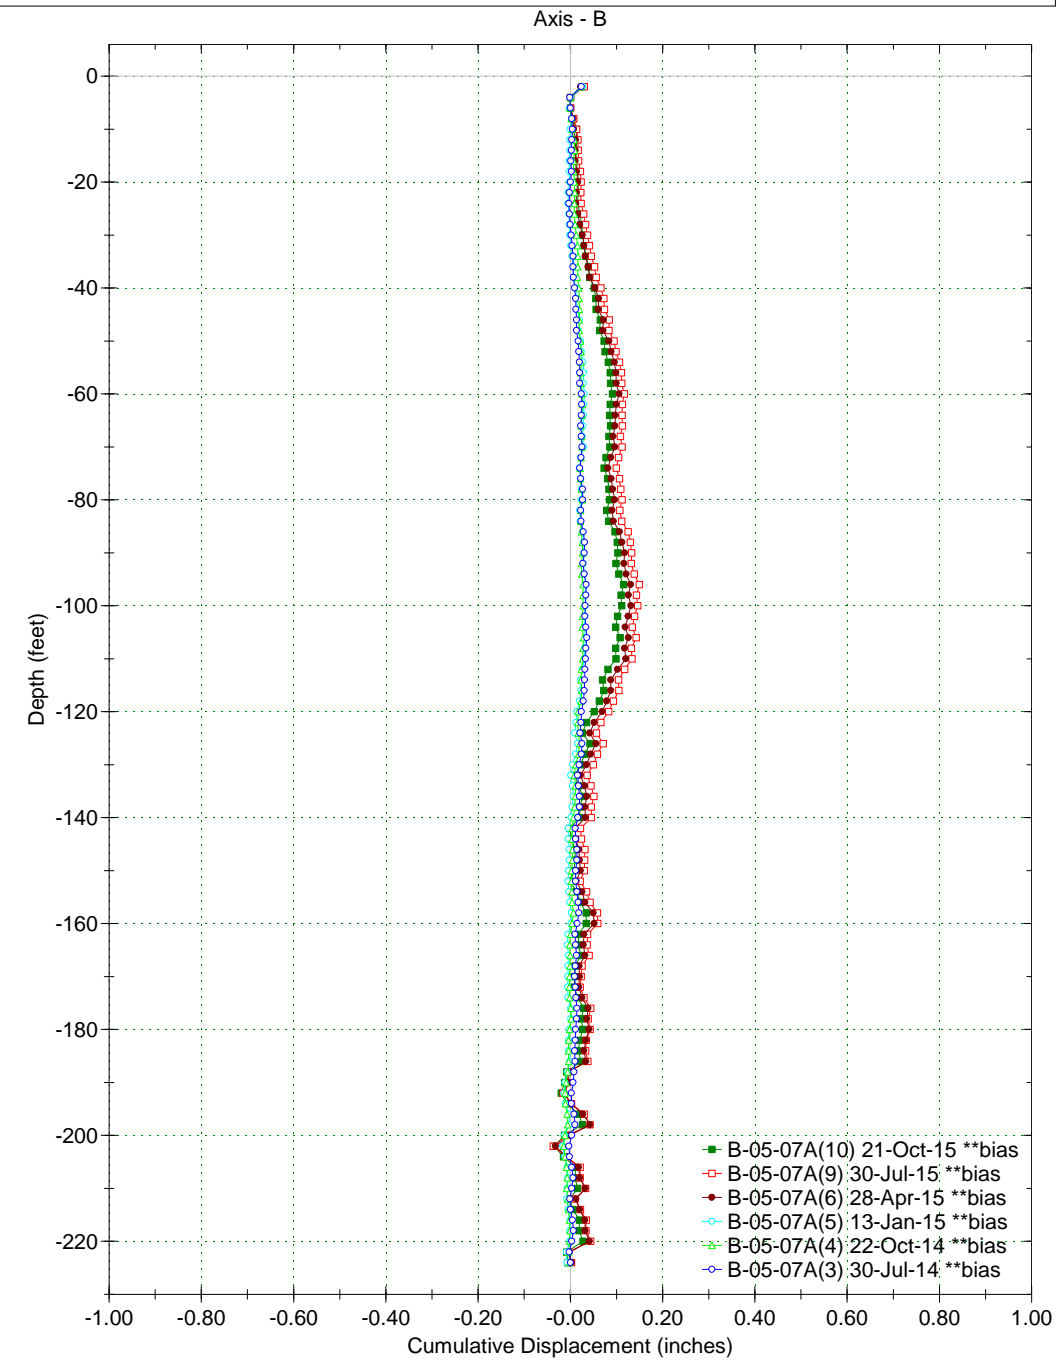
B-05-07. The April and July readings for this location indicated negative A-axis rotation from the surface to about 104 feet with a maximum displacement in July of about 0.32 inches at the surface. The April readings indicated a B-axis "bulge" between 20 and 140 feet with a maximum displacement in July of about 0.15 inches at 100 feet. The October 2015 readings indicate that the displacements in both axis directions reversed slightly towards the baseline.

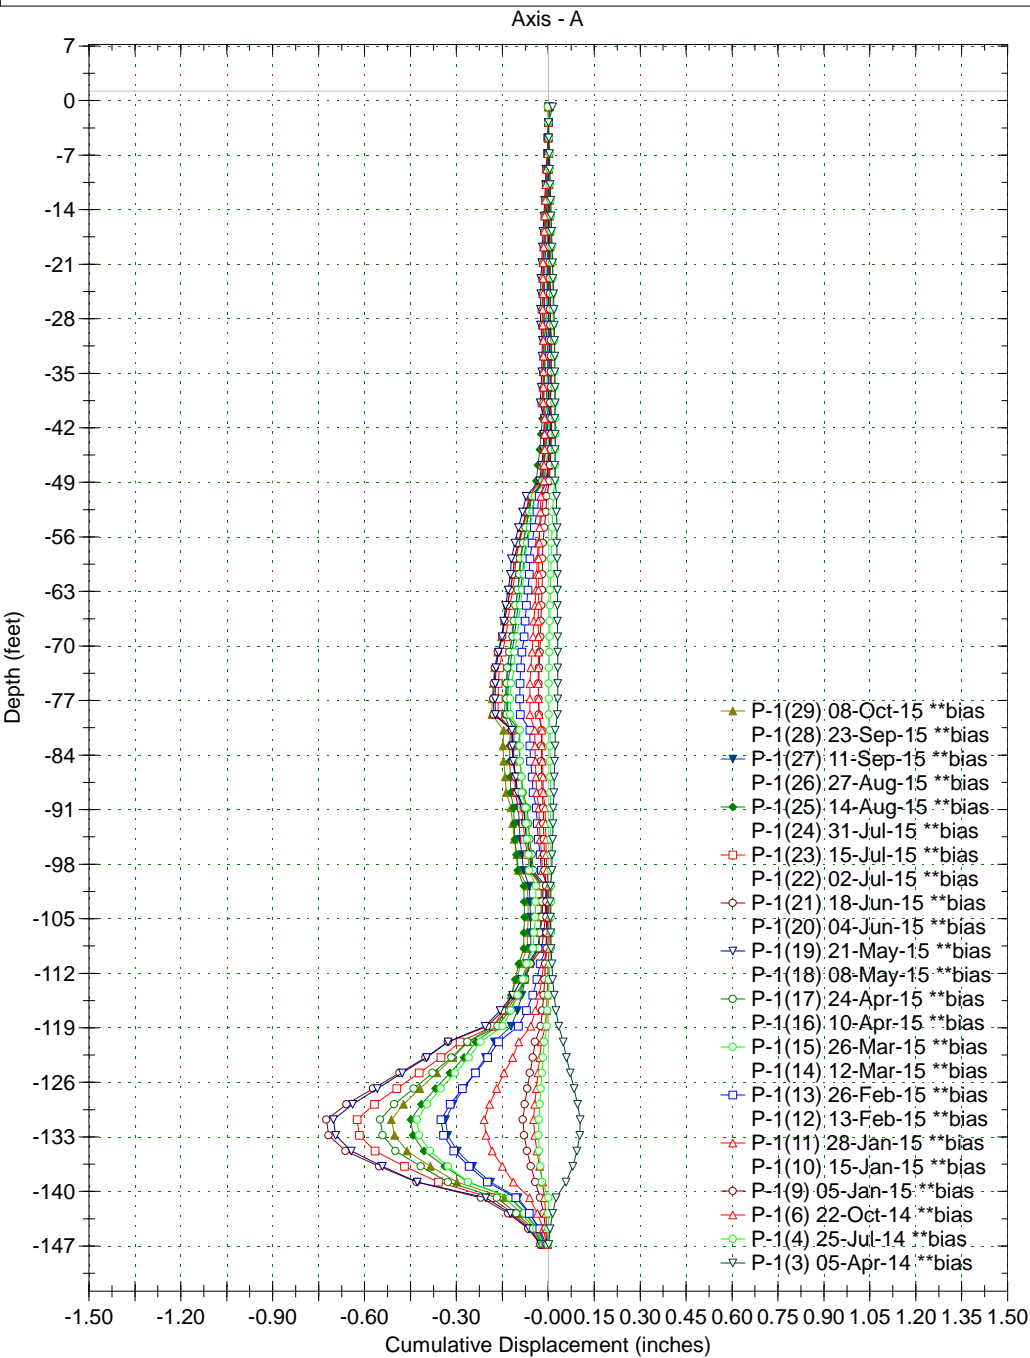
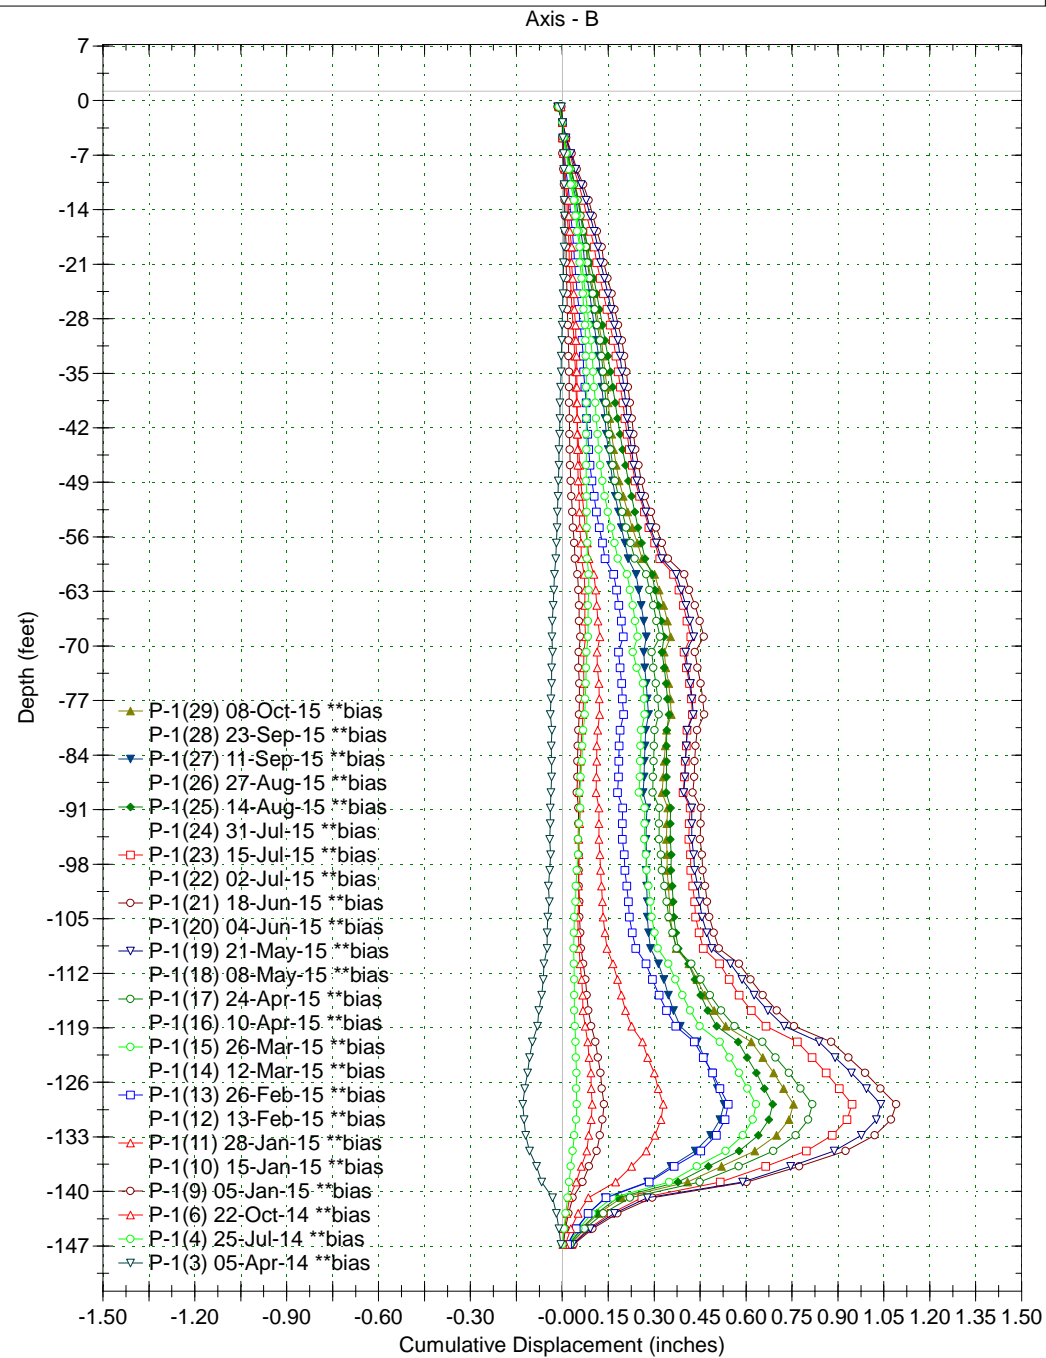
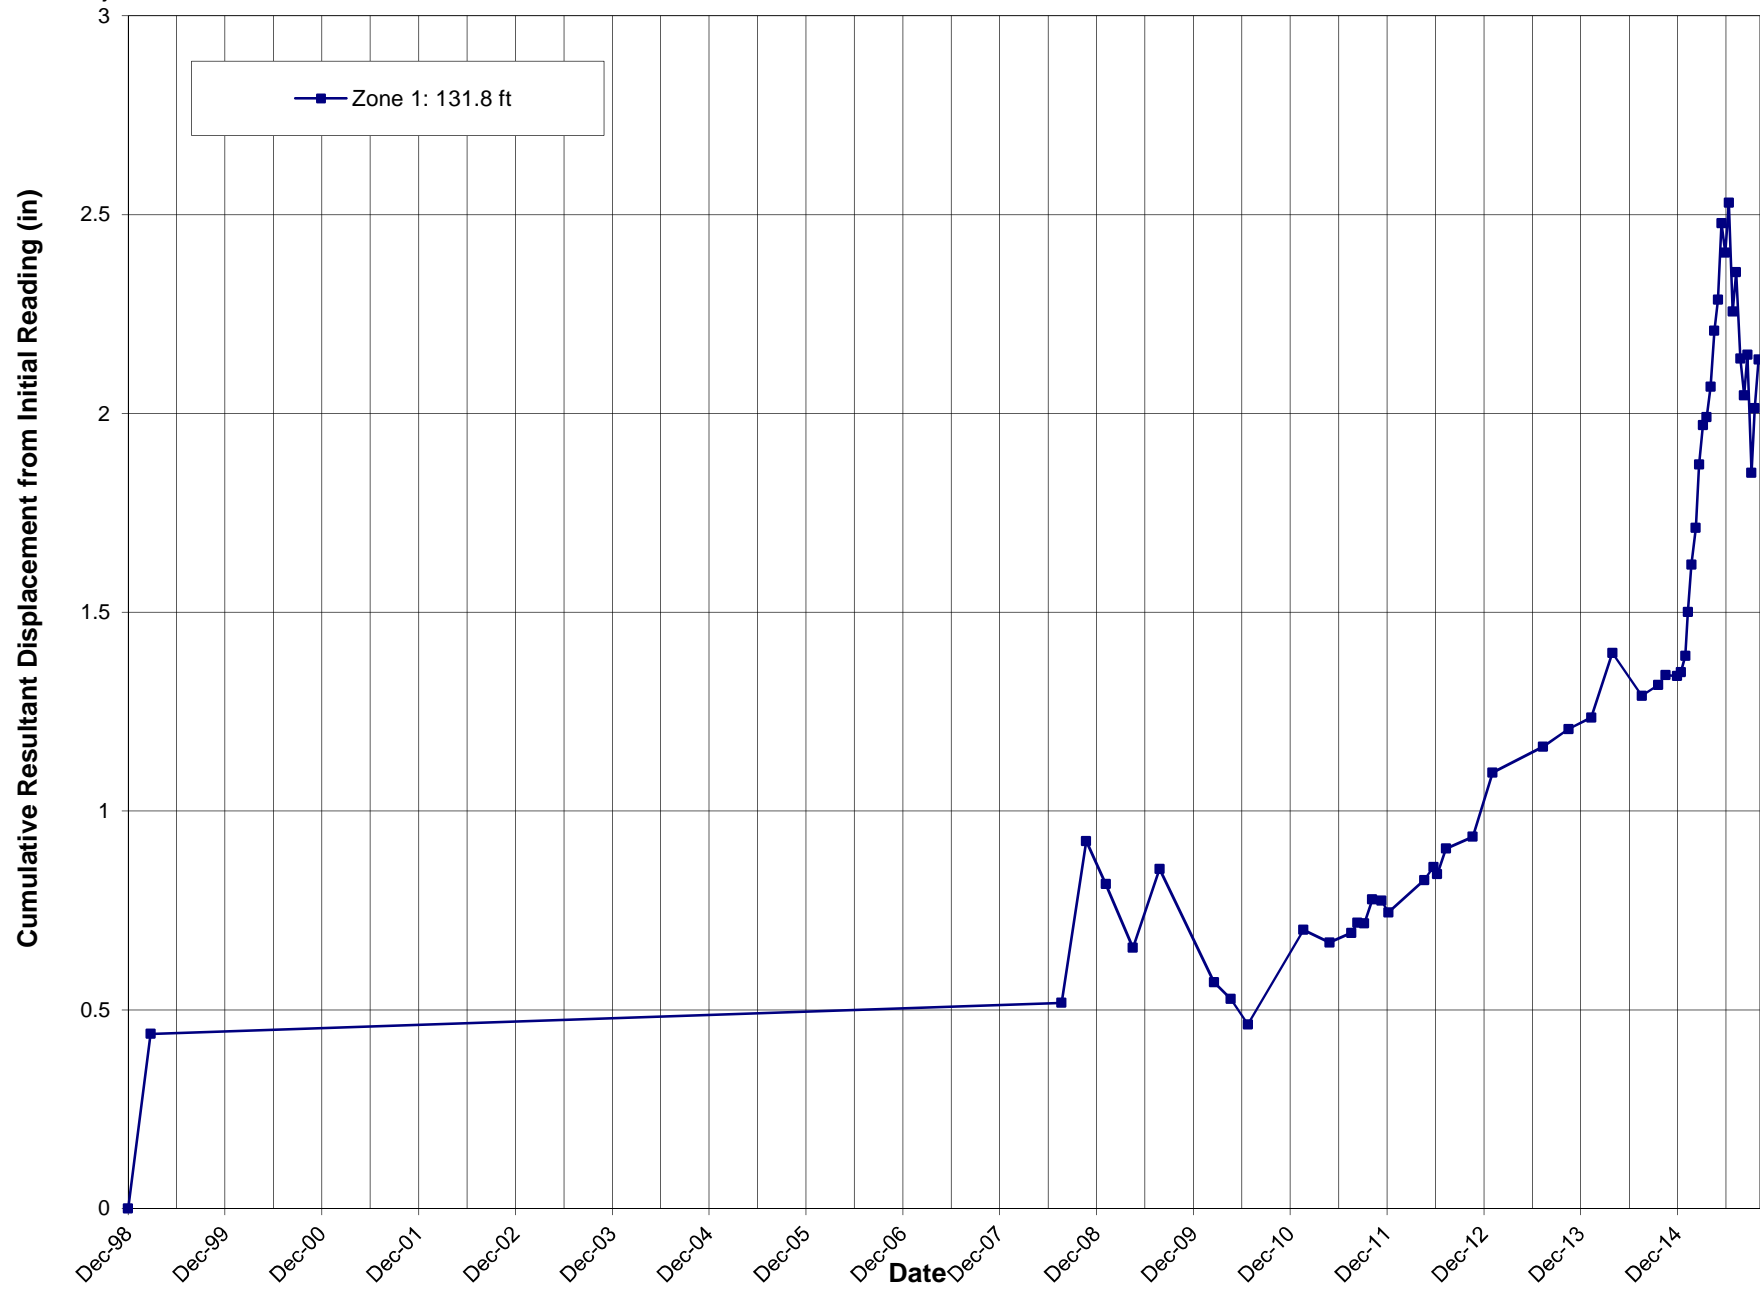
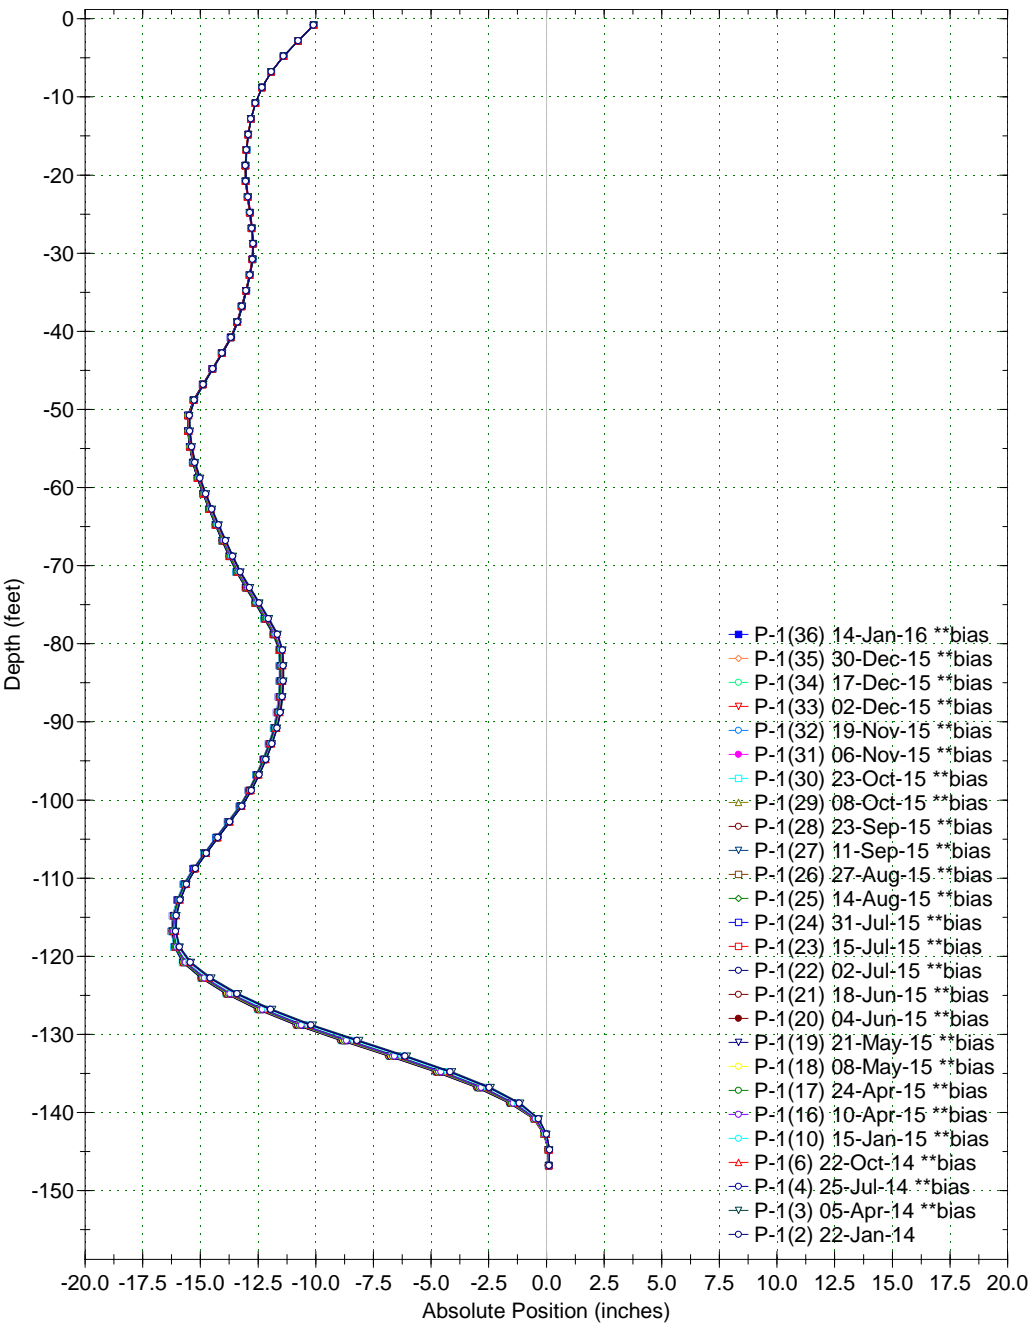
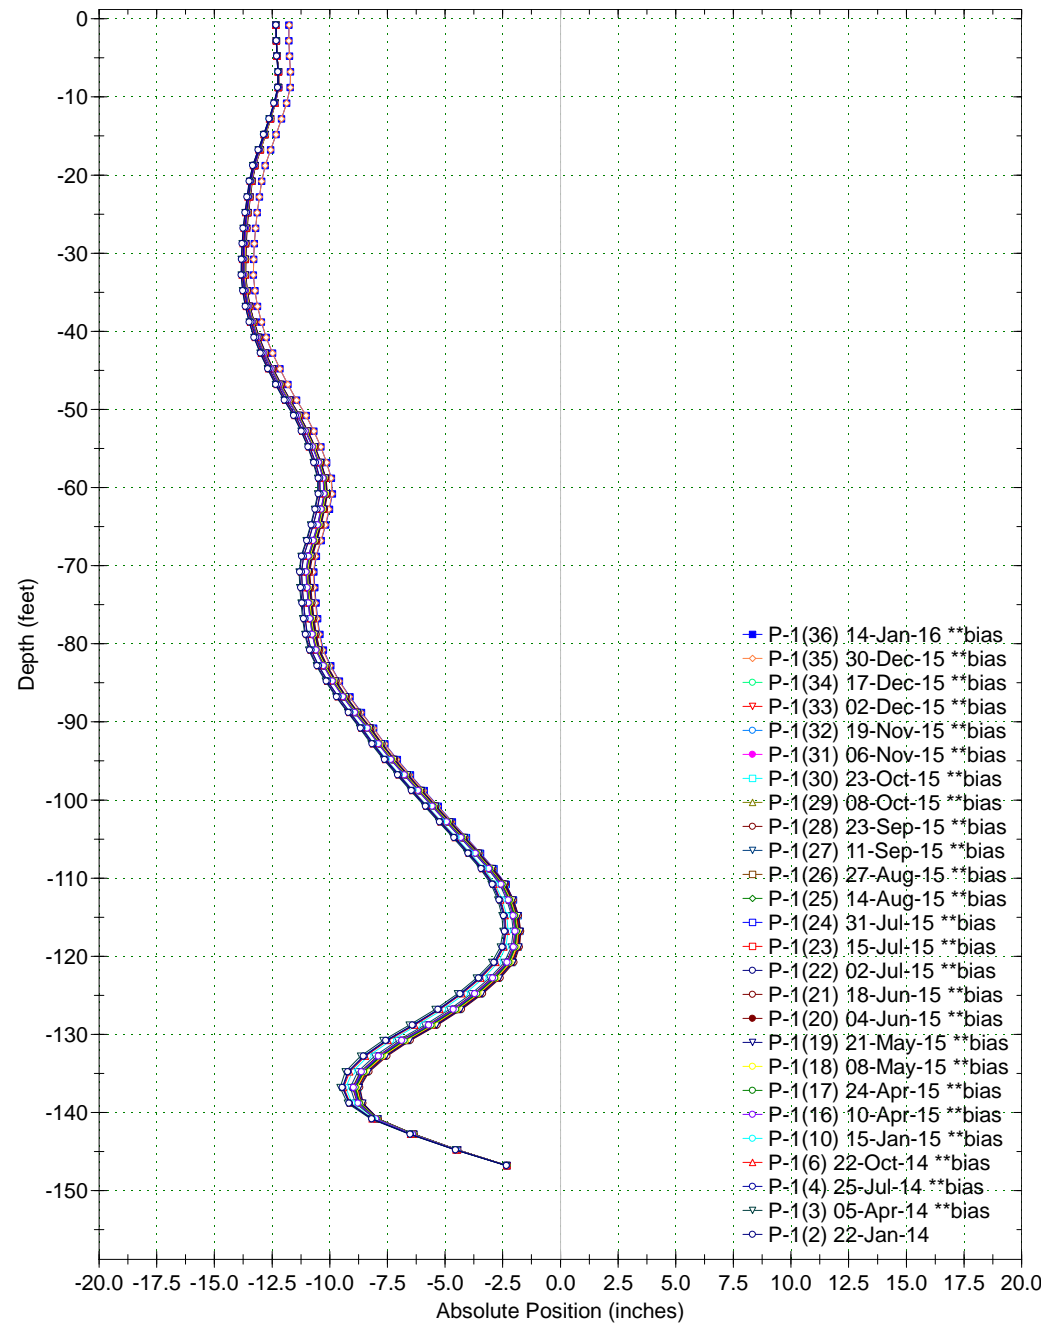
P-1

P-1. The movement observed at Pier 1 of the stabilization structure has been perplexing. The area of concern extends from about 115 feet to the bottom of the pier. The inclinometer readings indicate relative large lateral displacement over this depth range with the largest displacement occurring between 120 and 140 feet. Movement is occurring in both the A and B-axis directions. In an attempt to better understand this movement we compiled a plot of the cumulative resultant displacement at a depth of 132 feet where the maximum displacement is occurring. This plot, which is based on the initial baseline readings taken in 1998, is included with the attachments.

The plot shows that there was about 1/2 inch of lateral displacement that occurred over about a three month period as the stabilization structure initially took up load. From then until July 2007 there was little increase in displacement. For the next two years, until July 2009, the plot indicates that displacement increased by about another 1/2 inch and then reversed cancelling out all the increase. From July 2009 to January 2015 displacement increased at a constant rate accumulating a total of about 0.9 inches of additional displacement. Then from January through

June 2015 the rate of movement increased significantly adding about 1.25 inches of displacement for a total of 2.5 inches of displacement since the pier was placed in service. Since the end of June 2015, the readings show a reversal with some back and forth and an overall downward trend at about the same rate as the rate of increase that was seen between January and June of this year. The total reversal was about 0.7 inches in September 2015. Then the displacement began to increase again so that by the time of the October readings, the total displacement was about 2.2 inches.

We should consider what affect the data interpretations have on the plots. The computer program that interprets the raw data, assumes fixity at the bottom of the slope tube. If the bottom of the tube is not fixed, this would affect the resulting plot. It seems apparent from the plots that the bottom of the pier may not be adequately fixed against both lateral movement and rotation. In addition, we have assumed that the top of the pier is fixed in the pier cap and the cap is not moving. This may not be true because the pier cap can move laterally parallel to the river since the only restraint, although substantial, is the stiffness of the piers. The pier cap can also rotate horizontally around a vertical axis, and it can tilt around the axis parallel to the river due to the eccentricity of the reactions from the tiebeams. Although the stabilization structure is very stiff, the applied earth loads are great enough to cause small movements which the inclinometer can measure. Thus, at least some of the apparent displacement seen in the plots may be due to the zero displacement boundary conditions forced in the data interpretation.

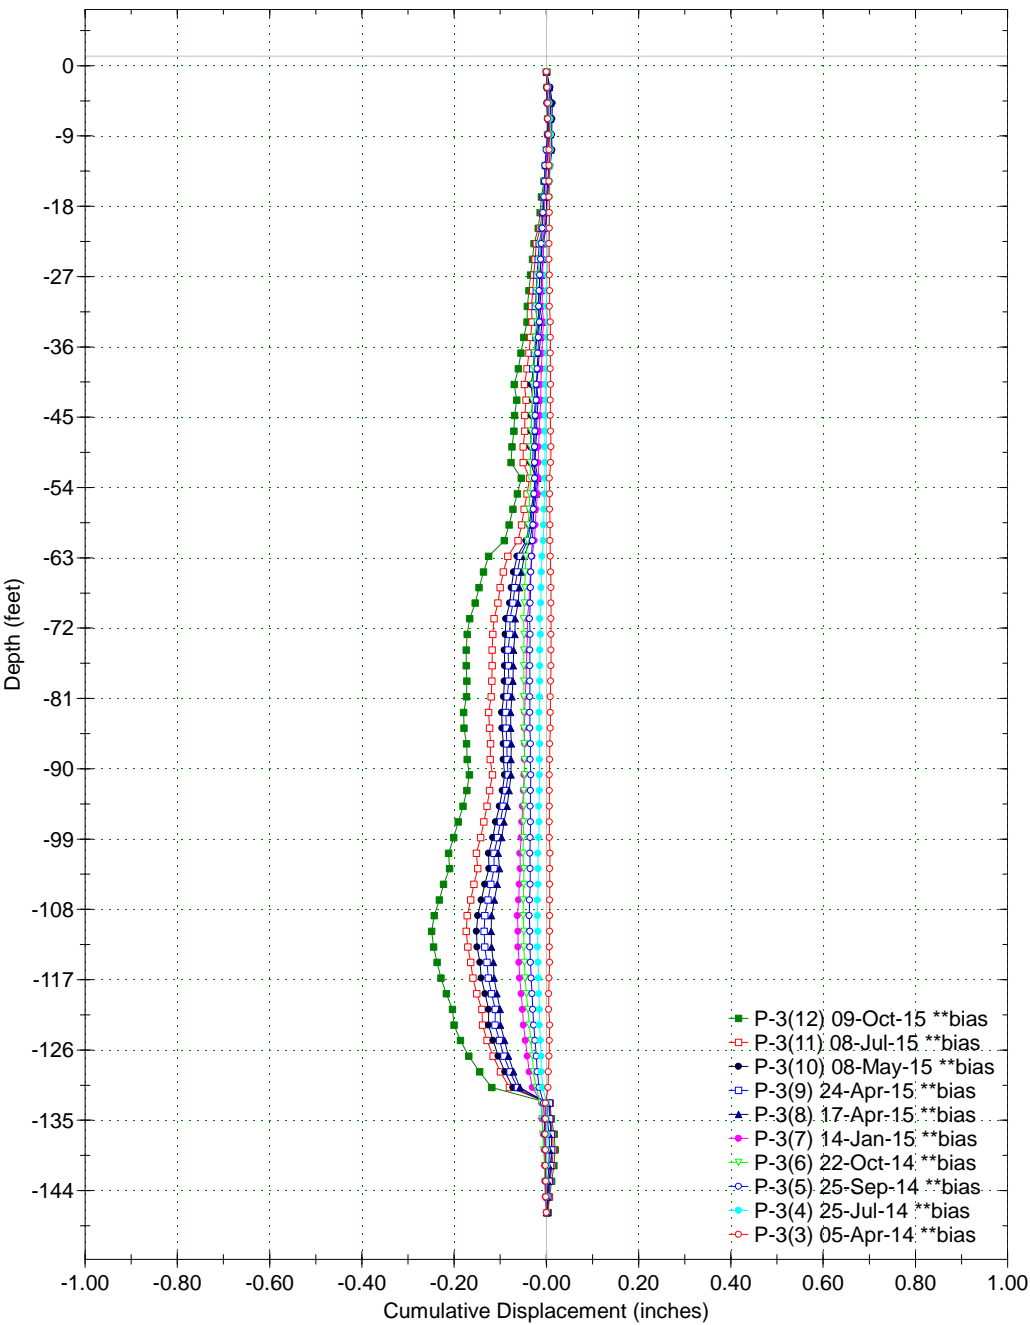
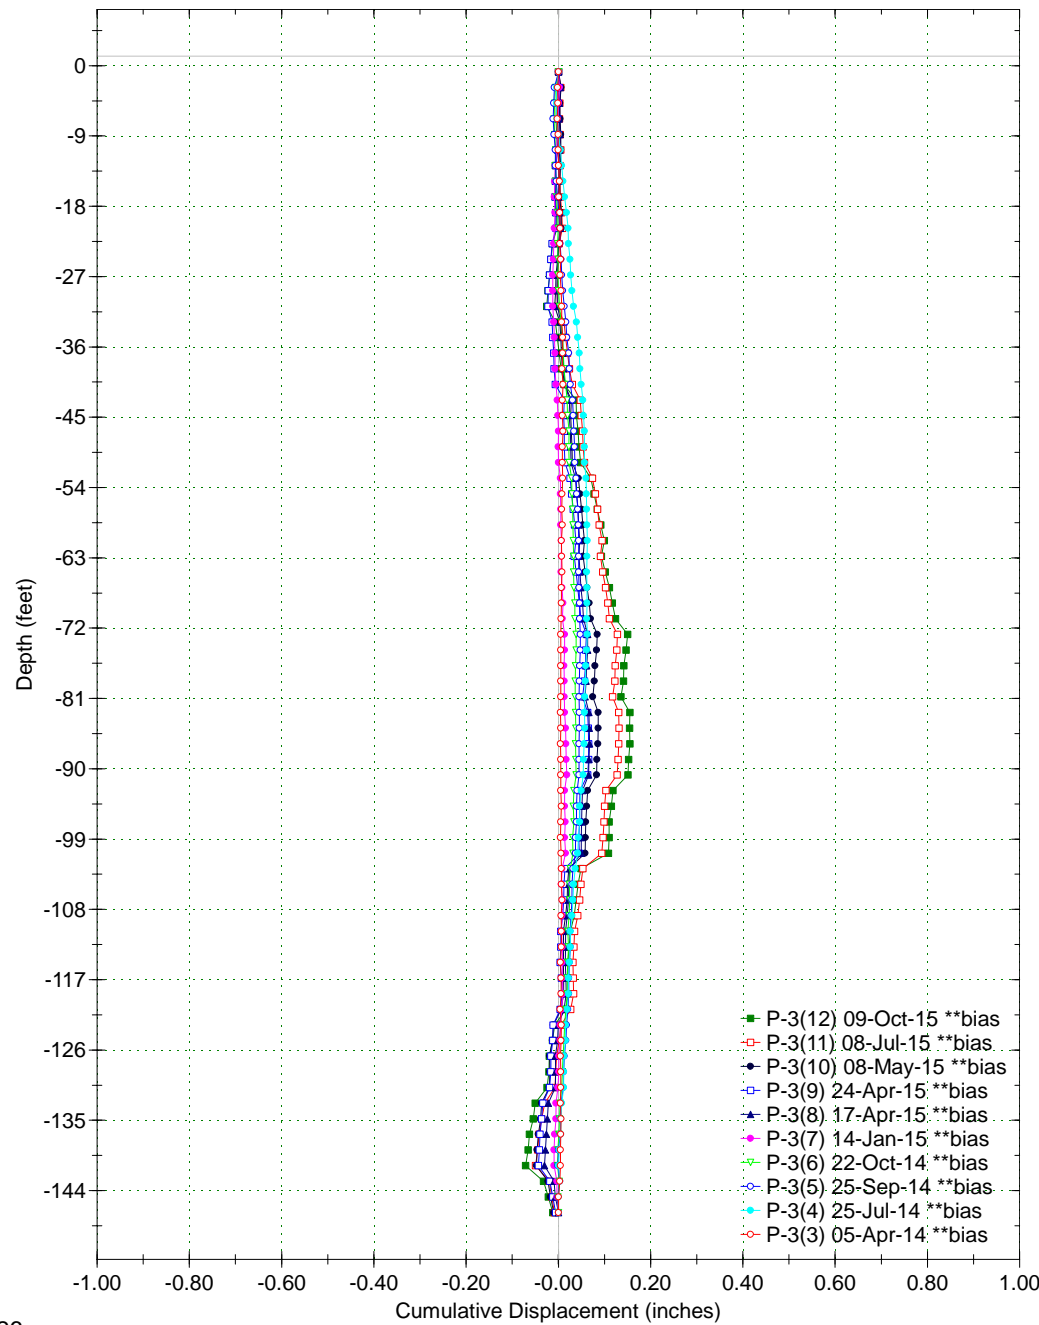
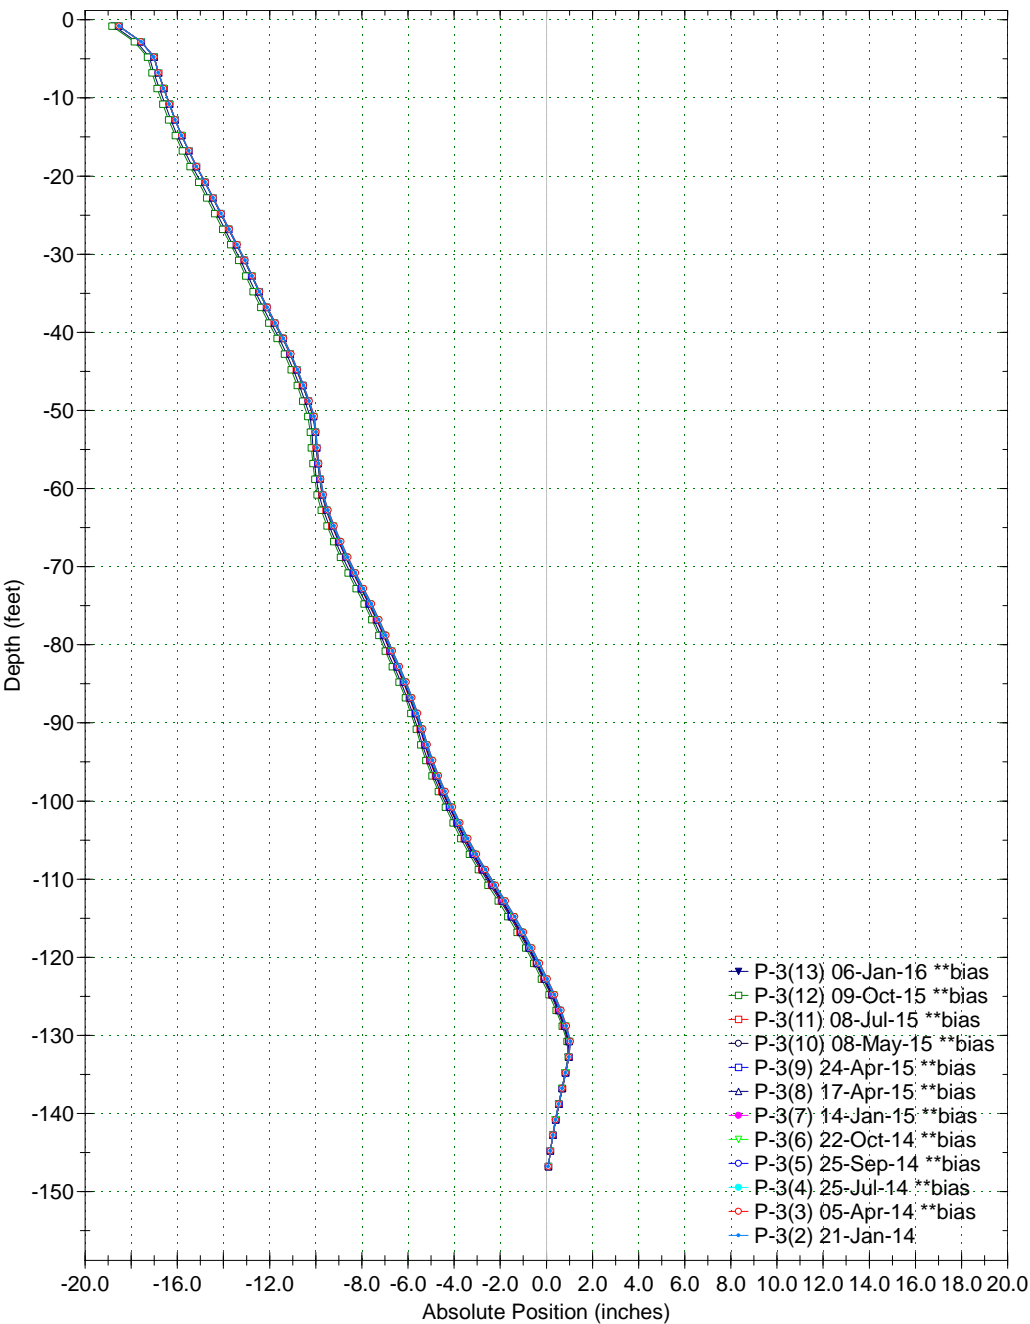
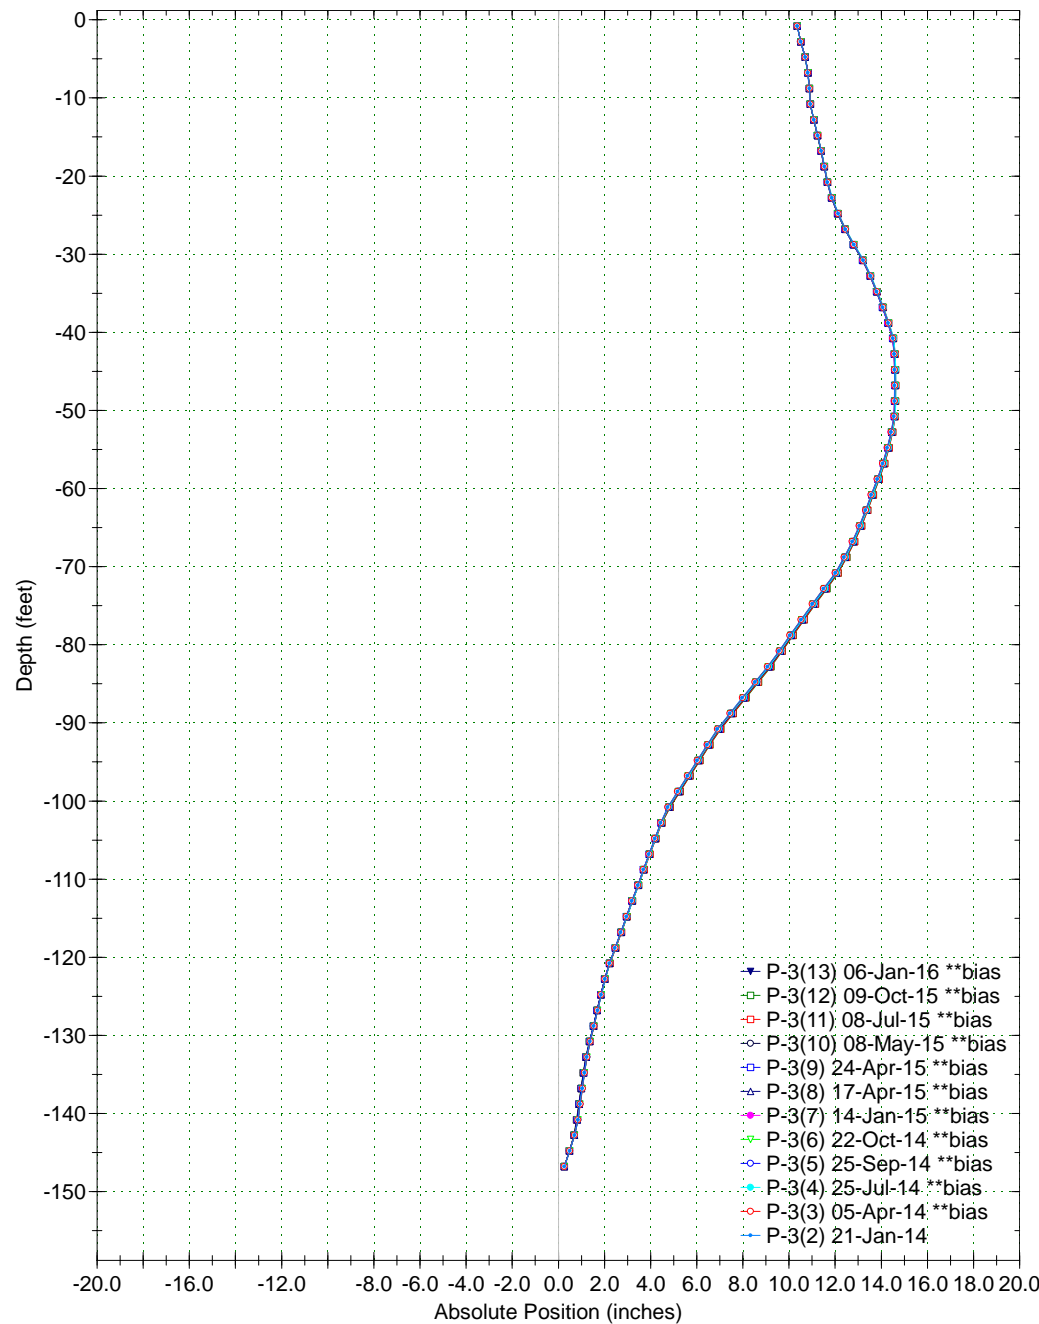
P-3. Since July 2014, inclinometer readings at this location have been showing increasing displacements in the negative A-axis direction at about 130 feet and in the positive B-axis direction between 51 and 103 feet. Larger increases occurred in January to April and July to October especially in the A-axis direction which has now reached about 0.25 inches at its maximum point of displacement compared to the January 2014 baseline.

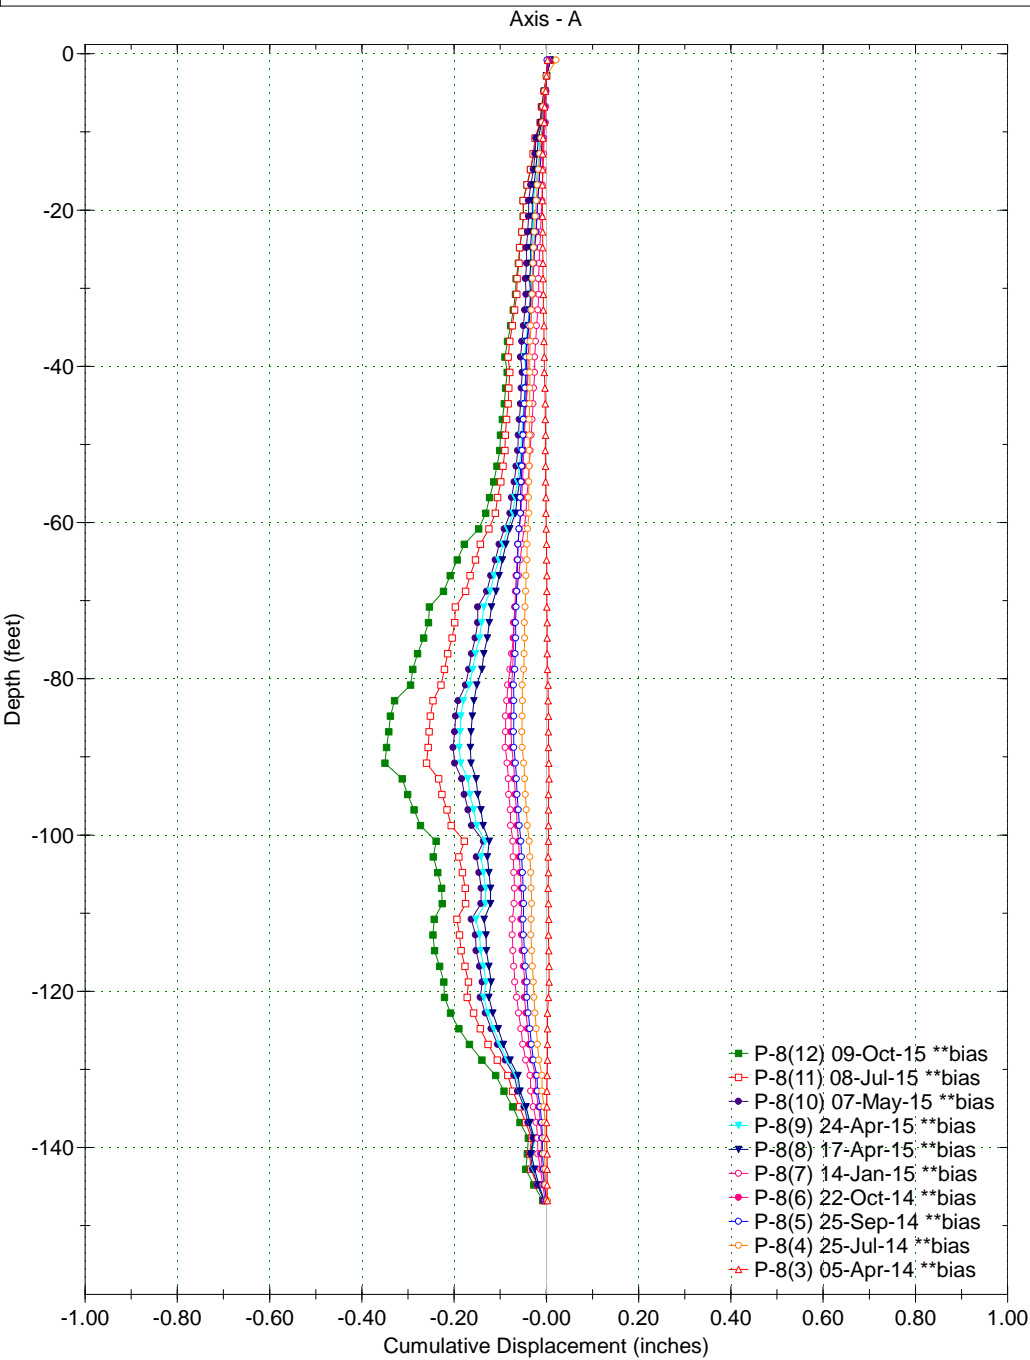
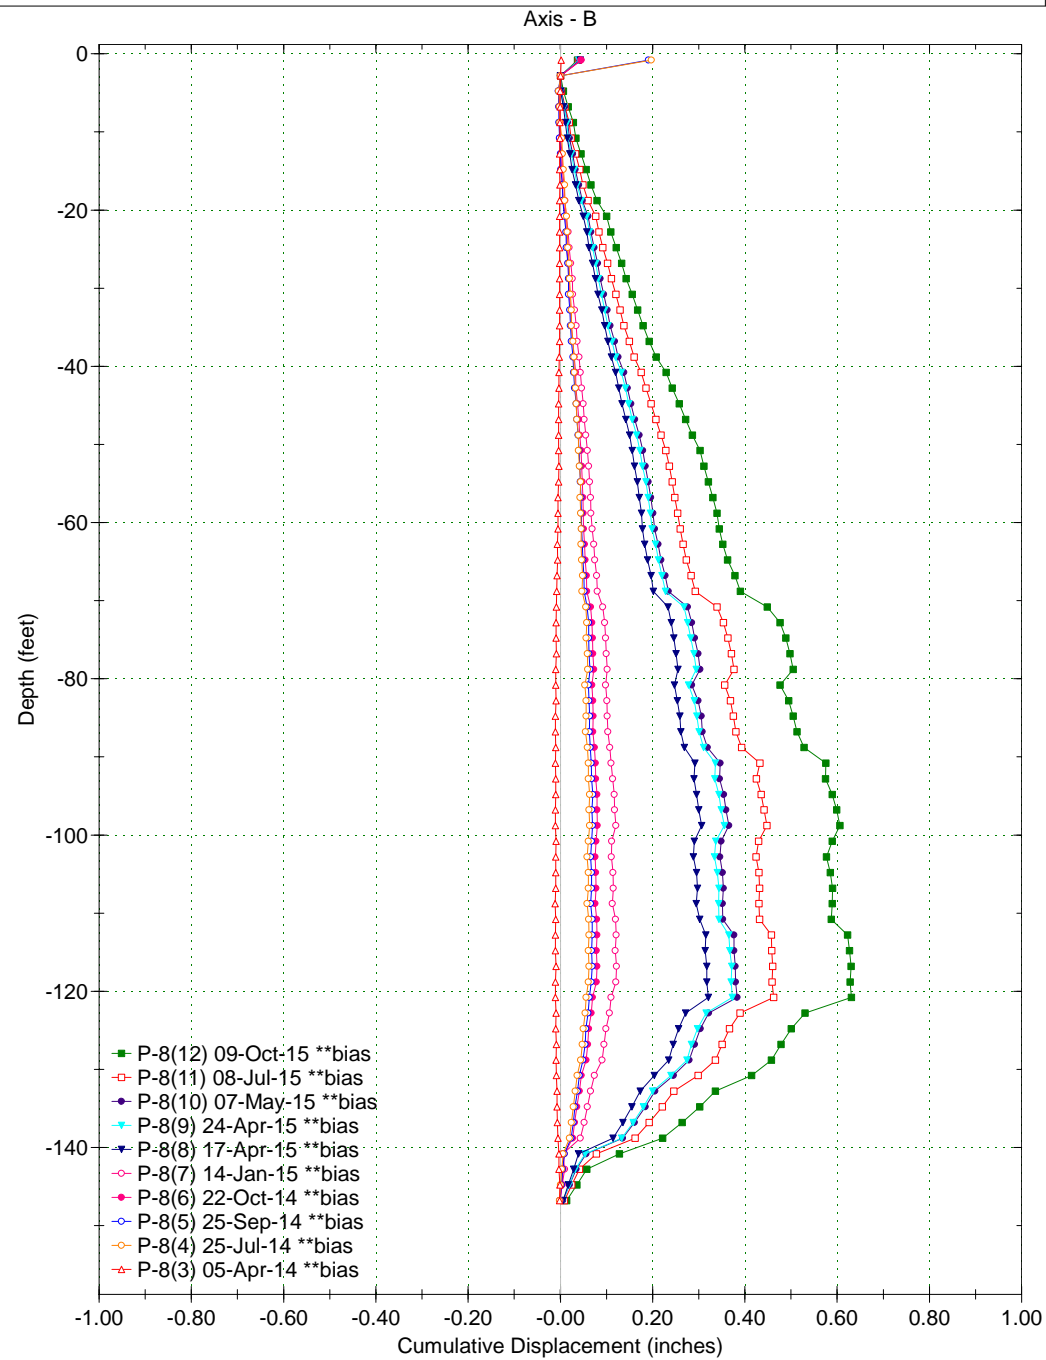
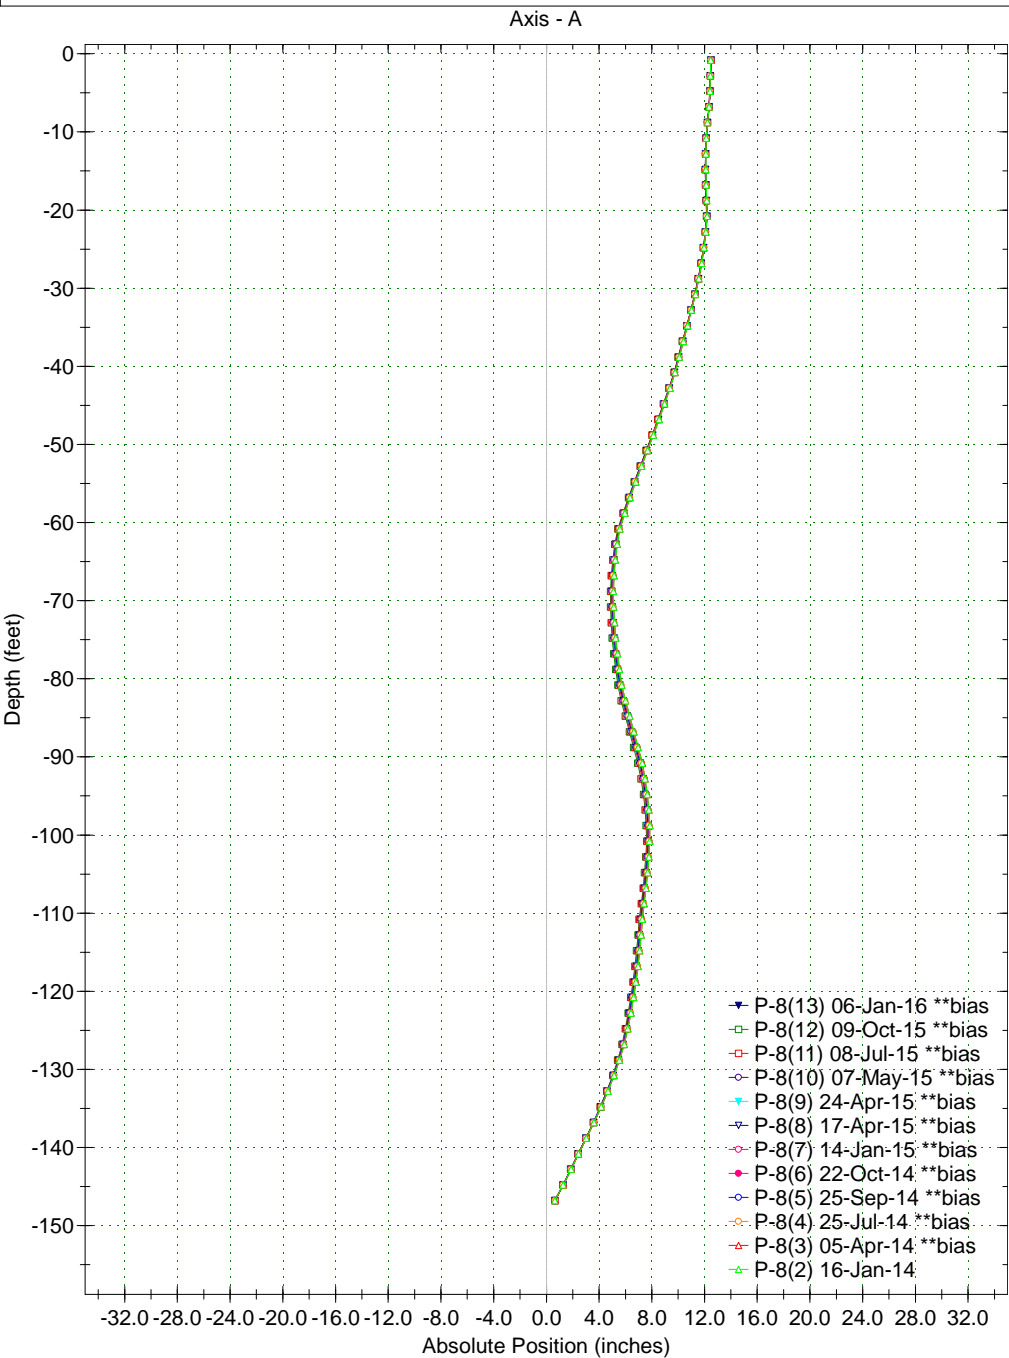
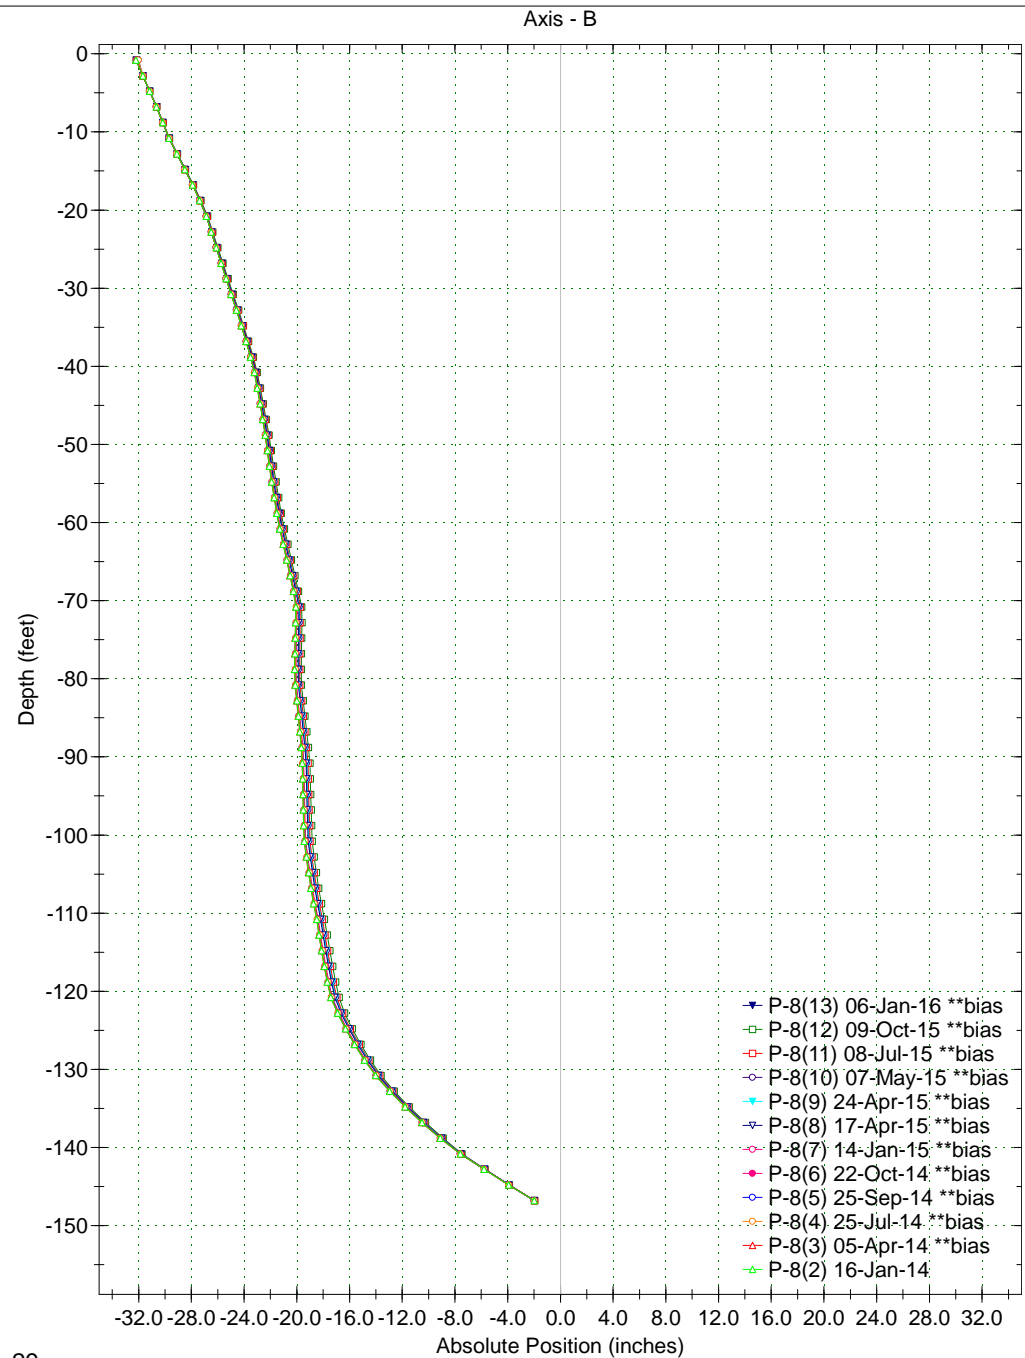
P-8. Inclinometer readings at this location indicate continued movement throughout the length of the slope tube in both axis directions. Compared to the January 2014 baseline, the maximum displacement in the negative A-axis direction is about 0.35 inches and in the positive B-axis direction is about 0.62 inches. B-axis displacements increased by about 0.5 inches this past year.
