Re: October 2015 Annual Report
CUY-90-15.24 Slope Monitoring
PID 96504
EDP Project No. 069032.00

OCTOBER 2015 QUARTERLY REPORT

**CUY-90-15.24 SLOPE MONITORING
PID 96504
CLEVELAND, OHIO
SME PROJECT NO. 069032.00**

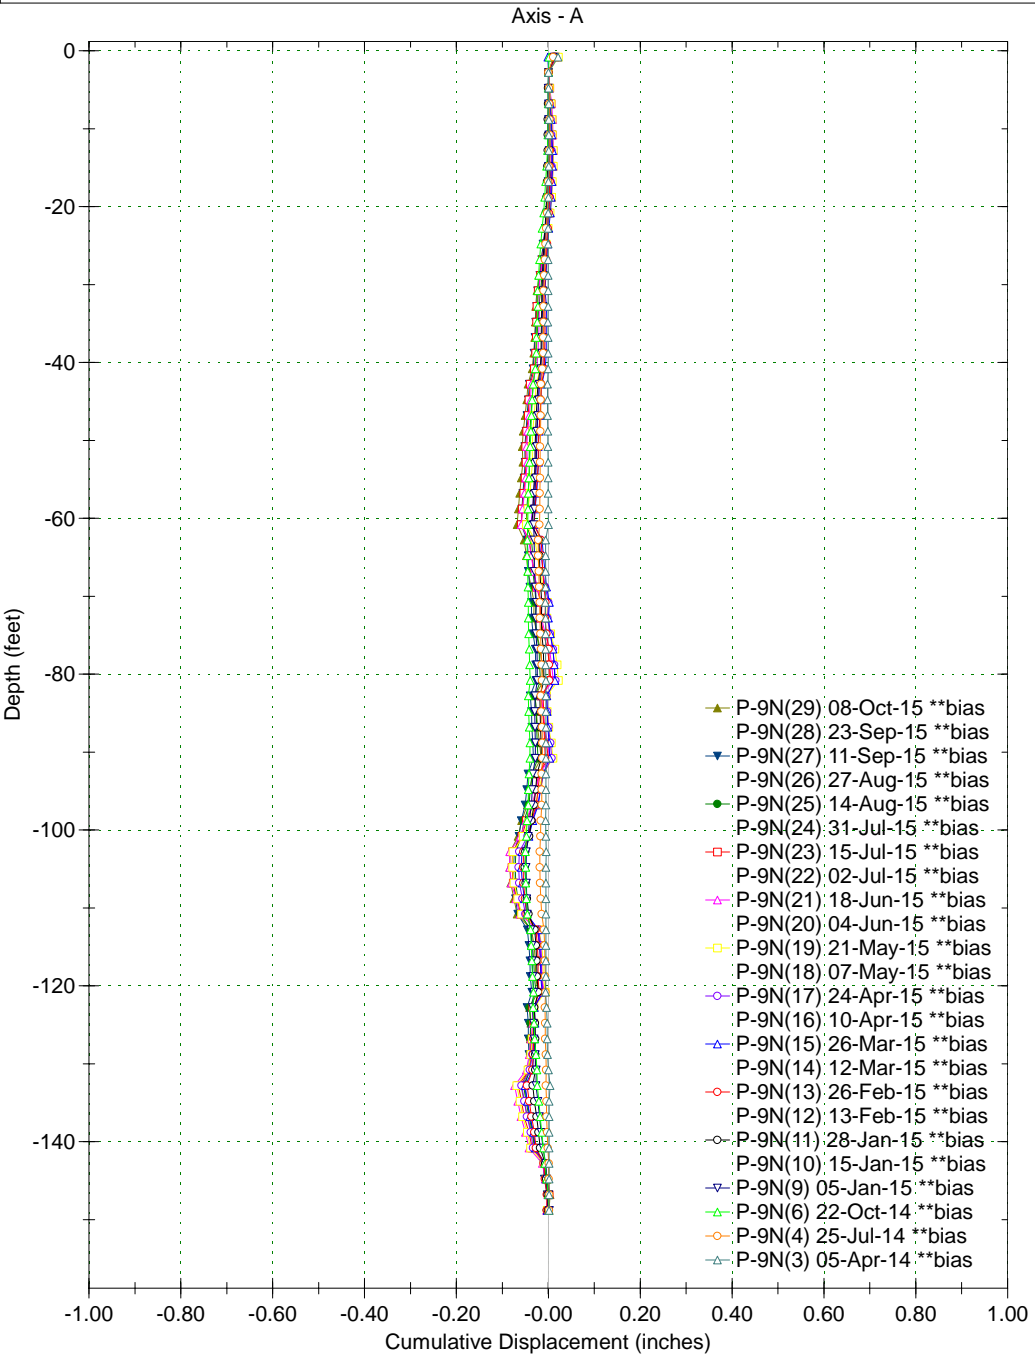
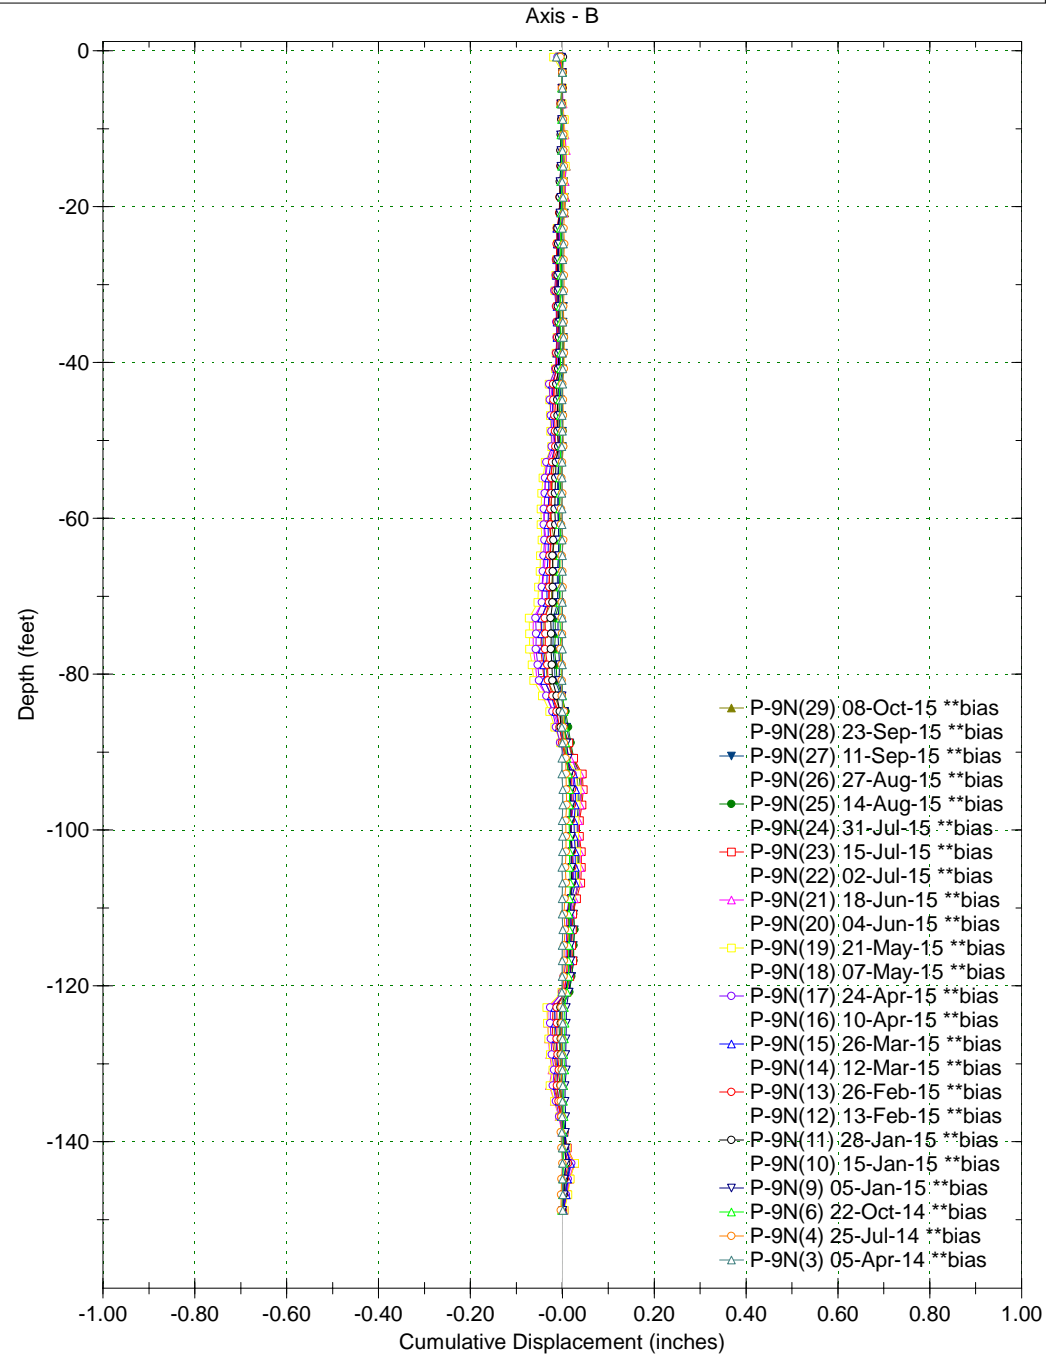
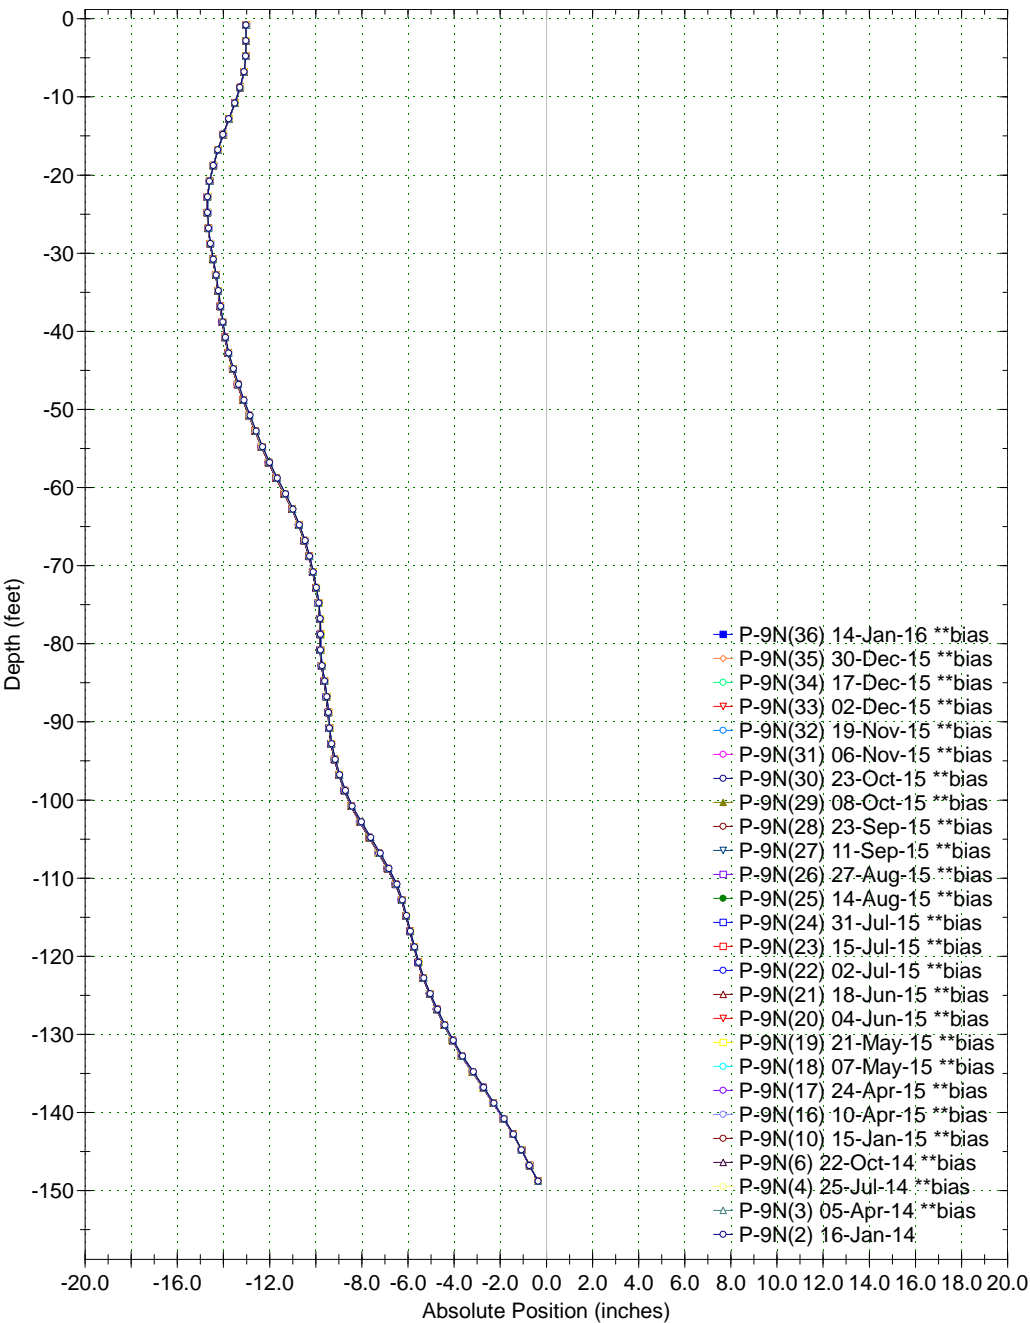
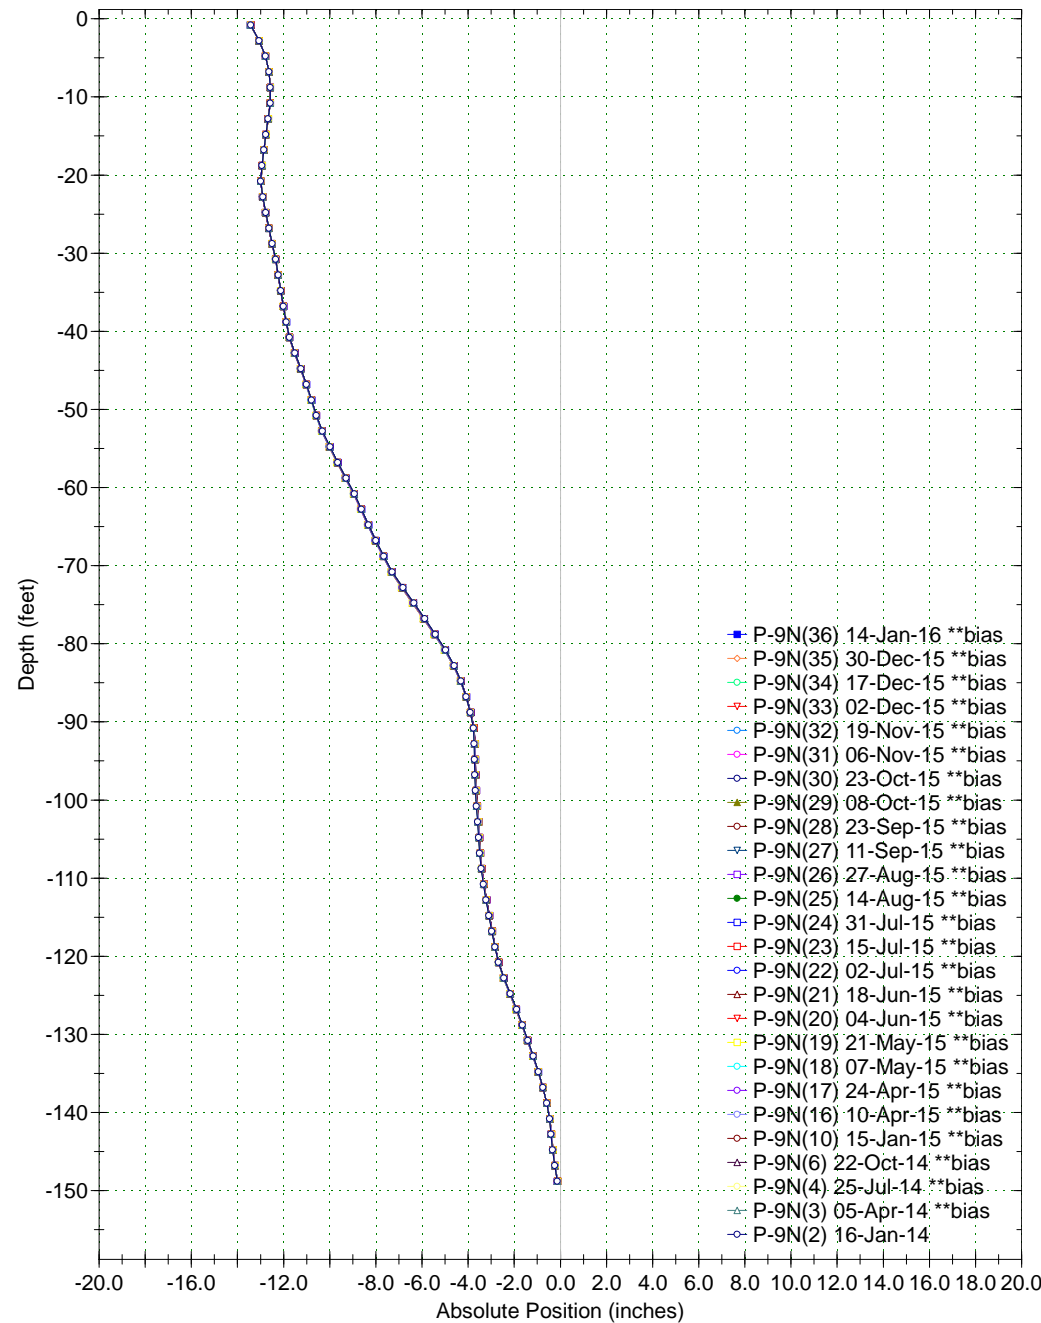
P-9N. The plot for this location is included here relative to the discussion about the possible cause of the movements and reversals shown by the inclinometer plots. This slope tube is read weekly. See the weekly reports for more detail.

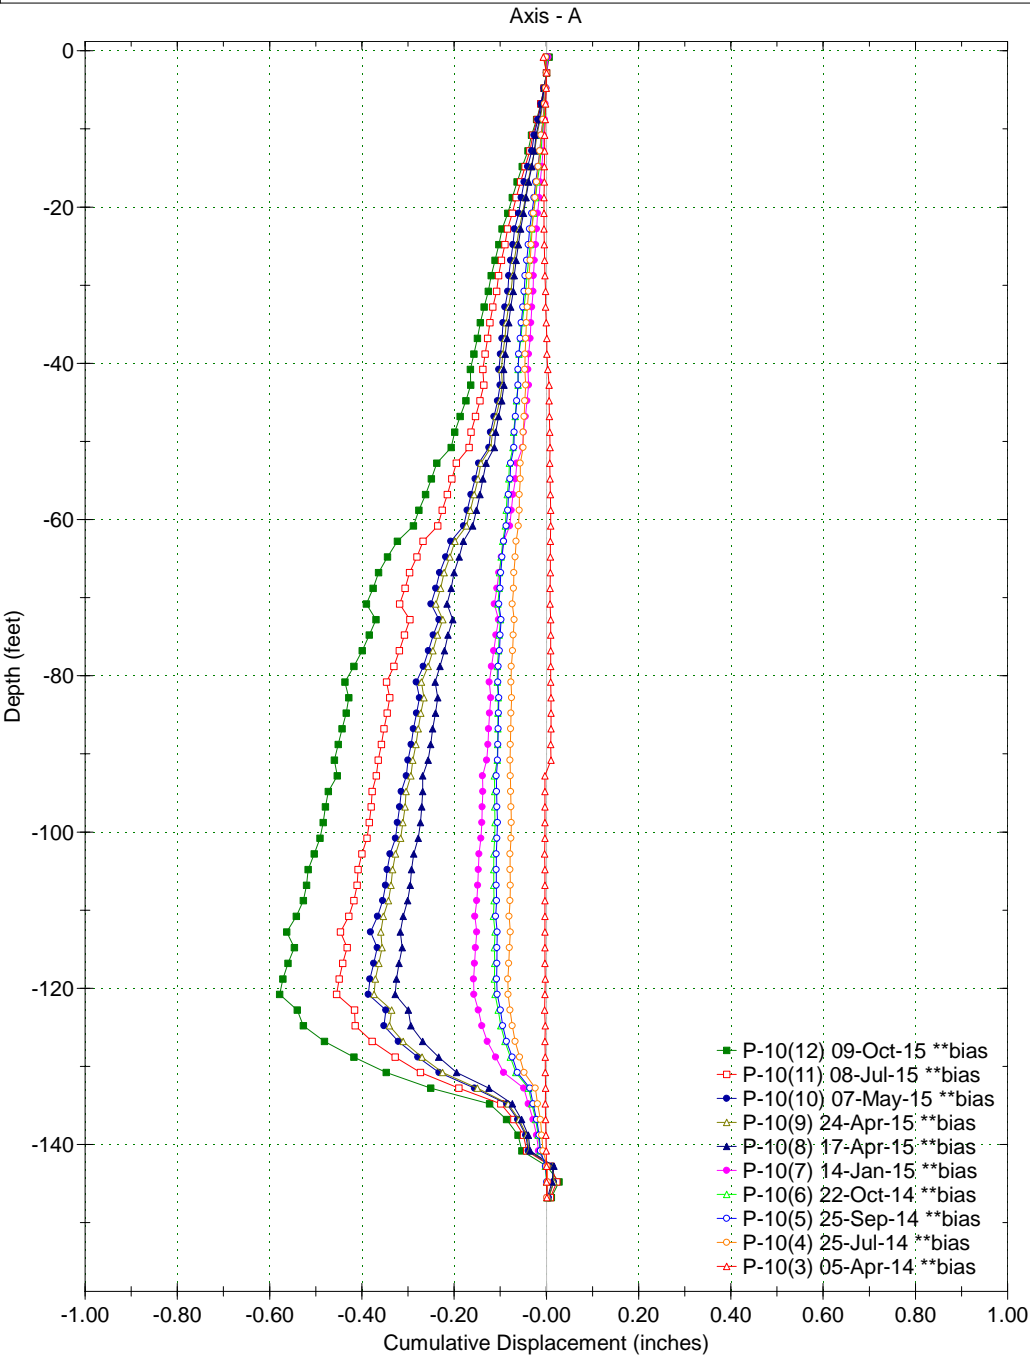
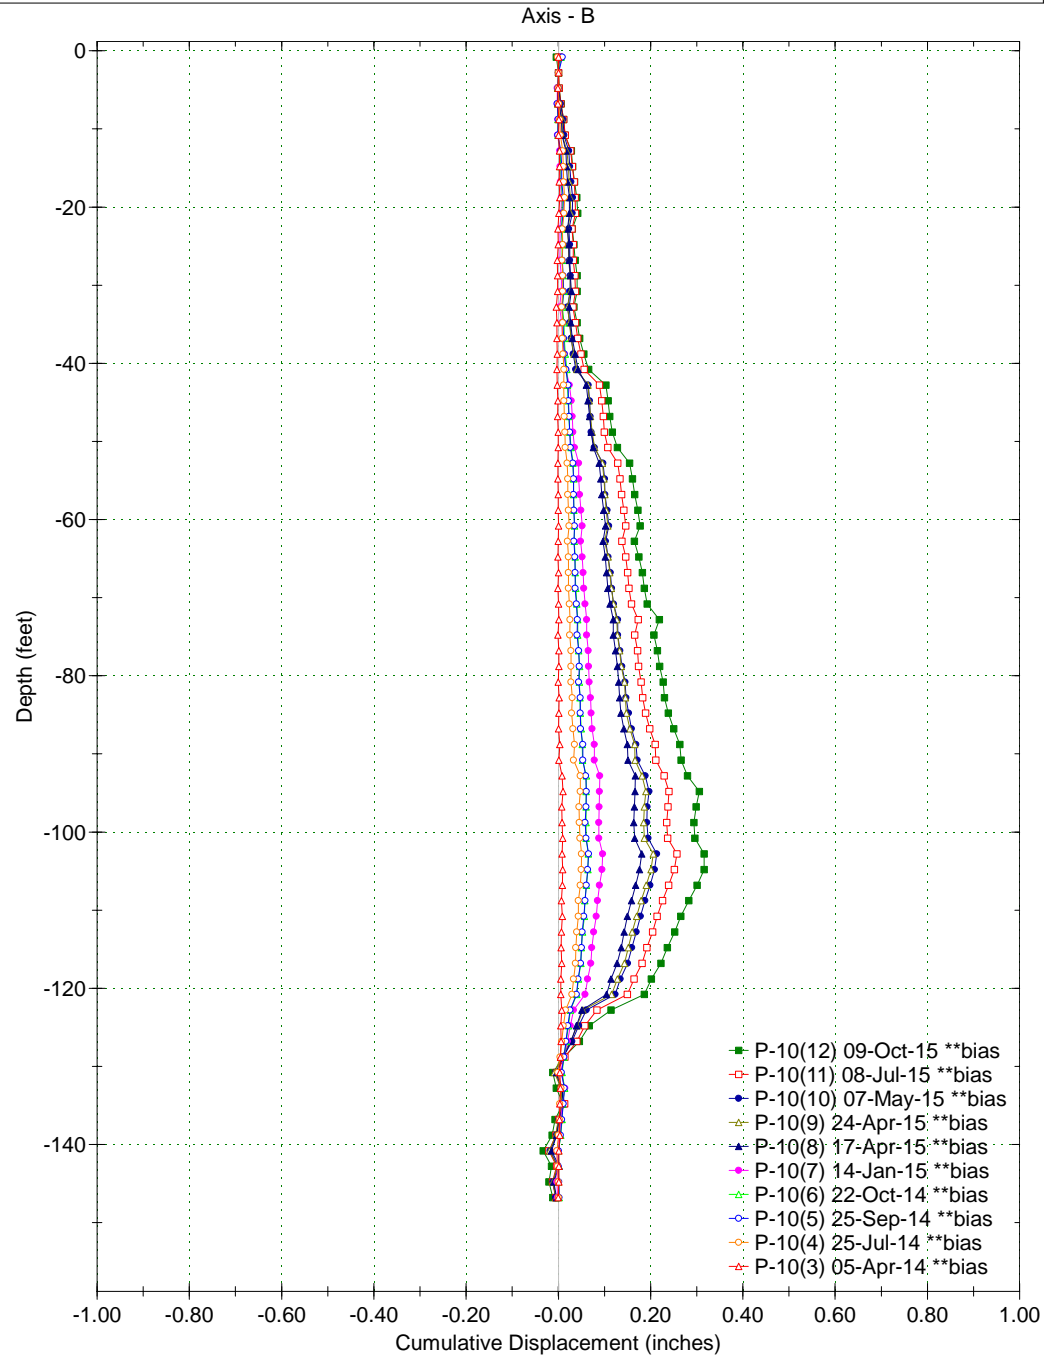
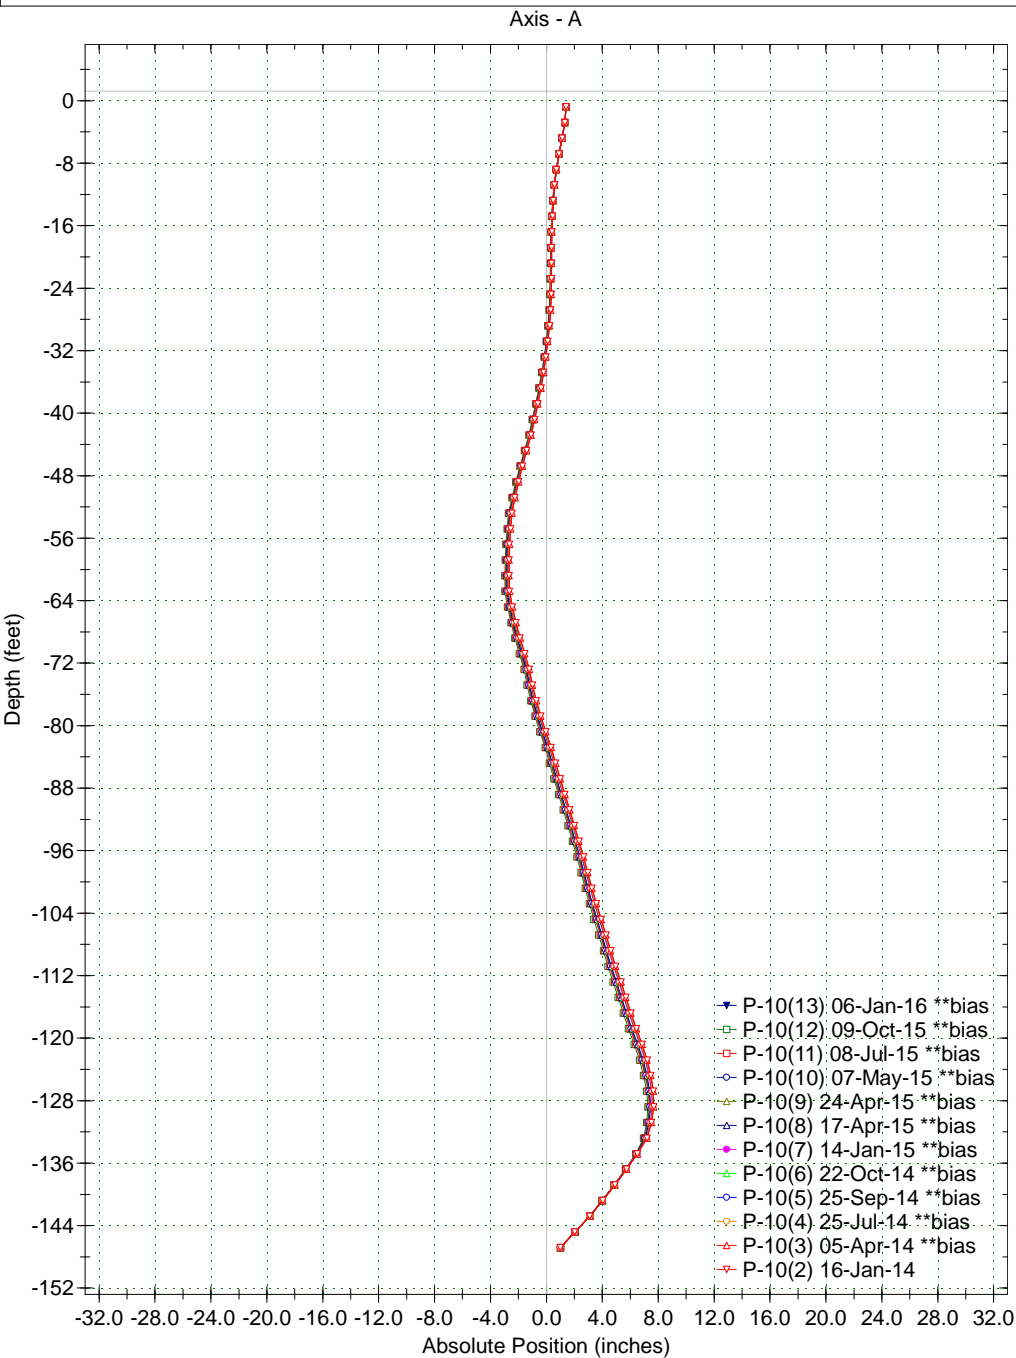
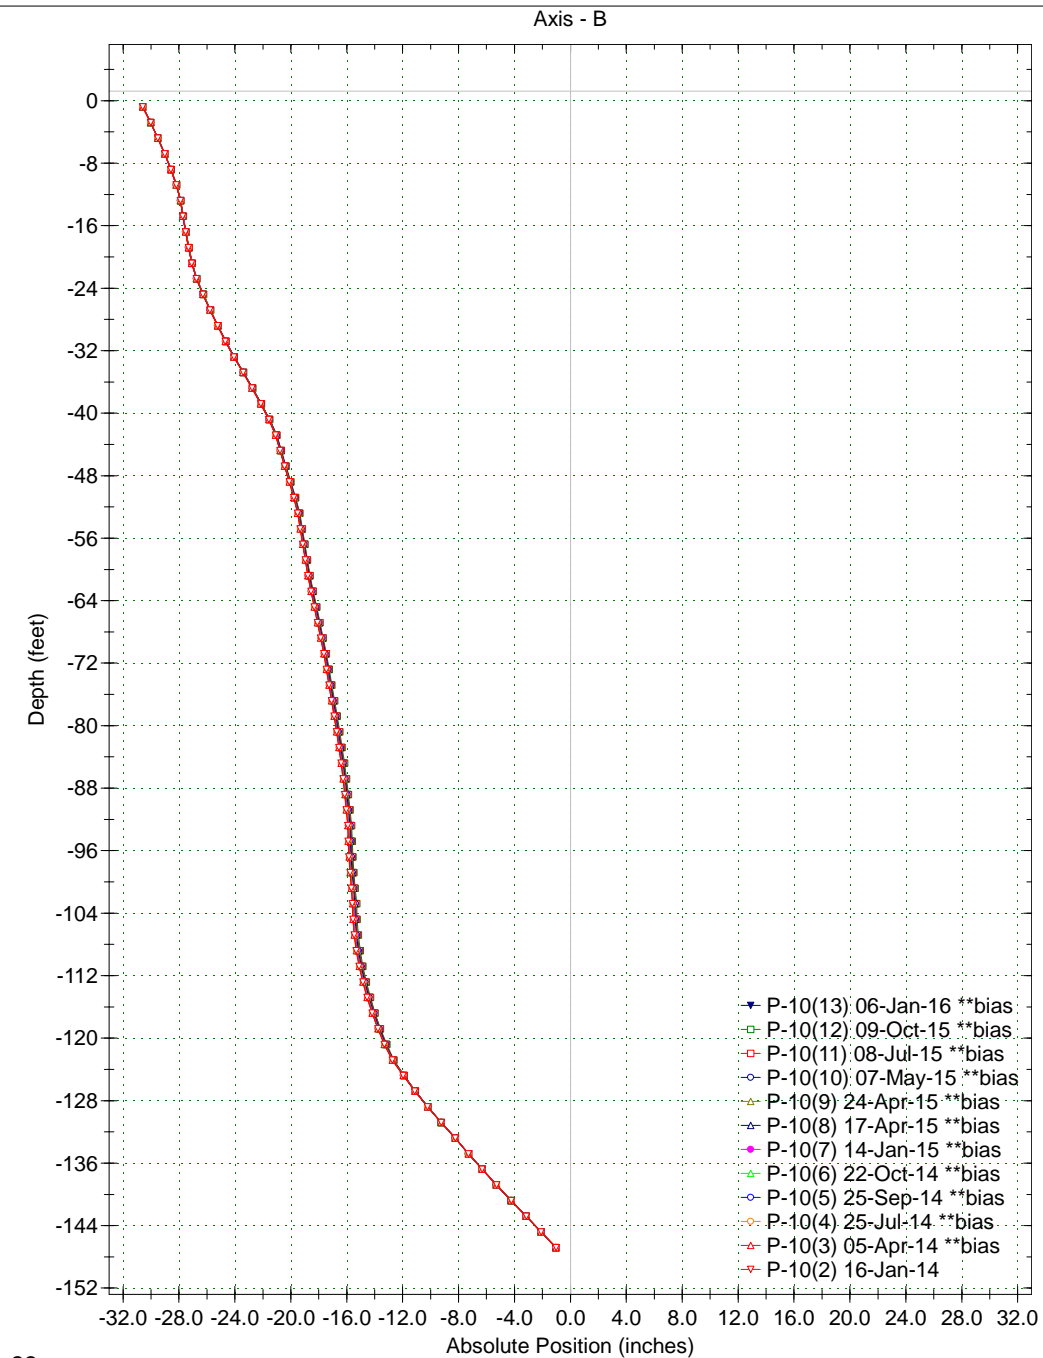
P-10. Continued movement is indicated at this location throughout the length of the slope tube in both axis directions. Maximum negative A-axis displacement has reached about 0.58 inches compared to the January 2014 baseline with about 0.5 inches of that occurring in the past year. Maximum positive B-axis displacement is about 0.3 inches compared to the baseline with the majority of that movement occurring in the past year.

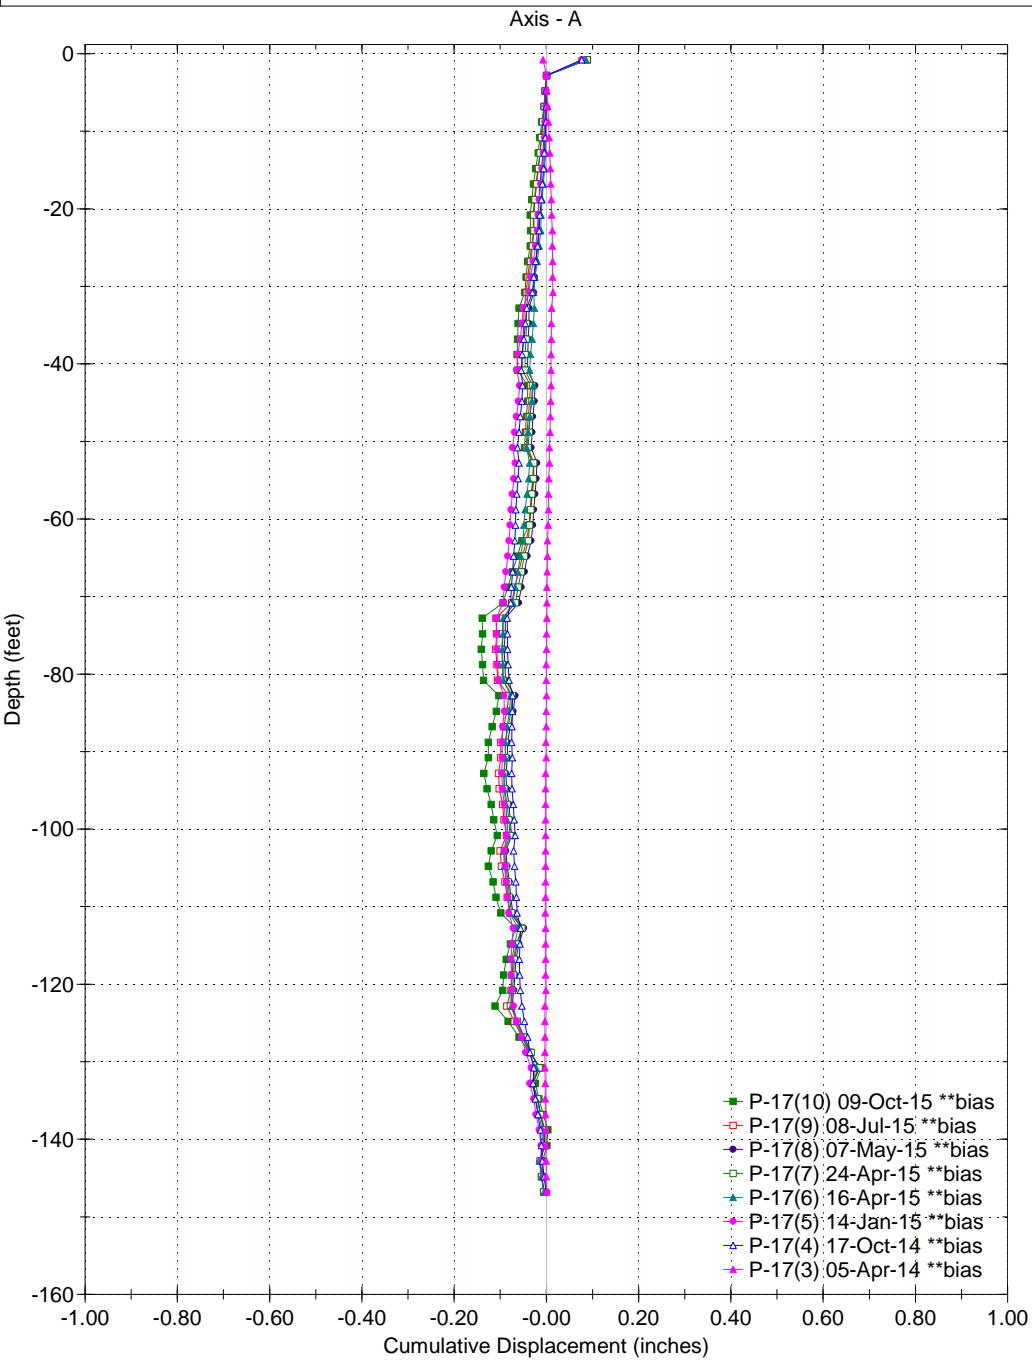
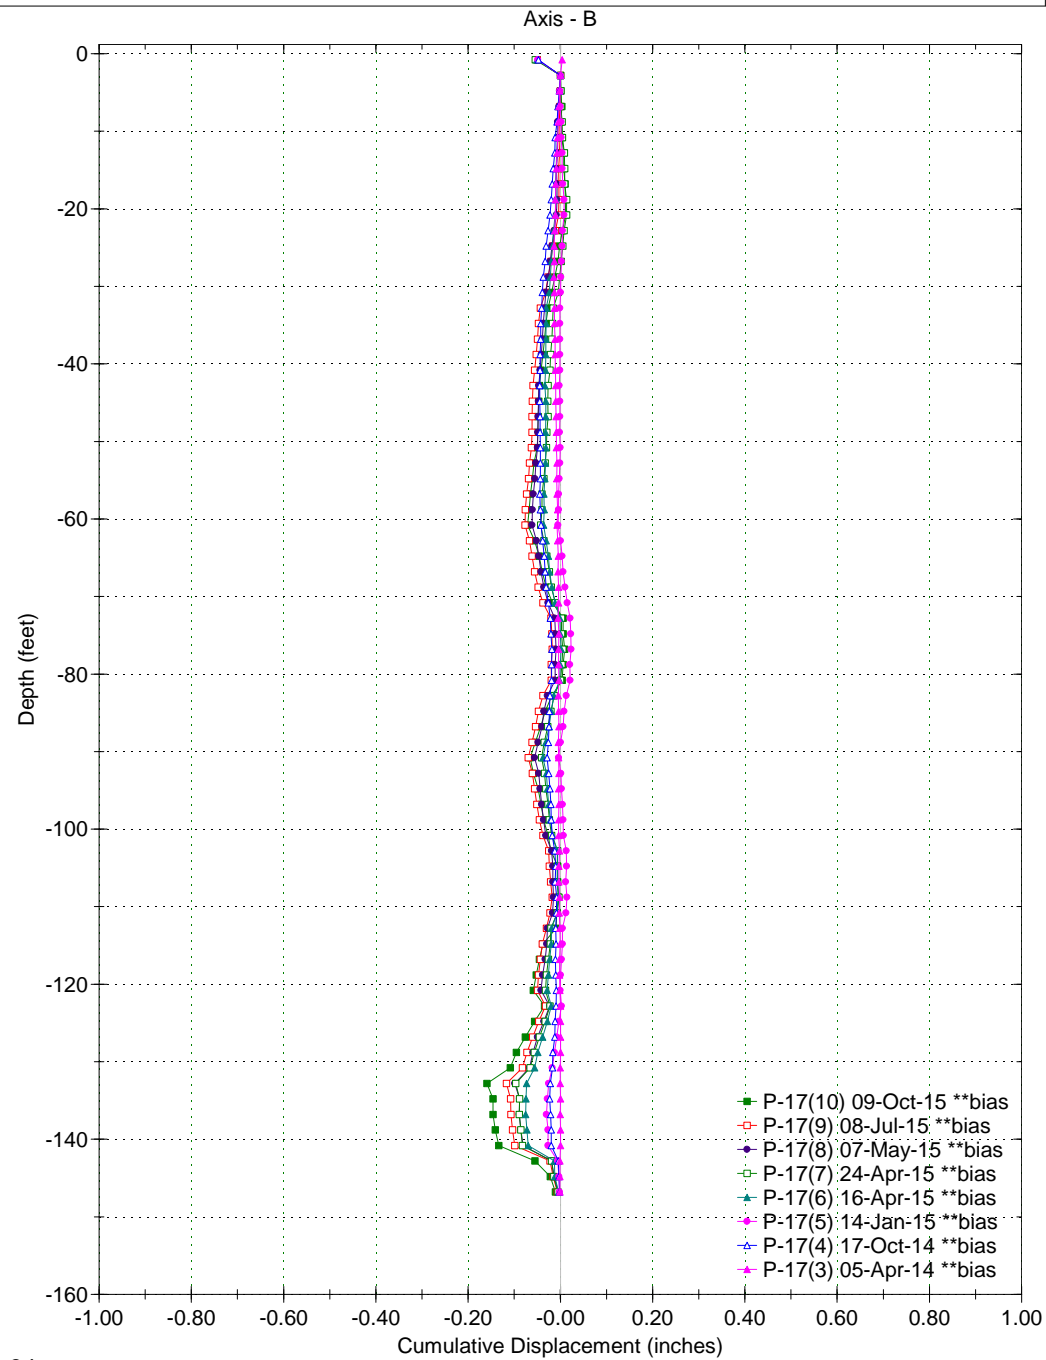
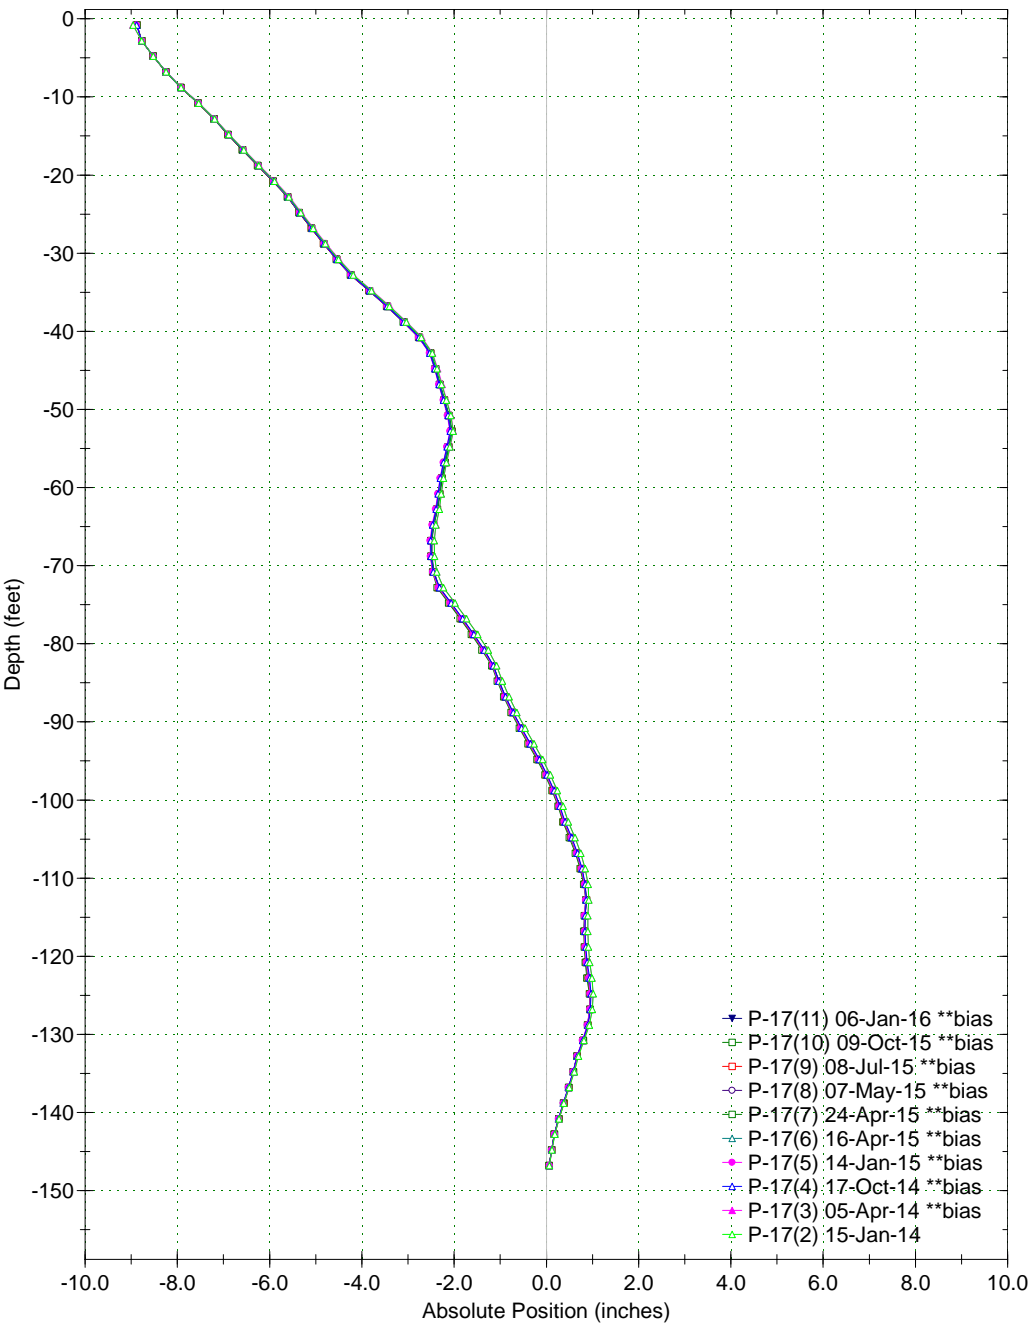
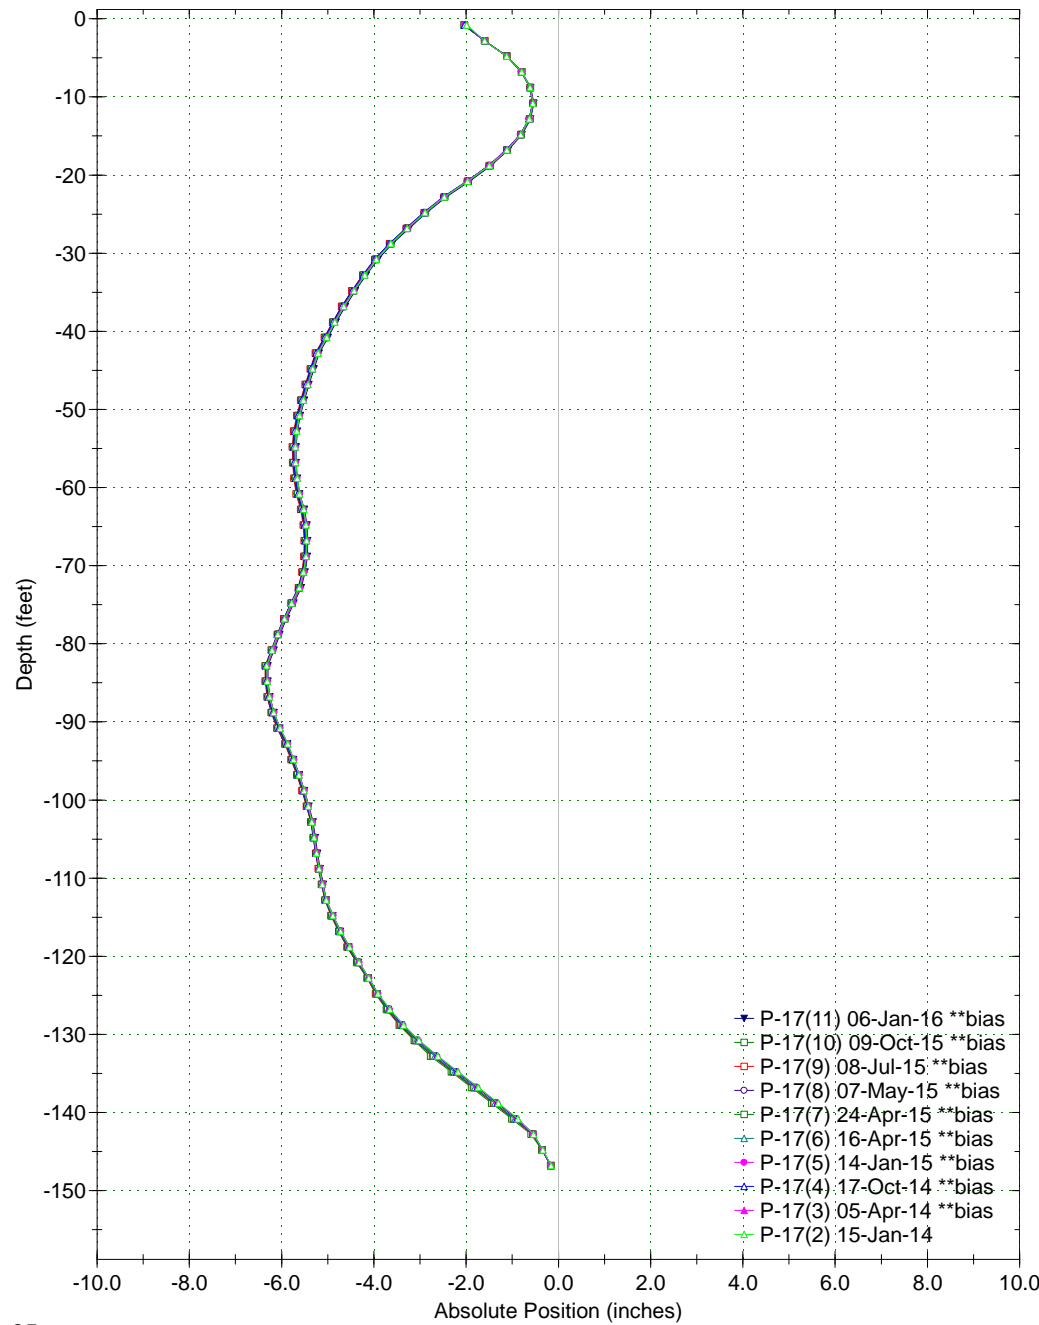
P-17. About 0.1 inches of negative A-axis displacement occurred throughout the length of the slope tube in October 2014. Since that time, displacements have been small, now totaling about 0.15 inches at the maximum point. B-axis movements appeared to be negligible until April 2015

when displacements between 141 and 143 feet increased. Displacements have continued to increase at this depth and are now about 0.15 inches from the baseline.
