Re: October 2015 Annual Report
CUY-90-15.24 Slope Monitoring
PID 96504
EDP Project No. 069032.00

OCTOBER 2015 QUARTERLY REPORT

**CUY-90-15.24 SLOPE MONITORING
PID 96504
CLEVELAND, OHIO
SME PROJECT NO. 069032.00**

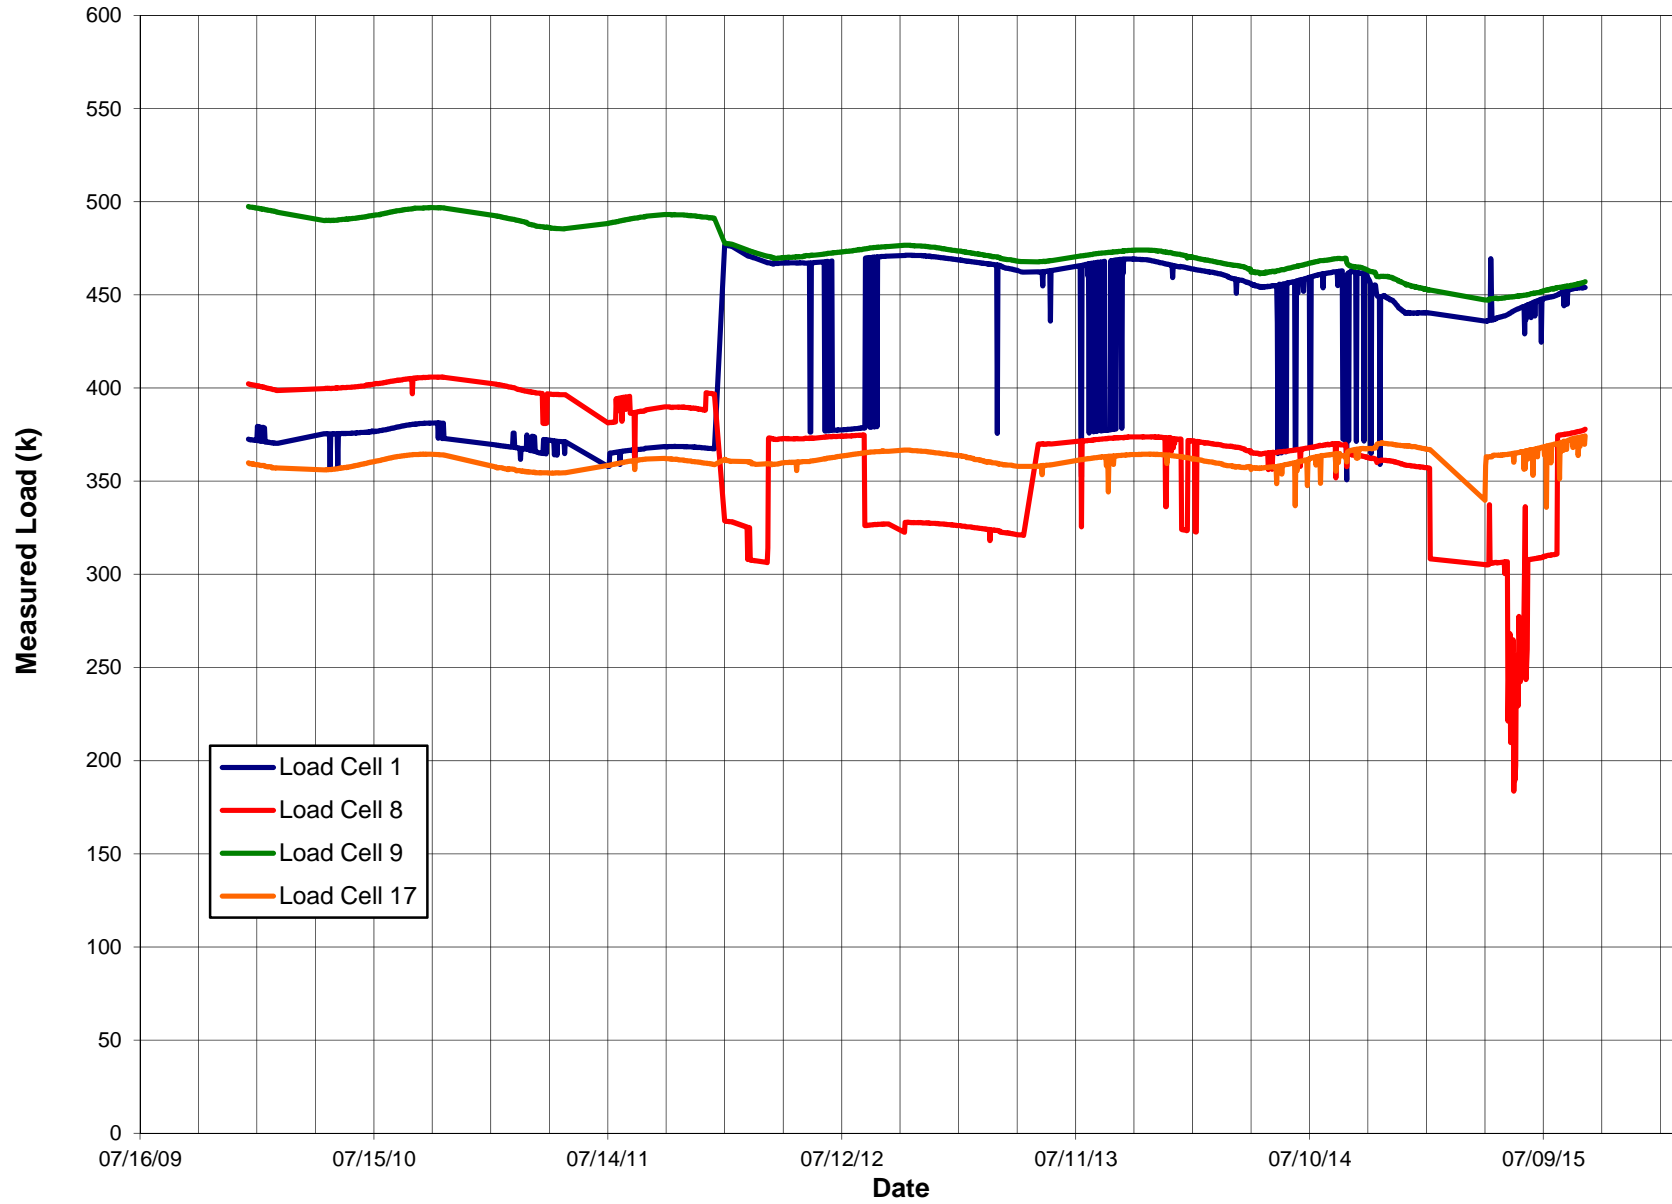
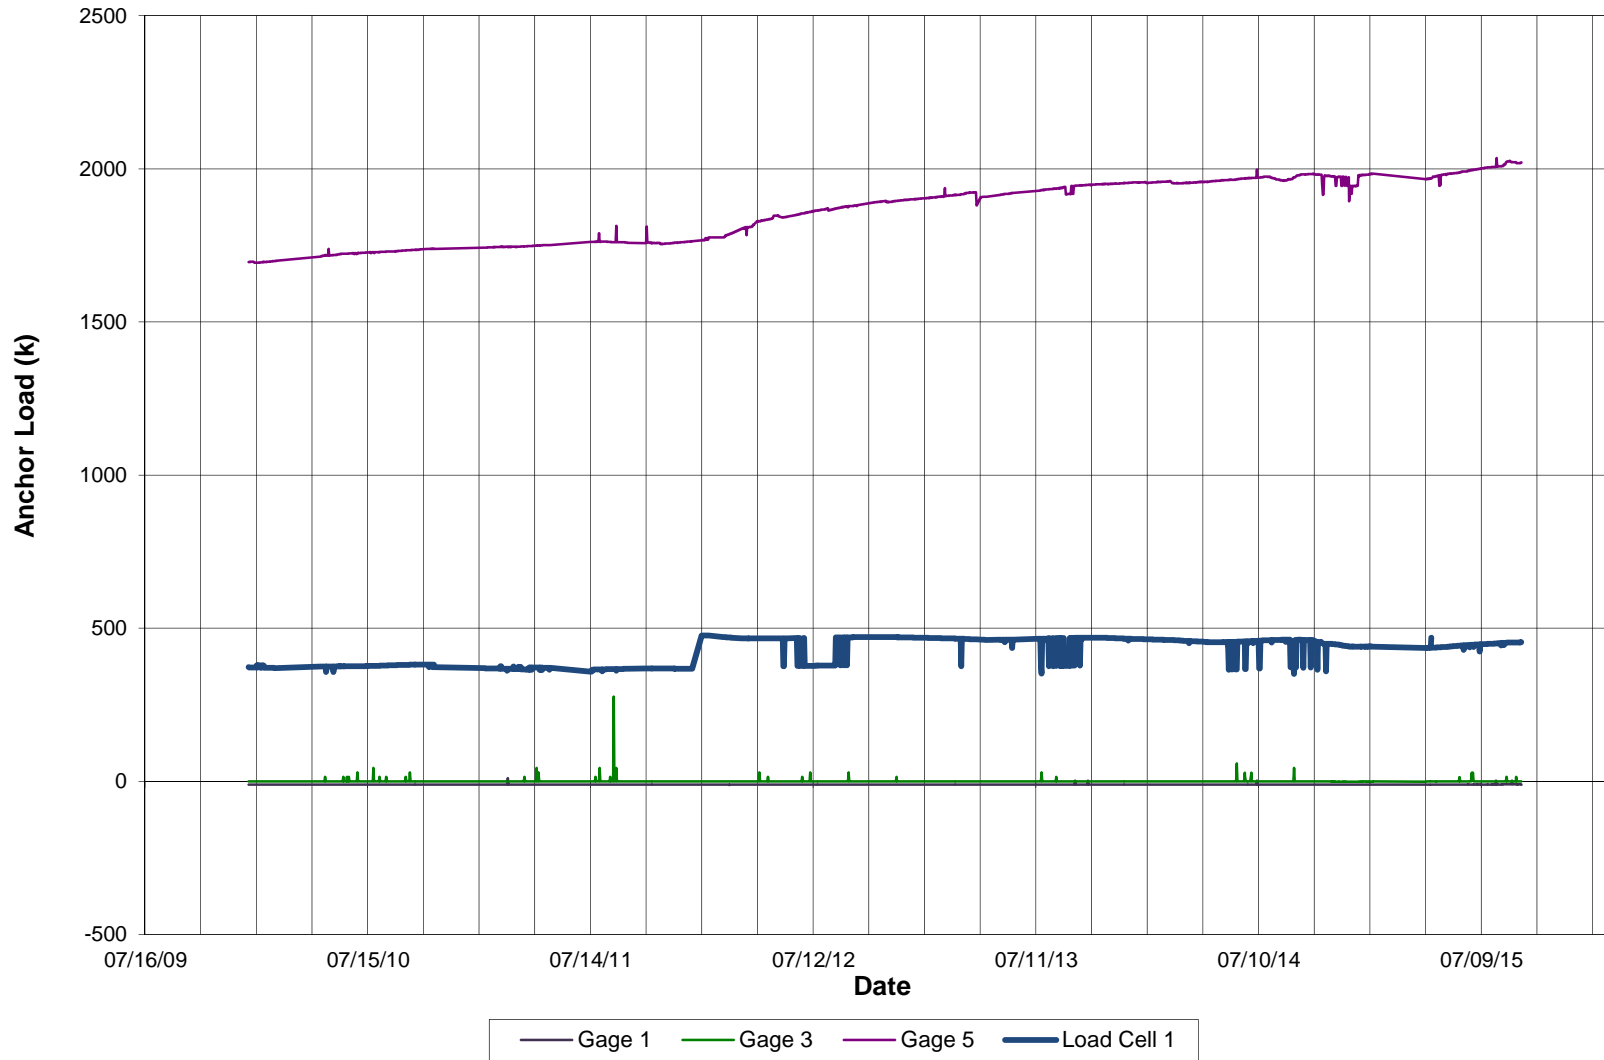
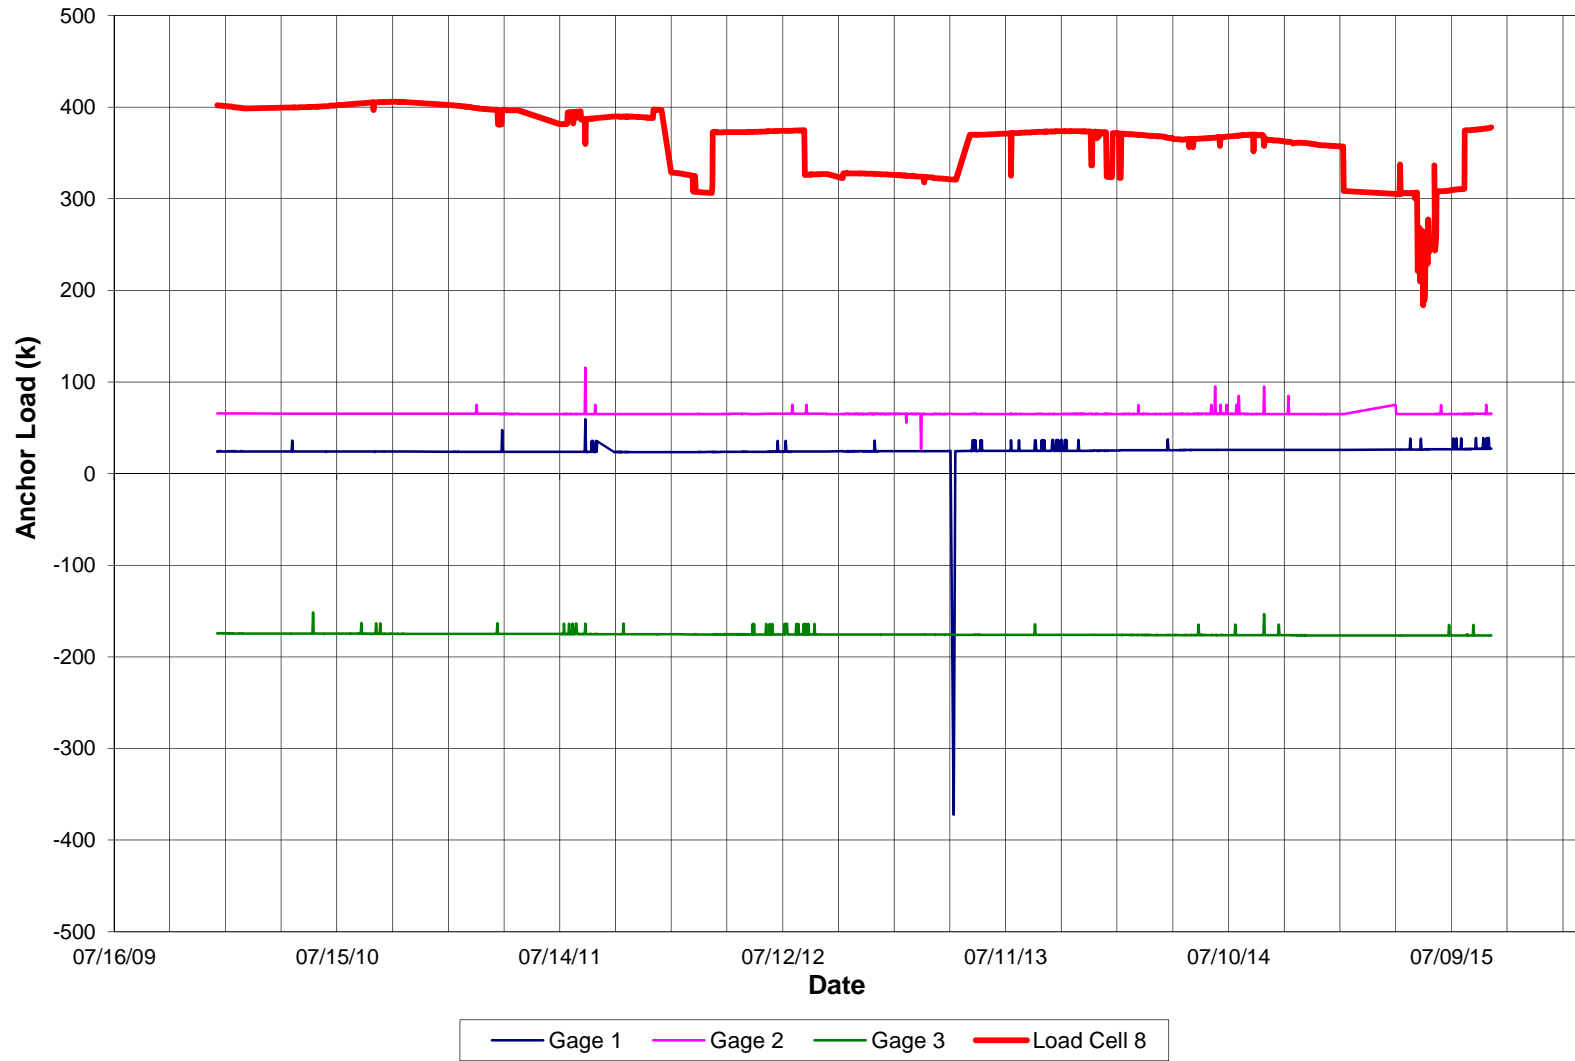
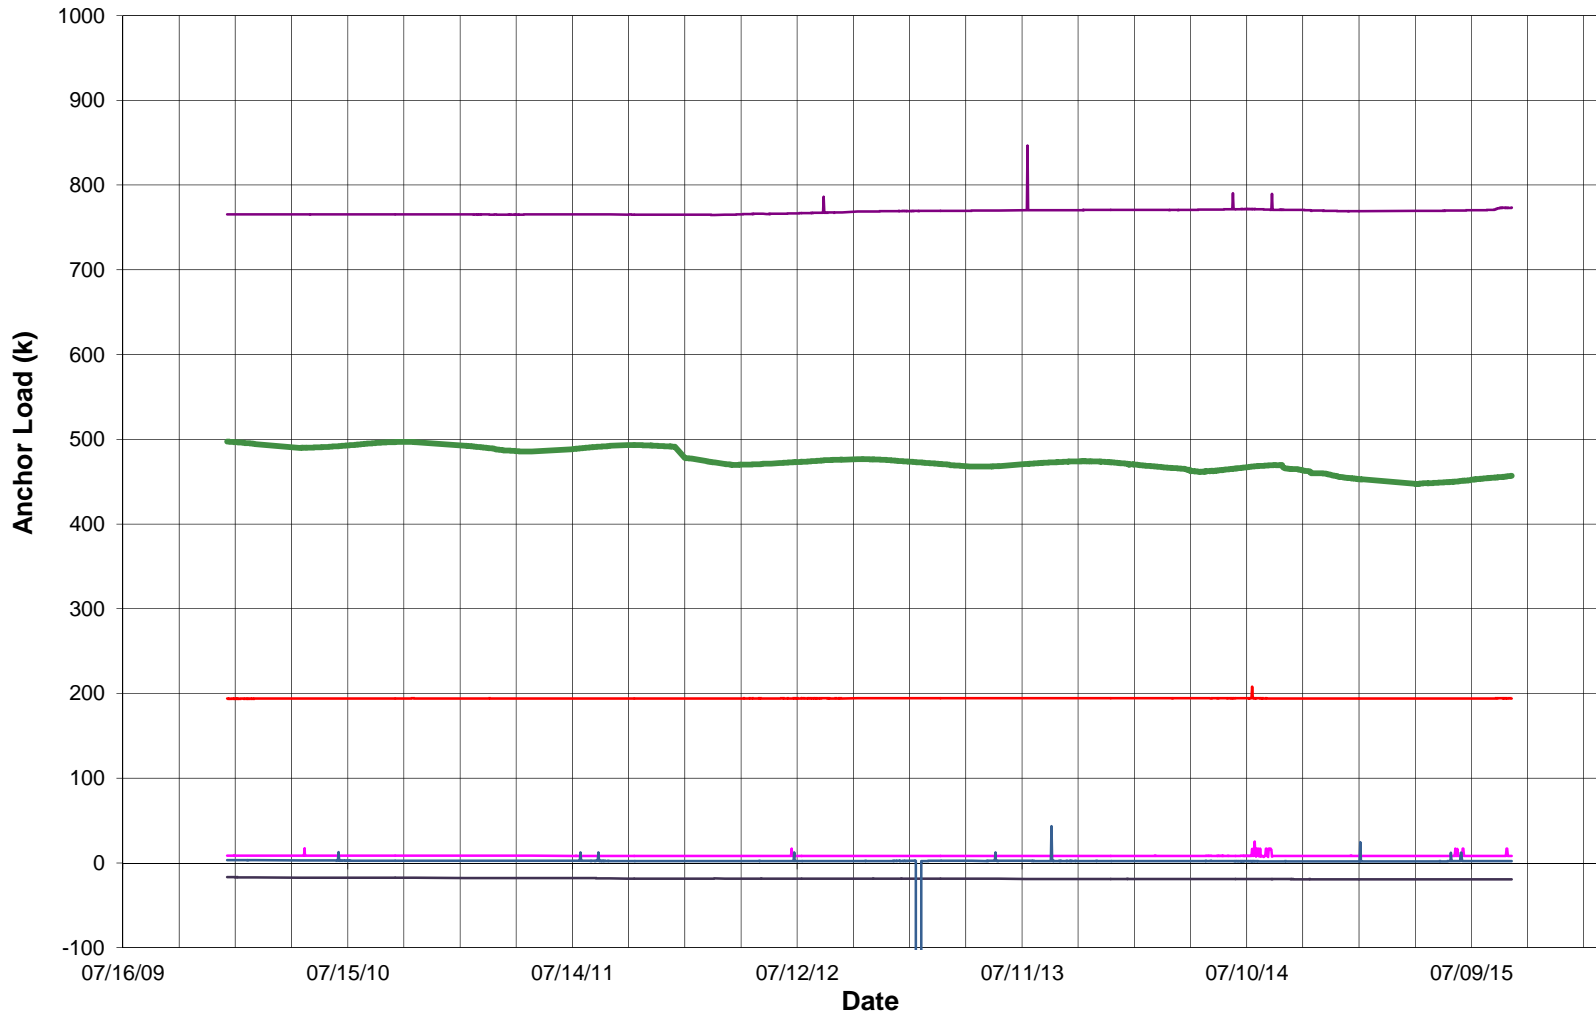
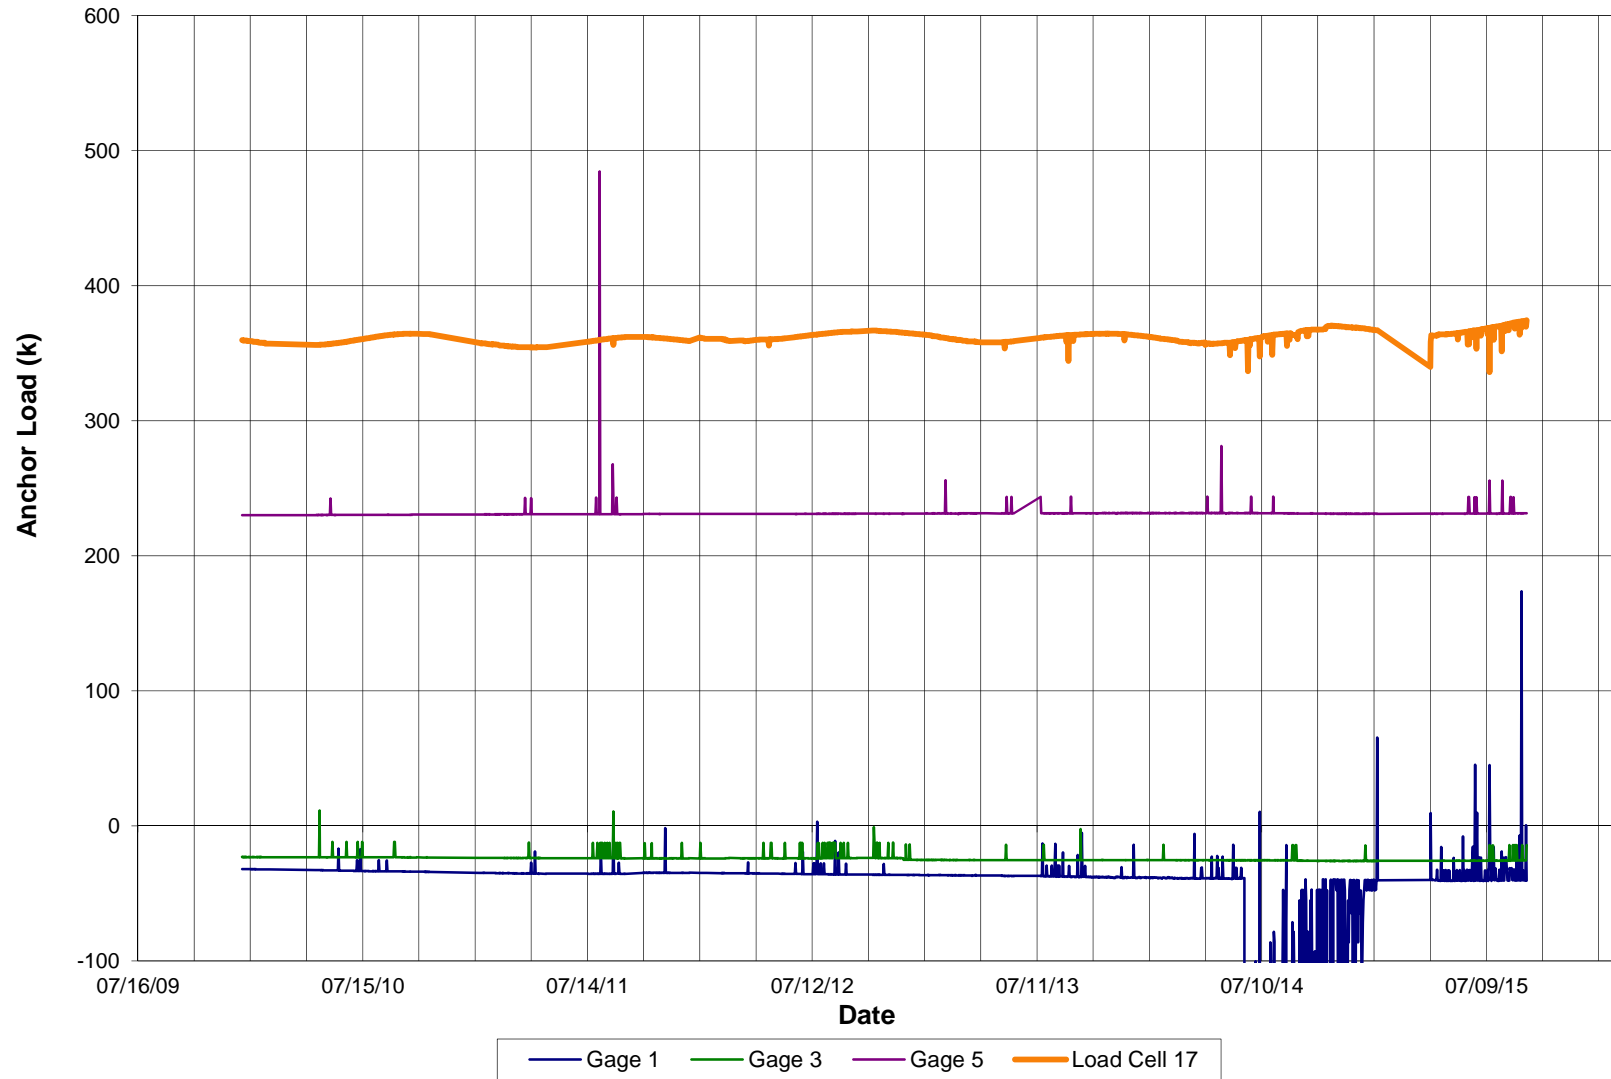
Load Cell Measurements

Seasonal variations are apparent in the plots for all of the load cells with the usual increase in load in the summer months. Loads in Load Cells 1, 8 and 9 continue to trend downward. The plot for Load Cell 8 shows a sudden drop of about 50 kips in January 2015 followed by an equivalent increase in July 2015. This is due to one of the gauges failing and then recovering. The load in Load Cell 17 appears to be creeping upward slightly. The spikes in the plots, especially for Load Cells 1 and 8, occur when one or more of the gauges in a load cell fail to record. Table 1 shows which gauges were active in each of the load cells this quarter. A plot of the load cell data is included in Appendix C.

Loads recorded for all active strandmeters on the instrumented anchors remained virtually constant this past quarter with the exception of an occasional spike caused by gauges failing to record. The plot for Gage 5 on Anchor 1 indicates a continued increase in load over the past year. This has been the trend since 2010. The magnitude of the load is obviously incorrect since it is unrealistically high and is much greater than the load indicated by the load cell. Most data for Gage 1 on Anchor 17 was erroneous between June 2014 and January 2015. Since then more valid data has been recorded but there are still frequent spikes in the data. Average loads this quarter for the load cells and active strandmeters are listed in Table 2. We also report the percent change in load from last quarter. Strandmeter gages that have failed are indicated by an "x" in the table.

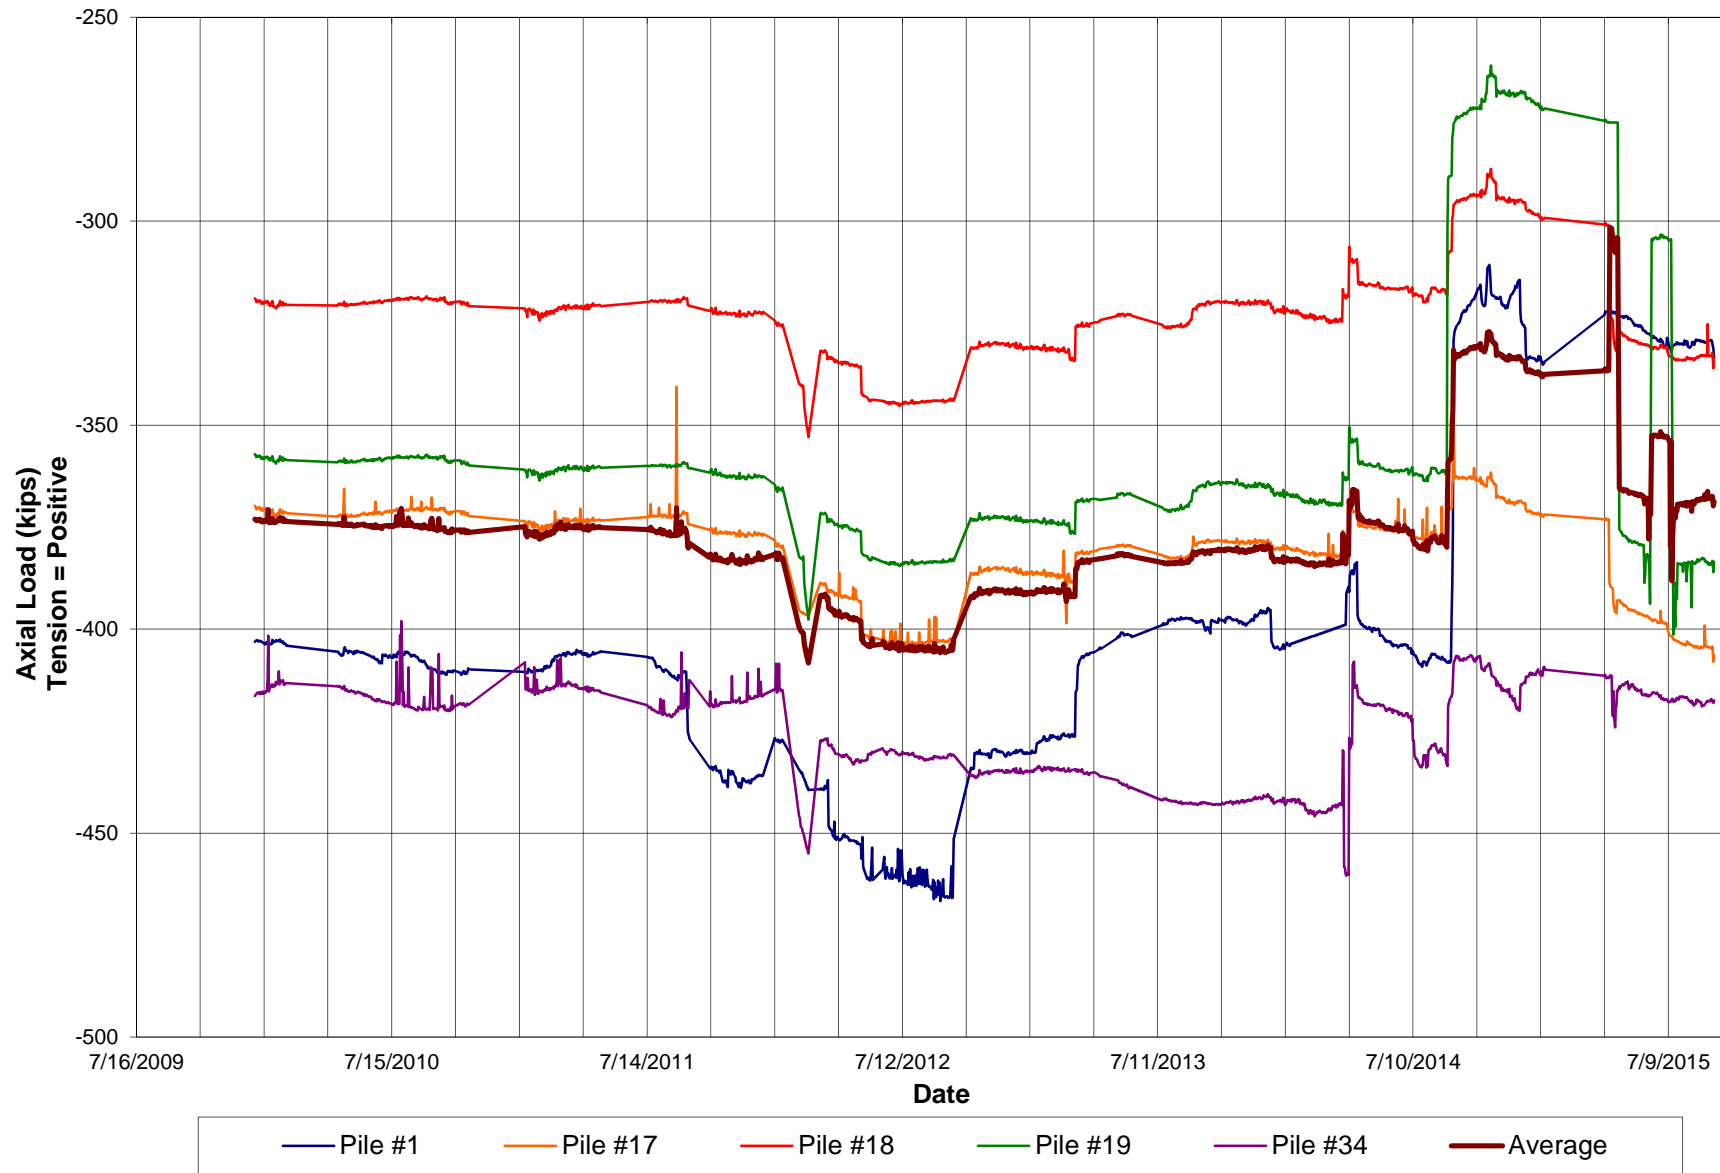
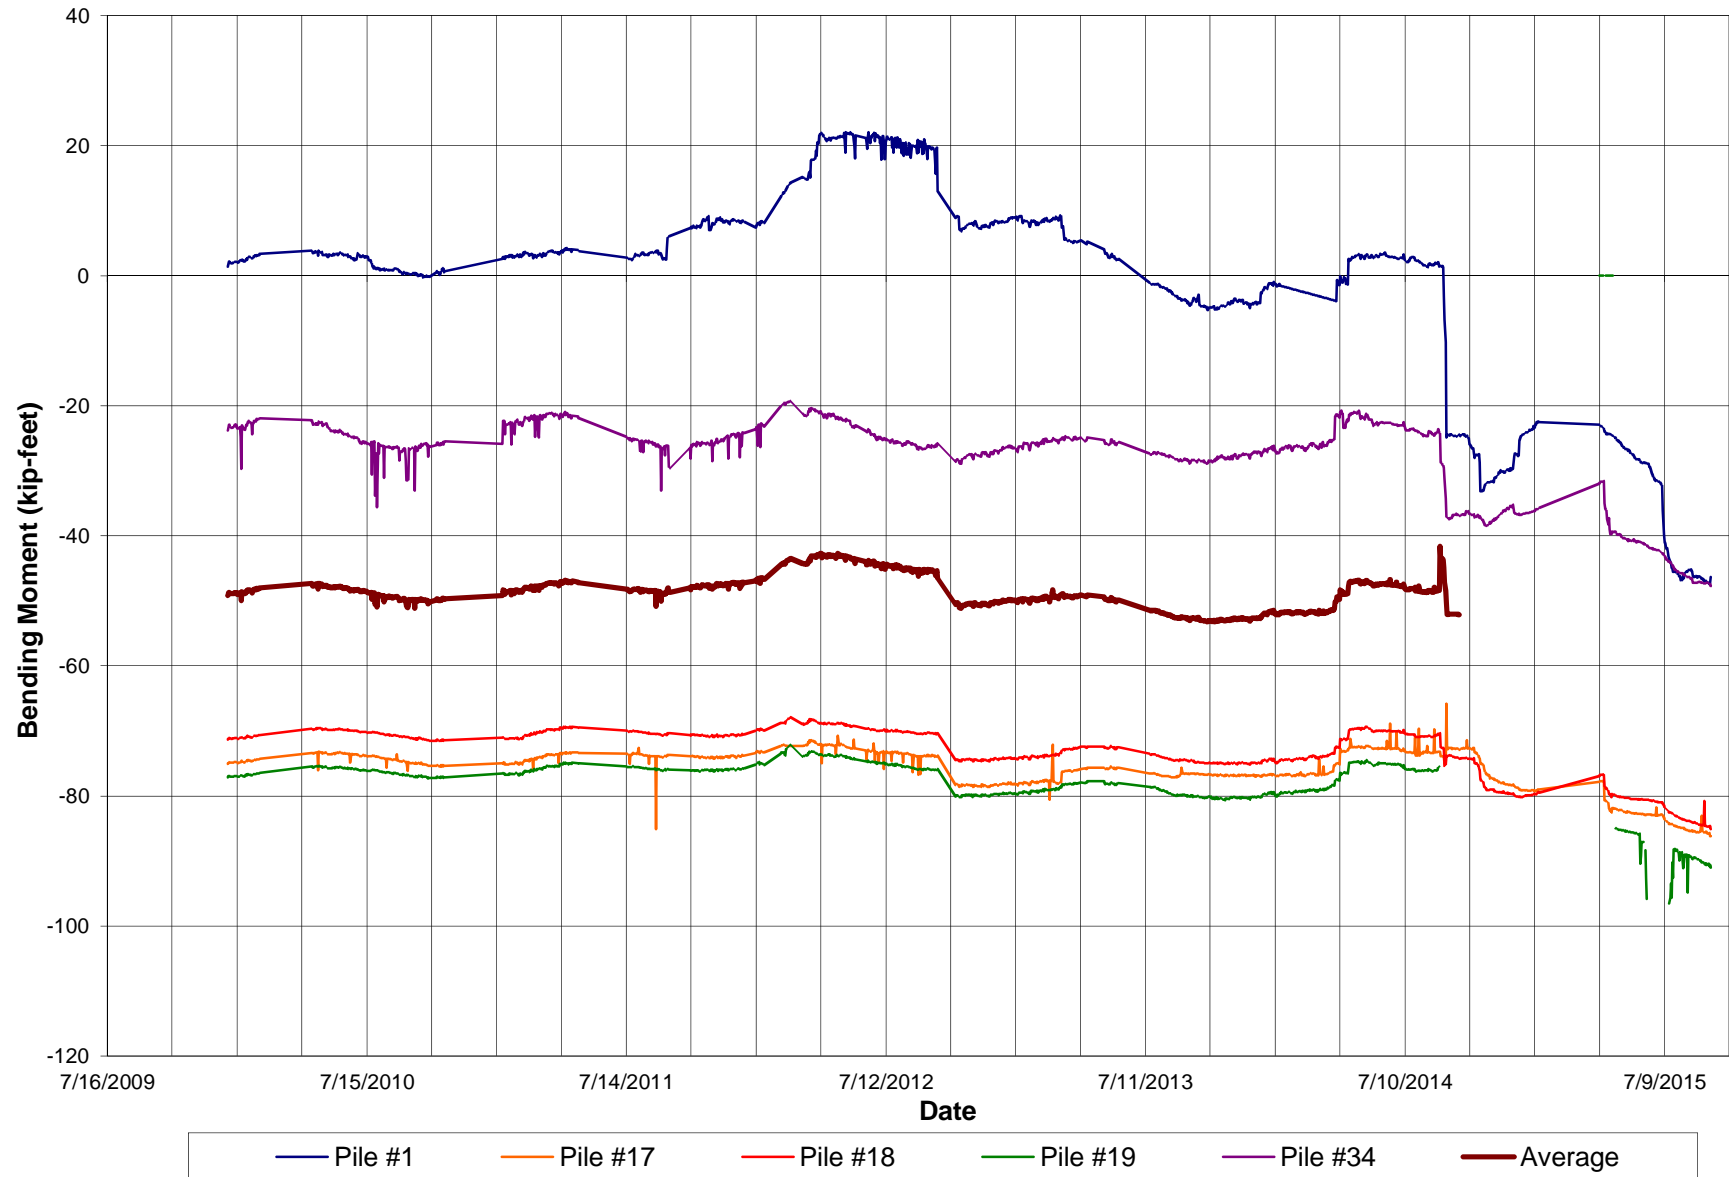
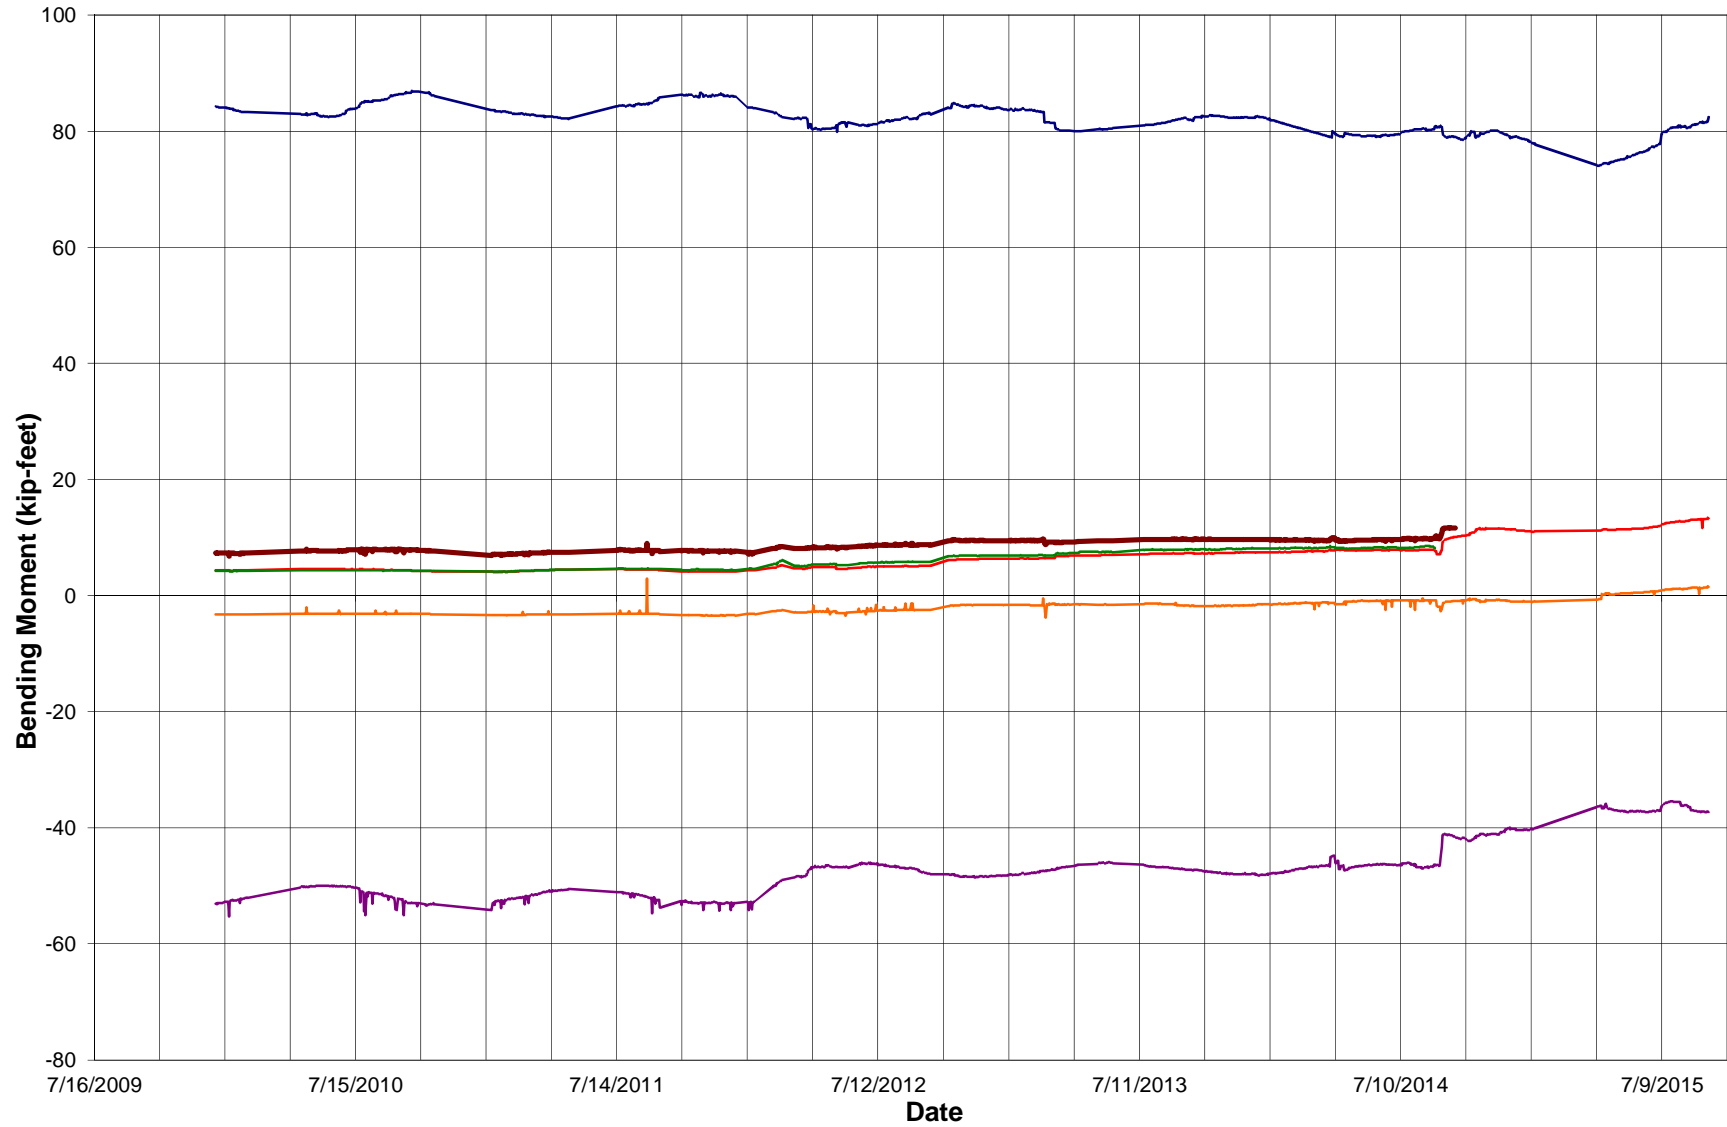
The large “jumps and drops” in the axial load plots for the driven piles and the loss of data for the first quarter of 2015 obscure the actual changes that are occurring. Generally it appears that the axial loads are increasing in all piles except for Pile 1. The data for Pile 1 has been so erratic since the middle of 2011 that it is impossible to draw any reliable conclusion about changes in that pile’s load. For the other piles it appears that the loads increased by about 10 (Pile 34) to 15 (Pile 17) kips this past year. The large jumps and drops in the plots are caused by the intermittent loss of data for individual gauges. This also affects the bending moment plots.

Strong axis bending moments increased in all of the driven piles for the year. It is difficult to estimate the magnitude of the increases due to the effect of the gauge failures especially for Pile 1 where the actual increase is likely less than we can estimate from the plot. It appears that the increases may be in the range of about 10 kip-ft in Pile 34, to about 13-15 kip-ft in Piles 17, 18, and 19, to about 22 kip-ft in Pile 1. Weak axis bending moments increased slightly in all of the piles except Pile 34. The increases averaged about 3 kip-ft. The load in Pile 34 decreased by about 5 kip-ft. Due to gauge failures, much of the bending moment data for Pile 19 has been removed from the plots.

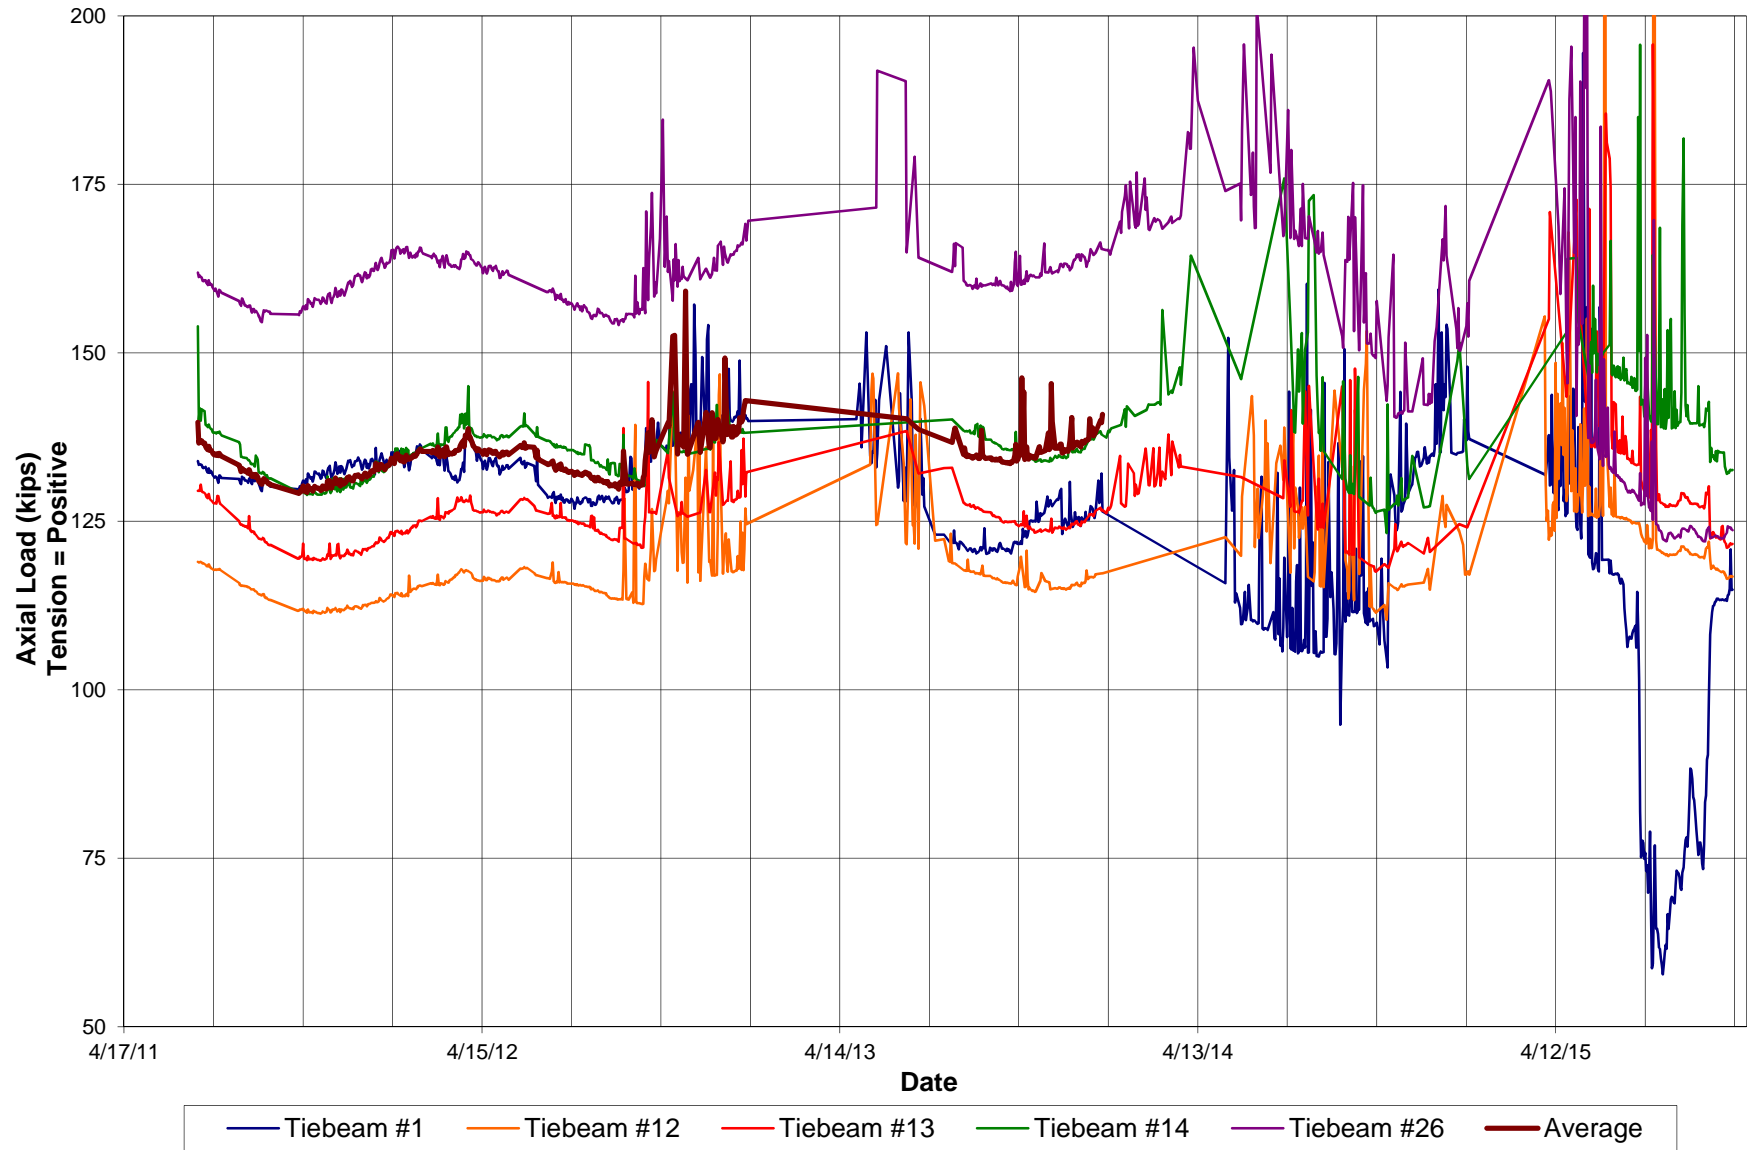
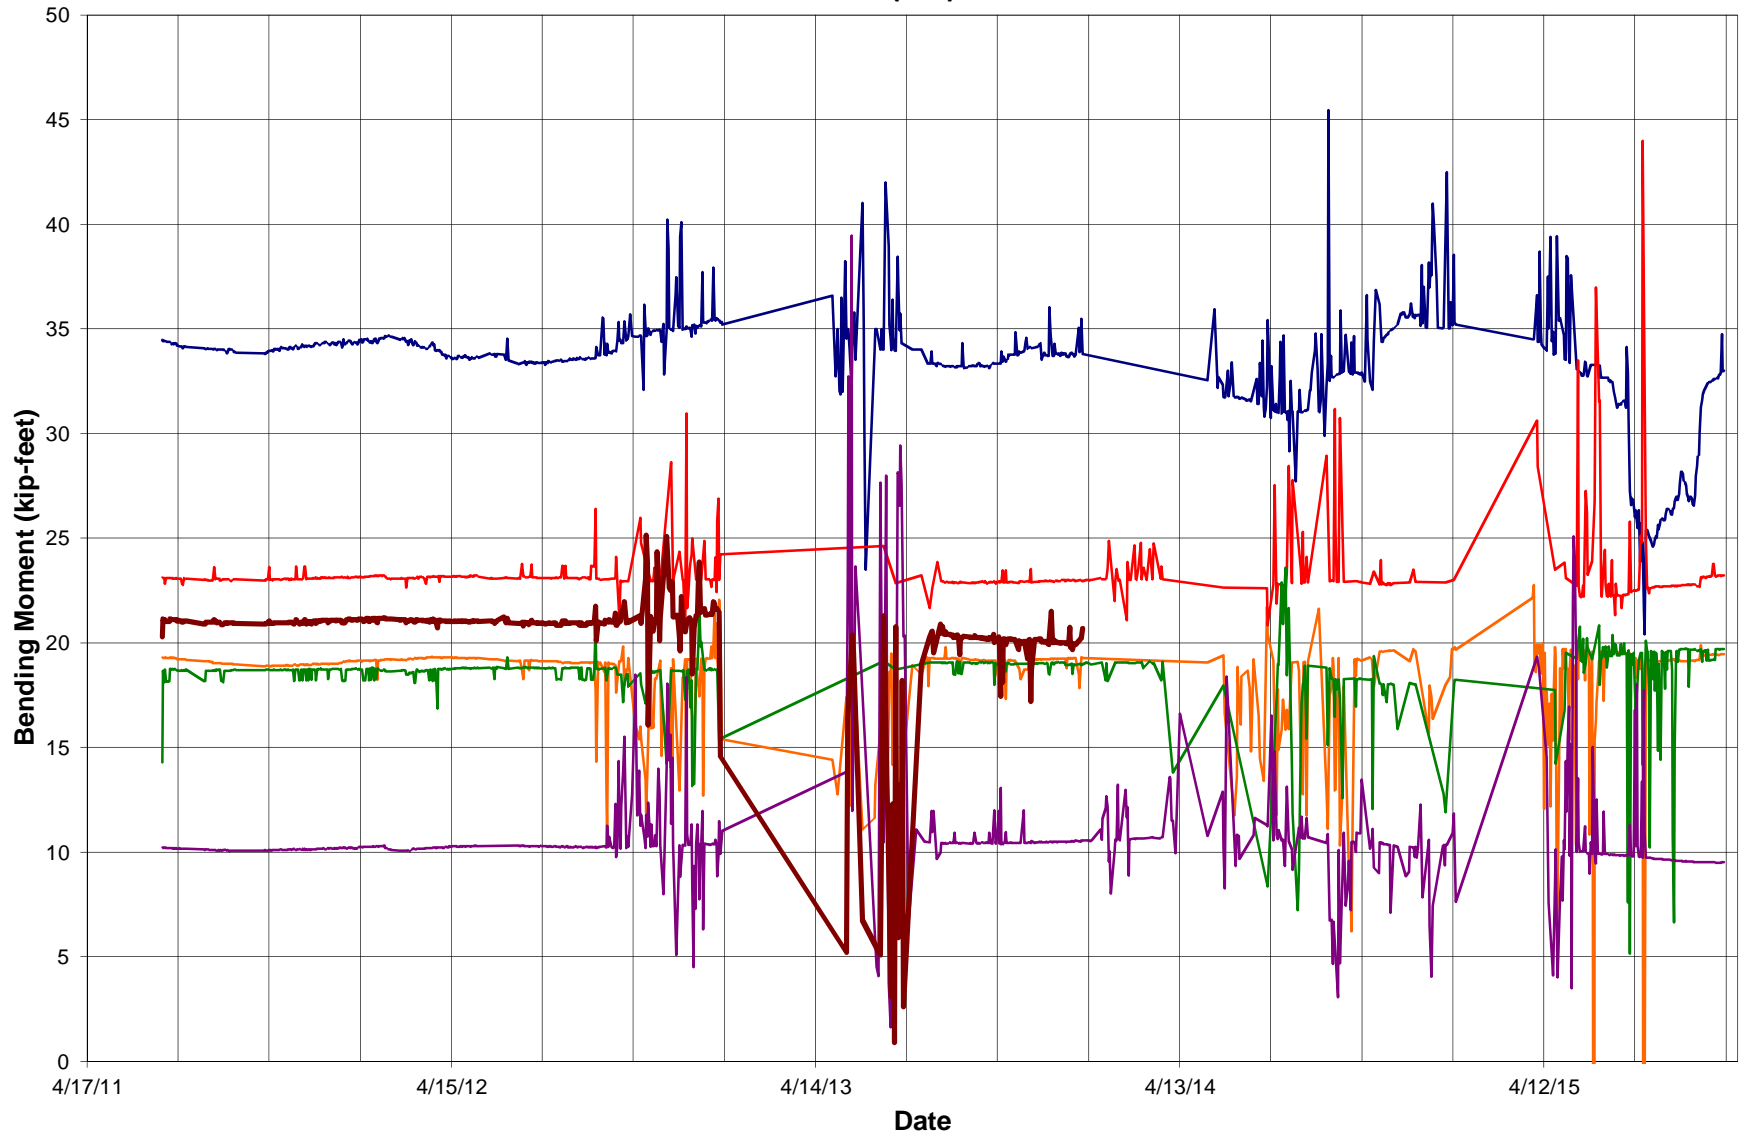
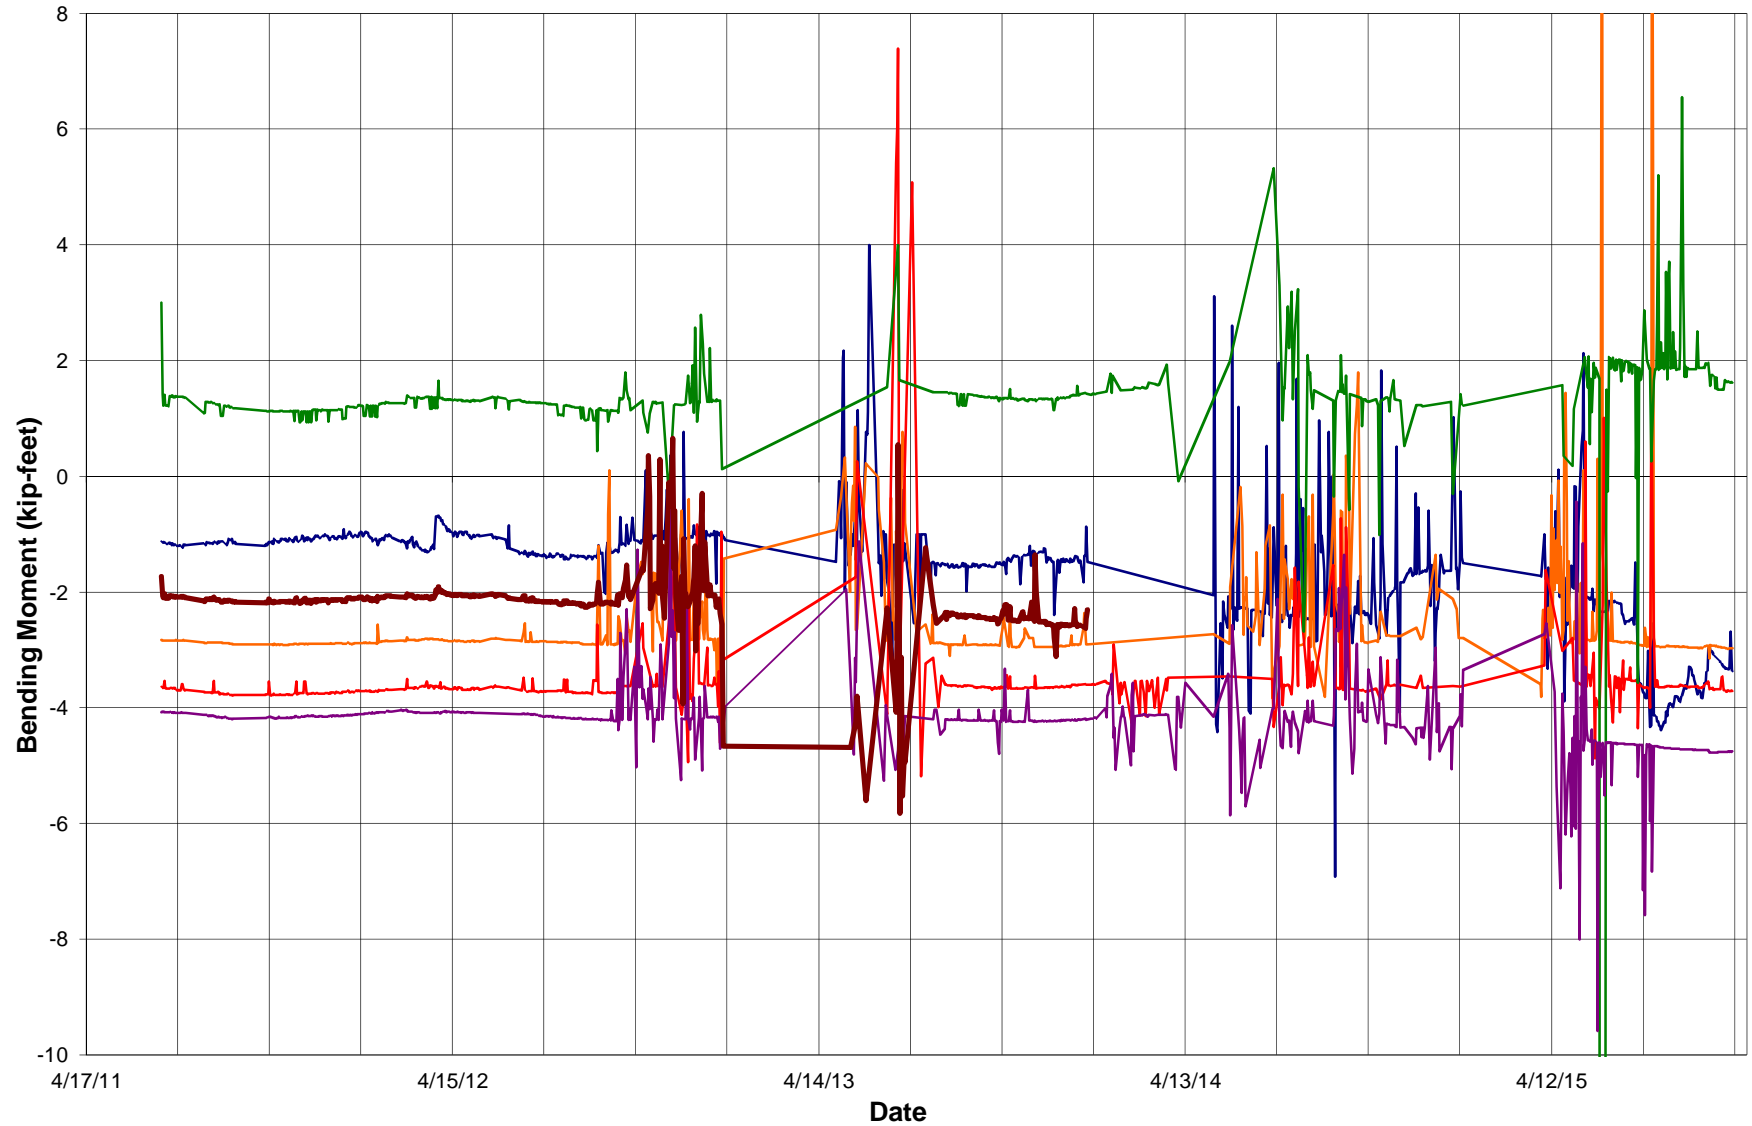
The axial loads at the anchor end of the tiebeams again show the usual seasonal variations for the year with the maximum load occurring in May-June and the minimum load occurring in October-November. Looking at the trends for the past four years for Tiebeams 12, 13, and 14, there has been some up or down variation from year to year but overall the average axial loads appear to be constant. The axial load in Tiebeam 1 has been trending downward (decreasing) at an average rate of about 3 kips per year. Since 2013 the axial load in Tiebeam 26 has been trending downward at a two-year average rate of about 18 kips per year.

Strong axis bending moments remained constant in Tiebeams 12 and 13, and appear to have increased slightly in Tiebeam 14 and decreased slightly in Tiebeam 26. It is difficult to see what has happened to the bending moment in Tiebeam 1, although from the last few data points for the year we might conclude that the moment was about the same as it was a year ago.

Weak axis bending moments appear to be unchanged in Tiebeams 12 and 13 and appear to have increased slightly in Tiebeams 14 (more positive) and 26 (more negative). It is impossible to tell what change may have occurred in Tiebeam 1.
