Re: October 2015 Annual Report
CUY-90-15.24 Slope Monitoring
PID 96504
EDP Project No. 069032.00

OCTOBER 2015 QUARTERLY REPORT

**CUY-90-15.24 SLOPE MONITORING
PID 96504
CLEVELAND, OHIO
SME PROJECT NO. 069032.00**

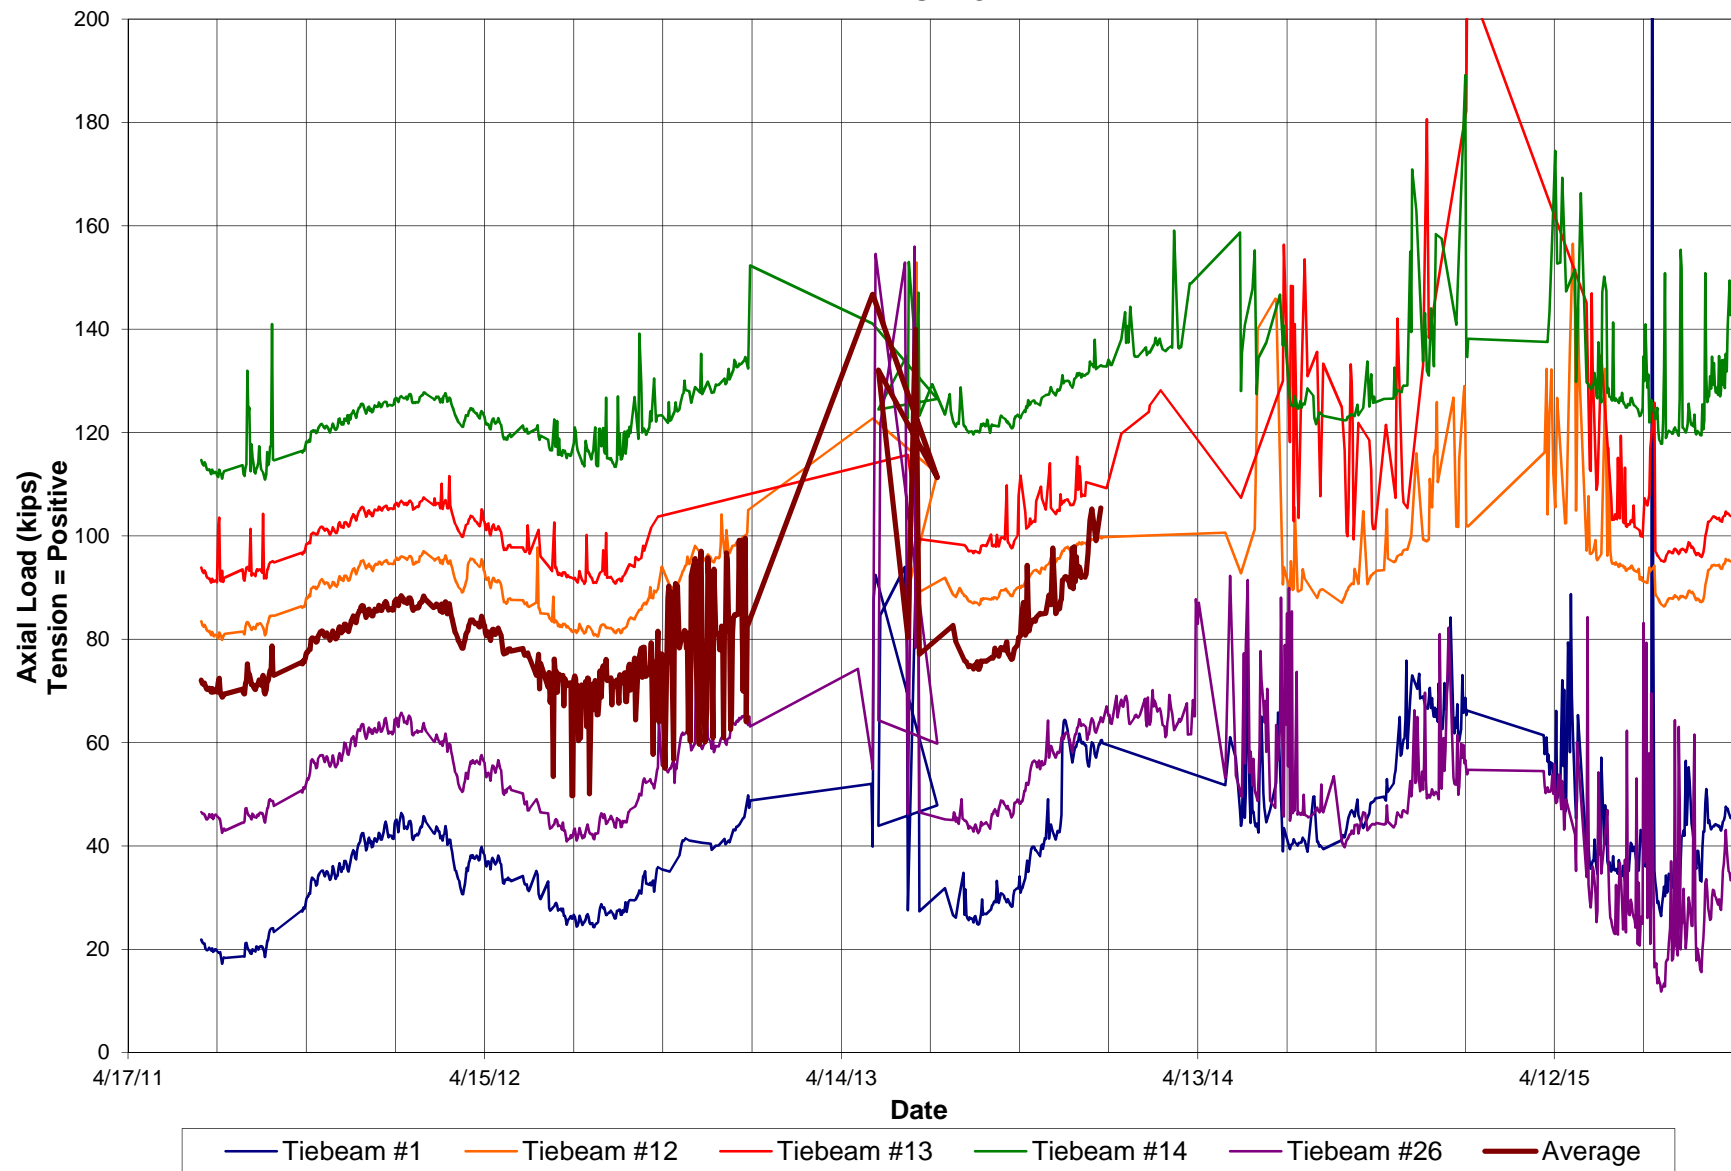
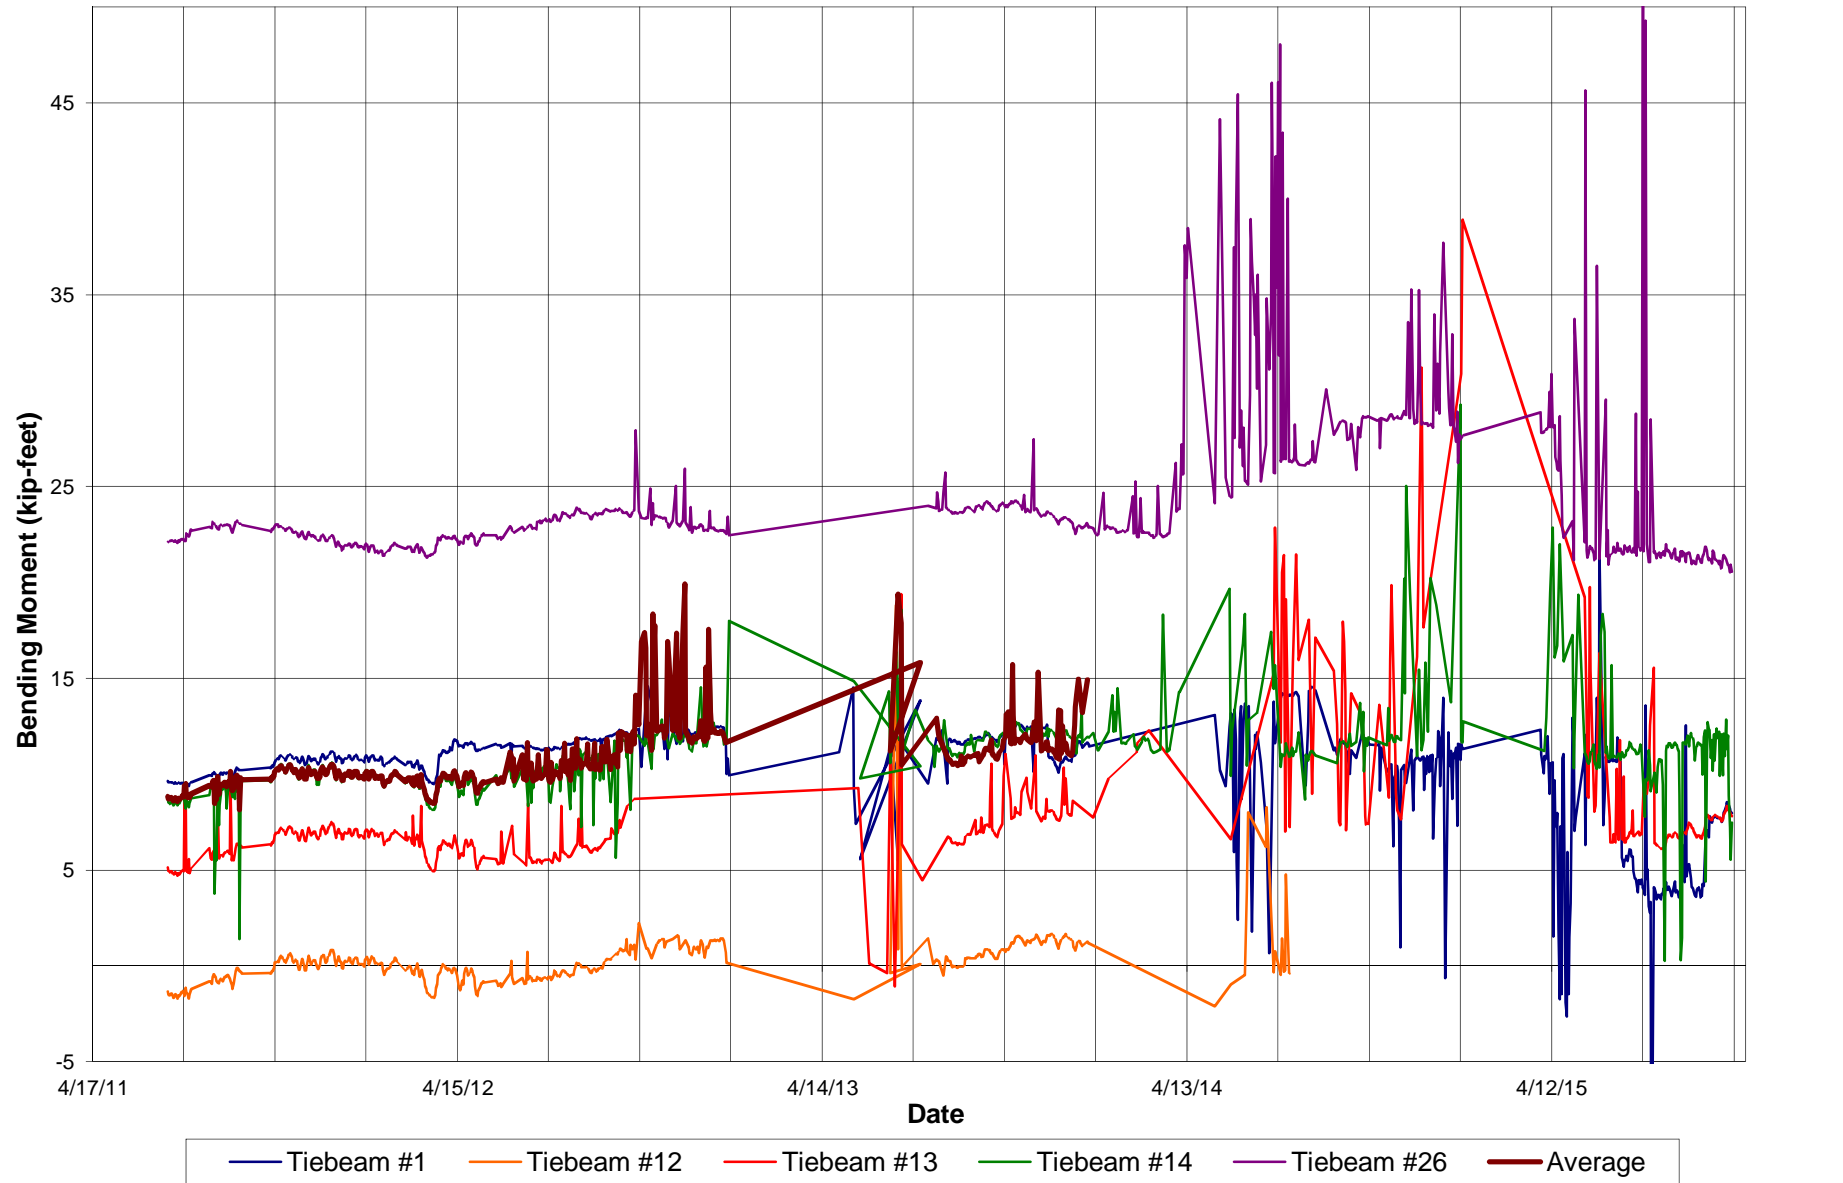
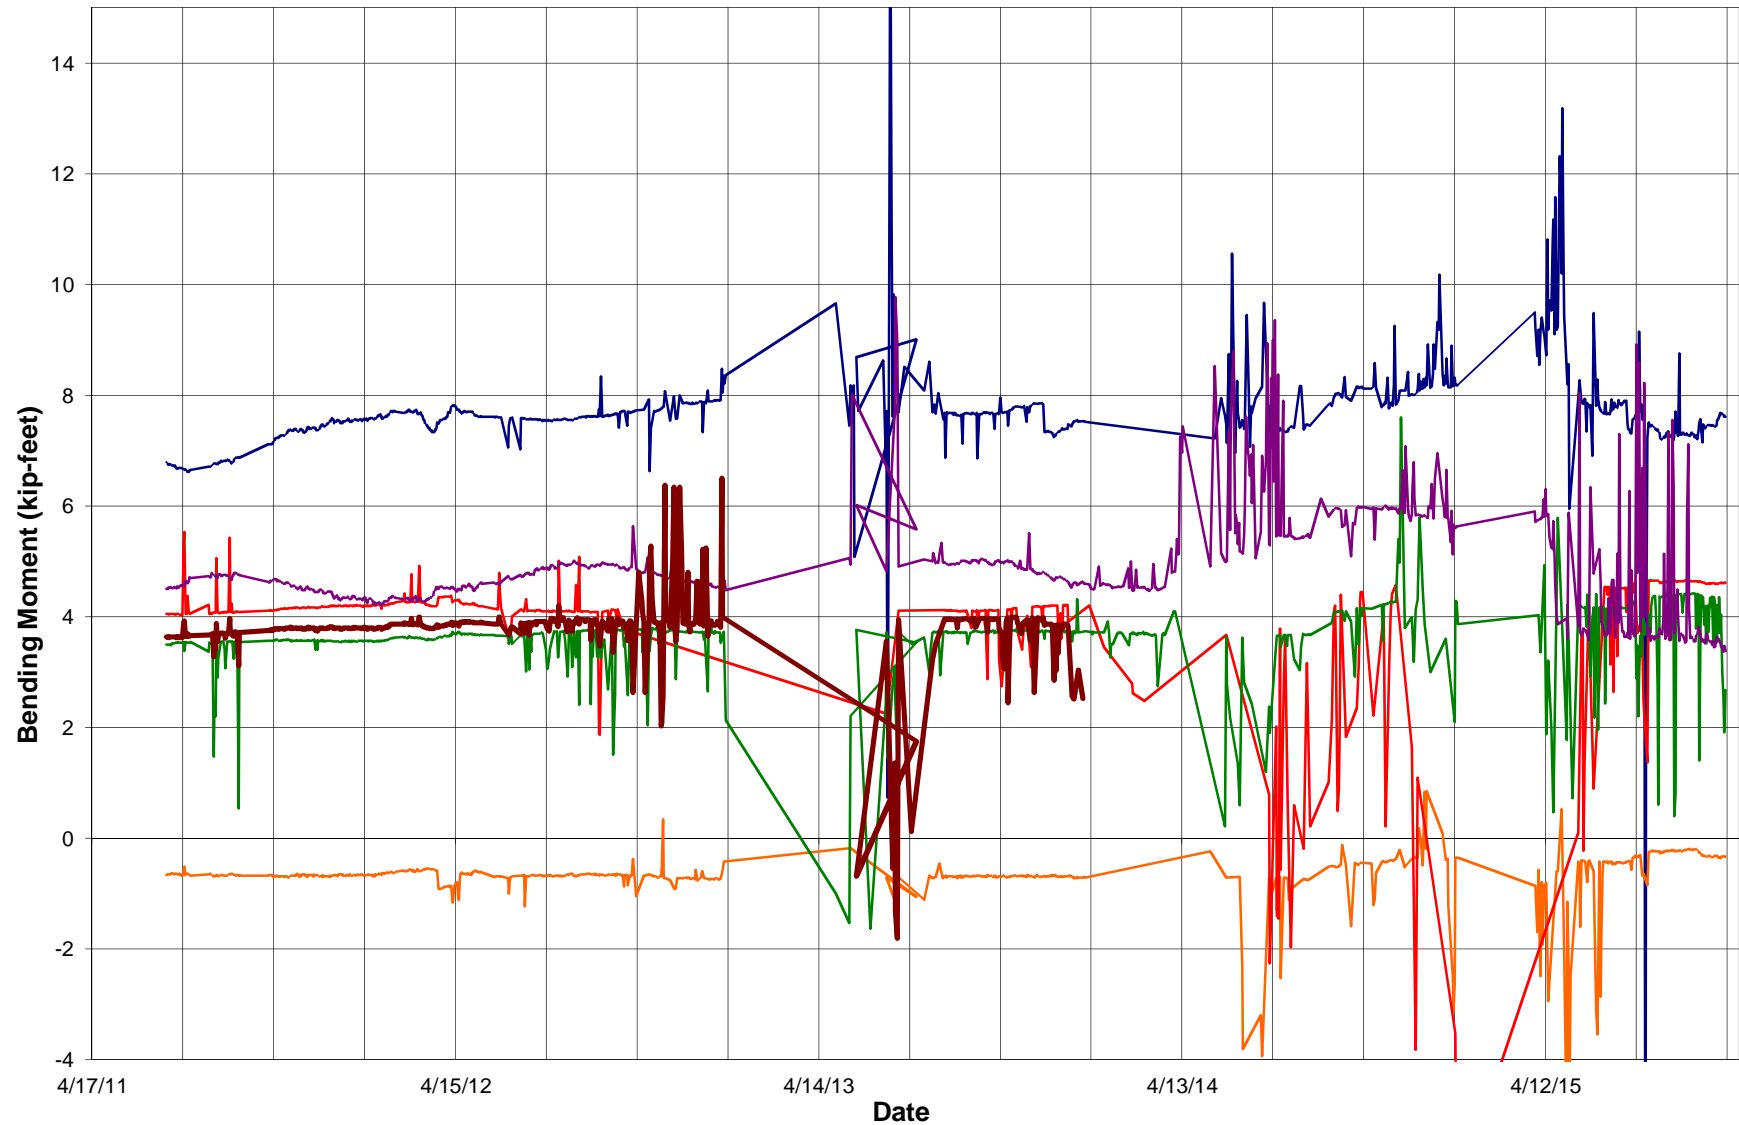
Axial loads at the drilled pier end of the tiebeams continue to follow the seasonal trends. In the past, the magnitude of the loads appeared to be increasing each year. This year, the loads are similar to what was observed in 2013 except for Tiebeams 1 and 26. Compared to 2013 the axial load is somewhat greater in Tiebeam 1 and lower in Tiebeam 26. Overall for the past four years, the axial loads appear to be increasing in all tiebeams except Tiebeam 26 where the load appears to be decreasing. However, the poor data for 2015 for Tiebeams 1 and 26 make it difficult to clearly see the trends. Due to a gauge failure, strong axis bending moments for Tiebeam 12 are omitted from the plot.

Strong axis bending moments at the drilled pier end of the tiebeams appear to be lower than a year ago except for Tiebeam 14 which appears to be about the same as last year. For the past four years the strong axis bending moments appear to be decreasing in Tiebeams 1 and 26 and remaining about the same in Tiebeams 13 and 14.

Weak axis bending moments in Tiebeams 1, 12, and 26, decreased compared to last year although the change for Tiebeam 26 is probably due the loss of data from one of the gauges. The weak axis bending moment stayed about the same in Tiebeam 14.
