February 3, 2016

Re: January 14 and 15, 2016 Bi-Weekly Readings
CUY-90-15.24 Slope Monitoring
PID 96504
SME Project No. 069032.00

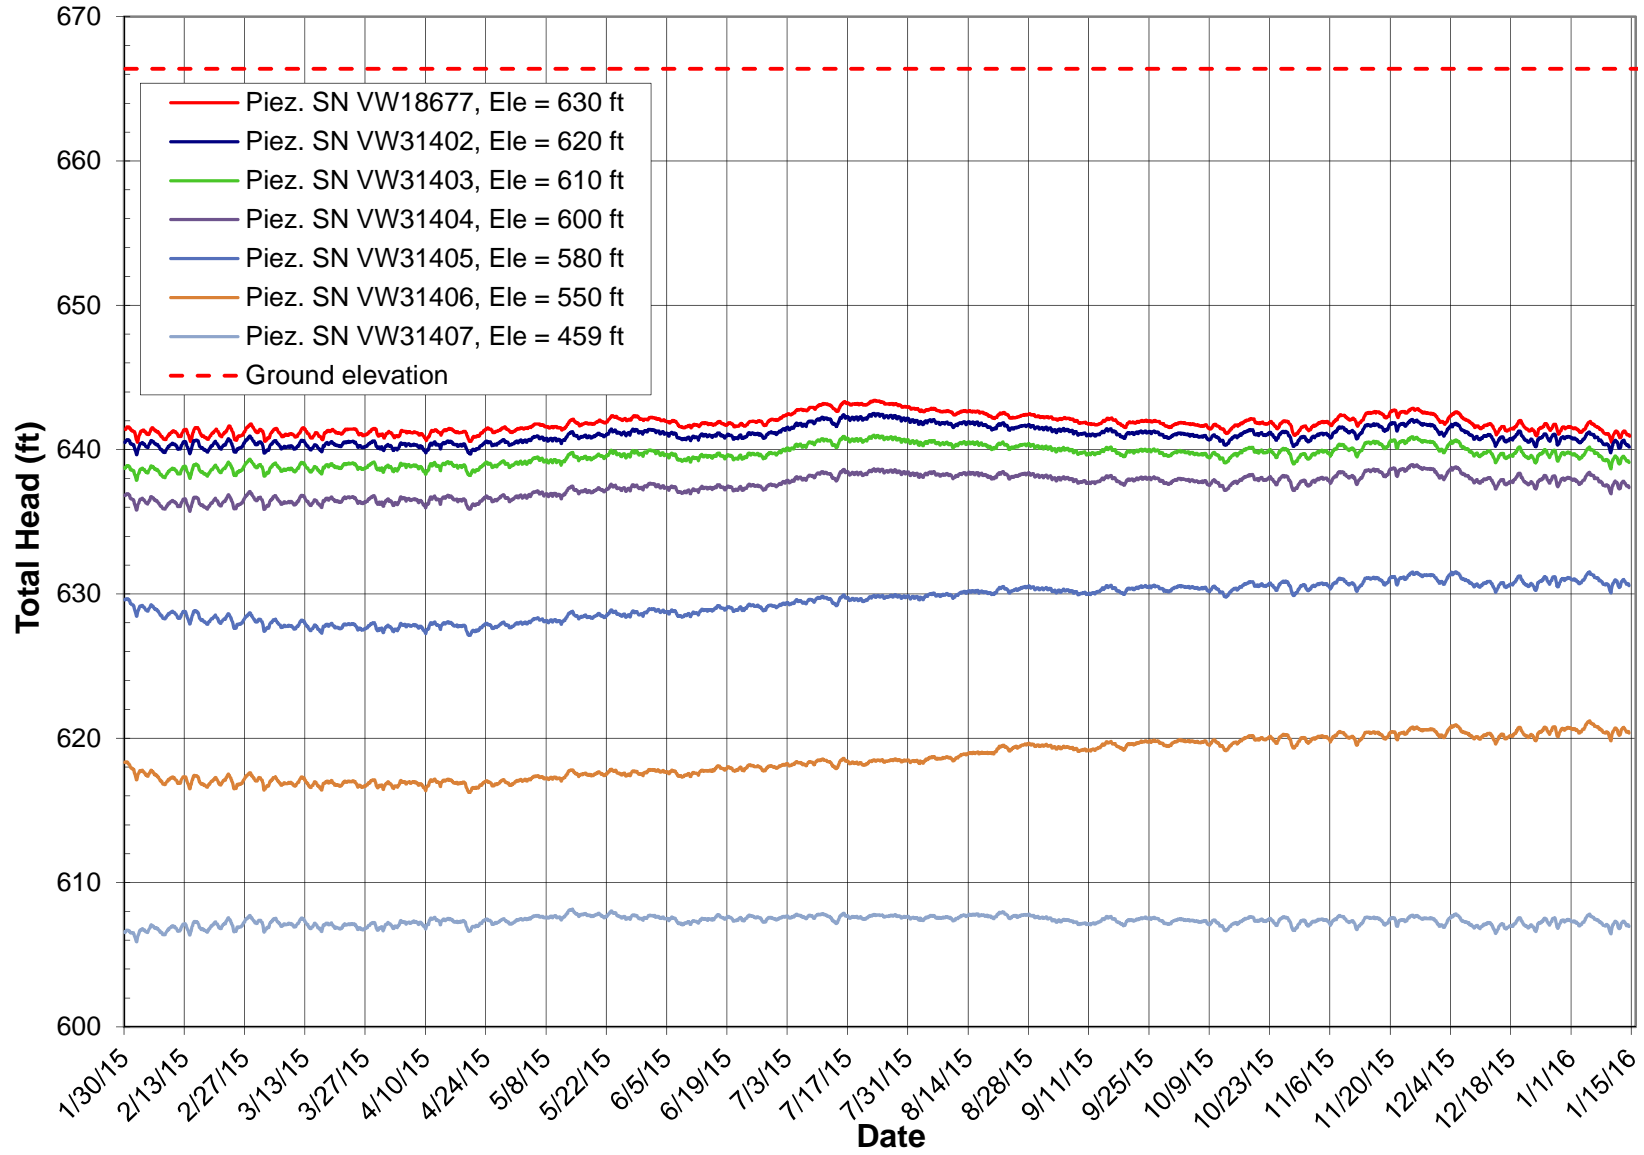
P-001-13 VW Piezometer Readings

P-001-13, P-009-13, B-05-A-11 – Pore pressure readings indicate a decrease in total head of up to about 0.5 feet in all piezometers at these locations over the past two weeks.

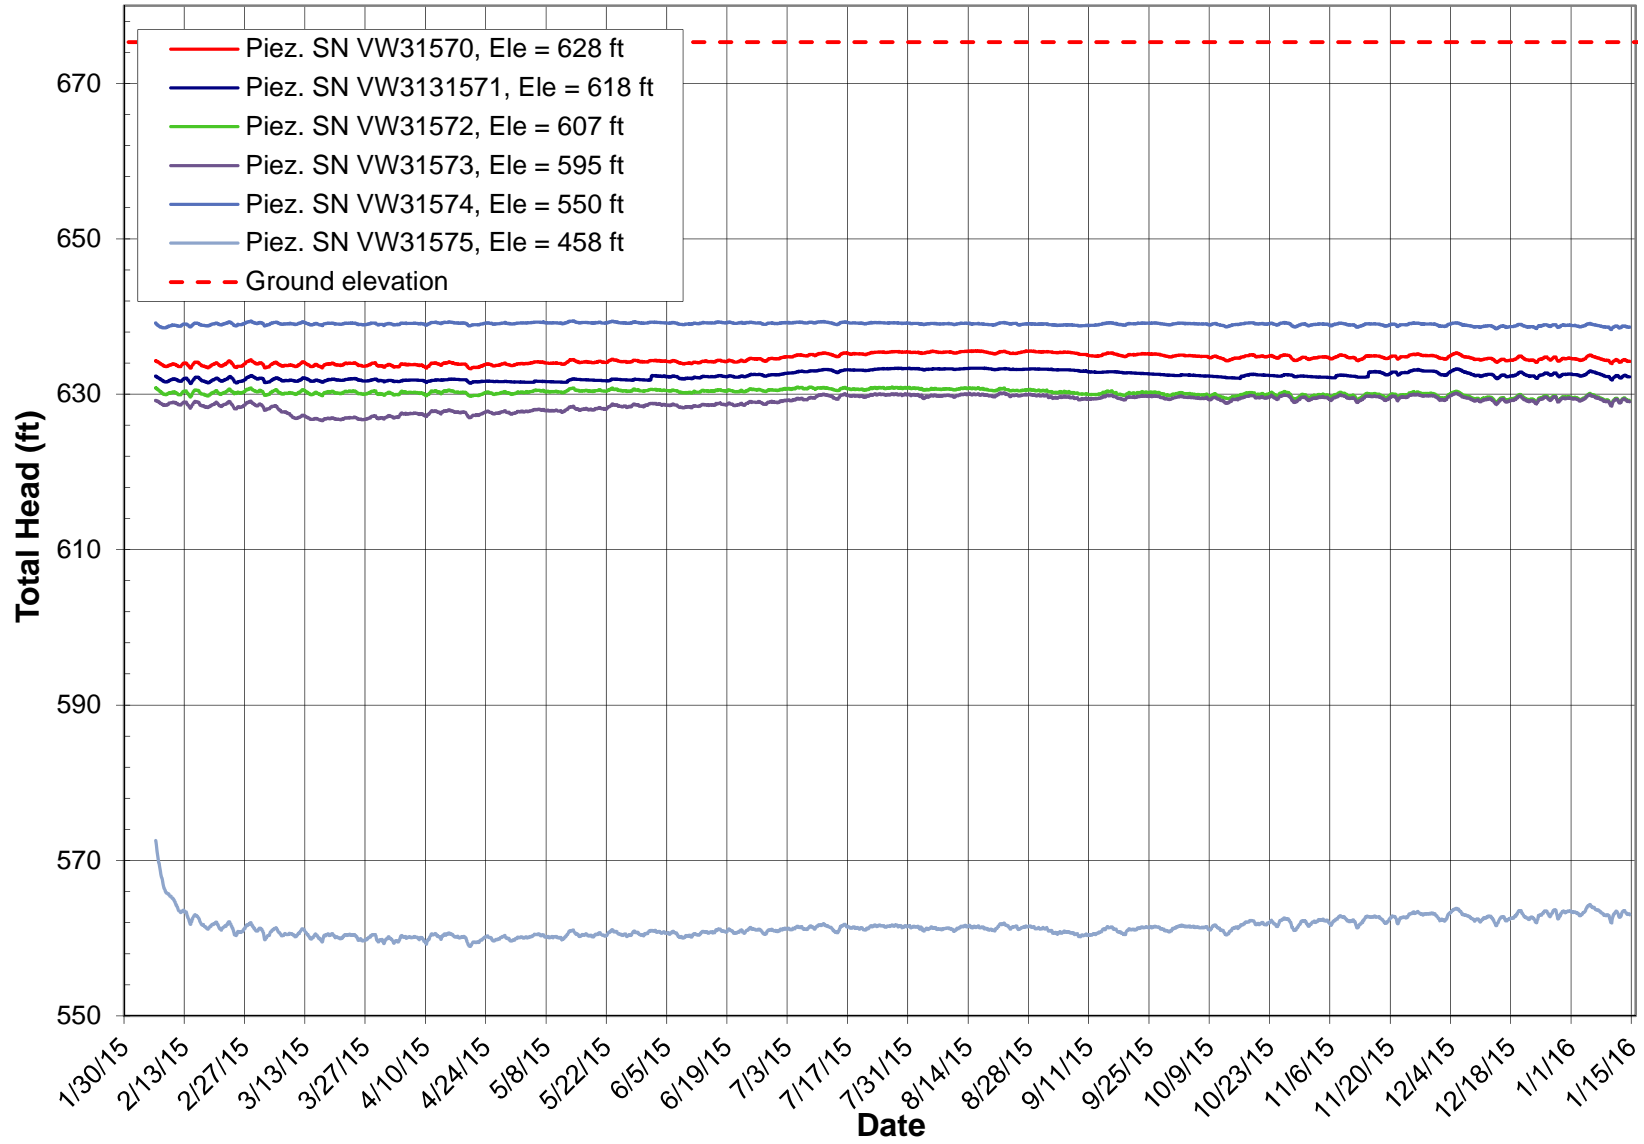
P-002-13 VW Piezometer Readings

P-002-13, B-05-04 – Pore pressure readings at these locations indicate minor fluctuations in total head over the past two weeks with virtually no net change.

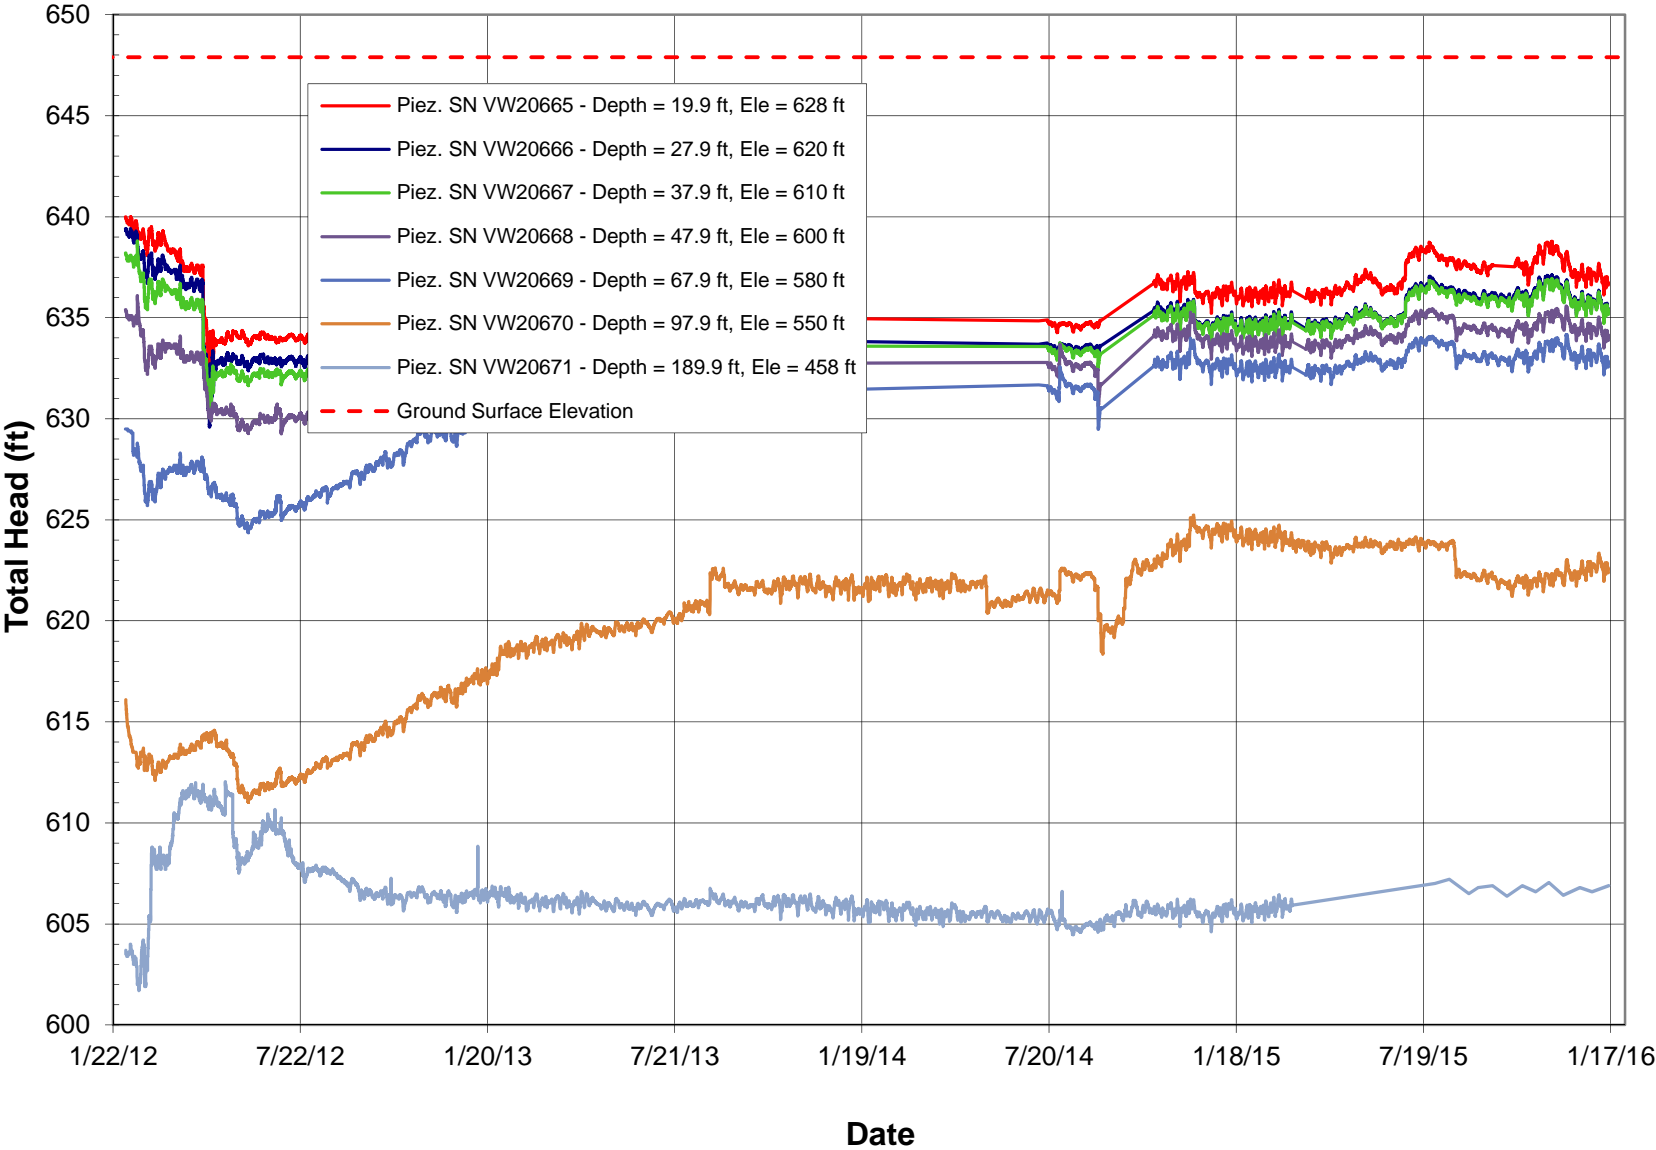
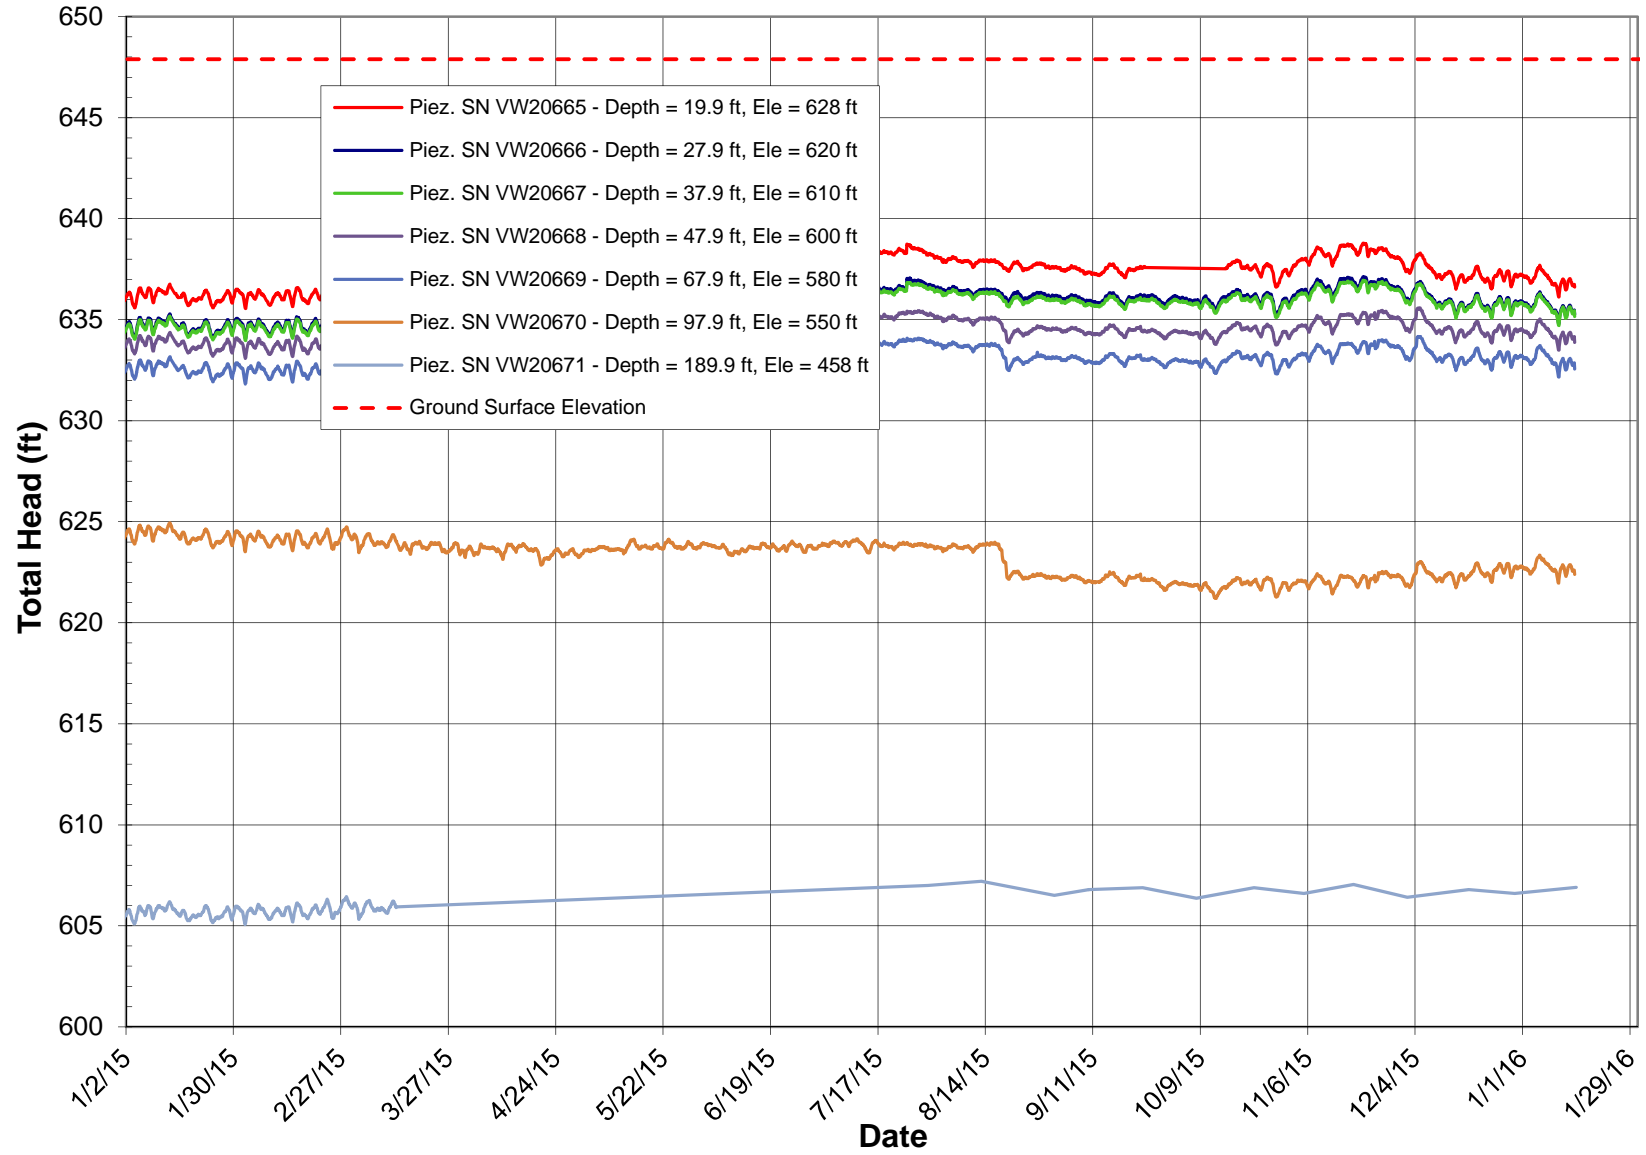
P-003-10 VW Piezometer Readings

P-003-10 – Total head in the five shallowest piezometers at this location decreased by about 0.5 feet over the past two weeks. The piezometer at 98 feet showed some fluctuations, but virtually no net change. The deepest piezometer, which is read manually, indicated a slight increase in total head.

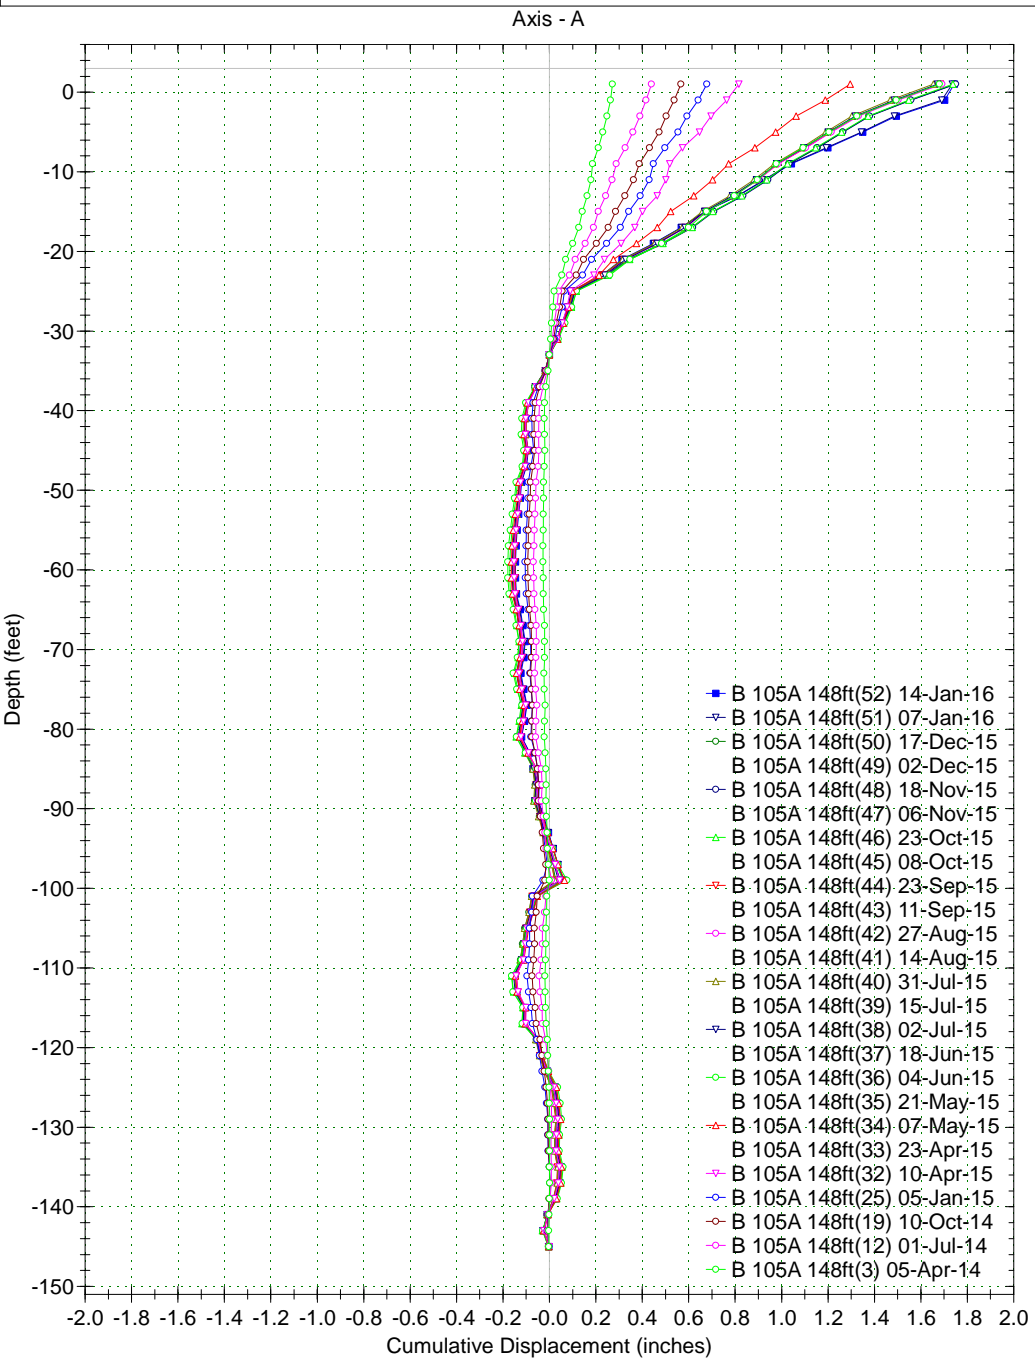
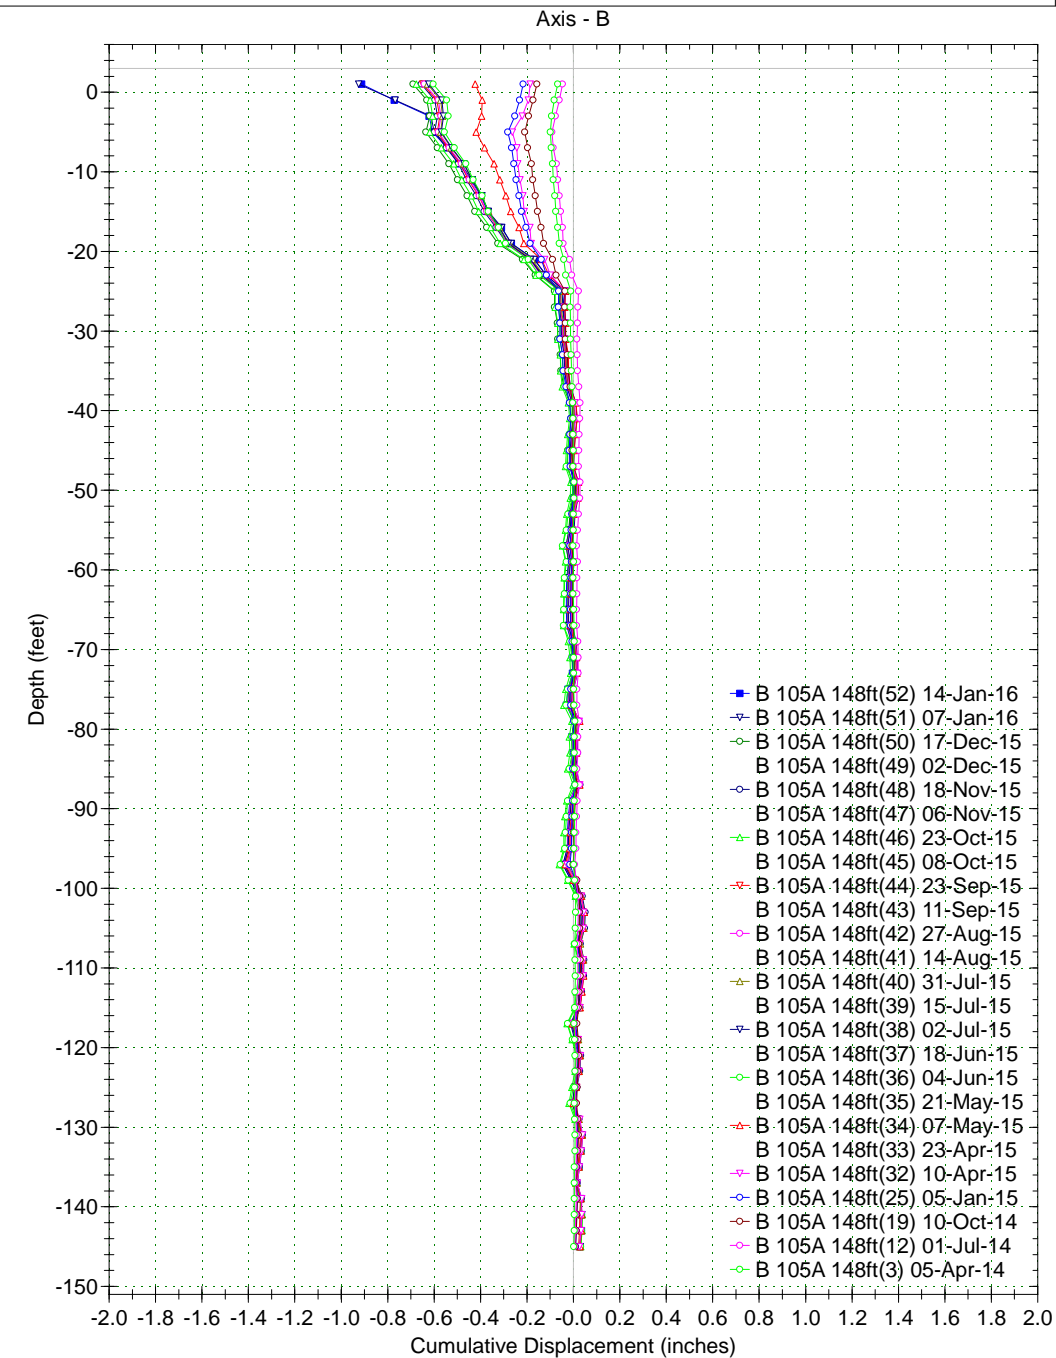
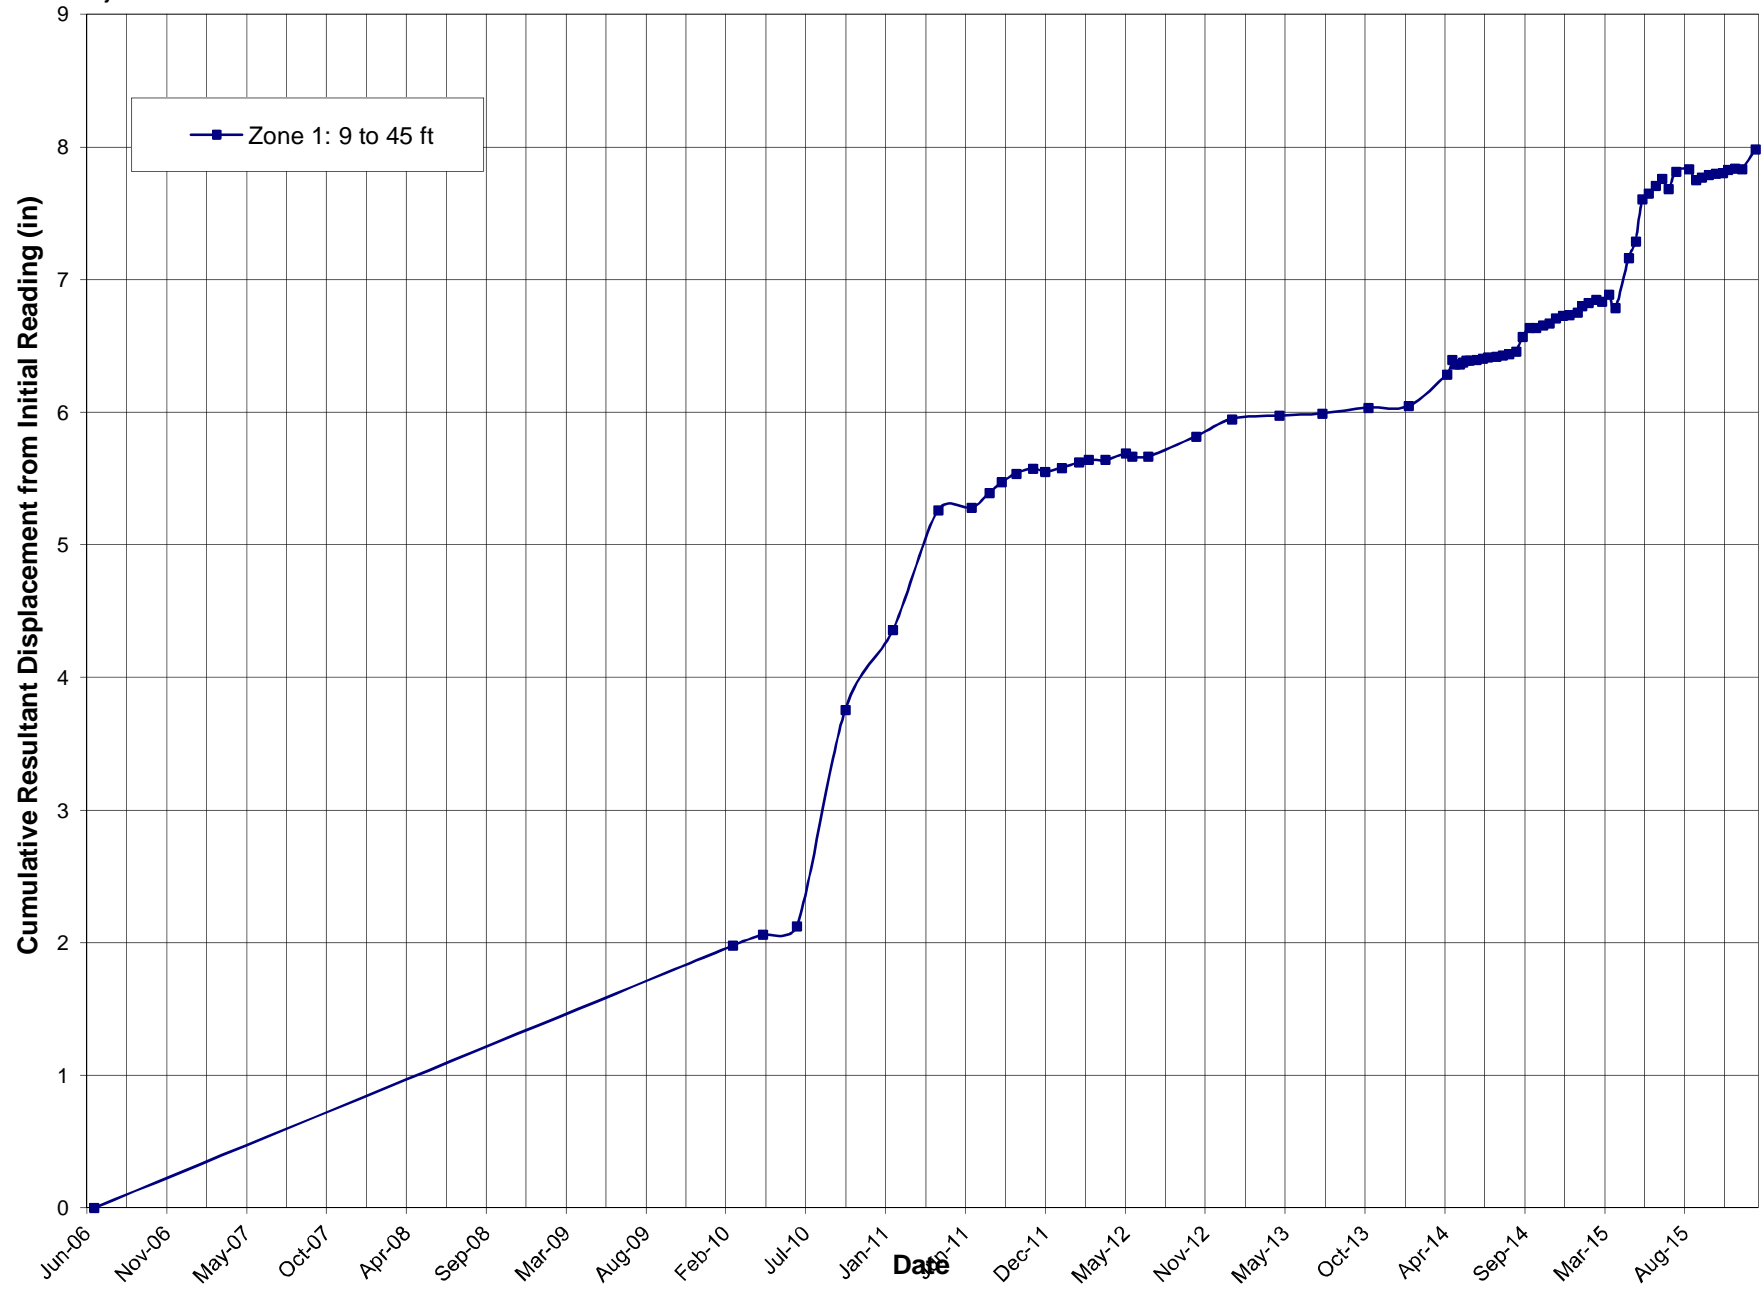
B-105A – The inclinometer at this location was damaged during excavation behind the bulkhead. Fortunately, the tube separated cleanly at a joint and we were able to attach a short section of tubing to line up with past readings. The attached plot shows past readings with the top 8 feet removed and the two recent readings taken after the interim “repair.” These last two readings show no movement. Compared to readings taken before the dock wall work, there was about 0.2 inches of displacement in the negative B-axis direction in the remaining top 4 feet (12 feet below the original top of casing) and slight displacement in the remaining top 10 feet in the positive A-axis direction. The zone plot for this location has been updated to show cumulative resultant displacements from 9 to 45 feet, which is now 1 to 37 feet from the new top of the slope tube.

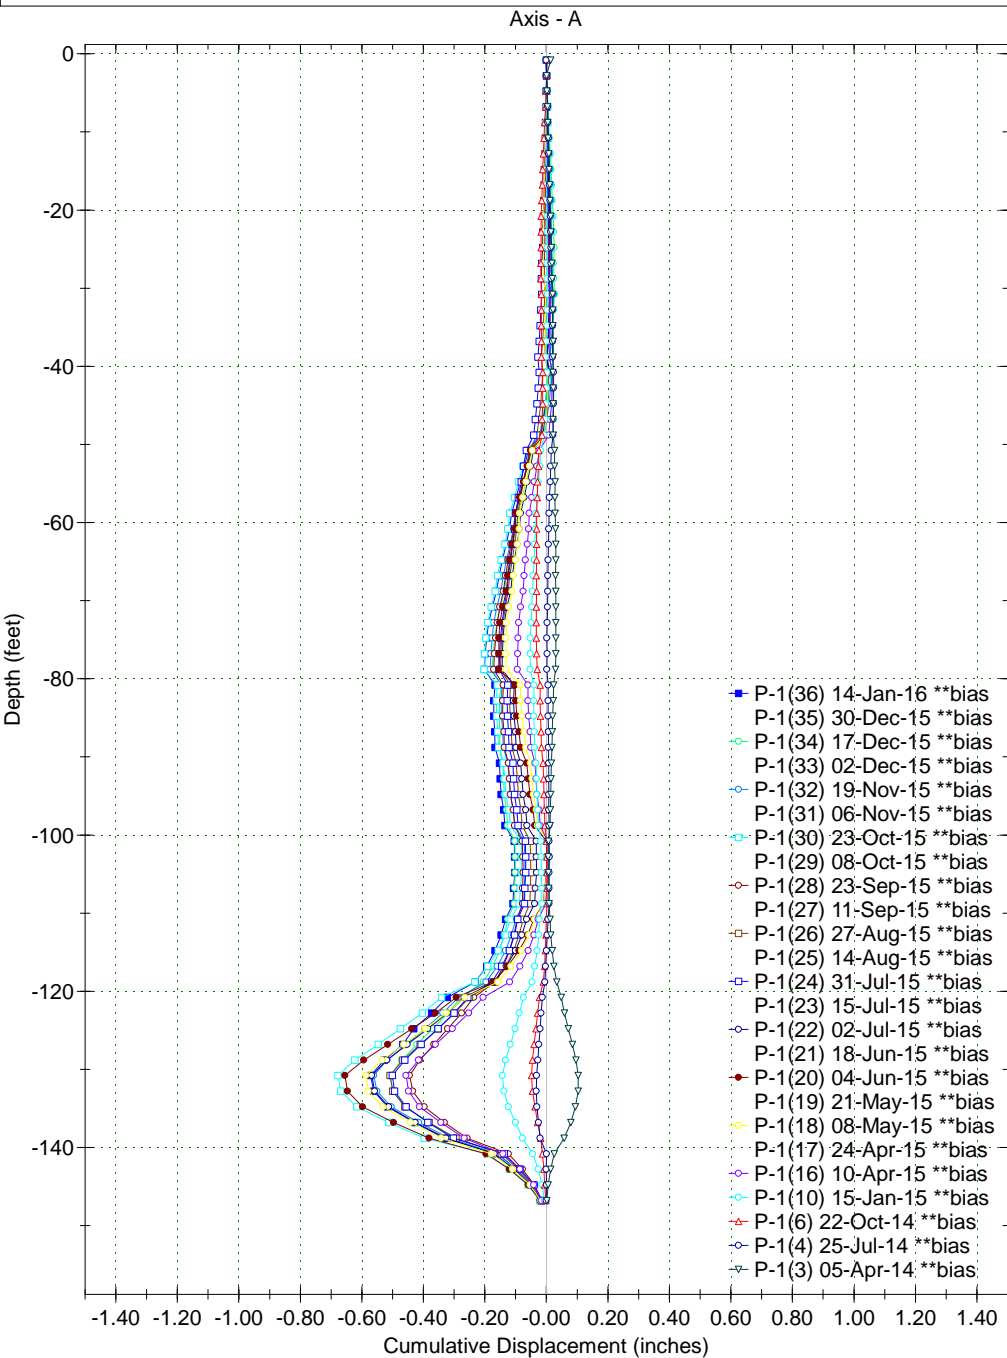
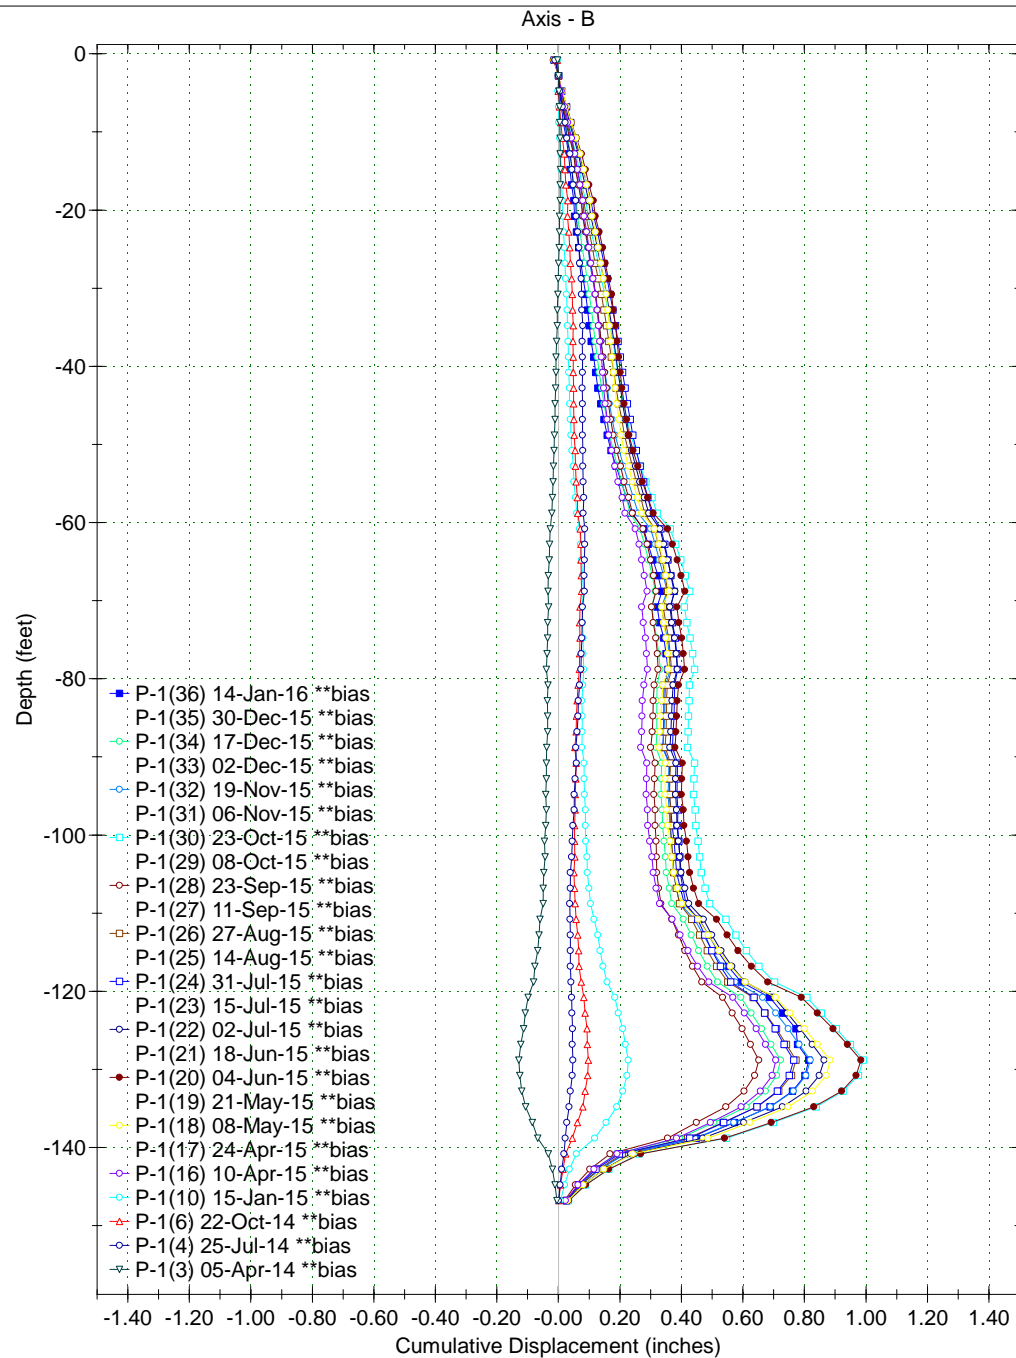
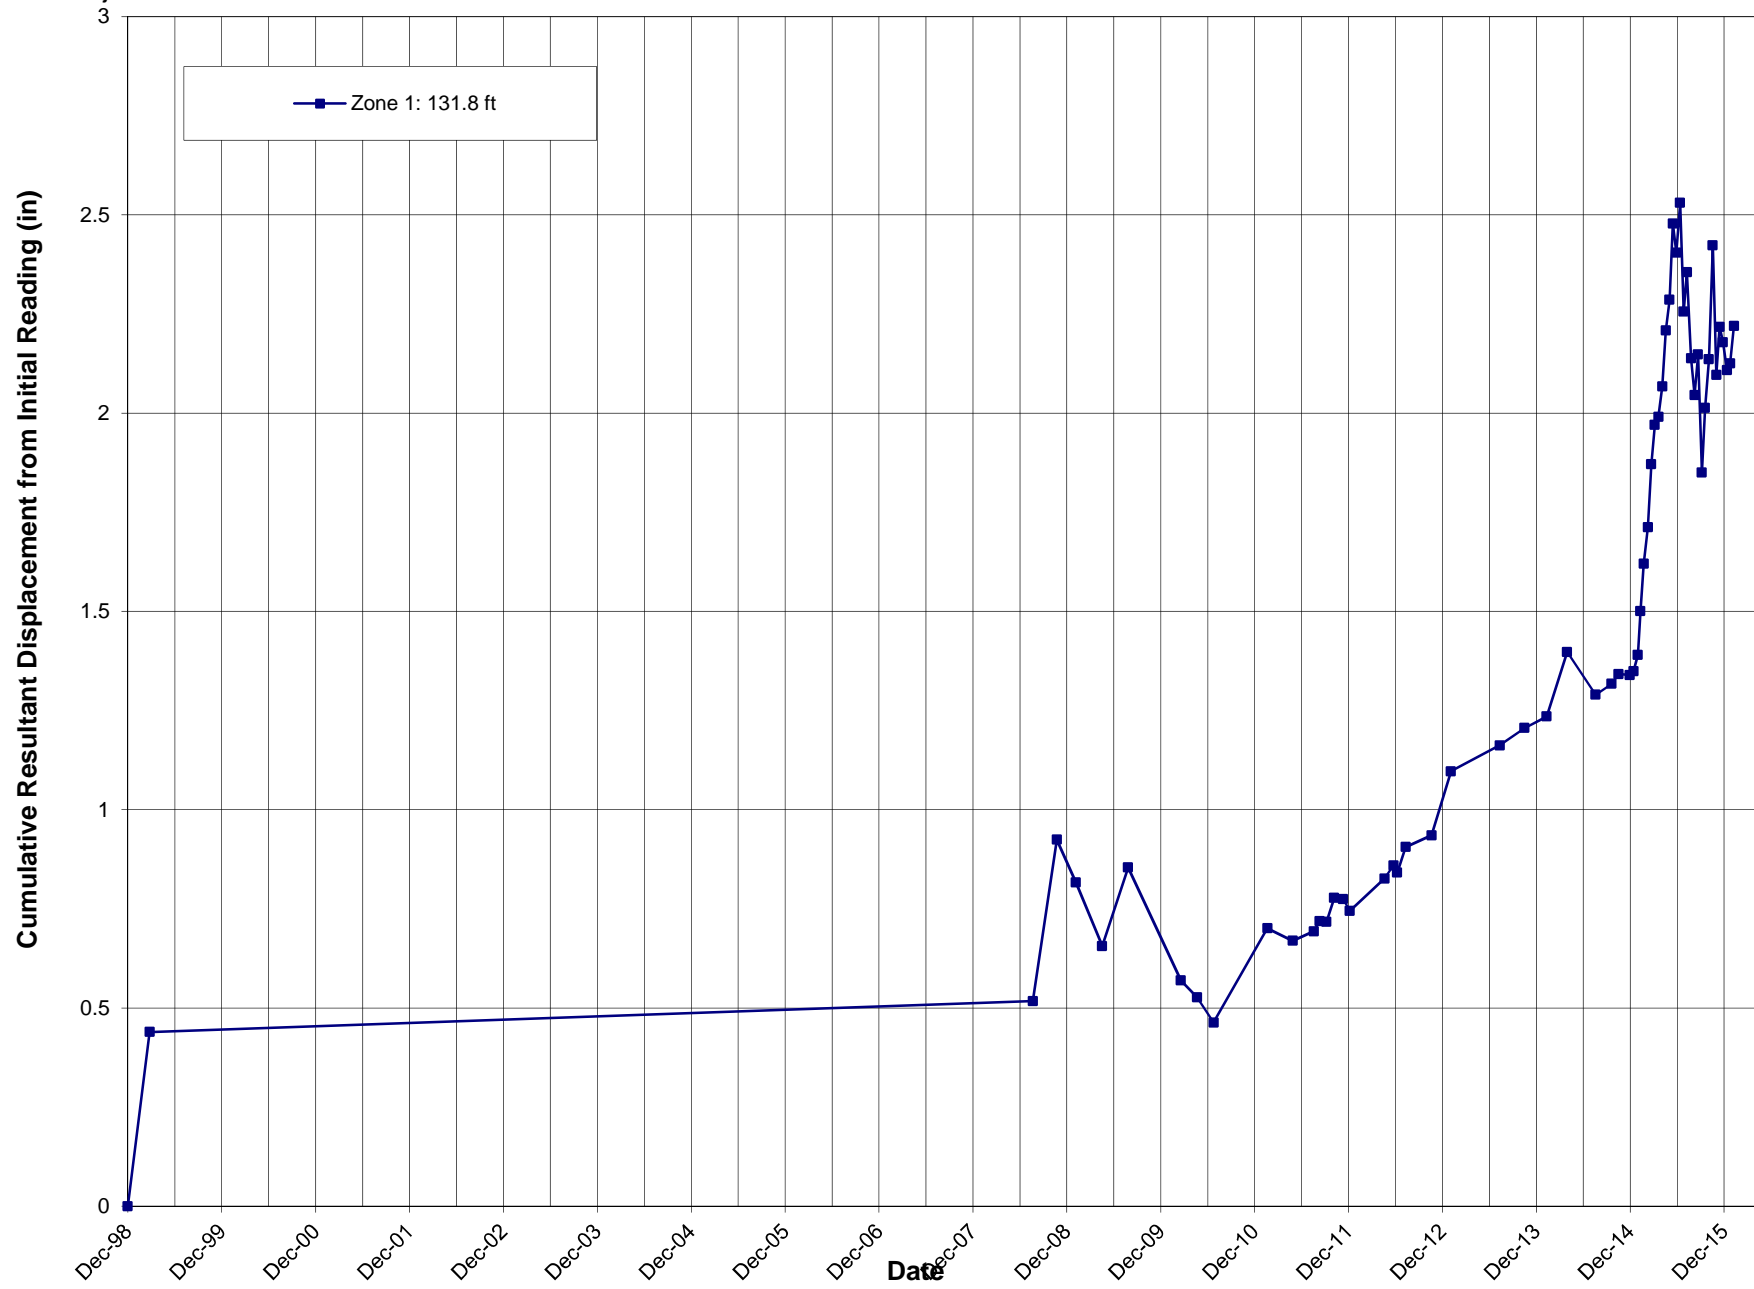
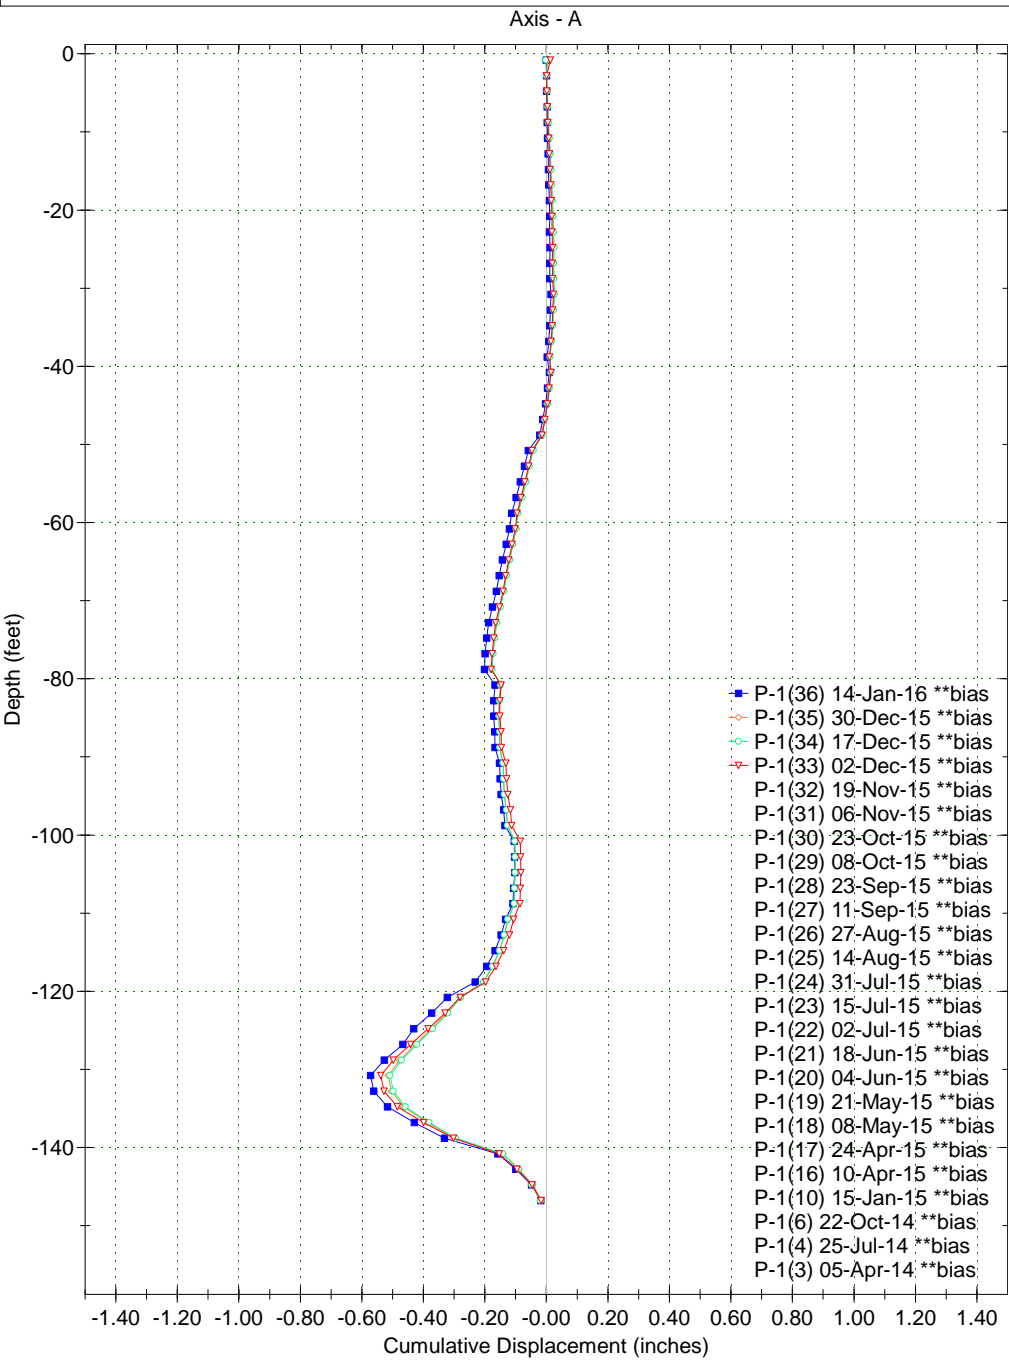
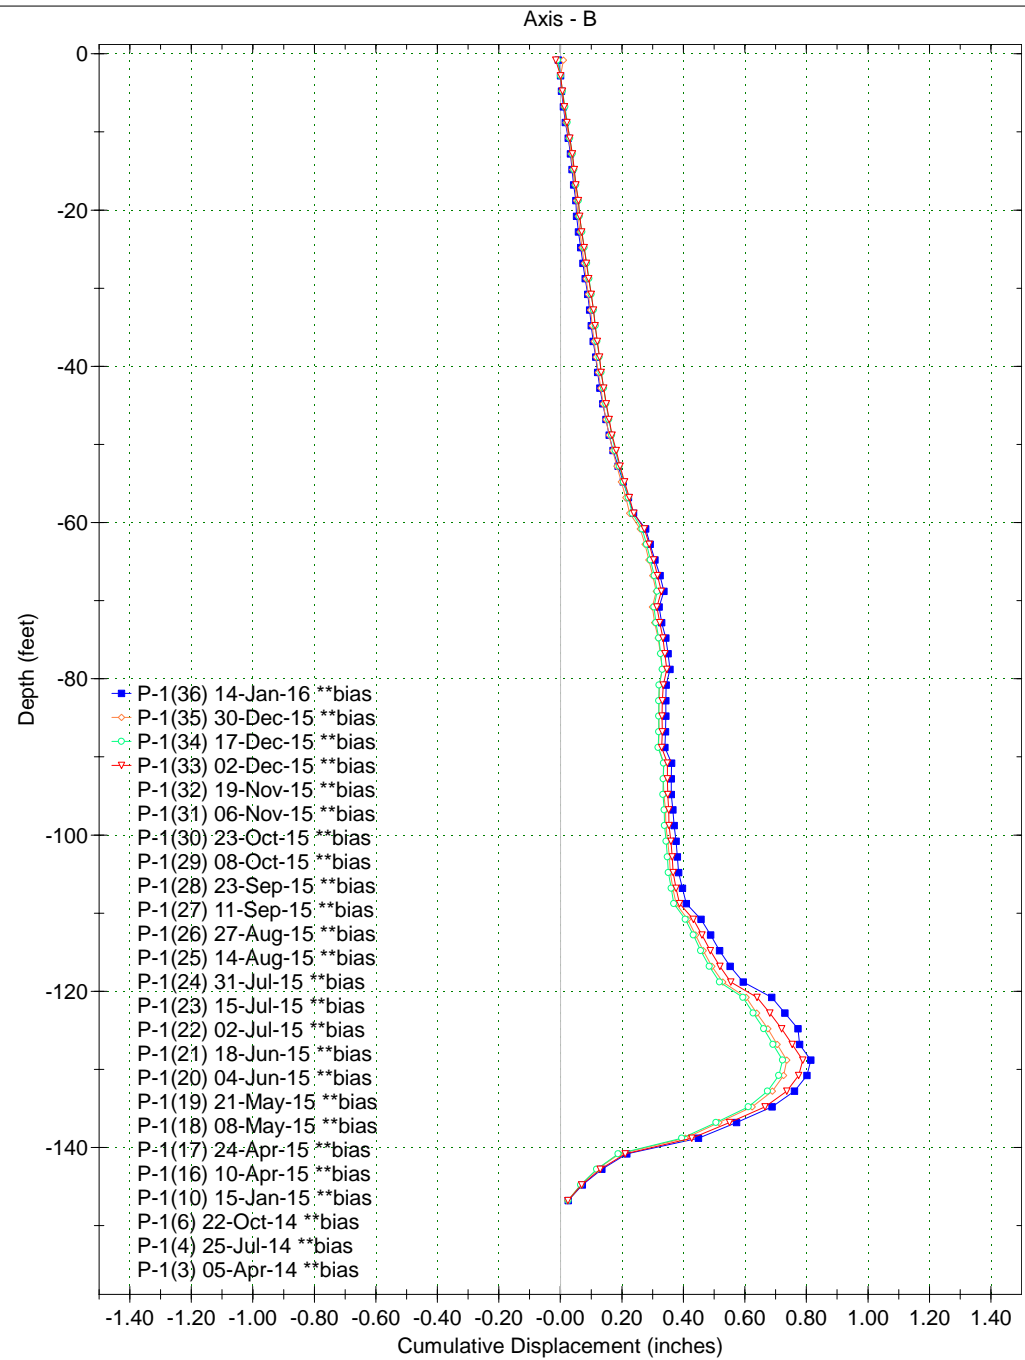
P-1 – At this location, the inclinometer readings indicate an increase in displacement between 120 and 140 feet in the negative A-axis direction and in the positive B-axis direction. The cumulative resultant displacement zone plot at 132 feet shows an increase of about 0.1 inches. The displacement is still well below the maximum displacement reading.
