February 4, 2016

Re: January 28 and 29, 2016 Bi-Weekly Readings
CUY-90-15.24 Slope Monitoring
PID 96504
SME Project No. 069032.00

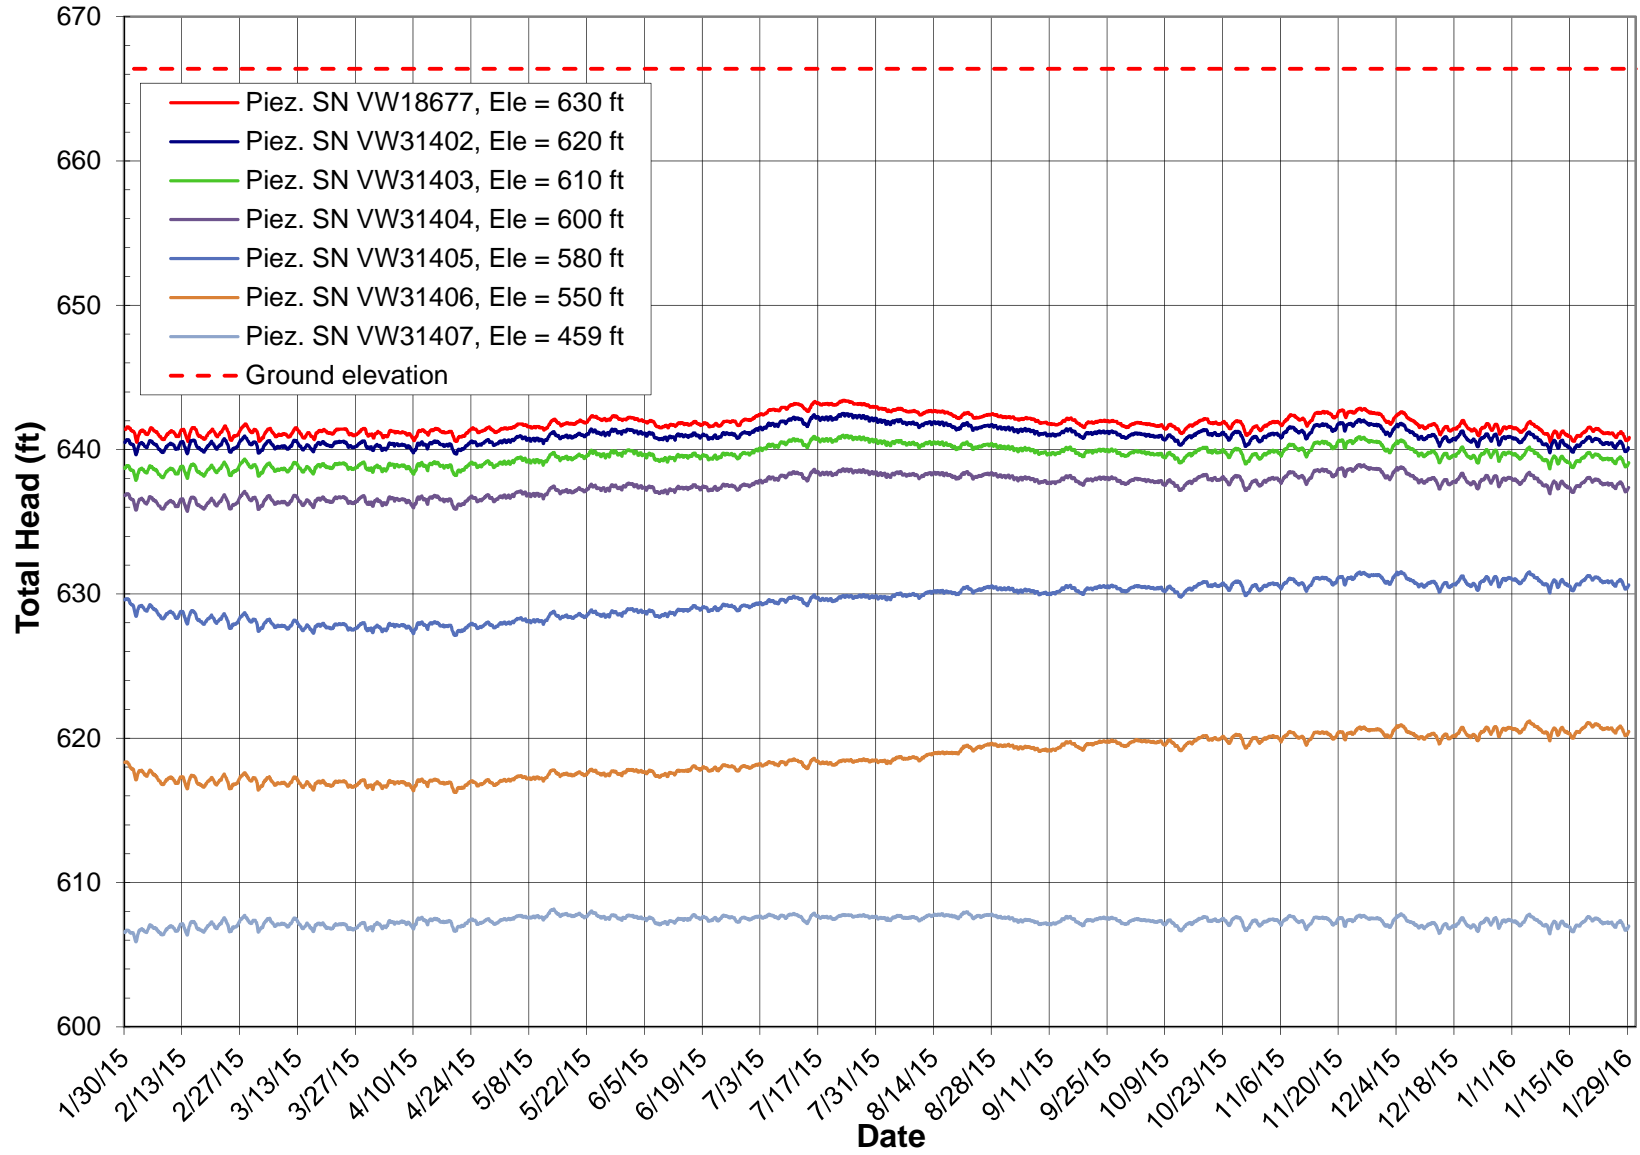
P-001-13 VW Piezometer Readings

P-001-13, P-002-13, P-003-10, B-05-04, B-05-A-11 –Pore pressure readings at these locations indicate slight fluctuations in total head throughout this reading period but virtually no net change.

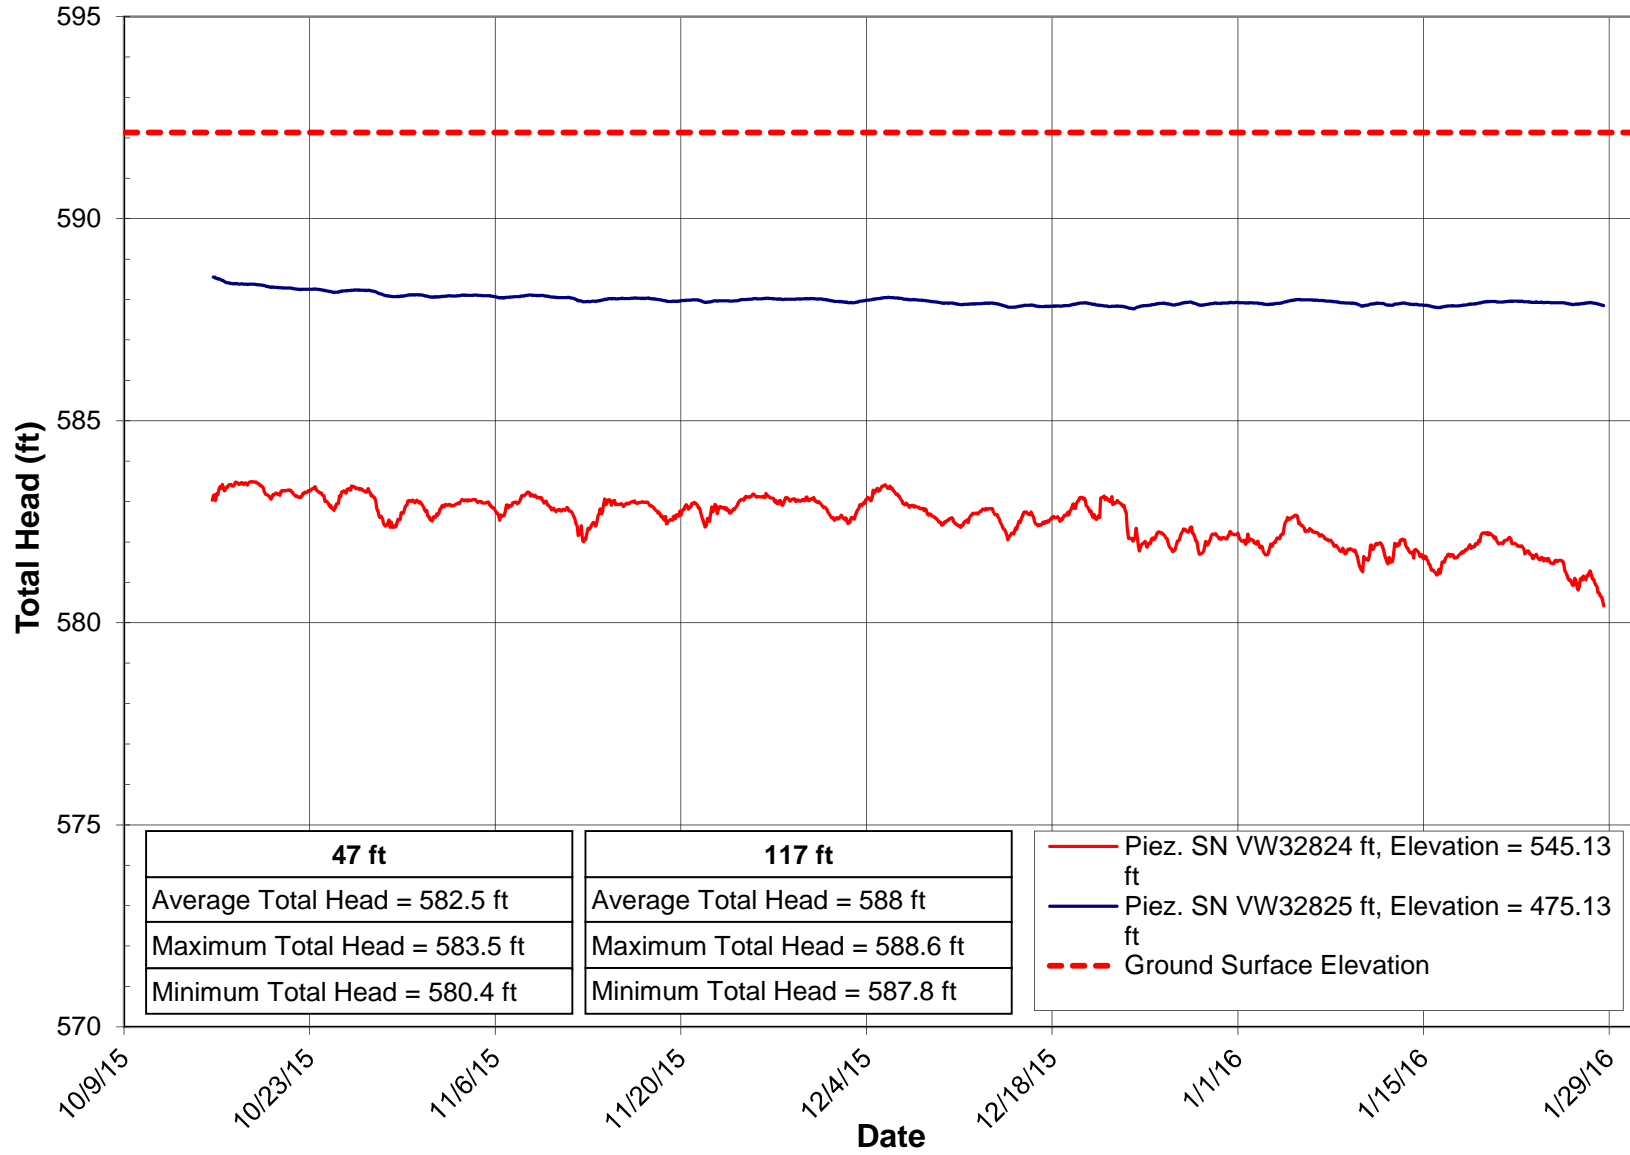
P-004-13 VW Piezometer Readings

P-004-13 – Instruments at this location are now accessible. The last time we were able to download data from the dataloggers was December 18, 2015. Since that time, the total head in the shallow piezometer has shown a net decrease of 2.2 feet. There was virtually no change in the pore pressure recorded by the deep piezometer.

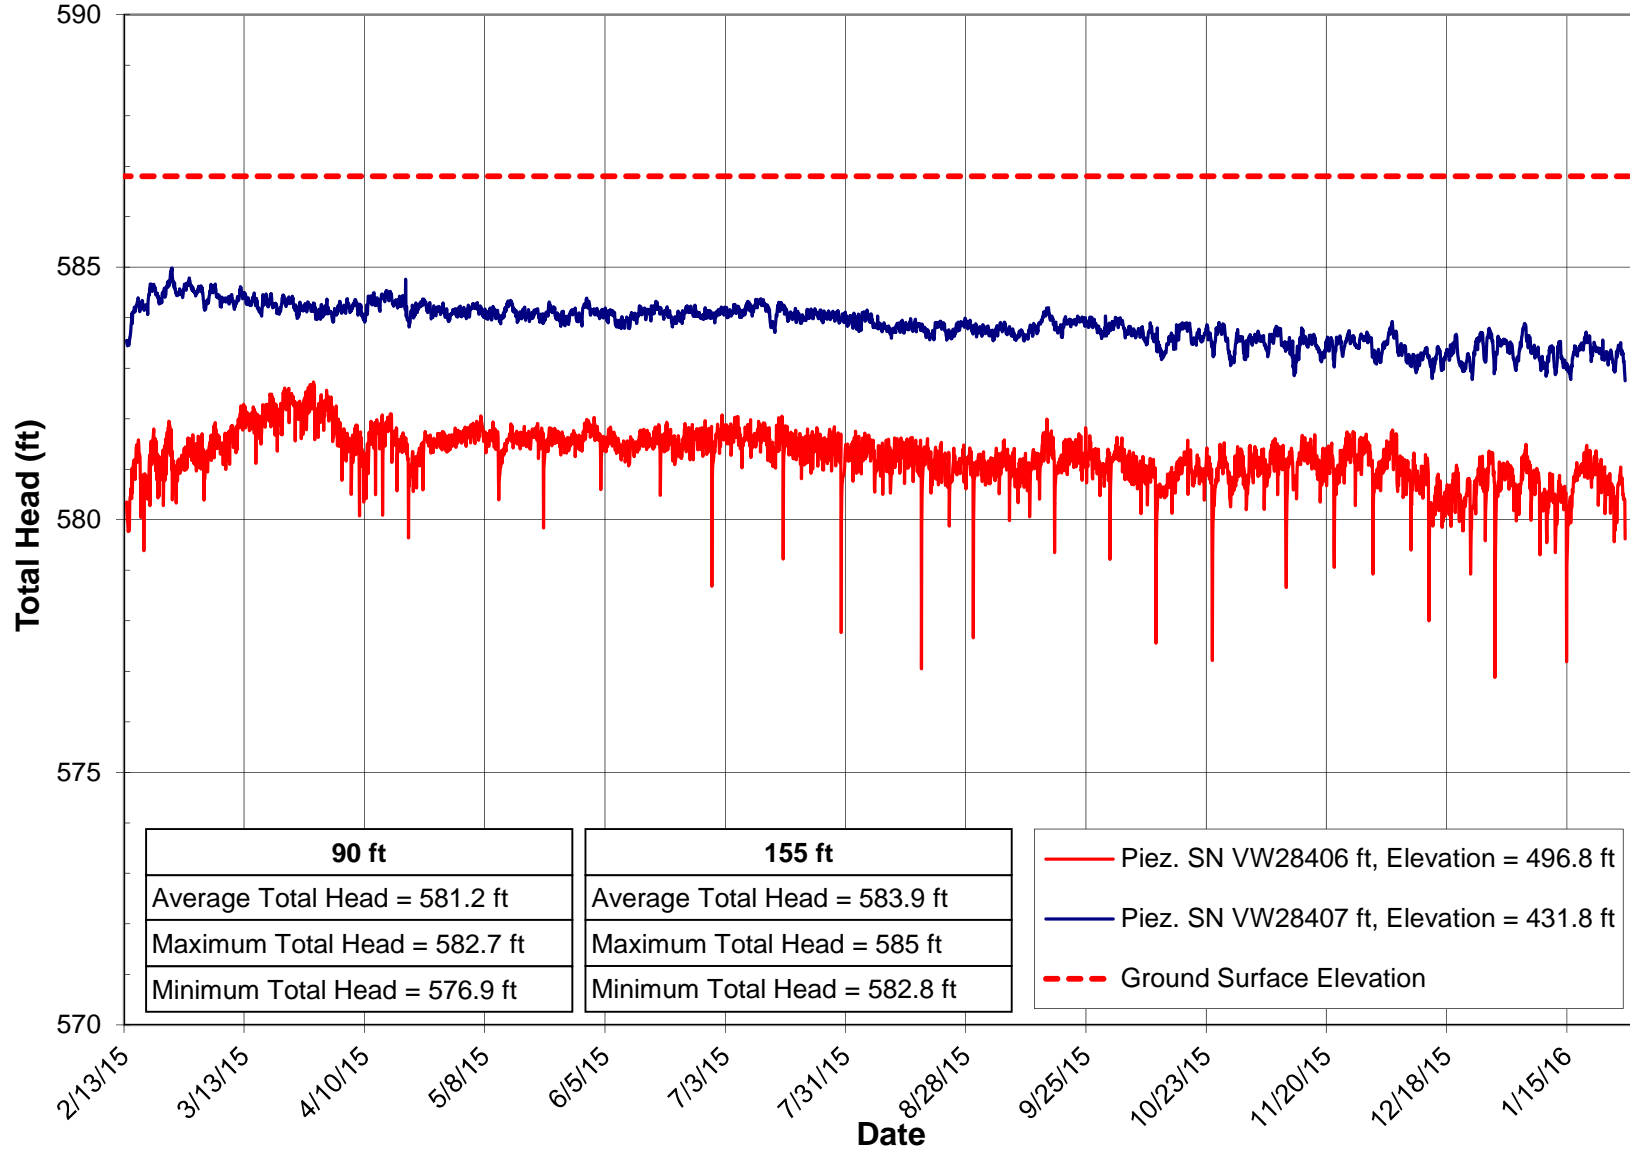
P-009-13 VW Piezometer Readings

P-009-13 – Pore pressures at this location varied over a range of about 2 feet but ended the two-week period with pore pressures about the same as at the start of the period.

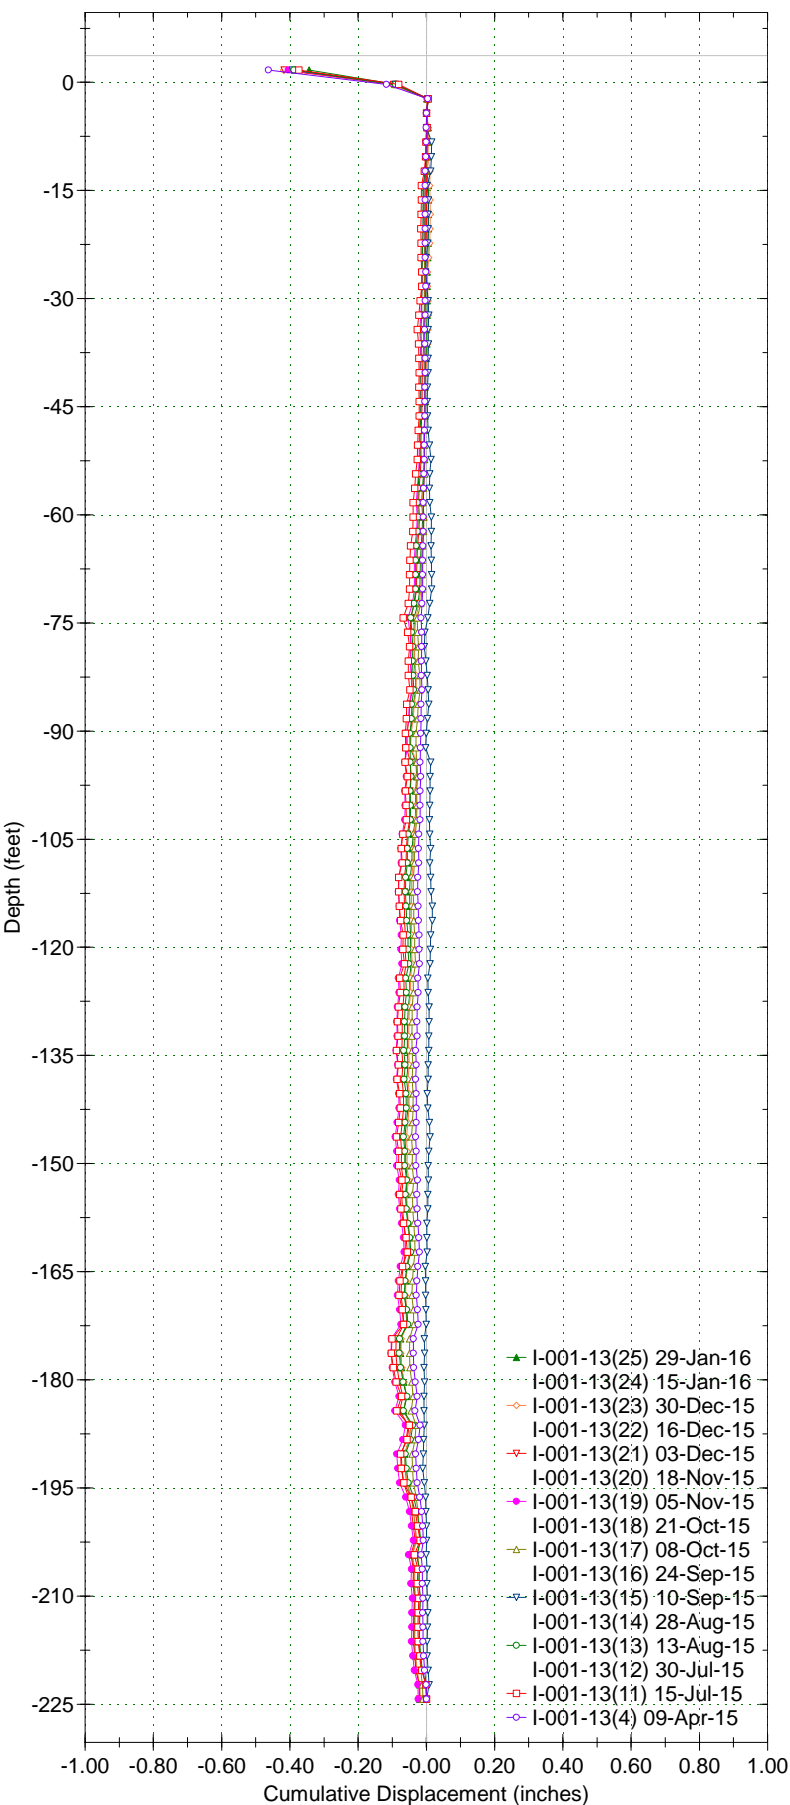
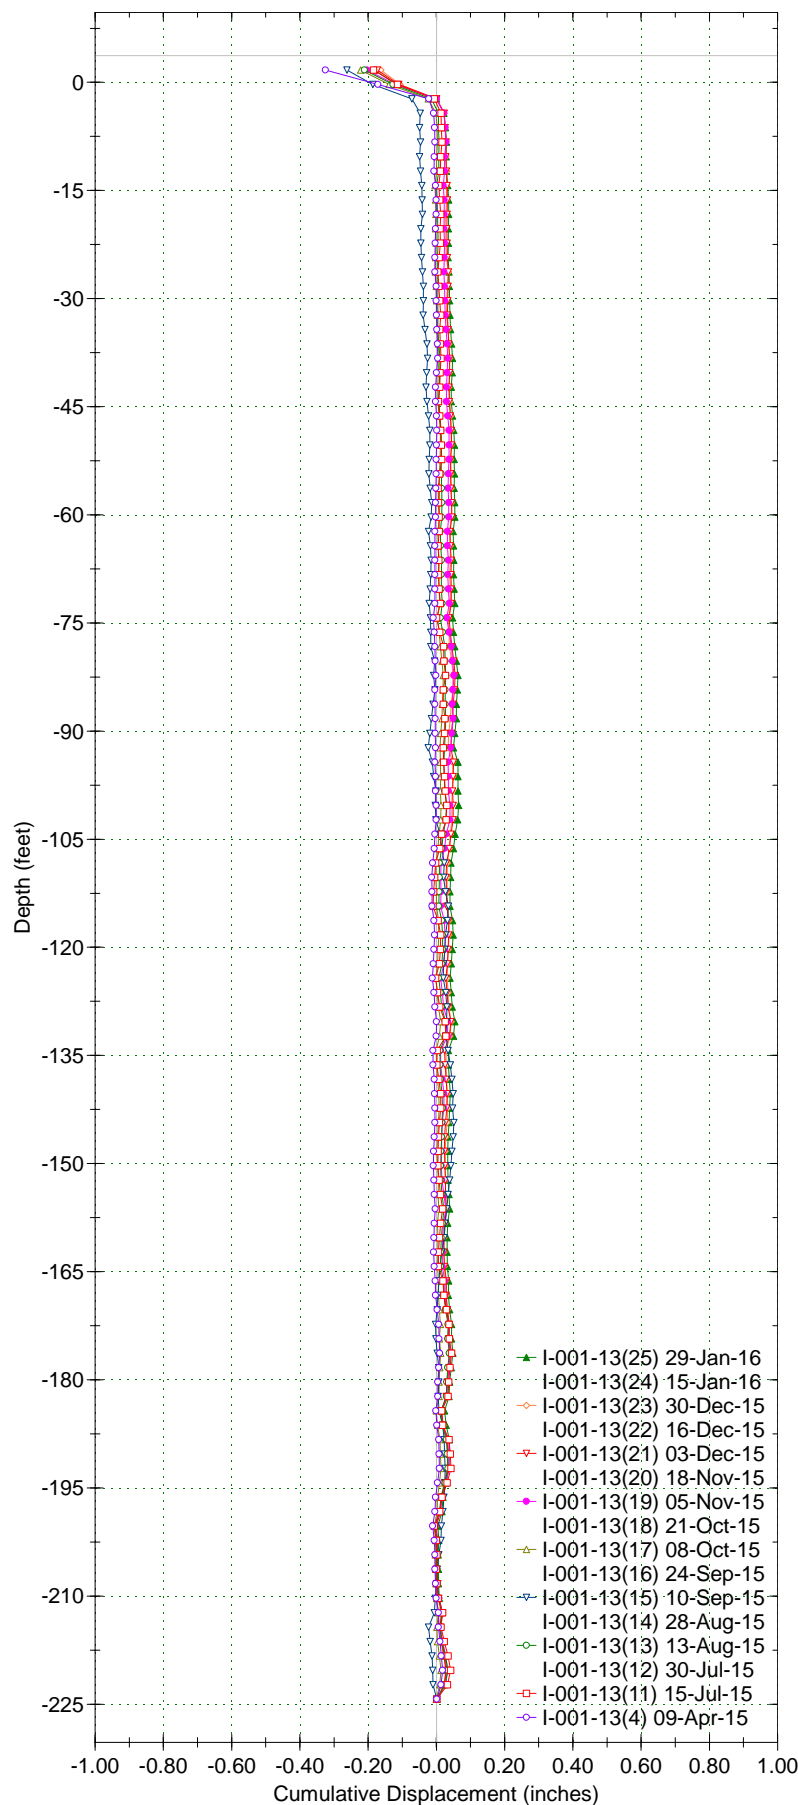
Borehole : I-001-13
Project : CUY-90-15-24
Location : Cleveland, Ohio
Northing :
Easting :
Collar :

Inclinometer readings at I-001-13, I-002-13, I-003-10B-101, B-102, B-105A, B-05-04, B-05-A-11, P-1, P-9N, and TGR I-4 showed virtually no movement this two-week period. Displacements shown at the top of some slope tubes is due to flexing of the tube when readings are taken because some of the protective covers are only temporarily set in place until earthwork near these installations is completed.

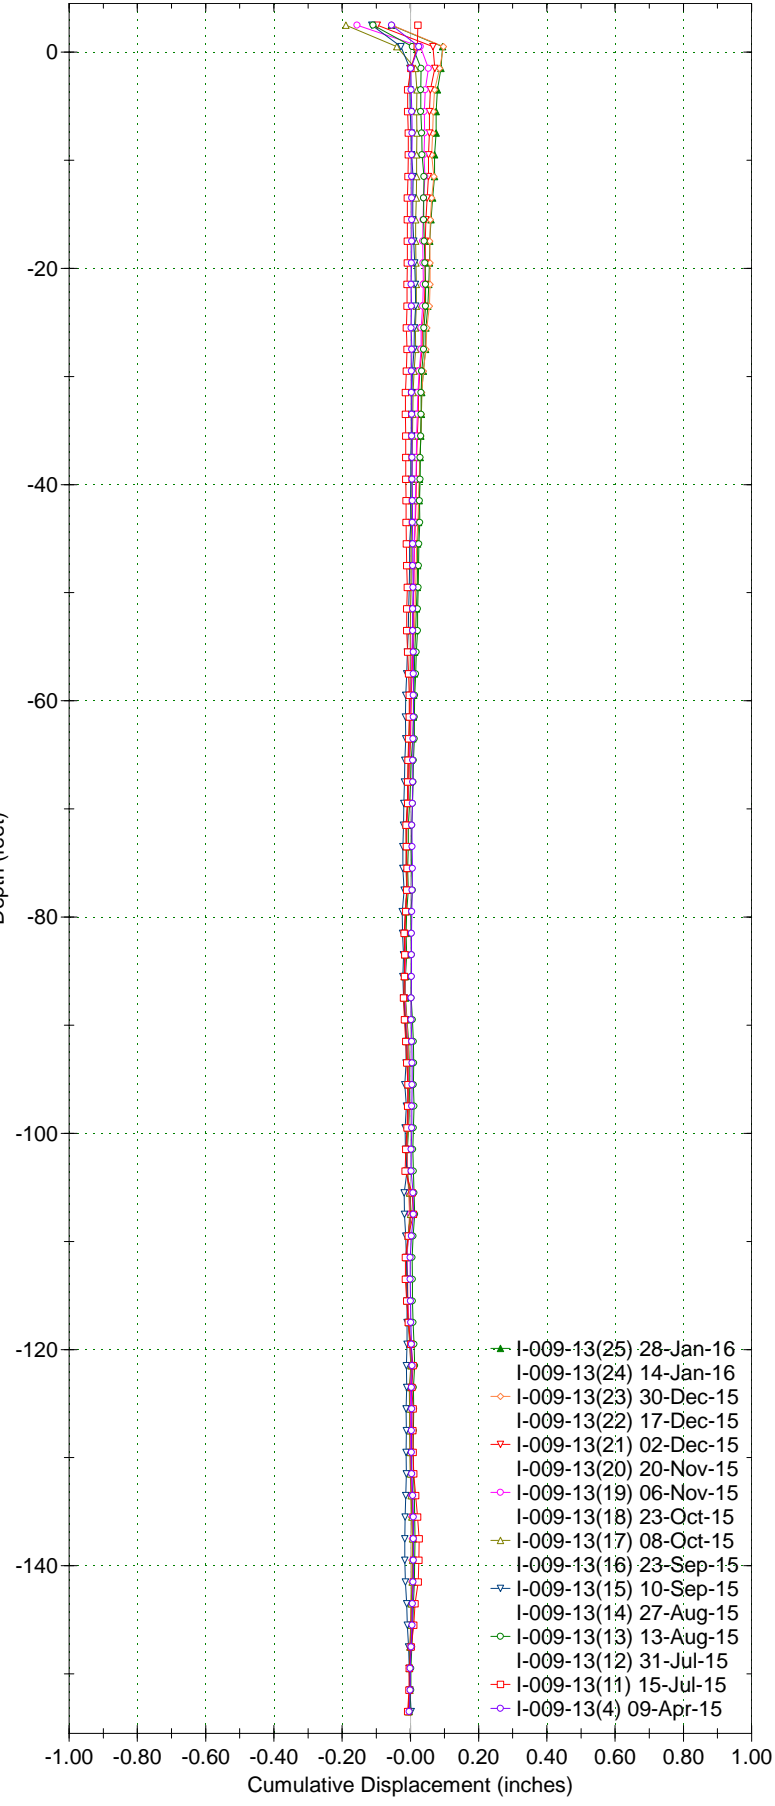
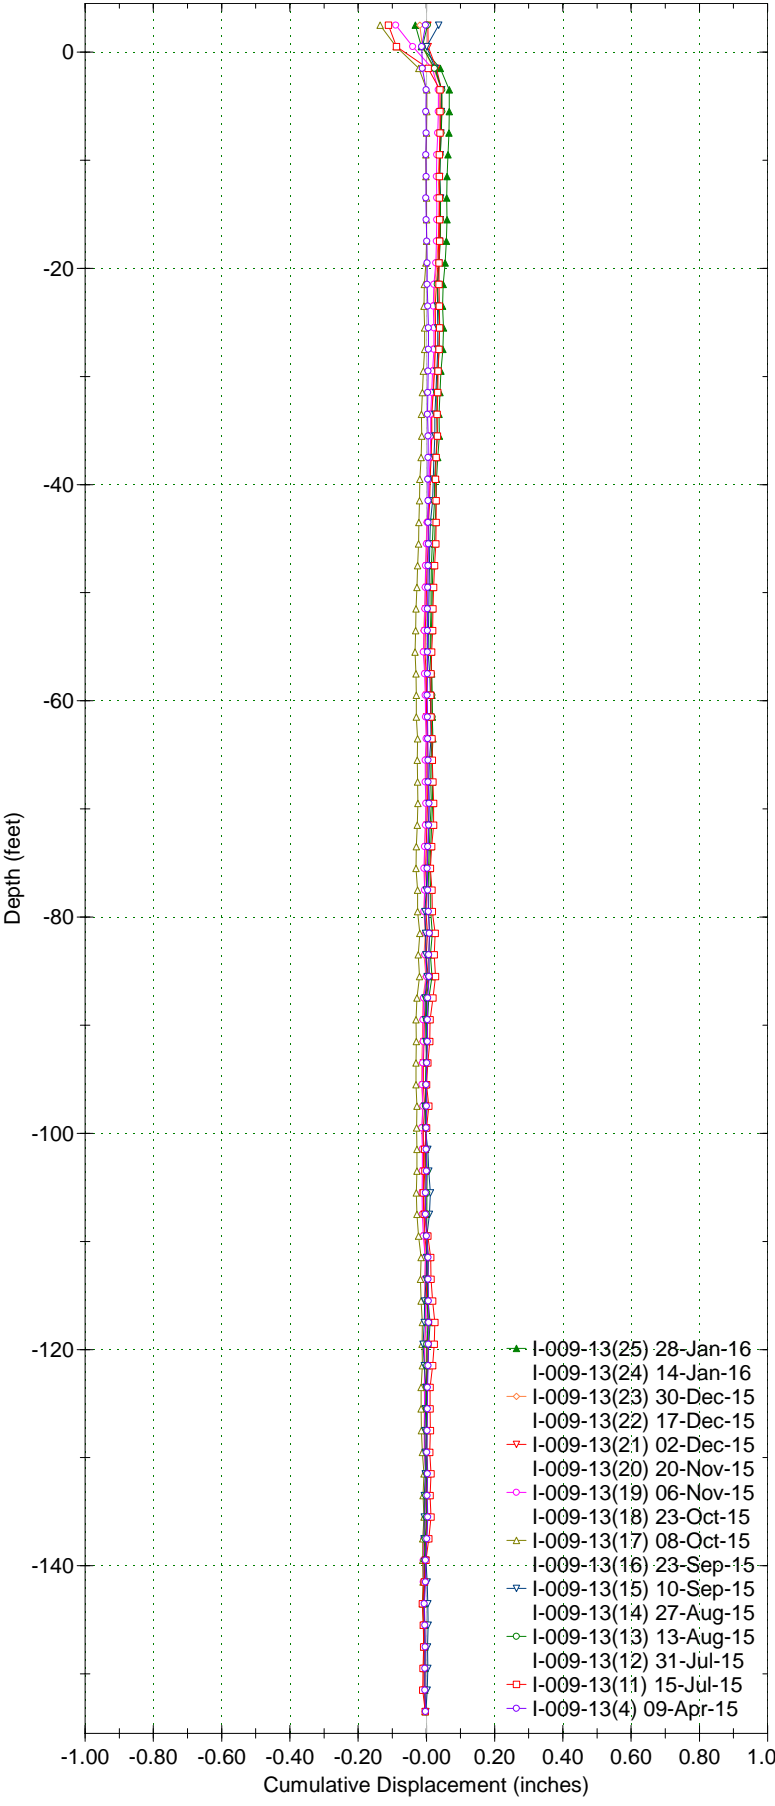
Borehole : I-009-13
Project : CUY-90-15-24
Location : Cleveland, Ohio
Northing :
Easting :
Collar :

I-009-13 – Readings this period indicate slight positive A-axis displacement in the upper 10 feet and slight B-axis displacement in the upper 30 feet of the profile.
