Re: January 2016 Quarterly Report
CUY-90-15.24 Slope Monitoring
PID 96504
EDP Project No. 069032.00

JANUARY 2016 QUARTERLY REPORT

CUY-90-15.24 SLOPE MONITORING
PID 96504
CLEVELAND, OHIO
SME PROJECT NO. 069032.00

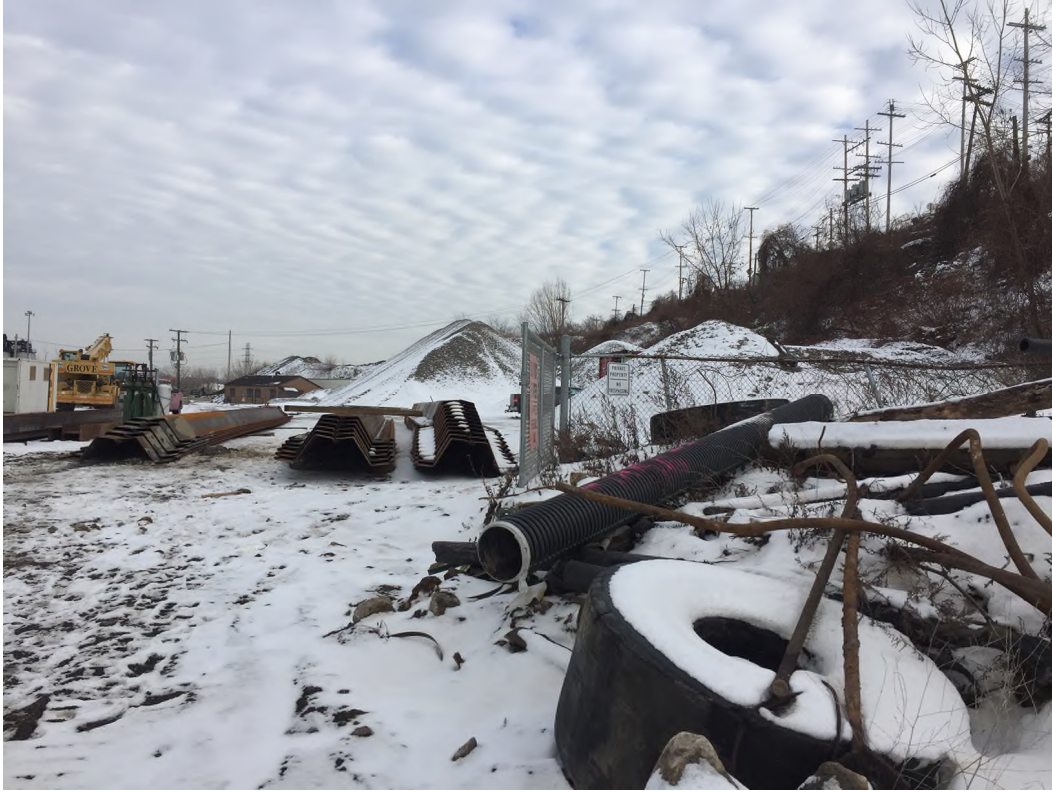
Figure 4. Aggregate stockpile east of the ODOT right-of-way (January 15, 2016)

We observed and photographed the aggregate stockpiles on January 15, 2016. The photos are Figures 4 and 5 which are included in Appendix A. Only a small pile of aggregate closest to the right-of-way fence remains. This pile has been virtually unchanged since January 2014. The pile is about 8 feet high and covers only a small area of the property.

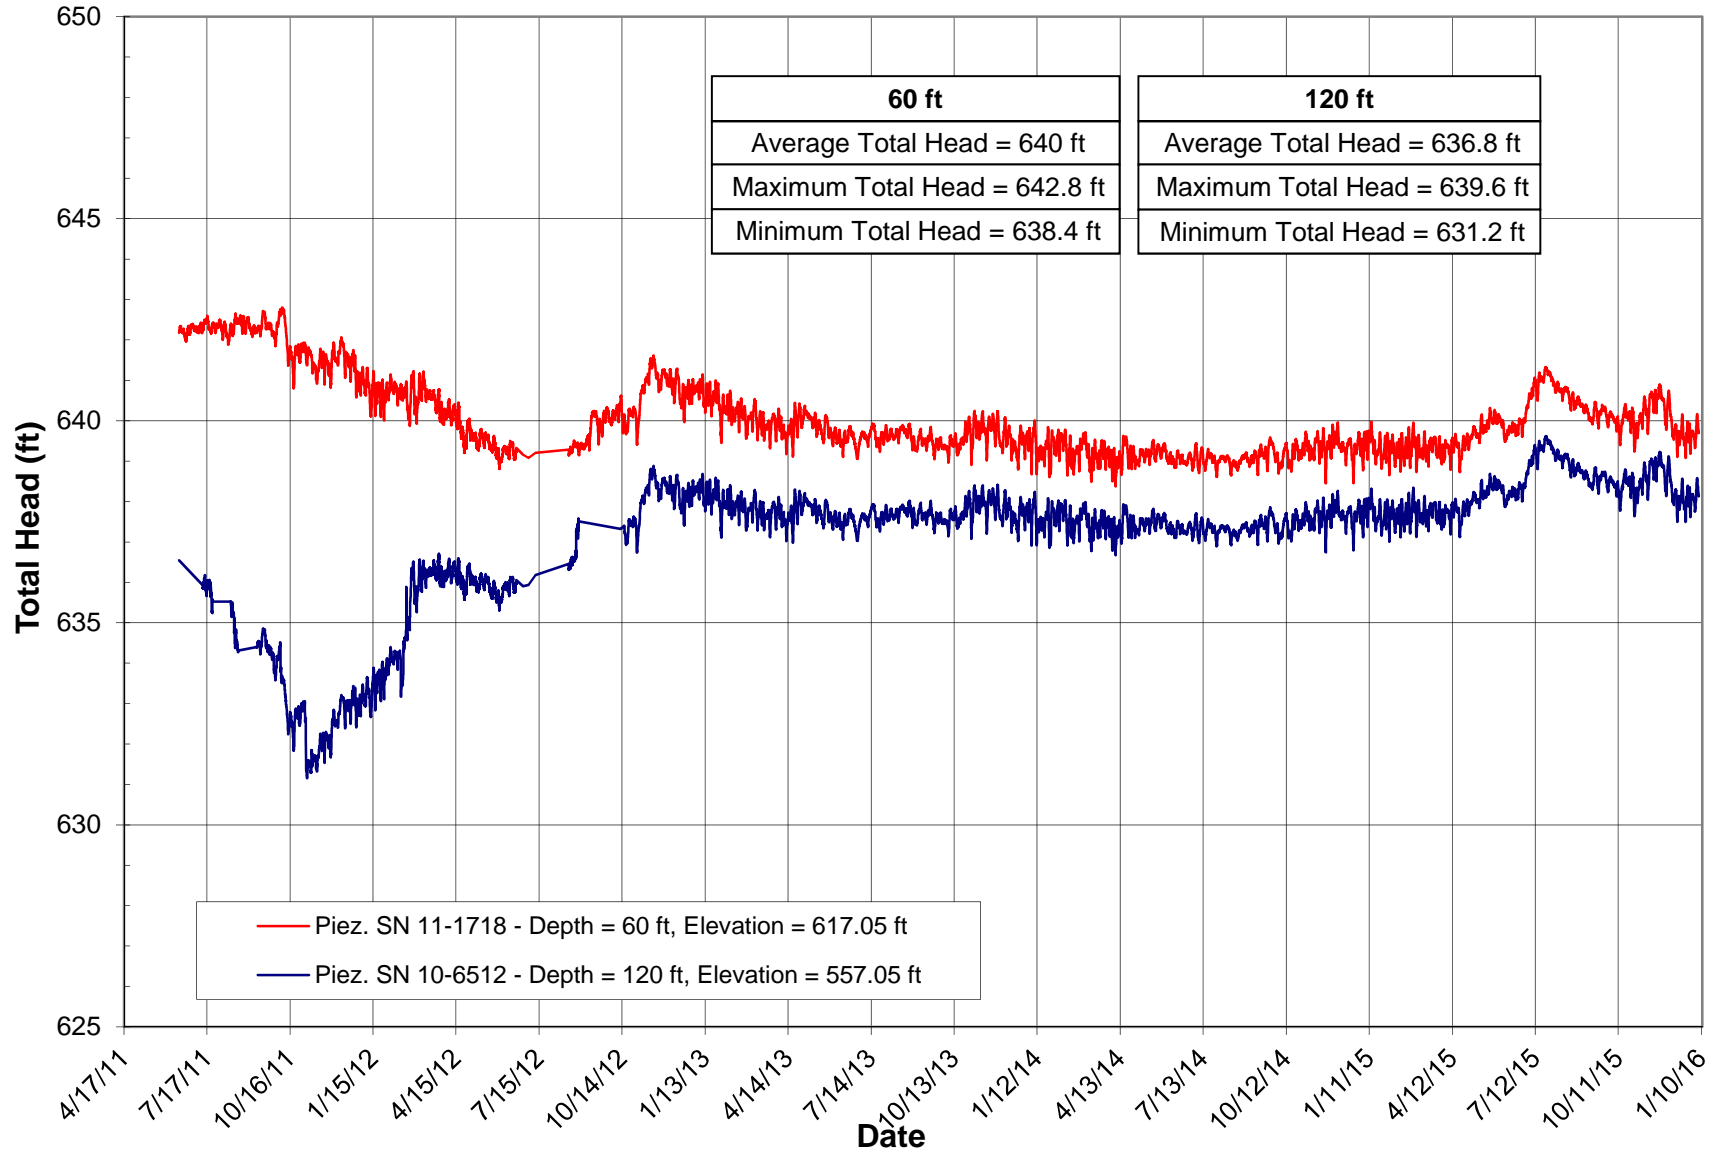
P-001-10 VW Piezometer Readings

P-001-10. Total head in both piezometers at P-001-10 increased by about 1 foot through the first half of this quarter then decreased by about the same amount with virtually no net change for the quarter.

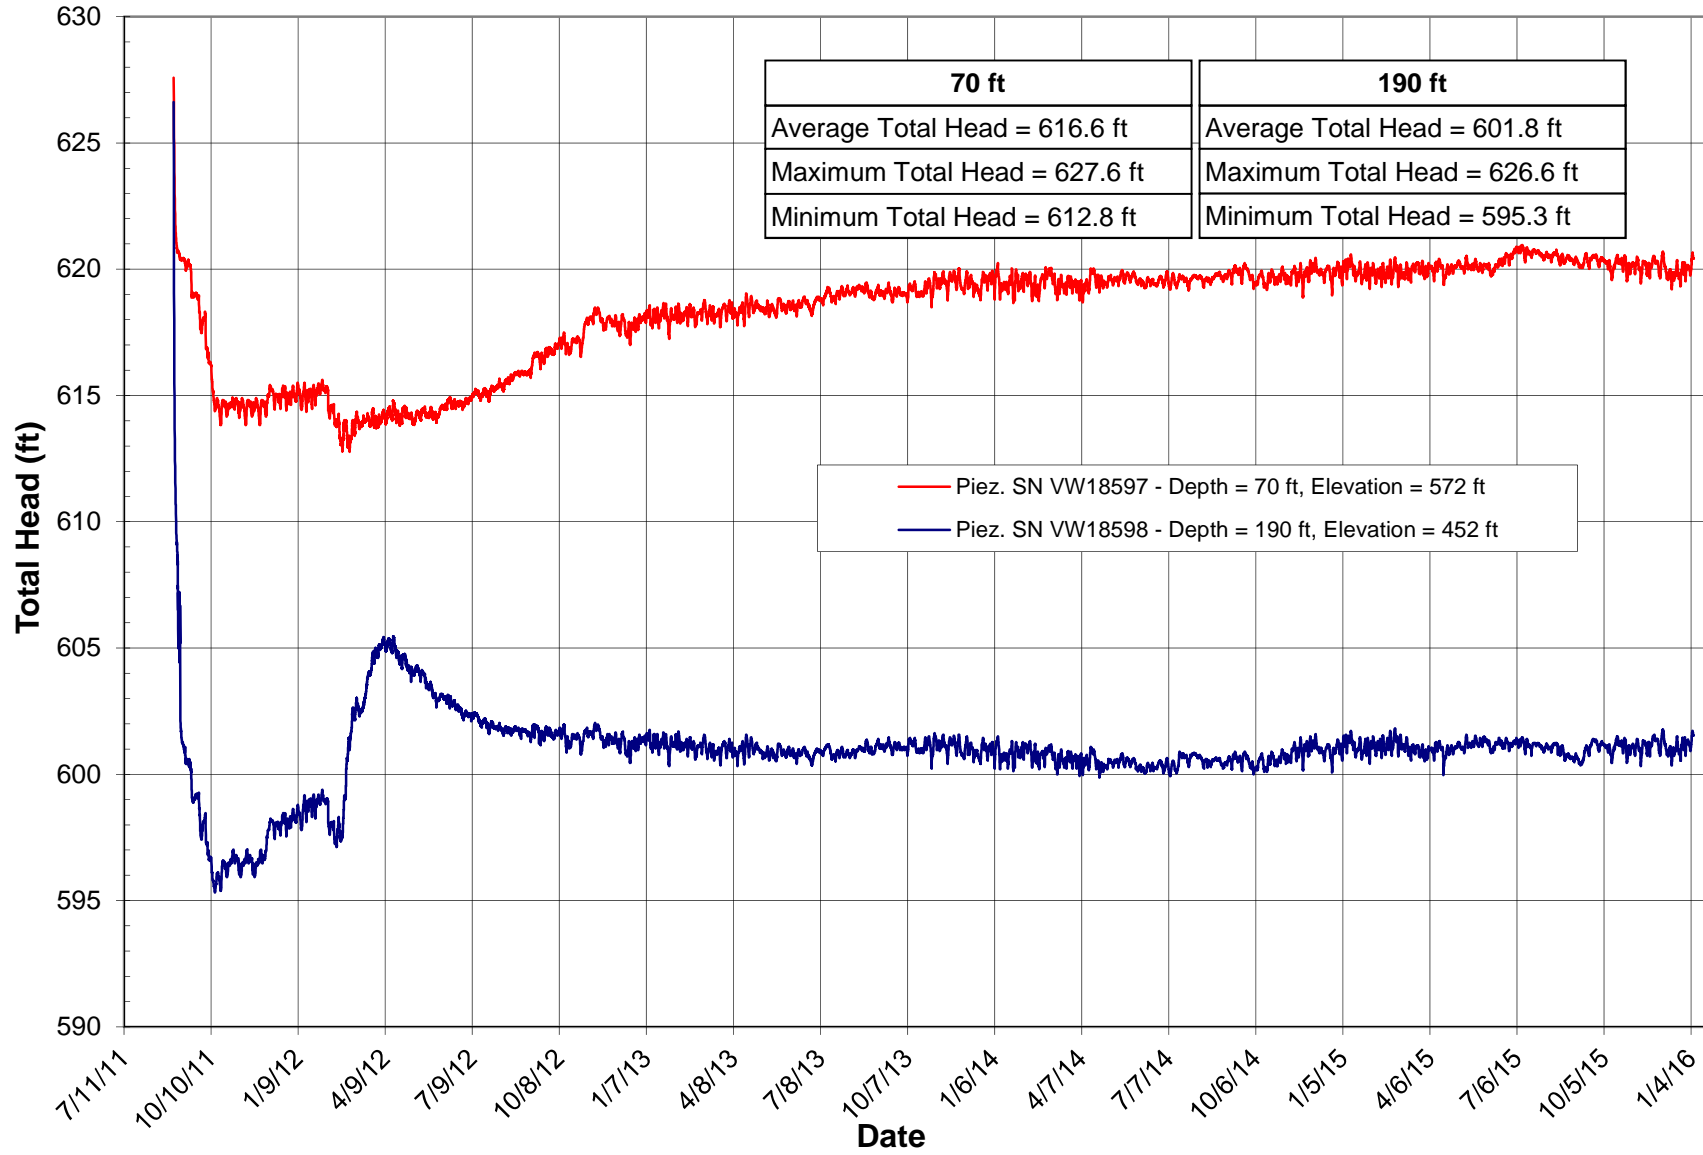
P-002-10 VW Piezometer Readings

P-002-10. Total head in both piezometers at P-002-10 fluctuated slightly over the past quarter, but show virtually no net change.

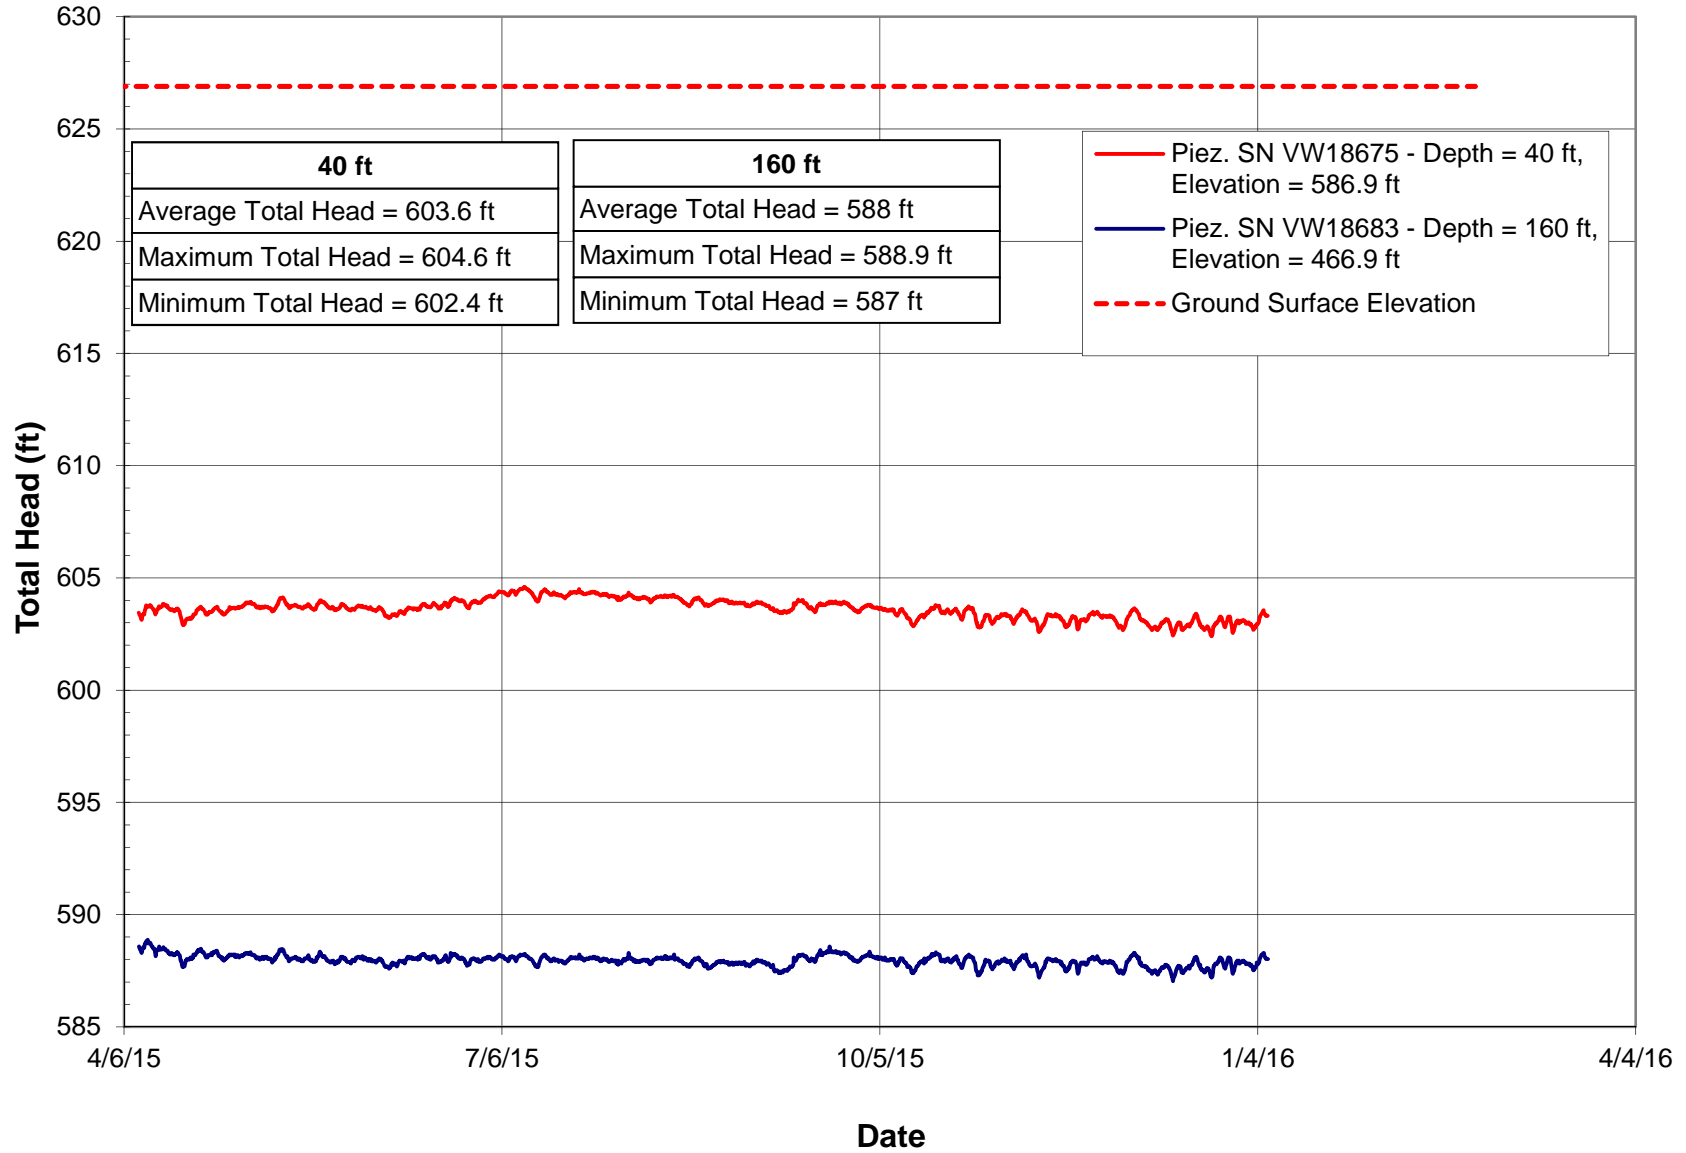
P-007-13 VW Piezometer Readings

P-007-13. In both piezometers at P-007-13, pore pressure readings indicate only minor fluctuations in total head over the past quarter with no significant changes.

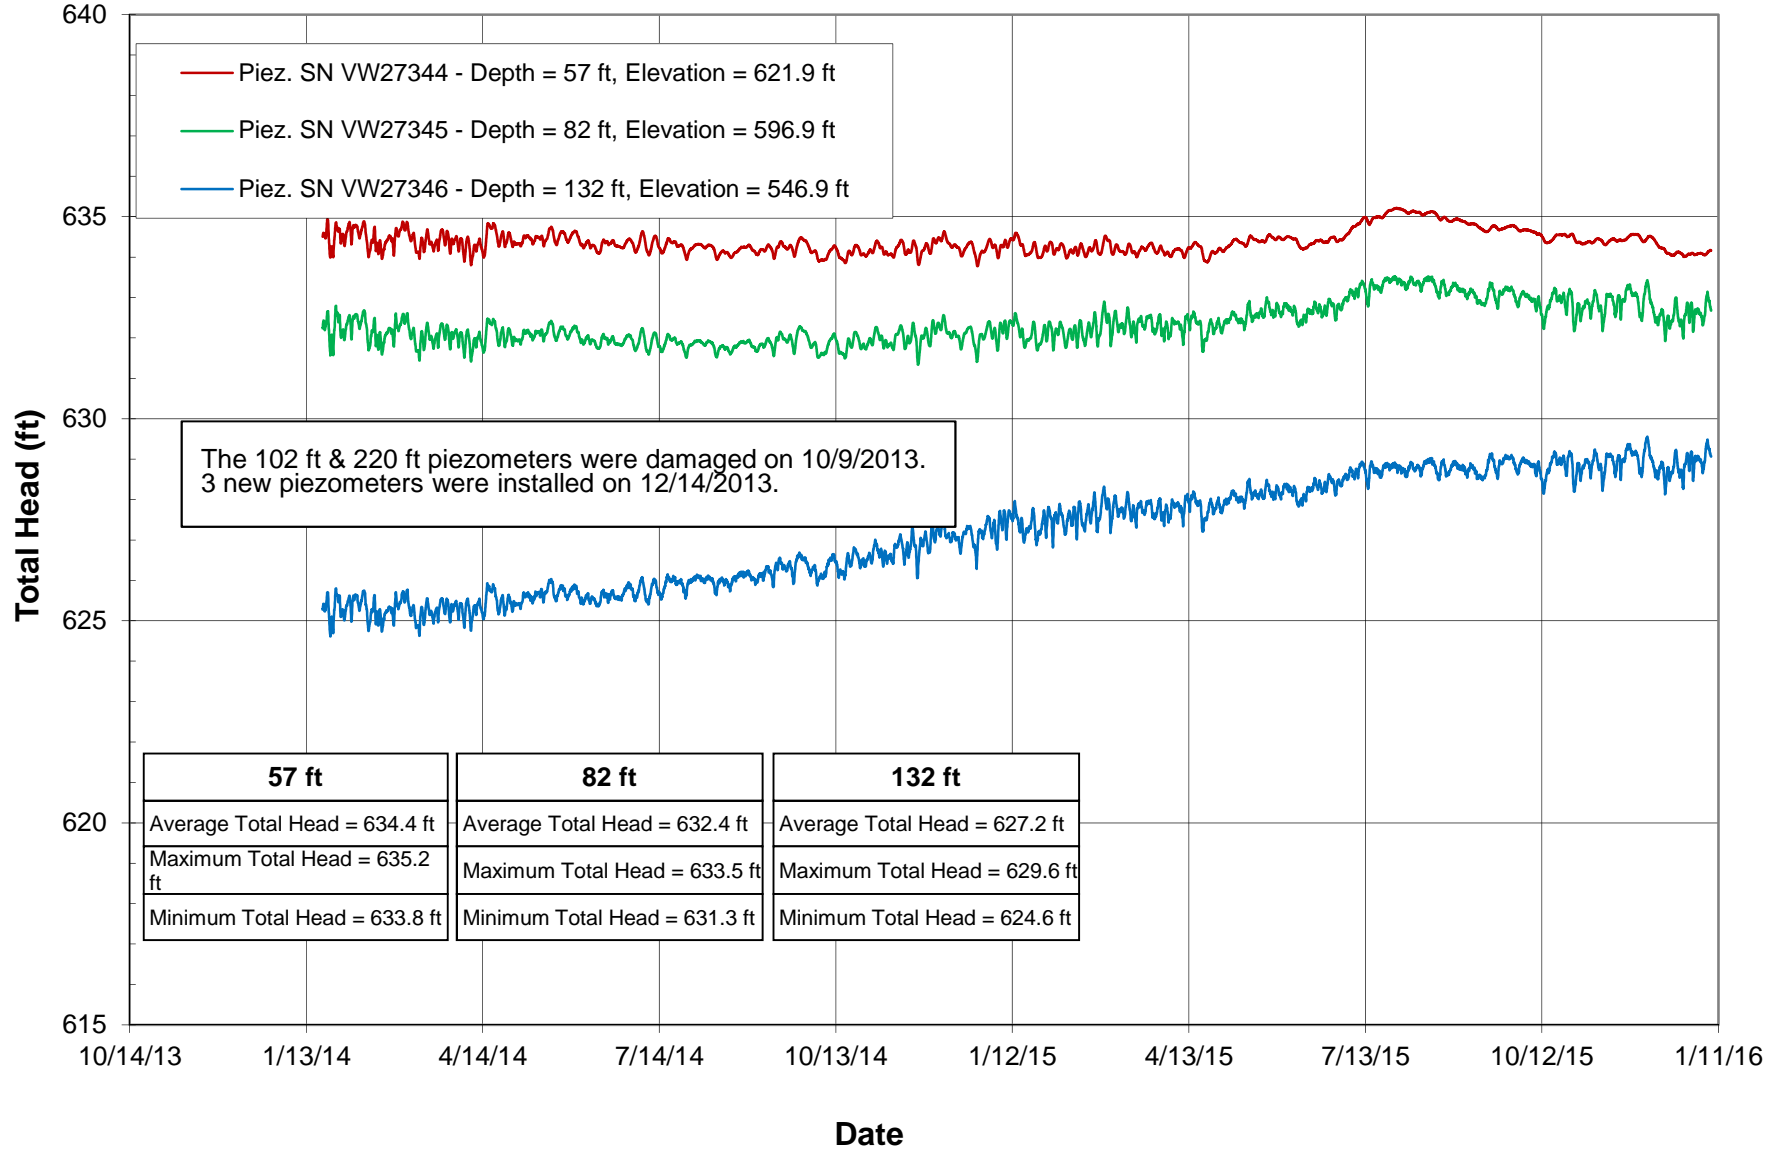
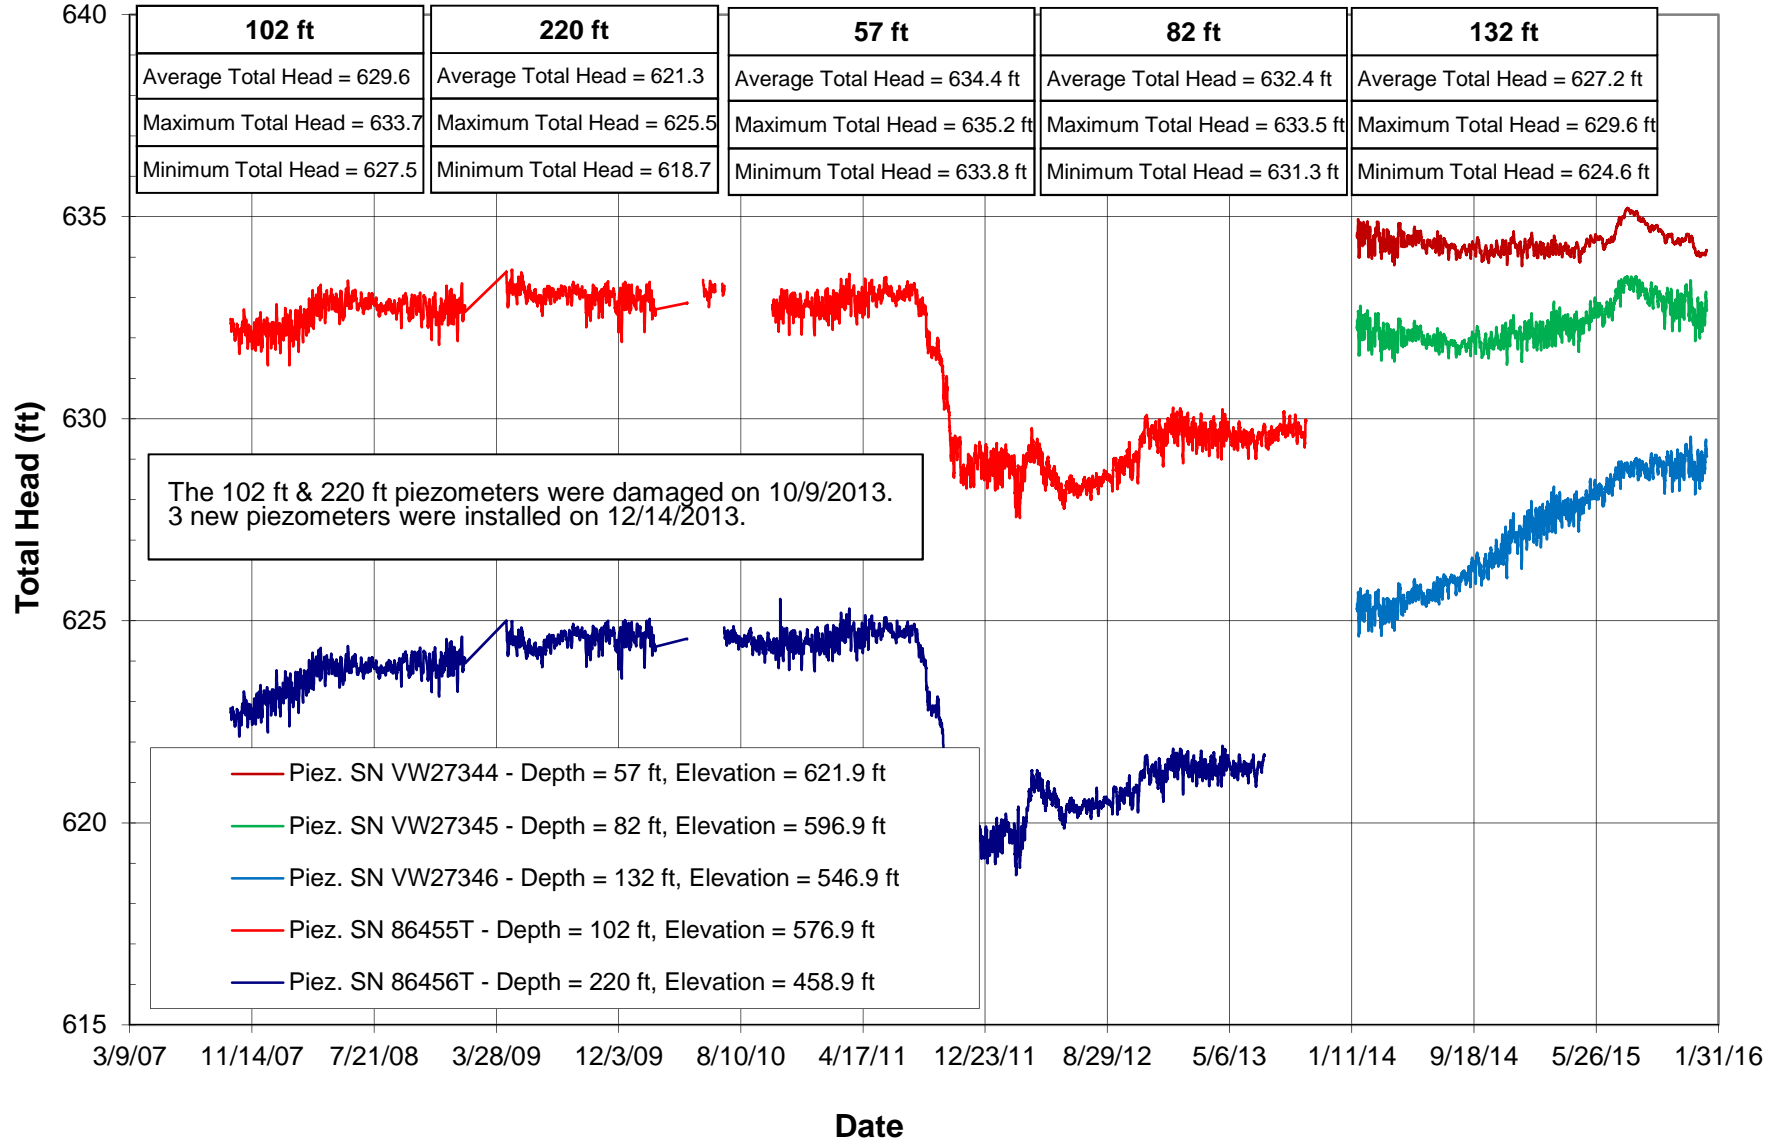
B-05-07 VW Piezometer Readings

B-05-07. Pore pressures in the deepest piezometer continue to increase at a slow rate with an increase in total head of about 0.5 feet this quarter and about 3.8 feet since April 2014. Readings in the two shallower piezometers showed no significant change through the first two thirds of this quarter, but decreased slightly during December.

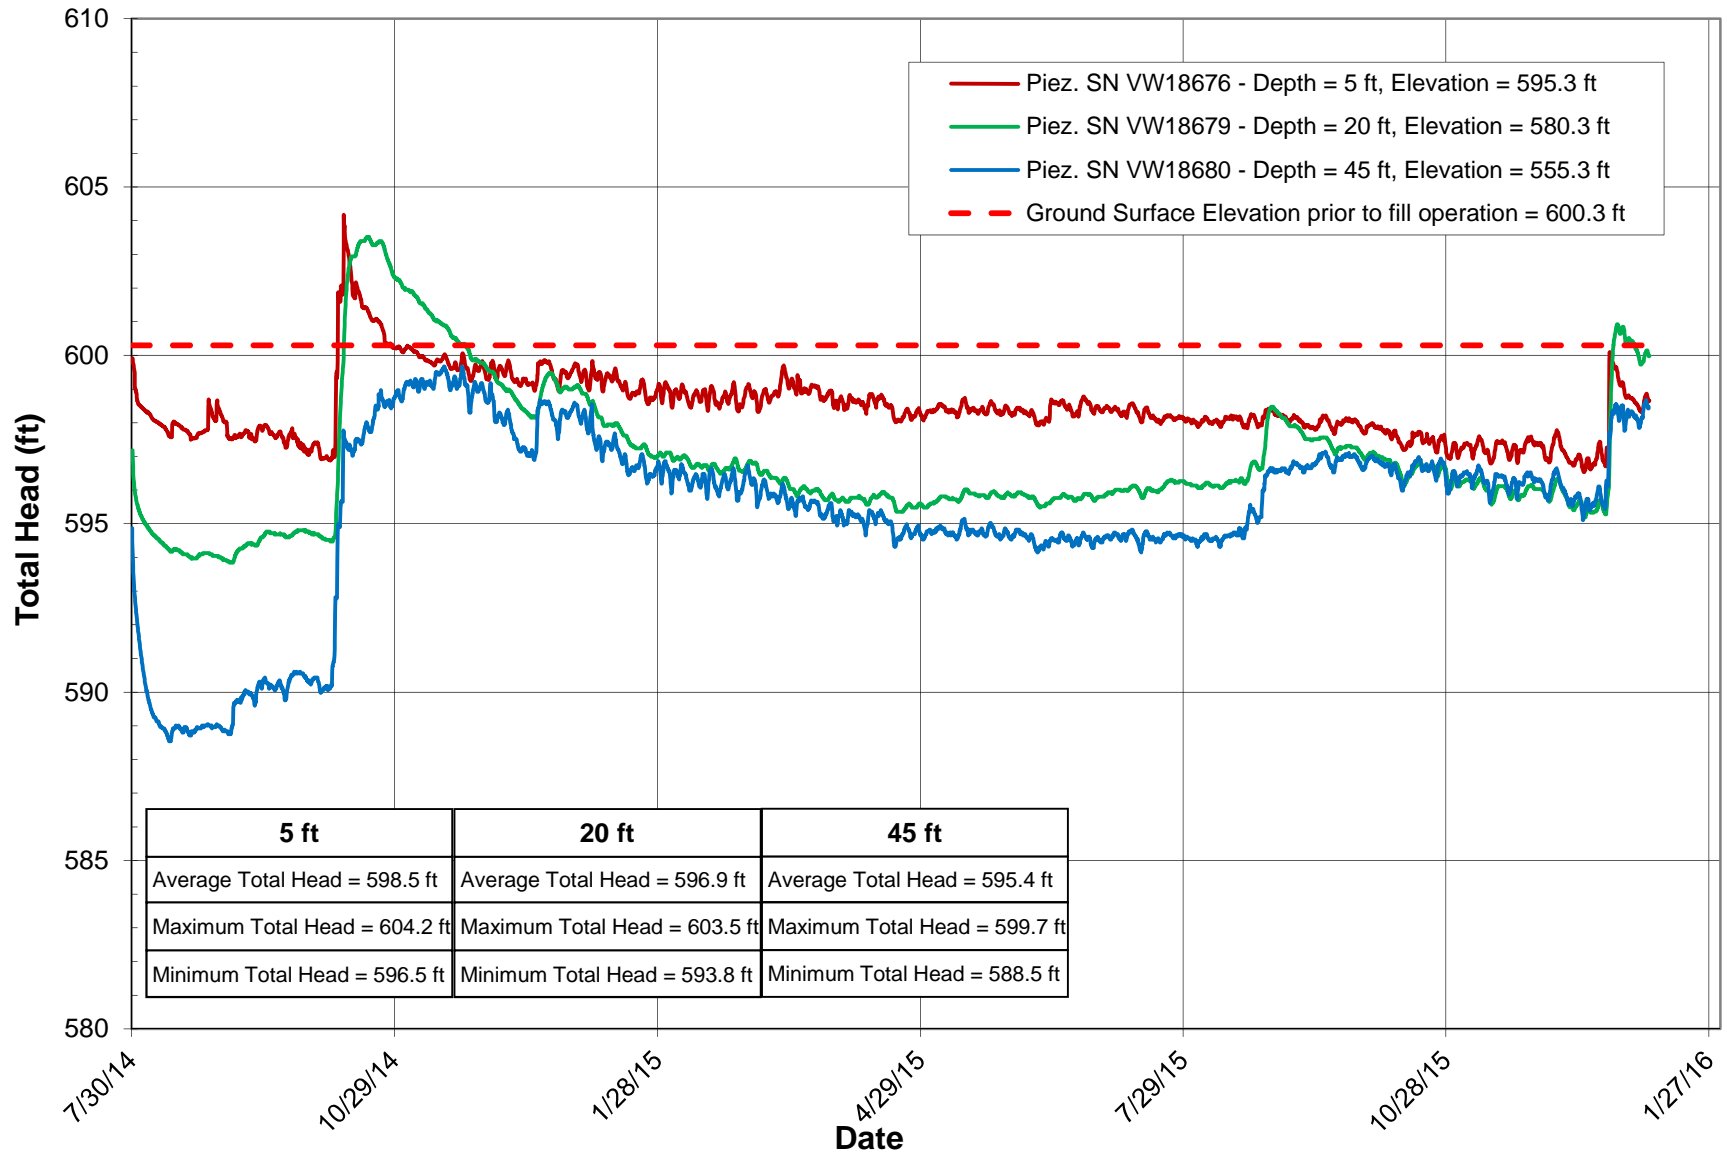
TGR P-3 VW Piezometer Readings

TGR P-3. Total head in the piezometers at this location were trending downwards for most of this past quarter. On December 23, 2015, total head increases of 3 to 5 feet are shown in all

three piezometers. This increase was likely caused by a large amount of fill placed in the area that we observed during our following biweekly visit. The pore pressures then began to decrease with the rate of decrease slowing with increasing depth. On January 4, 2016, the pore pressure data indicates small increases in all three piezometers.

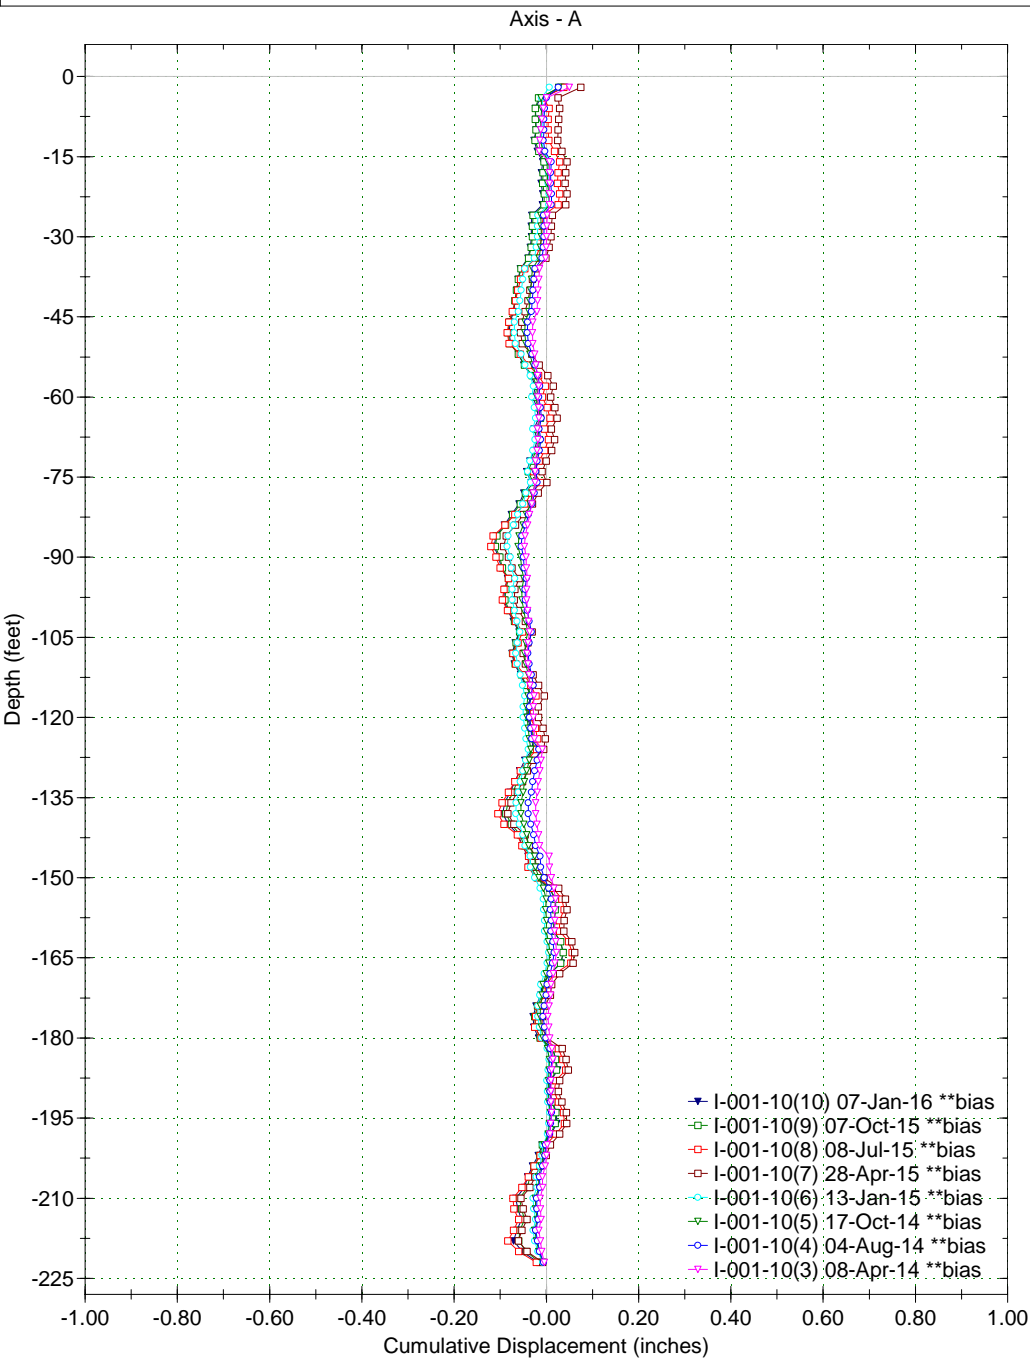
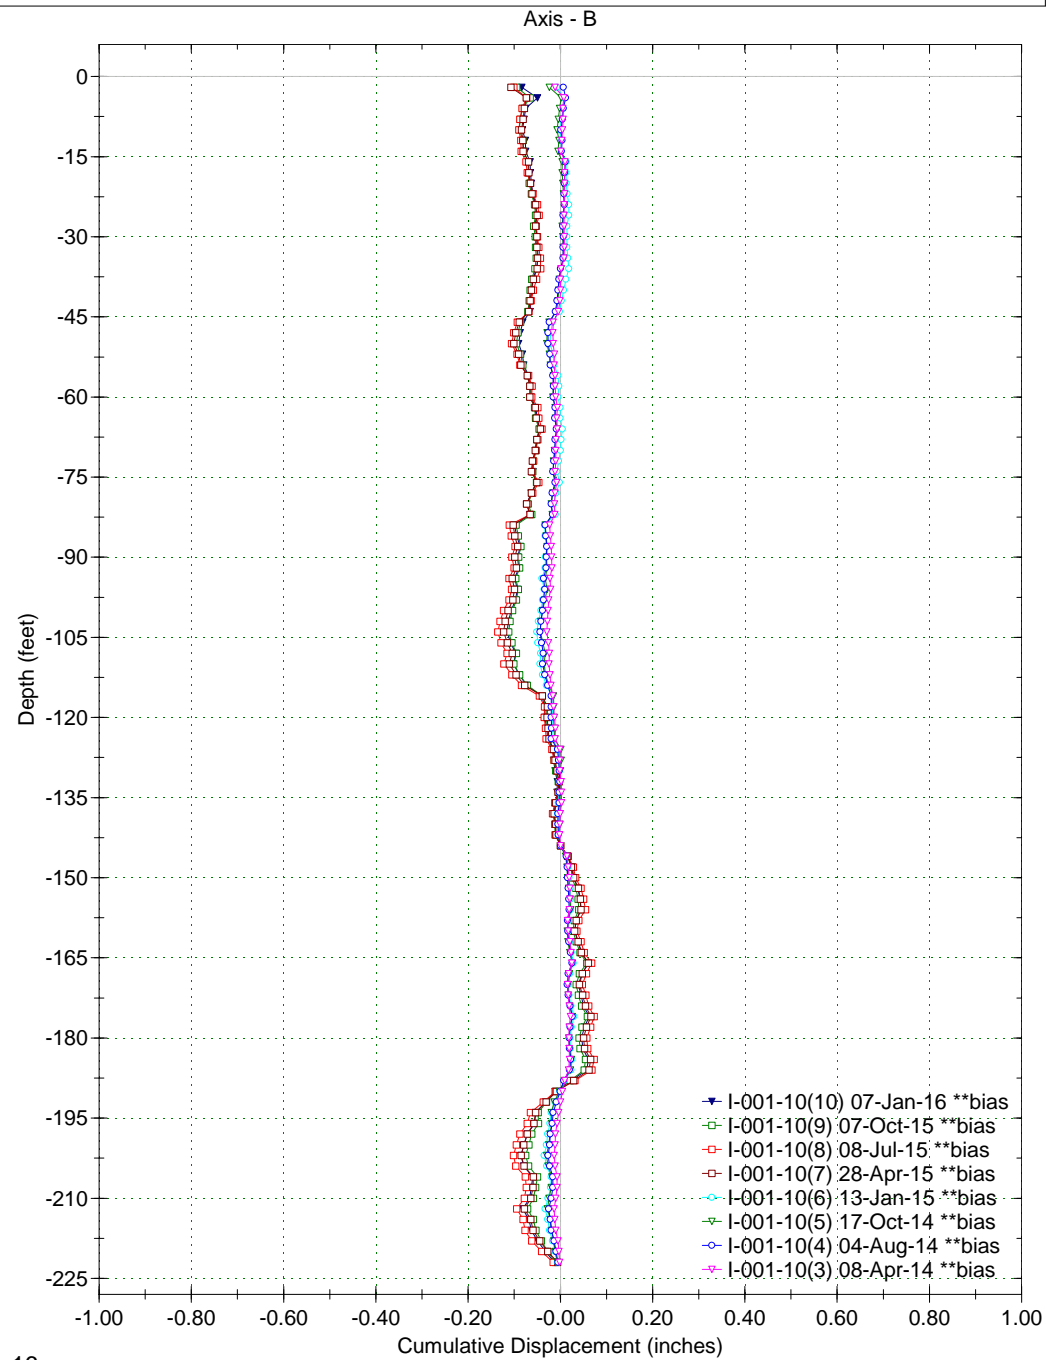
Borehole : I-001-10
Project : CUY-90-15-24
Location : Cleveland, Ohio
Northing : 663346.19
Easting : 2189917.266
Collar :

I-001-10. Inclinerometer readings at this location indicate virtually no movement since the April 2015 quarterly readings.

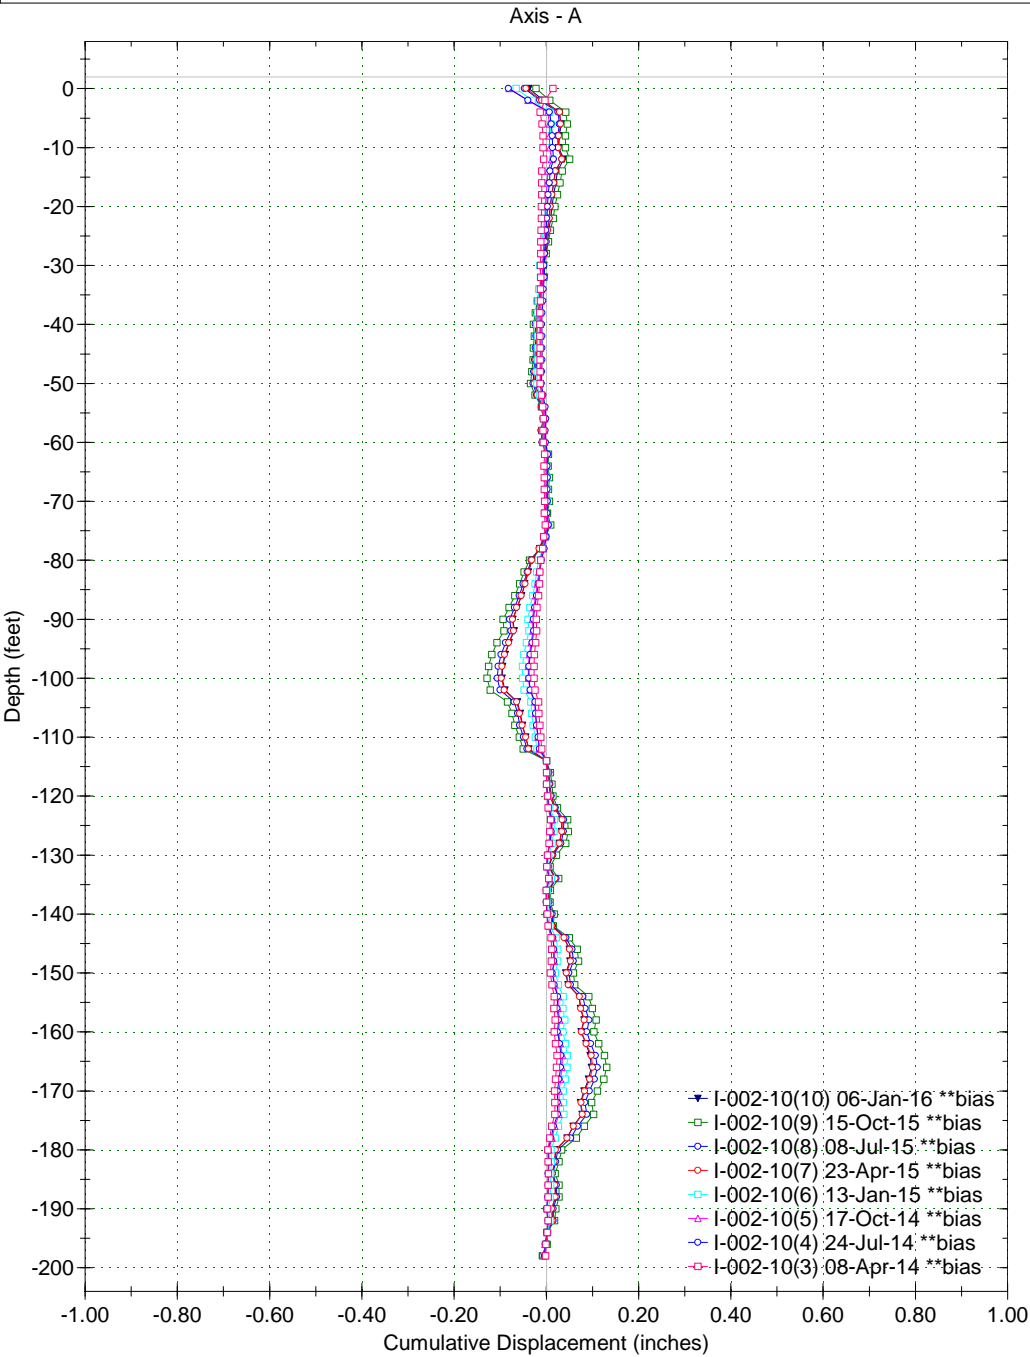
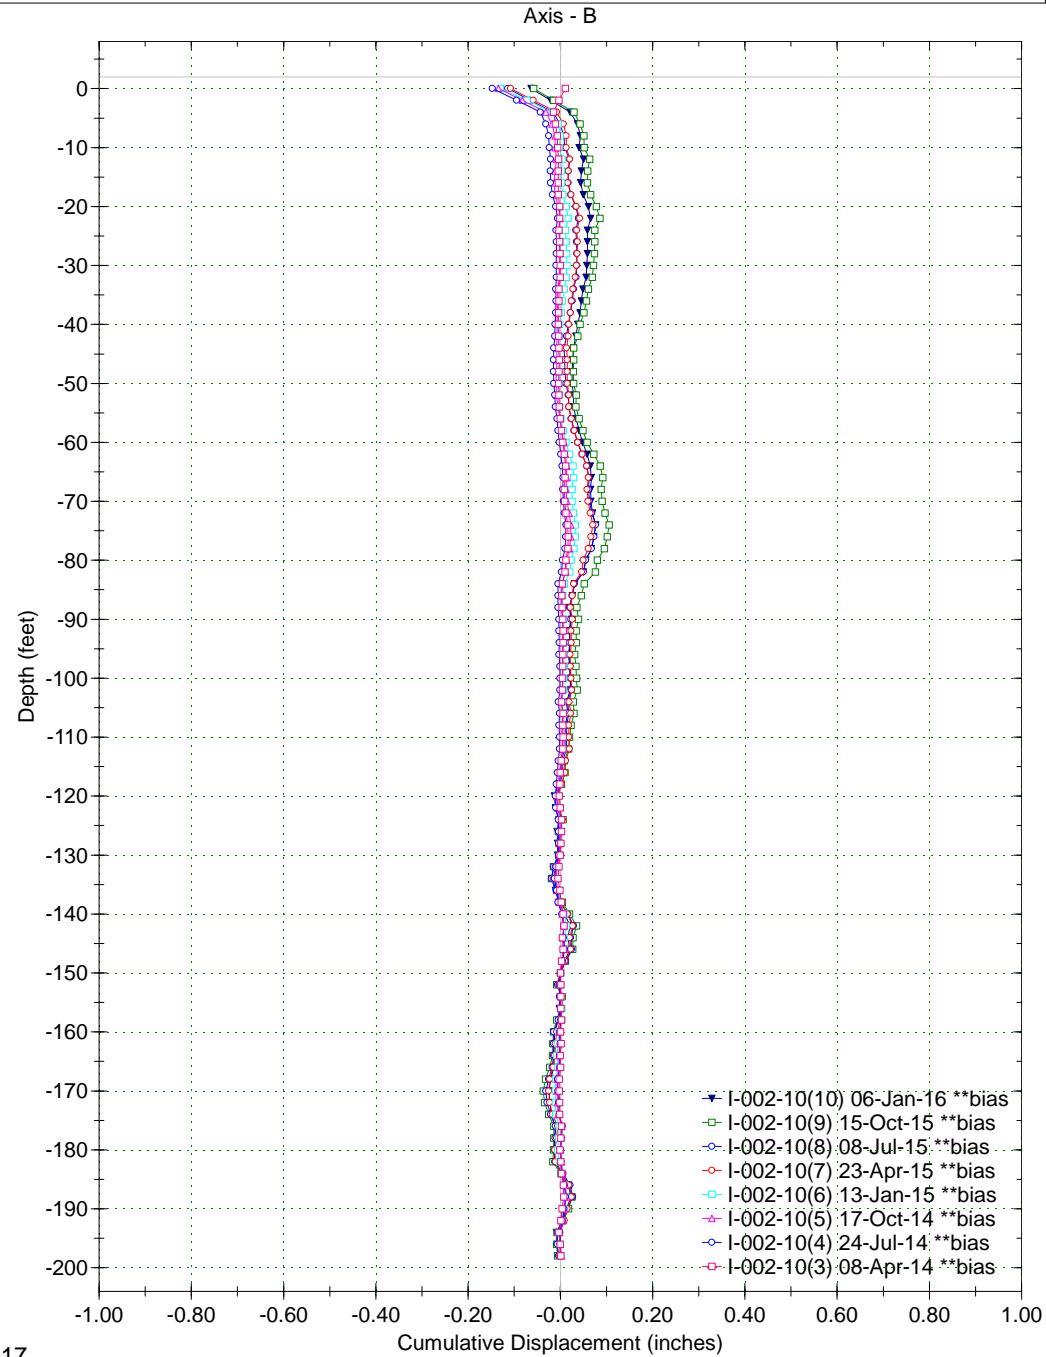
Borehole : I-002-10
Project : CUY-90-15-24
Location : Cleveland, Ohio
Northing : 663622.262
Easting : 2189778.413
Collar :

I-002-10. A slight reversal in the direction of previous displacements is indicated by this quarter's readings at I-002-10. Slight A-axis displacement towards the baseline is indicated from about 80 to 110 feet and from 140 to 180 feet. Slight B-axis displacement towards the baseline is indicated from about 10 to 40 feet and from 58 to 90 feet.

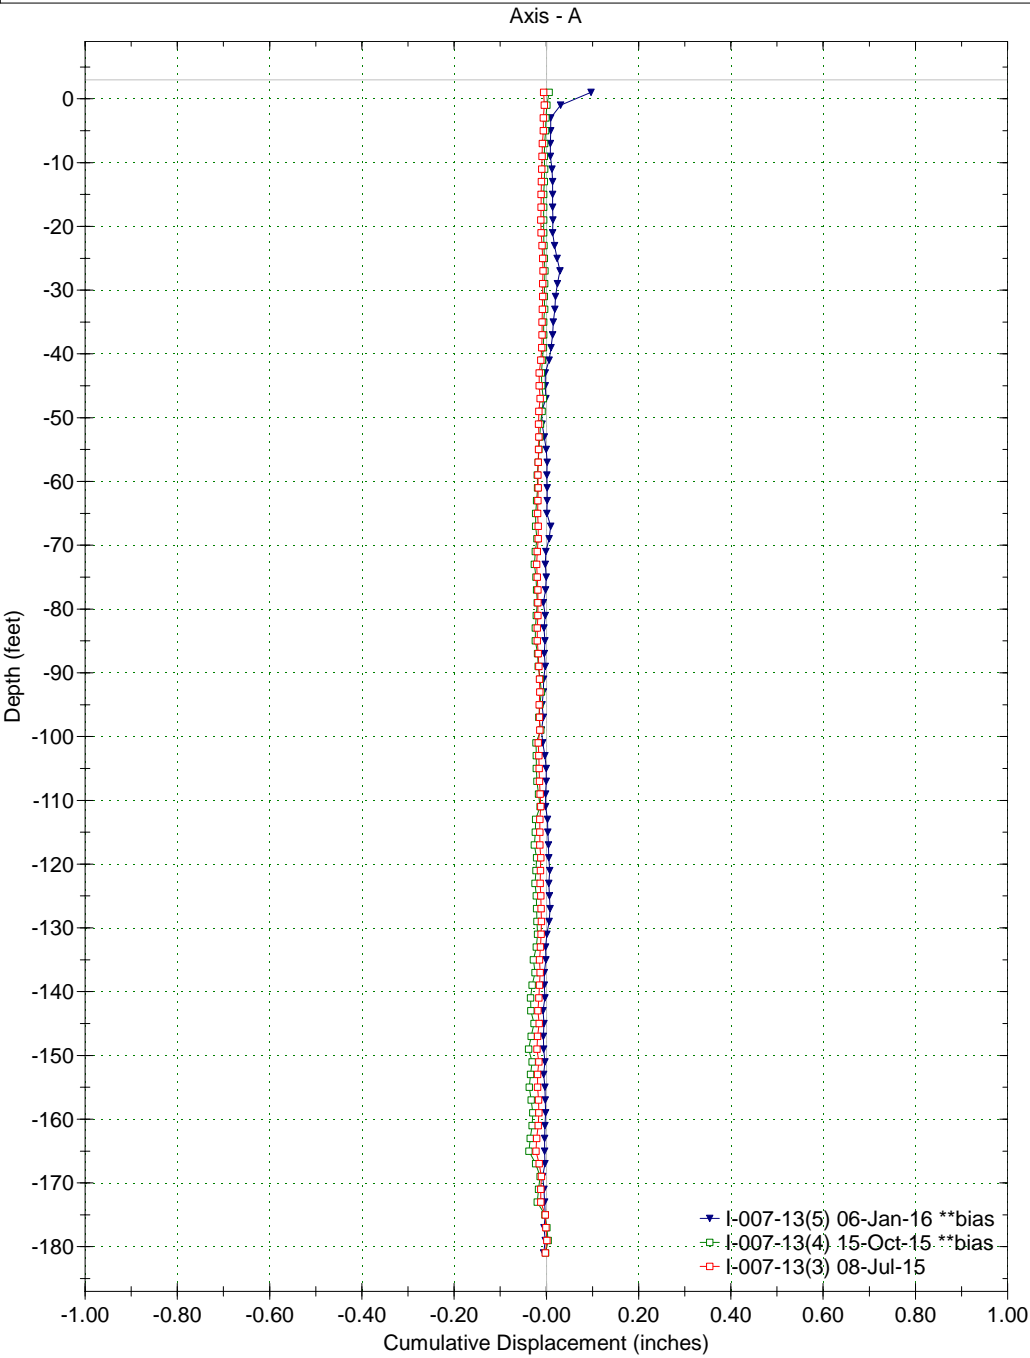
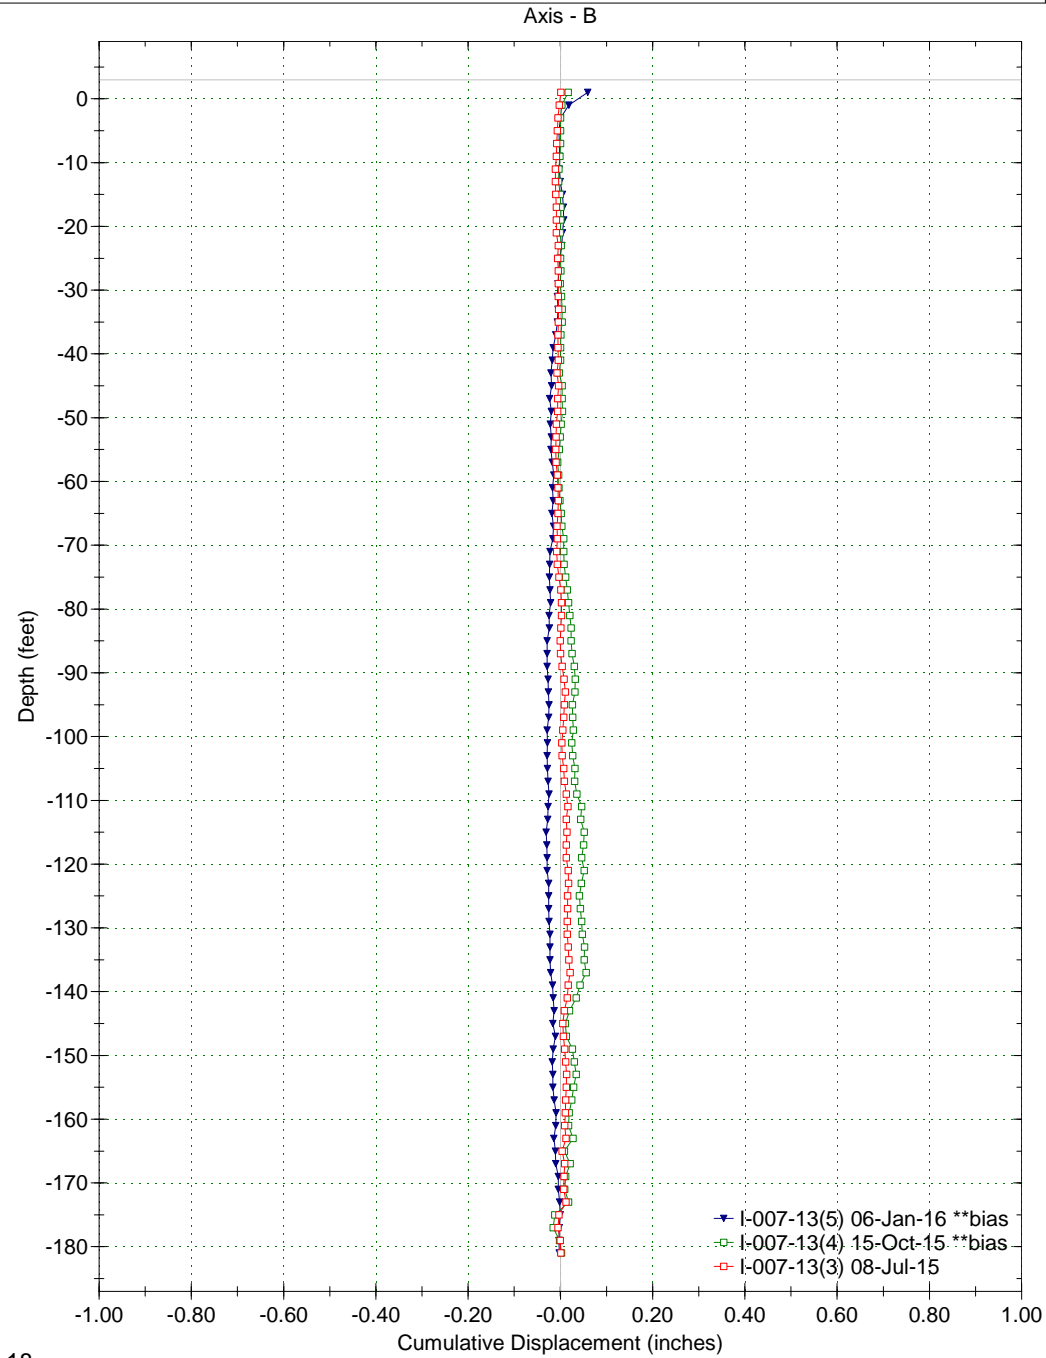
Borehole : I-007-13
Project : CUY-90-15-24
Location :
Northing :
Easting :
Collar :

I-007-13. Movement is shown in the positive A-axis direction from the surface to about 50 feet. B-axis readings indicate a reversal back to the April 2015 baseline.
