Re: January 2016 Quarterly Report
CUY-90-15.24 Slope Monitoring
PID 96504
EDP Project No. 069032.00

JANUARY 2016 QUARTERLY REPORT

CUY-90-15.24 SLOPE MONITORING
PID 96504
CLEVELAND, OHIO
SME PROJECT NO. 069032.00

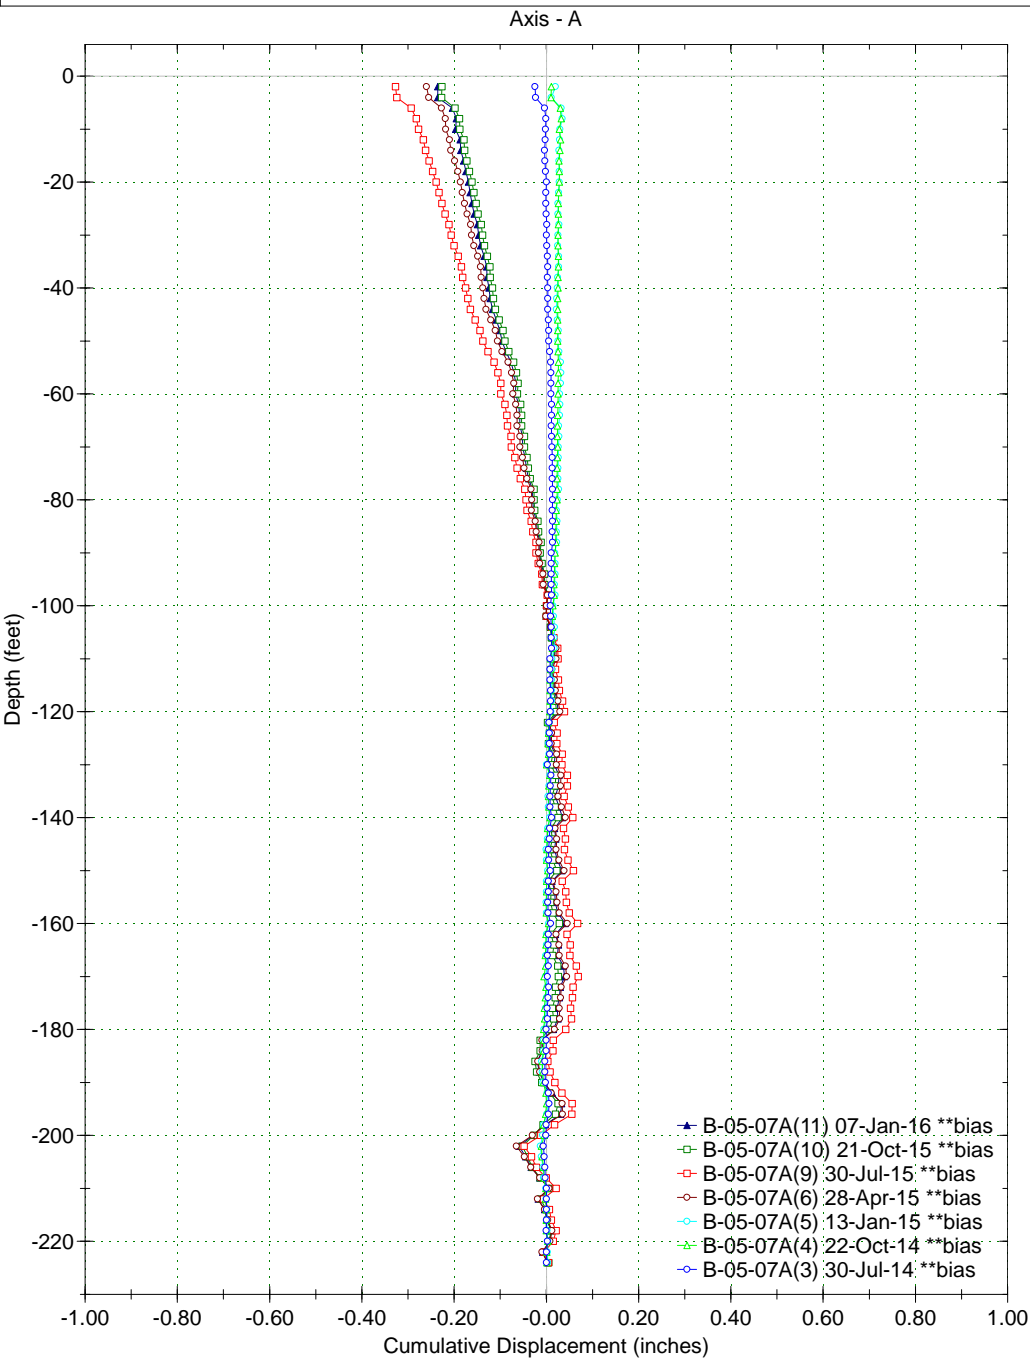
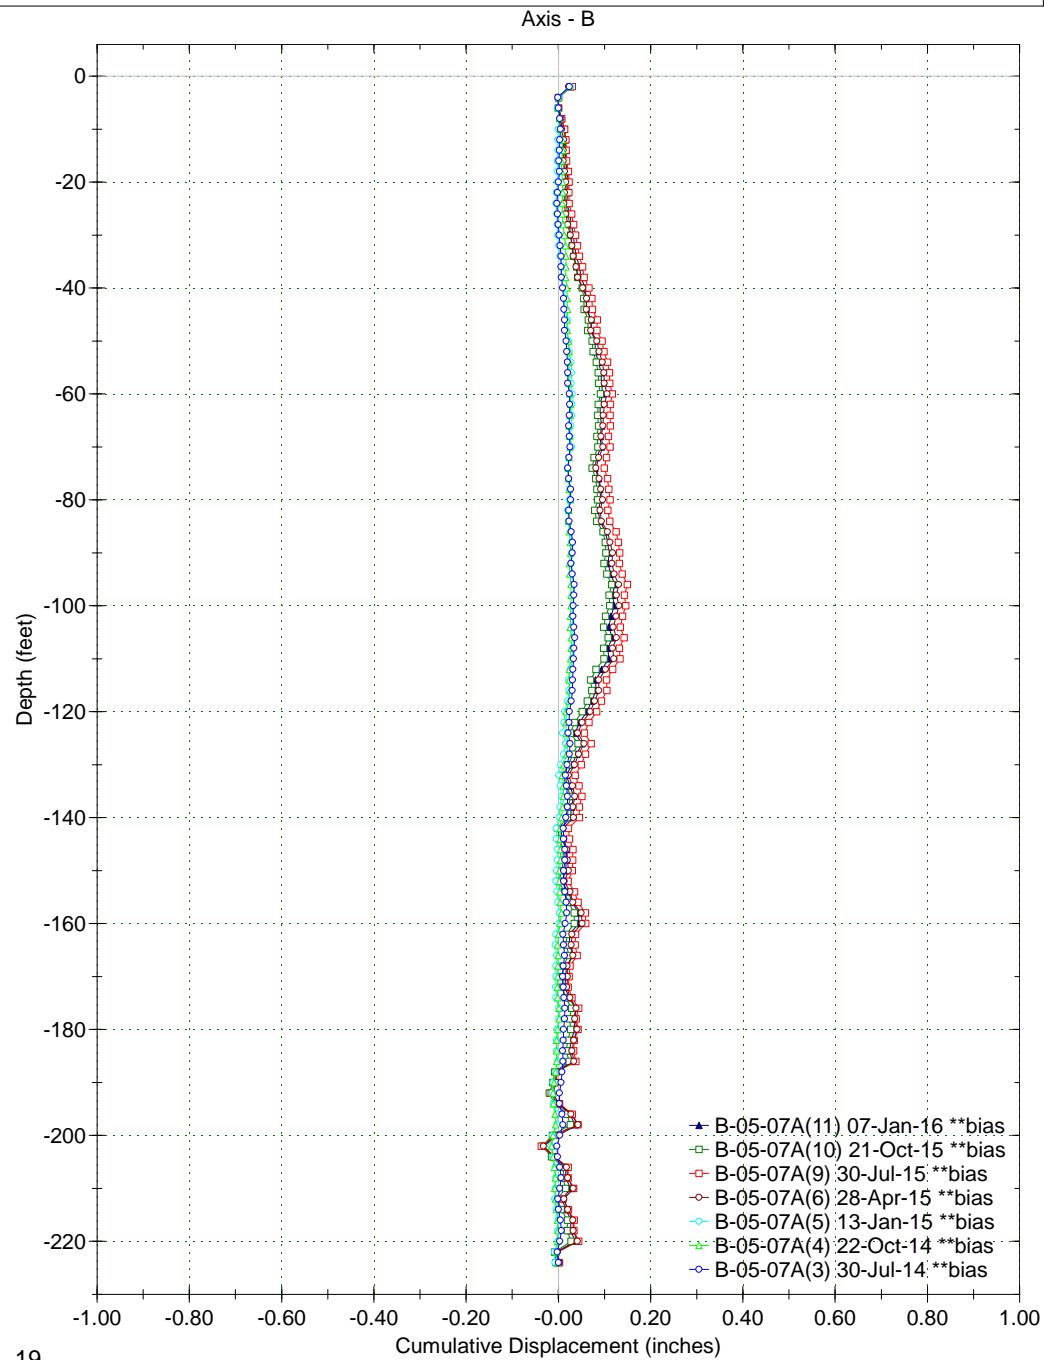
Borehole : B-05-07A
Project : CUY-90-15-24
Location : Cleveland, Ohio
Northing : 663369.991
Easting : 2189805.799
Collar :

B-05-07. Inclinerometer readings at this location indicate virtually no movement since the October 2015 quarterly readings.

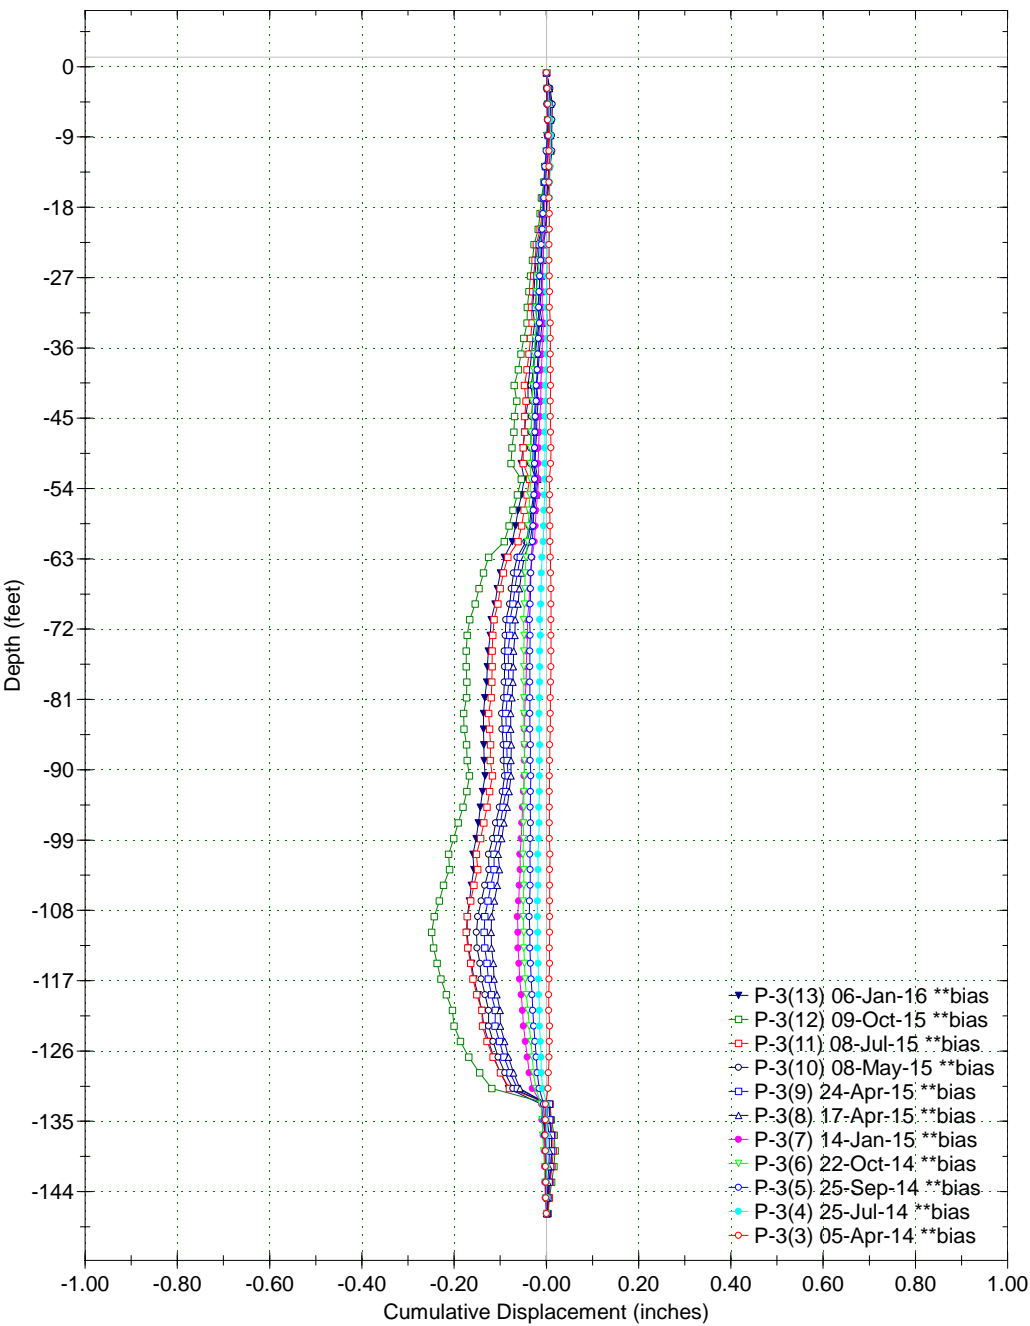
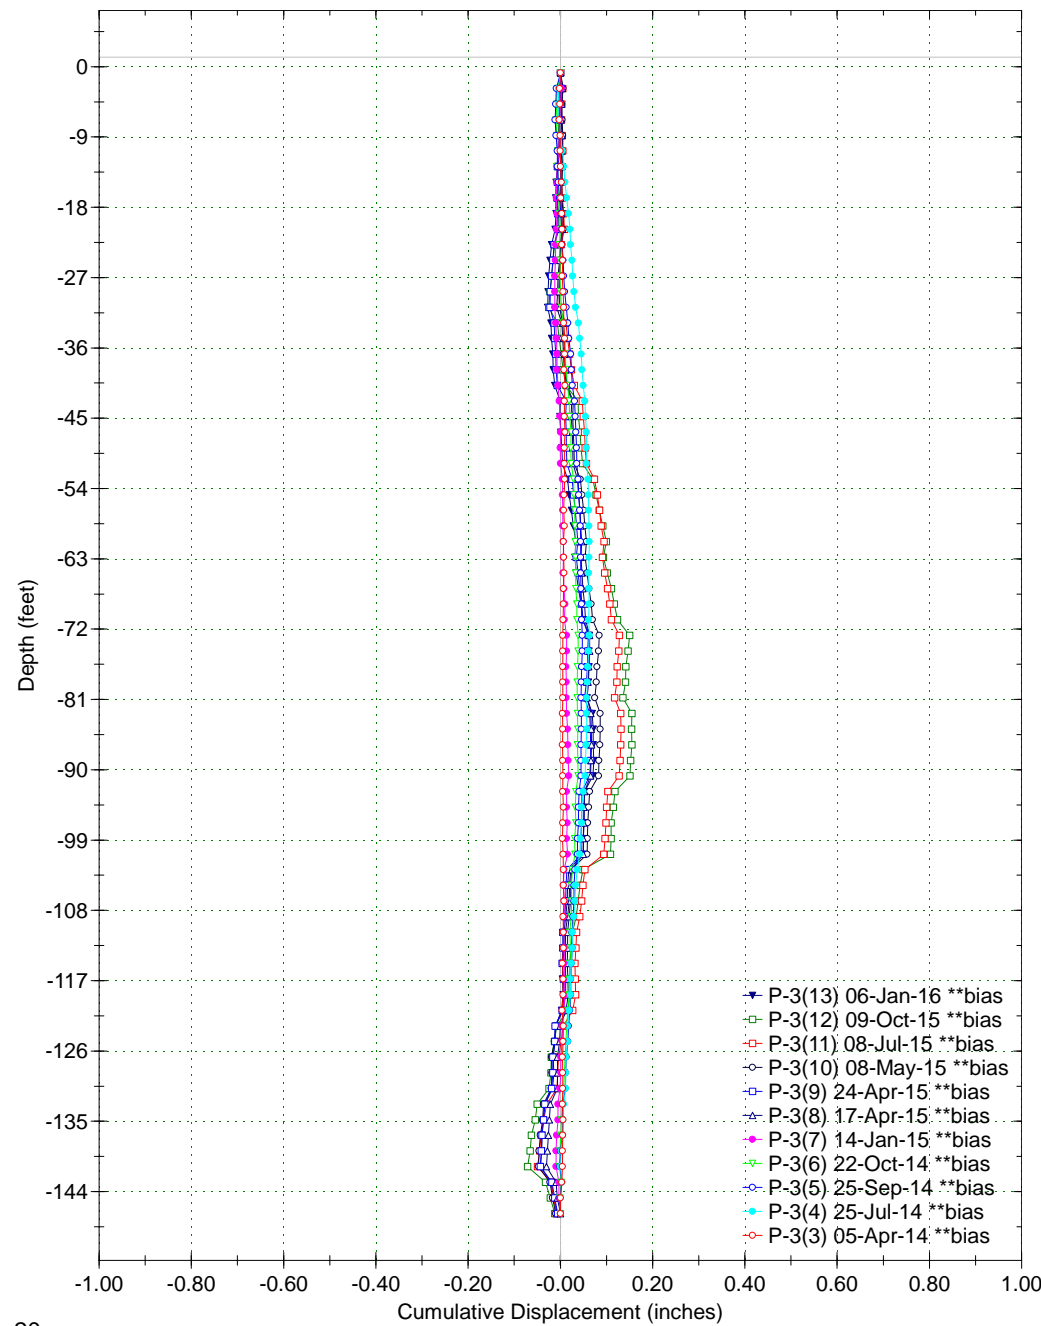
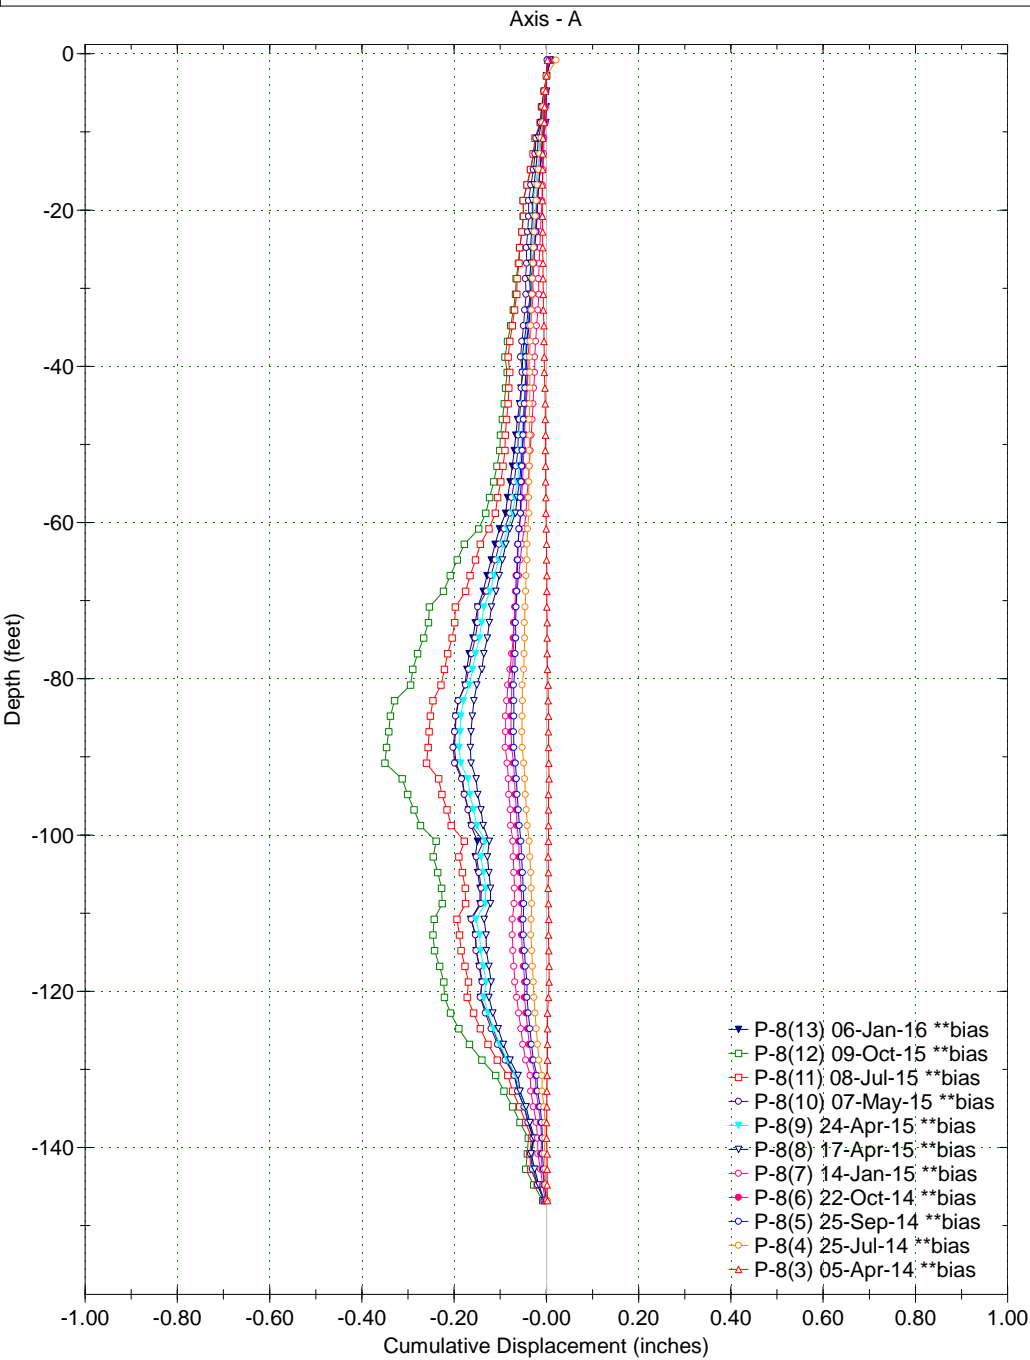
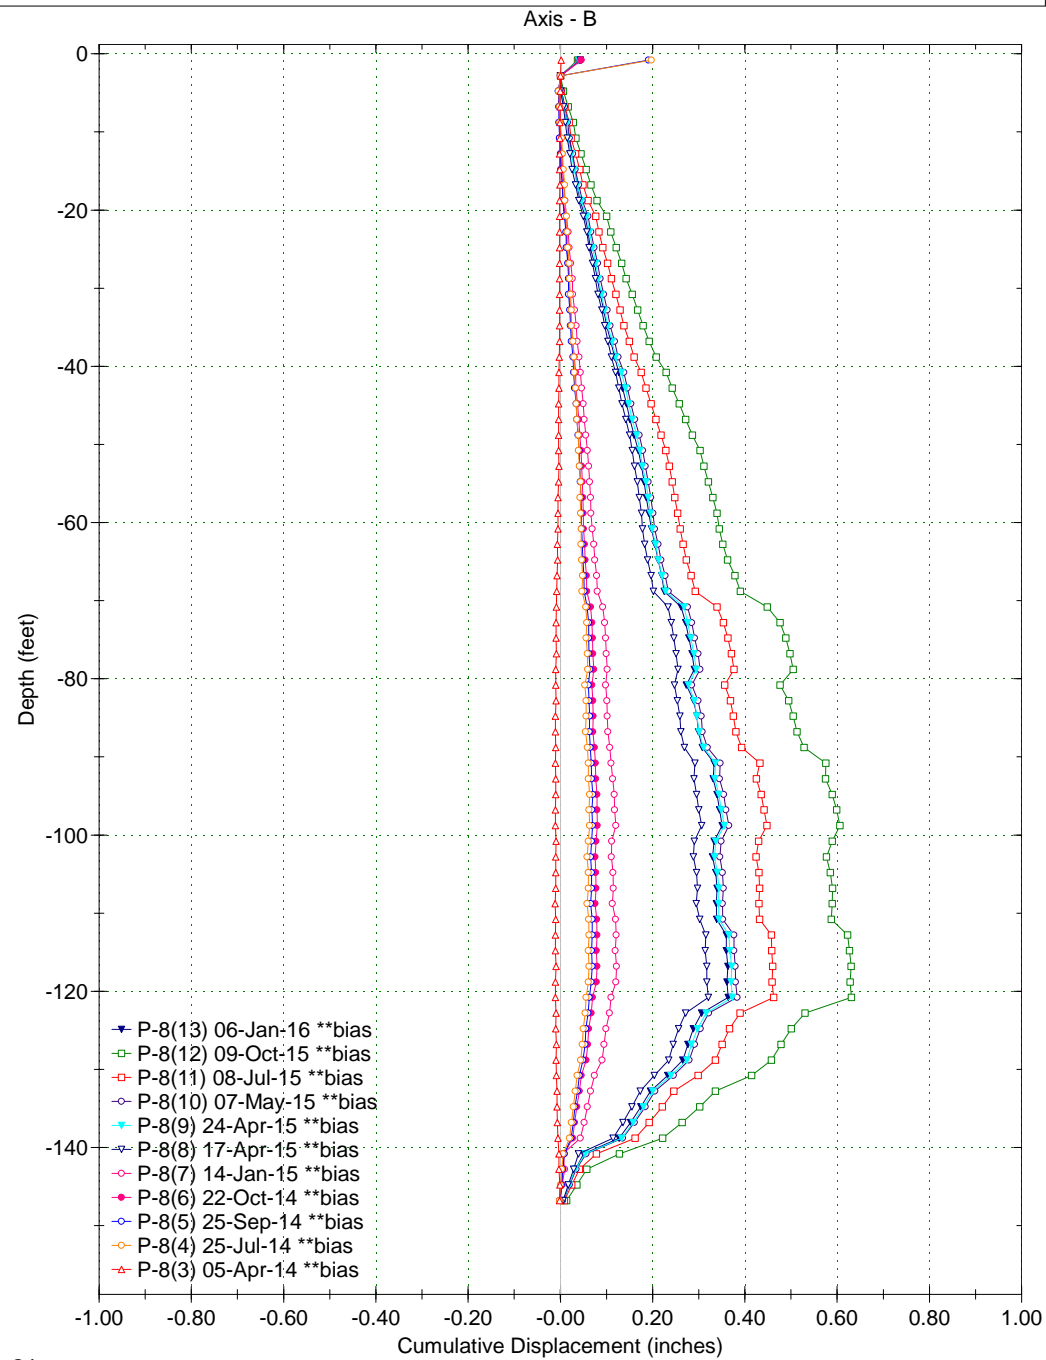
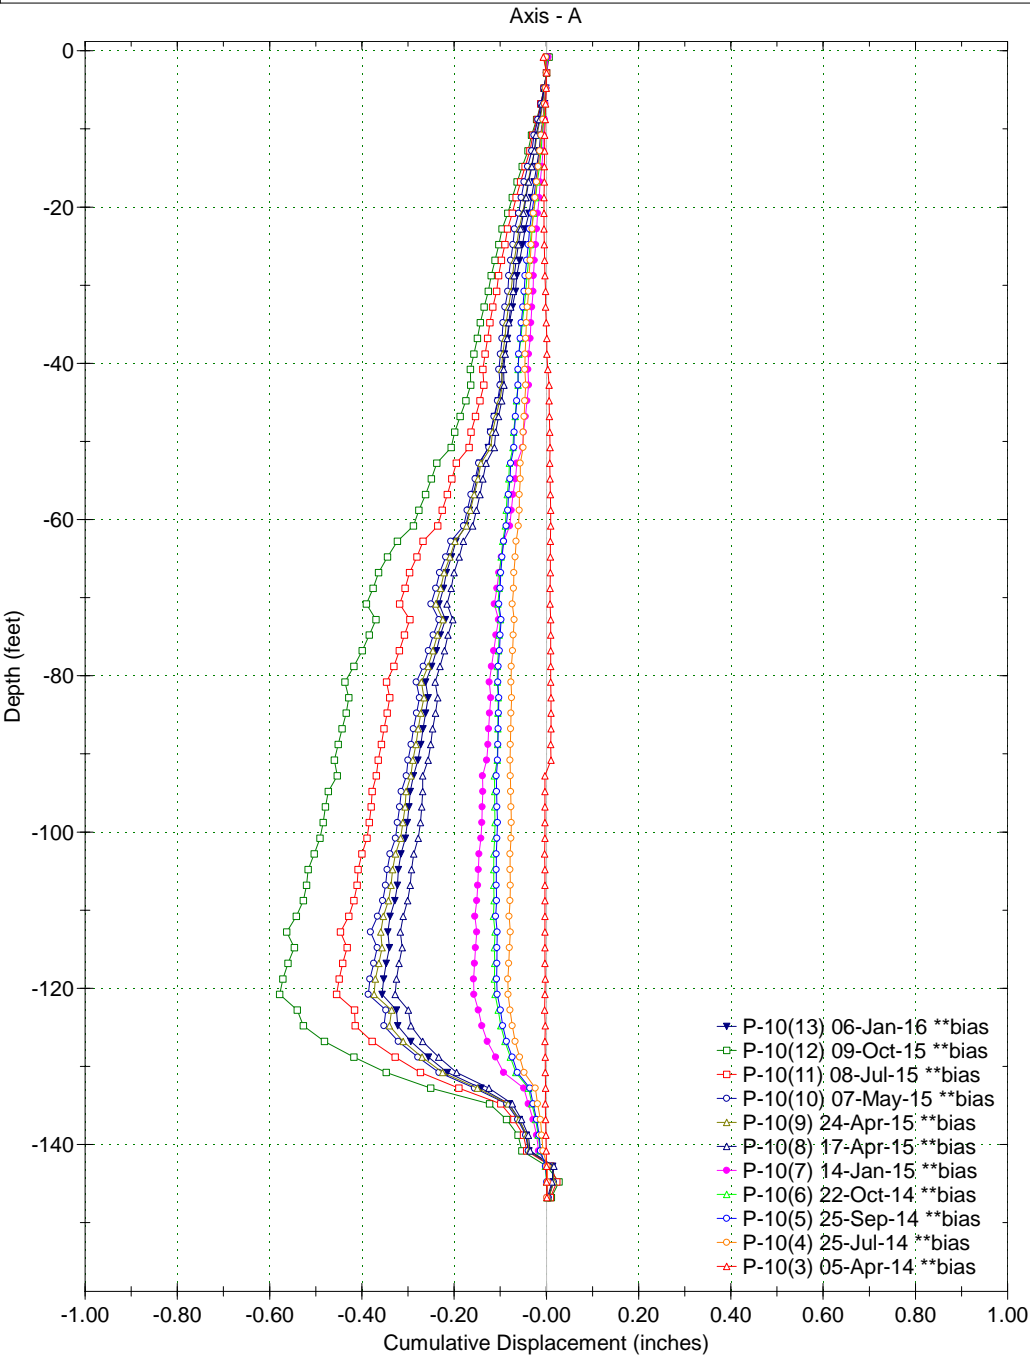
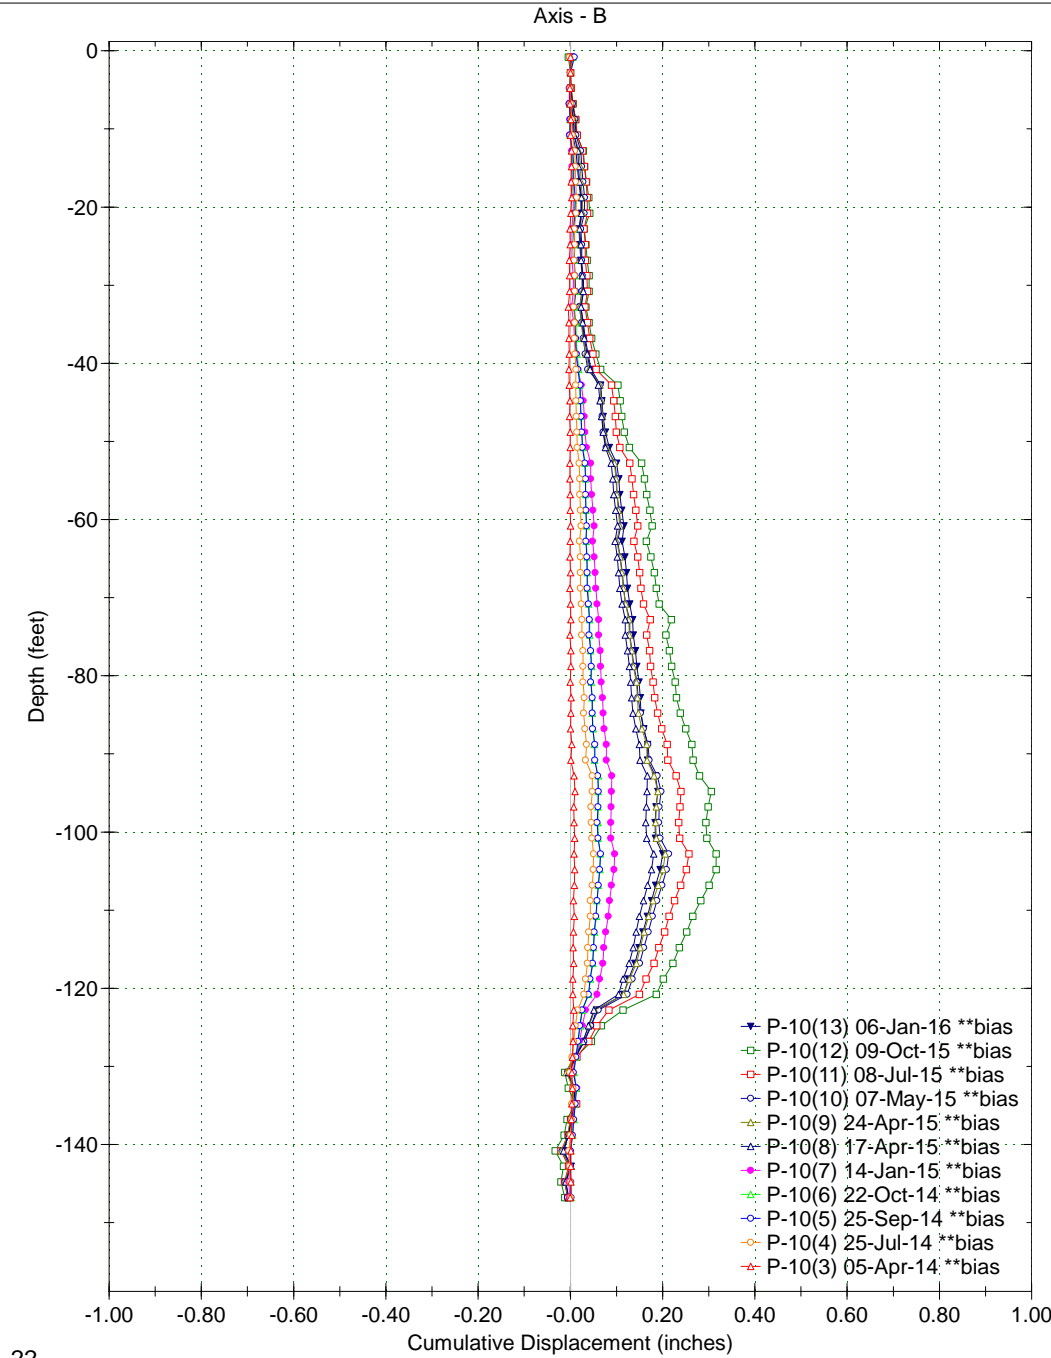
P-3, P-8, P-10. Inclinerometer readings at these locations indicate a reversal in the direction of movement this quarter. Displacements in both axes now align with readings taken between April and July 2015.

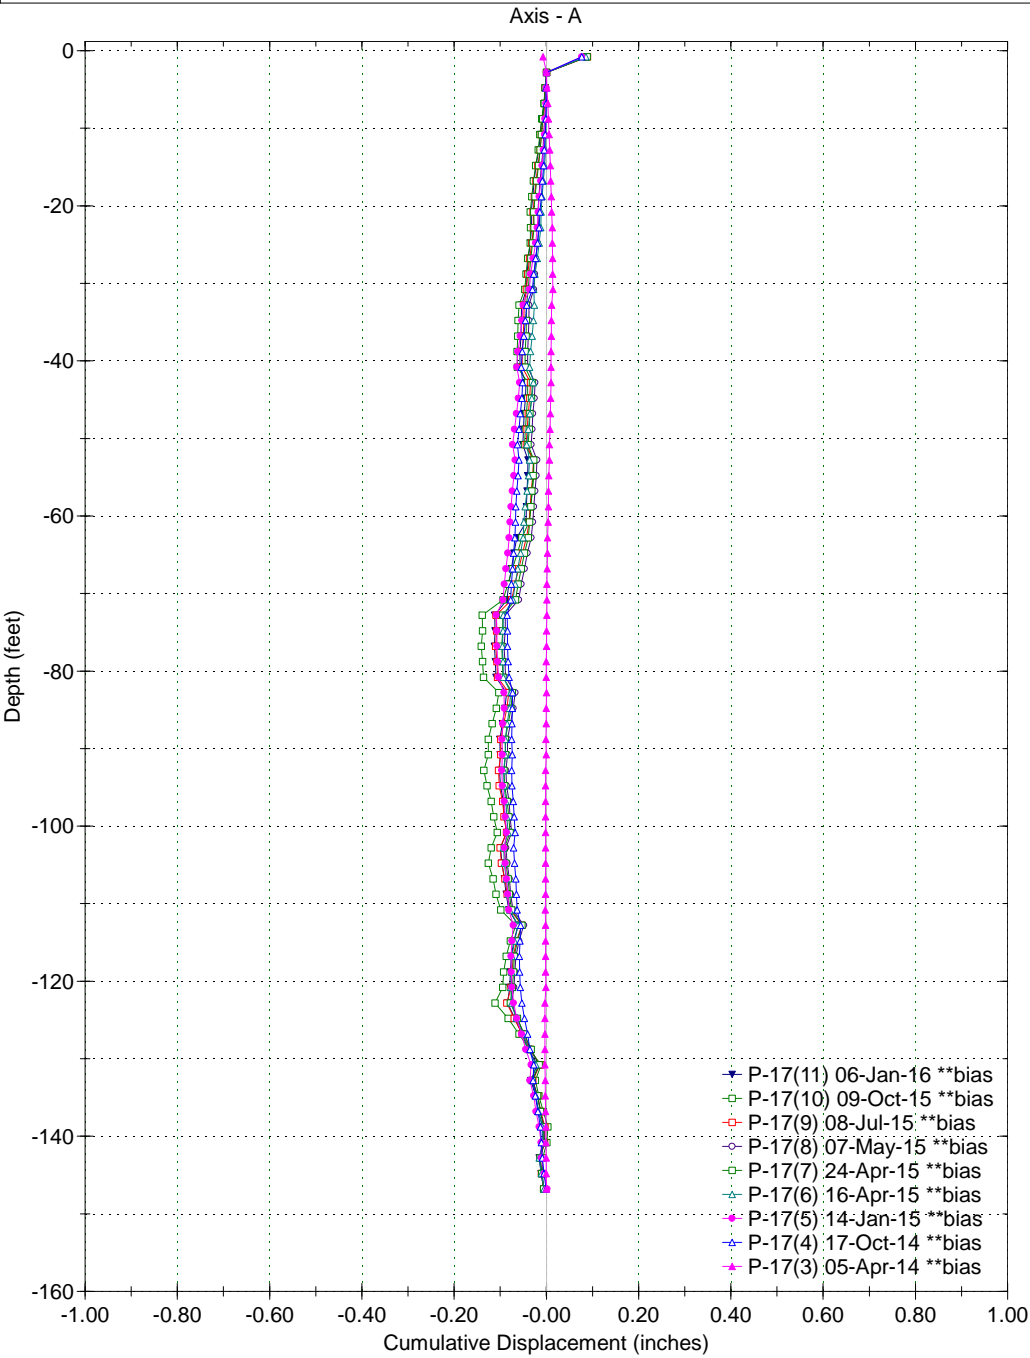
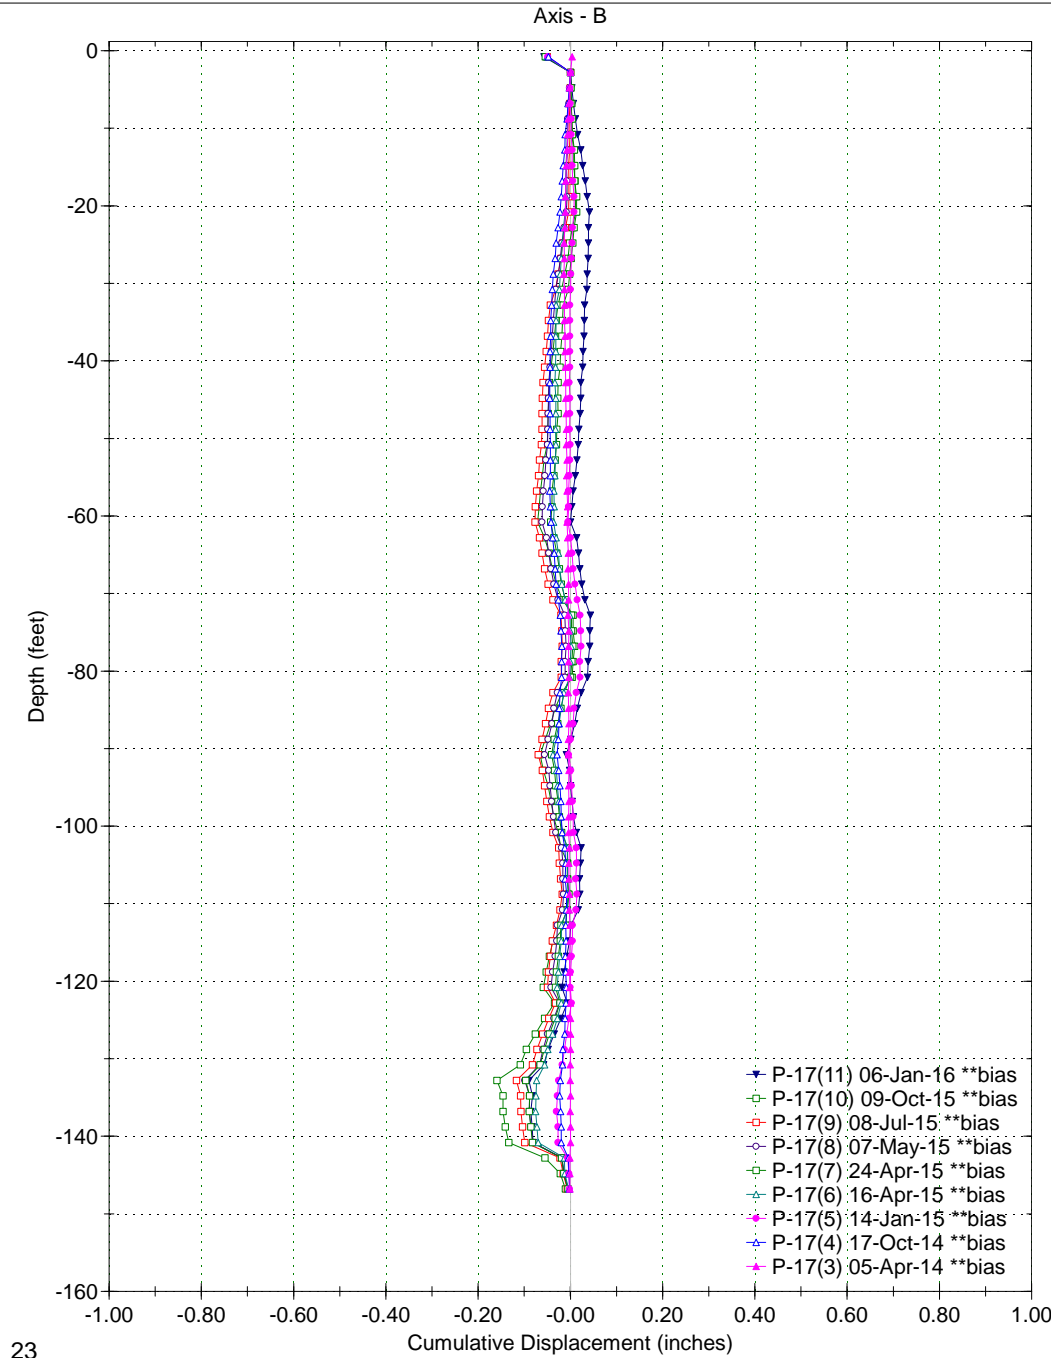
Borehole : P-17
Project : CUY-90-15-24
Location : Cleveland, Ohio
Northing :
Easting :
Collar :

P-17. Inclinerometer readings at this location indicate a slight displacement in the positive B-axis direction through most of the length of drilled shaft. No A-axis displacement is indicated this quarter.

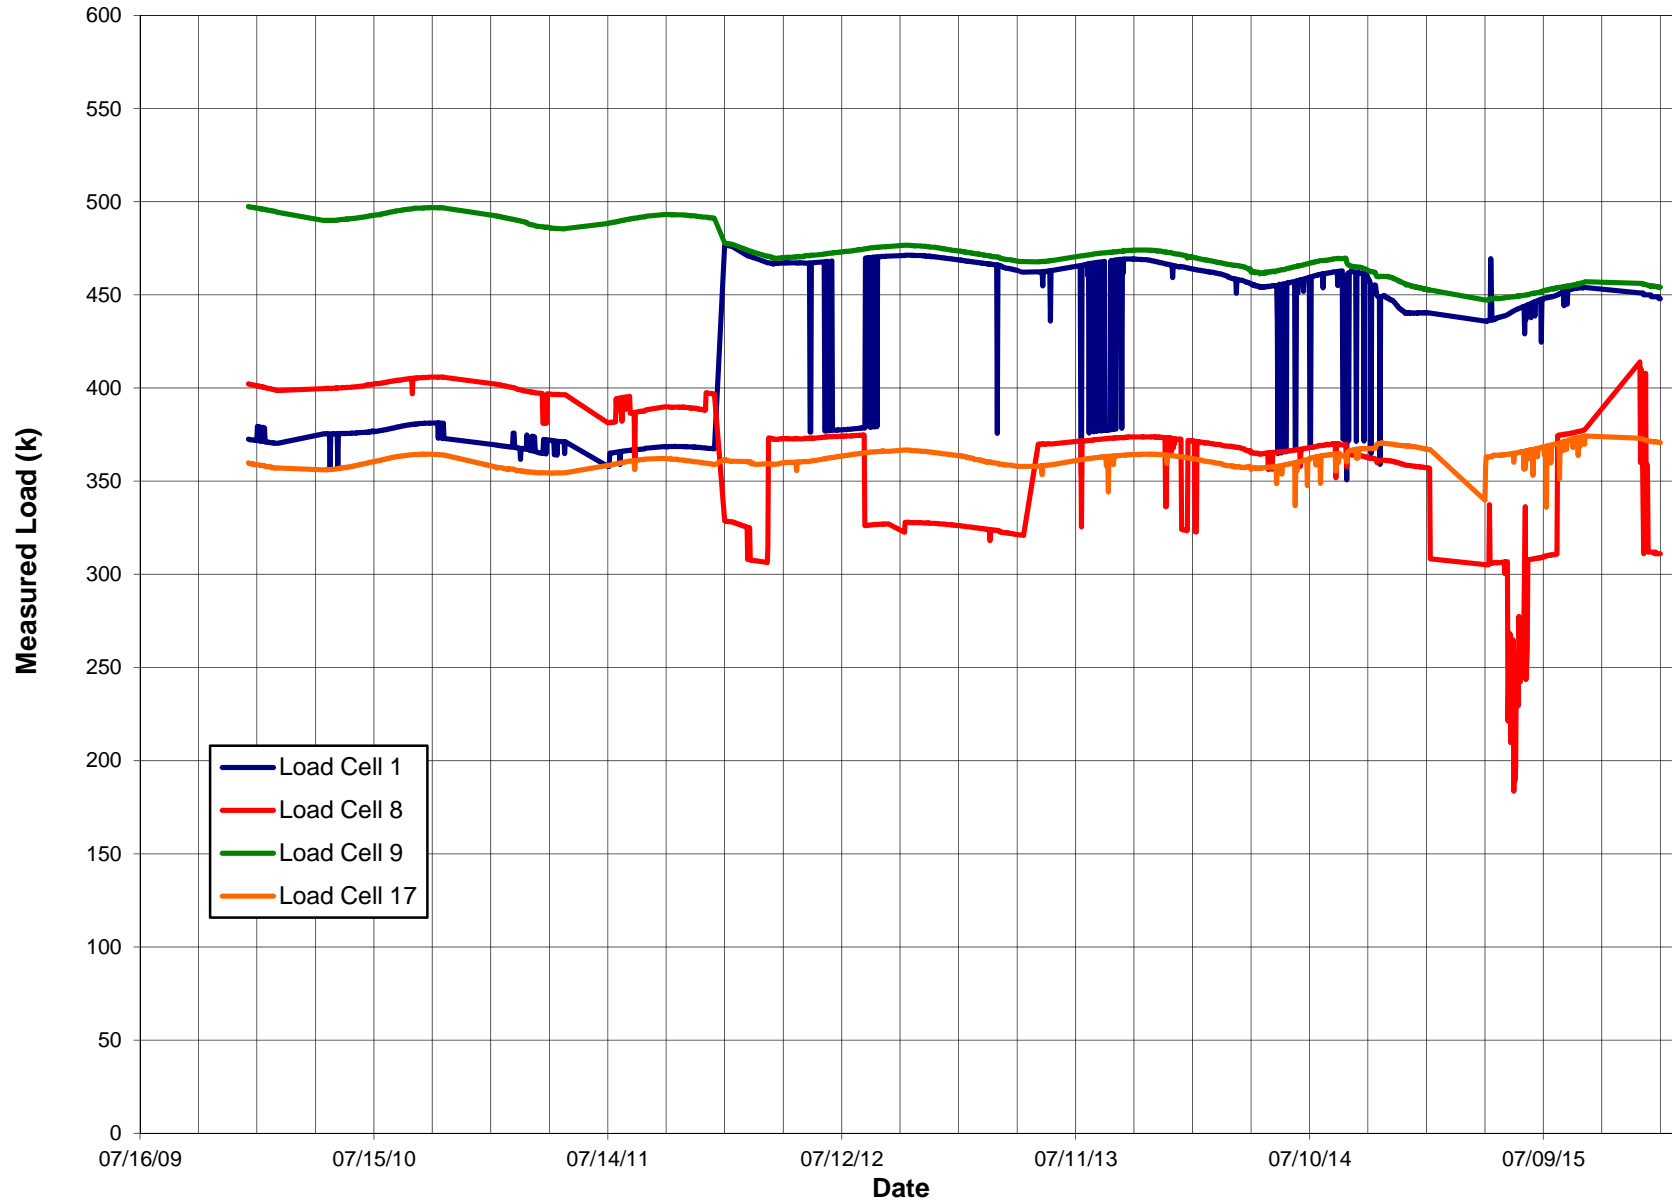
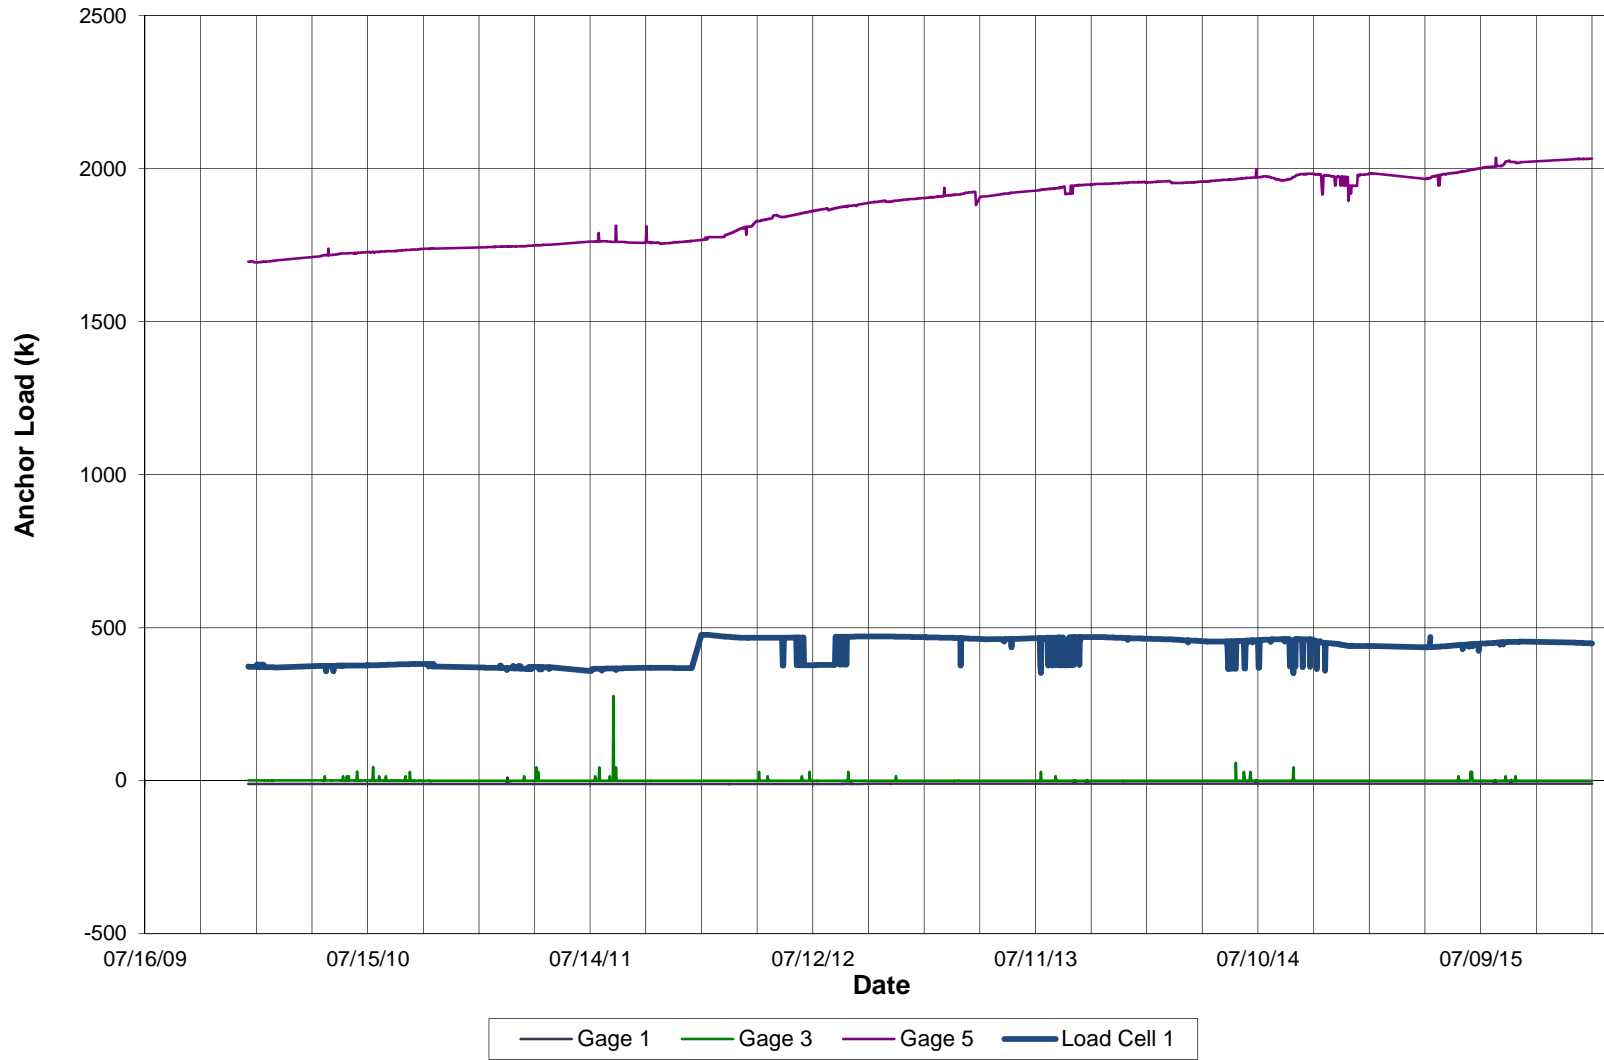
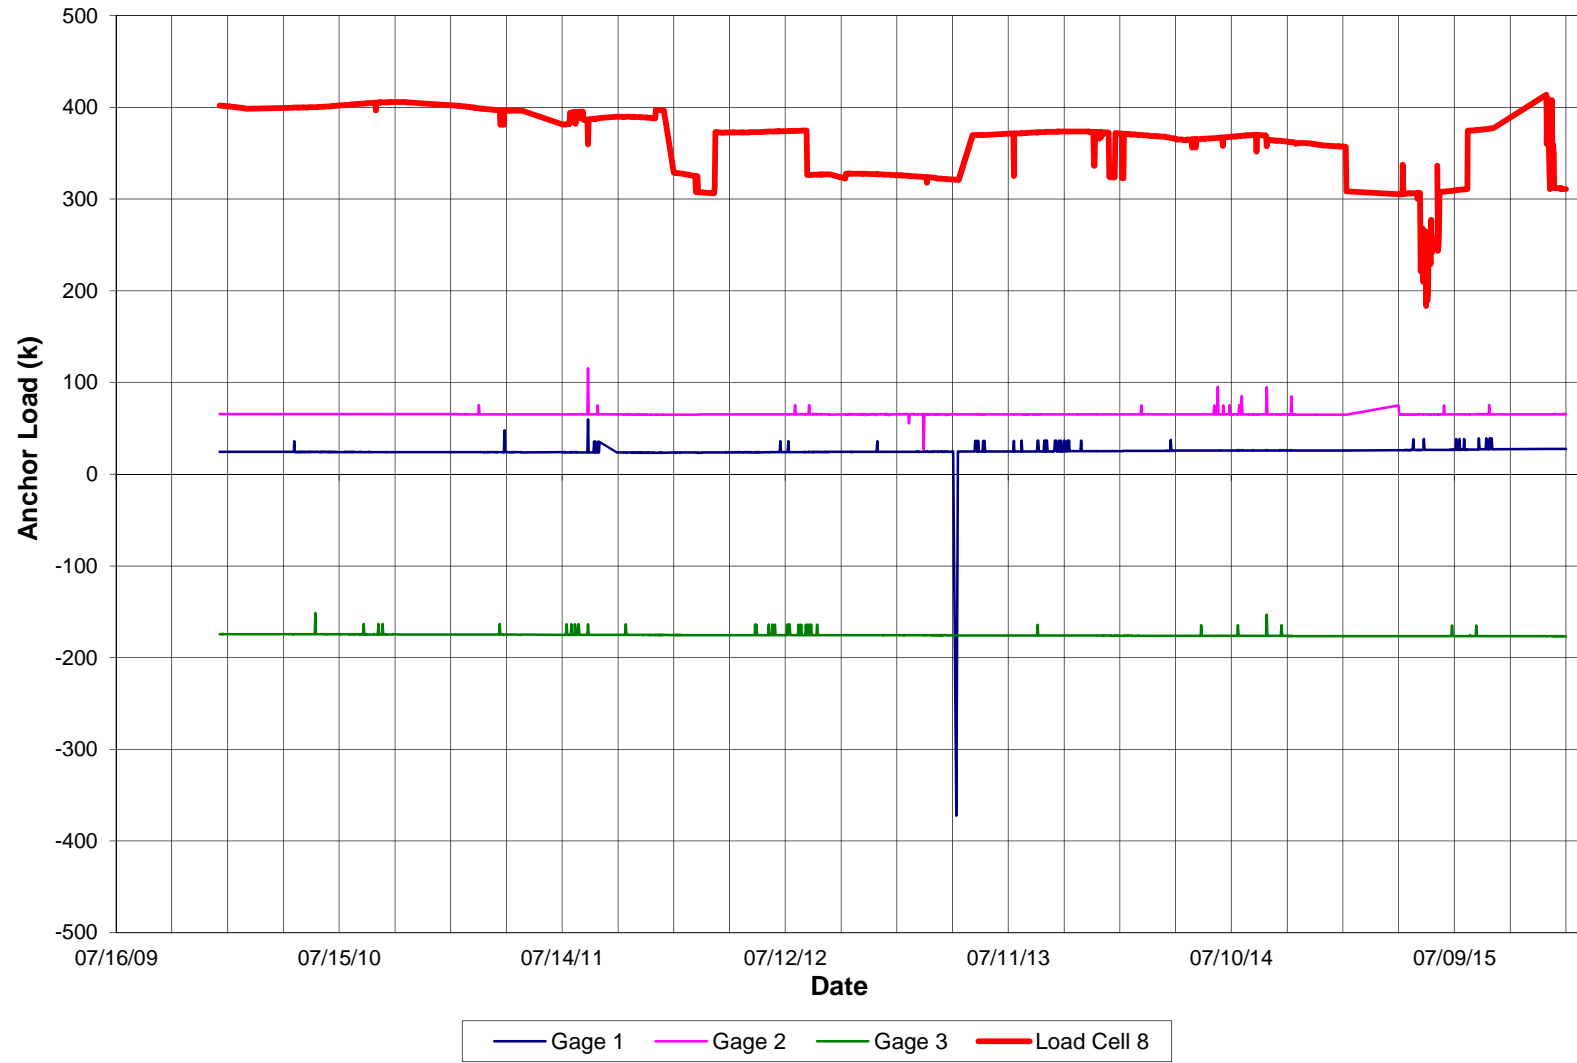
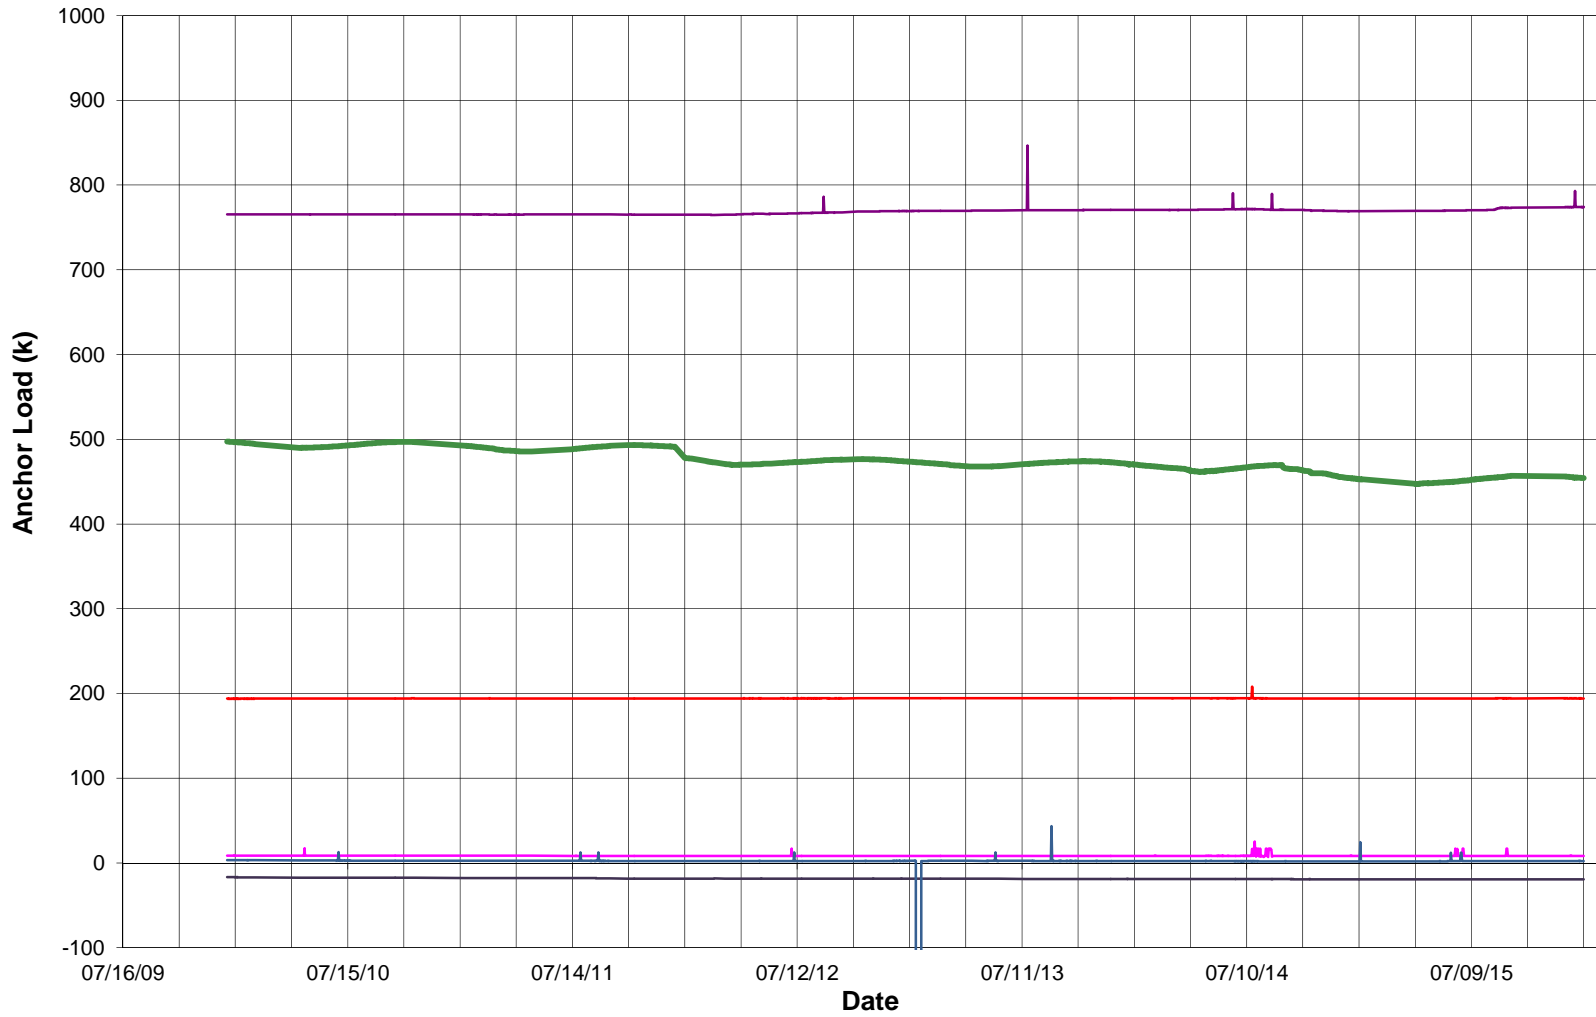
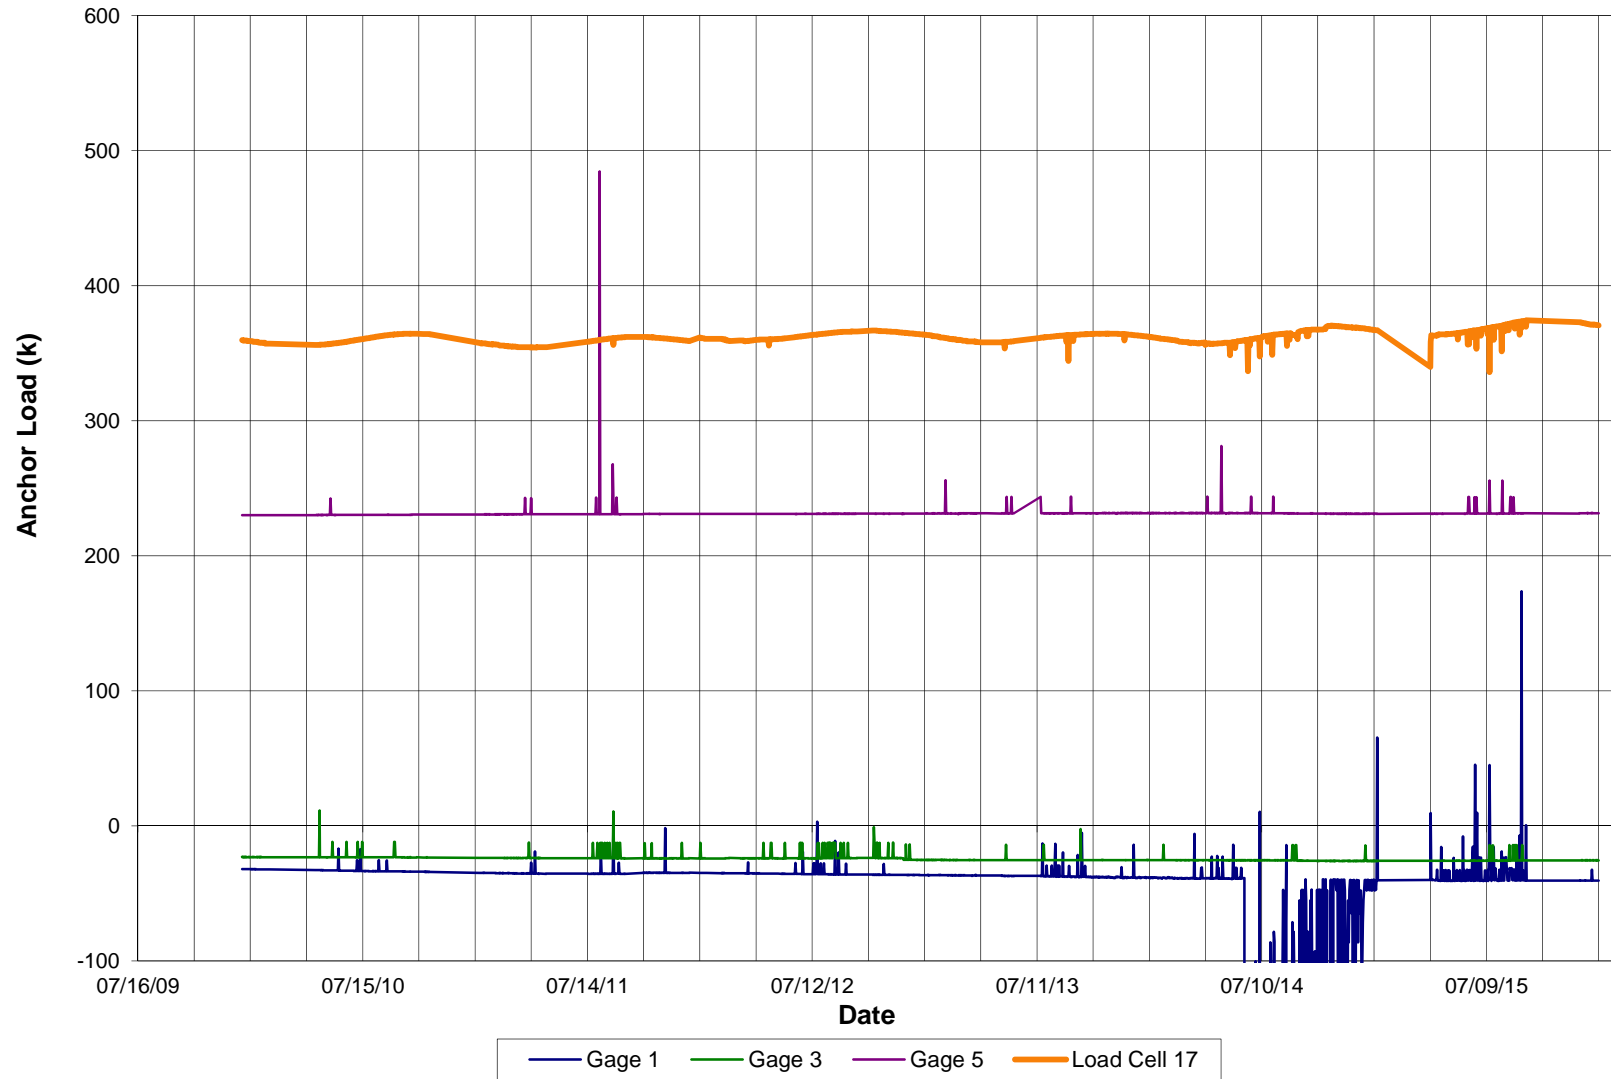
Load Cell Measurements

Seasonal variations are apparent in the plots for all of the load cells with the usual decrease in load seen during the winter months. Loads in Load Cells 1 and 9 have continued to trend downward since 2010. Load Cell 17 has increased slightly compared to past seasonal variations. The many spikes in the plots, especially for Load Cells 1 and 8, occur when one or more of the gauges in a load cell fail to record. Gage 4 in Load Cell 8 failed to record data starting on December 19, 2015, which is why a large decrease is shown in that plot. Table 2 shows which

Loads recorded for all active strandmeters on the instrumented anchors remained virtually constant this past quarter with the exception of an occasional spike caused by gages failing to record. The plot for Gage 5 on Anchor 1 indicates a continued slight increase this quarter. The magnitude of the load is obviously incorrect since it is unrealistically high. Average loads this quarter for the load cells and active strandmeters are listed in Table 3. We also report the percent change in load from last quarter. Strandmeter gages that have failed are indicated by an "x" in the table.
