Re: January 2016 Quarterly Report
CUY-90-15.24 Slope Monitoring
PID 96504
EDP Project No. 069032.00

JANUARY 2016 QUARTERLY REPORT

CUY-90-15.24 SLOPE MONITORING
PID 96504
CLEVELAND, OHIO
SME PROJECT NO. 069032.00

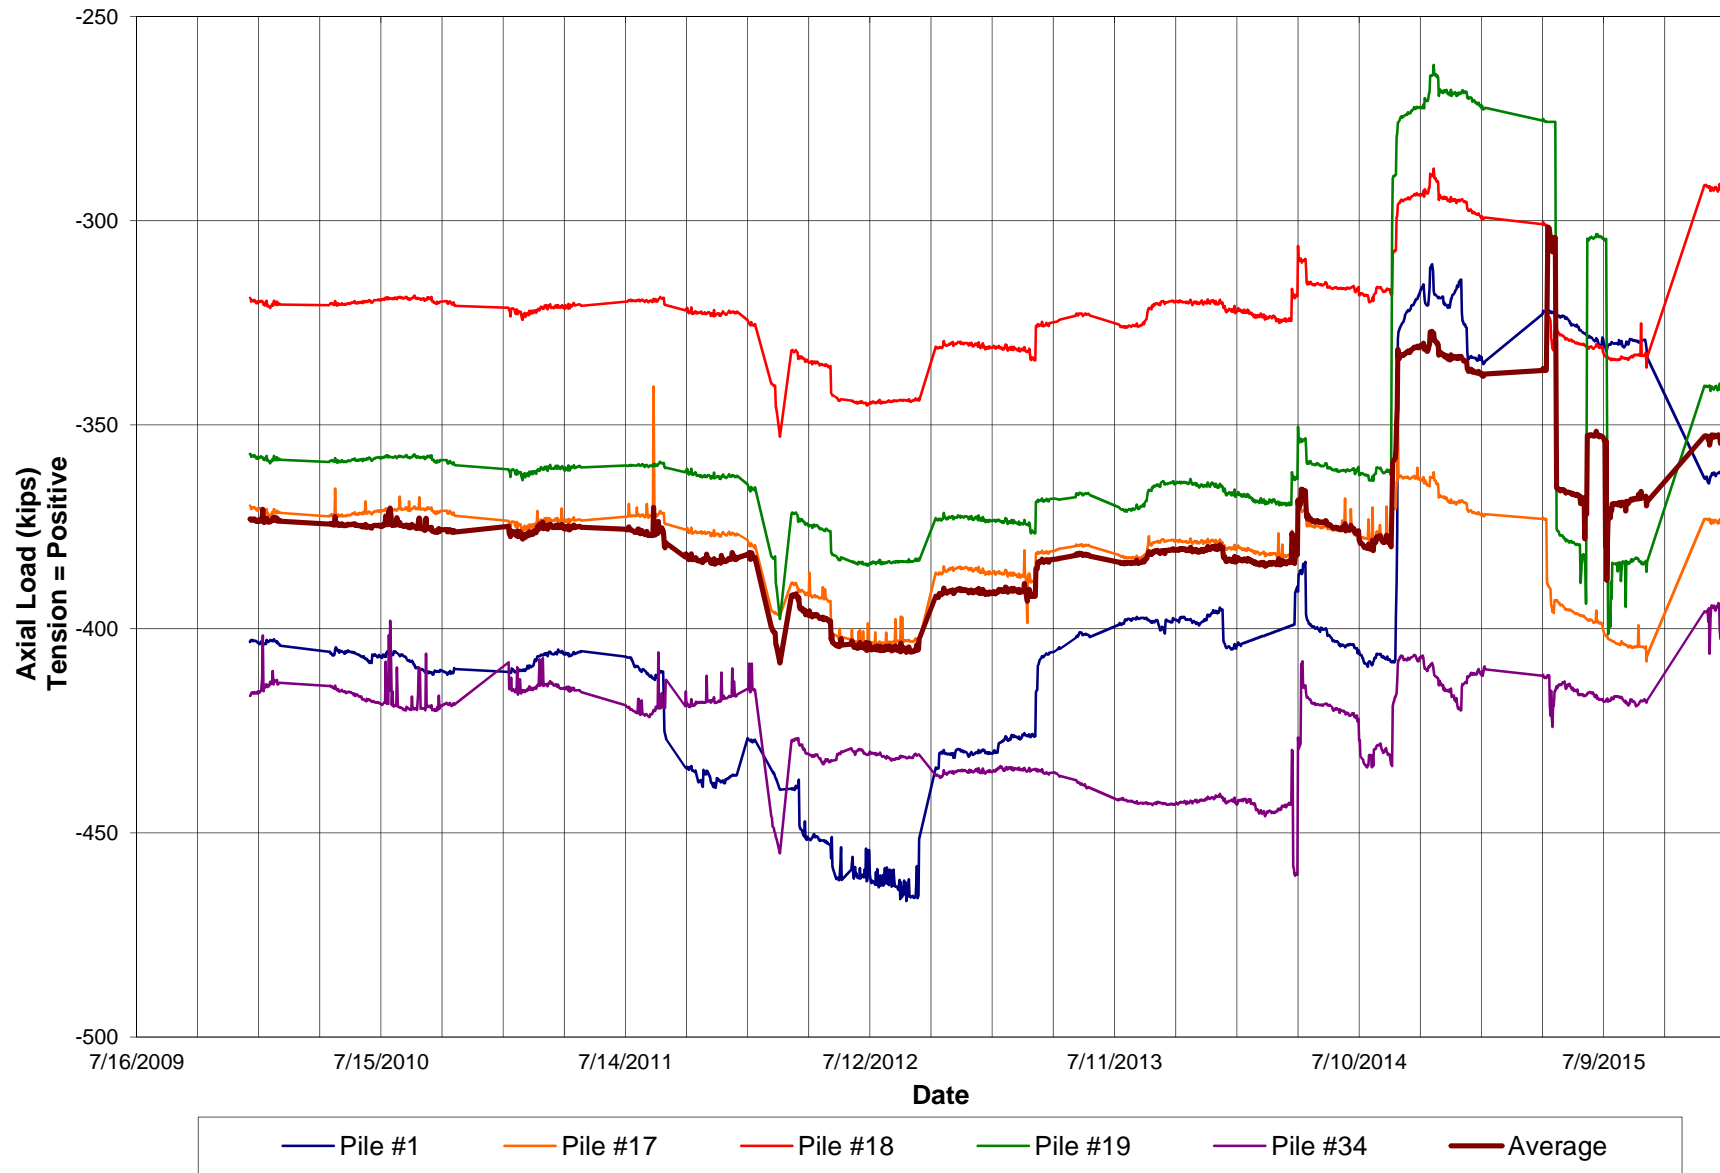
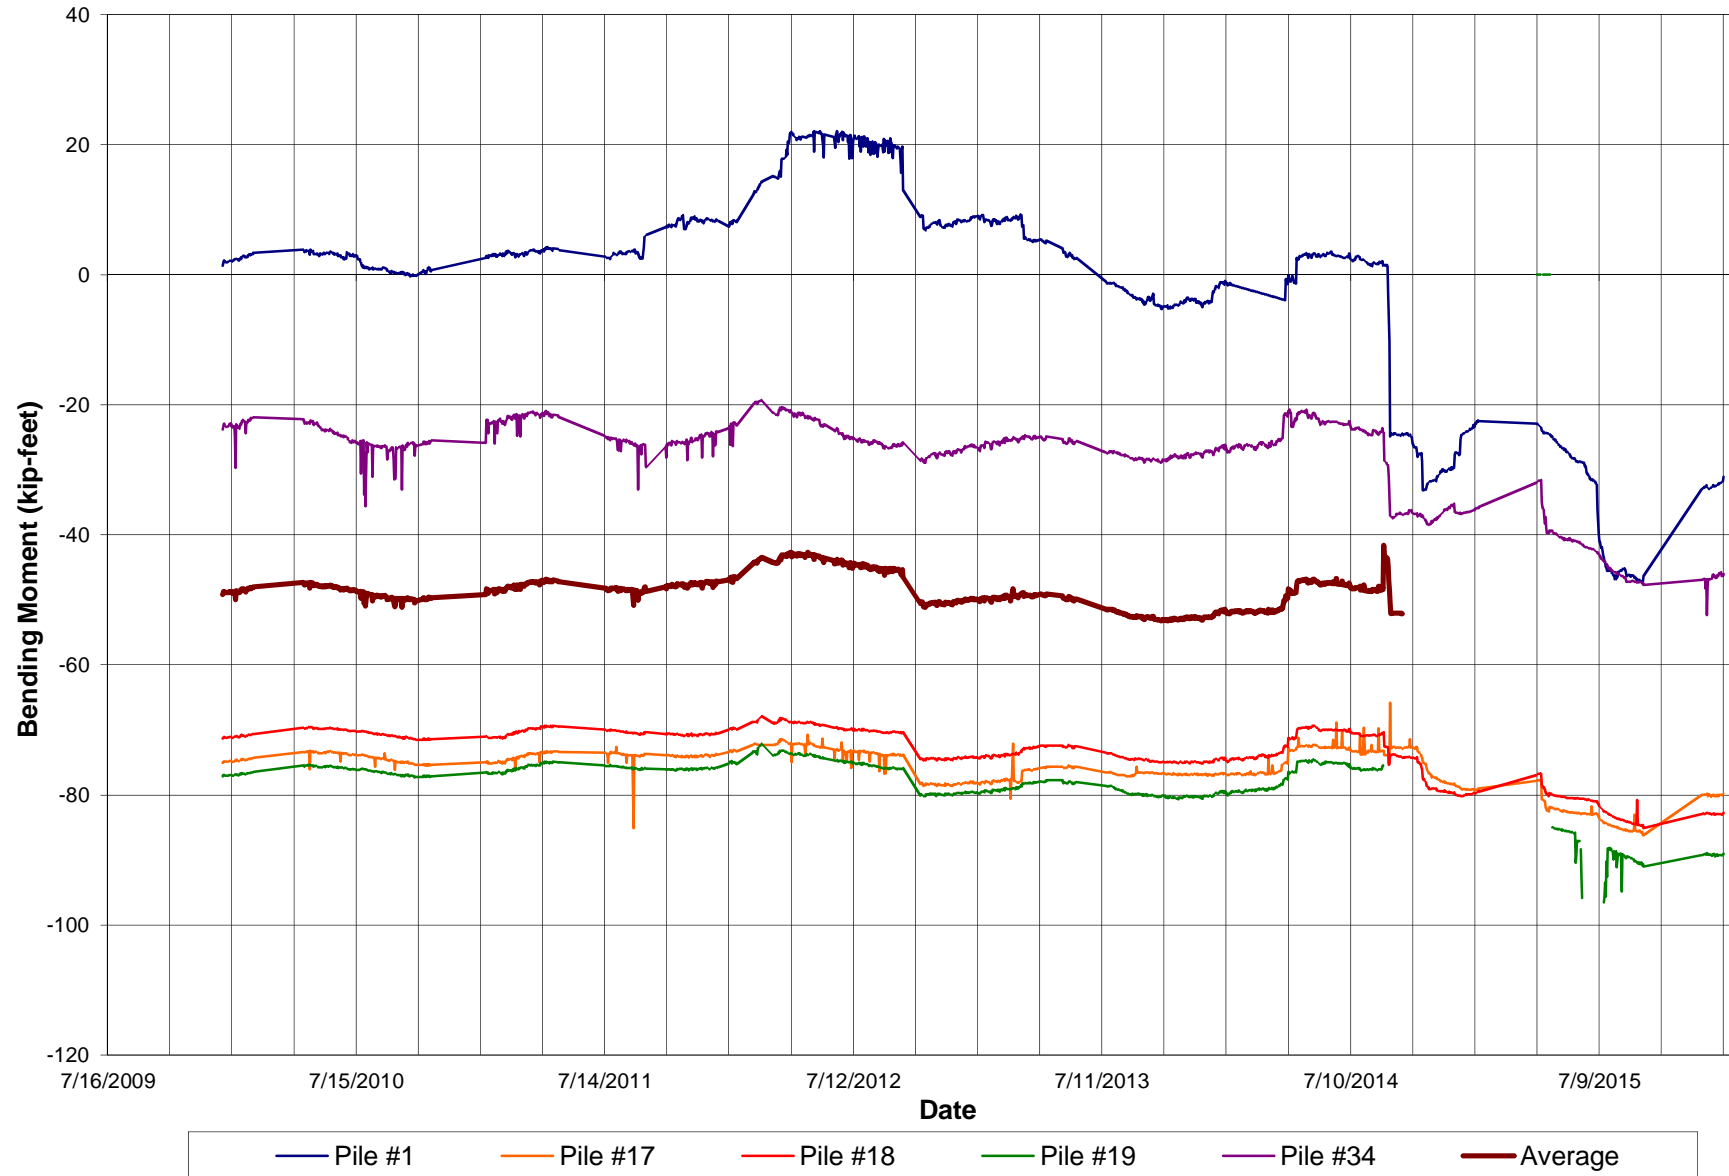
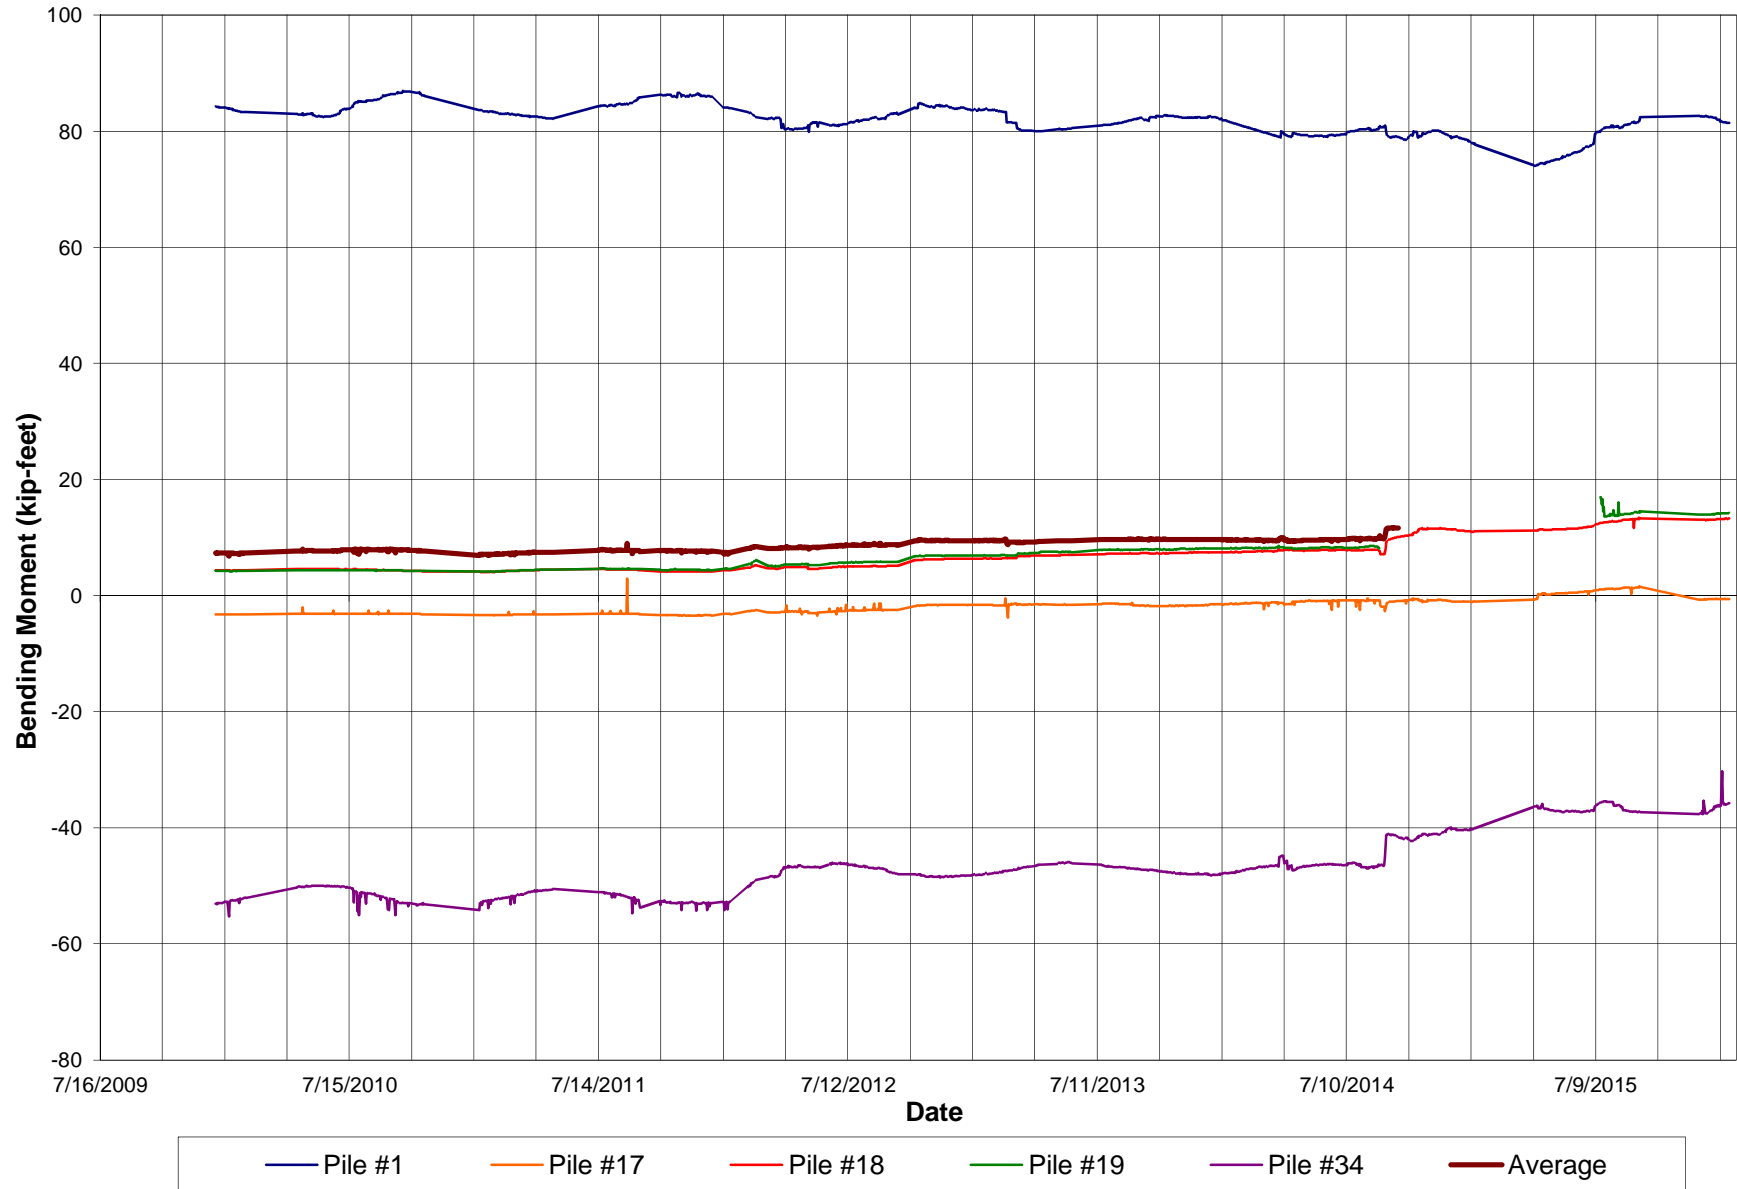
Axial loads in all driven piles except Pile 1 decreased this quarter with changes ranging from about 16 to 43 kips. The axial load in Pile 1 increased by about 27 kips. The attached plot shows these changes to be sloped straight lines due to the lack of data during the time that the data loggers stopped recording. Since December 6, 2015, the axial load in Pile 1 has been decreasing. The axial load in Pile 34 increased by about 6 kips on December 29, 2015 and has remained constant since then. Axial loads in the remaining driven piles have remained constant since December 6, 2015. Several gages are skipping or recording obviously erroneous data including Gage 2 on Pile 1 and Gage 3 on Pile 17.

Strong axis bending moments in all of the driven piles decreased this quarter. The greatest decrease of 15 kip-feet occurred in Pile 1, and the moment is continuing to decrease. Decreases

in the remaining piles ranged from 2 to 6 kip-feet. Bending moments have remained constant since the beginning of December 2015. Weak axis bending moments this quarter decreased slightly in Piles 1, 17, and 34. Weak axis bending moments in Pile 19 are now included on the plot since the gages appear to be functioning normally again. Changes in weak axis bending moments in Pile 18 and 19 were negligible.

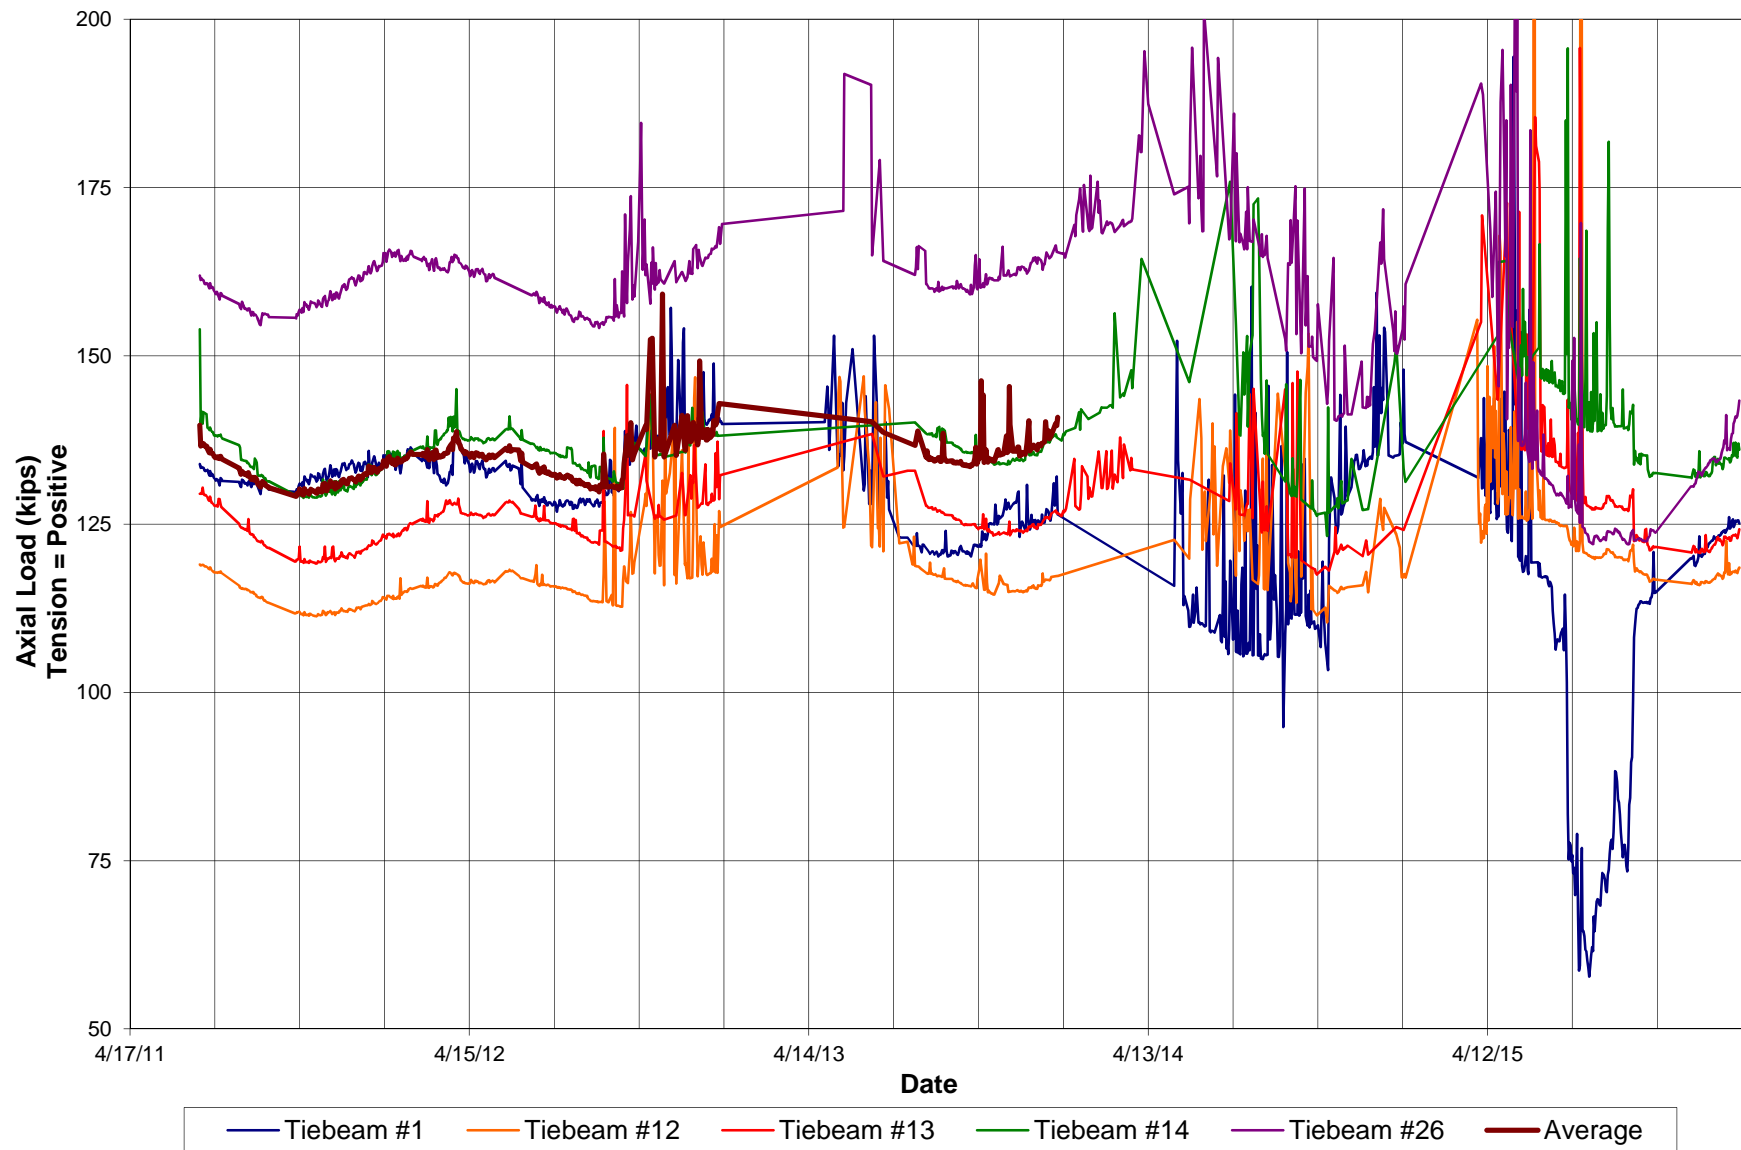
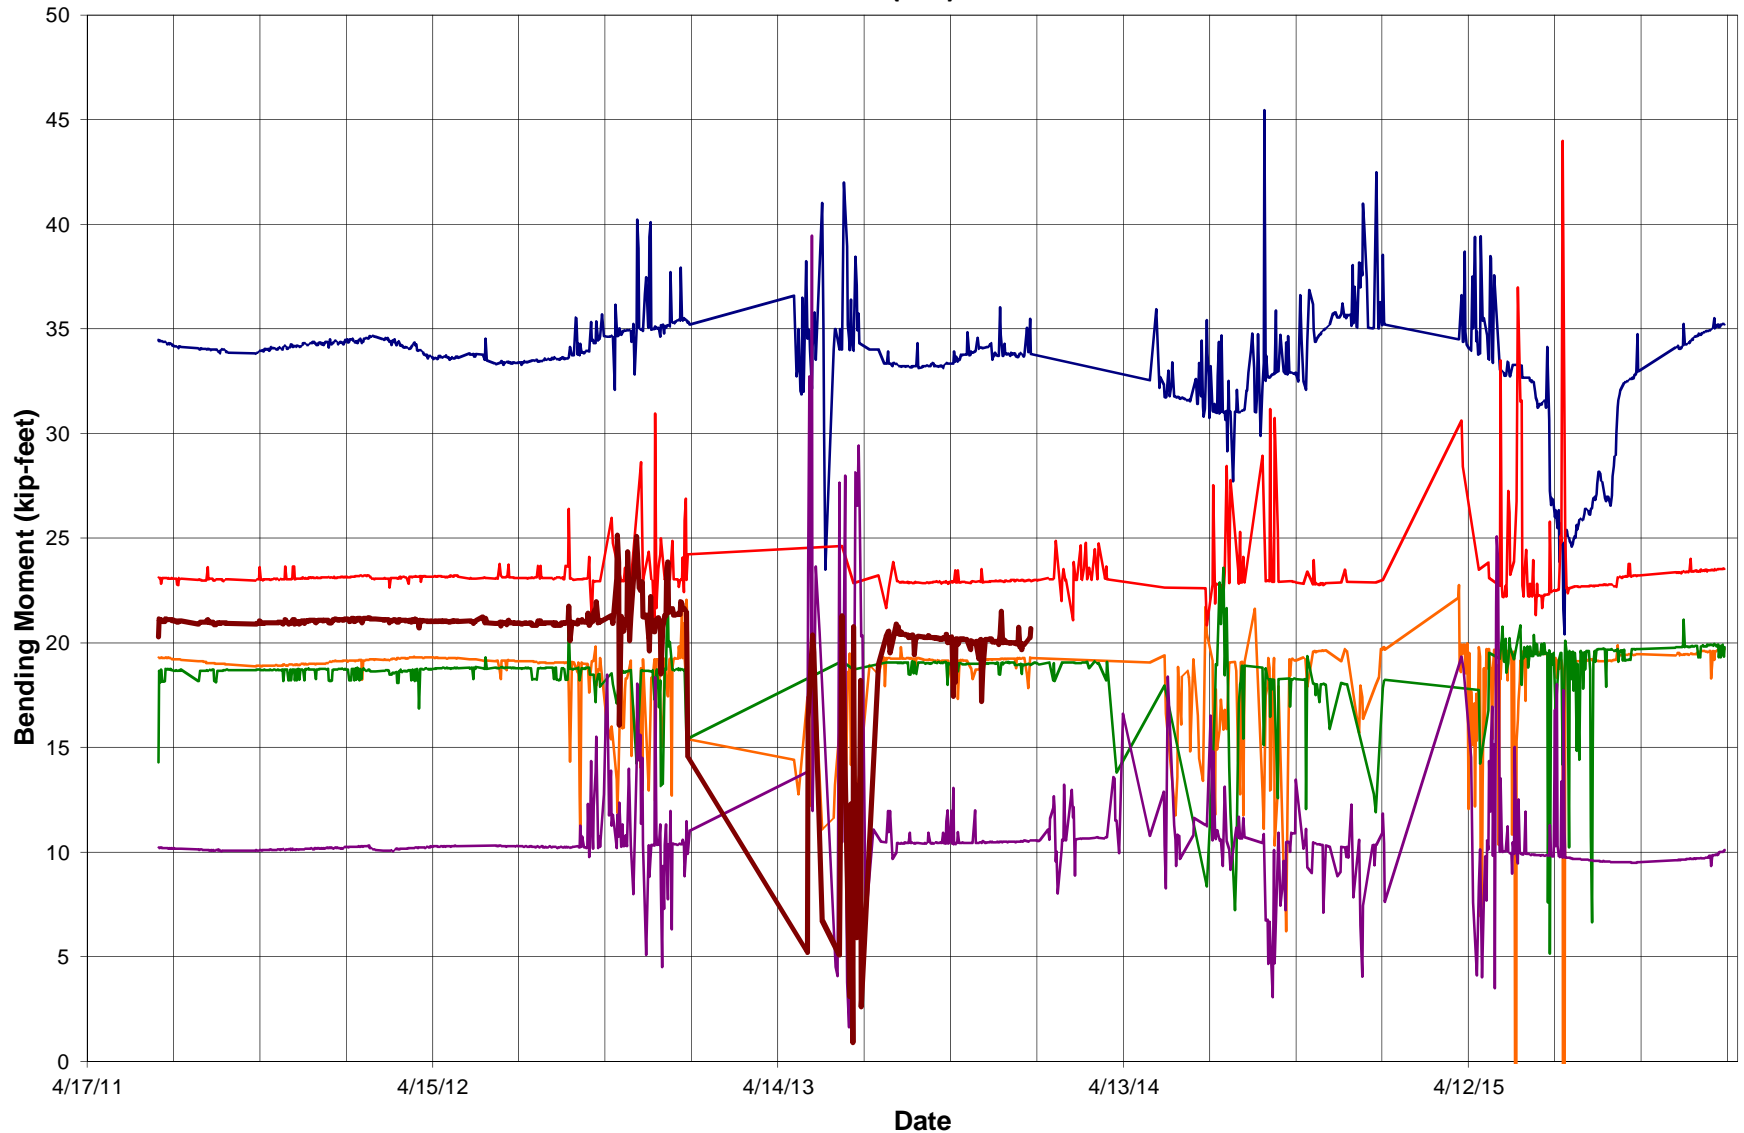
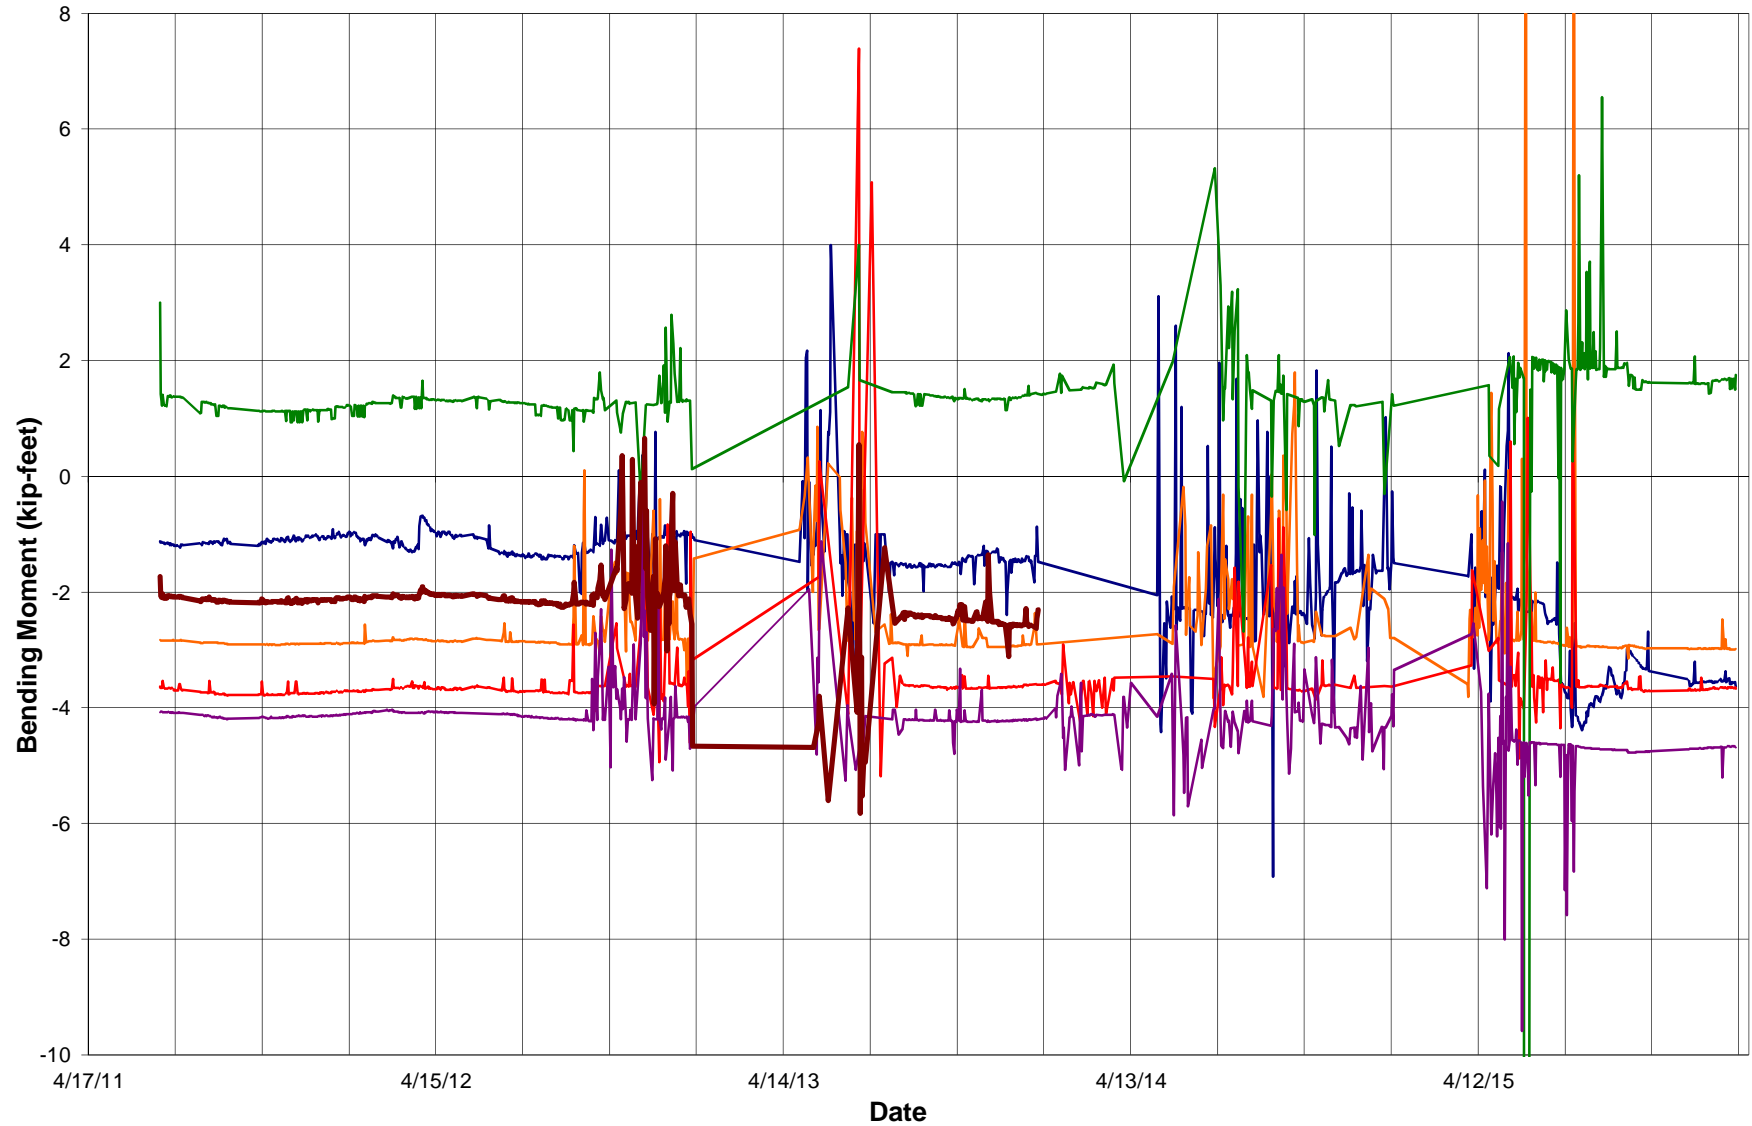
The axial loads at the anchor end of the tiebeams increased this quarter reflecting seasonal variations like those seen in past years. Axial loads in Tiebeams 1 and 26 increased at a much faster rate than the remaining tiebeams. The greatest increase in strong axis bending moment occurred in Tiebeam 1 which increased by about 2 kip-feet. Strong axis bending moments in the other tiebeams increased slightly or remained the same. Changes in weak axis bending moments were negligible.

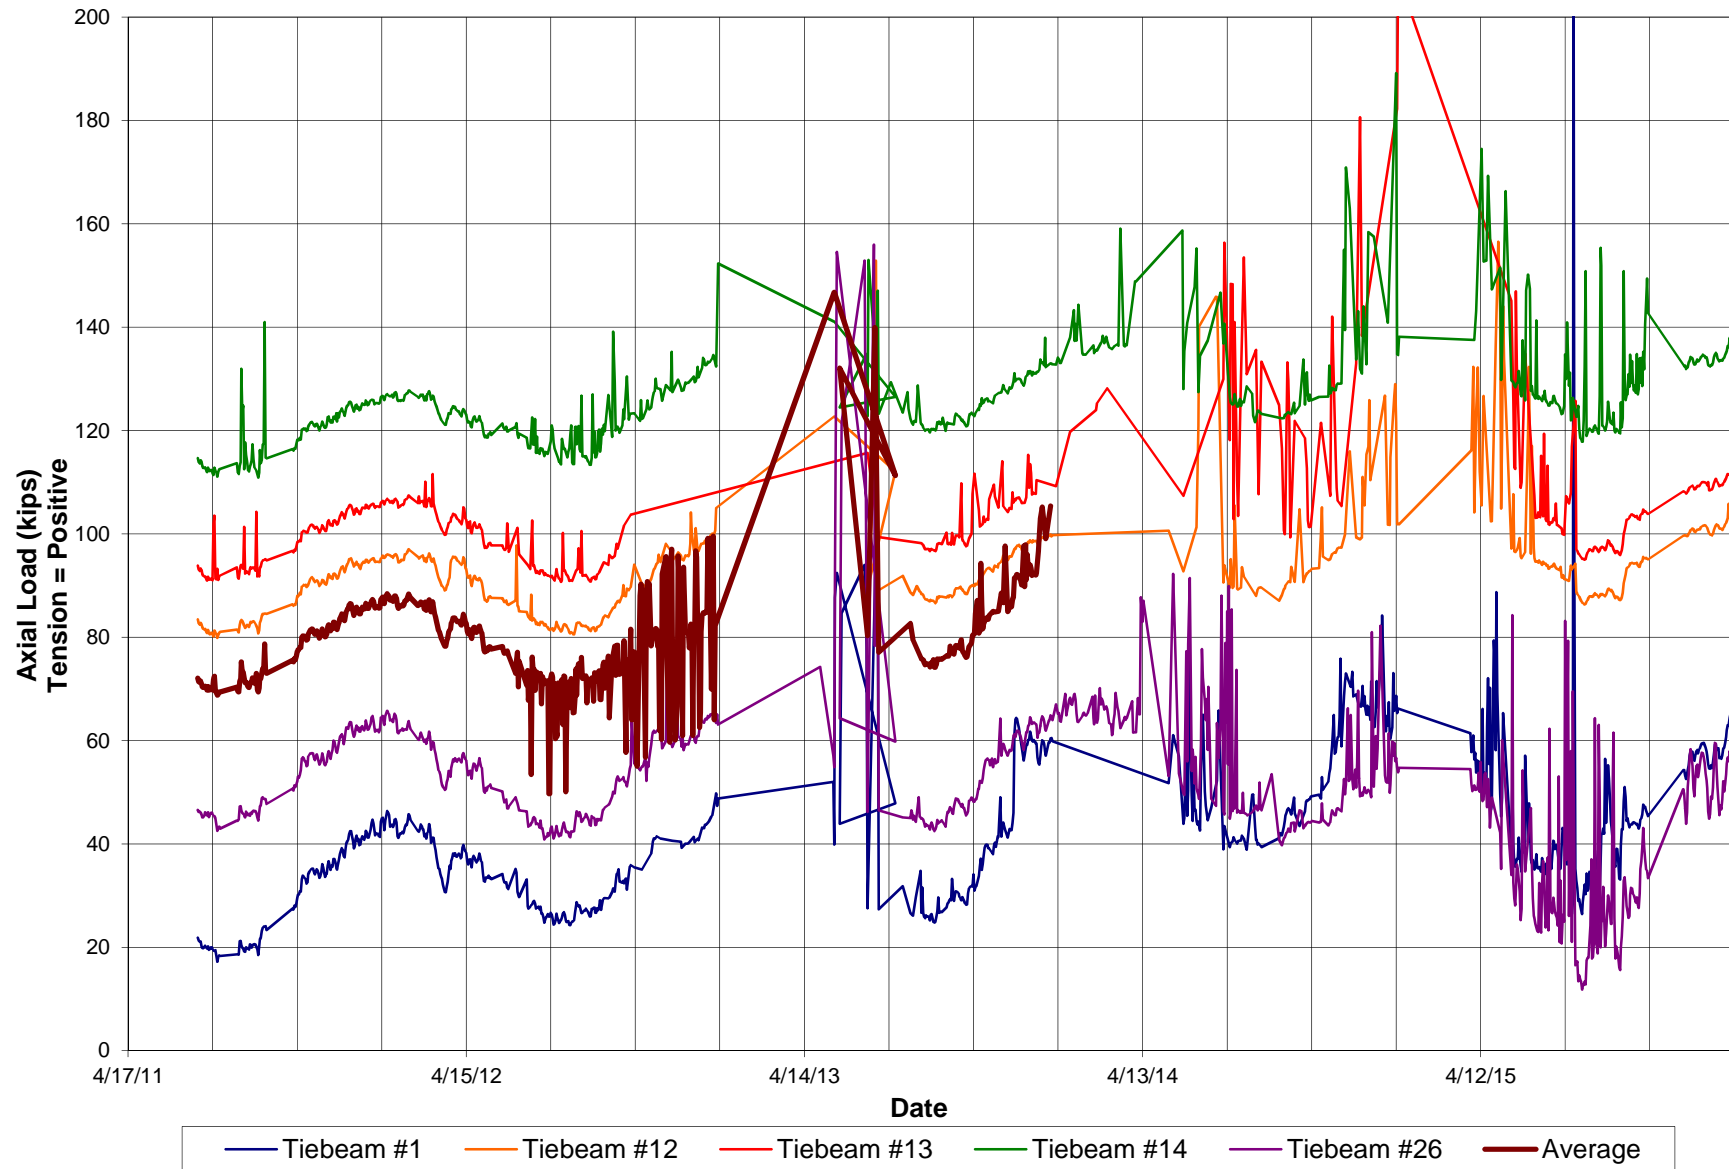
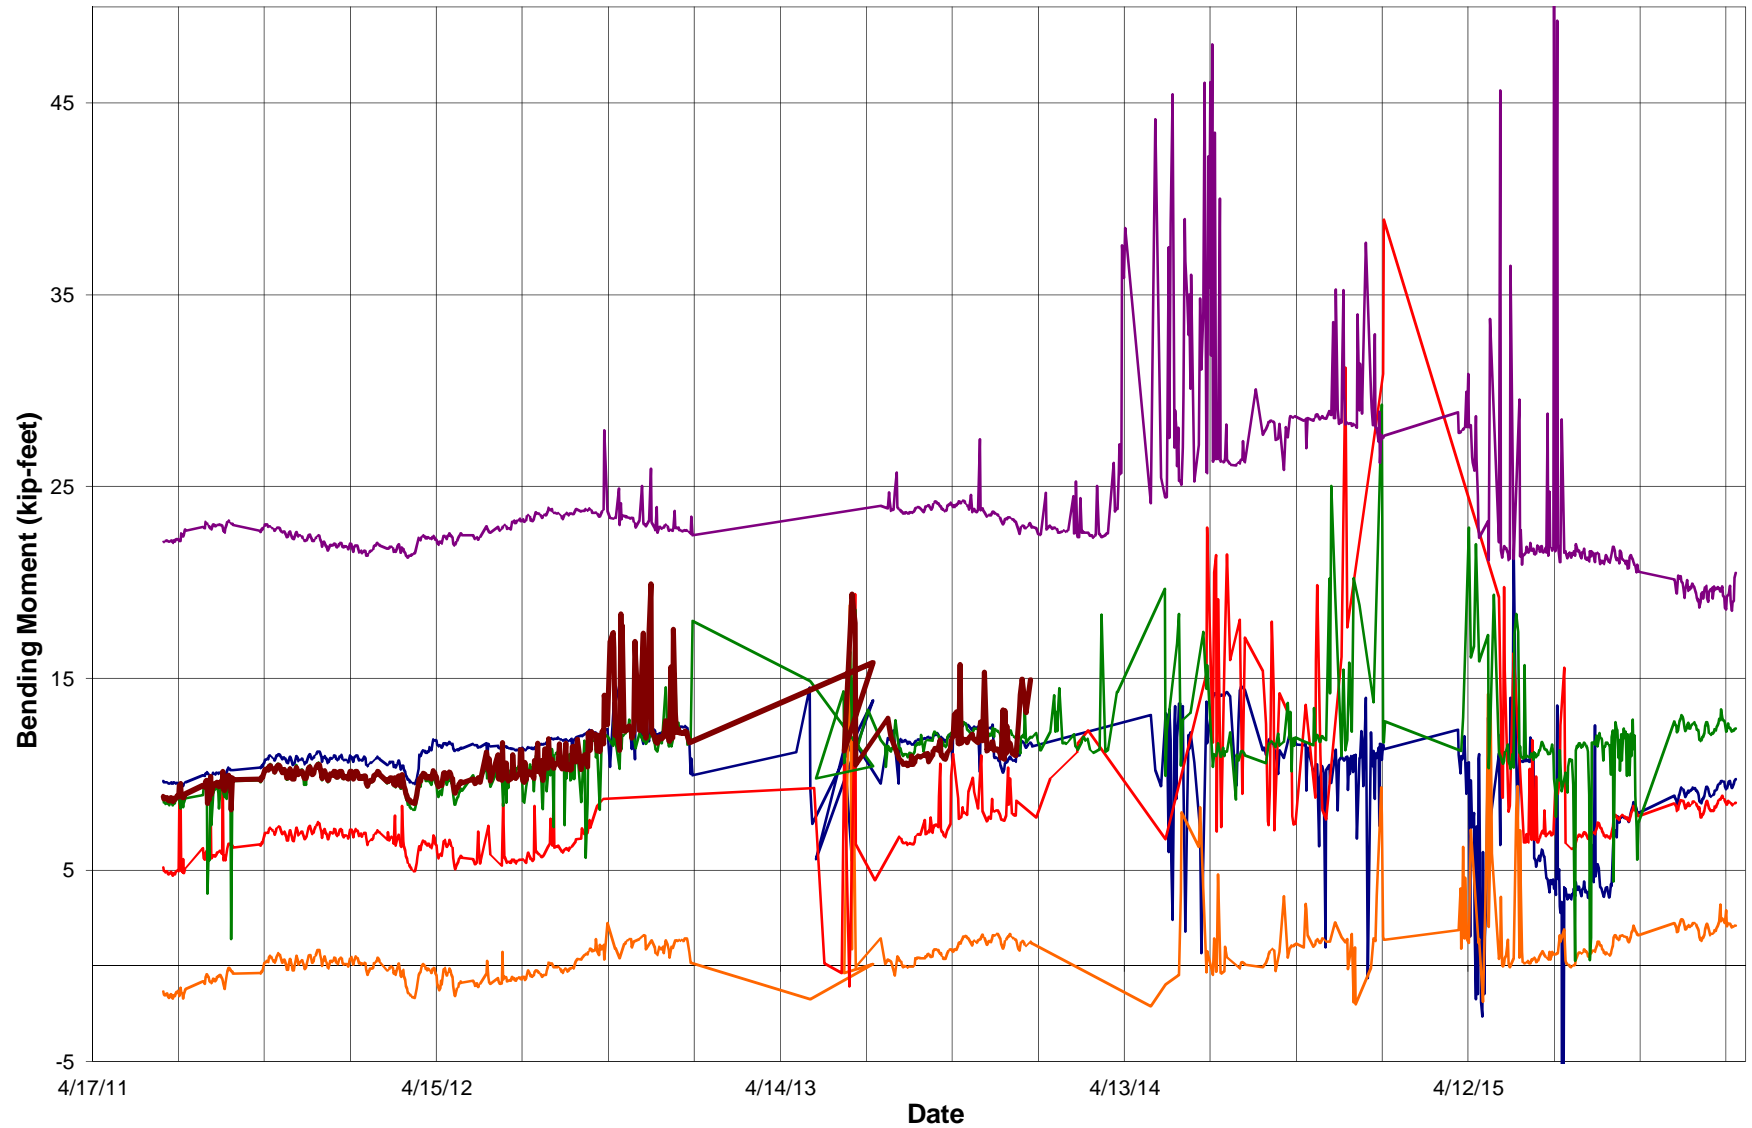
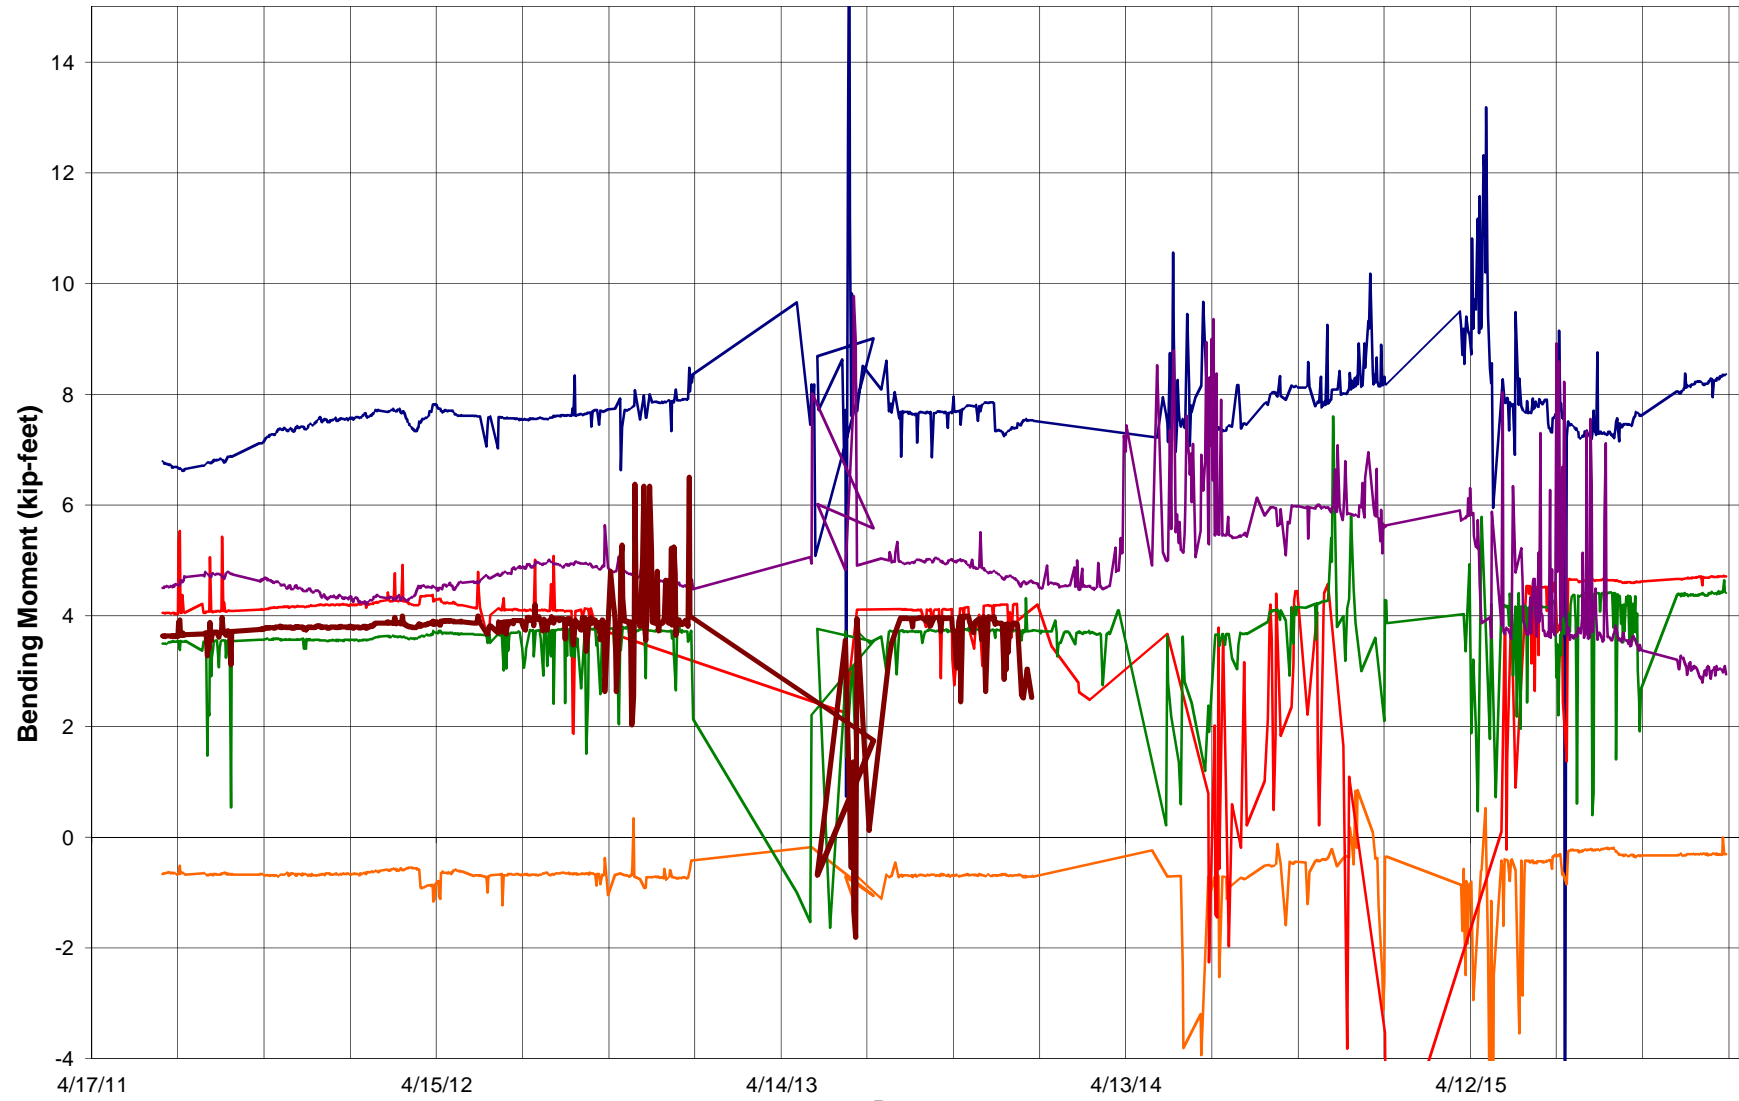
The axial loads at the drilled pier end of the tiebeams also increased this quarter following the seasonal trend. With the exception of Tiebeam 26 axial loads have gradually increased over the past several years. The load in Tiebeam 26 has gradually decreased. A similar trend is apparent in the strong axis bending moments. Weak axis bending moments increased in Tiebeam 1 and decreased in Tiebeam 26. Weak axis bending moments remained about the same in Tiebeams 12, 13, and 14.
