Re: January 2016 Quarterly Report
CUY-90-15.24 Slope Monitoring
PID 96504
EDP Project No. 069032.00

JANUARY 2016 QUARTERLY REPORT

CUY-90-15.24 SLOPE MONITORING
PID 96504
CLEVELAND, OHIO
SME PROJECT NO. 069032.00

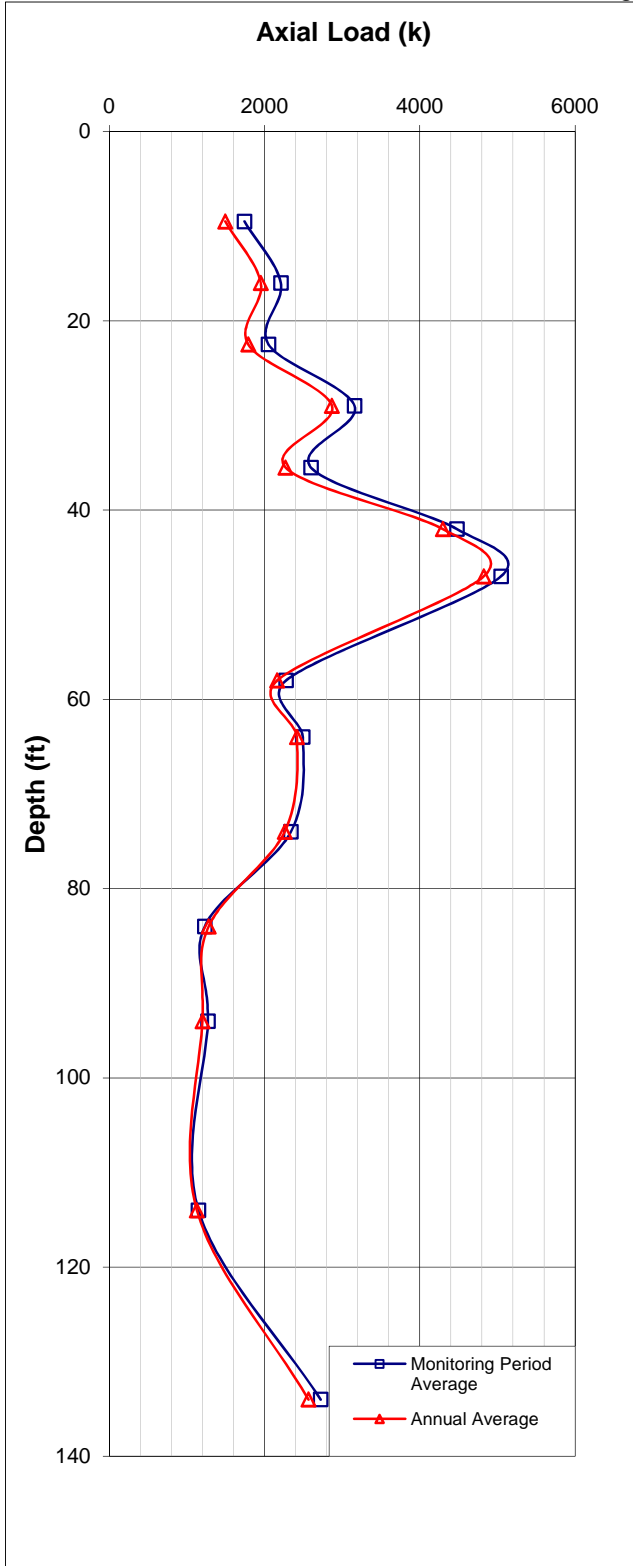
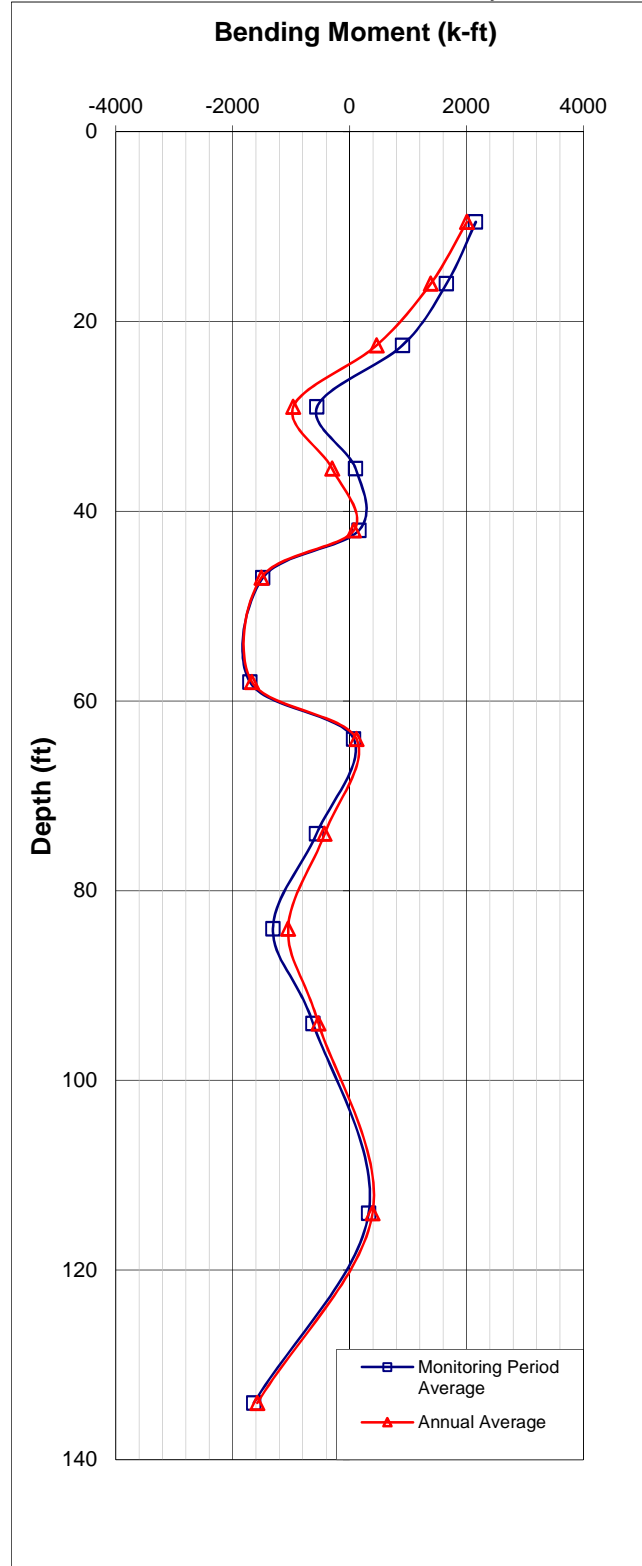
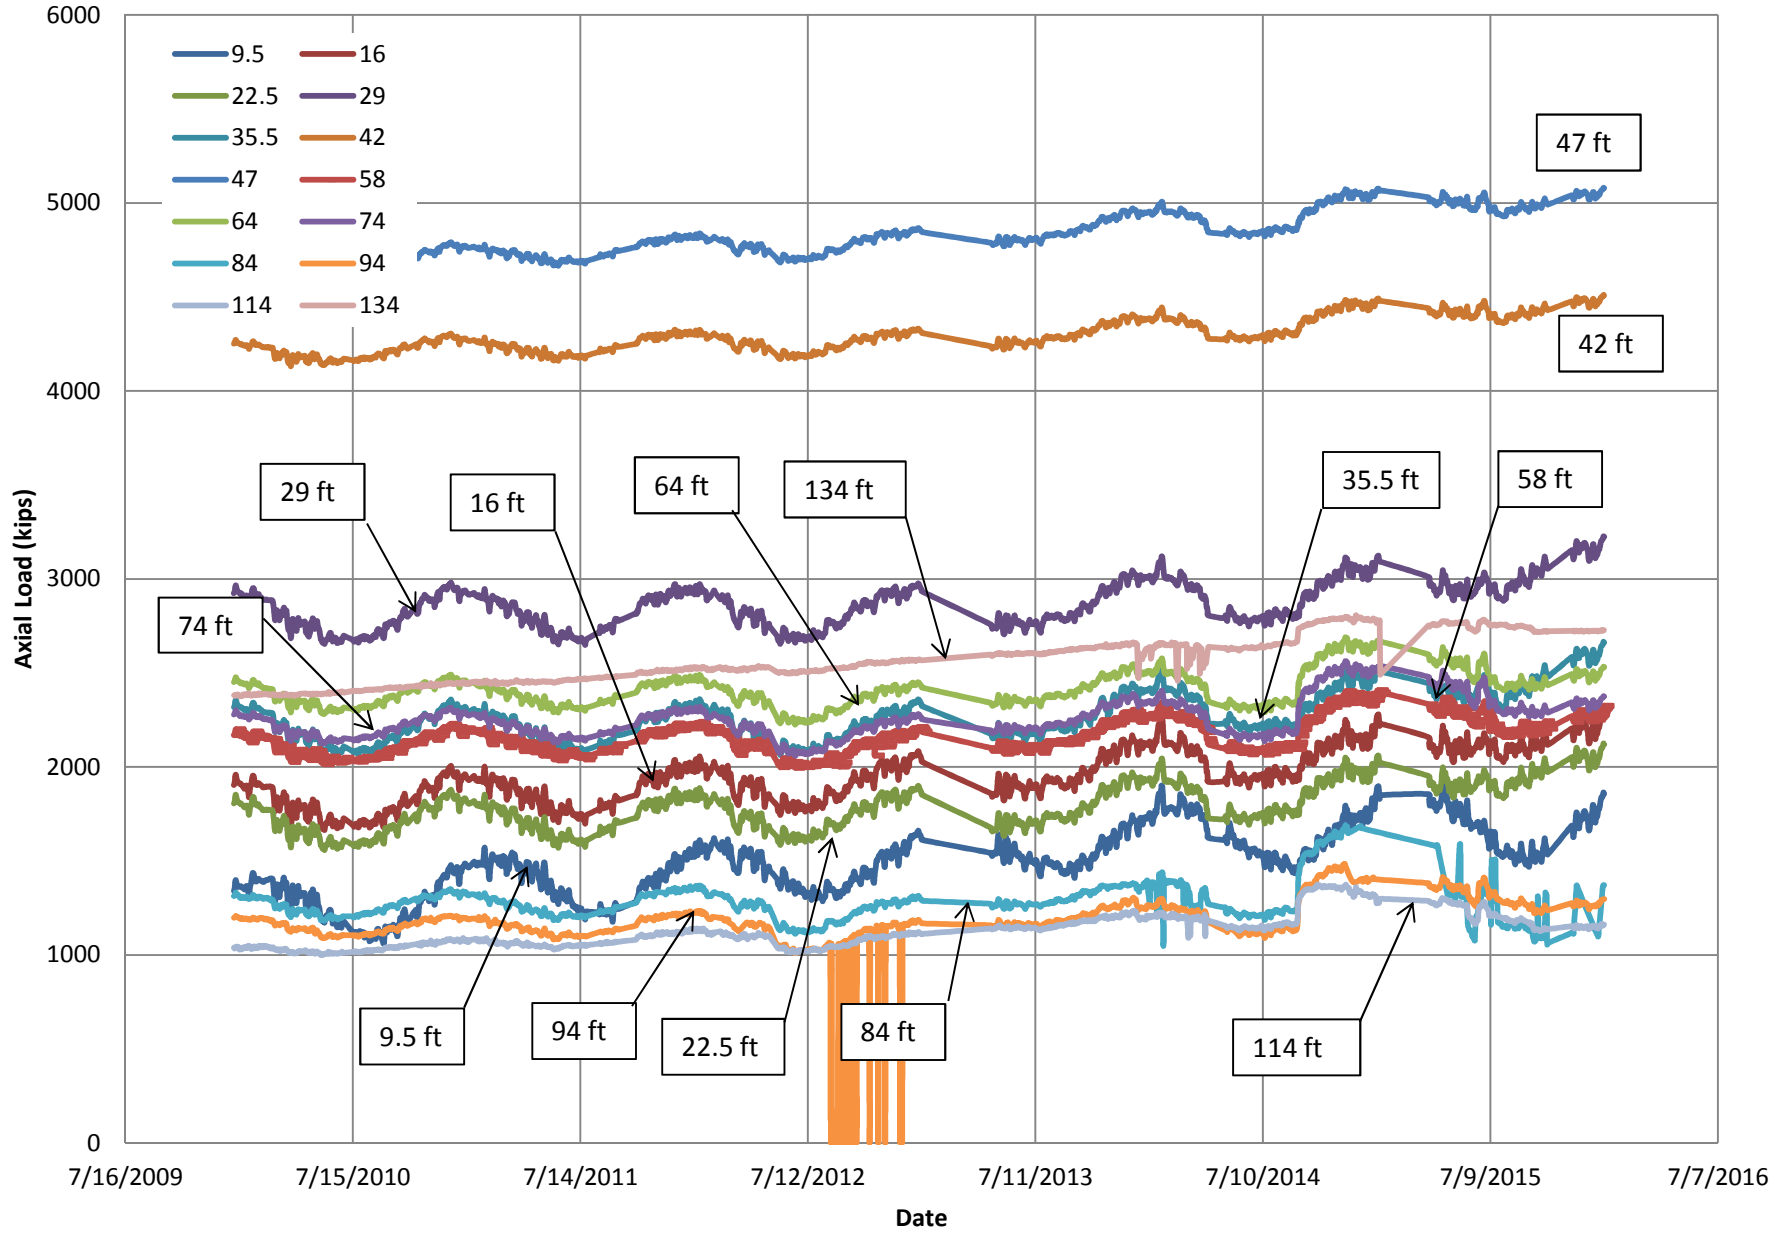
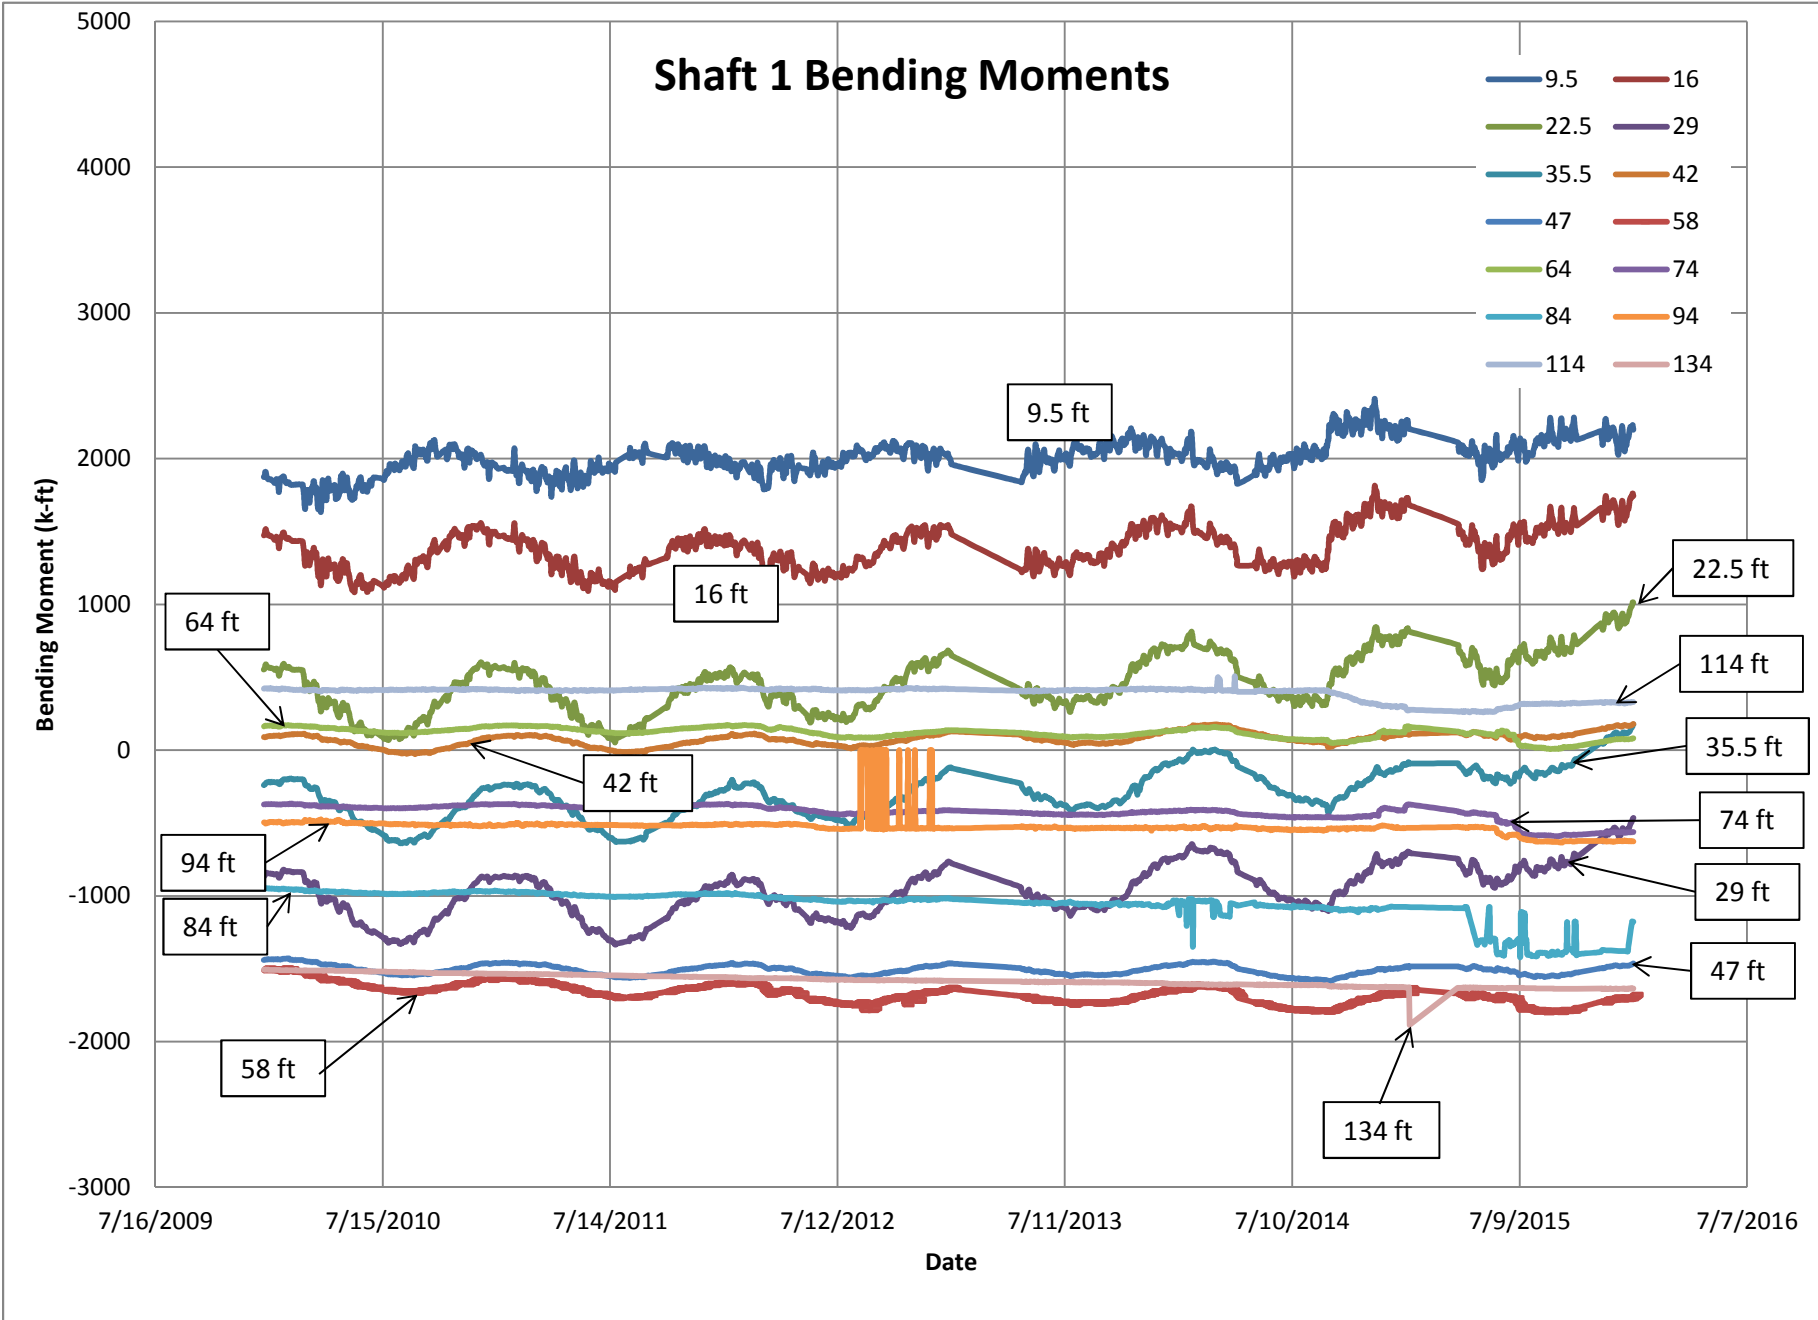
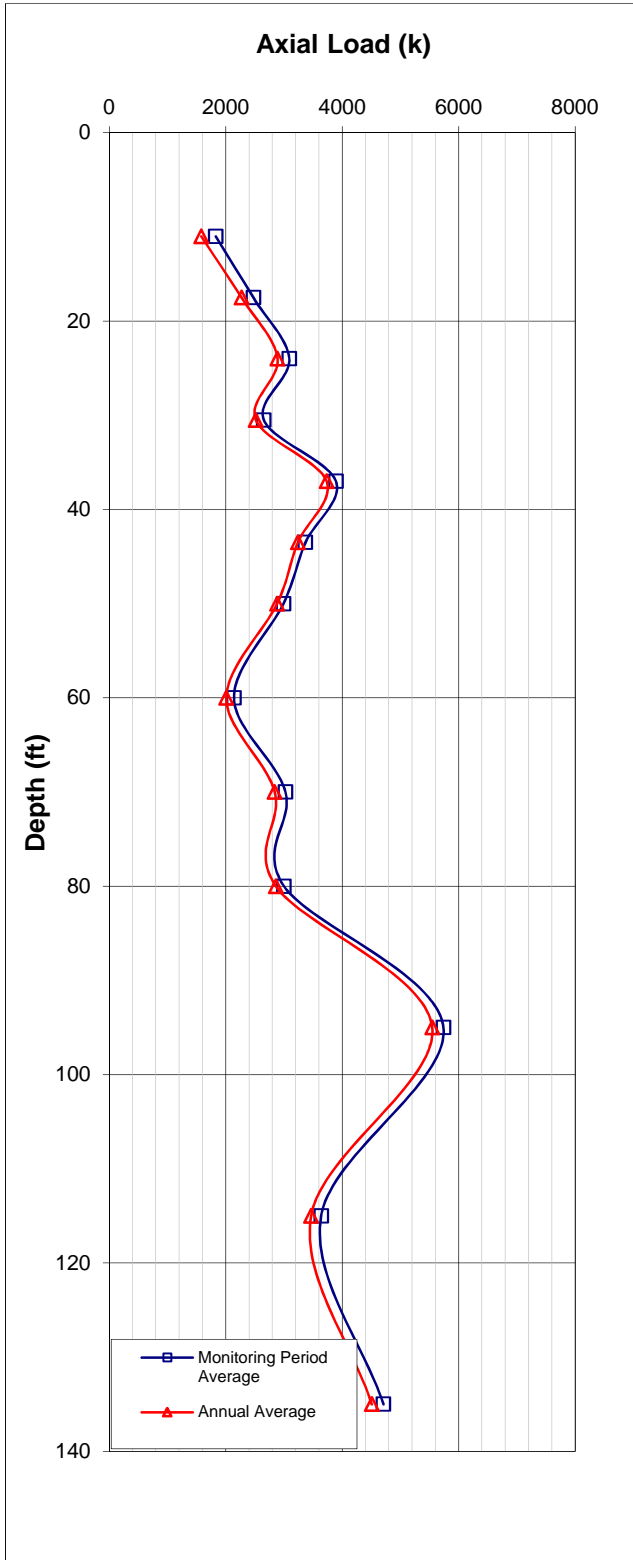
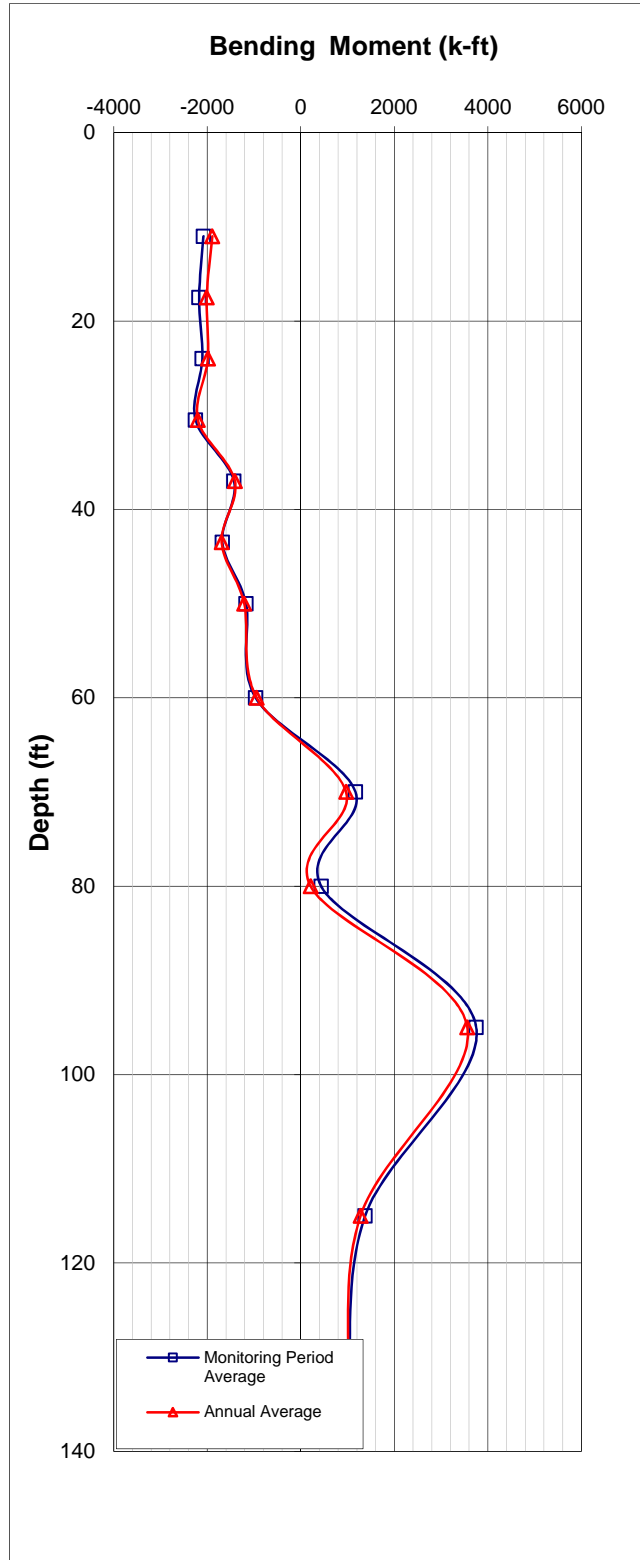
The profile plots for both instrumented piers suggest a general increase in axial load over most of the length of the piers this quarter. Plots of axial load vs. time show that axial loads are near a seasonal high in Pier 1 and a seasonal low in Pier 9. These load vs. time plots continue to show a gradual increase in axial load over time in both shafts at all depths. Some erratic data was again recorded for the gages at 84 feet in Pier 1. This affects both the axial load and bending moment plots but the data does not appear to indicate a significant change from past trends at this depth.

Bending moments in Pier 1 are changing most at the shallow and deep ends of the pier with moments decreasing over time at 29, 35.5, and 114 feet, and increasing above 22.5 feet and below 74 feet. At depths between 42 and 74 feet the bending moments remain relatively constant. A similar trend occurs in Pier 9 where the bending moments remain relatively constant between 30 and 50 feet and are increasing at all other depths. Changes in Pier 1 this quarter at 16, 22.5, and 29 feet were greater than we have seen in the past.
