February 16, 2016

Re: February 10 and 11, 2016 Bi-Weekly Readings
CUY-90-15.24 Slope Monitoring
PID 96504
SME Project No. 069032.00

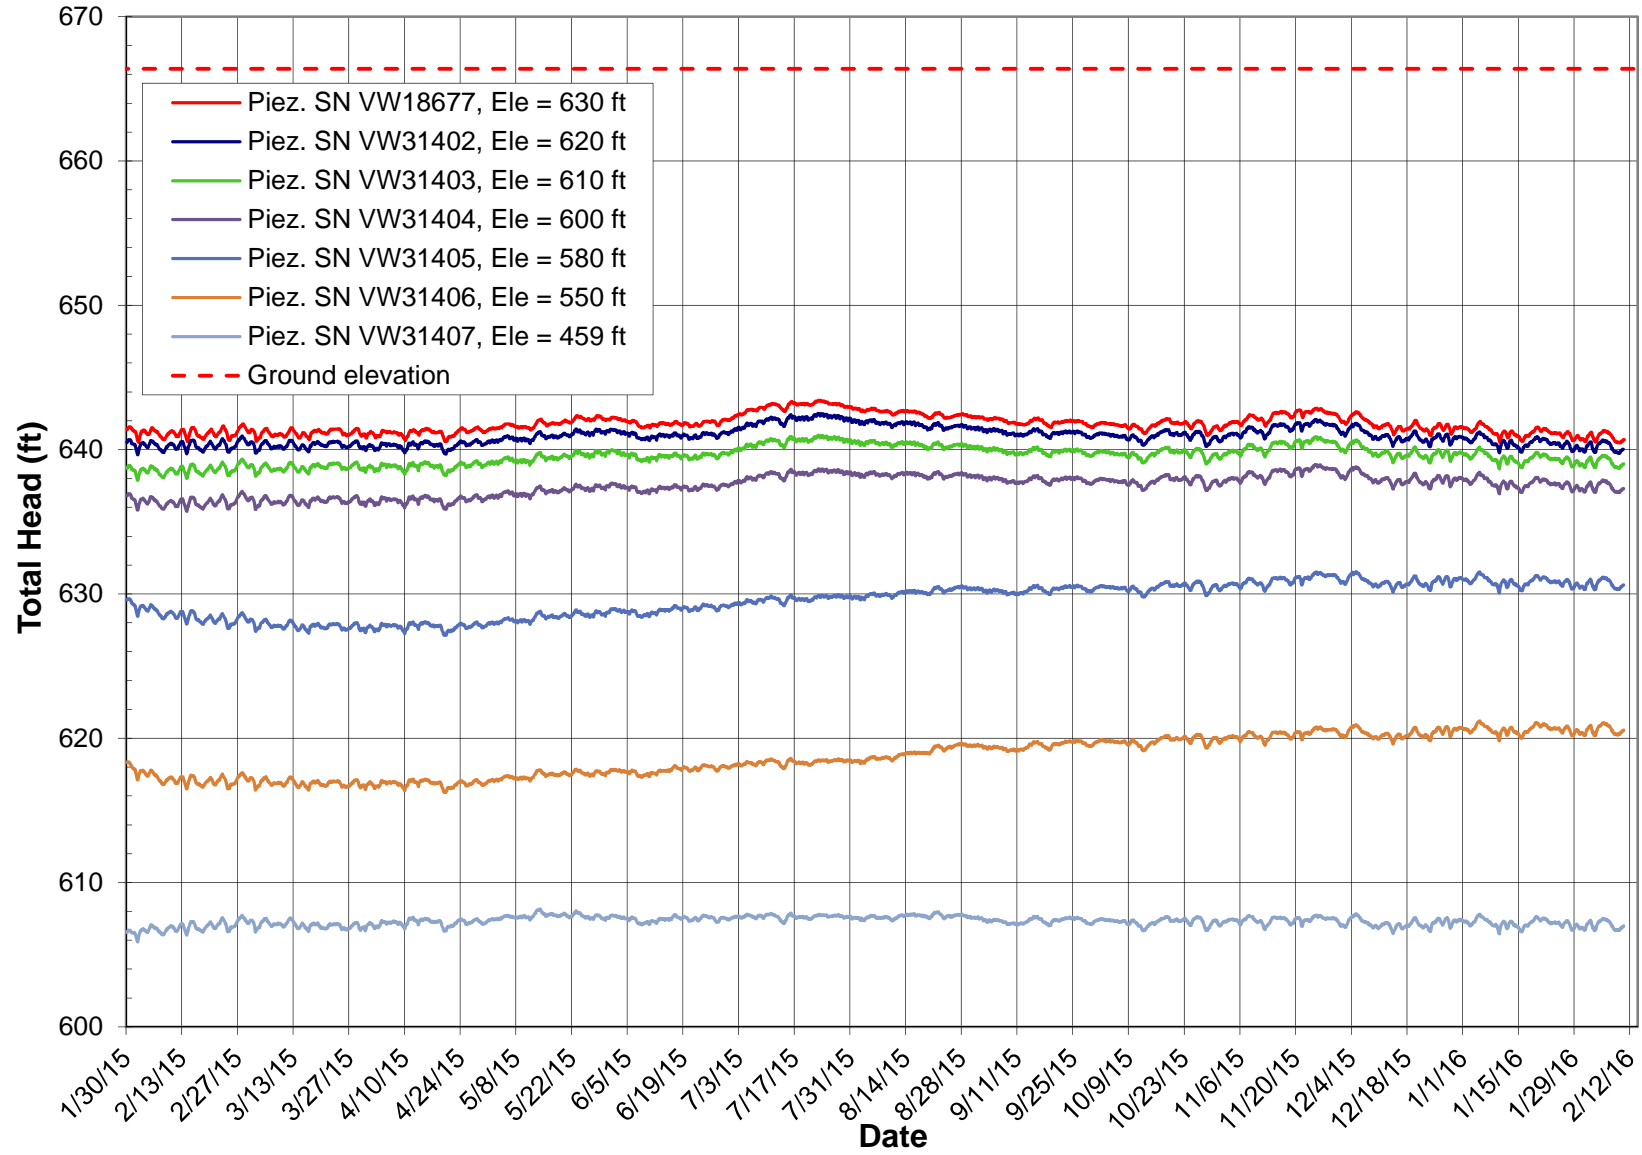
P-001-13 VW Piezometer Readings

P-001-13, P-002-13, P-003-10, B-05-A-11 – Pore pressure readings at these locations indicate slight fluctuations in total head throughout this reading period but virtually no net change. The shallowest piezometer at P-003-10 output all erroneous data. We think this is due to a loose connection, which has occurred with this piezometer in the past. We will attempt to reconnect the piezometer this week during our weekly B-105 site visit.

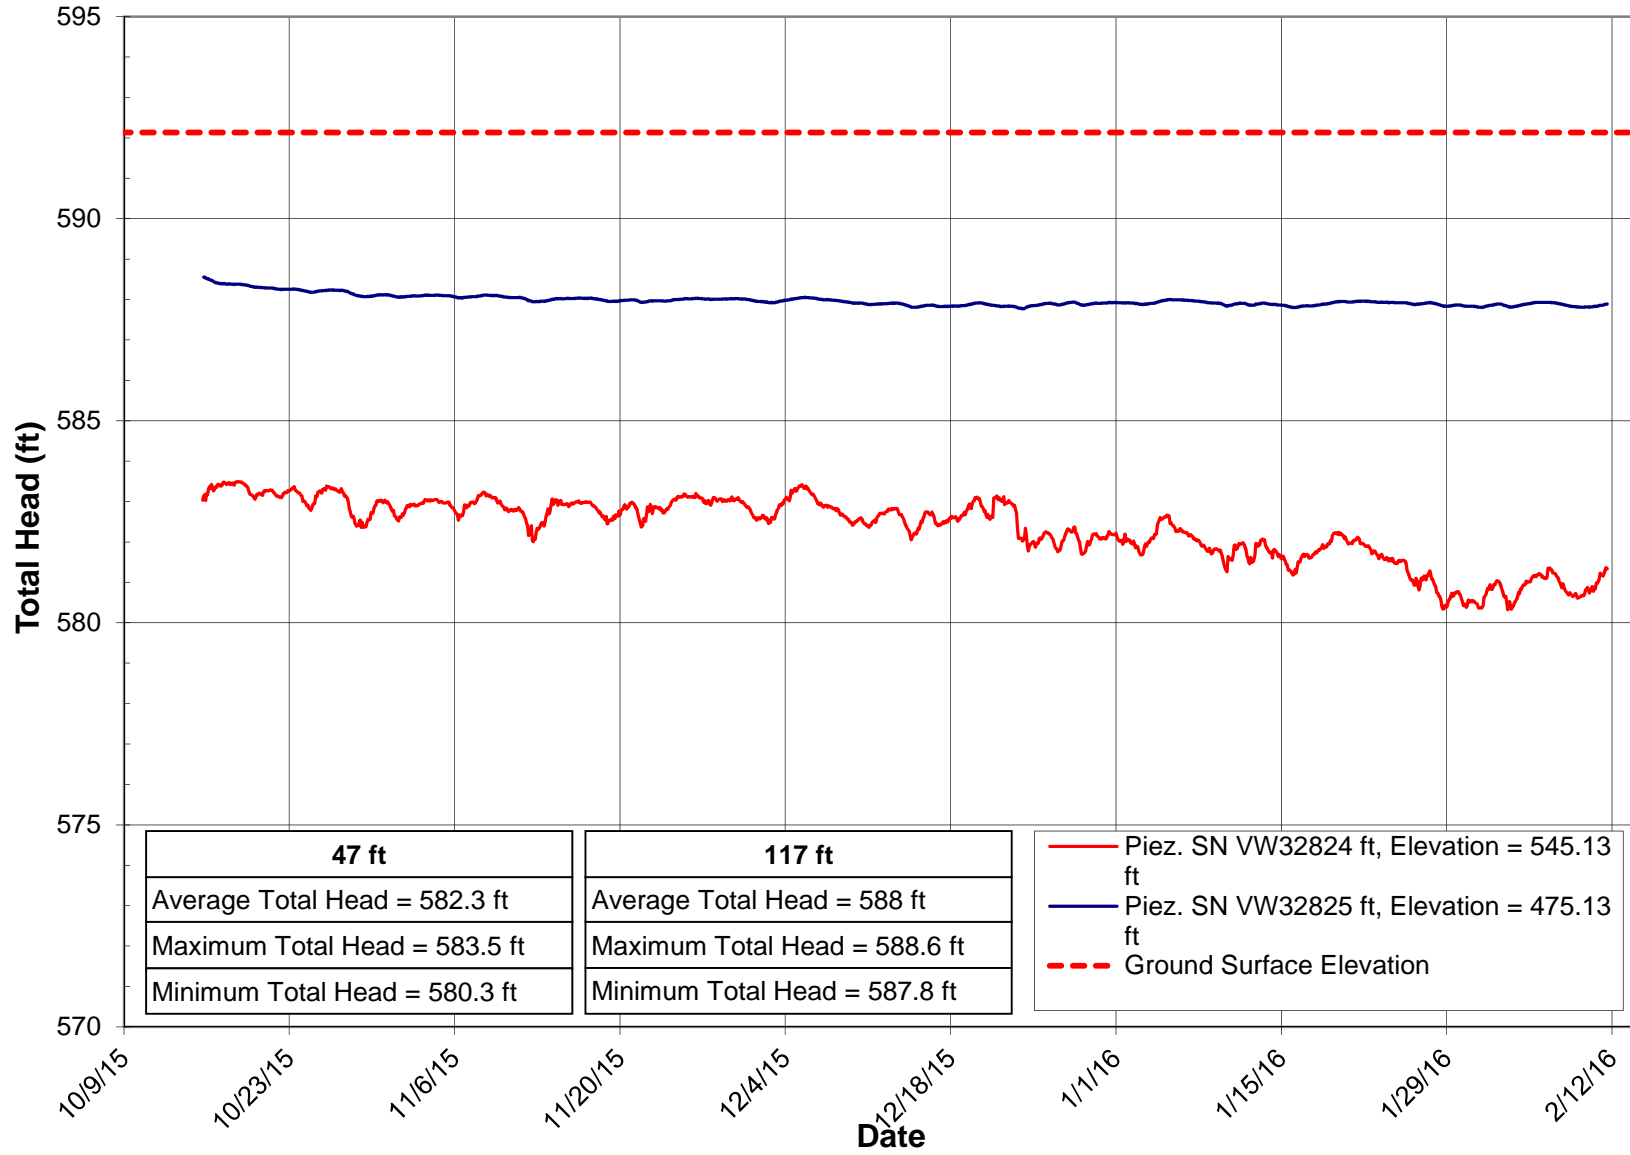
P-004-13 VW Piezometer Readings

P-004-13 – At this location the pore pressure readings in the shallow piezometer show a net increase of about 1 foot in total head over the past two weeks. There was virtually no change in the pore pressure recorded by the deep piezometer.

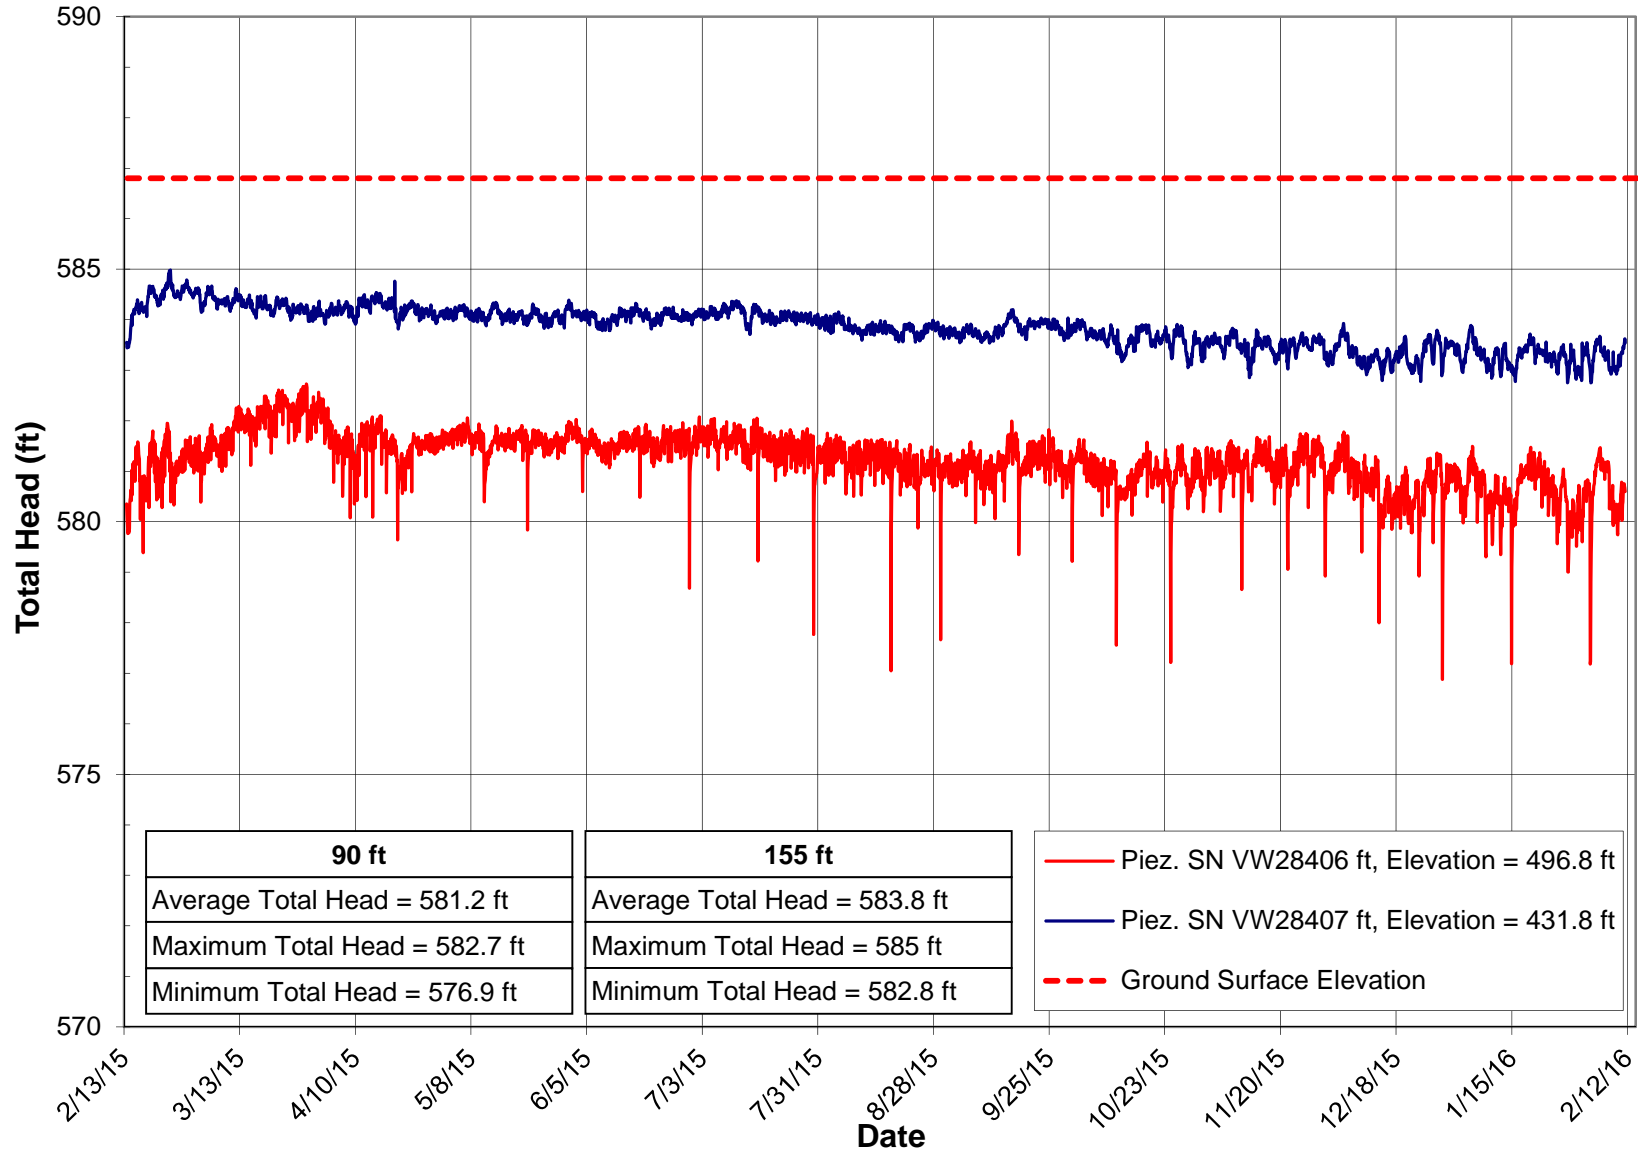
P-009-13 VW Piezometer Readings

P-009-13 – Pore pressure readings in the shallow piezometer at this location indicate a net increase of about 0.5 feet over this past two-week period. Pore pressures in the deep piezometer fluctuated, but show virtually no net change.

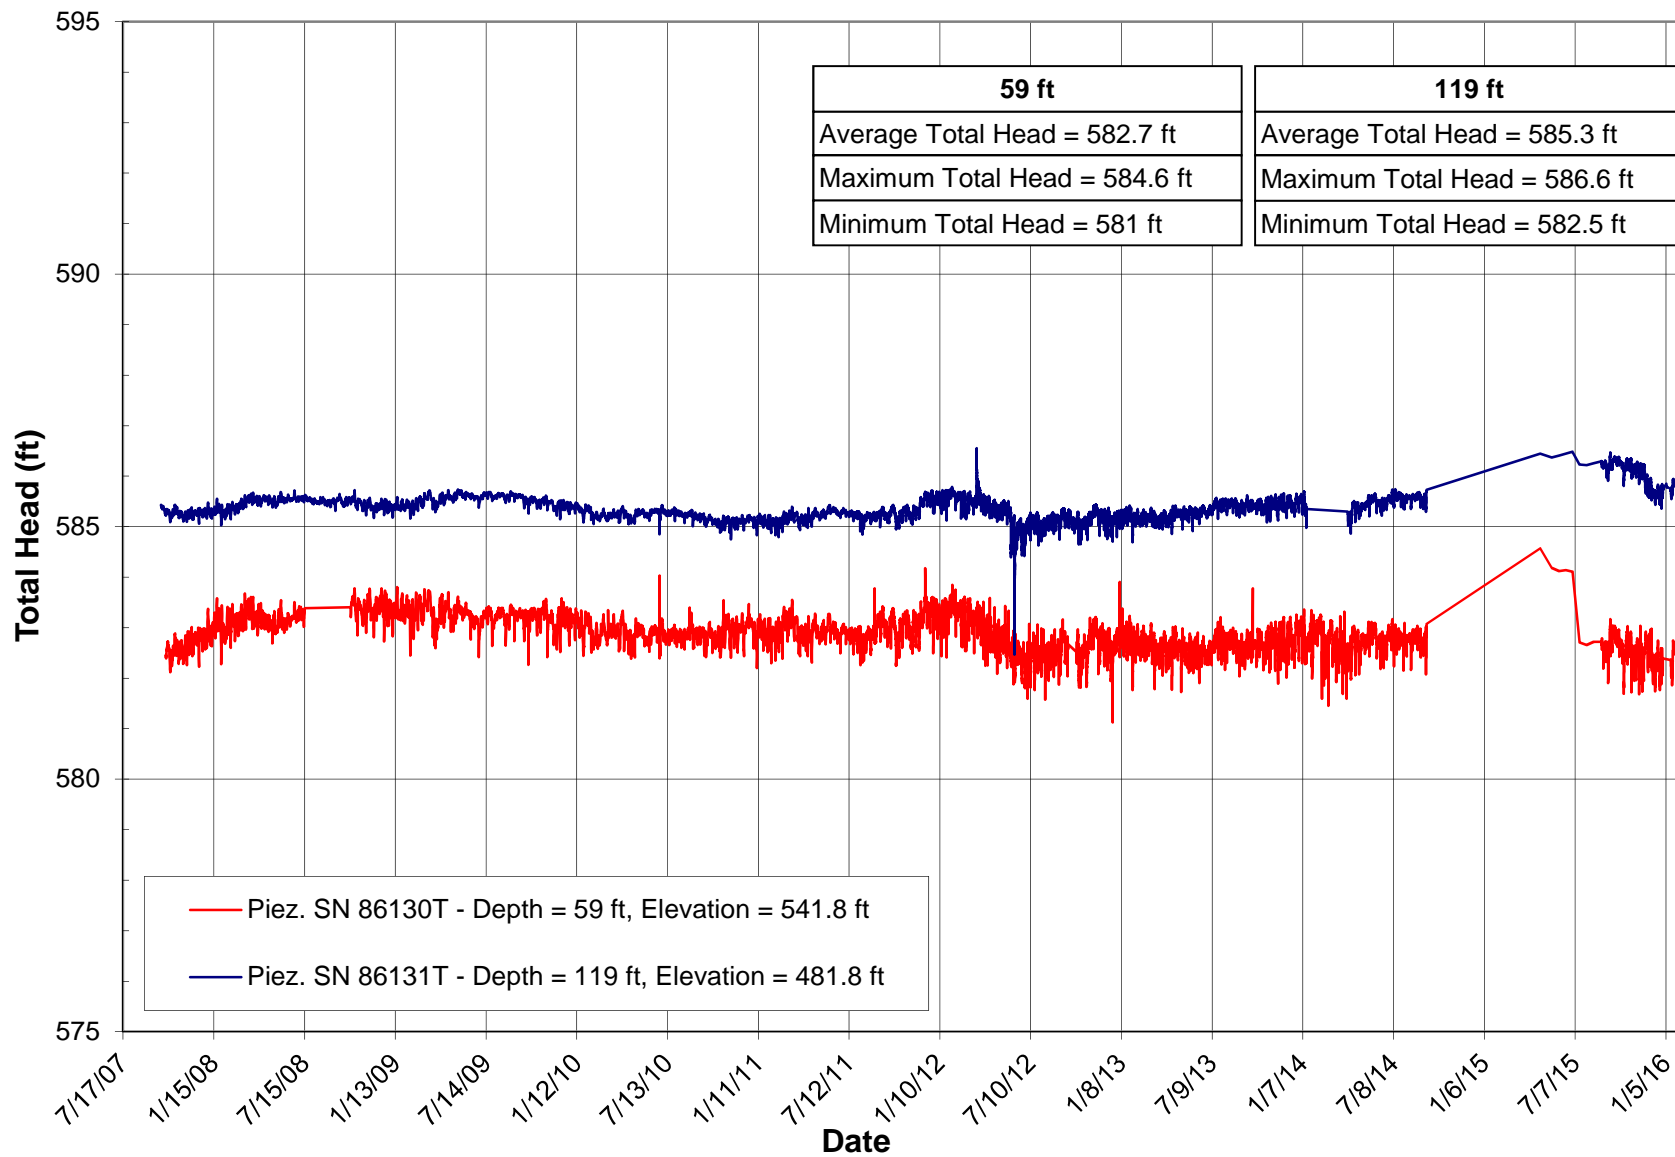
B-05-04 VW Piezometer Readings

B-05-04 – Bi-weekly readings at this location show increases in total head of about 0.5 feet in both piezometers during the past two weeks.

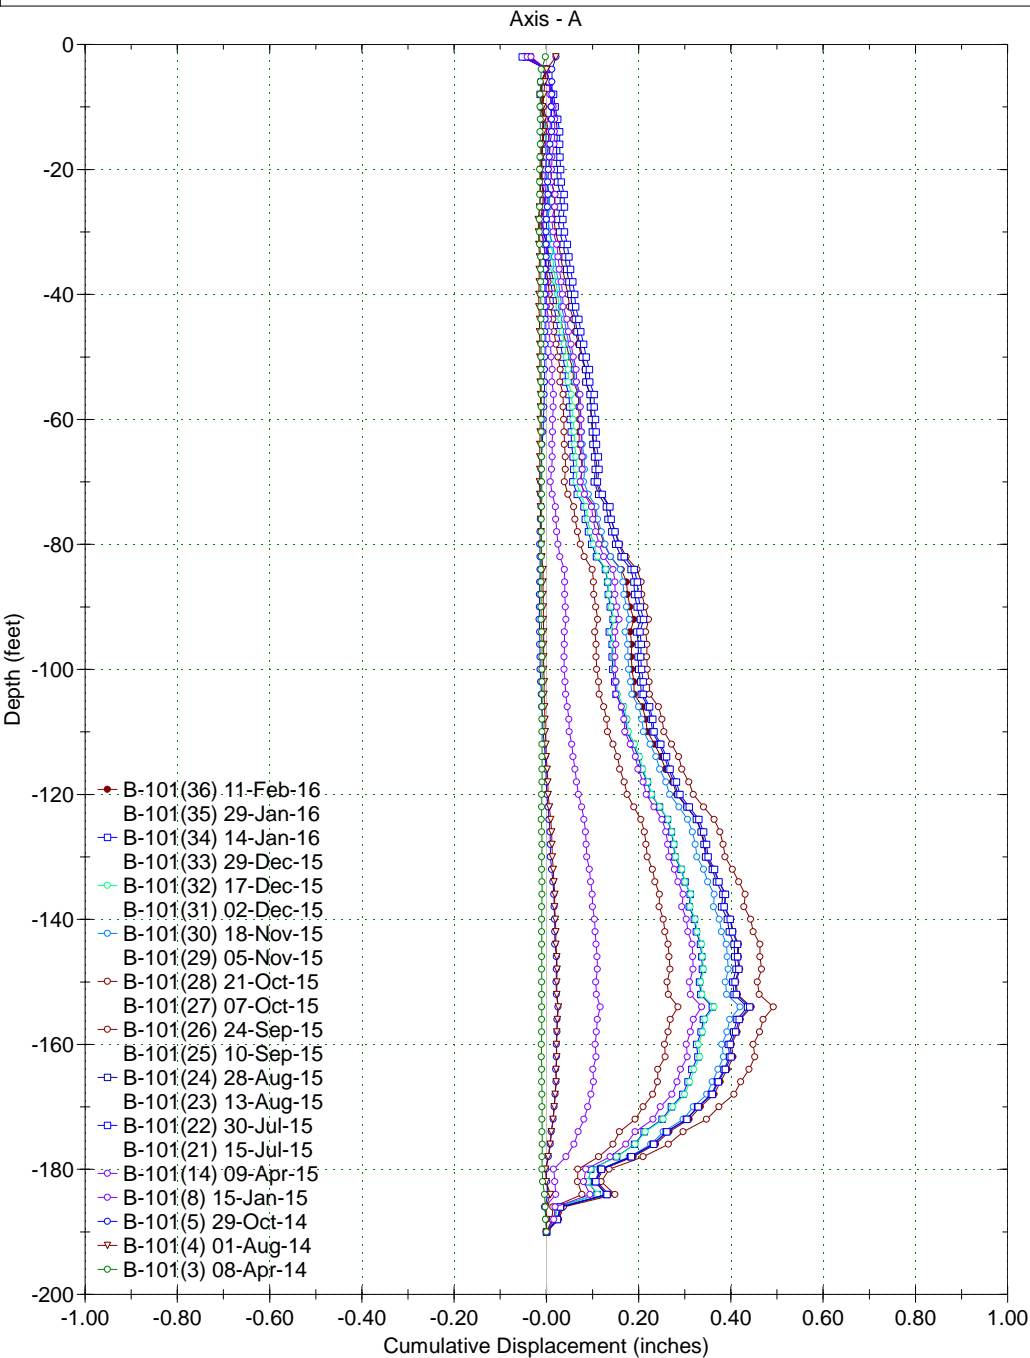
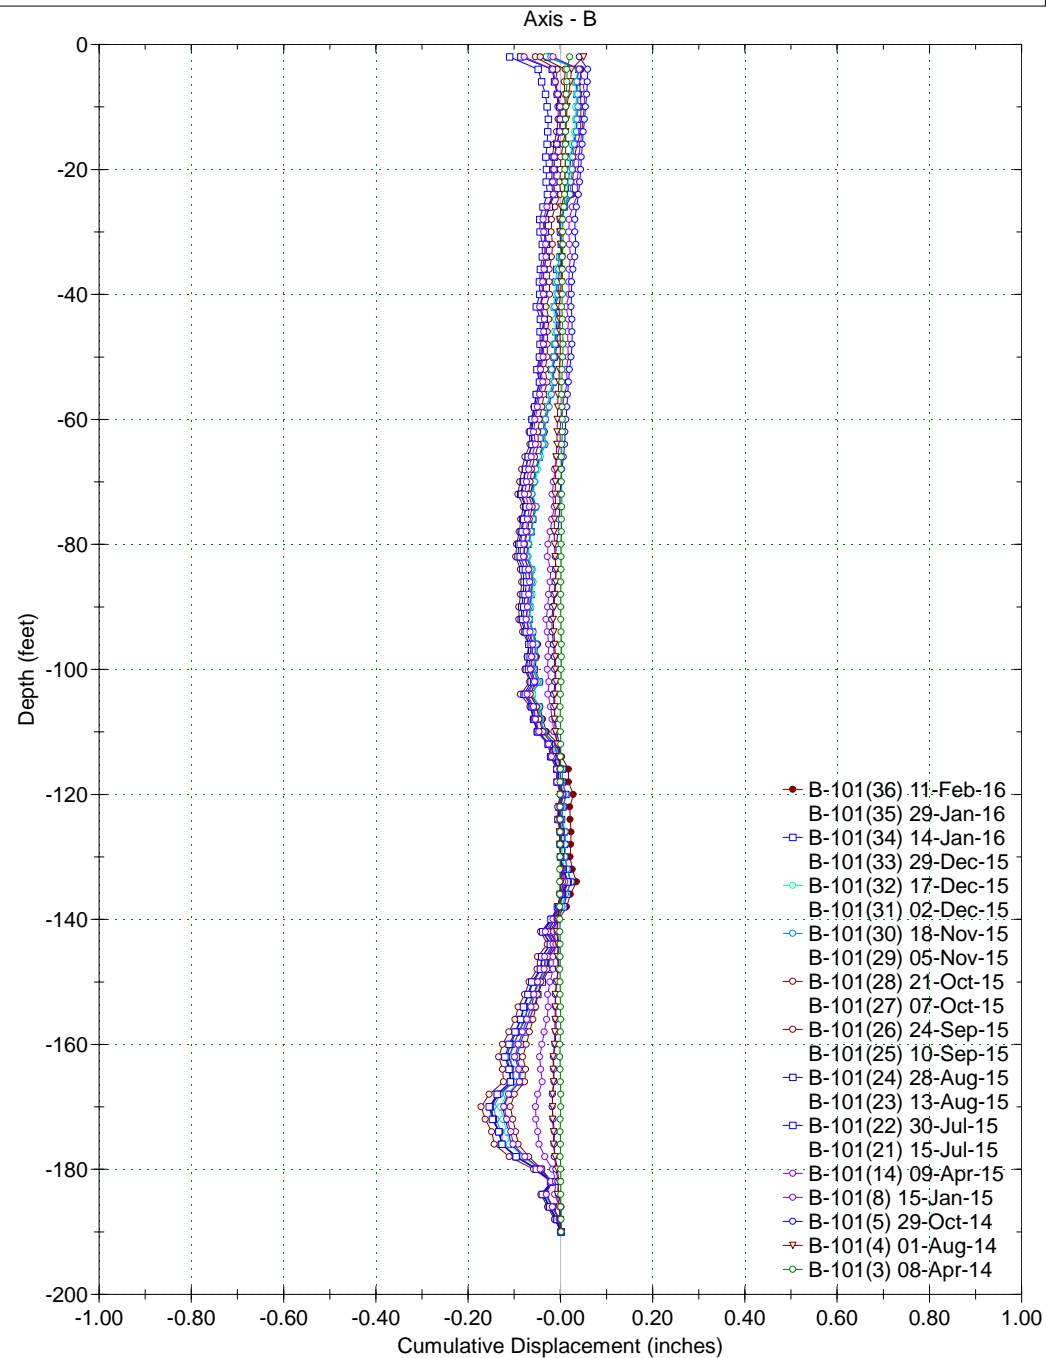
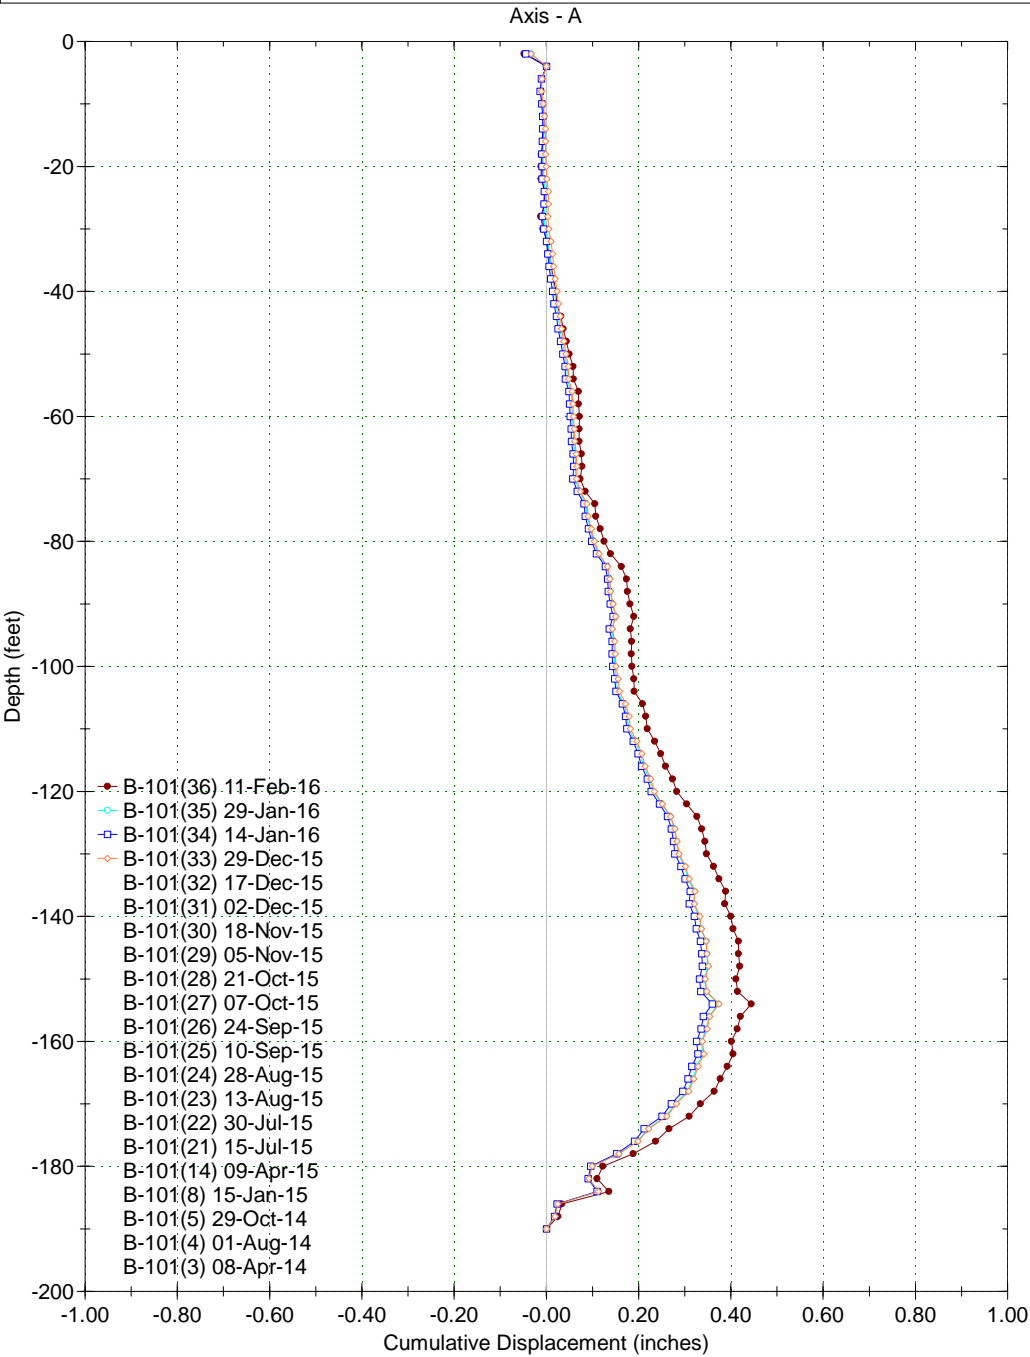
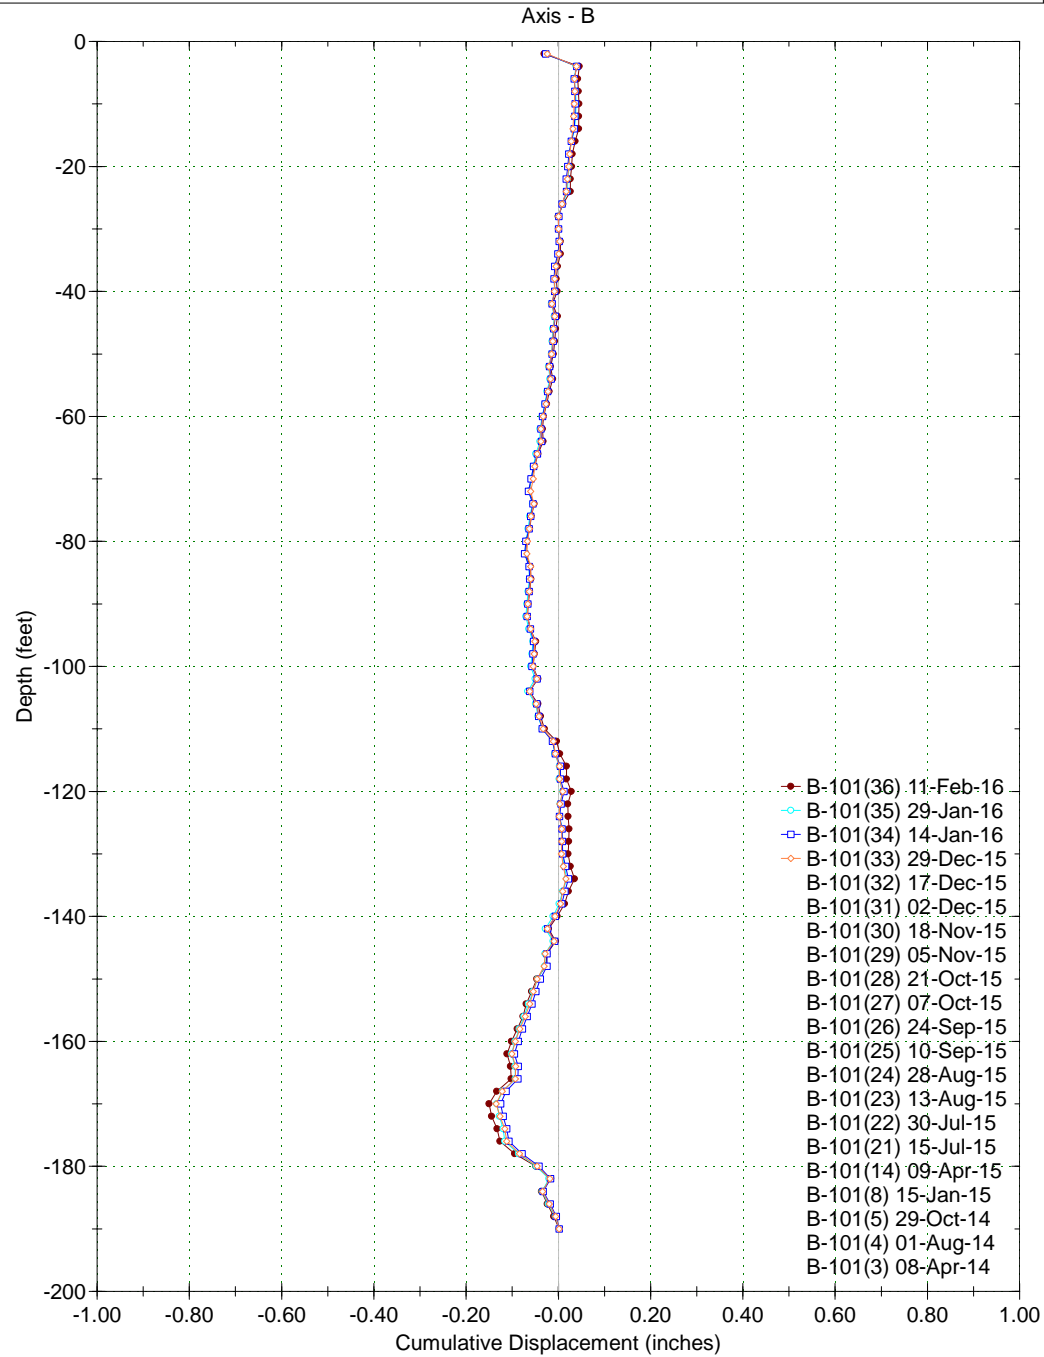
Borehole : B-101
 Project : CUY-90-15-24
 Location : Cleveland, Ohio
 Northing : Sta. 15+06.50
 Easting : 120.7' Rt of CL
 Collar :

B-101 – Inclinometer readings at this location indicate an increase in the positive A-axis direction from about 50 to 180 feet, with a maximum displacement of about 0.1 inches occurring at 154 feet.

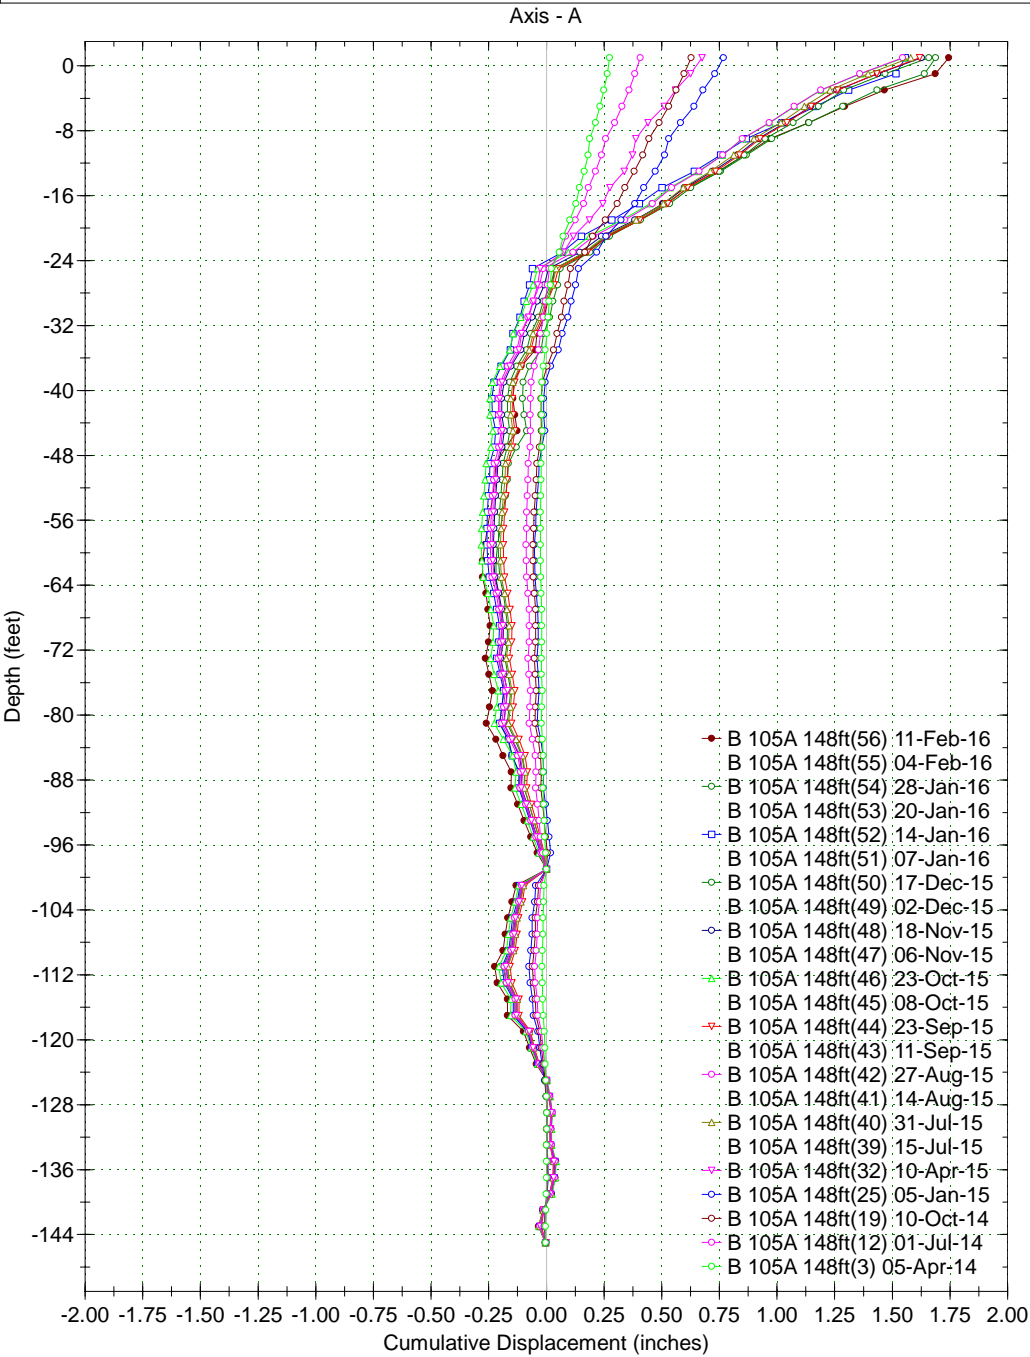
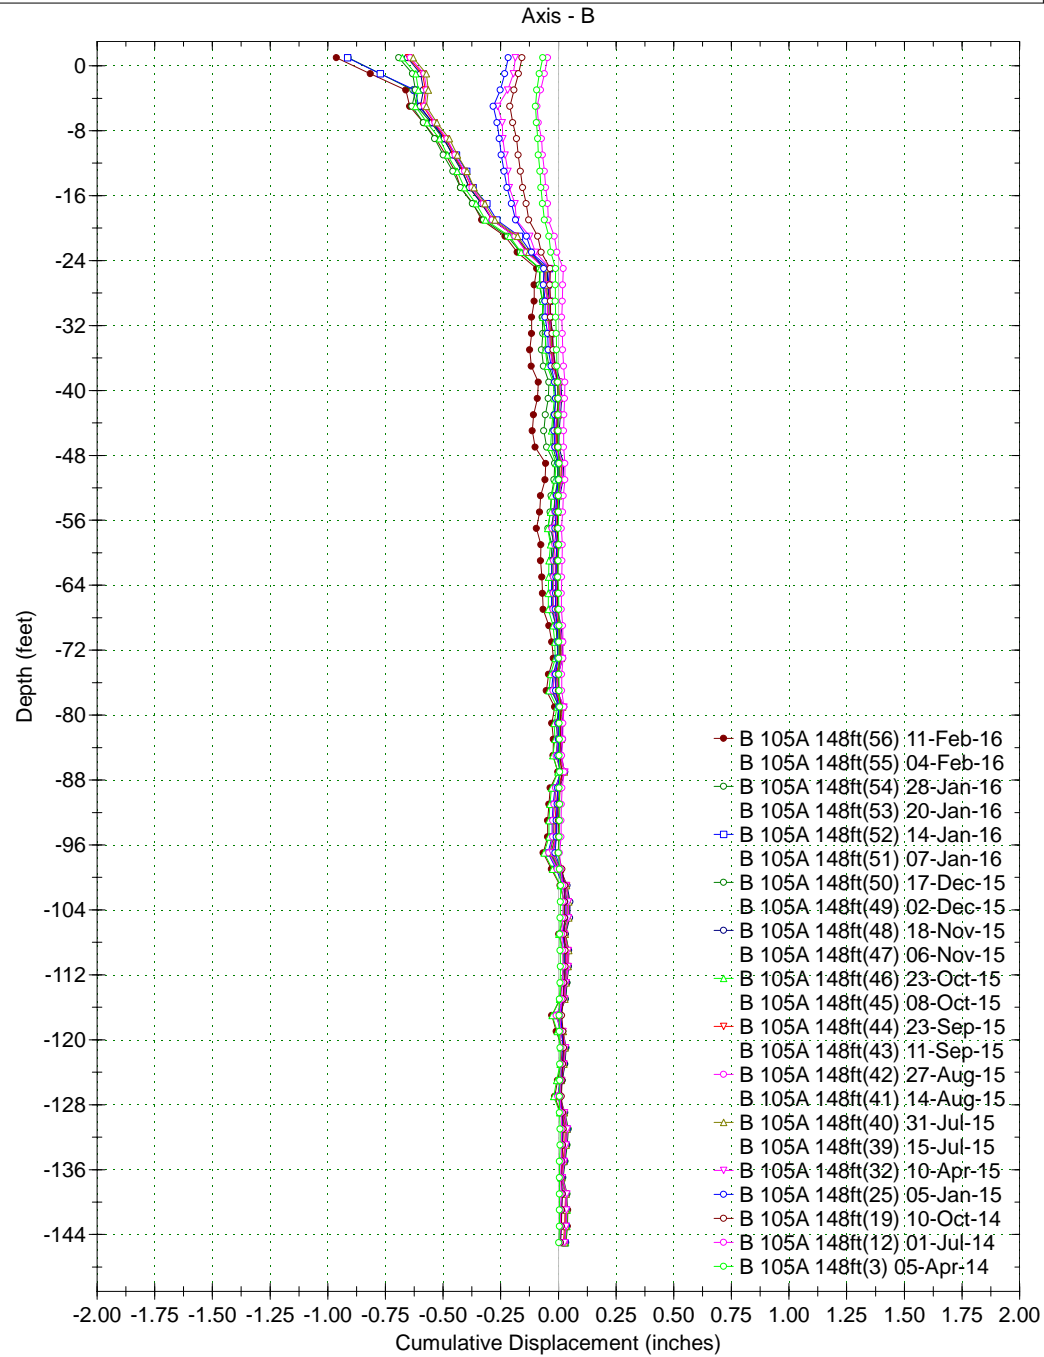
Borehole : B 105A 148ft
 Project : CUY-90-15-24
 Location : Cleveland, Ohio
 Northing : Sta. 19+11.38
 Easting : 90.9' Rt of CL
 Collar :

B-105A – At this location, inclinometer readings indicate slight displacements in the positive A-axis direction from the surface to about 5 feet and in the negative B-axis direction from the surface to about 70 feet.

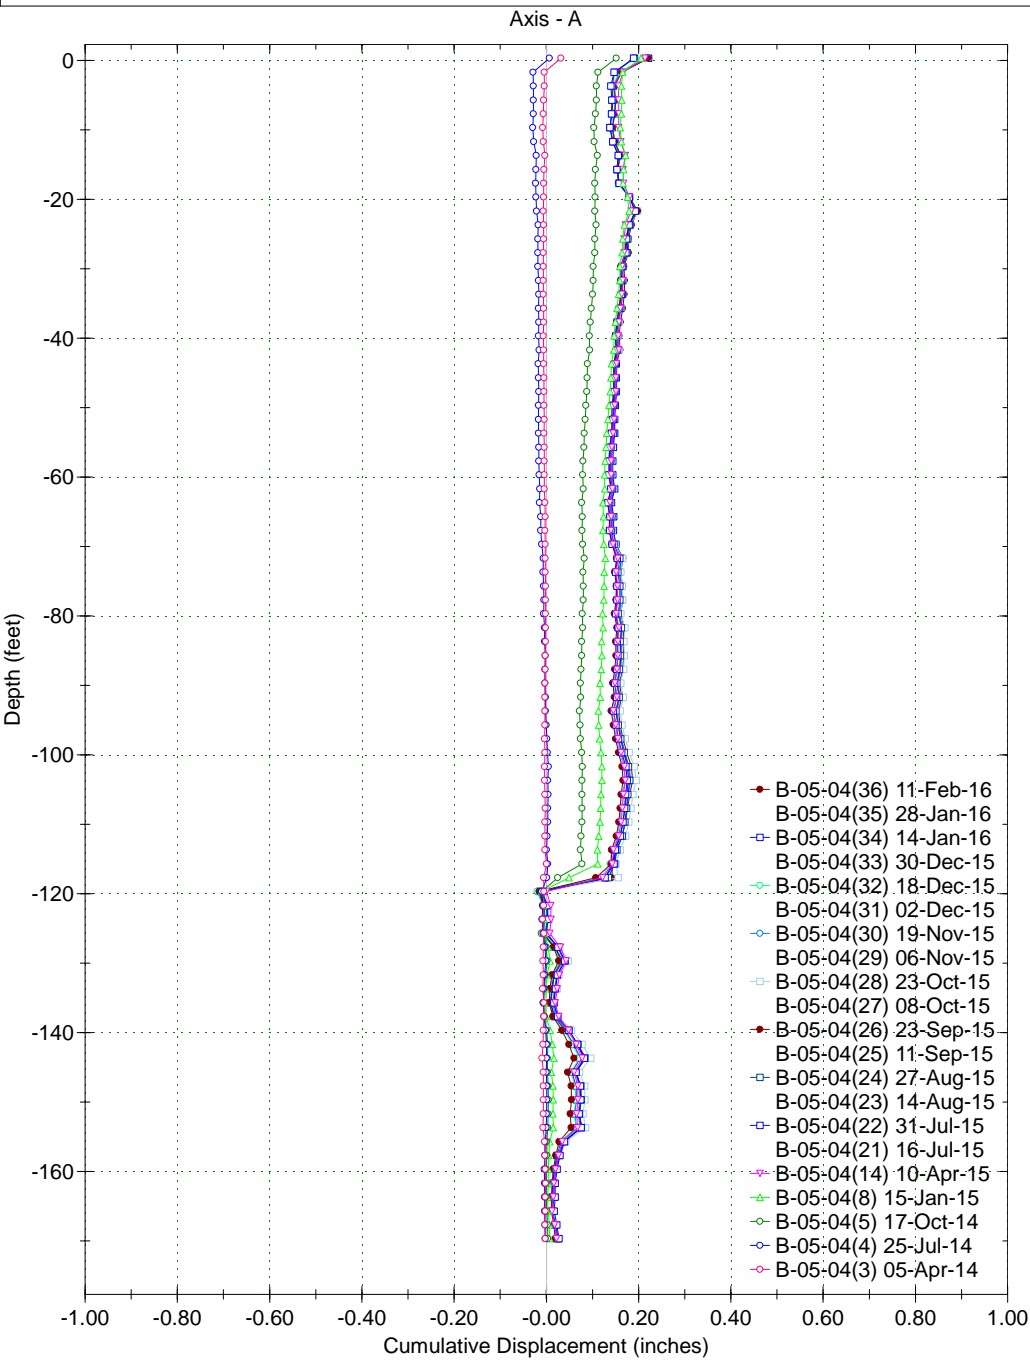
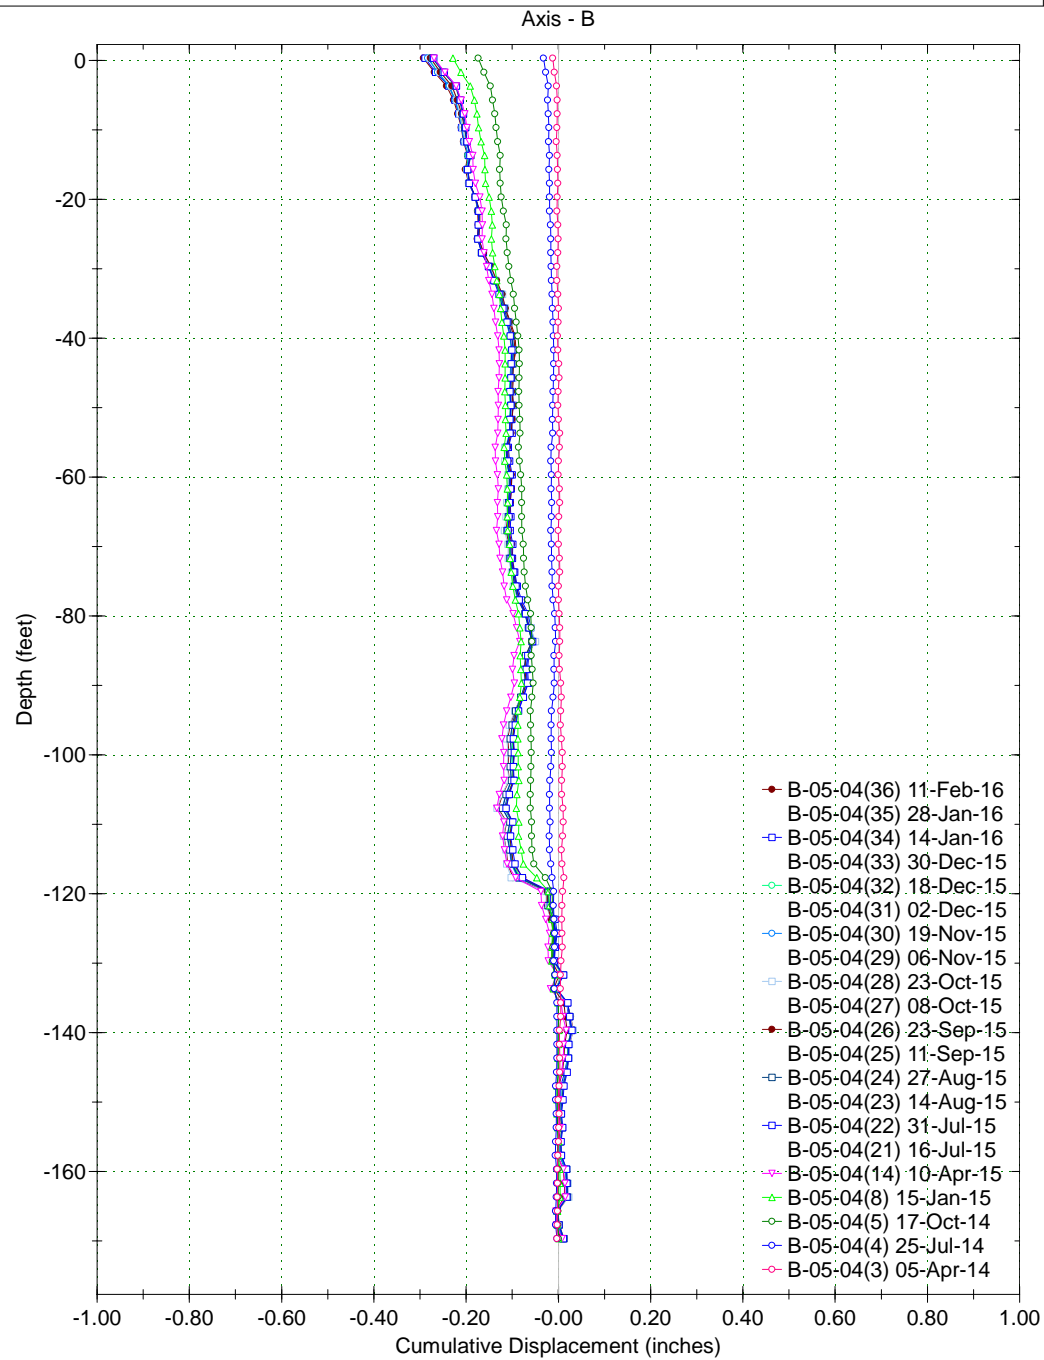
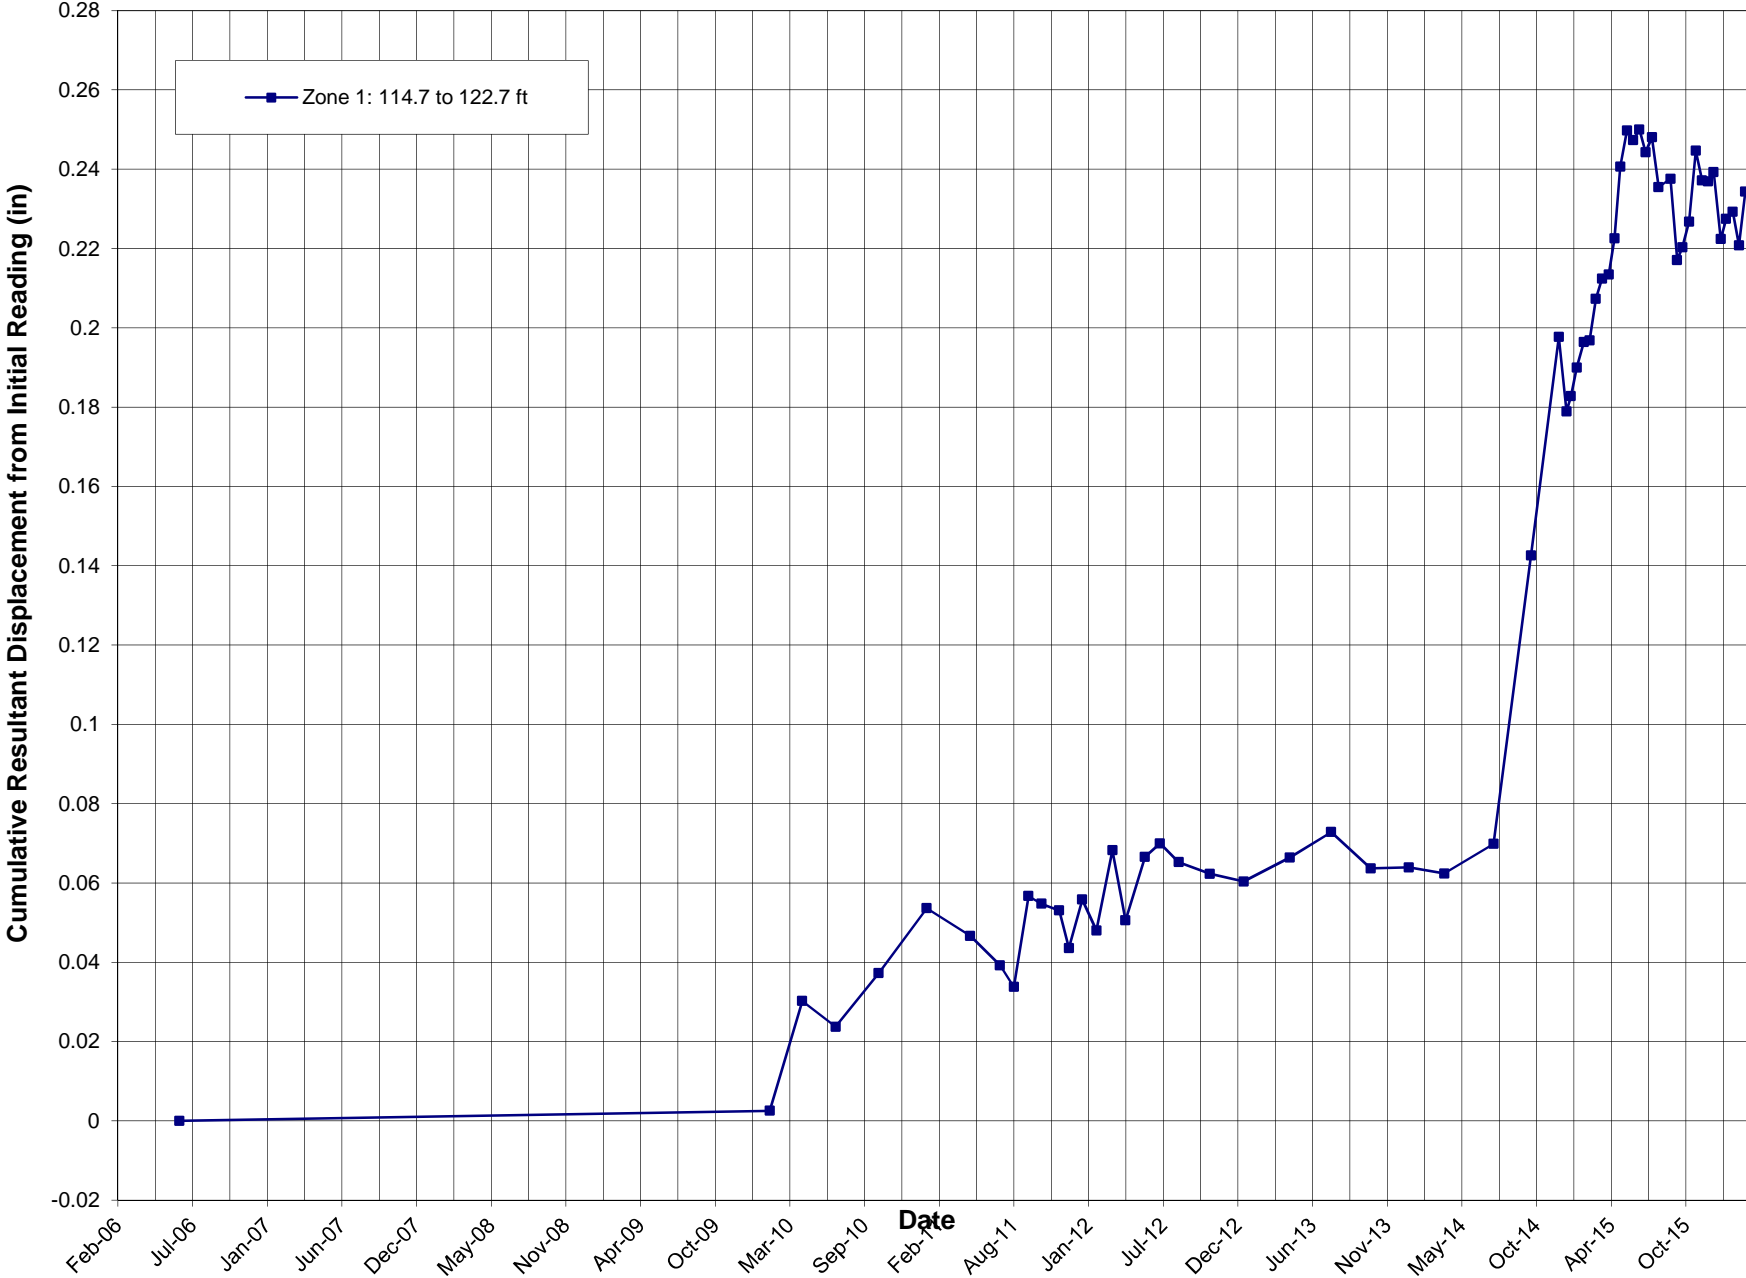
Borehole : B-05-04
Project : CUY-90-15-24
Location : Cleveland, Ohio
Northing : Sta. 133+51.67
Easting : 242.09' Rt of CL
Collar :

B-05-04 – The cumulative resultant displacement zone plot between 115 and 123 feet indicates a slight increase of about 0.02 inches. The cumulative displacement graph shows virtually no movement.
