February 16, 2016

Re: February 10 and 11, 2016 Bi-Weekly Readings
CUY-90-15.24 Slope Monitoring
PID 96504
SME Project No. 069032.00

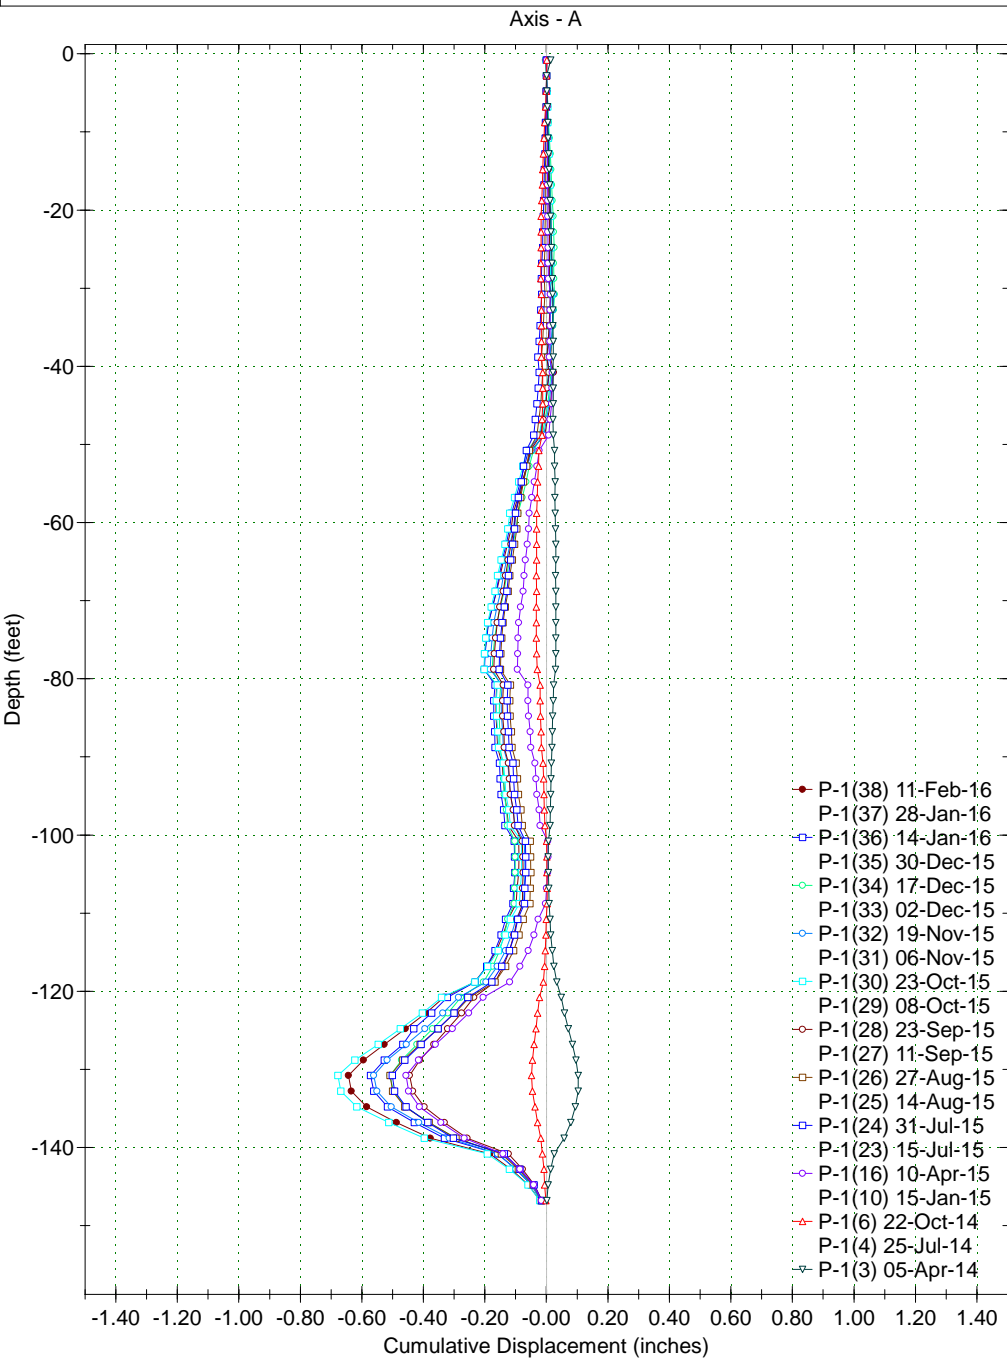
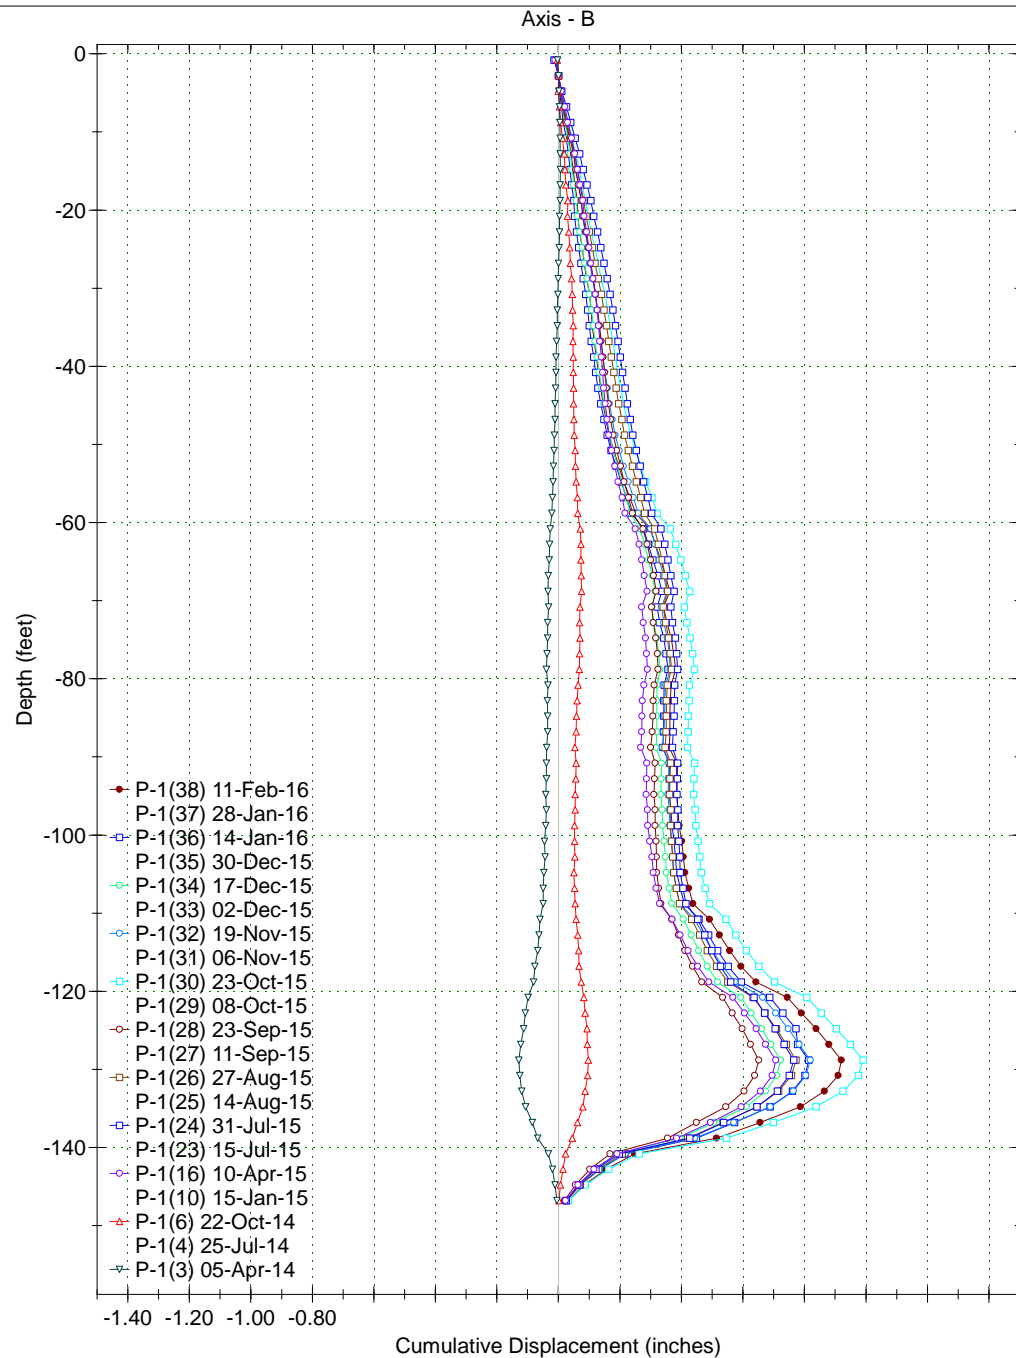
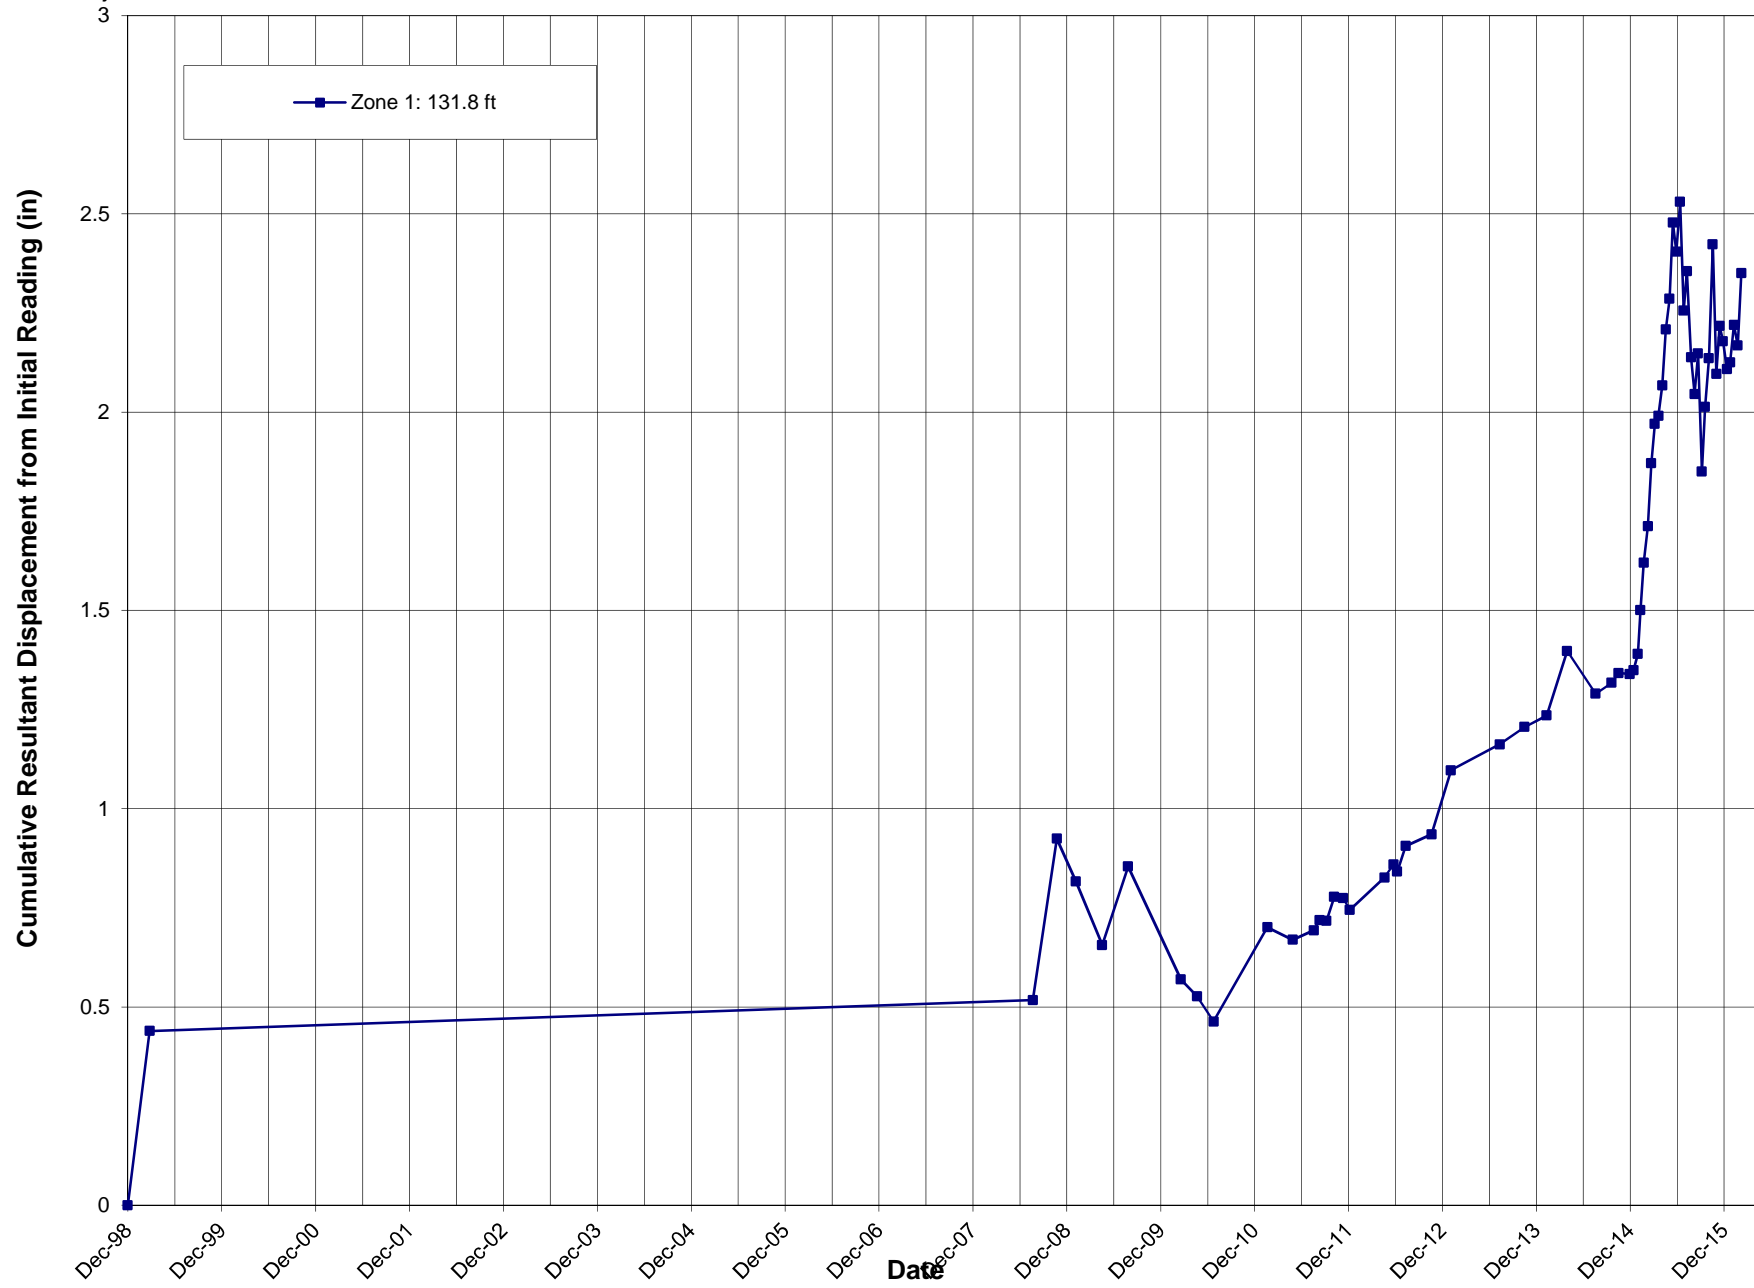
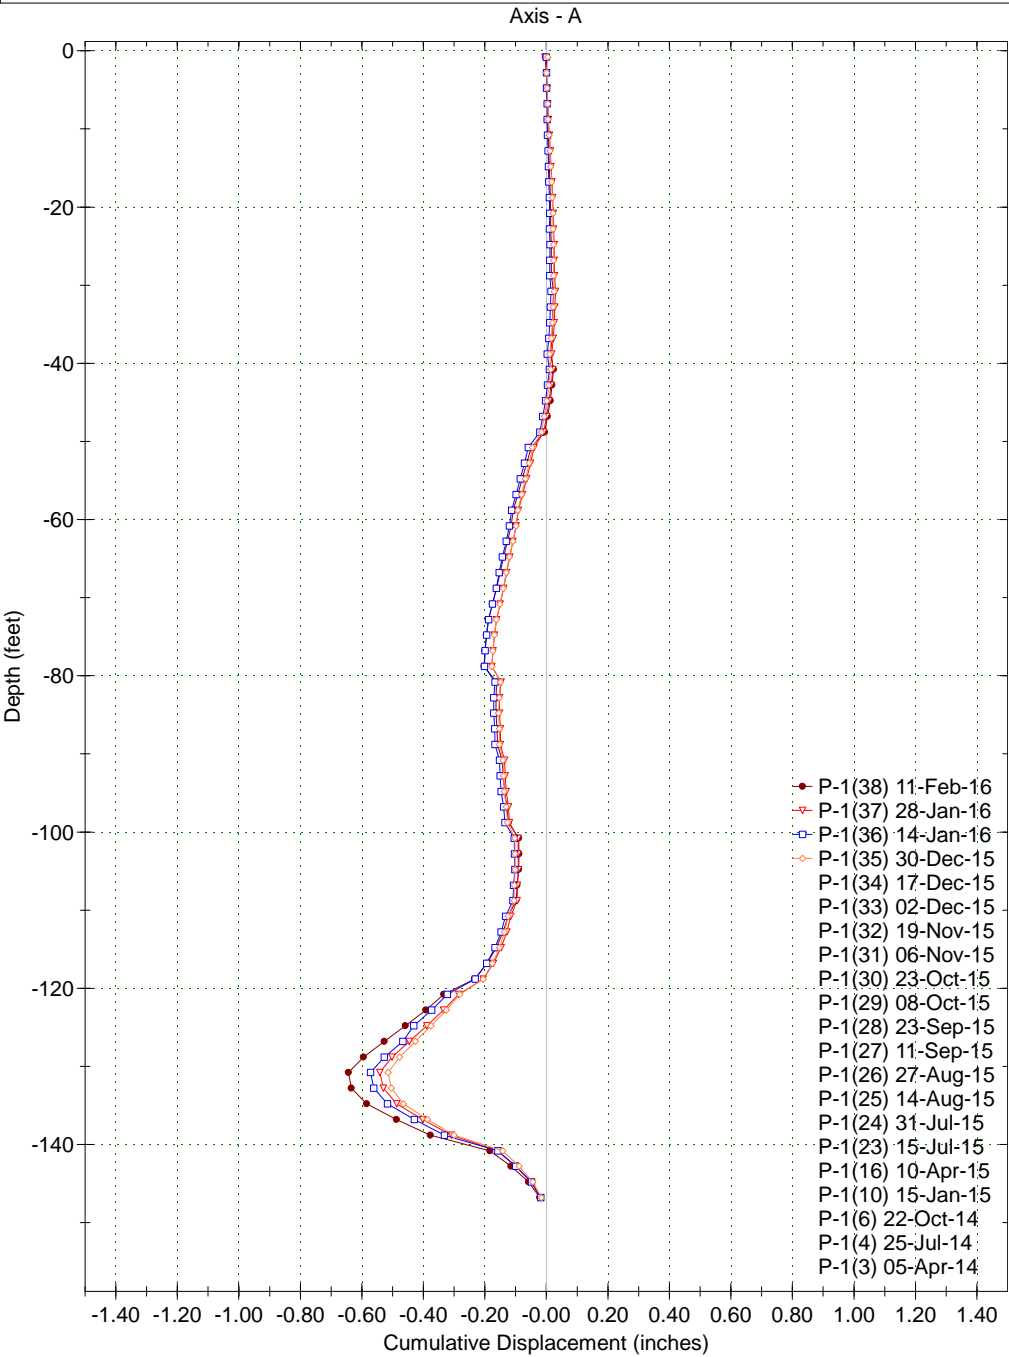
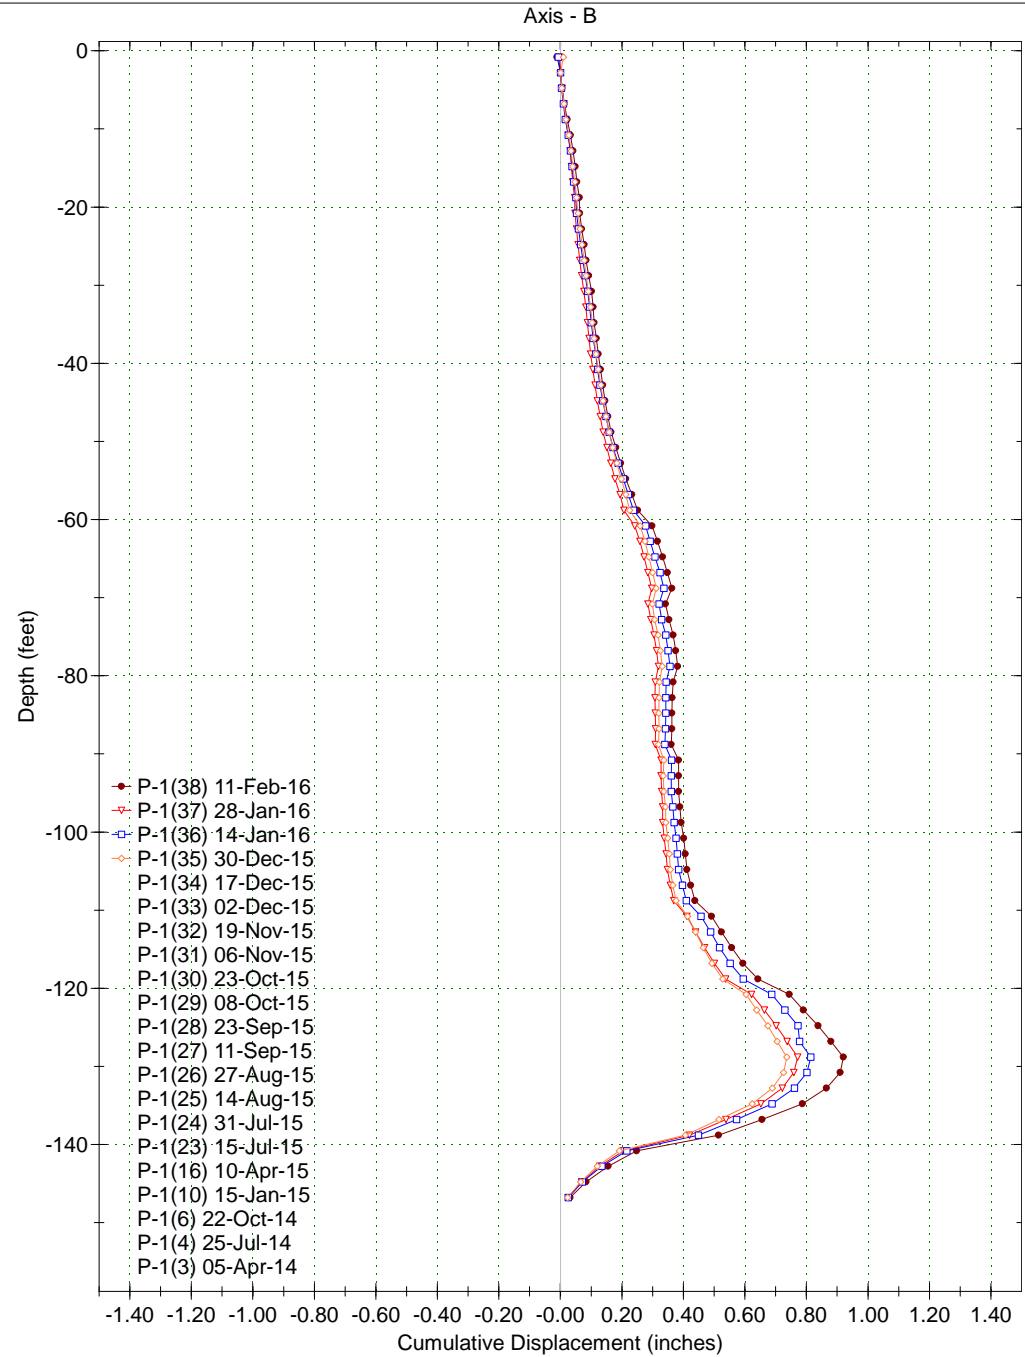
Borehole : P-1
Project : CUY-90-15-24
Location : Cleveland, Ohio
Northing :
Easting :
Collar :

P-1 – Inclinometer readings at this location indicate increasing displacements in the negative A-axis direction and positive B-axis direction between about 120 and 140 feet. The cumulative resultant displacement zone plot at 132 feet indicates an increase of about 0.2 inches.
