March 5, 2016

Re: February 29 and March 1, 2016 Bi-Weekly Readings
CUY-90-15.24 Slope Monitoring
PID 96504
SME Project No. 069032.00

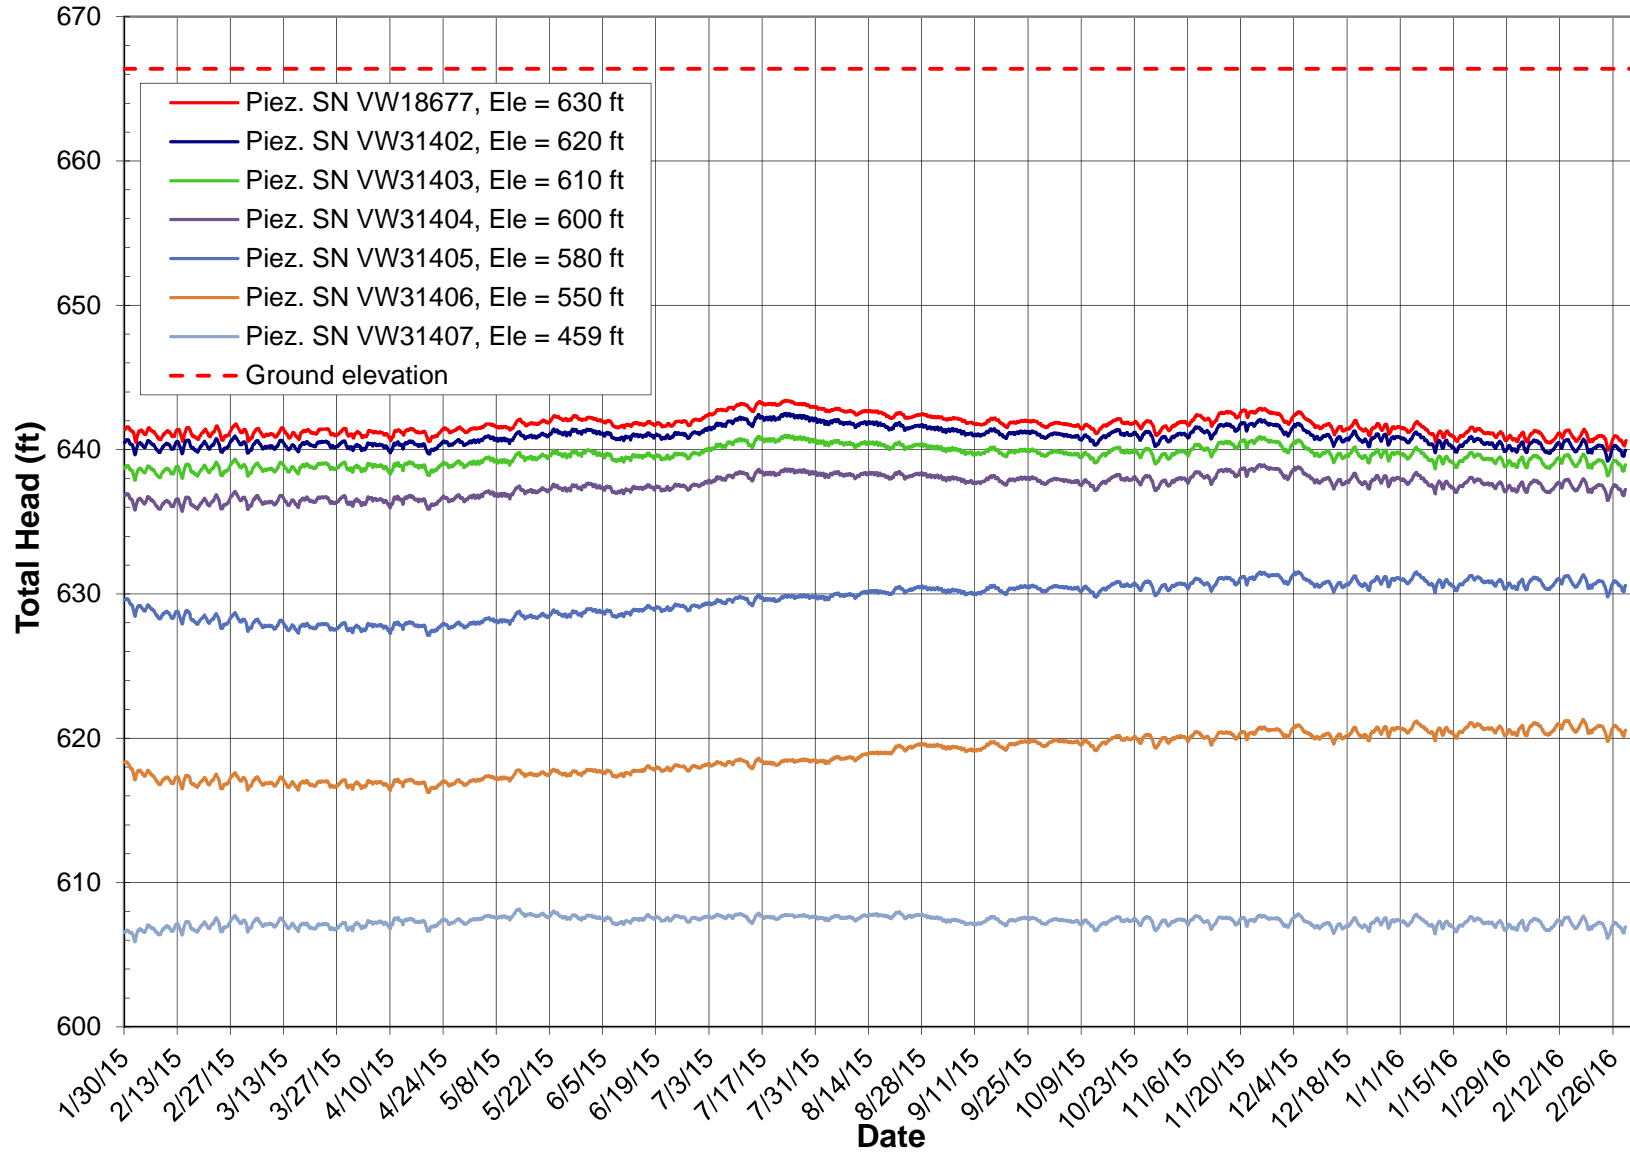
P-001-13 VW Piezometer Readings

P-001-13 – In every piezometer at this location, pore pressure readings indicate a decrease in total head of about 0.5 feet over the past two weeks.

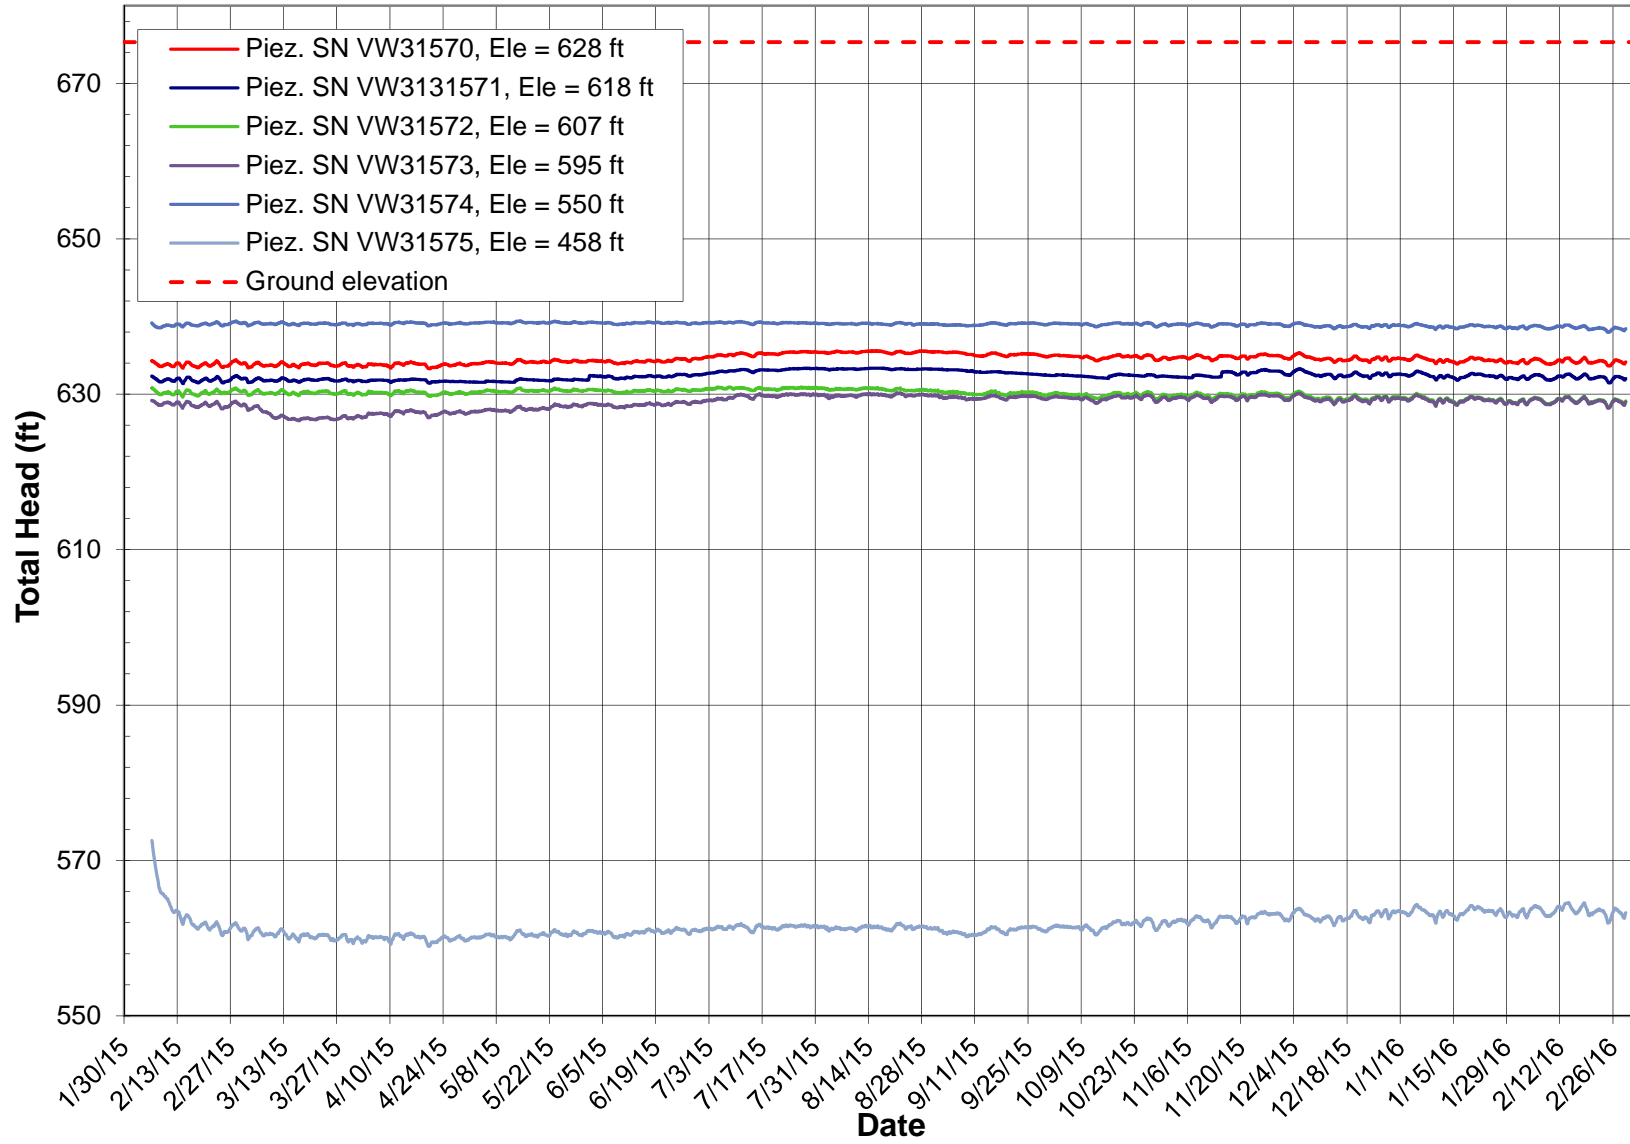
P-002-13 VW Piezometer Readings

P-002-13 – Pore pressure readings at this location indicate a decrease in total head of about 0.5 feet in the five shallowest piezometers and about 1 foot in the deepest piezometer.

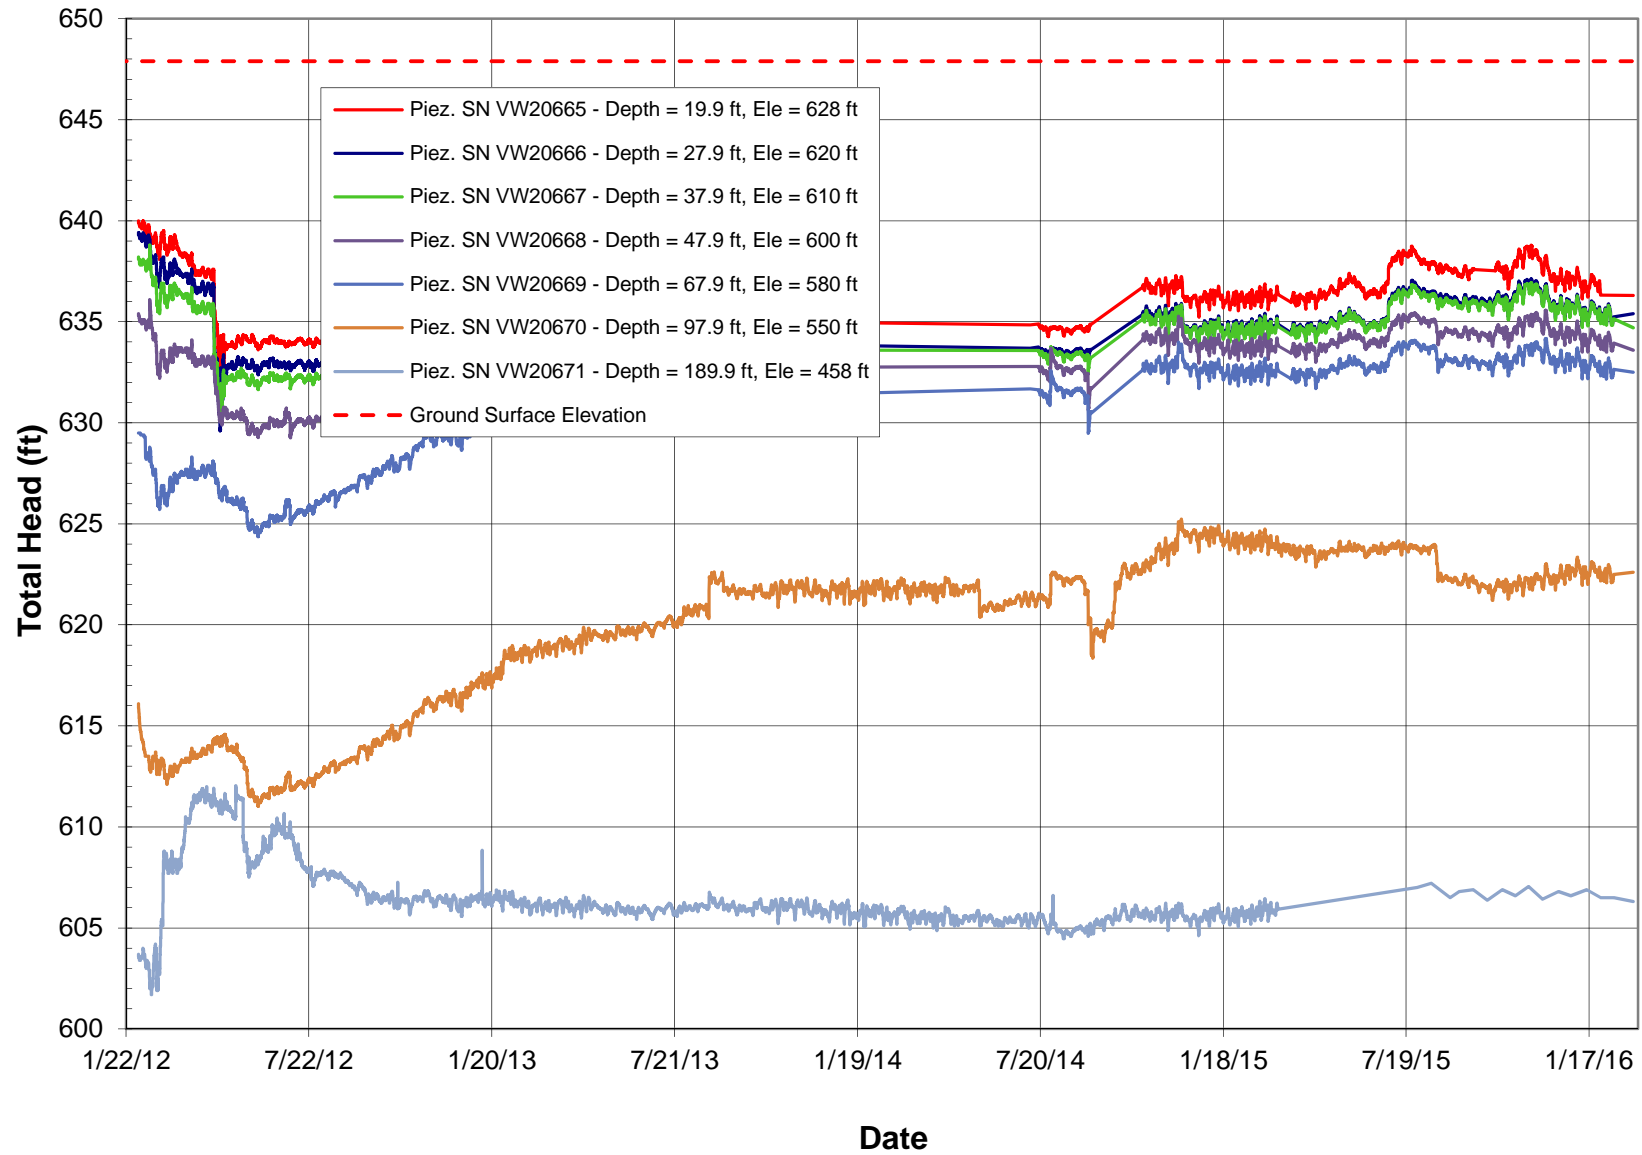
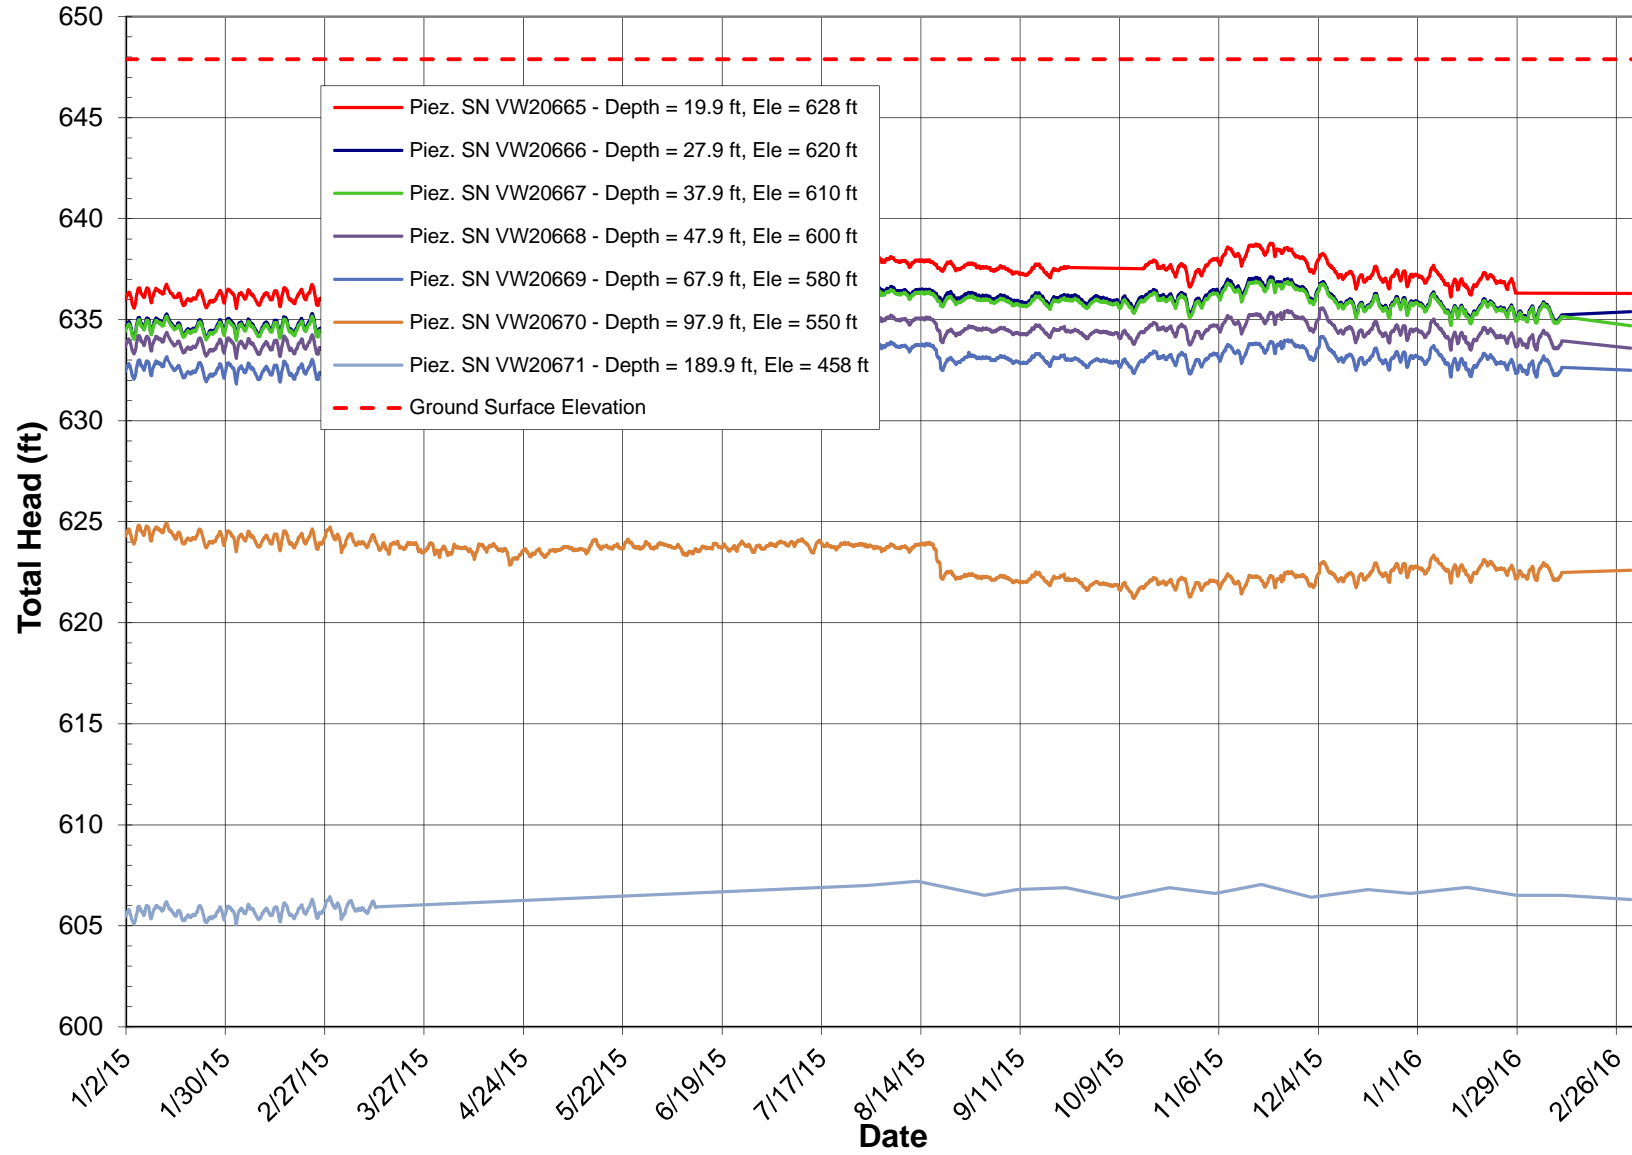
P-003-10 VW Piezometer Readings

P-003-10 – We temporarily removed the data loggers at this location and spliced an extension onto each piezometer cable to route the piezometers cables under and behind the gabion baskets that are being installed in this area. When the gabion wall is completed and backfill, we will install a protective cover and reattach the data loggers. For the interim we will be taking manual readings. Readings this period indicate a decrease in total head of 0.5 feet in the piezometer at 38 feet. The remaining piezometers show no change.

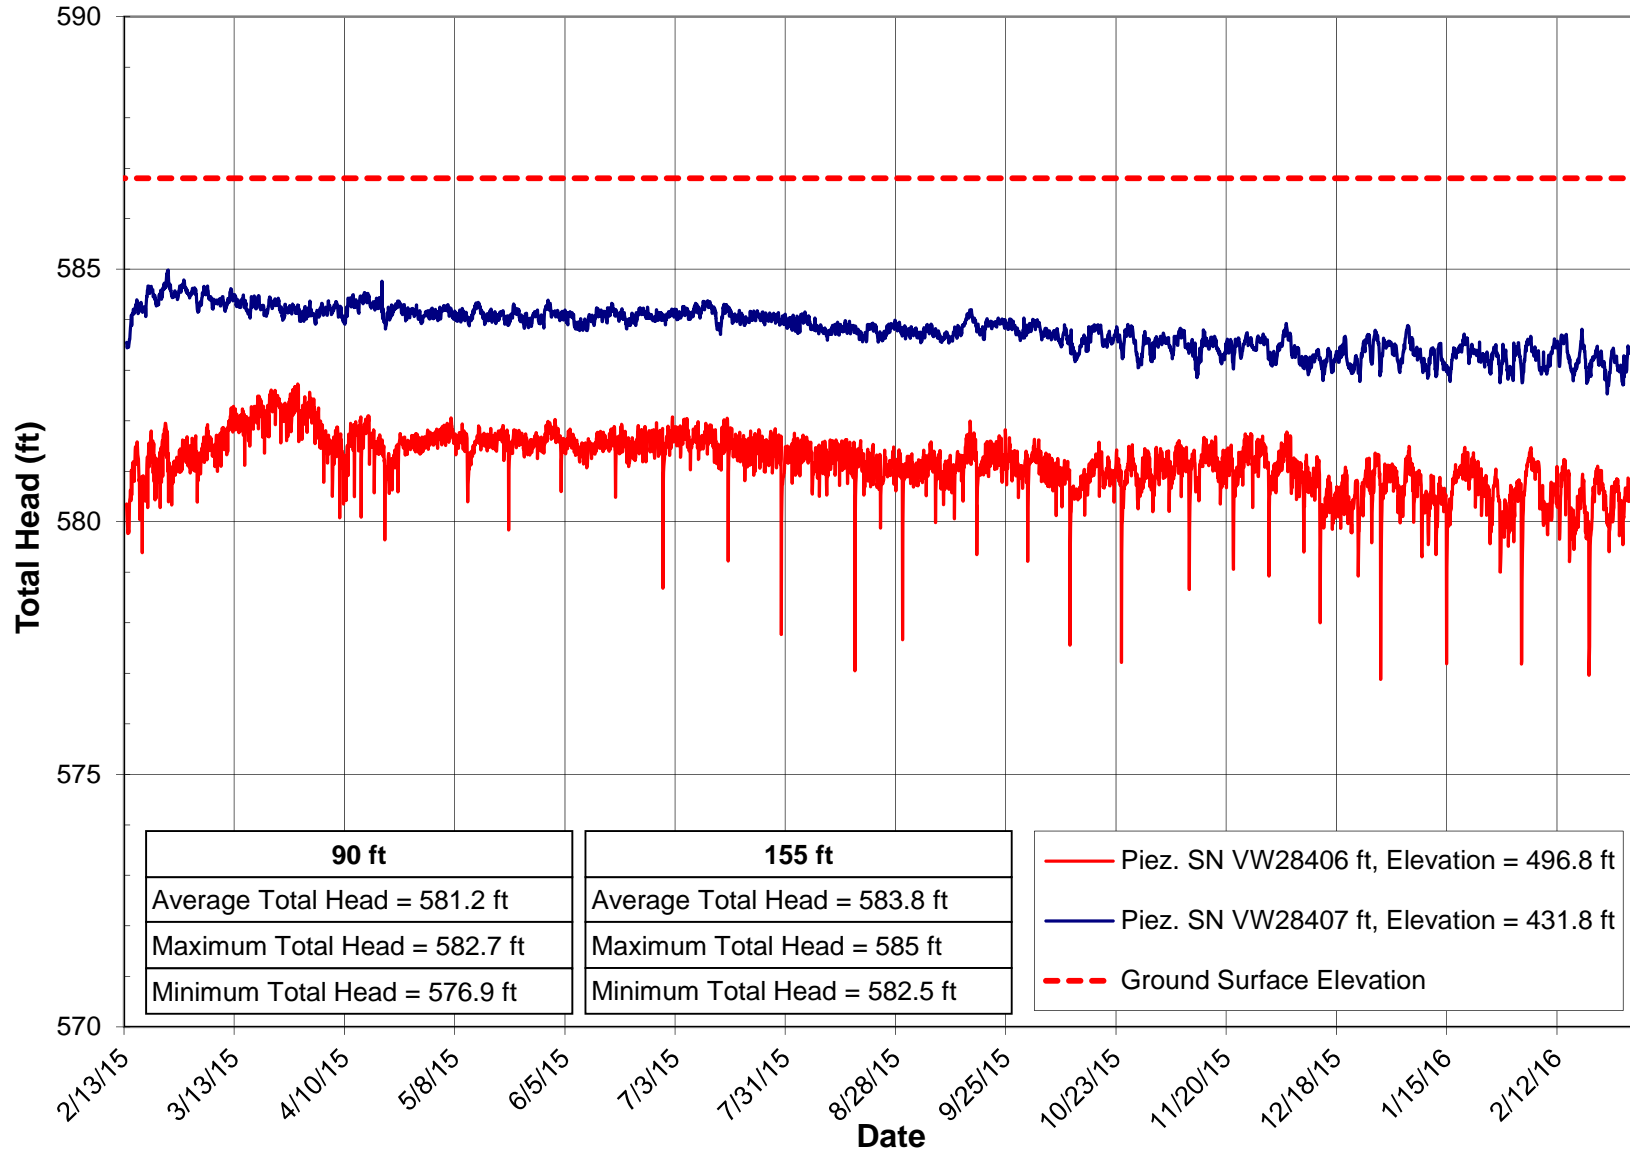
P-009-13 VW Piezometer Readings

P-009-13 – Pore pressure readings in both piezometers at this location fluctuated throughout the past two weeks, but show virtually no net change.

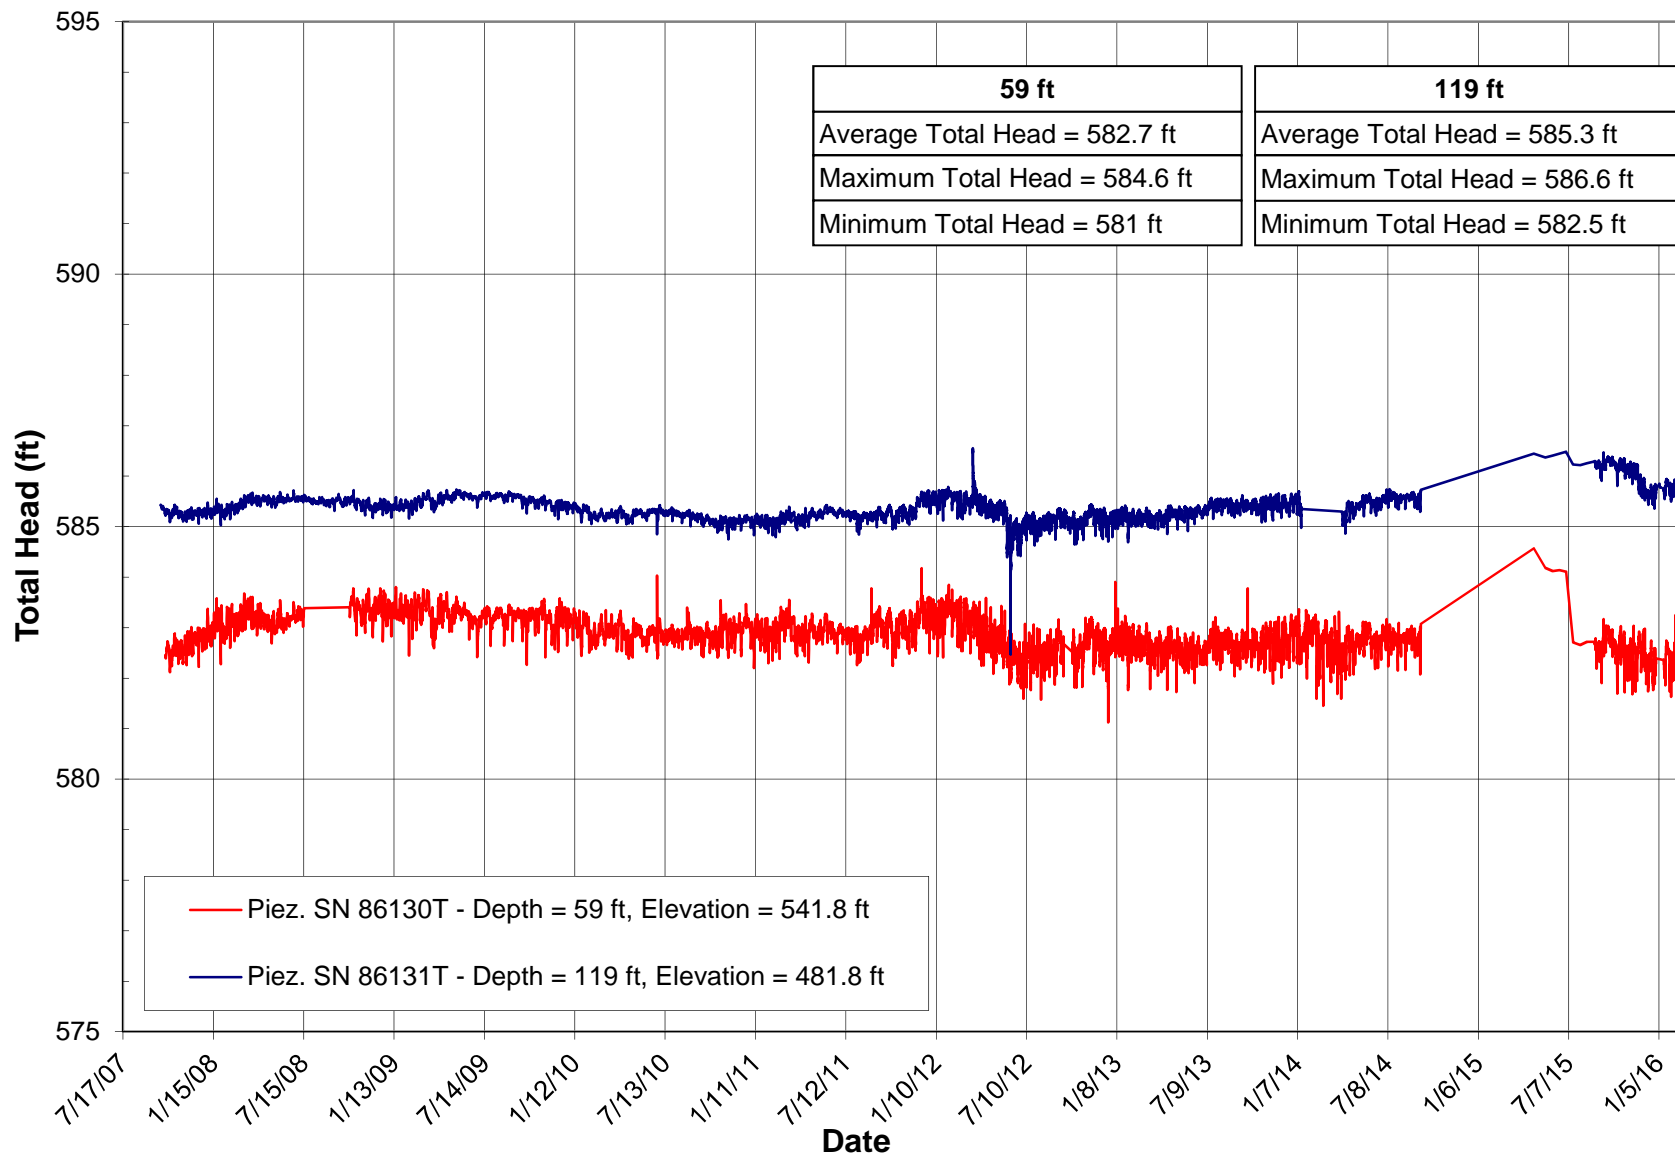
B-05-04 VW Piezometer Readings

B-05-04 – Bi-weekly readings at this location show decreases in total head of about 1 foot in the shallow piezometer and about 0.5 feet in the deep piezometer.

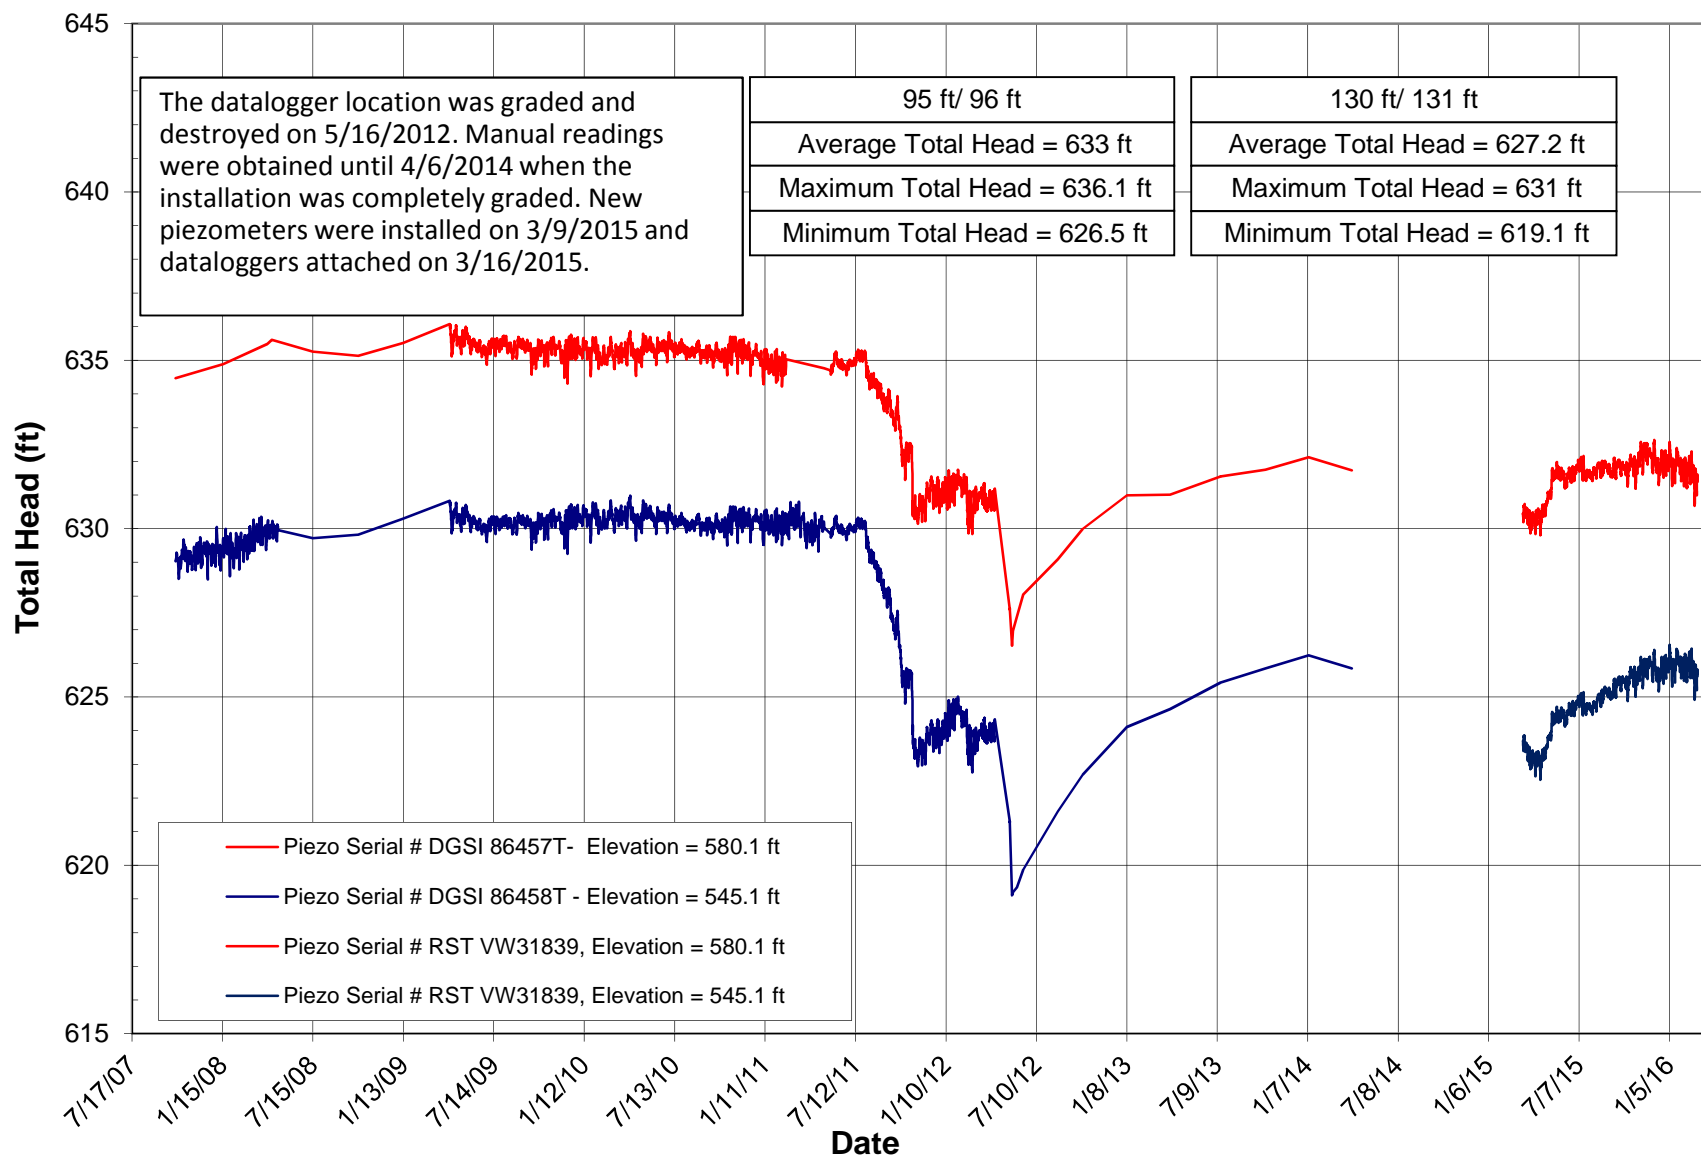
B-05-11/B-05-A-11 VW Piezometer Readings

B-05-A-11 – Pore pressure readings at this location indicate a decrease in total head of about 0.6 feet in both piezometers during the past two weeks.

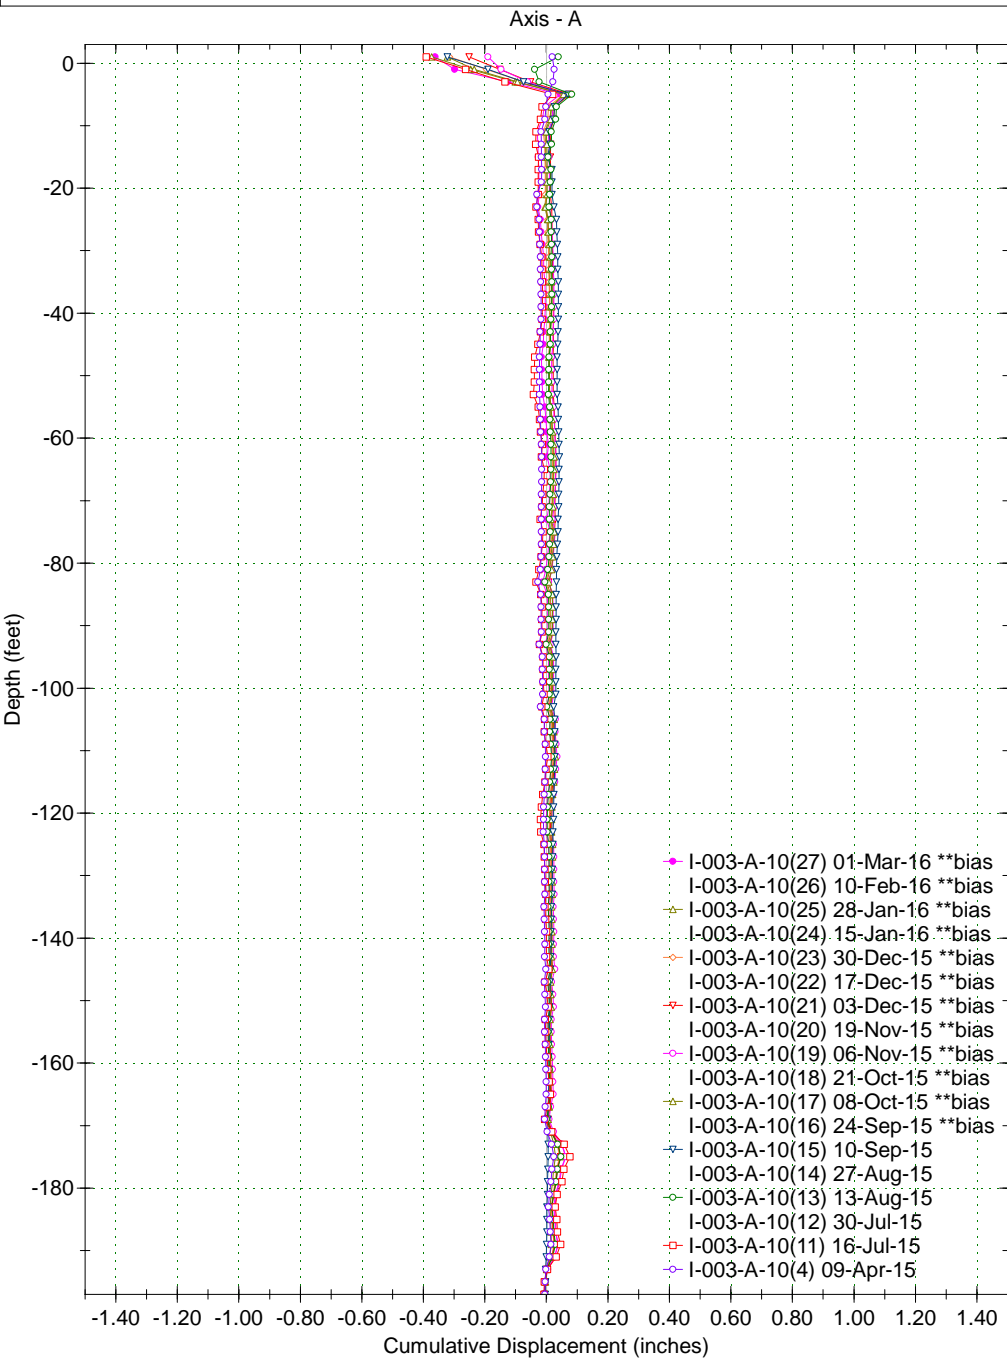
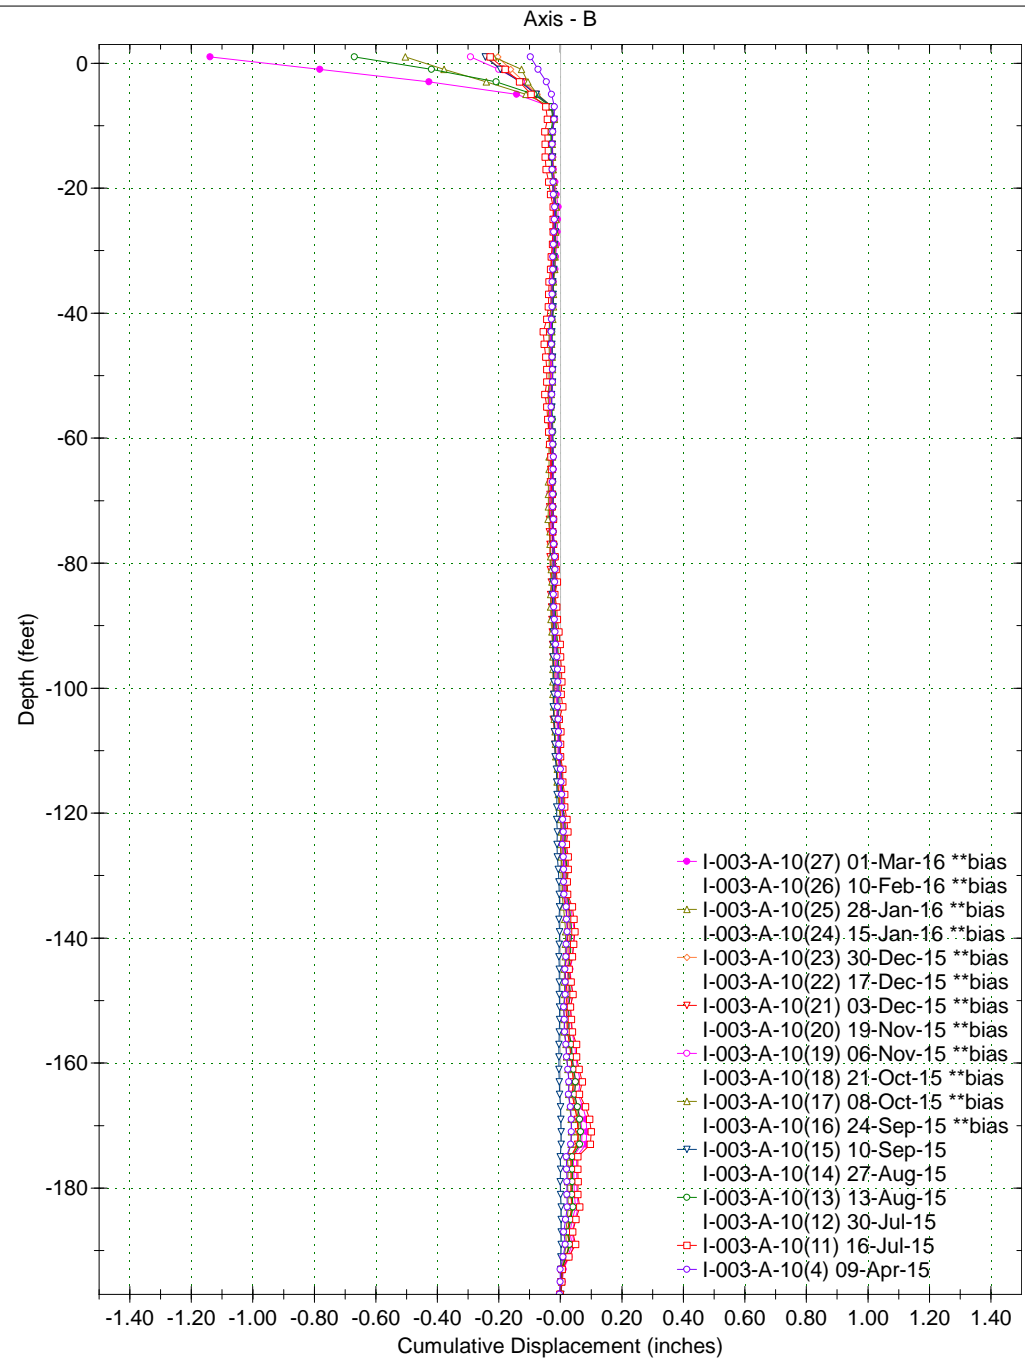
Borehole : I-003-A-10
Project : CUY-90-15-24
Location :
Northing :
Easting :
Collar :

I-003-10 – The negative B-axis displacement in the top 10 feet of the inclinometer casing at this location was likely caused by the adjacent construction work on the gabion wall. No other significant movement was observed at this location.

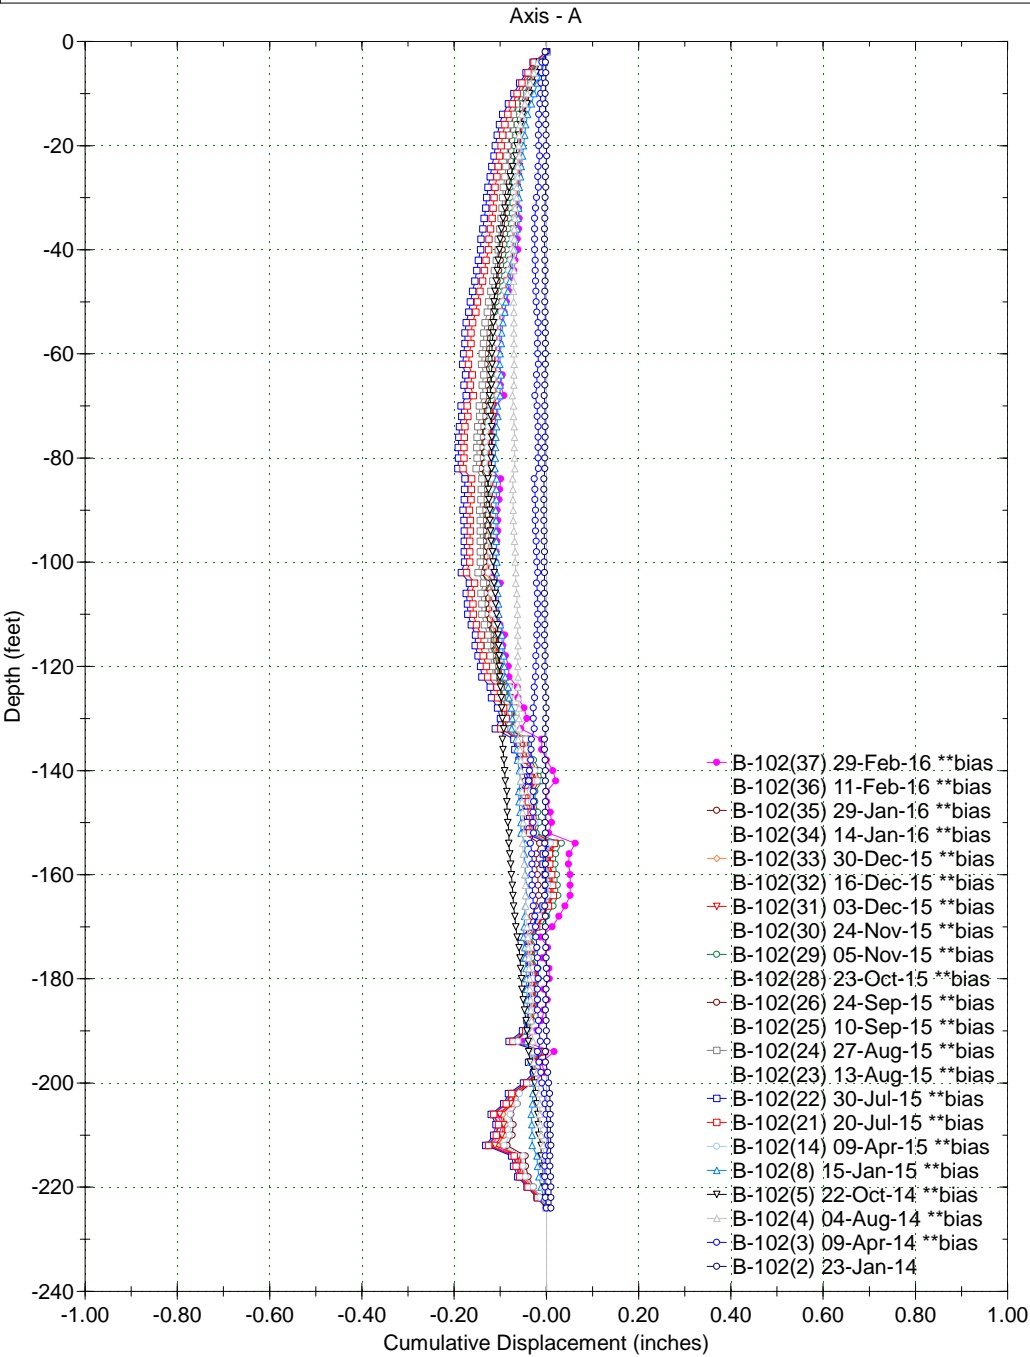
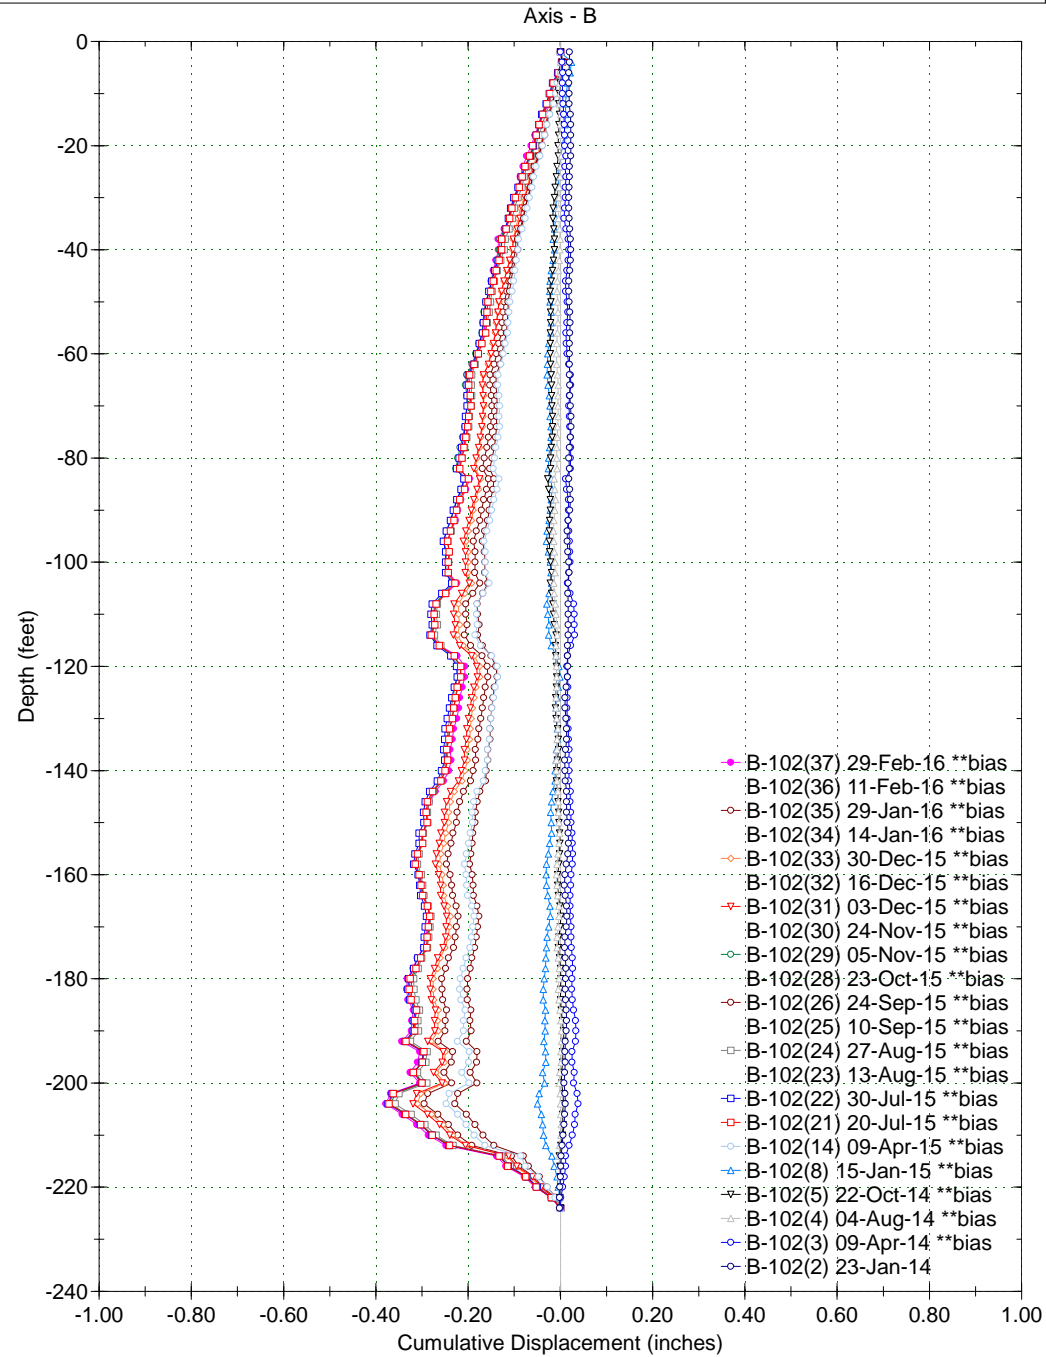
Borehole : B-102
Project : CUY-90-15-24
Location : Cleveland, Ohio
Northing : Sta. 15+95.34
Easting : 134.7' Rt of CL
Collar :

B-102 – Inclinometer readings for this location indicate slight displacement in the positive A-axis direction between 120 and 200 feet.
