March 5, 2016

Re: February 29 and March 1, 2016 Bi-Weekly Readings
CUY-90-15.24 Slope Monitoring
PID 96504
SME Project No. 069032.00

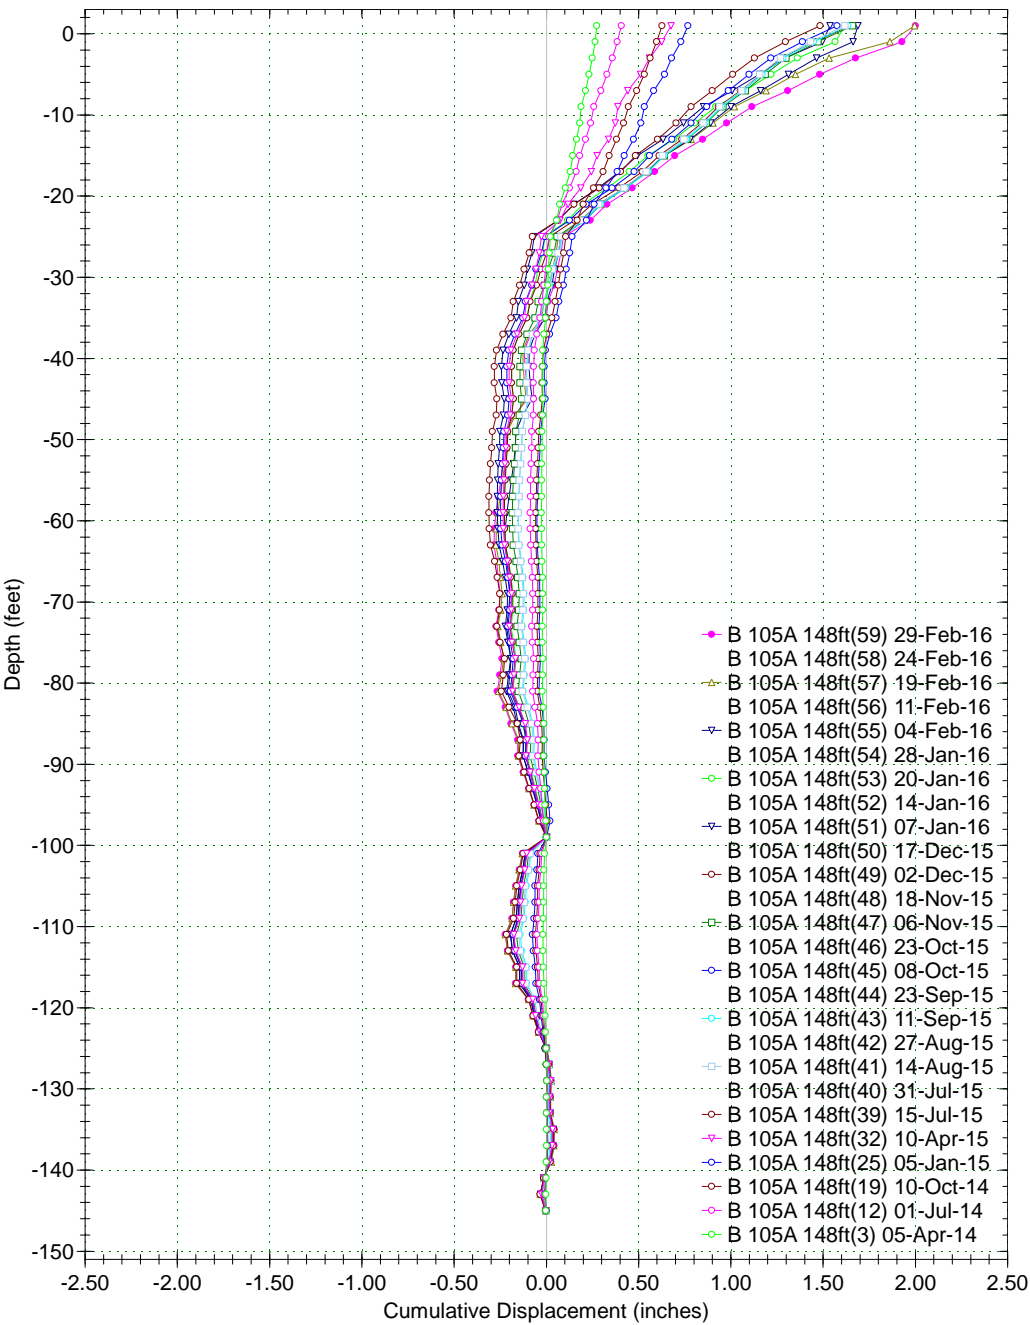
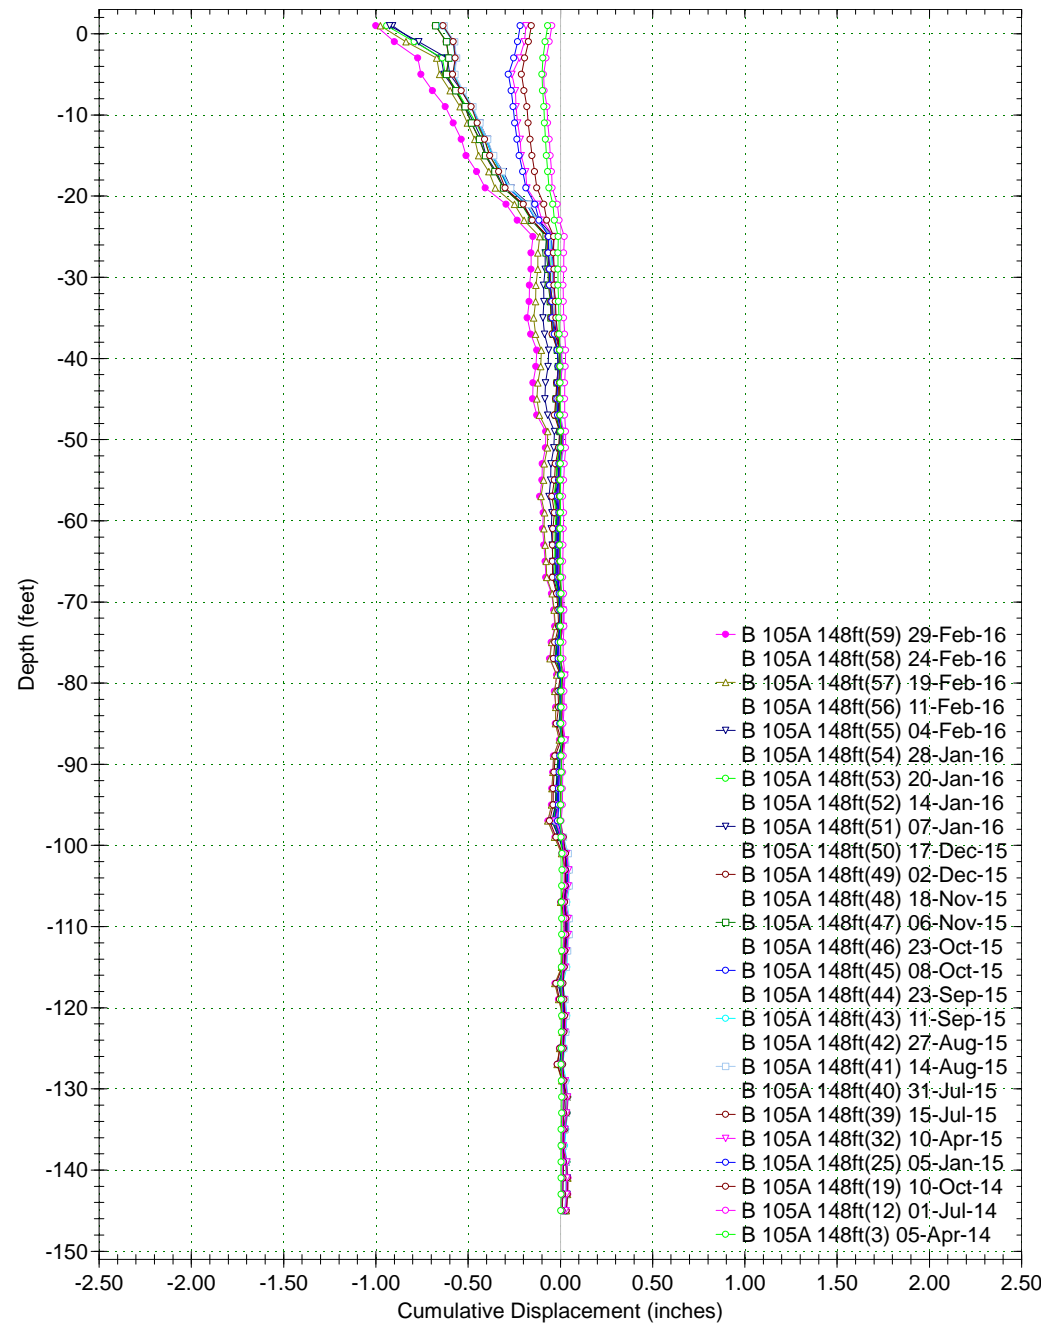
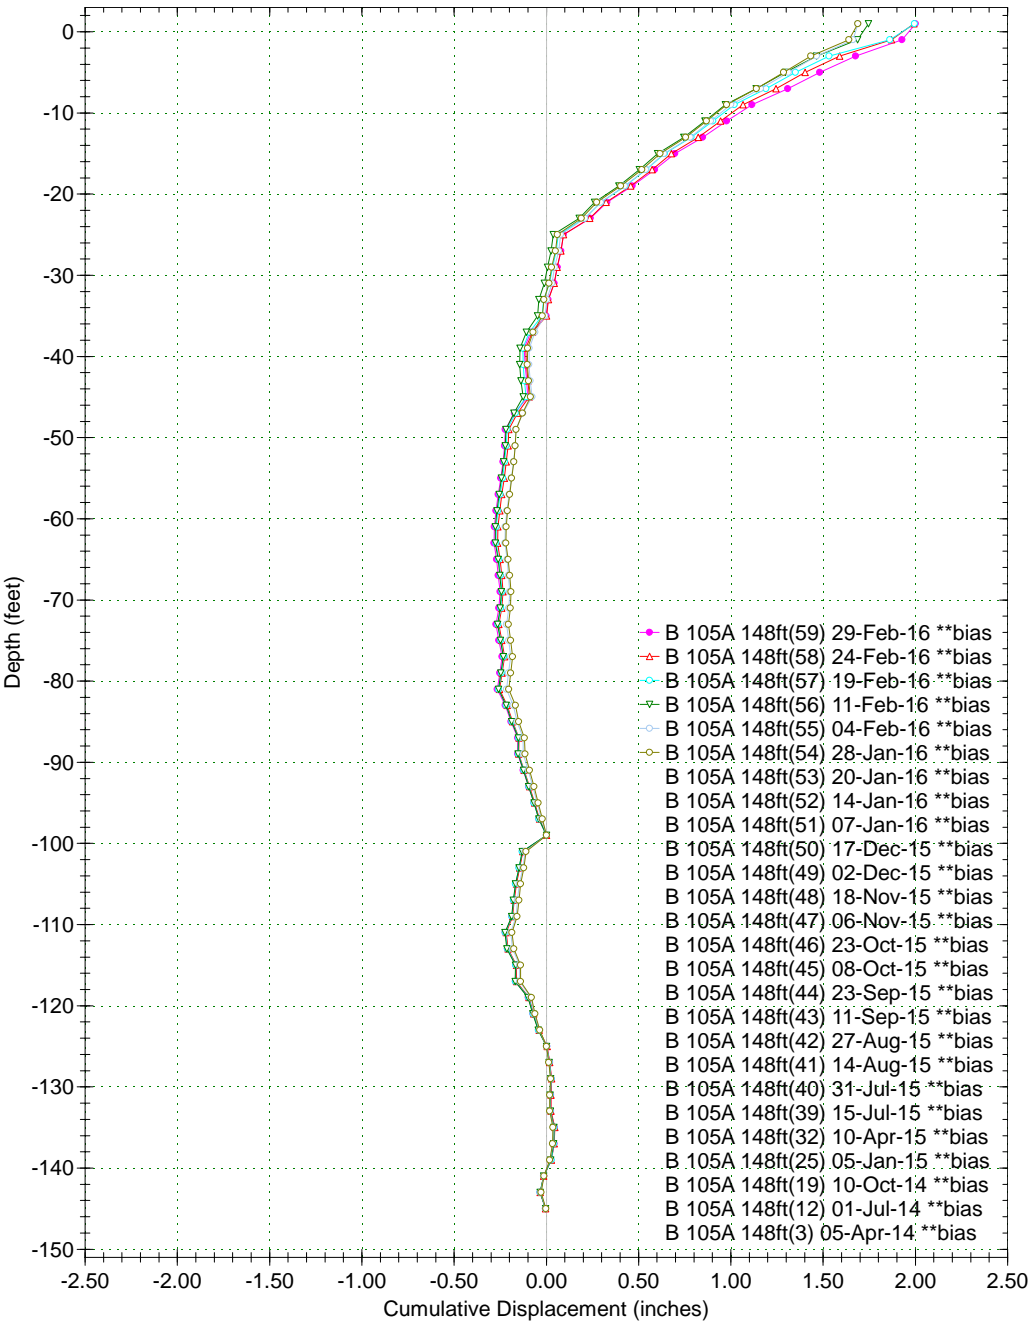
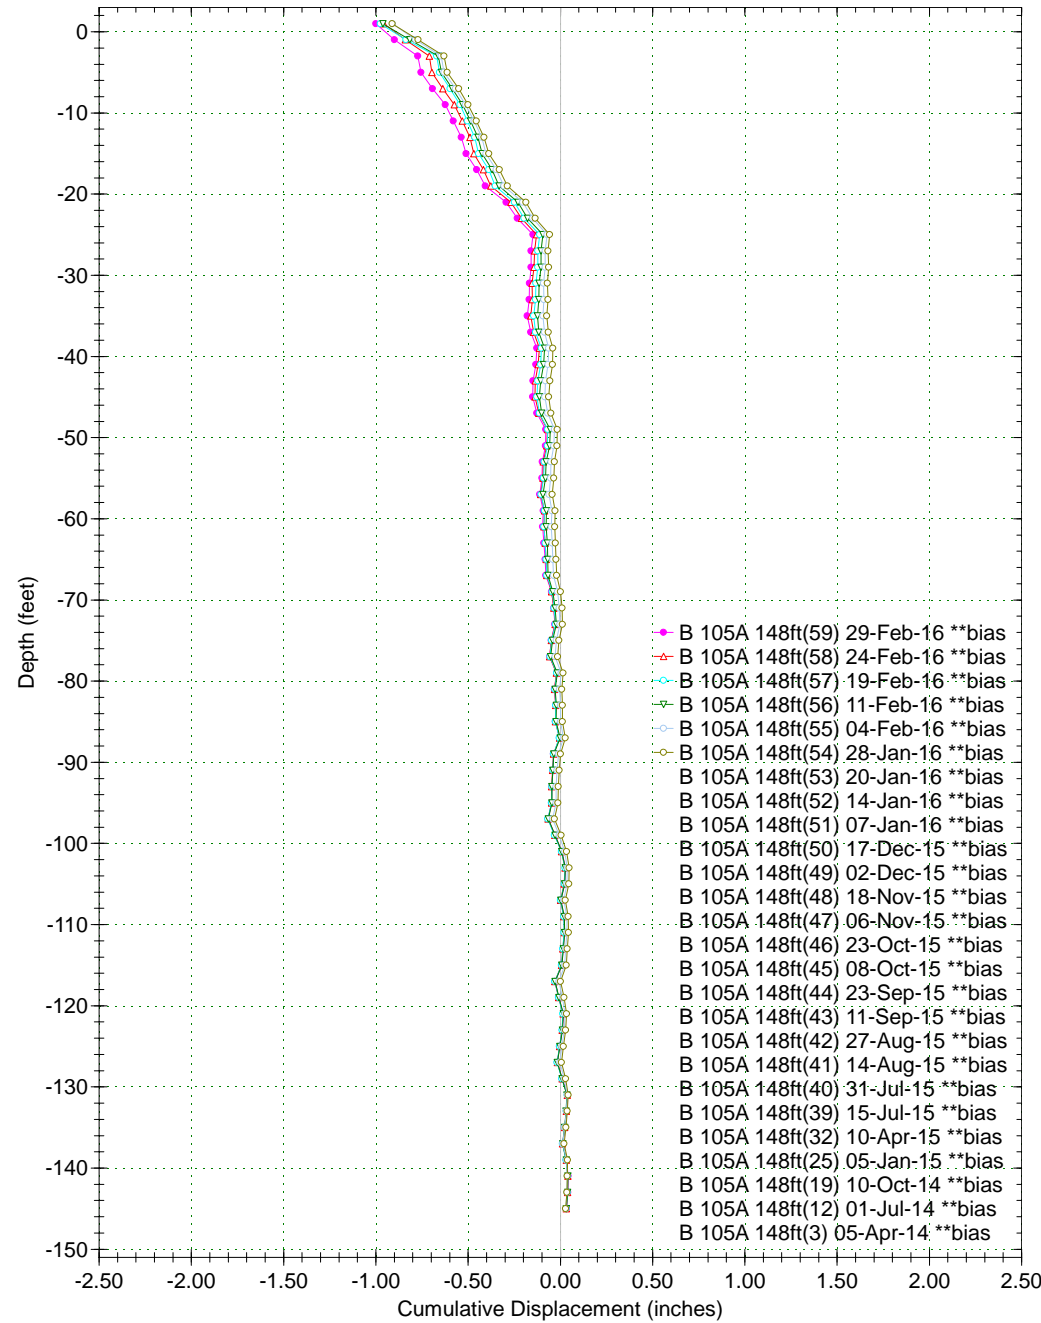
Borehole : B 105A 148ft
 Project : CUY-90-15-24
 Location : Cleveland, Ohio
 Northing : Sta. 19+11.38
 Easting : 90.9' Rt of CL
 Collar :

B-105A – Inclinometer readings for this location, indicate slight positive A-axis and negative B-axis displacements from the surface to about 50 feet. TGR is currently in the process of backfilling the area surrounding this inclinometer. We have extended the inclinometer casing and asked TGR to take special care when compacting fill near this instrument.

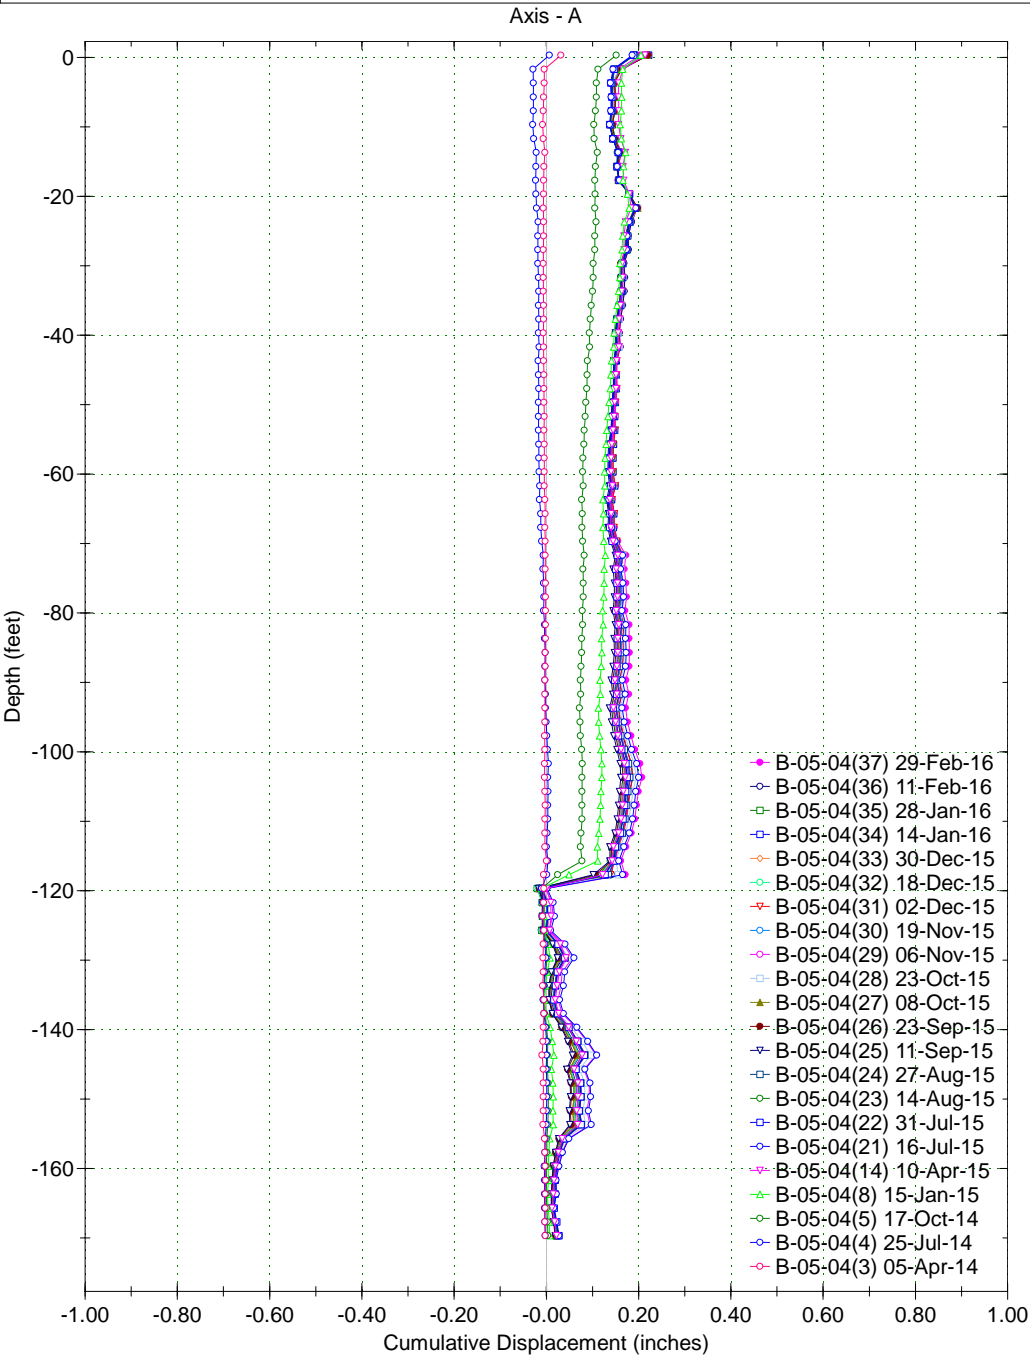
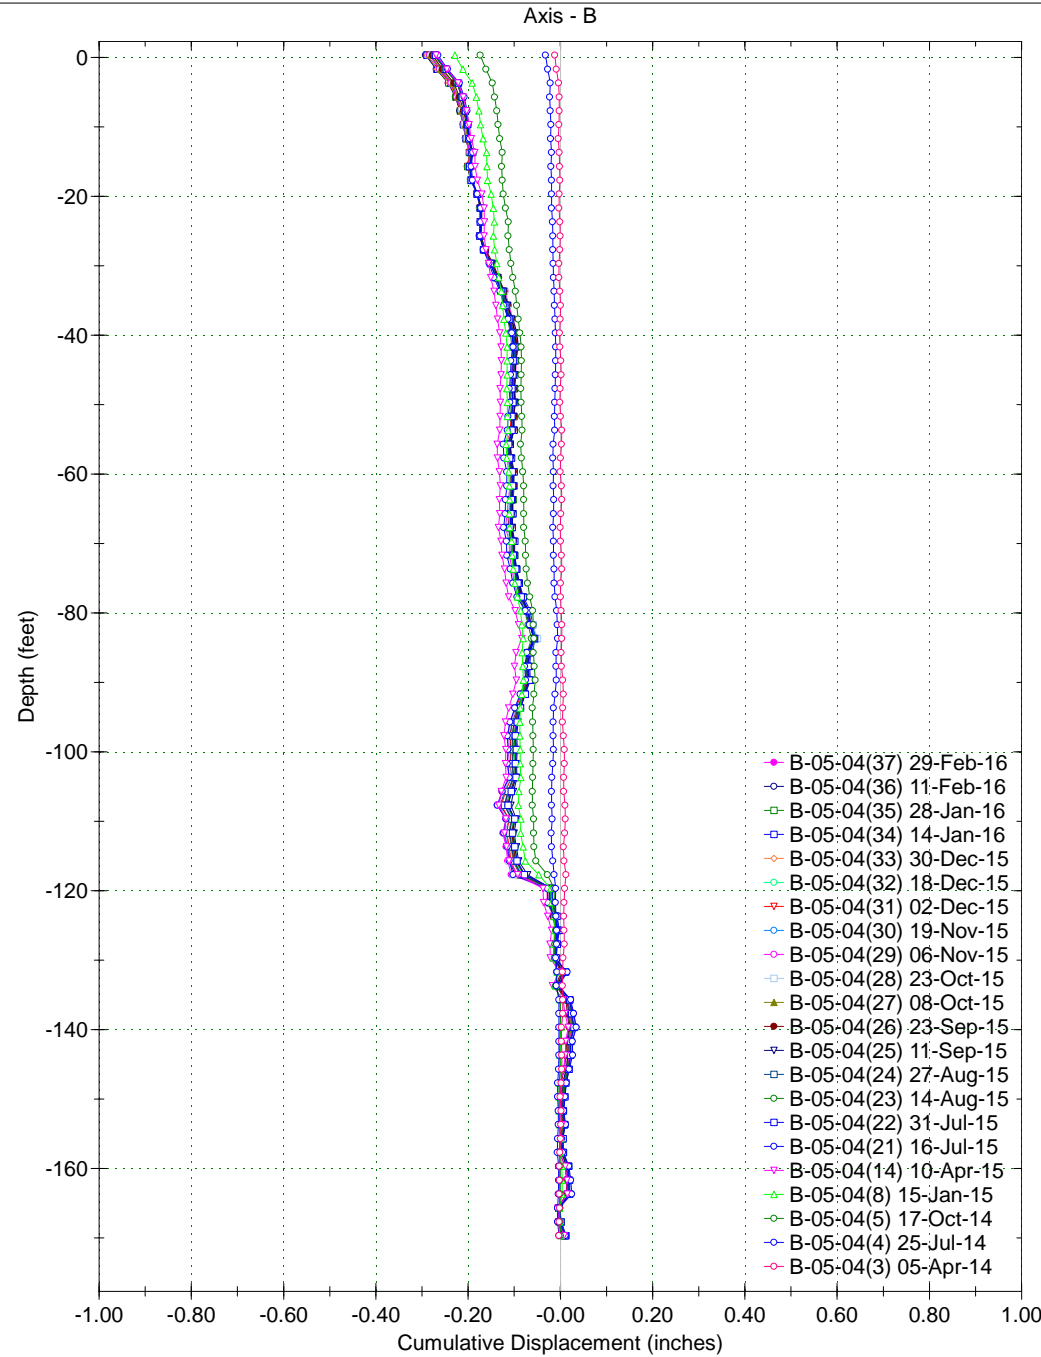
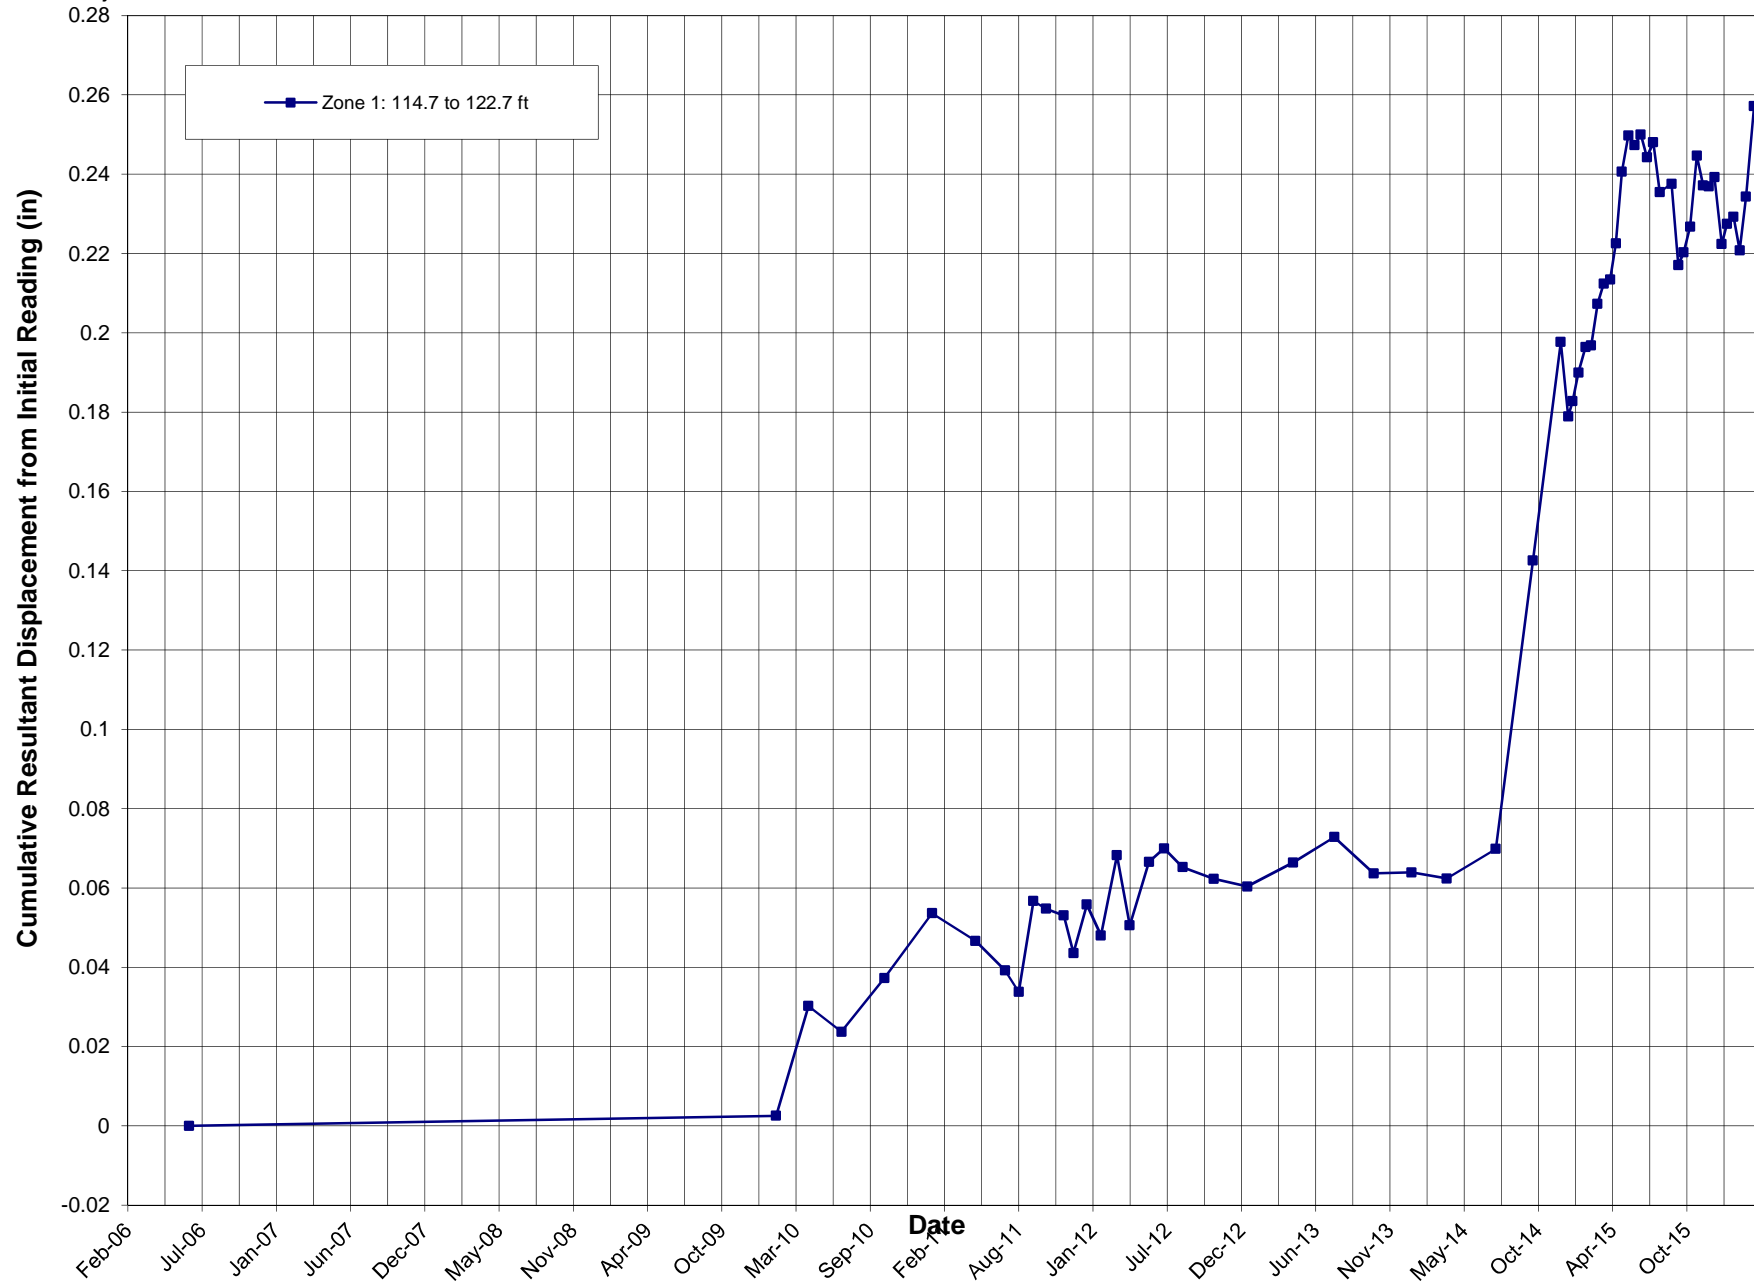
Borehole : B-05-04
Project : CUY-90-15-24
Location : Cleveland, Ohio
Northing : Sta. 133+51.67
Easting : 242.09' Rt of CL
Collar :

B-05-04 – The cumulative resultant displacement zone plot between 115 and 123 feet indicates an increase of about 0.02 inches over the past two weeks. The cumulative displacement plot shows that this positive A-axis displacement which is occurring between about 50 and 120 feet.

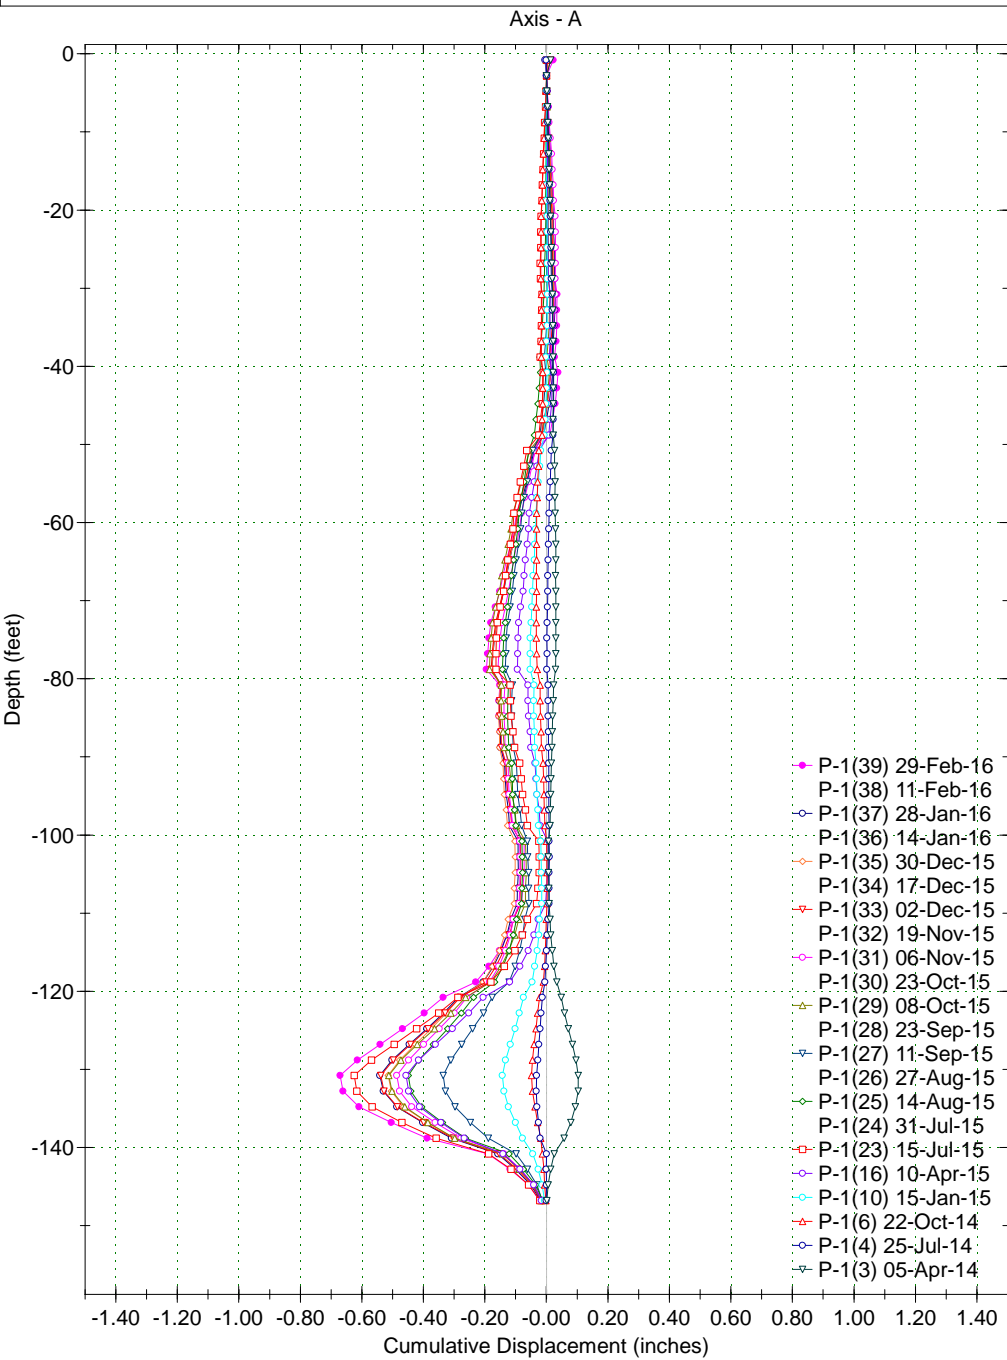
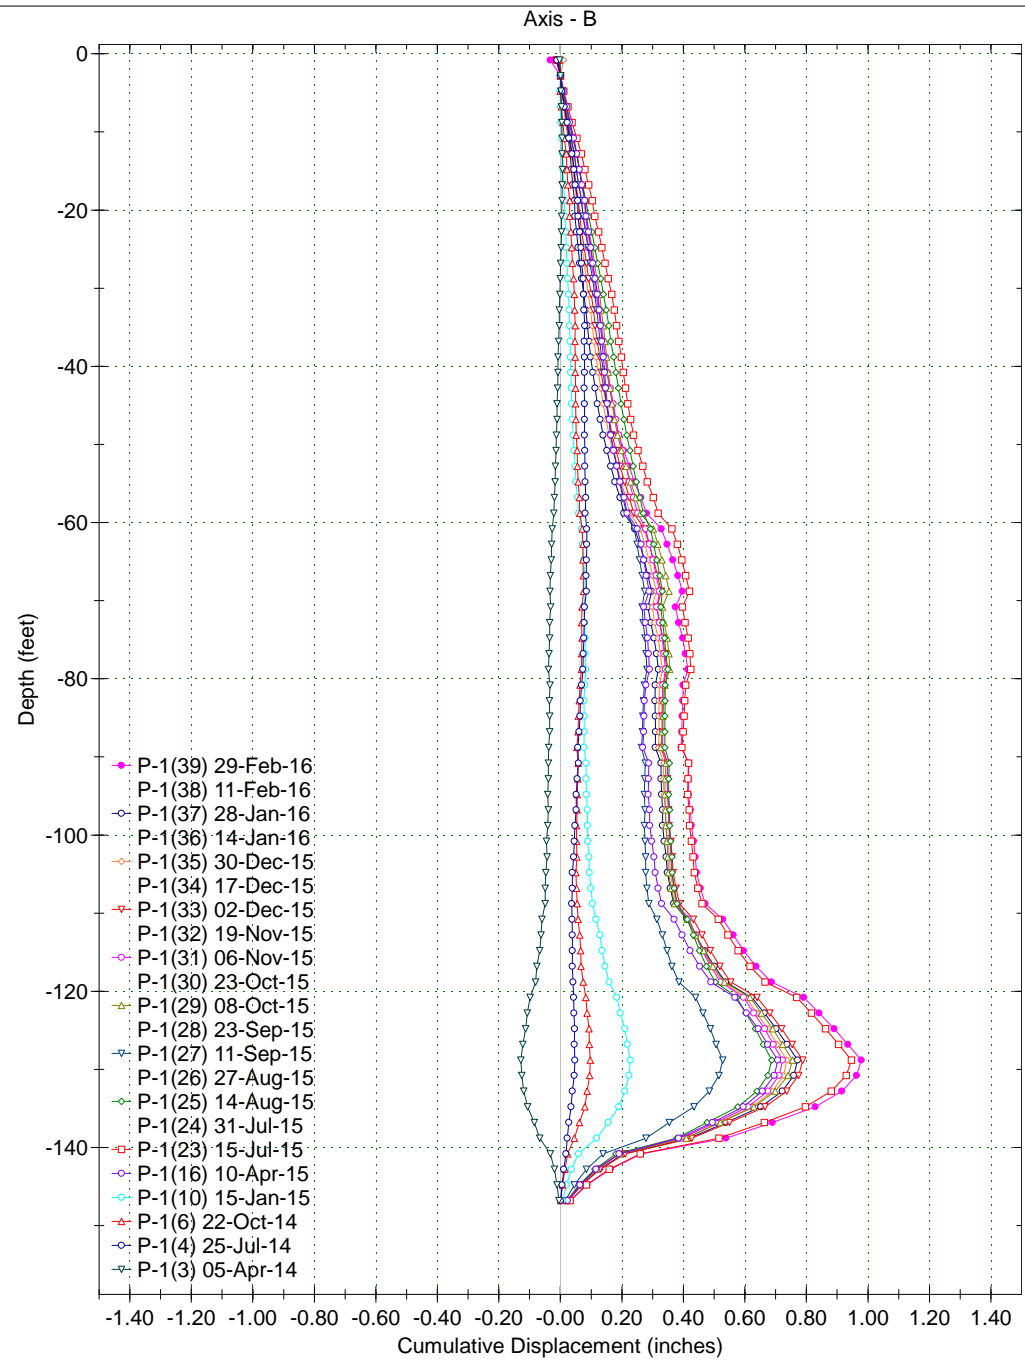
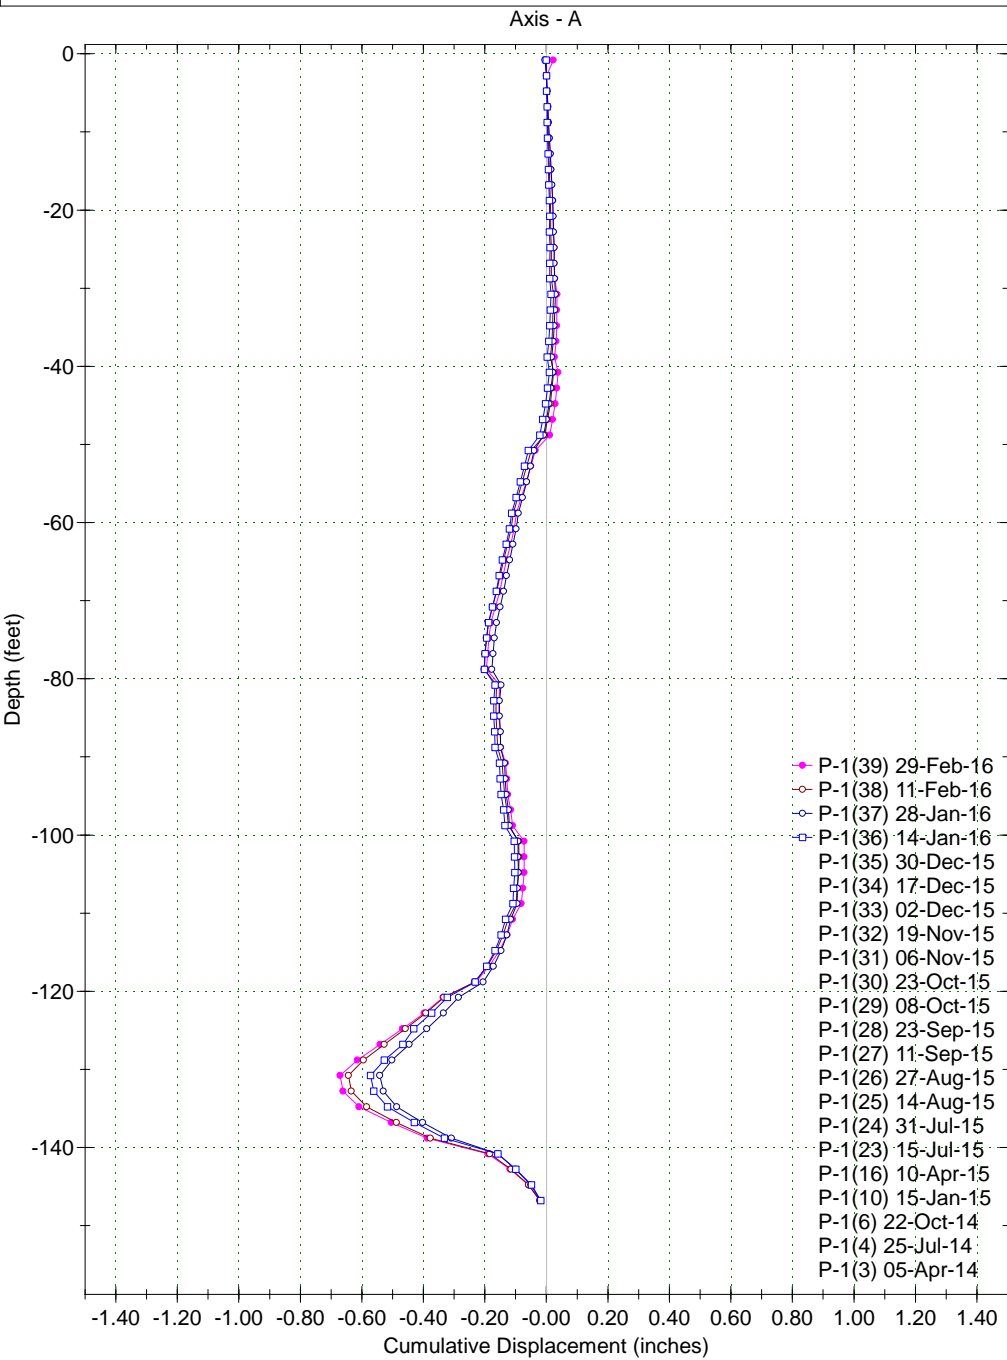
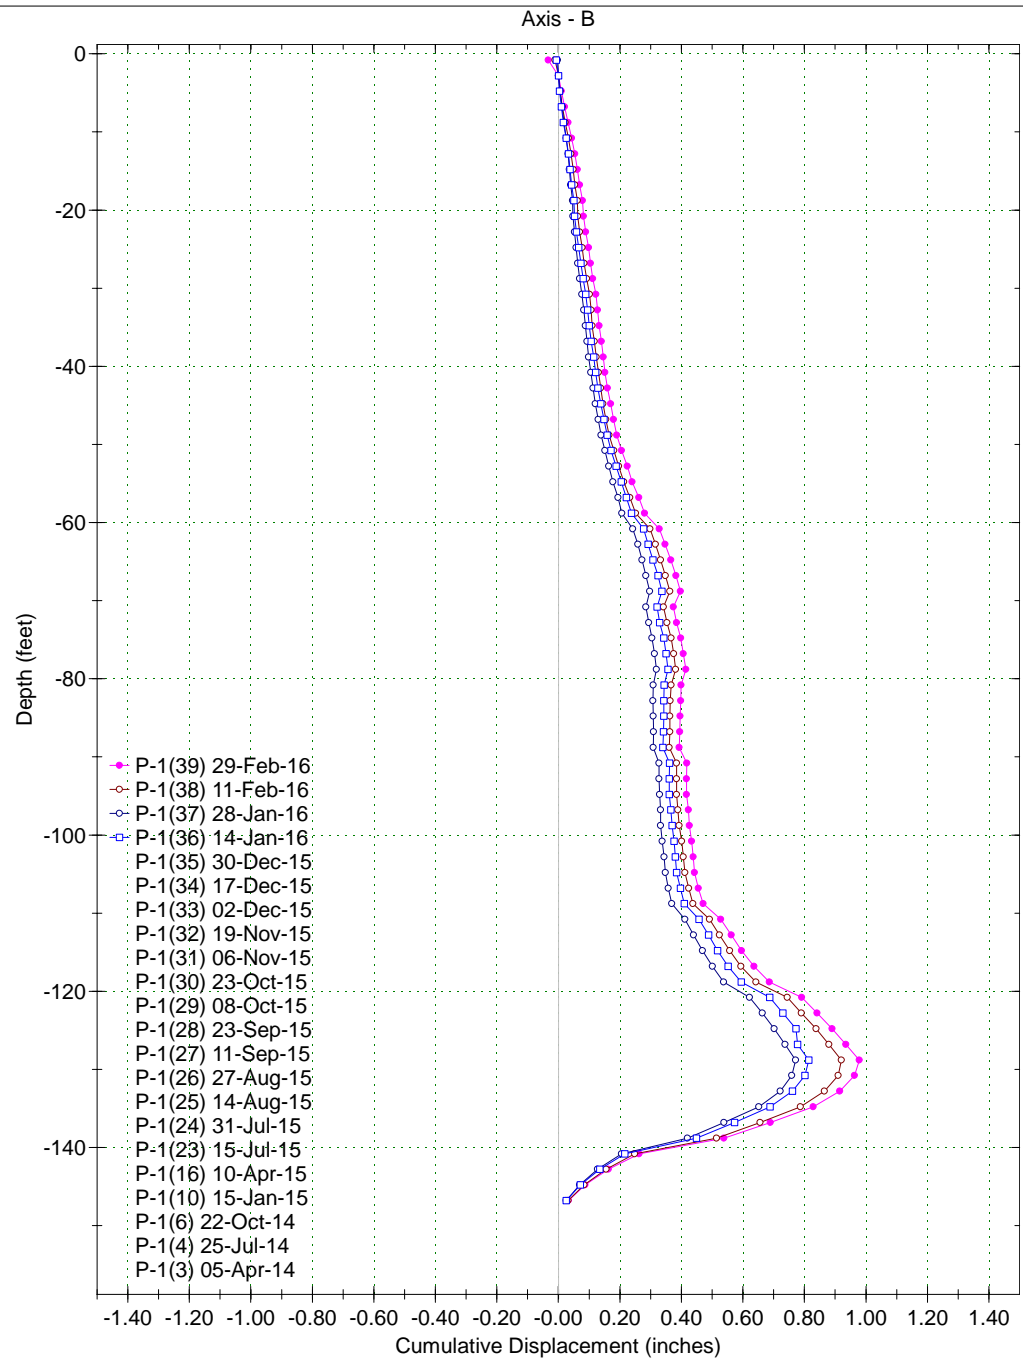
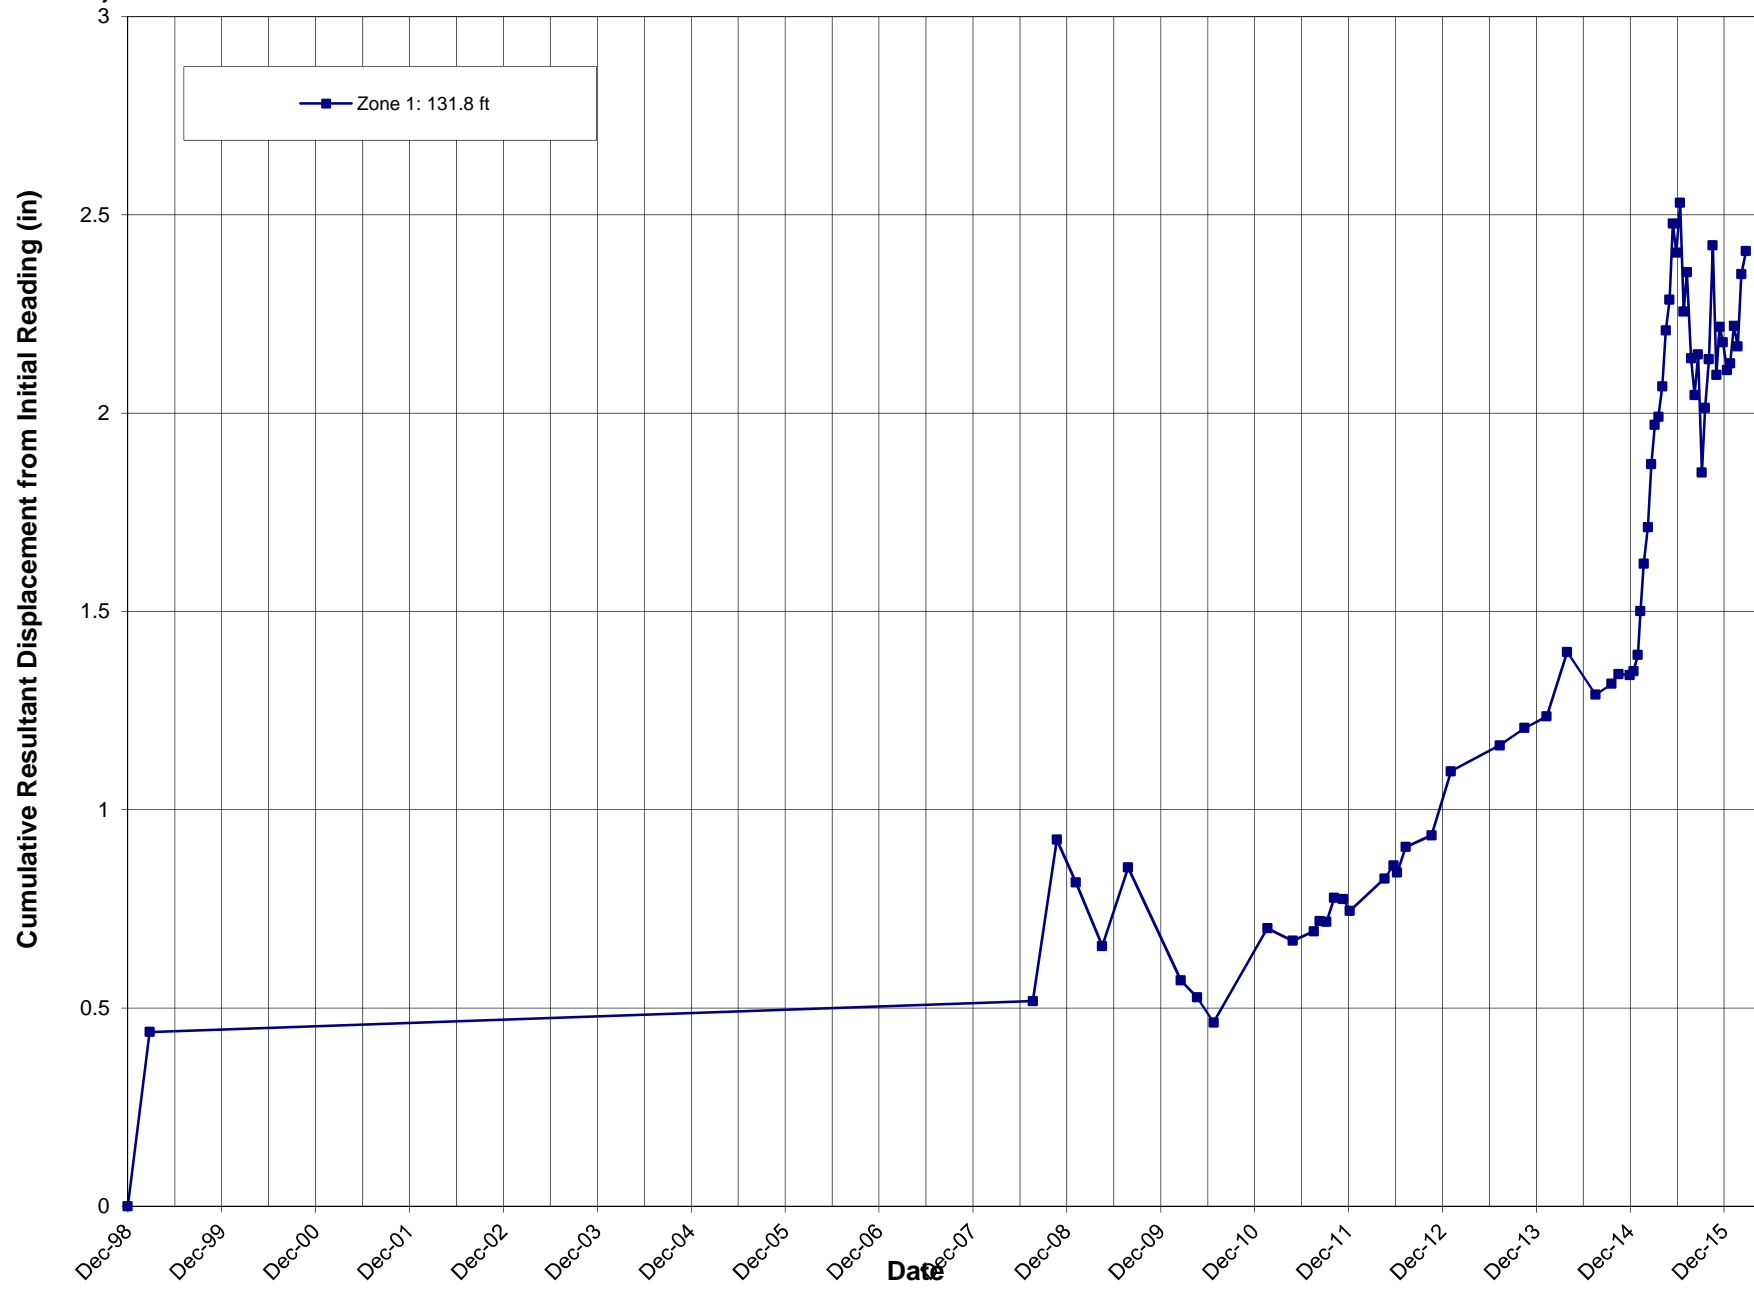
Borehole : P-1
 Project : CUY-90-15-24
 Location : Cleveland, Ohio
 Northing :
 Easting :
 Collar :

P-1 – Inclinometer readings for this location indicate an increase in negative A-axis and positive B-axis displacement between about 120 and 140 feet. The cumulative resultant displacement zone plot at 132 feet indicates a slight increase.
