March 31, 2016

Re: March 23 and 24, 2016 Bi-Weekly Readings
CUY-90-15.24 Slope Monitoring
PID 96504
SME Project No. 069032.00

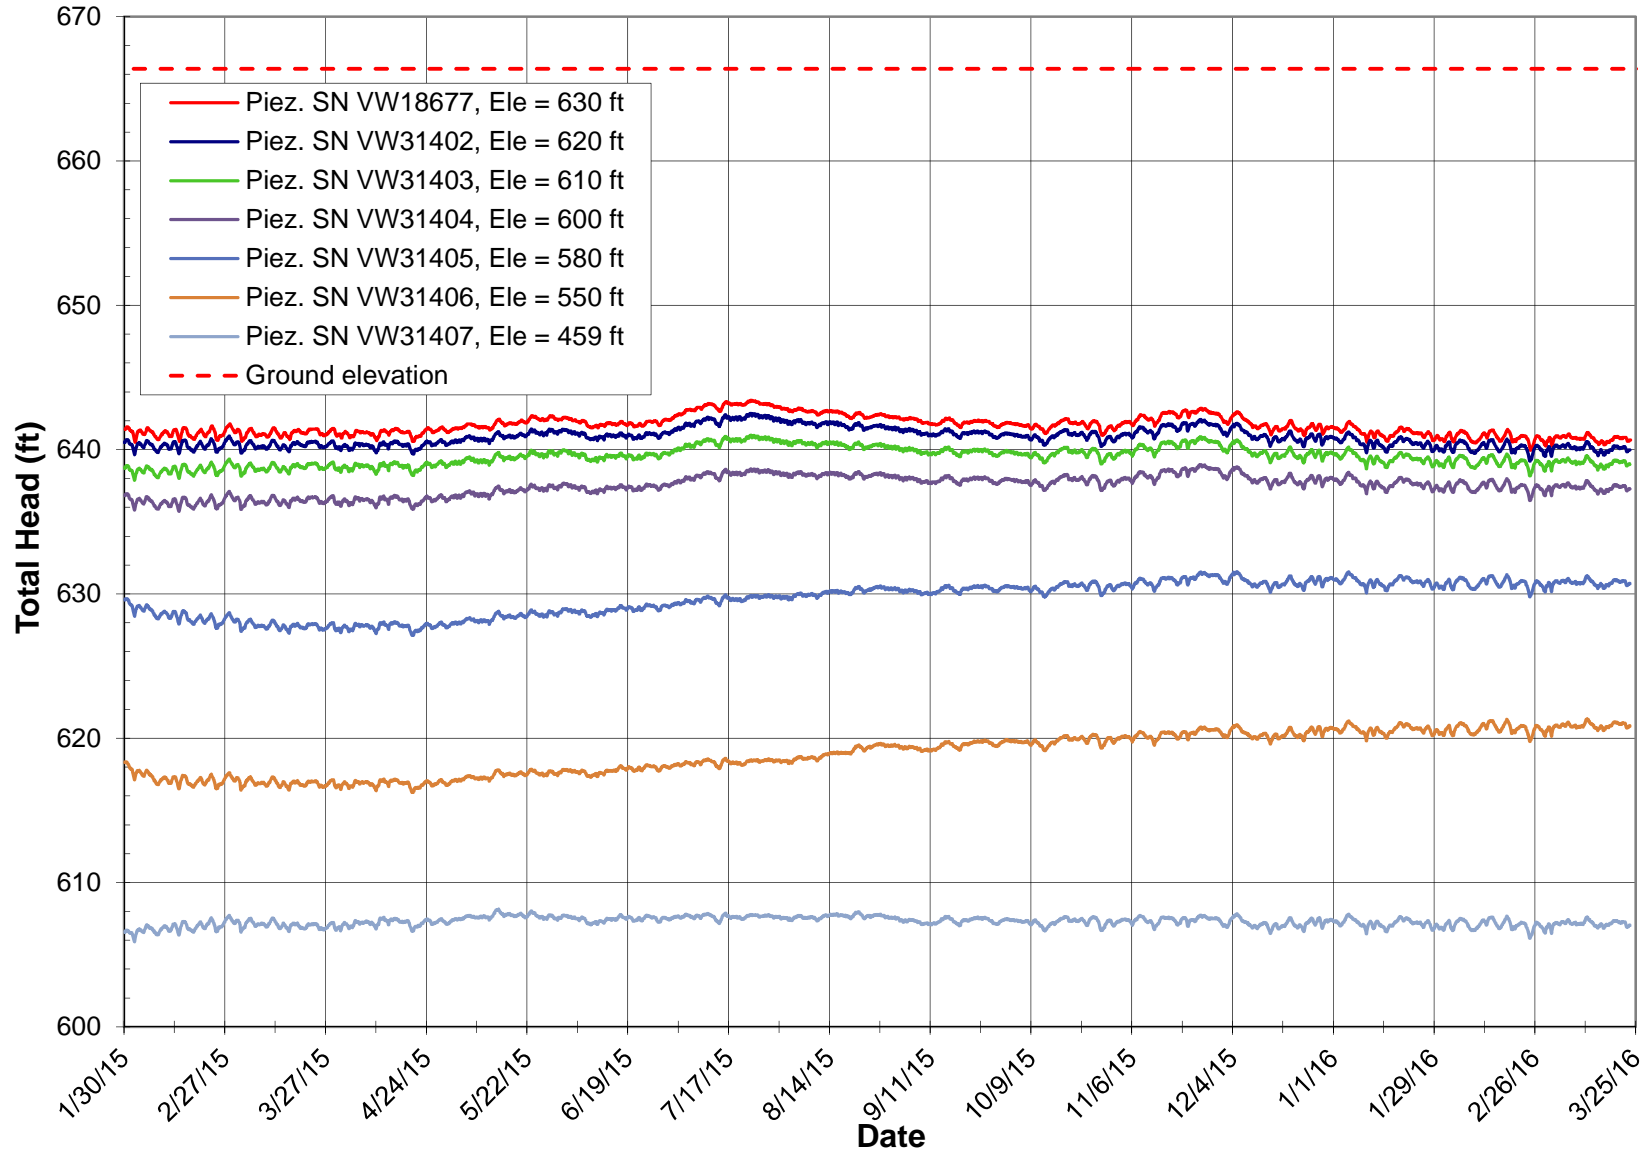
P-001-13 VW Piezometer Readings

P-001-13, P-002-13, B-05-04, B-05-A-11 – Pore pressure readings at these locations indicate minor fluctuations in total head over the past two weeks with virtually no net change.

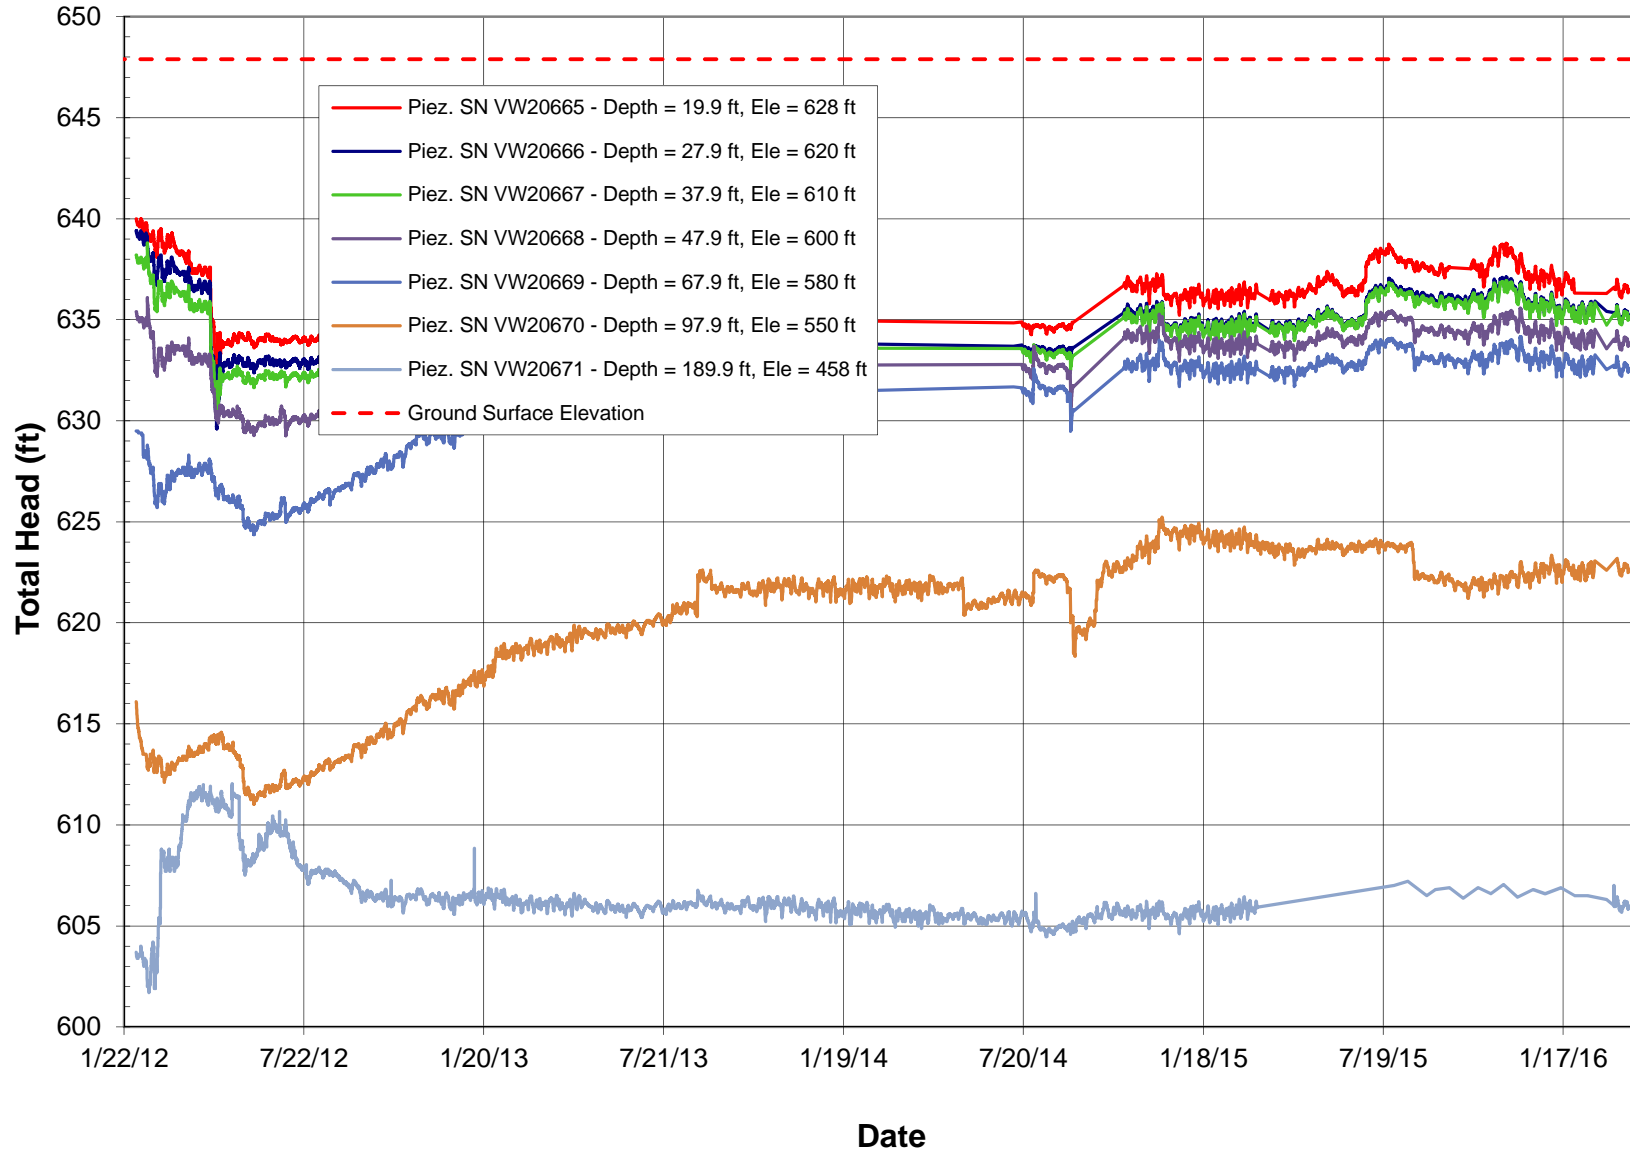
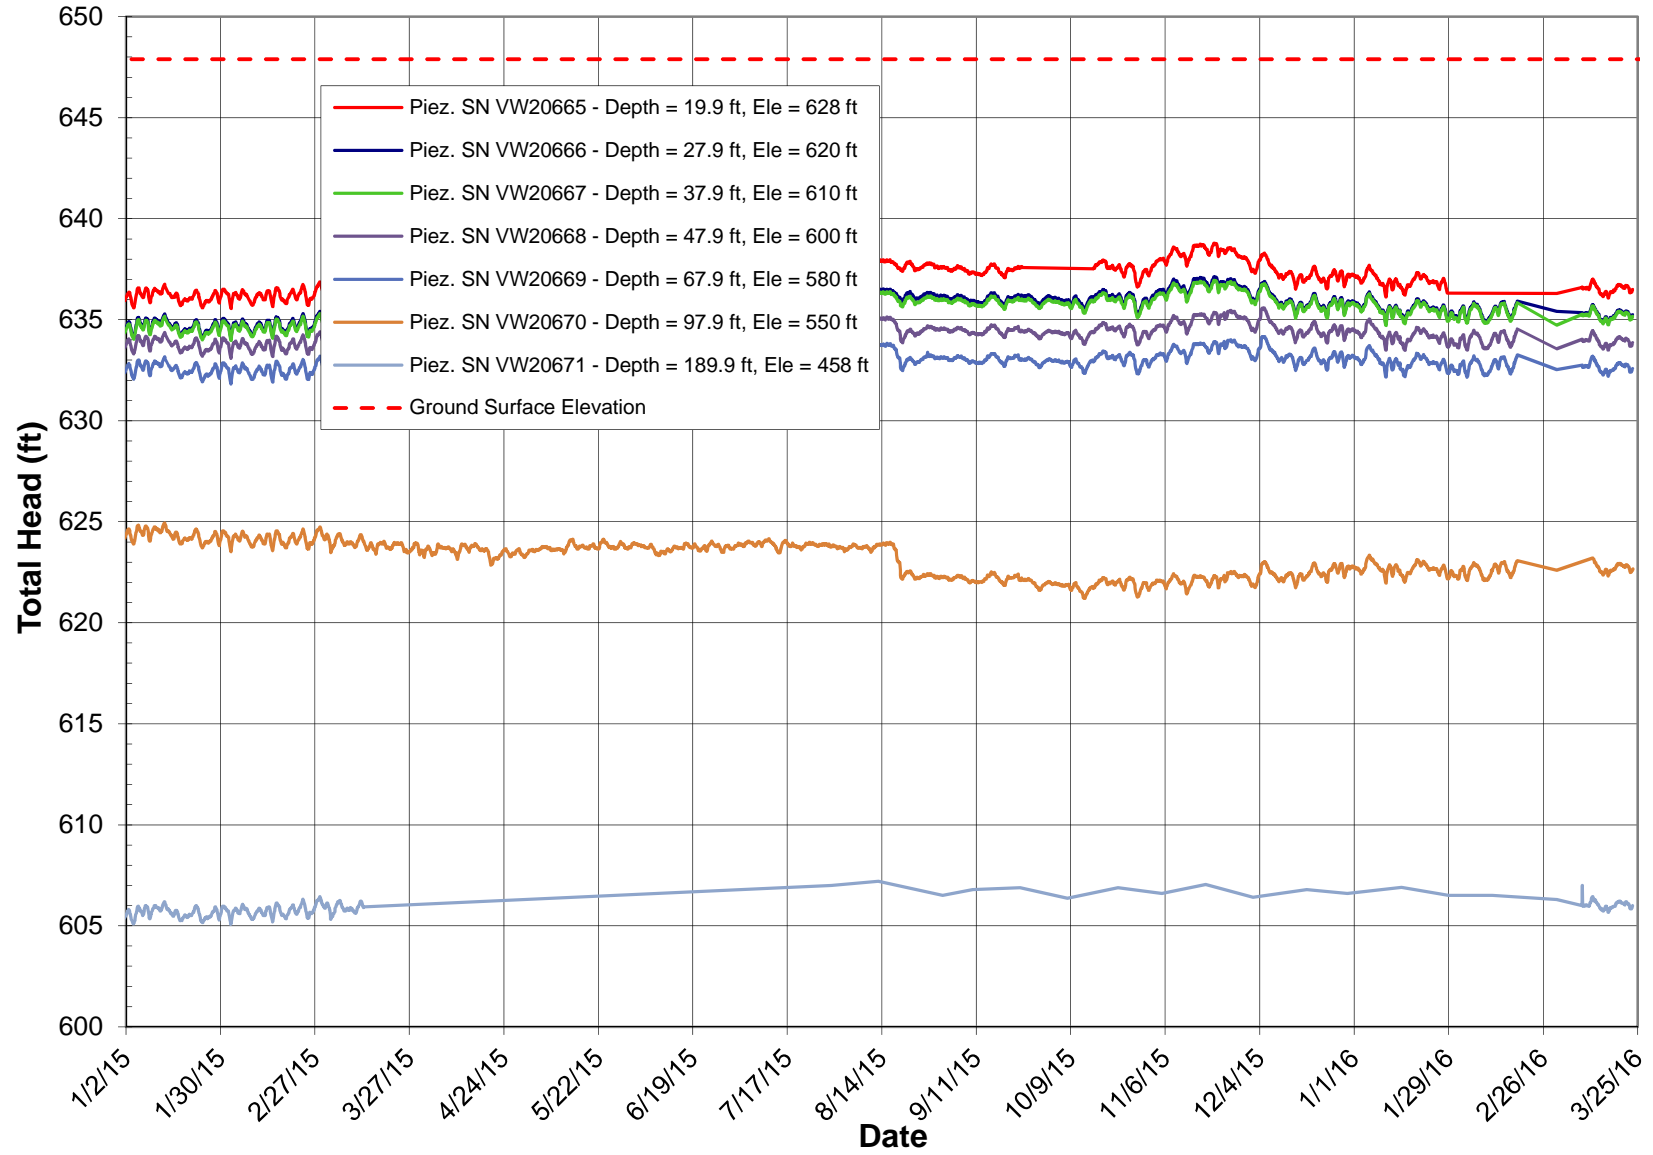
P-003-10 VW Piezometer Readings

P-003-10 – Pore pressure readings indicate a decrease in total head of about 0.5 feet in all piezometers at this location.

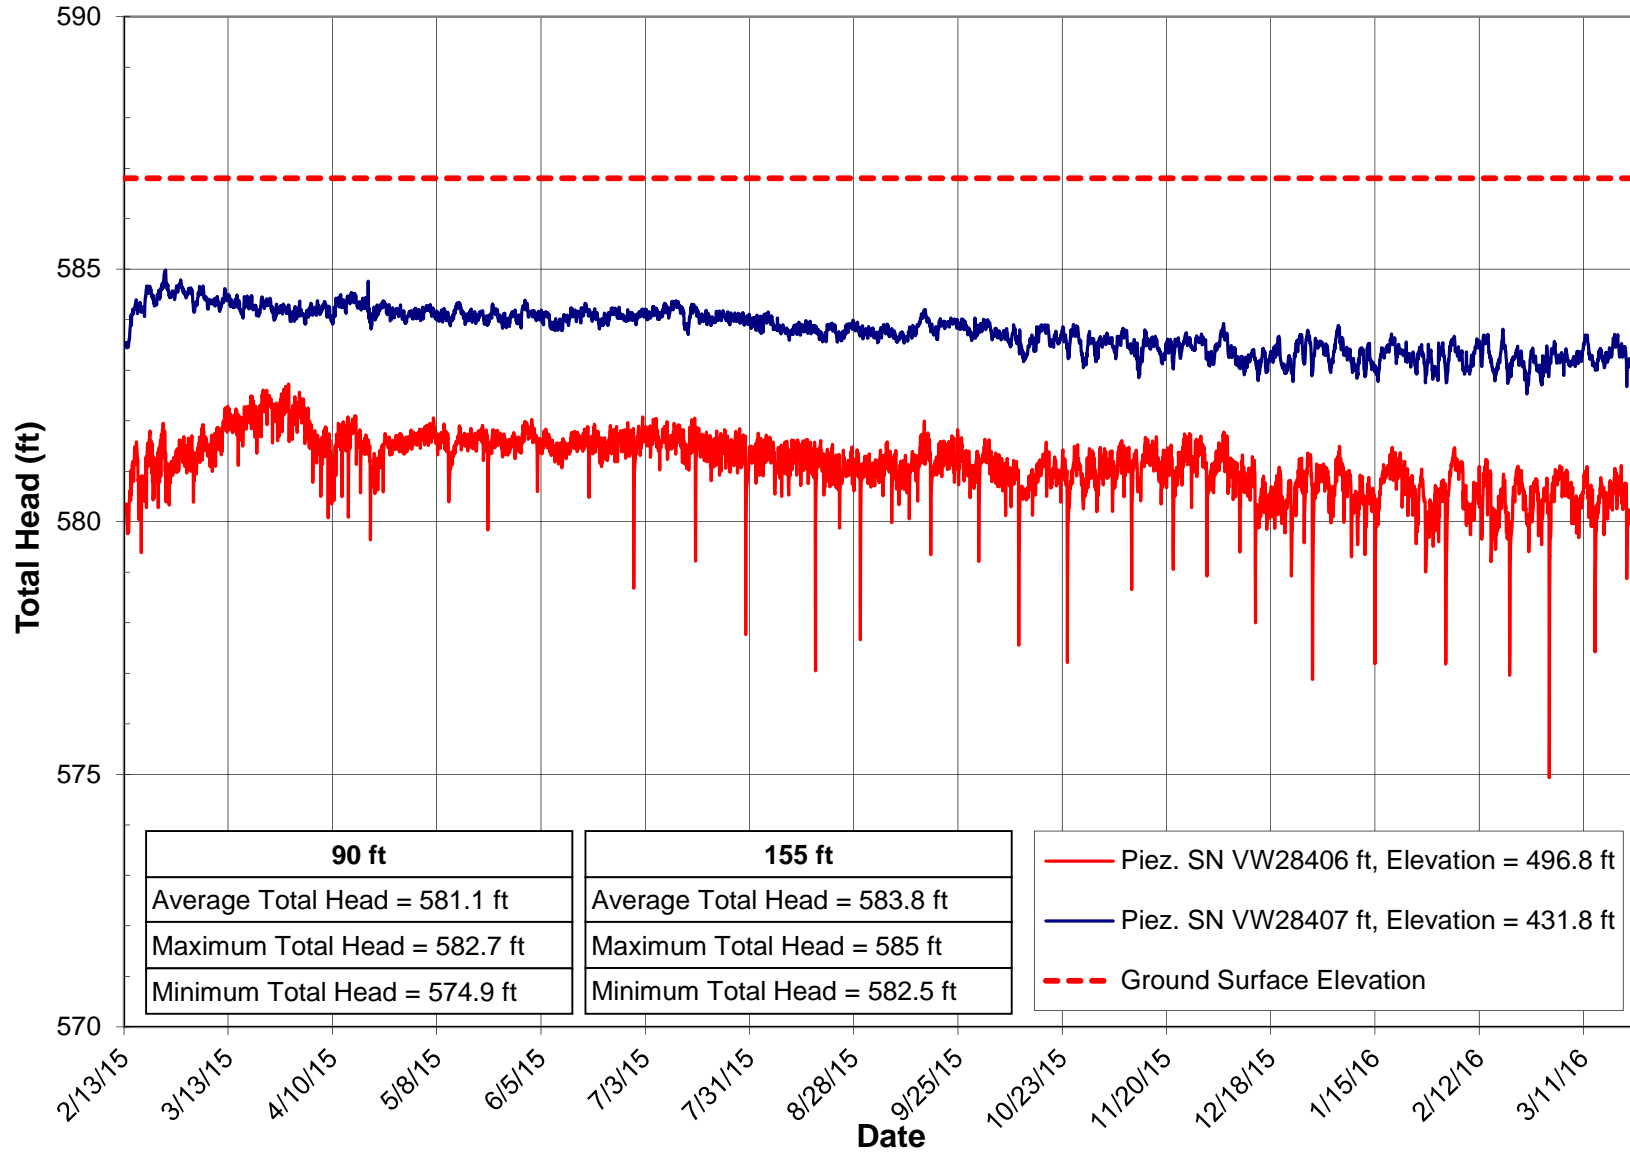
P-009-13 VW Piezometer Readings

P-009-13 – Readings in both piezometers at this location indicate variation in total head of more than a foot, but no change in the average total head.

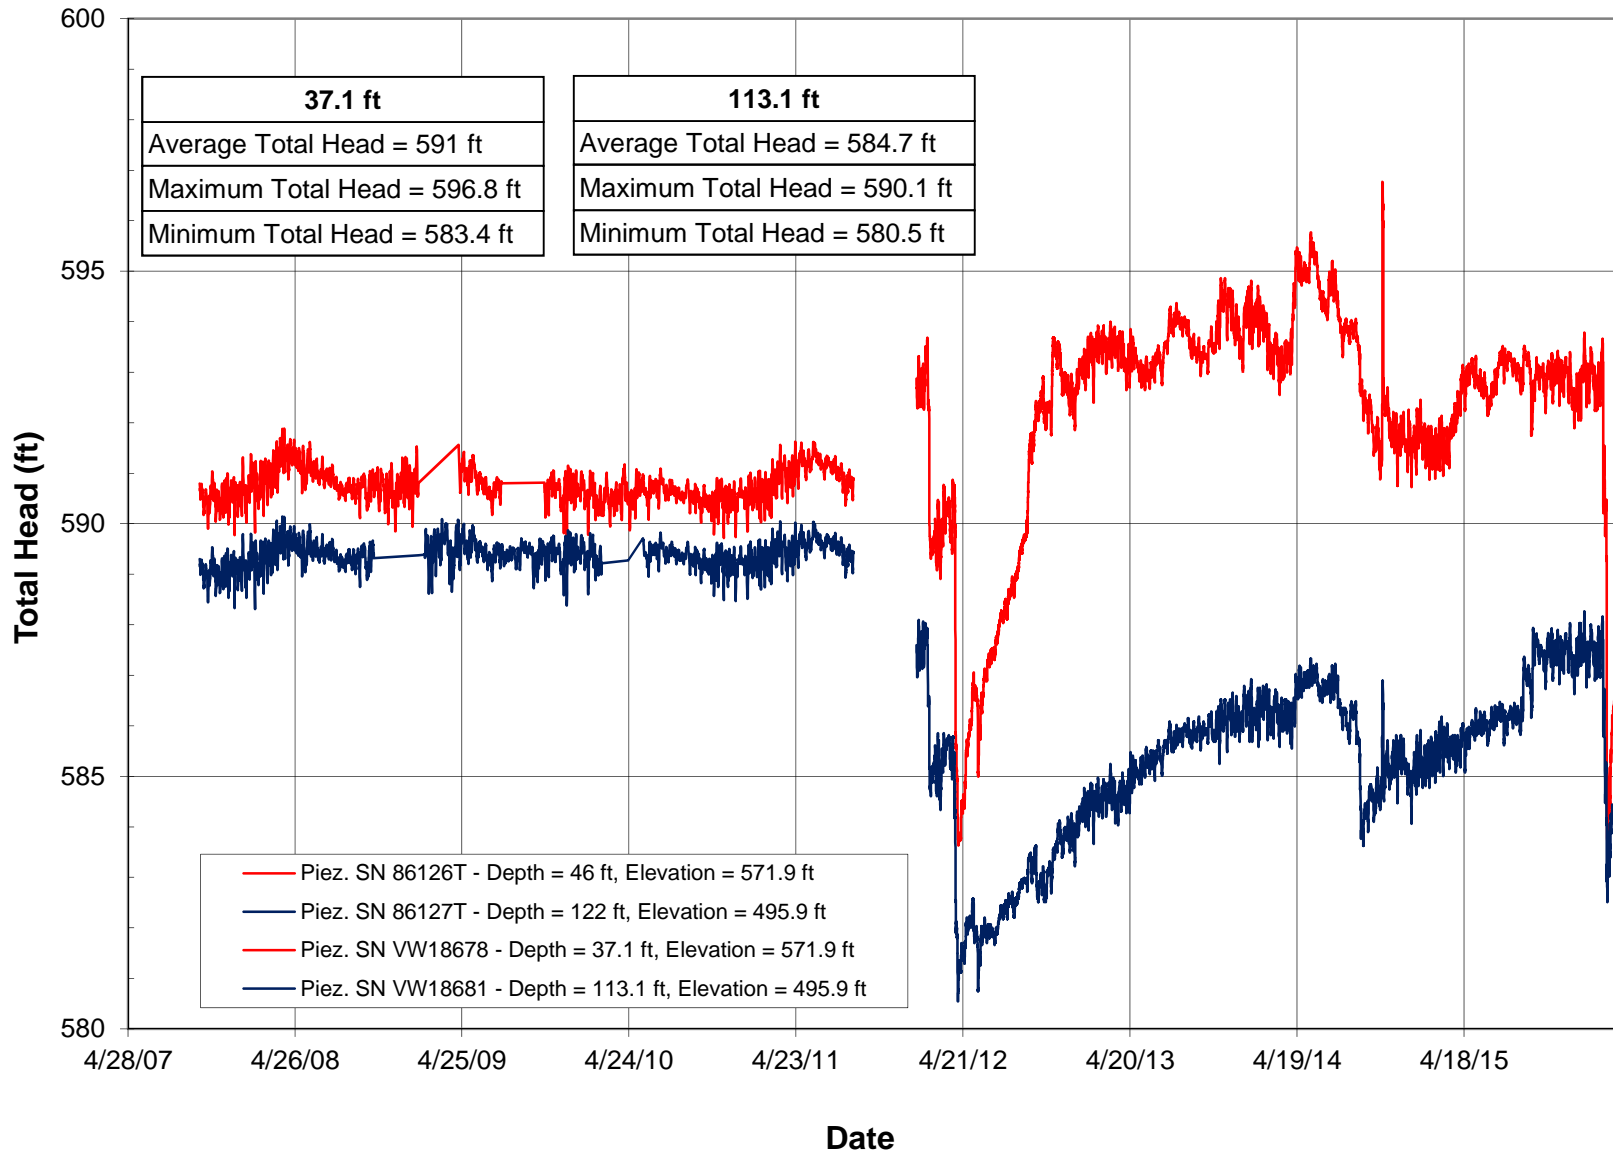
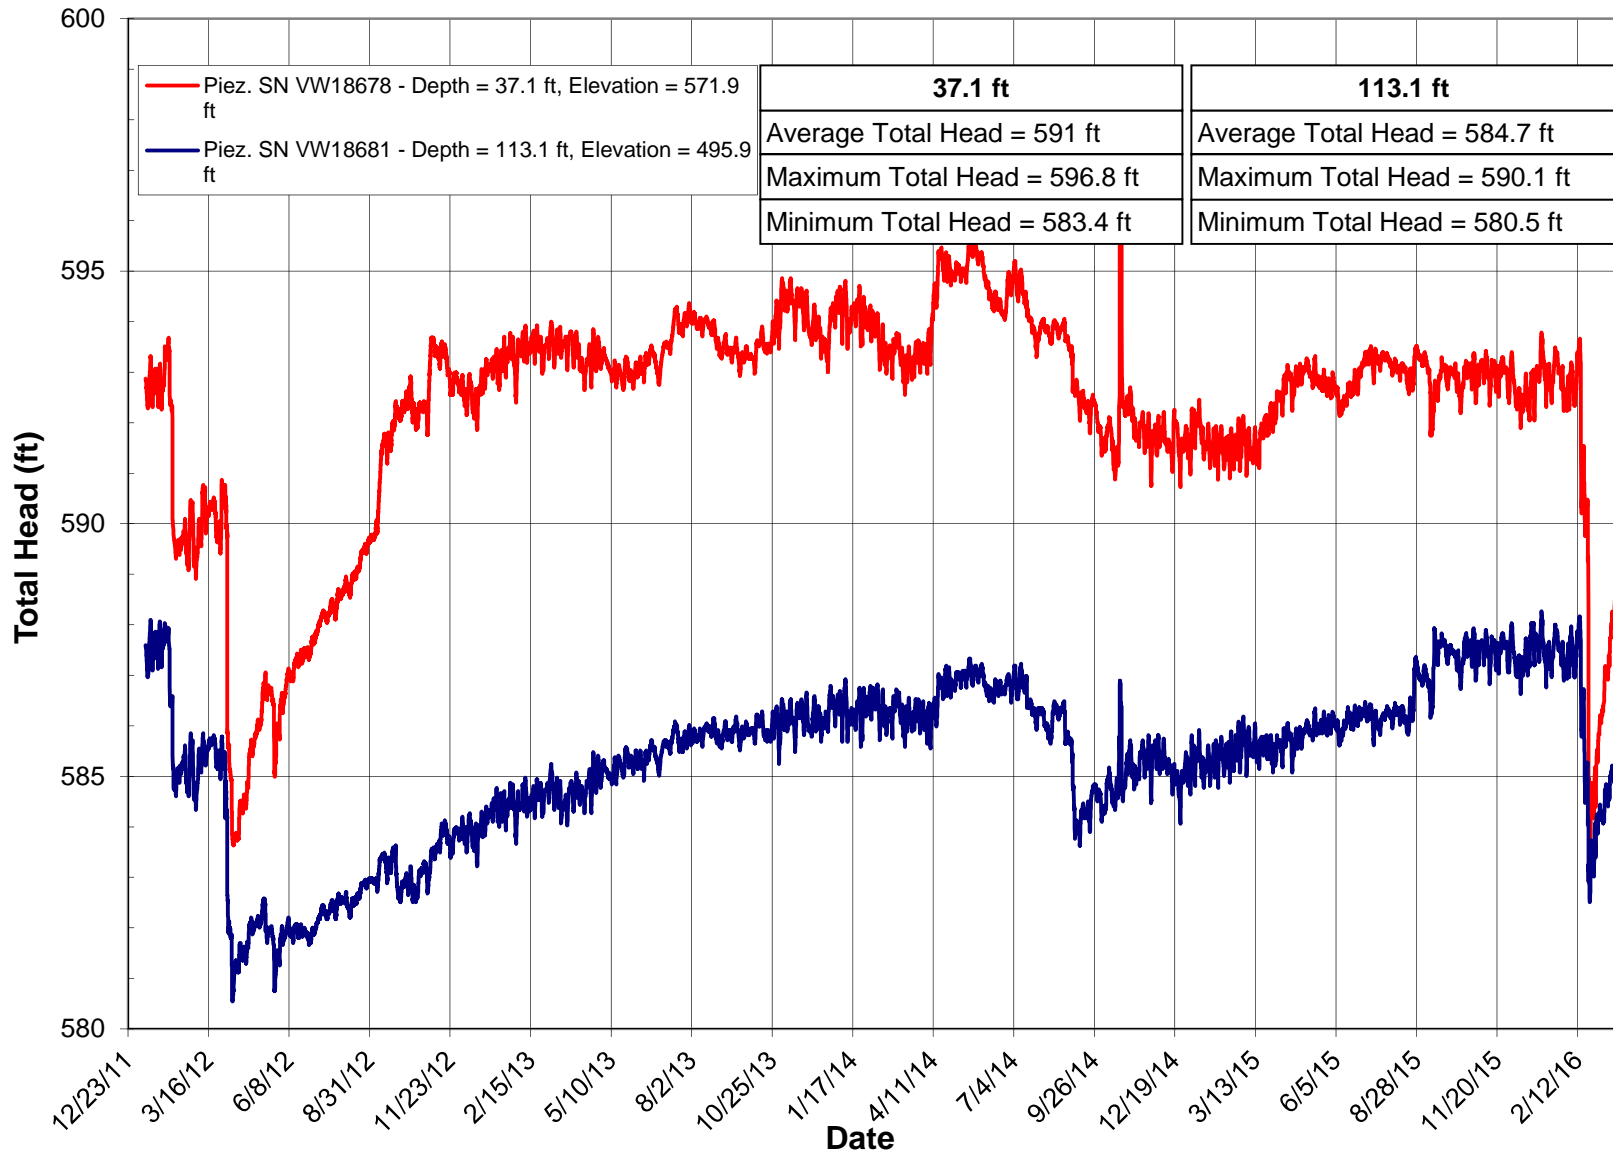
B-05-02 VW Piezometer Readings

B-05-02 – The piezometers at this location were recently uncovered. The last data download at this location was on August 1, 2014. The dataloggers continued to record during the time the instruments were buried and inaccessible. Pore pressure data indicates a decrease in total head in both piezometers that occurred between April and October 2014 in the shallow piezometer and between June and September 2014 in the deep piezometer. The total head in both piezometers then increased steadily throughout 2015 with increases of about 2 feet in the shallow piezometer and about 4 feet in the deep piezometer.

Beginning on February 14, 2016, the total head in both piezometers decreased rapidly by 10.3 feet in the shallow piezometer and 5.7 feet in the deep piezometer. This decrease continued until February 24, 2016, when total head in both piezometers began to increase again. Since February 2016, the total head has increased by 5.3 feet in the shallow piezometer and 2.5 feet in the deep piezometer. The large decrease in pore pressure that occurred on February 14 was the result of the excavation in this area. The increase that began on February 24 shows the pore pressures returning to equilibrium.

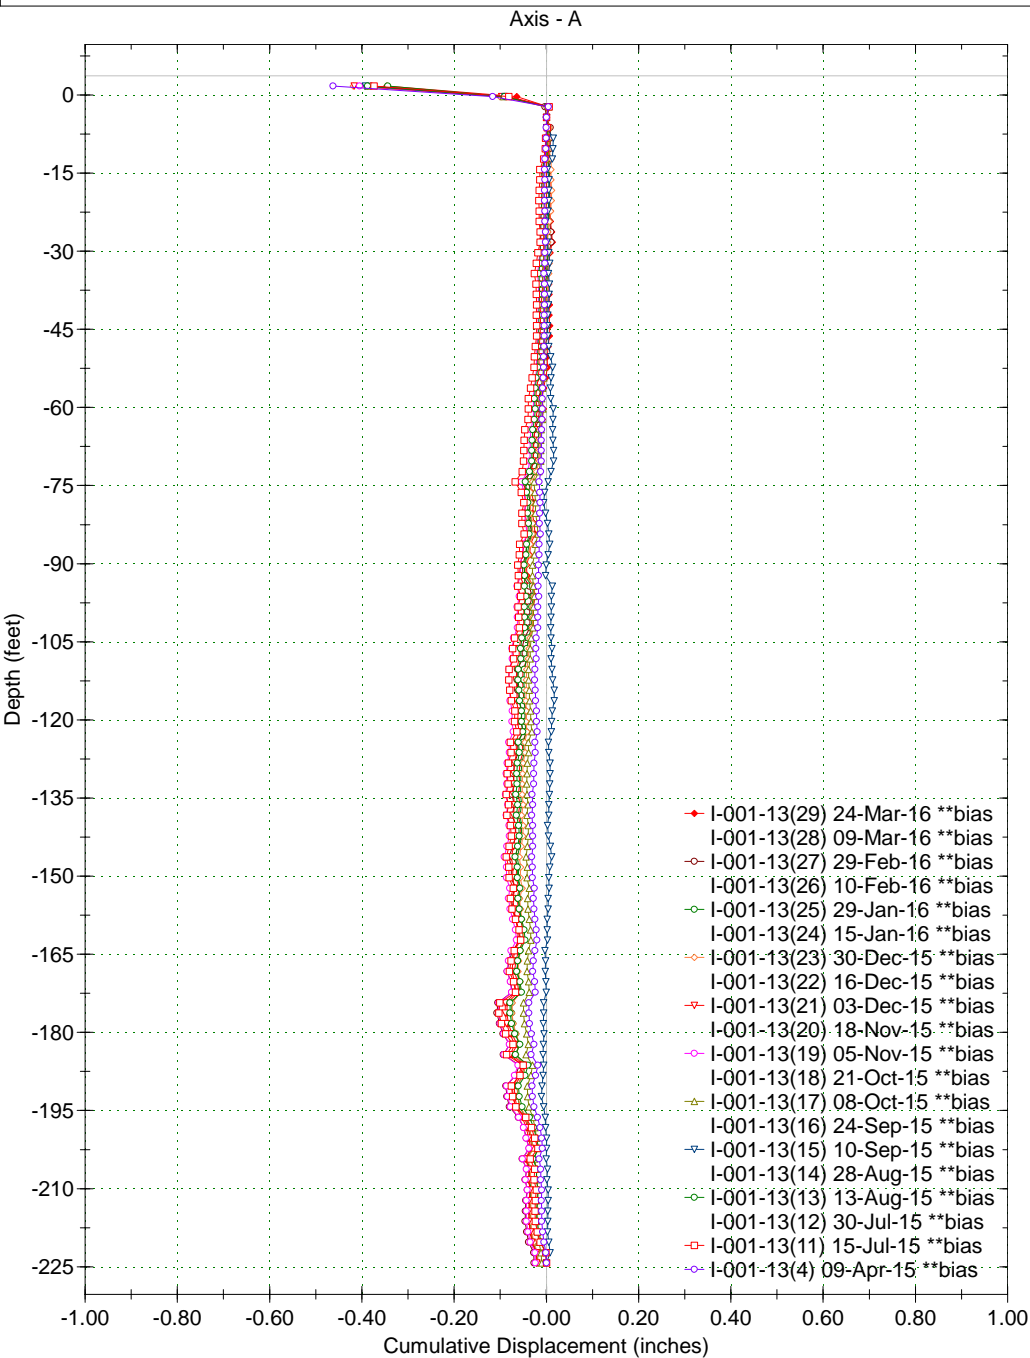
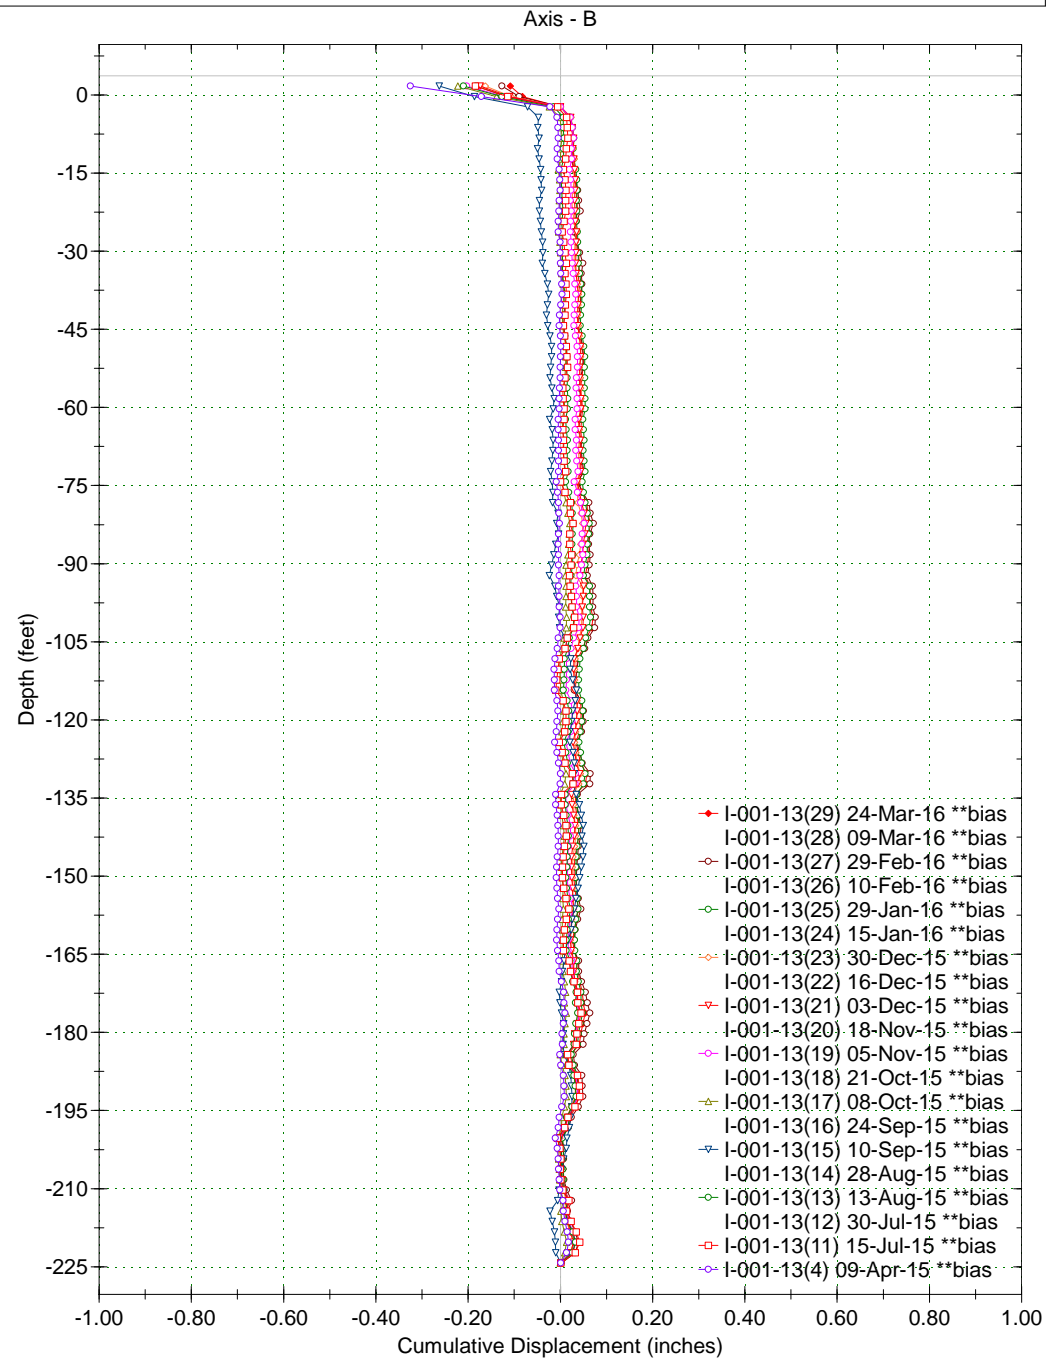
Borehole : I-001-13
Project : CUY-90-15-24
Location : Cleveland, Ohio
Northing :
Easting :
Collar :

Inclinometer readings at I-001-13, I-002-13, I-003-10, B-101, B-102, B-05-04, B-05-A-11, P-1, P-9N, and TGR I-4 showed virtually no movement this two-week period. Displacements at the top of some slope tubes is due to construction disturbance or slight bending of the tube when readings are taken because some of the protective covers are only temporarily set in place.

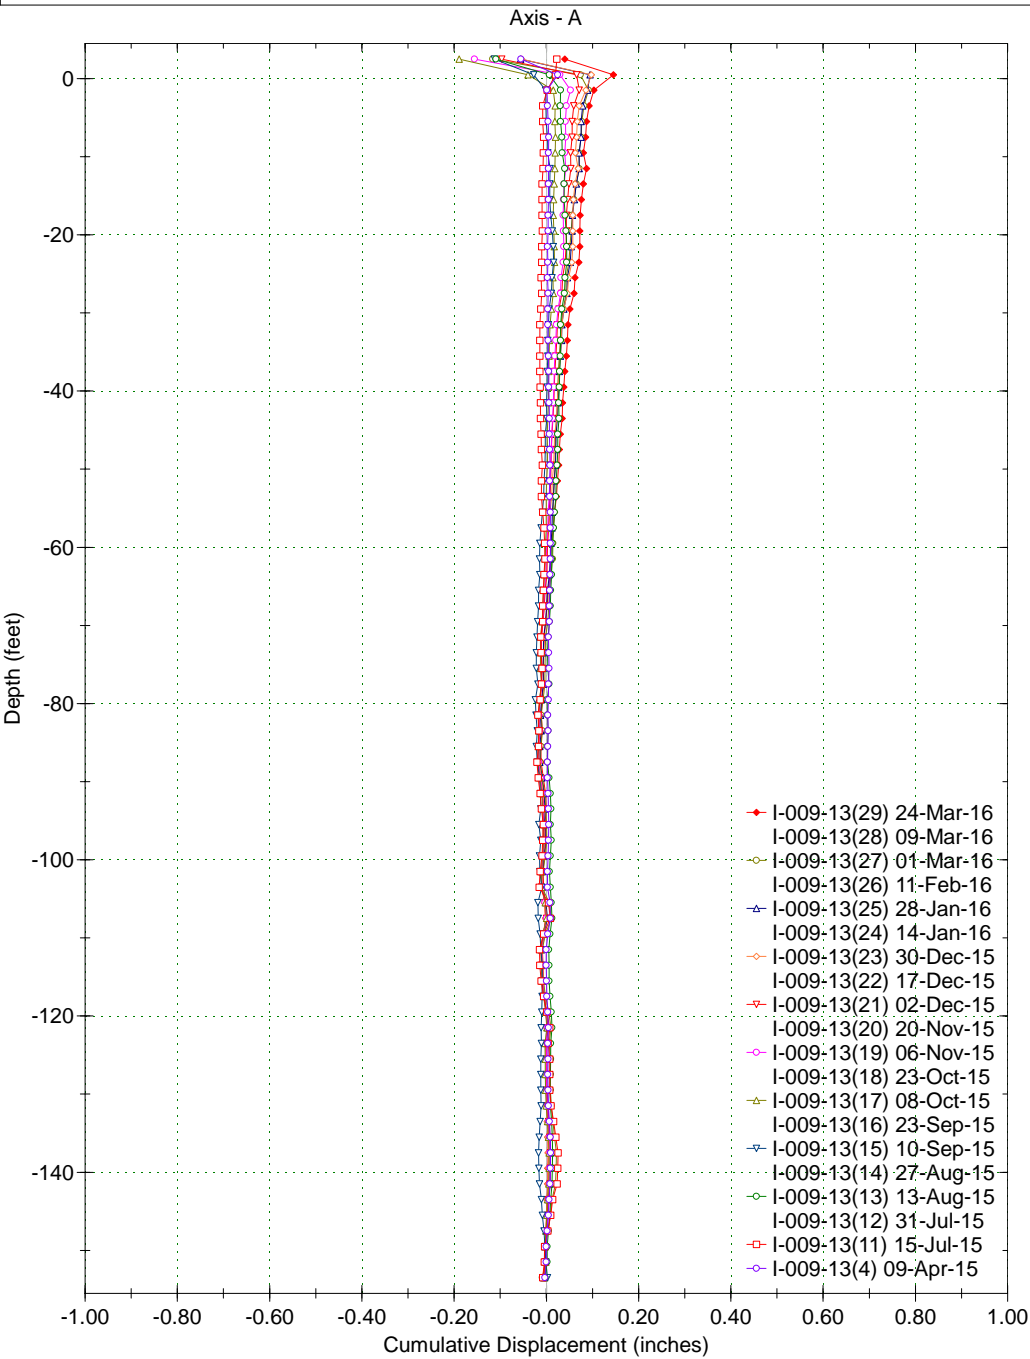
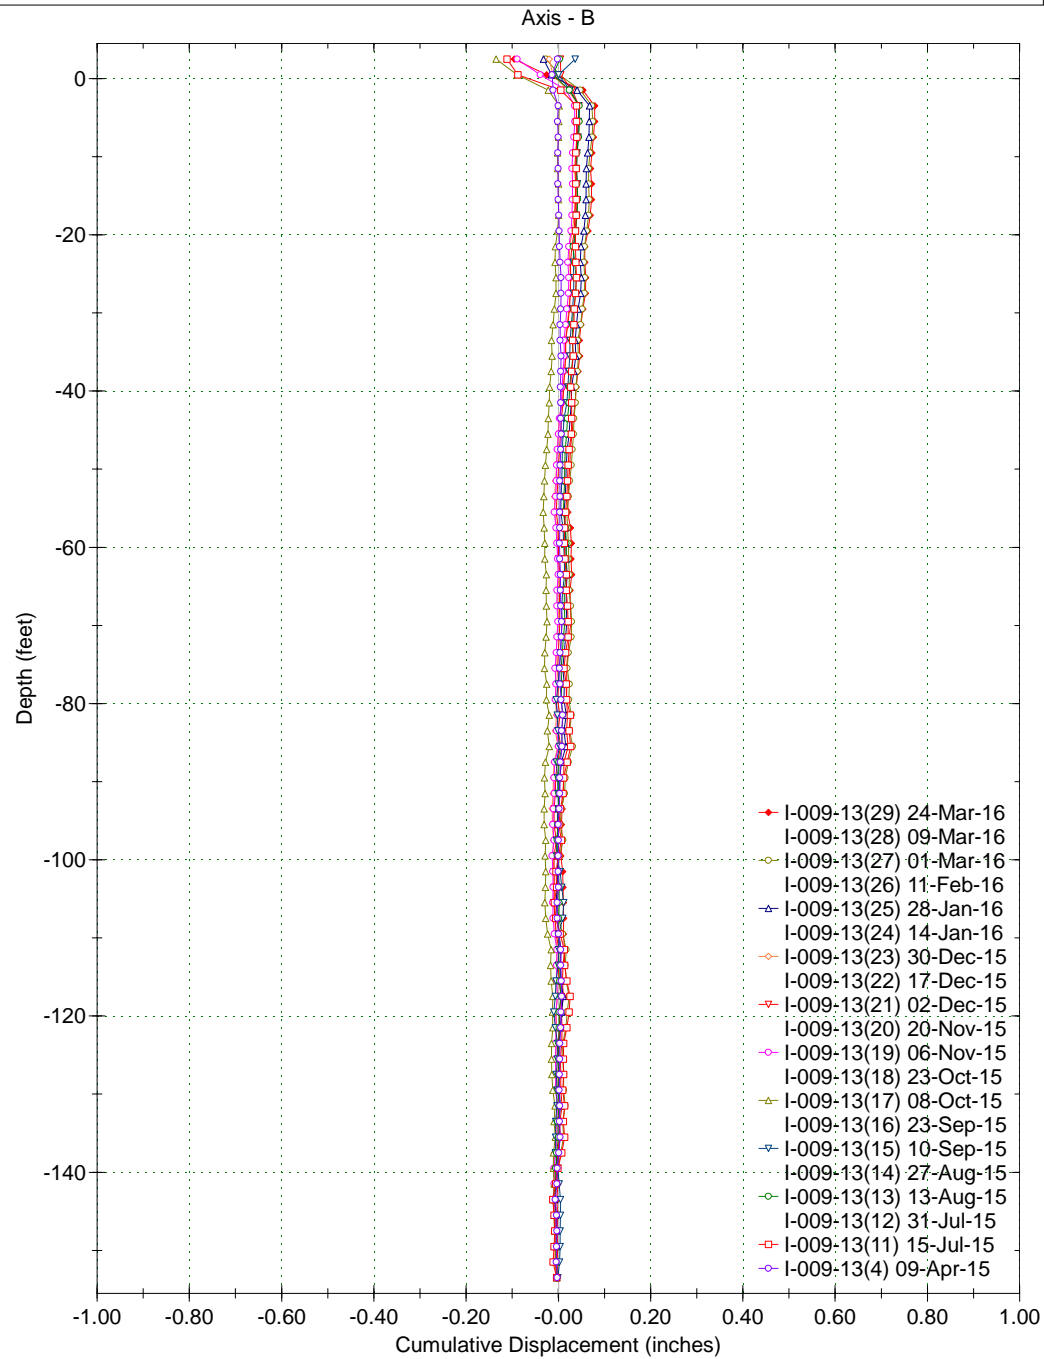
Borehole : I-009-13
Project : CUY-90-15-24
Location : Cleveland, Ohio
Northing :
Easting :
Collar :

I-009-13 – Inclinometer readings at this location indicate slight movement in the positive A-axis direction above 40 feet. No movement was indicated in the B-axis direction.
