March 31, 2016

Re: March 23 and 24, 2016 Bi-Weekly Readings
CUY-90-15.24 Slope Monitoring
PID 96504
SME Project No. 069032.00

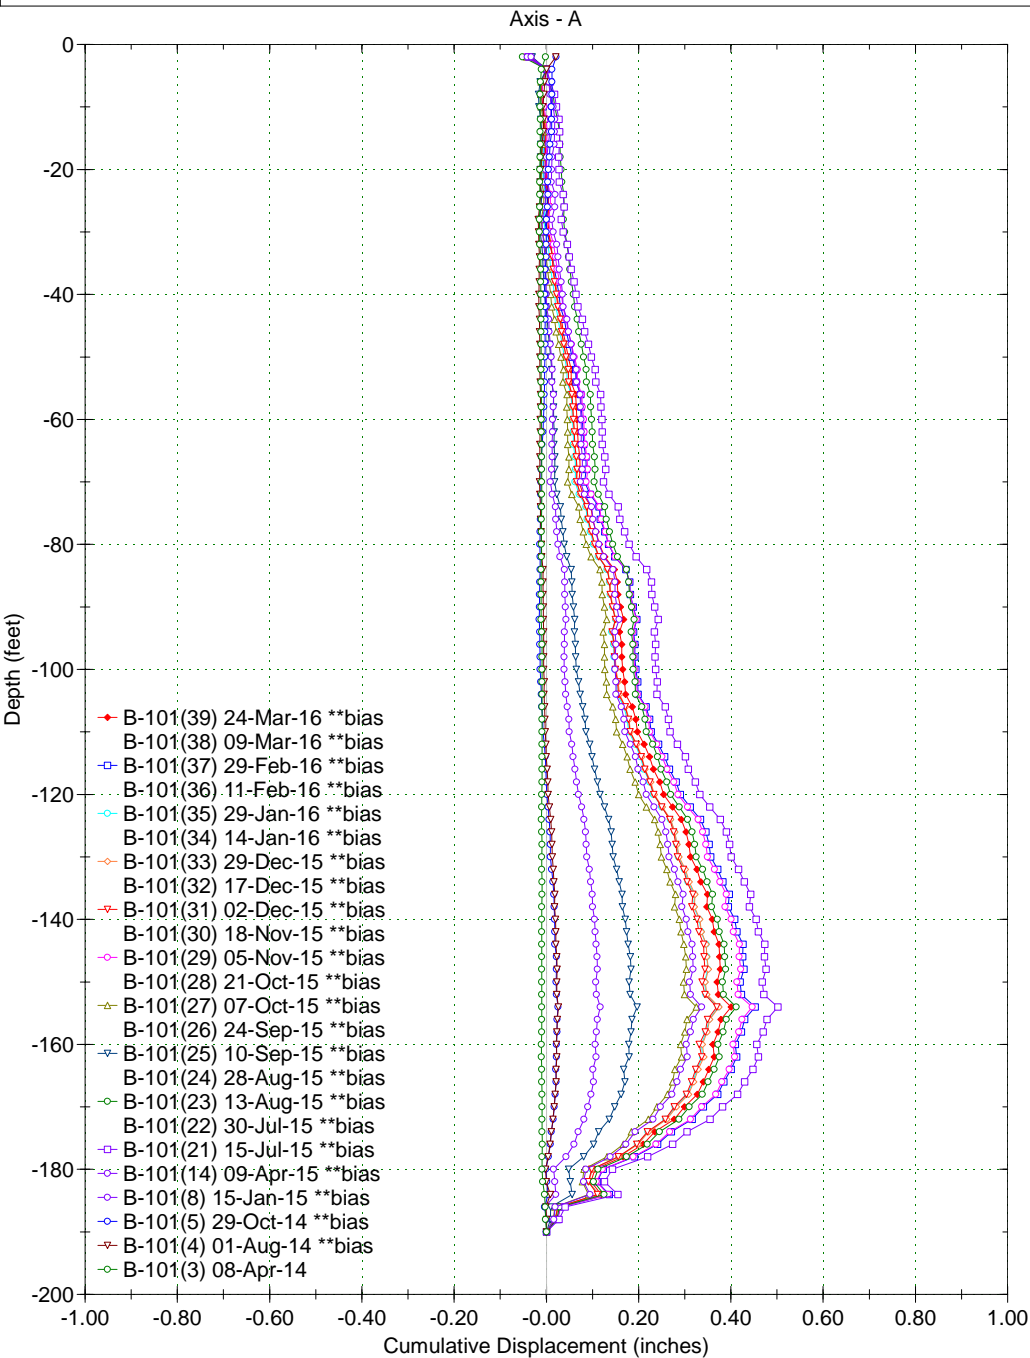
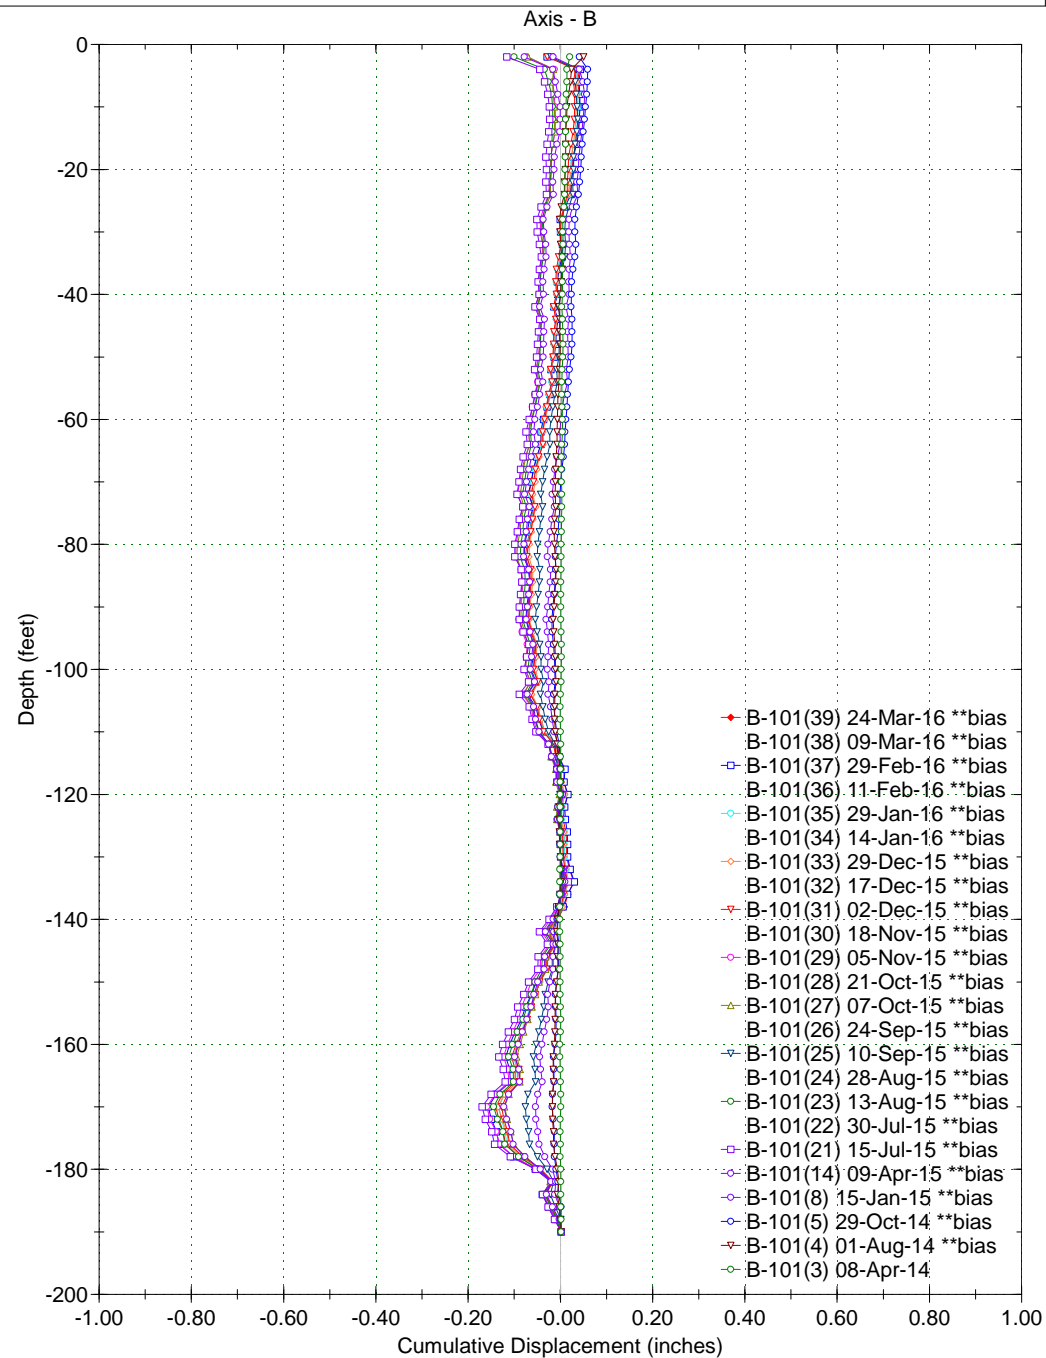
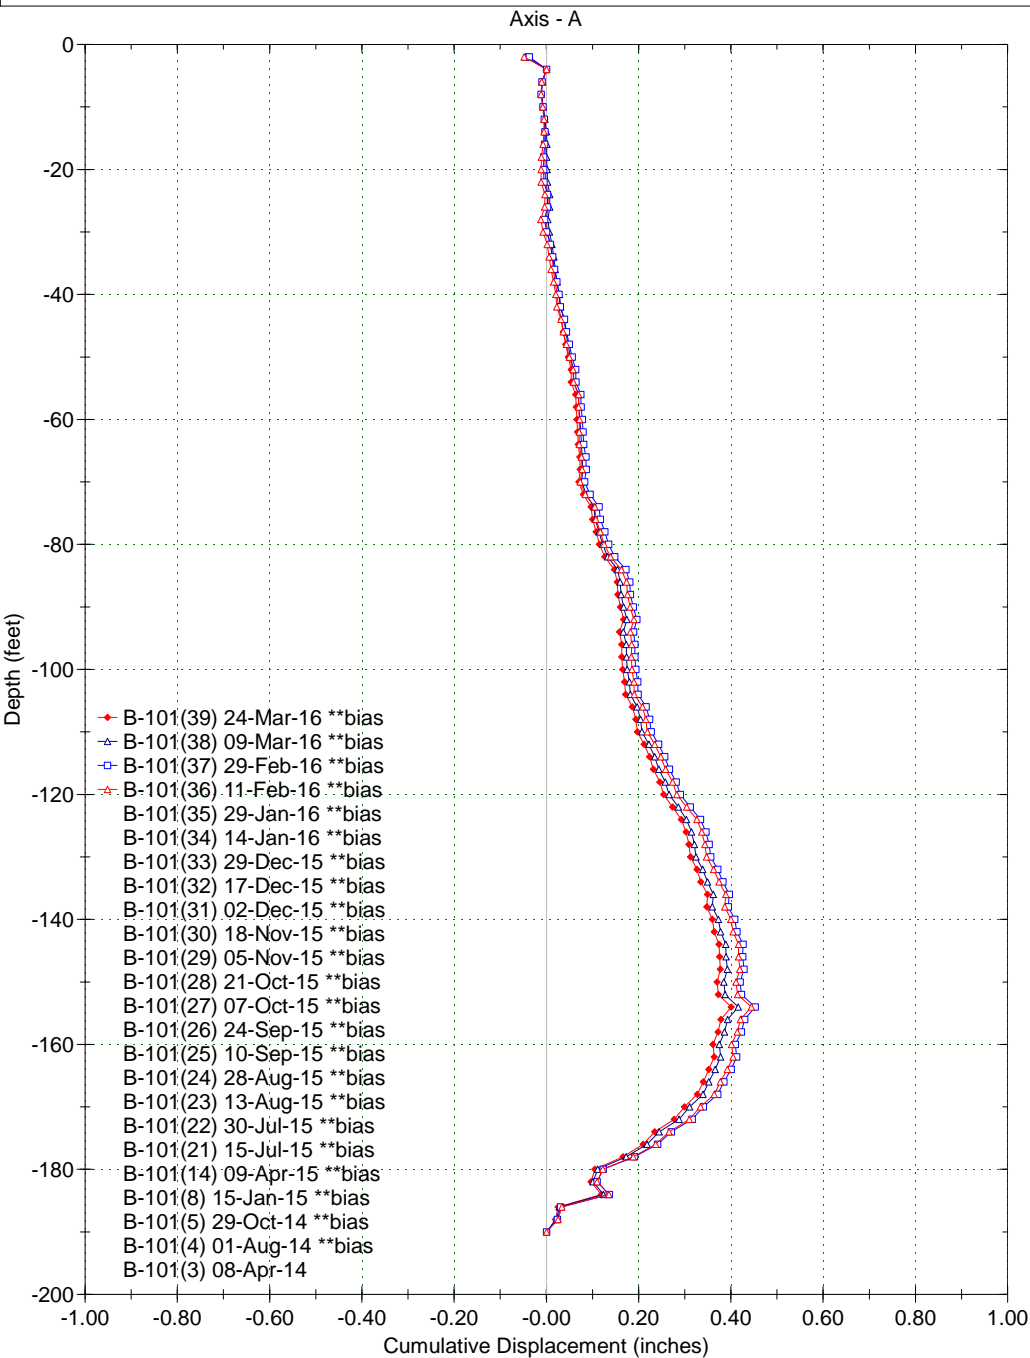
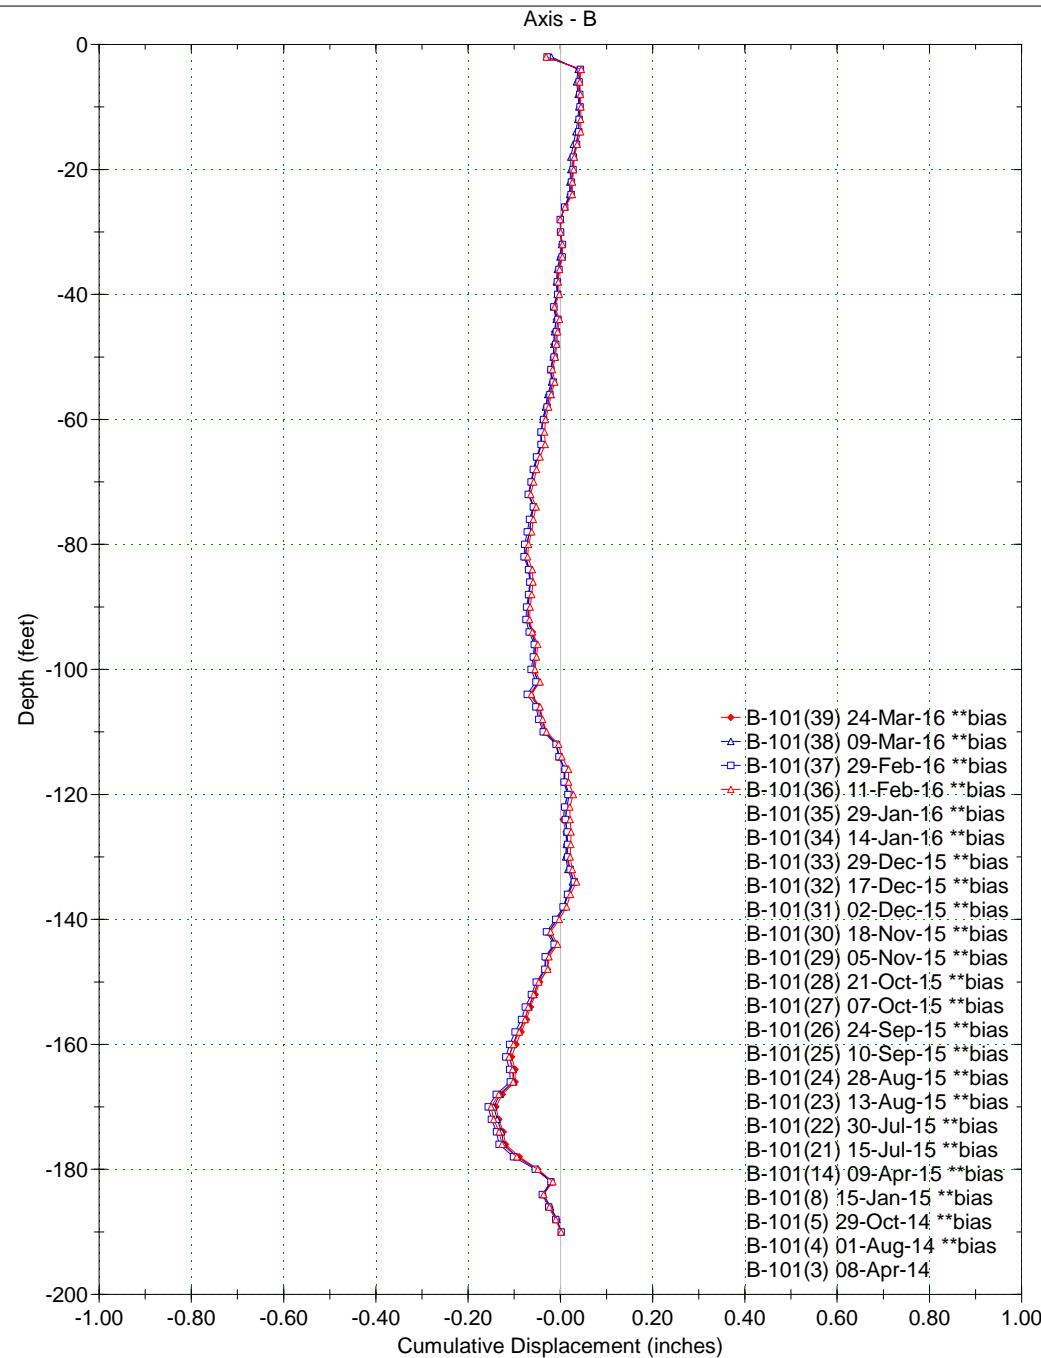
Borehole : B-101
Project : CUY-90-15-24
Location : Cleveland, Ohio
Northing : Sta. 15+06.50
Easting : 120.7' Rt of CL
Collar :

Inclinometer readings at I-001-13, I-002-13, I-003-10, B-101, B-102, B-05-04, B-05-A-11, P-1, P-9N, and TGR I-4 showed virtually no movement this two-week period. Displacements at the top of some slope tubes is due to construction disturbance or slight bending of the tube when readings are taken because some of the protective covers are only temporarily set in place.
