April 21, 2016

Re: April 6, 7, and 8, 2016 Bi-Weekly Readings
CUY-90-15.24 Slope Monitoring
PID 96504
SME Project No. 069032.00

Bi-weekly instrument readings for the I-90 west slope taken between April 6 and 8, 2016, are presented in this report. Bi Weekly readings currently include instruments at I/P-001-13, I/P-002-13, I/P-003-A-10, I/P-004-13, I/P-009-13, B-101, B-102, B-105A, B-05-03, B-05-04, B-05-A-11, P-1, P-9N, TGR I-2, and TGR I-4.

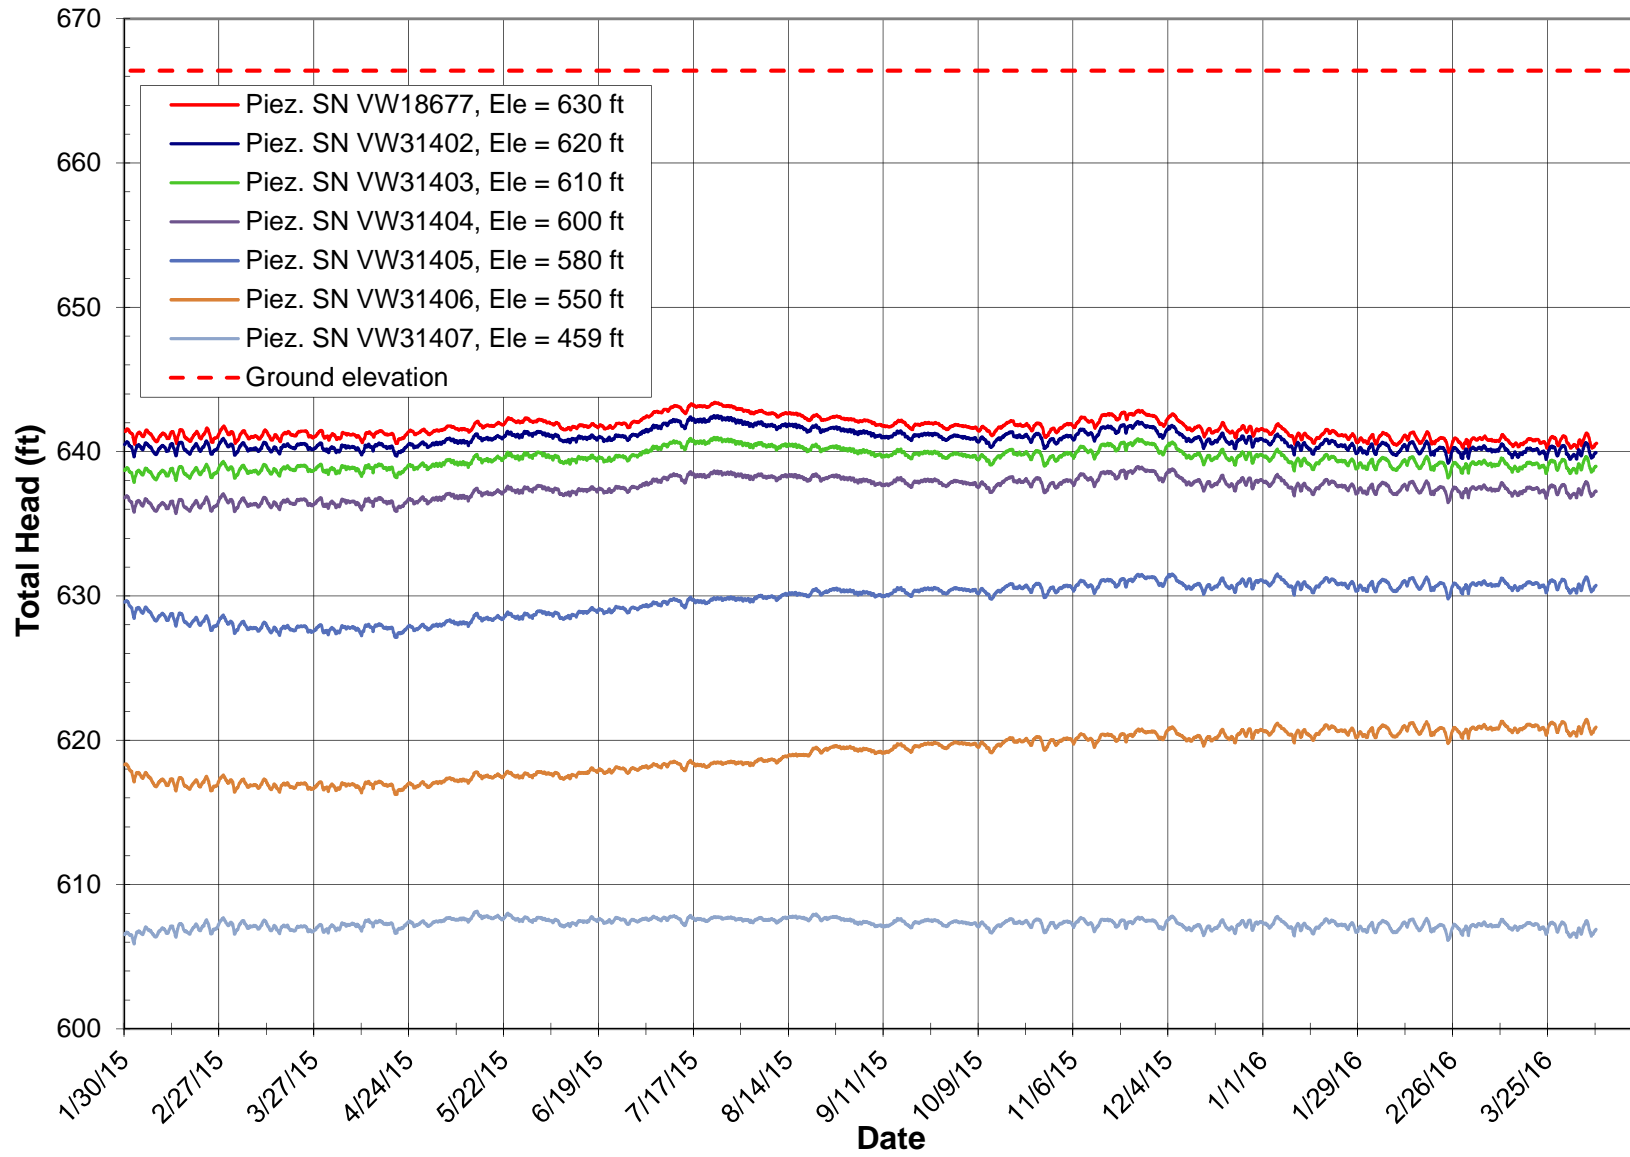
P-001-13 VW Piezometer Readings

P-001-13, P-002-13, P-003-10, P-009-13, B-05-04, B-05-A-11 – Pore pressure readings at these locations indicate minor fluctuations with magnitudes no greater than 1 foot of total head over the past two weeks and virtually no net change.

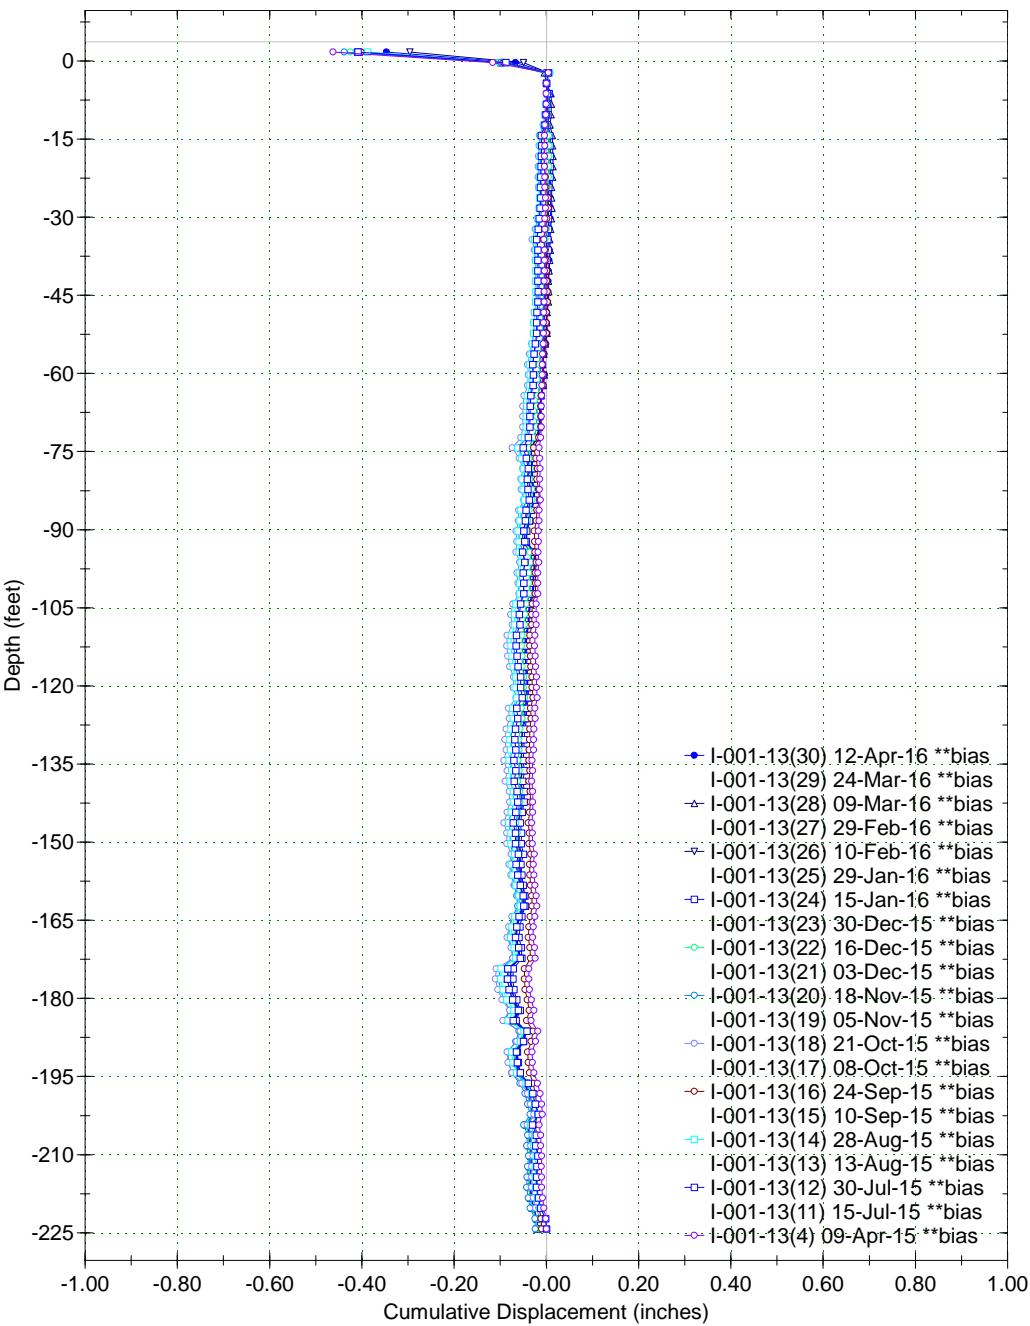
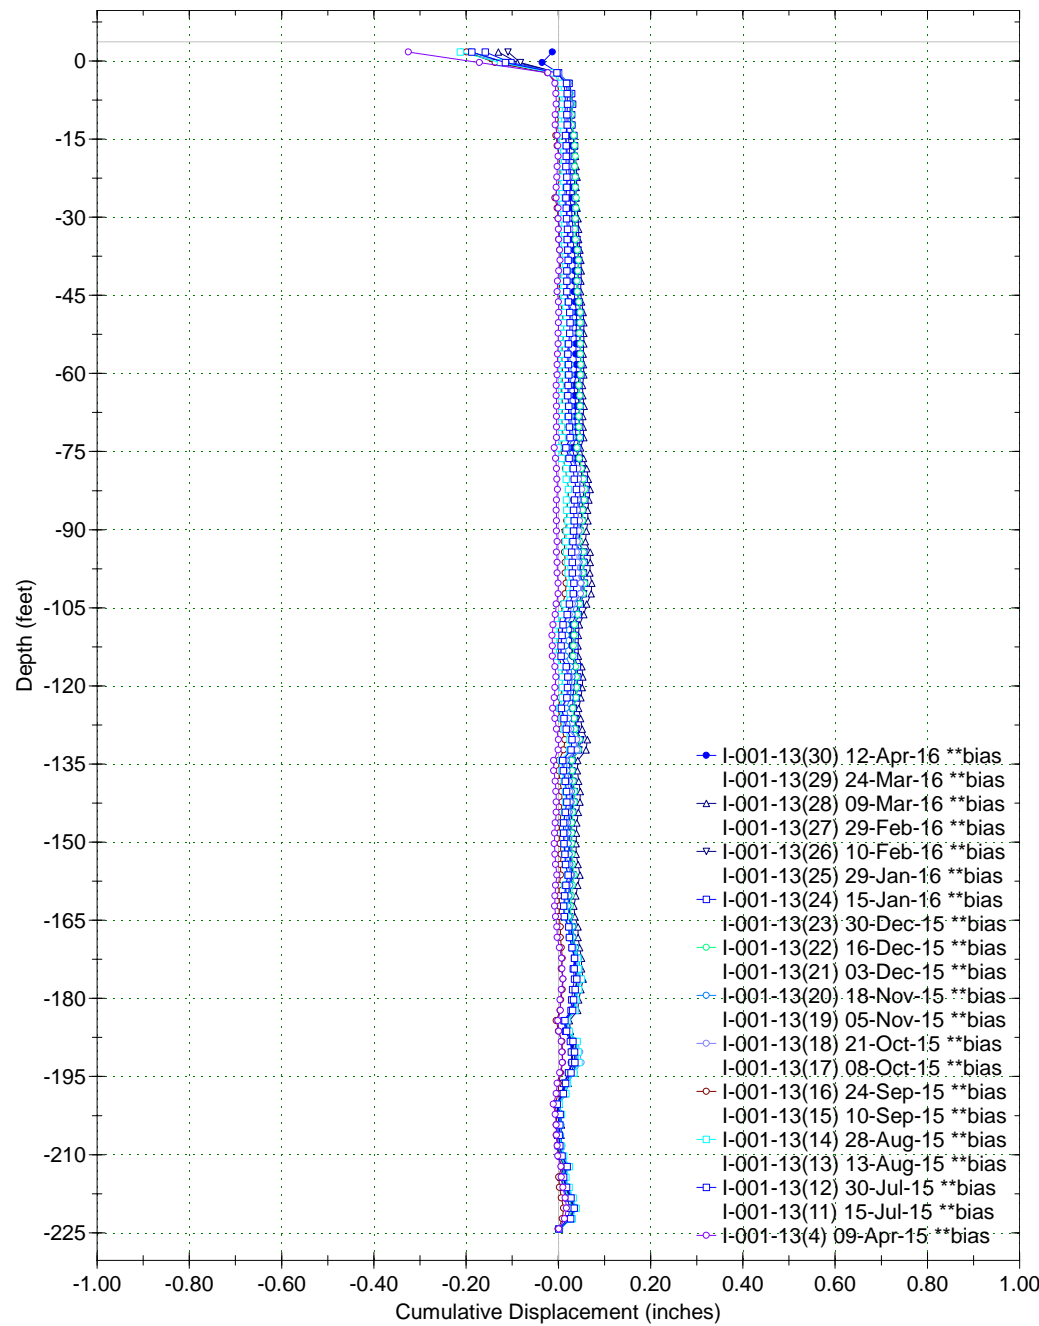
Borehole : I-001-13
Project : CUY-90-15-24
Location : Cleveland, Ohio
Northing :
Easting :
Collar :

Inclinometer readings at I-001-13, I-002-13, I-009-13, B-101, B-102, B-05-04, B-05-A-11, P-1, P-9N, and TGR I-4 showed virtually no movement this two-week period. Displacement at the top of some slope tubes is due to construction disturbance or slight bending of the tube when readings are taken because some of the protective covers are only temporarily set in place.

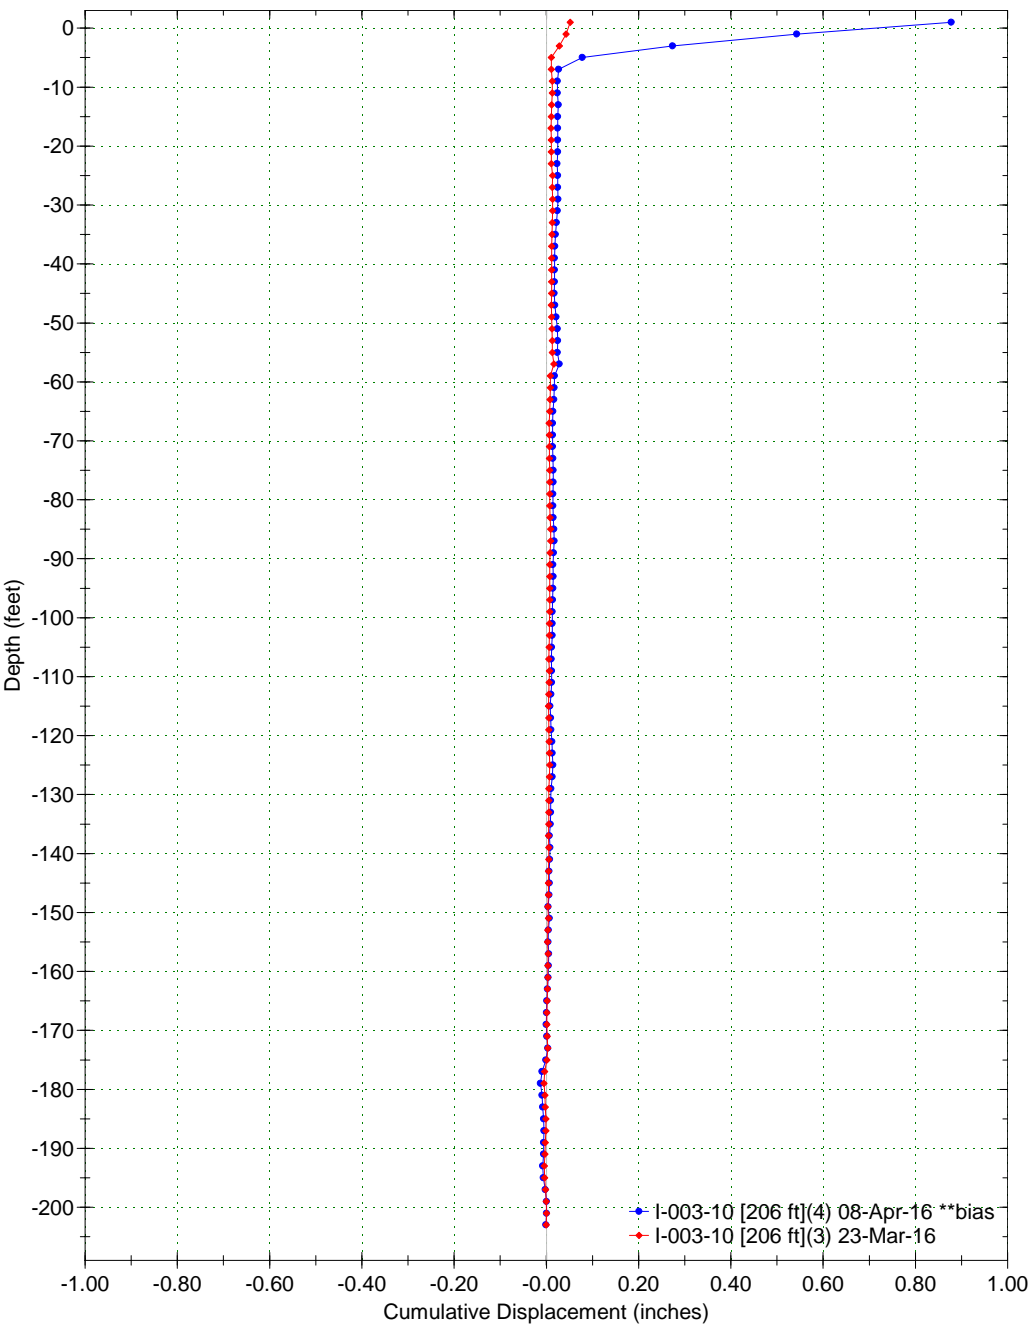
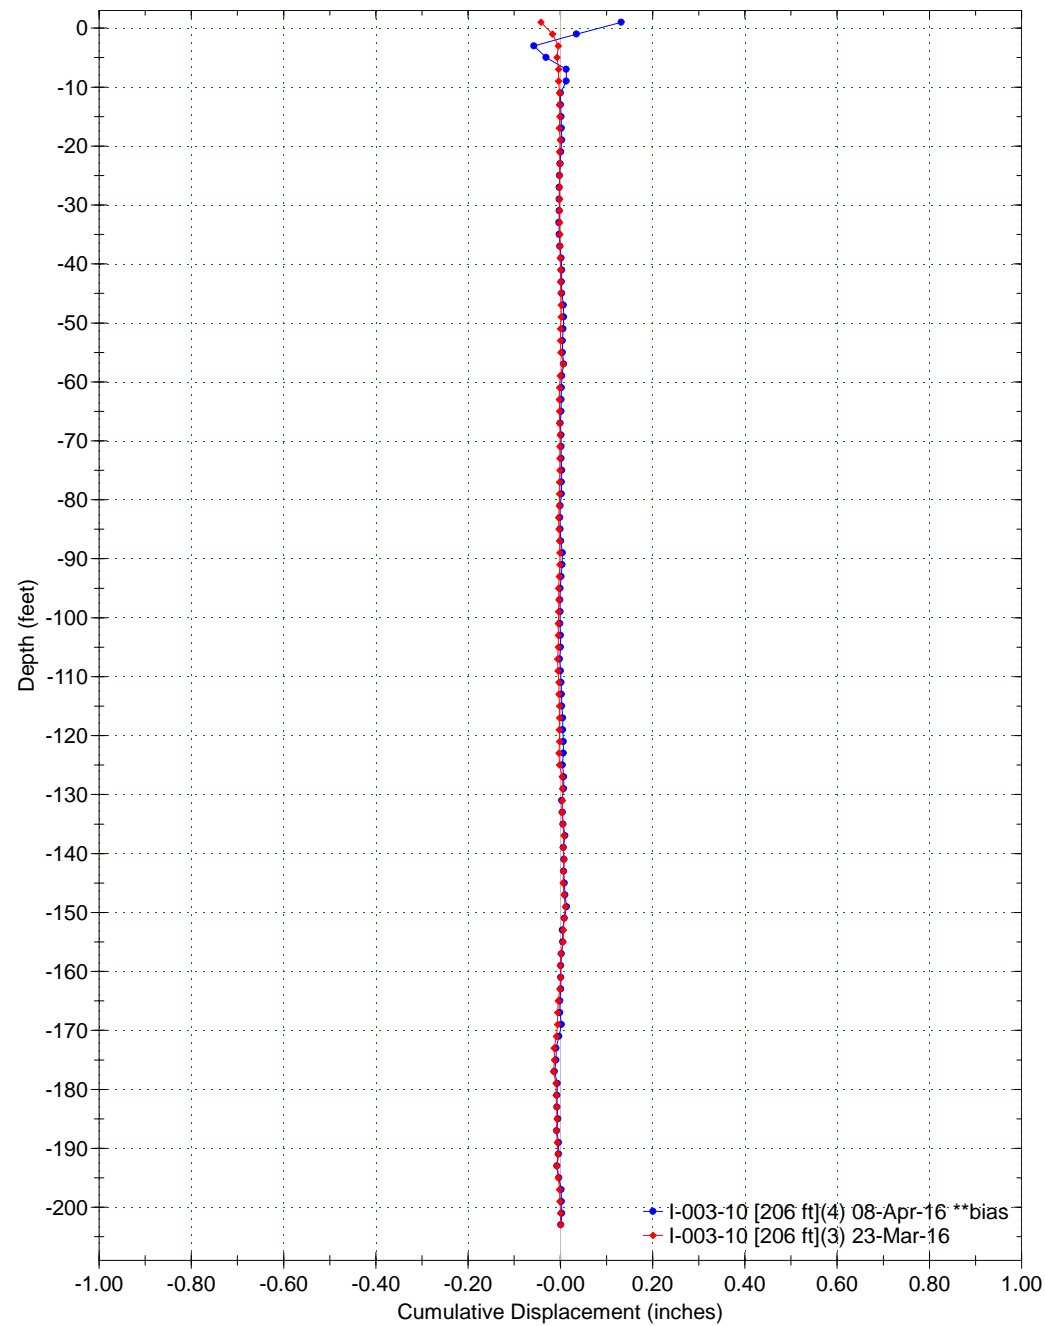
Borehole : I-003-10 [206 ft]
Project : CUY-90-15-24
Location :
Northing :
Easting :
Collar :

I-003-10 – Inclinometer readings at this location show relatively large displacements in the top 8 feet of the casing. This is due to movement that occurred when a protective cover was installed recently.

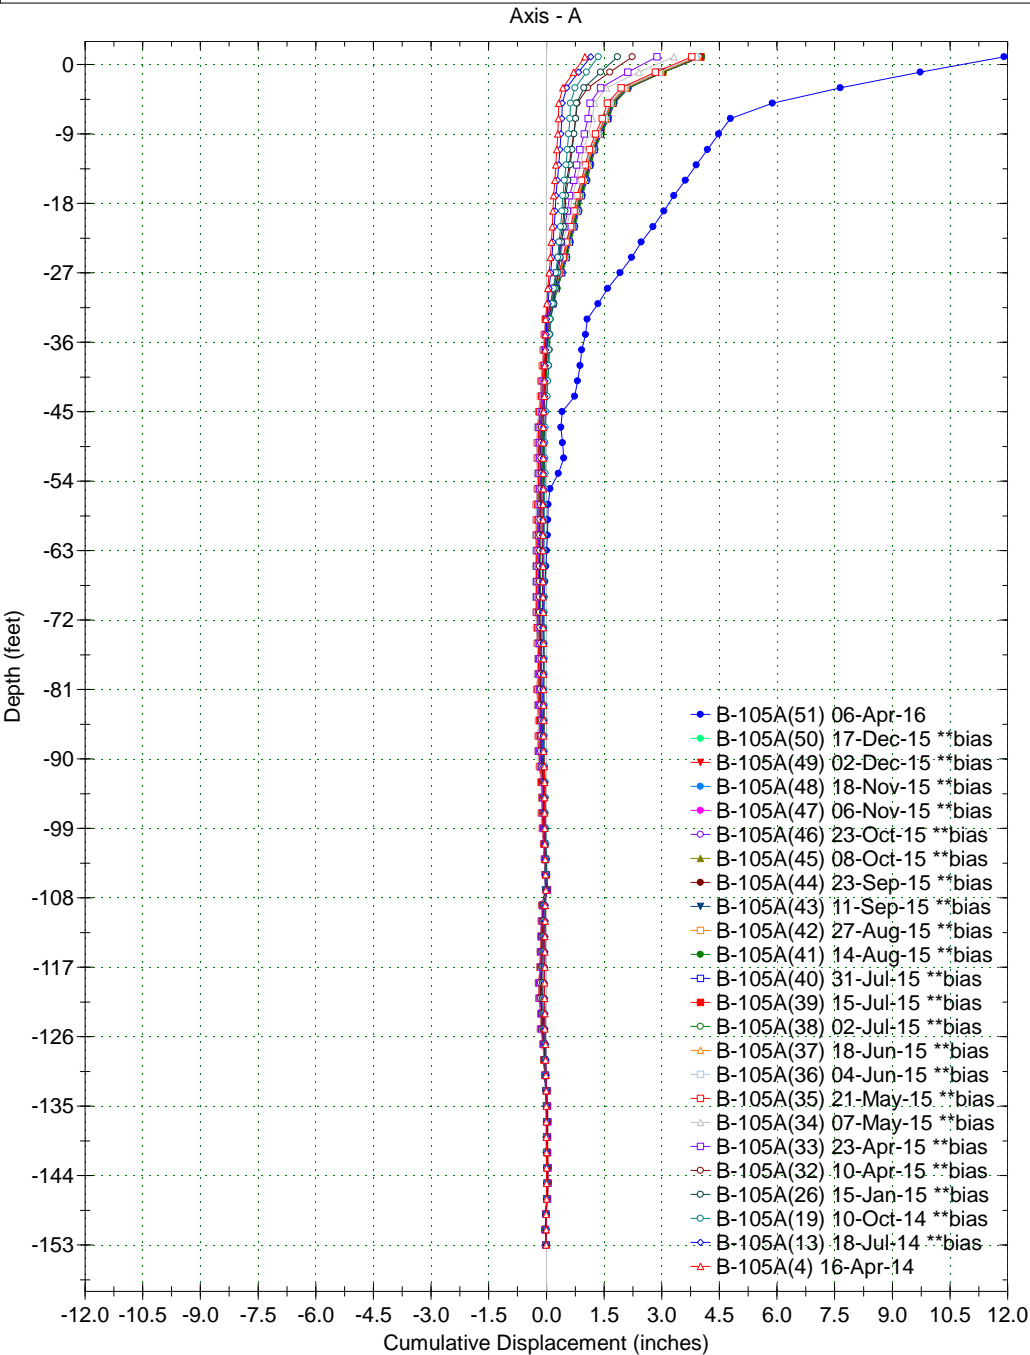
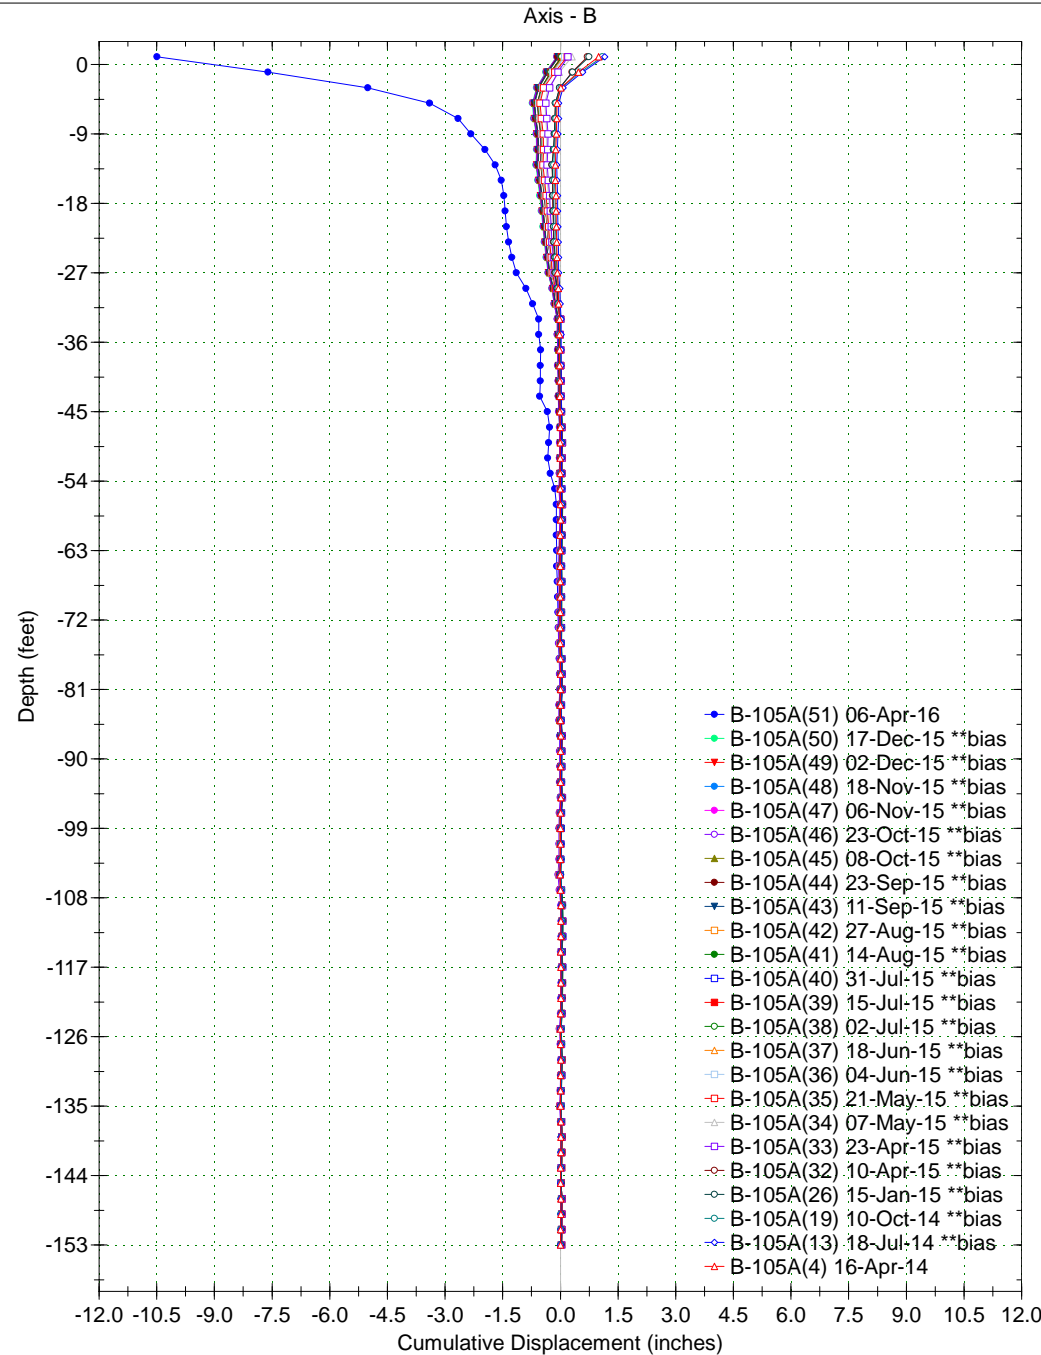
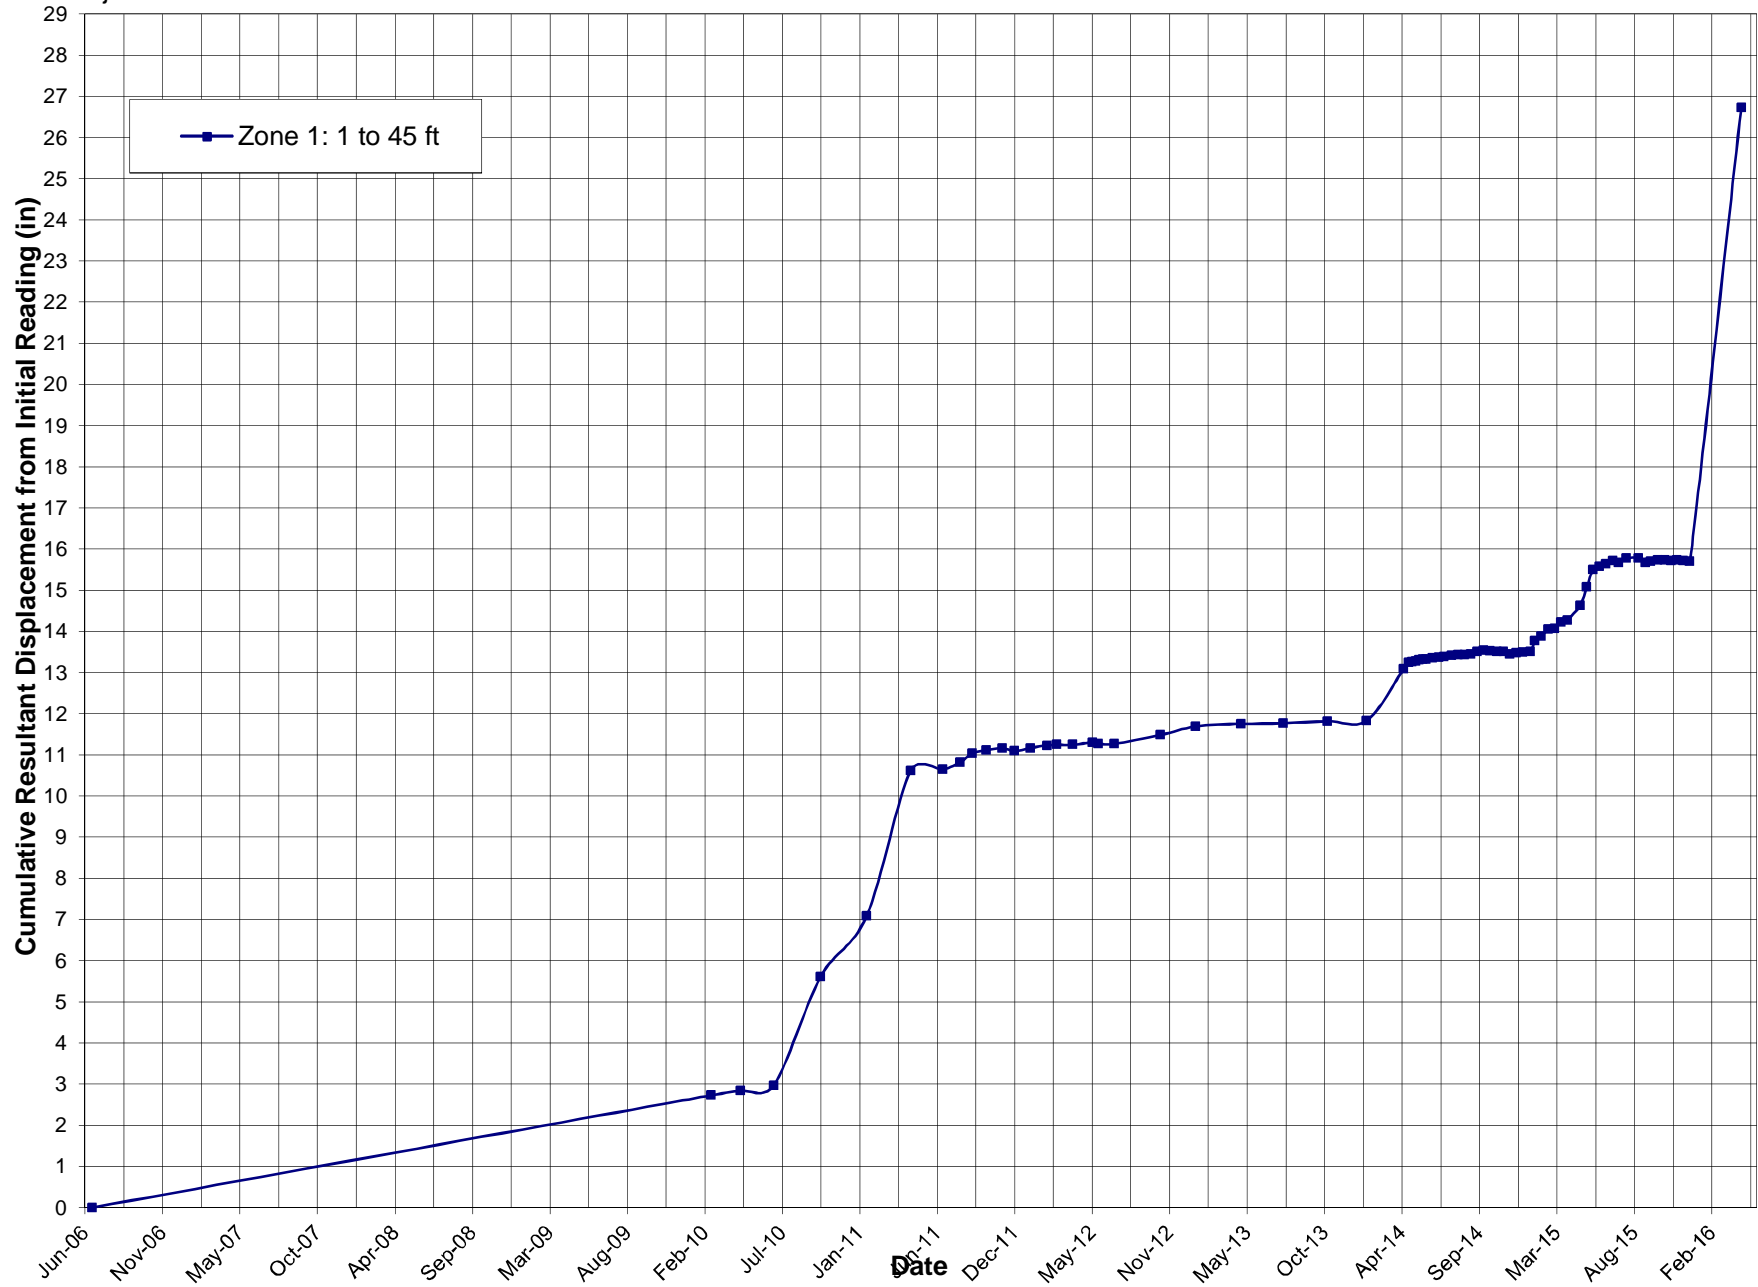
Borehole : B-105A
Project : CUY-90-15-24
Location : Cleveland, Ohio
Northing : Sta. 19+11.38
Easting : 90.9' Rt of CL
Collar :

B-105A – We added an extension to the inclinometer casing at this location, which now matches the top of casing prior to January 7, 2016, when the bulkhead was excavated. The inclinometer plot for this location does not include readings taken from January 7 to February 29, 2016, during the time that the casing was cut down 8 feet. The section of corrugated plastic pipe that TGR installed around the casing to protect it during the backfill operation is still in place. This protective pipe is in contact with the negative A-axis side of the casing. Large displacements are shown on the attached plots above 56 feet in each axis direction, with 1 foot of displacement in the positive A-axis direction, and 10.5 inches of displacement in the negative B-axis direction. The cumulative resultant plot shows an increase of 11 inches over the top 45 feet of the casing. This movement likely occurred during the backfill operation.
