June 15, 2016

Re: June 2 and 3, 2016 Bi-Weekly Readings
CUY-90-15.24 Slope Monitoring
PID 96504
SME Project No. 069032.00

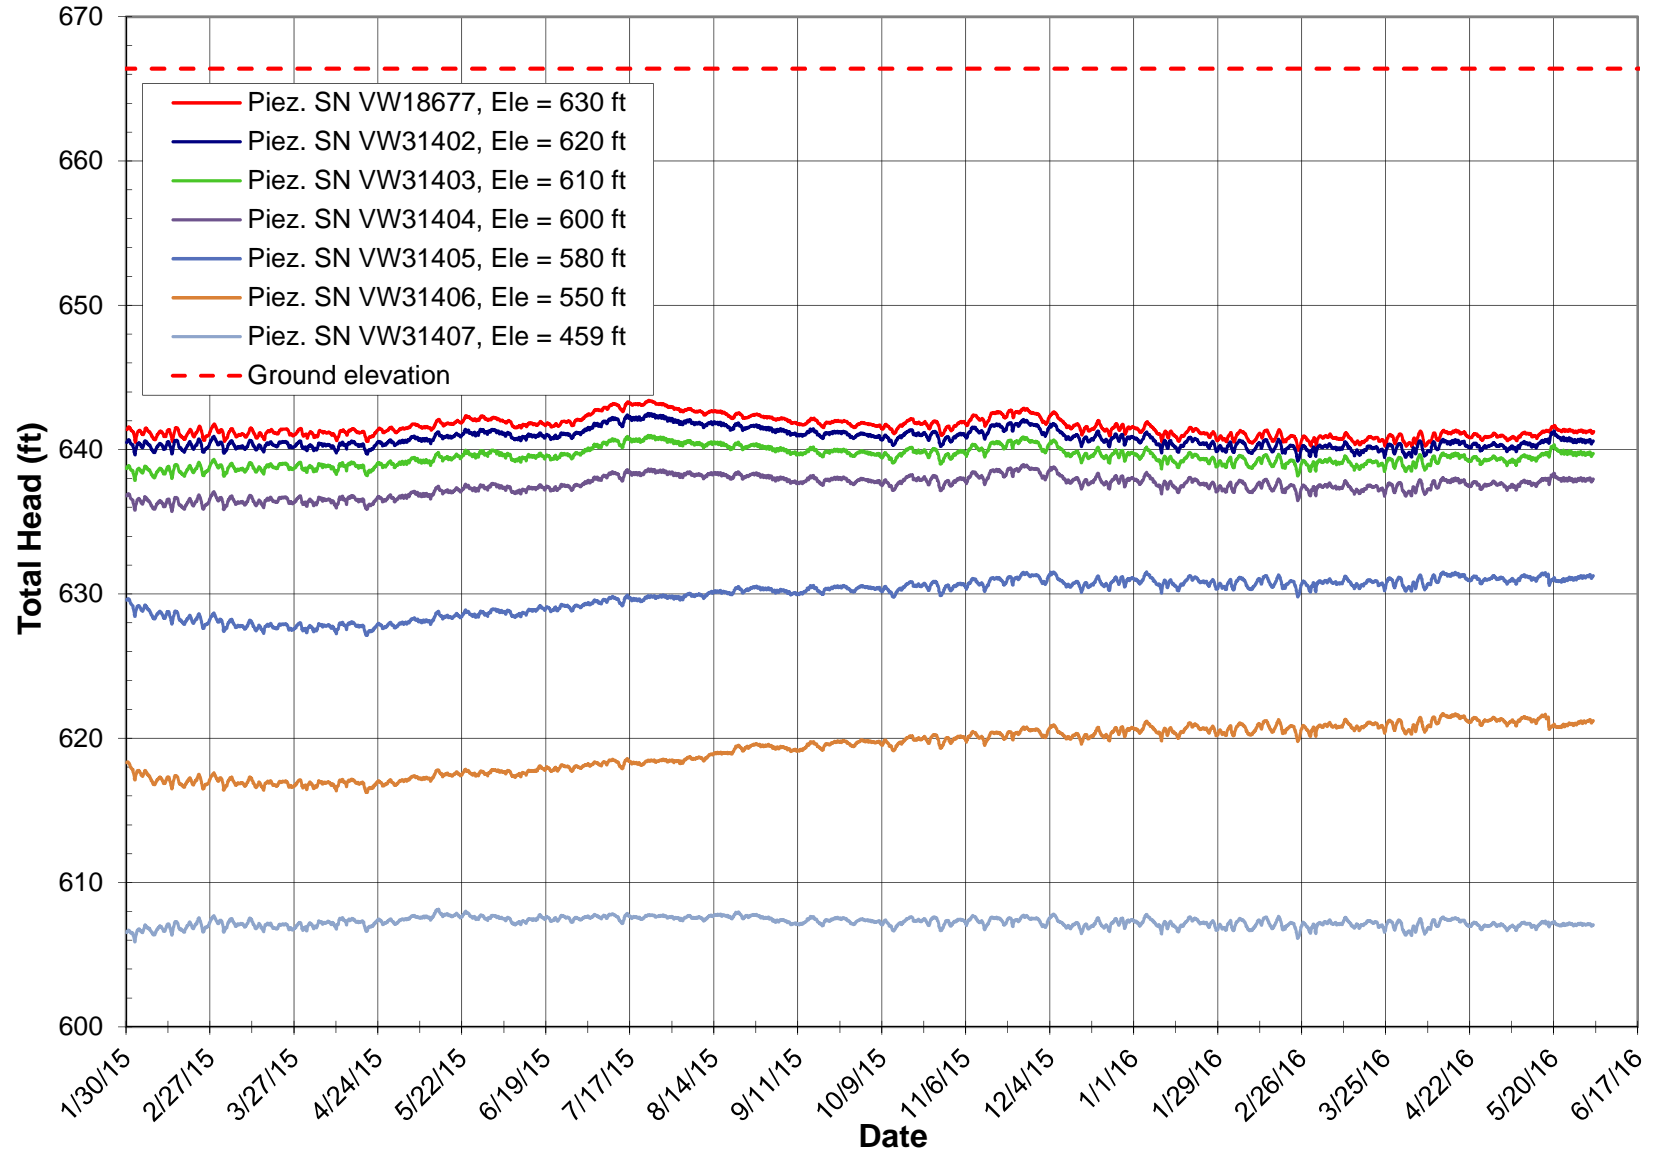
P-001-13 VW Piezometer Readings

P-001-13 – At this location, pore pressure readings indicate an increase in total head of about 0.5 feet in the piezometers at 86 feet and 116 feet. The remaining piezometers showed virtually no change.

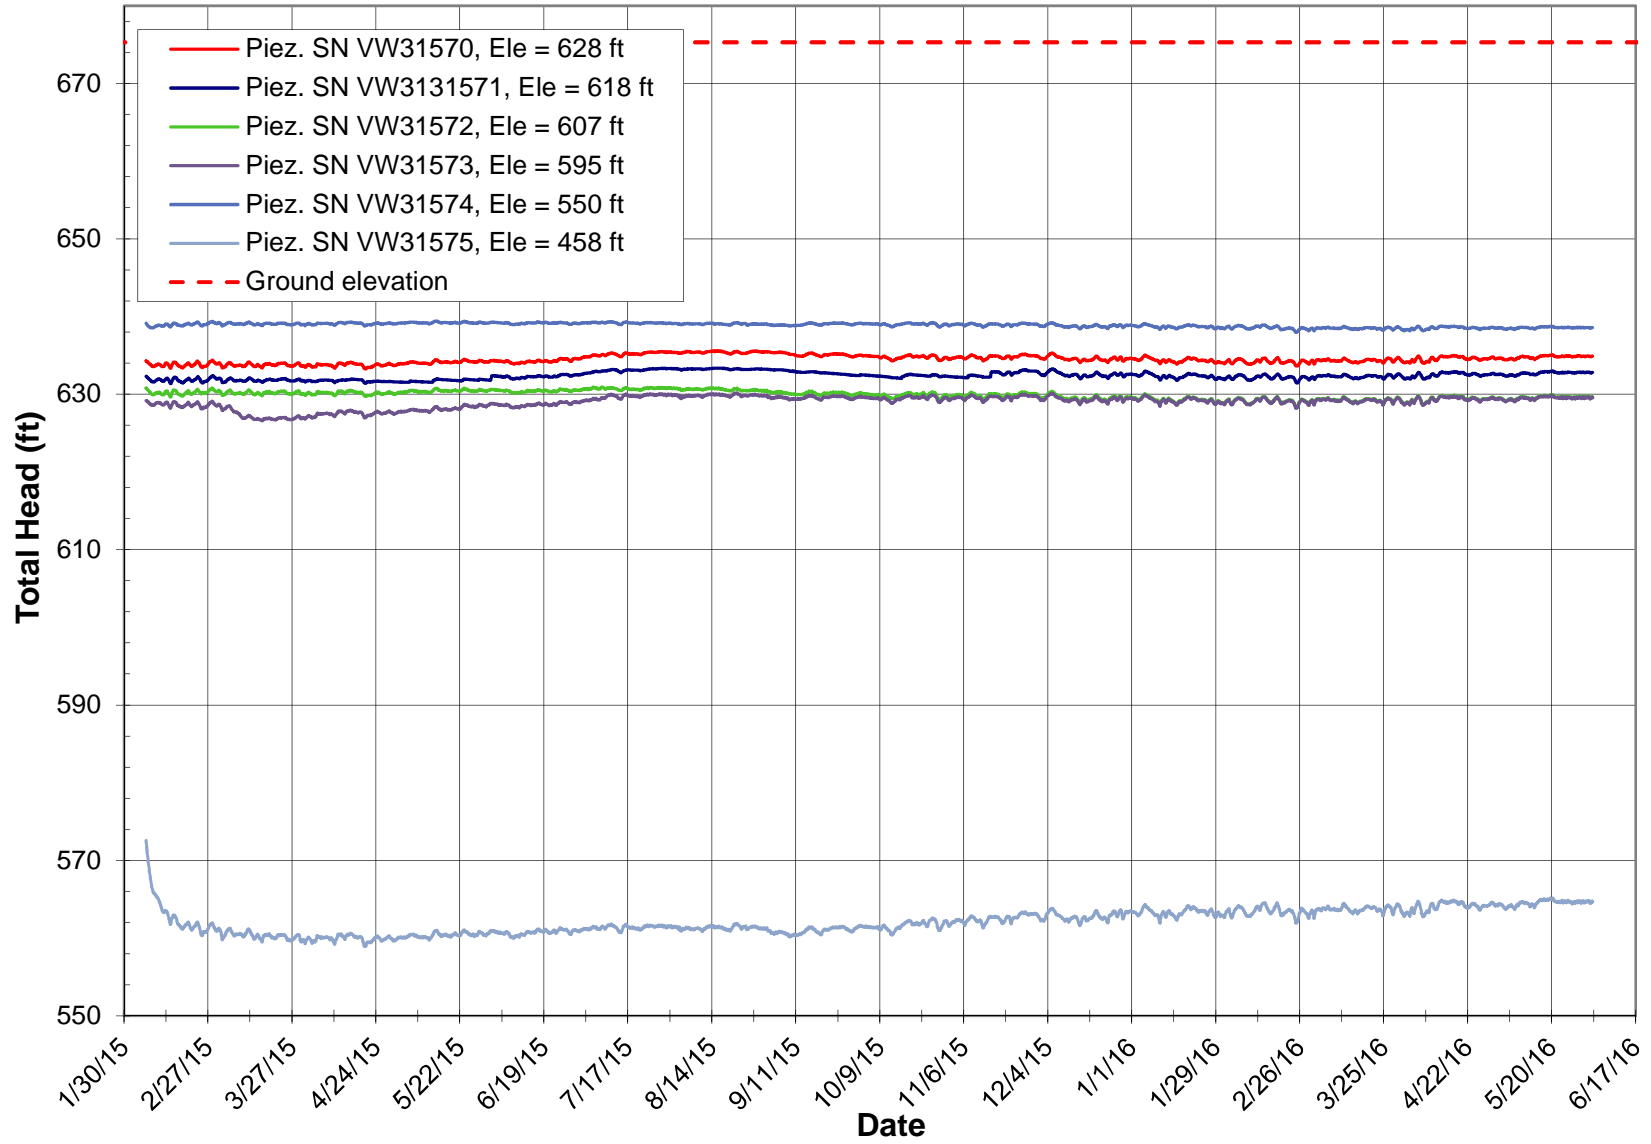
P-002-13 VW Piezometer Readings

P-002-13, P-003-10, P-009-13, B-105-A, B-05-04, B-05-A-11 – Pore pressure readings at these locations show virtually no change in total head.

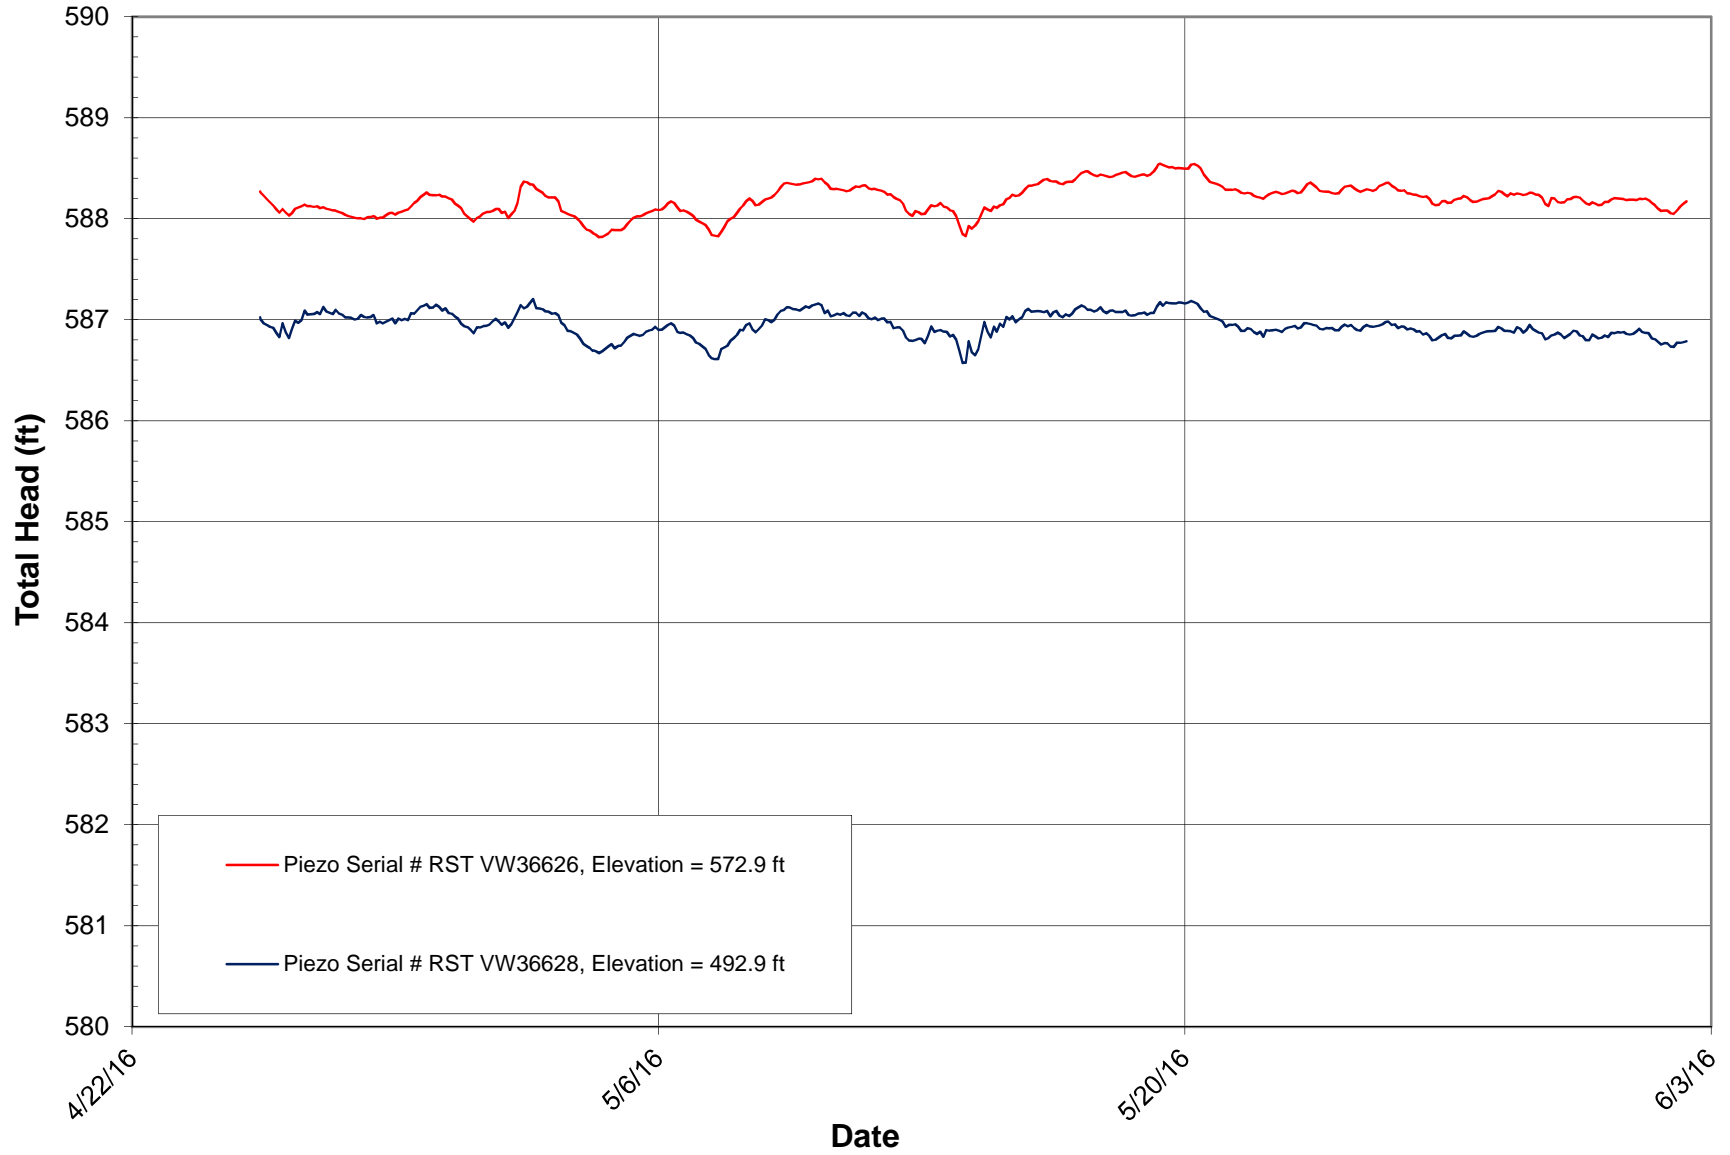
B-05-A-03 VW Piezometer Readings

B-05-A-03 – Pore pressure readings at this location indicate a decrease in total head of about 0.5 feet in both piezometers.

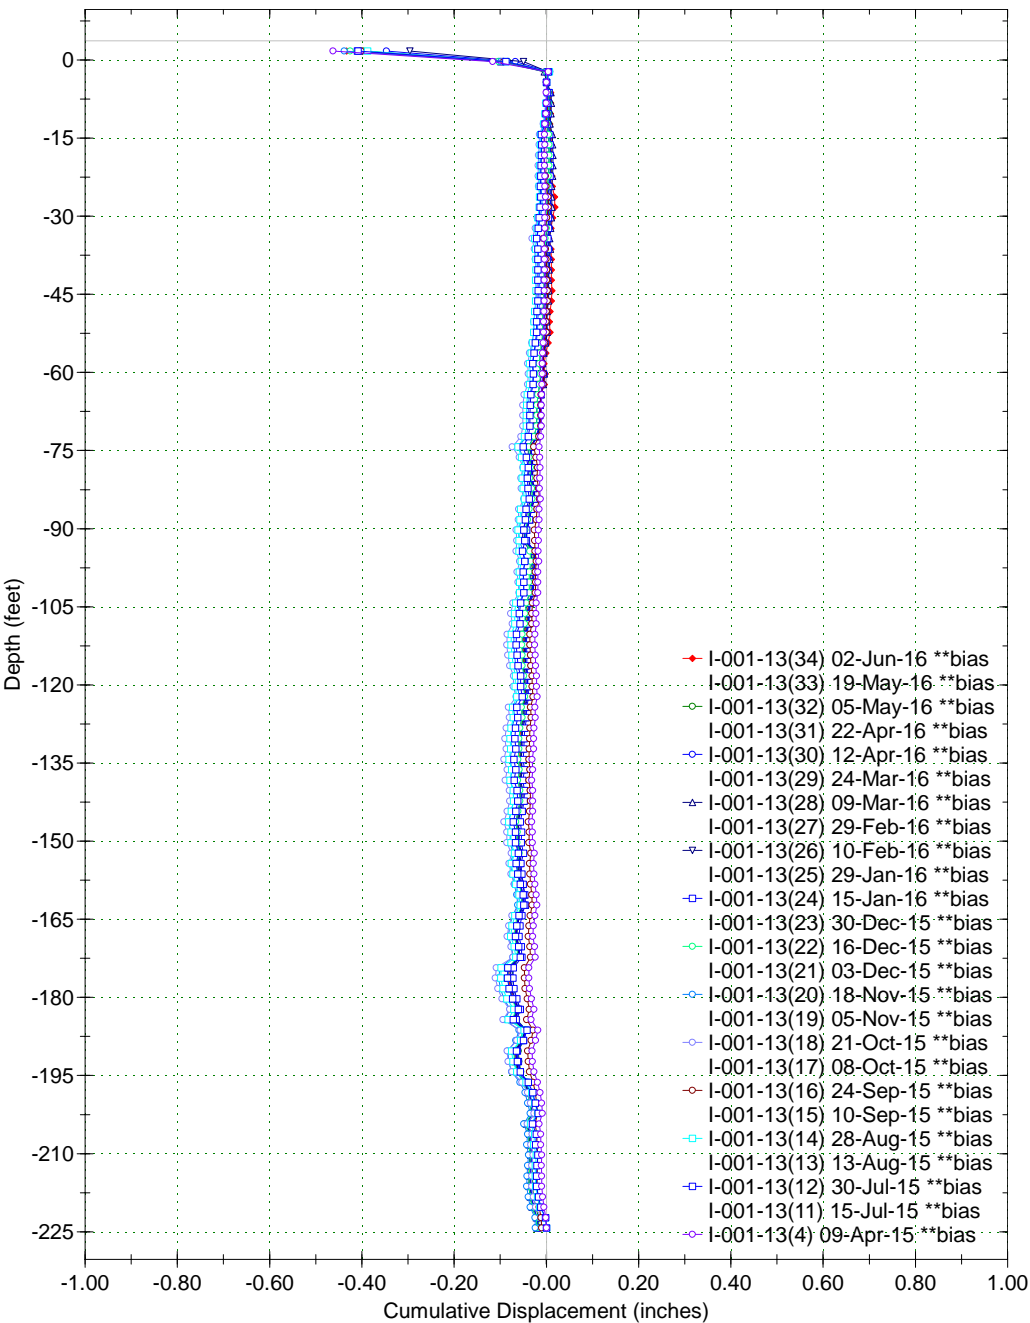
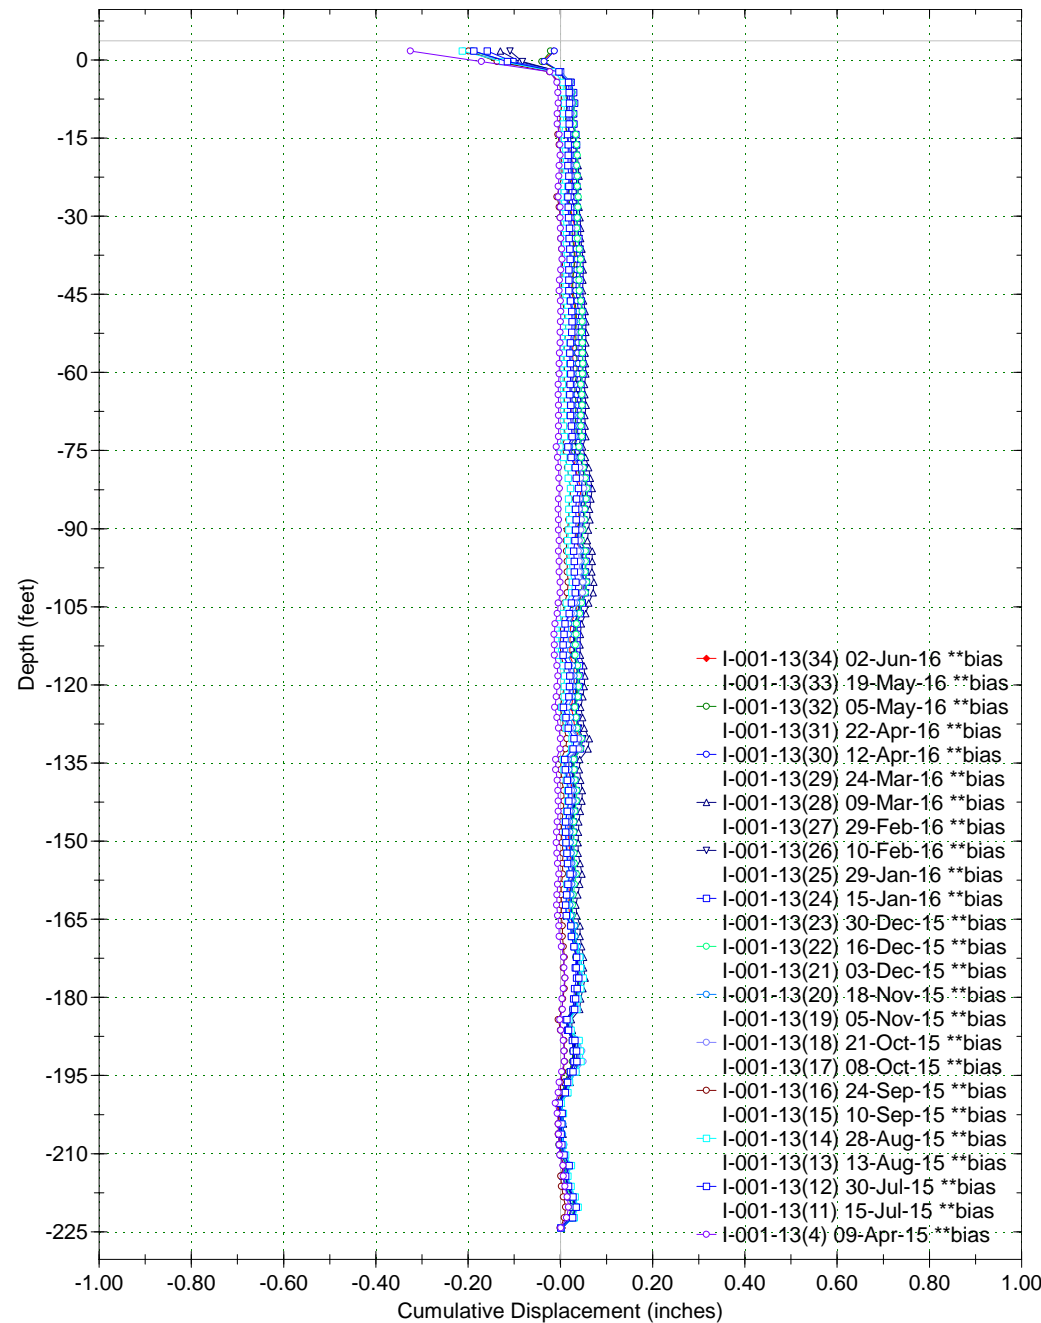
Borehole : I-001-13
Project : CUY-90-15-24
Location : Cleveland, Ohio
Northing :
Easting :
Collar :

Inclinometer readings at I-001-13, I-003-10, I-009-13, B-105A, B-05-04, B-05-A-11, P-1, P-9N, and TGR I-4 showed virtually no movement. Displacement at the top of some slope tubes is due to construction disturbance or flexing of the inclinometer tube as readings were taken where the protective covers have not been concreted in place because of the ongoing construction activity.

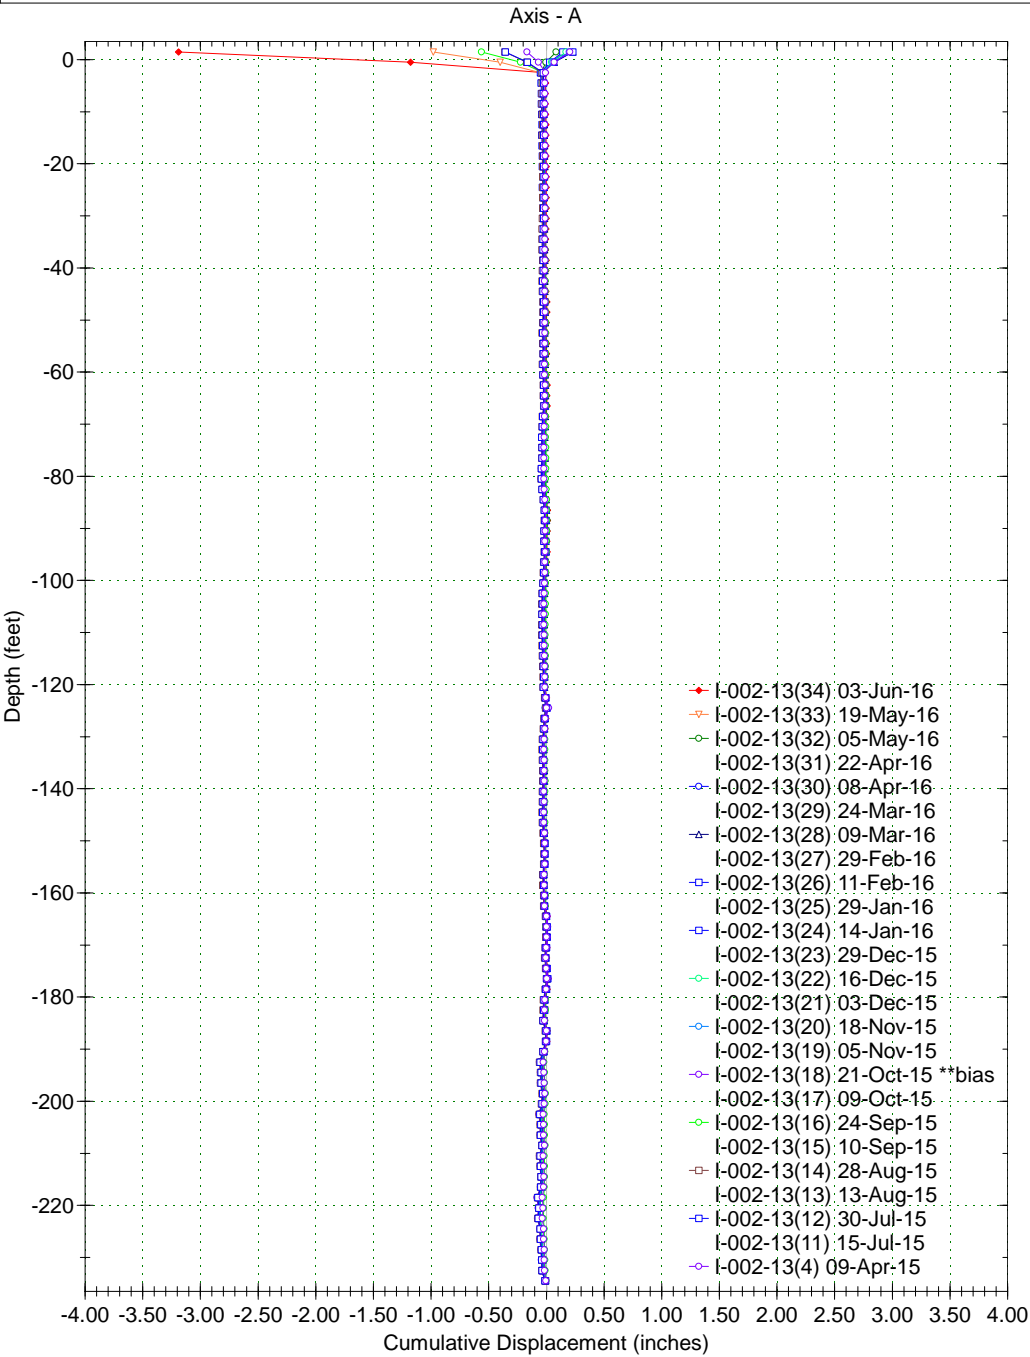
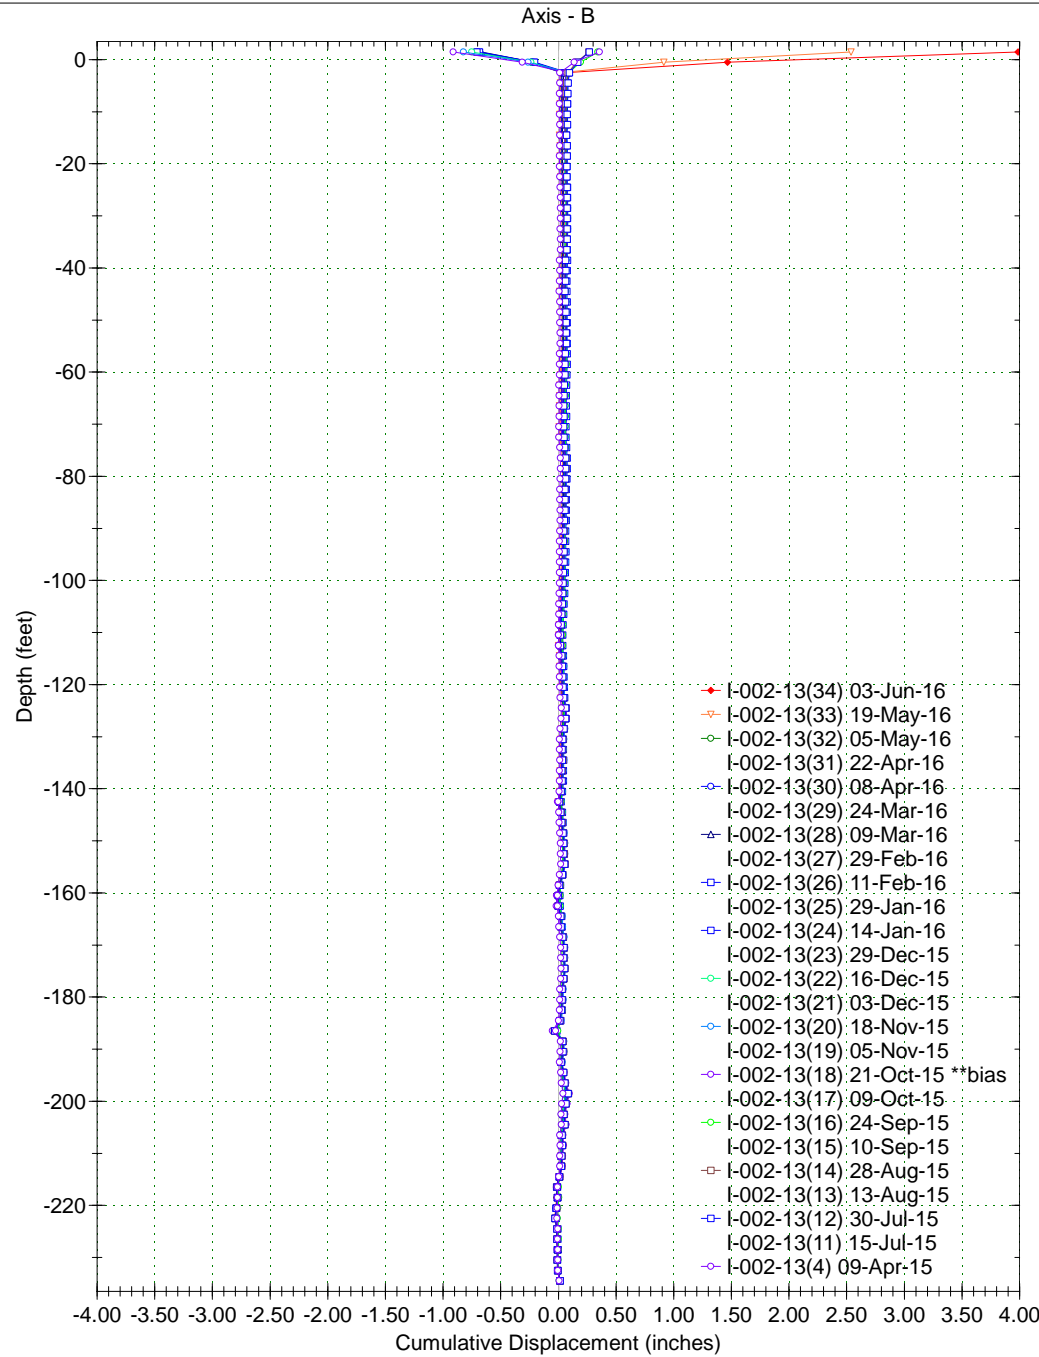
Borehole : I-002-13
 Project : CUY-90-15-24
 Location : Cleveland, Ohio
 Northing :
 Easting :
 Collar :

I-002-13 – Inclinometer readings at this location show additional large displacements in the top 4 feet of the casing. This is due to the grading work in the surrounding area.

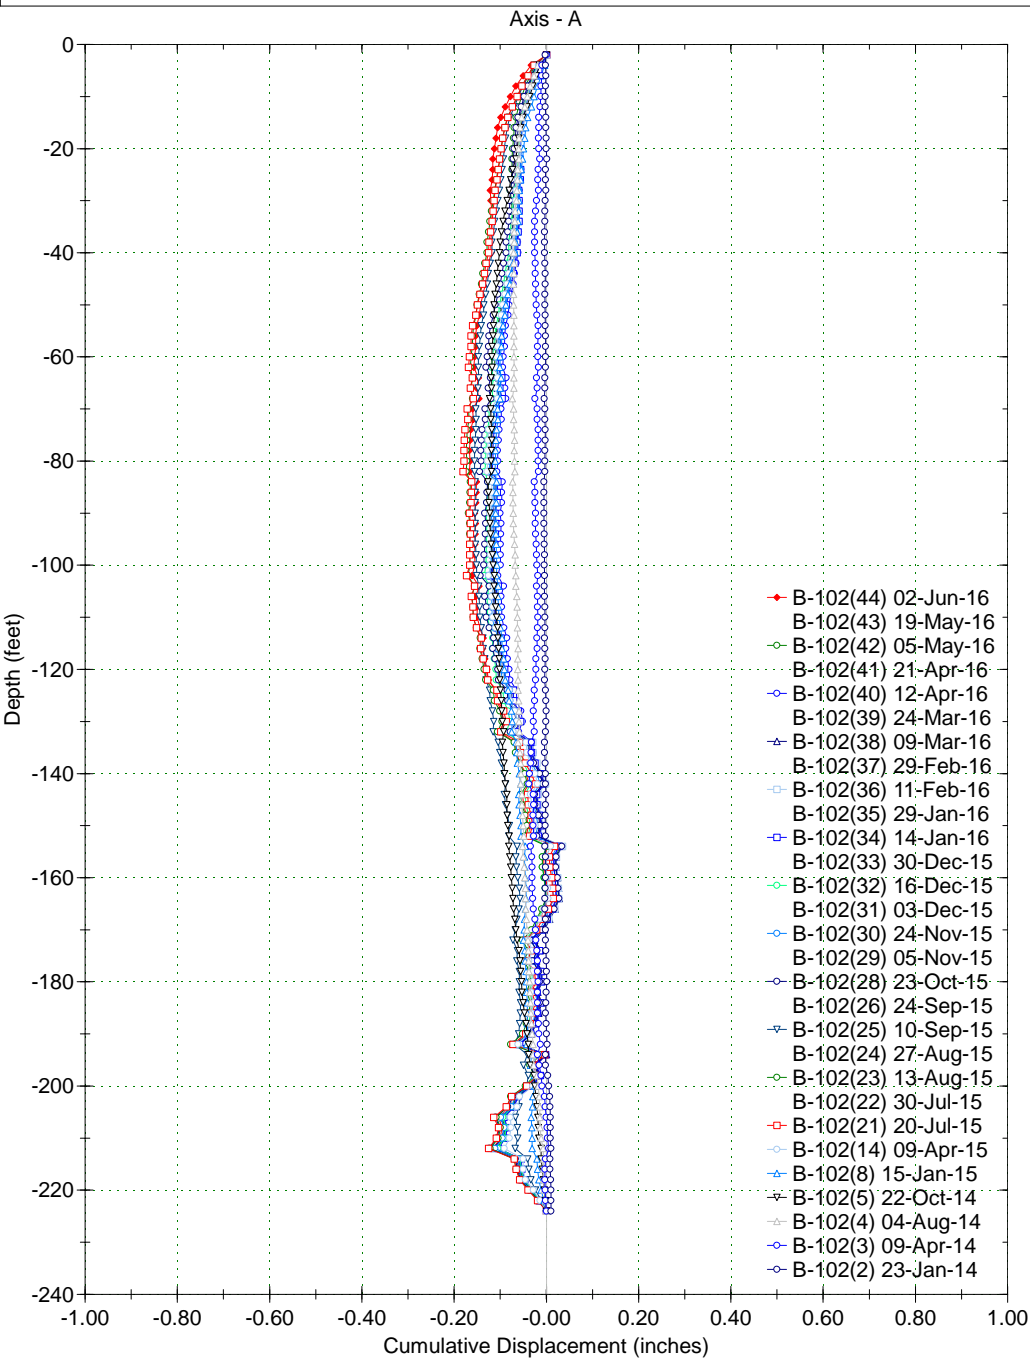
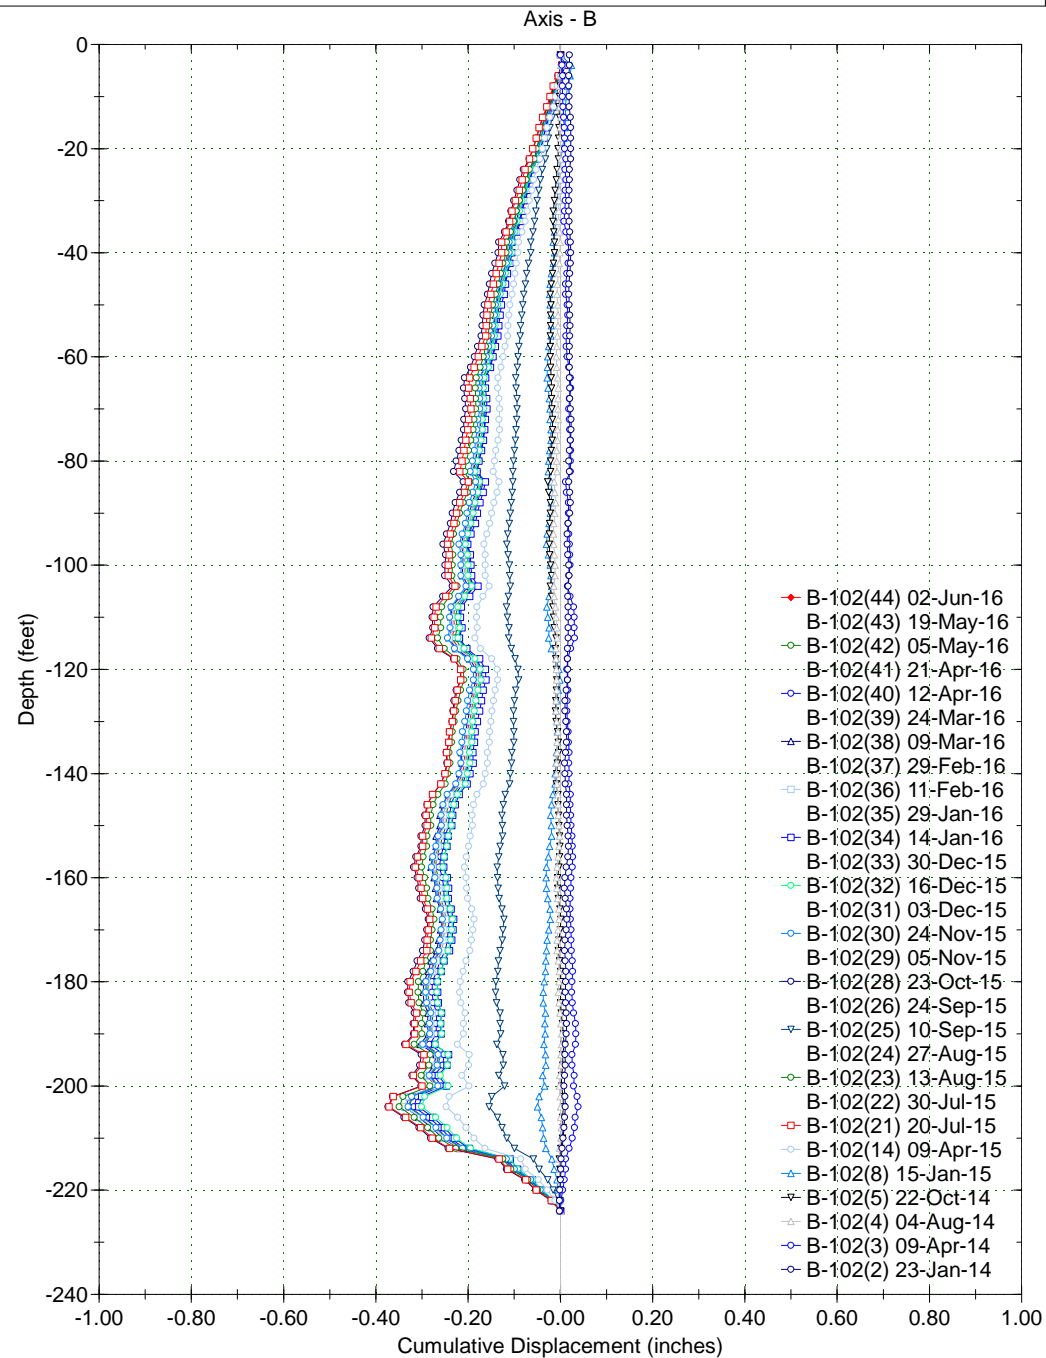
Borehole : B-102
 Project : CUY-90-15-24
 Location : Cleveland, Ohio
 Northing : Sta. 15+95.34
 Easting : 134.7' Rt of CL
 Collar :

B-102 – At this location, slight movement is indicated in the negative A-axis direction from the surface to about 30 feet.

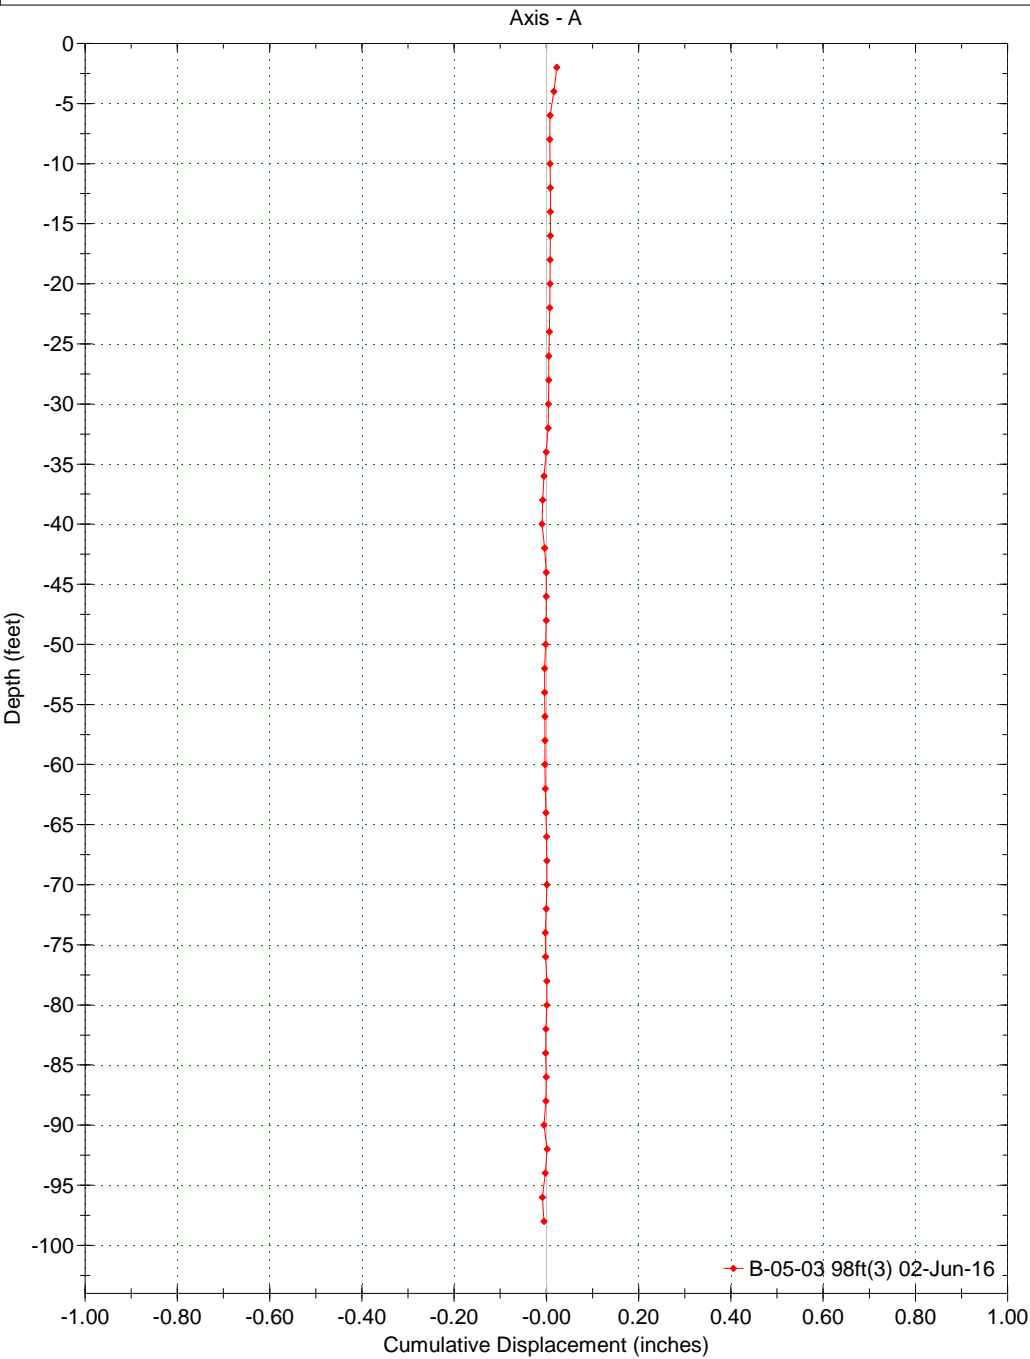
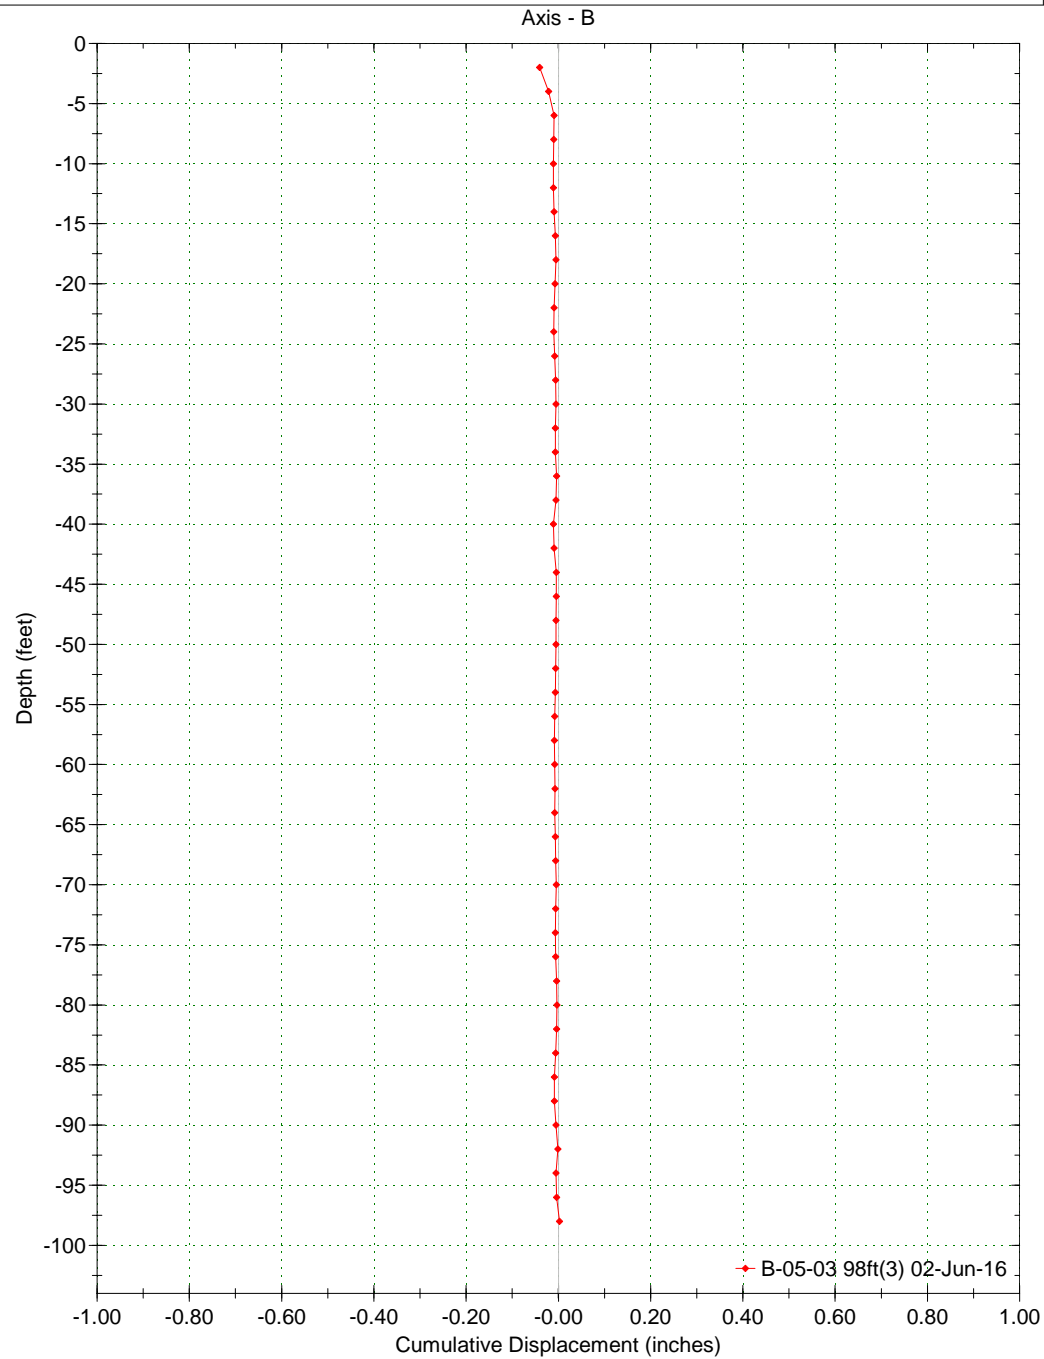
Borehole : B-05-A-03 [98 ft]
Project : CUY-90-15-24
Location :
Northing :
Easting :
Collar :

B-05-03A – The cumulative displacement plot for the upper 98 feet of casing is attached. No movement is shown except for some small displacements in the top 4 feet.
