August 23, 2016

Re: August 11, 12, and 15, 2016 Bi-Weekly Readings  
CUY-90-15.24 Slope Monitoring  
PID 96504  
SME Project No. 069032.00

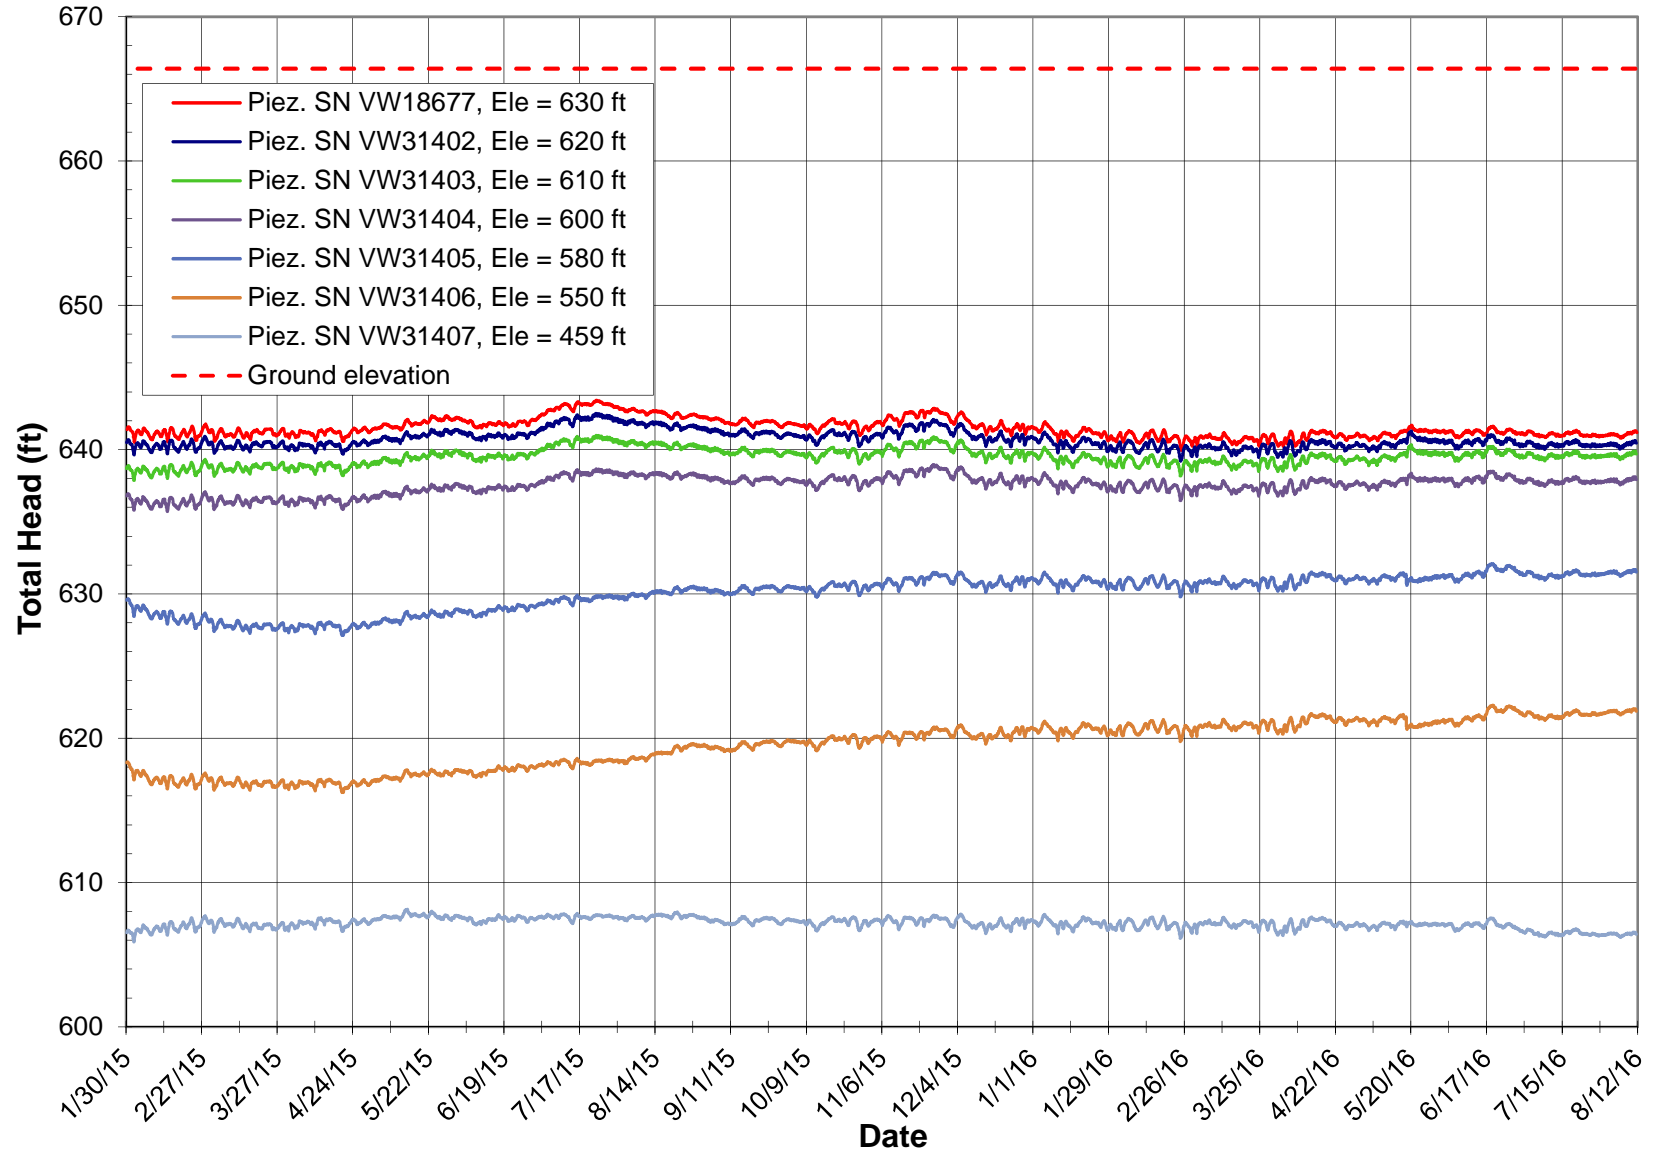
# P-001-13 VW Piezometer Readings

**P-001-13** – Seven piezometers are installed at this location. Five of the seven fluctuated by less than 0.5 feet. Piezometers at elevations 550 feet and 580 feet have continued to trend upward since October 2015.

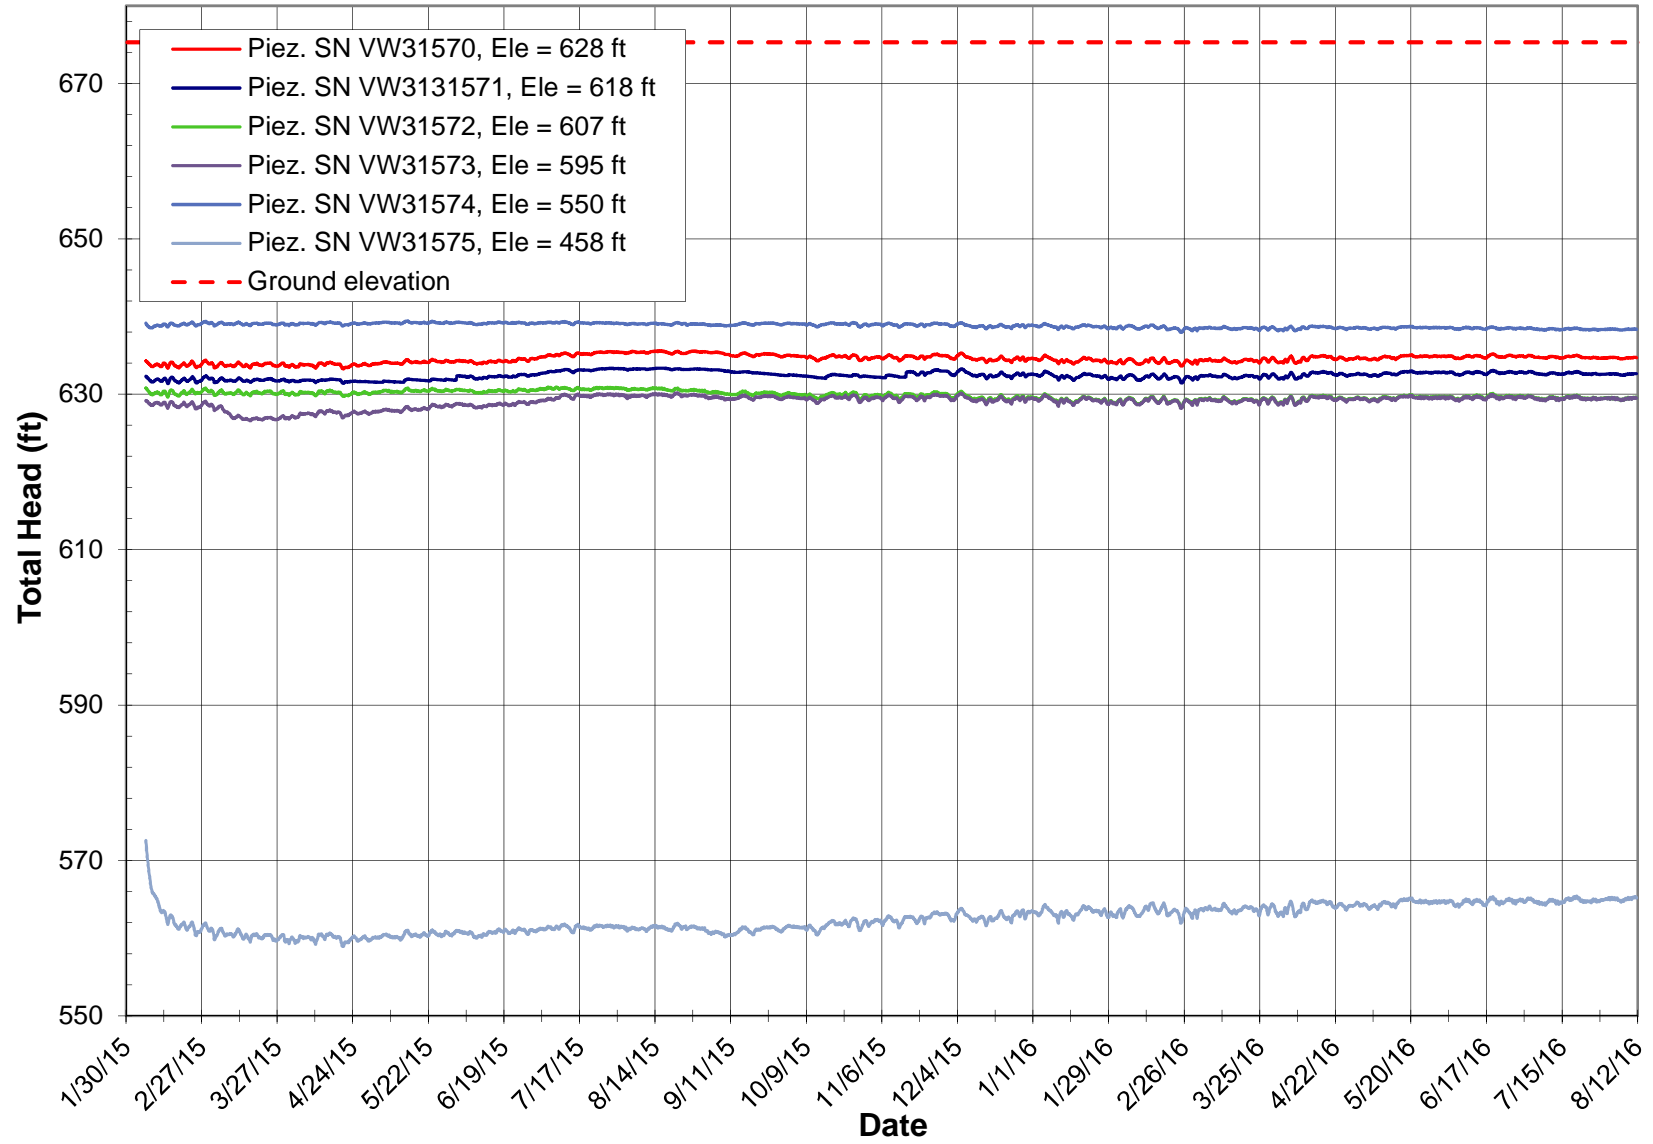
# P-002-13 VW Piezometer Readings

P-002-13, P-004-13, B-05-02, B-05-A-03, B-05-04 – Pore pressure readings at these locations fluctuated by less than 0.5 feet, but show virtually no net change in total head.

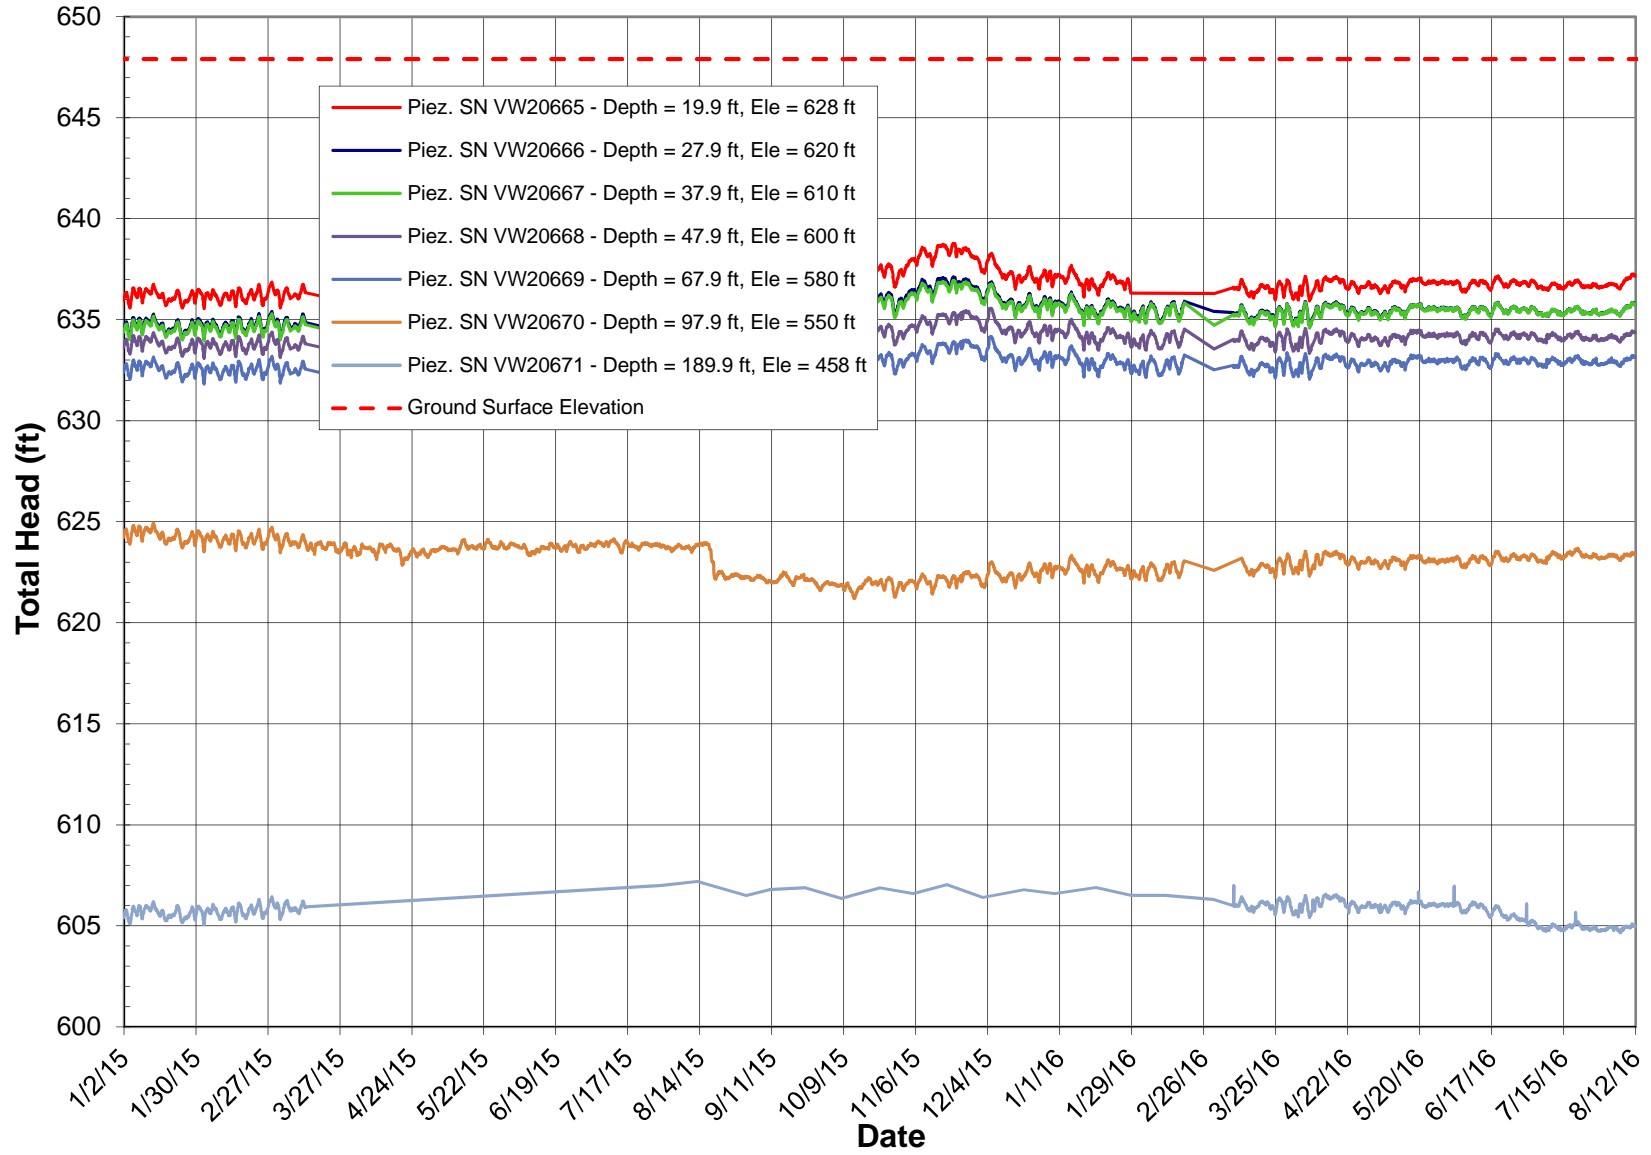
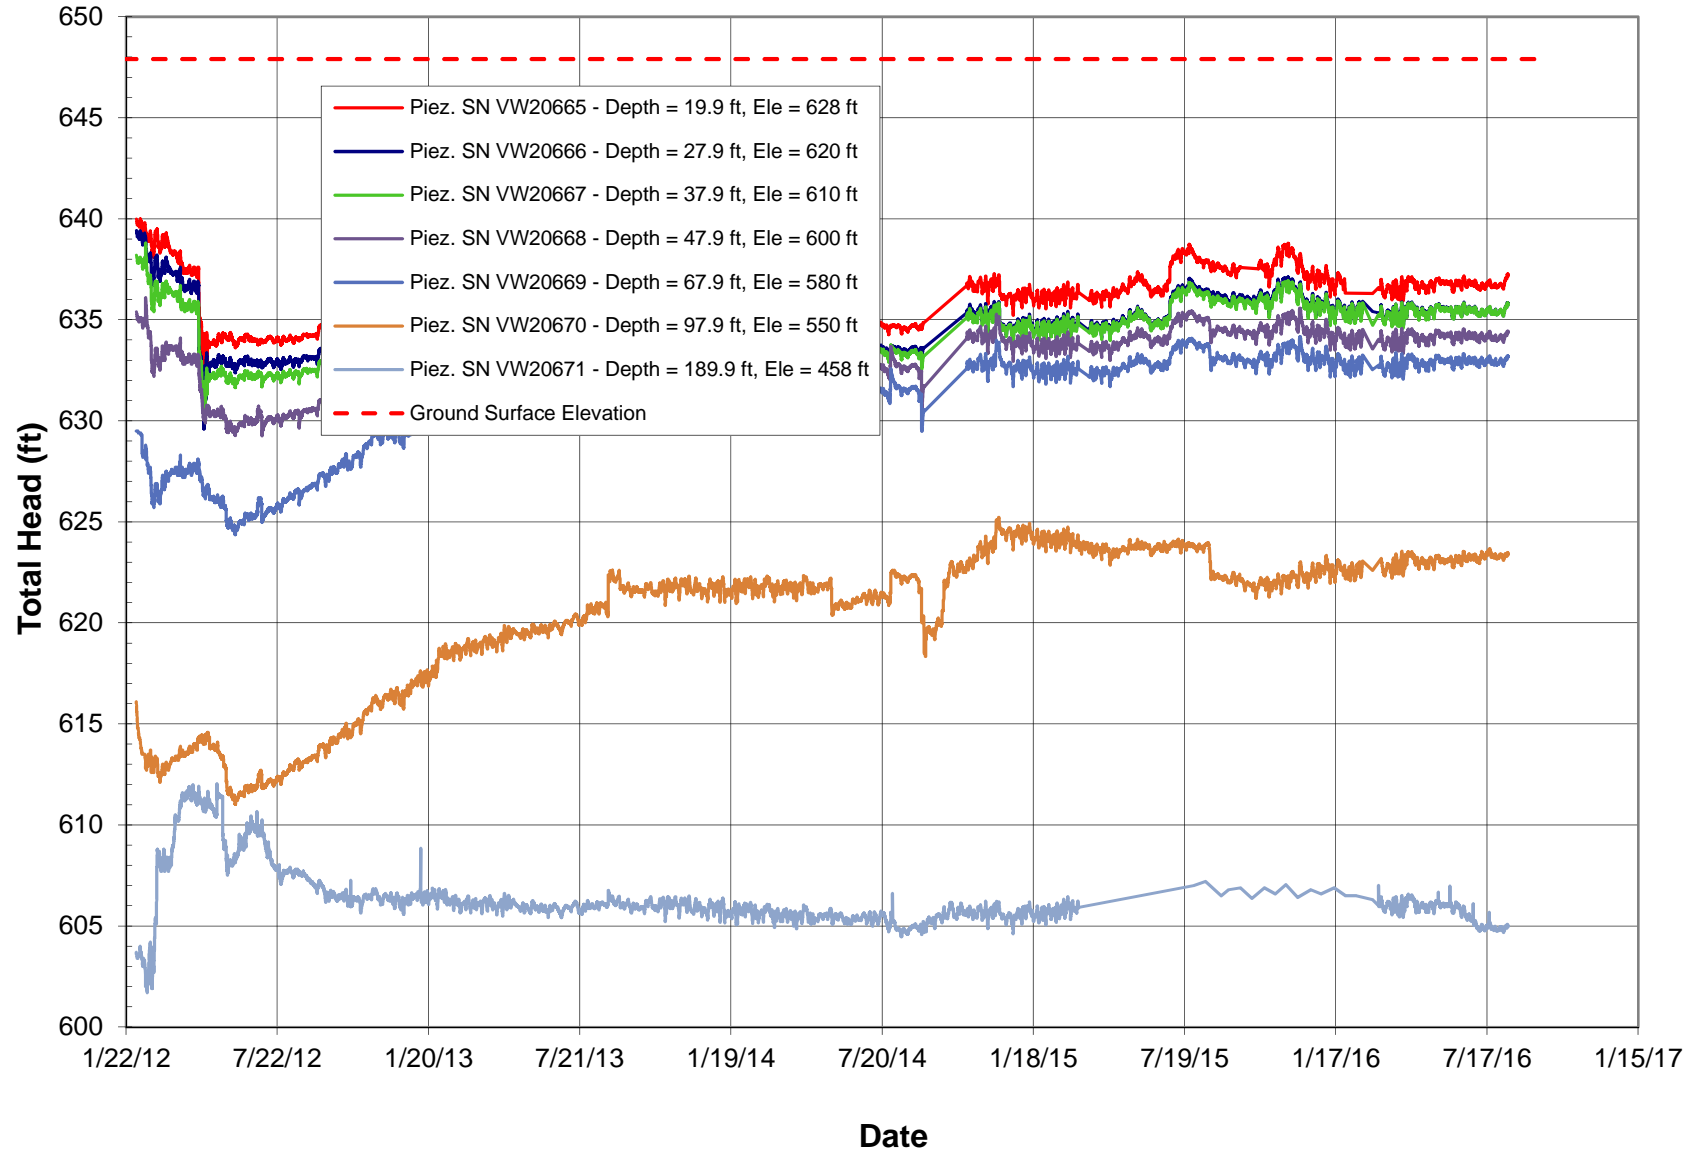
# P-003-10 VW Piezometer Readings

**P-003-10** – Seven piezometers are installed at this location. Total head in the four shallowest piezometers increased by about 0.6 feet this period. Readings in the other piezometers show slight increases in total head.

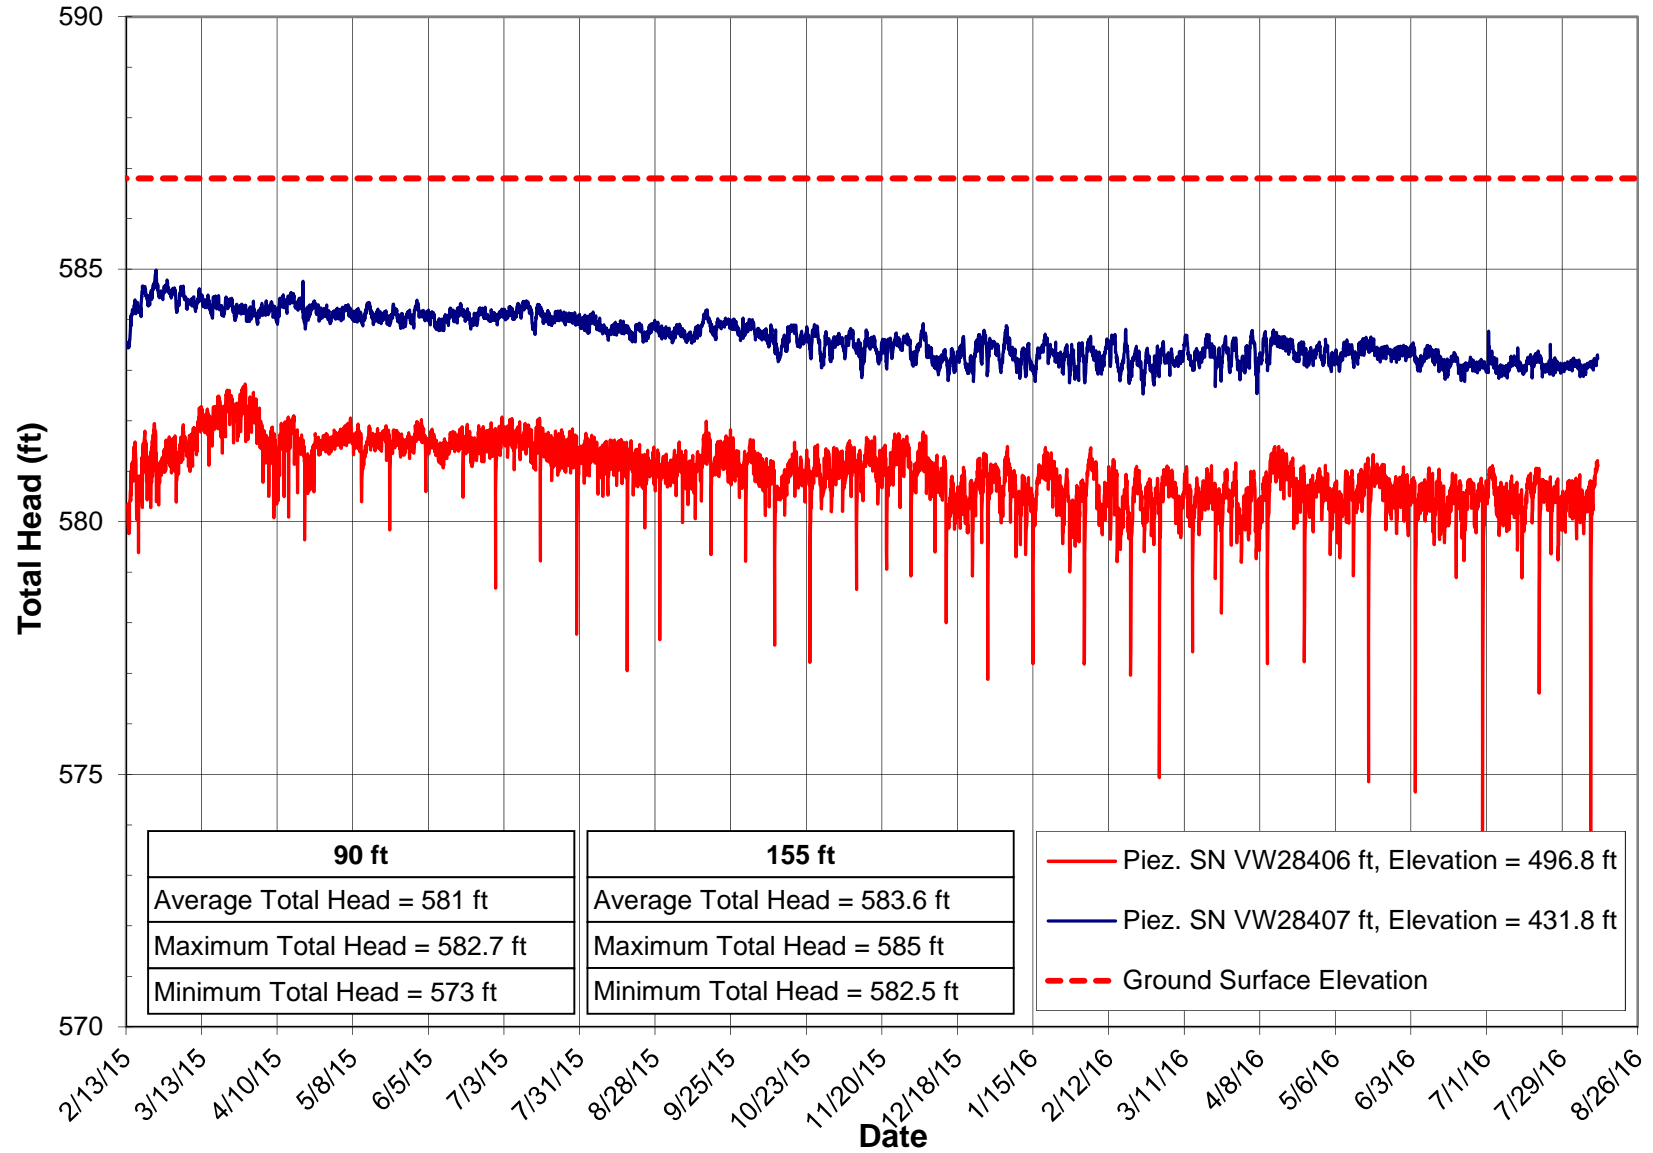
# P-009-13 VW Piezometer Readings

**P-009-13** – Total head in the shallow piezometer at this location increased by about 1 foot. Readings in the deep piezometer show virtually no change in total head.

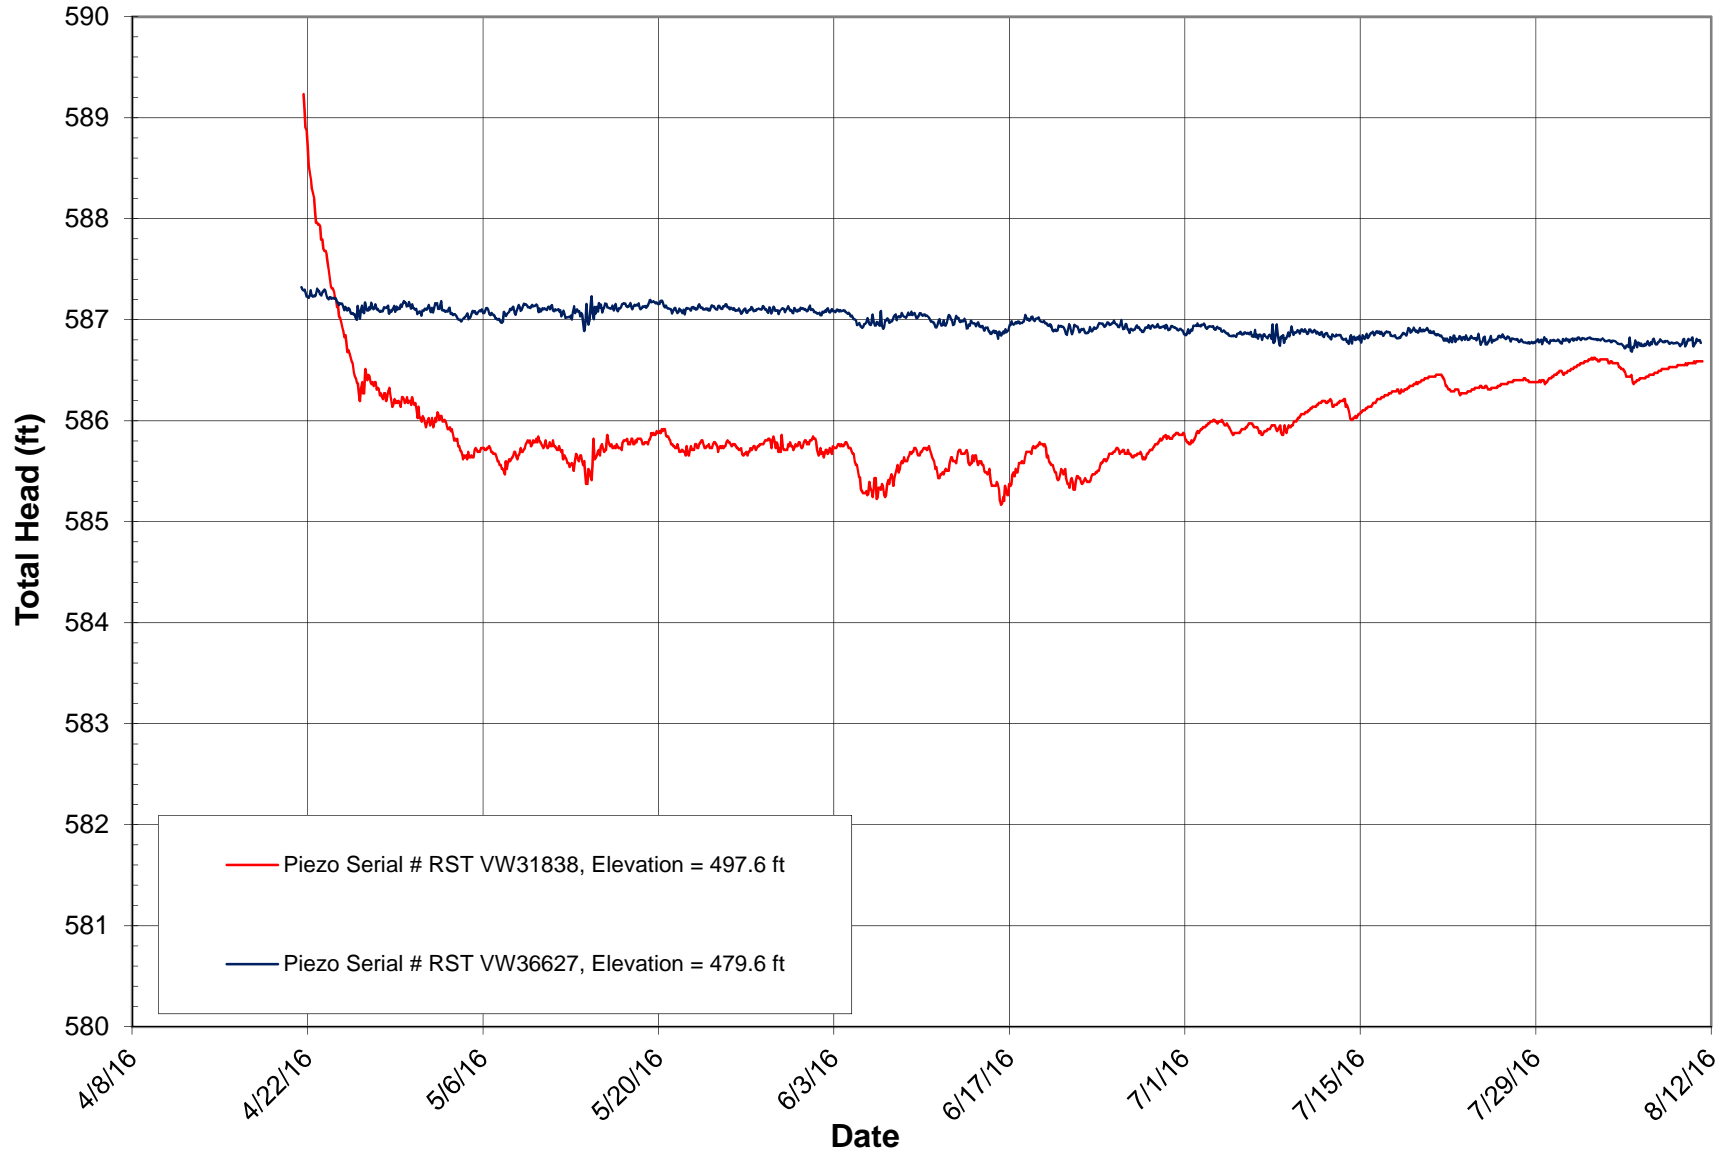
# B-105A VW Piezometer Readings

**B-105-A** – The total head in the shallow piezometer increased by about 0.2 feet. total head has been trending upward since mid-June 2016. Total head in the deep piezometer decreased only slightly this period but has

continued to trend downward since the beginning of June 2016. Since June 3, 2016 the change has been about 0.3 feet.

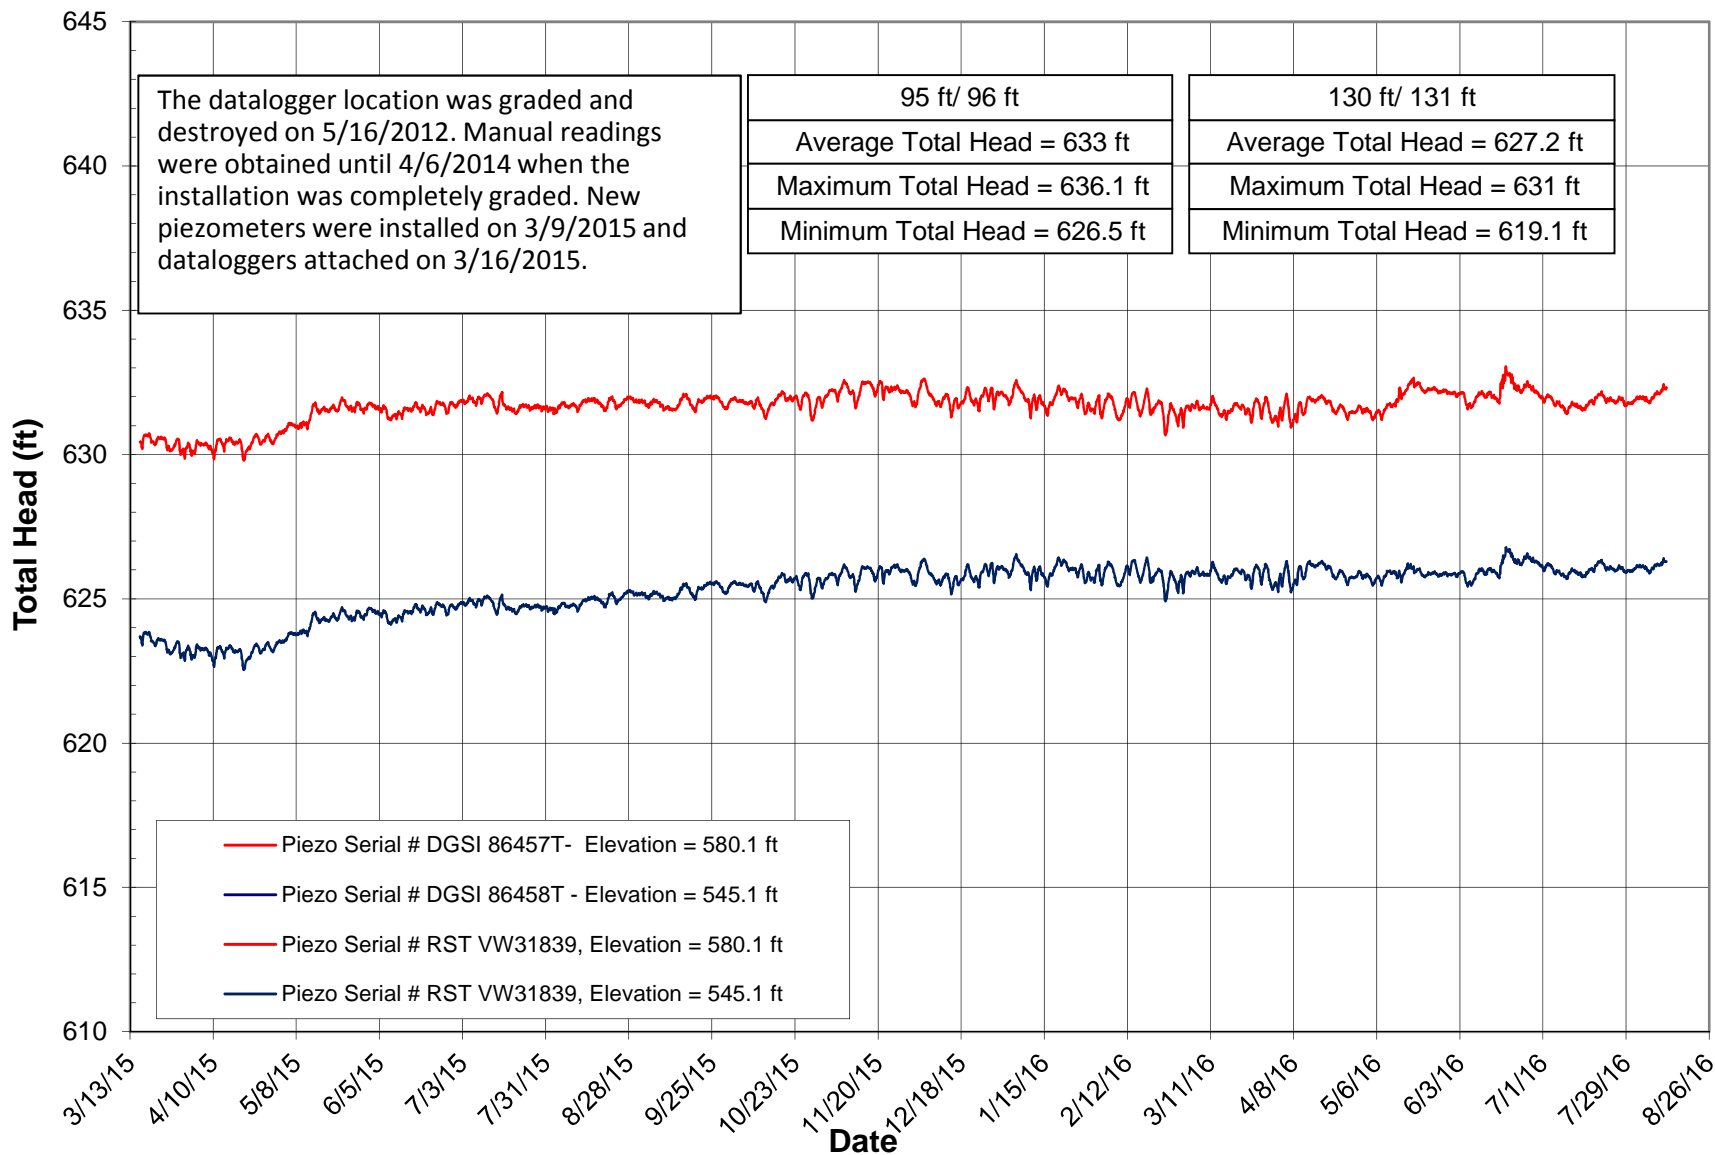
## B-05-11/B-05-A-11 VW Piezometer Readings

**B-05-A-11** – Pore pressure readings indicate an increase in total head of about 0.6 feet in the shallow piezometer and about 0.3 feet in the deep piezometer at this location.

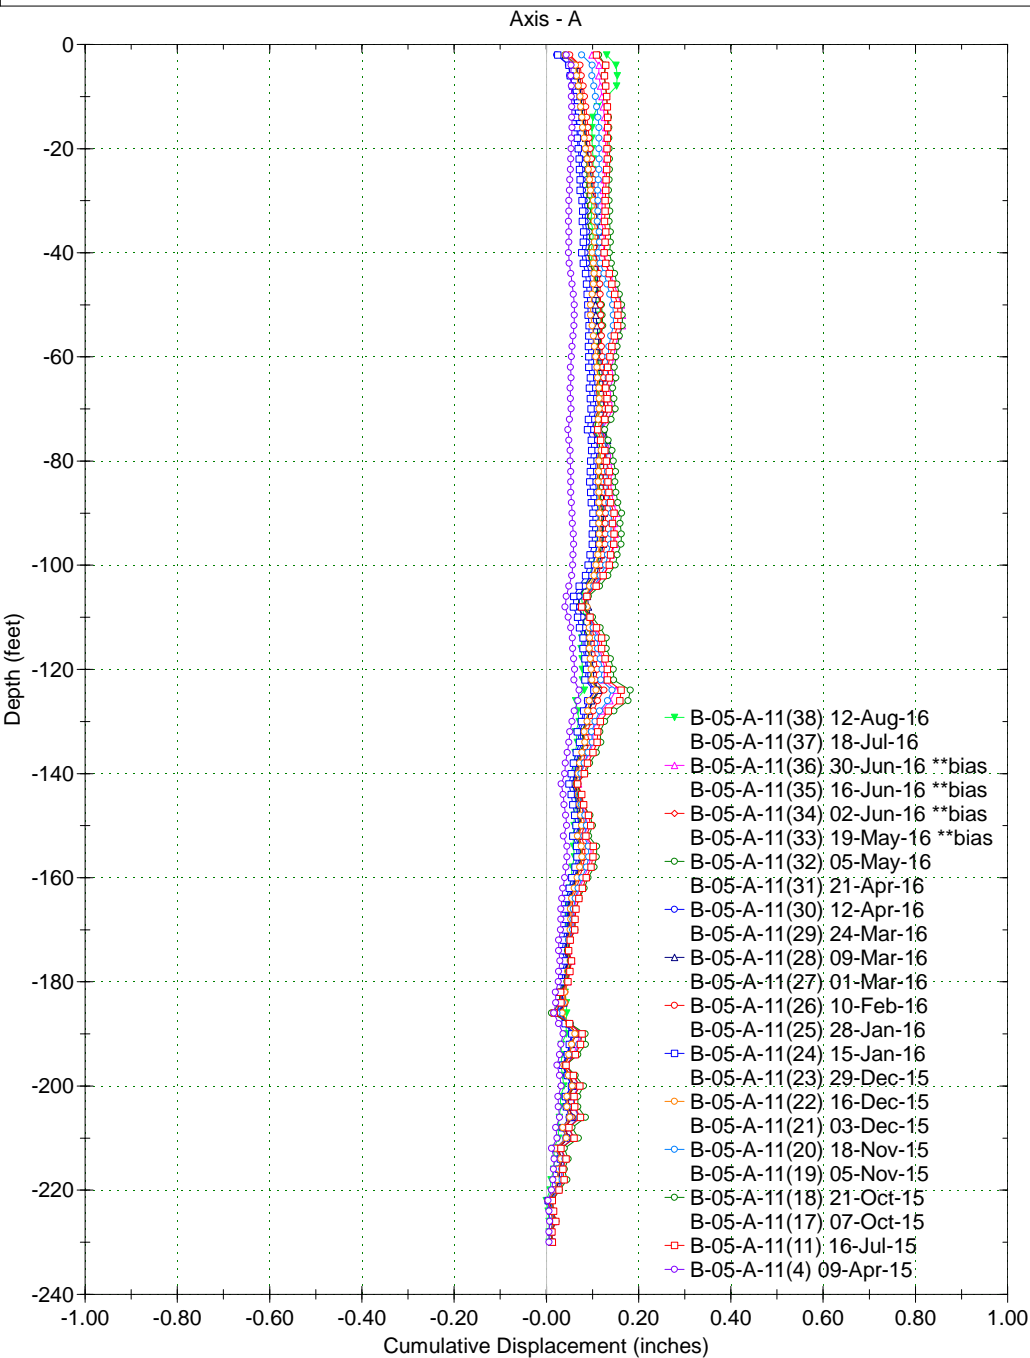
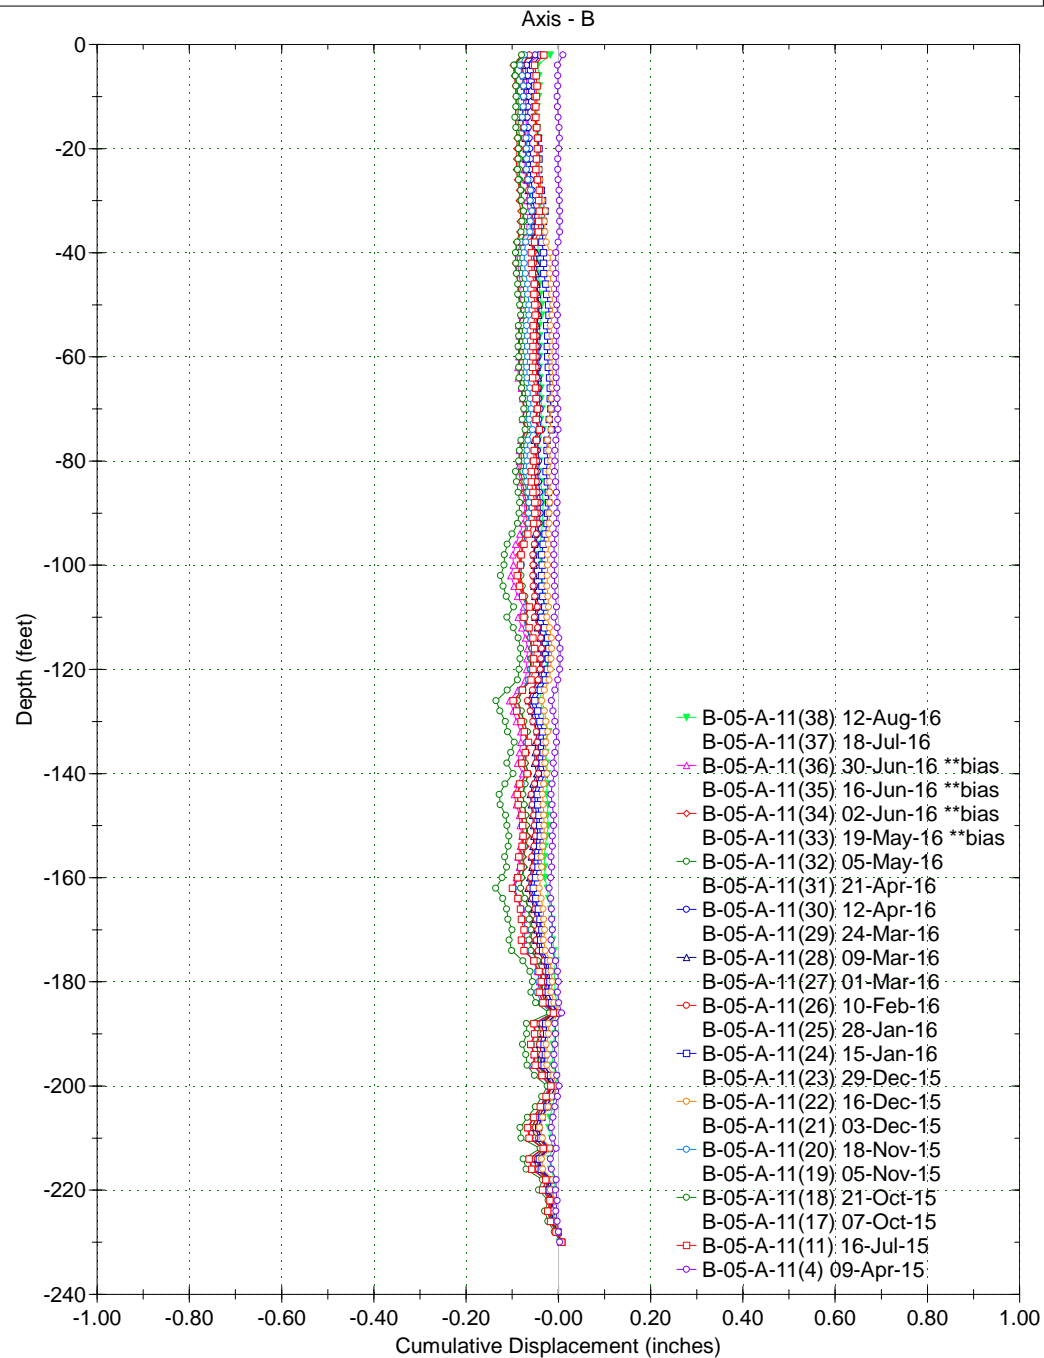
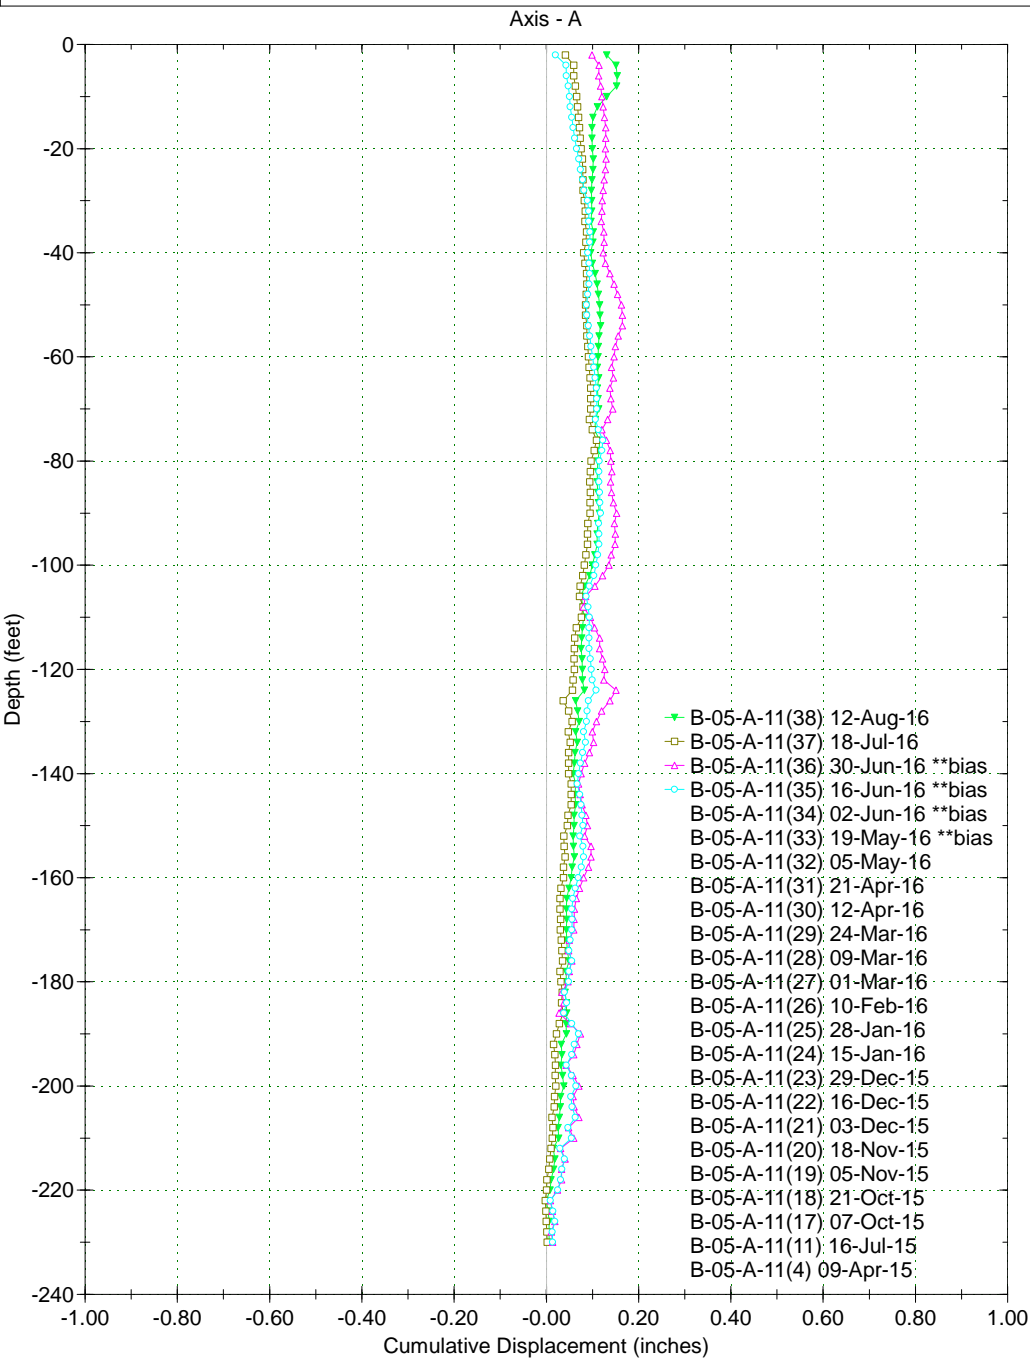
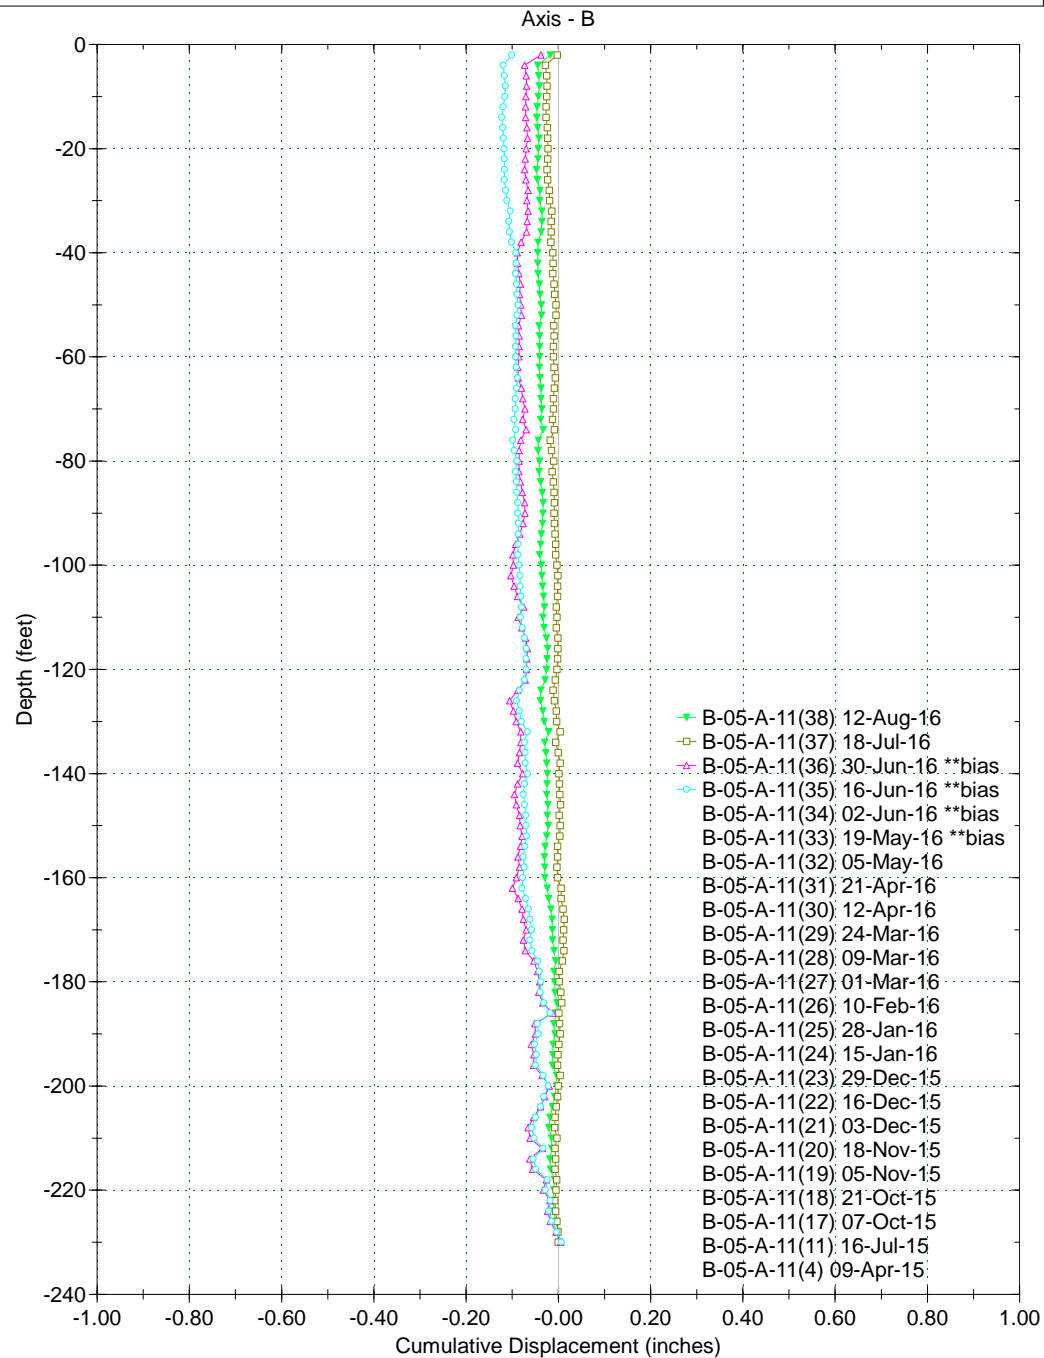
Borehole : B-05-A-11  
 Project : CUY-90-15-24  
 Location :  
 Northing :  
 Easting :  
 Collar :

**B-05-A-11** – Inclinometer readings at this location indicate movement in the positive A-axis direction from the surface to about 10 feet. This movement is due to the excavation of the slope adjacent to this location for the construction of the gabion basket wall.
