Re: September 22, 23, 26, and 27, 2016 Bi-Weekly Readings
CUY-90-15.24 Slope Monitoring
PID 96504
SME Project No. 069032.00

Bi-weekly instrument readings for the I-90 west slope taken on September 22, 23, 26, and 27, 2016, are presented in this report. Bi-weekly readings currently include instruments at I/P-001-13, I/P-002-13, I/P-003-10, I/P-004-13, I/P-009-13, B-101, B-102, B-105A, B-05-02, B-05-A-03, B-05-04, B-05-A-11, P-1, P-9N, and TGR I-4. Changes reported for the individual instruments are for the previous two-week period unless noted otherwise.

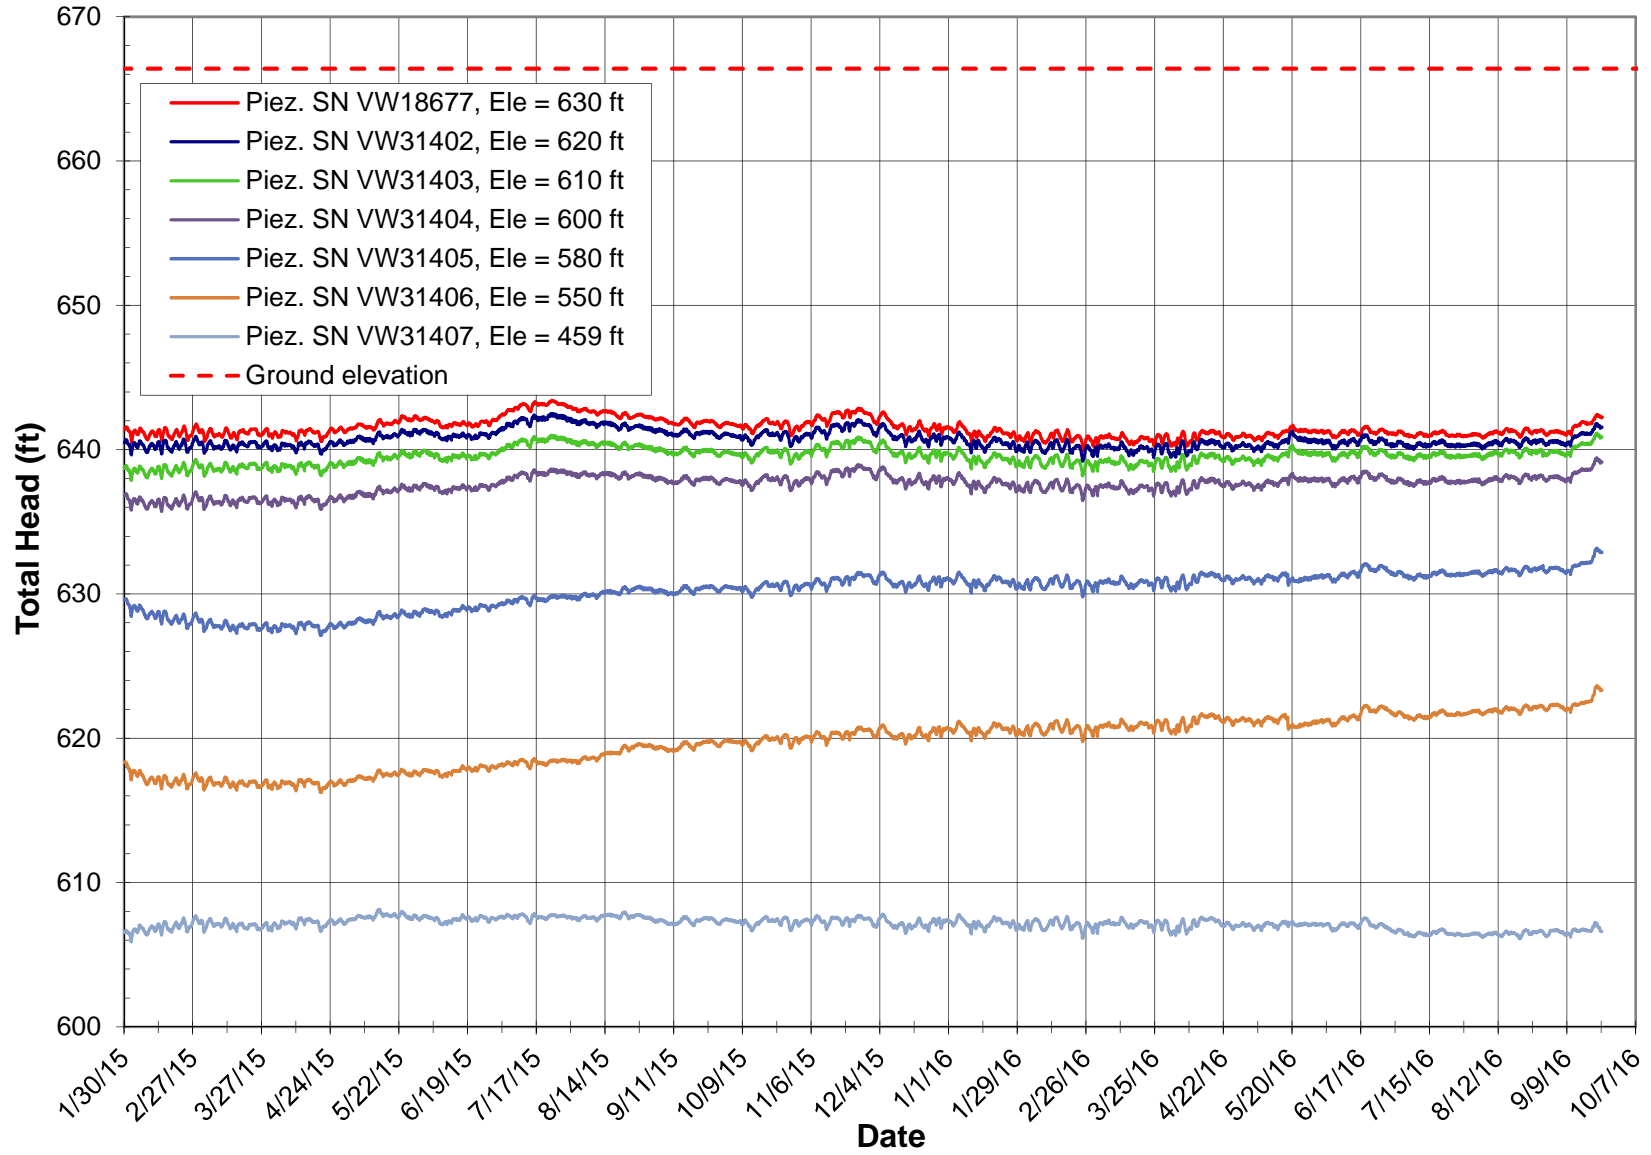
P-001-13 VW Piezometer Readings

P-001-13 – Pore pressure readings at this location indicate increases in total head ranging from 1.1 to 1.5 feet. The magnitude of the increase increases with depth except for the deepest piezometer which only increased by 0.2 feet.

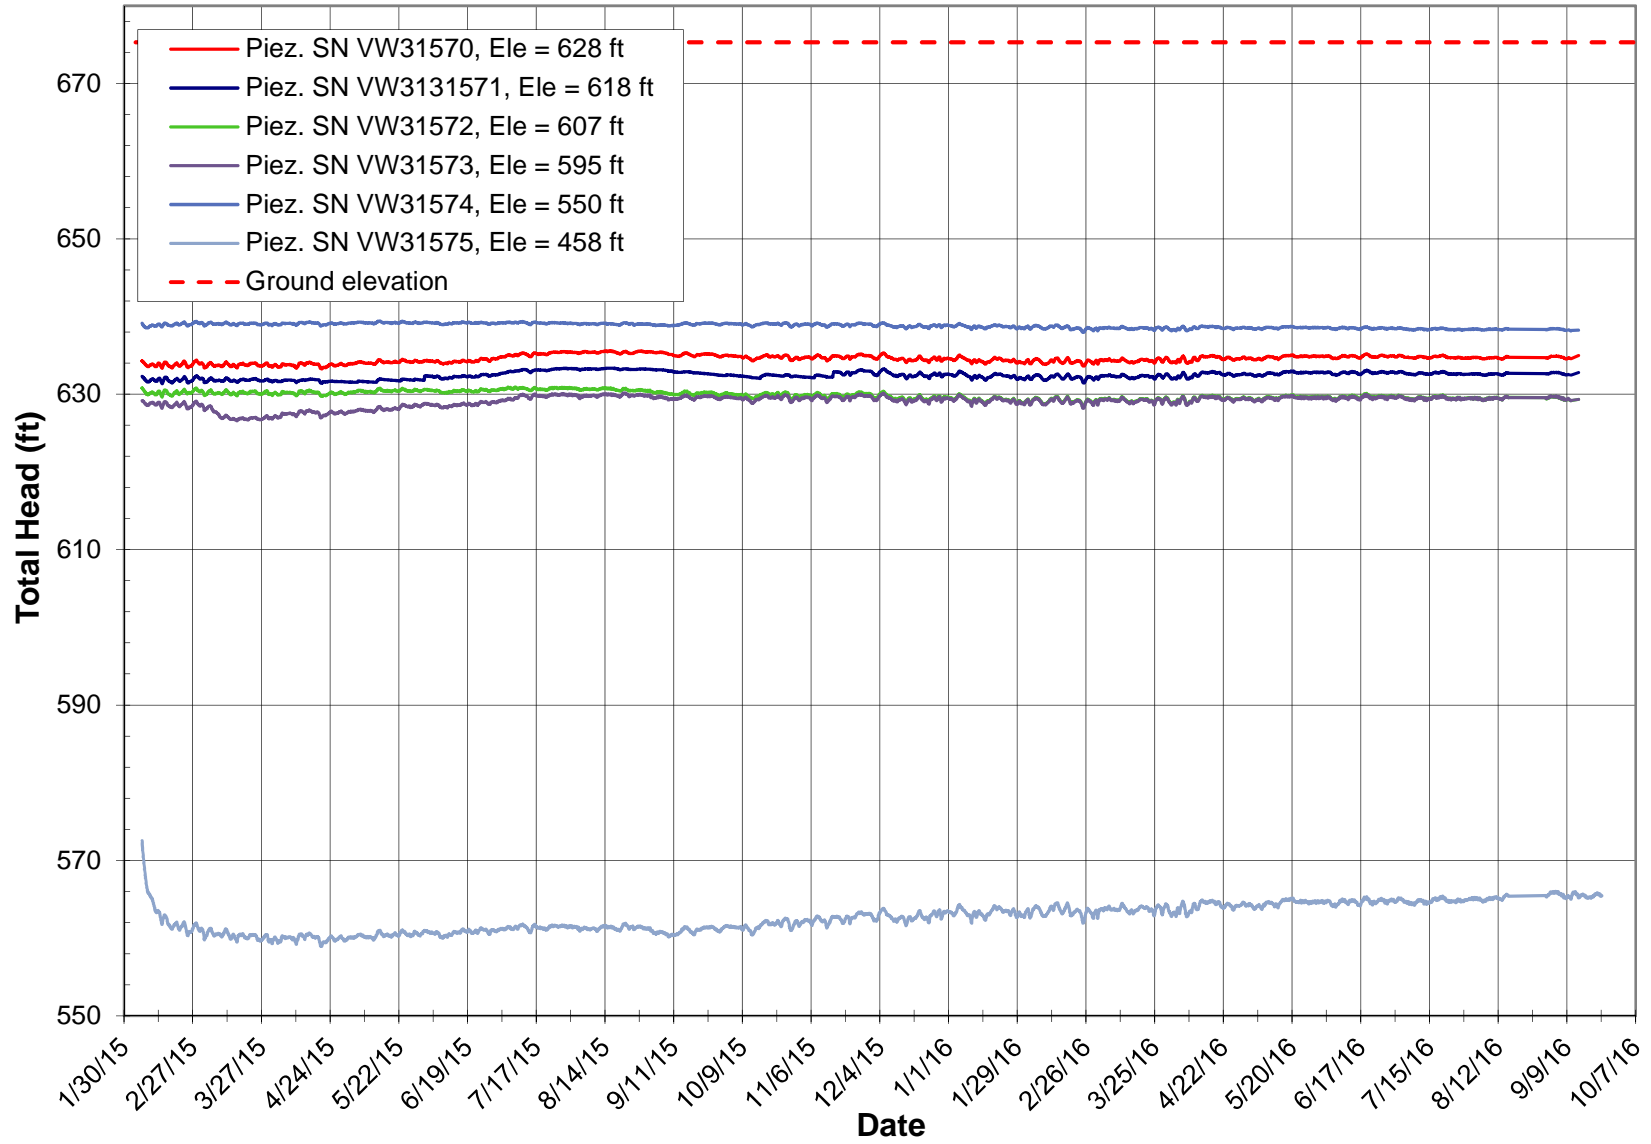
P-002-13 VW Piezometer Readings

P-002-13 – The multichannel logger at this location, which tracks the five shallow piezometers, failed to respond during our attempts to download data. We are currently working to fix this issue by updating the firmware. If this fails, we will send the logger to the manufacturer for repair. Pore pressures in the deep piezometer show virtually no change in total head.

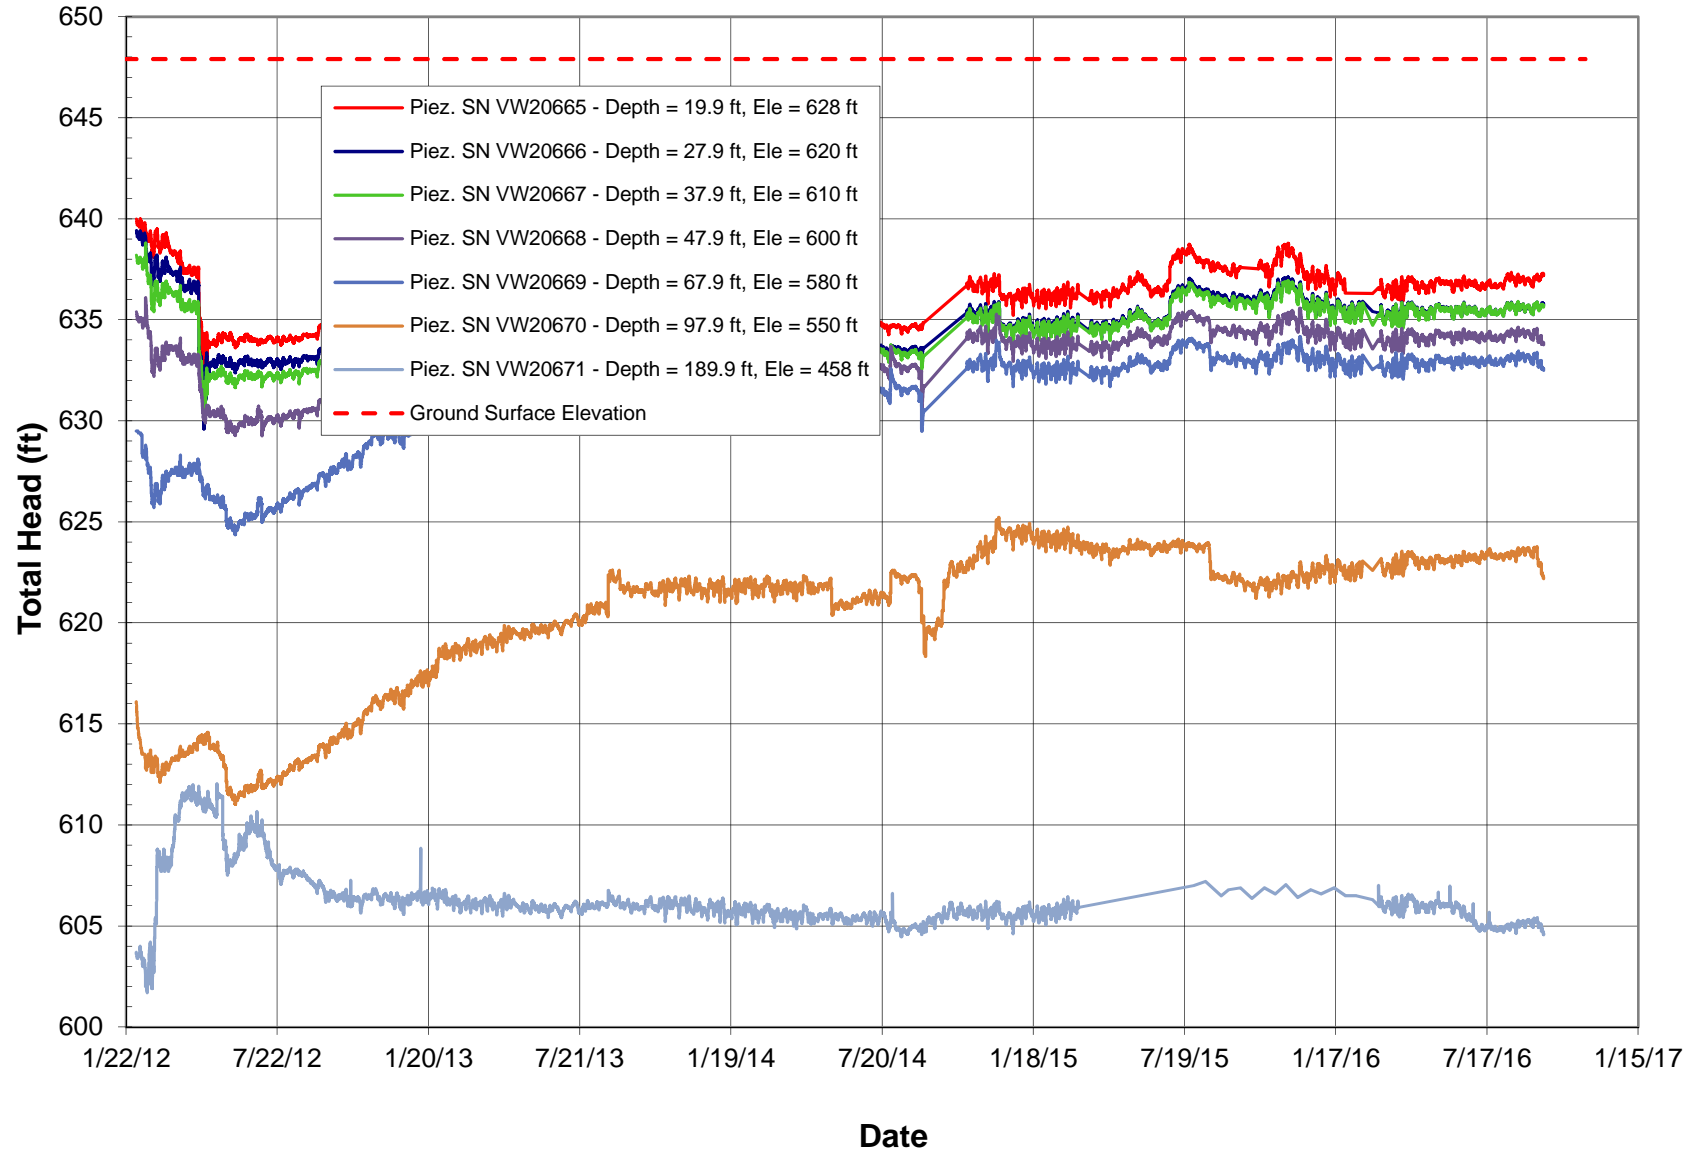
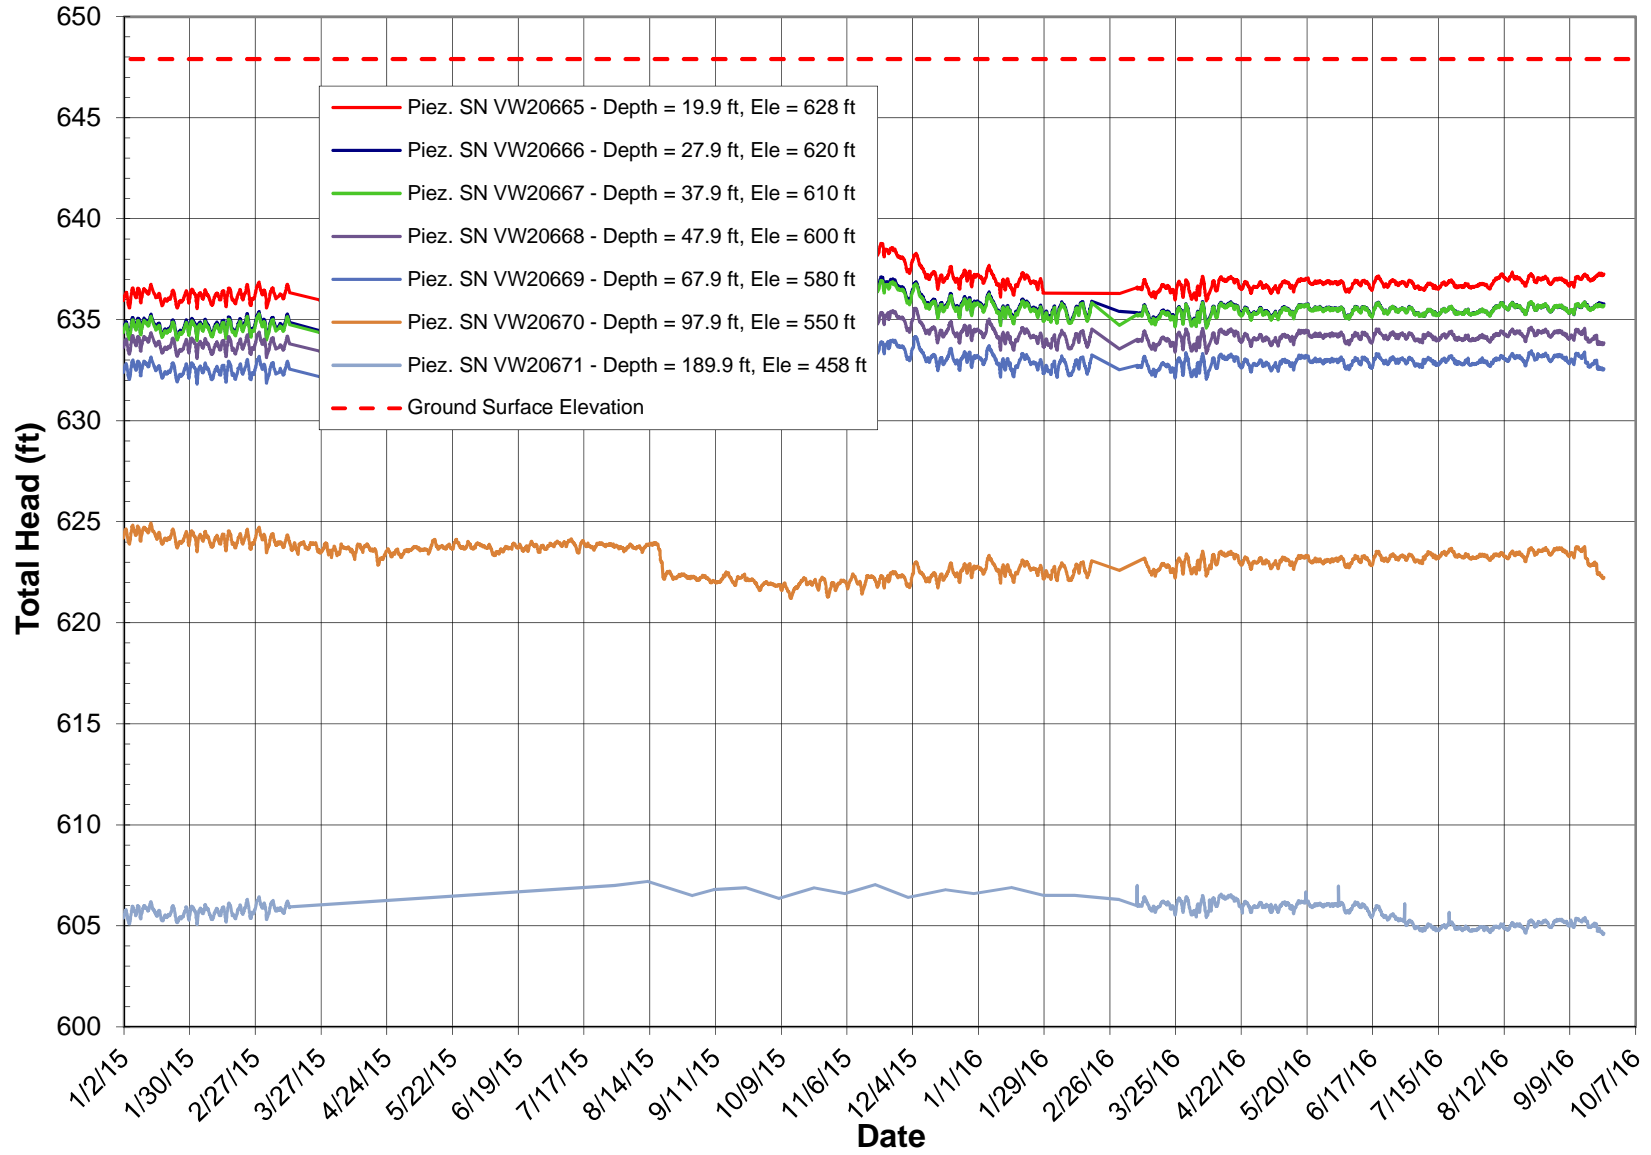
P-003-10 VW Piezometer Readings

P-003-10 – Pore pressure readings in the three shallowest piezometers at this location indicate total head increases of less than 0.5 feet. Total head in the four deeper piezometers decreased by amounts ranging from 0.3 to 1.2 feet. The largest decrease occurred at 98 feet.

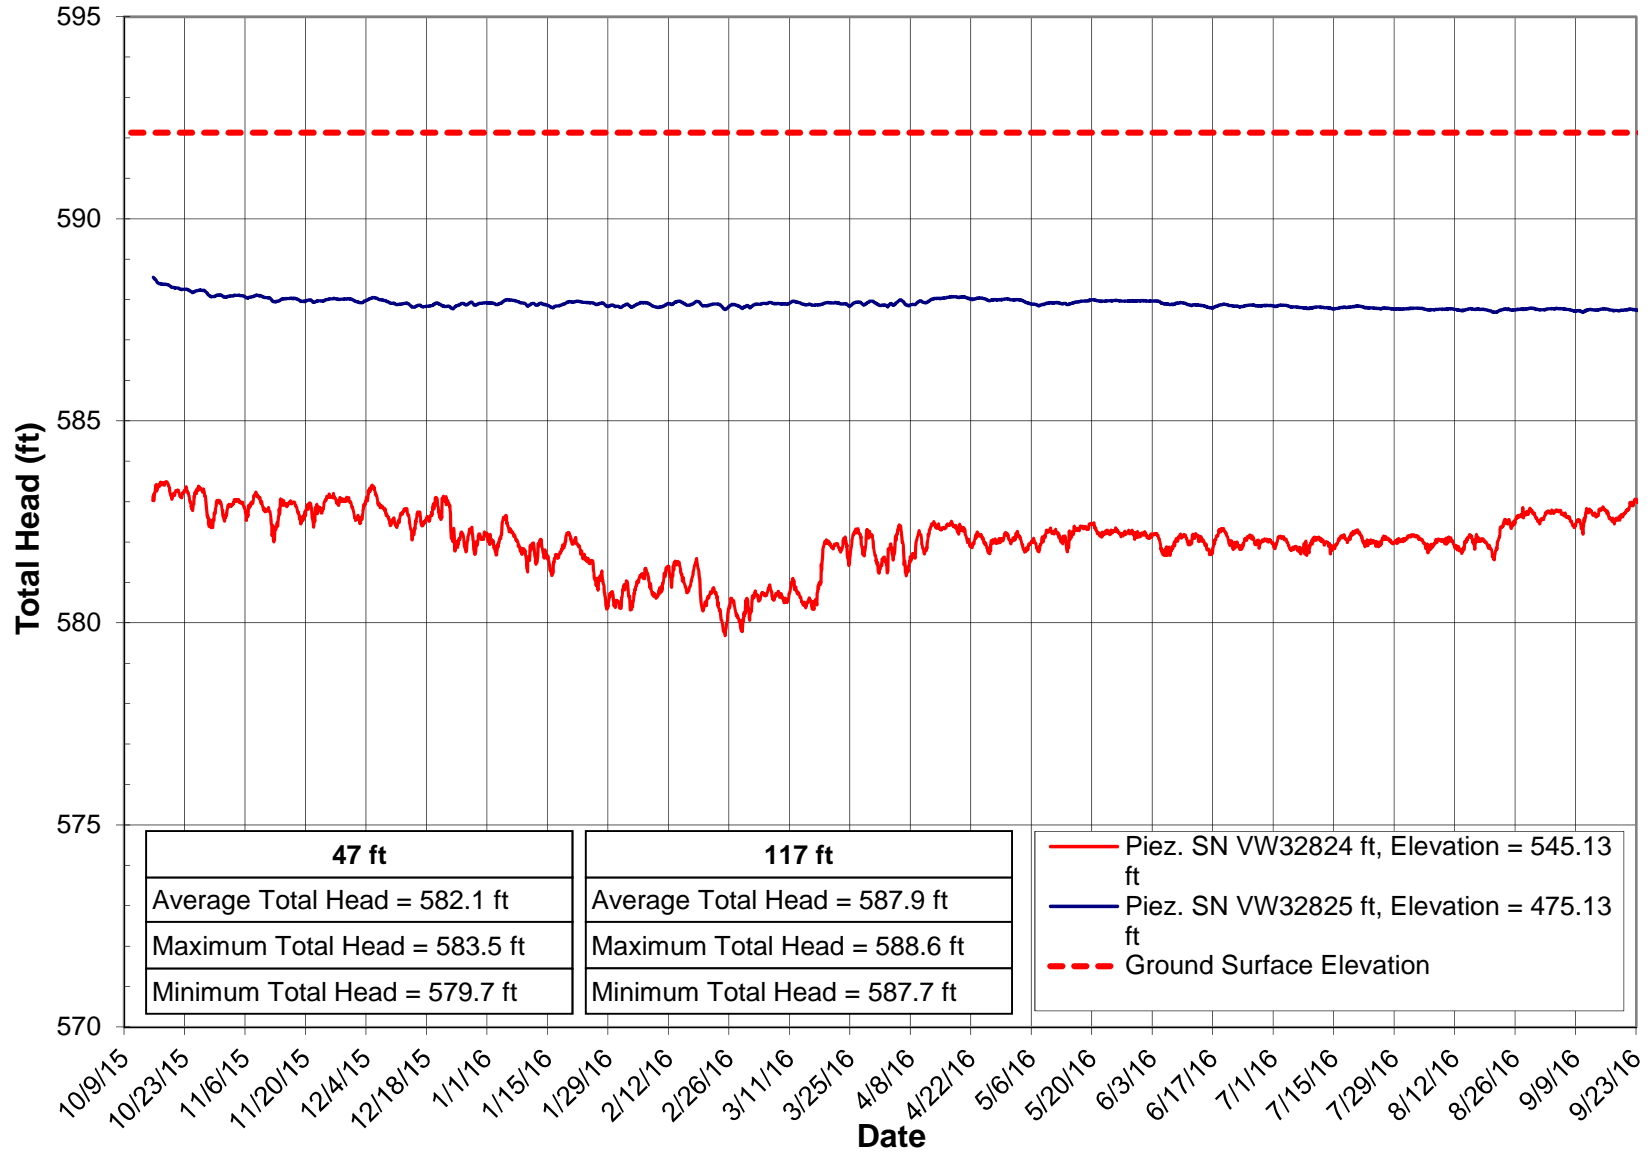
P-004-13 VW Piezometer Readings

P-004-13 – Total head in the shallow piezometer at this location increased by about 0.5 feet. Total head in the deep piezometer has remained virtually constant since its installation.

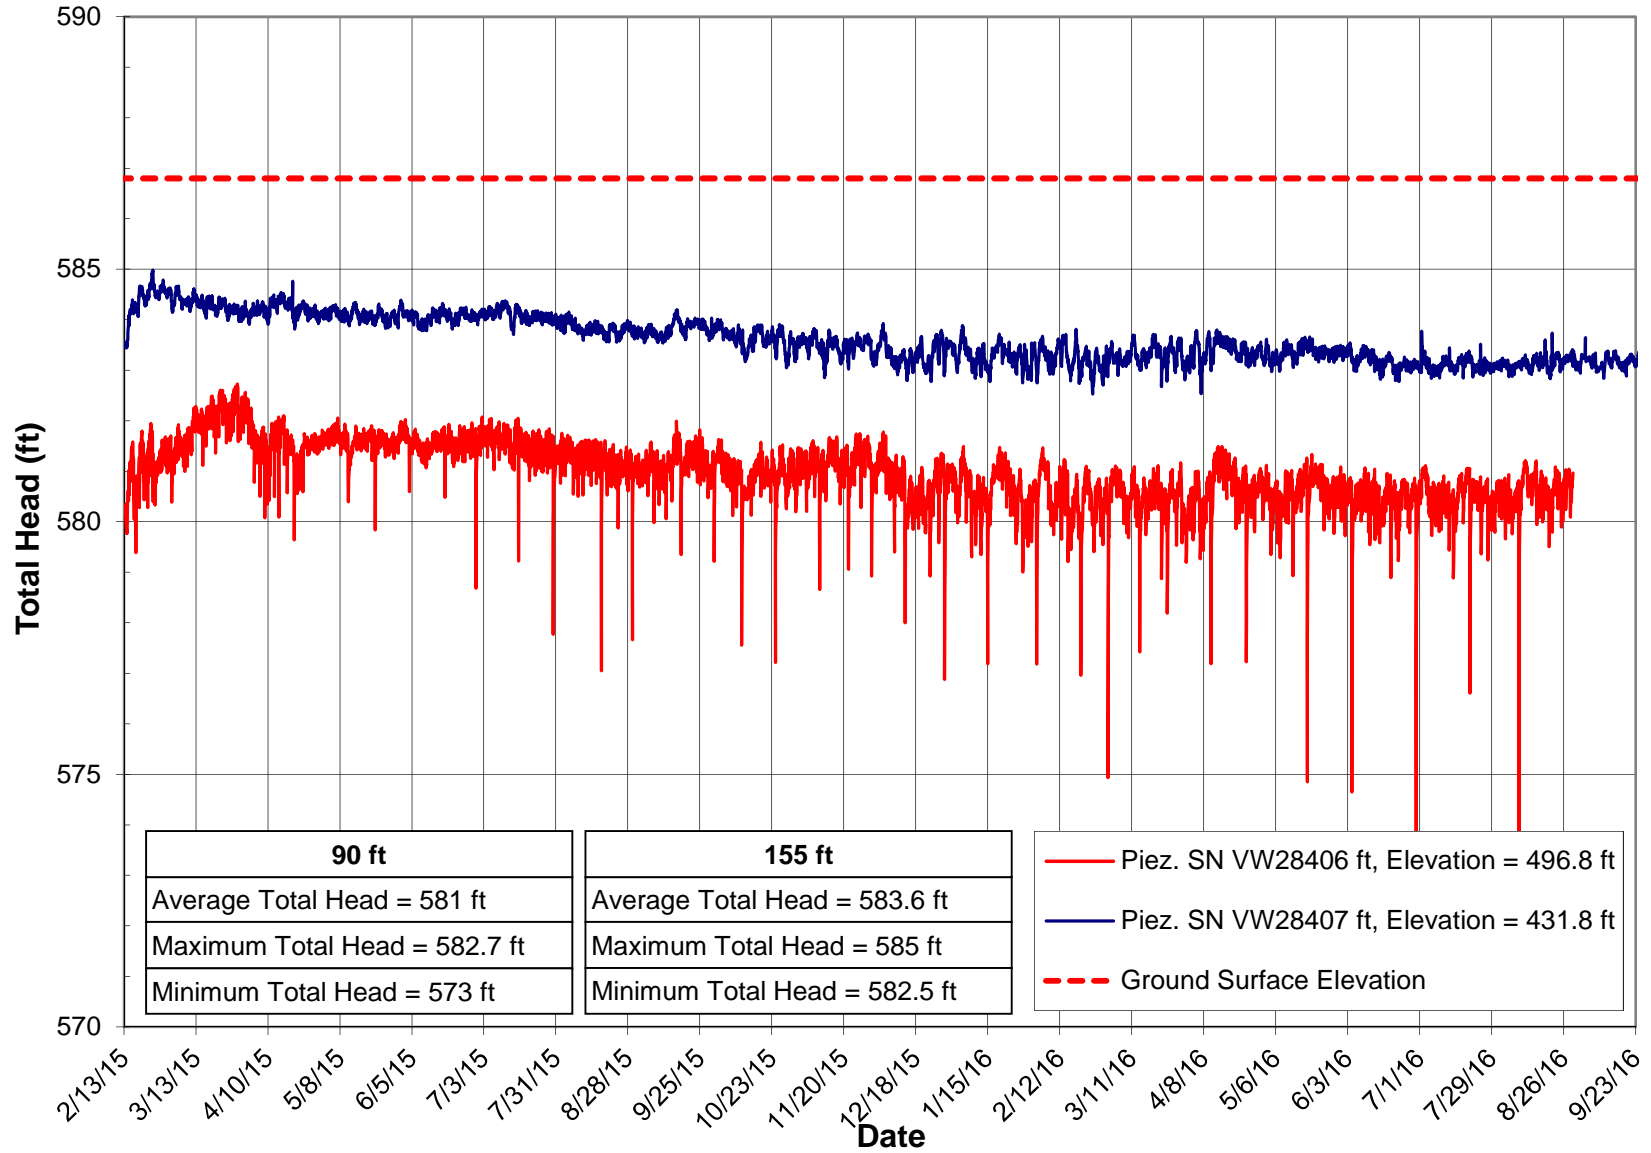
P-009-13 VW Piezometer Readings

P-009-13 – We were unable to download data from the data logger attached to the shallow piezometer. We communicated with the manufacturer and attempted to update the firmware in the data logger. This did not resolve the issue. It appears that the firmware is corrupted. We are sending the data logger to the manufacturer to repair this issue. Pore pressures in the deep piezometer show virtually no change in total head.

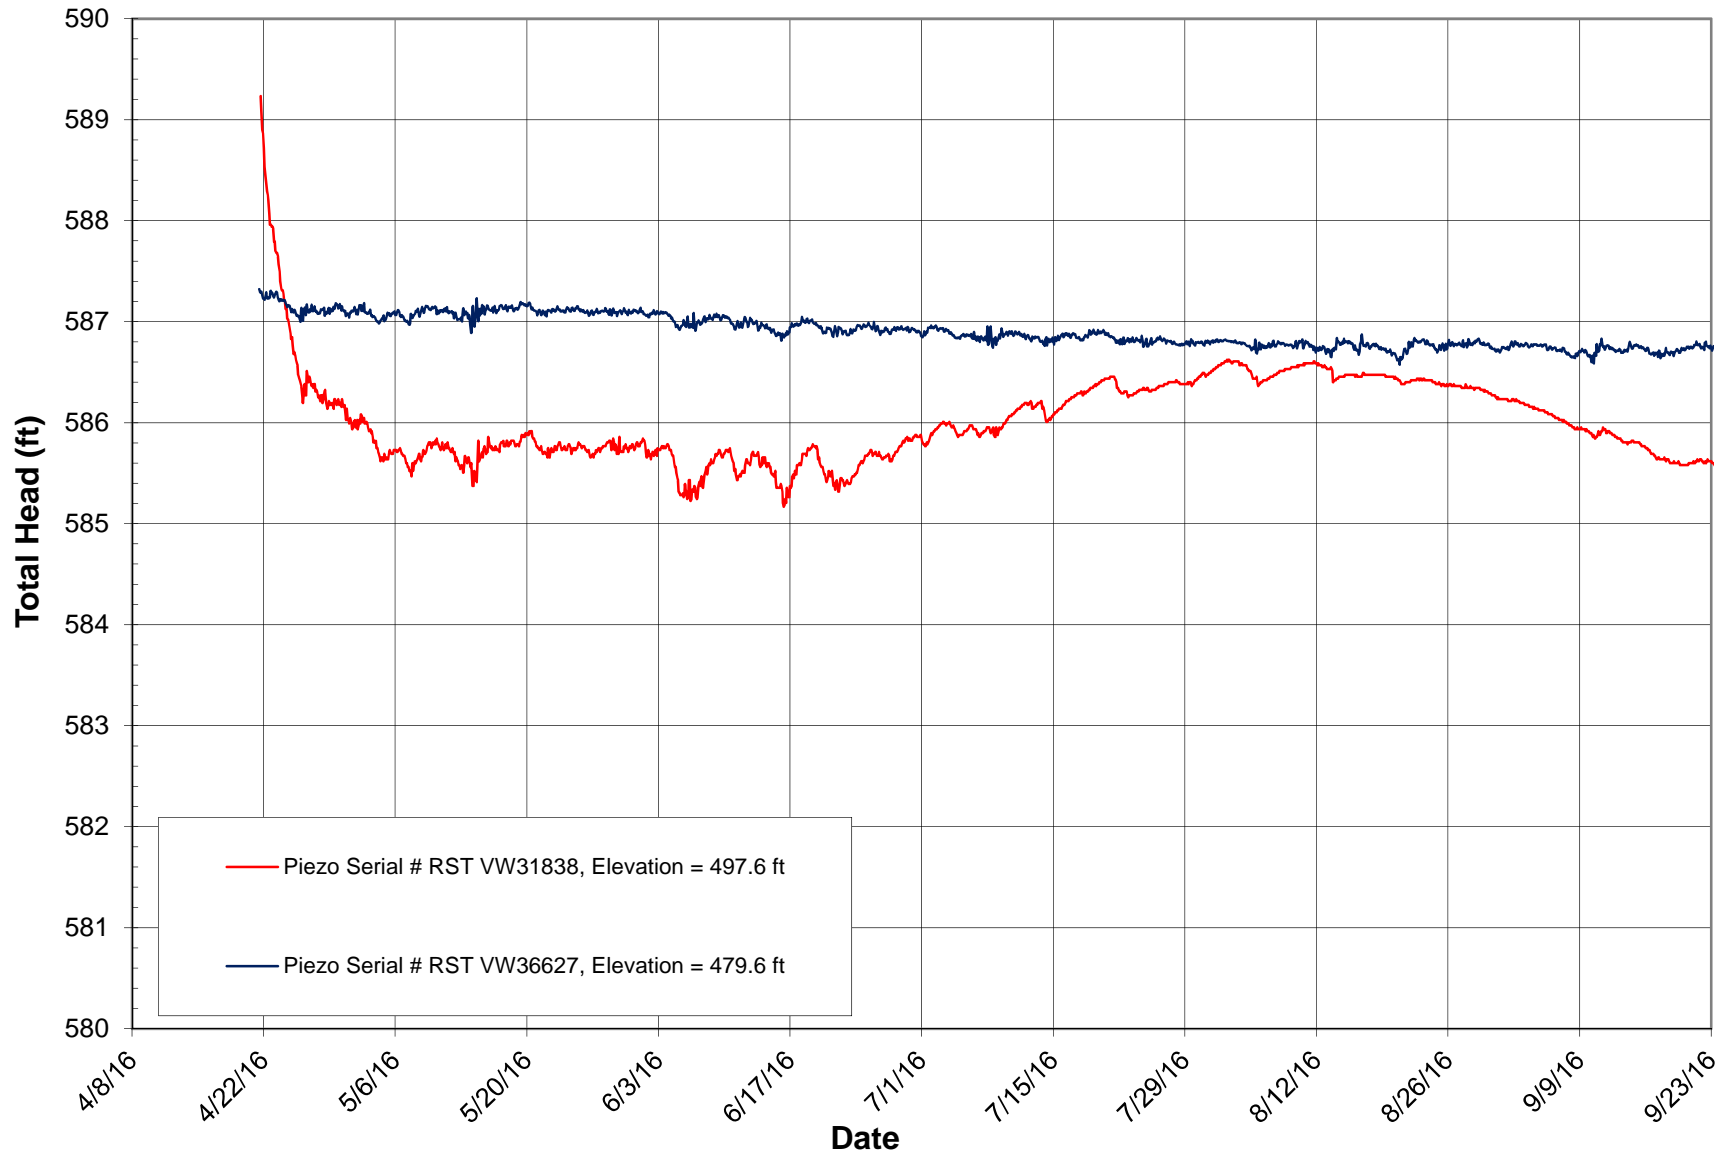
B-105A VW Piezometer Readings

B-105A – Total head in the shallow piezometer at this location continued to decrease for the first half of this recording cycle, then became virtually constant for the remainder. From August 13 to September 17, 2016, the total head in this piezometer decreased by 0.9 feet. Pore pressures in the deep piezometer show virtually no change.

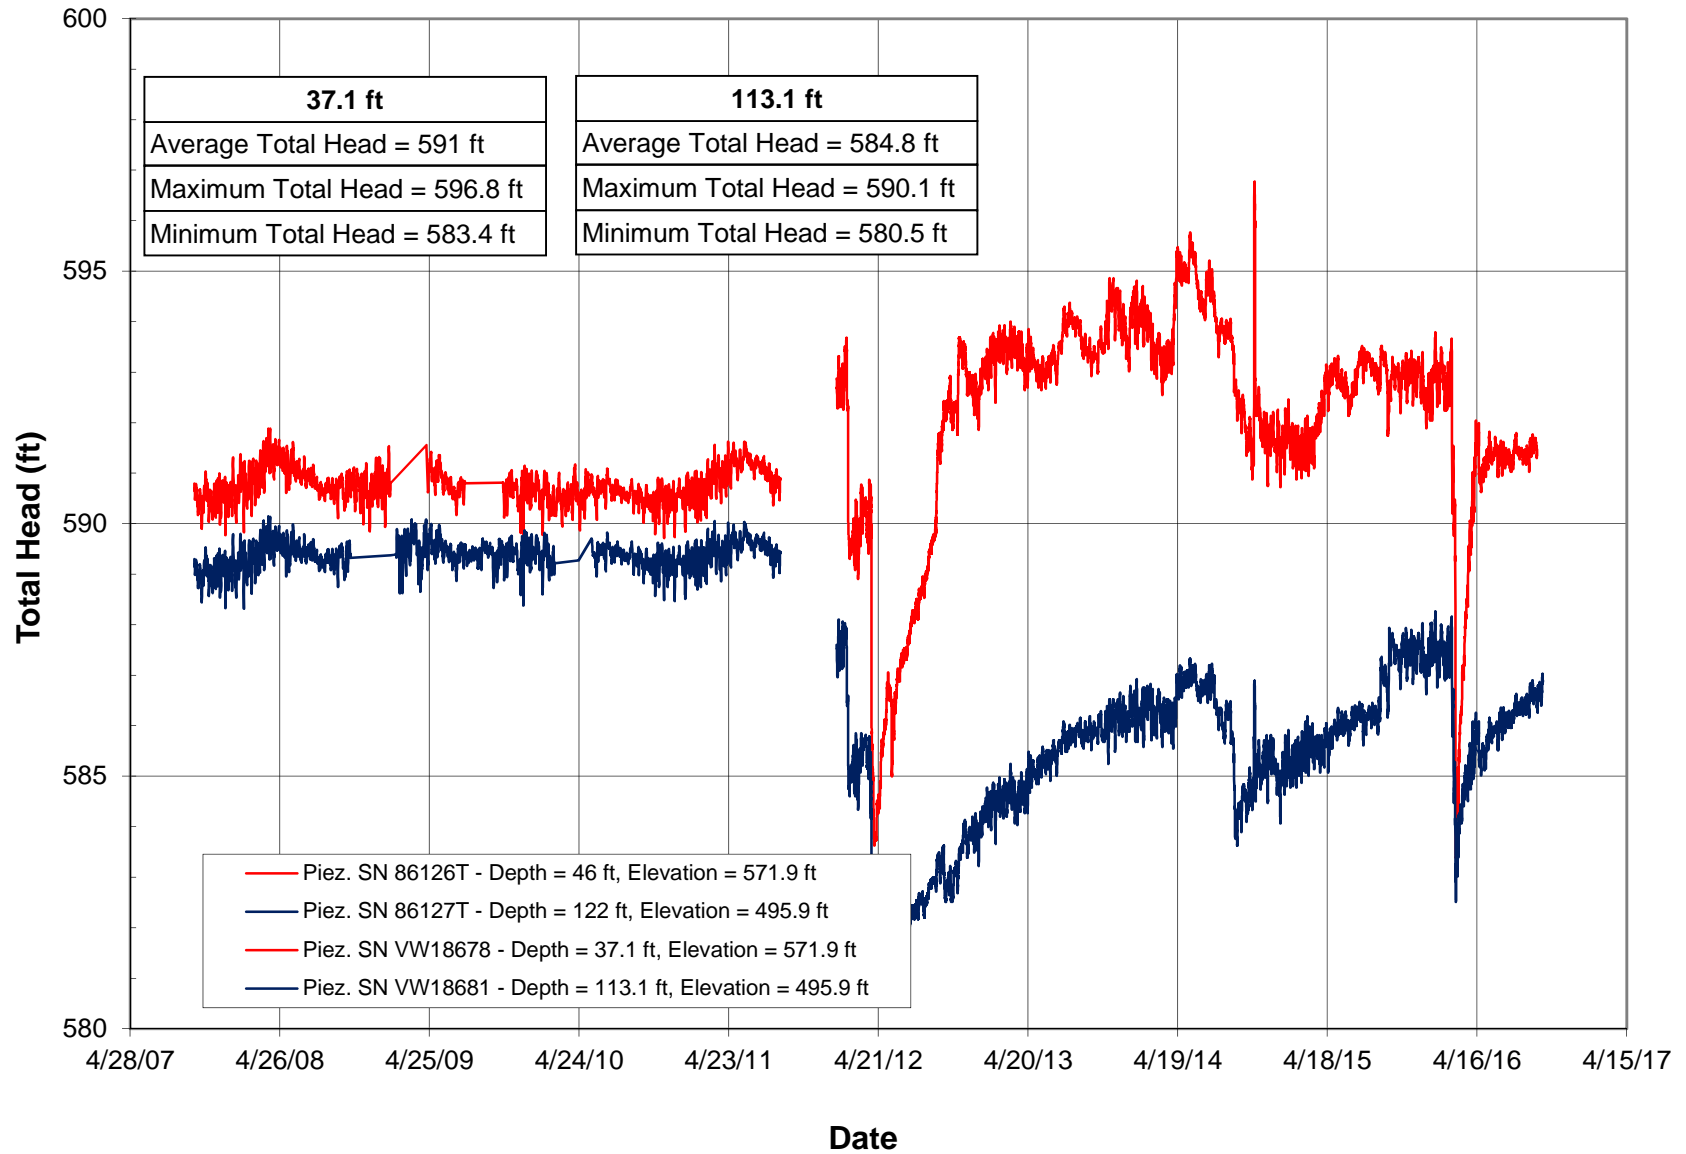
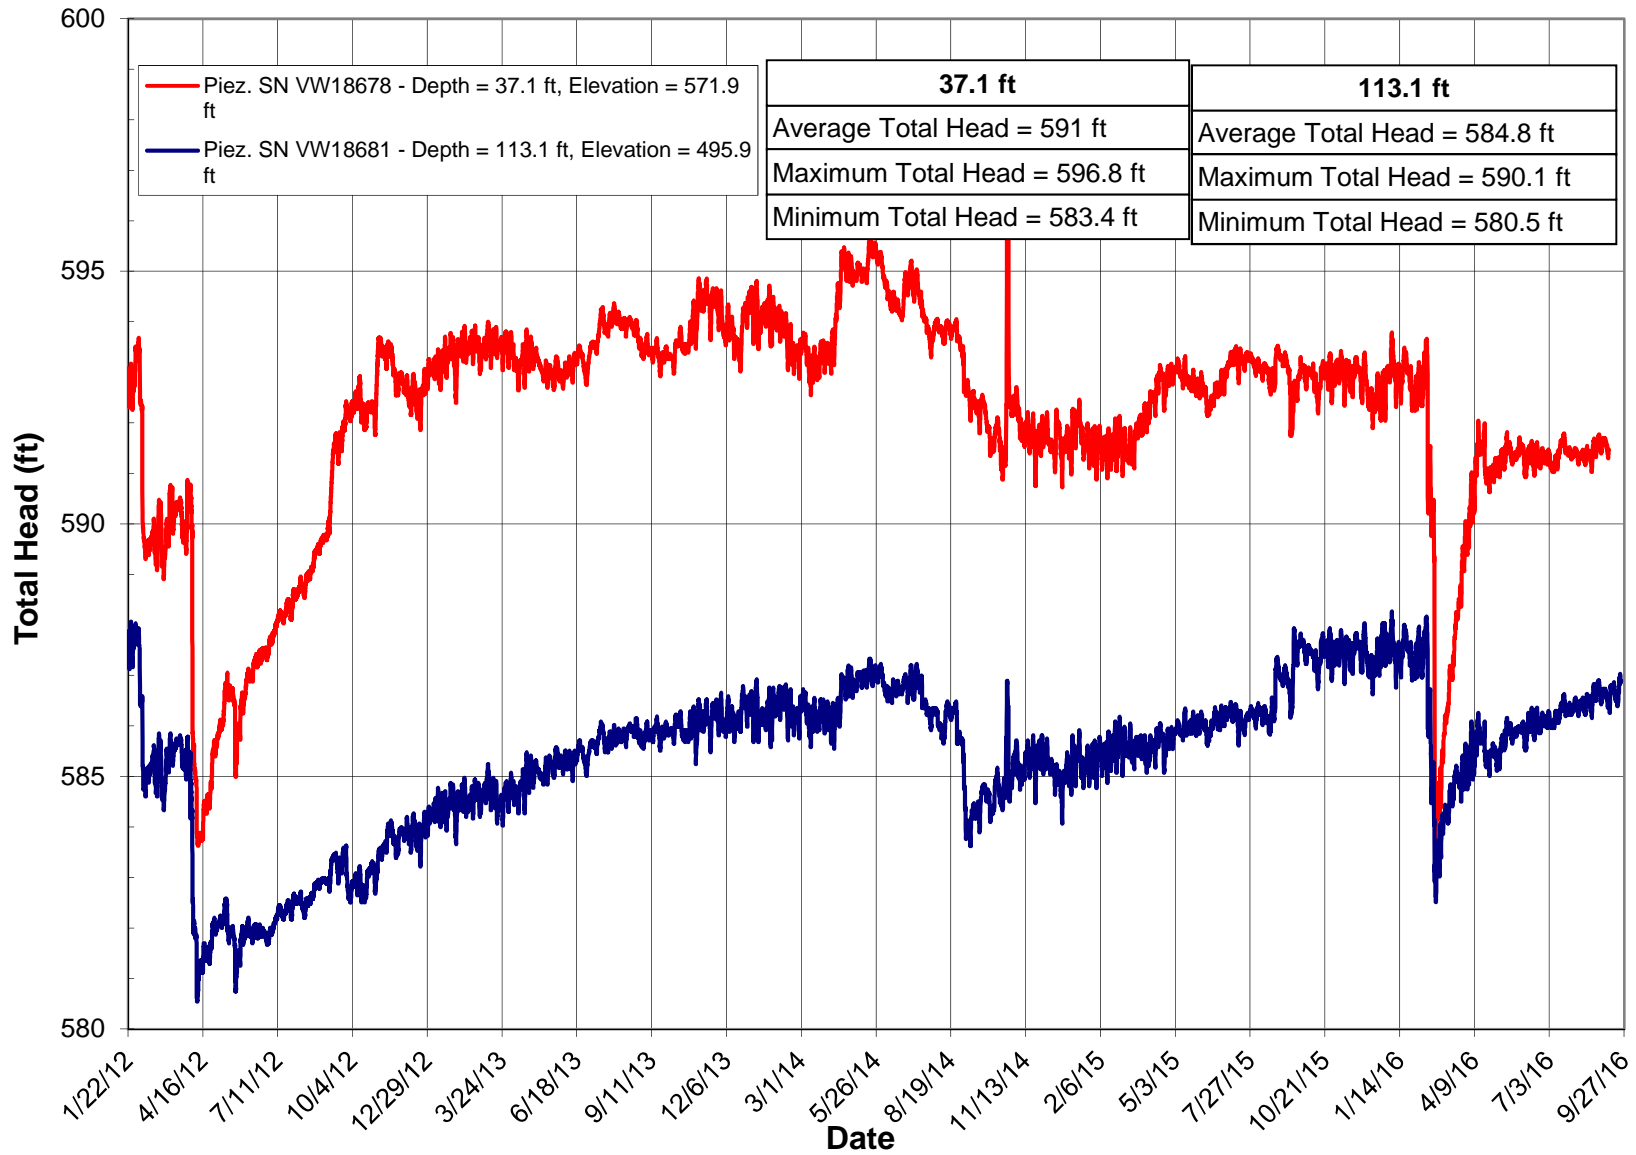
B-05-02 VW Piezometer Readings

B-05-02 – Pore pressure readings in the deep piezometer at this location indicate an increase in total head of 0.3 feet. Total head in this piezometer has been increasing since February 2016. Due to an issue with the data logger, we were not able to download data for the shallow piezometer this week. This was due to a faulty battery which has now been replaced.

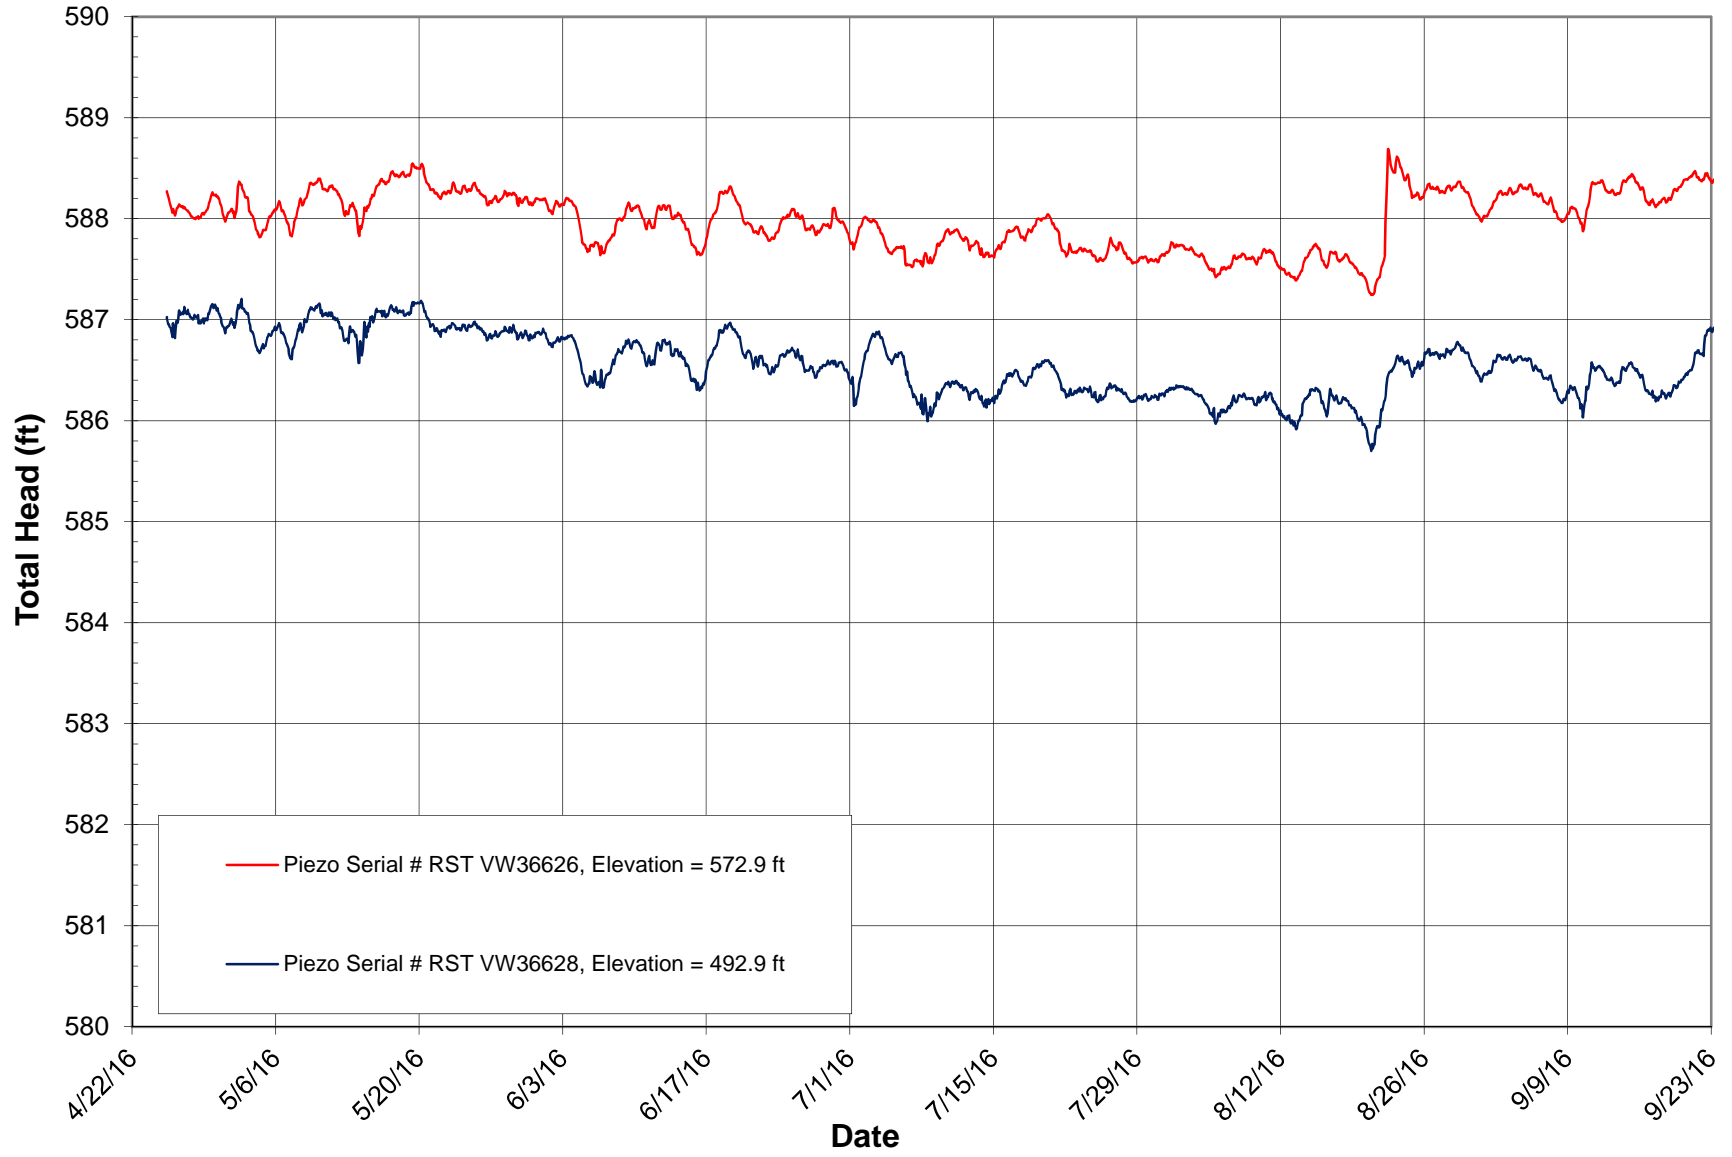
B-05-A-03 VW Piezometer Readings

B-05-A-03 – At this location, pore pressure readings indicate an increase in total head of 0.3 feet in the shallow piezometer and 0.6 feet in the deep piezometer.

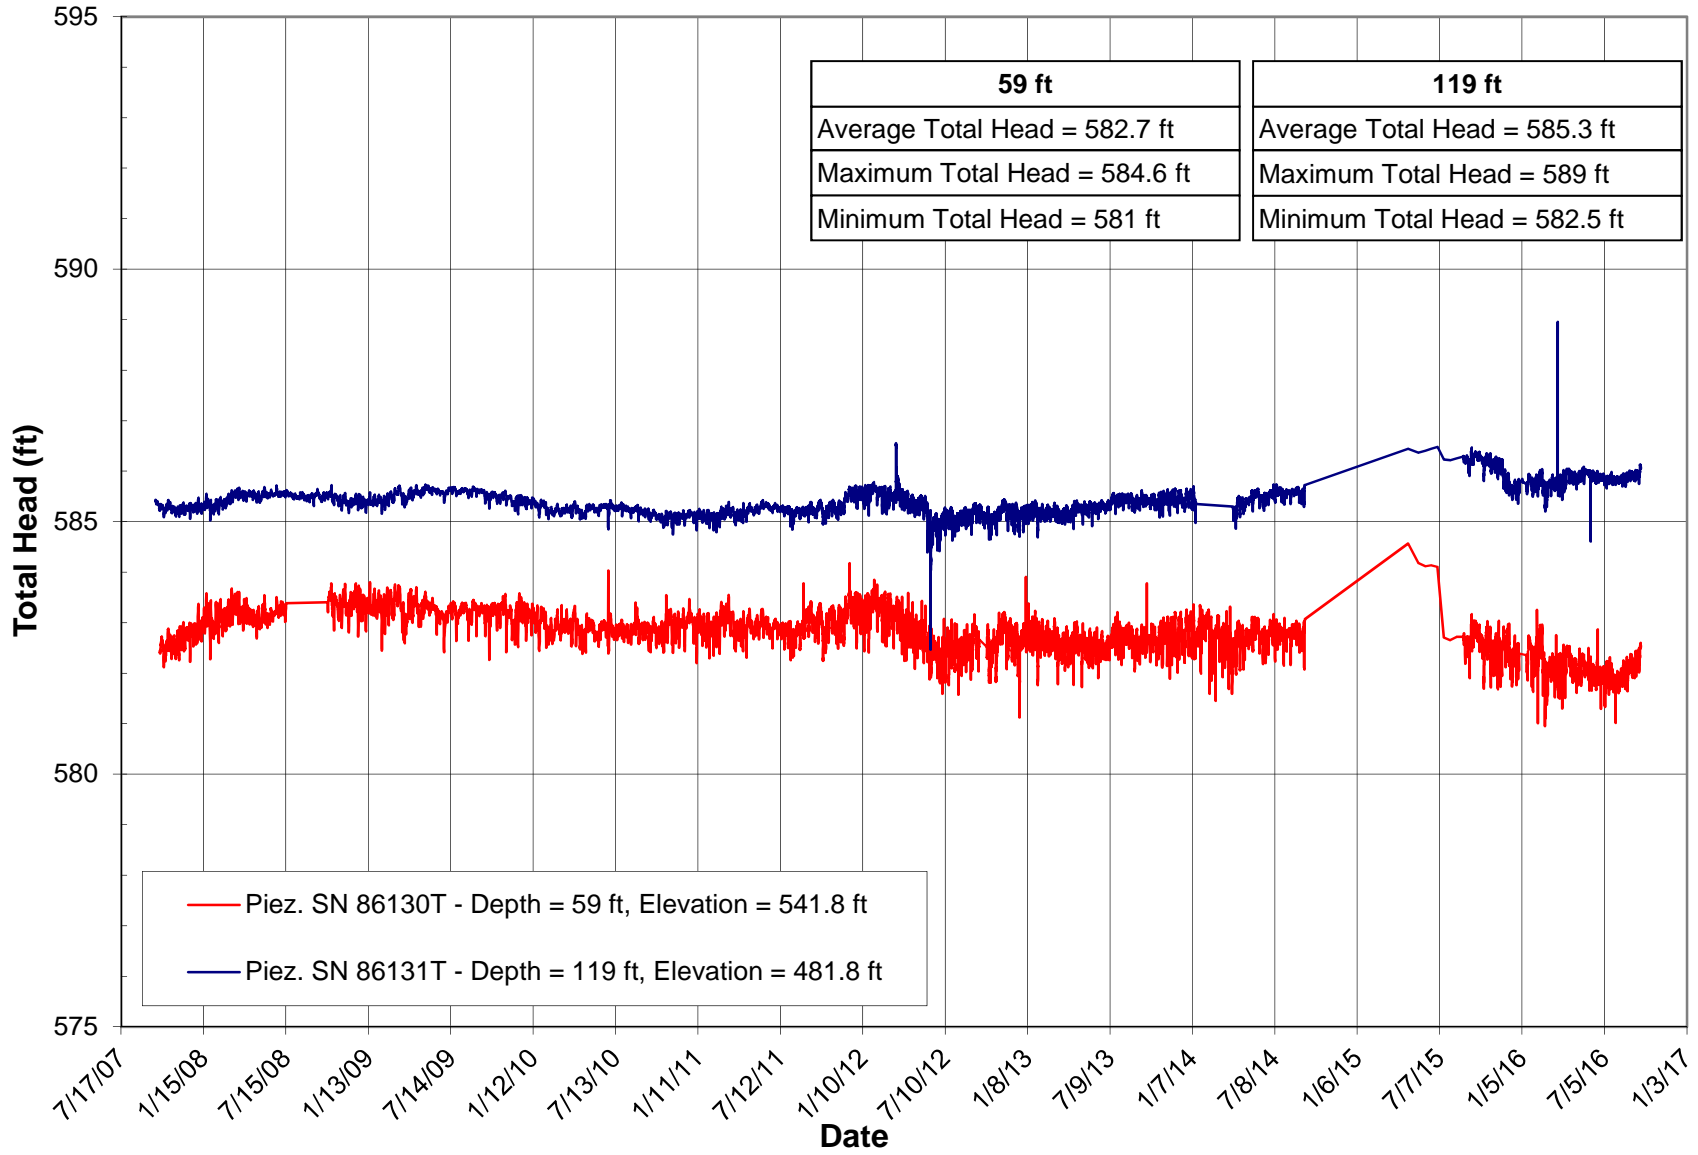
B-05-04 VW Piezometer Readings

B-05-04 – Pore pressure readings indicate an increase in total head of 0.5 feet in the shallow piezometer and 0.2 feet in the deep piezometer. Total head in the shallow piezometer has been increasing since the beginning of August 2016.
