Re: September 22, 23, 26, and 27, 2016 Bi-Weekly Readings
CUY-90-15.24 Slope Monitoring
PID 96504
SME Project No. 069032.00

Bi-weekly instrument readings for the I-90 west slope taken on September 22, 23, 26, and 27, 2016, are presented in this report. Bi-weekly readings currently include instruments at I/P-001-13, I/P-002-13, I/P-003-10, I/P-004-13, I/P-009-13, B-101, B-102, B-105A, B-05-02, B-05-A-03, B-05-04, B-05-A-11, P-1, P-9N, and TGR I-4. Changes reported for the individual instruments are for the previous two-week period unless noted otherwise.

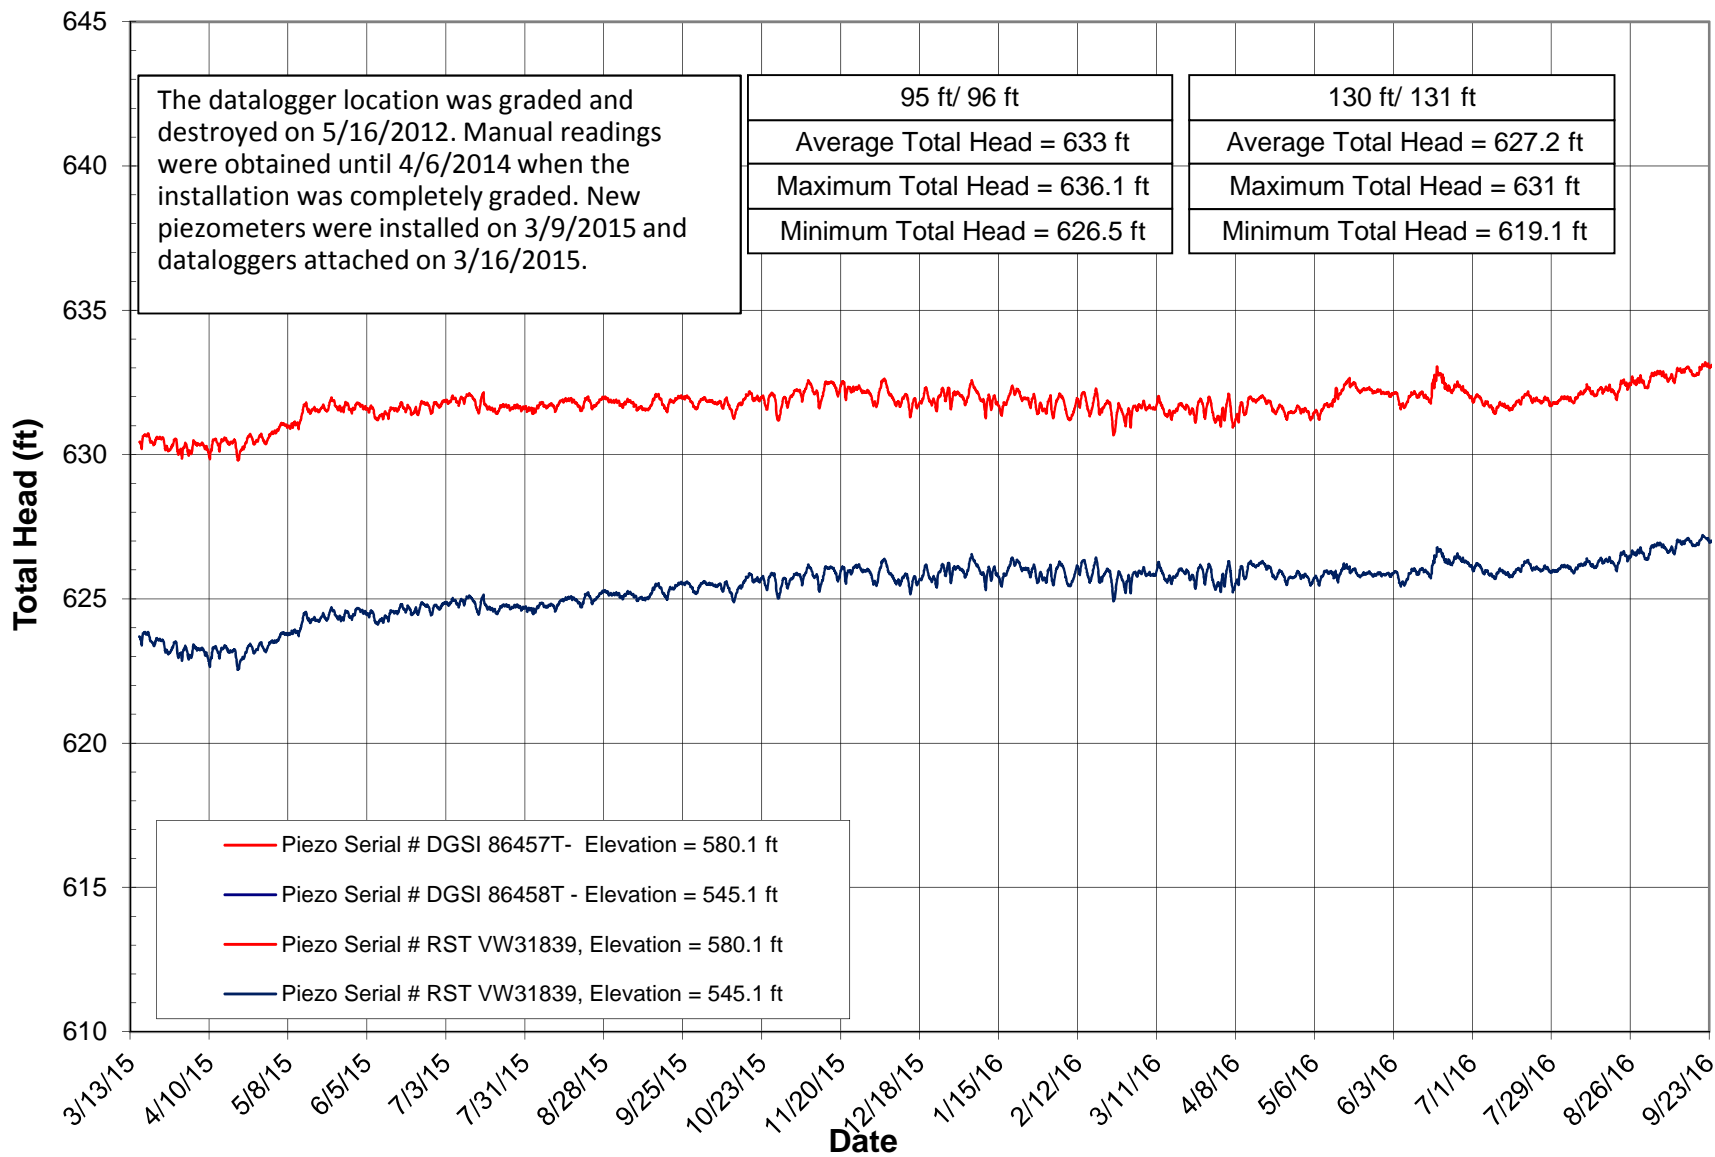
B-05-11/B-05-A-11 VW Piezometer Readings

B-05-A-11 – Pore pressure readings at this location indicate a continued increase in total head in both piezometers at this location. Total head has increased by 1.8 feet in the shallow piezometer and 1.3 feet in the deep piezometer since July 9, 2016.

B-05-A-11 – Concrete was placed around the instrument at this location. The contractor cut the inclinometer casing down to make the protective flush-mount cover flush with the new concrete. New baseline readings were taken.

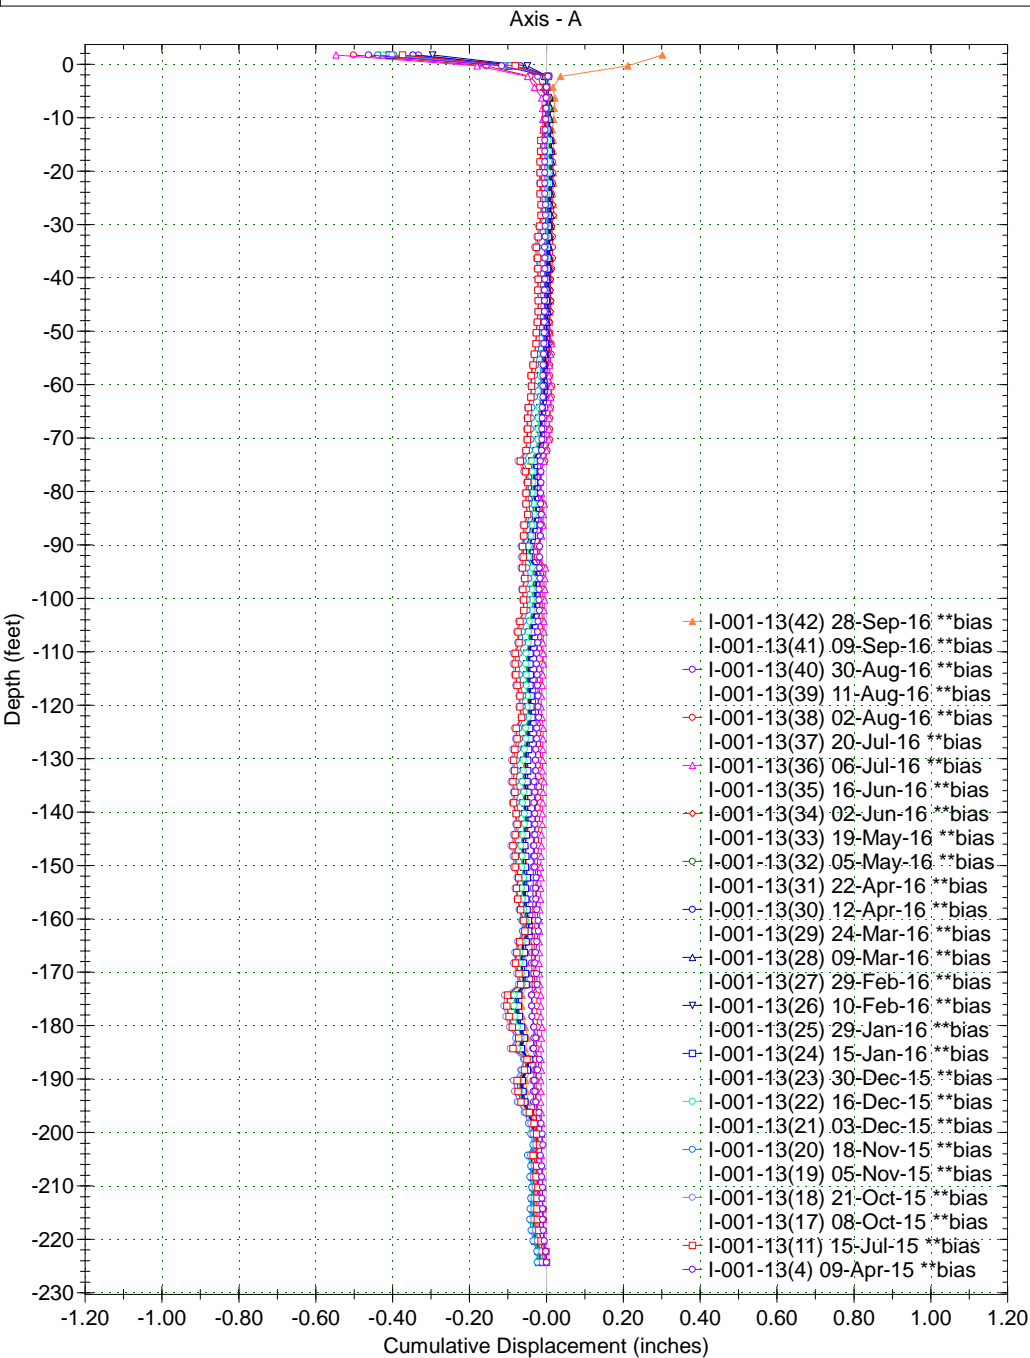
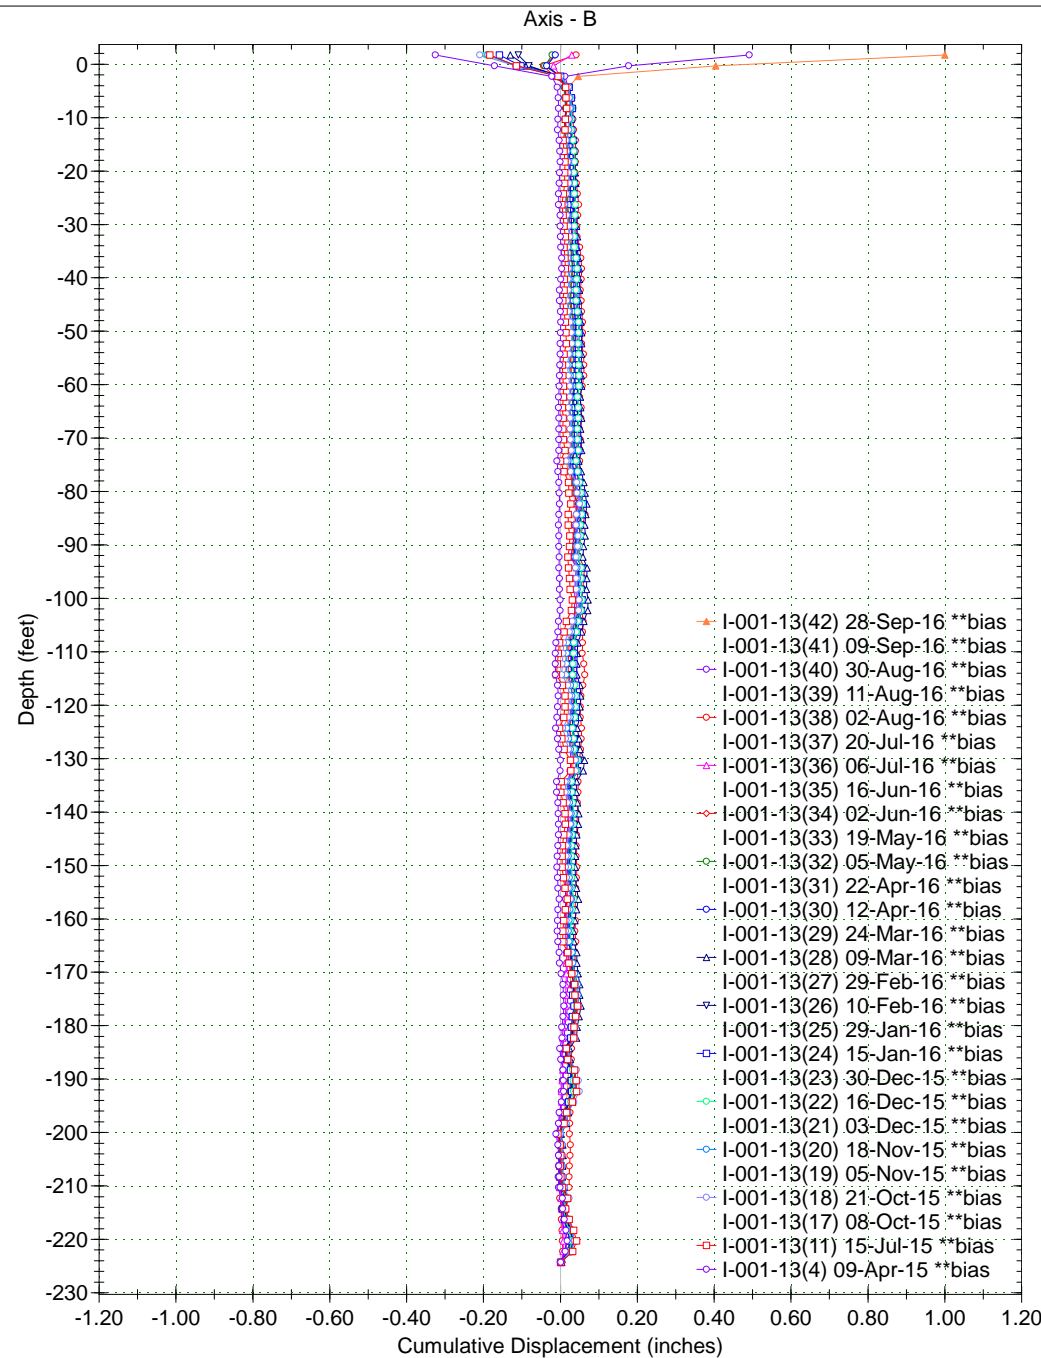
Inclinometer readings at I-001-13, I-002-13, I-004-13, I-009-13, B-101, B-102, B-105A, B-05-02, B-05-A-03, B-05-04, P-1, P-9N, and TGR I-4 showed virtually no movement. Displacement at the top of some slope tubes is due to surface disturbance adjacent to the installation or flexing of the inclinometer tube as readings were taken in instances where the protective covers have not yet been concreted in place because of the ongoing construction activity.
