October 21, 2016

Re: October 6, 7, and 13, 2016 Bi-Weekly Readings
CUY-90-15.24 Slope Monitoring
PID 96504
SME Project No. 069032.00

Bi-weekly instrument readings for the I-90 west slope taken on October 6, 7, and 13, 2016, are presented in this report. Bi-weekly readings currently include instruments at I/P-001-13, I/P-002-13, I/P-003-10, I/P-004-13, I/P-009-13, B-101, B-102, B-105A, B-05-02, B-05-A-03, B-05-04, B-05-A-11, P-1, P-9N, and TGR I-4. Changes reported for the individual instruments are for the previous two-week period unless noted otherwise.

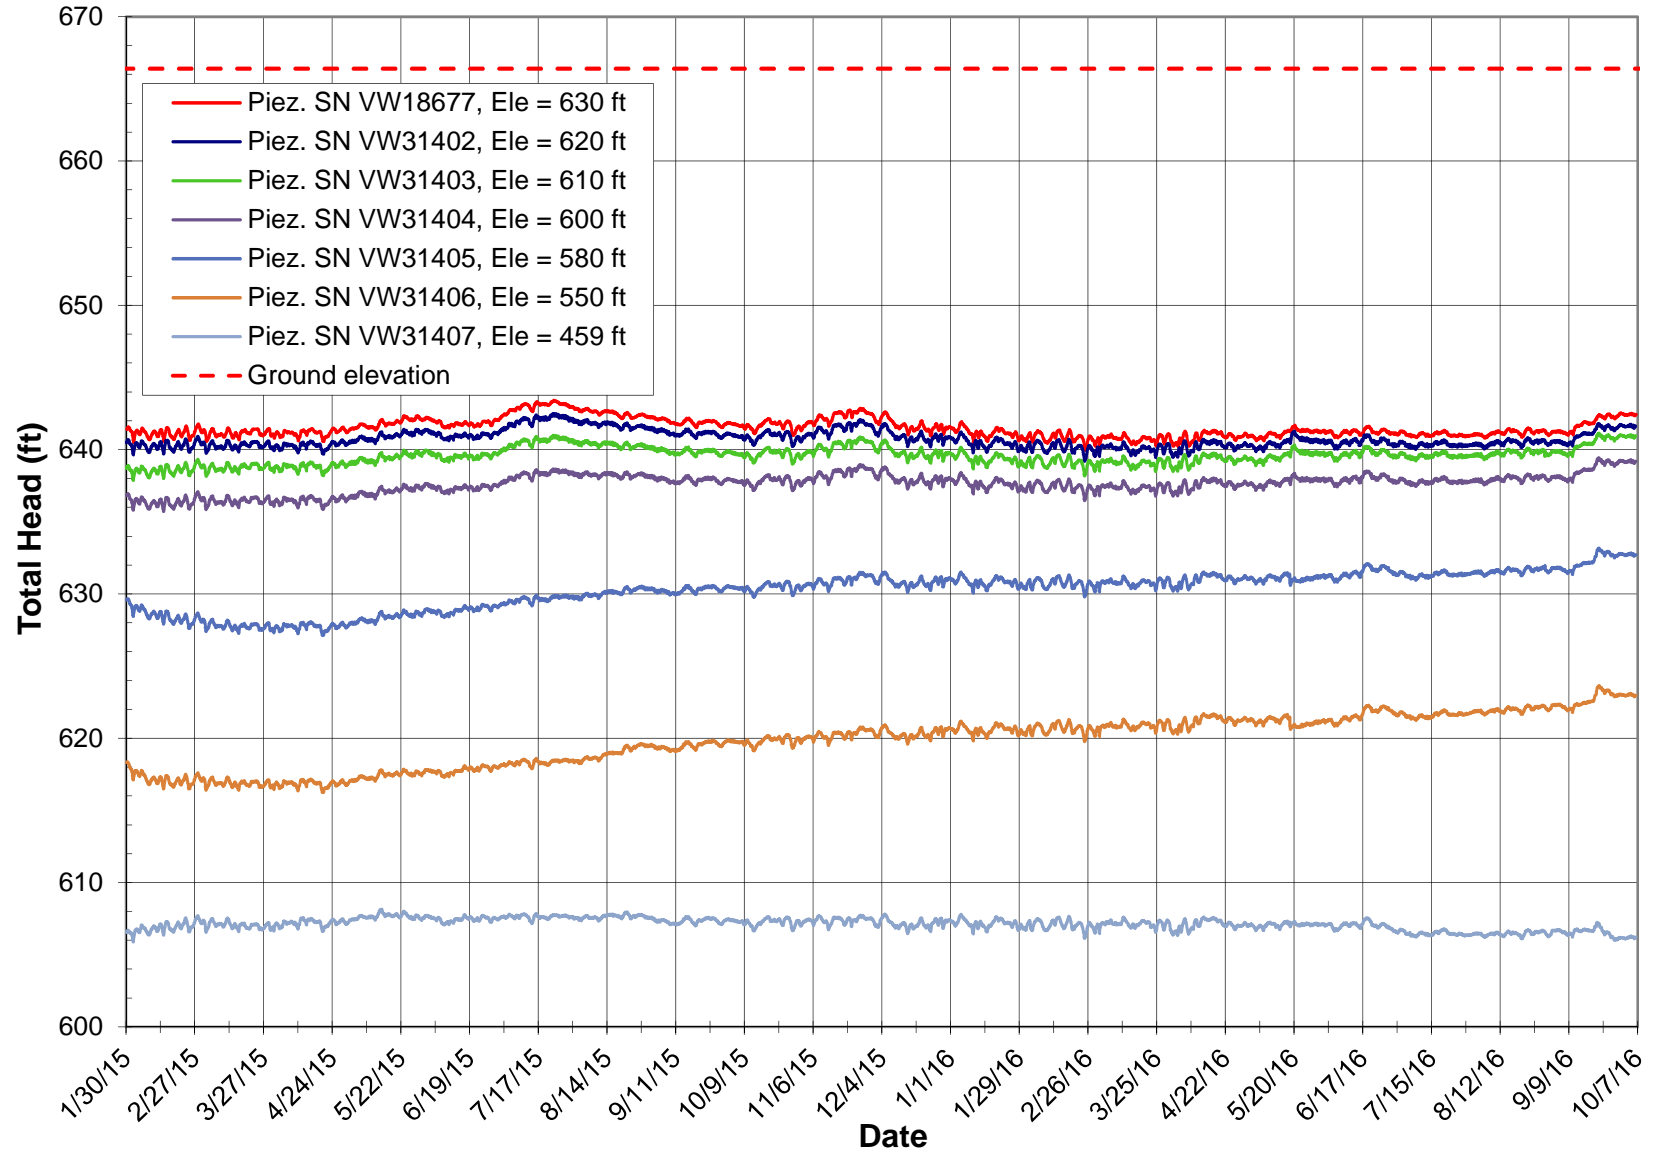
P-001-13 VW Piezometer Readings

P-001-13, P-002-13, P-009-13, B-05-A-11– Pore pressure readings at these locations fluctuated by less than 0.5 feet, and show virtually no net change in total head for the period.

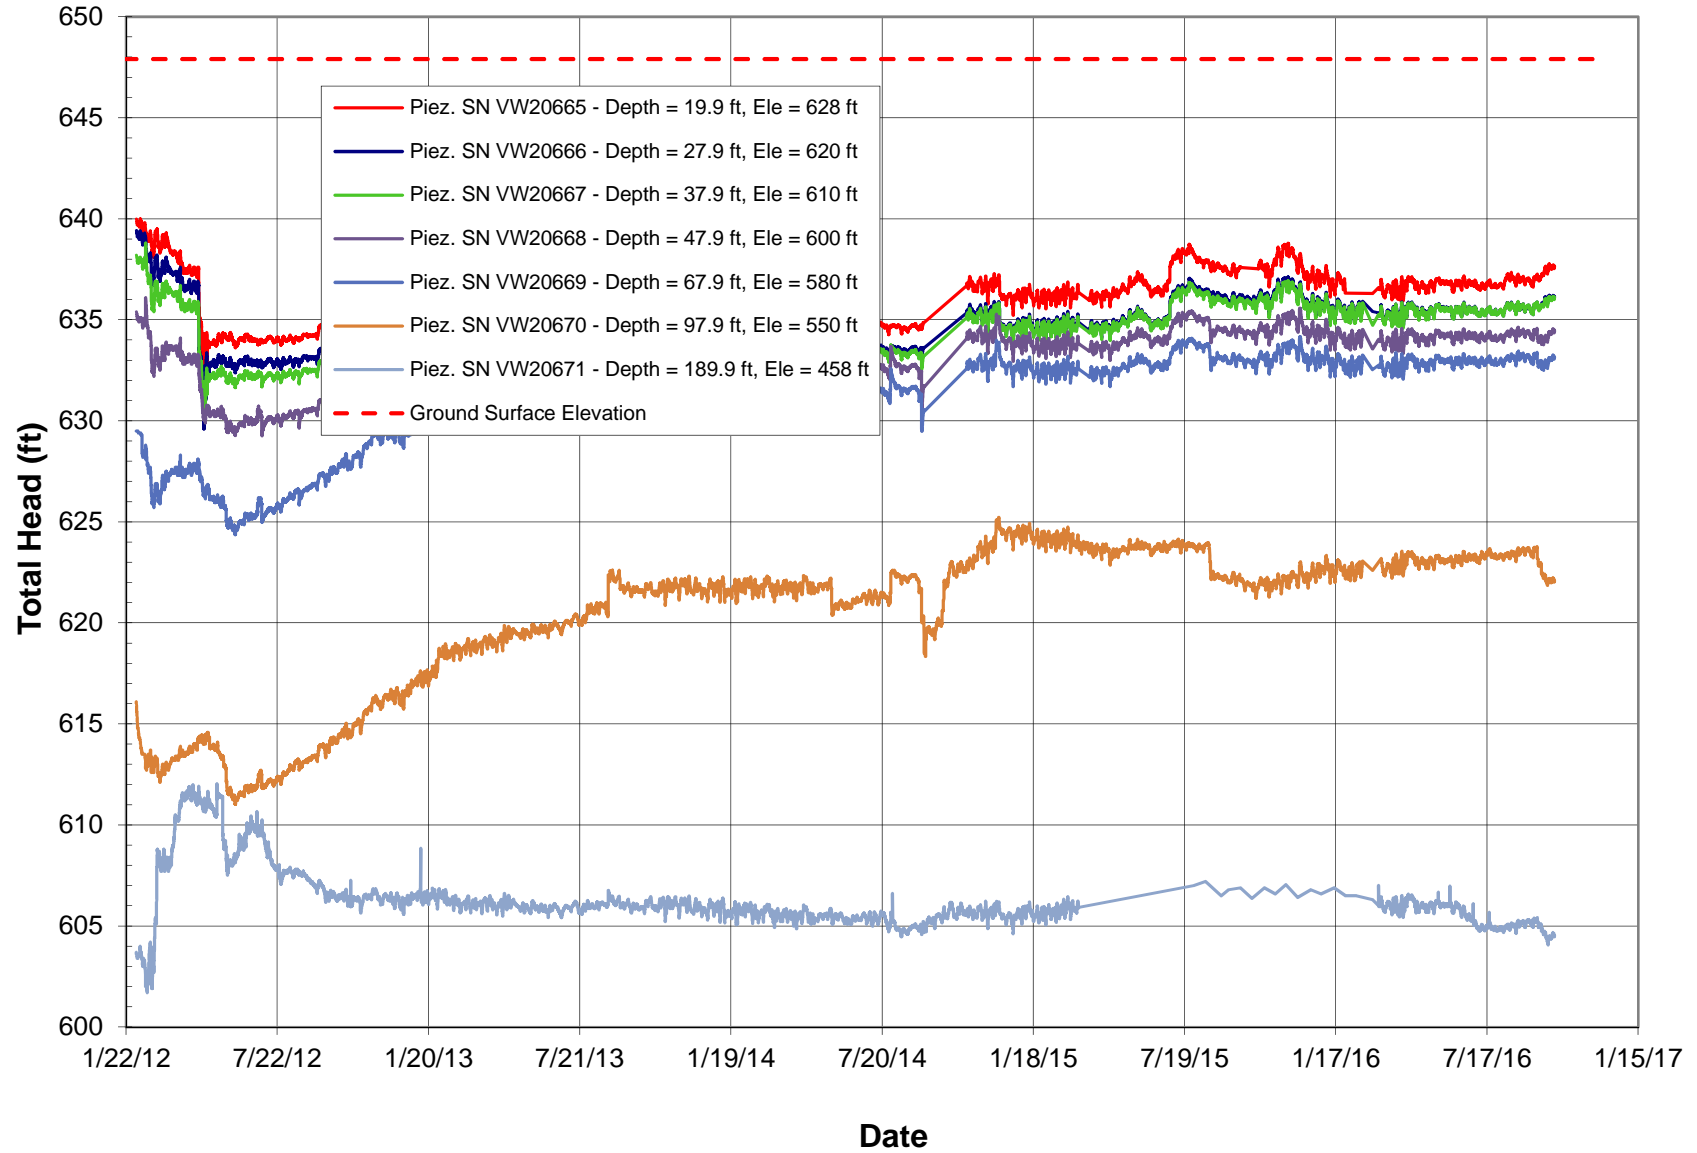
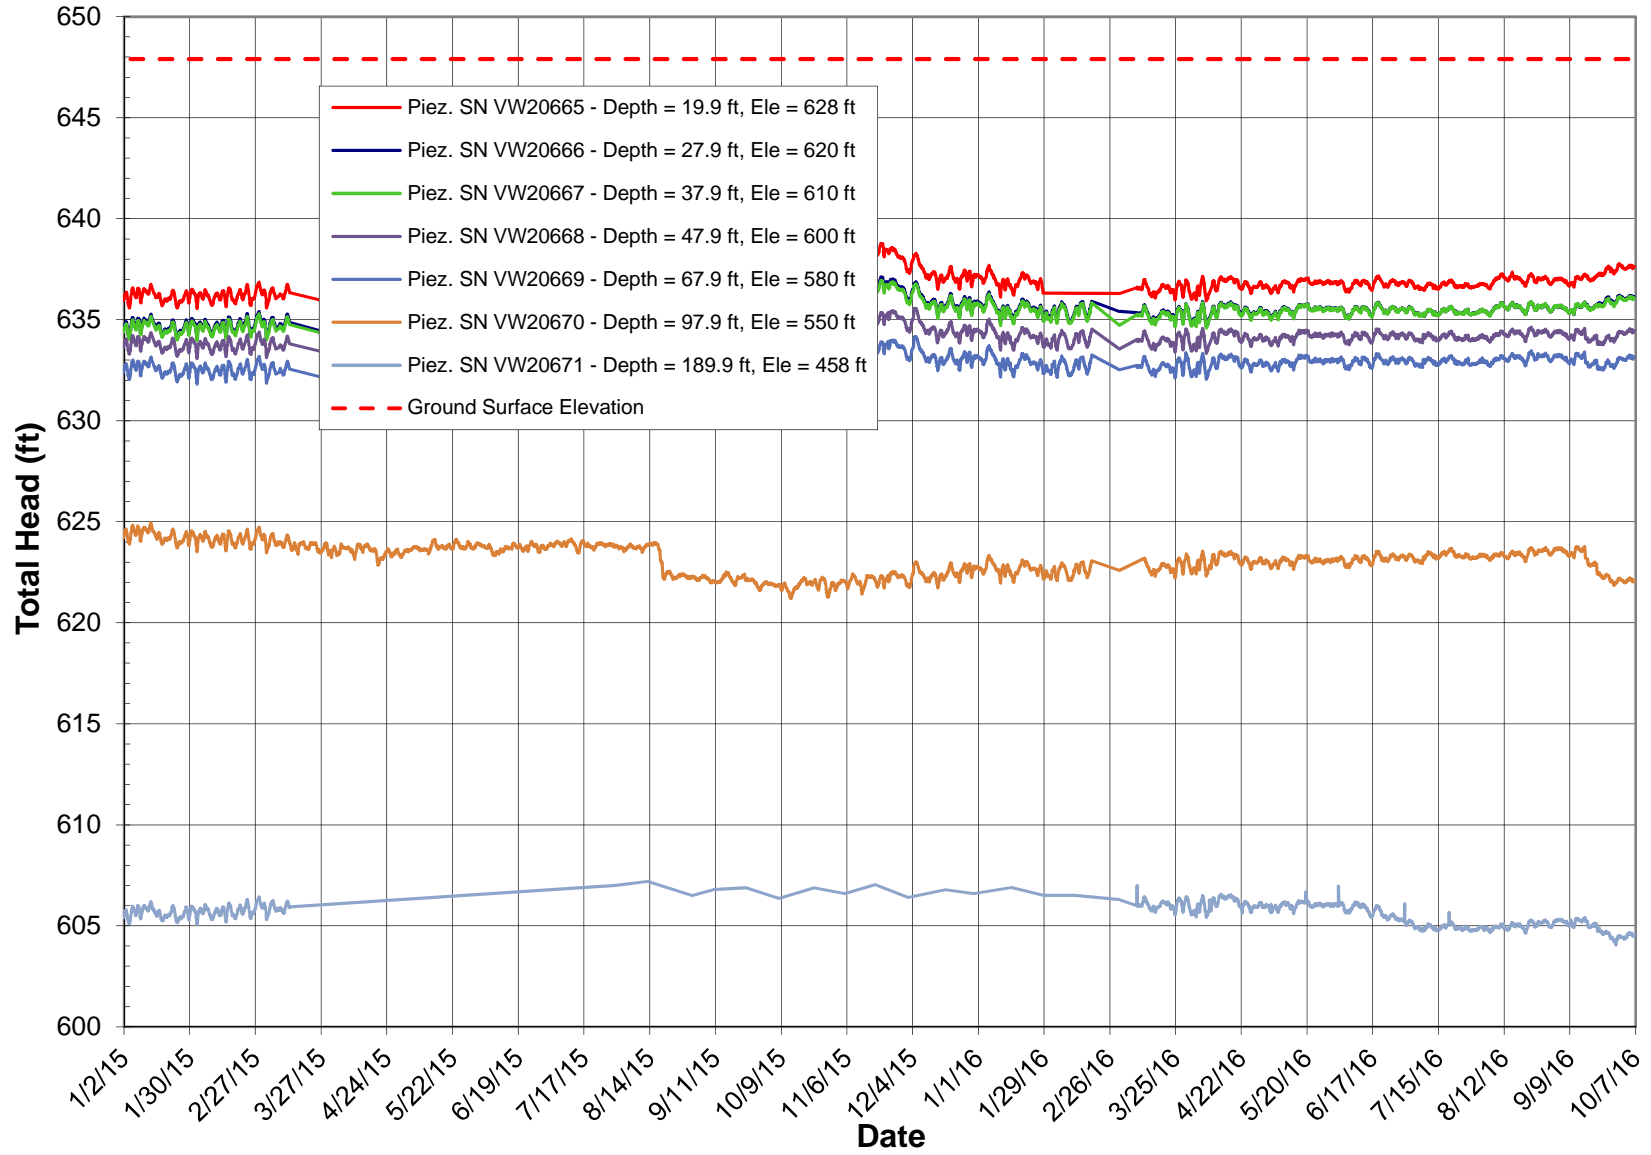
P-003-10 VW Piezometer Readings

P-003-10 – Pore pressure readings in the five shallowest piezometers at this location indicate total head increases ranging from 0.3 to 0.6 feet, with the largest increases occurring at 48 feet and 68 feet. Total head in the two deepest piezometers remained virtually constant.

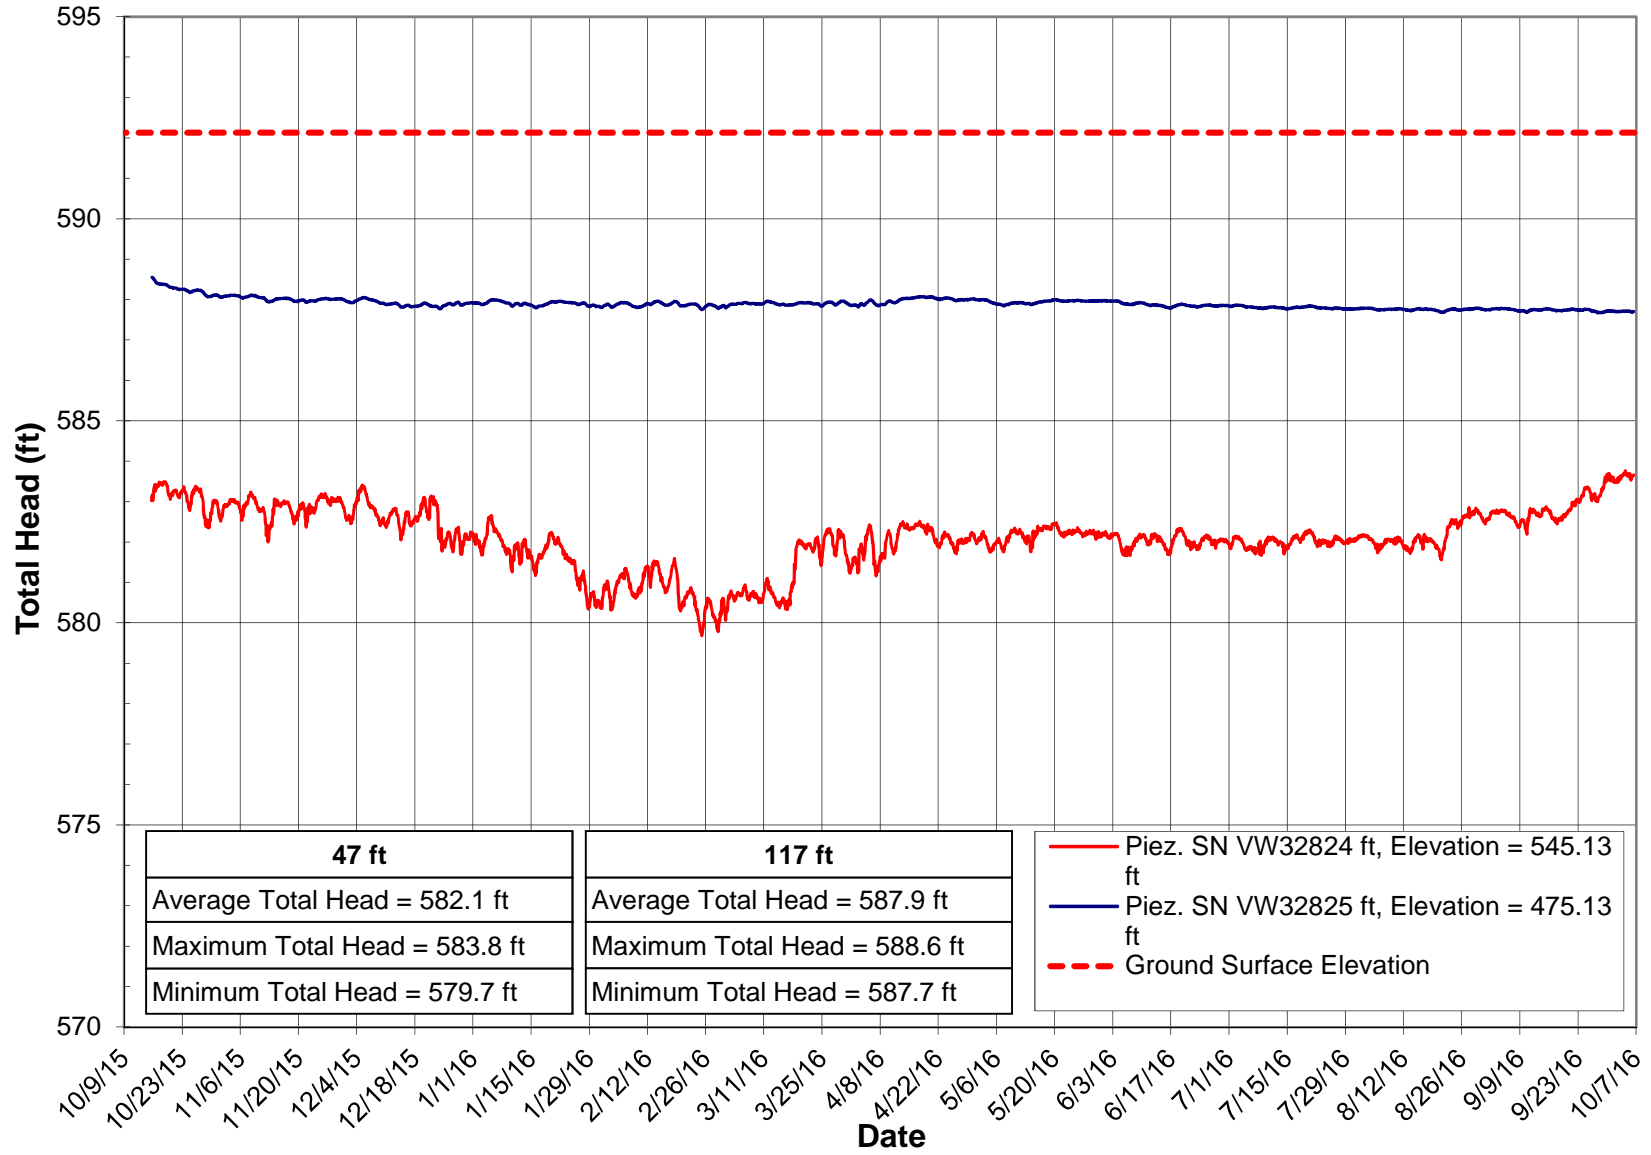
P-004-13 VW Piezometer Readings

P-004-13 – Total head in the shallow piezometer at this location increased by 0.7 feet during this period, which equates to an increase of 2.1 feet since August 21, 2016. Total head in the deep piezometer has remained virtually constant since its installation.

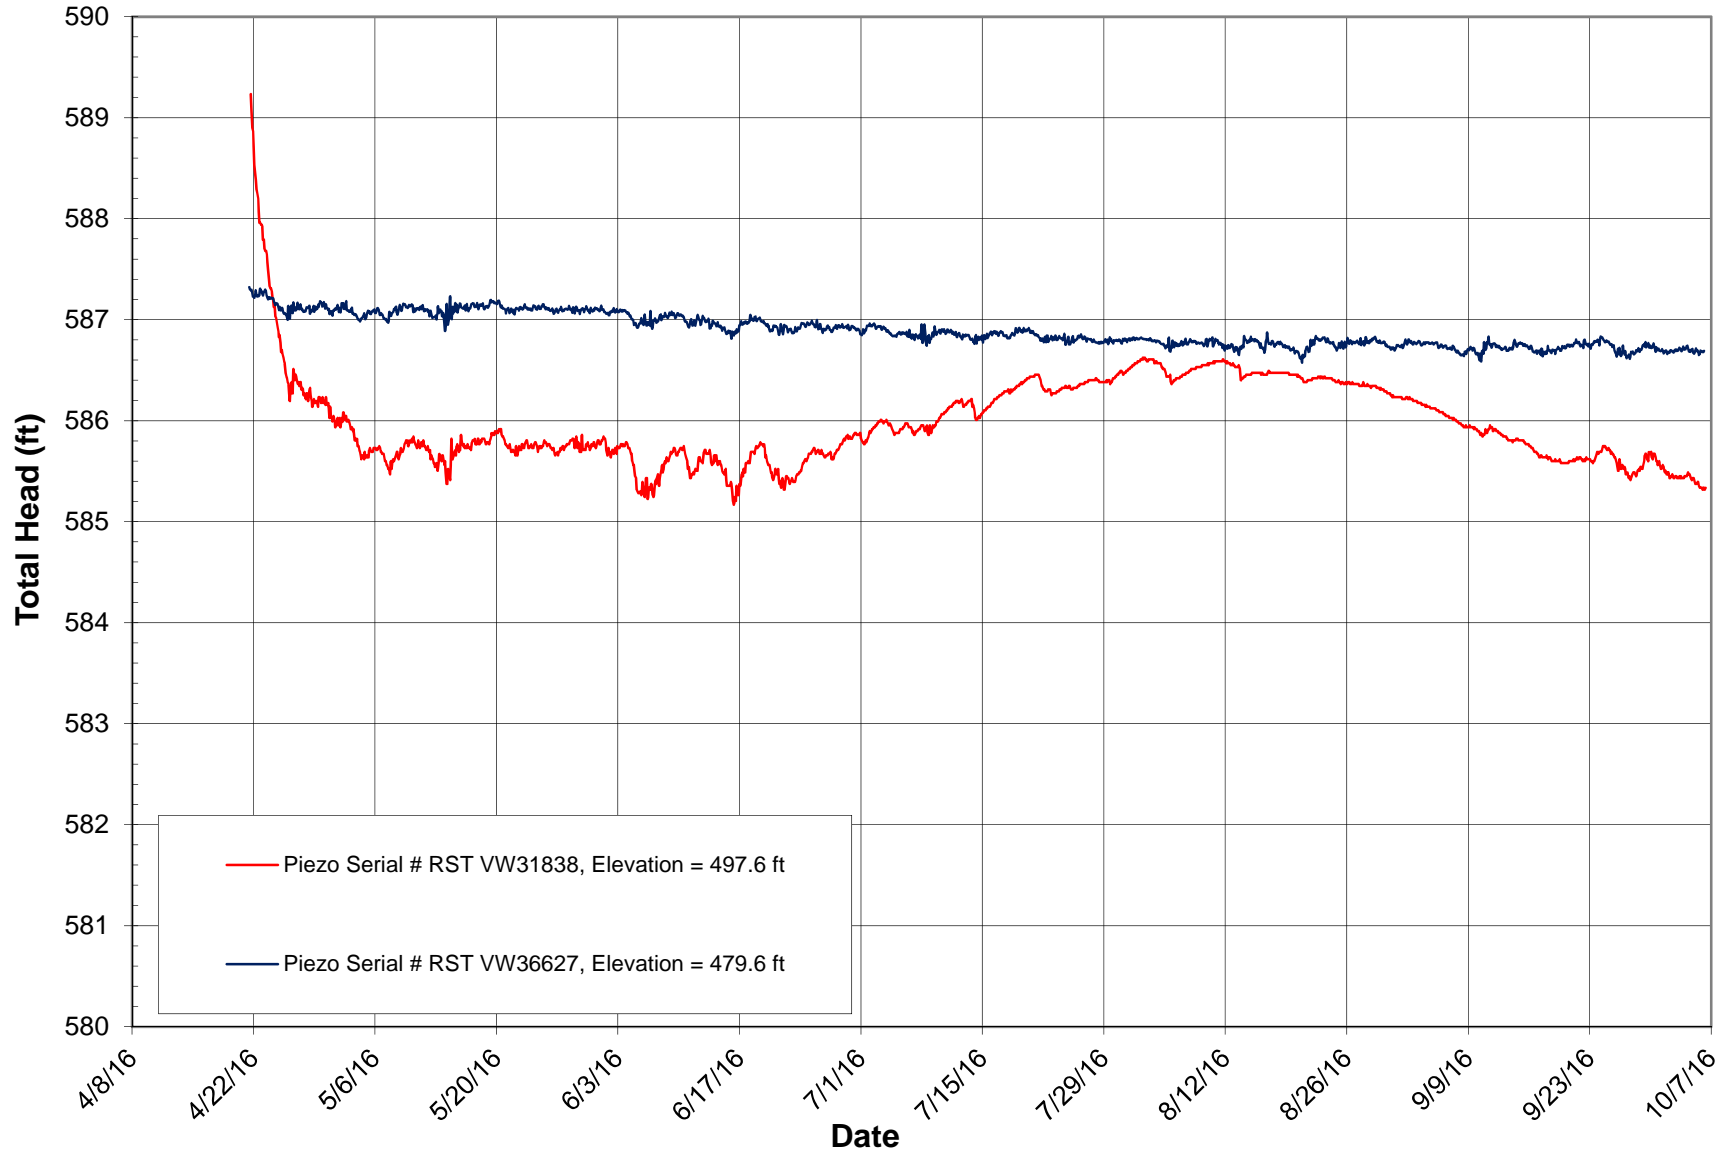
B-105A VW Piezometer Readings

B-105A – Total head in the shallow piezometer at this location continued to decrease during this recording cycle. From August 13 to October 14, 2016, the total head in this piezometer decreased by 1.1 feet. Pore pressures in the deep piezometer show virtually no change in total head.

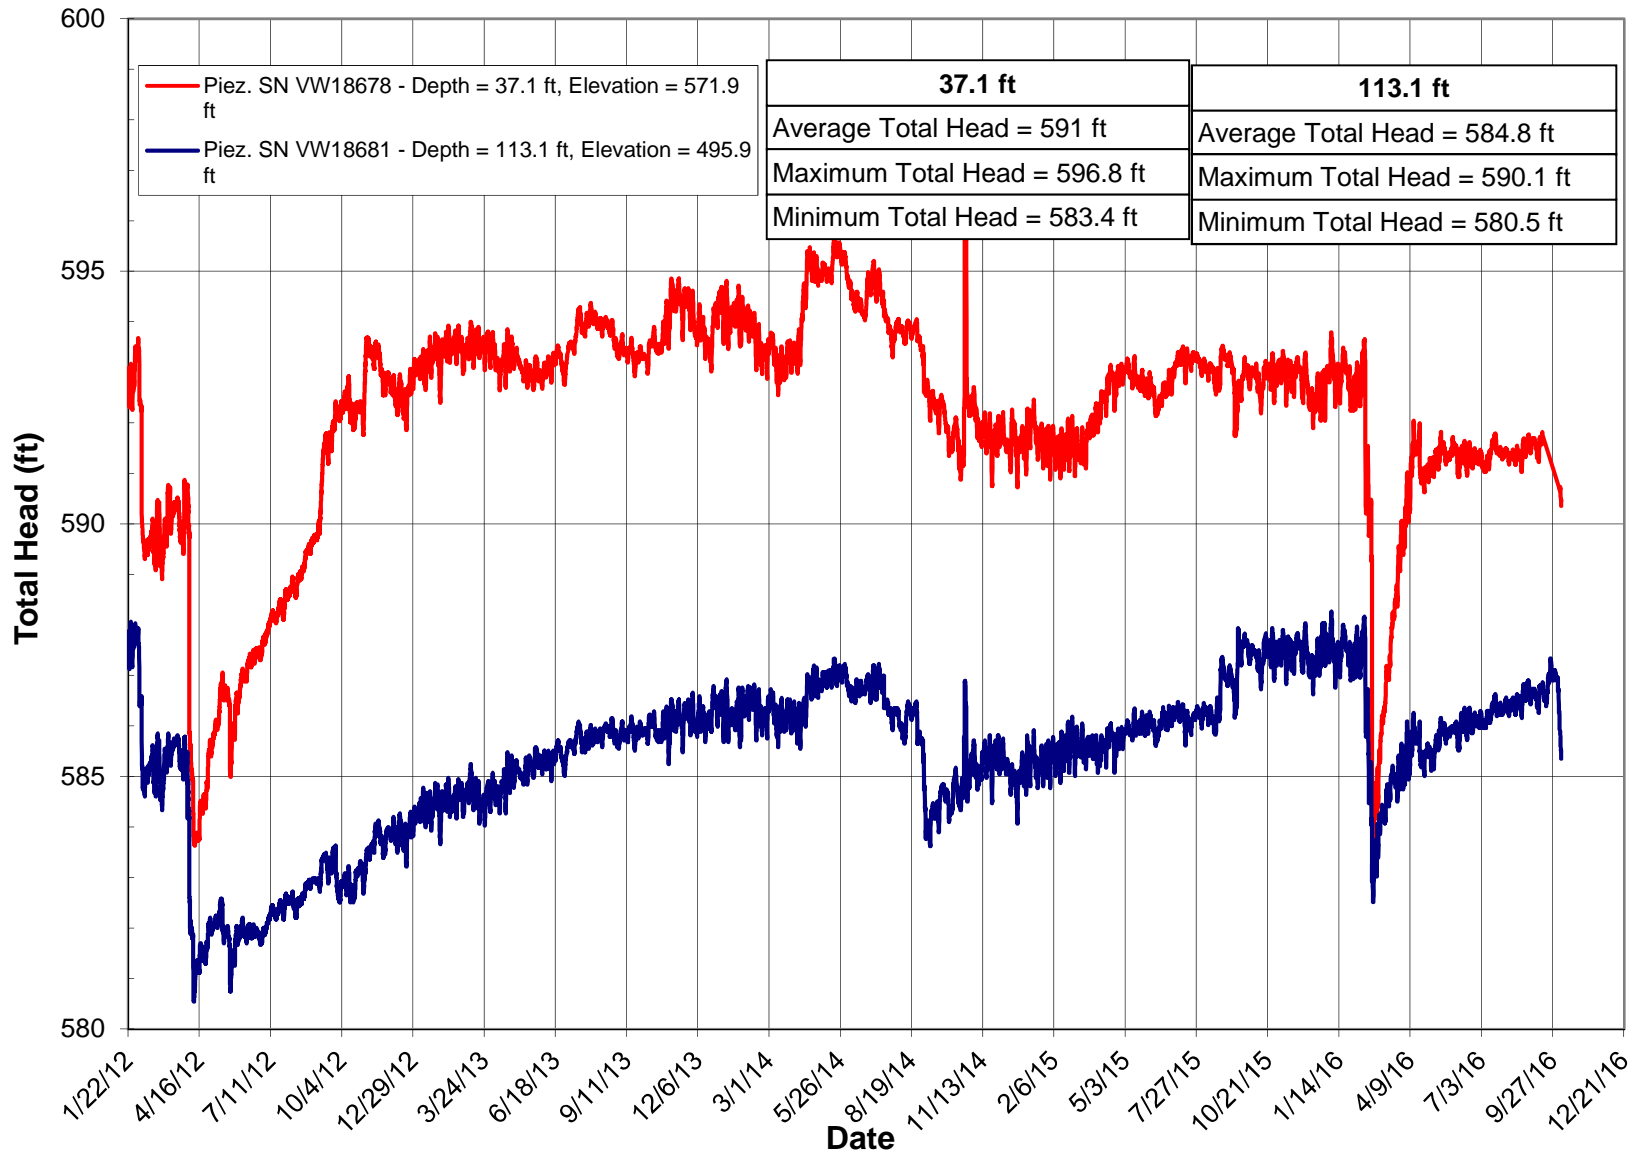
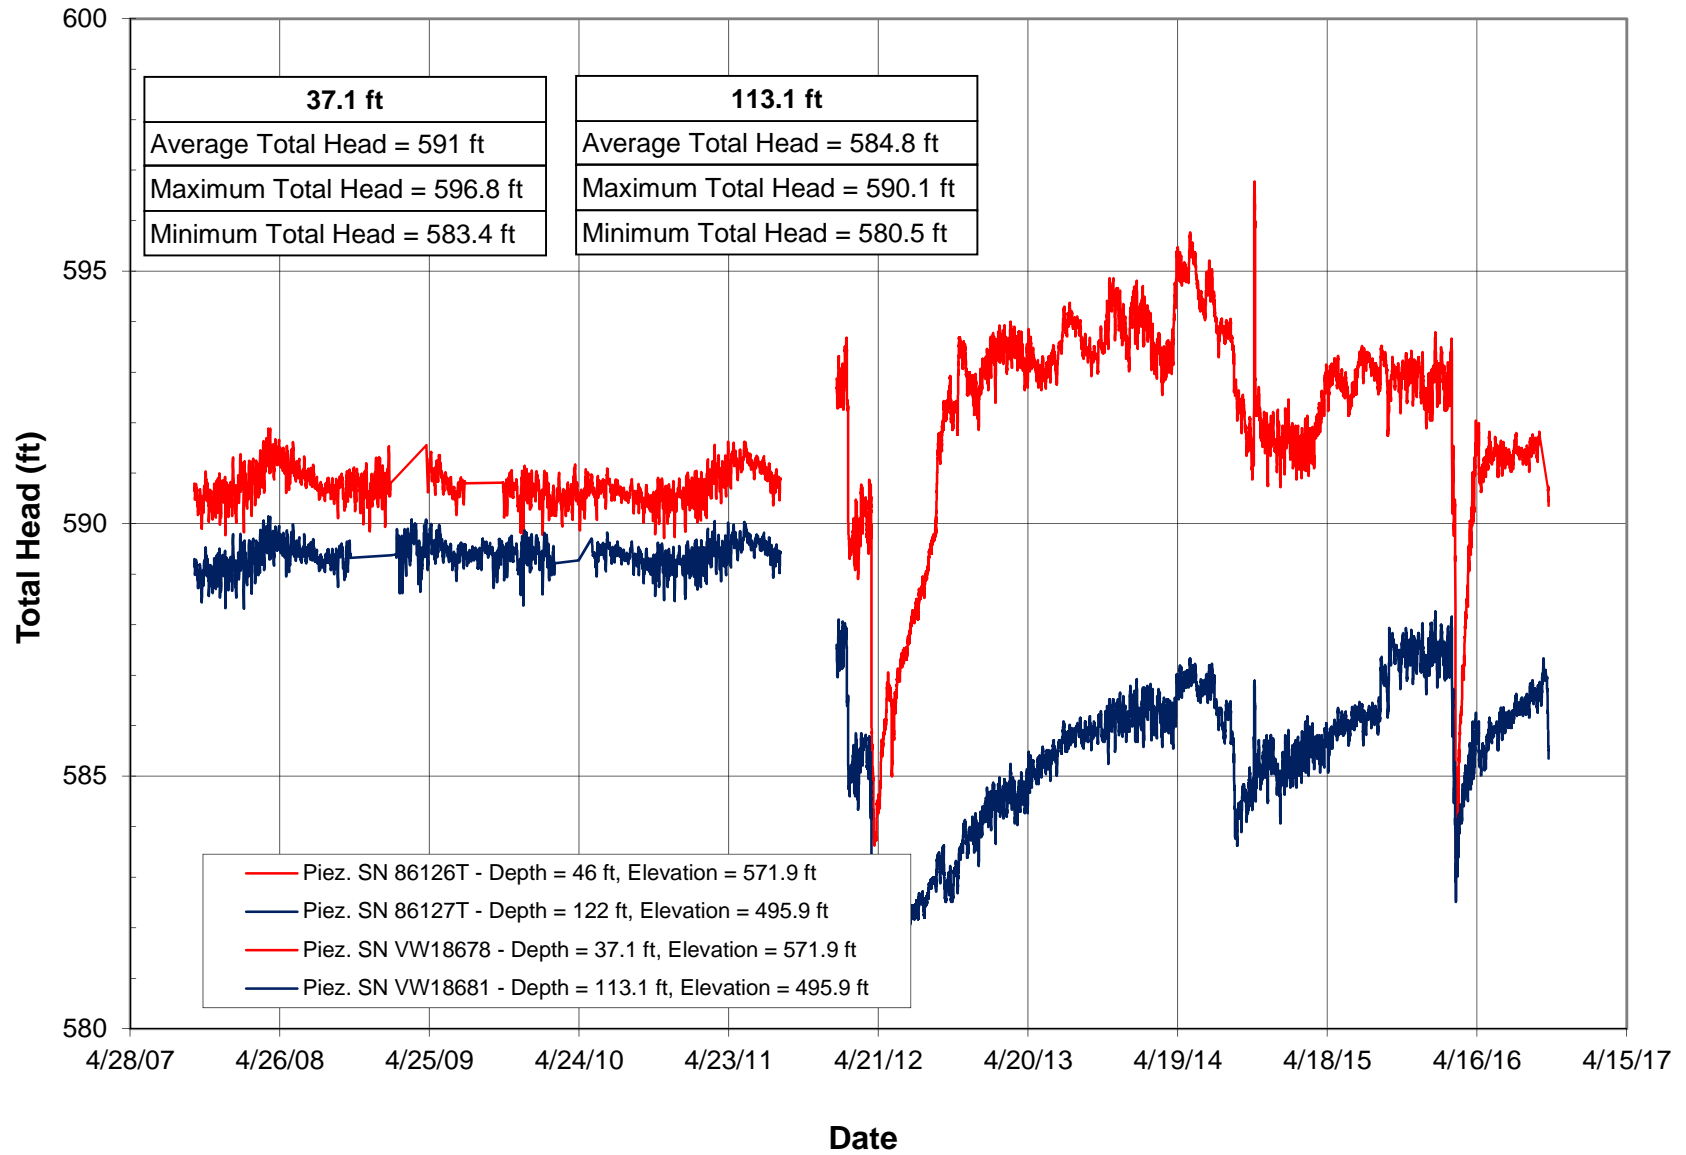
B-05-02 VW Piezometer Readings

B-05-02 – Pore pressure readings indicate decreases in total head of 1.4 feet in the shallow piezometer and 1.7 feet in the deep piezometer.

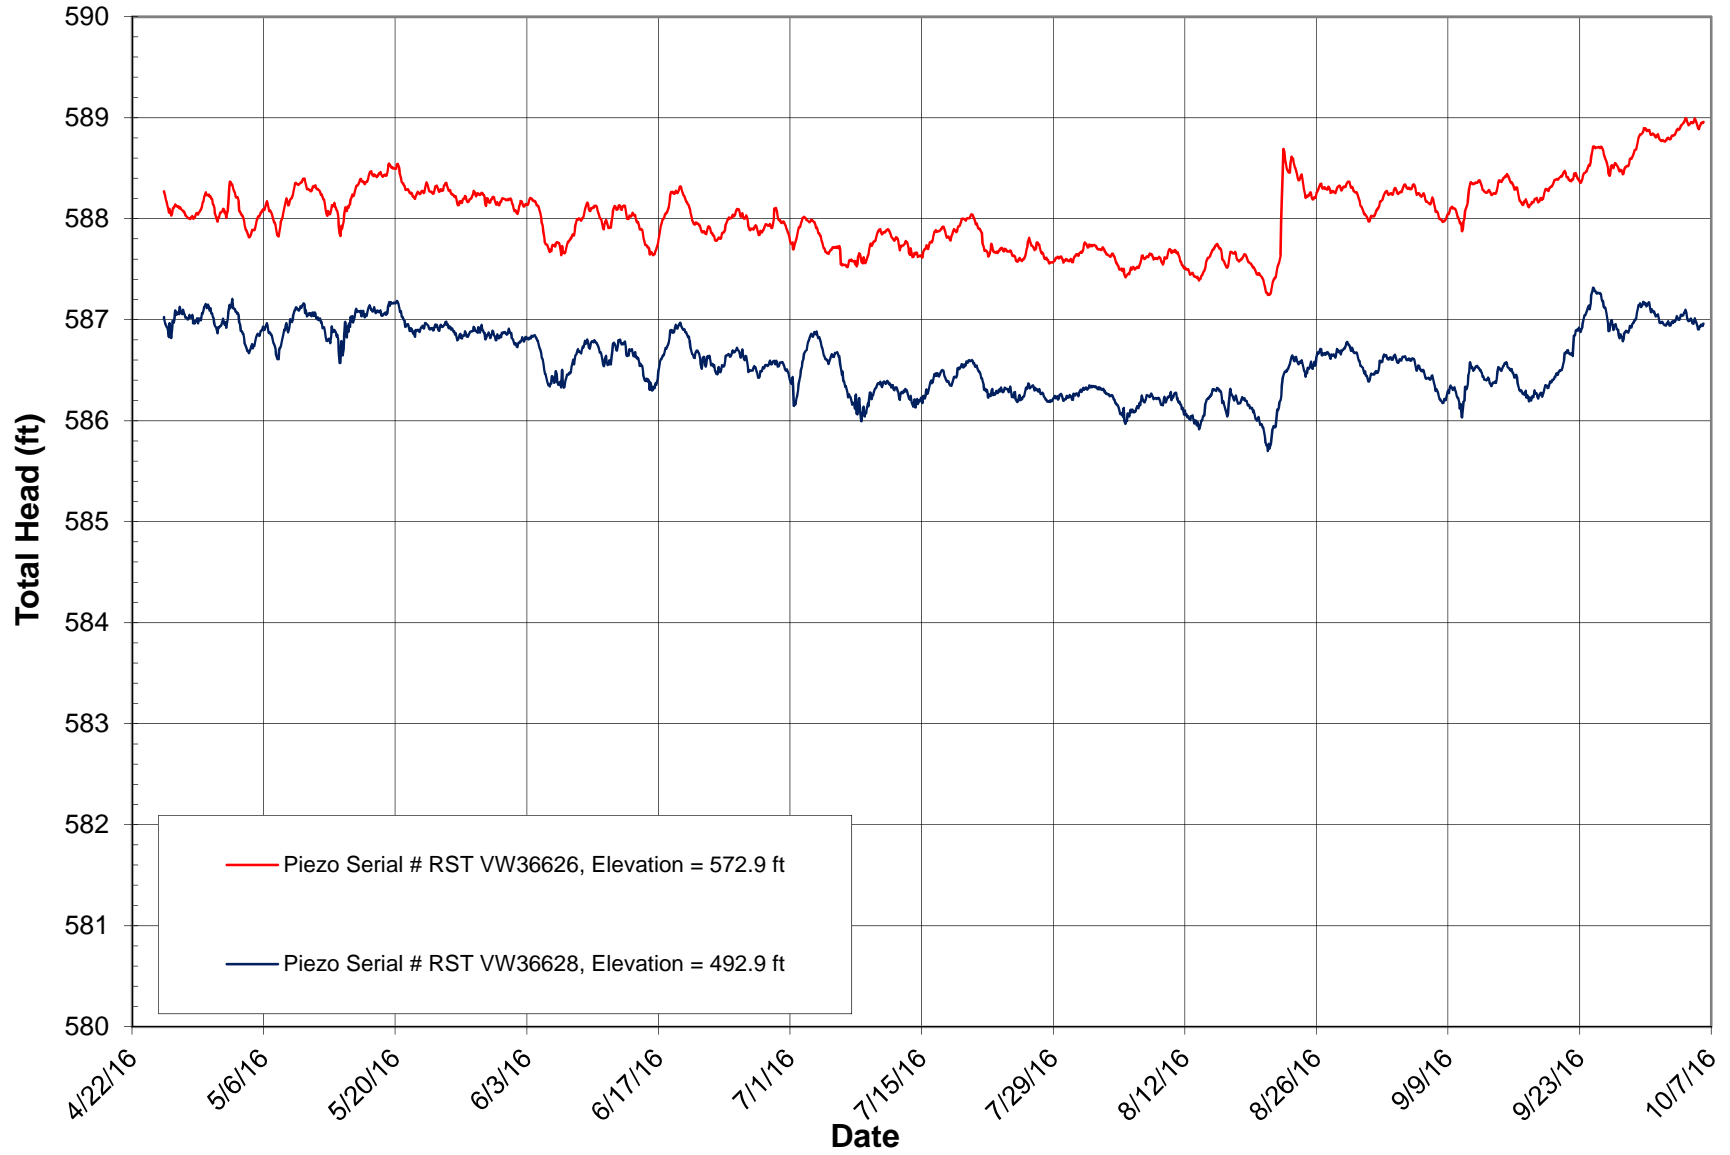
B-05-A-03 VW Piezometer Readings

B-05-A-03 – At this location, pore pressure readings in the shallow piezometer indicate an increase in total head of 1 foot since September 9, 2016. Total head in the deep piezometer fluctuated, but shows no net change during this period.

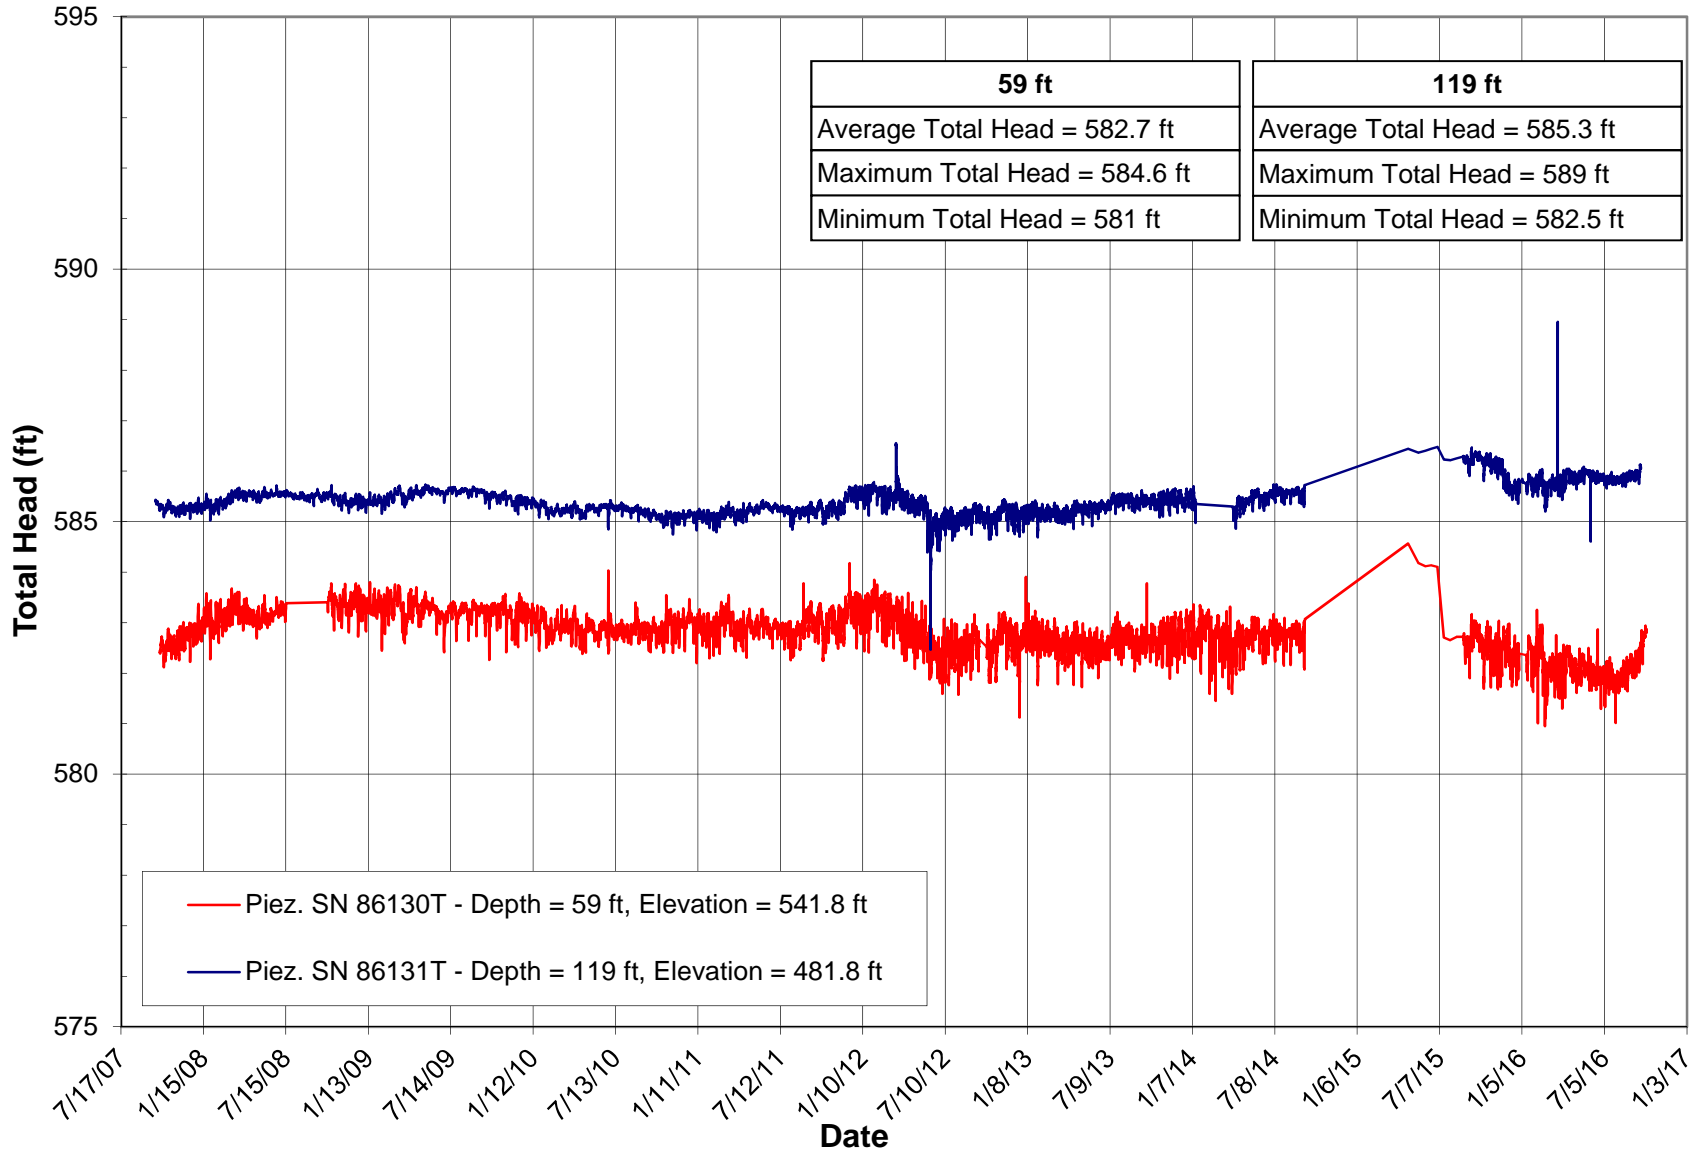
B-05-04 VW Piezometer Readings

B-05-04 – Pore pressure readings indicate an increase in total head of 1 foot in the shallow piezometer since September 9, 2016. Due to a data logger issue (data logger is not recording), we were unable to obtain data for the deep piezometer. We will replace the battery during our next site visit to see if that fixes the issue.

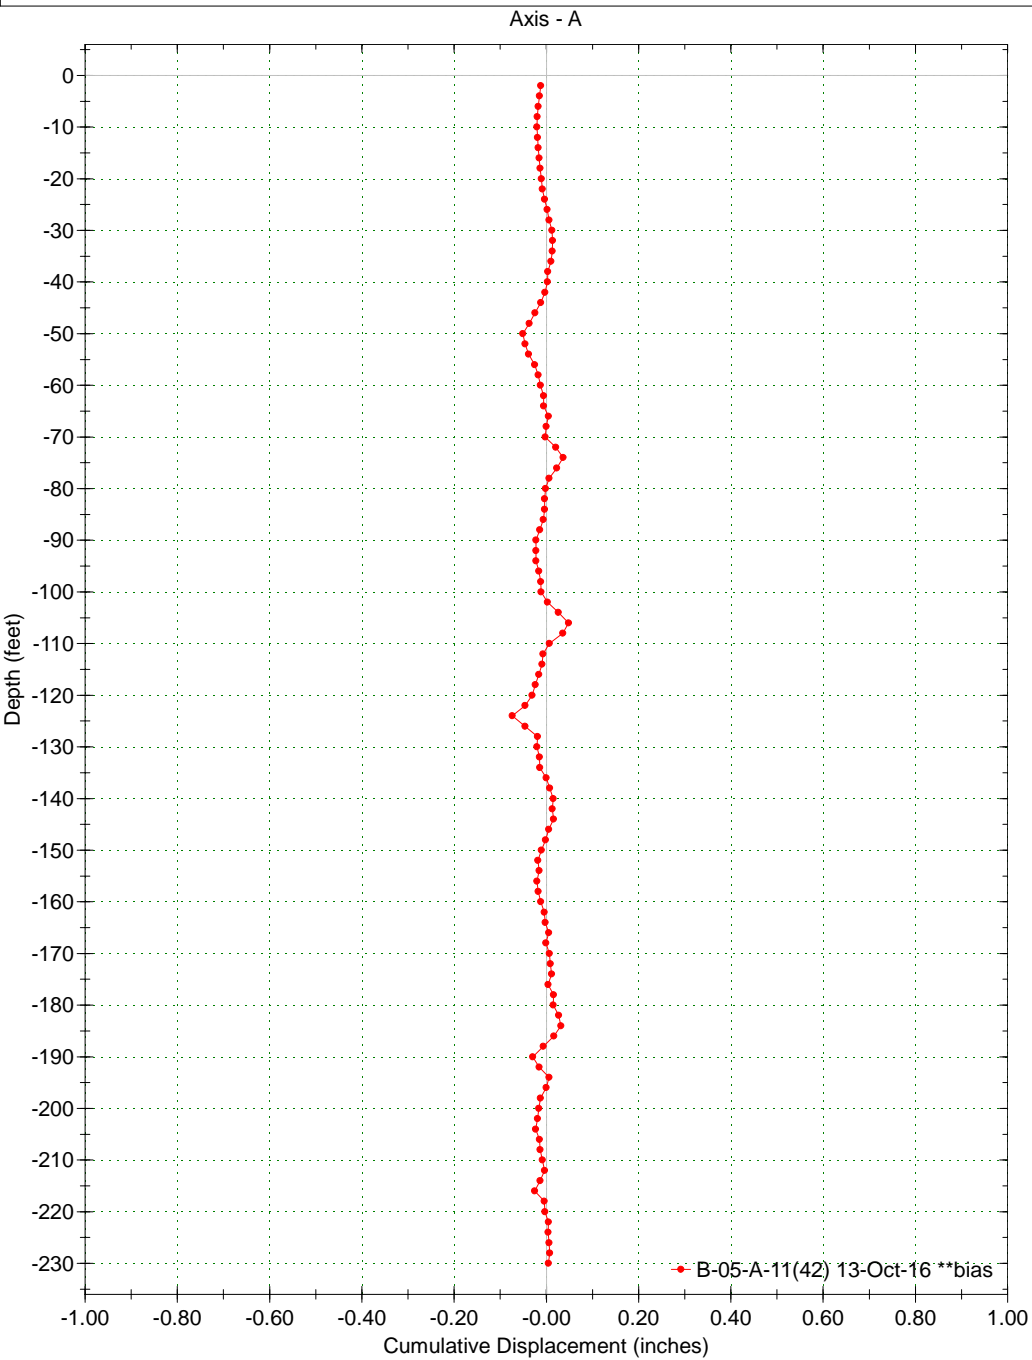
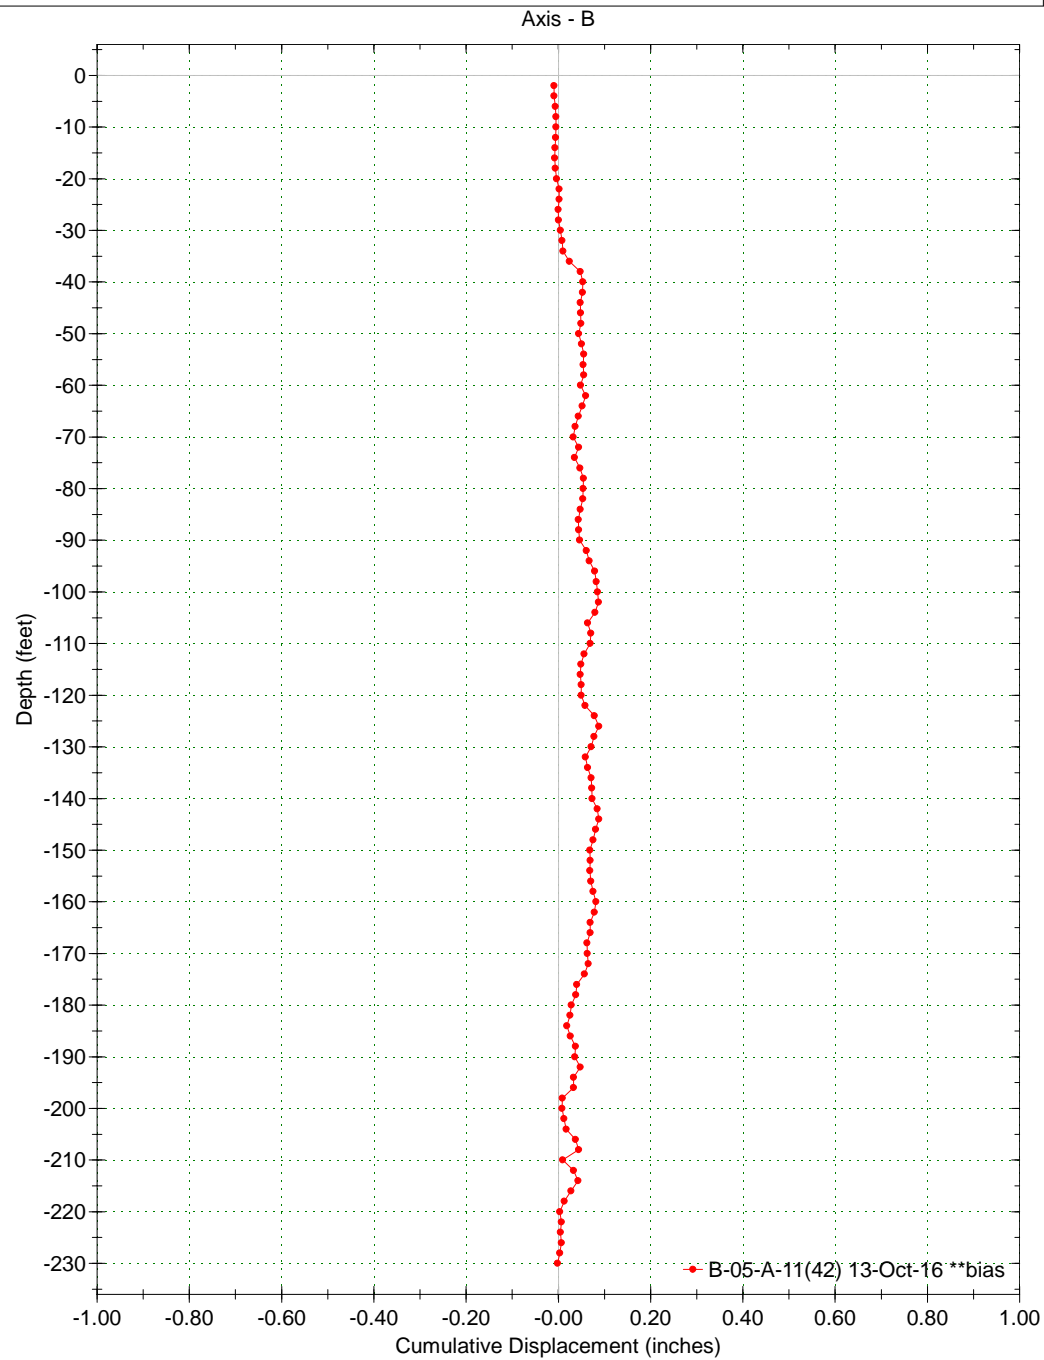
Borehole : B-05-A-11 230 ft
Project : CUY-90-15-24
Location :
Northing :
Easting :
Collar :

B-05-A-11 – The graph showing the first reading since the new baseline is included with this report. Displacements throughout the length of the casing appear to be a mirror image of previous readings. This mirror image plot has occurred at other locations generally with the first readings taken after the baseline. We have not been able to determine what is causing this and the manufacturer has not provided an explanation.
