November 8, 2016

Re: October 20, 25 and 26, 2016 Bi-Weekly Readings
CUY-90-15.24 Slope Monitoring
PID 96504
SME Project No. 069032.00

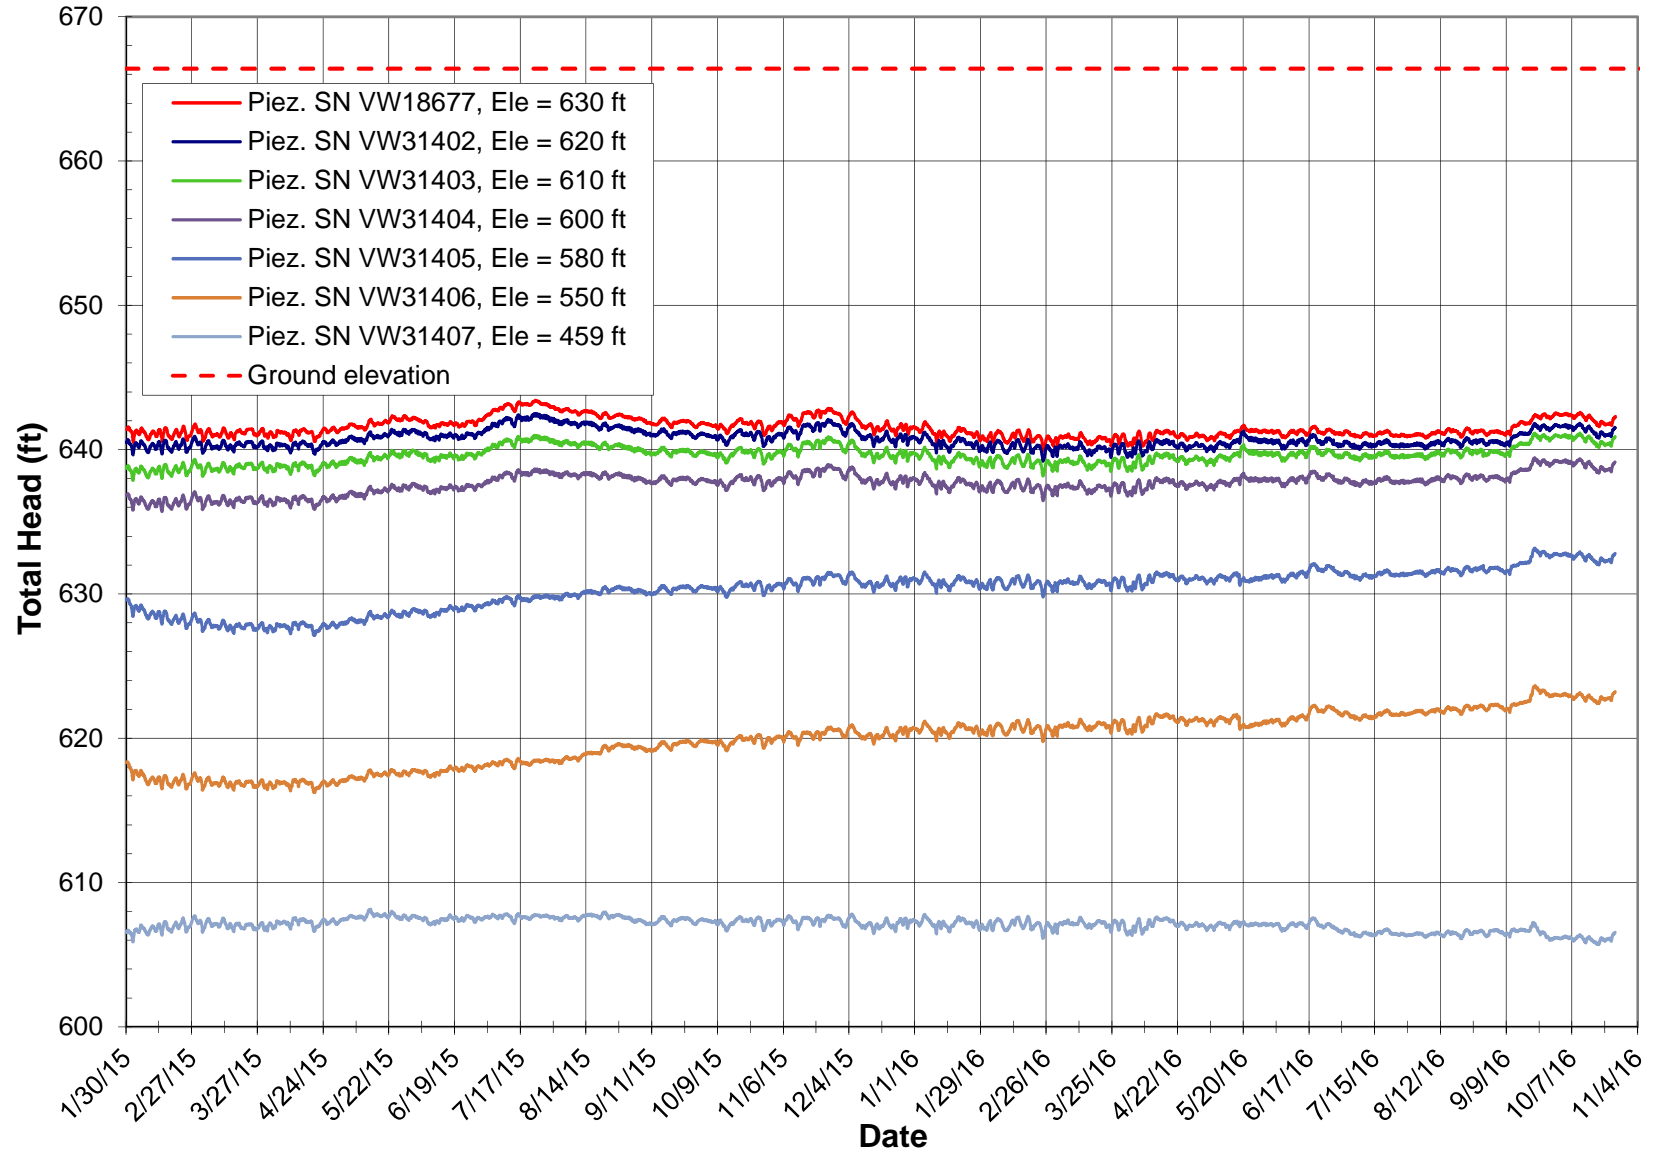
P-001-13 VW Piezometer Readings

P-001-13, P-002-13, P-003-10, P-004-13, B-05-02, B-05-04 – Pore pressure readings at these locations fluctuated by less than 0.5 feet and show virtually no net change in total head for the period.

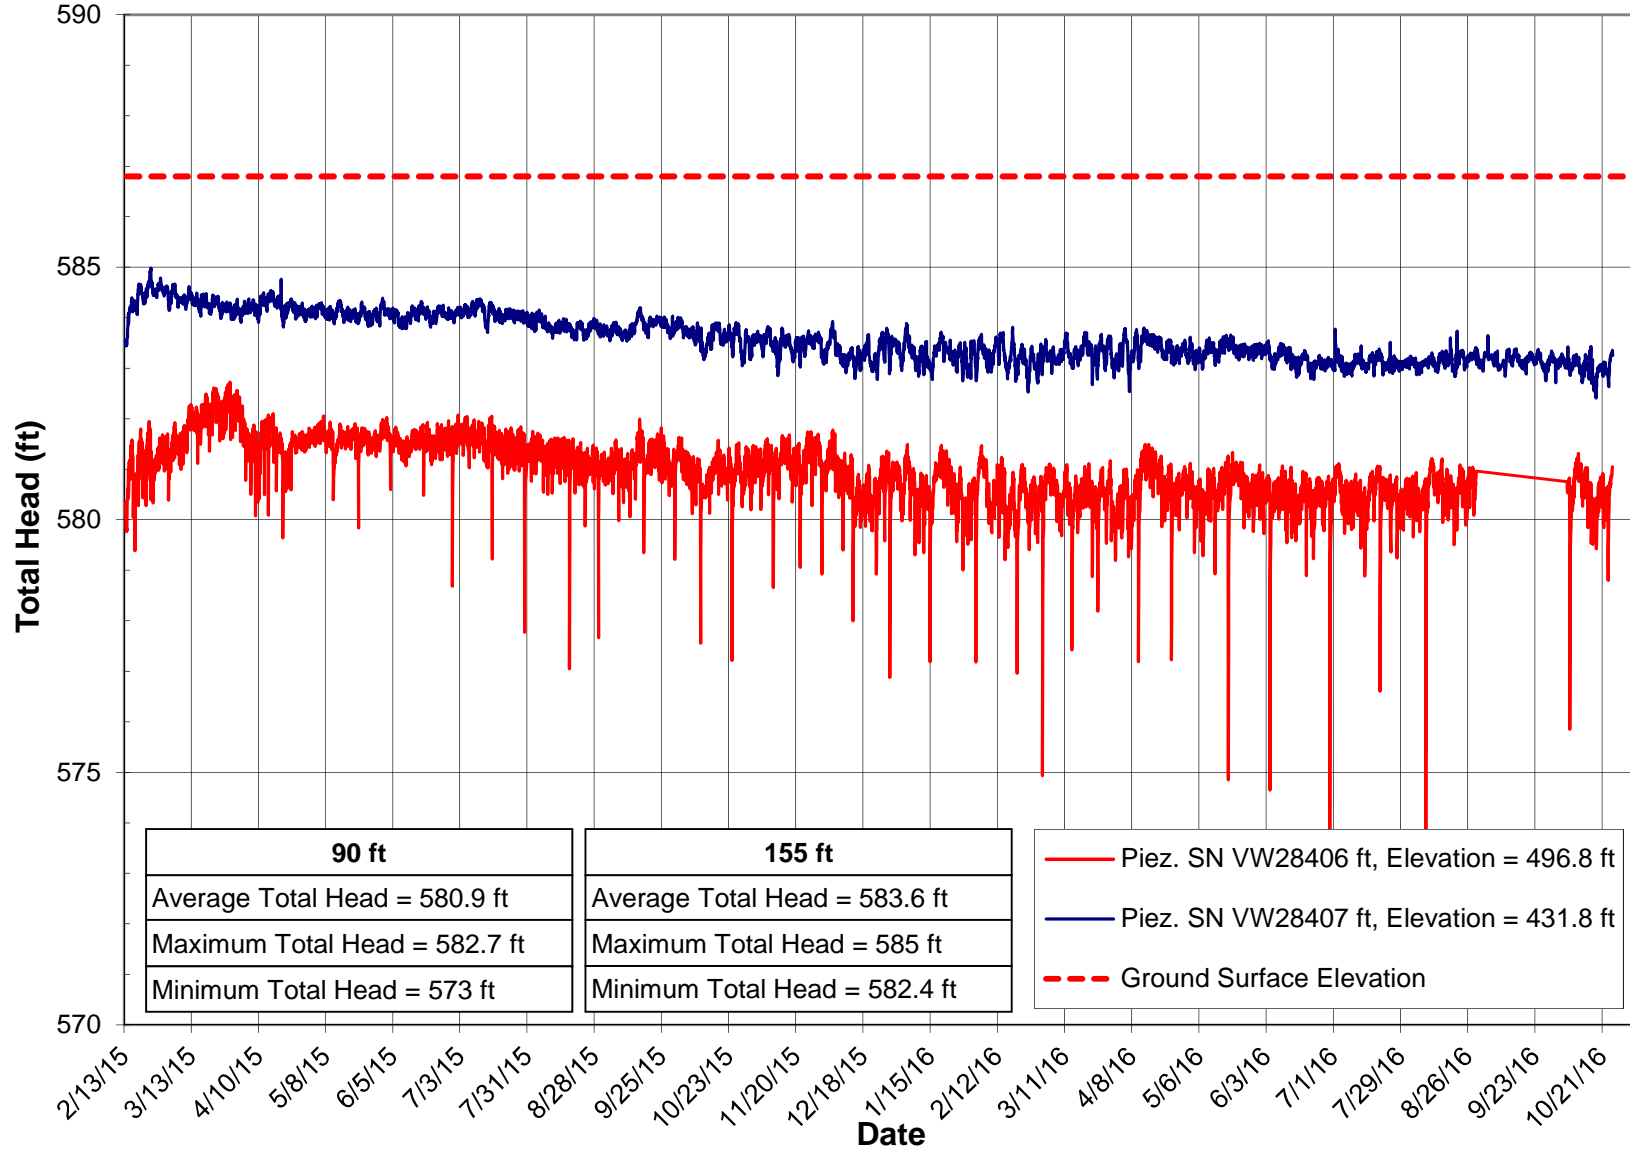
P-009-13 VW Piezometer Readings

P-009-13 – Total head in the shallow piezometer varied over a range of more than 2 feet during the period but at the end of the period the total head was within the range of values for the past 10 months. Variation in total head for the deep piezometer was less than 0.5 feet.

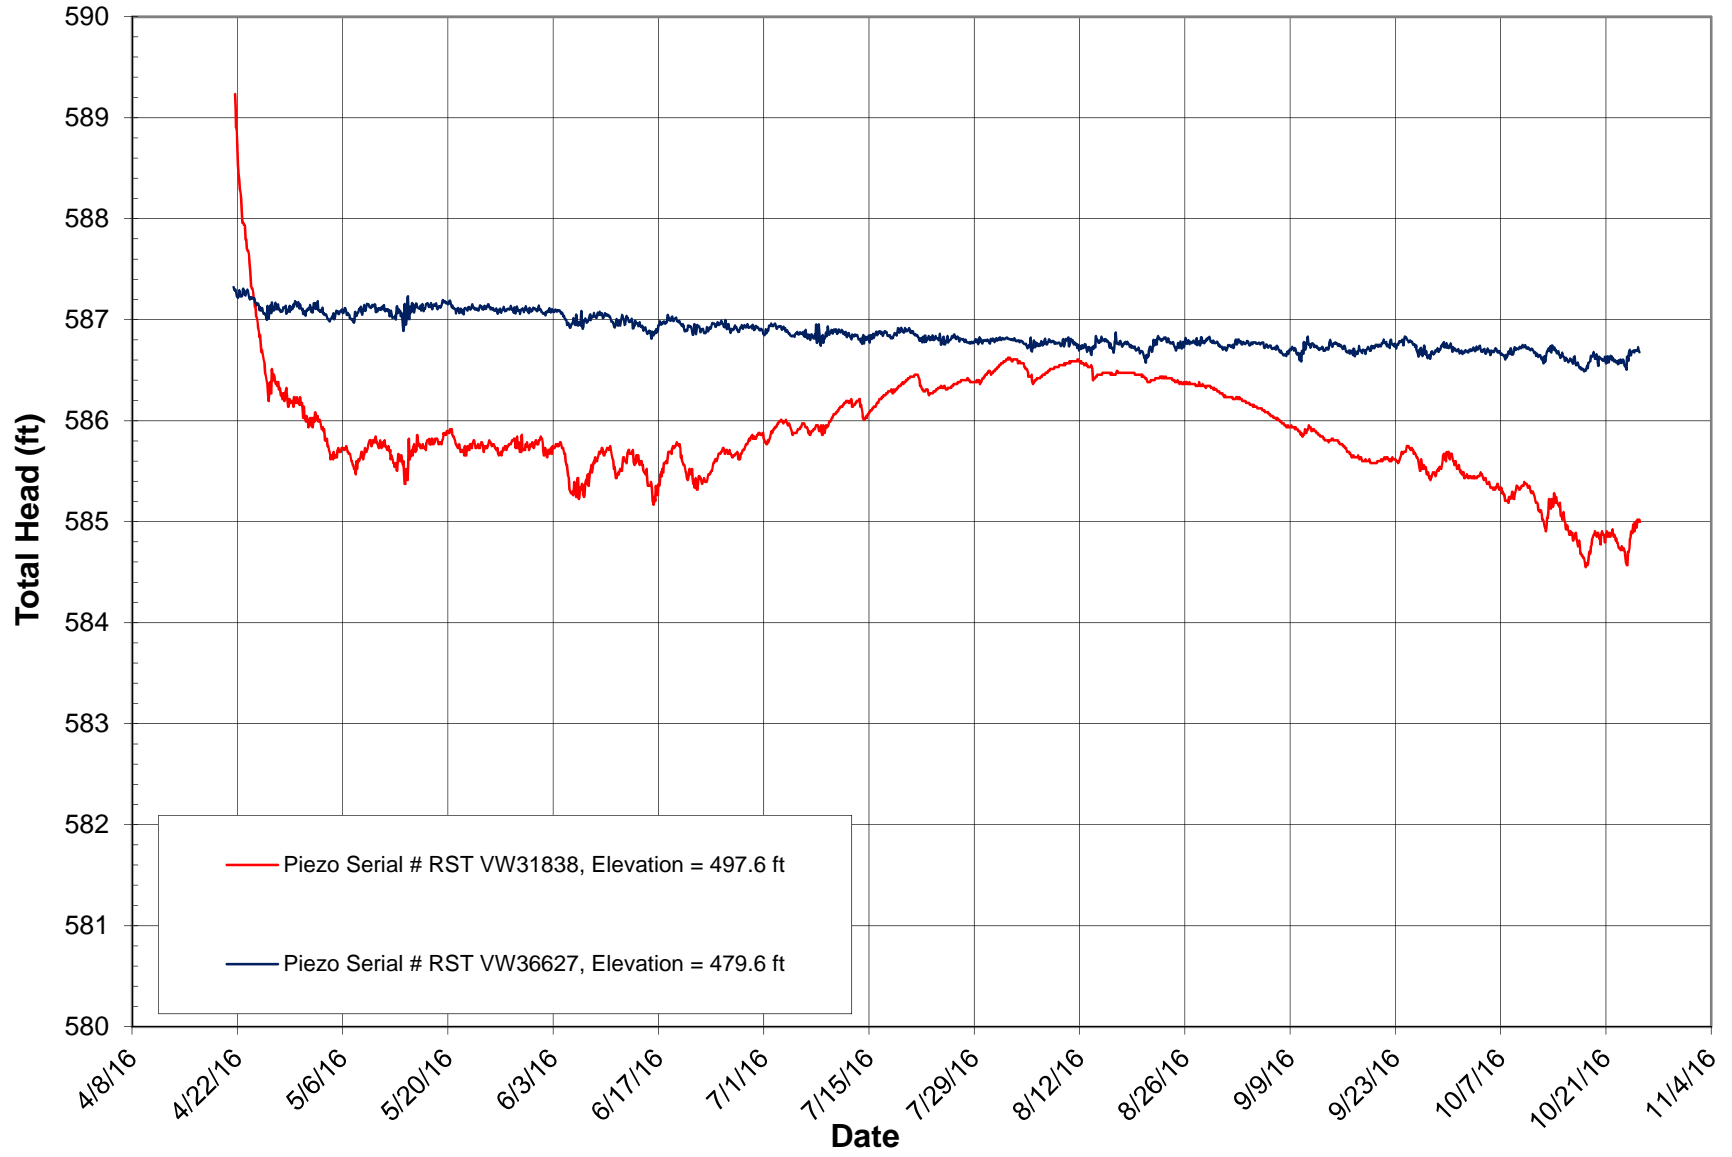
B-105A VW Piezometer Readings

B-105A – Total head in the shallow piezometer at this location continued to decrease during most of this recording cycle and then increased slightly during the final two days of the cycle. From August 13 to October 25, 2016, the net decrease in total head was 1.7 feet. Pore pressures in the deep piezometer show virtually no change in total head.

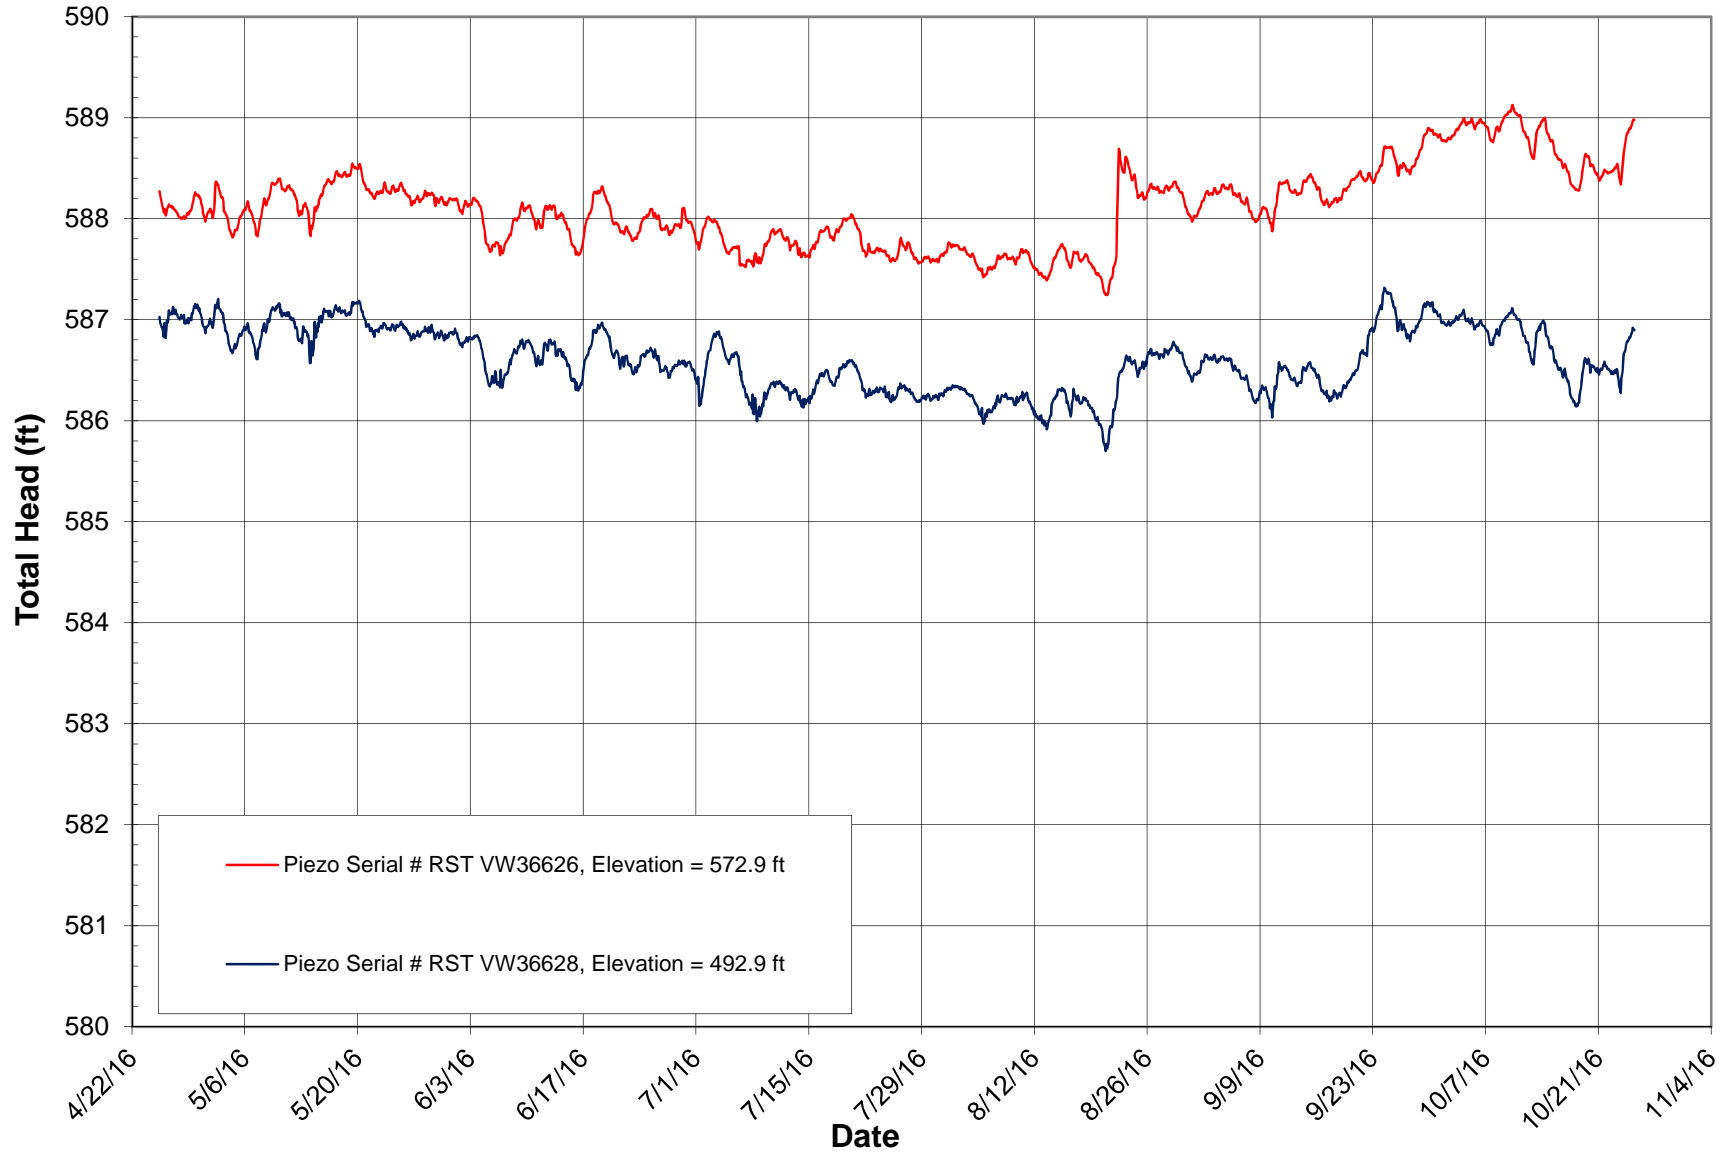
B-05-A-03 VW Piezometer Readings

B-05-A-03 – At this location, pore pressure readings indicate fluctuations in total head of 0.6 feet in the shallow piezometer and 0.9 feet in the deep piezometer but show no net change during this period.

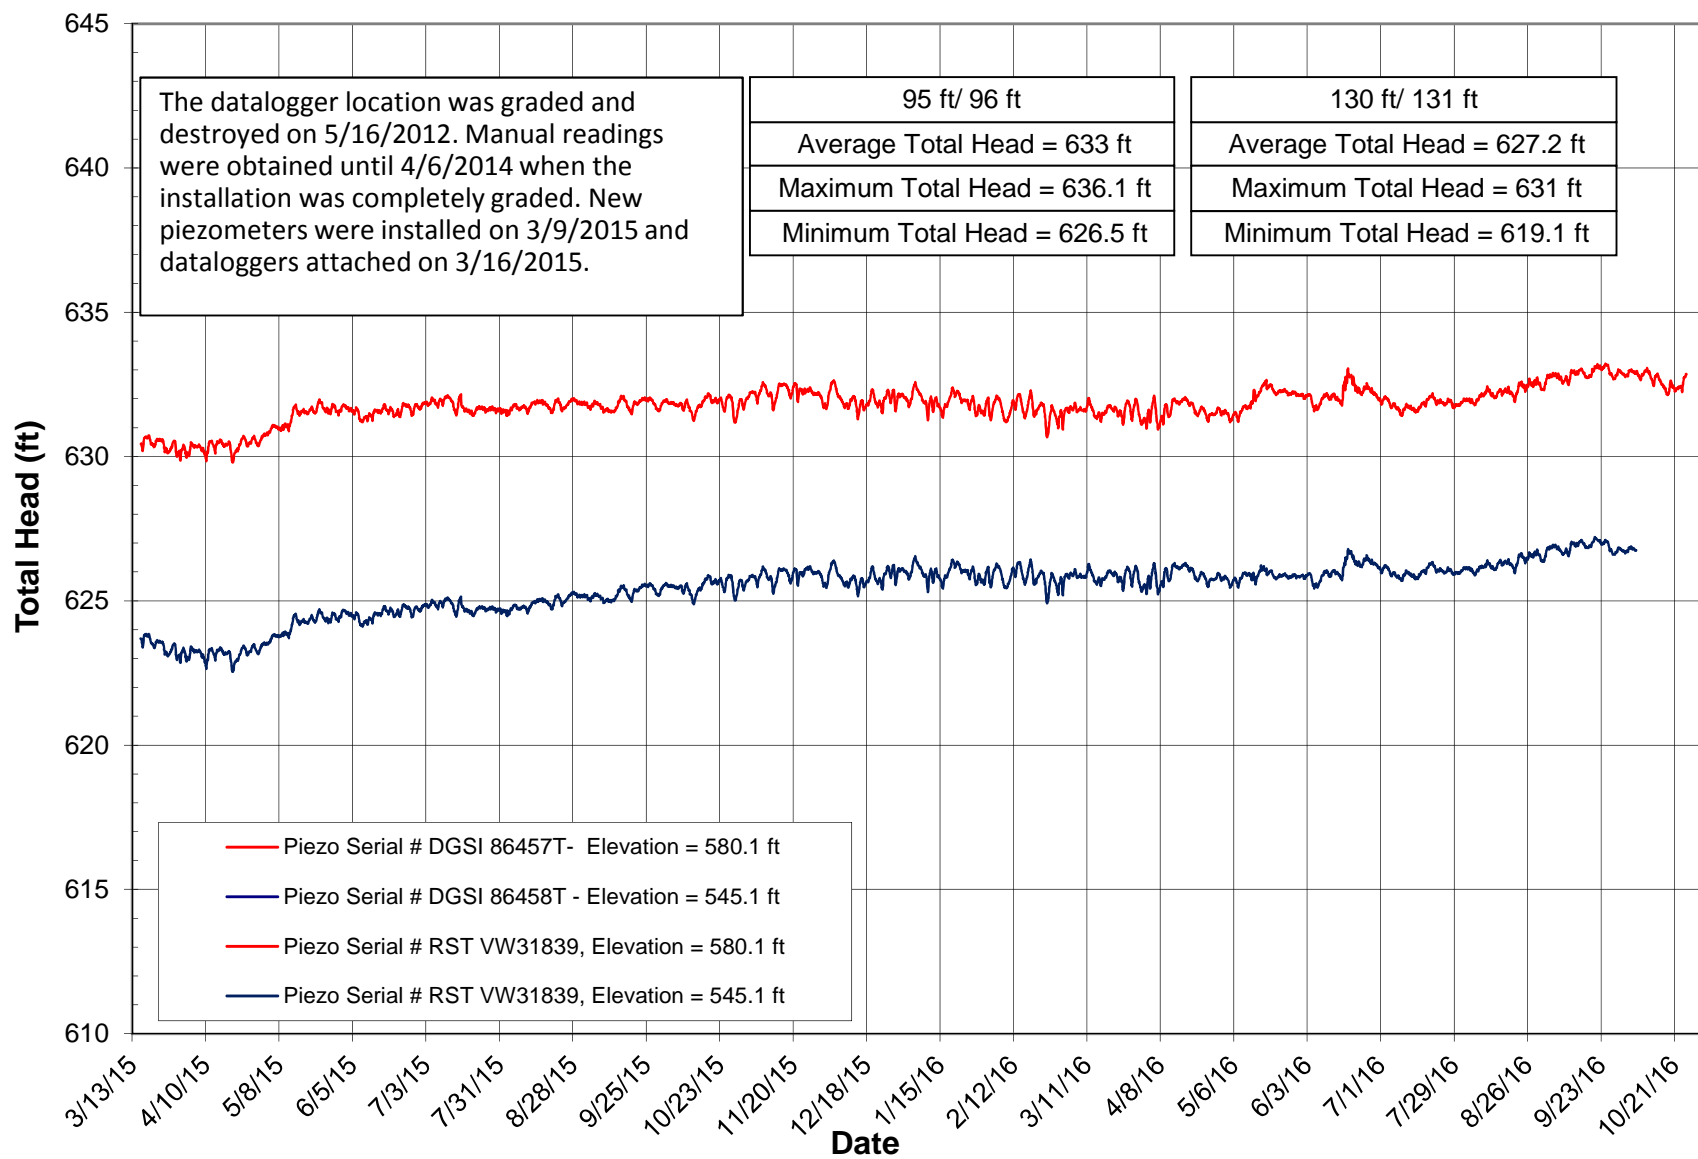
B-05-11/B-05-A-11 VW Piezometer Readings

B-05-A-11 – The data logger for the deep piezometer at this location is currently malfunctioning. We updated the firmware but we are still unable to connect. We will replace it with a temporary data logger and ship the malfunctioning data logger to the manufacturer for repair. Readings for the shallow piezometer indicate slight fluctuations in total head but virtually no net change.

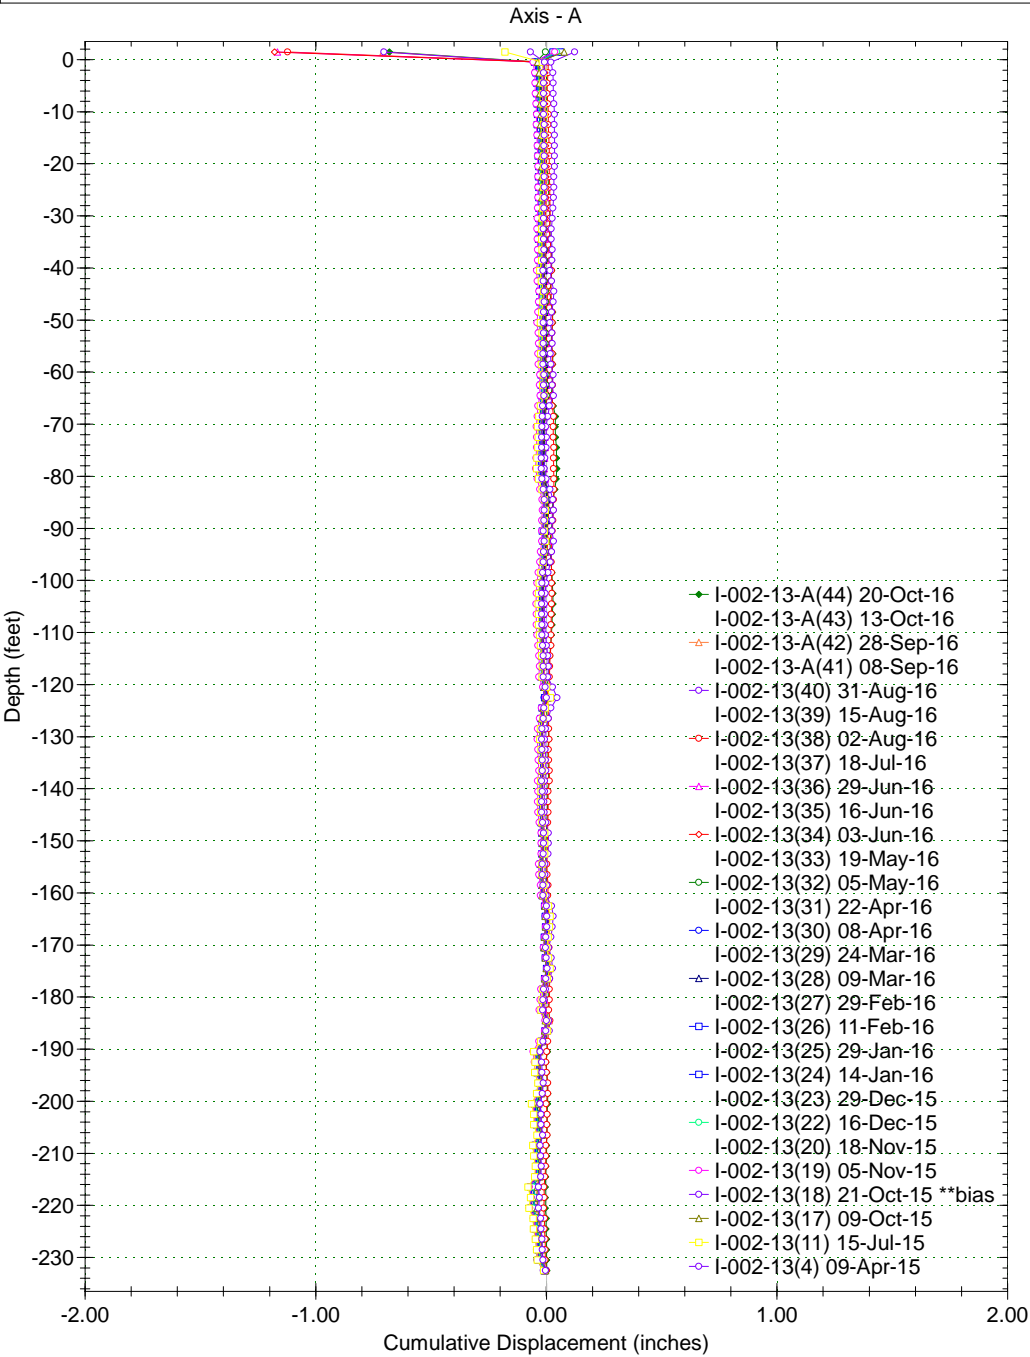
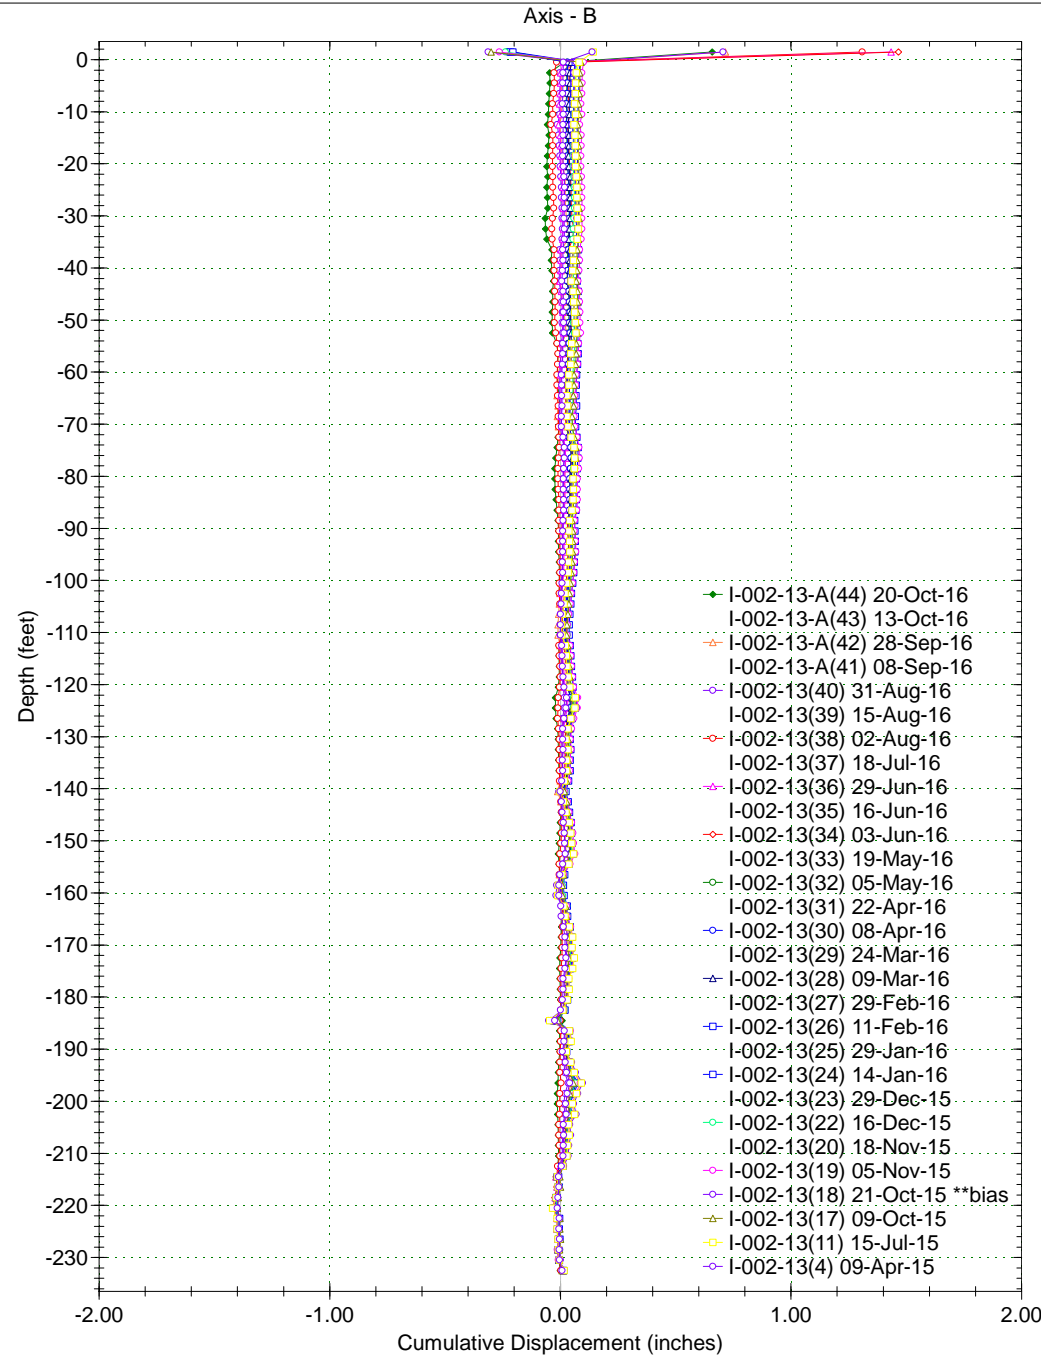
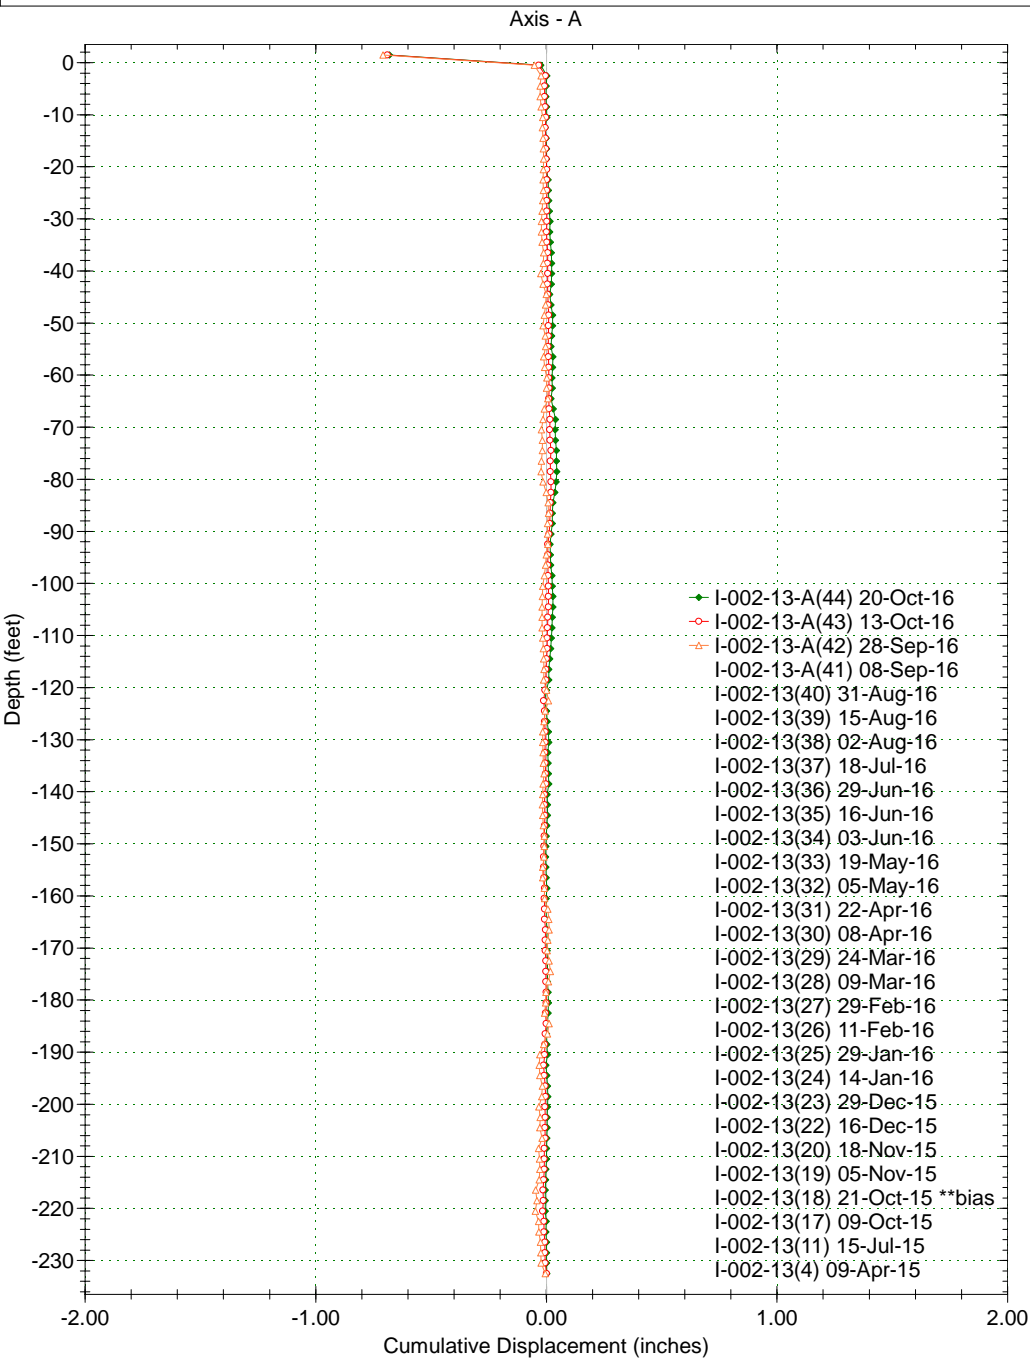
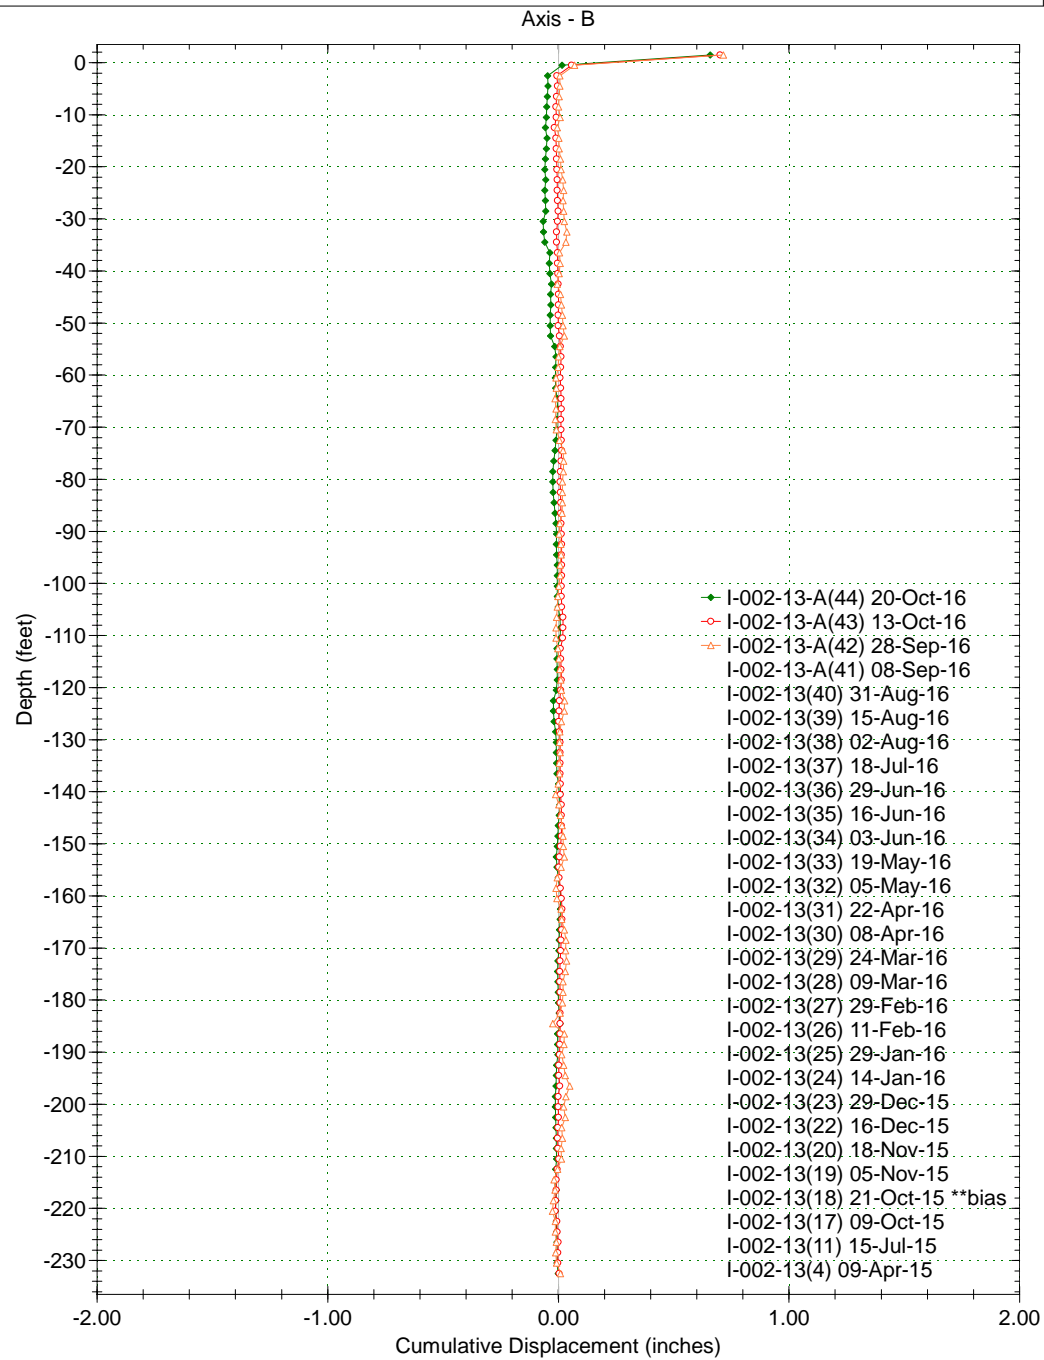
Borehole : I-002-13
Project : CUY-90-15-24
Location : Cleveland, Ohio
Northing :
Easting :
Collar :

I-002-13 – Inclinometer readings at this location indicate slight displacement in the negative B-axis direction especially above 55 feet. Movement in the A-axis direction is negligible. To clearly show this movement, we've included a second plot showing the three most recent readings. The plots show slight displacements at greater depths that appear to be the mirror image of the past displacements.

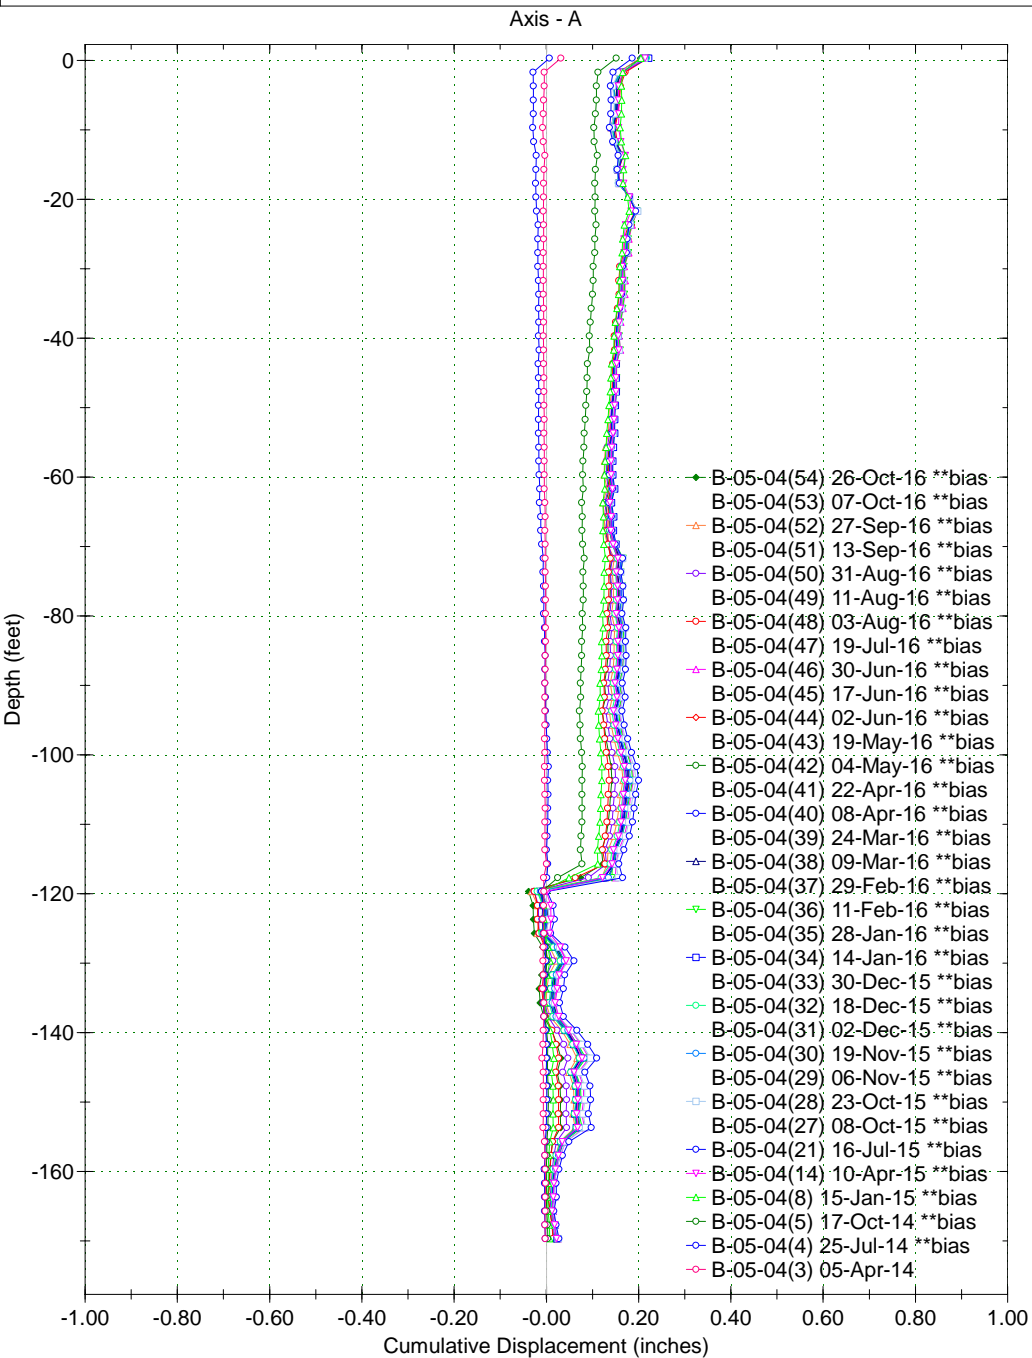
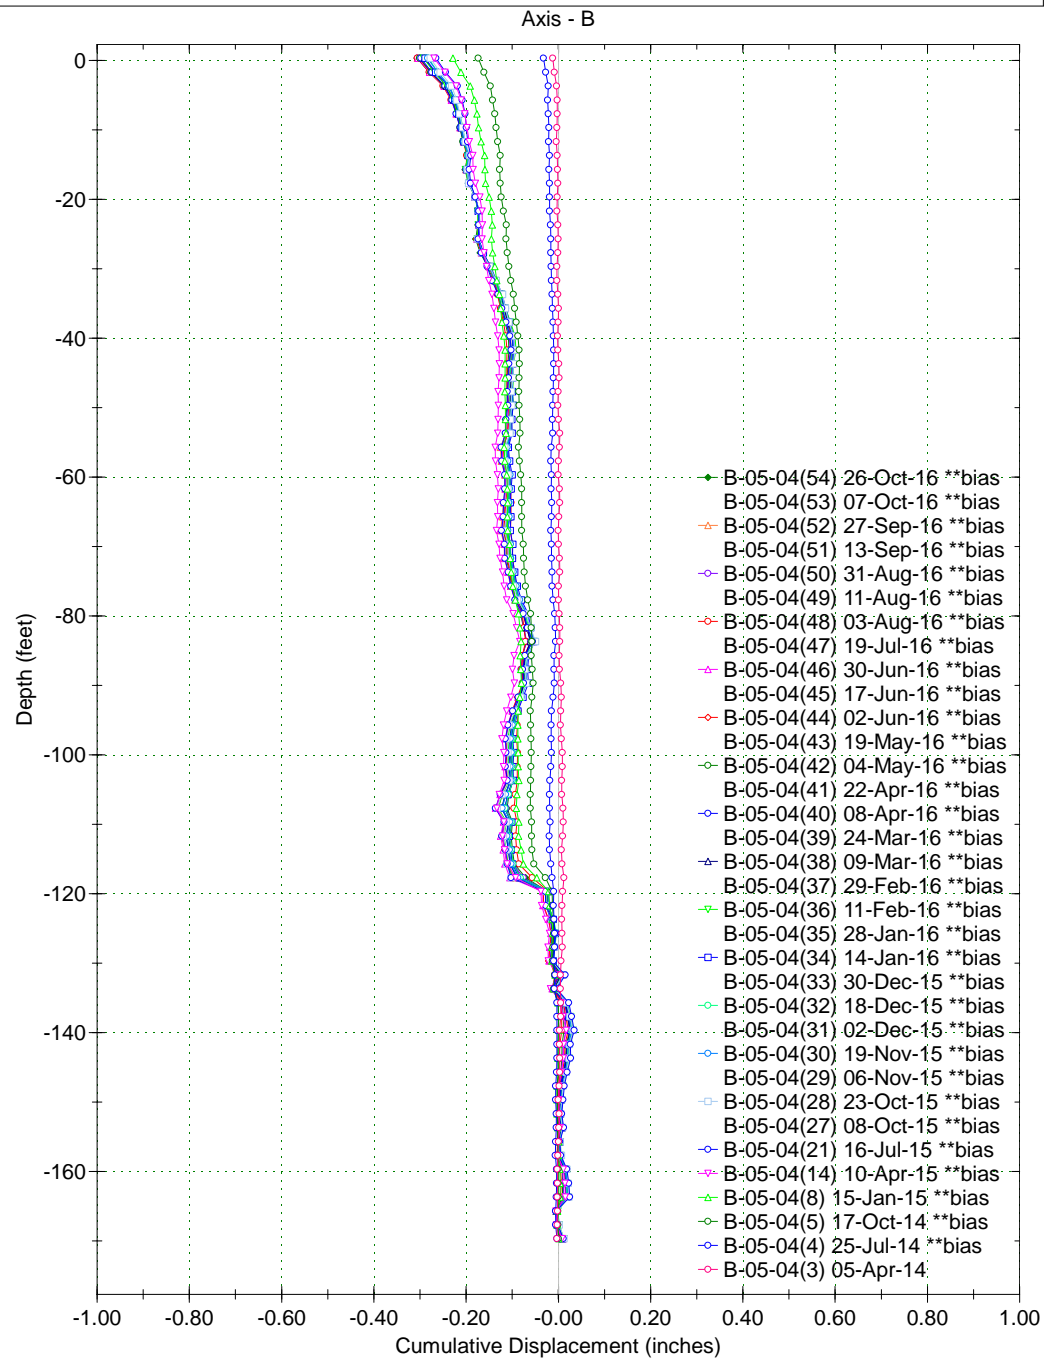
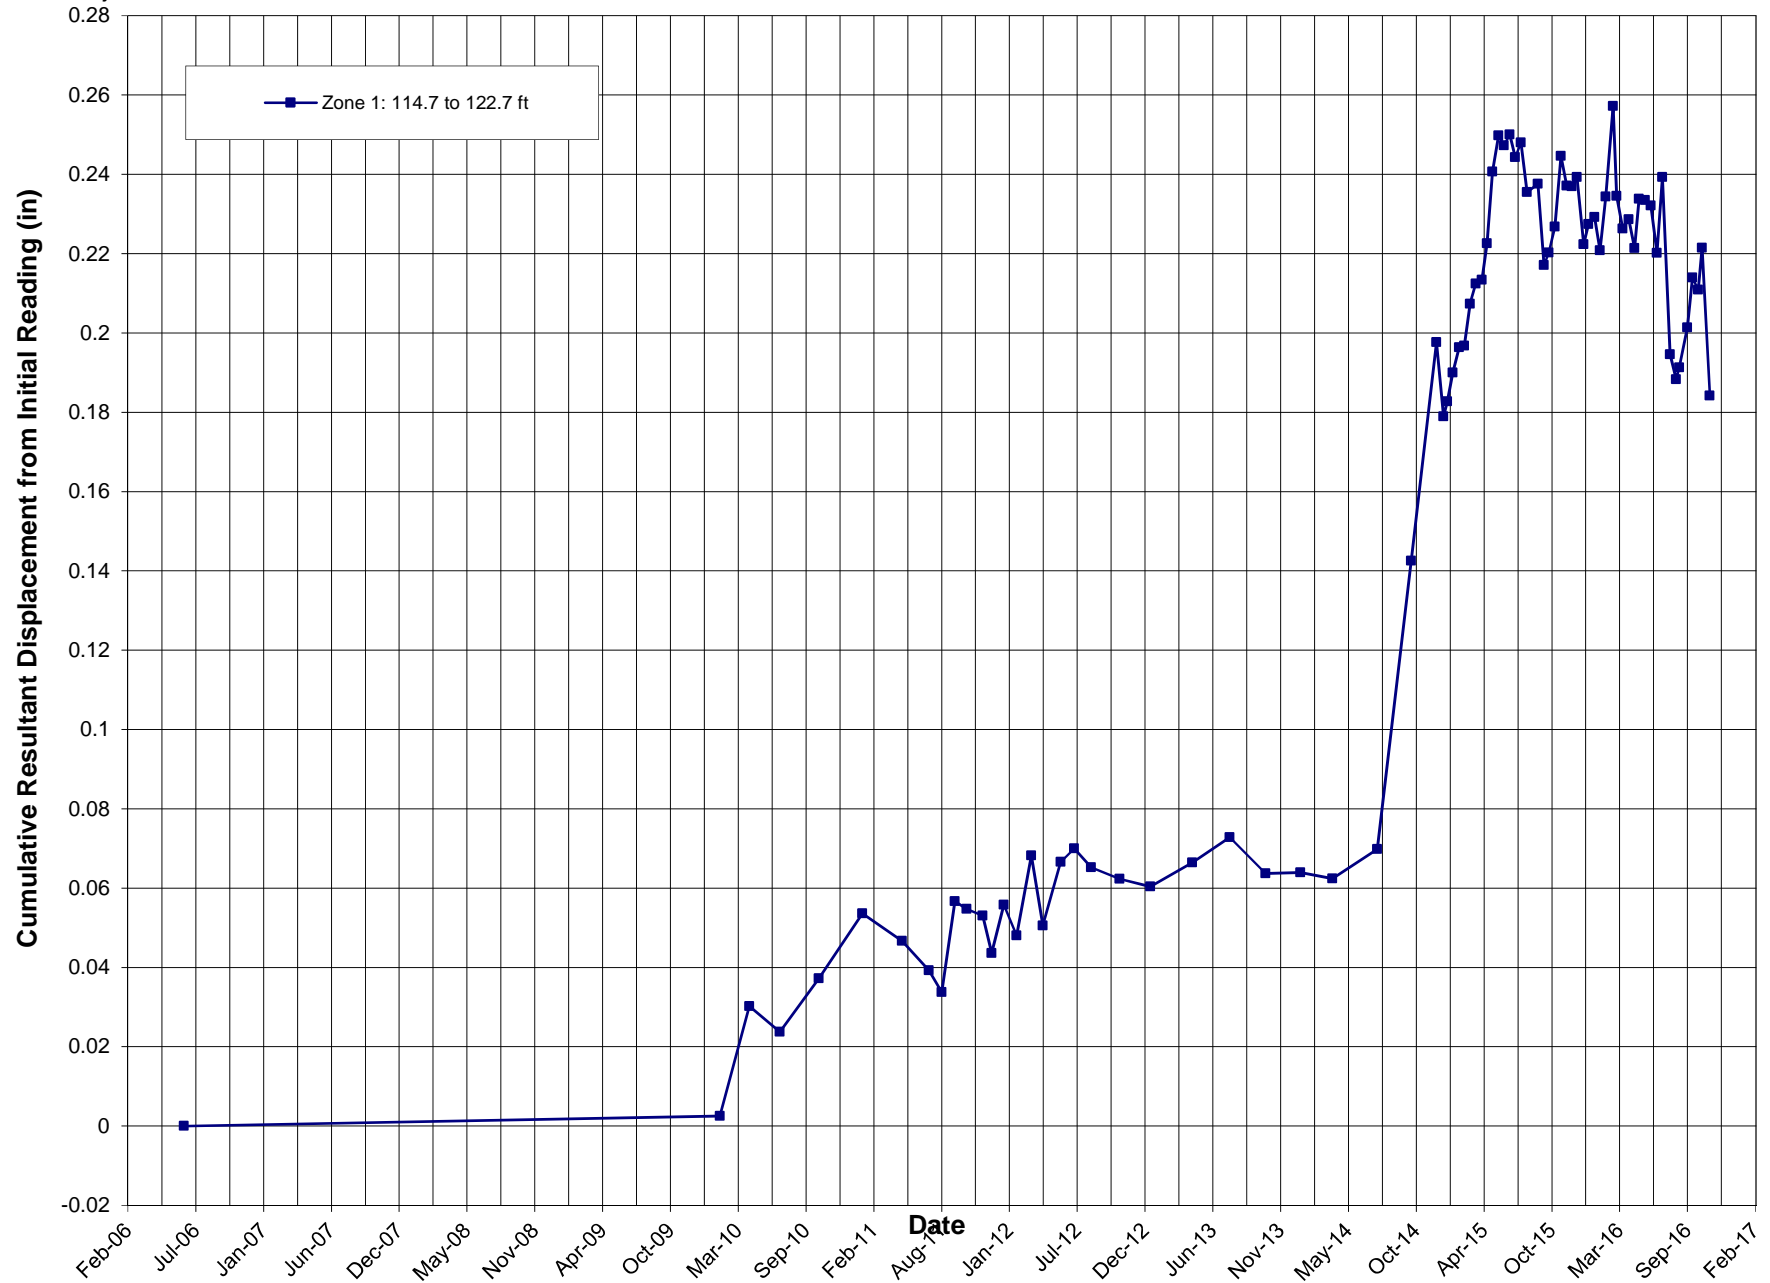
Borehole : B-05-04
 Project : CUY-90-15-24
 Location : Cleveland, Ohio
 Northing : Sta. 133+51.67
 Easting : 242.09' Rt of CL
 Collar :

B-05-04 – The resultant displacement plot indicates reverse displacement in the zone from approximately 115 to 123 feet. The cumulative displacement plot shows this to be A-axis displacement. This may be largely due to the bias correction.
