November 8, 2016

Re: October 20, 25 and 26, 2016 Bi-Weekly Readings
CUY-90-15.24 Slope Monitoring
PID 96504
SME Project No. 069032.00

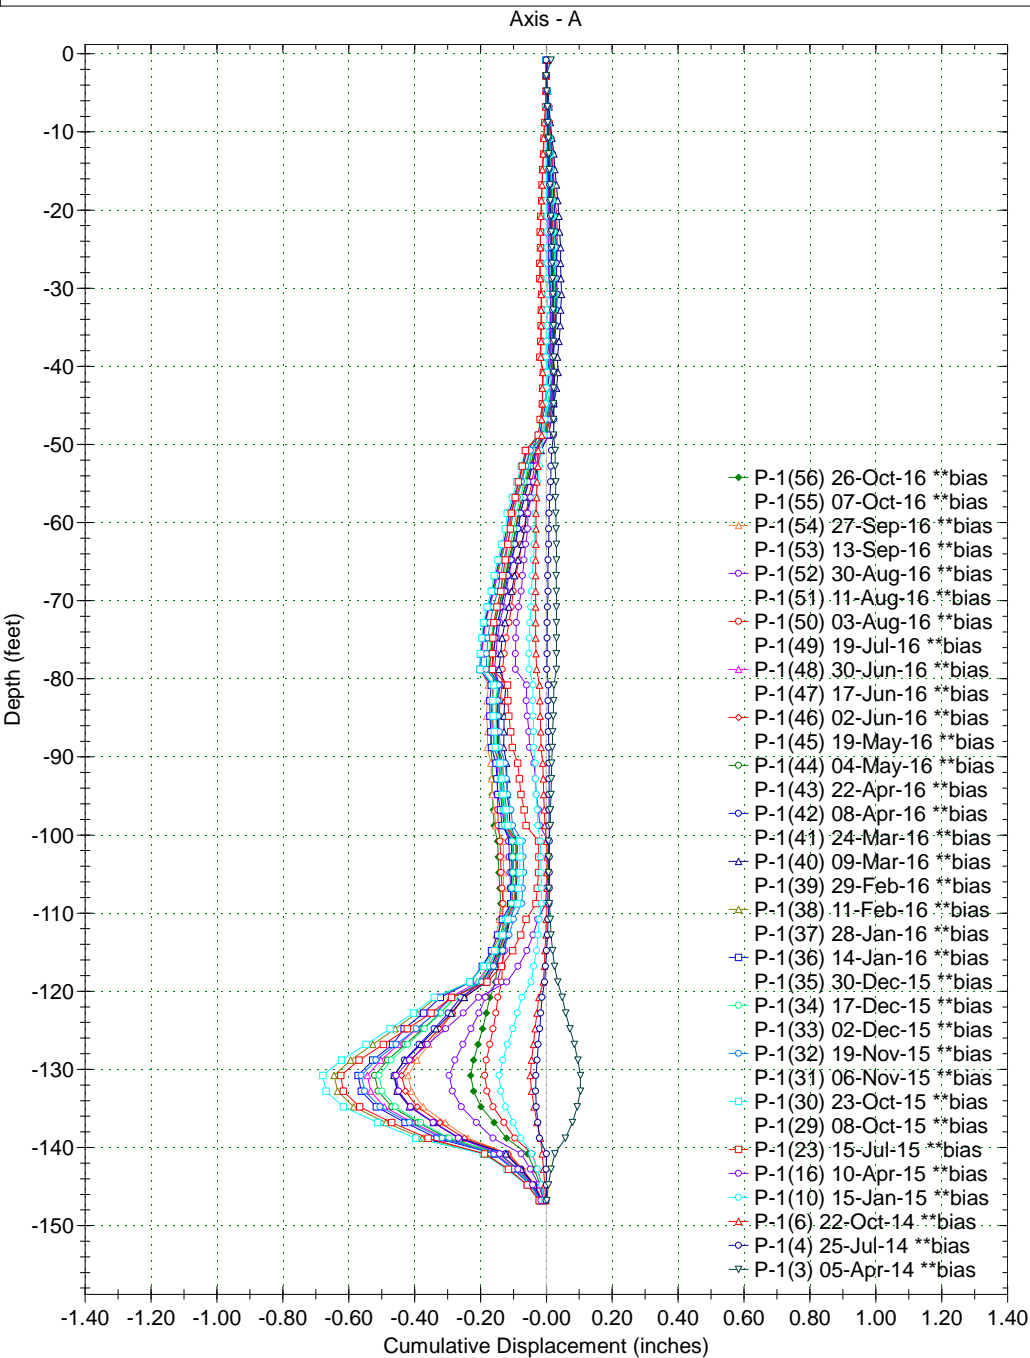
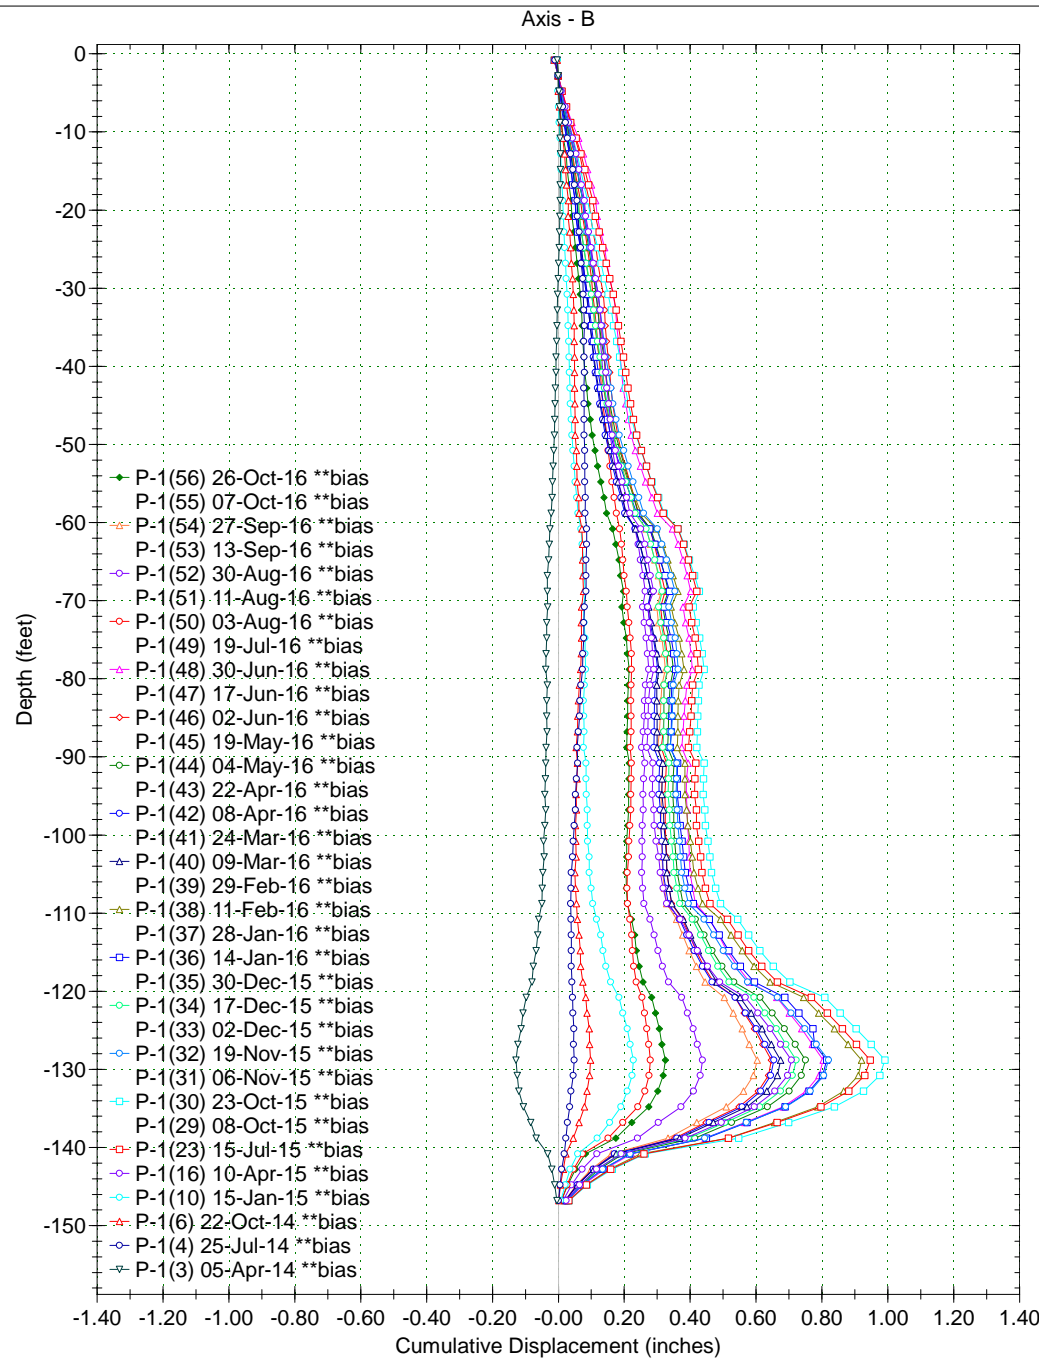
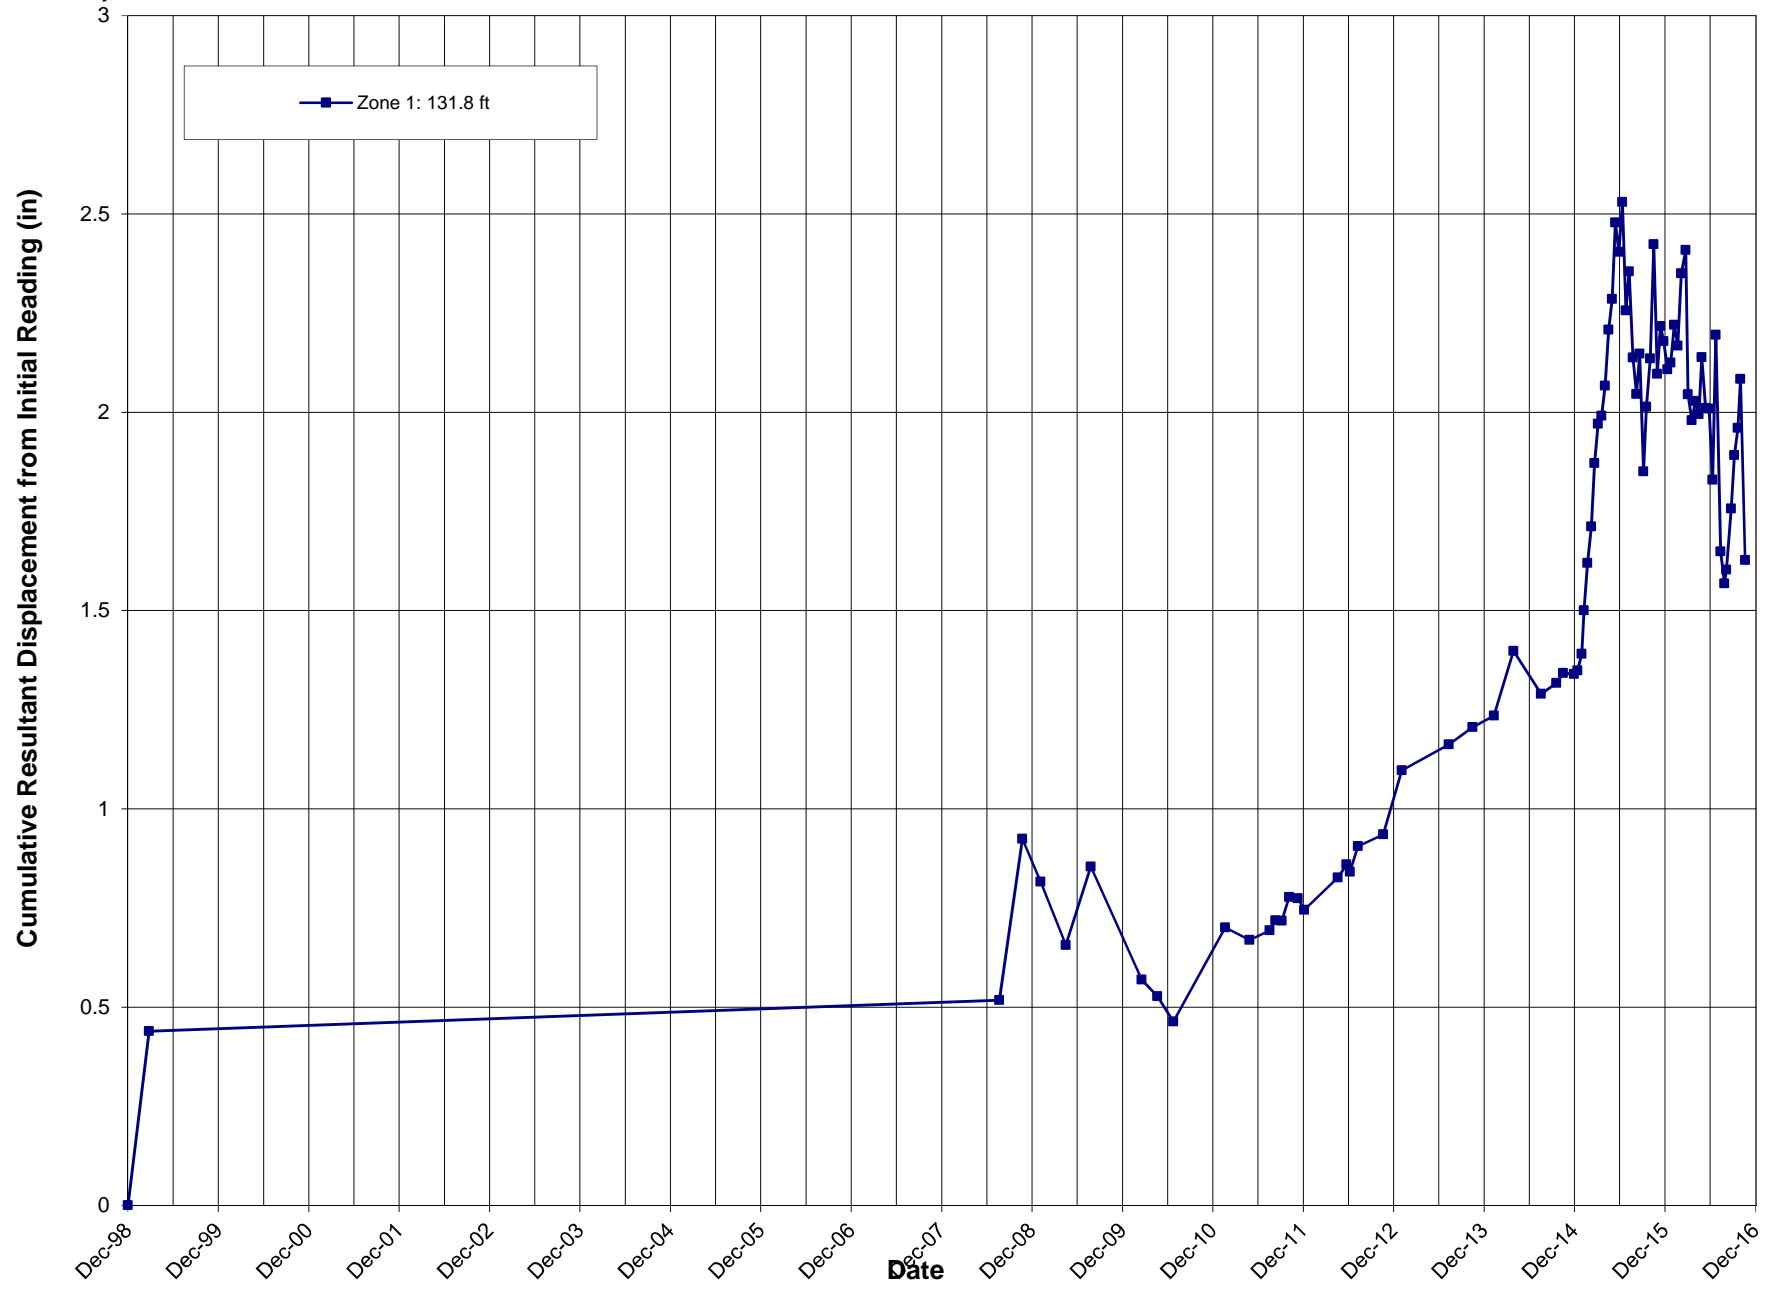
Borehole : P-1
Project : CUY-90-15-24
Location : Cleveland, Ohio
Northing :
Easting :
Collar :

P-1 – Inclinometer readings at this location show another reverse in the direction of movement in both axes. The cumulative resultant displacement plot for this location shows a decrease of 0.5 feet at a depth of 132 feet.

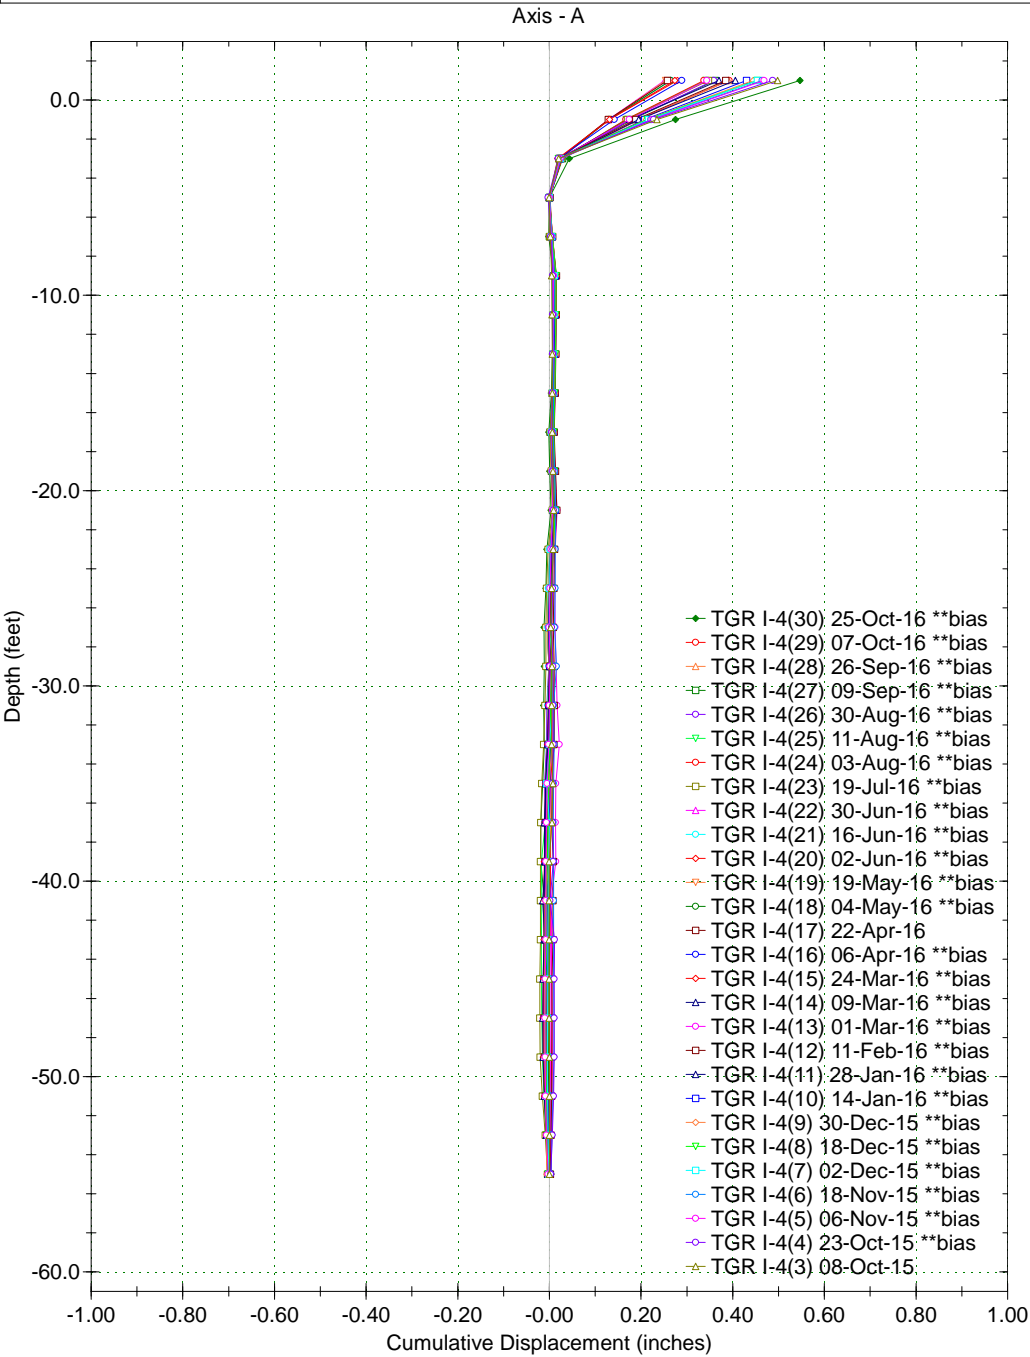
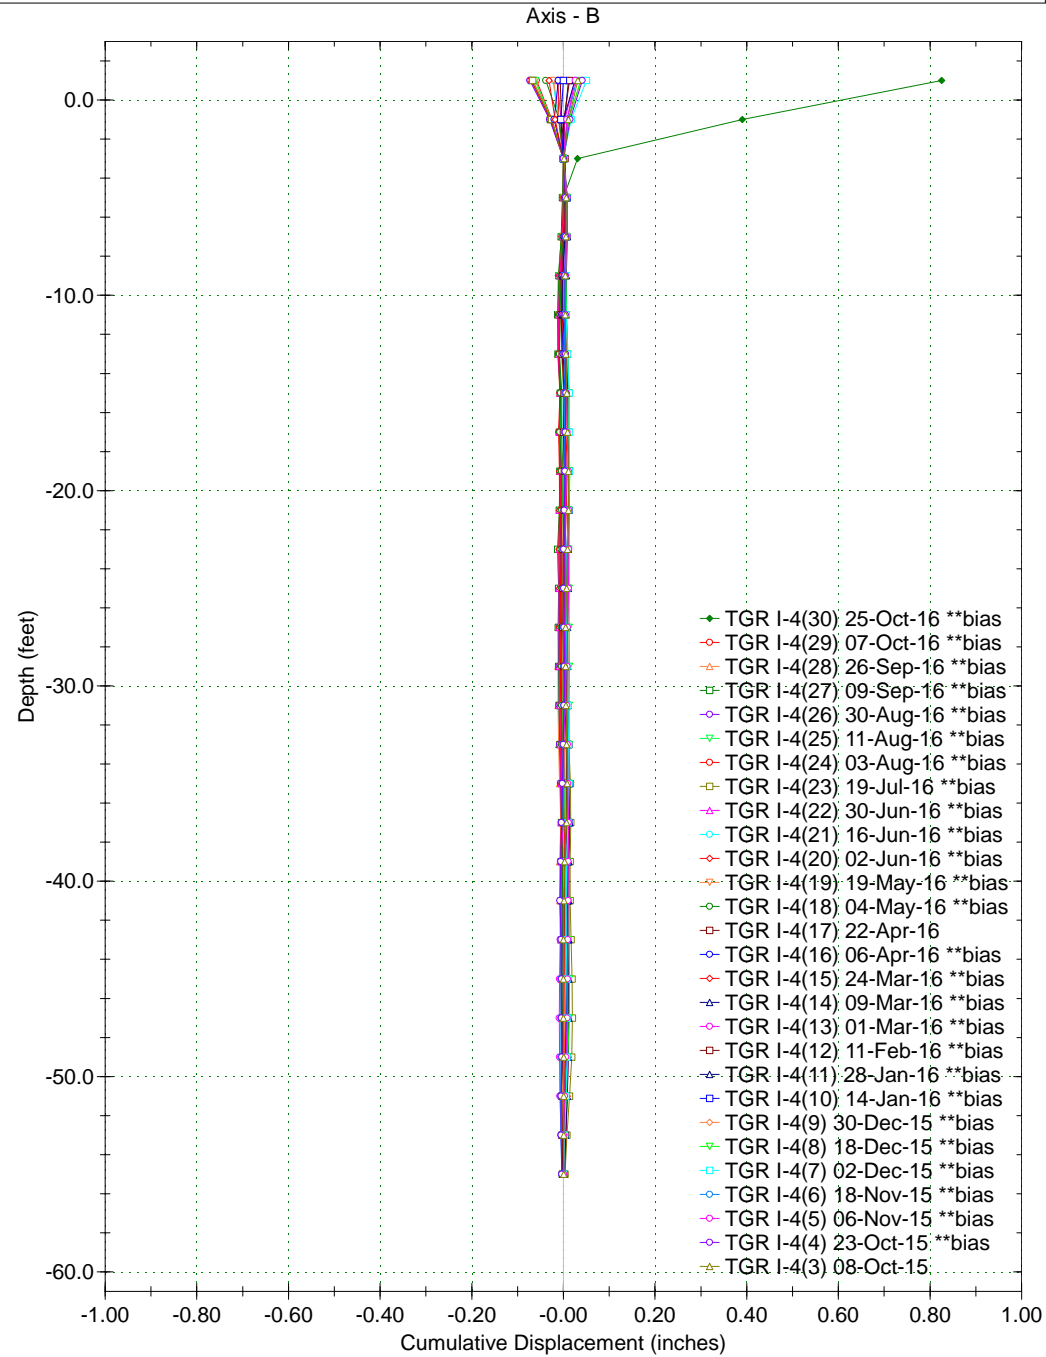
Borehole : TGR I-4
Project : CUY-90-15-24
Location :
Northing :
Easting :
Collar :

TGR I-4 – Inclinometer readings at this location indicate near surface displacement of about 0.8 inches in the positive B-axis direction and 0.05 inches in the A-axis direction. This was likely caused by adjacent construction activity.
