Re: November 2, 3, and 4, 2016 Bi-Weekly Readings
CUY-90-15.24 Slope Monitoring
PID 96504
SME Project No. 069032.00

Bi-weekly instrument readings for the I-90 west slope taken on November 2, 3, and 4, 2016, are presented in this report. Bi-weekly readings currently include instruments at I/P-001-13, I/P-002-13, I/P-003-10, I/P-004-13, I/P-009-13, B-101, B-102, B-105A, B-05-02, B-05-A-03, B-05-04, B-05-A-11, P-1, P-9N, and TGR I-4. Changes reported for the individual instruments are for the previous two-week period unless noted otherwise.

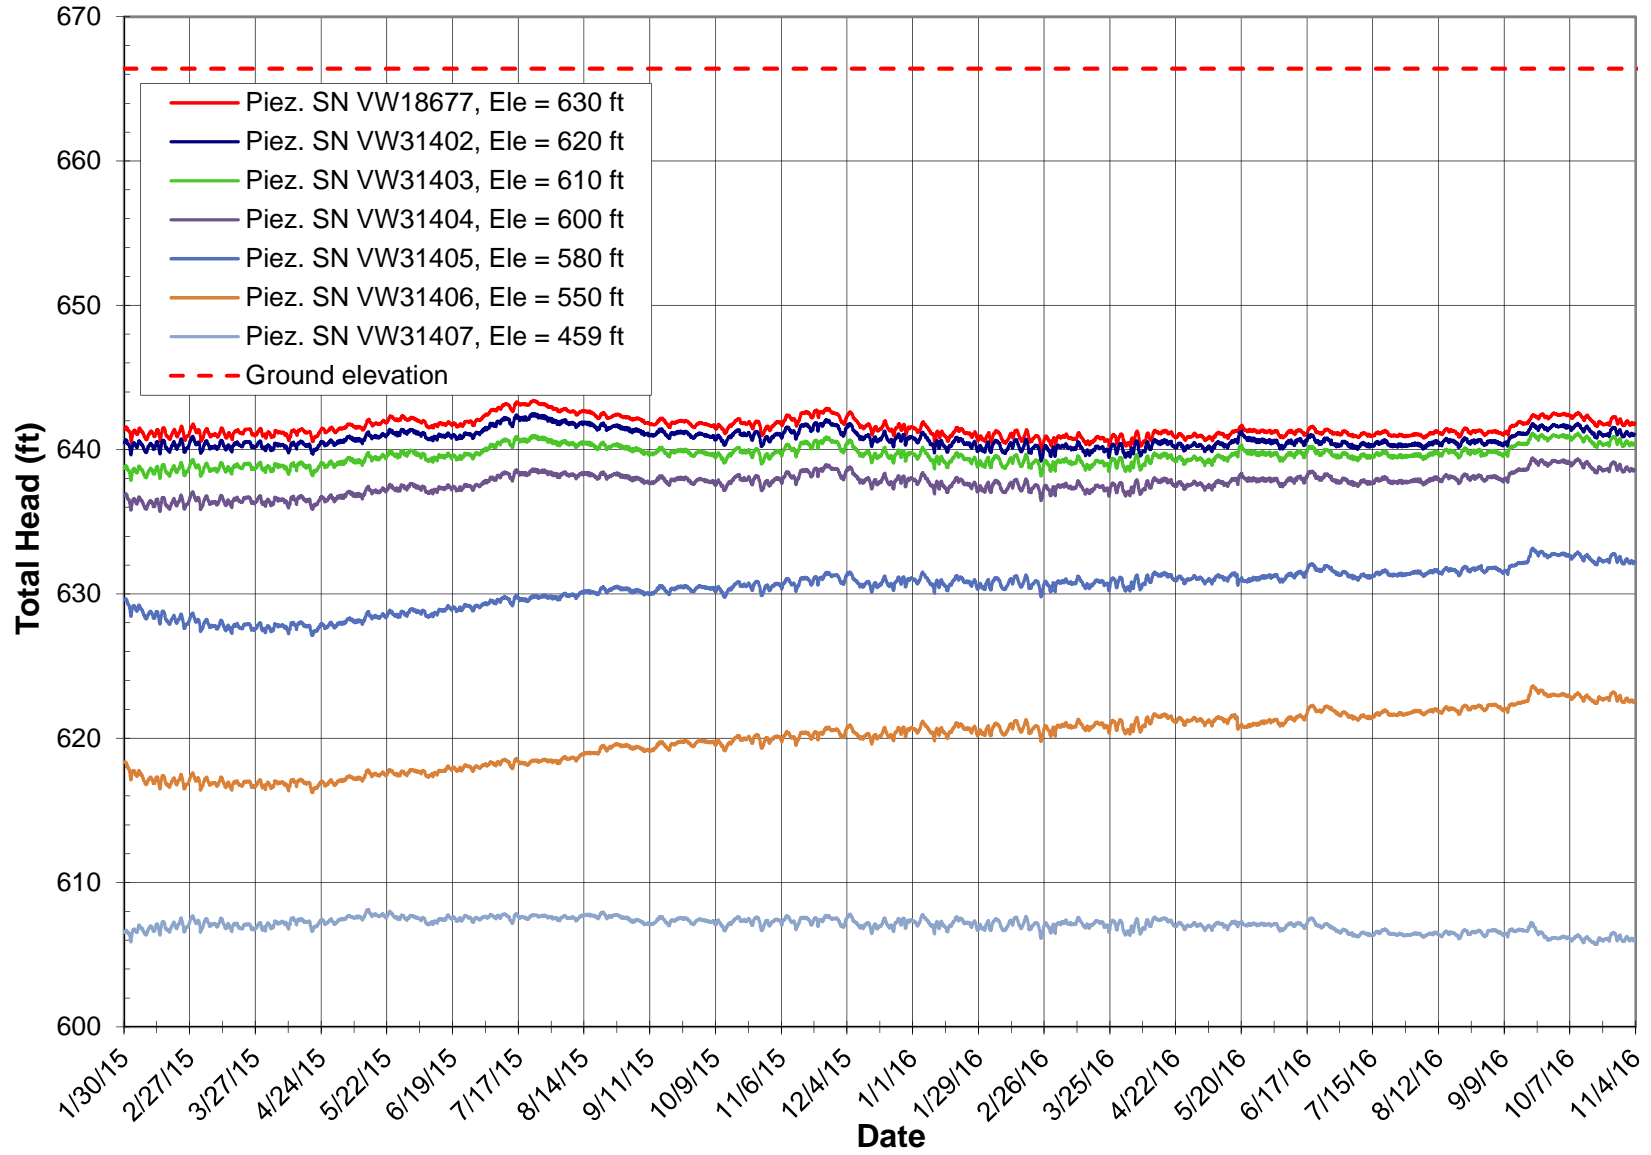
P-001-13 VW Piezometer Readings

P-001-13, P-002-13, P-003-10, P-004-13, P-009-13, B-05-02, B-05-A-11
– Pore pressure readings at these locations fluctuated by less than 0.5 feet and show virtually no net change in total head for the period.

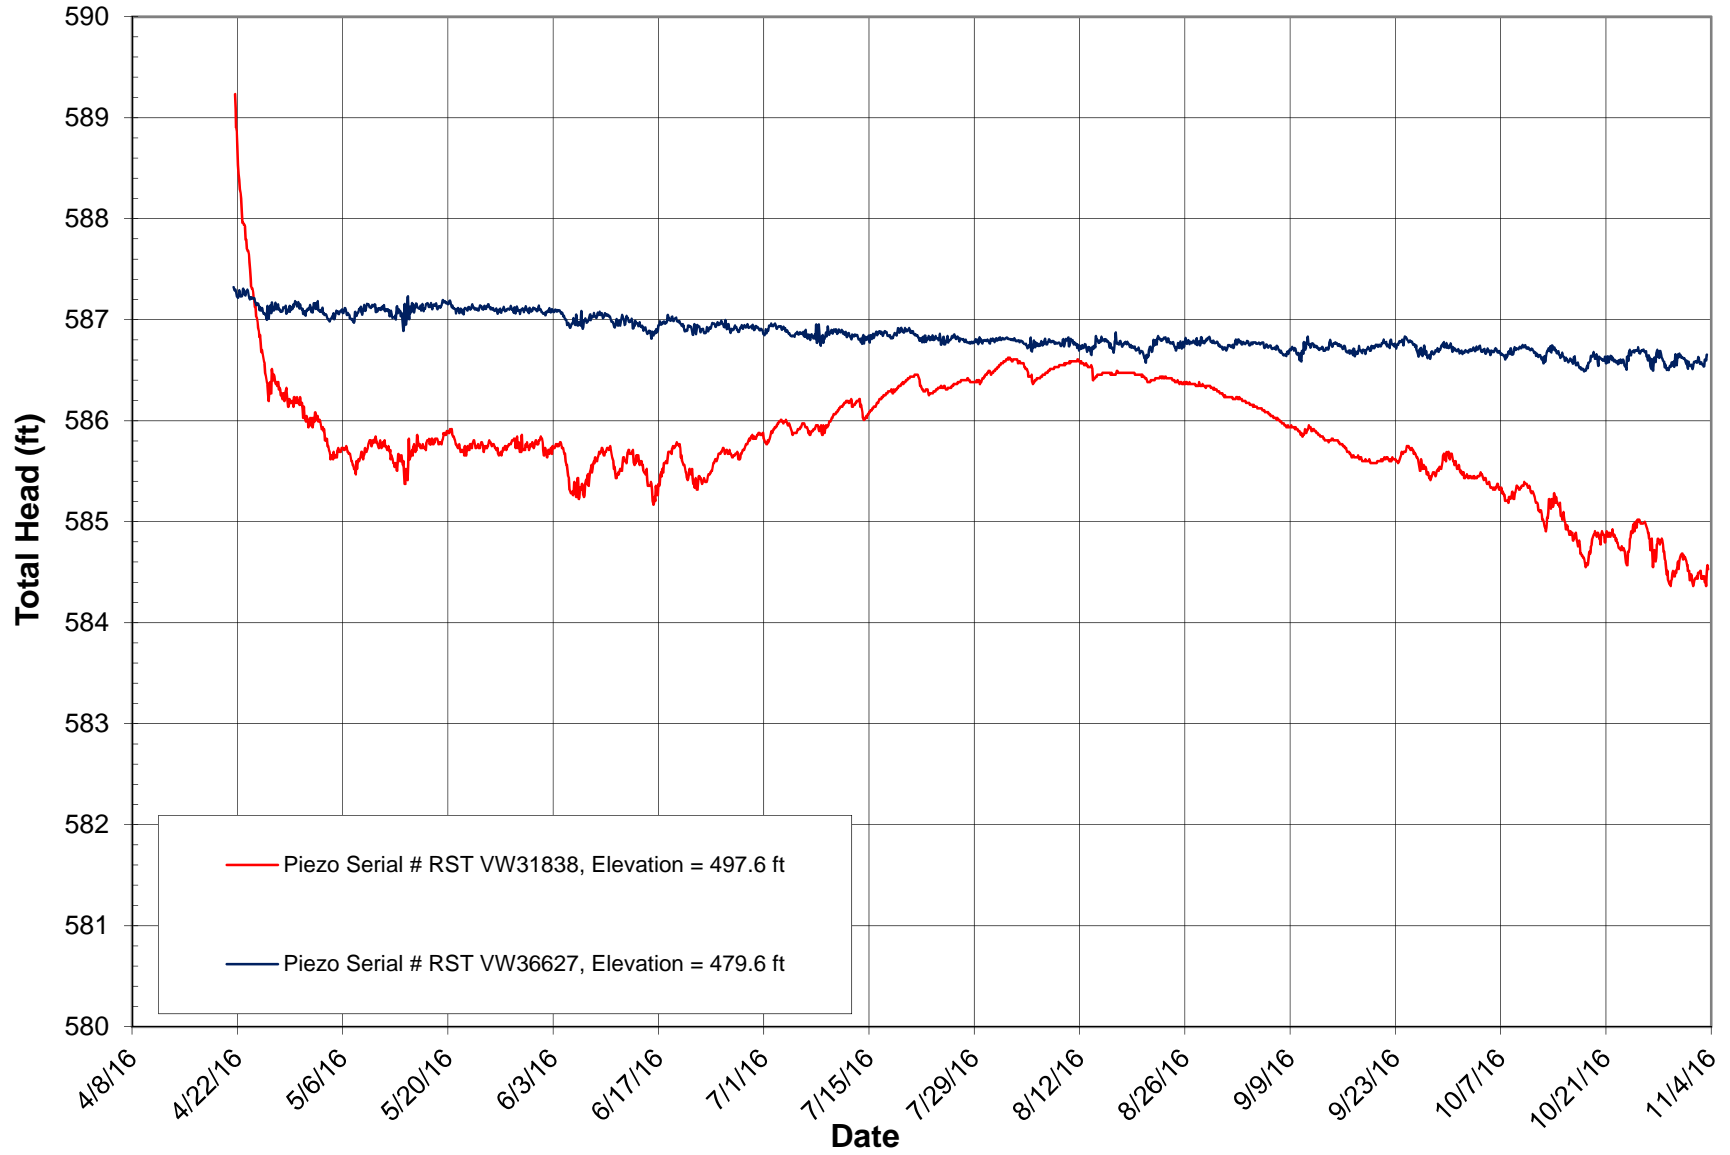
B-105A VW Piezometer Readings

B-105A – Total head in the shallow piezometer at this location continued to decrease during this recording cycle. From August 13 to November 3, 2016, the net decrease in total head has been 2.15 feet. Pore pressures in the deep piezometer show virtually no change.

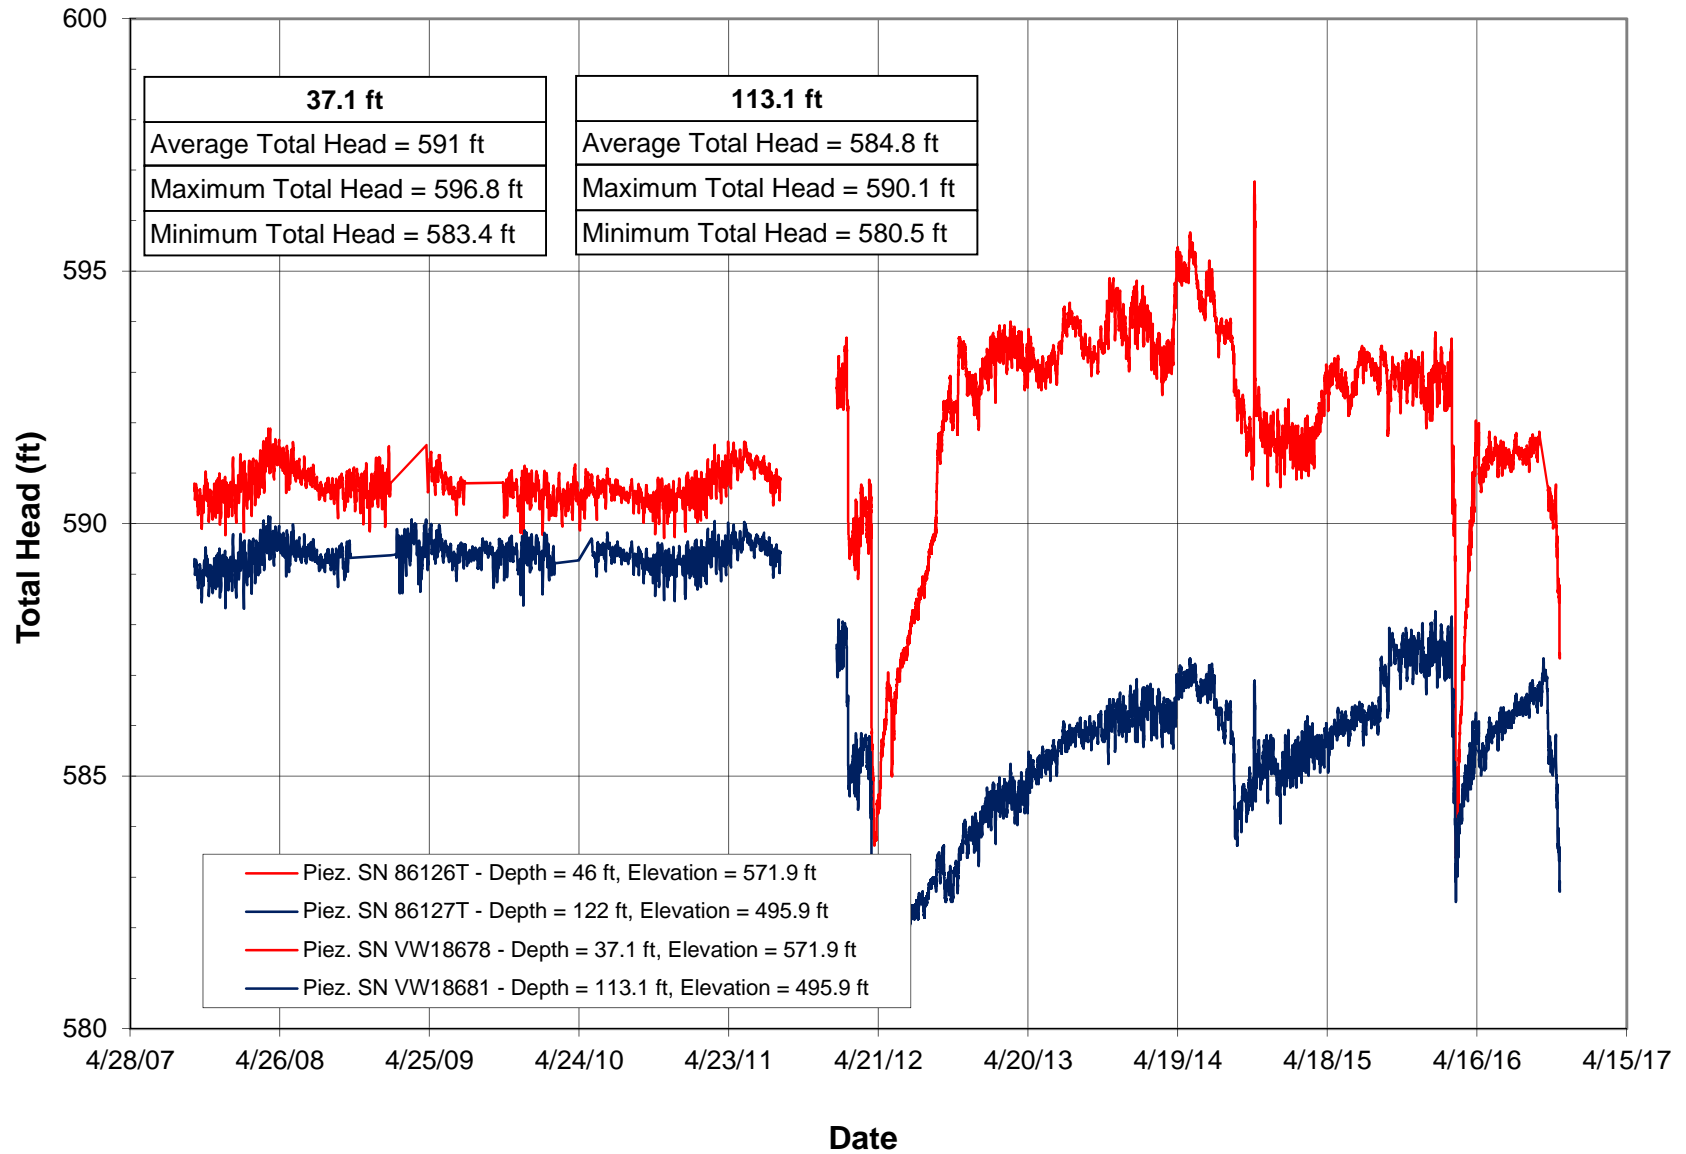
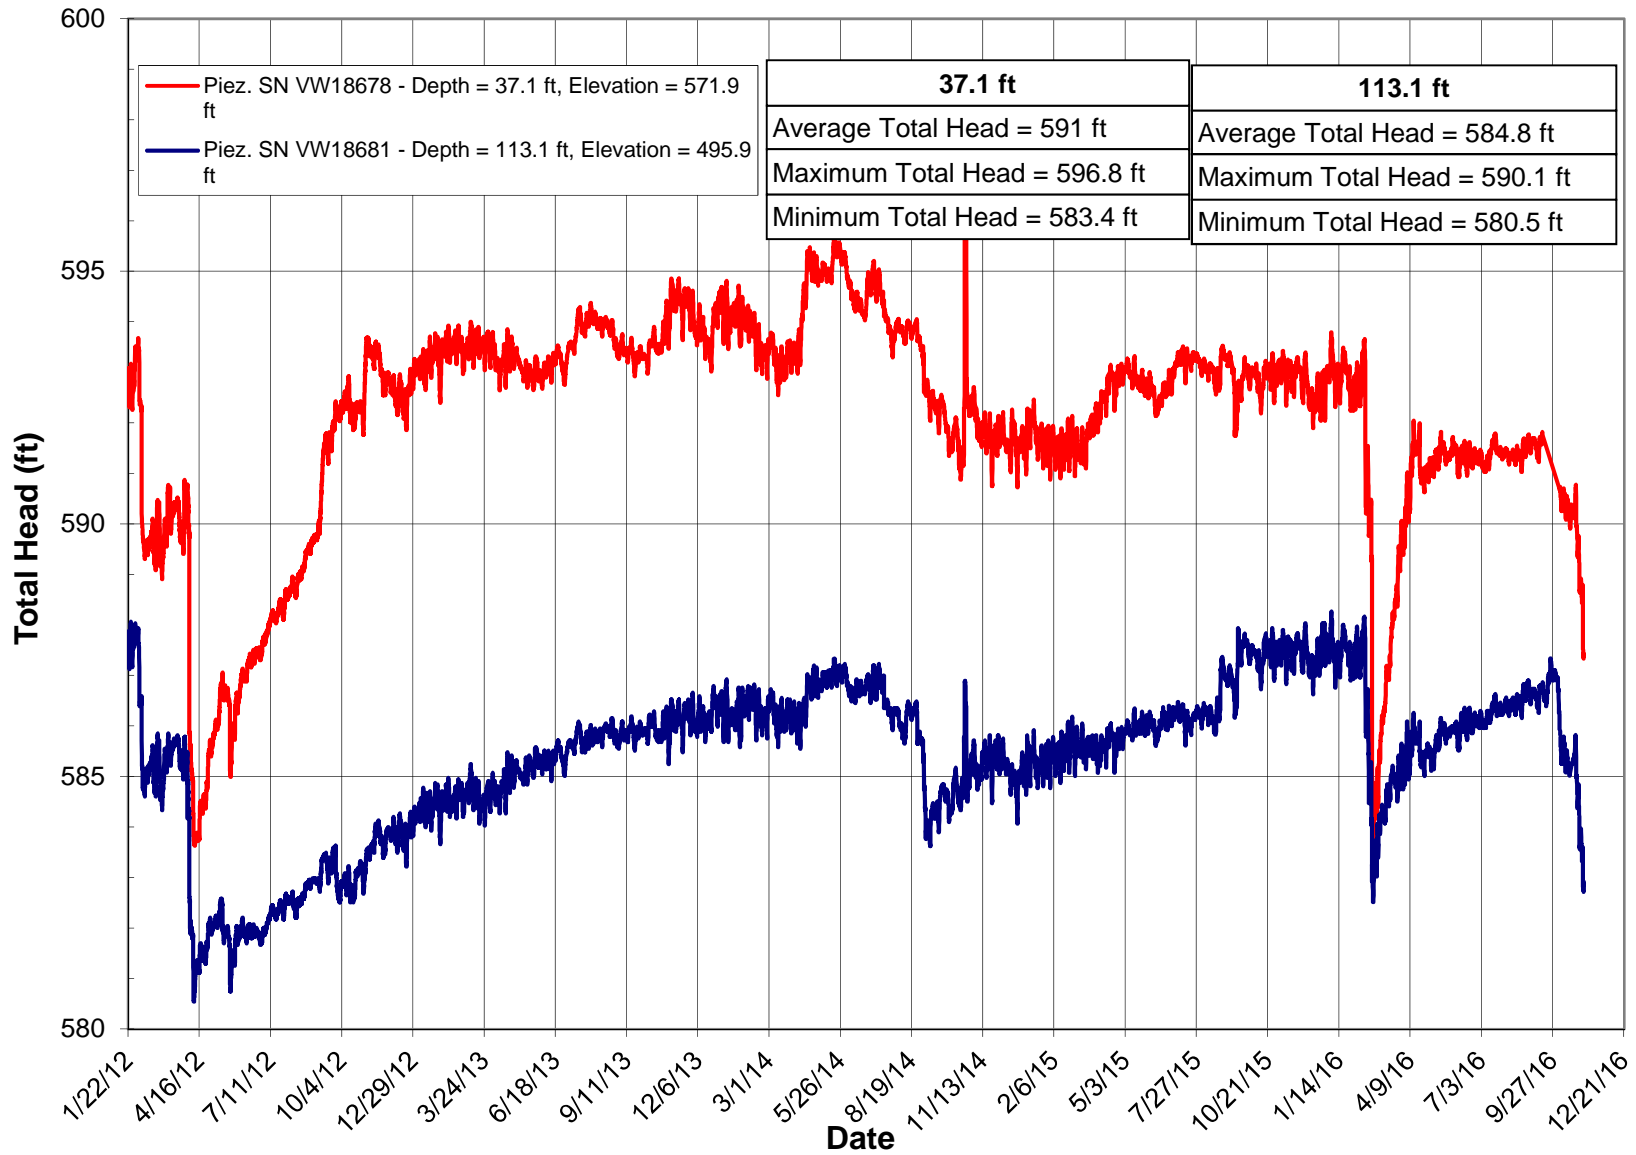
B-05-02 VW Piezometer Readings

B-05-02 – Since the last week of September, pore pressures decreased about 4.5 feet in both piezometers at this location. This is likely due to earthwork operations in the area of these instruments.

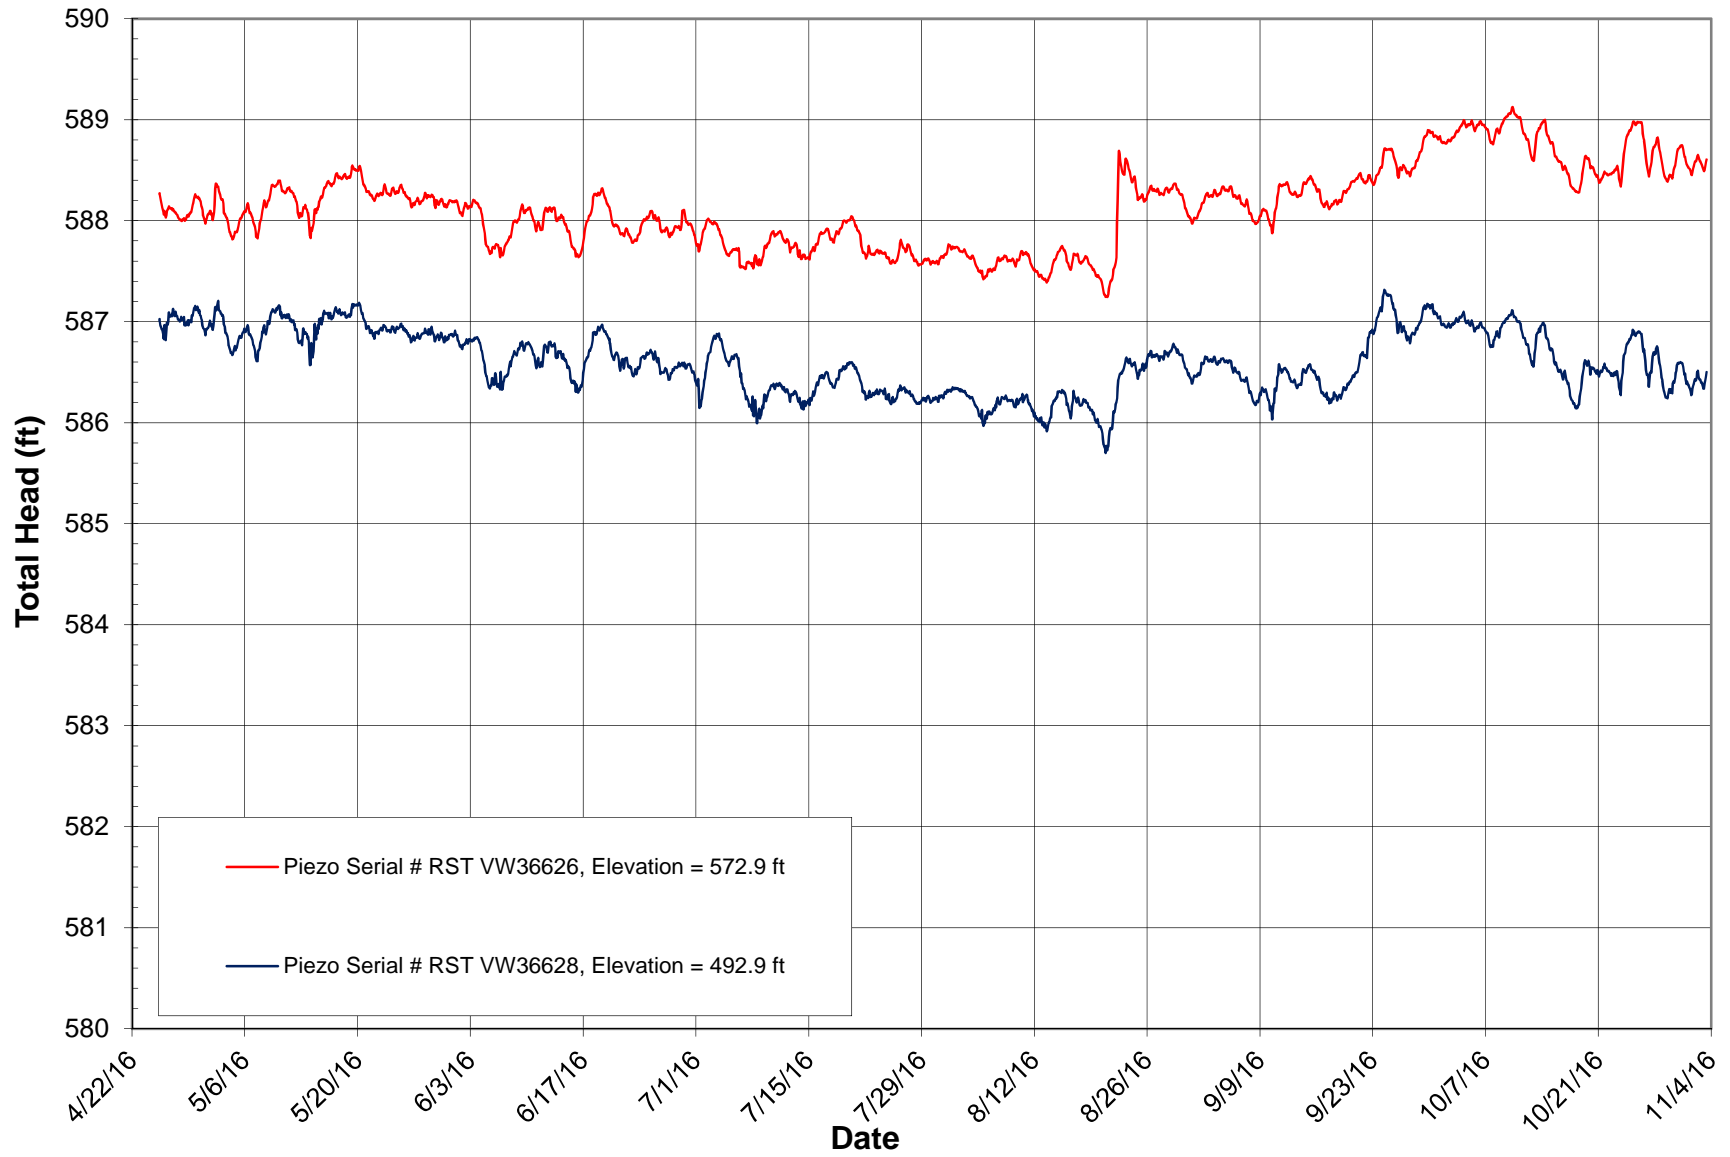
B-05-A-03 VW Piezometer Readings

B-05-A-03 – At this location, pore pressure readings in both piezometers indicate fluctuations over a range of about 0.8 feet but no net change during this period.

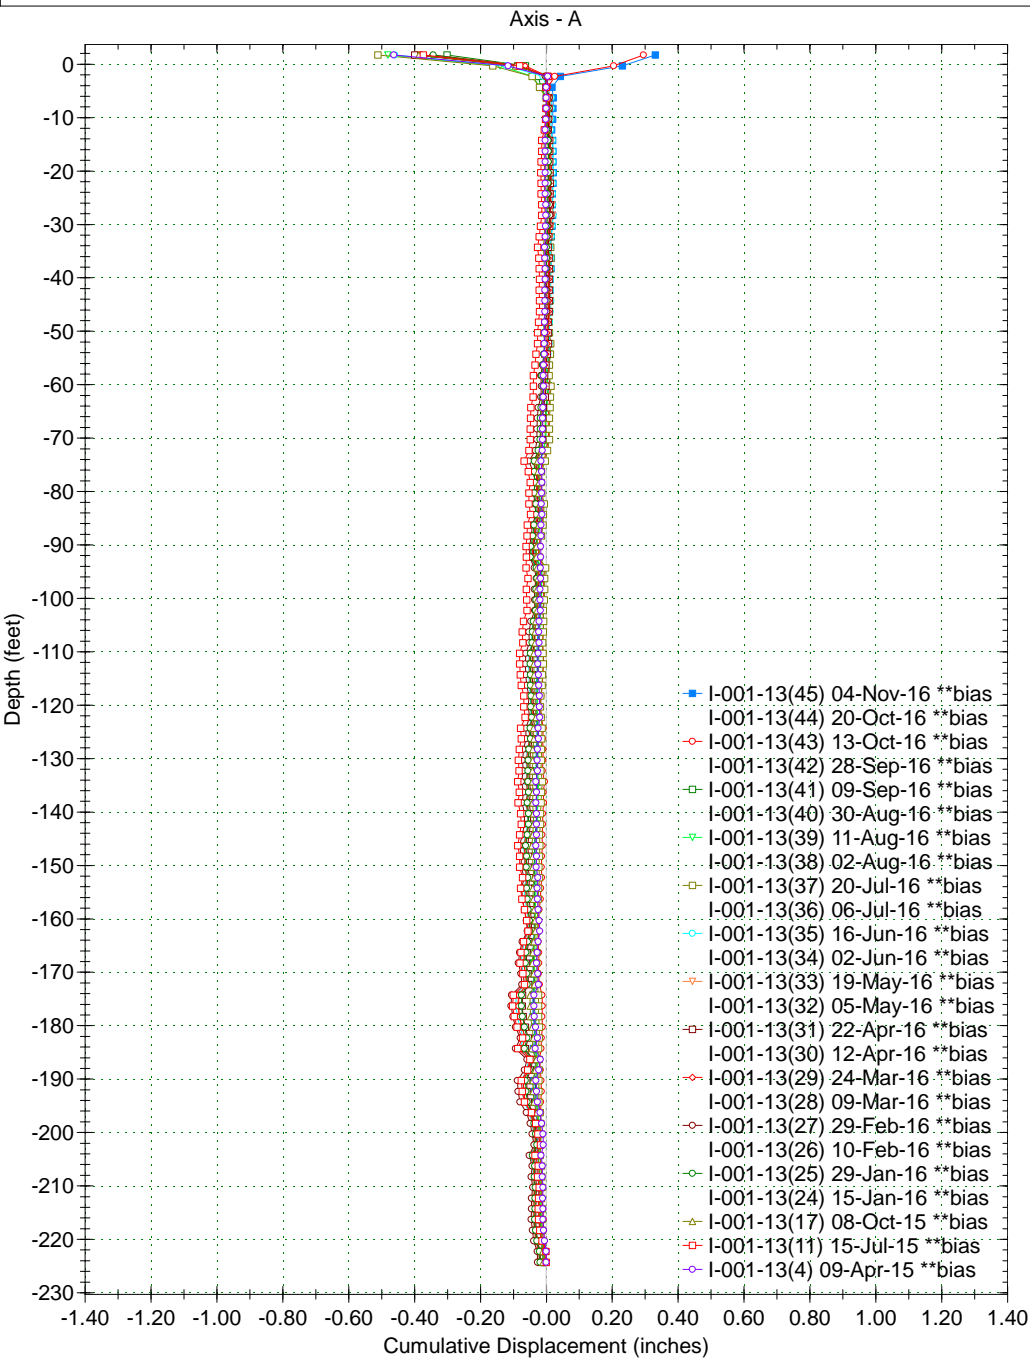
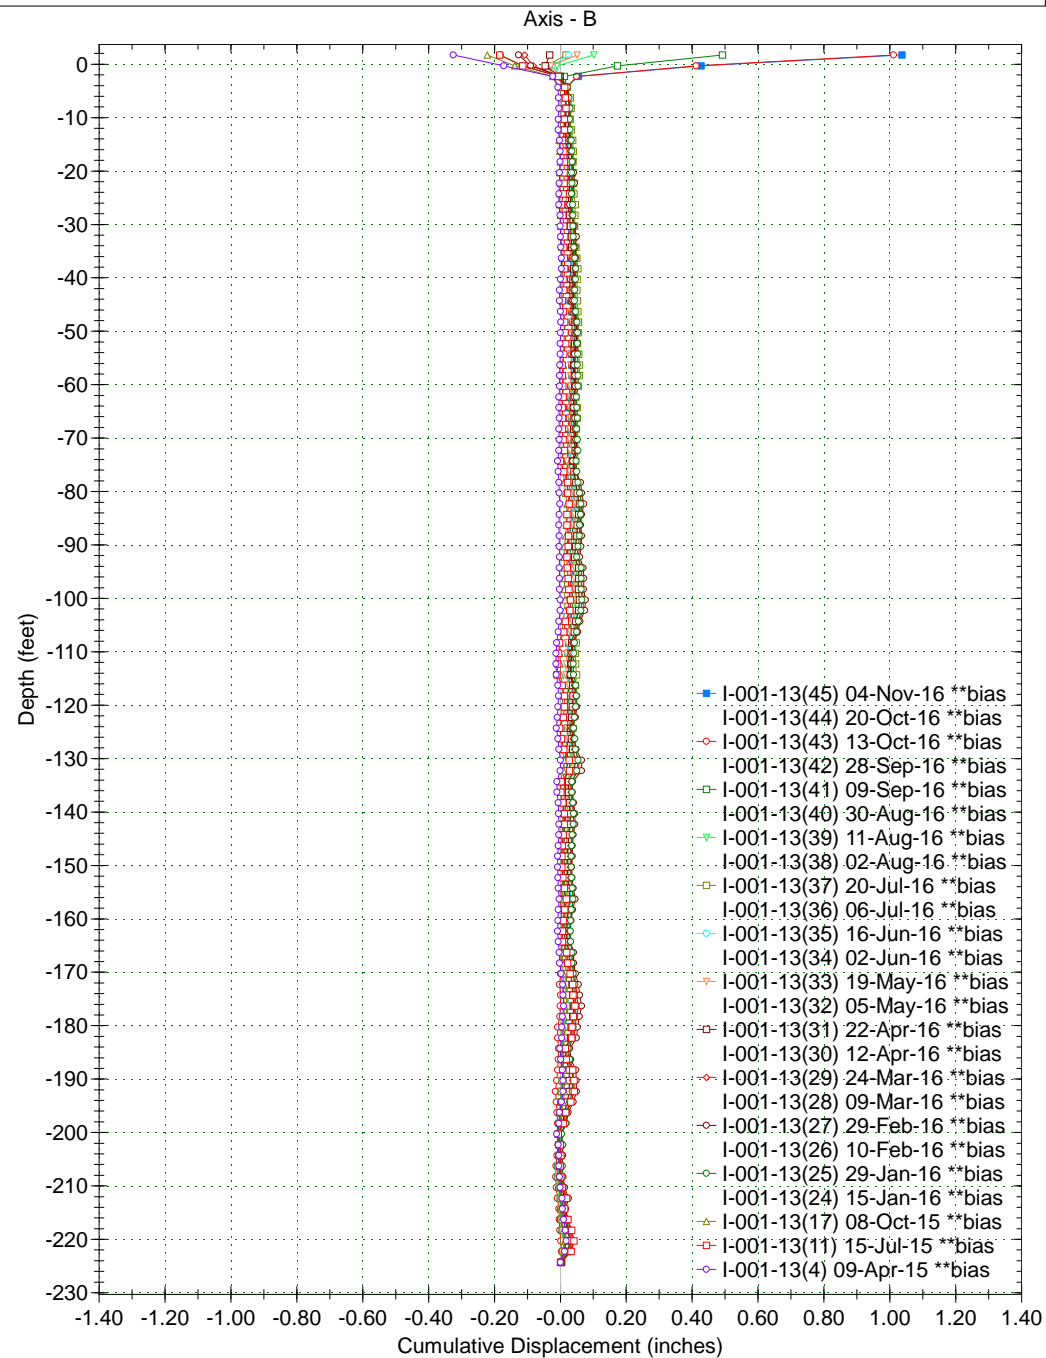
Borehole : I-001-13
Project : CUY-90-15-24
Location : Cleveland, Ohio
Northing :
Easting :
Collar :

Prior to failure of inclinometer probe, we obtained readings at I-001-13, I-002-13, I-004-13, I-009-13, B-101, B-102, B-05-A-11. Plots for all of these locations show virtually no movement this period. In some cases, the plots indicated displacement at the top of the casing. This is due to disturbance of the area around the casing that occurred during construction. Protective covers have not yet been permanently concreted in place because of the ongoing construction near these instruments.

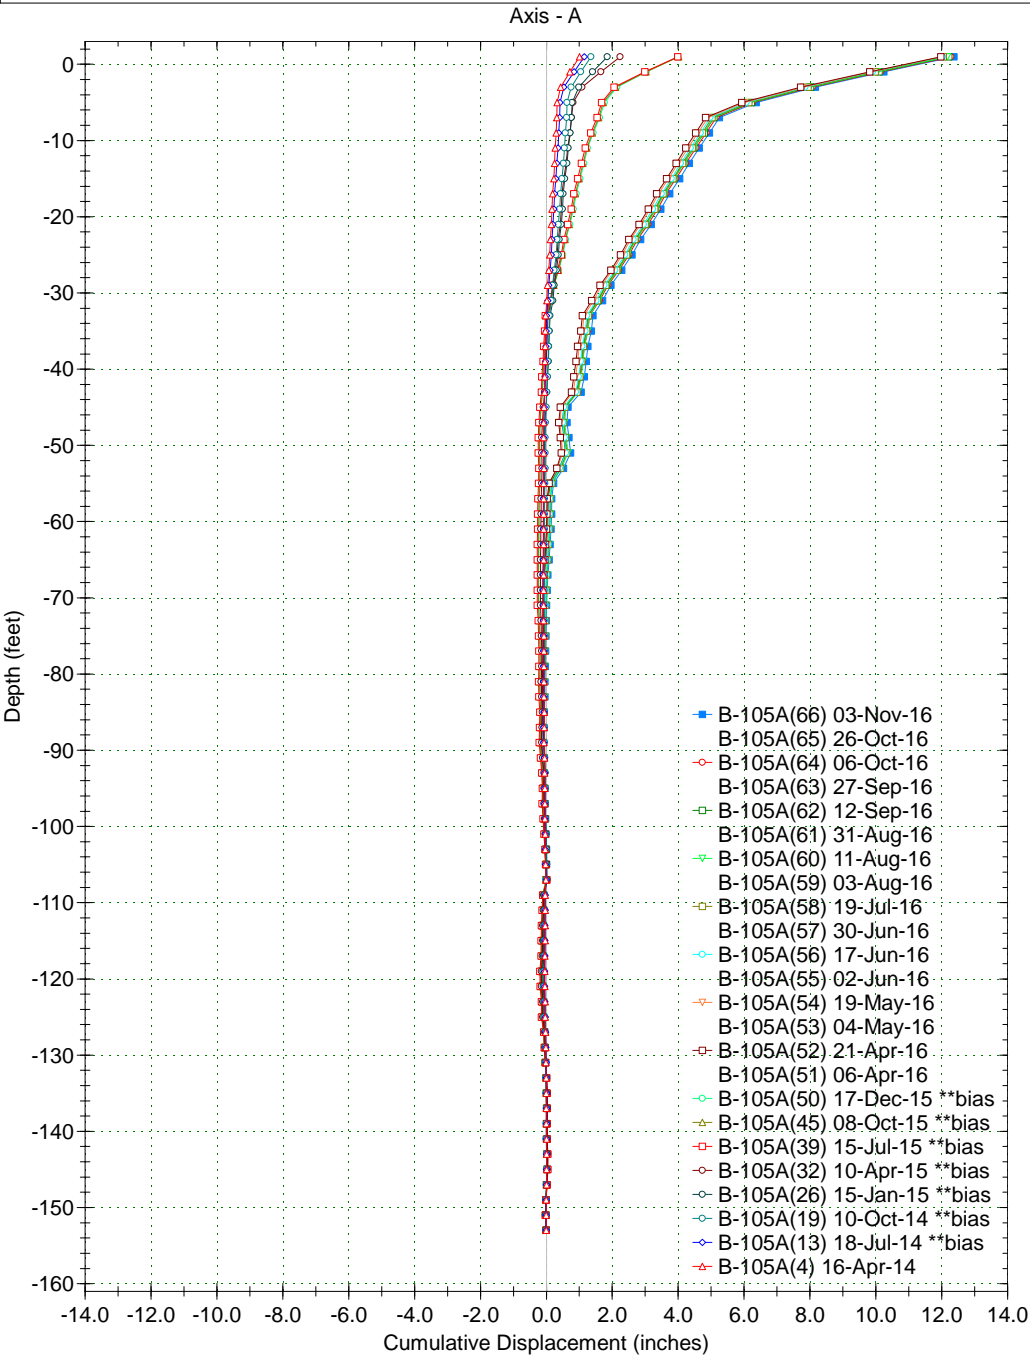
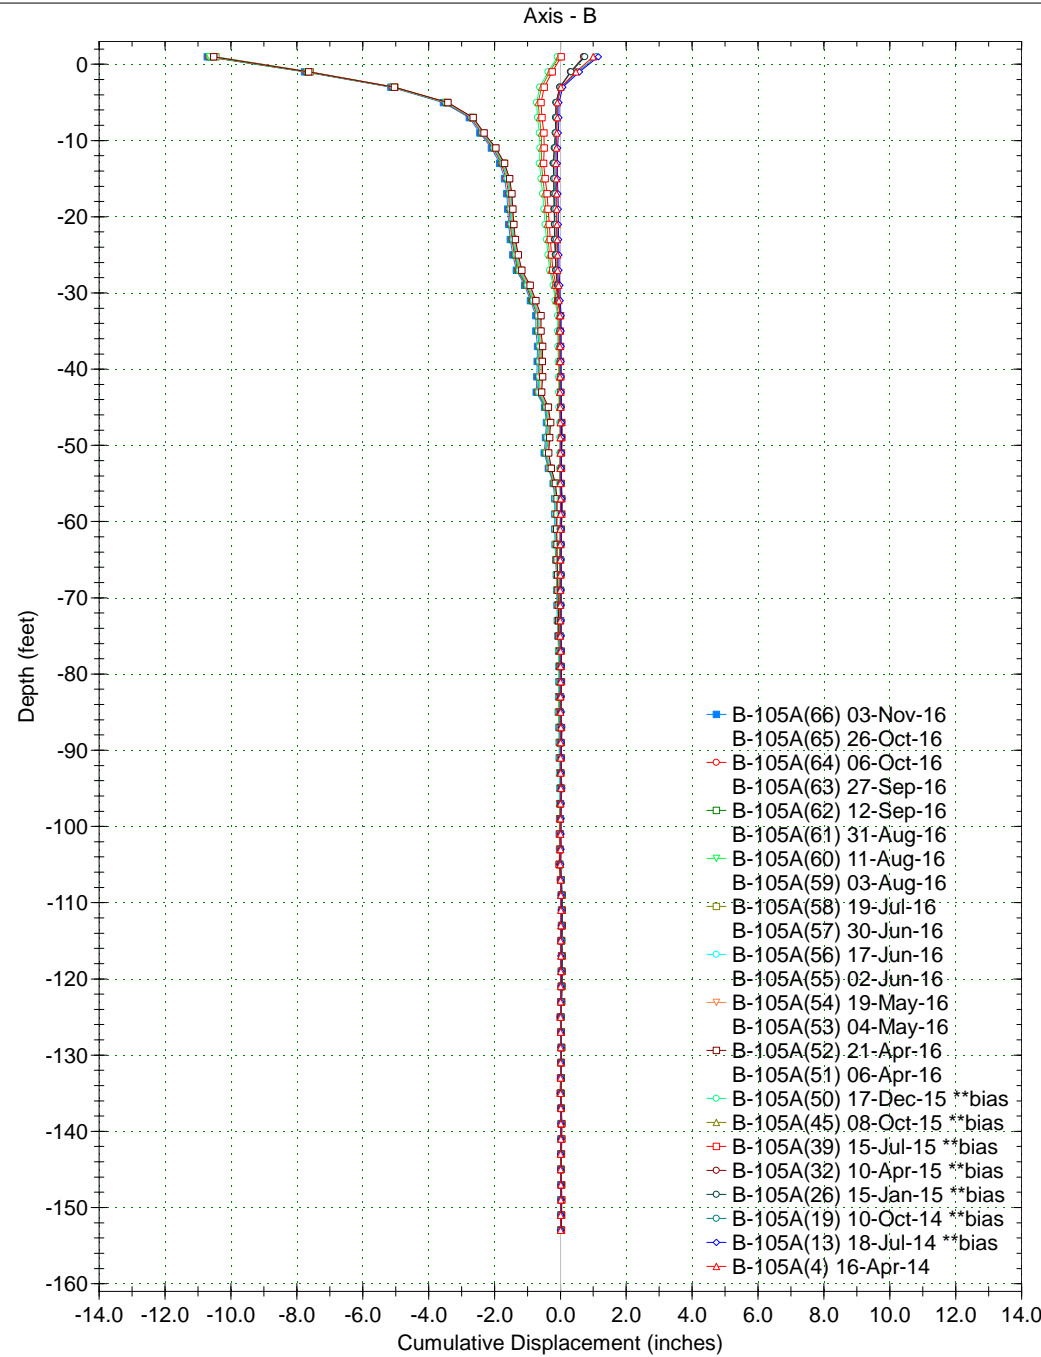
Borehole : B-105A
Project : CUY-90-15-24
Location : Cleveland, Ohio
Northing : Sta. 19+11.38
Easting : 90.9' Rt of CL
Collar :

B-105A – The current plot indicates a slight increase in positive A-axis and negative B-axis displacement of the top 60 to 70 feet of the casing.
