March 1, 2017

Re: February 2 and 3, 2017 Bi-Weekly Readings
CUY-90-15.24 Slope Monitoring
PID 96504
SME Project No. 069032.00

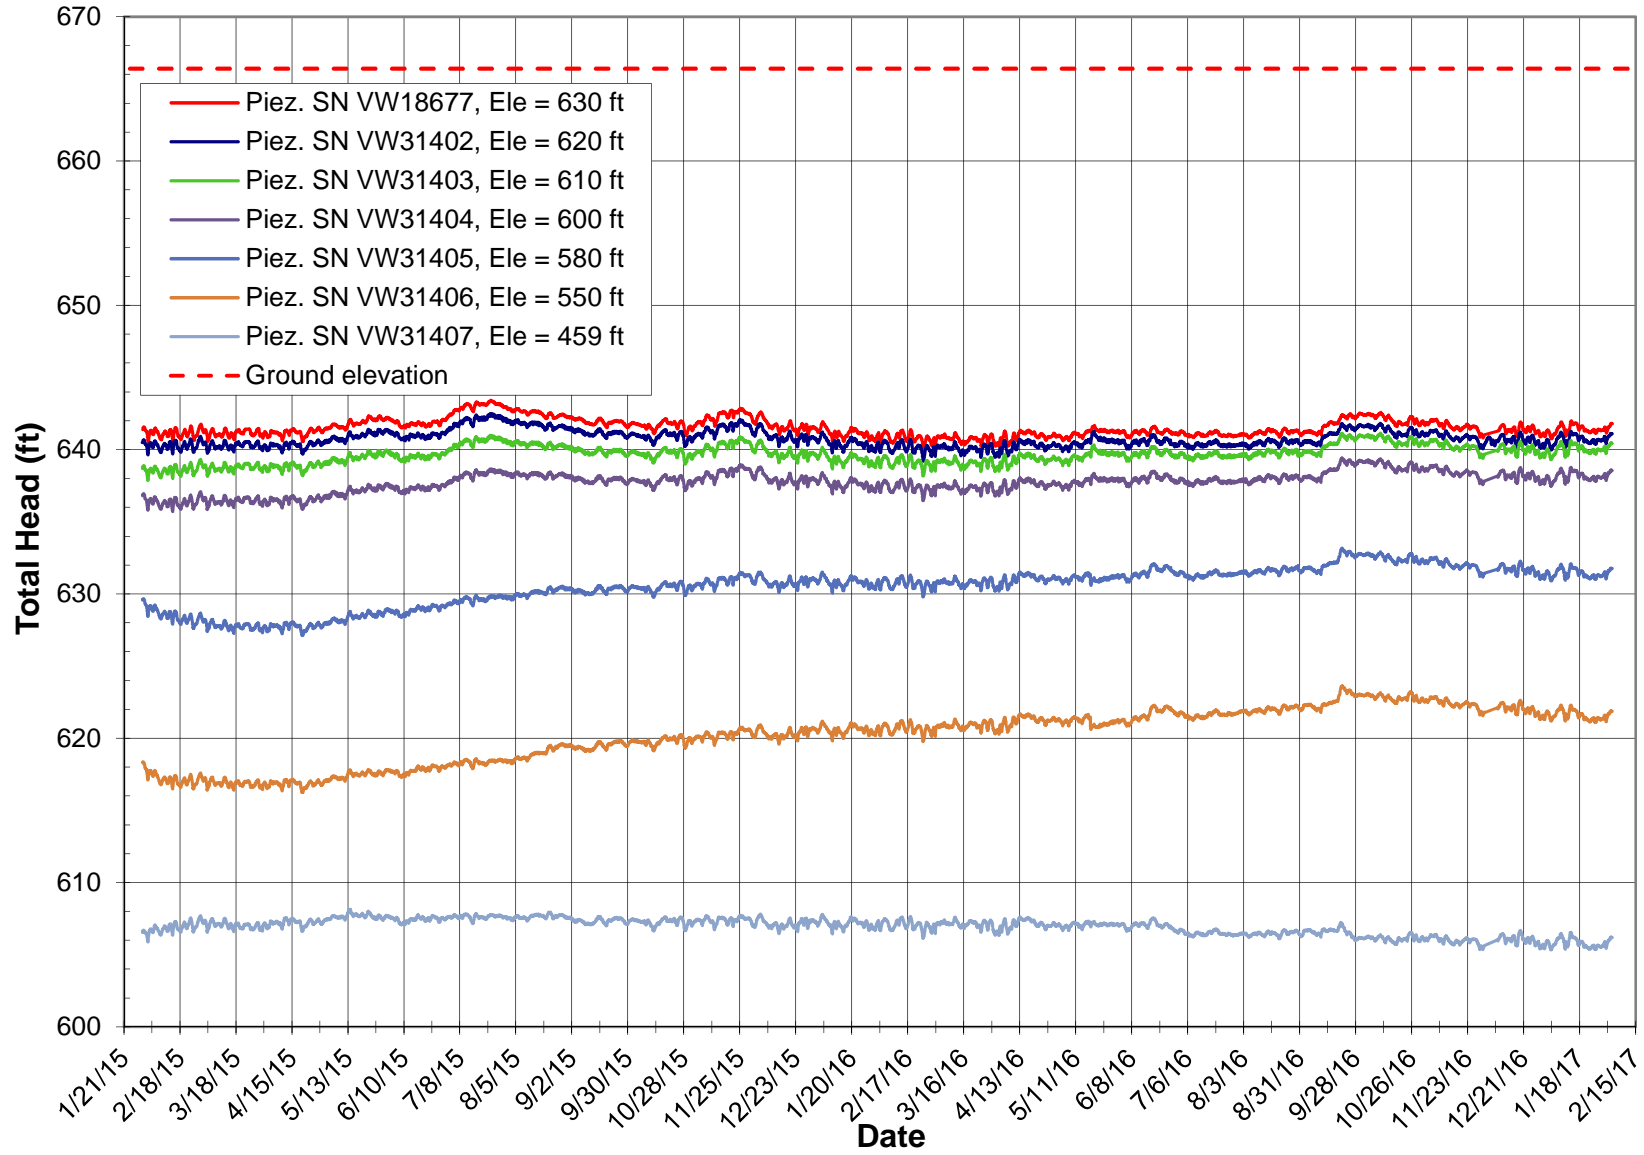
P-001-13 VW Piezometer Readings

Pore pressure readings at P-001-13, P-002-13, P-003-10, P-003-13, P-004-13, P-009-13, B-105A, B-05-A-03, B-05-04, and B-05-A-11 show slight increases in total head of less than 0.5 feet for the period.

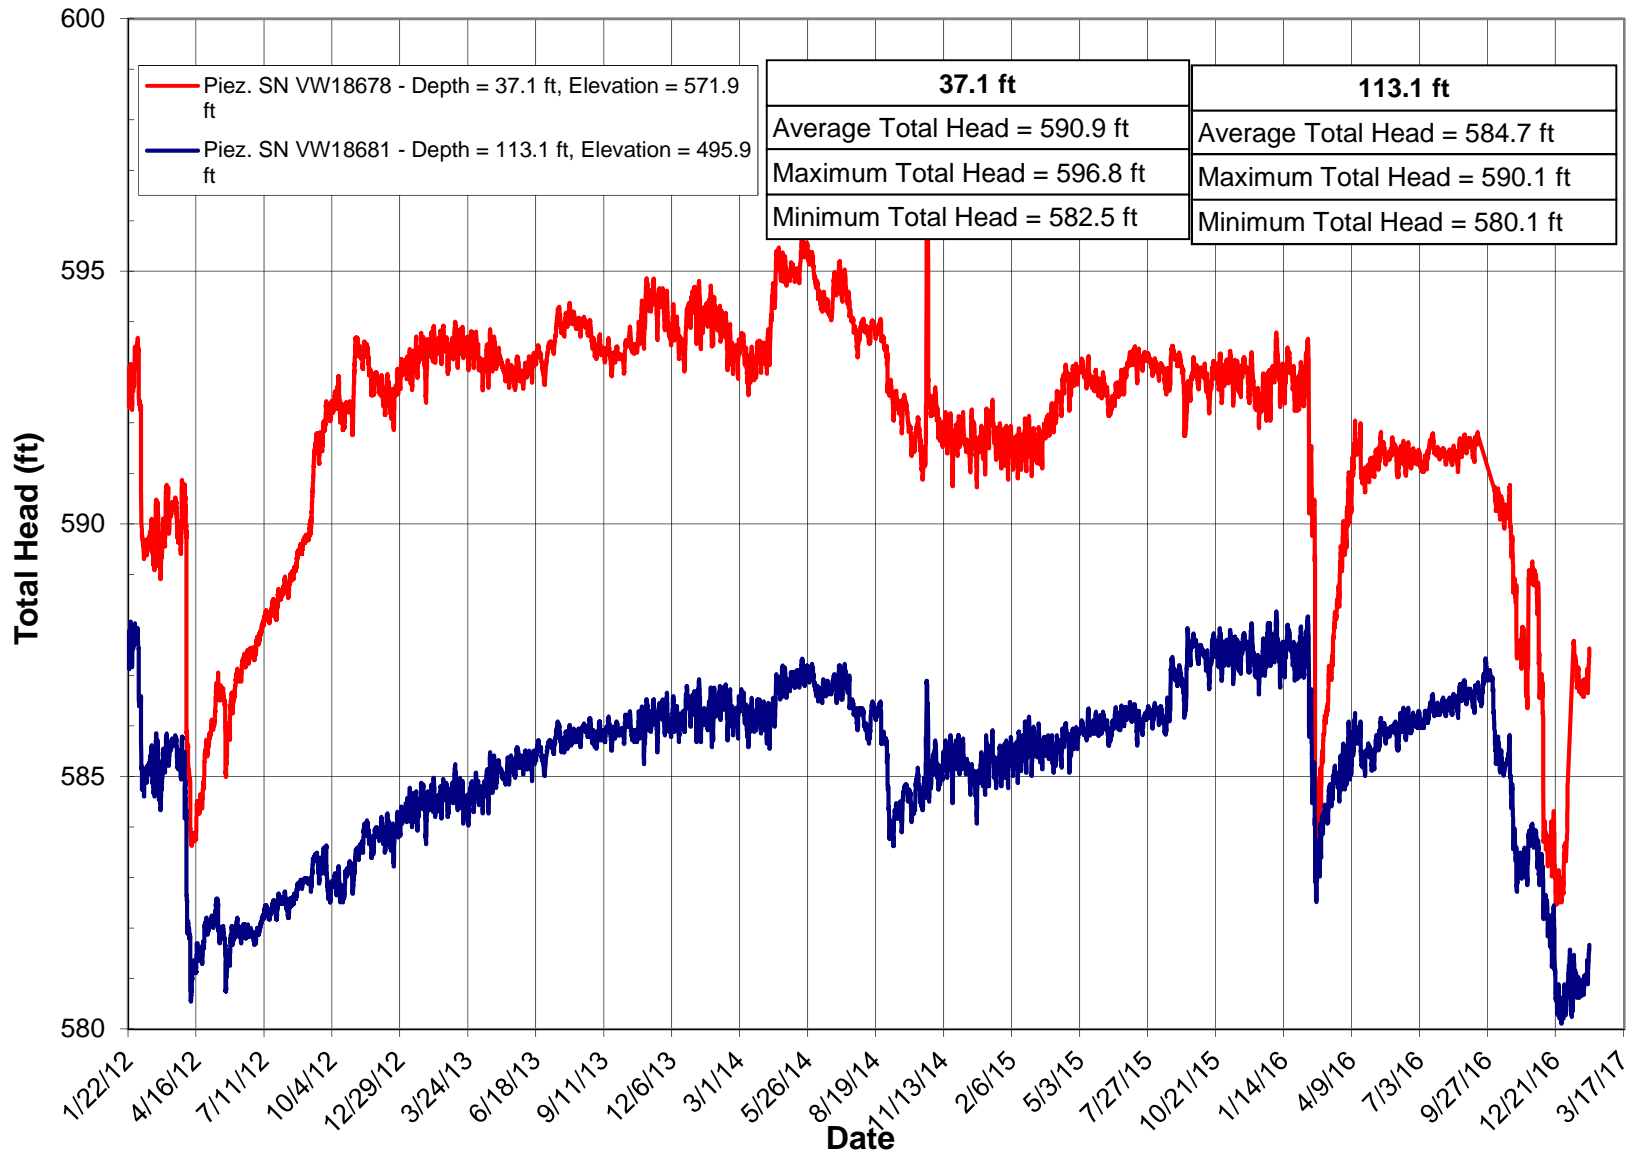
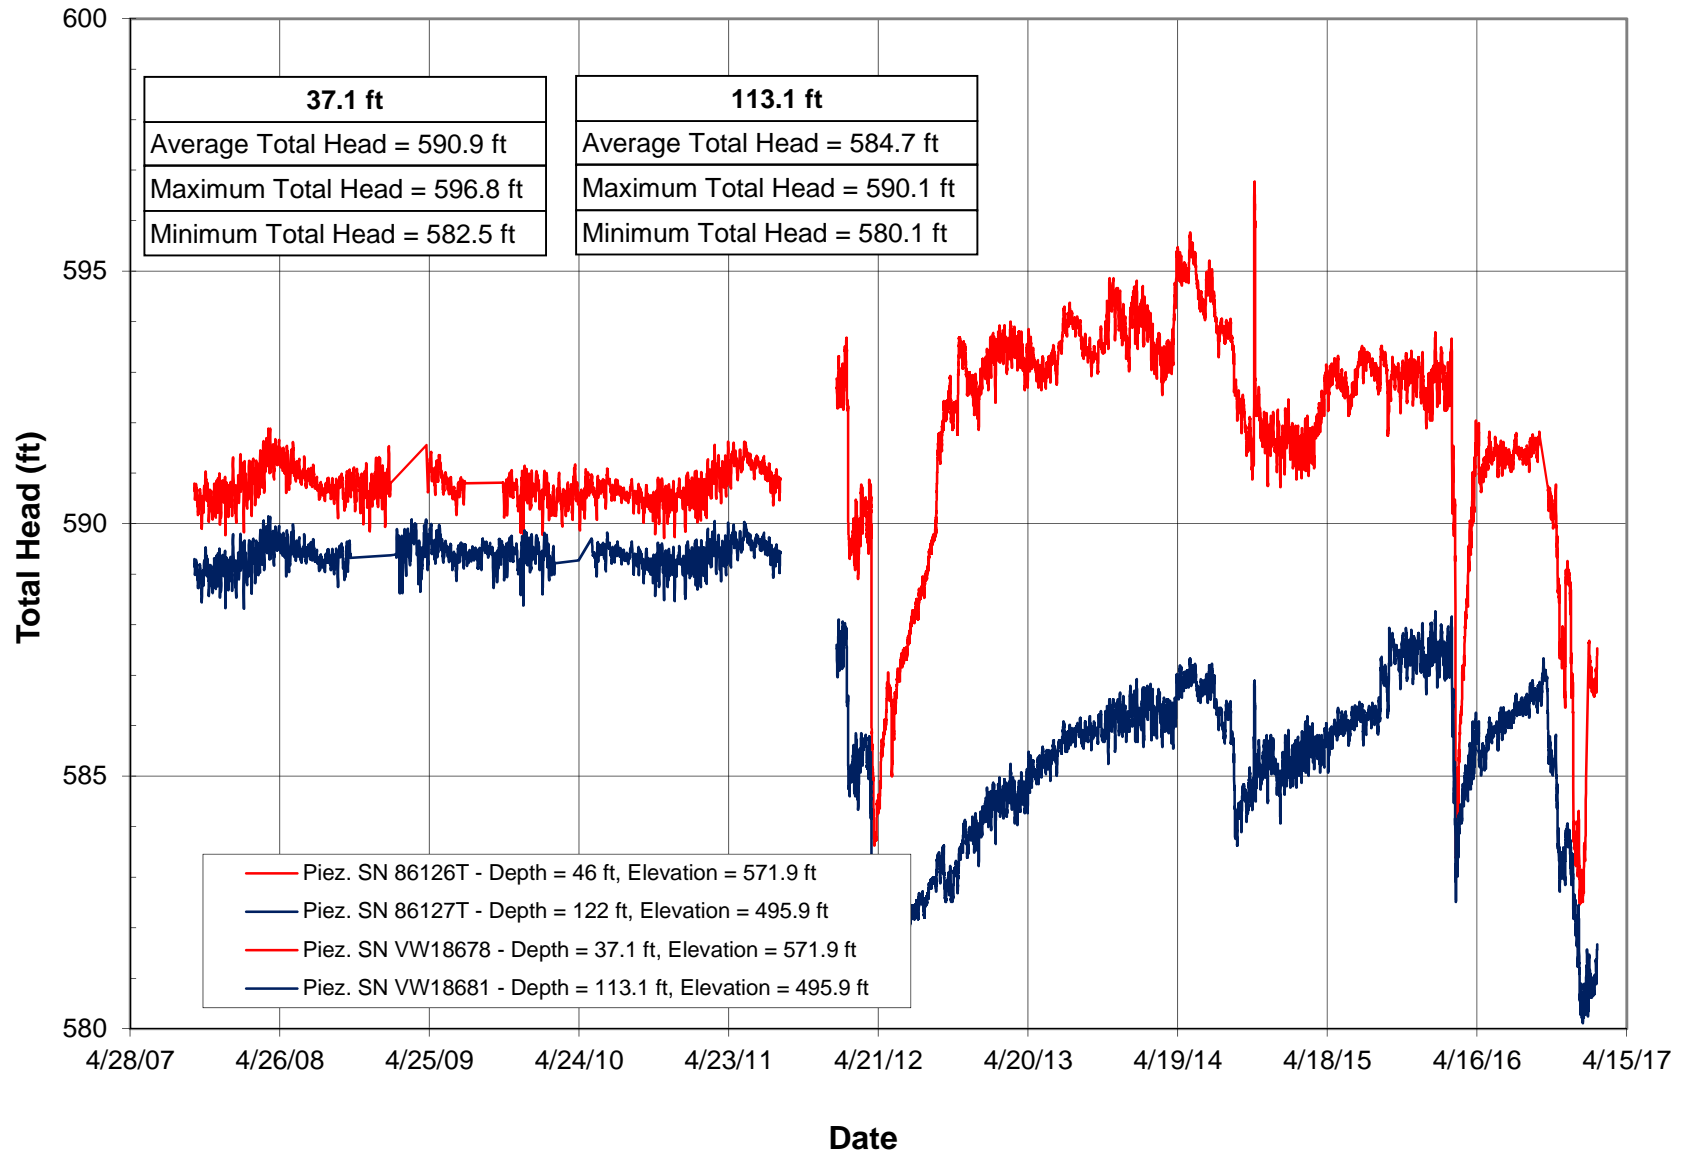
B-05-02 VW Piezometer Readings

B-05-02 – Pore pressures had been dropping at the end of the last two-week period but increased again this period. Pore pressures in the shallow piezometer remain slightly below the highest pressure recorded during the last two-week period and have increased by about 5 feet since December 29, 2016. Pore pressures in the deep piezometer increased by about 0.7 feet this period. Pore pressures in both piezometers remain well below the highest pressures read during the past four years.
