March 21, 2017

Re: February 17, 21, and 22, 2017 Bi-Weekly Readings
CUY-90-15.24 Slope Monitoring
PID 96504
SME Project No. 069032.00

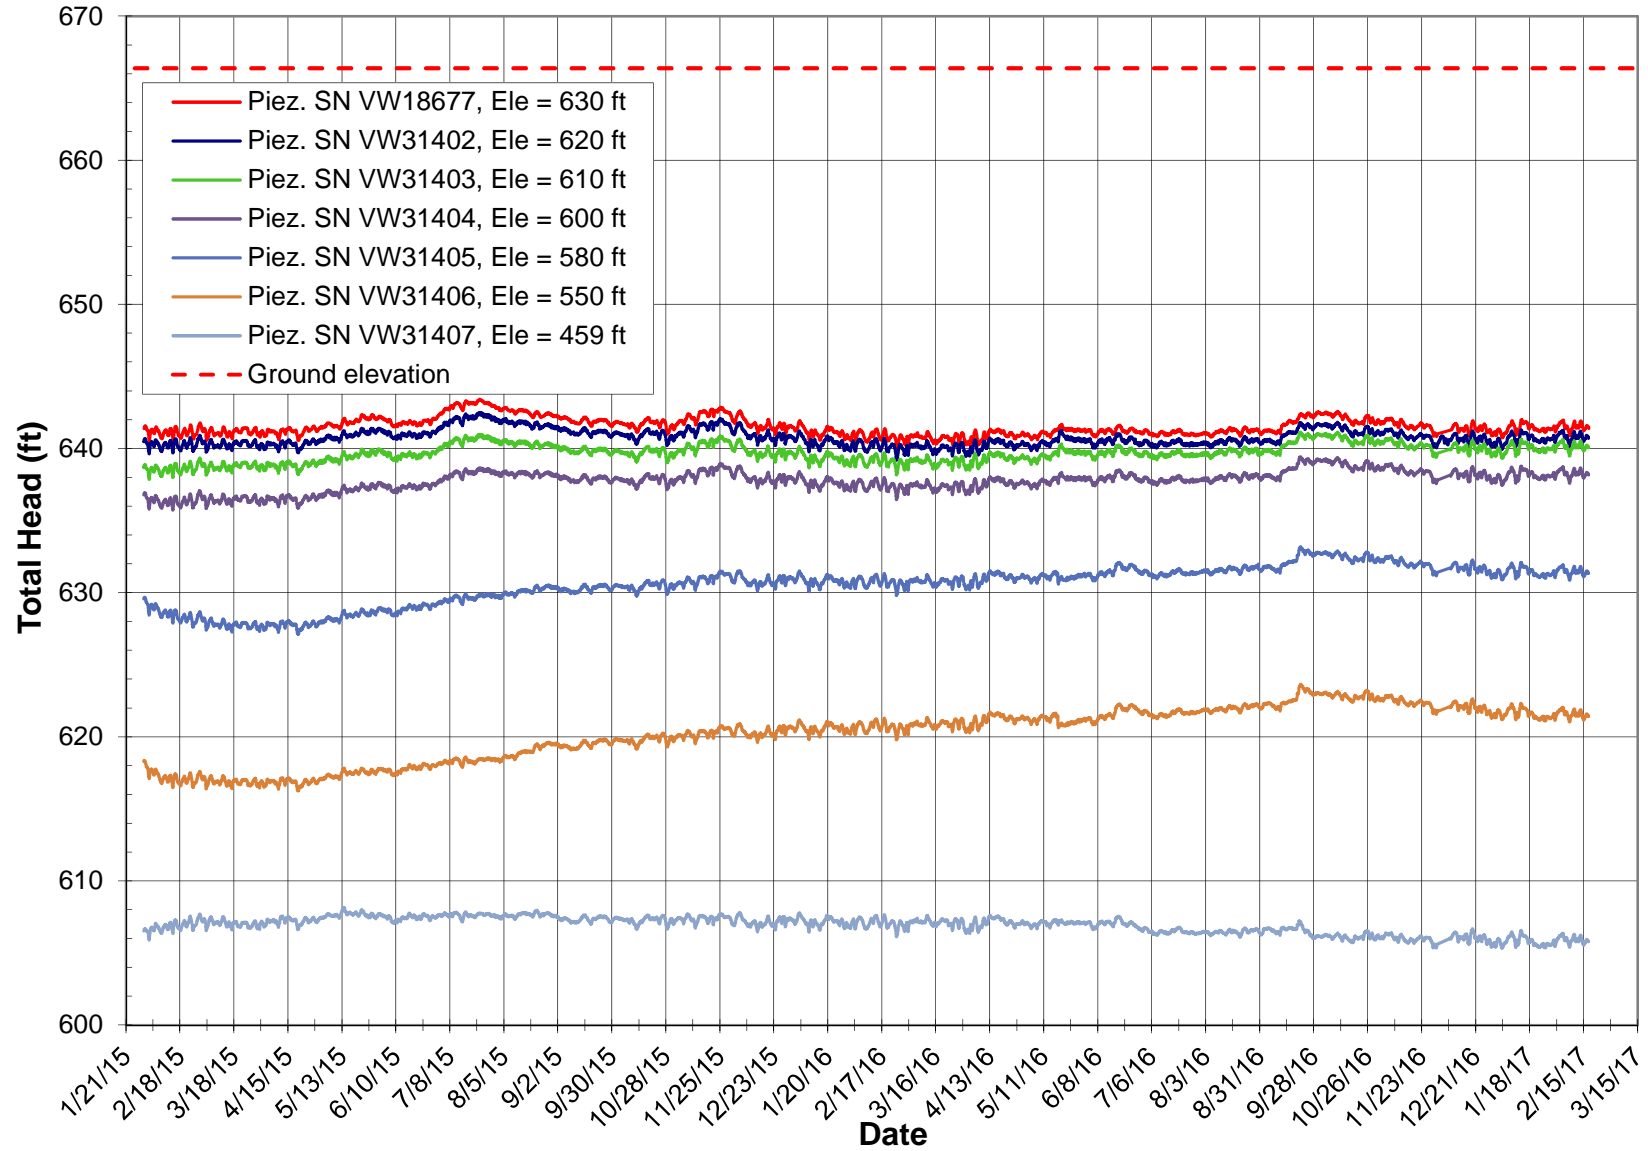
P-001-13 VW Piezometer Readings

P-001-13 – Pore pressure readings in the piezometers at elevations 580 feet and 550 feet show decreases in total head of 0.5 feet. The remaining piezometers at this location show decreases of 0.4 feet in total head.

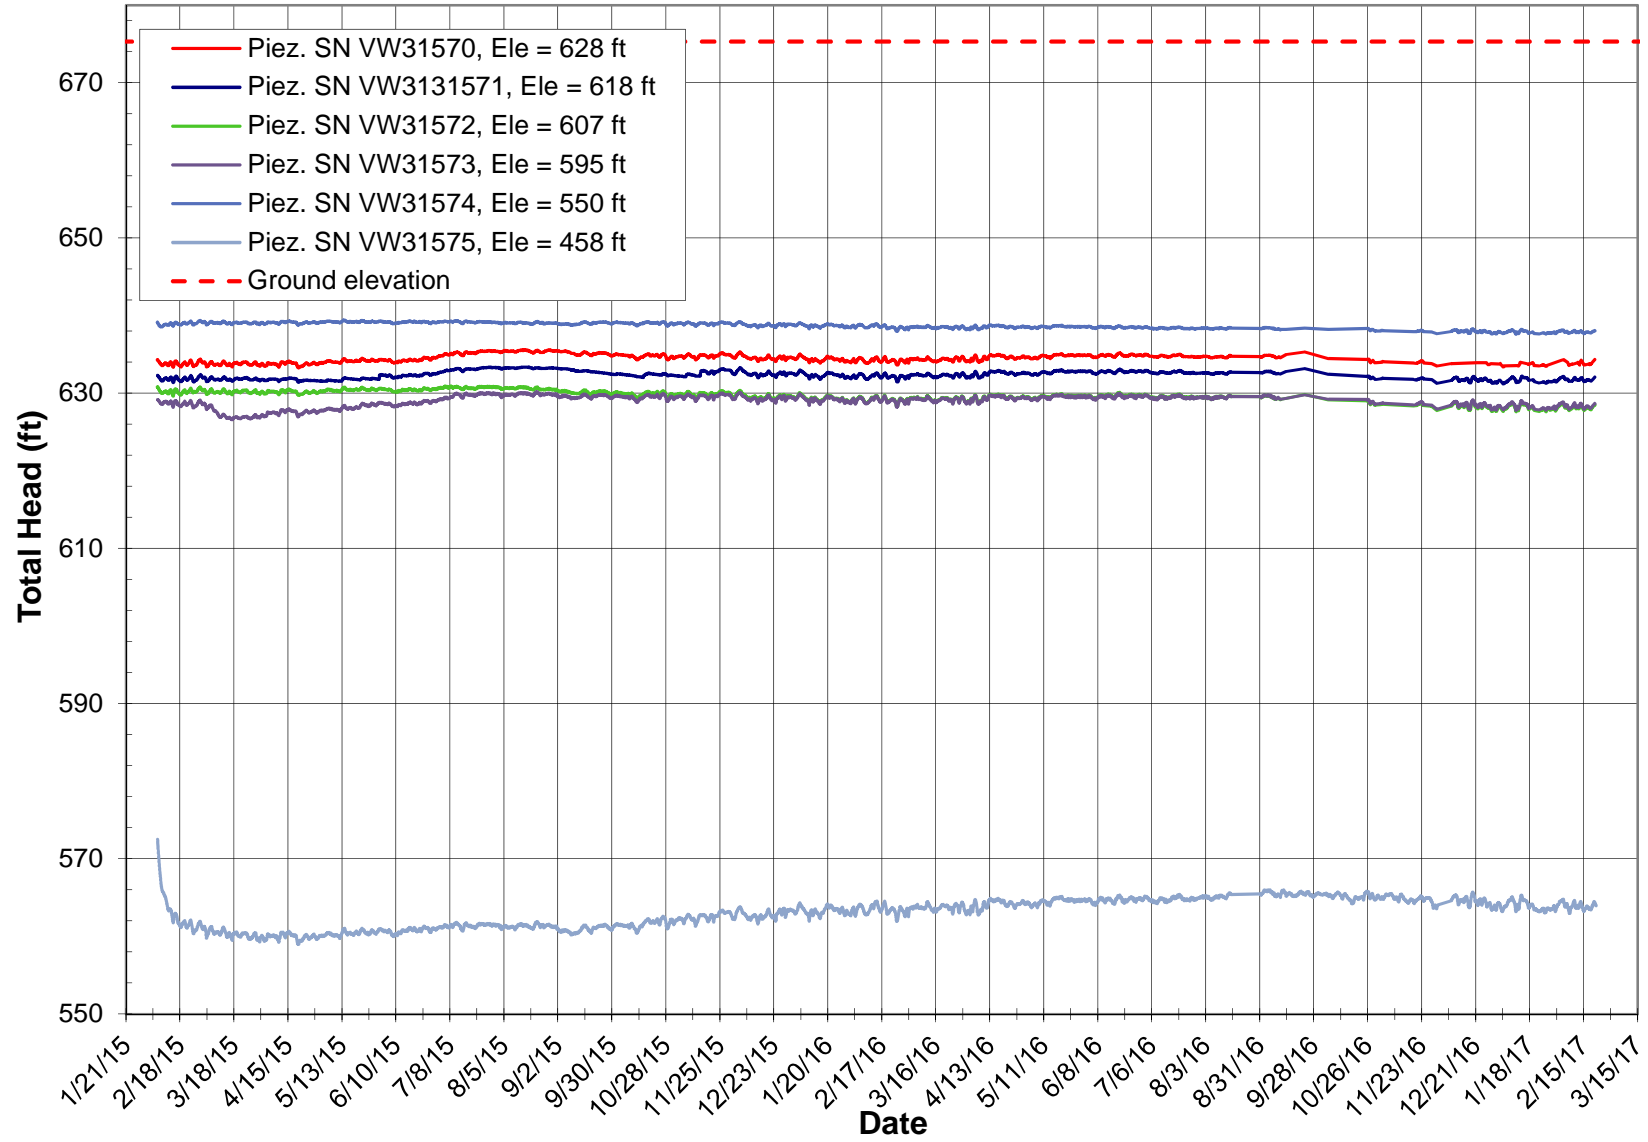
P-002-13 VW Piezometer Readings

P-002-13 – At this location, pore pressure readings in the deepest piezometer at elevation 458 feet show a decrease in total head of 0.6 feet. The remaining piezometers at this location show virtually no change.

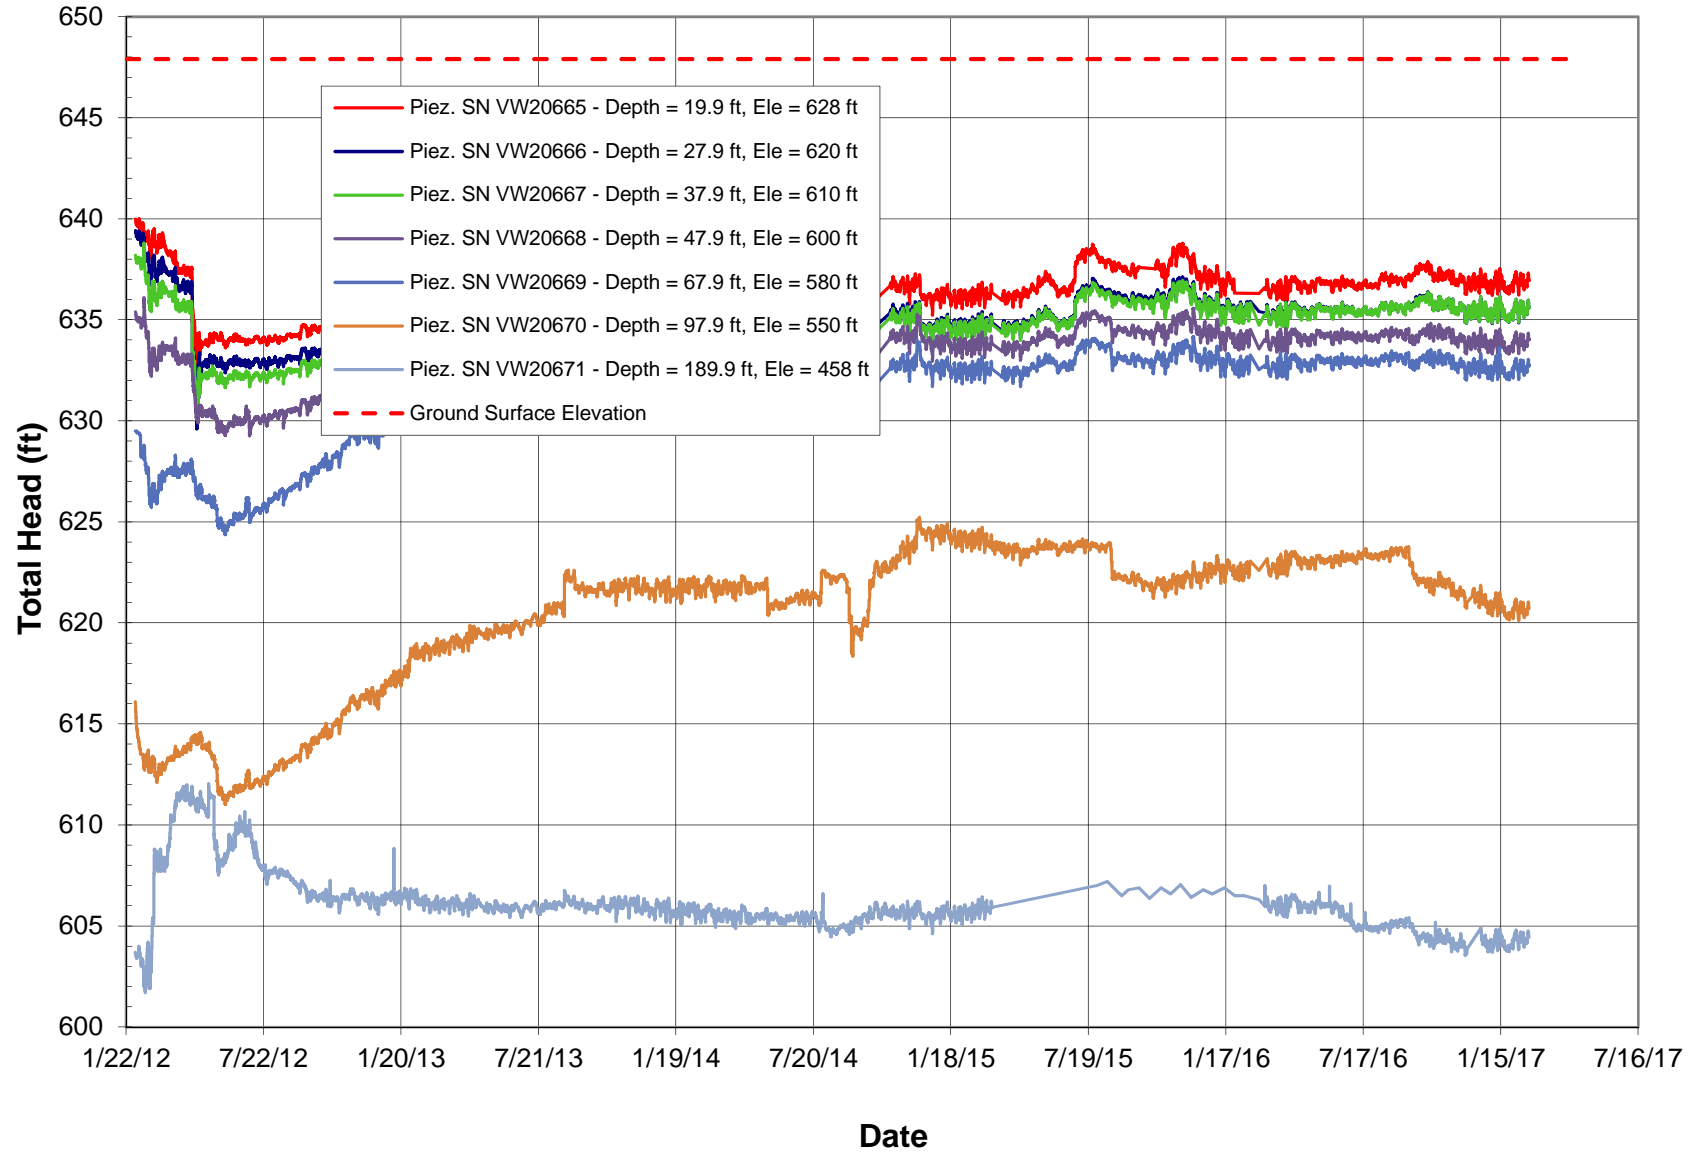
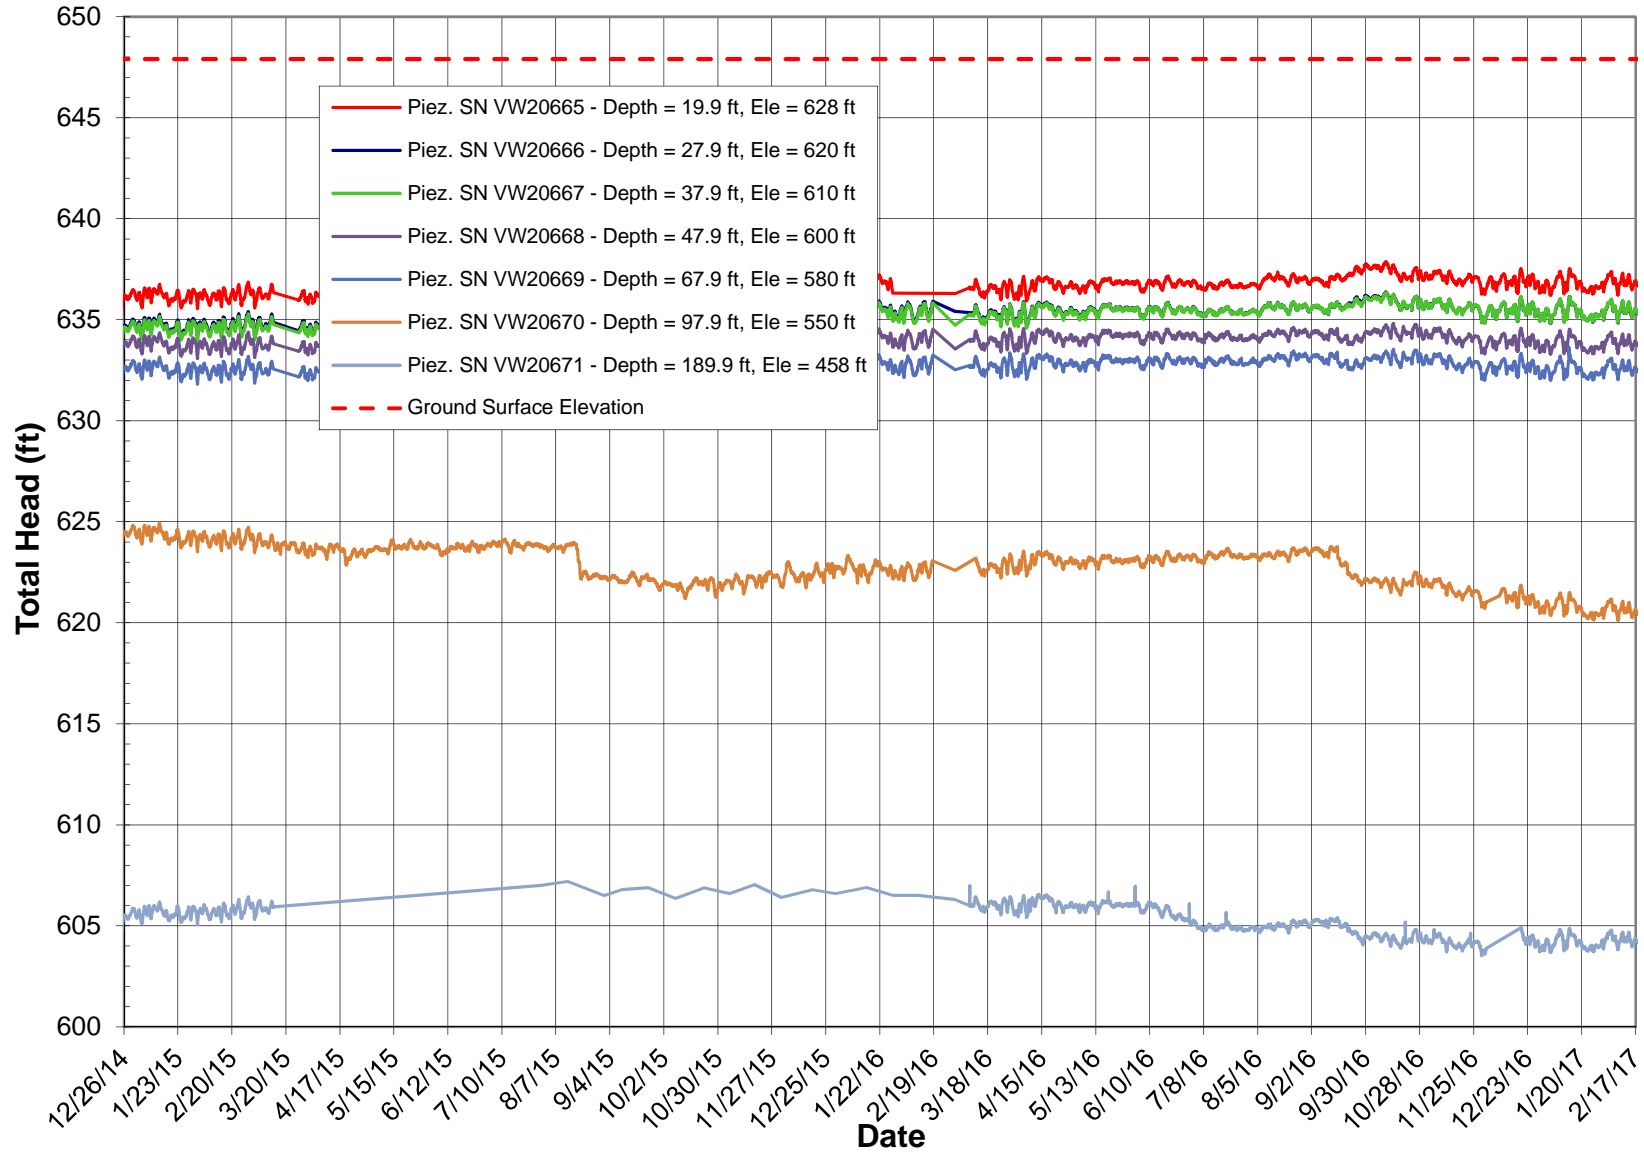
P-003-10 VW Piezometer Readings

Pore pressure readings at P-003-10, P-003-13, P-004-13, B-05-02, and B-05-A-11 show variations in total head of less than 0.5 feet for the period.

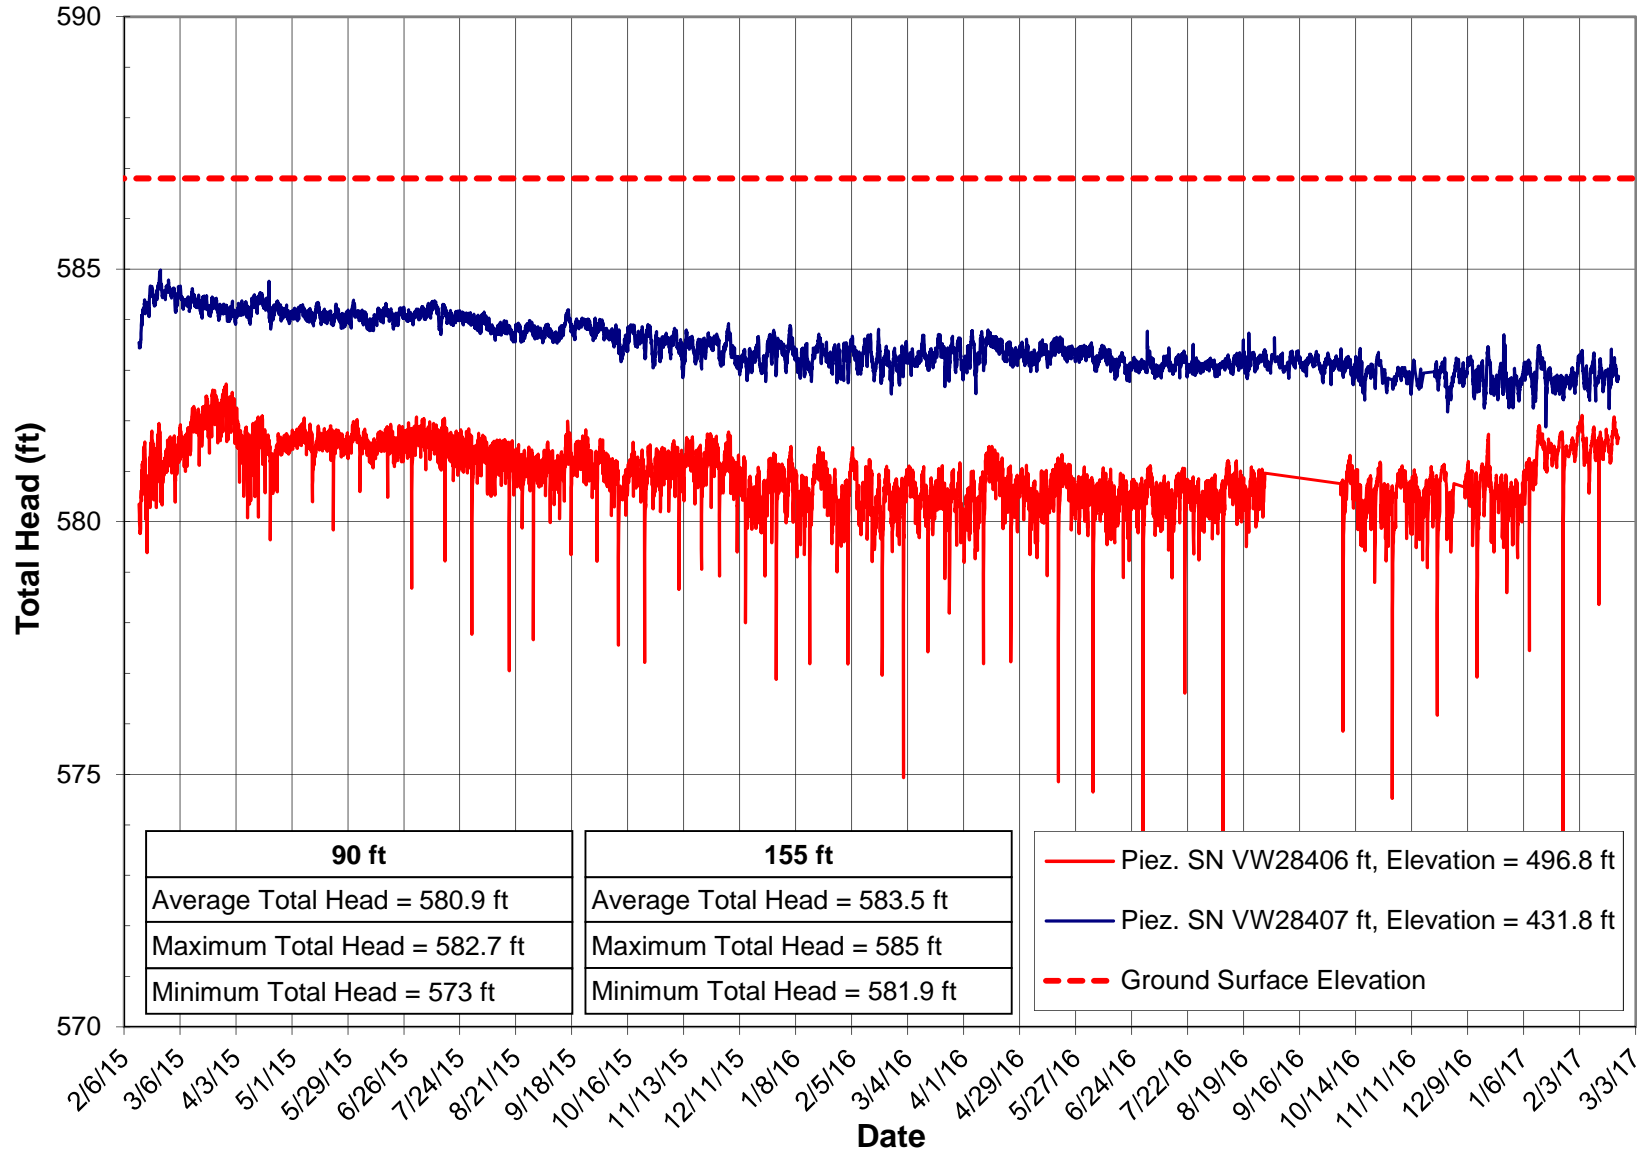
P-009-13 VW Piezometer Readings

P-009-13 – Pore pressures varied over a range of 1 (shallow) to 1.5 (deep) feet at this location during this two-week period. The net change for the period was negligible.

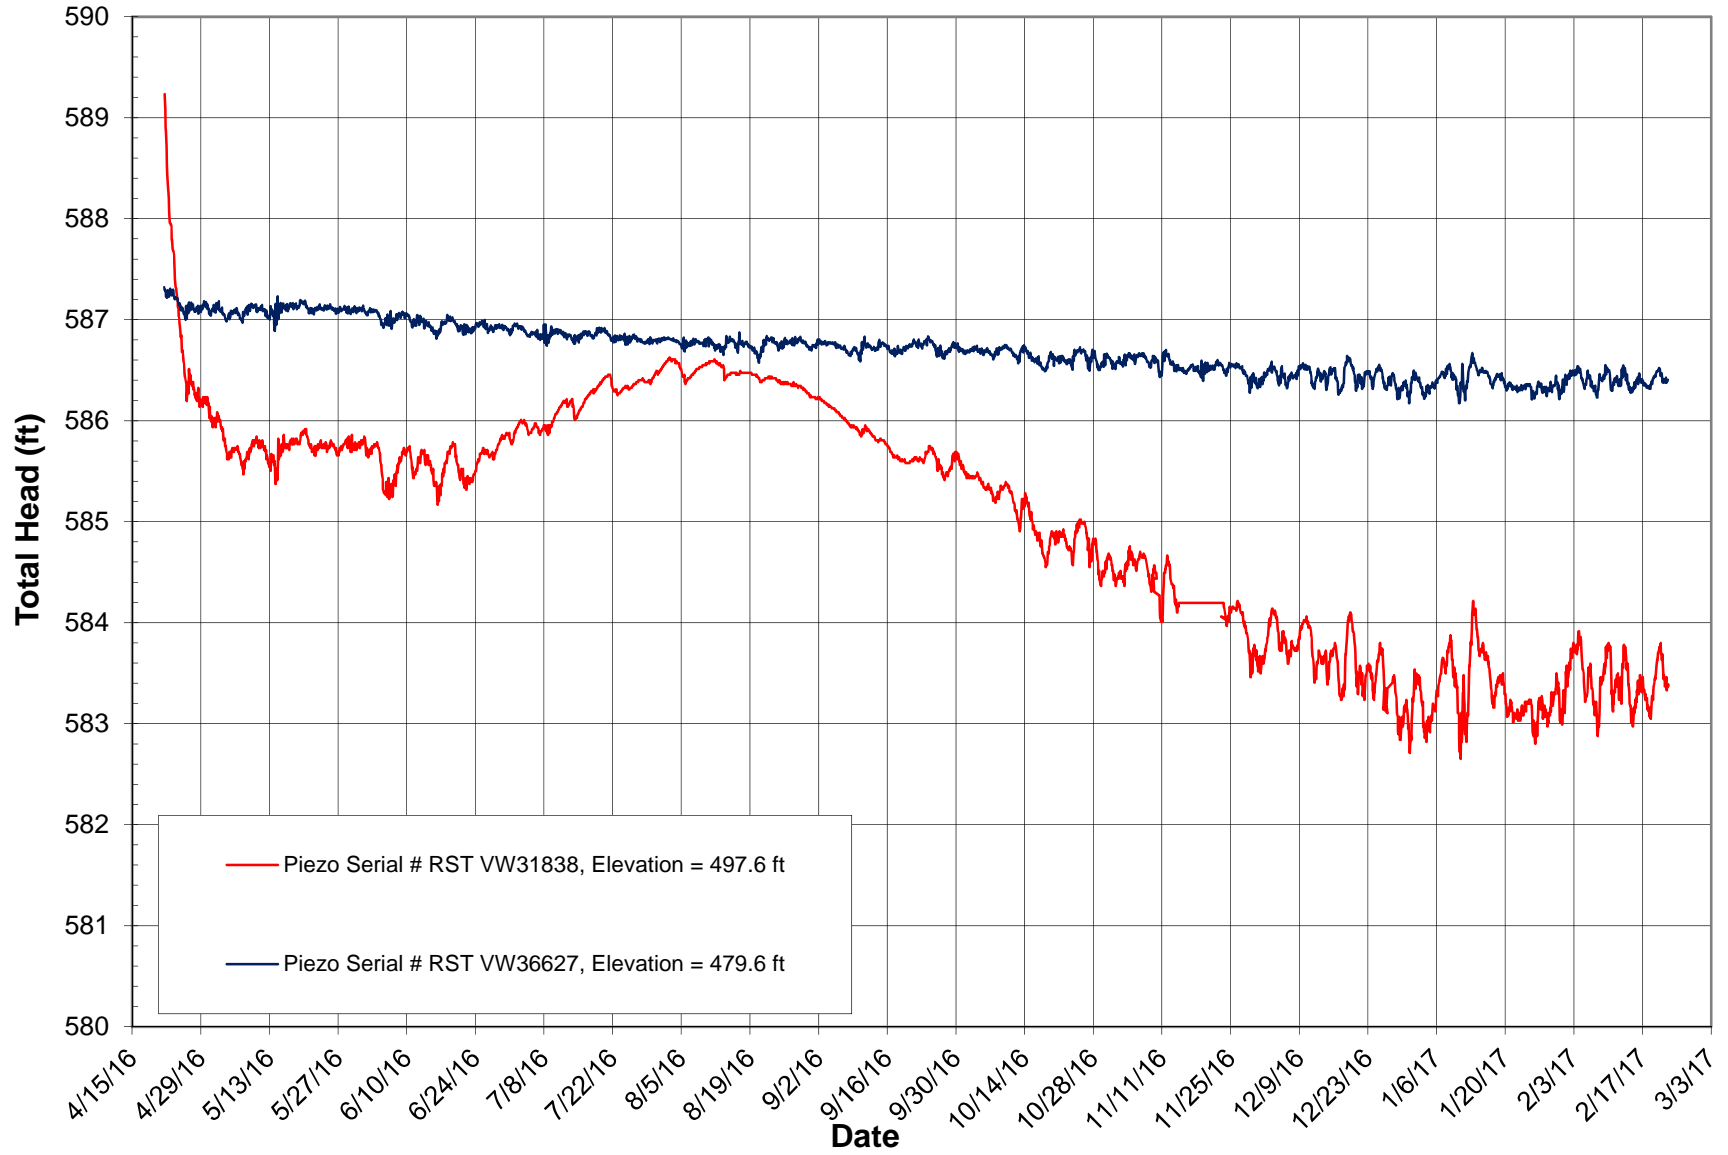
B-105A VW Piezometer Readings

B-105A – Pore pressures varied over a range of about 1 foot in the shallow piezometer at this location. Variation in the deep piezometer was less than 0.5 feet.

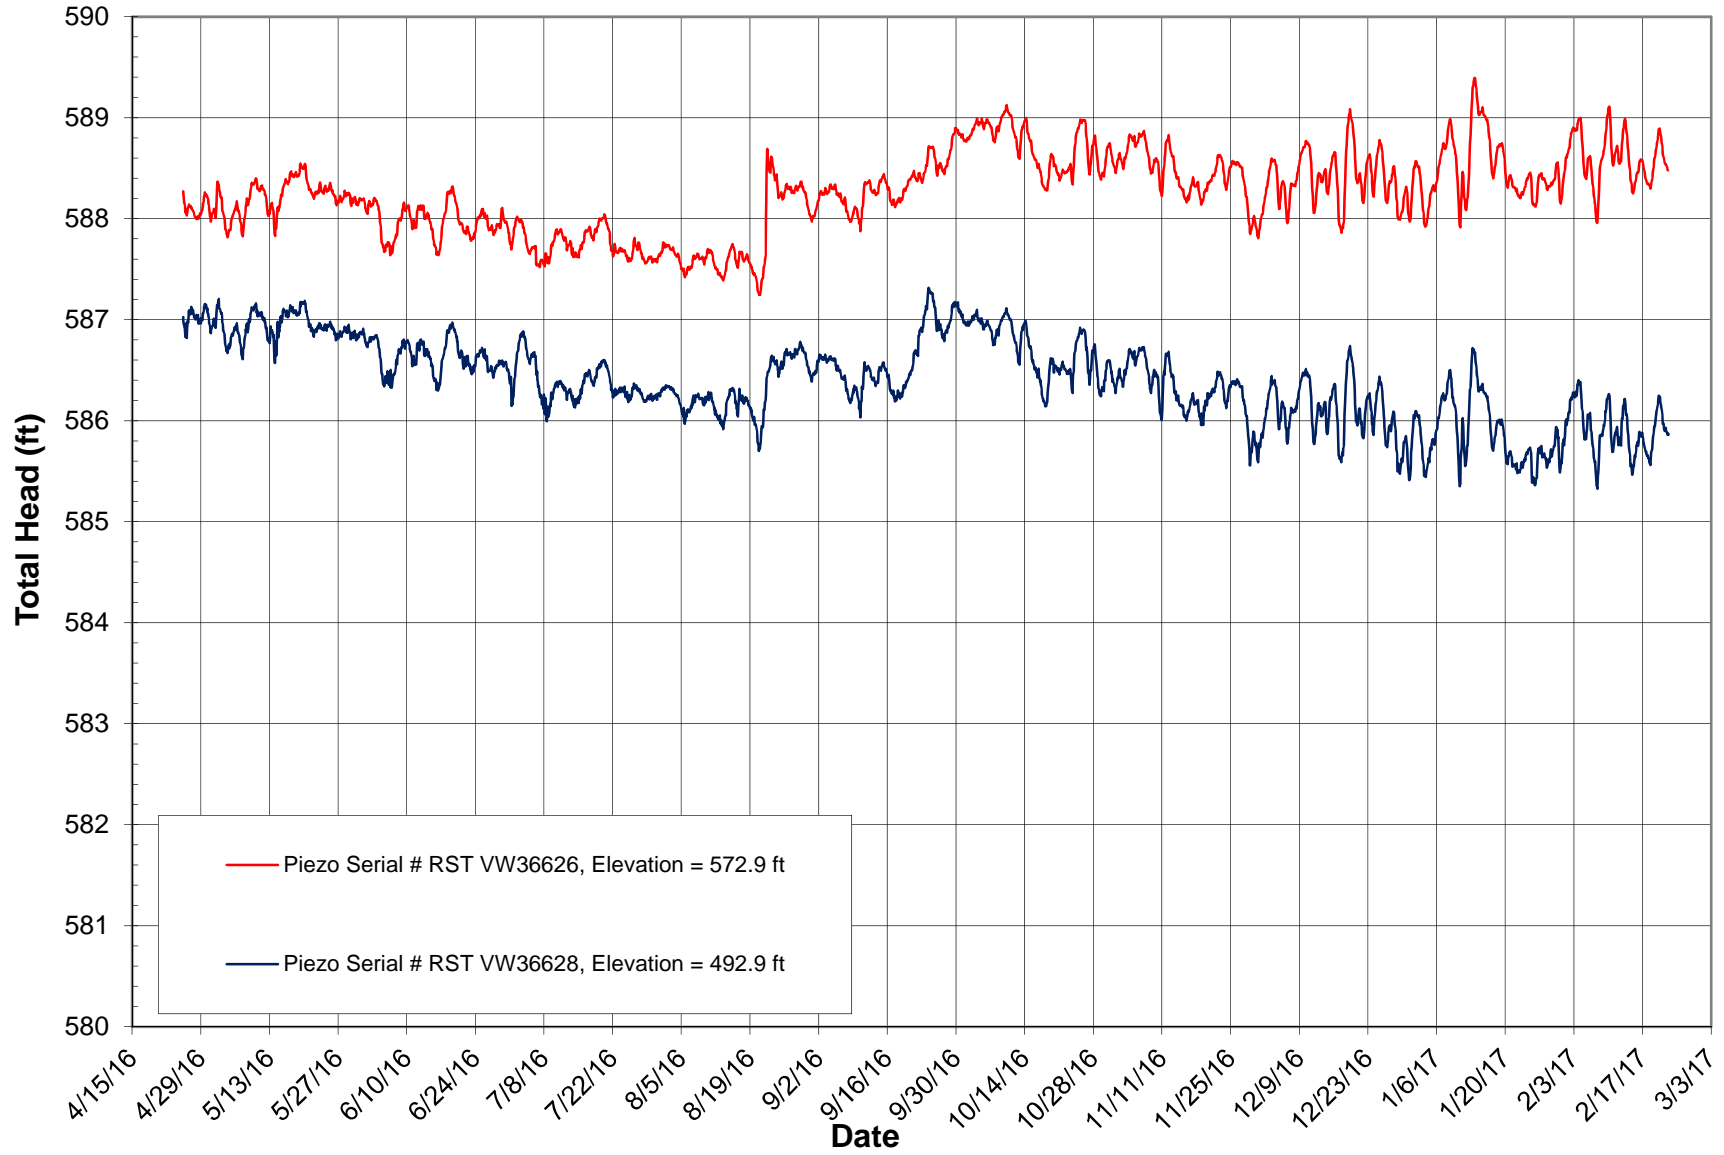
B-05-A-03 VW Piezometer Readings

B-05-A-03 – Pore pressures in both piezometers varied over a range slightly greater than 1 foot for the period. Net change for the period was negligible.

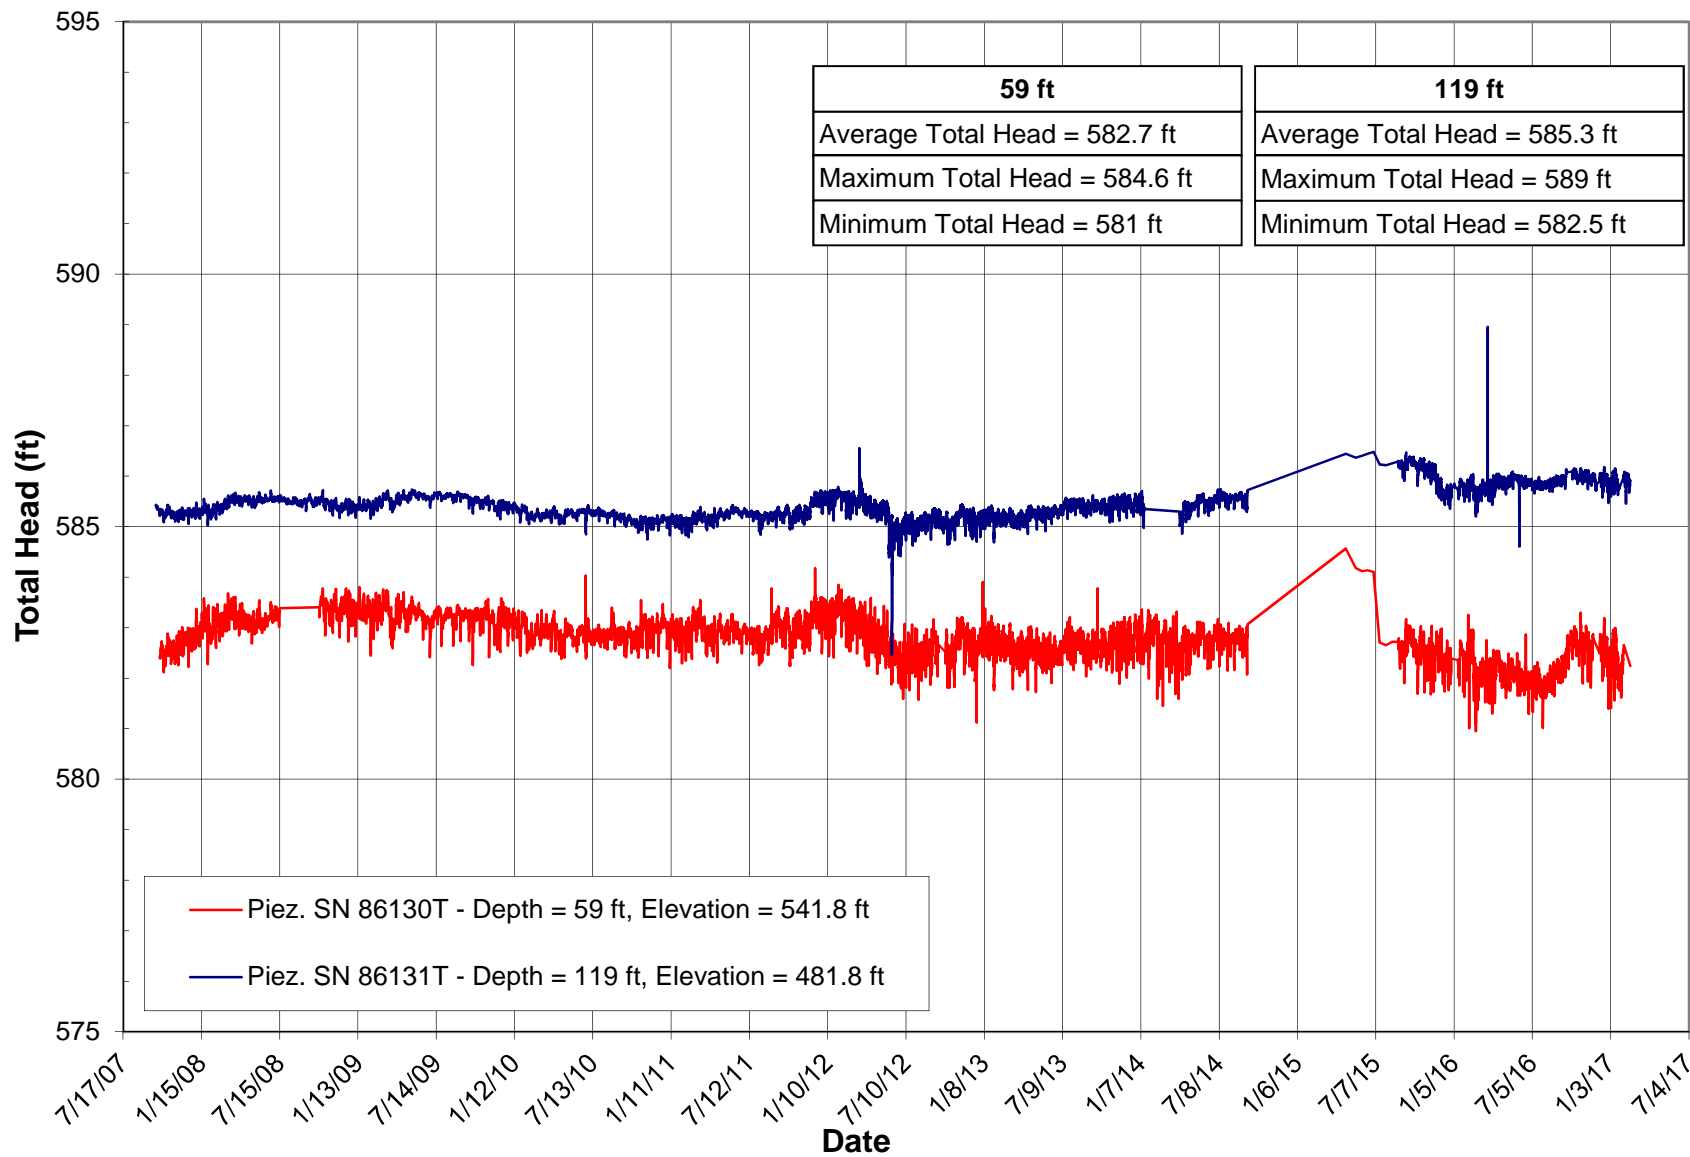
B-05-04 VW Piezometer Readings

B-05-04 – Pore pressure readings at this location show decreases in total head of 0.5 feet and 0.2 feet in the shallow and deep piezometers, respectively.

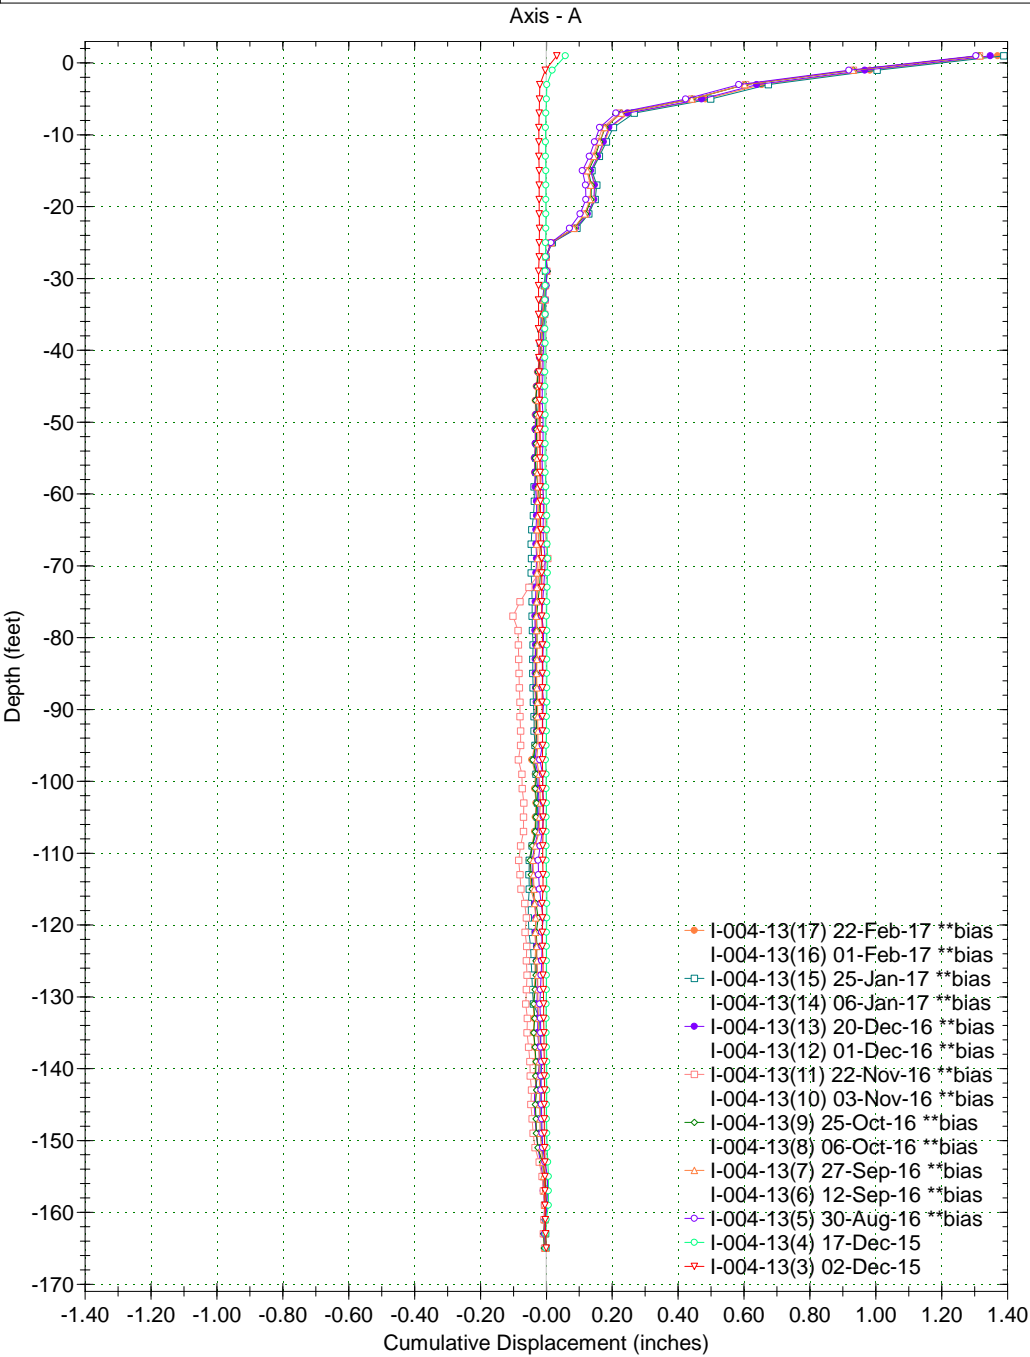
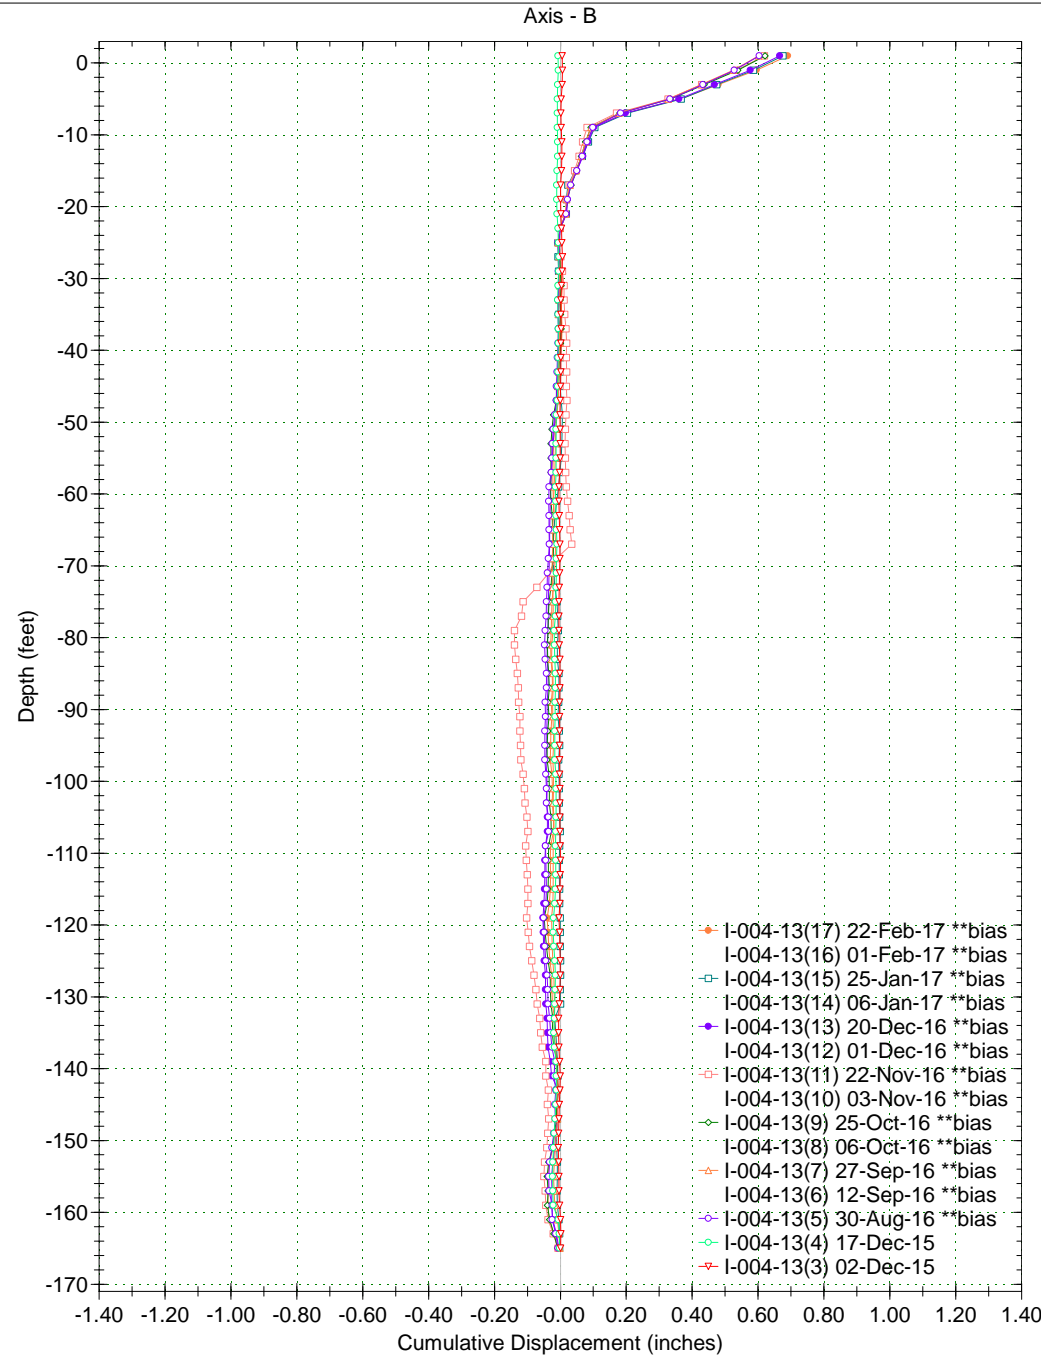
Borehole : I-004-13
Project : CUY-90-15-24
Location :
Northing :
Easting :
Collar :

Inclinometer readings at I-001-13, I-002-13, I-003-10, I-004-13, I-008-10, I-009-13, B-101, B-105A, B-05-02, B-05-A-03, B-05-04, B-05-A-11, P-1, P-9N, and TGR I-4 showed virtually no movement this period. In some cases, the plots indicated displacement at the top of the casing. This is due to disturbance of the area around the casing that occurred during construction. Protective covers have not yet been permanently concreted in place because of the ongoing construction near these instruments.

I-004-13 and B-05-A-03 – TGR is preparing to adjust the ground surface to final grade in the vicinity of these instruments. We will make the necessary adjustments to the inclinometer casing when the grading is completed.
