Re: April 2017 Quarterly Report
CUY-90-15.24 Slope Monitoring
PID 96504
EDP Project No. 069032.00

APRIL 2017 QUARTERLY REPORT

CUY-90-15.24 SLOPE MONITORING
PID 96504
CLEVELAND, OHIO
SME PROJECT NO. 069032.00

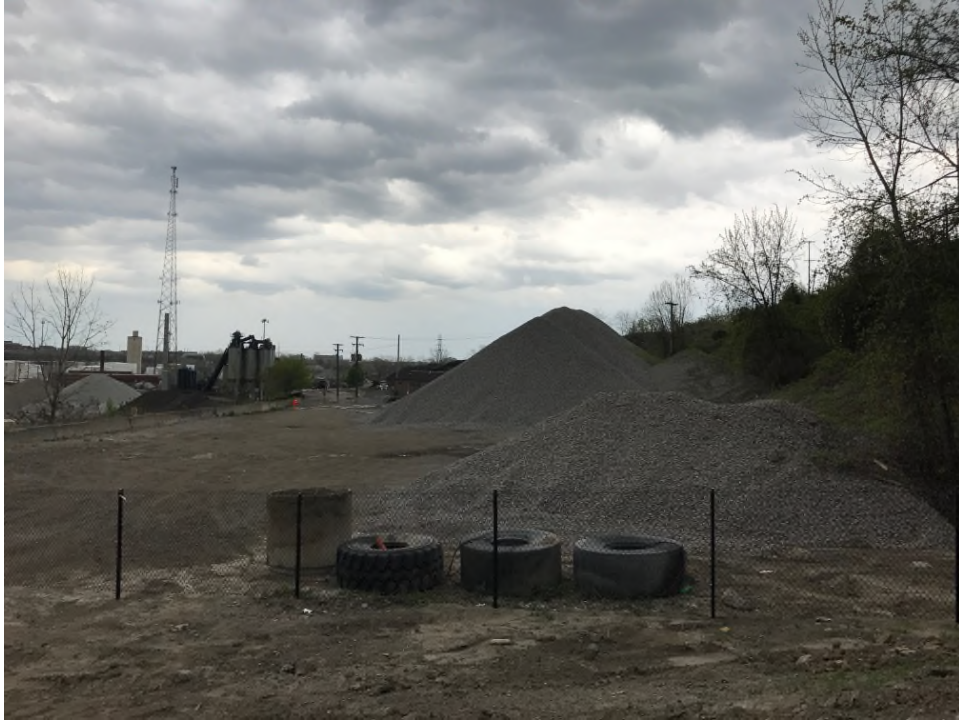
We observed and photographed the aggregate stockpiles on April 28, 2017. The photos are included in Appendix A as Figures 4 and 5. Only a small pile of aggregate remains closest to the right-of-way fence. This pile has not changed since January 2014. The pile is about 8 feet high and covers only a small area of the property.

Figure 4. Aggregate stockpile east of the ODOT right-of-way (April 28, 2017).

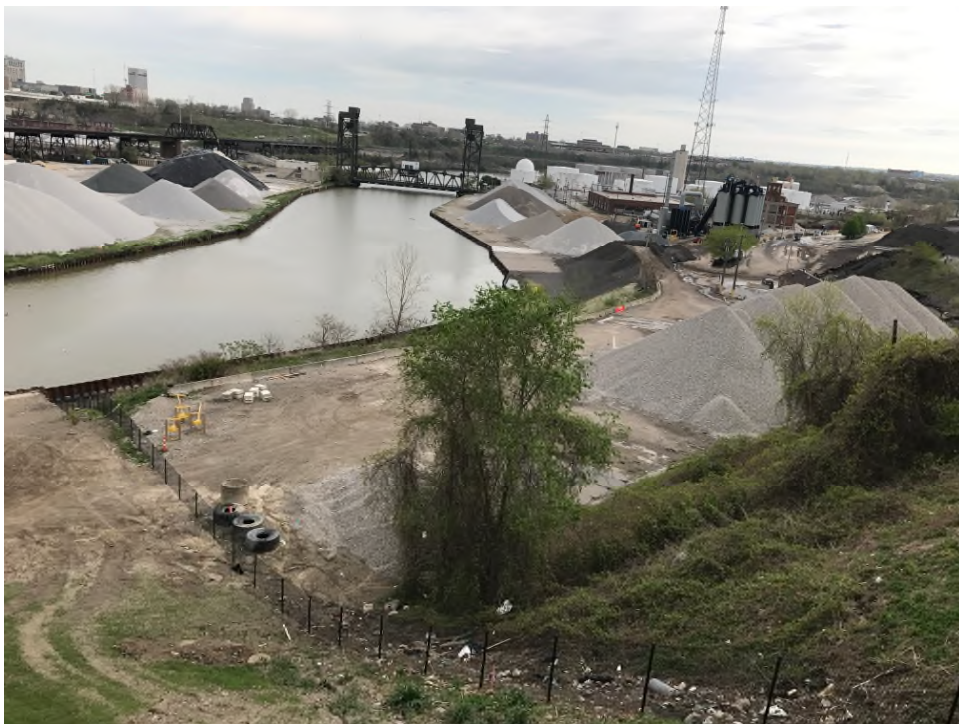
Figure 5. Aggregate stockpile near ODOT's east right-of-way fence (April 28, 2017).

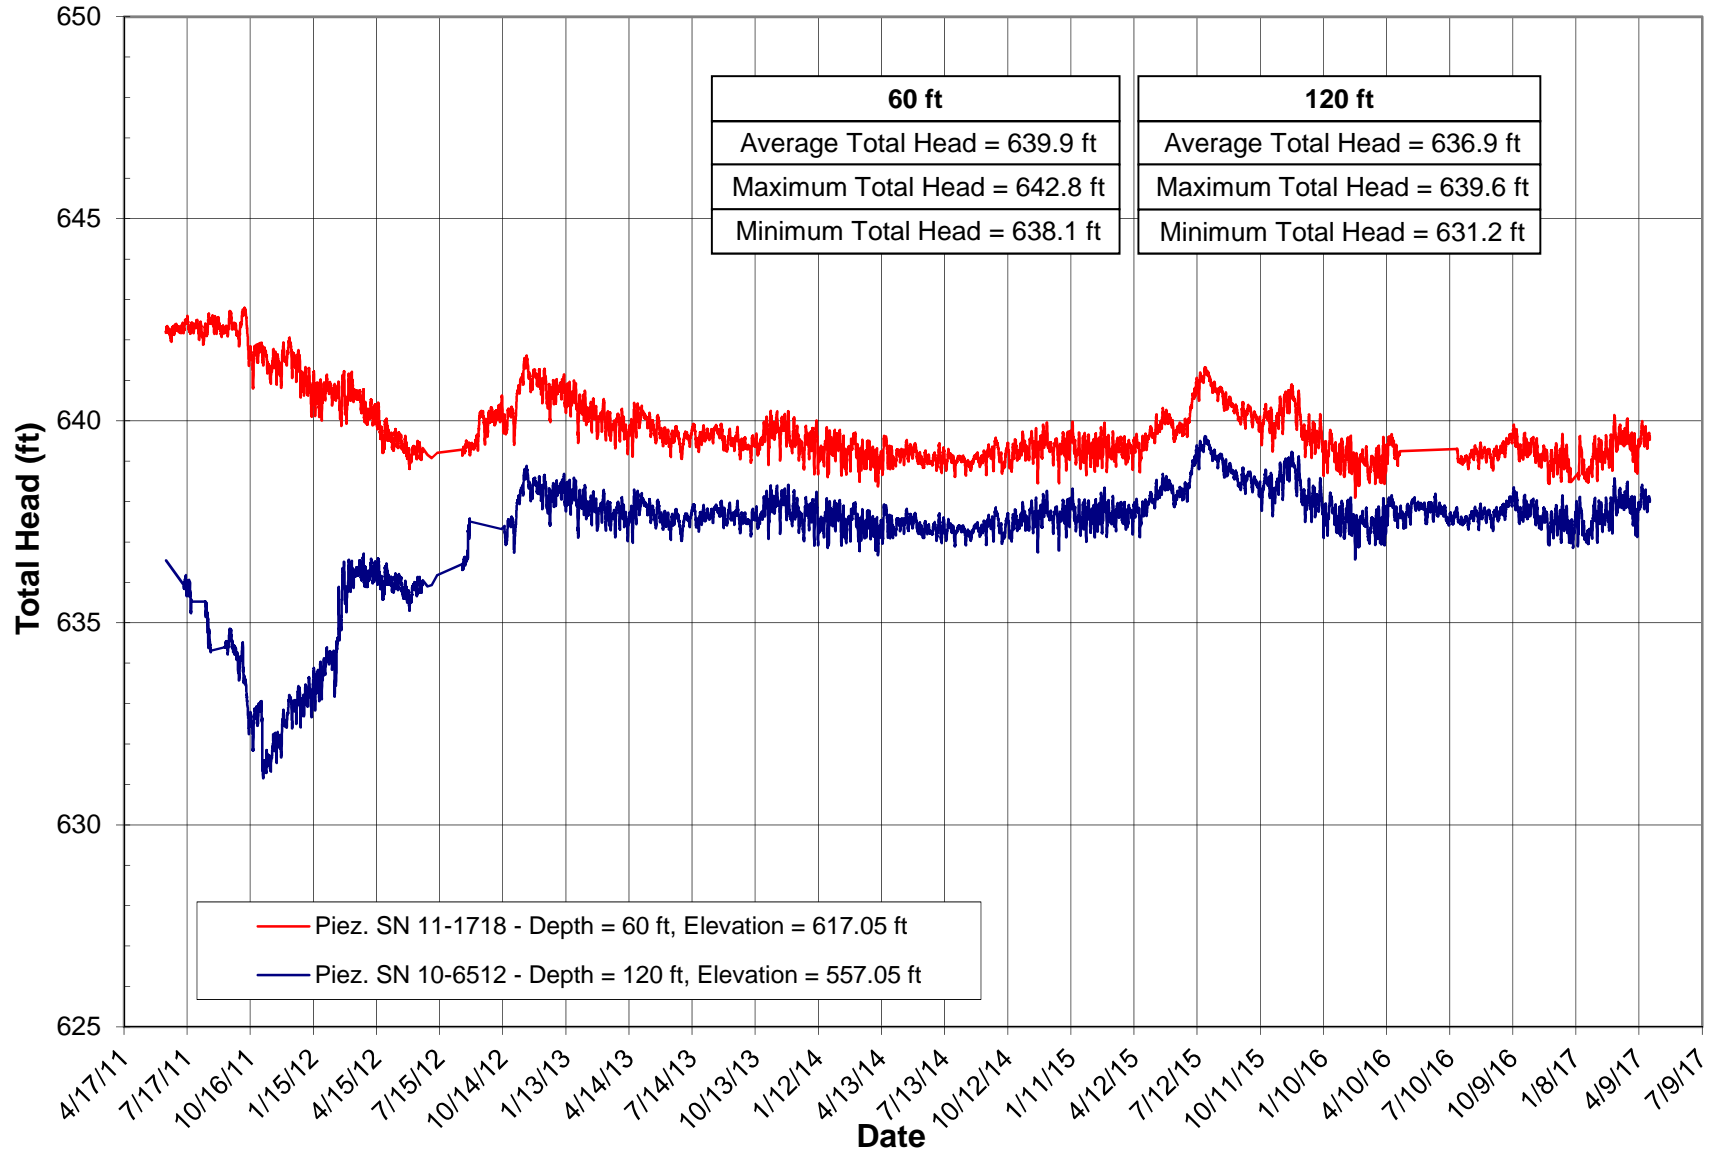
P-002-10 VW Piezometer Readings

P-001-10. Total head in both piezometers at P-001-10 fluctuated by about 1 foot this past quarter. Both piezometers show a net increase of about 0.8 feet since January 2017.

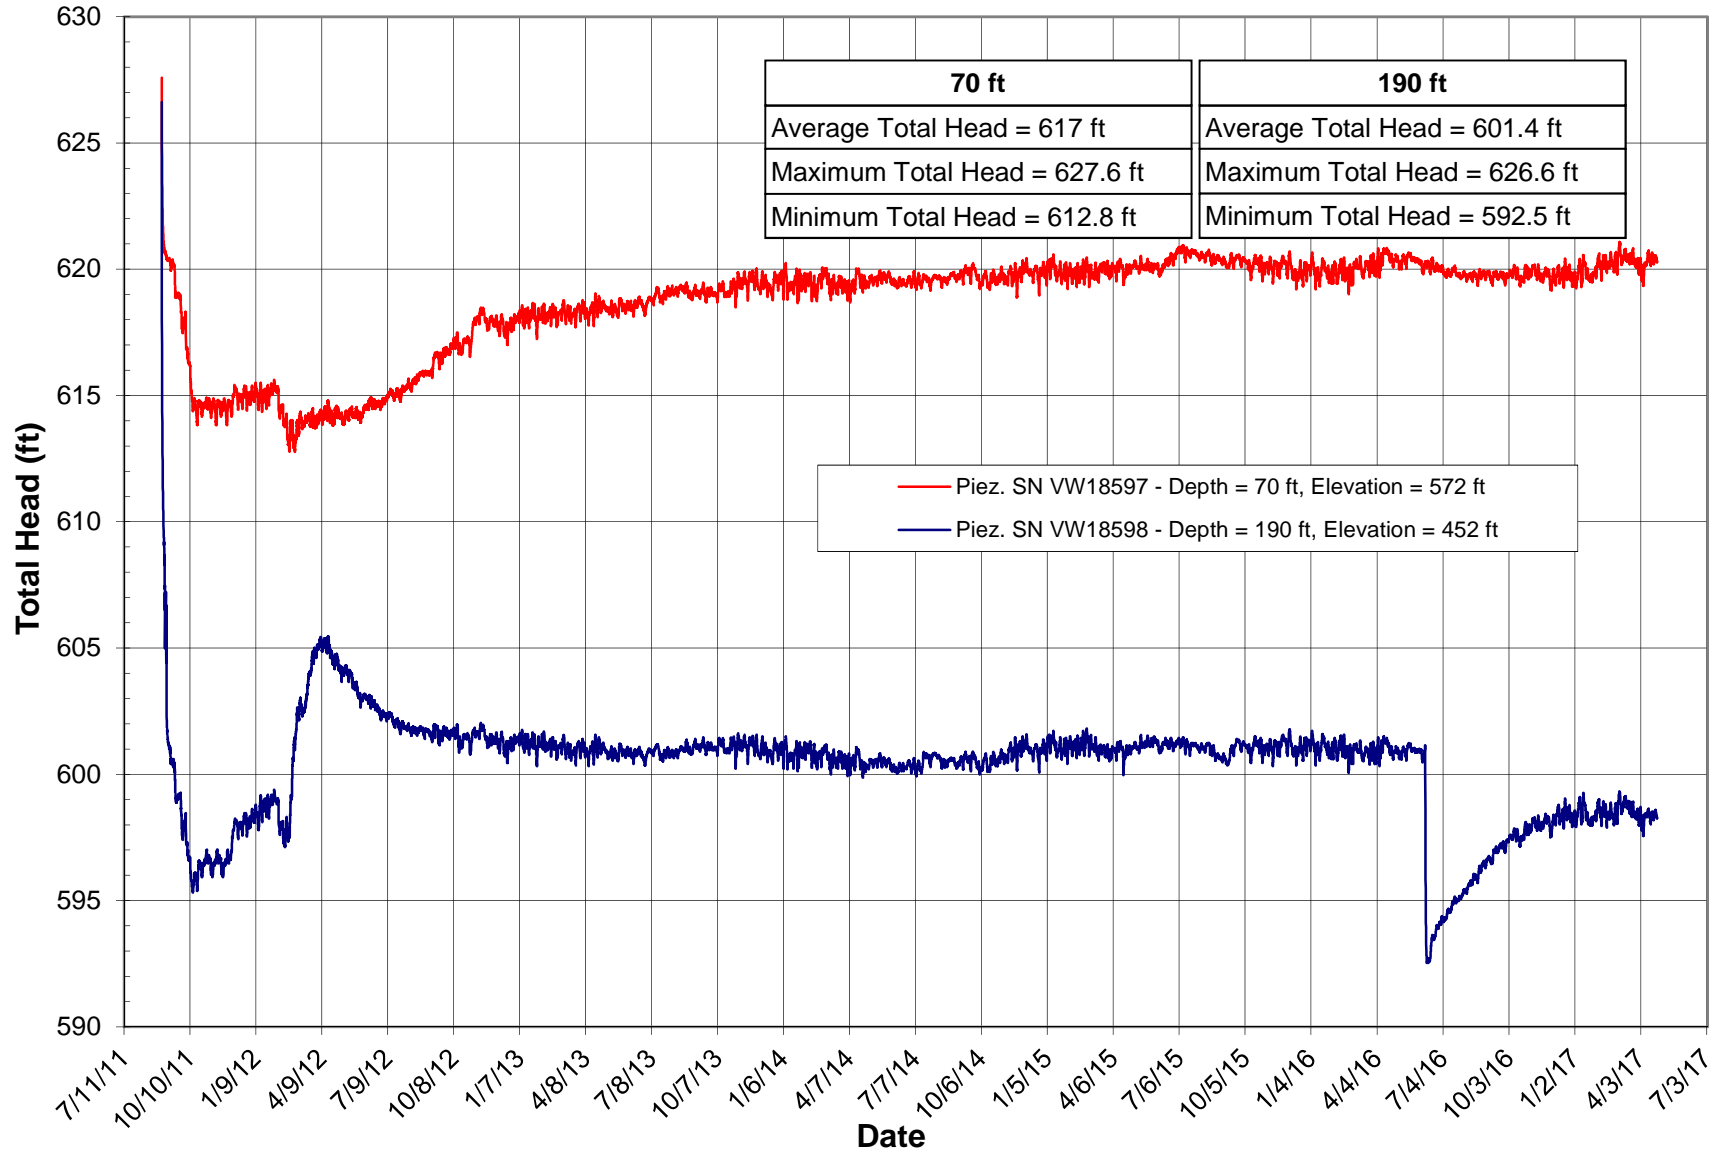
P-007-13 VW Piezometer Readings

P-002-10. Total head in the shallow piezometer at P-002-10 increased by about 0.6 feet since January 2017. Total head in the deep piezometer fluctuated by about 0.5 feet this quarter with virtually no net change.

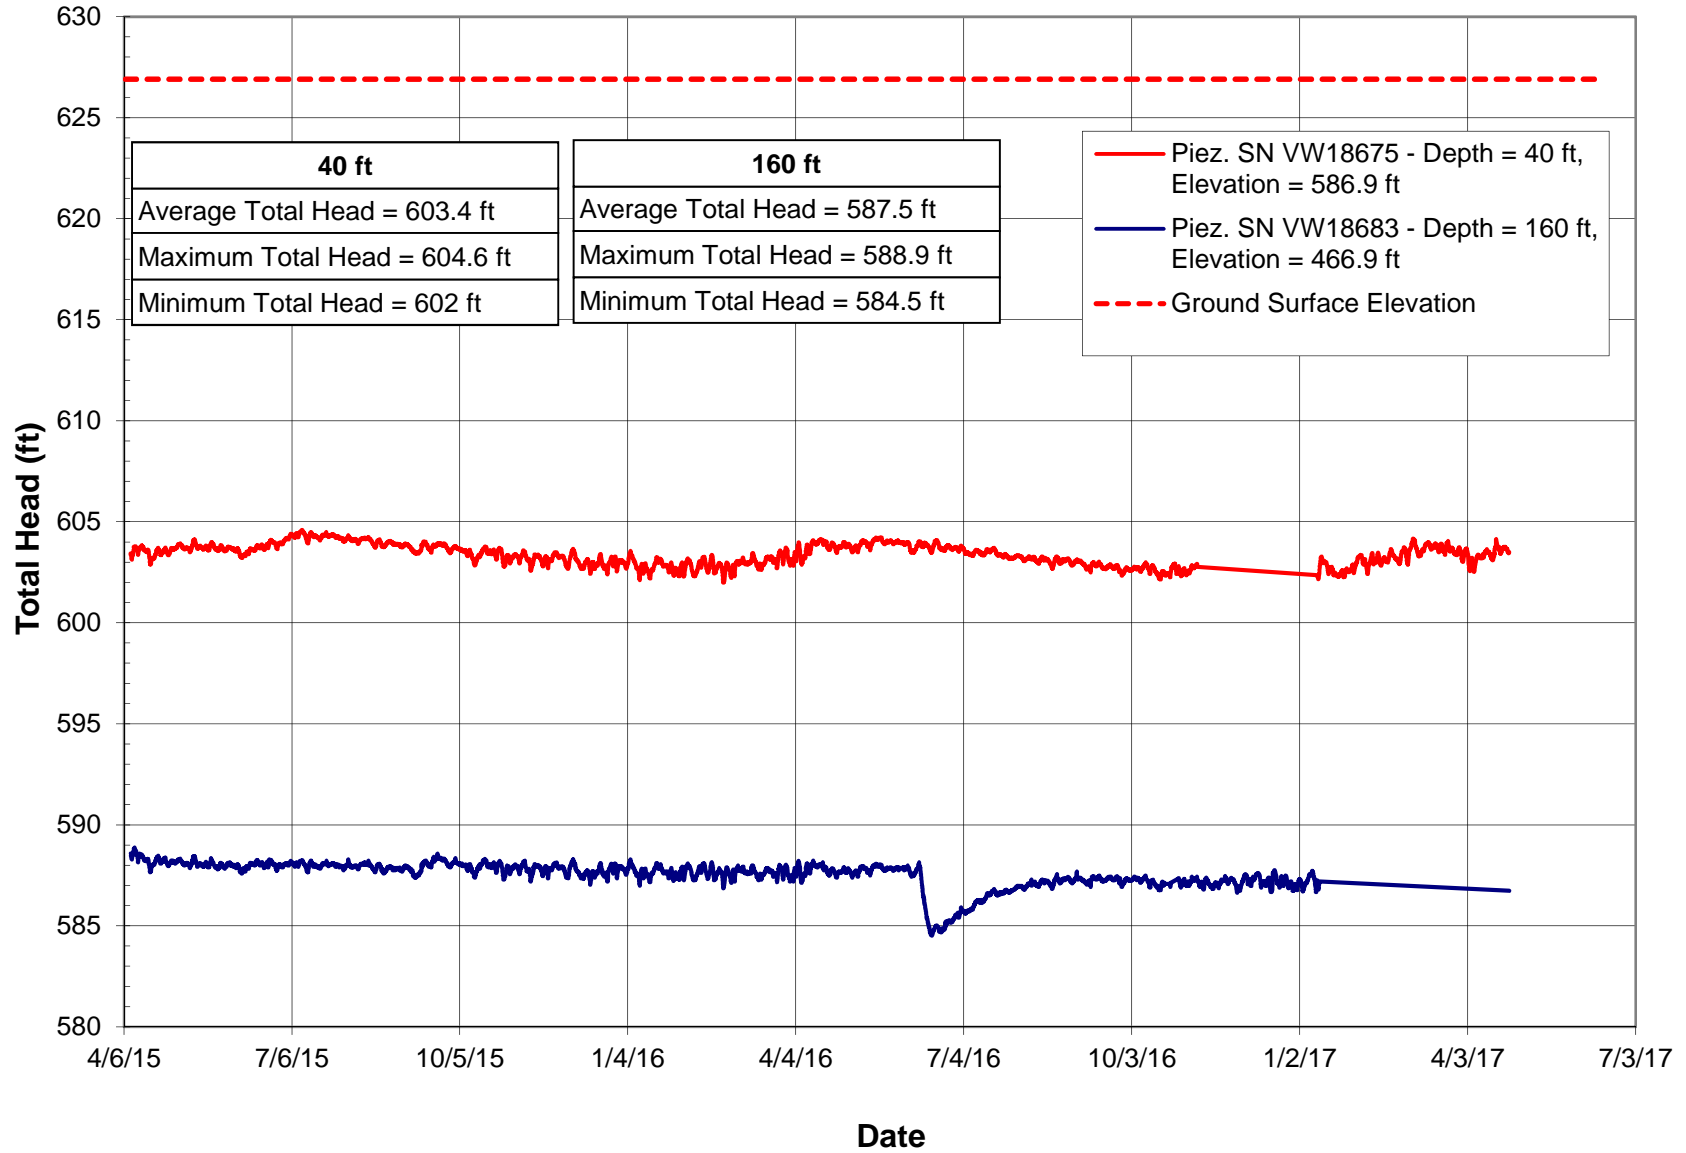
B-05-07 VW Piezometer Readings

P-007-13. Total head in the shallow piezometer at P-007-13 increased by 0.7 feet this quarter. The datalogger for the deep piezometer failed to record this quarter. We replaced the battery, but it appears to be a faulty data logger. We are contacting RST to look into this issue further. In the meantime, we have replaced this datalogger with the datalogger from the shallowest piezometer at TGR P-3. A single reading taken in April 2017 shows a 0.5 foot decrease in total head since January 2017.

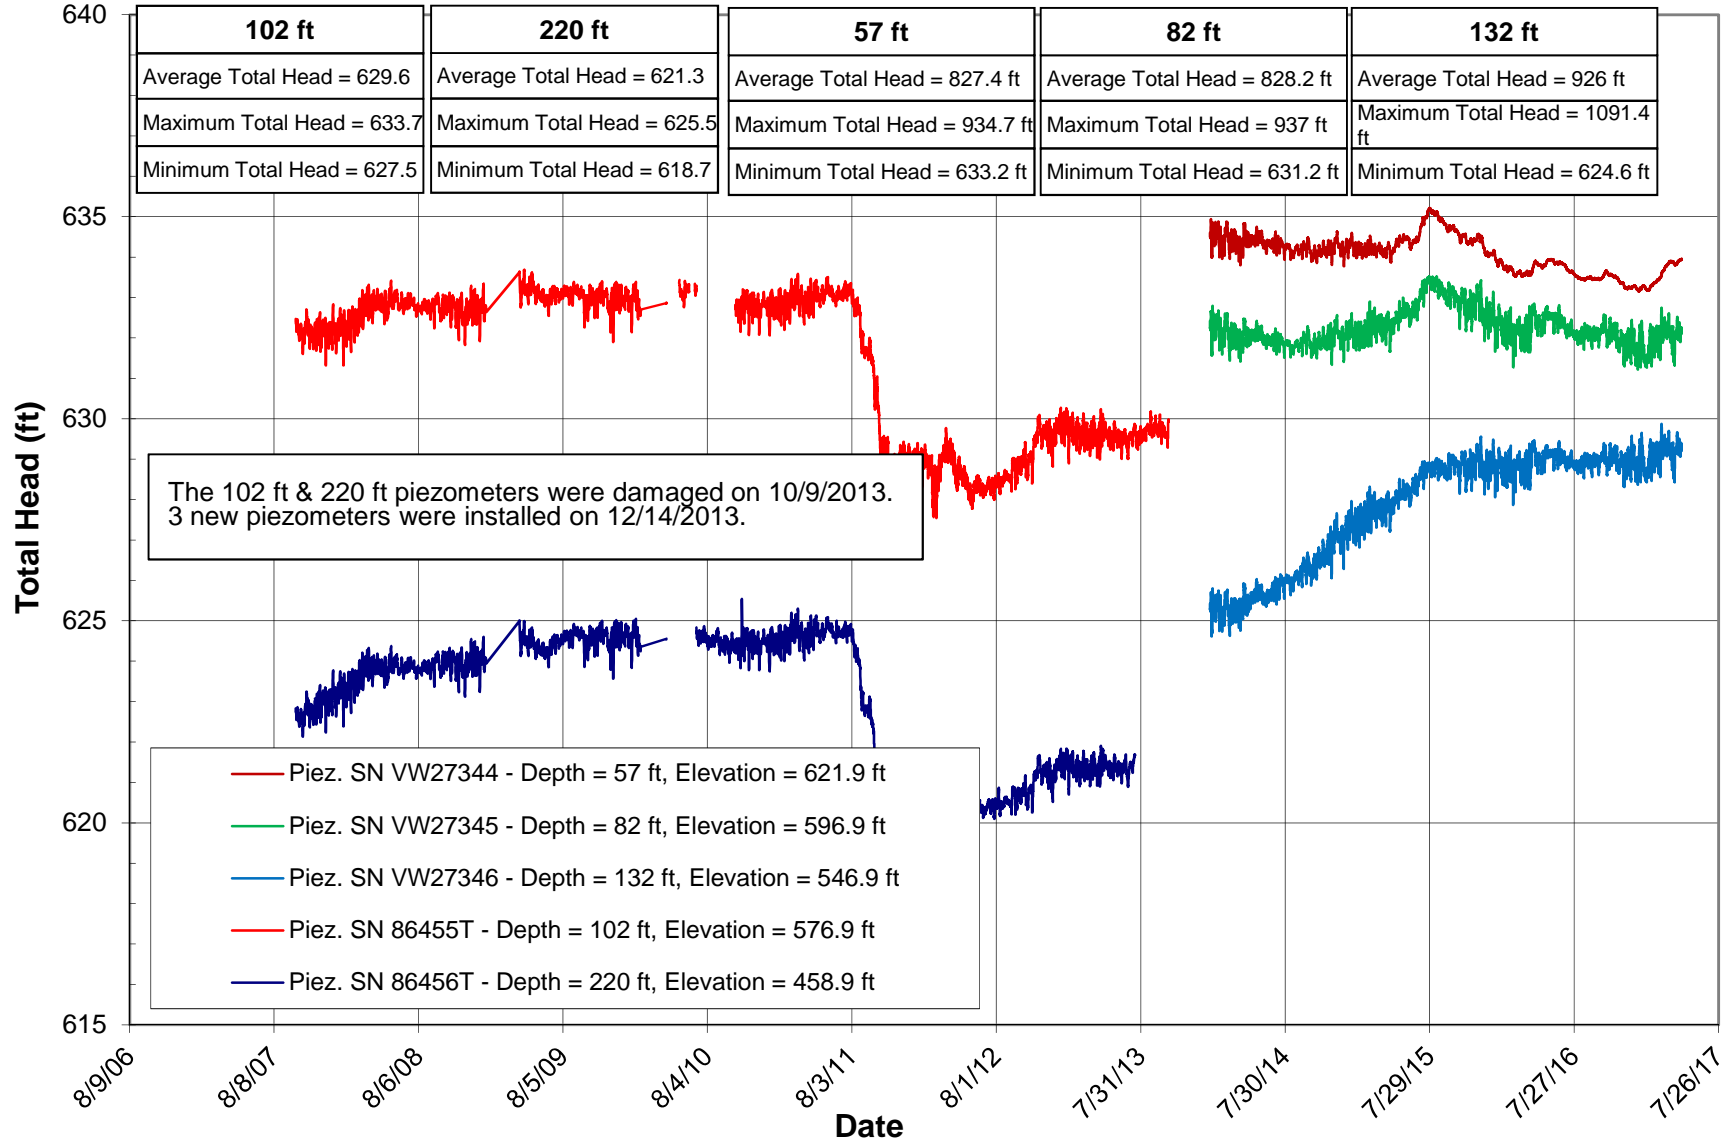
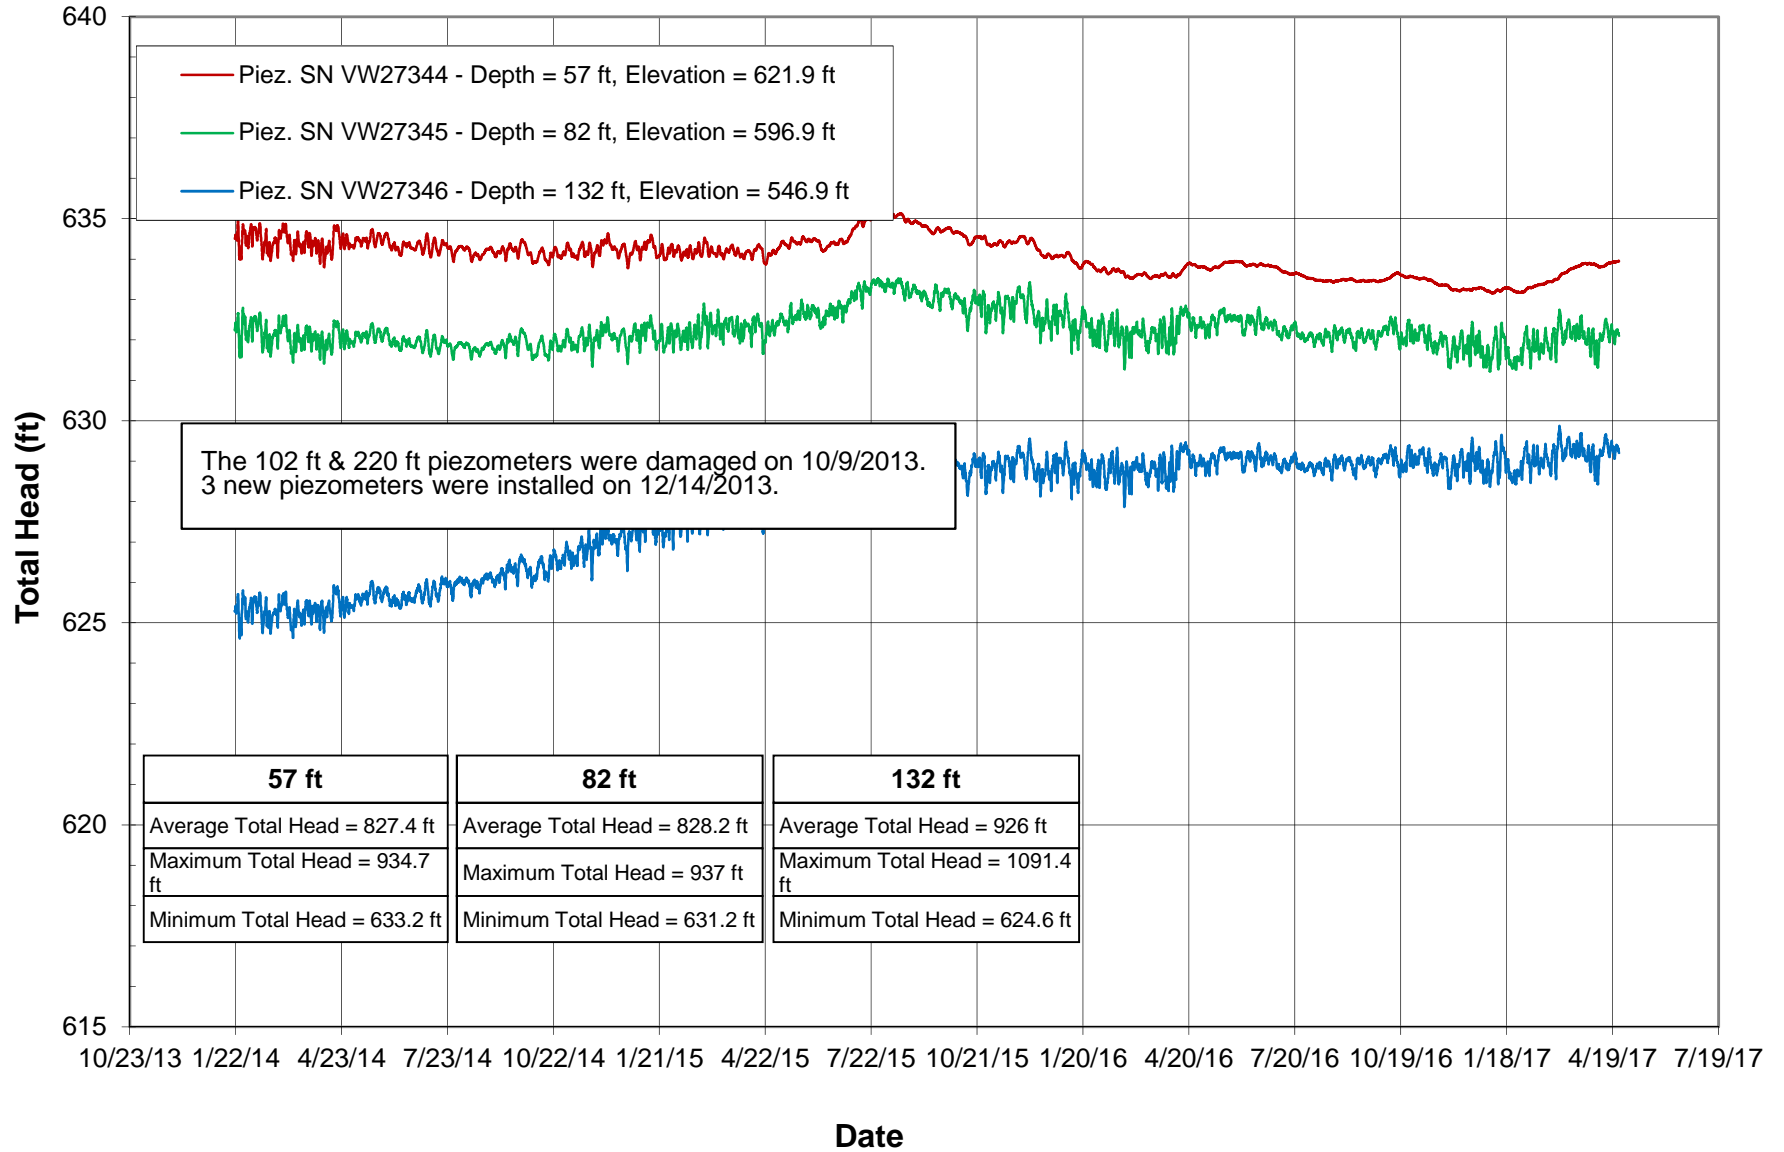
B-05-07 VW Piezometer Readings

B-05-07. Pore pressure readings show a net increase of about 0.8 feet in total head in all piezometers this quarter, with fluctuations of about 1 foot in the middle and deep piezometers.

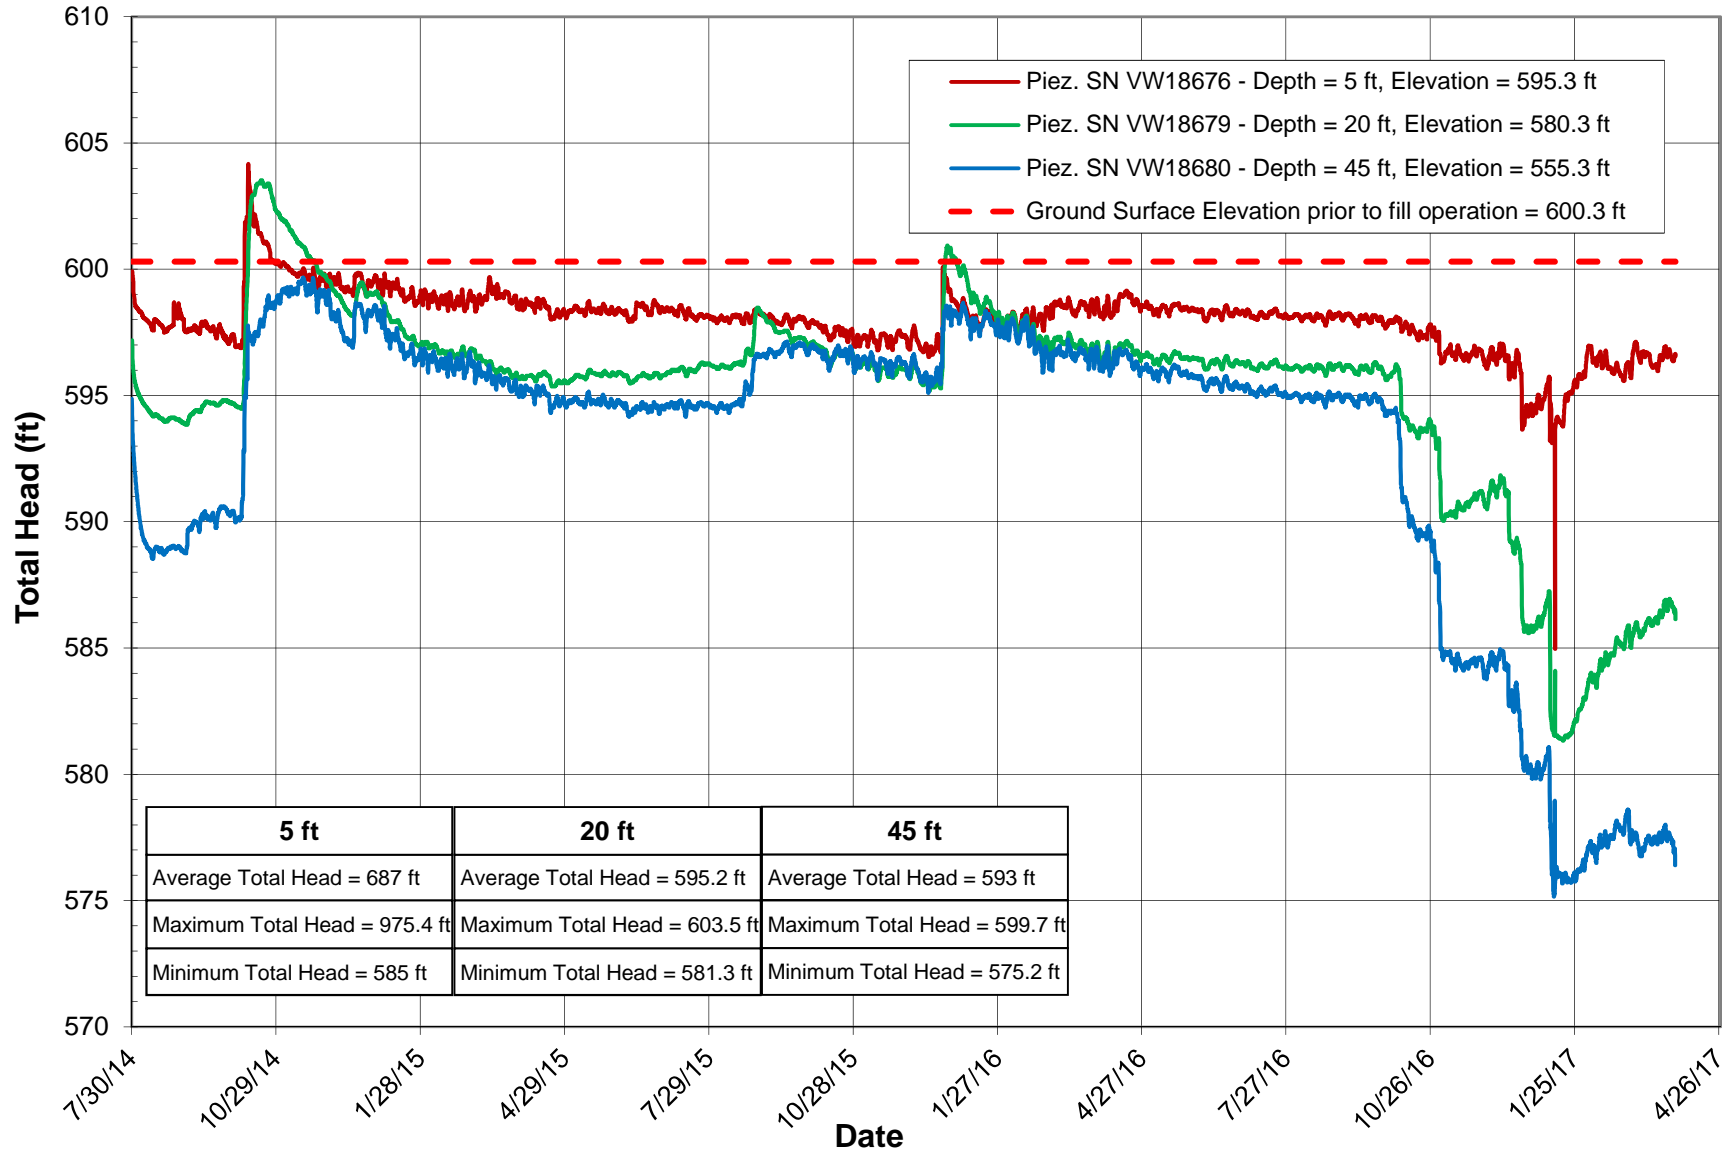
TGR P-3 VW Piezometer Readings

TGR P-3. Three piezometers are installed at this location. Due to final grading operations in the area of these instruments, total head in all three piezometers decreased in stages between October 2016 and January 2017. Starting in January 2017, total head in all three piezometers began to increase. Total head has increased by about 3 feet in the shallow piezometer and 5 feet in the middle piezometer. Total head in the deep piezometer increased during the first half of the quarter, then decreased in the second half for a net increase of 0.5 feet. The shallow piezometer is now only a couple of feet below grade and the datalogger was recording negative pore pressures. We moved the datalogger from this location to temporarily replace the malfunctioning datalogger at P-007-13.

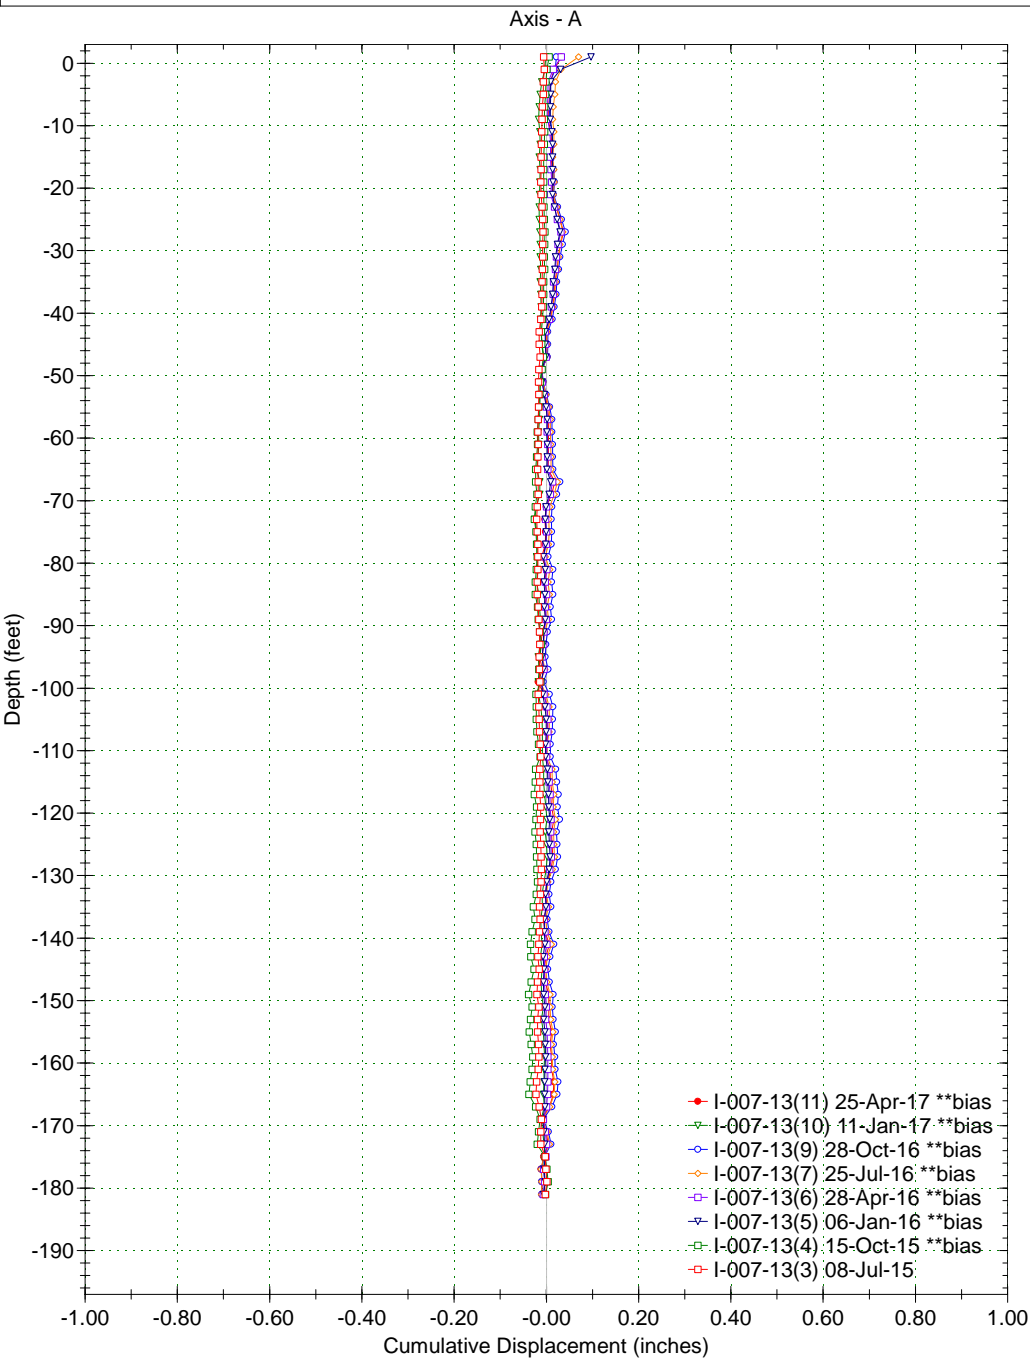
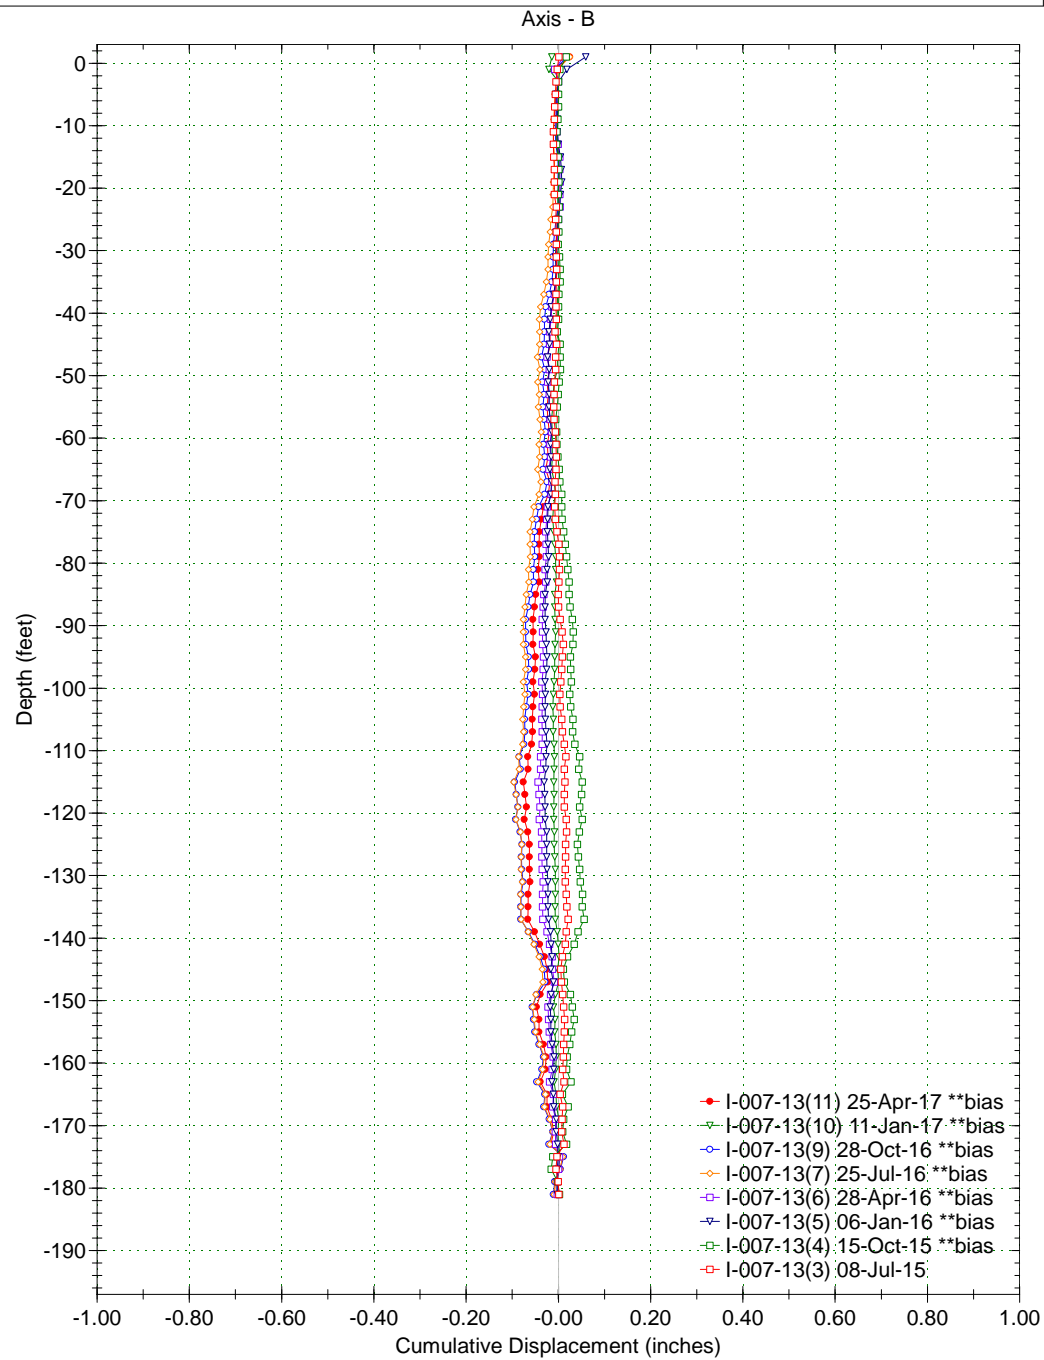
Borehole : I-007-13
Project : CUY-90-15-24
Location :
Northing :
Easting :
Collar :

I-007-13. The inclinometer reading at this location shows displacement in the negative B-axis direction relative to the January 2017 reading. This quarter's reading plots between the July 2016 and April 2016 plots.

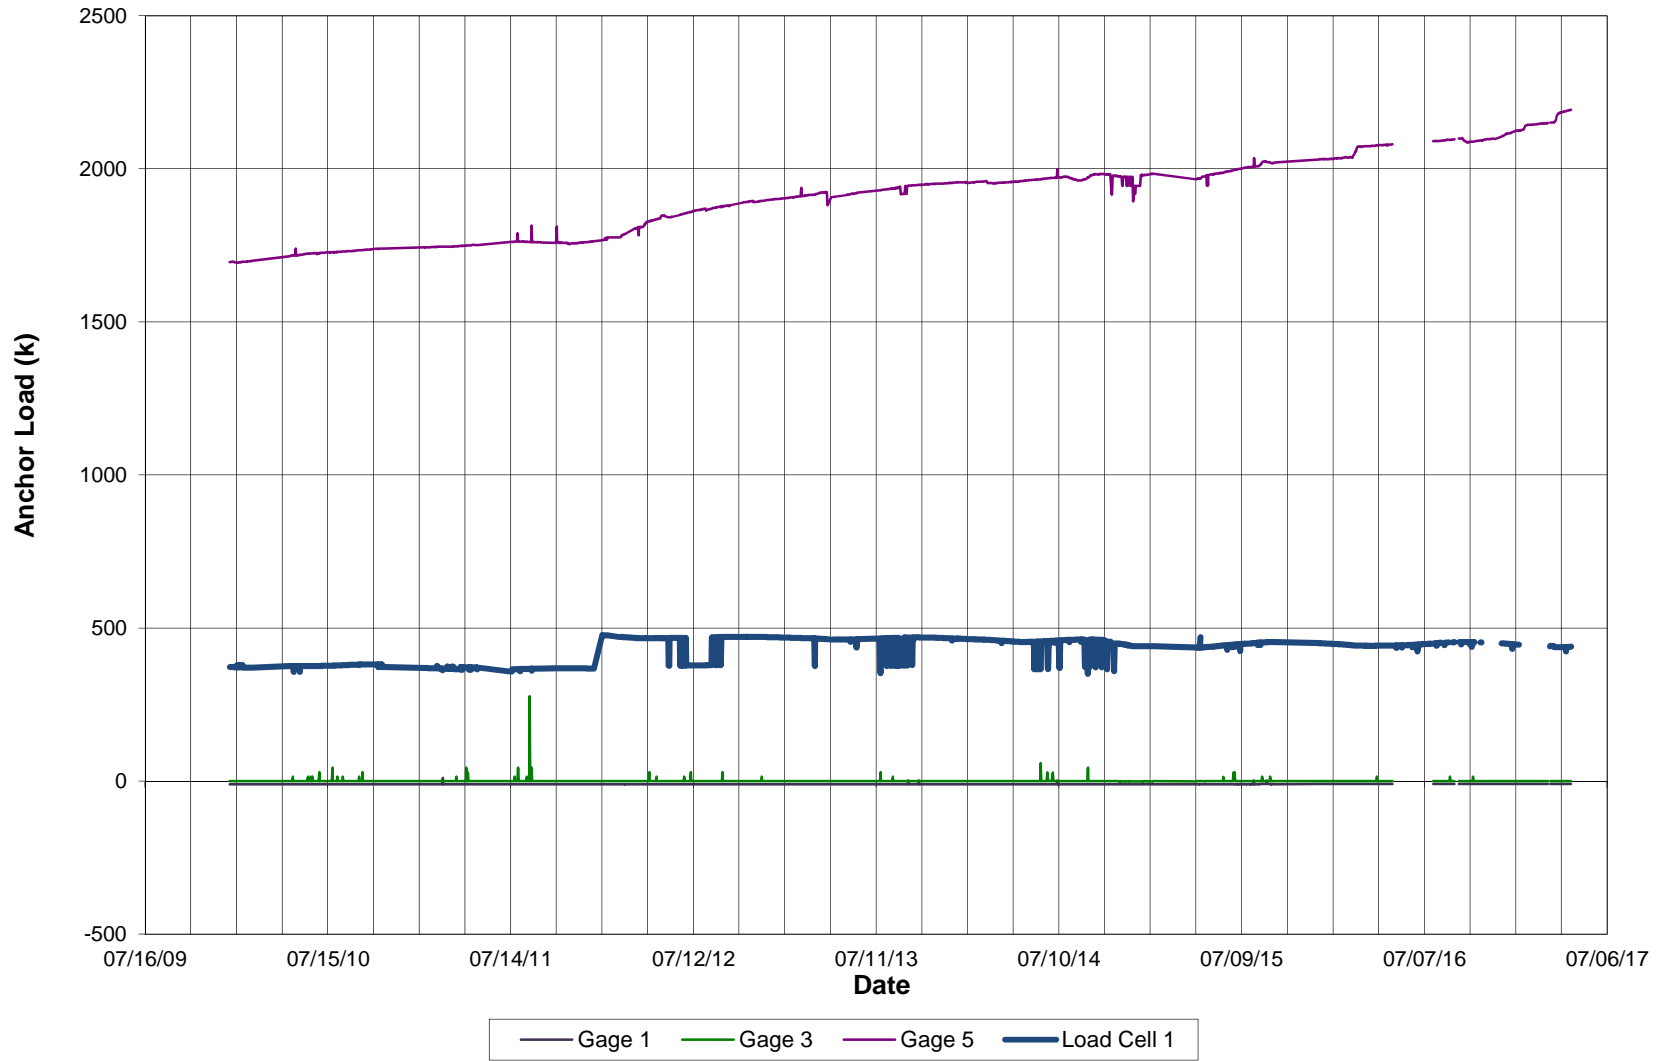
Anchor #1 - Load Cell #1

Seasonal variations are apparent in the plots for all the load cells with the usual decrease in load occurring during the winter months. The random spikes shown in the plots occur when one or more of the gages in the load cell fail to record. These spikes are occurring in all load cells with the exception of Load Cell 9. Gage 4 in Load Cell 1 failed from January 12 to March 14, 2017, then started recording again. Gage 3 in Load Cell 8 started intermittently giving erroneous readings after March 5, 2017. These erroneous readings were deleted to "clean up" the plots. Table 2 shows which gages were active in each of the load cells this quarter. A plot of the load cell data is included in Appendix B.

Loads recorded for most active strandmeters on the instrumented anchors remained virtually constant this quarter. The plot for Gage 5 on Anchor 1 indicates the continuing upward trend that has been ongoing since at least 2010. The magnitude of the load is obviously incorrect since it is unrealistically high and is more than four times the load indicated by the load cell. Average loads this quarter for the load cells and active strandmeters are listed in Table 3. We also report the percent change in load from last quarter. Strandmeter gages that have failed are indicated by an "x" in the table. Negative (compression) loads and loads in the individual gages that exceed the load indicated by the load cell are not possible. Assuming uniform load transfer from the anchor to the rock over the bond length, we should expect the load indicated by the strandmeters to increase progressively from Gage 1 to Gage 5 which is closest to the top end of the bond zone. Only a few of the data points listed in Table 3 seem to be valid.

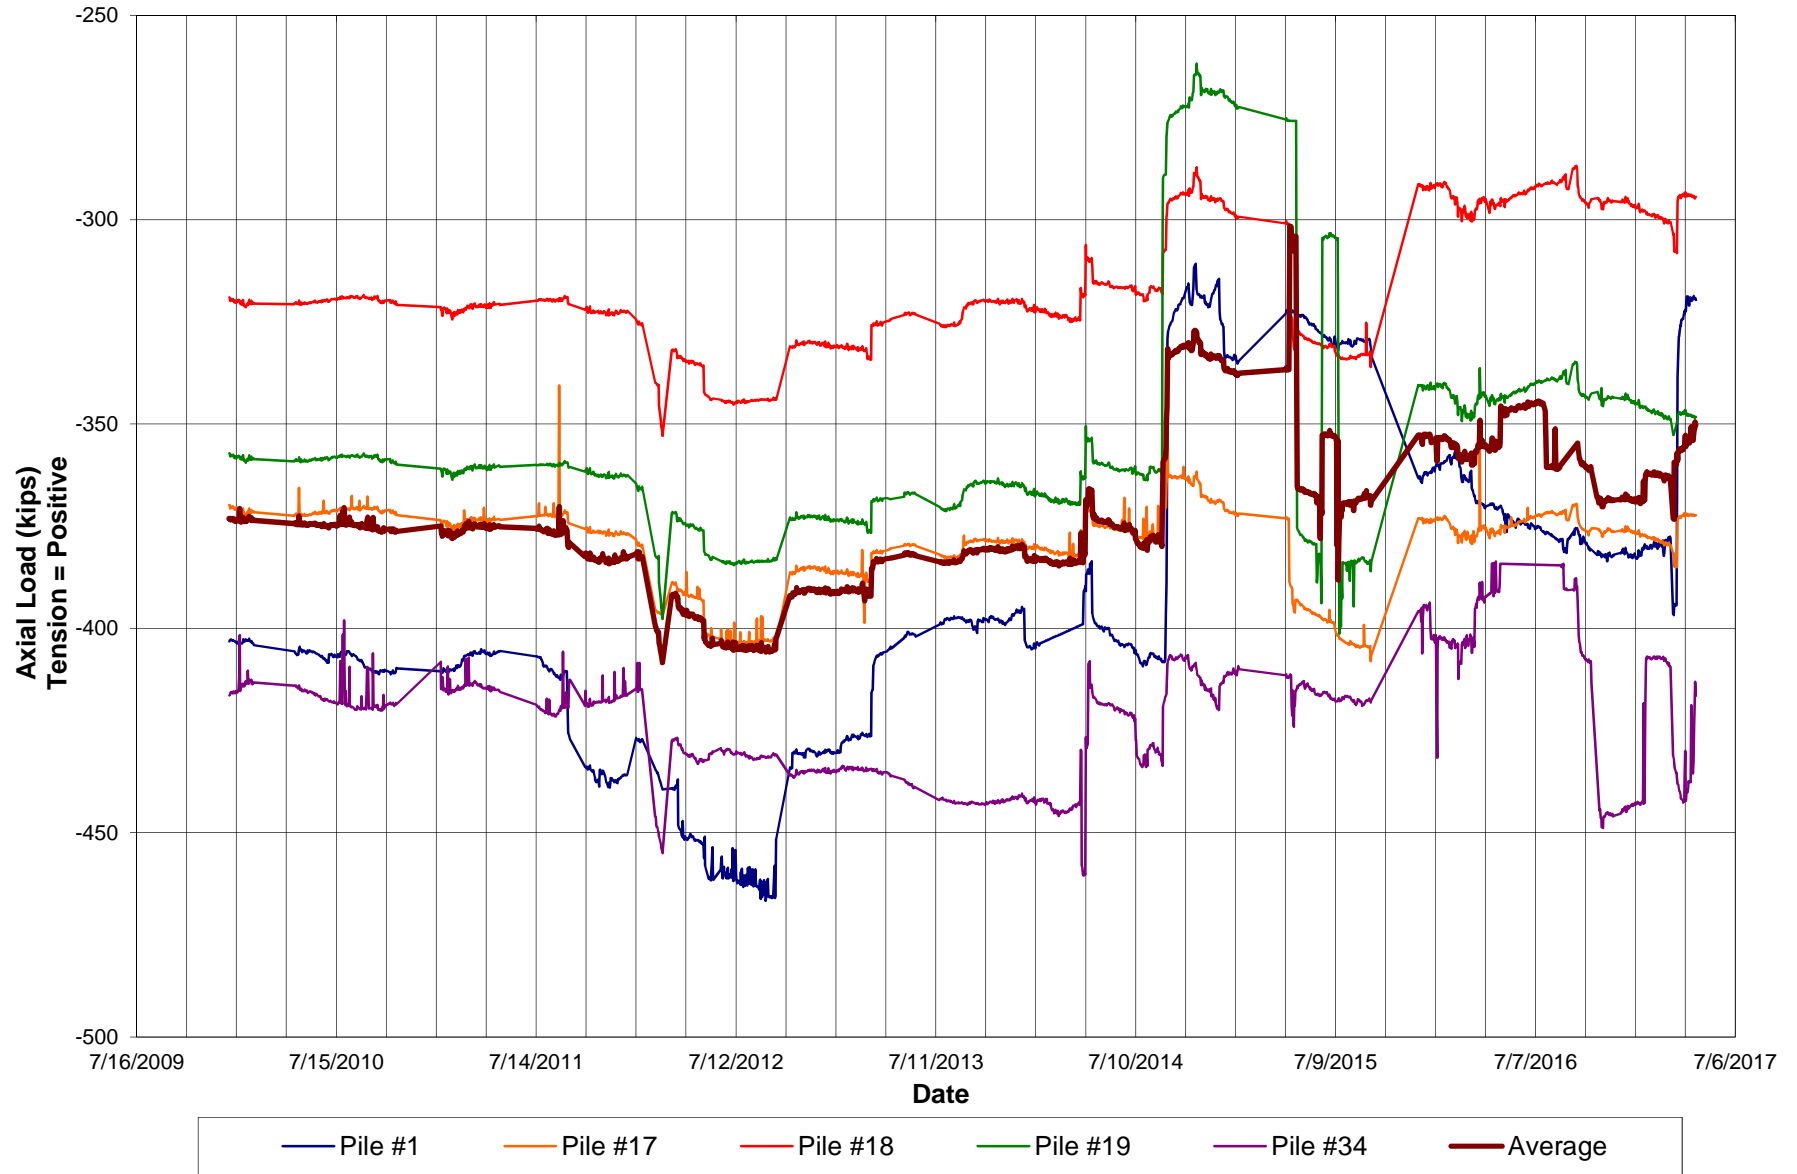
Axial loads in all Driven Piles, except Pile 1, steadily increased from January through March, 2017. The large decrease for Pile 34 in January 2017 was caused by gage 1 working again after it had been malfunctioning since October 2016. Axial loads in Pile 1 steadily decreased from January through March 2017. In mid-March 2017, axial loads in all Driven Piles suddenly increased then decreased by large magnitudes. The axial load plot for Pile 1 shows the largest changes, increasing by 18 kips then decreasing by 76 kips. Following this event, axial loads remained nearly constant in Piles 1, 17, and 18, increased slightly in Pile 19, and continued a sharp decrease in Pile 34.
