Re: April 2017 Quarterly Report
CUY-90-15.24 Slope Monitoring
PID 96504
EDP Project No. 069032.00

APRIL 2017 QUARTERLY REPORT

CUY-90-15.24 SLOPE MONITORING
PID 96504
CLEVELAND, OHIO
SME PROJECT NO. 069032.00

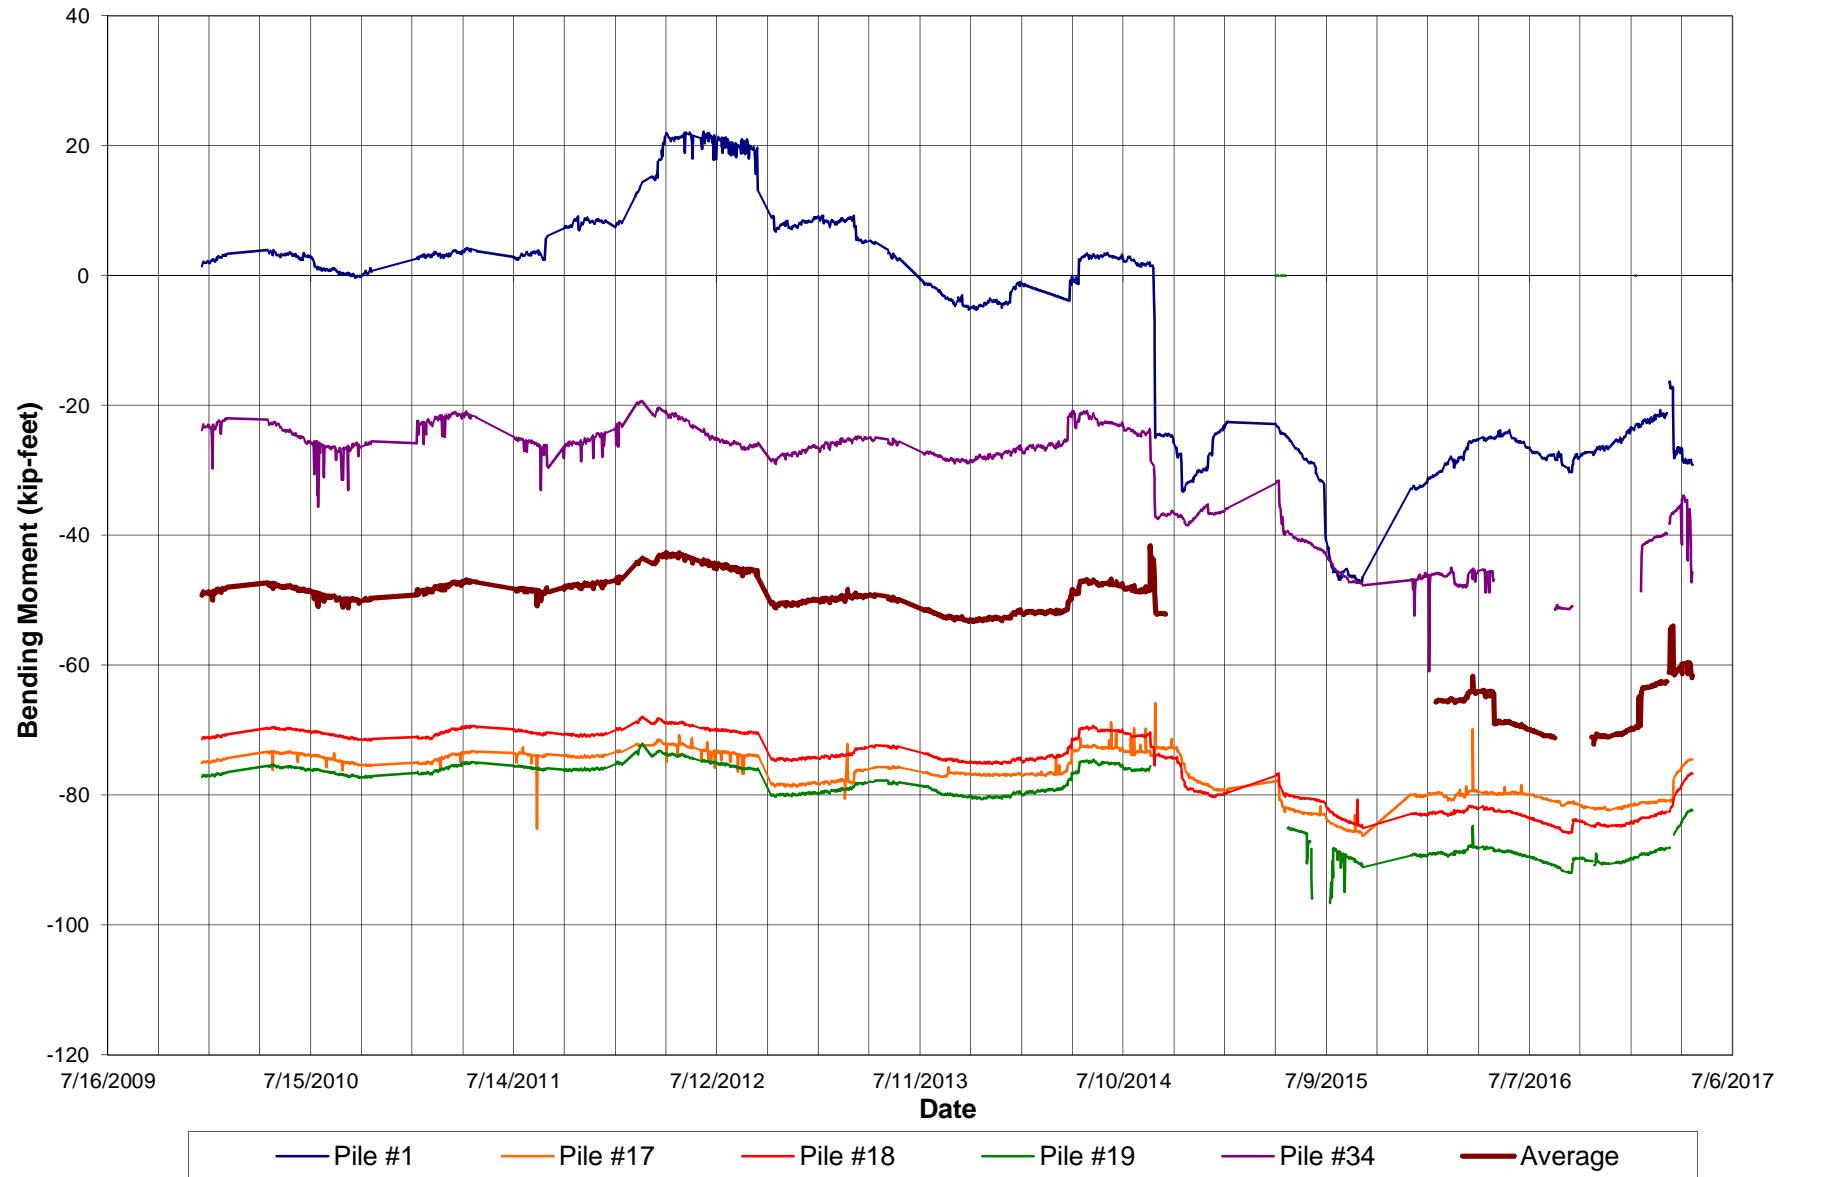
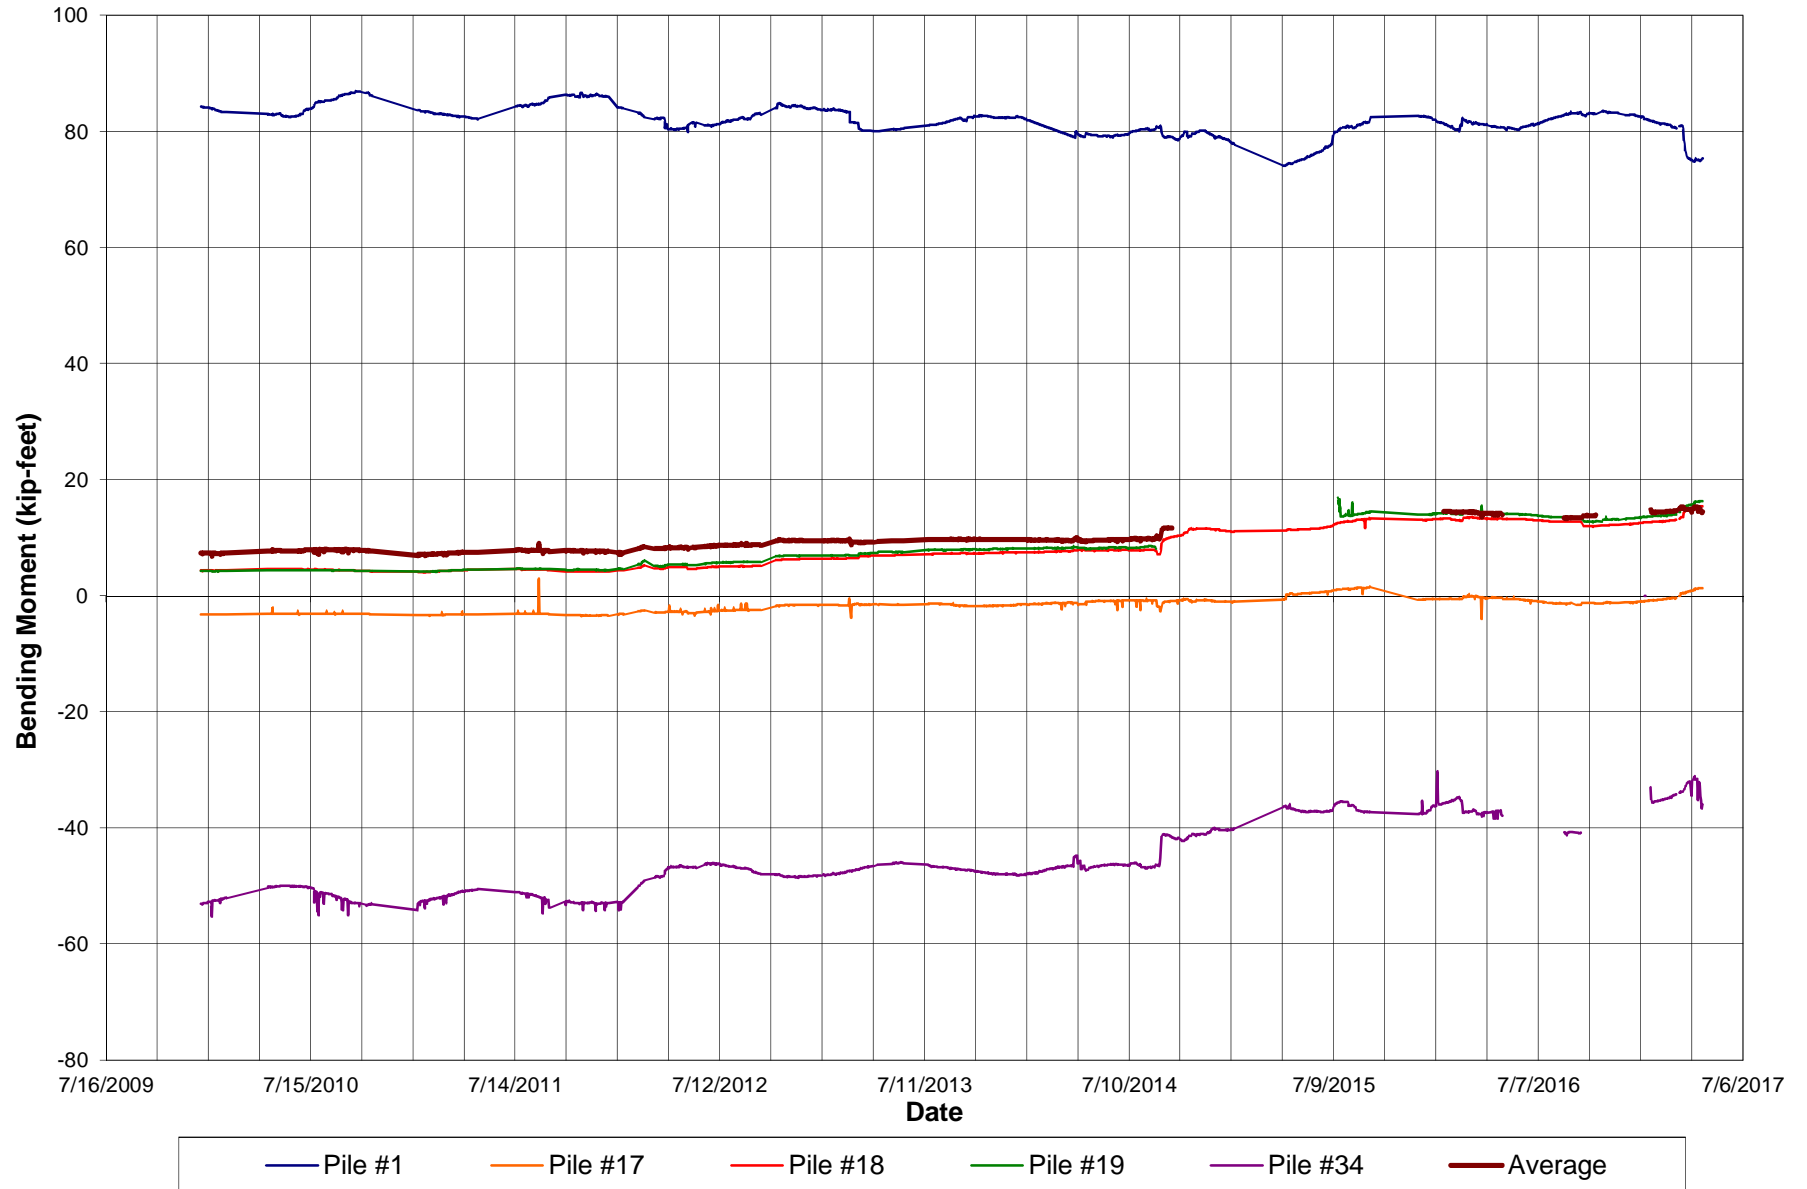
Strong axis bending moments in all of the driven piles decreased slightly through mid-March. Then in mid-March, the rate of change increased in all piles except Pile 1, which began to increase. The spikes shown in Piles 1 and 34 are caused by erroneous fluctuations in the gage readings. Average weak axis bending moments showed similar trends to the strong axis bending moments but at lower magnitudes.

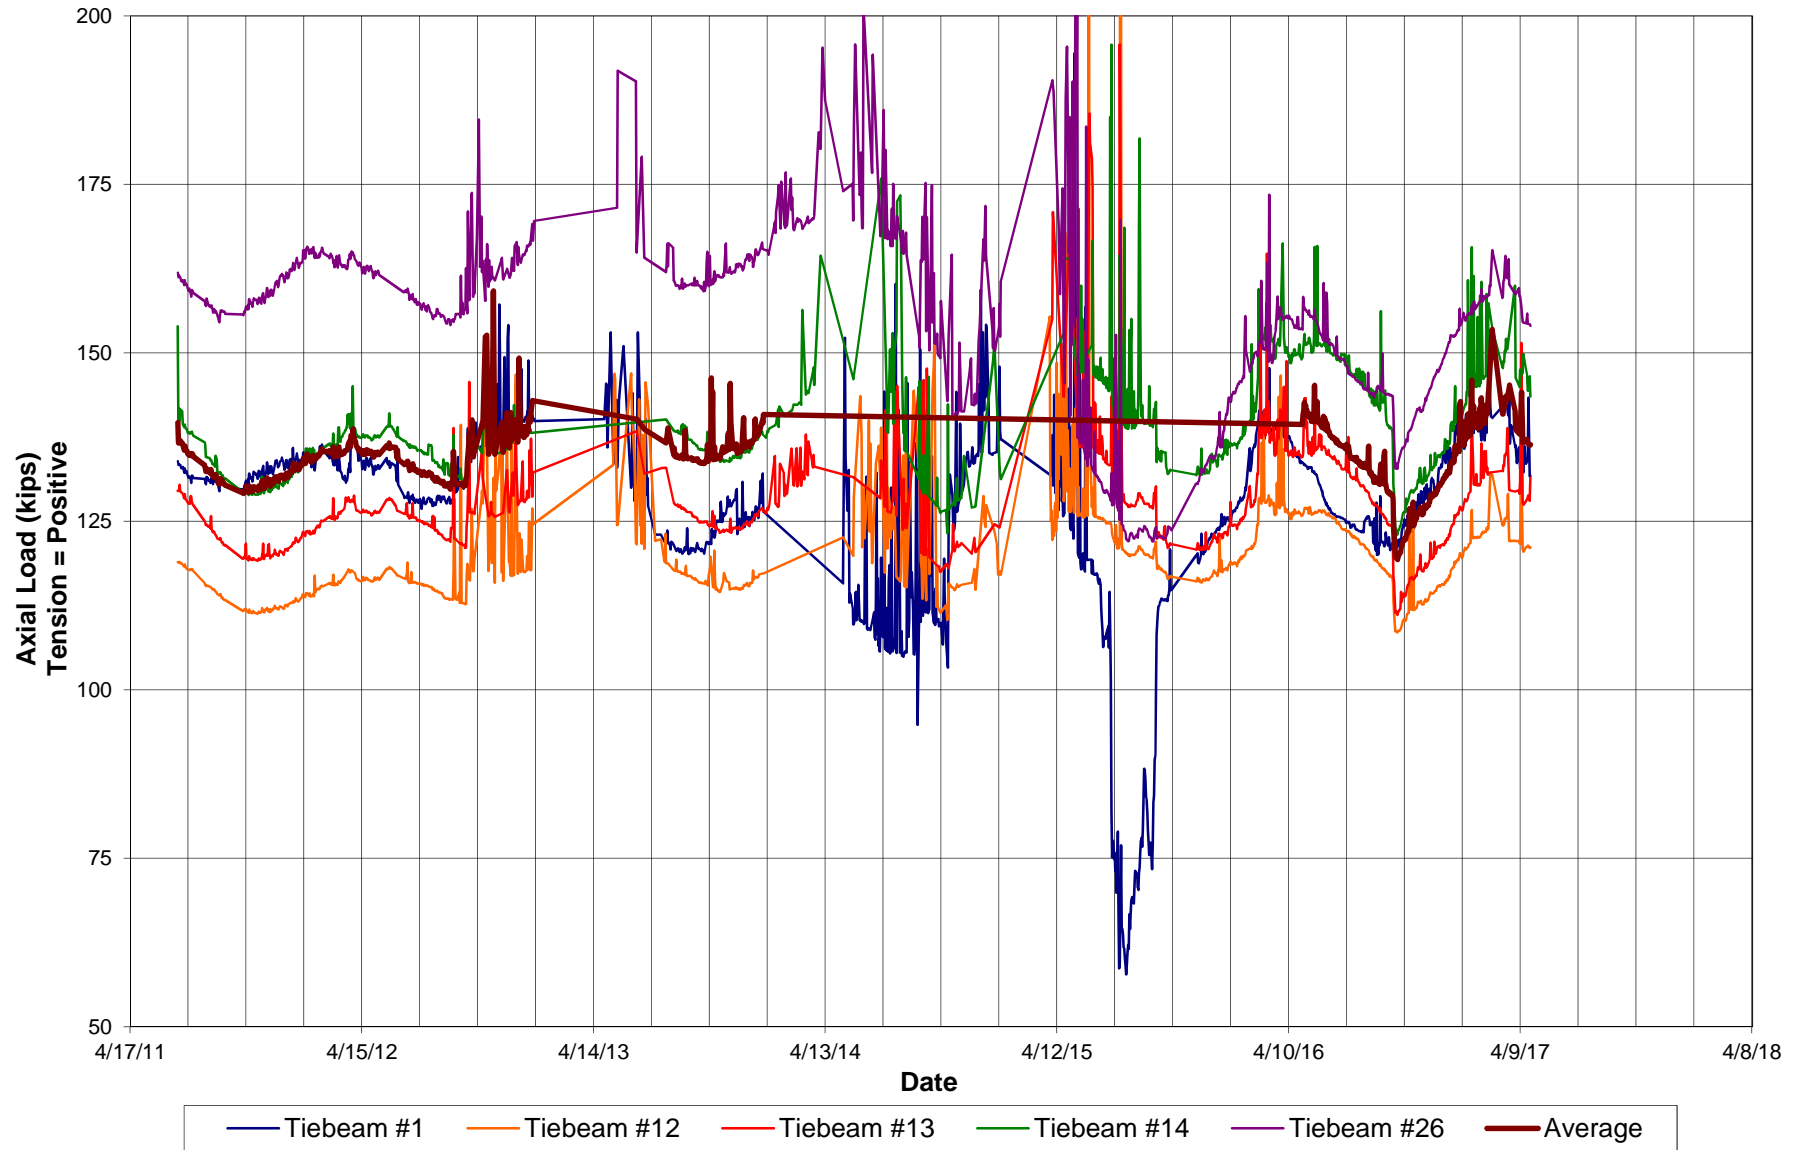
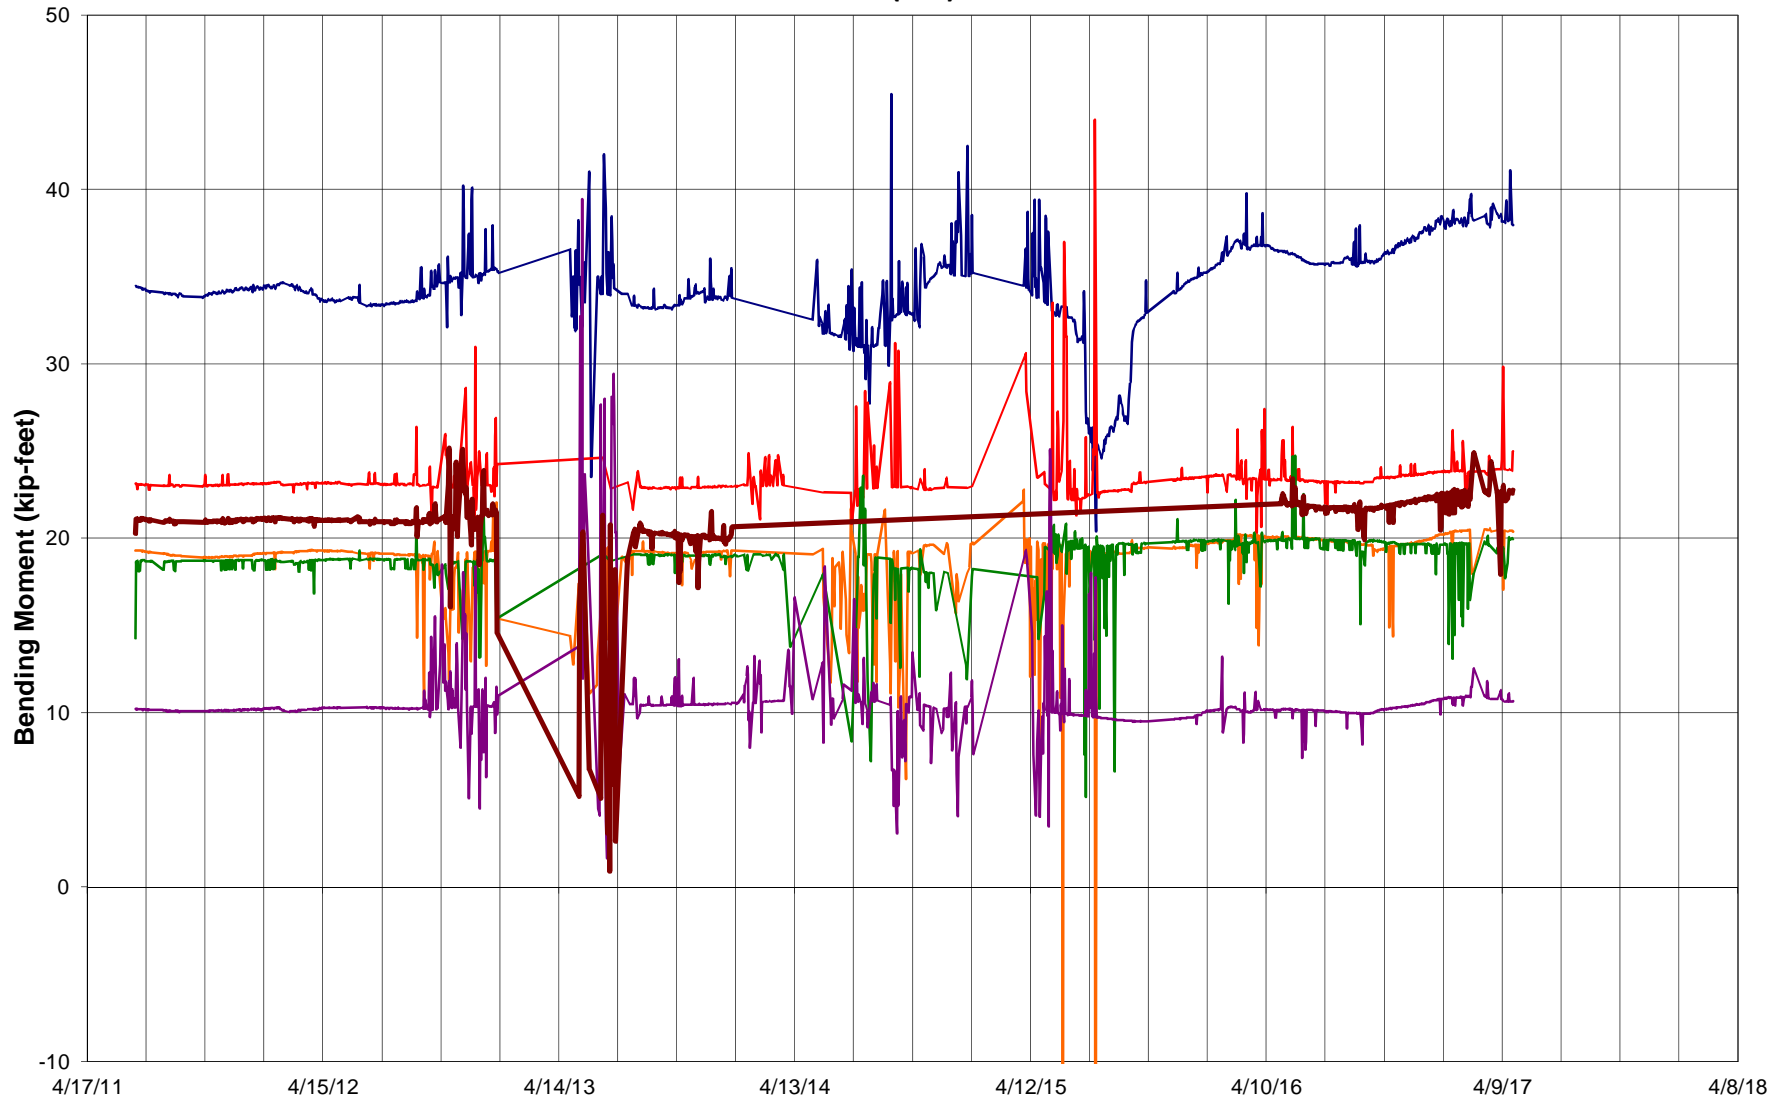
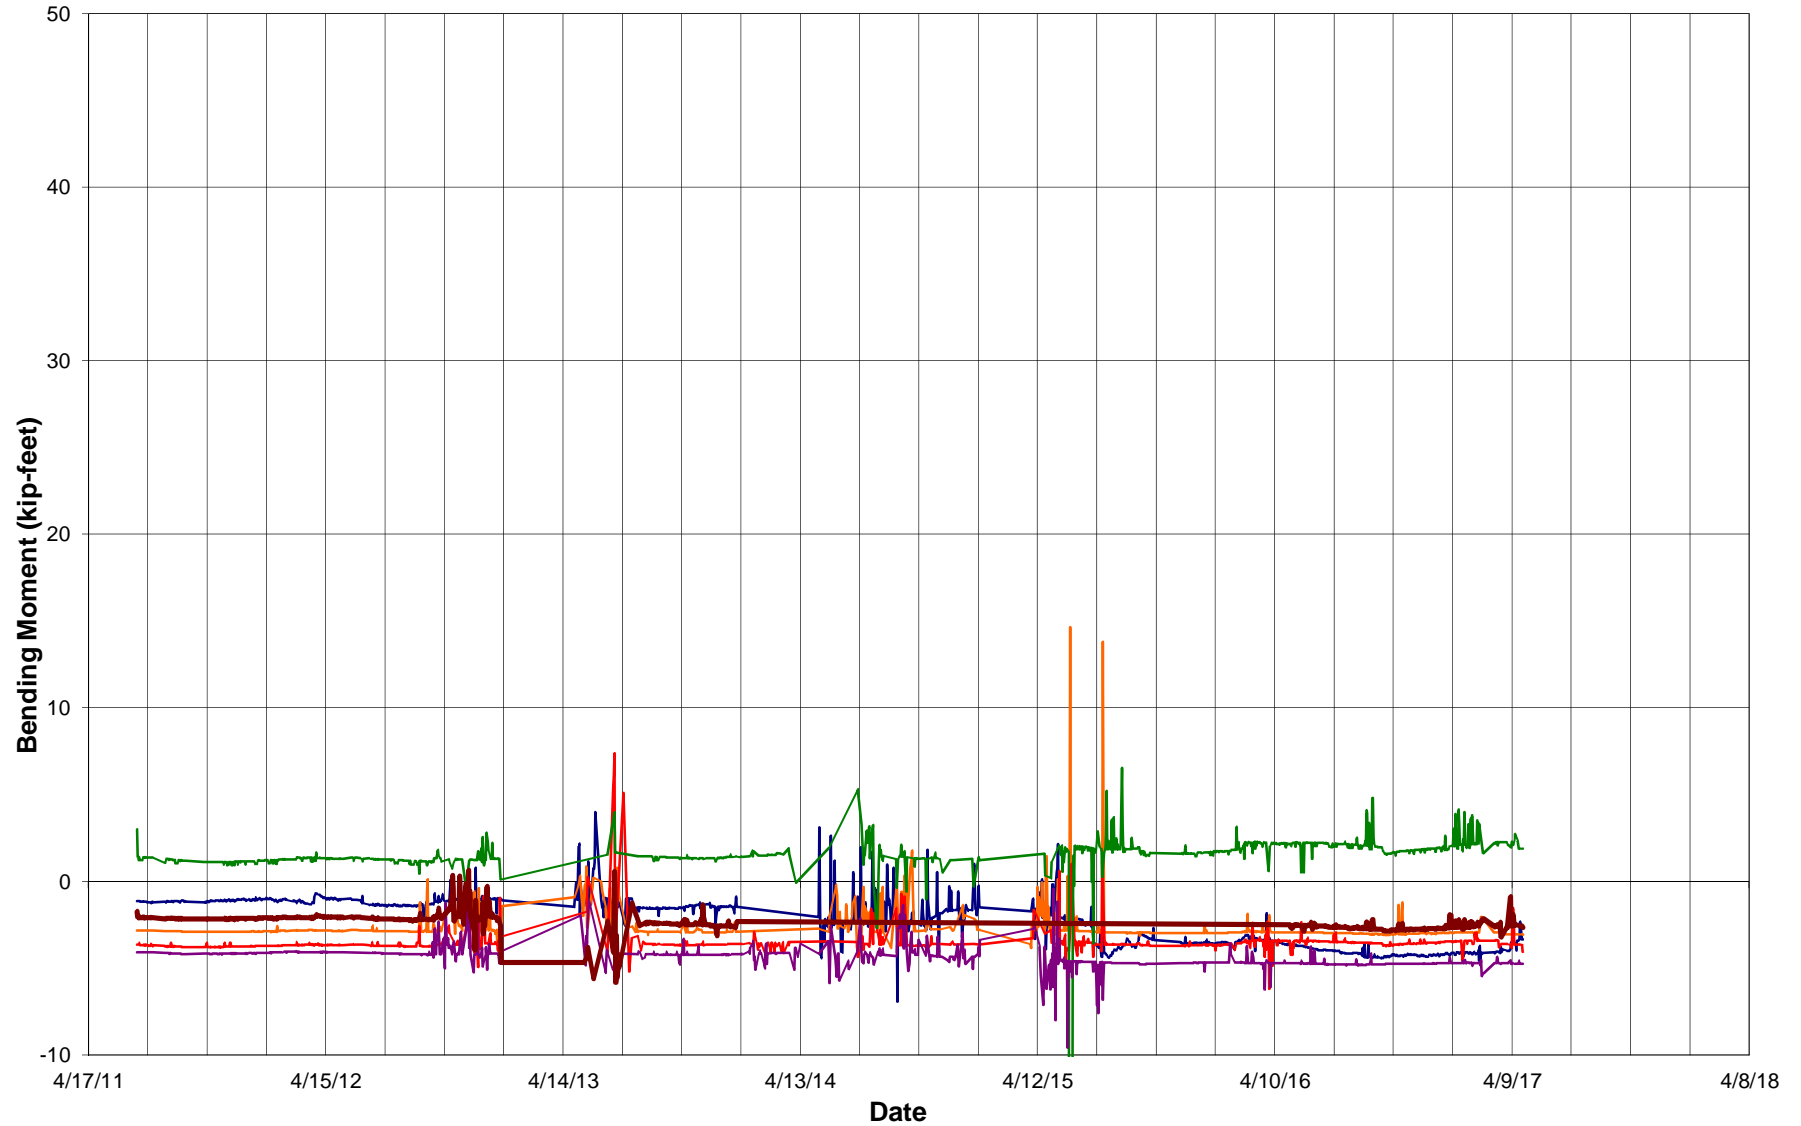
Axial loads at the anchor end of the tiebeams began to decrease in March 2017 following seasonal trends. From the downturn in mid-March to the end of this quarter, decreases in axial load range from 3 to 12 kips, with the largest decrease occurring in Tiebeam 1.

Strong axis bending moments in Tiebeams 1, 12, and 26 increased slightly until mid-March 2017, then began to decrease following the seasonal trend. The seasonal changes in Tiebeams 13 and 14 were barely noticeable. This year we see a small but noticeable change in Tiebeams 12 and 26. The seasonal variation has been more apparent in Tiebeam 1, which showed the largest increase in strong axis bending moment. Changes in weak axis bending moments were negligible for all tiebeams.

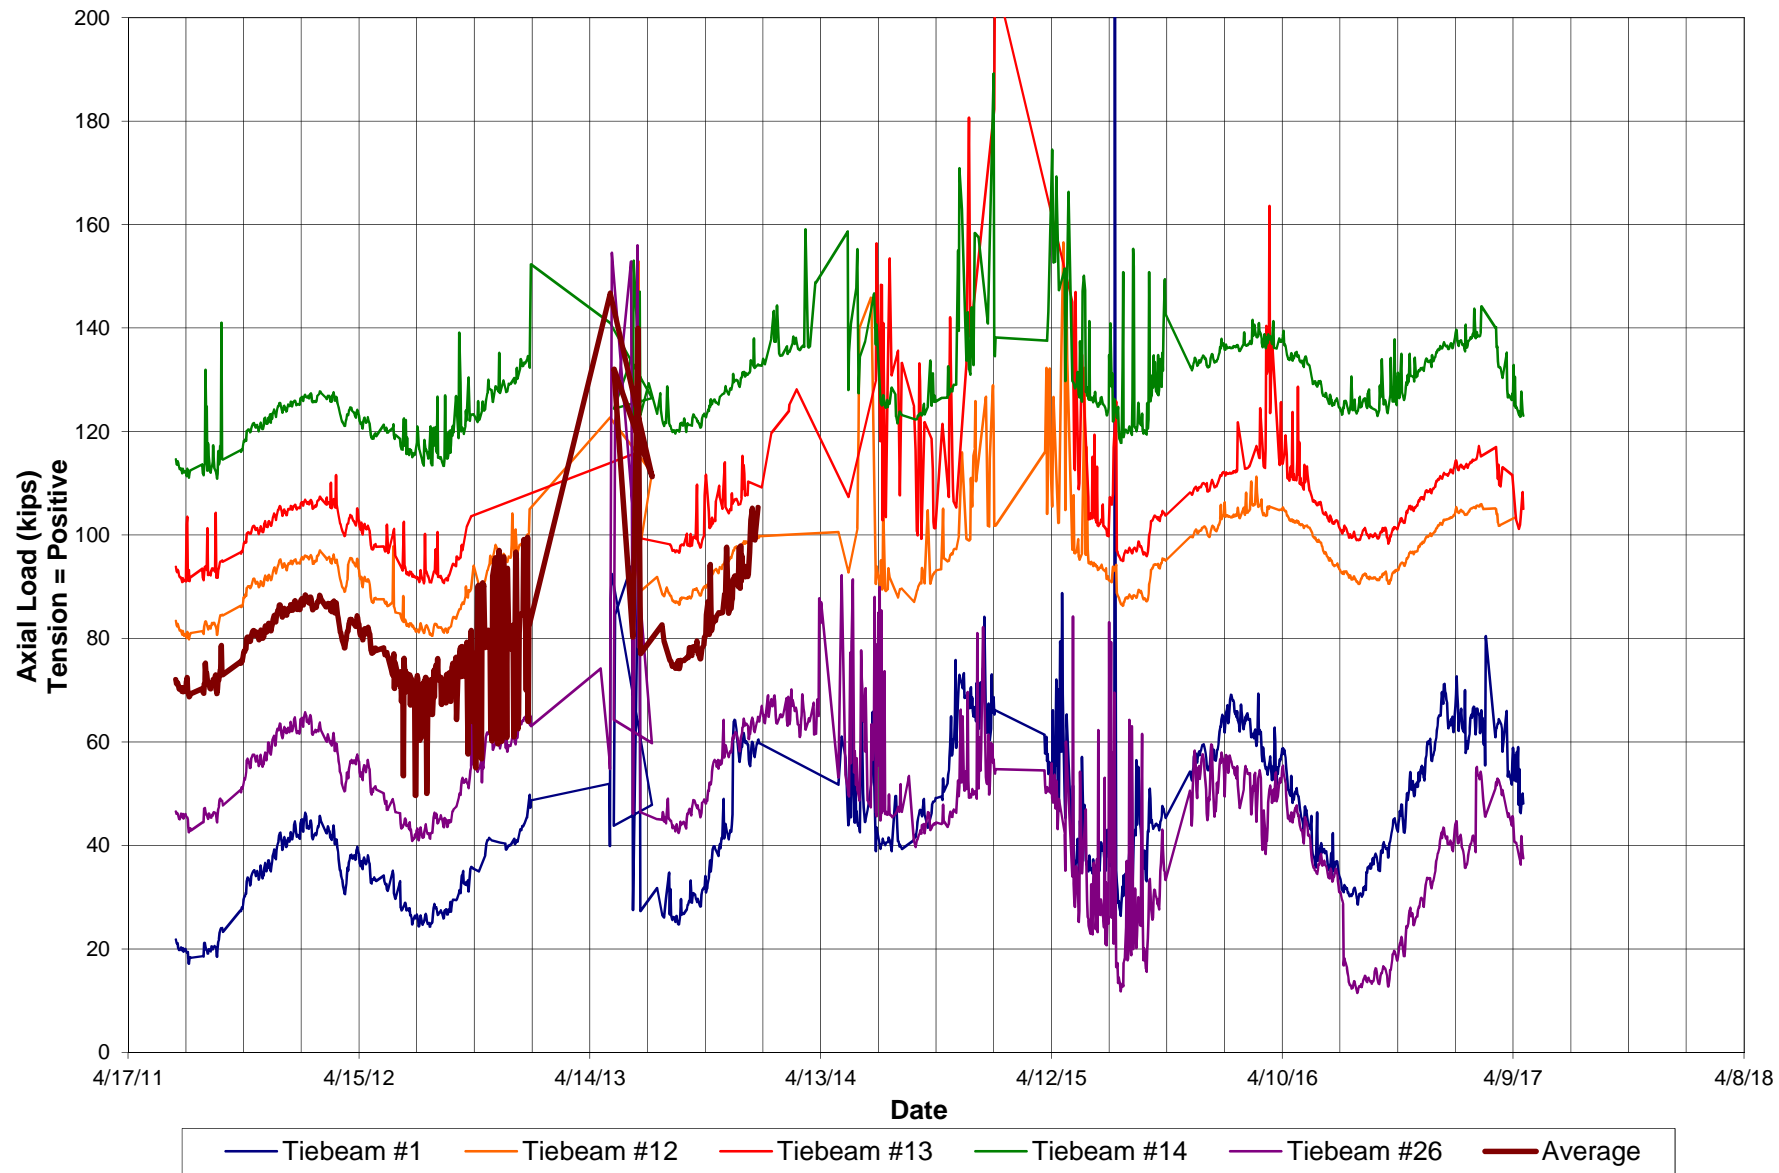
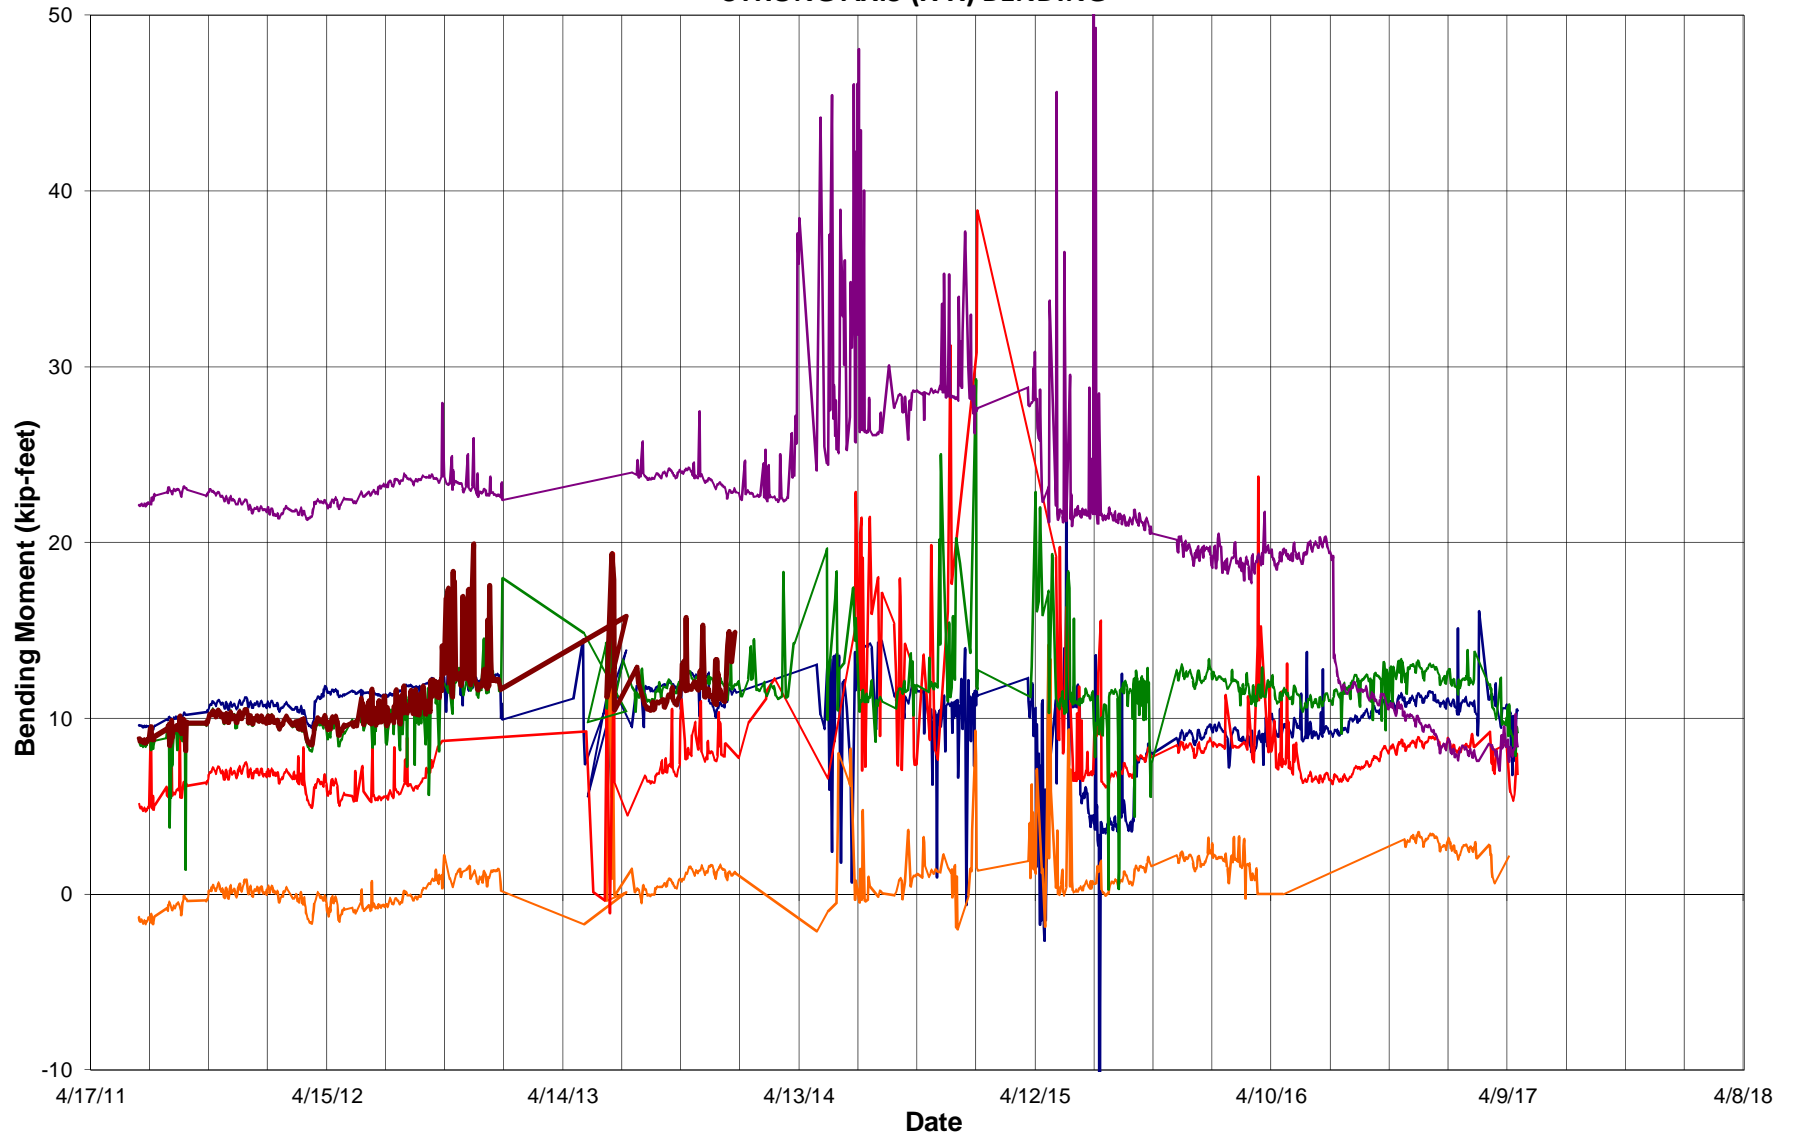
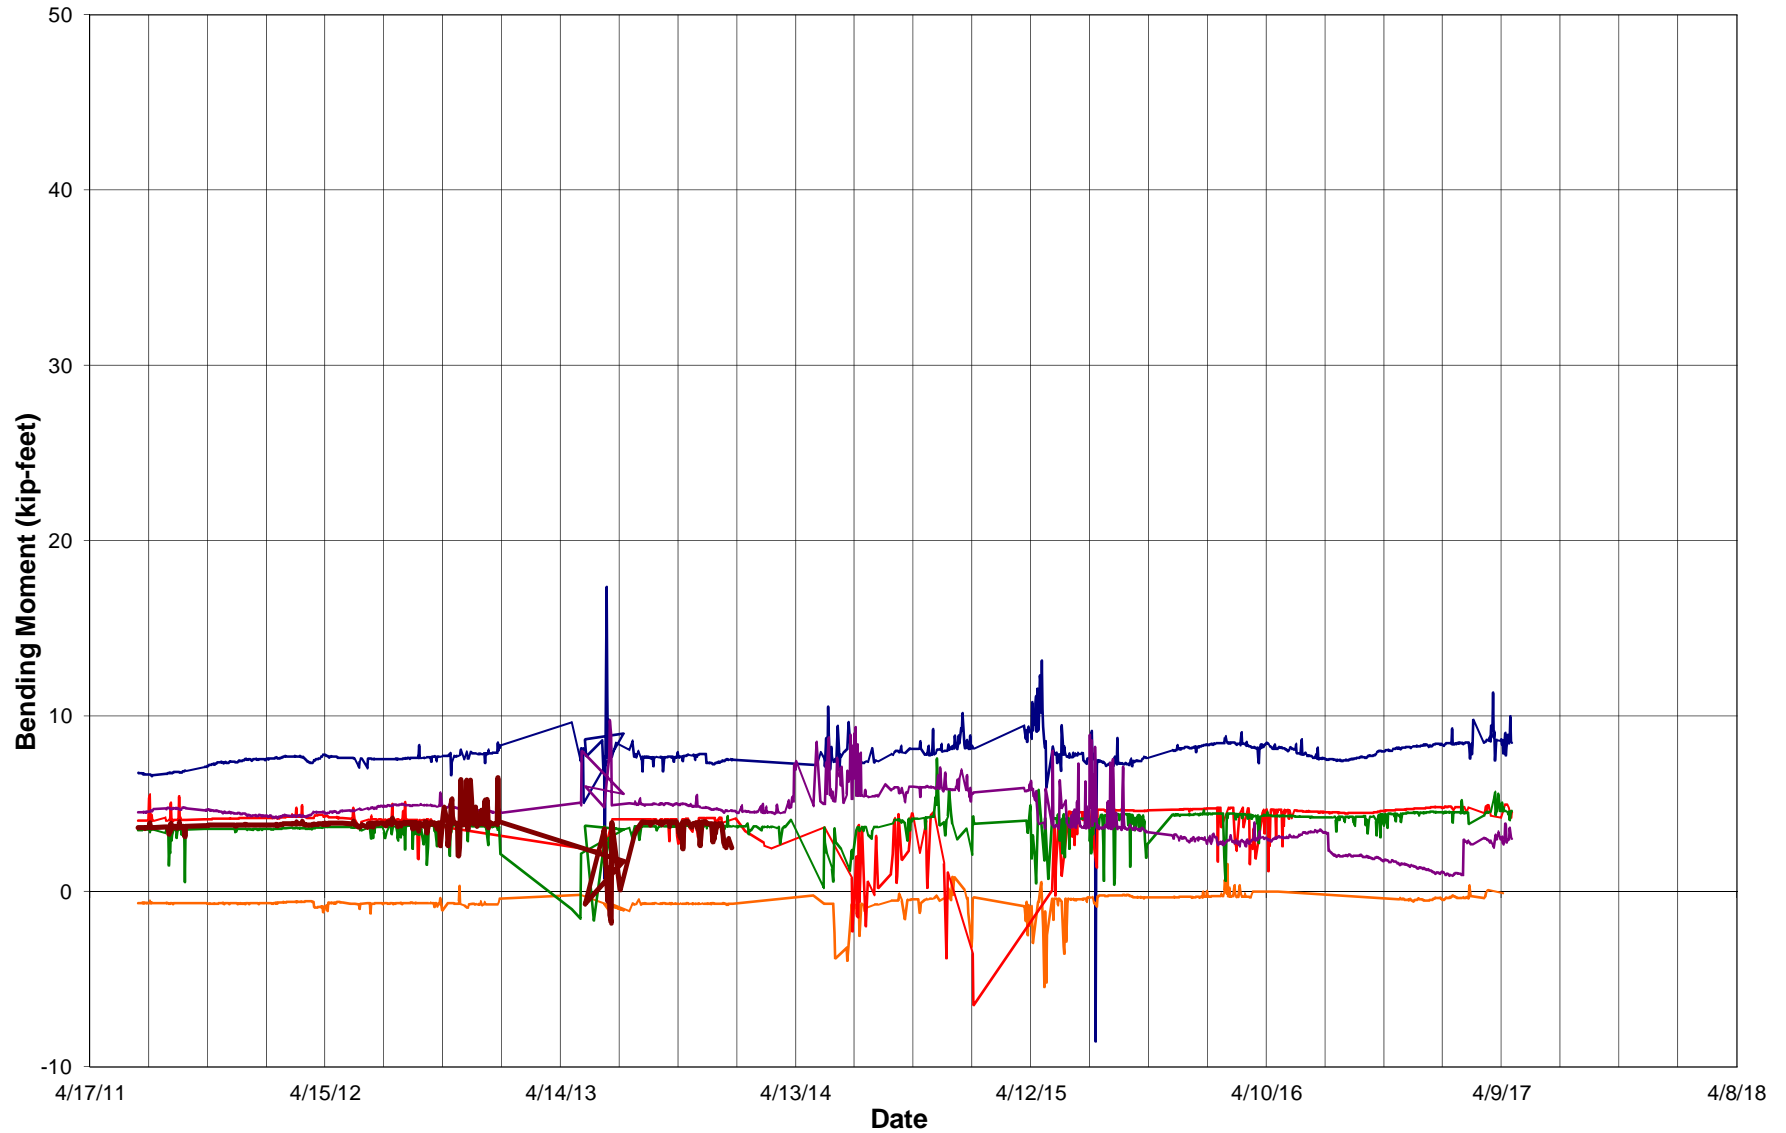
Seasonal changes are also seen in the axial loads in the tiebeams on the drilled pier side, which increased until March 2017, then began to decrease. This change is similar to the seasonal changes seen in the past except that the magnitude of variation in Tiebeams 1 and 26 is somewhat larger than in past years. Axial loads in the other tiebeams show seasonal changes similar to past years. There has been an upward trend in axial load in all tiebeams except Tiebeam 26 for the past 6 years. The axial load in Tiebeam 1 has been trending downward during this time.

Strong axis bending moments on the drilled pier side of Tiebeams 1, 12, 13, and 14 showed the typical seasonal changes with decreases starting this quarter. The strong axis bending moment in Tiebeam 14 decreased by 3 kip-feet, which is a larger change than previously seen. The plot for Tiebeam 26, shows a continued decrease in the strong axis bending moment until mid-March 2017, when it began to increase. Two gages are now malfunctioning on this end of Tiebeam 26, which is causing this unusual plot. We adjusted the calculations by using values for the companion gages on the opposite ends of the flange to compensate for the loss of these gages. This allows us to calculate bending moments. However, this introduces some error into the calculated moments which depends on the relative magnitude of the strong and weak axis moments. We are using the same type of correction to the data for Tiebeams 1 and 12.

Weak axis bending moments on the drilled pier side remained virtually constant, except for Tiebeam 26. The large increase shown on the plot for this tiebeam in February 2017 was caused by the second gage failing and a correction being applied to the calculation.
