Re: April 2017 Quarterly Report
CUY-90-15.24 Slope Monitoring
PID 96504
EDP Project No. 069032.00

APRIL 2017 QUARTERLY REPORT

CUY-90-15.24 SLOPE MONITORING
PID 96504
CLEVELAND, OHIO
SME PROJECT NO. 069032.00

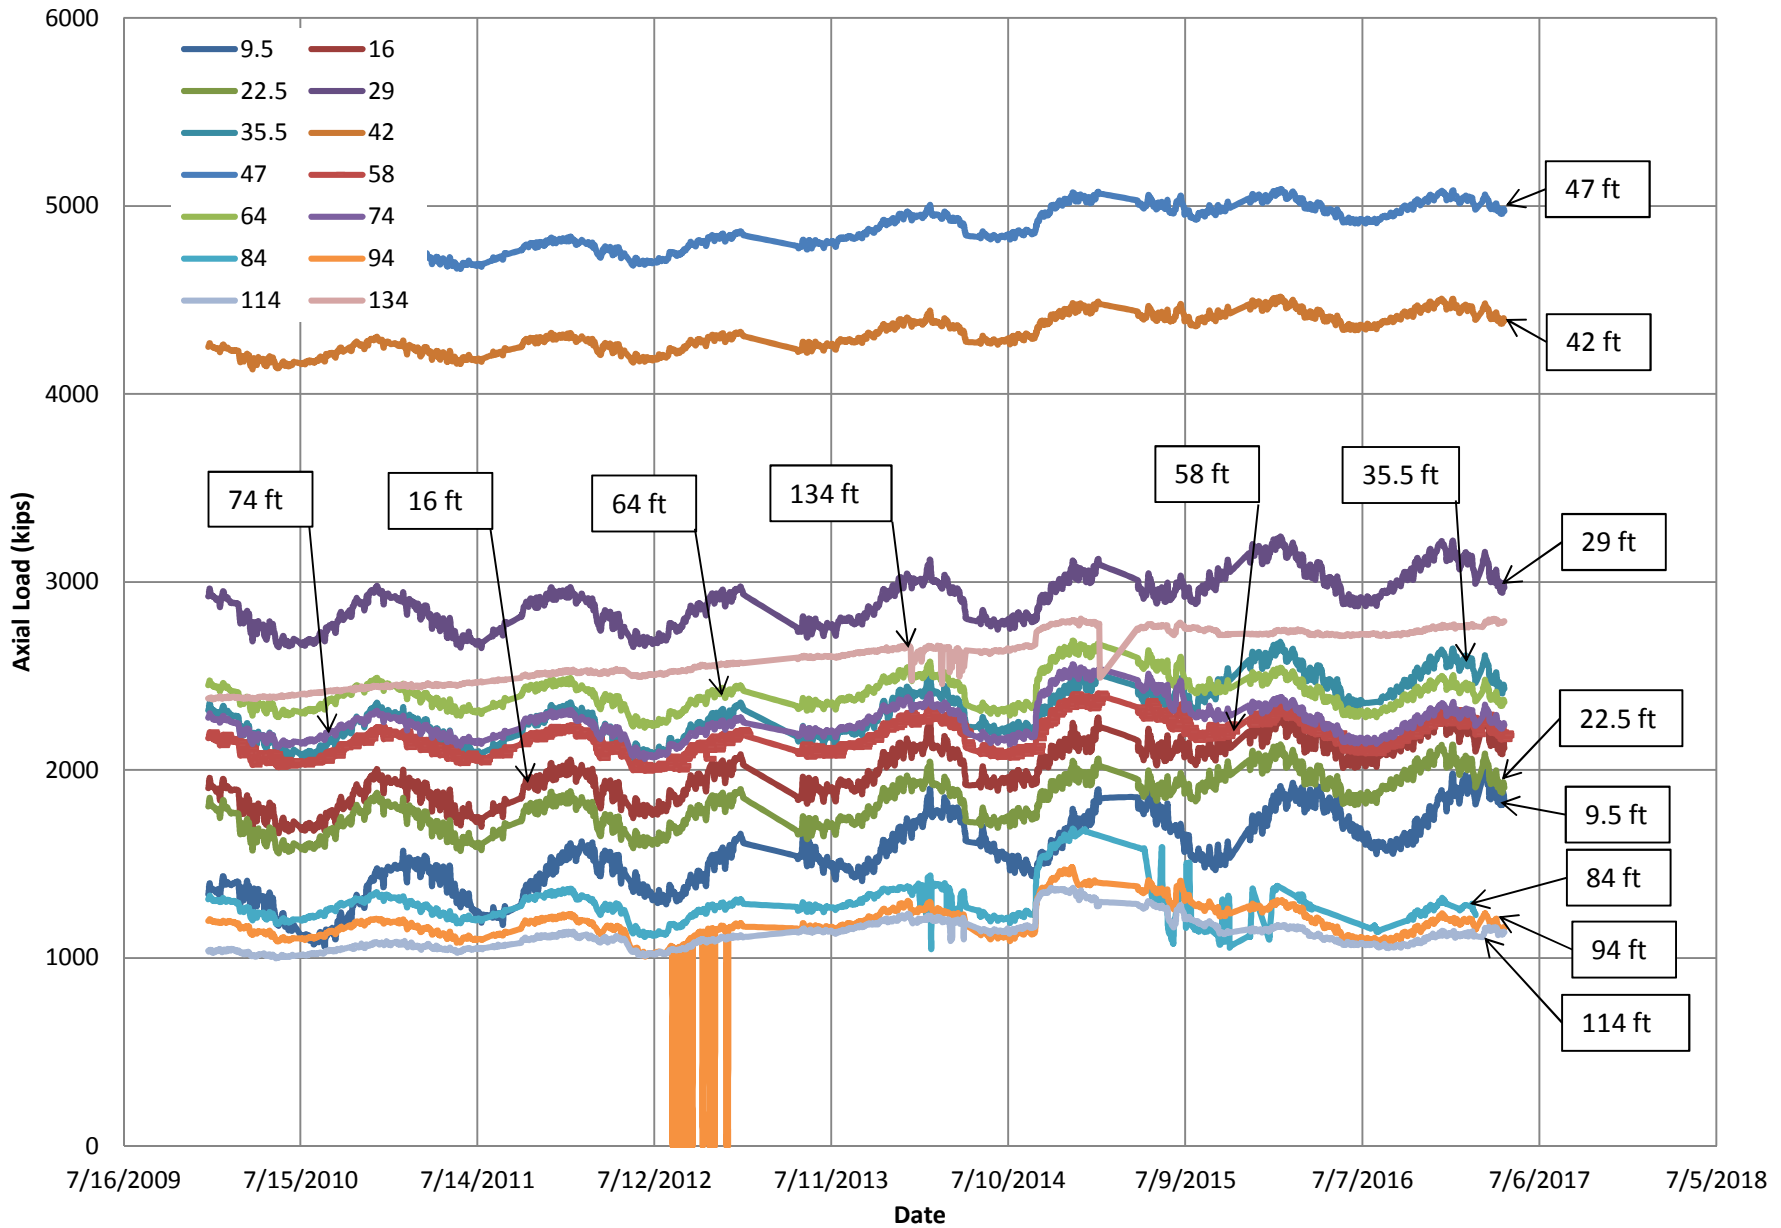
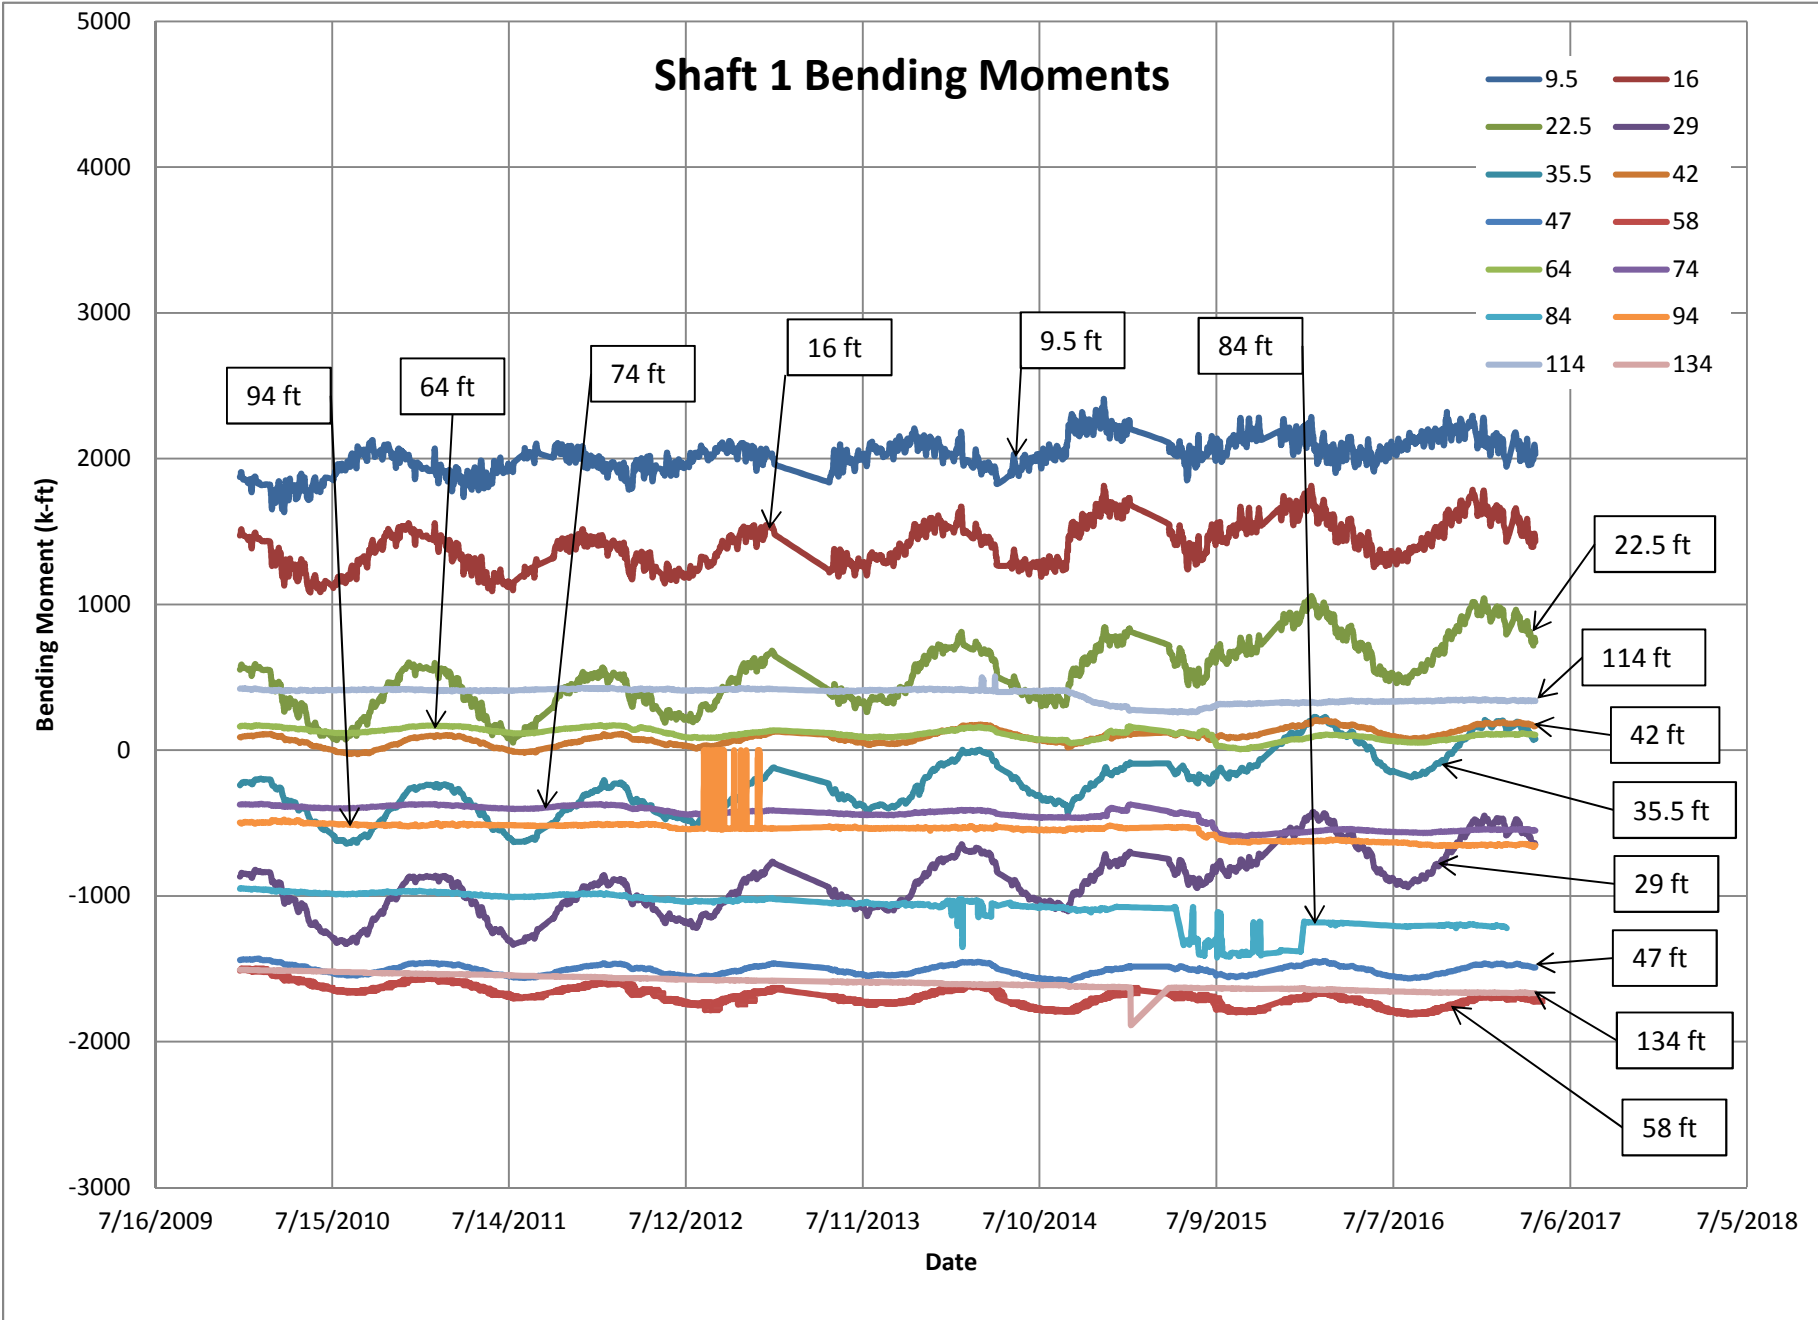
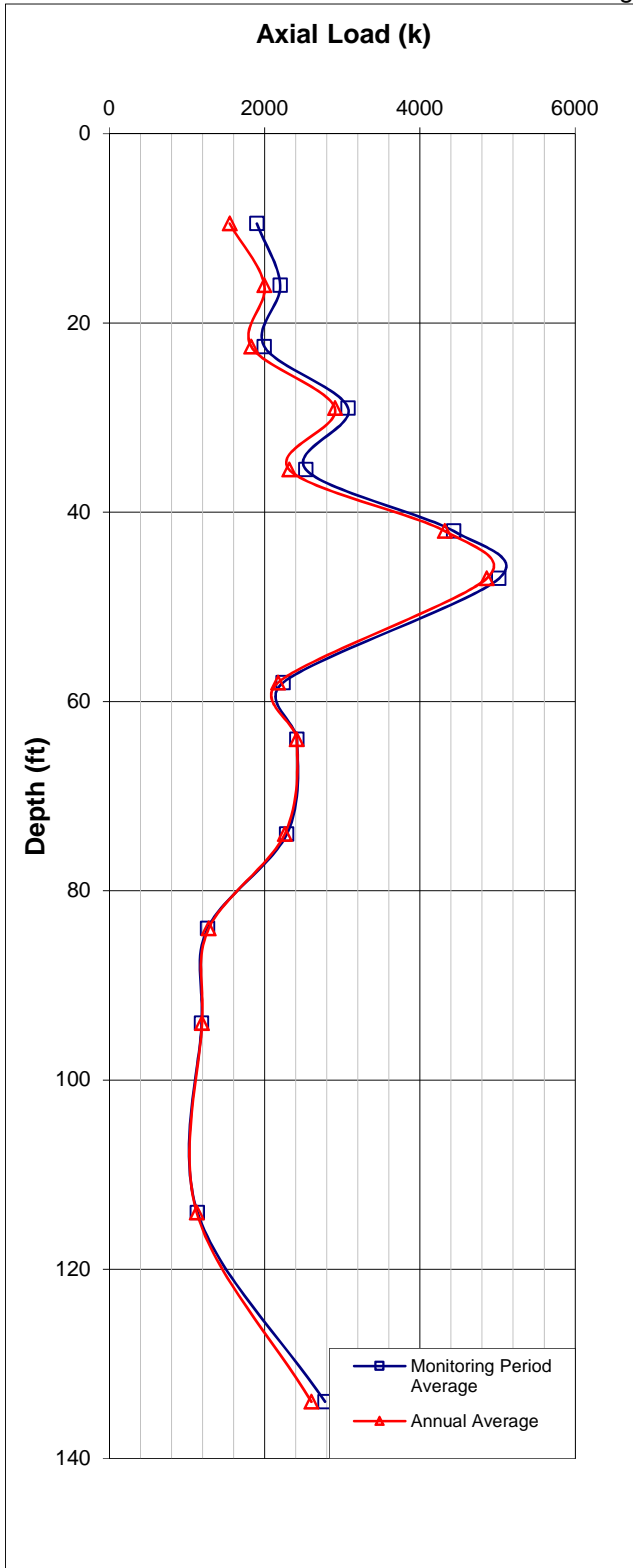
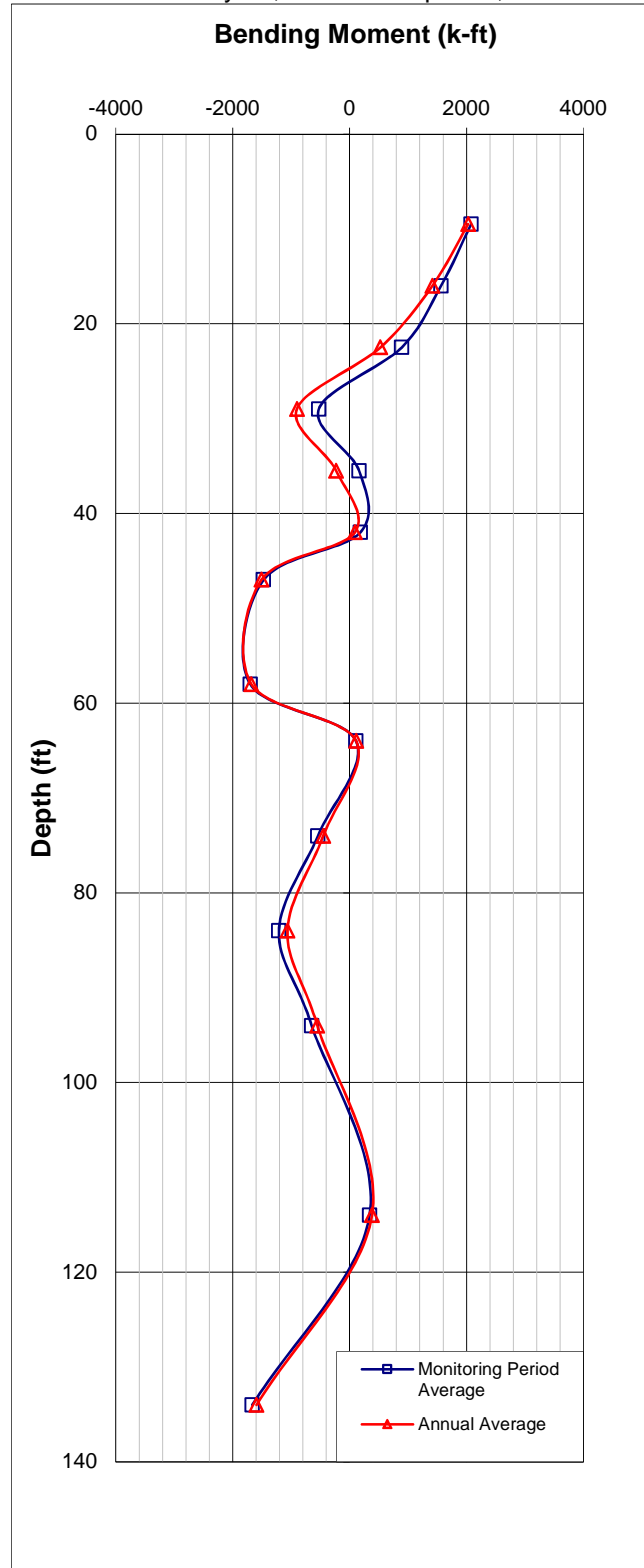
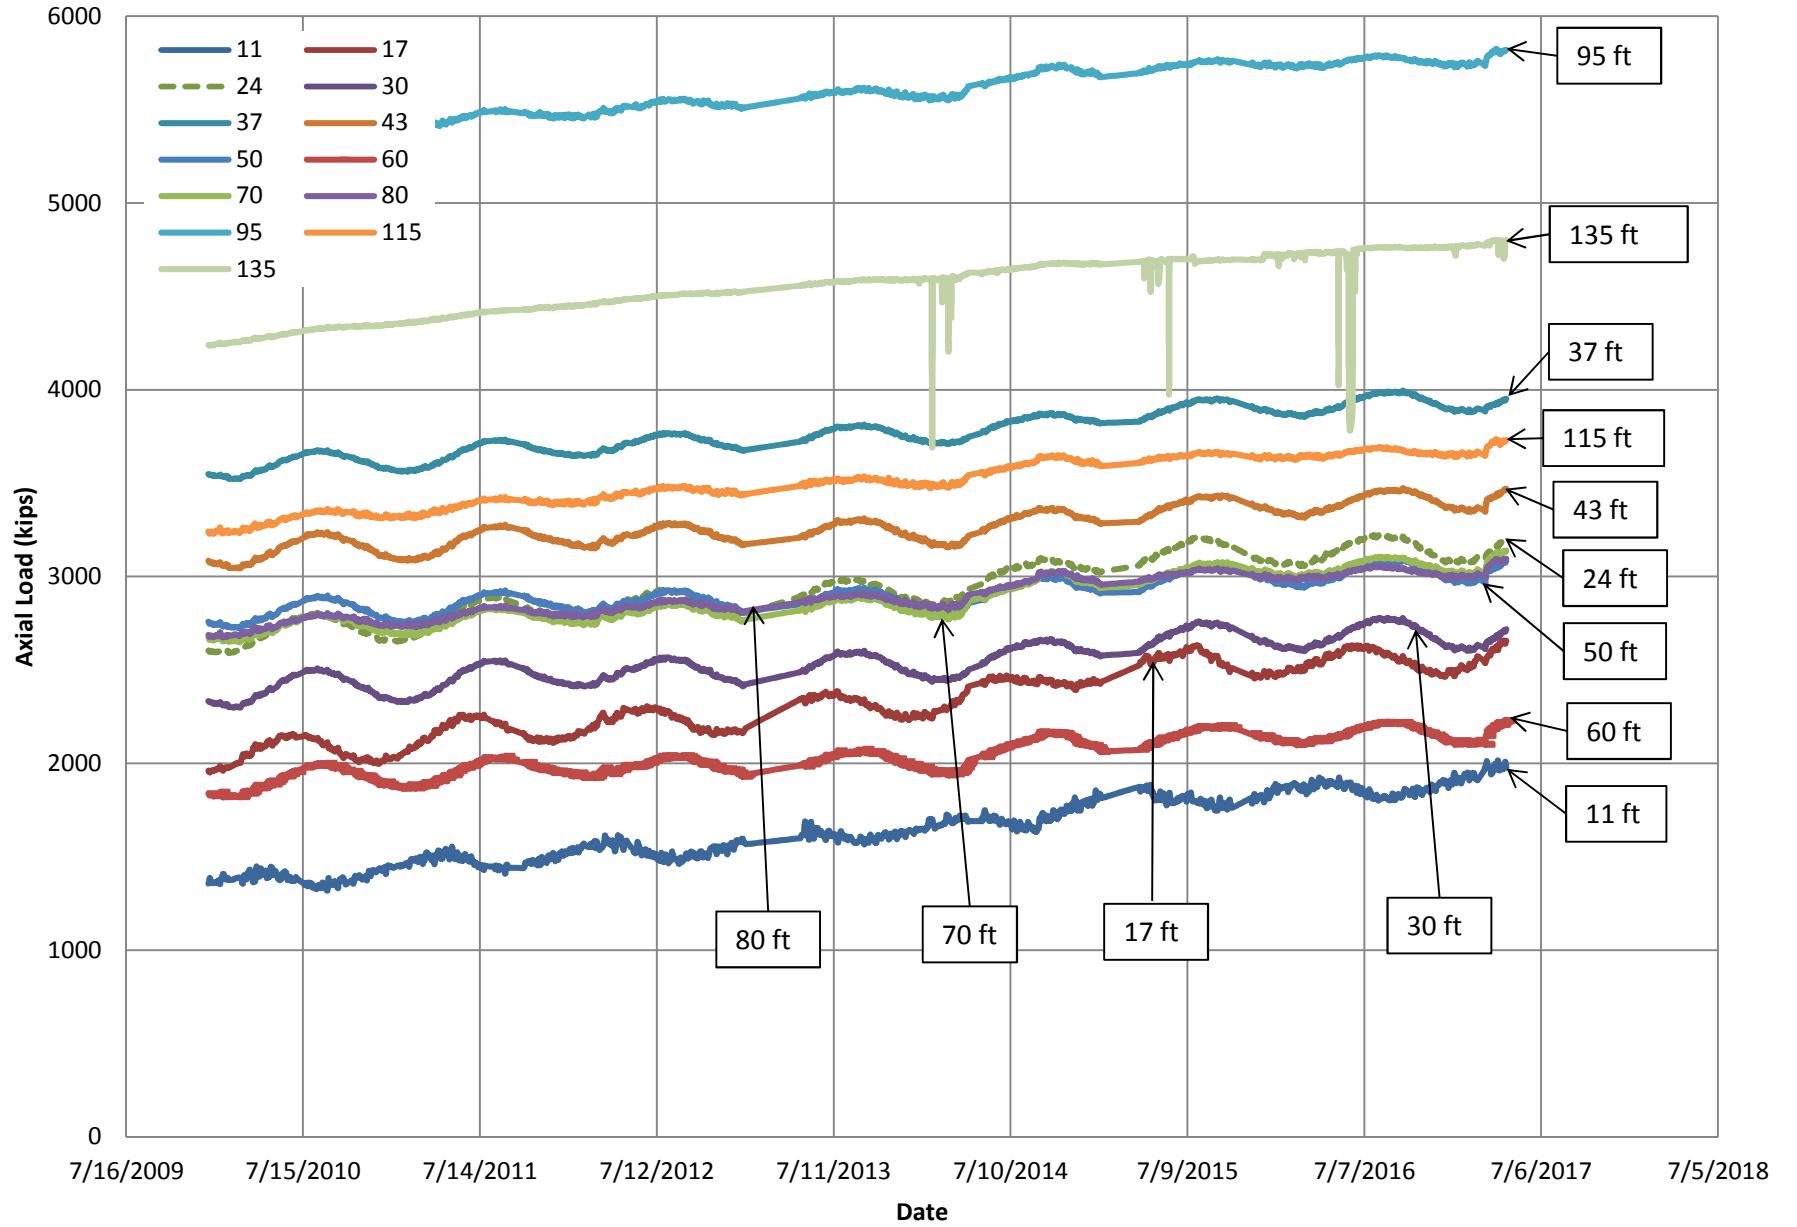
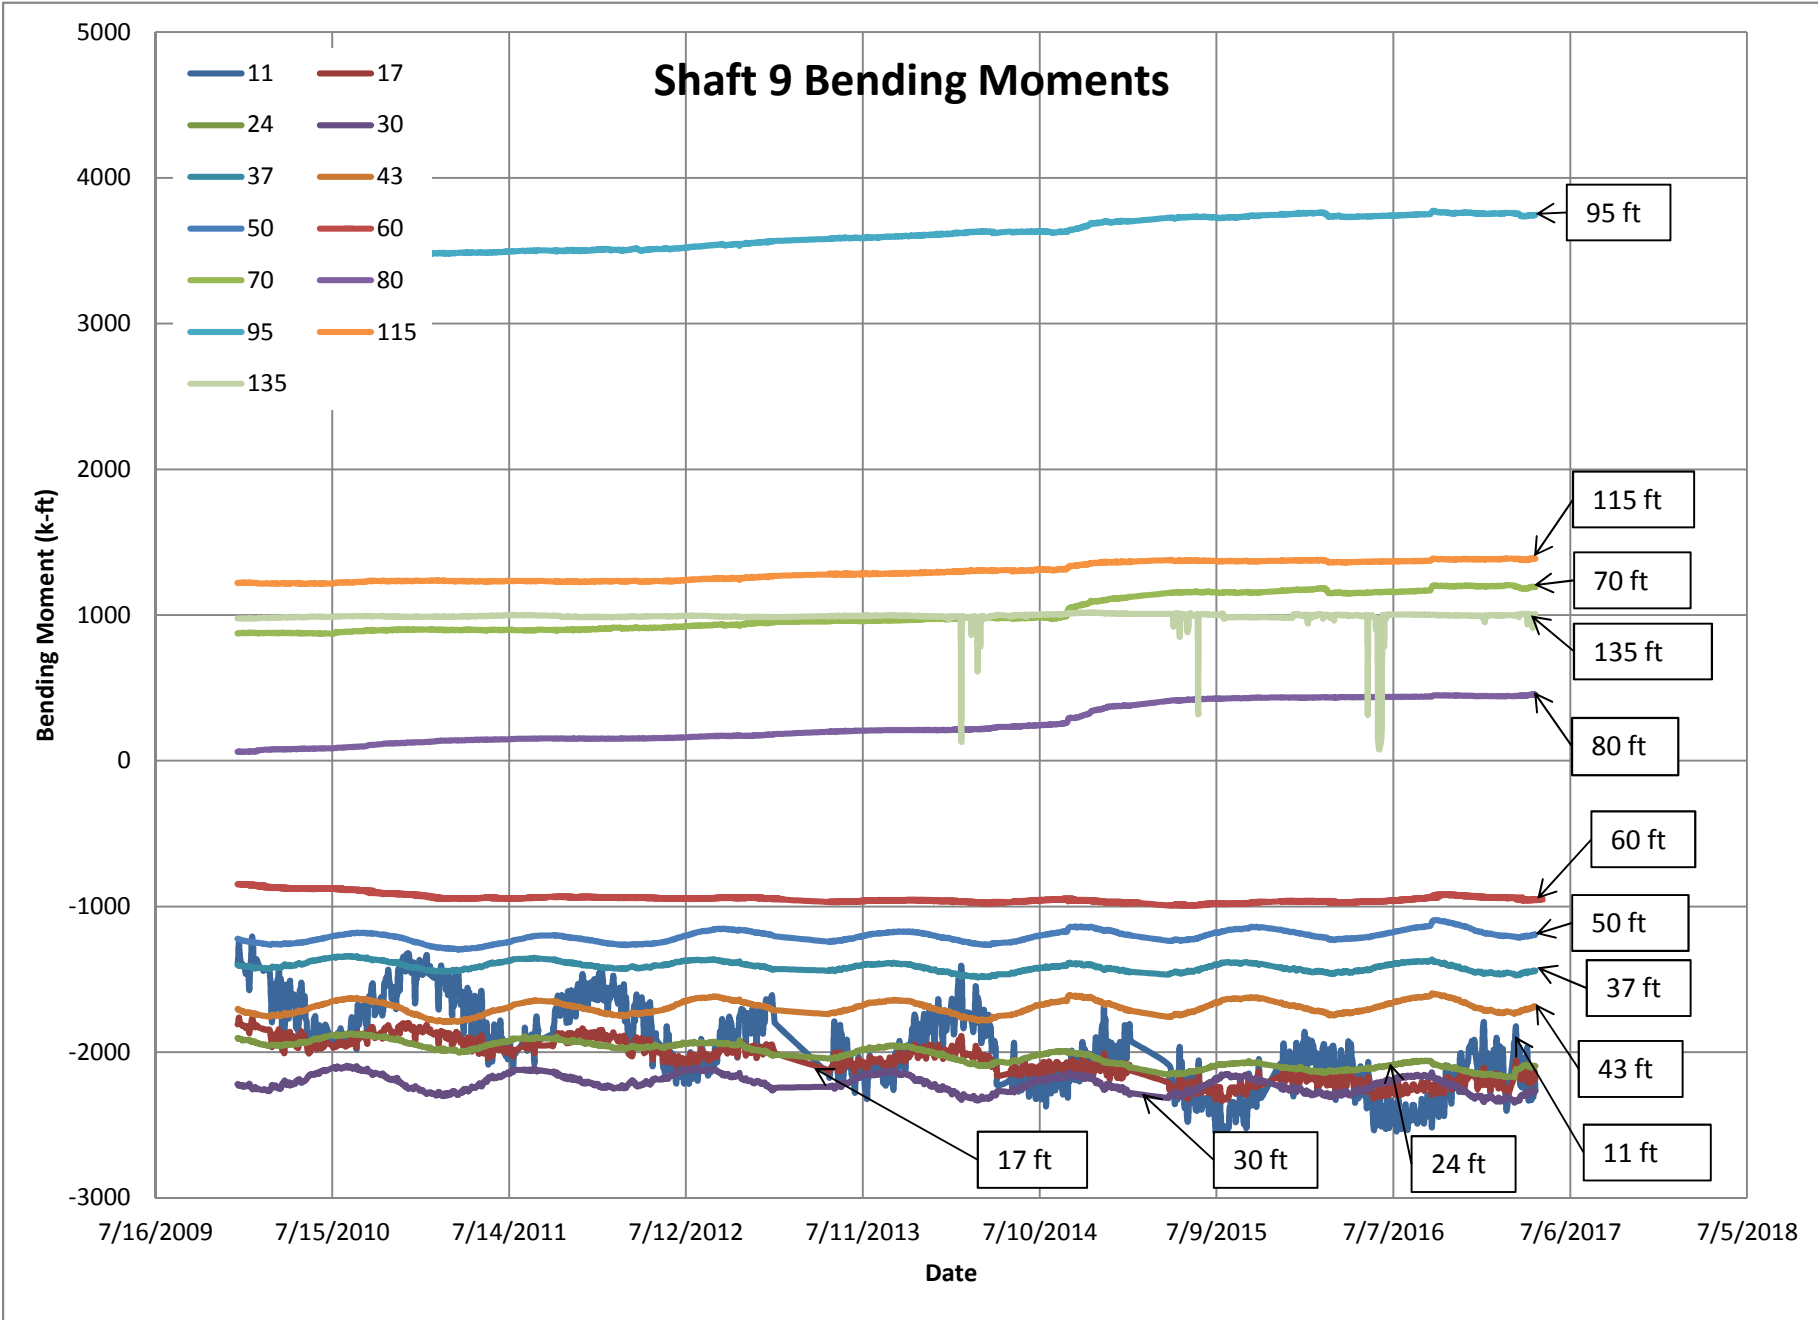
Plots of axial load and bending moment vs. time show the usual seasonal changes in both Piers. The axial load vs. time plots continue to show a gradual increase over time in both shafts at all depths except for depths at 84 feet and deeper in Shaft 1 where the axial load has remained relatively constant except for seasonal changes. The gage at 84 feet continues to intermittently record erroneous data, which has been deleted to “clean up” the plot.

Bending moments in Pier 1 show the largest seasonal changes at the top end of the pier. Moments are increasing below 35.5 feet. A similar trend occurs in Pier 9 where the seasonal changes in bending moments show the greatest variation at 50 feet and above.
