July 11, 2017

Re: May 23, 24, and 25, 2017 Monthly Readings
CUY-90-15.24 Slope Monitoring
PID 96504
SME Project No. 069032.00

INSTRUMENTATION PLAN
CUYAHOGA RIVER WEST BANK

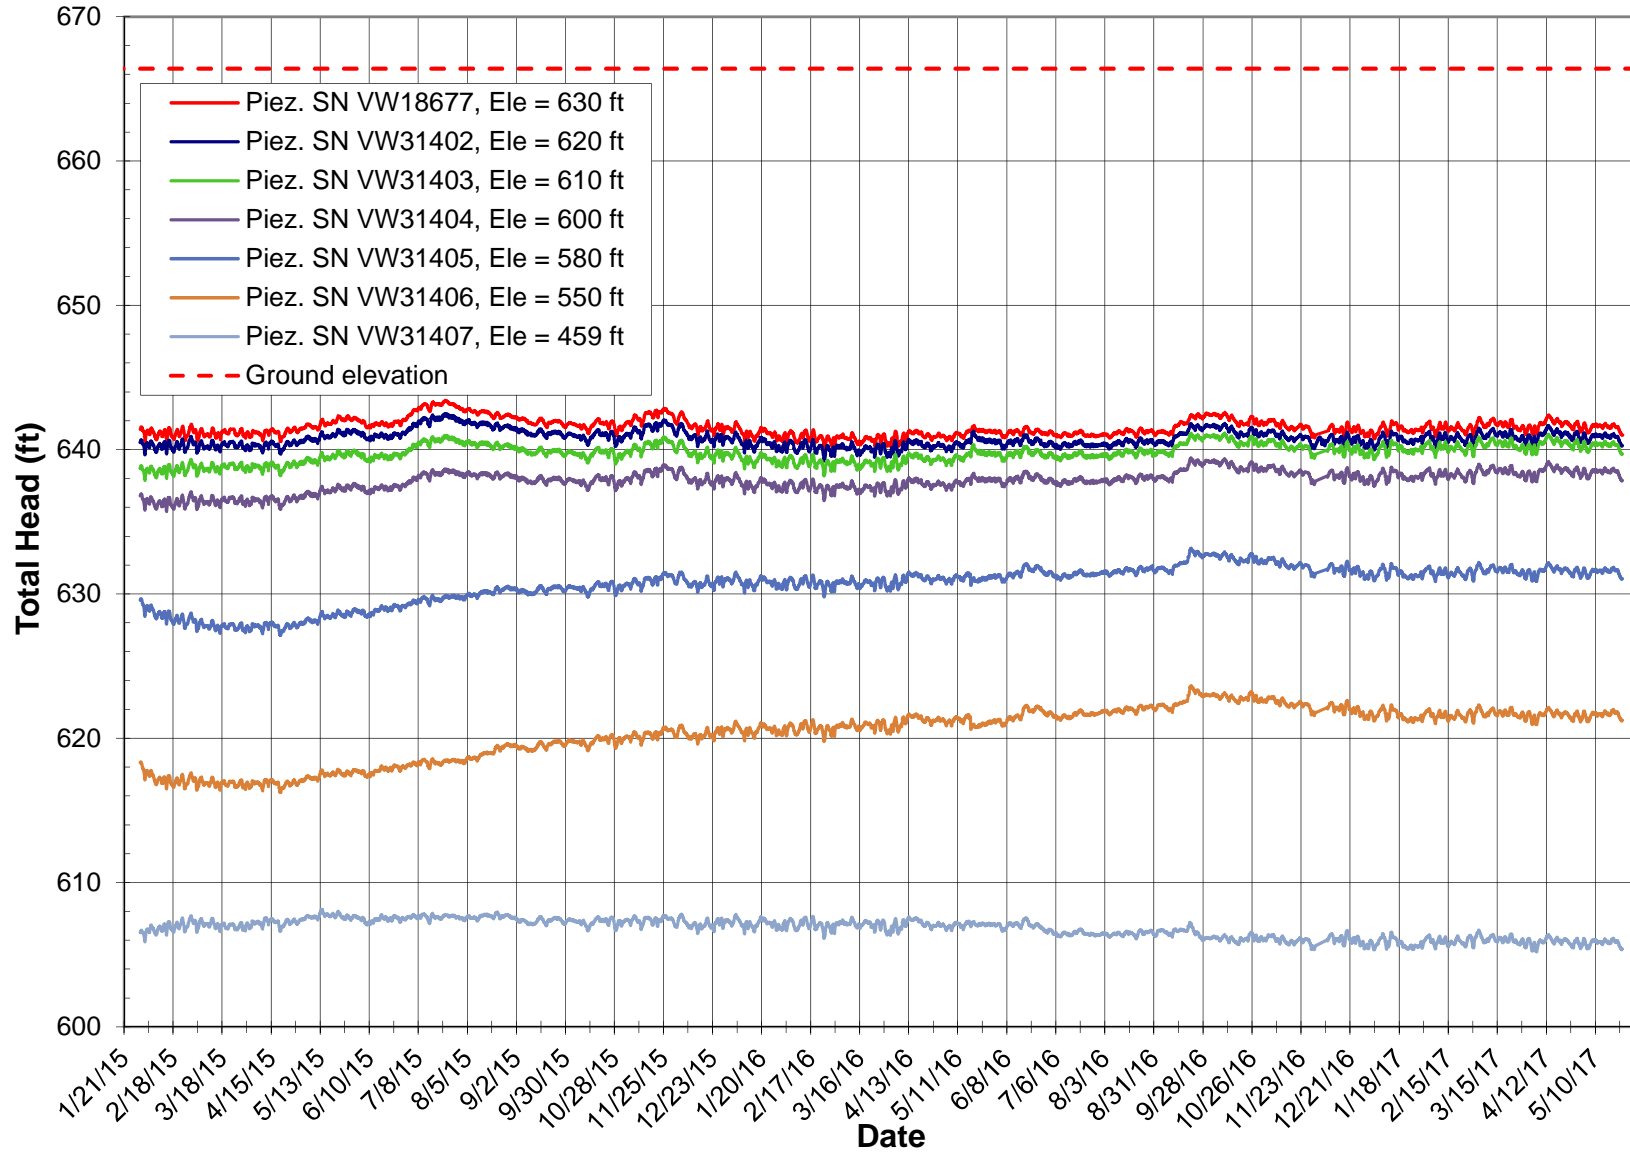
P-001-13 VW Piezometer Readings

P-001-13, P-003-10 – Pore pressure readings in all piezometers at these locations indicate a decrease of about 0.5 feet during the last week of May 2017.

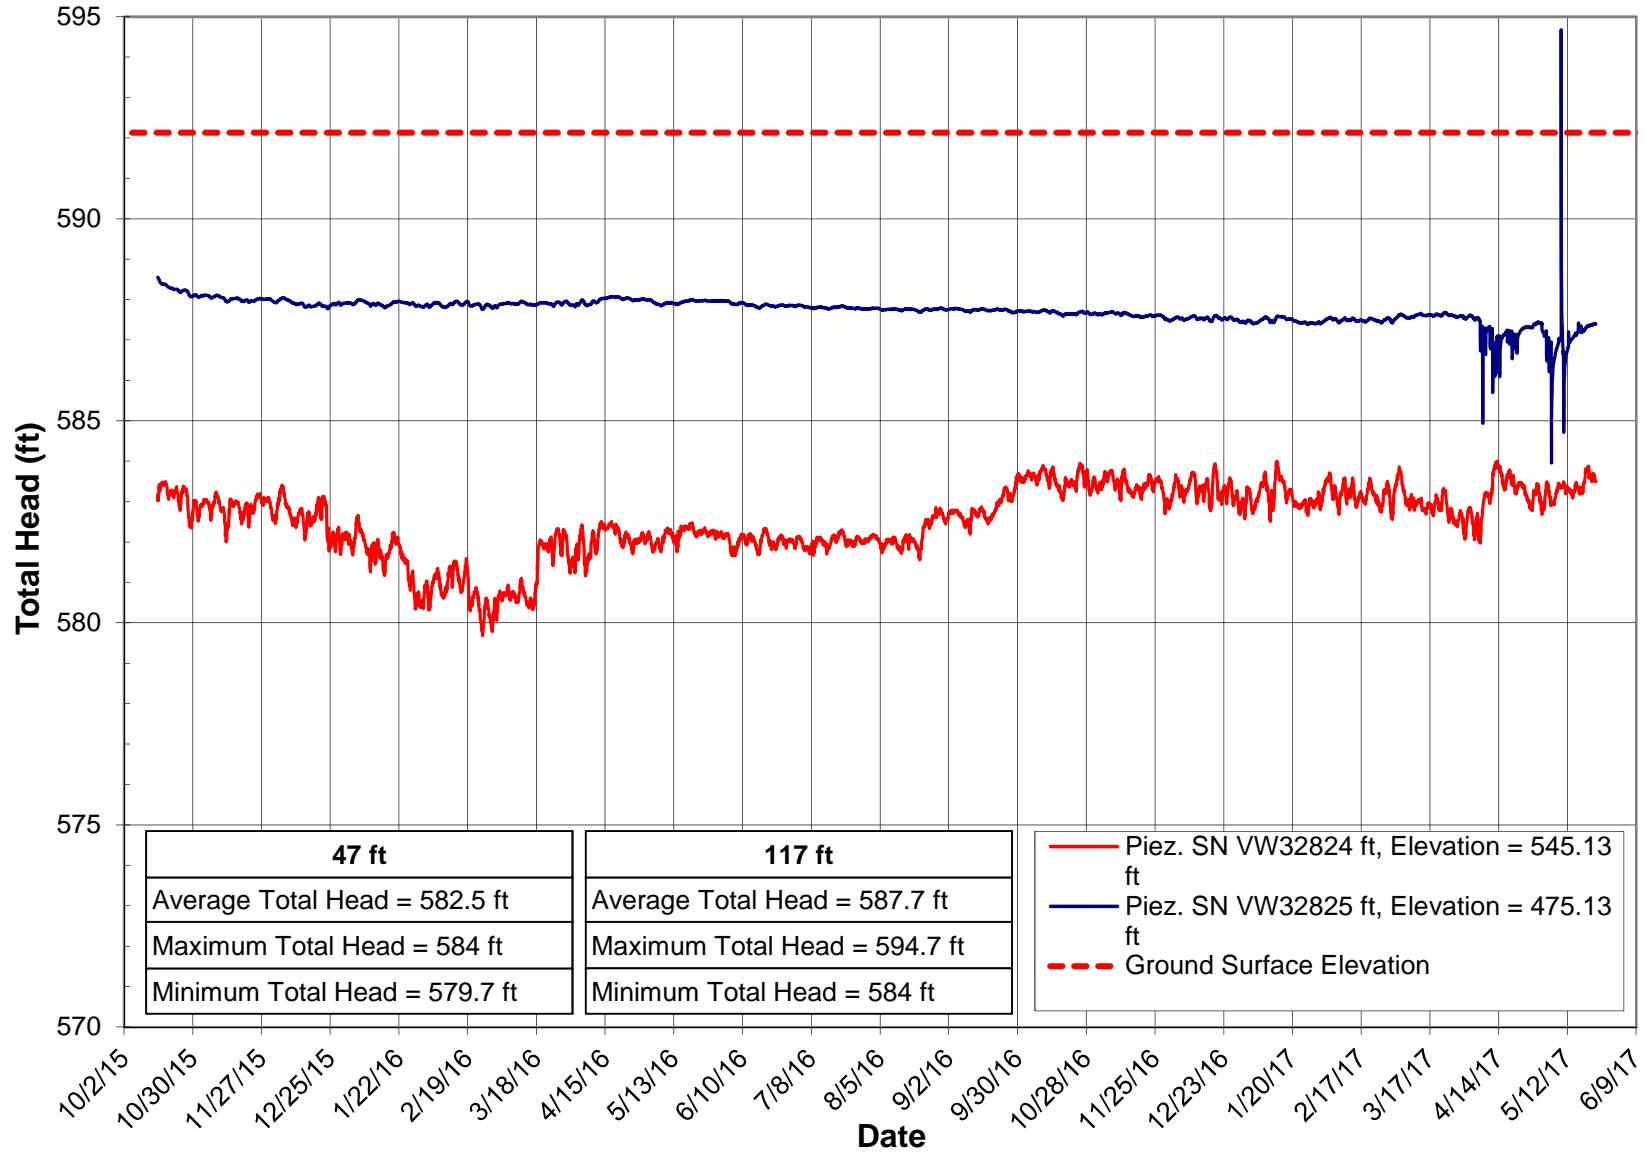
P-004-13 VW Piezometer Readings

P-004-13 – Pore pressure readings in the shallow piezometer at this location show a net increase of about 0.5 feet for the month. During the last monthly period, total head in the deep piezometer saw a sudden drop of about 2.5 feet in early April followed by a gradual recovery. That recovery continued into this month until May 5, 2017, when there was another sudden drop, this time of about 3.5 feet, followed by a gradual recovery. Large spikes with a differential of about 10 feet of total head occurred on or about May 9. Despite these fluctuations, there was virtually no net change in total head in deep piezometer for the month.

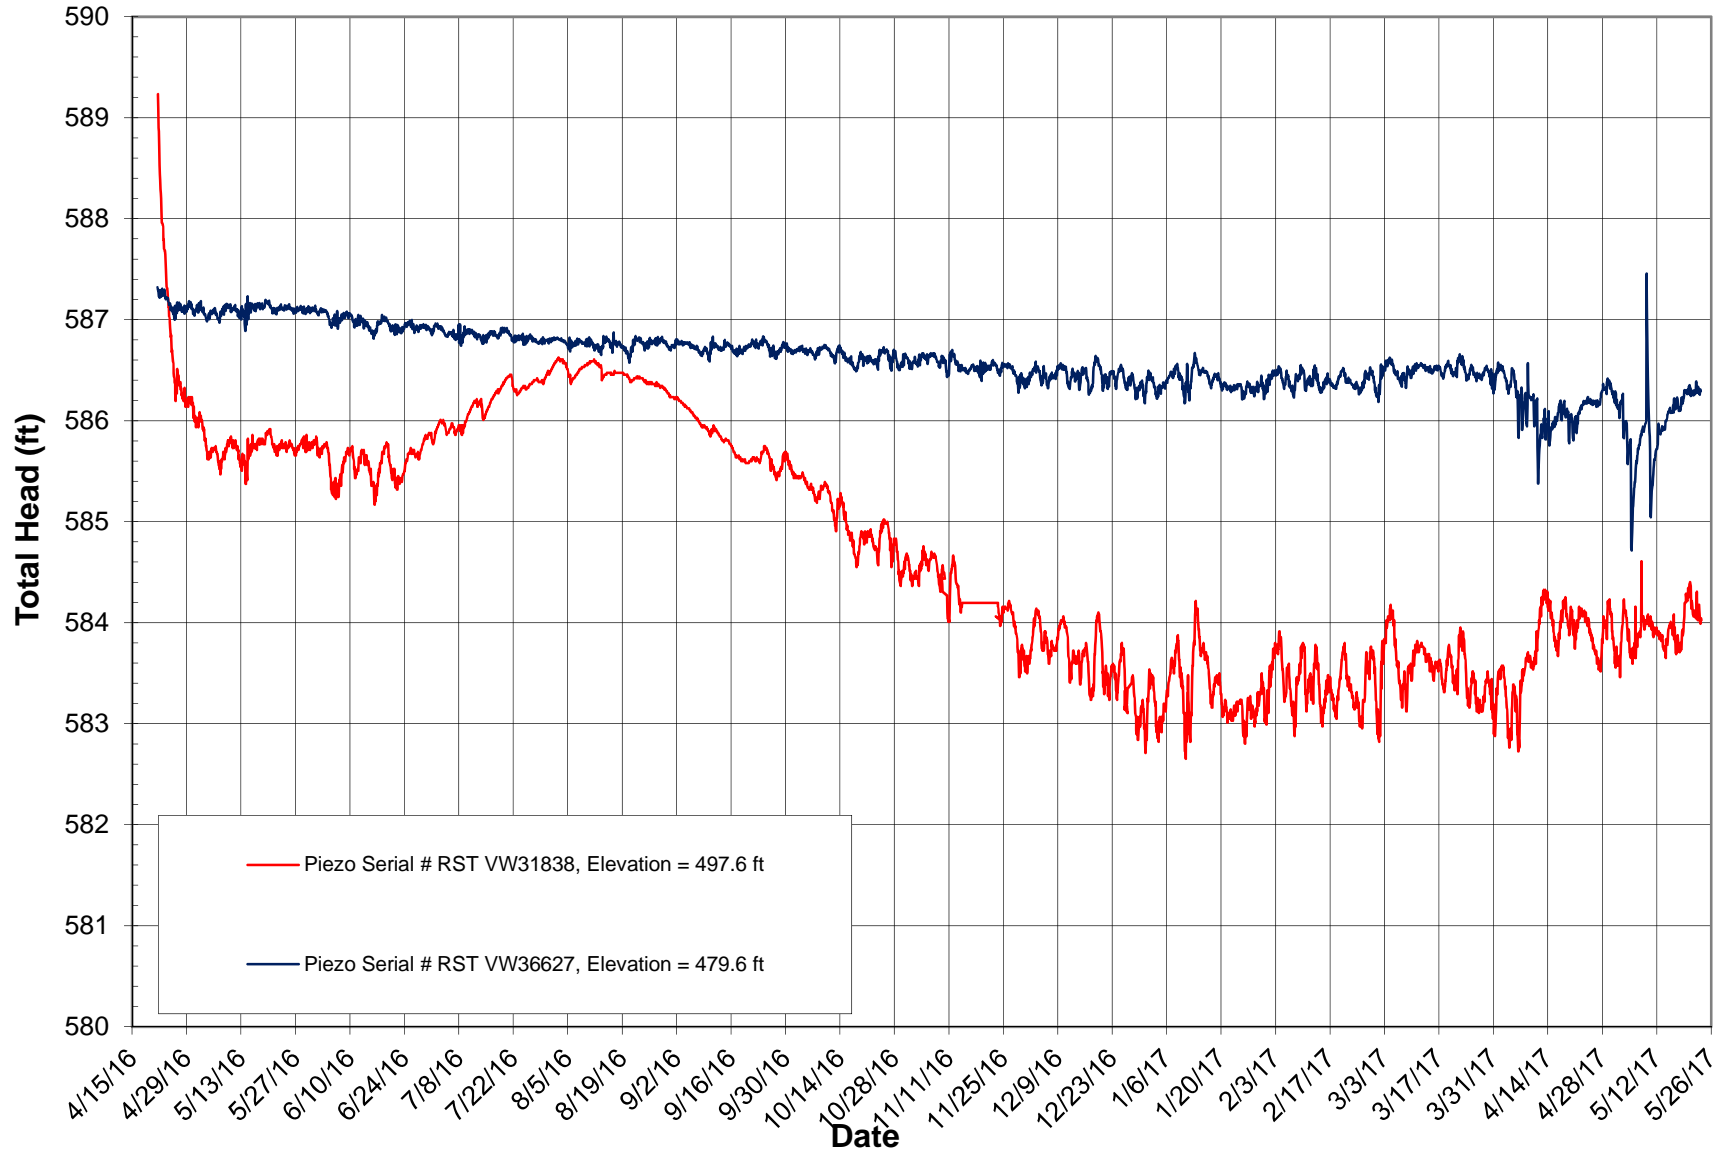
B-105A VW Piezometer Readings

B-105A – Pore pressures in the deep piezometer at this location follow a path similar to P-004-13 although the range of pressure variation is smaller than P-004-13. Pore pressures suddenly decreased on May 5, 2017, followed by a gradual recovery. Large spikes with a differential of about 2.5 feet occurred on May 9. There was virtually no net change in total head in the deep piezometer for the month. Data for the shallow piezometer indicates a slight increase this month.

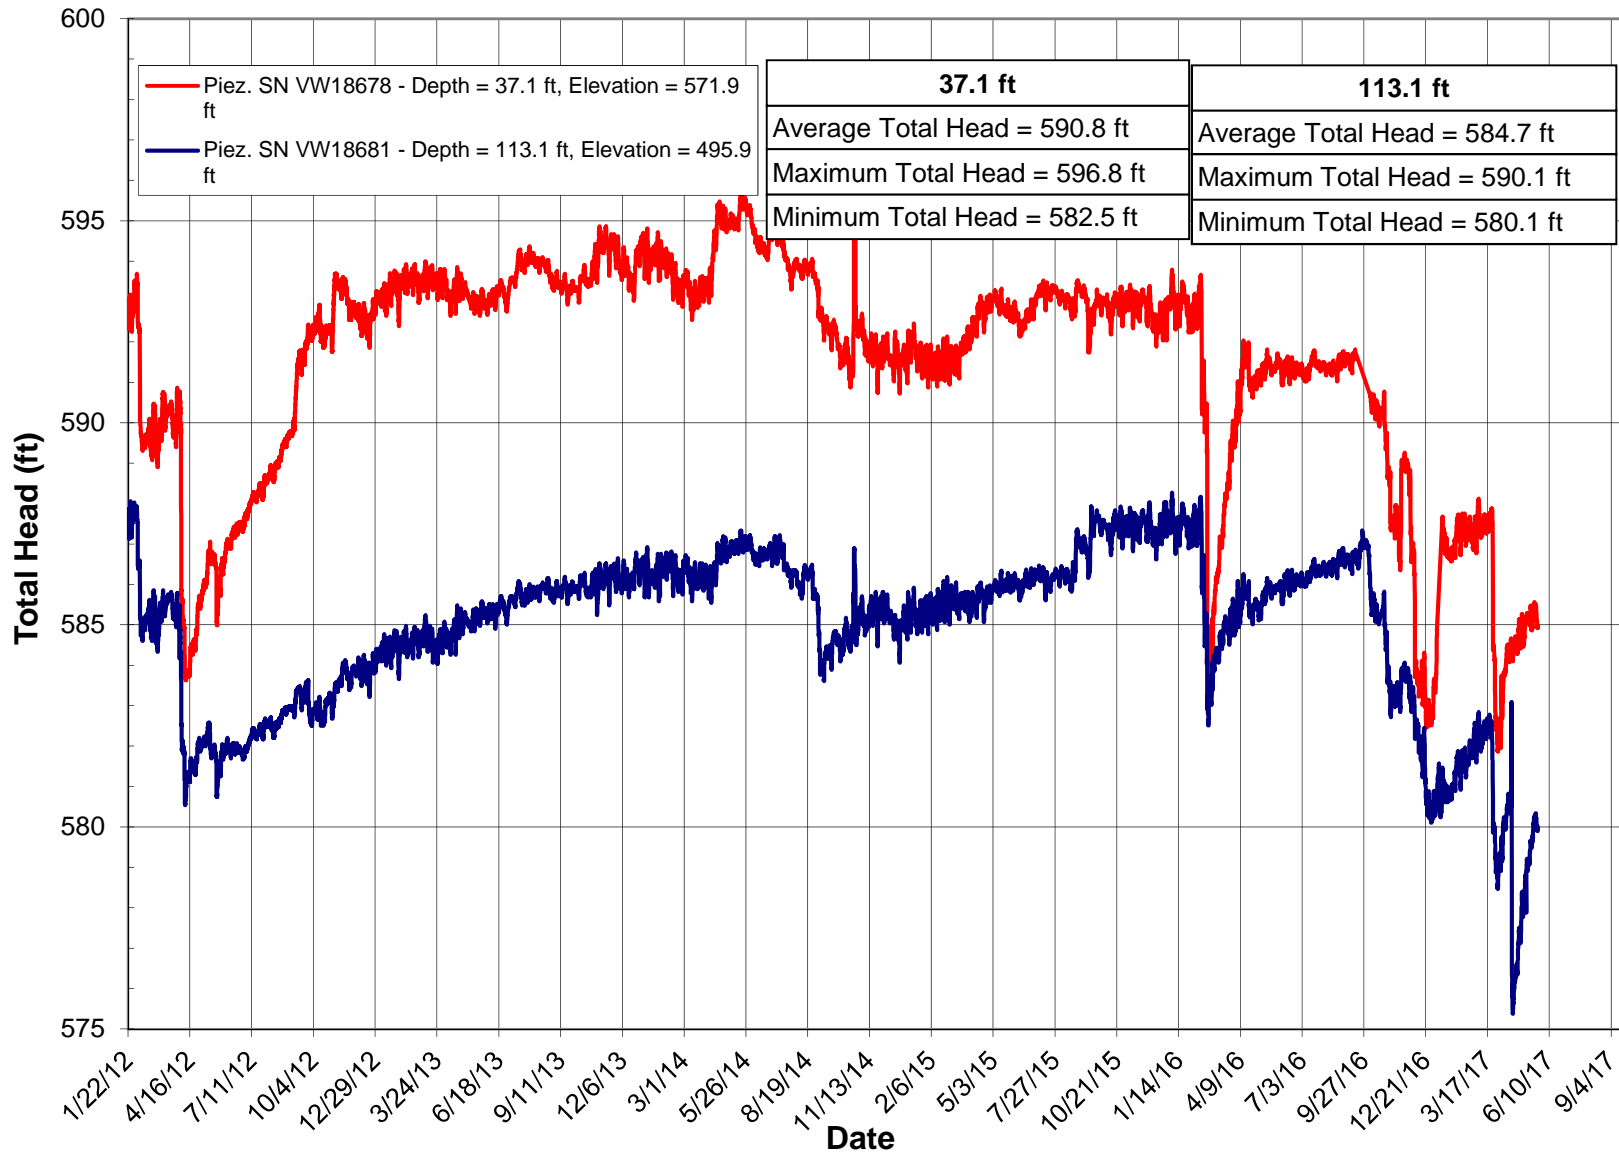
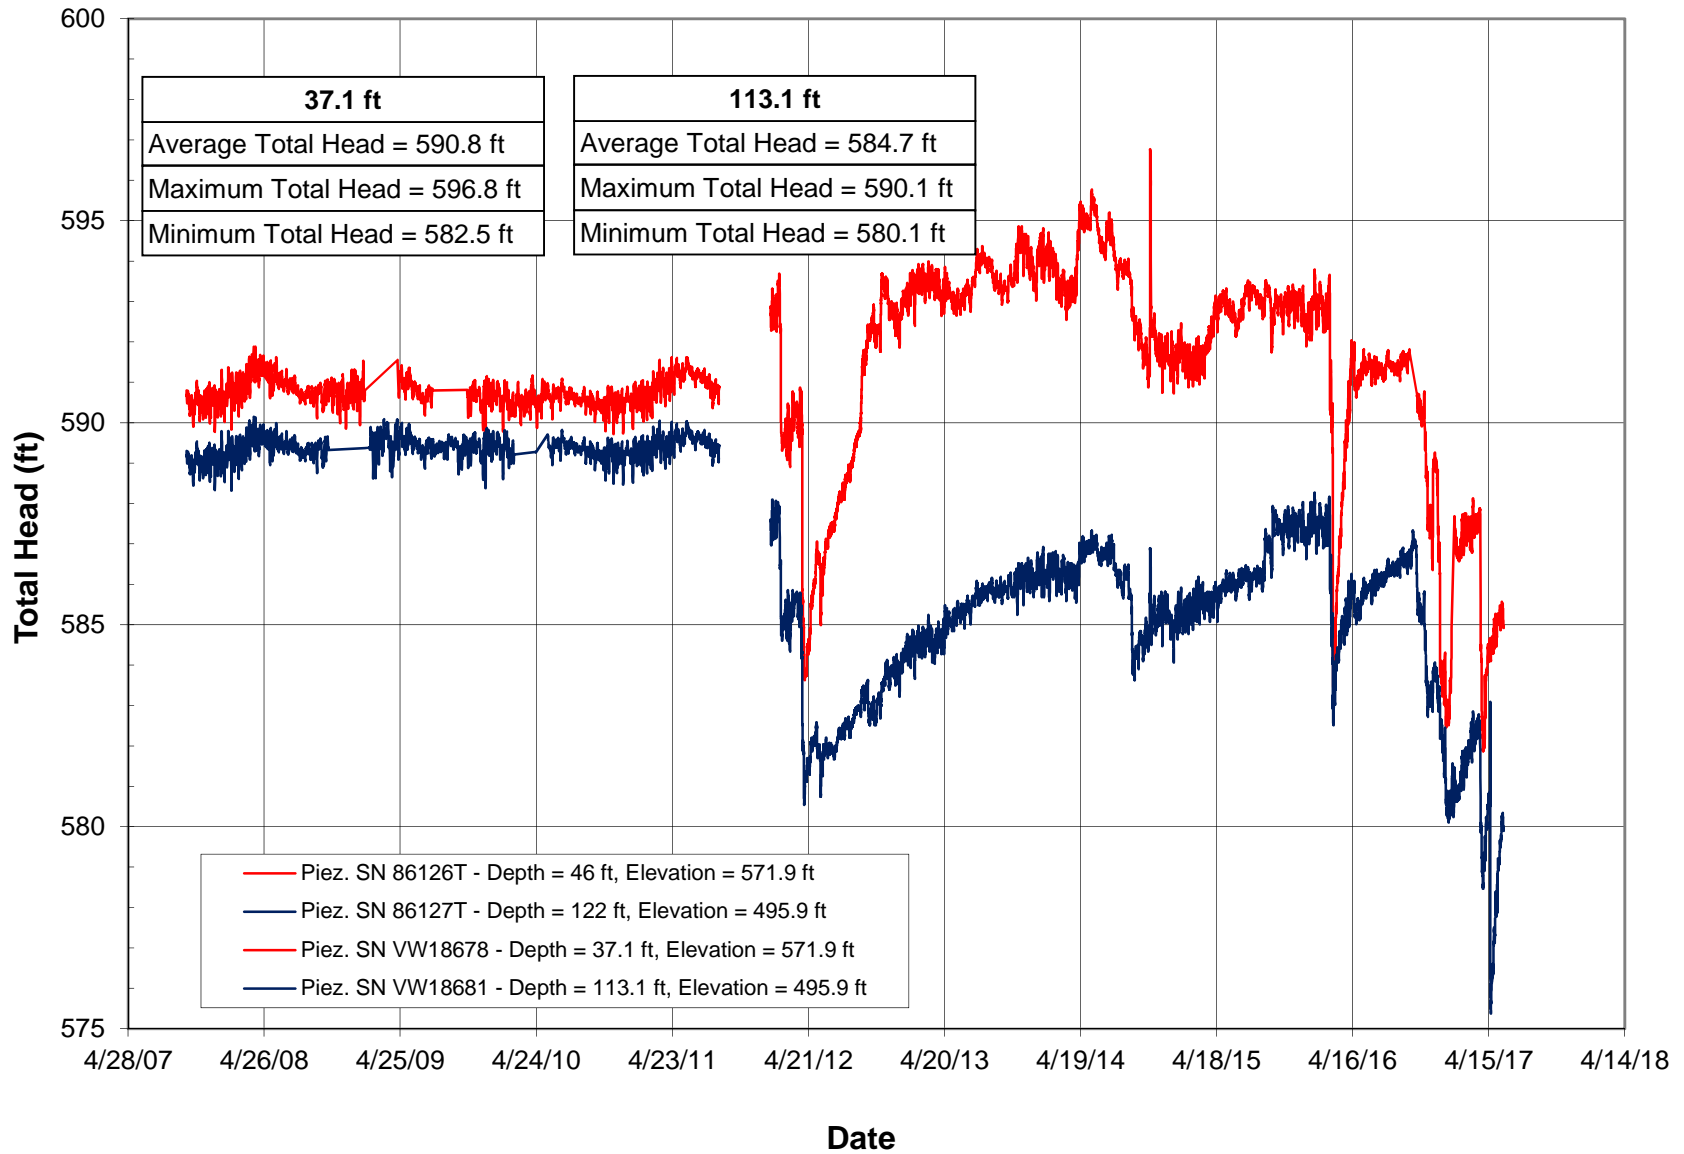
B-05-02 VW Piezometer Readings

B-05-02 – Both piezometers at this location indicate pore pressure increases. Total head in the shallow piezometer increased by 3.8 feet since March 23, 2017. Total head in the deep piezometer increased by 4.9 feet since April 20, 2017. These increases are likely due to site grading in this area.

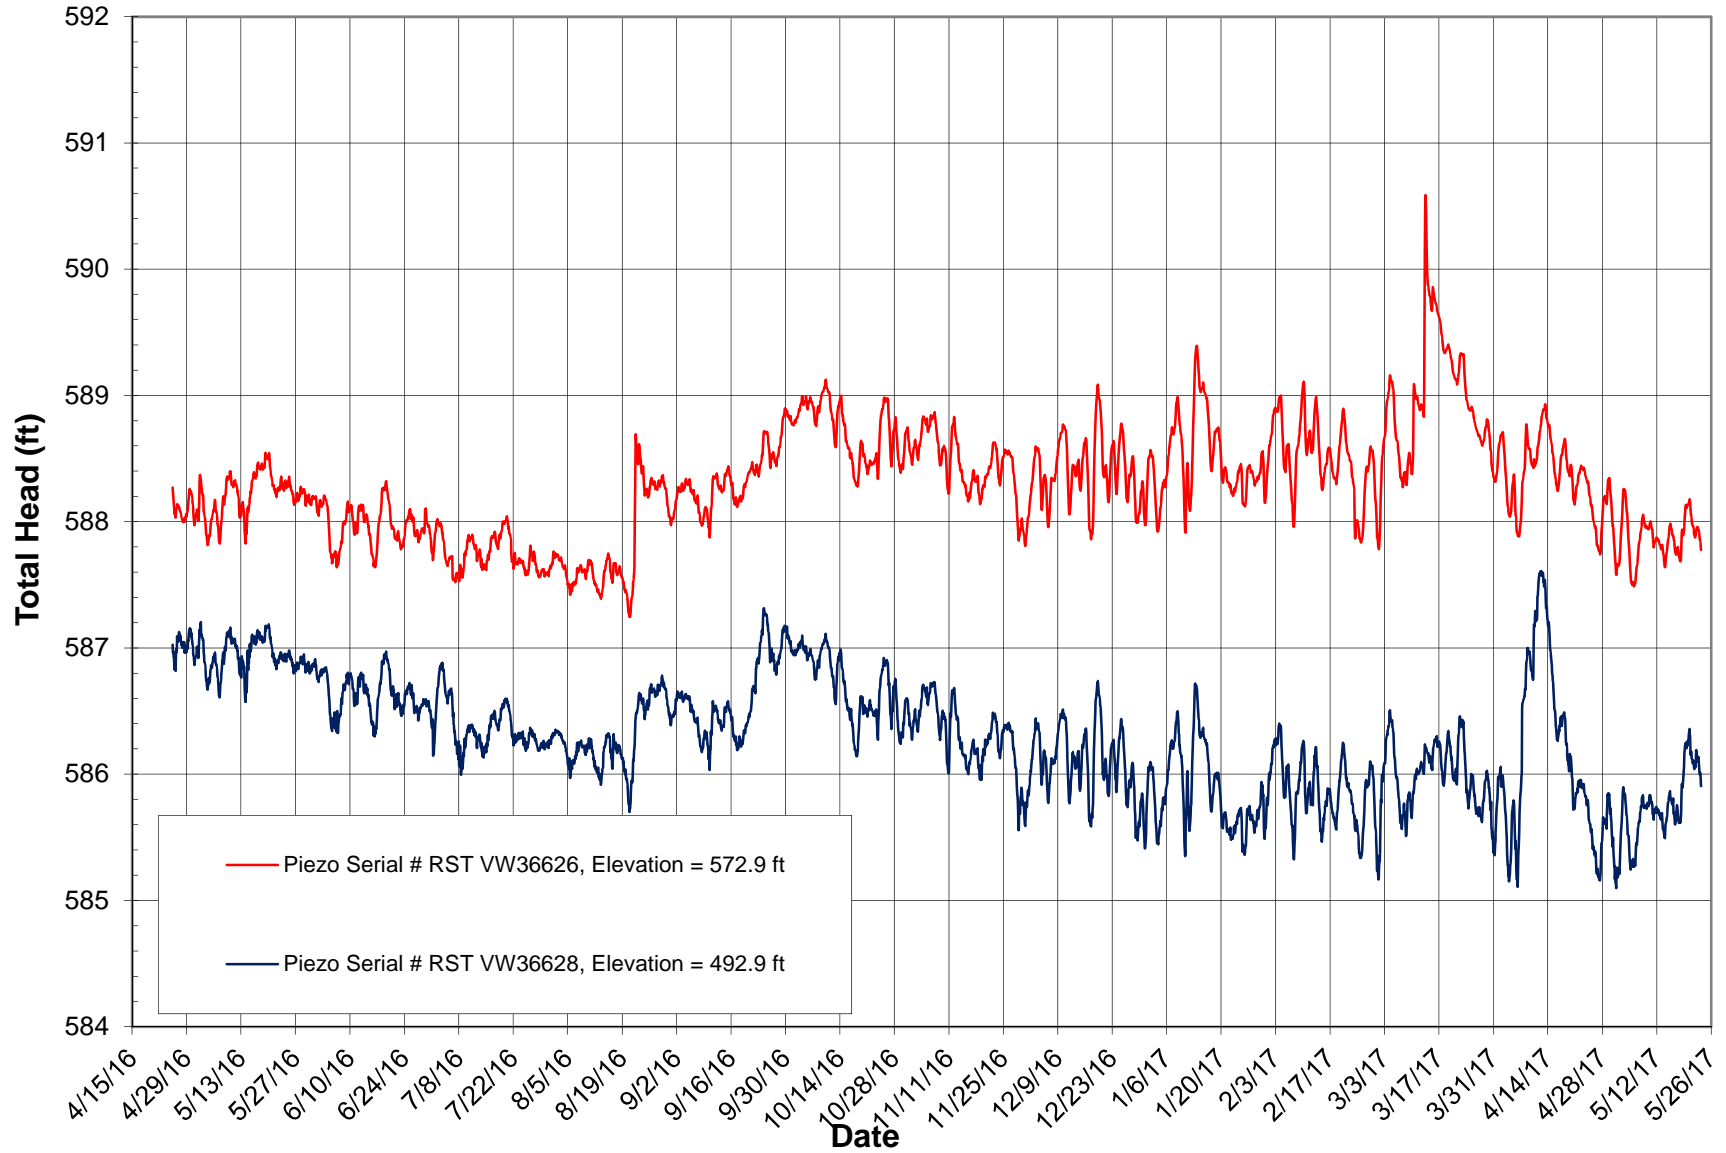
B-05-A-03 VW Piezometer Readings

B-05-A-03 – Pore pressures in both piezometers at this location were decreasing at the end of the April 2017. This decrease continued into May before reversing and starting to gradually increase. Data for the deep piezometer indicates a pore pressure increase of 0.8 feet for the month. Data for the shallow piezometer indicates pore pressure fluctuations, but no net change for the month. Pore pressures were again trending downward at the end of the month.

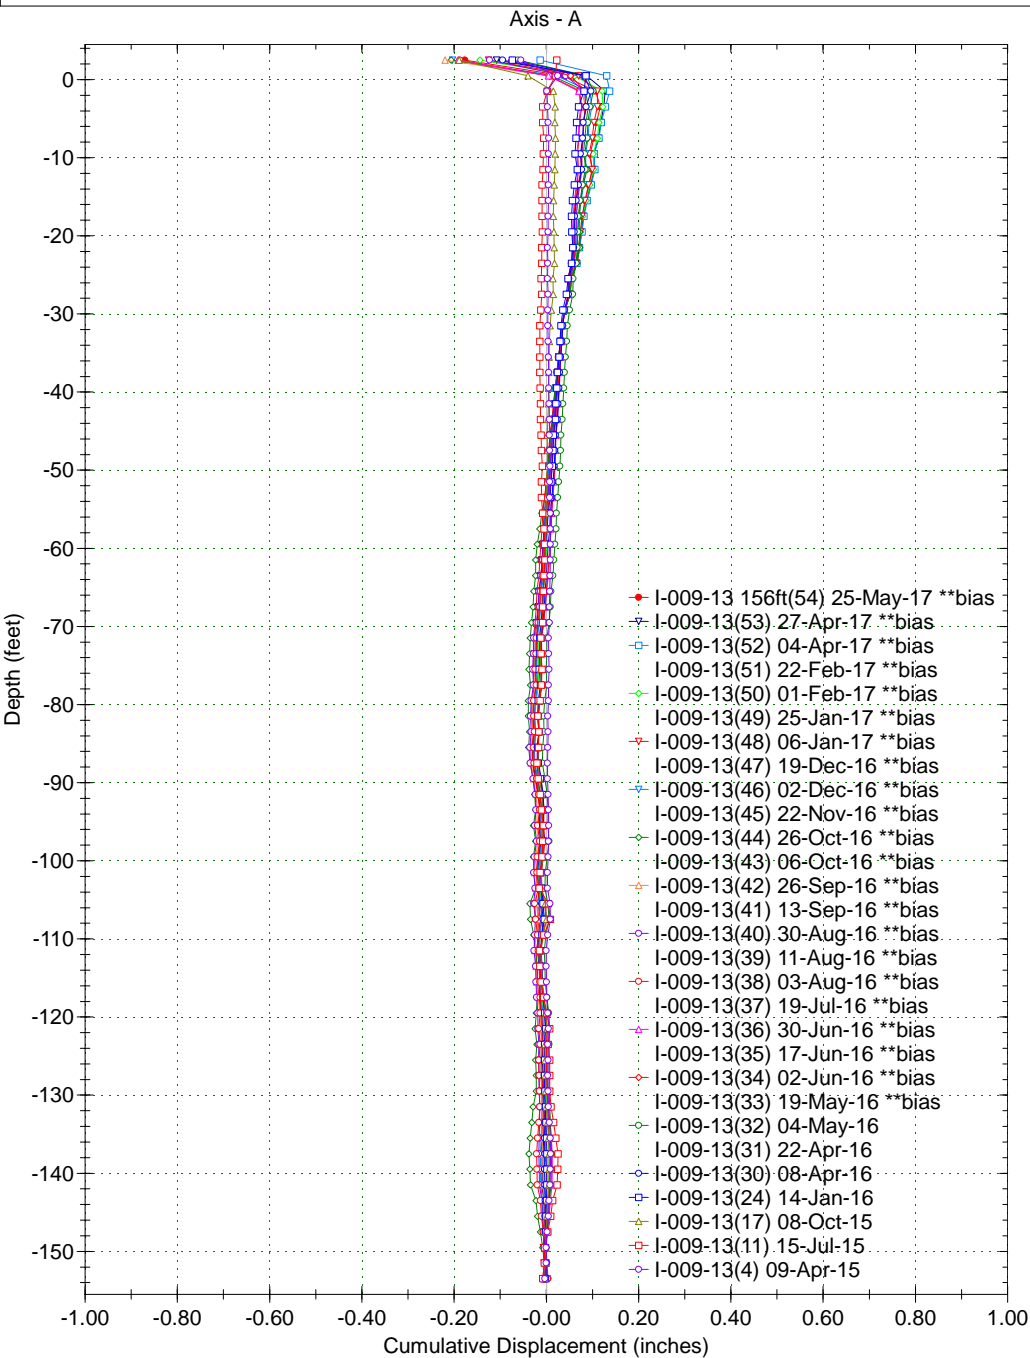
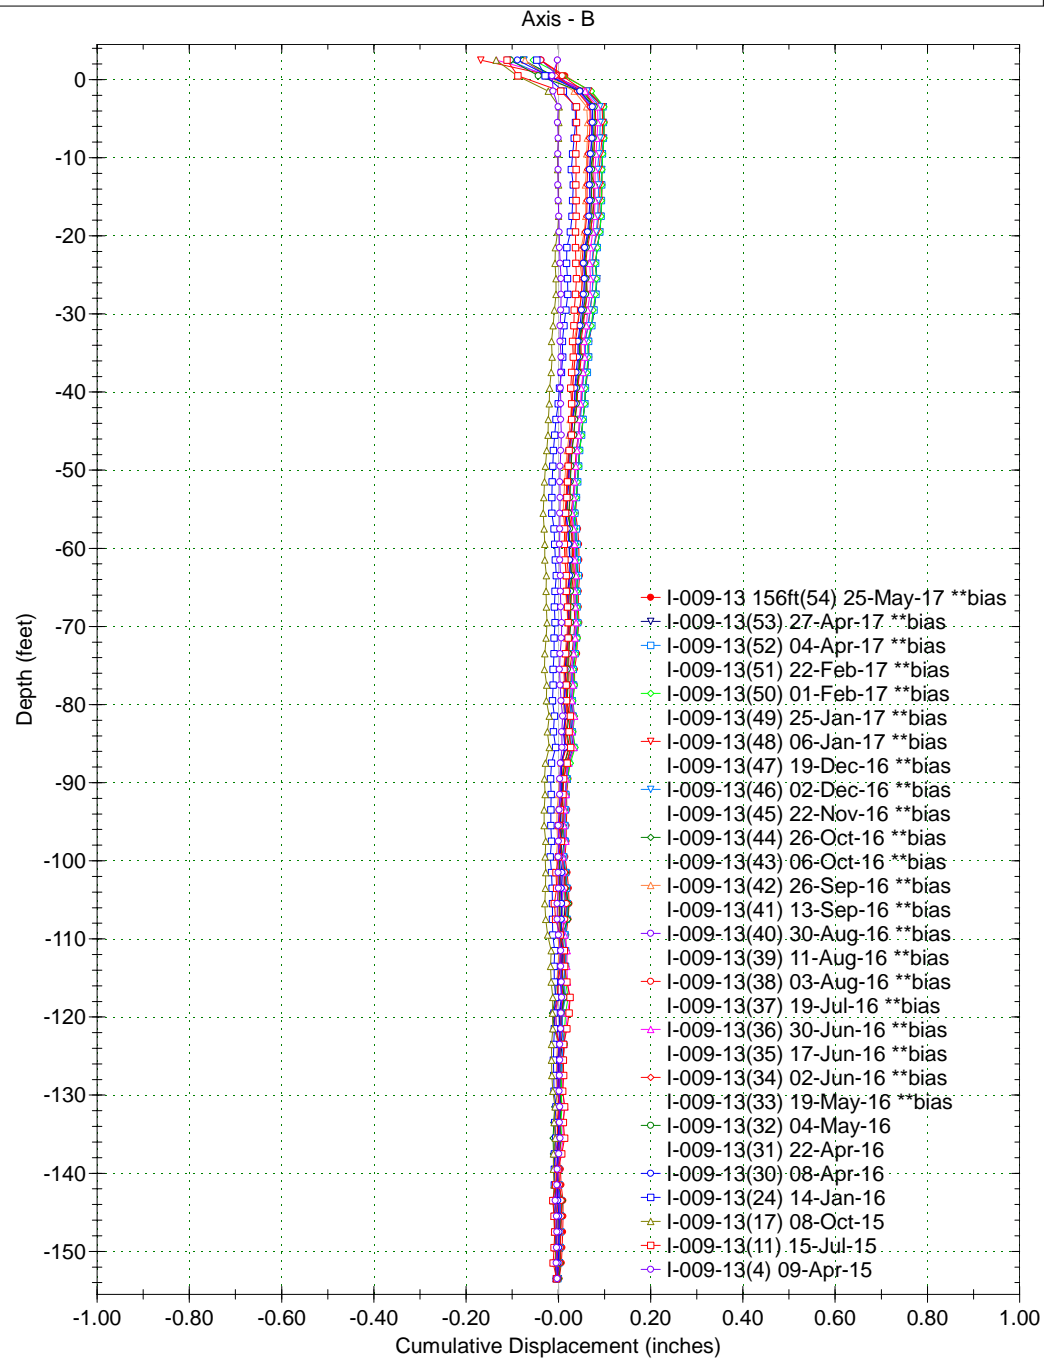
Borehole : I-009-13
Project : CUY-90-15-24
Location : Cleveland, Ohio
Northing :
Easting :
Collar :

I-009-13 – In order to set a final protective cover on this instrument, we cut down the inclinometer casing by 2 feet. The current plot shows an artificial reading at 2 feet for the May 25, 2017 reading. This was done so that past readings could be viewed alongside future readings.

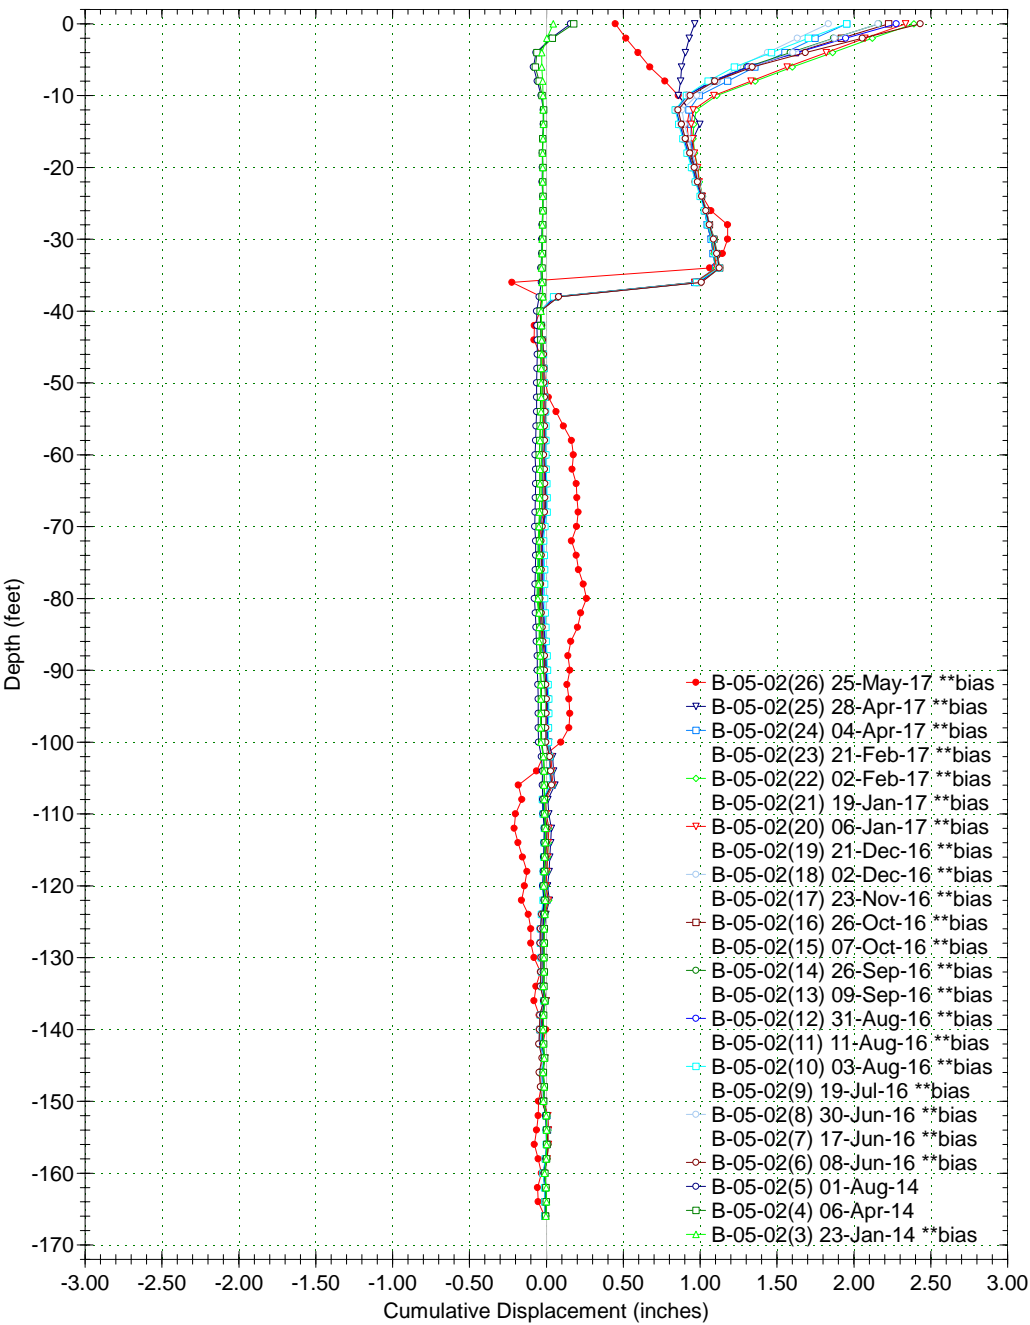
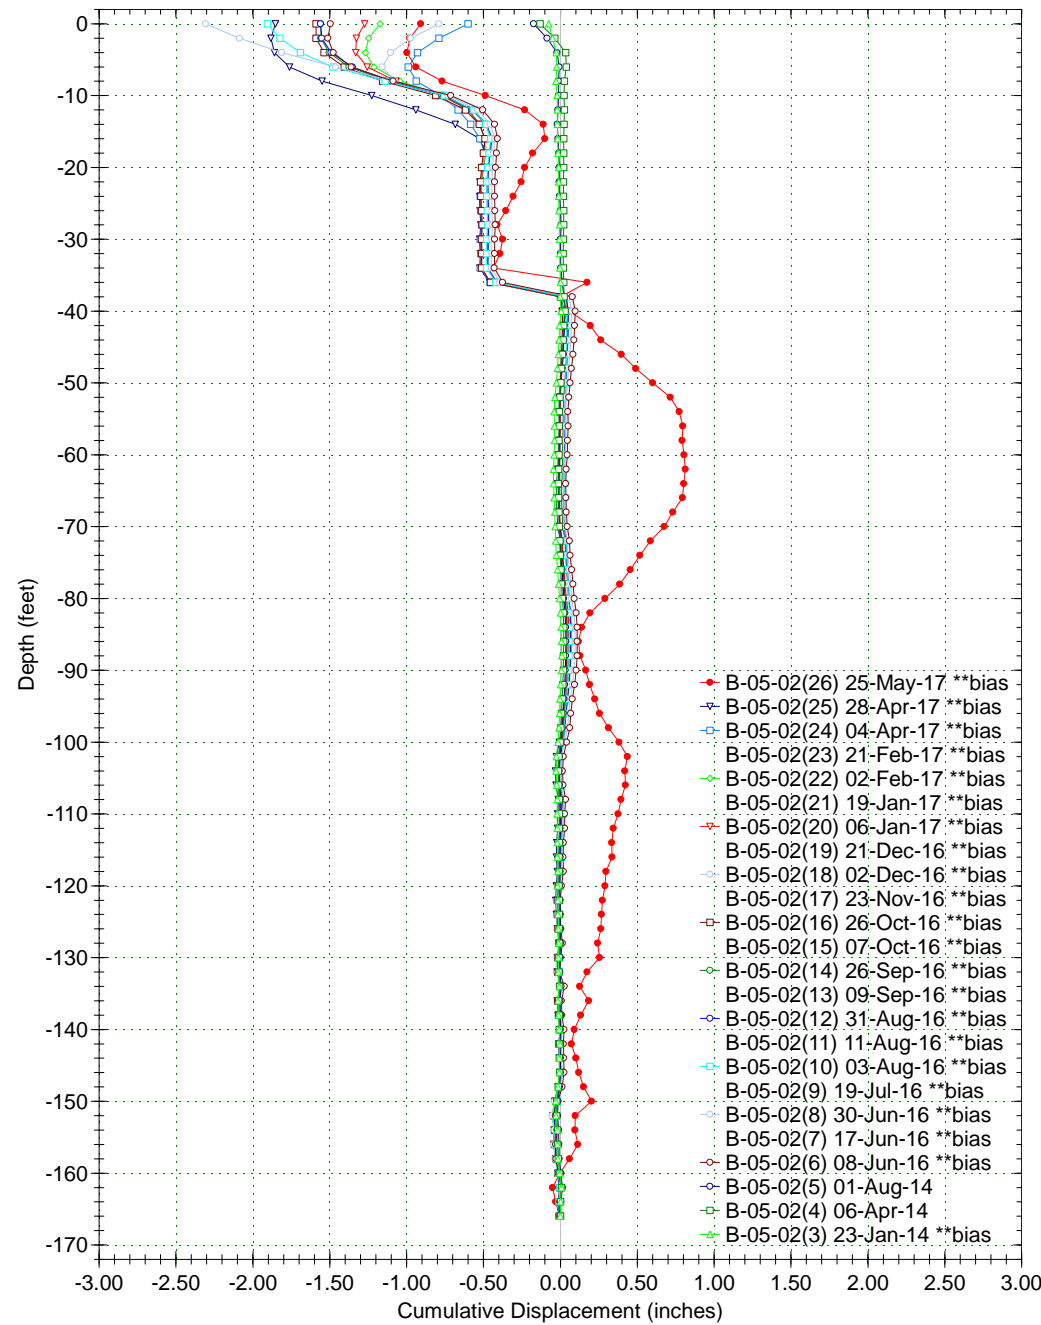
Borehole : B-05-02
 Project : CUY-90-15-24
 Location : Cleveland, Ohio
 Northing : 663737.939
 Easting : 2190289.081
 Collar :

B-05-02 – Inclinometer readings at this location show large, unrealistic displacements throughout the length of the casing in both axis directions. We believe this was caused by an erroneous data point that affects to cumulative plot. We will perform a follow-up reading to verify.
