July 11, 2017

Re: May 23, 24, and 25, 2017 Monthly Readings
CUY-90-15.24 Slope Monitoring
PID 96504
SME Project No. 069032.00

INSTRUMENTATION PLAN
CUYAHOGA RIVER WEST BANK

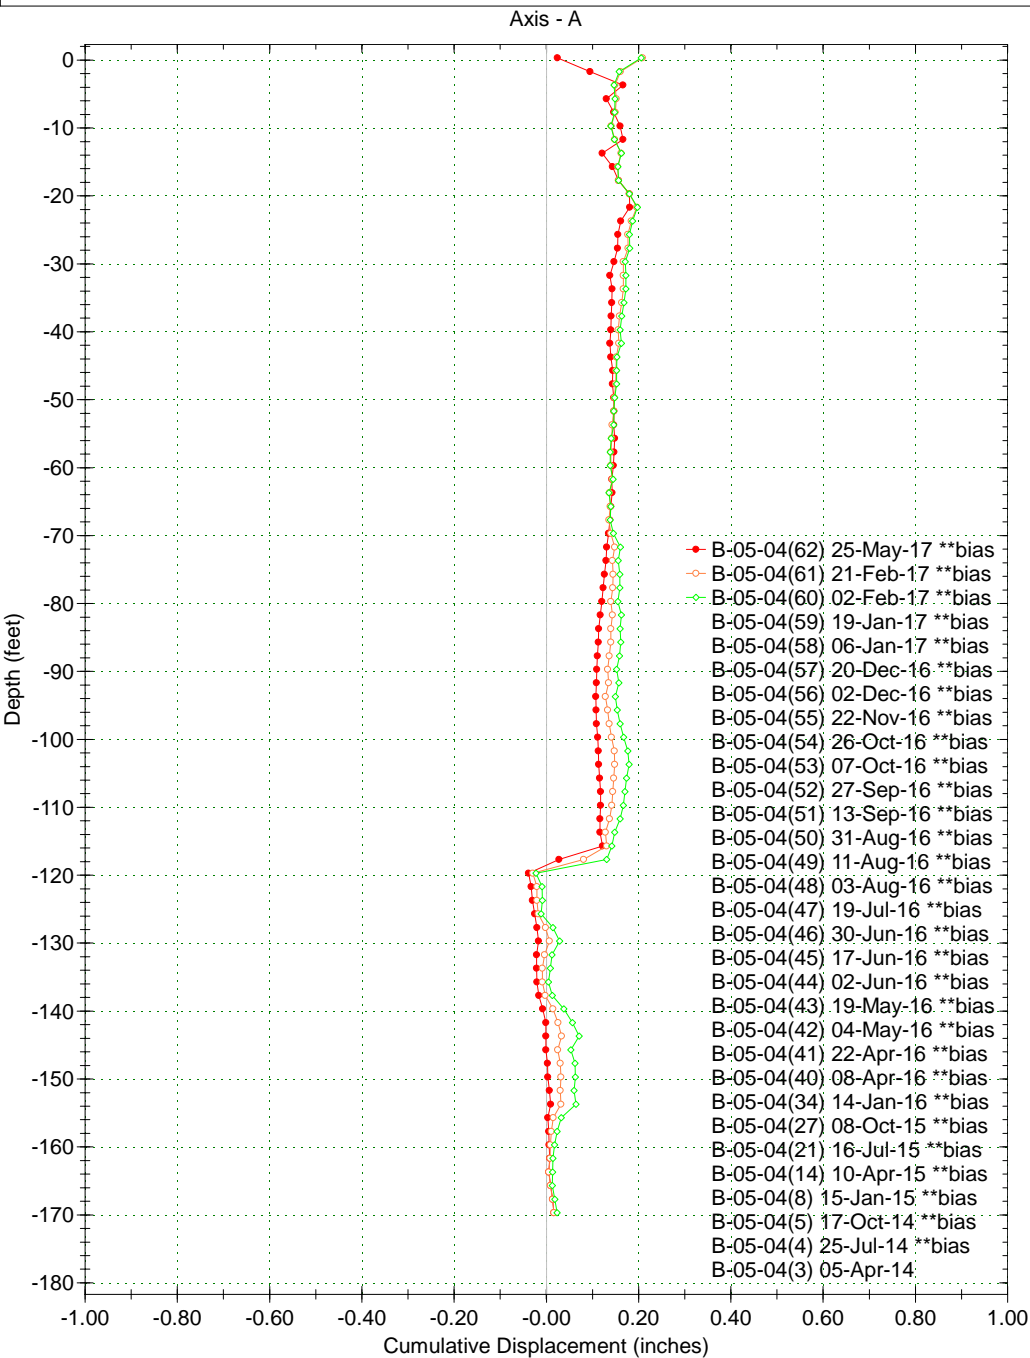
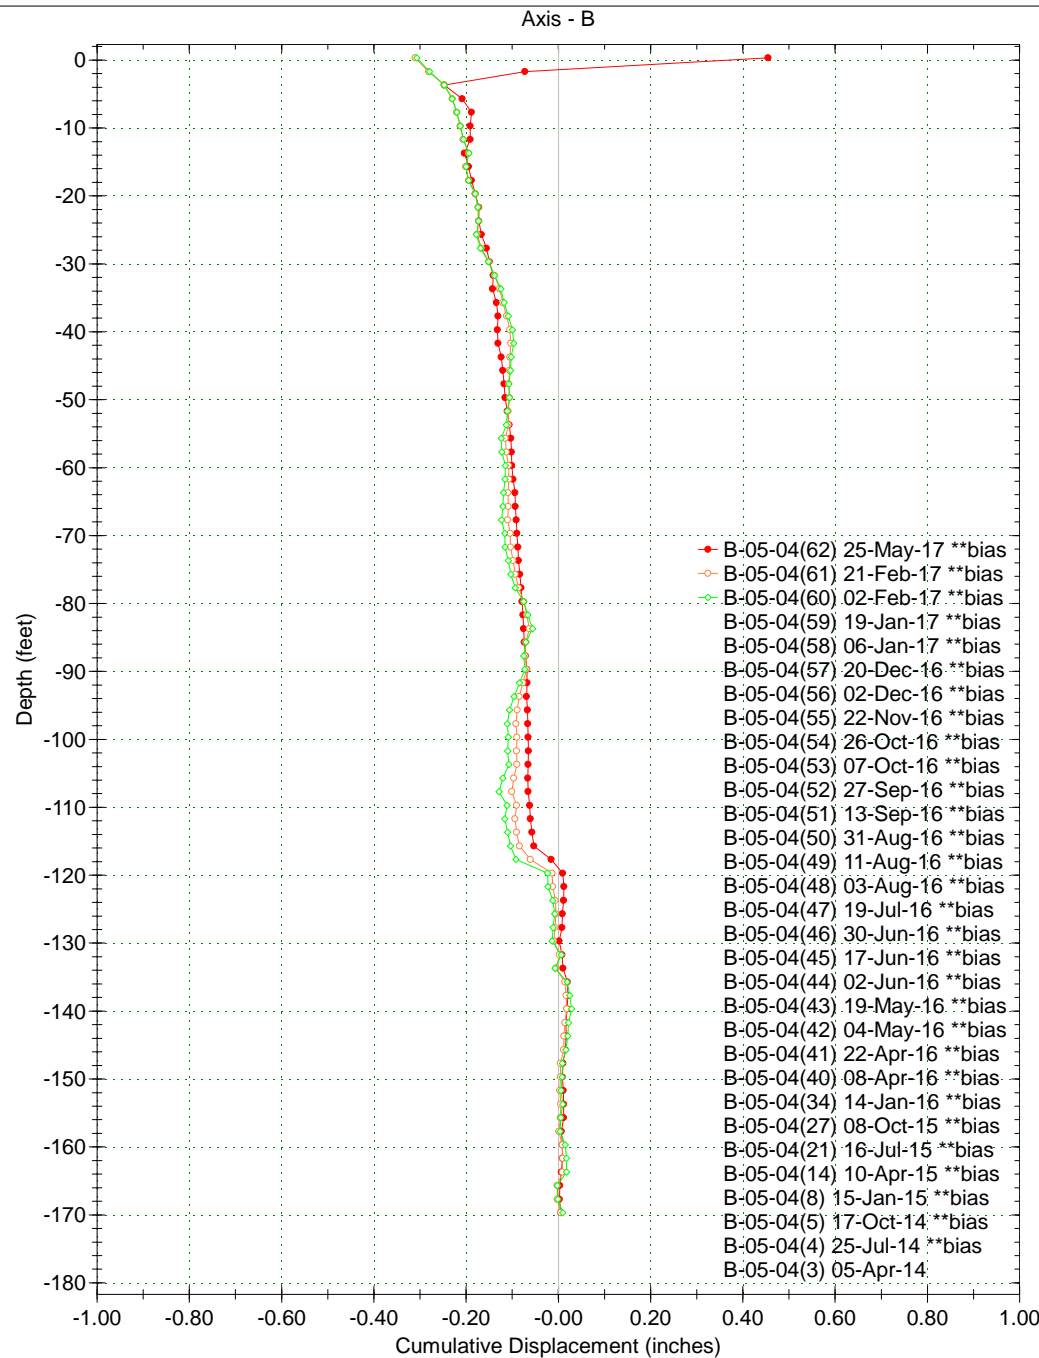
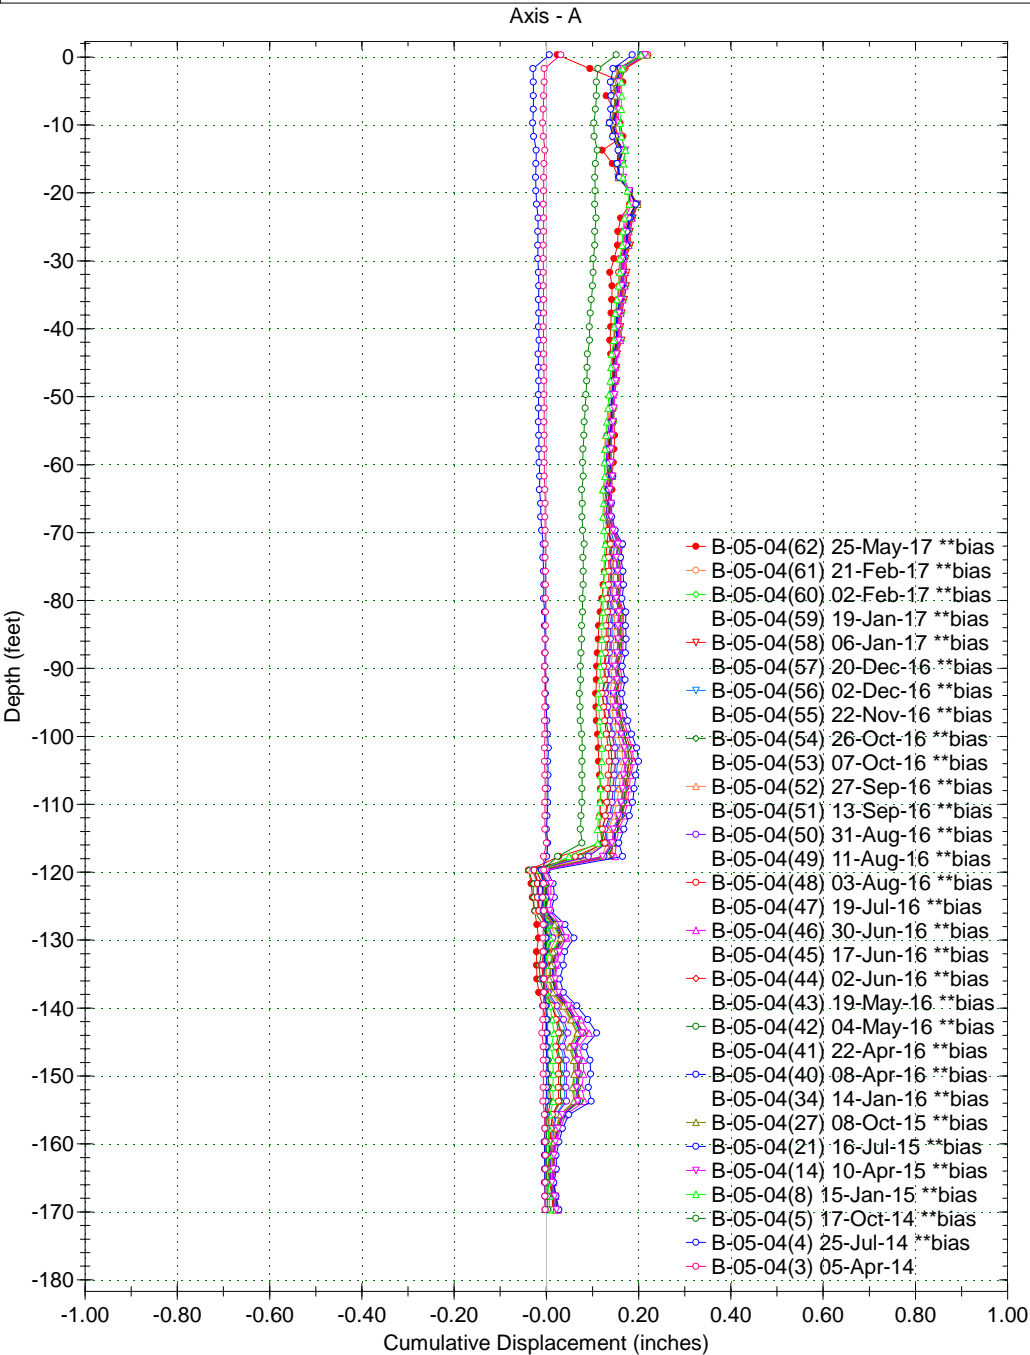
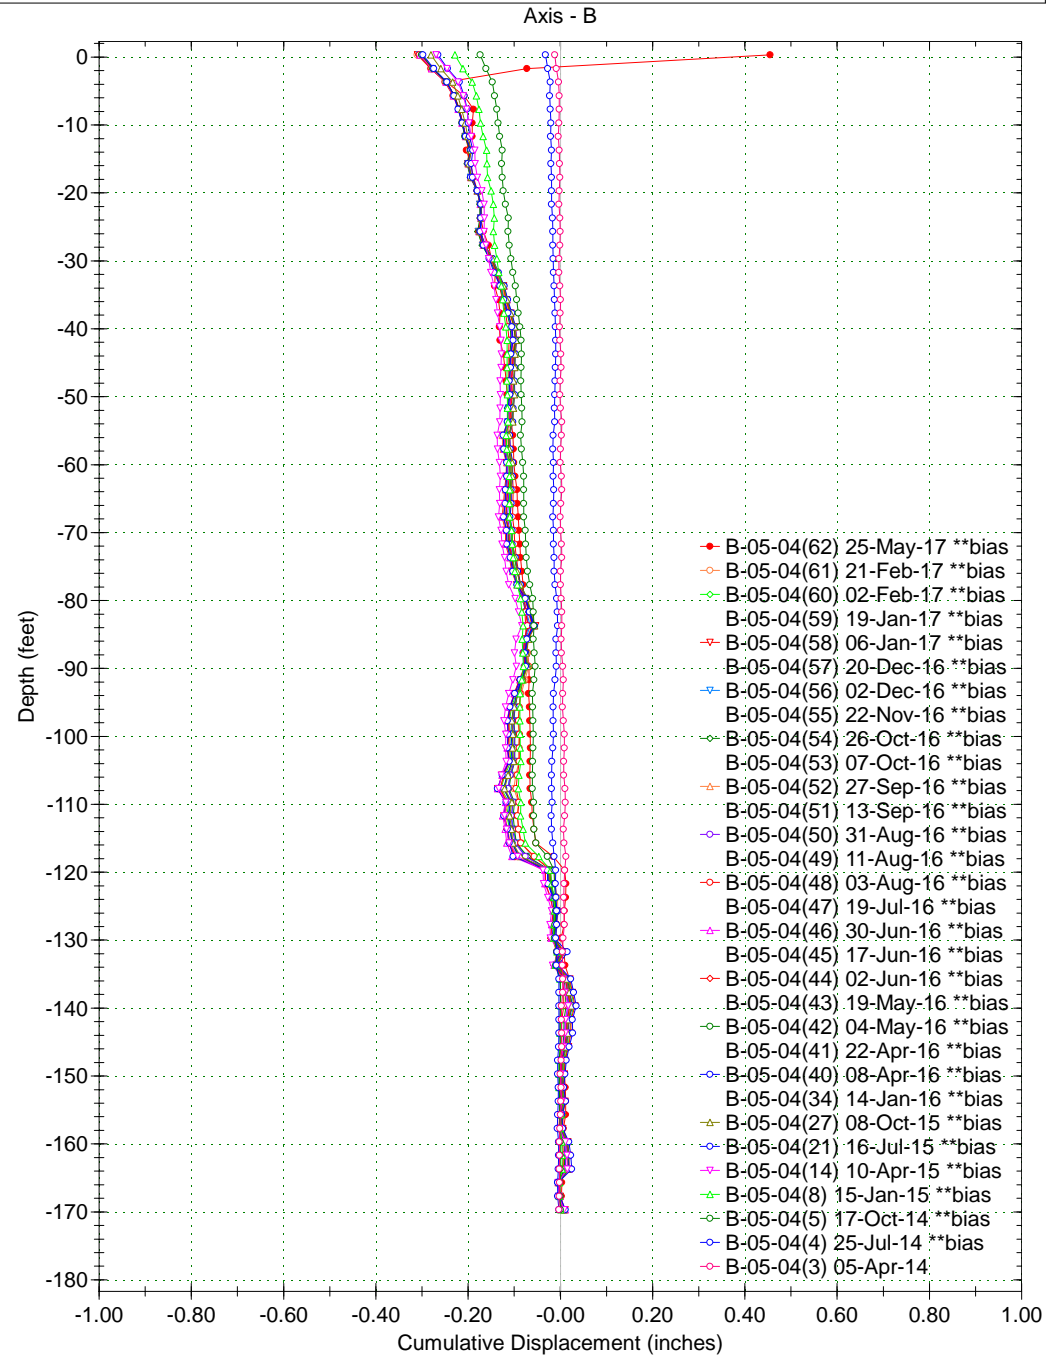
Borehole : B-05-04
 Project : CUY-90-15-24
 Location : Cleveland, Ohio
 Northing : Sta. 133+51.67
 Easting : 242.09' Rt of CL
 Collar :

B-05-04 – This inclinometer casing broke off and was partially filled with soil as the area around the instrument was being cut down to final grade. We flushed the casing, spliced on a new section of casing to provide adequate stickup, and installed a permanent protective cover. The old length of casing was 172 feet. The new length is 170 feet. An artificial reading has been added to the data to allow us to plot the current readings with the past readings. The apparent displacement at the top of the casing is due to these adjustments.
